Excavations
Inside Historic Structure 4,
The New Commissary,
at Fort Larned National Historic Site,
Kansas

by
Kristin L. Griffin

Midwest Archeological Center
Technical Report No. 6

1991

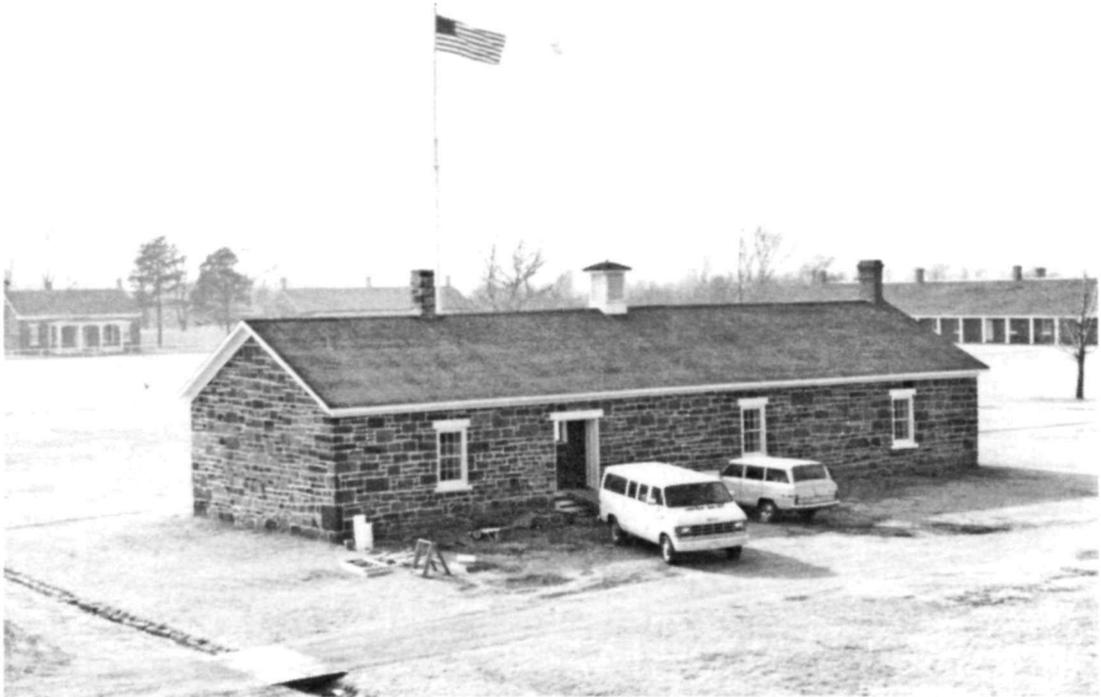
Figure 2. HS-4--exterior view, east side.

In March, 1989, a crew from the Midwest Archeological Center conducted excavations inside Historic Structure 4 (HS-4), the New Commissary, at Fort Larned National Historic Site, Kansas (Figures 1 and 2). Plans to restore a portion of the structure as a schoolroom and to adapt the rest of the structure as a curatorial facility and washroom called for the removal of up to three feet of deposits from the floor of the structure. The excavations were intended to determine whether the deposits contained intact military-period features and artifacts and to mitigate the impact of construction on such features and artifacts.
