EVALUATIVE TESTING AT THE FOUNTAIN CISTERN, TALLGRASS PRAIRIE NATIONAL PRESERVE, CHASE COUNTY, KANSAS

Midwest Archeological Center
Technical Report No. 95

**Midwest Archeological Center
National Park Service
U.S. Department of the Interior
February**

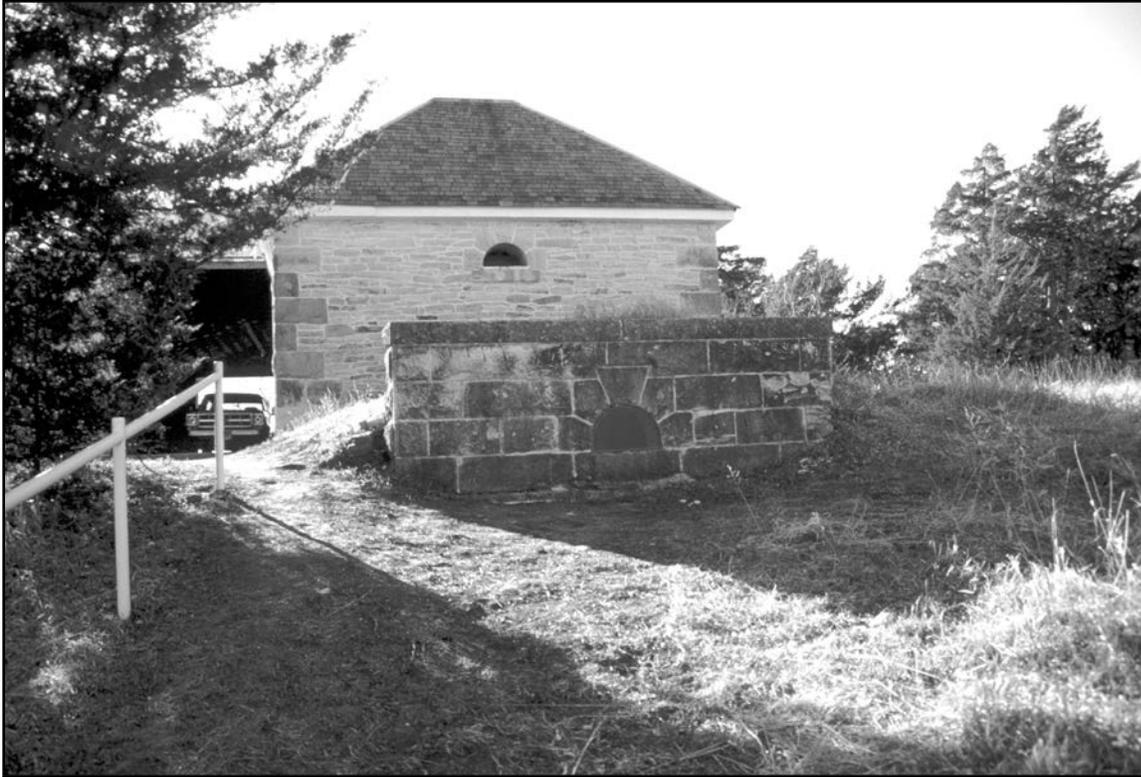
Figure 3. Cistern below the east side of the ice house, Spring Hill Ranch Headquarters complex. View to west from behind the main ranch house.

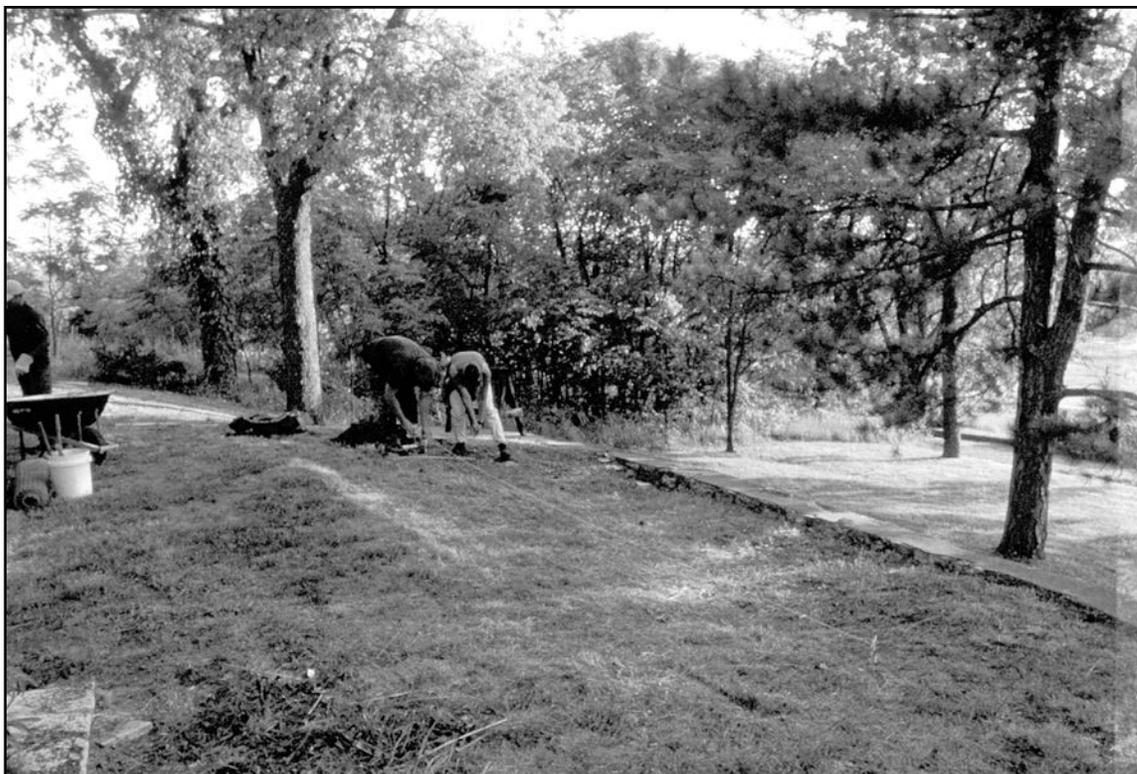
Figure 5. Depression atop the fountain cistern. The right side of the depression is bounded by the high retaining wall.

In the dry summer of 2002, a shallow depression formed in the top of the terrace (Figure 5) between the stone masonry retaining wall and the east side of HS-107. Soil cracks around the perimeter of the depression suggested the presence of a generally rectangular underground feature, the horizontal dimensions of which approximated 18 ft north-south by 10 ft east-west. The potential ramifications of the depression prompted concerns for visitor and staff safety, and in July, 2002 Preserve Superintendent Steve Miller contacted the NPS Midwest Archeological Center (Center) to request that the depression be investigated, with the understanding that it was probably the site of the feature described by Colleen Slabaugh, Tom Pinkston, and Jay Scott and perhaps the fountain cistern of ranch lore.

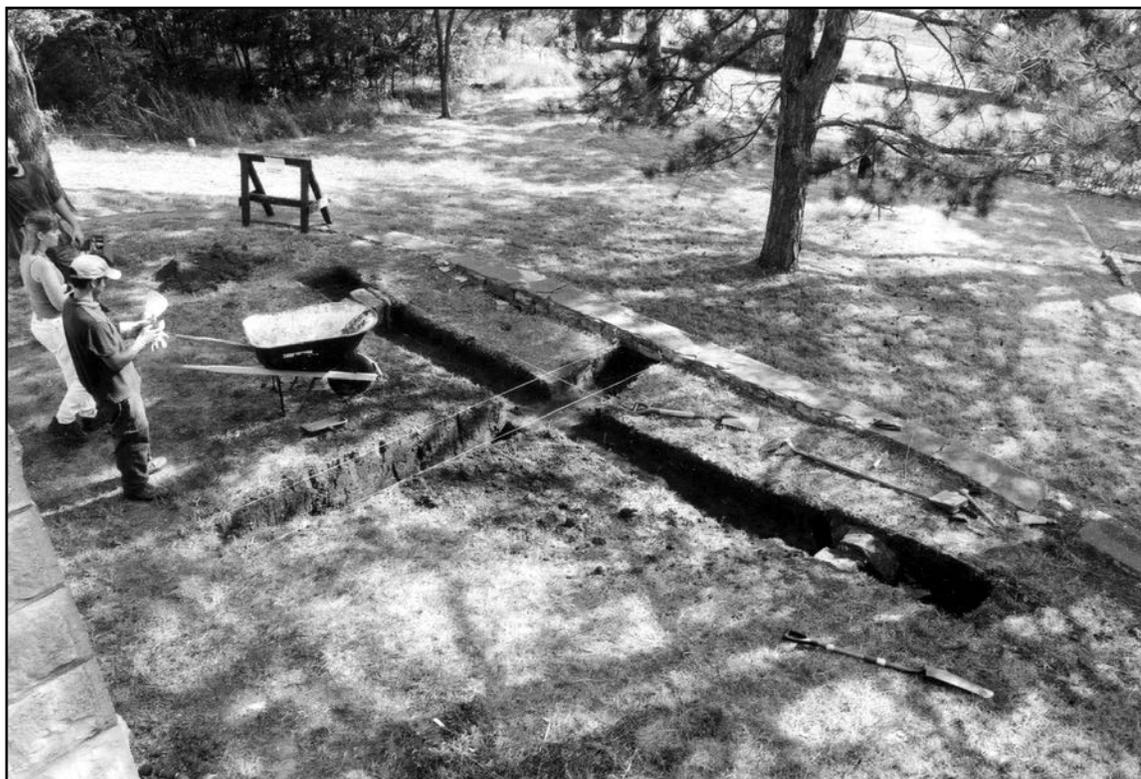
Figure 6. Initial excavation of shallow trenches across the cistern depression. View to the north.

Center personnel began work at the Spring Hill Ranch complex on September 9, 2002 and concluded their investigations on September 13 (Jones 2002b). They initially established a pair of intersecting 18 inch-wide trenches across the depression, which were then excavated to a depth of about 12 inches below the surface (inbs) in order to identify any remnant wall outlines and better define the dimensions of the underground feature (Figure 6).

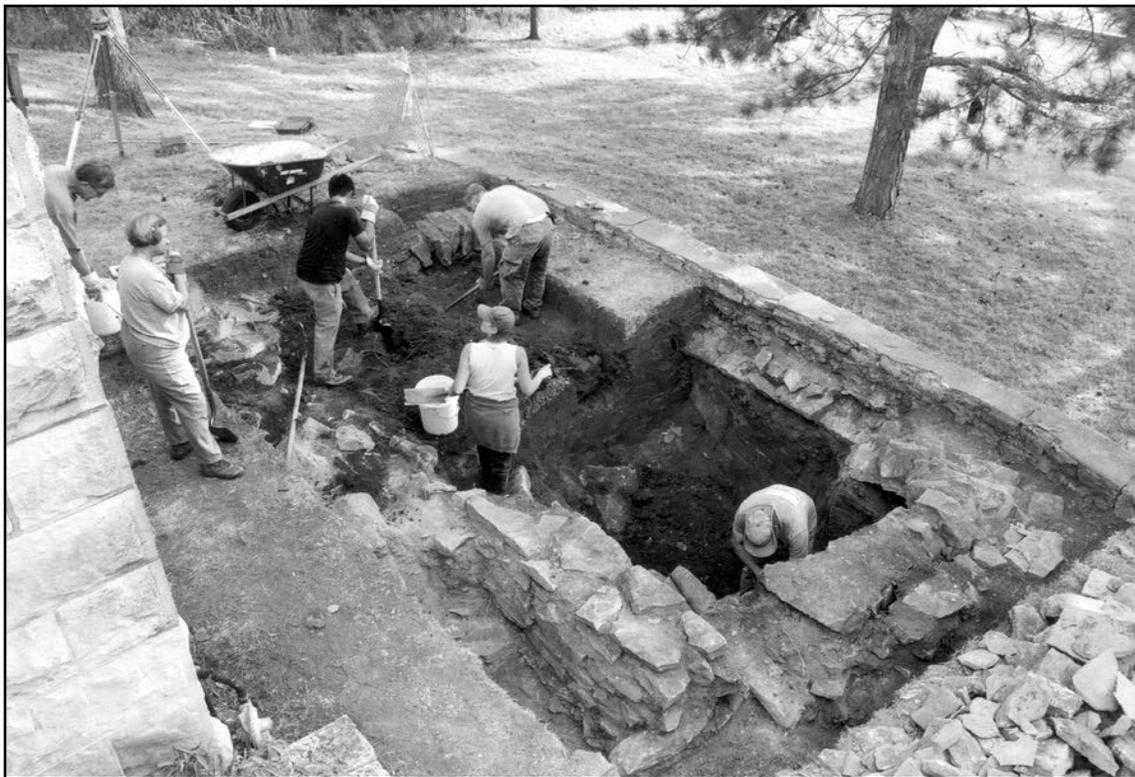
Figure 7. View to northwest across excavation.

In a short time, the three quadrant excavations exposed the outline of a stone masonry cistern (Figure 7), together with a separate dry-laid stone wall that ran north and south above the west side of the structure. Midway through the testing, the cistern was designated Feature 1 (F1), while the dry-laid stone wall was designated F2.

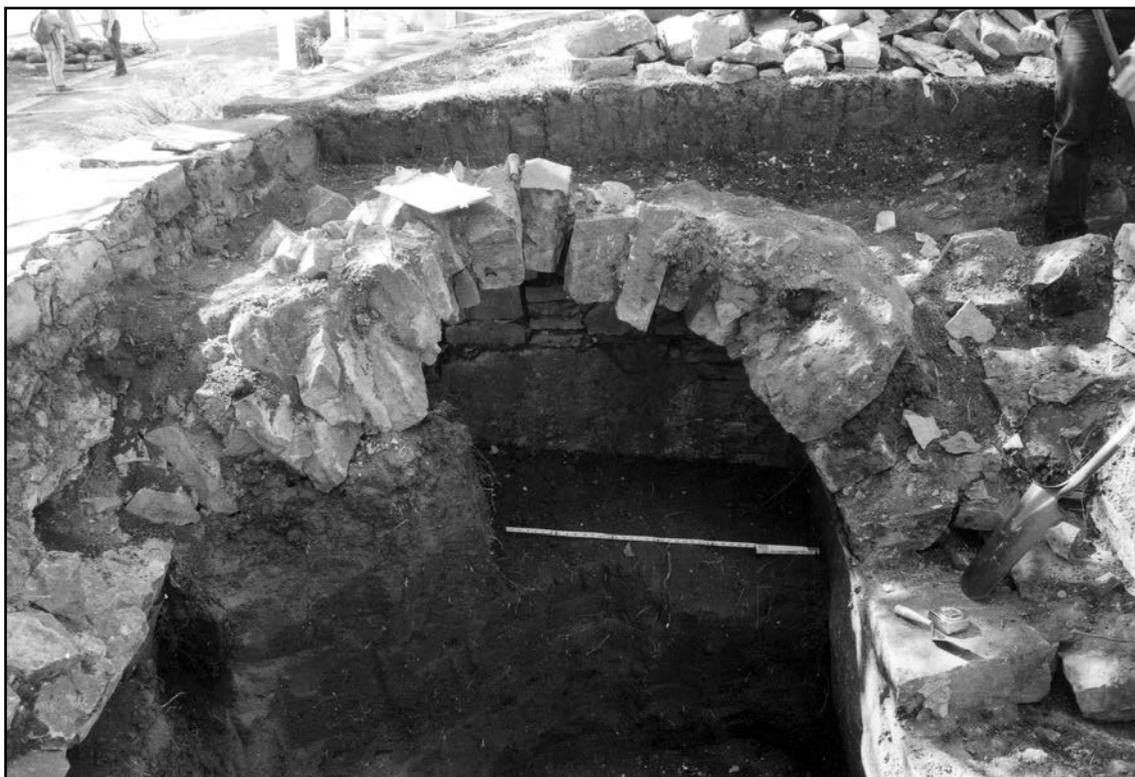
Figure 8. South end of the partially excavated cistern showing the intact vaulted roof. Parge coat is visible on the face of the end wall.

The stone roof of the cistern (Figure 8) was probably vaulted, formed with undressed, edge-set limestone slabs that were mortared in place. Along the east side of the cistern, the curved roof vault sprang from the thickened lower inside face of the retaining wall, with the stone forming the spring line of the vault keyed into the side of that wall (Figure 9). Along the west side of the structure (Figure 10), the stone roof vault appears to have simply rested atop the limestone ledge that forms the west cistern wall.

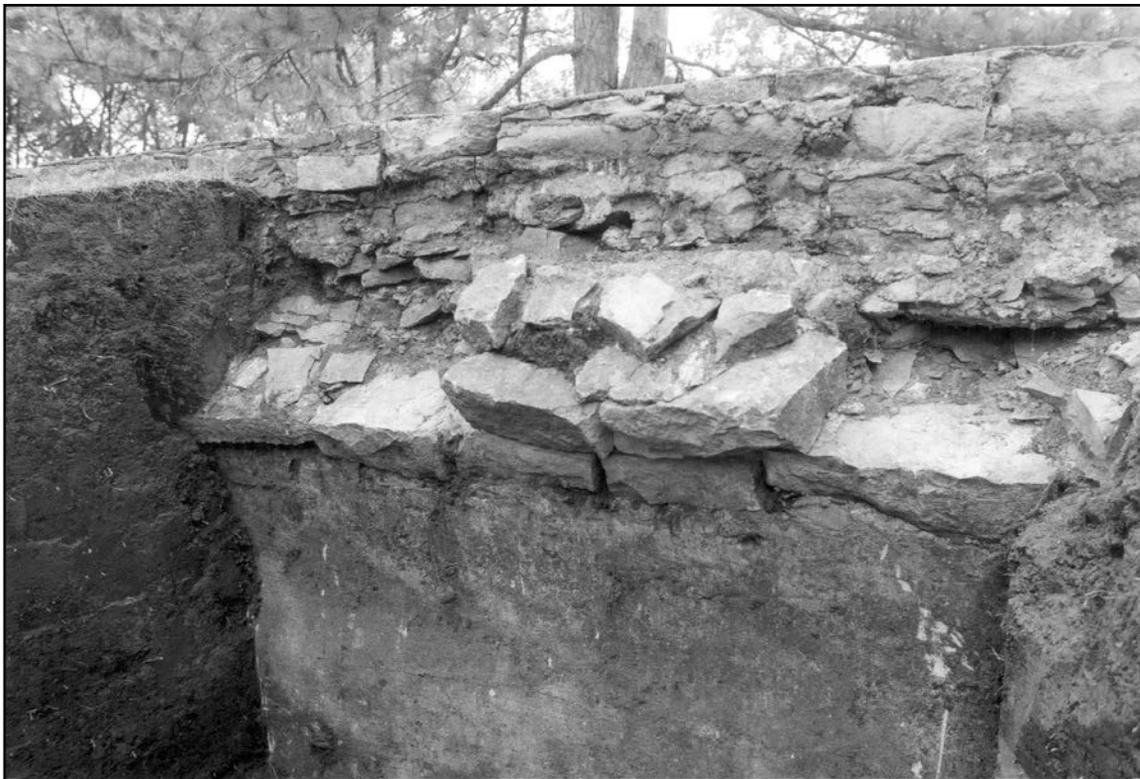
Figure 9. East wall of the cistern showing the spring line of the roof vault, which is tied into the inner face of the retaining wall.

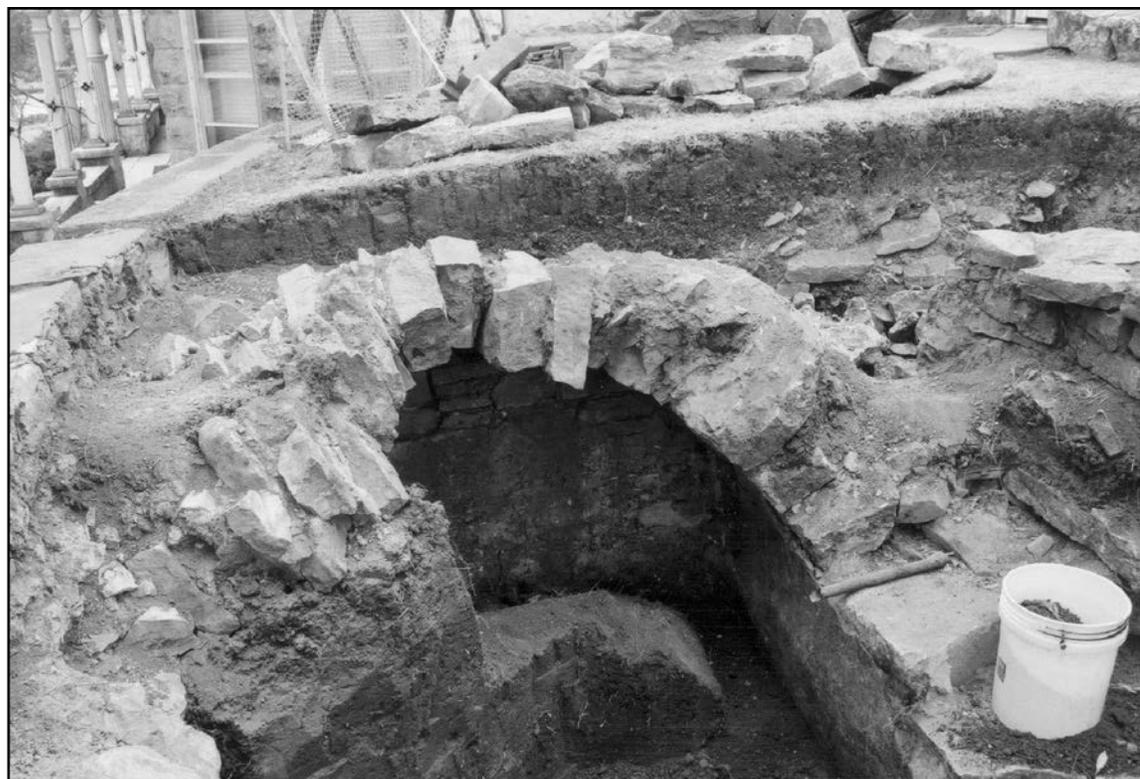
Figure 10. West wall of the cistern. The bucket rests on the Crouse Limestone ledge.

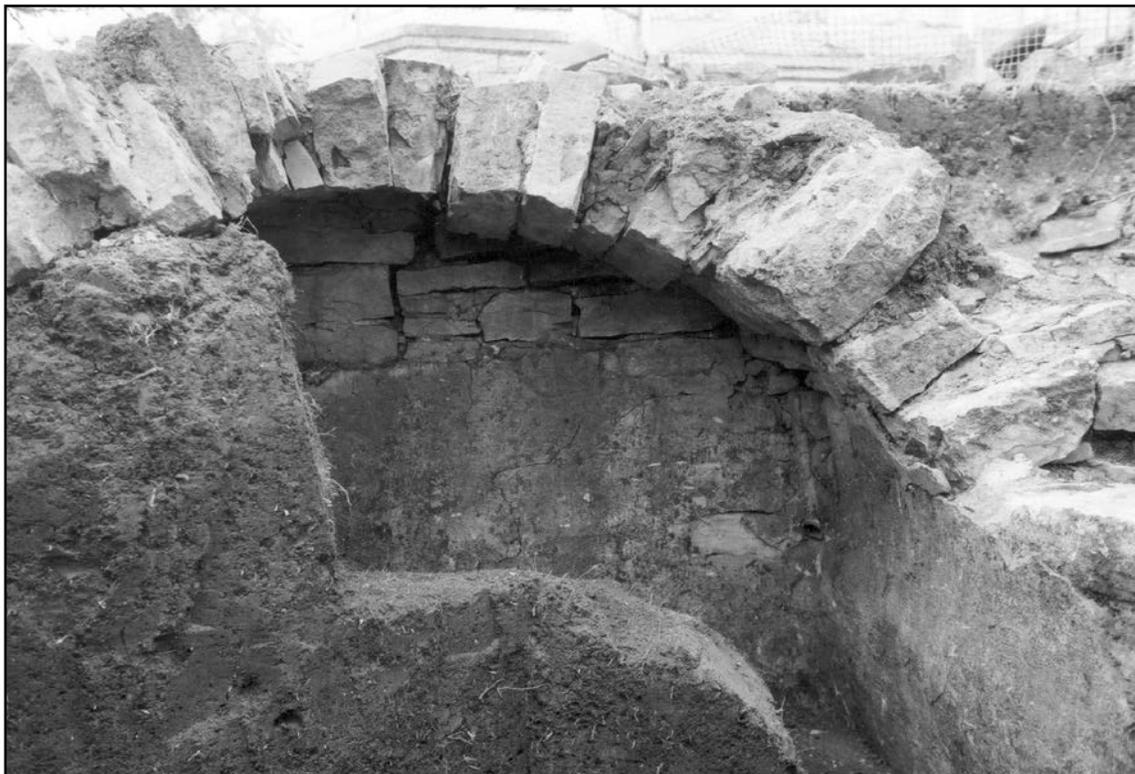
Figure 12. Close-up of the south interior cistern wall. The probable iron inlet pipe is visible at the lower right.

At the south end of F1, however, a section of 1¼-in iron pipe was exposed that descended through the south end wall (Figure 12), entering the cistern 6 ft 4 in above its floor and 1 ft 2 in below the top of the parge coat. The pipe appeared to dip gradually into the cistern from the south (from the general direction of the main ranch house), and it may have once carried water either from another cistern or from a barrel that collected rainwater runoff from the ranch house roof.

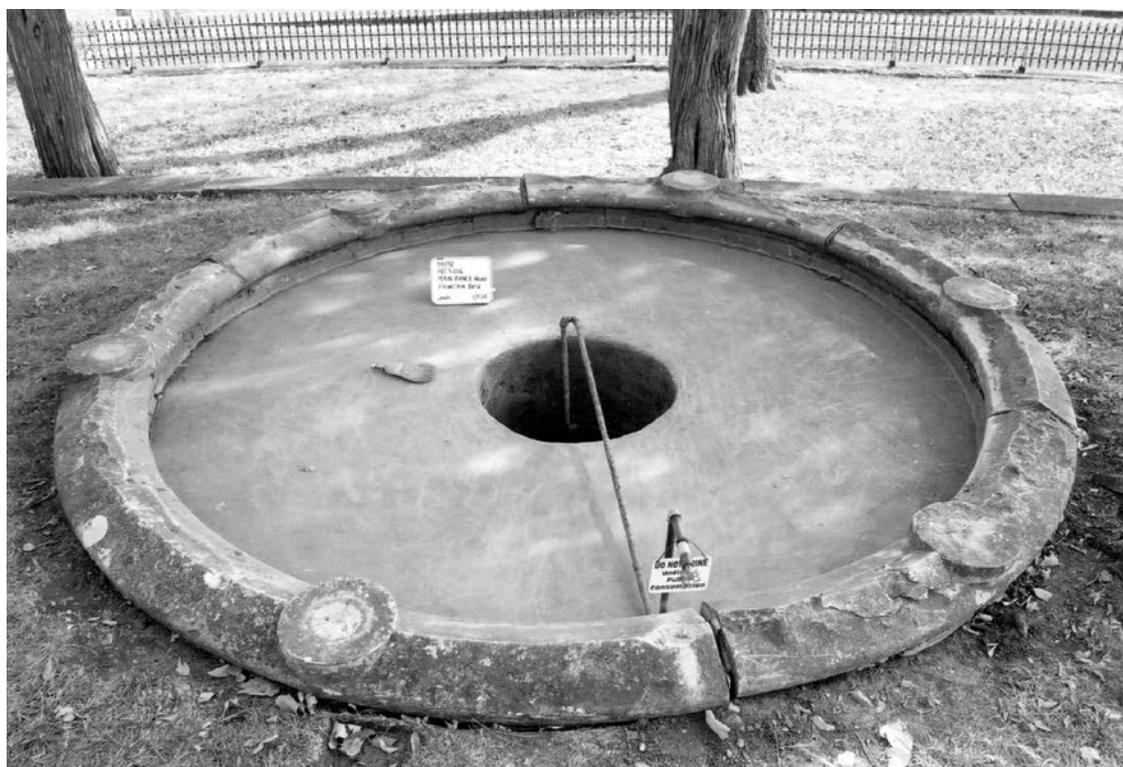
Figure 13. Excavated fountain pedestal in front of the main ranch house. View to the east.

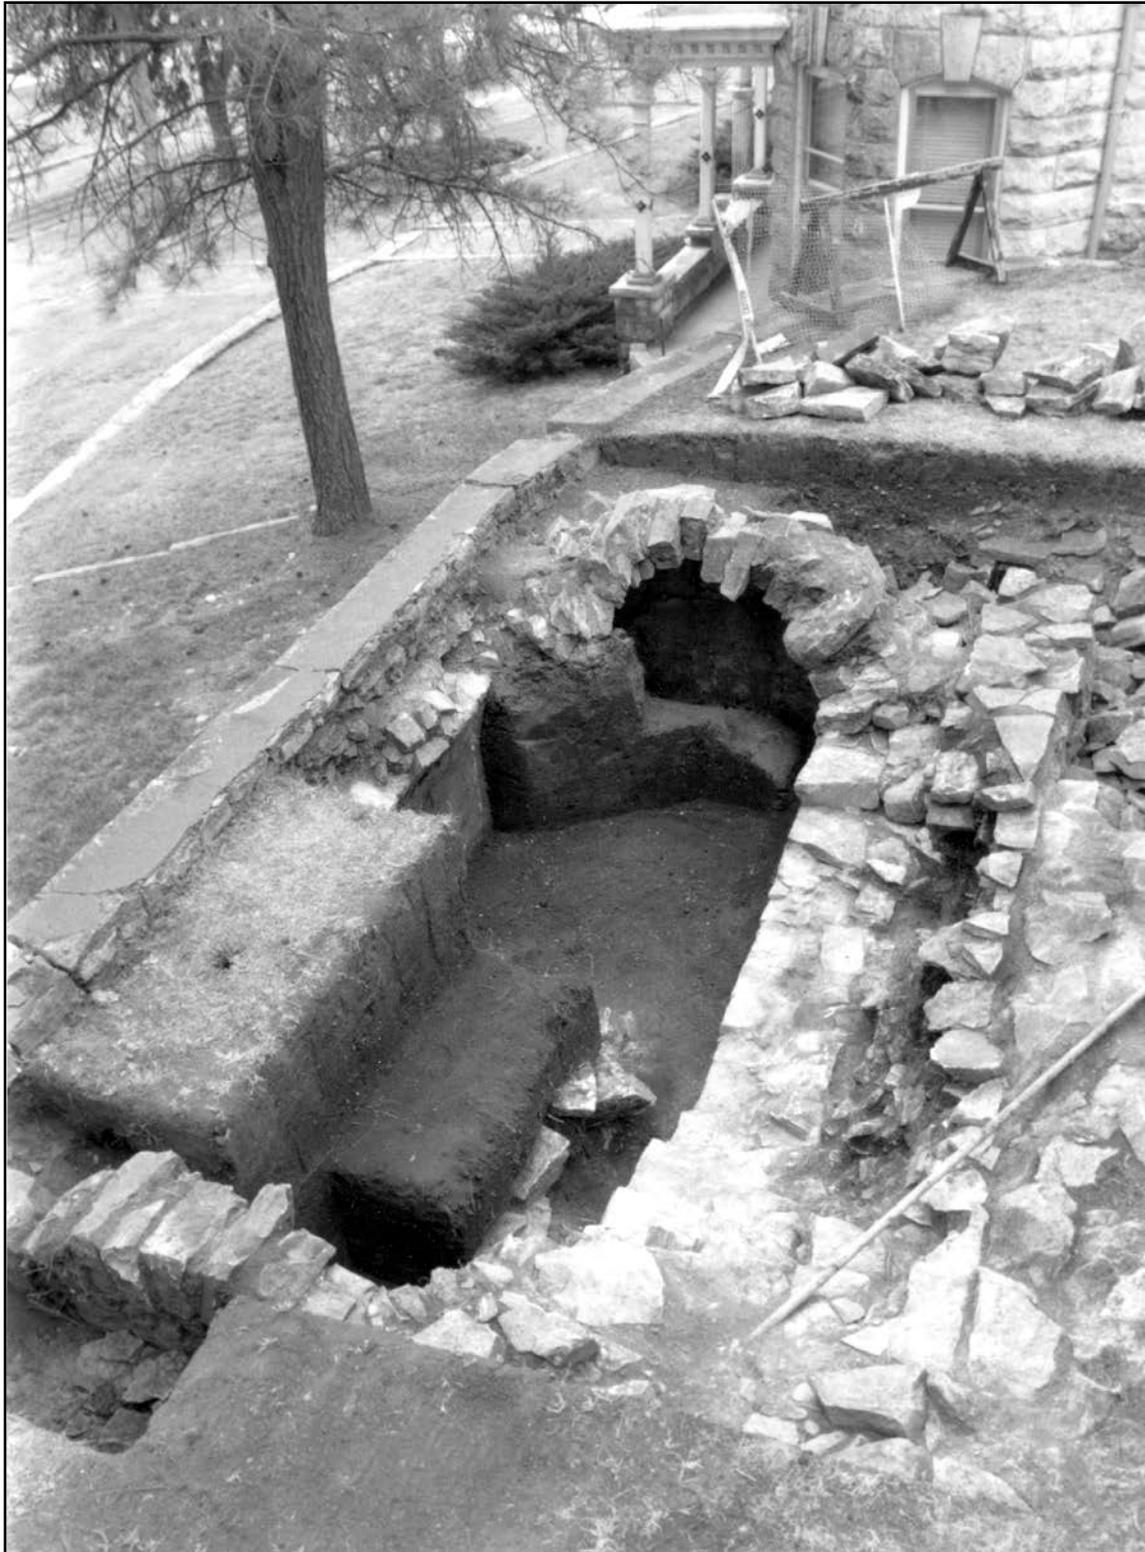
Figure 14. Completed test excavation of the fountain cistern at the Spring Hill Ranch Headquarters complex, Tallgrass Prairie National Preserve. View to the south toward the main ranch house.

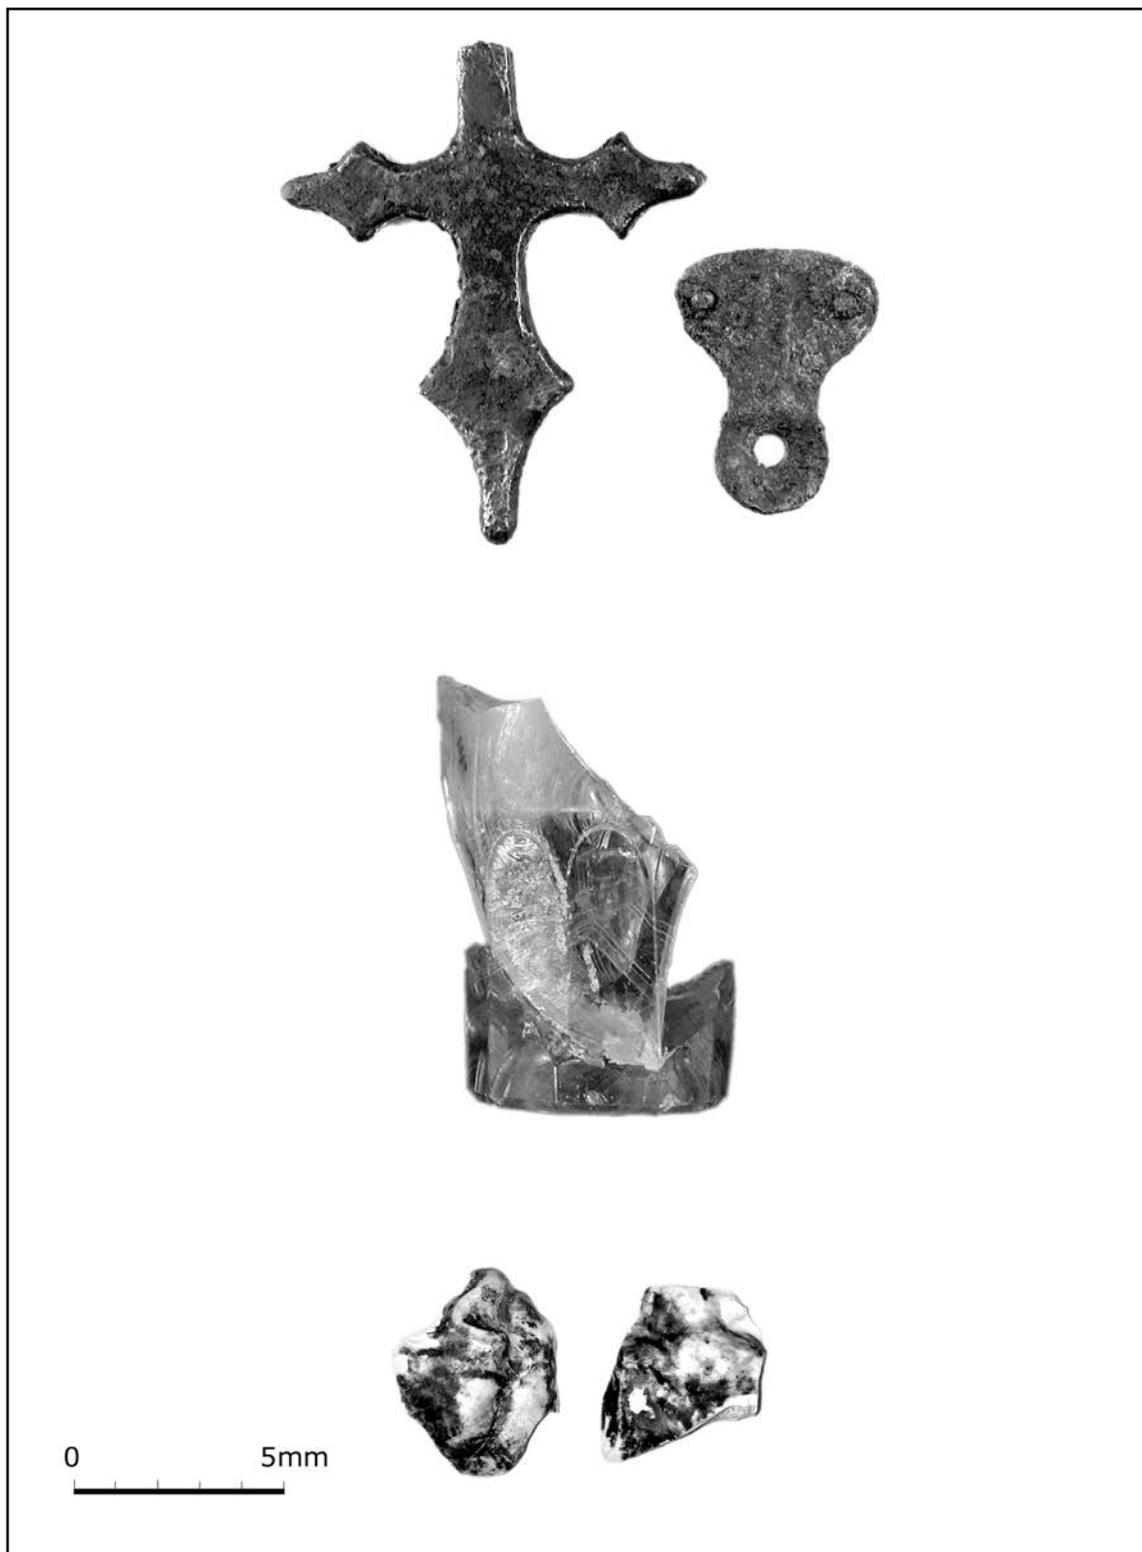
Figure 15. Artifact photographs.

The cross-shaped fragment (Figure 15:b), which has been broken at the base, was either made of puddled cast iron—molten iron poured into a shallow mold cavity in an open sand casting (Atlas Foundry Company, Inc. 2006) or in a flat-backed two-piece cope-and-drag type mold (Scott Lammers, personal communication, July 6, 2006; American Foundry Society 2006). The fragment has a slightly convex front face with rounded edges, and a flat reverse or pour face, the edges of which are ragged due to some mold overflow. The fragment is about 6 in tall, and has an intact 4 in-wide crossbar.

Two sherds in the collection bear raised ribs and appear to represent part of a large, rectangular panel bottle. Two other fitted fragments (Figure 15:c) include a faceted colorless glass container base and one body sherd, the latter bearing distinct vertical scallops. Fitted together, these sherds represent the constructed 2½ in diameter base and partial side of a heavy, ten-sided tumbler with flaring sides. The intact container would have been taller than 4 in.

The two remaining porcelain fragments (Figure 15:d-e) represent part of a medium-to large-sized figurine or console centerpiece, and probably depict either human hair on a porcelain bust, or perhaps part of an elaborate dress/costume on a human figure. The two fragments fit, but it is unclear just what part of the figurine/centerpiece they represent. Both bear traces of black and blue paint.

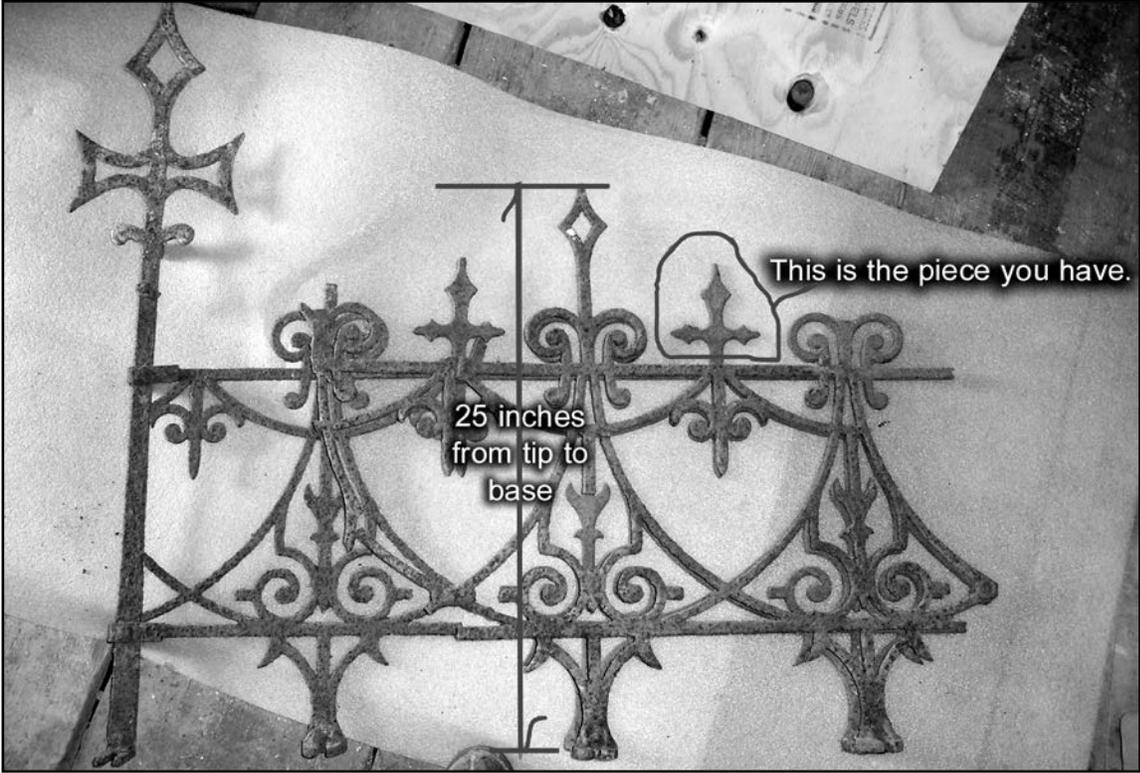
This piece is now known to be part of a panel or section of decorative iron cresting (Al O'Bright, personal communication, July 5, 2006) which once stood atop the roof of the main ranch house a few feet away from where the cistern lies. A partial section of intact cresting, which has fortunately survived (Figure 16: Heather Brown, personal communication, July 5, 2006), measures 25 in tall from the base to the top, with taller pieces attached to at least one end of each panel. As Figure 16 illustrates, the cross is in

fact the upper design component of a two-part element on the larger panel, the lower half of which, sharing the same vertical piece, forms a fleur-de-lis.

Figure 16. Intact cresting panel from the main ranch house.
