**NATIONAL REGISTER OF HISTORIC PLACES
INVENTORY -- NOMINATION FORM**

5190 HISTORIC HATTERAS WEATHER BUREAU STATION (Old)

**NATIONAL REGISTER OF HISTORIC PLACES
PROPERTY PHOTOGRAPH FORM**

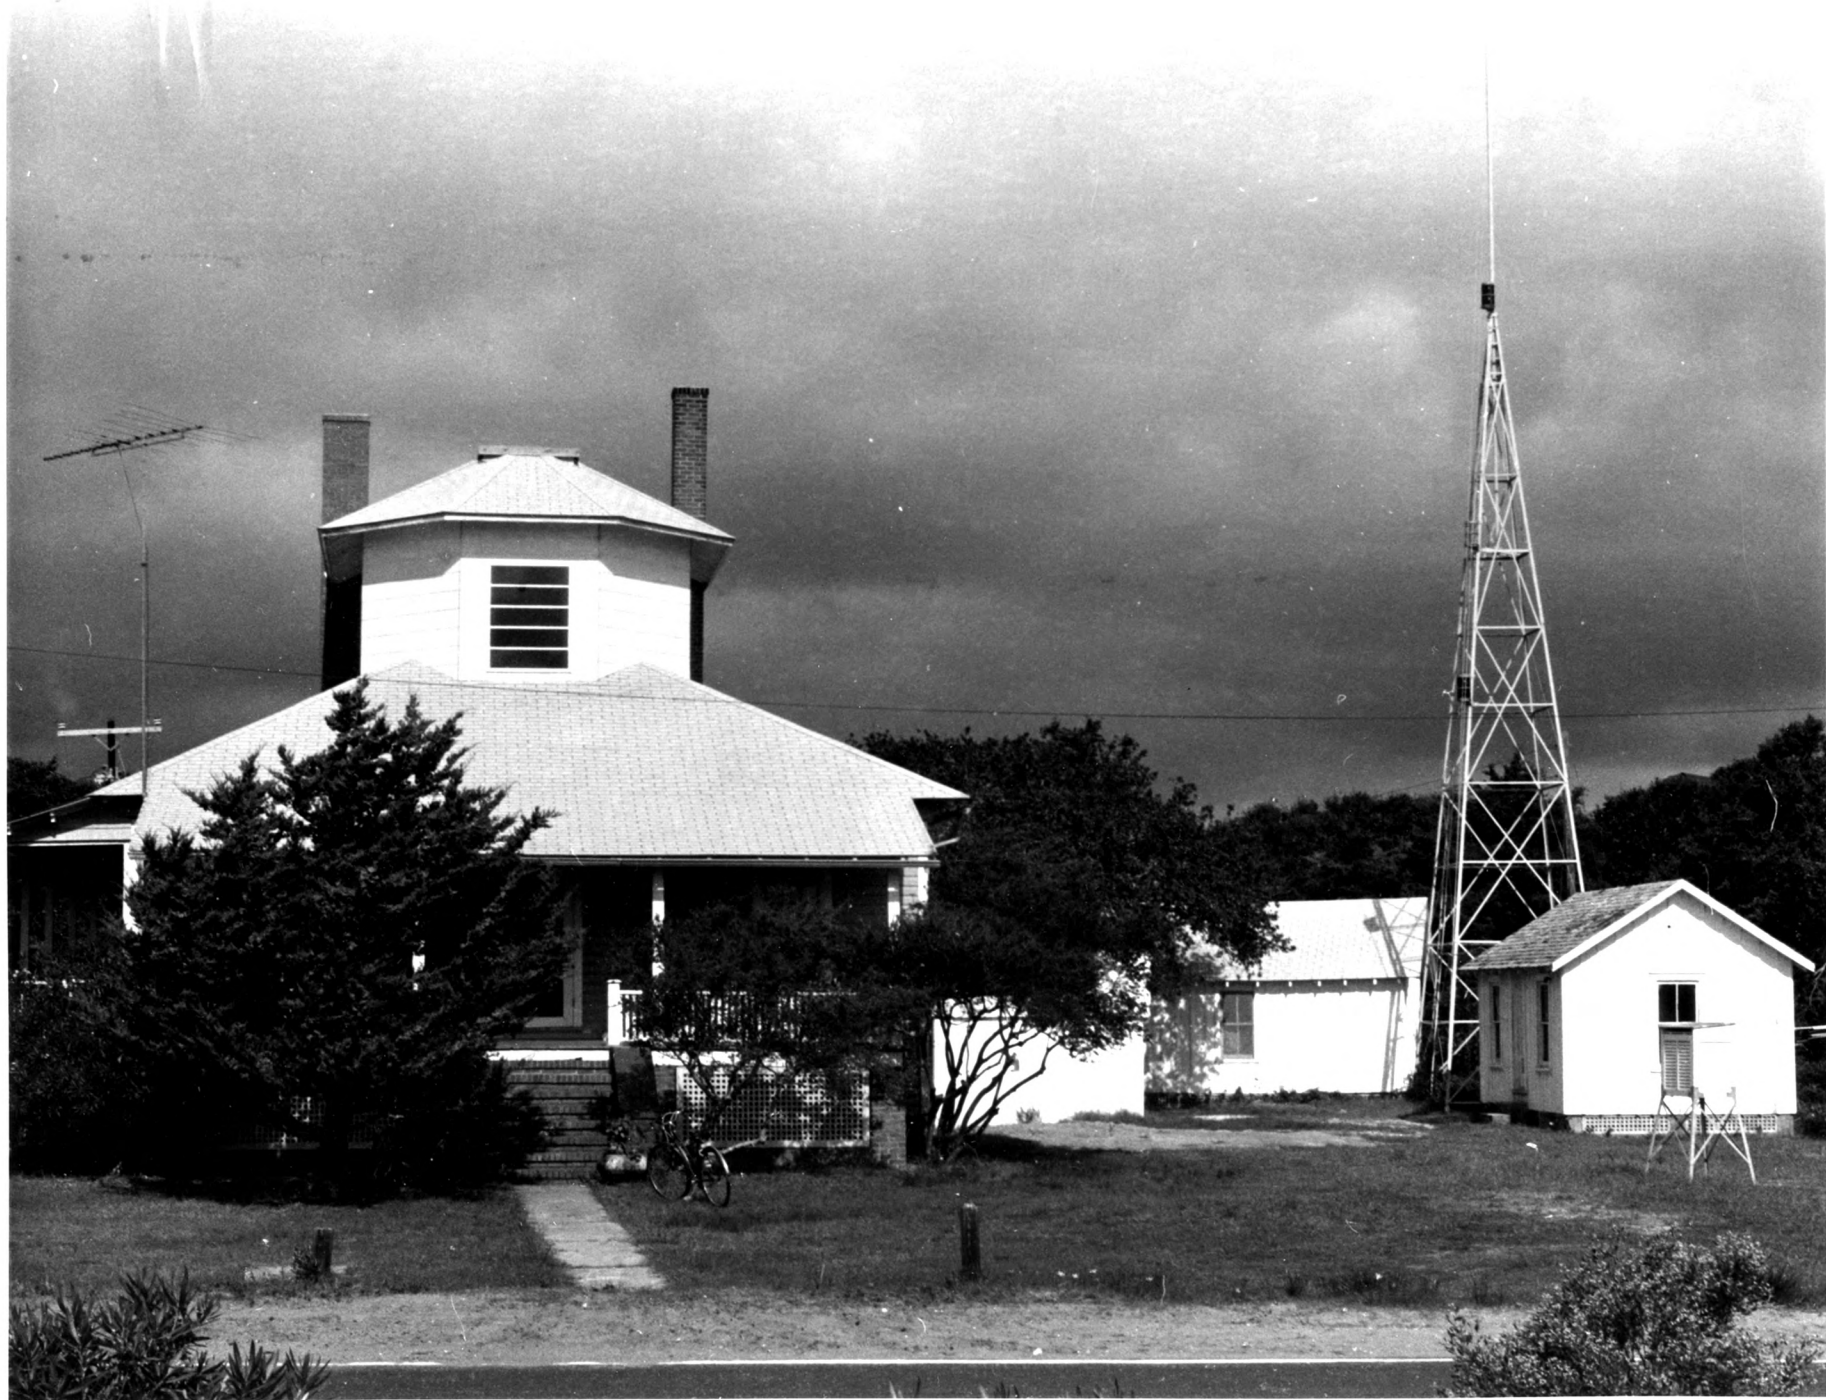
PHOTO NO. 1001

Front of station, view looking north
