Carl Sandburg Home National Historic Site Cultural Landscape Report

85% Draft Submittal
September 2021

Cultural Resources, Partnerships, and Science Division
Interior Region 2 - South Atlantic Gulf

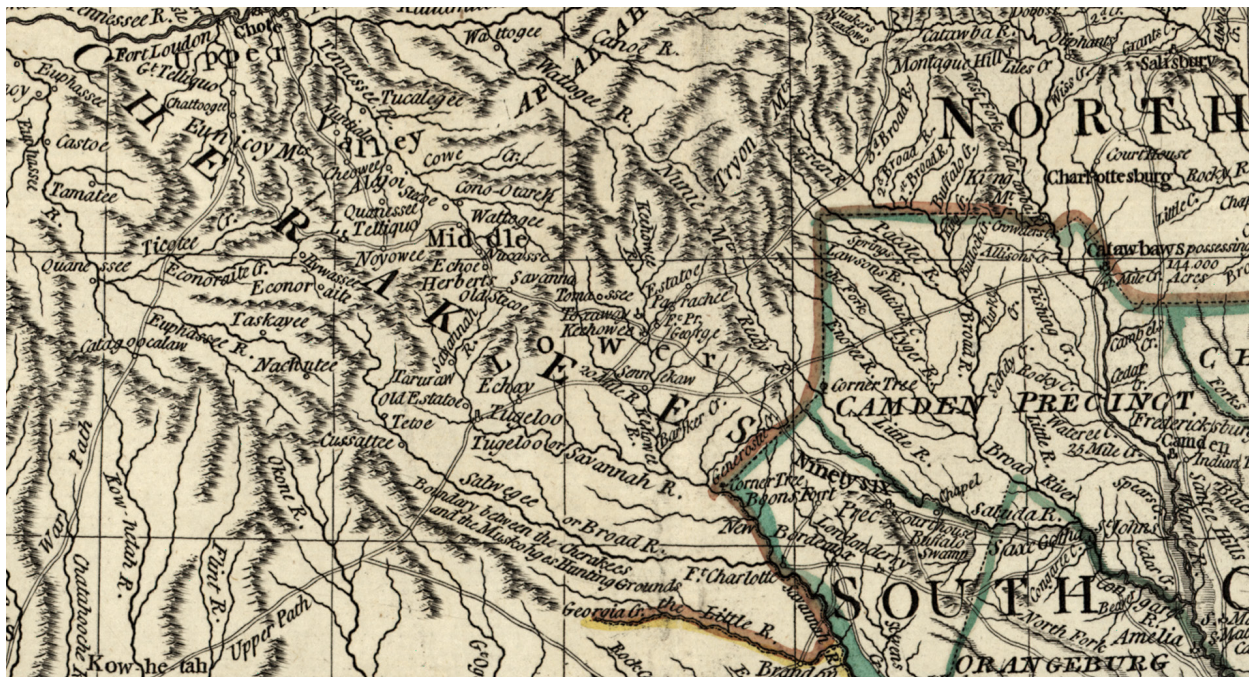
Figure 2. 1. The Cherokee controlled a large swath of territory across the Southern Appalachians and shared hunting ground with neighboring groups. This section of a colonial period map shows the general areas Southeastern tribes occupied, principal trails, as well as start of European settlement of the interior. The red box notes the general location of the project area. (Source: Romans, Bernard, *A general map of the southern British colonies in America, comprehending North and South Carolina, Georgia, East and West Florida, with the neighboring Indian countries, from the modern surveys of Engineer de Brahm, Capt. Collet, Mouzon, & others, and from the large hydrographical survey of the coasts of East and West Florida.* London, Printed for R. Sayer and J. Bennett, map, chart, and printsellers, 1776. Map. <https://www.loc.gov/item/gm71005467/>.)

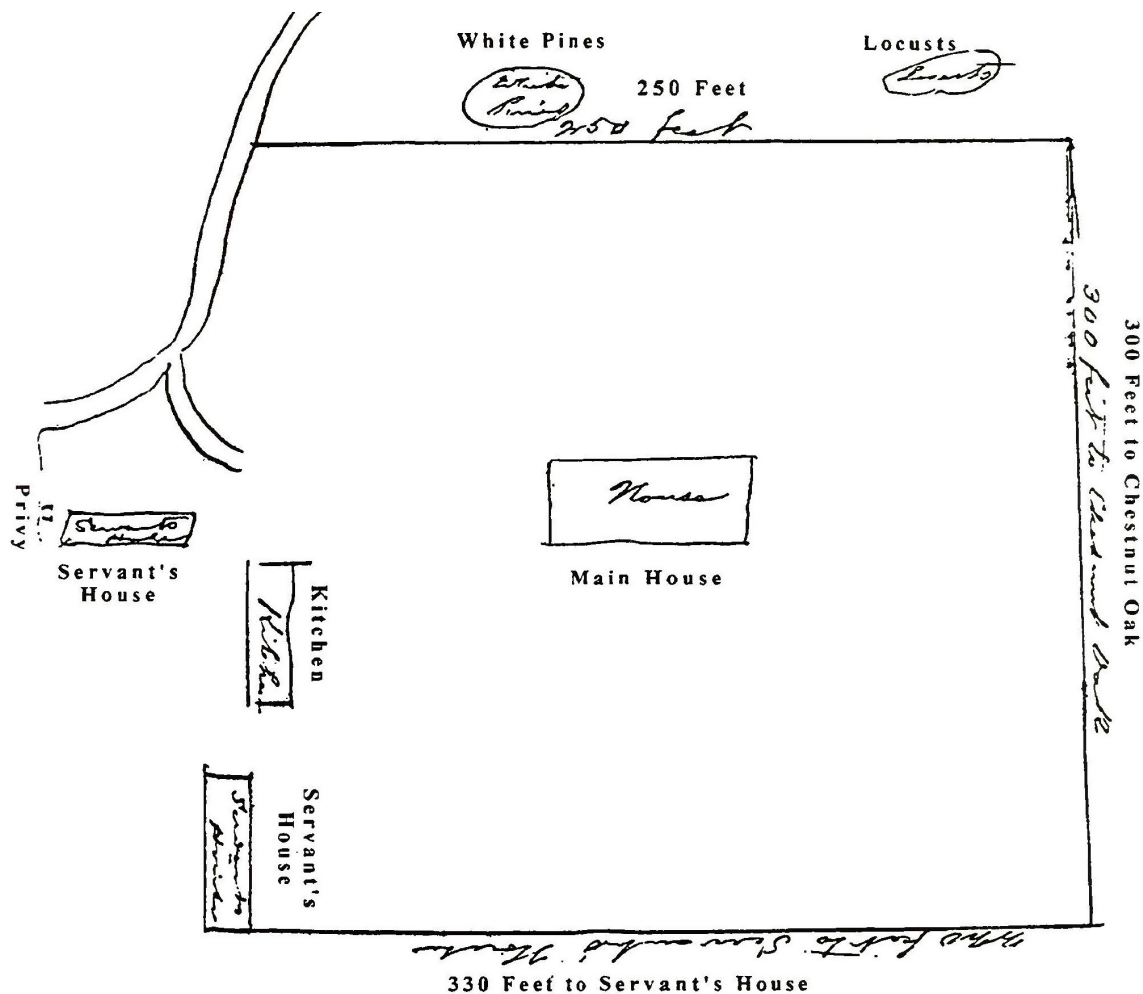
Figure 2. 5. This illustration shows the initial development of Memminger's Rock Hill property. Note the orientation of the buildings and the documentation of tree types. Image taken from the 1995 *Carl Sandburg Home National Historic Site Archeological Overview and Assessment* report.

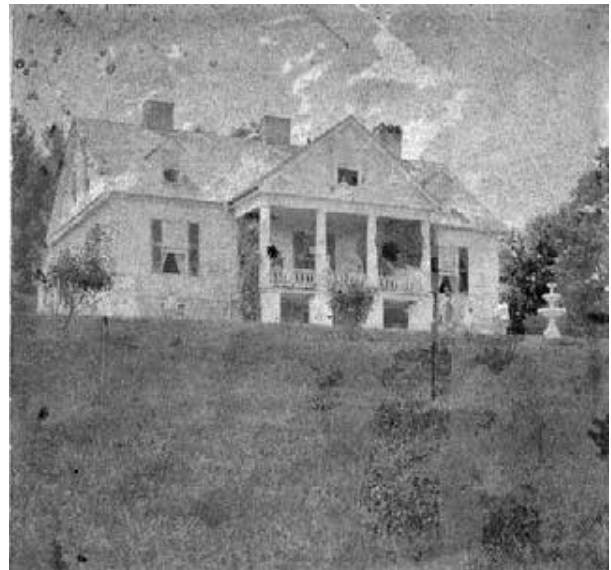
50 **Figure 2. 6.** This is the earliest known image of the Main
51 House at Rock Hill. It was taken some time around 1870.
52 Note the fountain on the right, and the scattered shrubs in
53 the front lawn. (Source: CARL archives, #28466).

40 Other improvements made during the Memminger
41 Period included the installation of a three-tiered
42 spring fed fountain in the front lawn on the north
43 side of the Main House. The fountain rose from a
44 shallow bowl set into the lawn (Figure 2. 6).

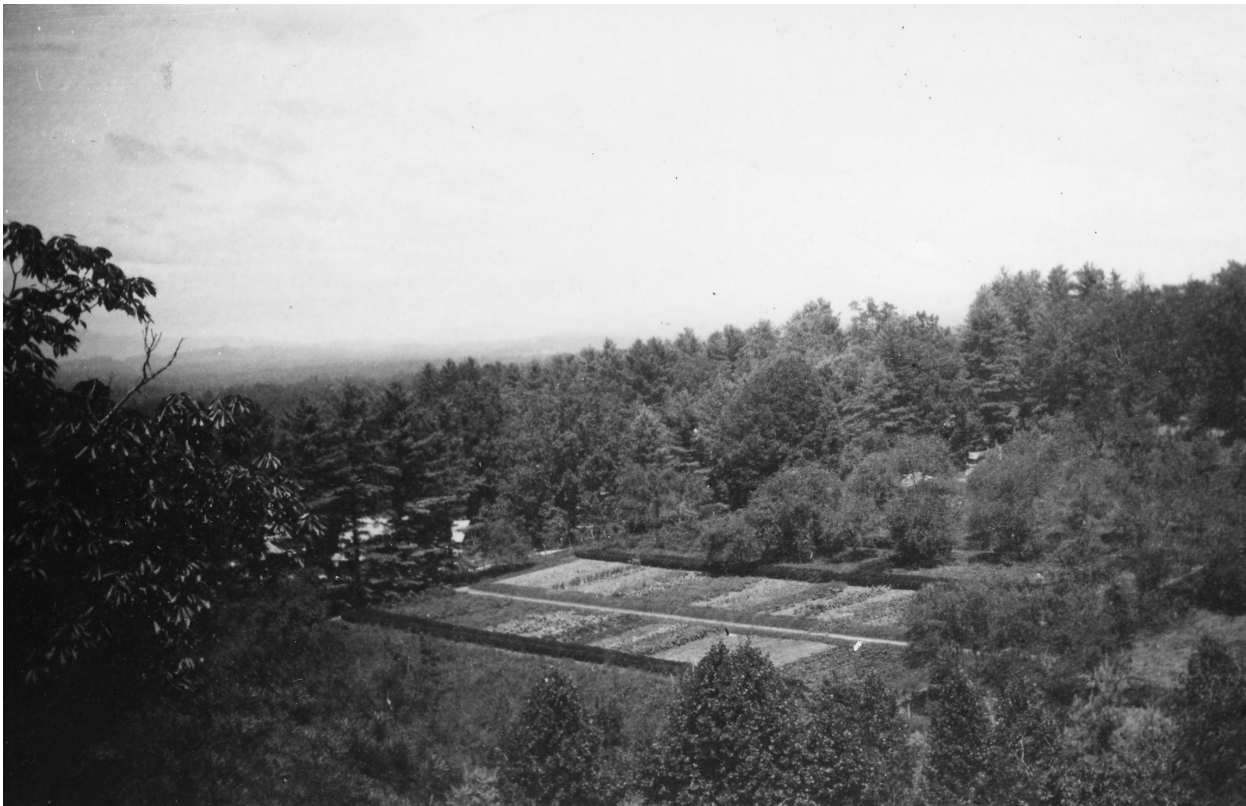
Figure 2. 10. This Smyth Period image, taken around 1925, the layout of the Vegetable Garden directly south of the barnyard. Note the formal arrangement, including its rows of boxwood, secondary boxwood enclosures containing specimen (possibly fruit) trees, and the overall scenic setting between hills (Source: CARL Archives, 3001.17.20p).

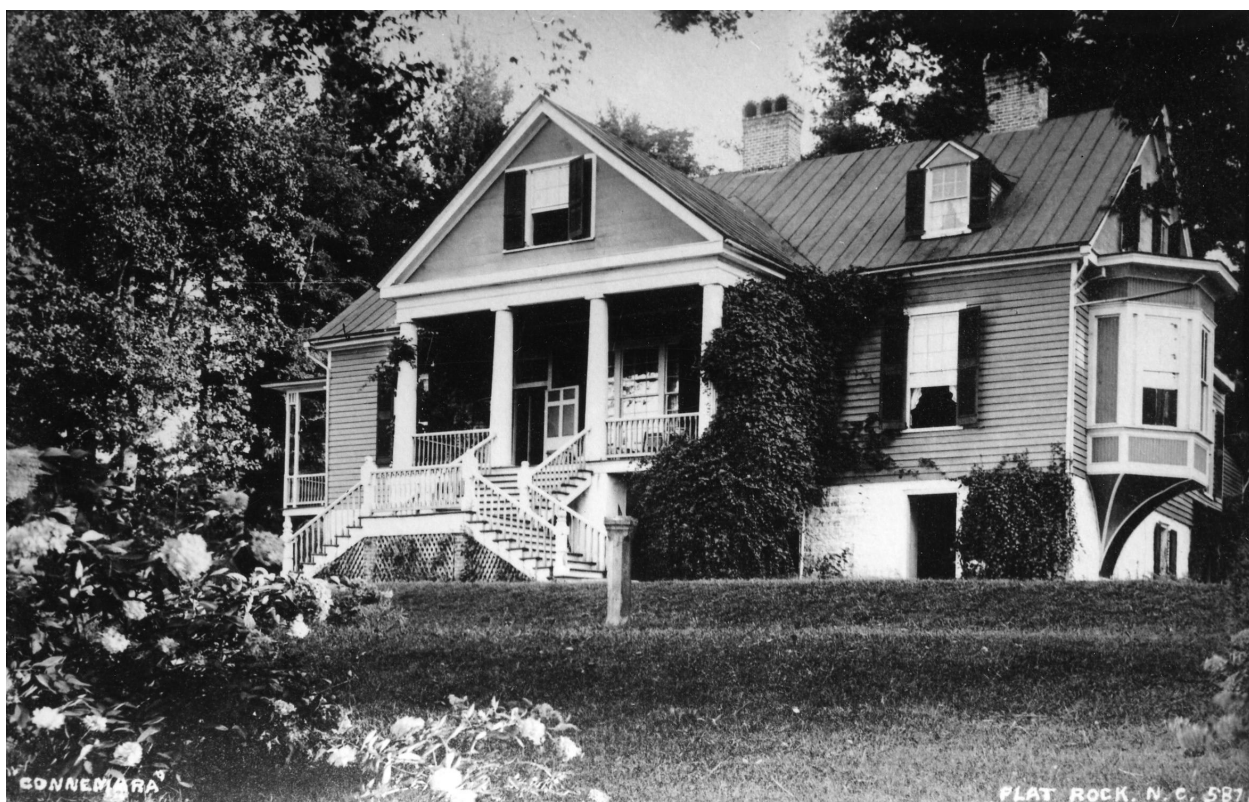
Figure 2. 12. This photo shows the condition of the Main House, sometime around 1915. Note the vines climbing onto the house, the terraced front lawn, sundial in center, and ornamental plantings (Source: CARL Archives, 3001.01.06p).

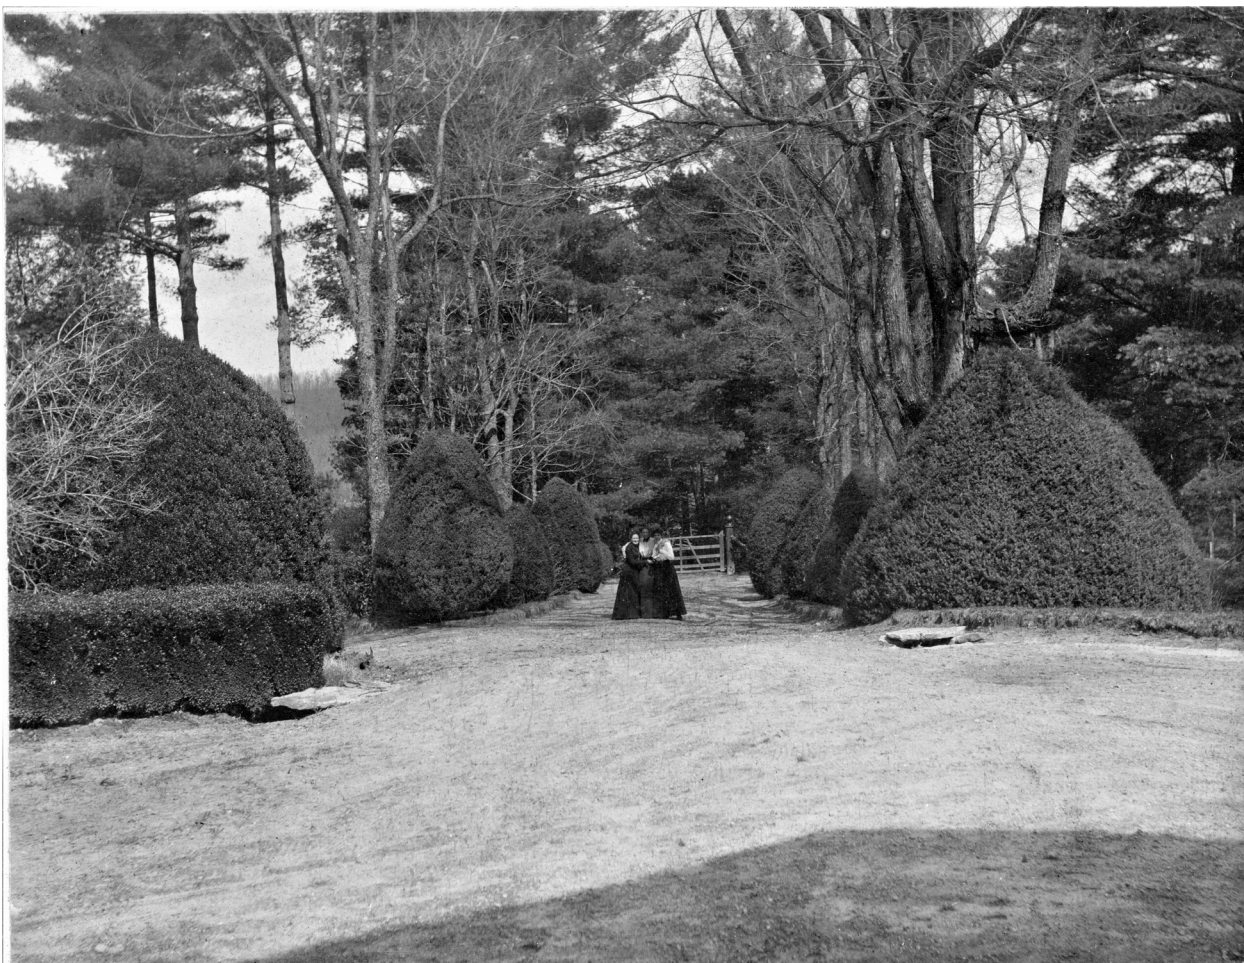
Figure 2. 13. This photo shows Cousin Lucile Adger, Olive Hill, and Sadie Smyth at south end of Front Drive on April 6, 1901. Note the shaped boxwood, including short box hedge, gate, and the American elms along the drive. (Source: CARL Archives).

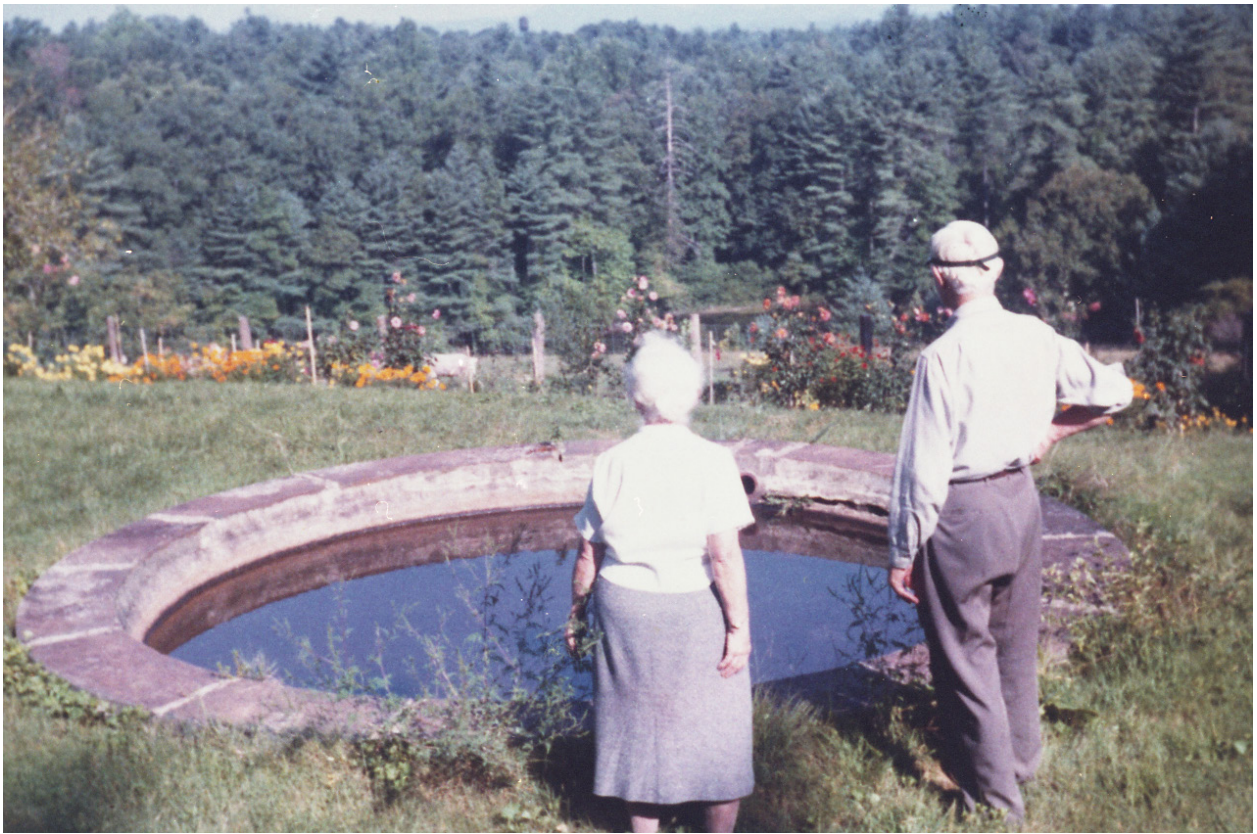
Figure 2. 16. 1961 photo of Carl and Paula Sandburg standing in the front yard looking towards the mountains in the distance. Note the colorful display of blooms along the fence line, as well as the tall height of the grass and weeds. The specific types of grass and weeds present in the lawn area during the Sandburg Period is unknown. (Source: CARL Archives, 3000_0081).

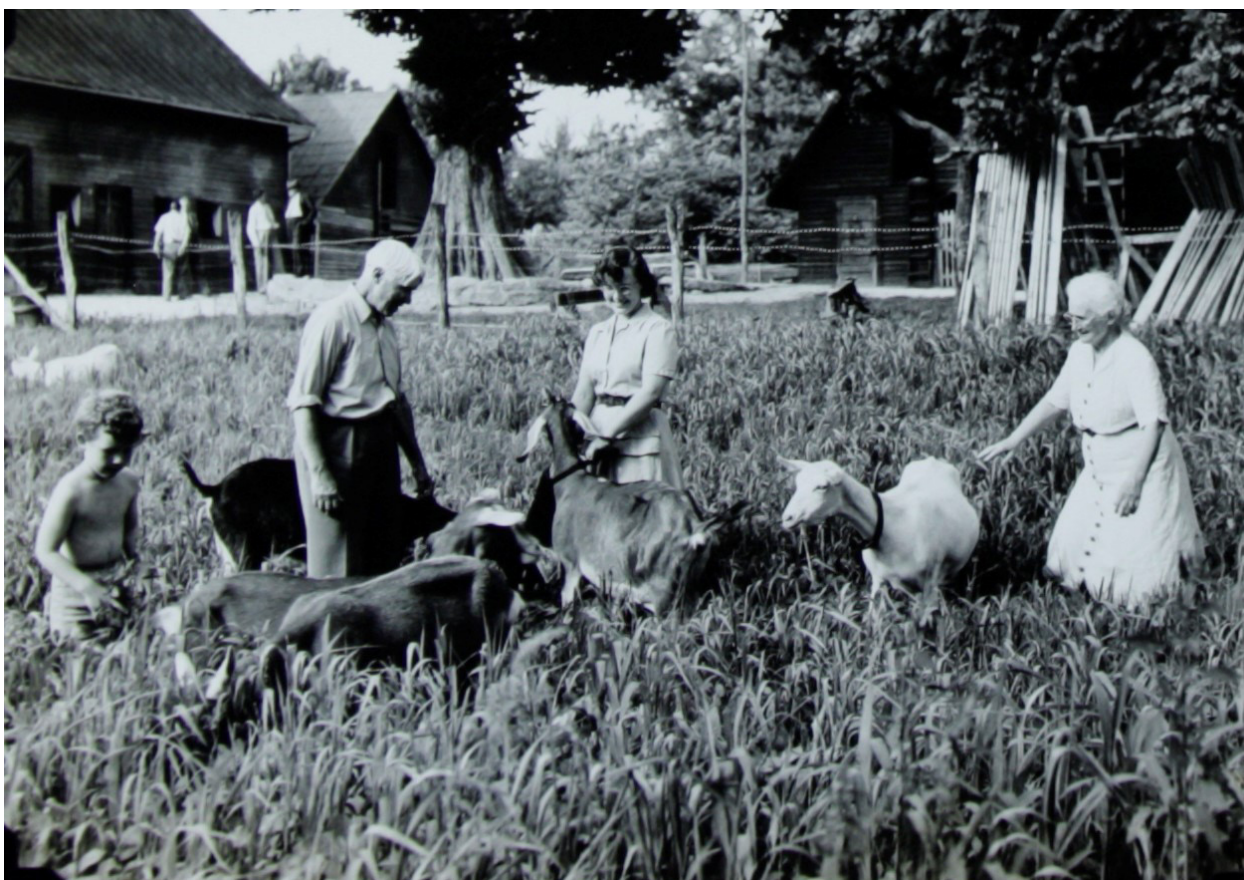
Figure 2. 17. Helga (at center), with her son and parents in the pasture west of the barnyard. Note tall grass (potentially orchard grass), straight strand wire fencing, and large elm in background (Source: CARL Archives, Steichen Album, page 15).

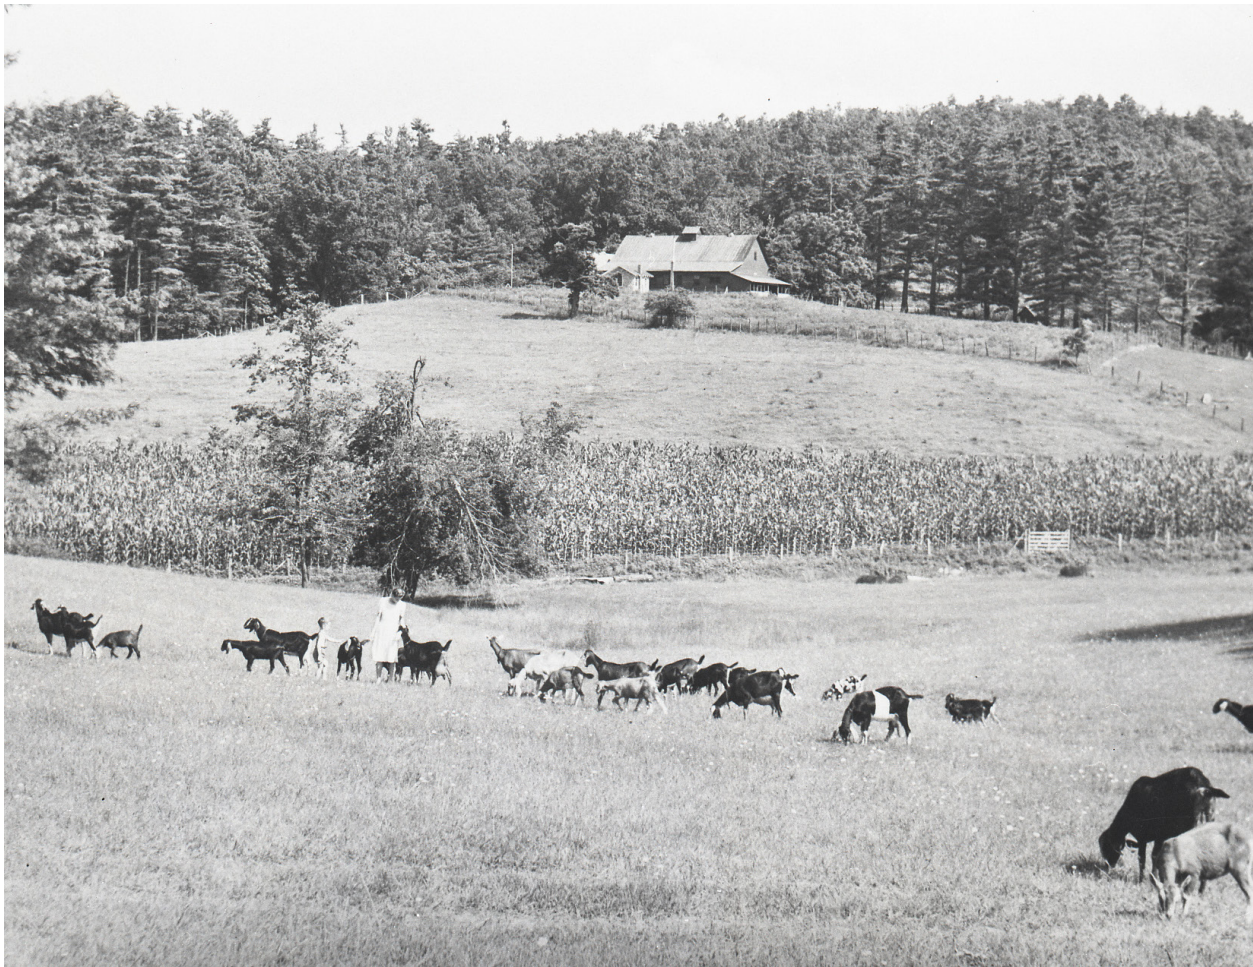
1 **Figure 2. 19.** Goats in the pasture north of the barnyard complex during the Sandburg Period. Note the corn growing in the
 2 low part of the landscape, post-and-wire fencing, and scattered trees (Source: CARL Archives, 3000_0529).

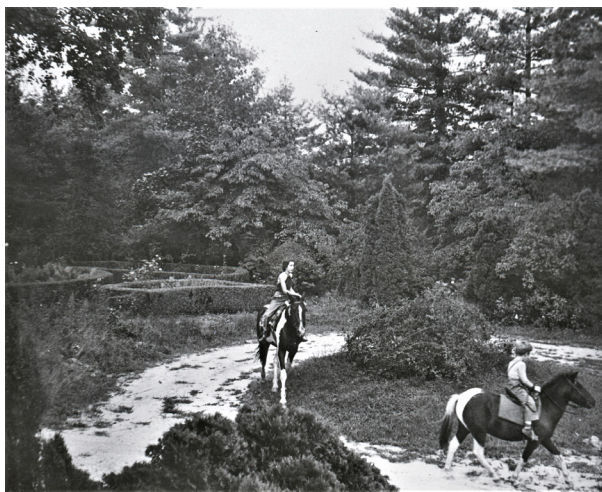
22 **Figure 2. 20.** The Sandburgs' grandchildren riding along
 23 the loop turnaround adjacent to the Main House. Note
 24 the boxwood gardens in the background and rose shrub in
 25 center of circle. (Source: CARL Archives, 3000_0531).

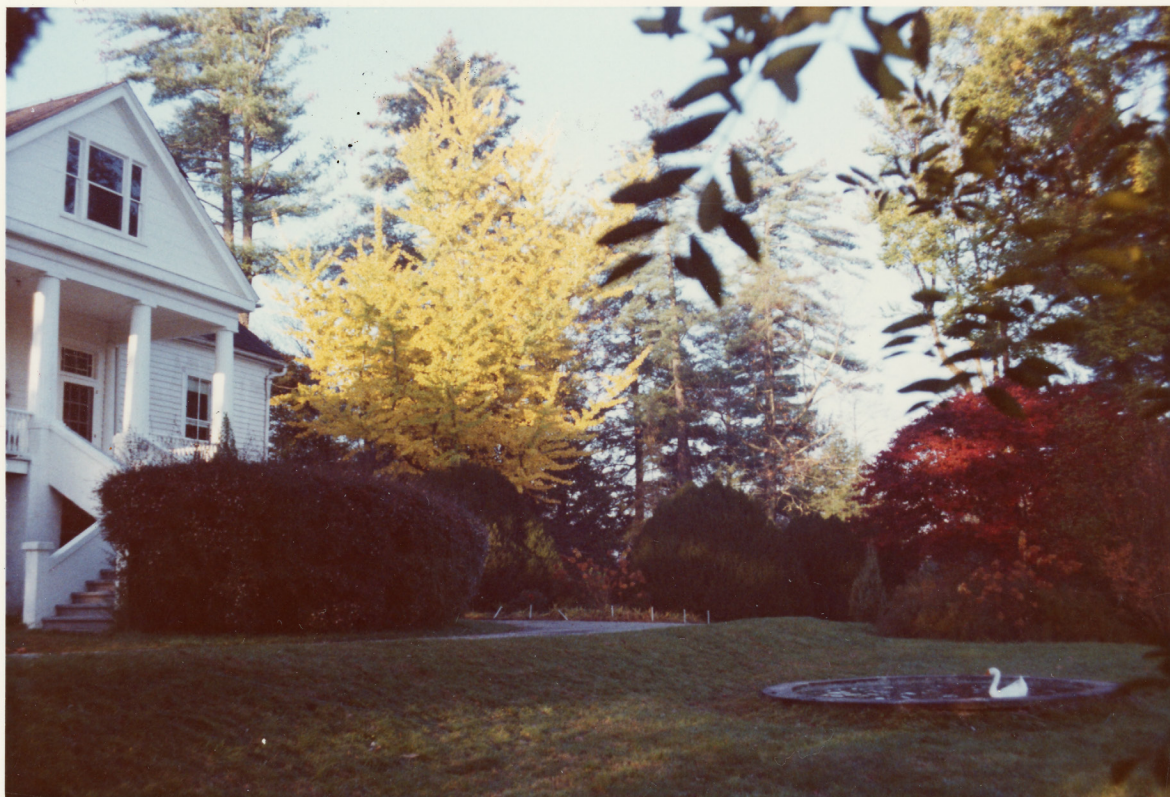
Figure 2. 21. The landscape surrounding the Main House contained a mixture of Smyth and Sandburg Period plantings. Note the ginkgo and maples showing their fall color, as well as a goose in the fountain pool. (Source: CARL Archives, 3000_0558).

18 In the front lawn, the Sandburgs removed the
 19 three-tiered fountain, but kept the basin in place
 20 (Figure 2. 21). This provided a shallow pool for the
 21 Sandburg grandchildren to play in and for animals

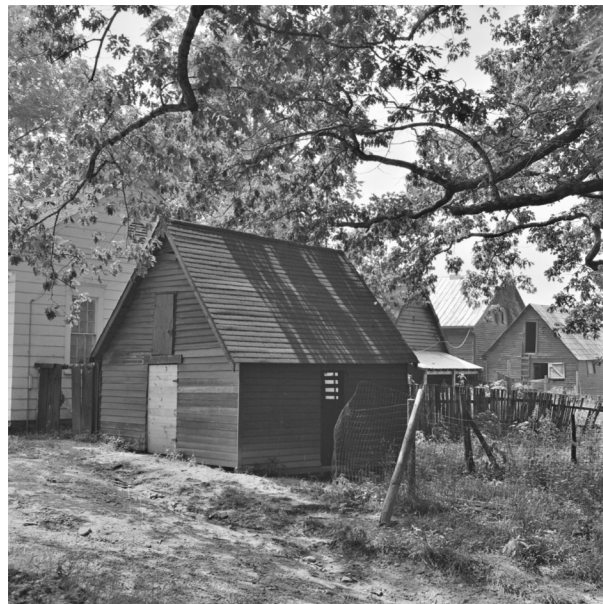
Figure 2. 24. The condition of the east side of the barnyard complex shortly after NPS acquisition in 1971. (Source: CARL Archives, 4008_12_002-2).

Just like the Sandburgs in 1945, the NPS purchased a property in need of care and attention with some resources compromised (Figure 2. 24). Accounts from the time note that several of the buildings were deteriorating, the dams were leaking, and the back drive was blocked with fallen trees, among other issues. The crew set to work despite a lack of funding and “began to clean the grounds, stabilize the historic buildings and cultural resources, process the collection in the Main House, conduct research for the interpretive programs, and acquire several goats to establish the living farm.” There was also a need to secure the property. This work was guided in part by various reports drafted and refined in the first few years of NPS management, including a Master Plan, a Land Management Survey, several Historic Structures Reports, and an Interpretive Prospectus. Park staff also simply did the best they could as they waited for the reports to be finalized and most importantly for the money to do appropriate repairs.¹⁶⁶

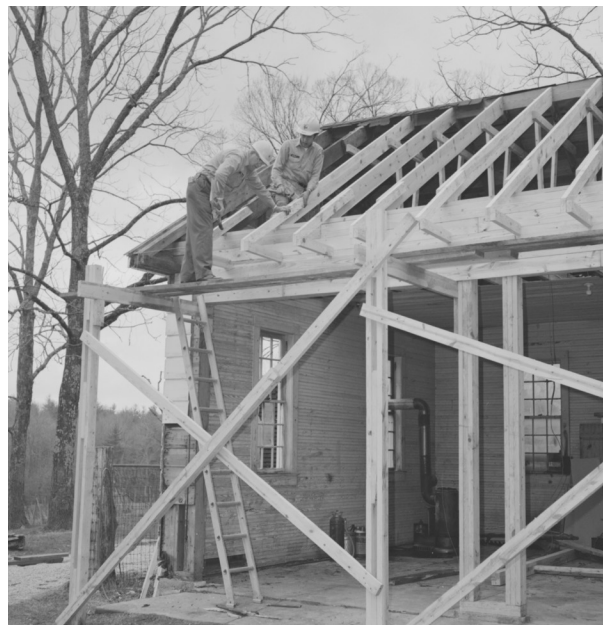
Figure 2. 25. 1972 image showing the Barn Garage building undergoing repairs by the NPS. (Source: CARL Archives, 4008_13_024-3).

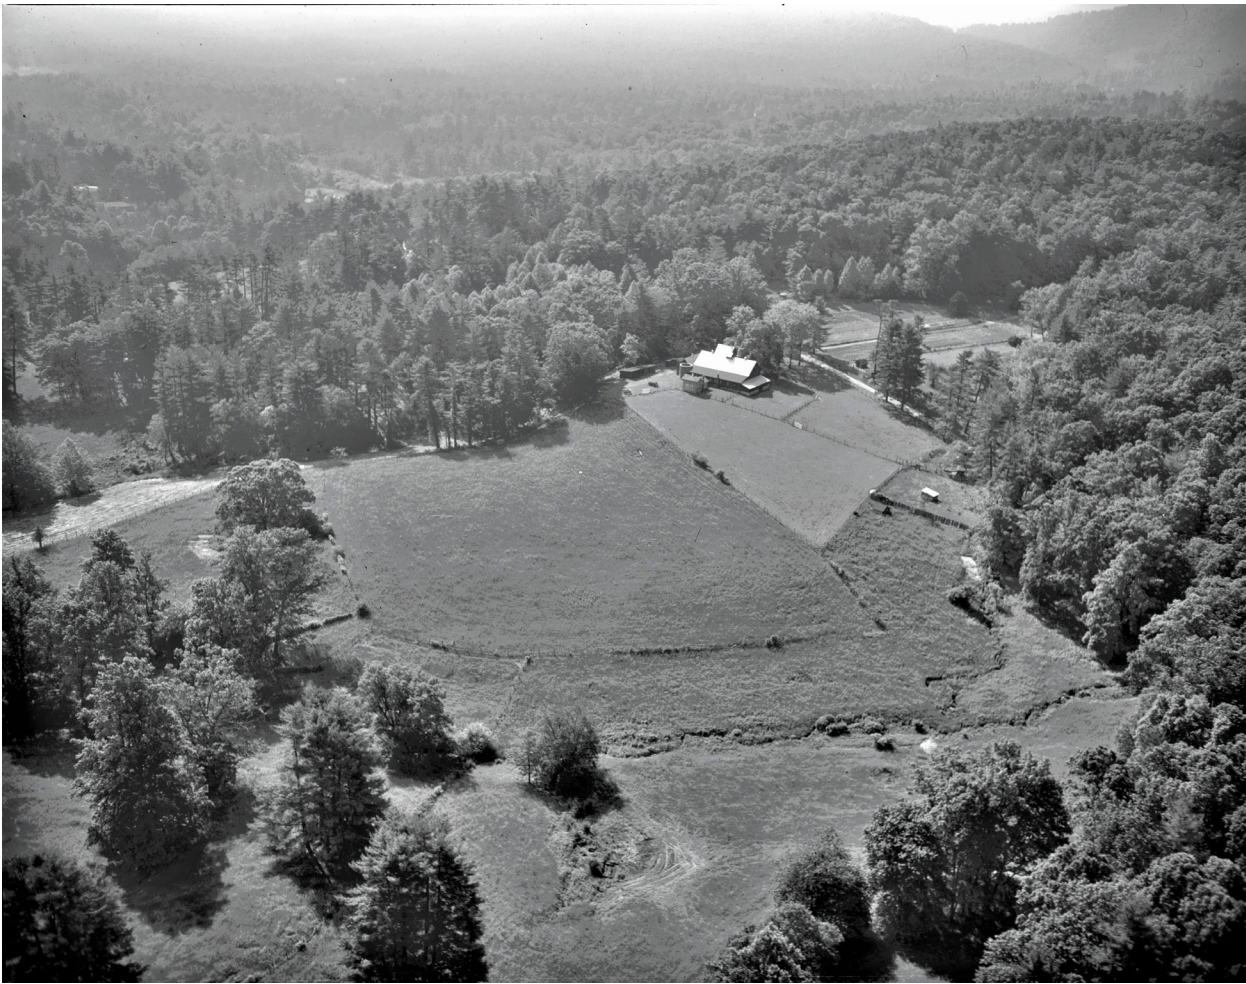
Figure 2. 26. 1976 aerial photograph of Connemara, looking southeast. The image shows the barnyard complex, pastures, fence lines, drainage features, and wooded hillside. (Source: CARL Archives, 4008_17_012).

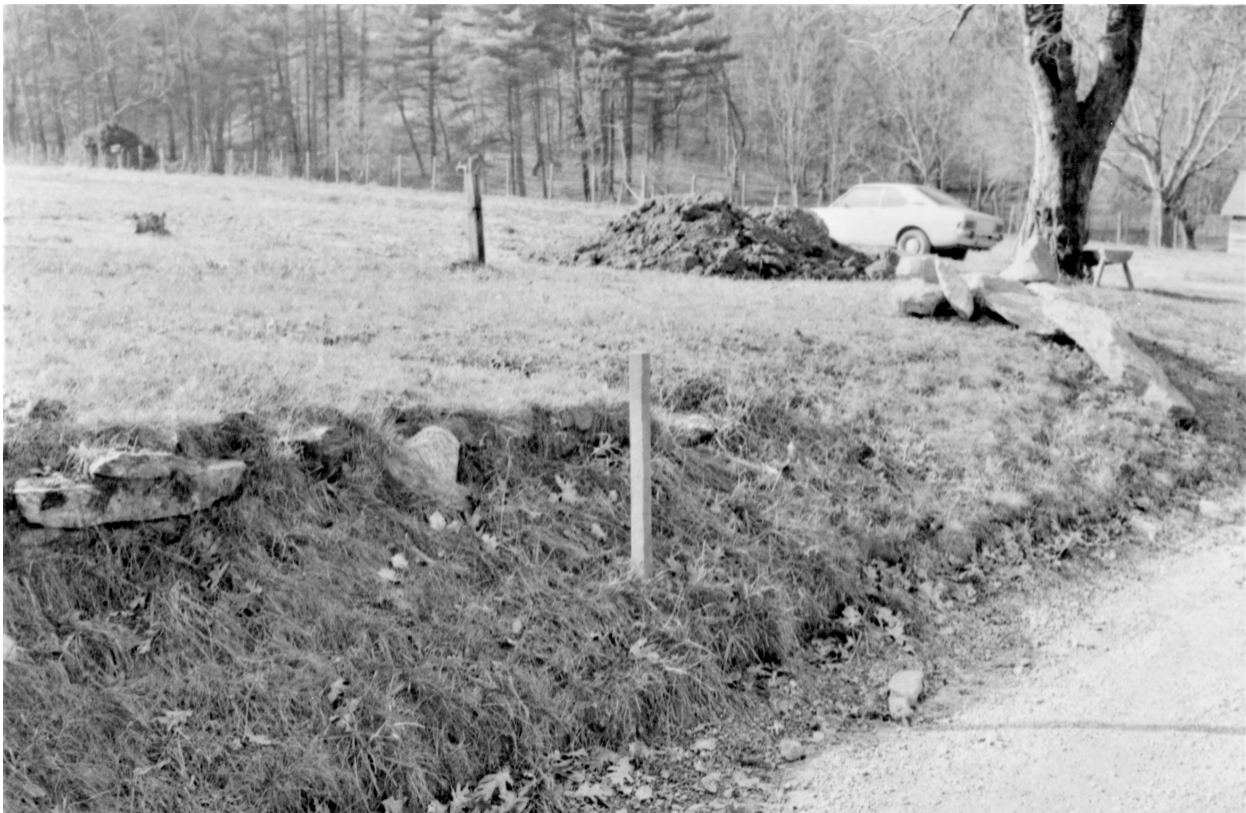
Figure 2. 30. 1975 image showing the poor condition of a section of rock wall prior to repair. (Source: CARL Archives 4008 /38/54P))

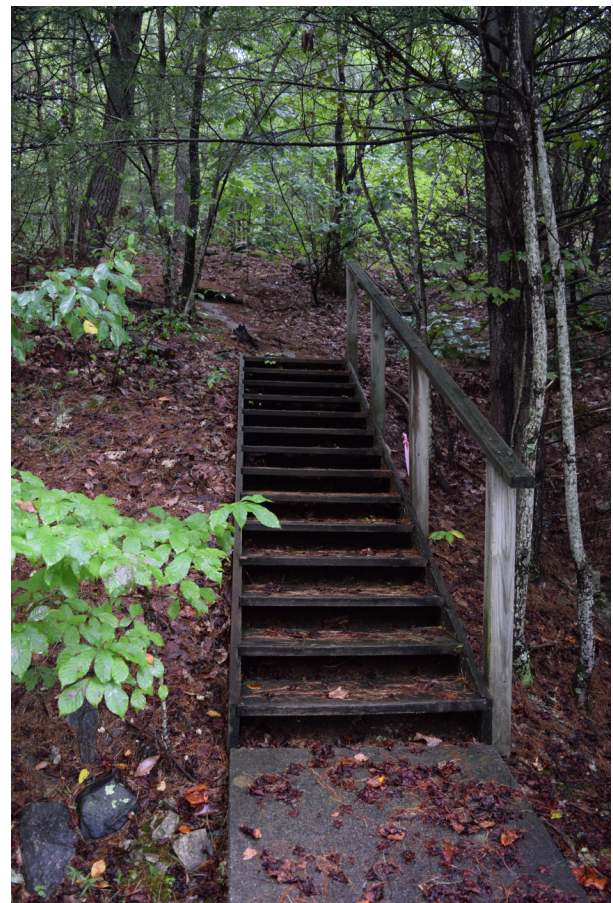
Figure 3. 5. Surrounding residential land use can have effects on the park, such as this unsanctioned stair access into the park from a neighboring community (Source: WLA Studio).

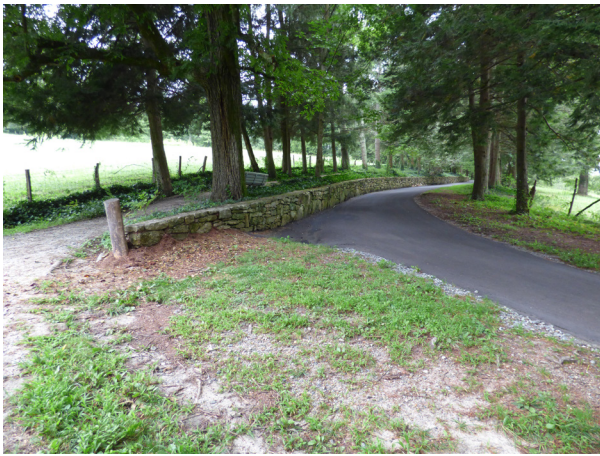
1 **Figure 3. 6.** The historic serpentine Entry Drive to the Main
2 House is paralleled by a pedestrian path atop the stone
3 retaining wall (Source: WLA Studio).

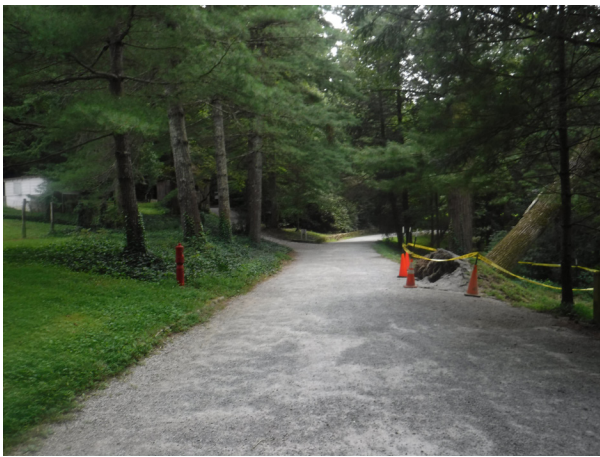
6 **Figure 3. 7.** The gravel Back Drive is lined by white pines and
7 hemlock, with English ivy on the ground plane. View to the
8 south (Source: WLA Studio).

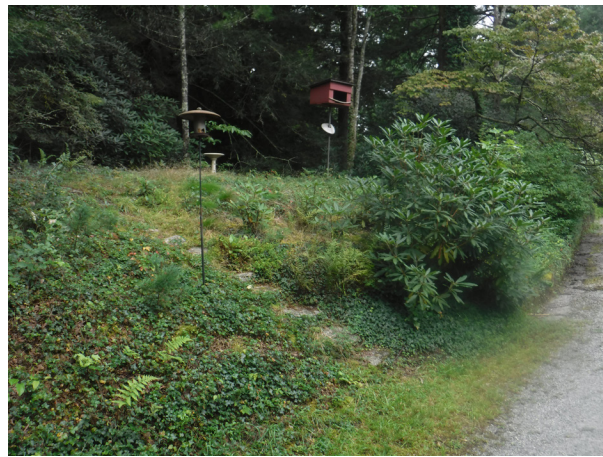
9 **Figure 3. 9.** Stairs along the hillside south of the Main House
10 lead to the bird feeding area and adjacent granitic dome.
11 Rhododendron, English Ivy, ferns, and dogwoods grow
12 along the hillside and retaining wall. View to the southwest
13 (Source: WLA Studio).

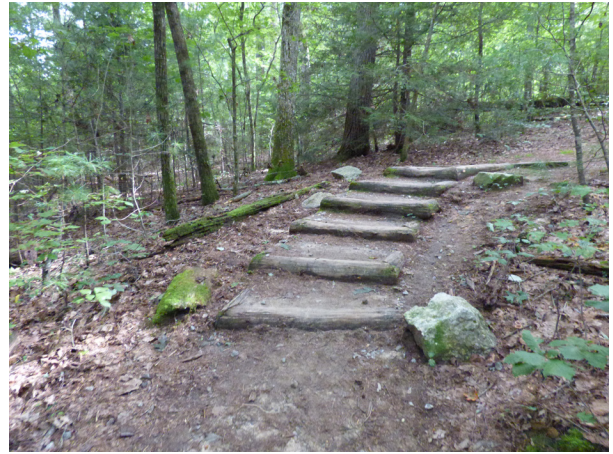
Figure 3. 12. Wood stairs such as these are a typical treatment for the pedestrian trail system within the park (Source: WLA Studio).

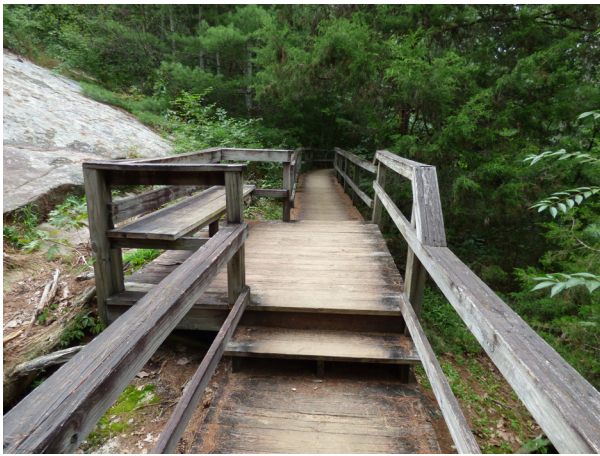
Figure 3. 13. This wooden bridge allows park visitors to experience the park's granitic dome communities without causing damage to the rare sensitive plant communities the domes support (Source: WLA Studio).

The Memminger Loop Trail is a .88-mile gravel and earthen path, oriented north-south. It follows a double-track trail that is accessible by maintenance vehicles. Memminger Loop Trail gains 160 feet in elevation from its origin in the Residential area to a saddle located where the trail intersects with Glassy Mountain Trail and Spring Trail, at 2,360 feet. Along the length of the loop are three sets of timber steps and one wooden bridge with handrails (Figure 3. 13). The stairs have five, eight, and six risers respectively, while the wooden bridge rises eight steps to cross over a granite dome, continuing

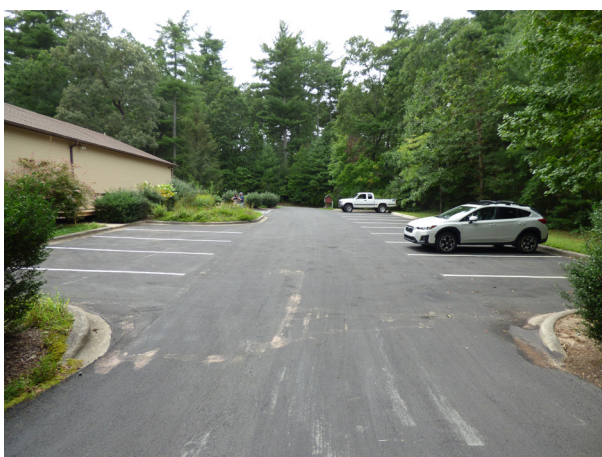
12 **Figure 3. 16.** The Administrative parking area used by park
13 staff has been paved recently in asphalt and edged with
14 concrete curbs (Source: WLA Studio).

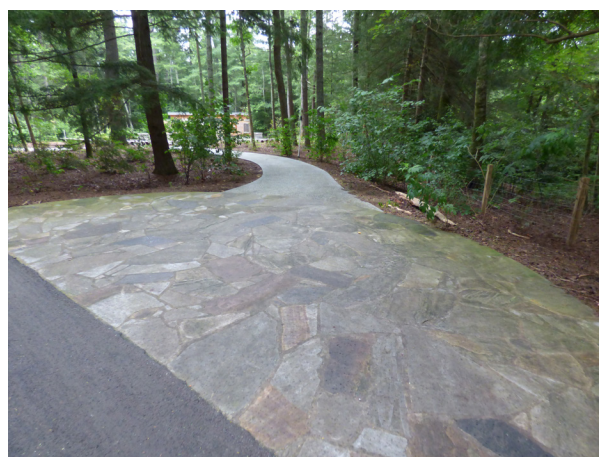
15 **Figure 3. 19.** These paved flagstone turnouts mark the
16 entryway to the Amphitheater and Pasture areas along the
17 Entry Drive (Source: WLA Studio).

Circulation in the Entrance Area directs visitors to either the Residential Core or the Forest area trails. The most prominent circulation feature is the historic serpentine Entry Drive (HS-45), which begins with a stone entrance at Little River Road. The Entry Drive is a winding asphalt-paved roadway lined with stone retaining walls and a mix of white pines (*Pinus strobus*) and hemlock trees (*Tsuga canadensis*) (Figure 3. 18). The roadway follows the grade approximately .25 miles up the hillside to the Main House. The lower section of the Entry Drive is only used to shuttle visitors up to the Main House; the historic gate is kept closed. Along the Entry Drive are two semicircular flagstone patios, one leading to a 5-foot-wide concrete pedestrian path to the recently built Amphitheater, and the second, which segues to a gate for a mown road used by park staff only (Figure 3. 19).

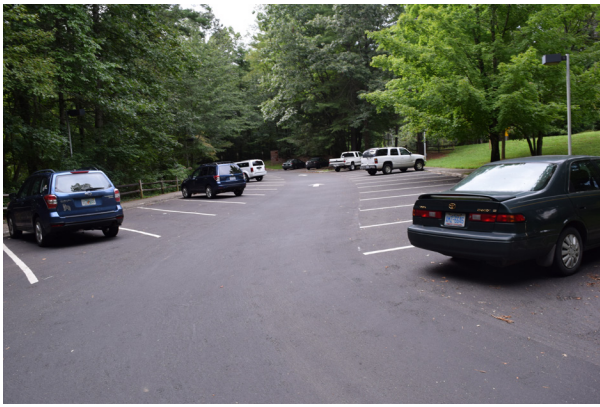
Figure 3. 20. The Main Visitor Parking Lot is asphalt with concrete curbs (Source: WLA Studio).

The Main Visitor Parking area is located along Little River Road, with one-way circulation through the parking area to the exit. The parking area has 33 marked spaces for passenger vehicles, including two accessible spaces, and three spaces for buses/RVs. The drive through the Main Visitor Parking area is 479 feet in length, with a 55 × 260-foot parking area (Figure 3. 20). From the parking area, a 6-foot-wide concrete paved sidewalk curves in a serpentine form following the natural grade to connect to the Visitor Contact Station. Behind the Visitor Contact Station, a short trail leads to a gravel picnic area. A 6-foot-wide wooden footbridge crosses over the Front Lake Dam, and a wide informal gravel area forms an intersection for three divergent paths, including a gravel service drive that leads behind the Amphitheater and connects to the lower part of the Entry Drive, and two other pedestrian trails, described below.

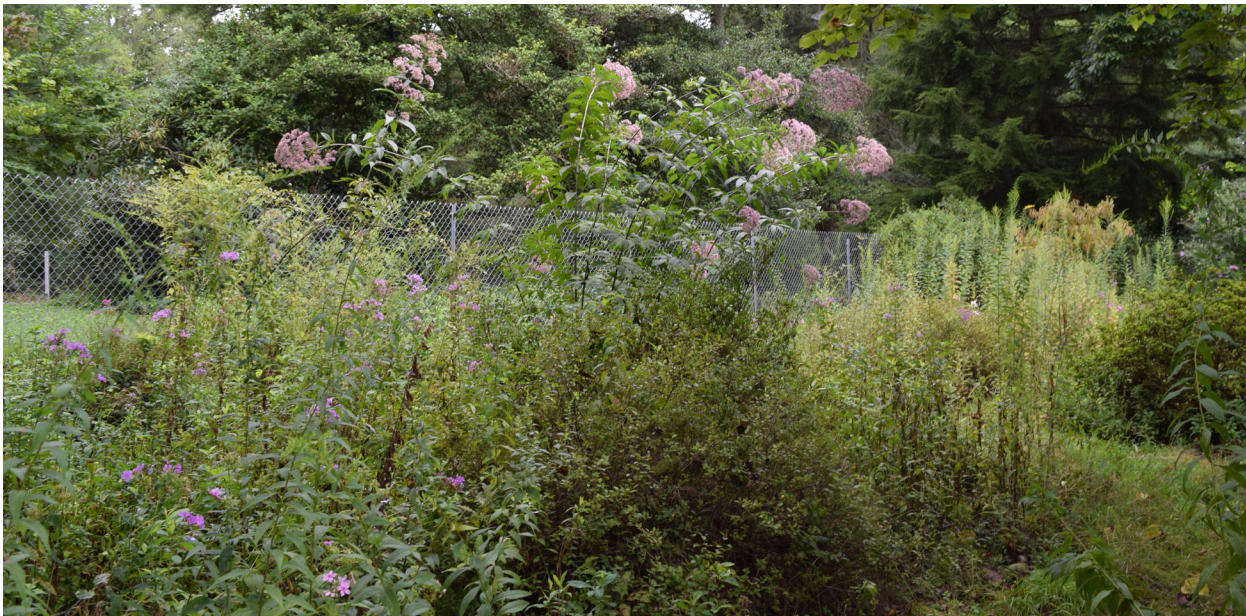
Figure 3. 21. The summer garden is a mix of perennial flowers and shrubs. The wild and unkempt appearance is consistent with the historic period conditions, but this condition was more evident during fieldwork due to labor issues related to the Covid-19 pandemic (Source: WLA Studio).

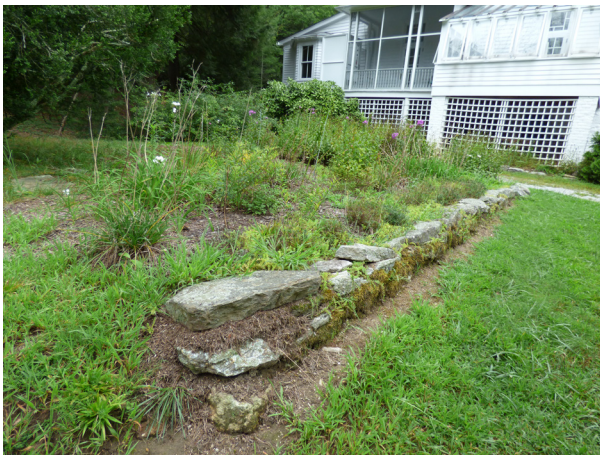
38 **Figure 3. 27.** The Lily Garden east of the Main House. The
39 garden is edged with a short retaining wall (Source: WLA
40 Studio).

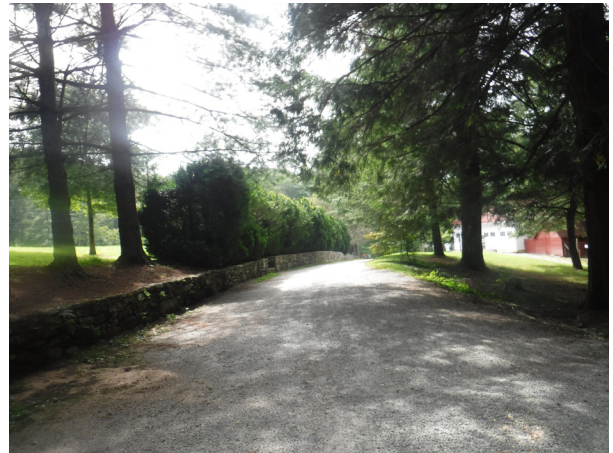
37 **Figure 3. 31.** Back Drive approaching the Farm Core area
 38 is lined by a row of boxwoods atop a stone retaining wall.
 39 View to the west (Source: WLA Studio).

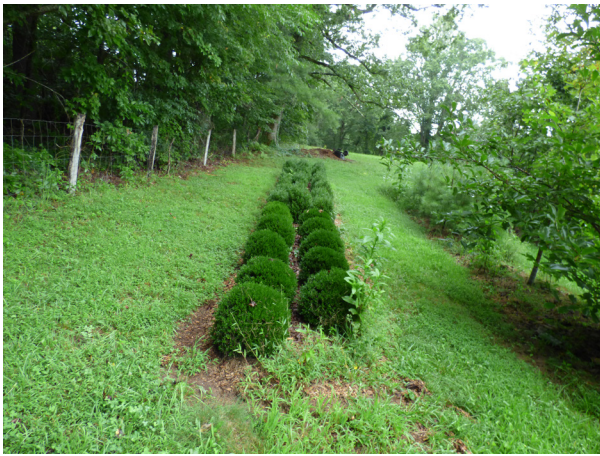
Figure 3. 42. Park staff keep a small nursery for replacing cultural vegetation if lost to disease or age (Source: WLA Studio).

33 Southeast of the administrative buildings, there are
 34 several rows of landscape plants being grown by
 35 park staff for use around the park to replace aging
 36 or failing cultural landscape plants (Figure 3. 42).
 37 The nursery is the result of a partnership between
 38 park staff, volunteers, Clemson University, and the
 39 South Carolina Botanical Garden.

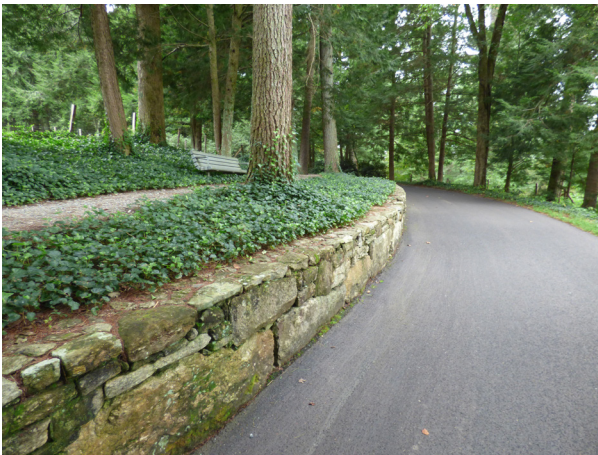
24 **Figure 3. 46.** The ivy growing atop the stone wall along the
 25 Entry Drive is kept clipped back. View to the west (Source:
 26 WLA Studio).

79 period hemlocks, and younger replacement trees,
80 the drive is not strictly uniform with single and
81 double rows of trees. The canopy is densest by
82 the entry gate, where forest surrounds the allée,
83 becoming more open farther up the drive where
84 the surrounding landscape is pasture. As the drive
85 nears the house, clusters of vegetation including
86 dogwood, holly, rhododendron, and mountain
87 laurel grow, with tulip poplar, dogwood, black
88 locust, black gum (*Nyssa sylvatica*), and hickory
89 trees scattered in intermittent patches. English
90 ivy grows atop the stone retaining wall and along
91 the pedestrian path running parallel to the Entry
92 Drive (Figure 3. 46). Park staff have an English ivy
93 monitoring and maintenance program established
94 to check the spread of the ivy.

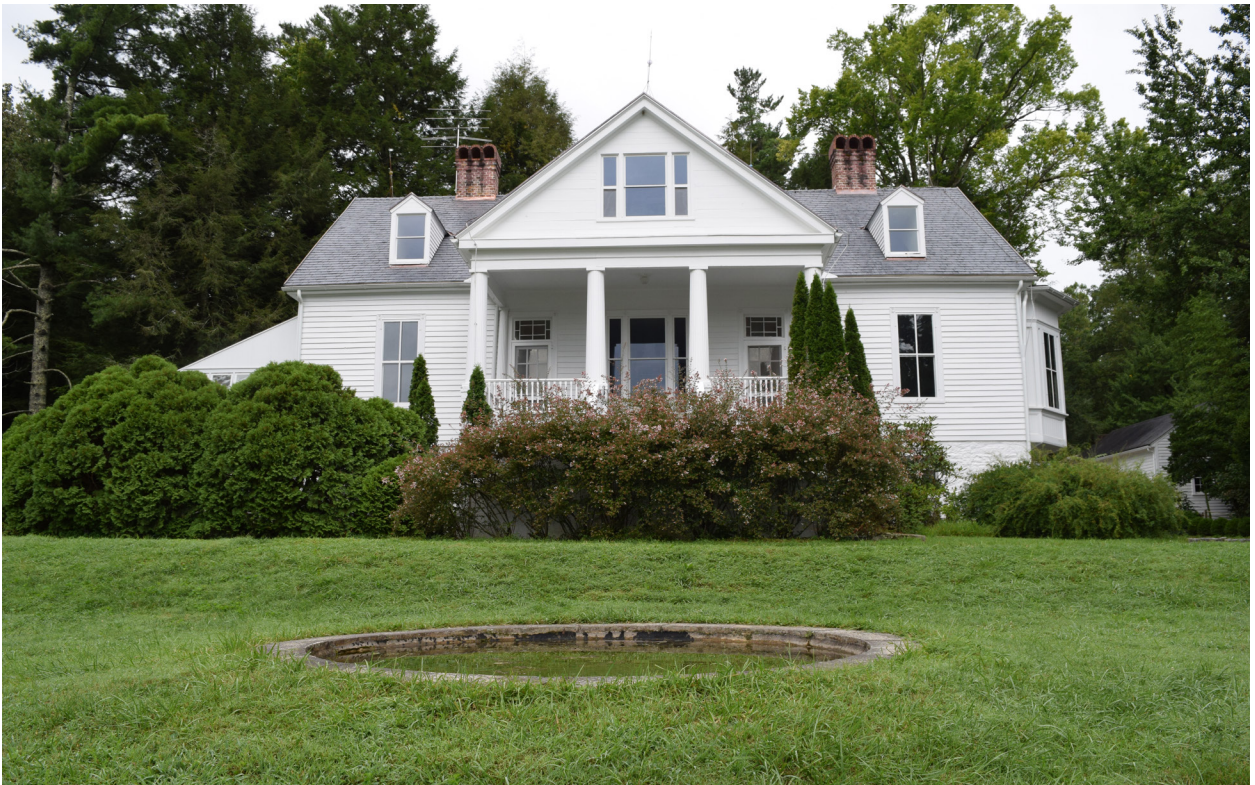
1 **Figure 3. 53.** The North Façade of the Main House (Source: WLA Studio).

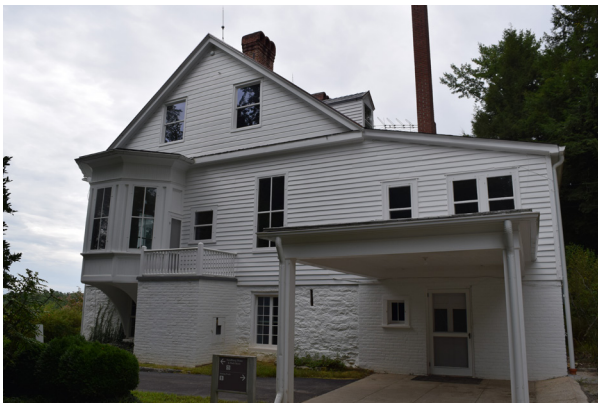
2 **Figure 3. 54.** The West Façade of the Main House (Source: WLA Studio).

57 The Main House was built between 1838-39 during
58 the Memminger Period (Figure 3. 53 - Figure 3. 56).
59 The house is a Greek Revival frame construction
60 with white wood siding and trim and rests on a
61 lime-mortared fieldstone and brick foundation.
62 The house is 1 ½ stories with a side-gabled roof,
63 facing northeast. Three doors and two double-
64 hung six-light windows are located at ground level
65 on the north facade. The front porch, located
66 on the main level, is a front-gabled, pedimented,
67 three-bay feature with four Doric order columns,
68 supported by a concrete foundation. The porch,
69 enclosed by a balustrade, opens to a central front
70 staircase which descends six steps to a landing and
71 splits into flanking staircases with nine risers on
72 the west side and eight on the east side. Flanking
73 the porch on either side are two dormer windows.
74 The south façade has three additional dormer
