Carl Sandburg Home National Historic Site Cultural Landscape Report

85% Draft Submittal
September 2021

Cultural Resources, Partnerships, and Science Division
Interior Region 2 - South Atlantic Gulf

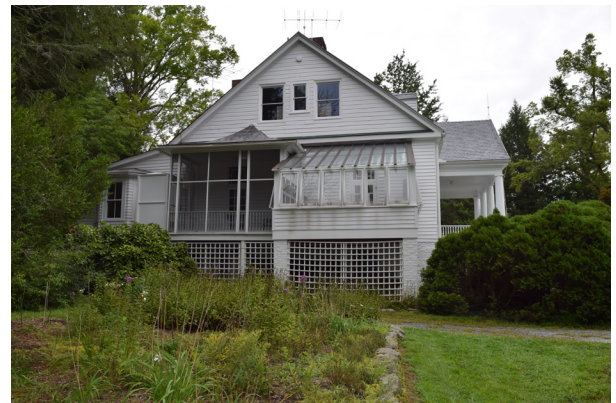
4 **Figure 3. 56.** The East Façade of the Main House (Source: WLA Studio).

57 The Main House was built between 1838-39 during
58 the Memminger Period (Figure 3. 53 - Figure 3. 56).
59 The house is a Greek Revival frame construction
60 with white wood siding and trim and rests on a
61 lime-mortared fieldstone and brick foundation.
62 The house is 1 ½ stories with a side-gabled roof,
63 facing northeast. Three doors and two double-
64 hung six-light windows are located at ground level
65 on the north facade. The front porch, located
66 on the main level, is a front-gabled, pedimented,
67 three-bay feature with four Doric order columns,
68 supported by a concrete foundation. The porch,
69 enclosed by a balustrade, opens to a central front
70 staircase which descends six steps to a landing and
71 splits into flanking staircases with nine risers on
72 the west side and eight on the east side. Flanking
73 the porch on either side are two dormer windows.
74 The south façade has three additional dormer

93 a three-sided bay window on the southeast corner
94 with three double-hung two-light sashes. This
95 is supported by a brick foundation with a single
96 square four-light, fixed window. Also on the east

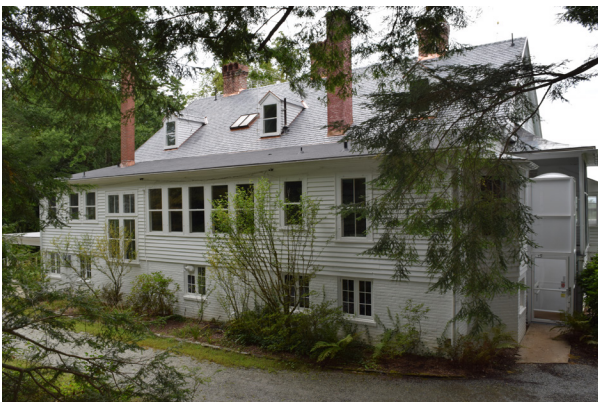
6 **Figure 3. 55.** The South Façade of the Main House (Source: WLA Studio).

5 façade are two enclosed porches accessible on the
6 main level. One porch is screened in, enclosing a
7 French door with a square multi-light transom.
8 Connected to the porch is a modern accessible
9 elevator of metal construction. The porch is
10 supported by a wood post foundation which is
11 enclosed with square wood lattice. The second
12 porch is a conservatory with a glass roof, enclosed
13 by top-swing casement windows on three sides.
14 The sunroom/greenhouse is supported by a brick
15 pier foundation which is enclosed with wood
16 lattice; the sunroom encloses a multi-paneled glass
17 door with a multi-panel transom on the main story.
18 There are three additional windows on the attic
19 level on the east façade. The house has five brick
20 chimneys. For the most part, the roof is a synthetic
21 (Enviroshake) material with copper flashing. The
22 shed roof on the back is 3-tab asphalt shingle.

23 Both of which were replaced recently. The house is
24 generally in good condition.

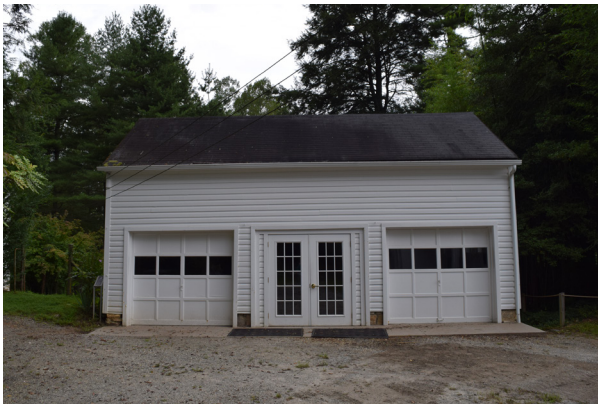
1 **Figure 3. 57.** The east façade of the Garage (Source: WLA
2 Studio).

26 The Garage was originally the house kitchen. It
27 was constructed in 1839 for Memminger and later
28 converted to a garage by the Sandburgs (Figure
29 3. 57 - Figure 3. 60). The building is a single story,
30 three-bay, frame building with wood siding and a
31 mix of masonry and brick foundations. The roof
32 is gabled and L-shaped, with a shed roof addition
33 enclosing the "L." The shed roof addition is
34 covered in composite roofing material. The Garage
35 is located just southwest of the Main House and
36 faces southeast towards the carport, axially aligned
37 with the Main House. Two of the three bays on the
38 east façade have wood garage doors; the central
39 bay was replaced with a modern French door.
40 The north façade has four double-hung, six-light

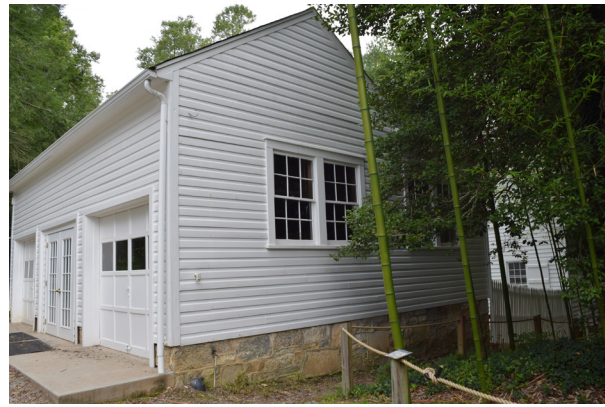
3 **Figure 3. 58.** The north façade of the Garage (Source: WLA
4 Studio).

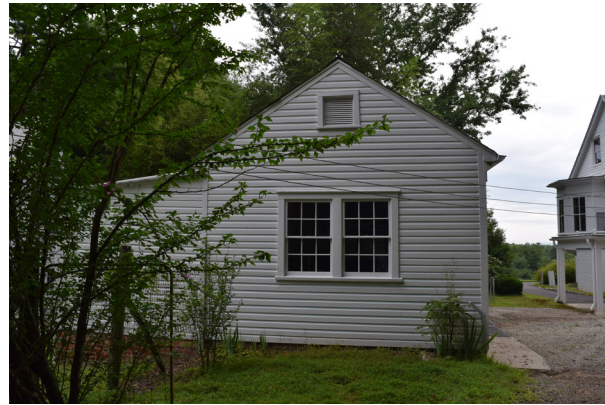
41 **Figure 3. 59.** The south façade of the Garage (Source: WLA
42 Studio).

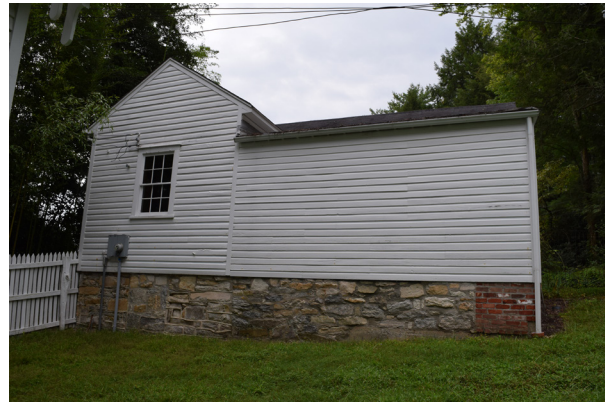
43 **Figure 3. 60.** The west façade of the Garage (Source: WLA
44 Studio).

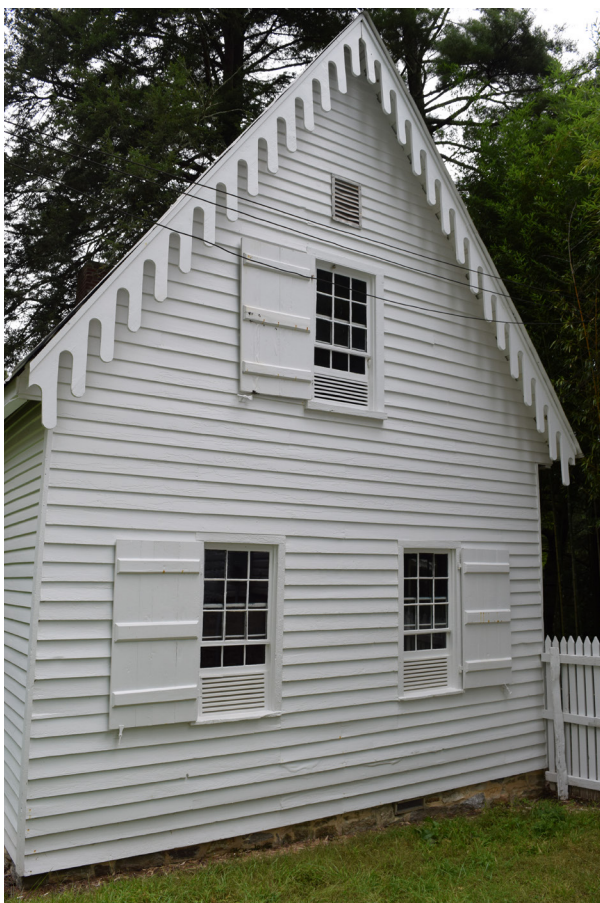
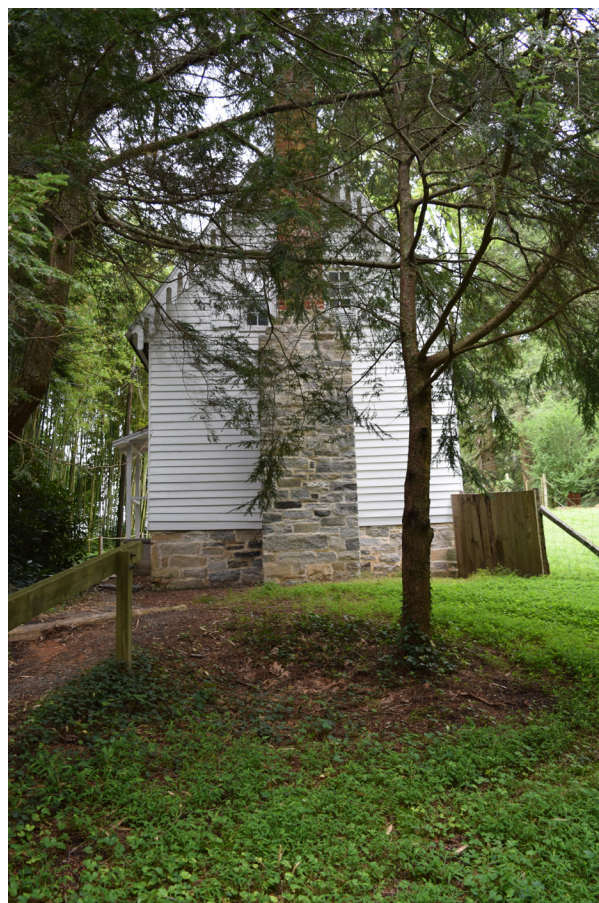
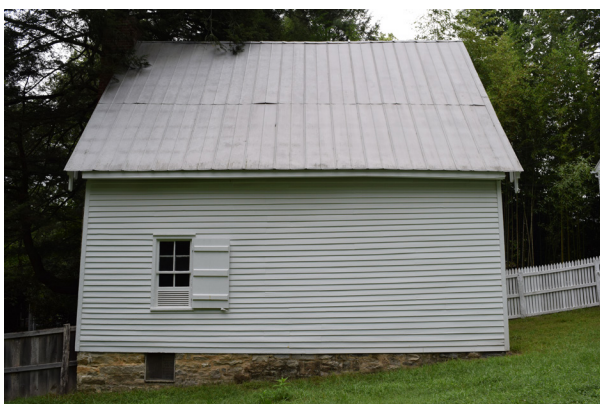
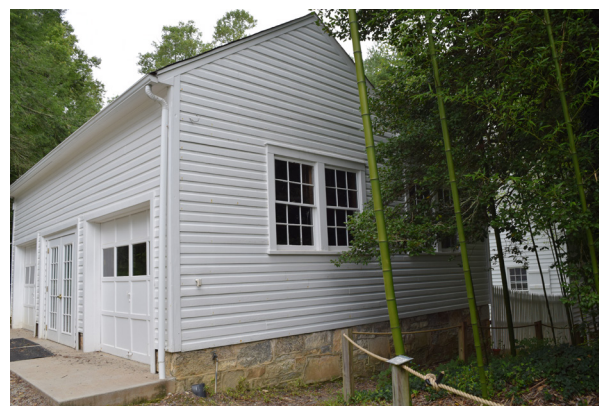
1 **Figure 3. 61.** The east façade of the Swedish House (Source: WLA Studio).
2

3 **Figure 3. 62.** The west façade of the Swedish House (Source: WLA Studio).
4

7 **Figure 3. 63.** The south façade of the Swedish House (Source: WLA Studio).
8

5 **Figure 3. 64.** The north façade of the Swedish House (Source: WLA Studio).
6

15 The Swedish House was constructed in the
16 1850s, during the Memminger Period (Figure
17 3. 61 - Figure 3. 64). Originally used to house
18 enslaved people, it was used by the Sandburgs as

2 an overflow library for books and magazines. The
 3 building is a two-story frame construction with
 4 wood siding painted white, a mortared fieldstone
 5 foundation, and a steep side-gabled tin roof with
 6 distinctive decorative trim on the gables. The house
 7 is approximately 18 feet west of the Garage, aligned
 8 on the north façade with the Garage and the rear
 9 of the Main House. The front door is located on
 10 the north façade, which faces the bamboo grove,
 11 obscuring its visibility from the Main House and
 12 Back Drive. The front stoop, which has a small
 13 lean-to roof overhang, is three concrete block steps
 14 with a concrete cap. Flanking the entrance are
 15 two windows, nine-over-six, with wood board-
 16 and-batten shutters. There are three windows of
 17 the same style on the east façade, as well as two
 18 two-over-two windows on the west façade, also
 19 with wood shutters. There is also one of this same

20 style on the south façade. Most windows are kept
 21 permanently open and have vents installed beneath
 22 the lower sash to reduce humidity in the building.
 23 The chimney, constructed of stone and brick,
 24 is on the west façade. The house has no visible
 25 concerning construction issues.

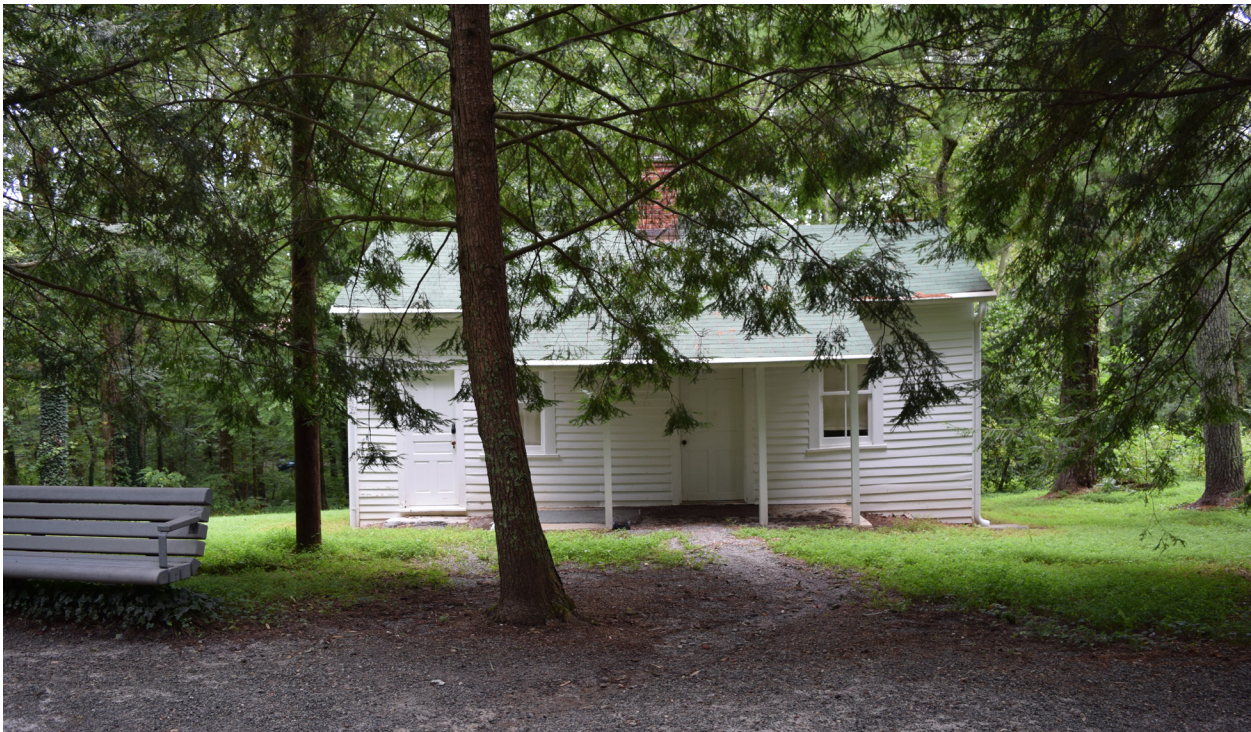
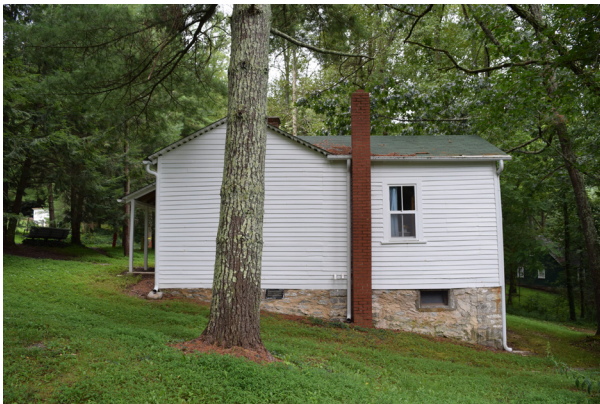
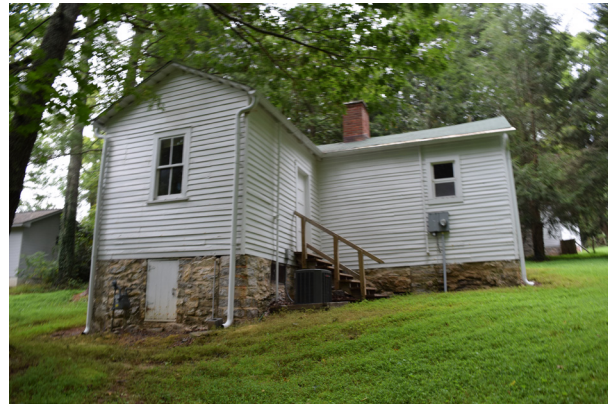
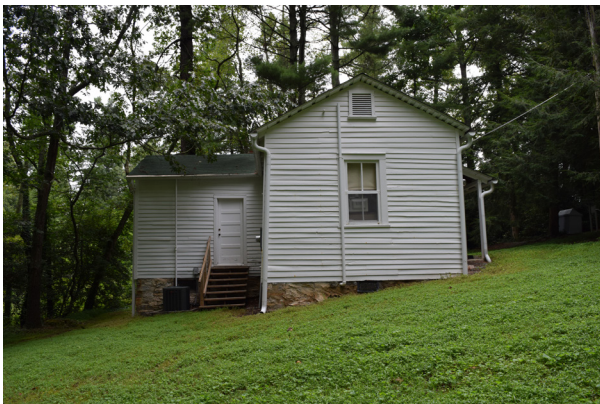
1 **Figure 3. 65.** The east façade of the Tenant House (Source: WLA Studio).

4 **Figure 3. 66.** The north façade of the Tenant House (Source: WLA Studio).
5

2 **Figure 3. 68.** The west façade of the Tenant House (Source: WLA Studio).
3

19 **Figure 3. 67.** The south façade of the Tenant House (Source: WLA Studio).
20

29 The Tenant House was built in 1900 during the
 30 Smyth Period, and was used by the Sandburgs to
 31 house farm help and guests. It is currently used
 32 as offices for the park staff (Figure 3. 65 - Figure
 33 3. 68). The house is a small, L-shaped single-story
 34 frame construction with wood siding painted white
 35 and an asphalt shingle roof. The house is located
 36 approximately 80 feet northwest of the Swedish
 37 House, facing southeast towards the Back Drive.
 38 The foundation is mortared stone piers filled in

with fieldstone to form a basement, built into the grade. There is an access door on the rear (west) façade. A shed roof supported by four wood posts atop a concrete slab forms the front stoop, which is flush with the grade. The front door is flanked by two-over-two windows and a second entry door, left of the front door. There are six windows in total, five two-over-two and a single one-over-one. The south façade has a set of seven wood stairs and a handrail leading to a rear entry door in the “L” corner of the building. There are two brick chimneys; one in the center of the side gable and one on the north facade. The building is connected to power and gas with an air conditioner and meters located on the rear of the building.

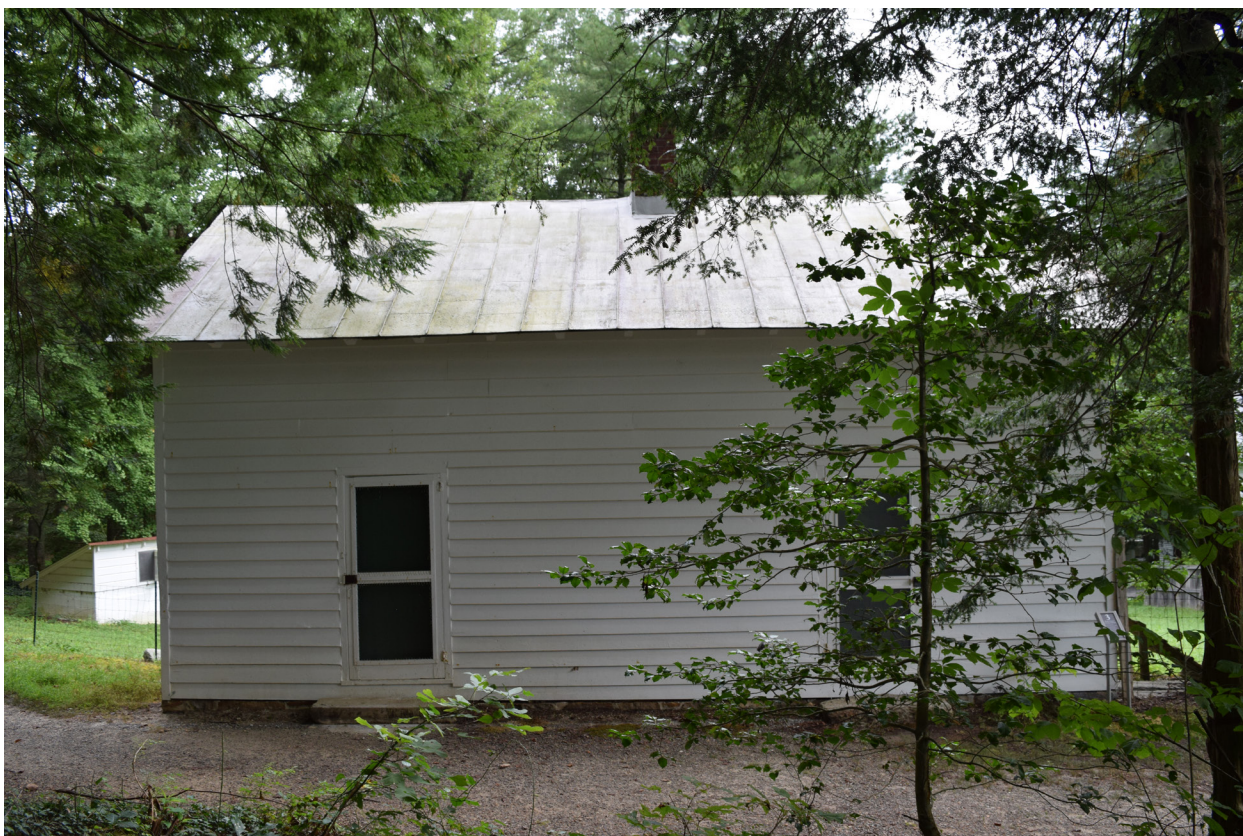
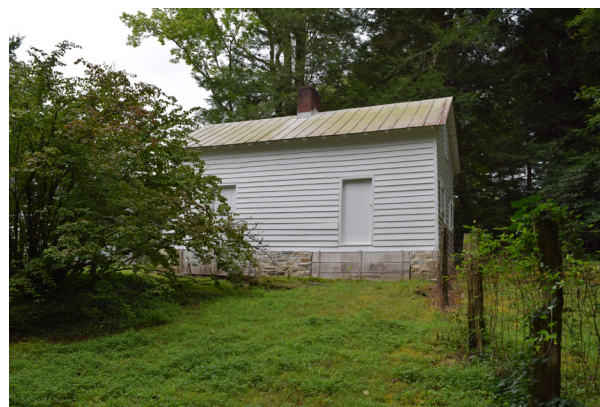
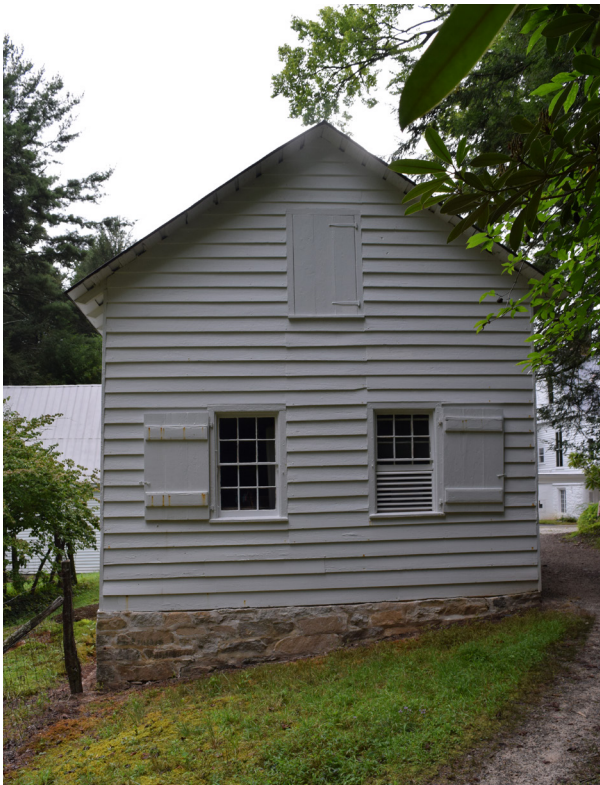
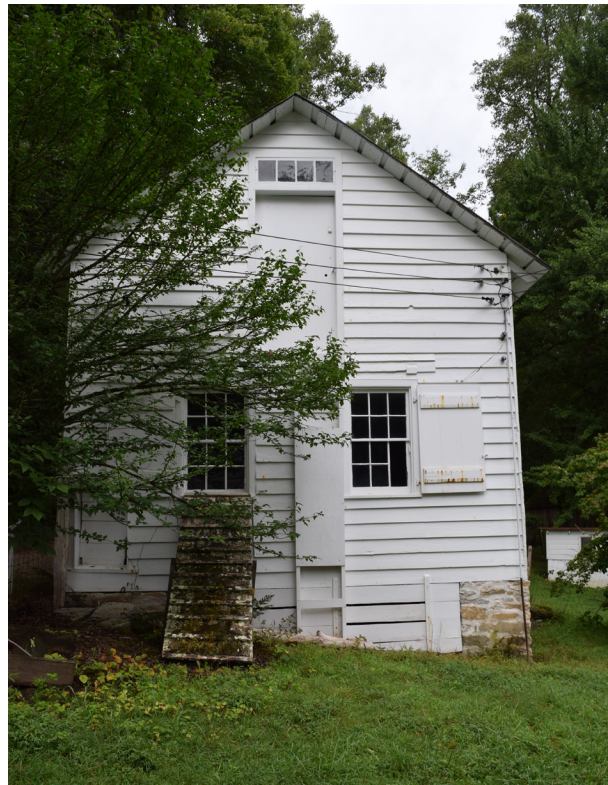
1 **Figure 3. 69.** The east façade of the Wash House (Source: WLA Studio).

26 **Figure 3. 70.** The west façade of the Wash House (Source:
 27 WLA Studio).

1 **Figure 3. 71.** The south façade of the Wash House (Source: 3
2 WLA Studio).

3 **Figure 3. 72.** The north façade of the Wash House (Source:
4 WLA Studio).

The Wash House is a side-gabled frame building with white wood siding, central brick chimney, tin roof, and fieldstone foundation. It was constructed in the 1840s during the Memminger Period (Figure 3. 69 - Figure 3. 72). The house was originally the quarters of enslaved workers; the Sandburgs used the Wash House as a chicken house and a wash house. The house is located south of the Garage, facing southeast to the gravel drive leading from the Main House. There are two doors on the southeast façade with single-step stone stoops. On the north façade a second-story door is accessed by a wood ladder which is installed between two six-over-six windows, with board-and-batten shutters. One window has a wood chicken ramp leading to it. There is another small opening near the ground whose use is unclear as it is boarded

up. An additional three six-over-six windows are on the south façade, also with shutters, with one window with a vent permanently held open. The west façade has two additional doors (missing entry steps) that are located approximately 4 feet above grade. There are three old-style power lines connected to the house on the north façade.

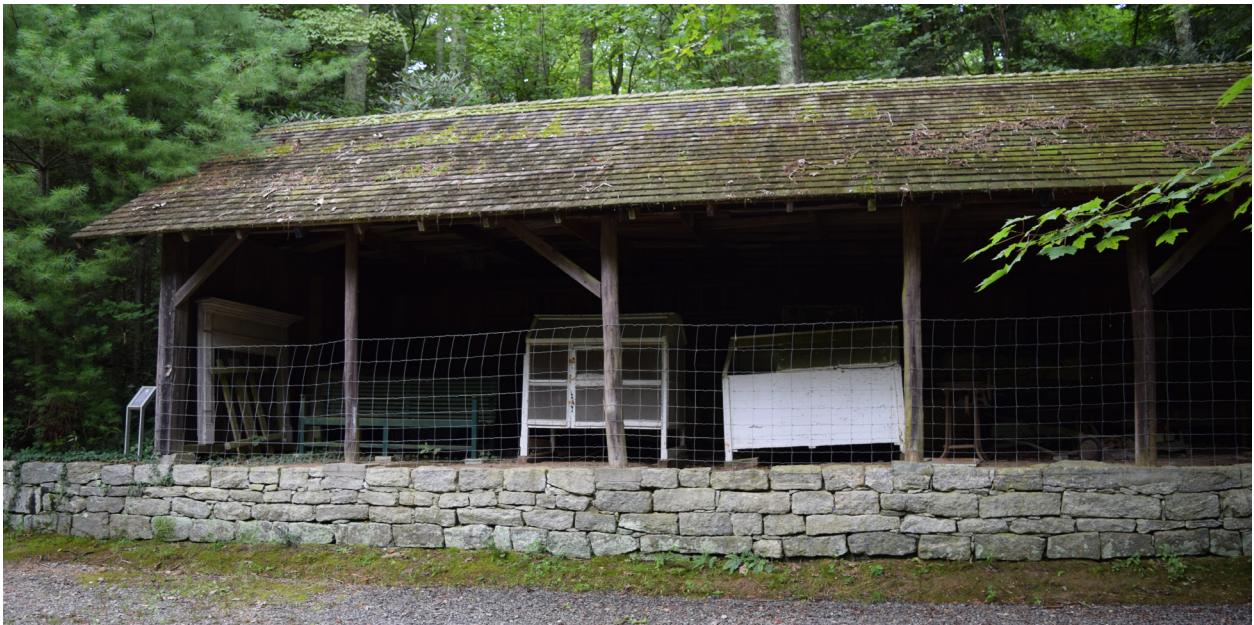
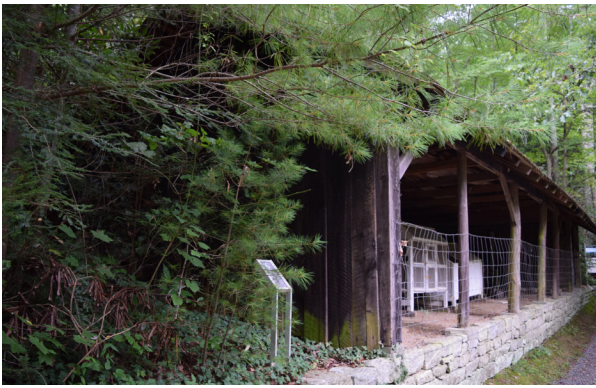
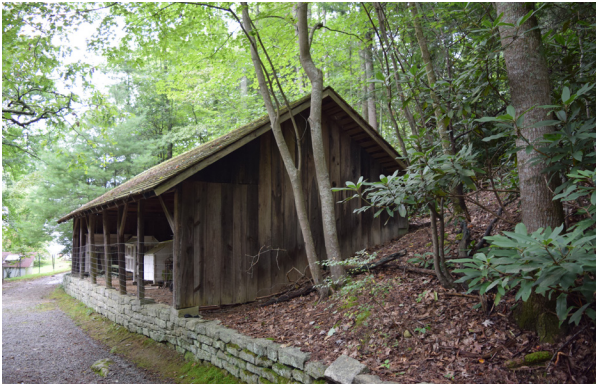
5 **Figure 3. 73.** The west side of the Wood Shed. The shed sits atop a dry-stack stone wall (Source: WLA Studio).

1 **Figure 3. 74.** The northwest side of the Wood Shed (Source:
2 WLA Studio).

5 **Figure 3. 75.** The southwest side of the Wood Shed (Source:
6 WLA Studio).

The Wood Shed is an open-front, unpainted six-bay post and beam structure with a shake roof. The shed is supported by wood posts and enclosed by vertical boards on the north, east, and south sides (Figure 3. 73 - Figure 3. 75). Built atop a stone retaining wall, the structure has an earthen floor and stone foundation wall along the back (east) side. The structure is located south of the Wash House, facing west to the Gravel Drive behind the Main House. Used by the Sandburgs as storage, it still houses architectural features, old farm equipment, and other furniture and tools. The structure is in good condition.

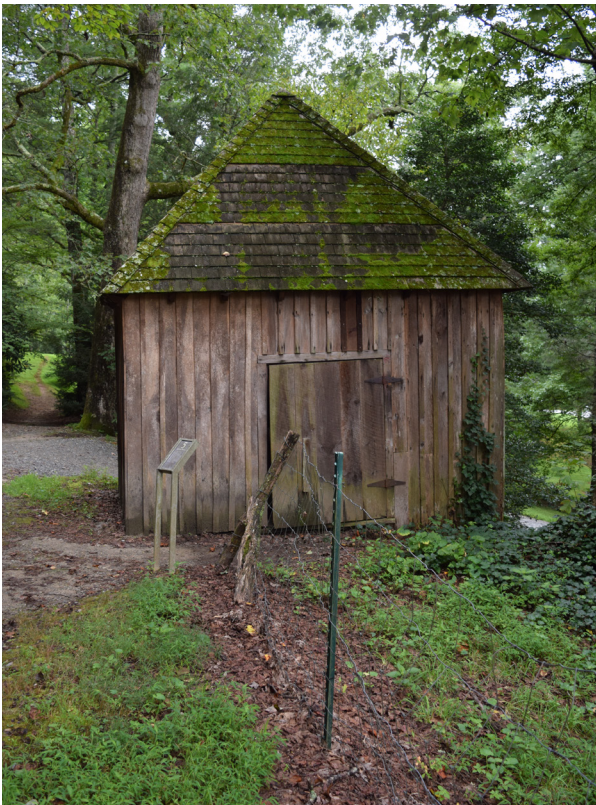
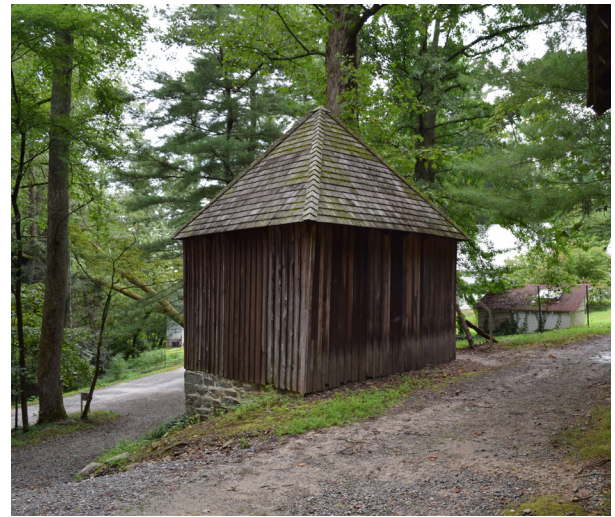
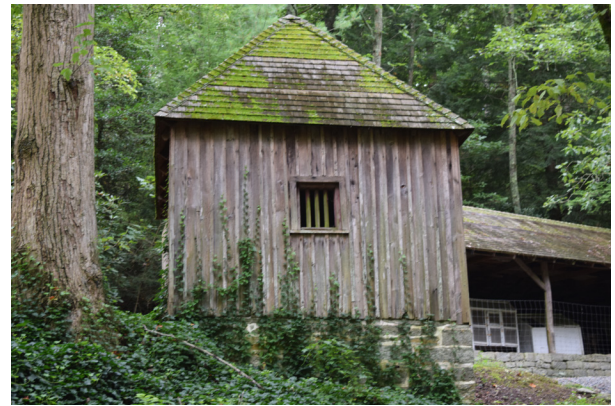
9 **Figure 3. 76.** The north façade of the Spring House (Source:
10 WLA Studio).

3 **Figure 3. 77.** The southeast façade of the Spring House
4 (Source: WLA Studio).

7 **Figure 3. 78.** The West façade of the Spring House (Source:
8 WLA Studio).

This is a small board-and-batten rectangular building with a pyramidal hipped, cedar shake roof (Figure 3. 76 - Figure 3. 78). The roof has significant moss growth. The building dates to 1853 and originally served as a spring house. The building was used by the Sandburgs as a cheese house. The building, facing north with a single door, is set upon a stone foundation into a steep grade change where the back service drive

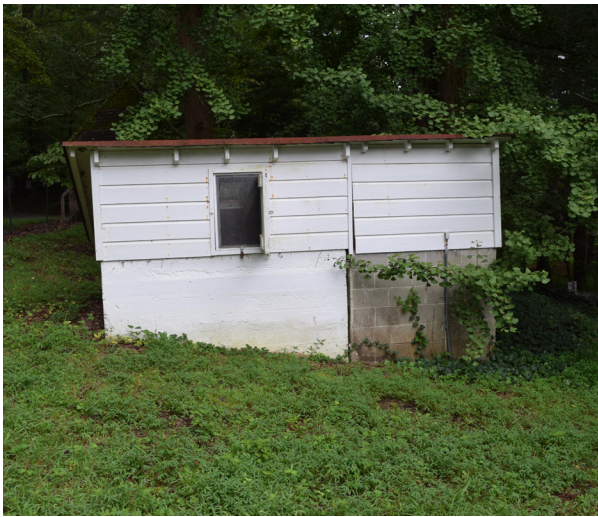
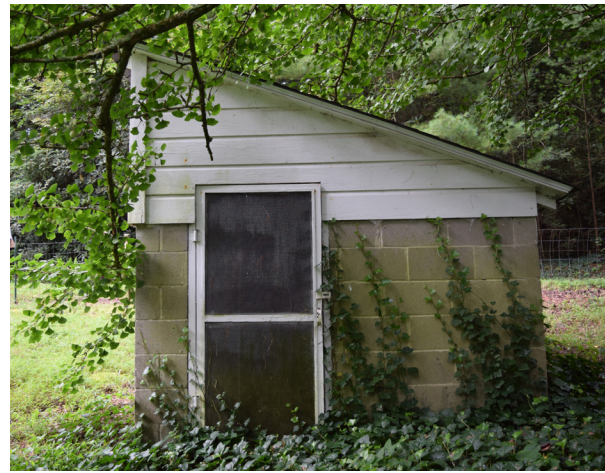
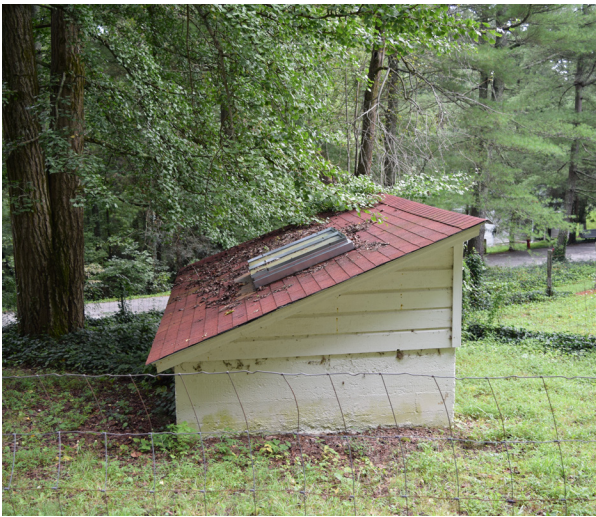
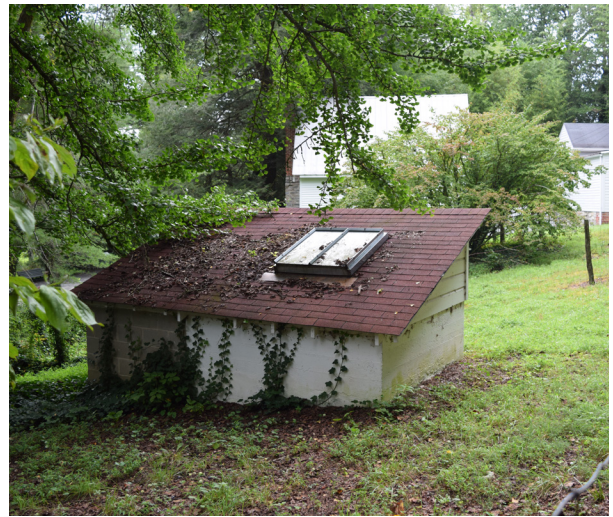
Figure 3. 79. The north façade of the Pump House (Source: WLA Studio).

Figure 3. 80. The west façade of the Pump House (Source: WLA Studio).

1 **Figure 3. 81.** The east façade of the Pump House (Source:
2 WLA Studio).

3 **Figure 3. 82.** The south façade of the Pump House (Source:
4 WLA Studio).

8 This is a small rectangular frame structure with
9 white wood siding and a red asphalt shed roof.
10 It sits on a board-formed concrete and concrete
11 block foundation (Figure 3. 79 - Figure 3. 82). The
12 structure has a single skylight and an access hatch
13 on the north side. The sole door is on the west side.
14 The structure is perpendicular to the back service
15 drive but not axially aligned to the Wash House or
16 any other nearby buildings. The structure is dated
17 circa 1900-1925 and was used as a Pump House
18 during the Sandburg Period. The two foundations
19 appear to be settling and drifting apart, with a gap
20 forming between them; the siding is pulling apart
21 from the trim at this juncture.

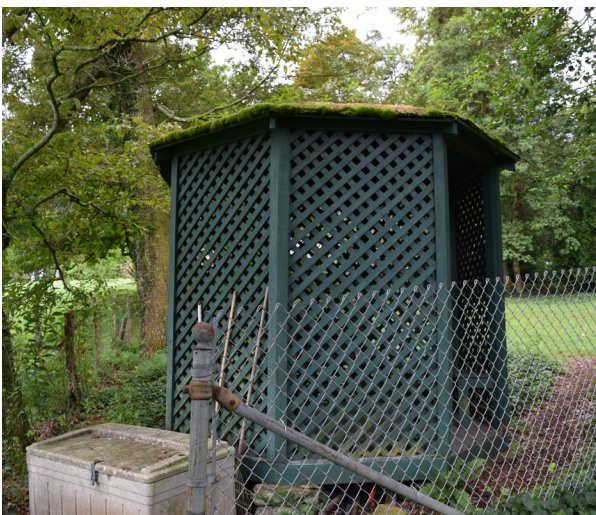
33 **Figure 3. 84.** The west side of the Gazebo (Source: WLA
34 Studio).

23 This small hexagonal frame structure is enclosed
24 by diagonal lattice, painted green (Figure 3. 83 -
25 Figure 3. 84). It is supported by stacked stones.
26 The structure, dating to circa 1900-1945, is located
27 northwest of the Main House, adjacent to the
28 Summer Garden. The roof has a thick layer of
29 moss. The structure was used by the Sandburgs to
30 store garden tools.

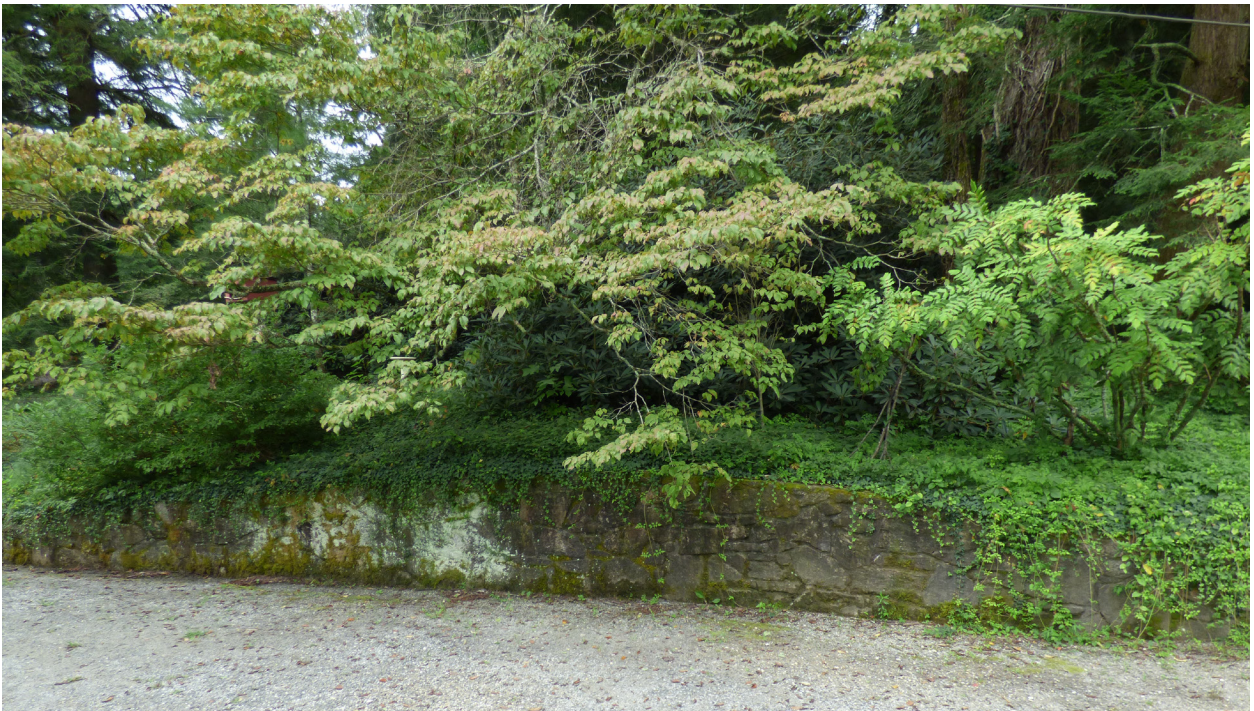
Figure 3. 91. The retaining wall behind the Main House. View to south (Source: WLA Studio).

There is an approximately 21-foot-long by 4-foot-tall stone retaining wall on the south side of the Main House (Figure 3. 91). There is an 8-foot-long, 2-foot-tall dry stack retaining wall on the north side of the Lily Garden (Figure 3. 92). A 2-foot-tall, approximately 23-foot-long stone retaining wall provides foundation for the Wood Shed building. A low stone wall, completely overgrown with ivy, spans approximately 26 feet between the Spring House and the Back Drive.

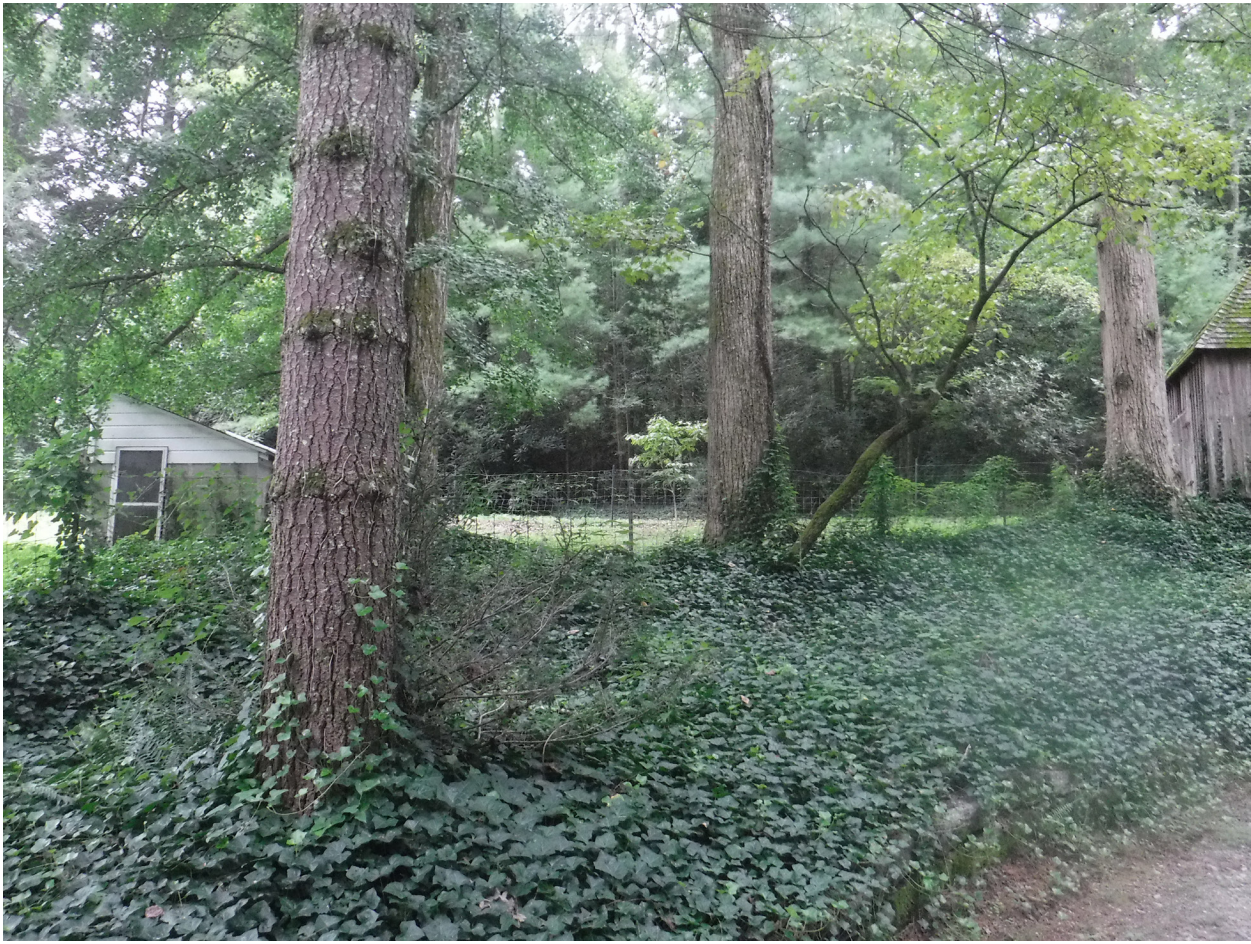
1 **Figure 3. 92.** A stone retaining wall northwest of the Spring House is barely visible underneath English Ivy (Source: WLA
2 Studio).

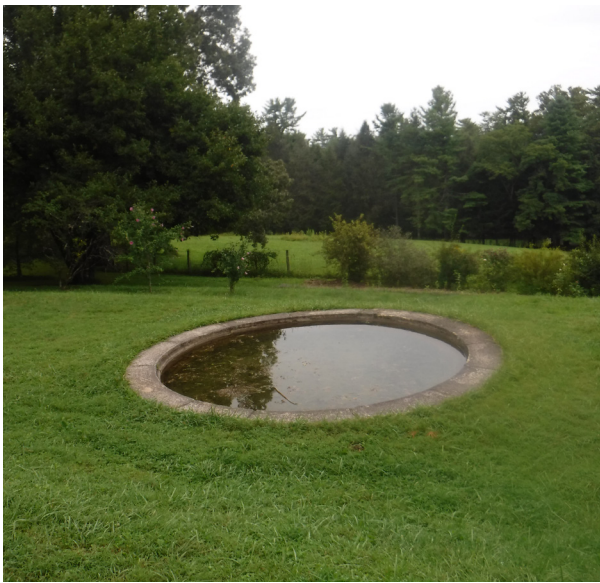
5 **Figure 3. 93.** The spring fed pool north of the Main House.
6 View to the north (Source: WLA Studio).

The Fountain Pool is a stone circular pool approximately 2 feet in depth and 15 feet in diameter (Figure 3. 93). A 1-foot-wide stone band surrounds the pool flush with the grade. The pool is spring fed.

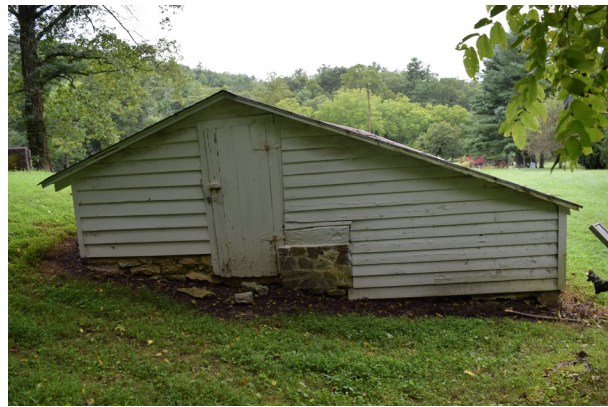
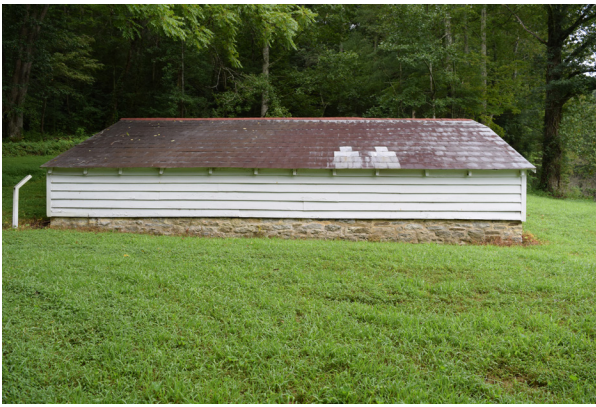
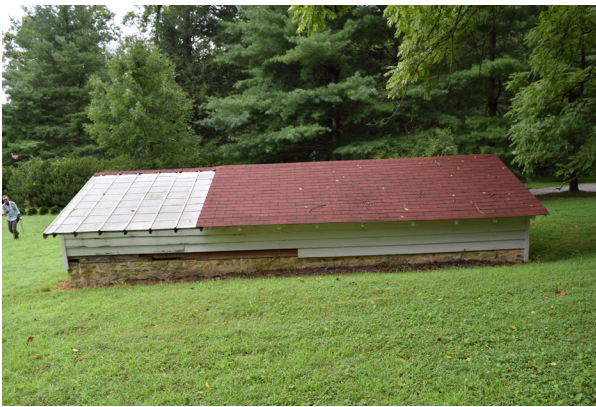
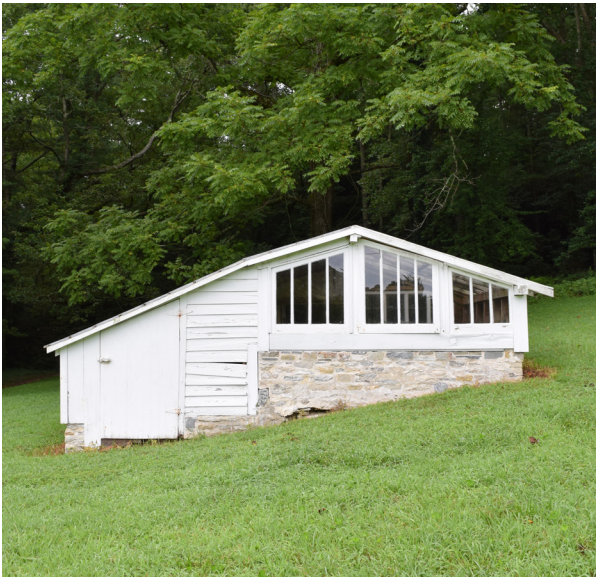
3 **Figure 3. 94.** The east façade of the Greenhouse (Source:
4 WLA Studio).

48 **Figure 3. 95.** The north façade of the Greenhouse (Source:
49 WLA Studio).

50 **Figure 3. 96.** The south façade of the Greenhouse (Source:
51 WLA Studio).

52 **Figure 3. 97.** The west façade of the Greenhouse (Source:
53 WLA Studio).

6 The Greenhouse dates to the Memminger
7 Period and was built originally as a root cellar.
8 The Sandburgs initially used the building as a
9 greenhouse or potting shed, but the family did not
10 maintain the building (Figure 3. 94 - Figure 3. 97).
11 The building is set into the grade with a fieldstone
12 foundation and subterranean ground floor. The
13 Greenhouse is located approximately 60 feet south
14 of the Back Drive, separated from the main farm
15 core cluster. The building is frame construction
16 with white siding and an irregular gable roof that
17 appears to have had modifications to the framing.
18 The west gable changes pitch, creating a steeper
19 pitch towards the north side of the building. The
20 east gable is missing the pitch change, indicating
21 that the roof may require structural repair. The
22 northern half of the gable has tin plate shingles,
23 while the southern half of the gable is partially

24 covered with red asphalt shingles and some tin
25 plate shingles with vertical seams. There are multi-
26 pane fixed and casement windows and one door
27 on the west façade, with a second door on the east
28 side. There are areas of noticeable rot and peeling
29 paint, as well missing boards and sections of the
30 stone foundation missing on the west façade. The
31 building is in fair condition.

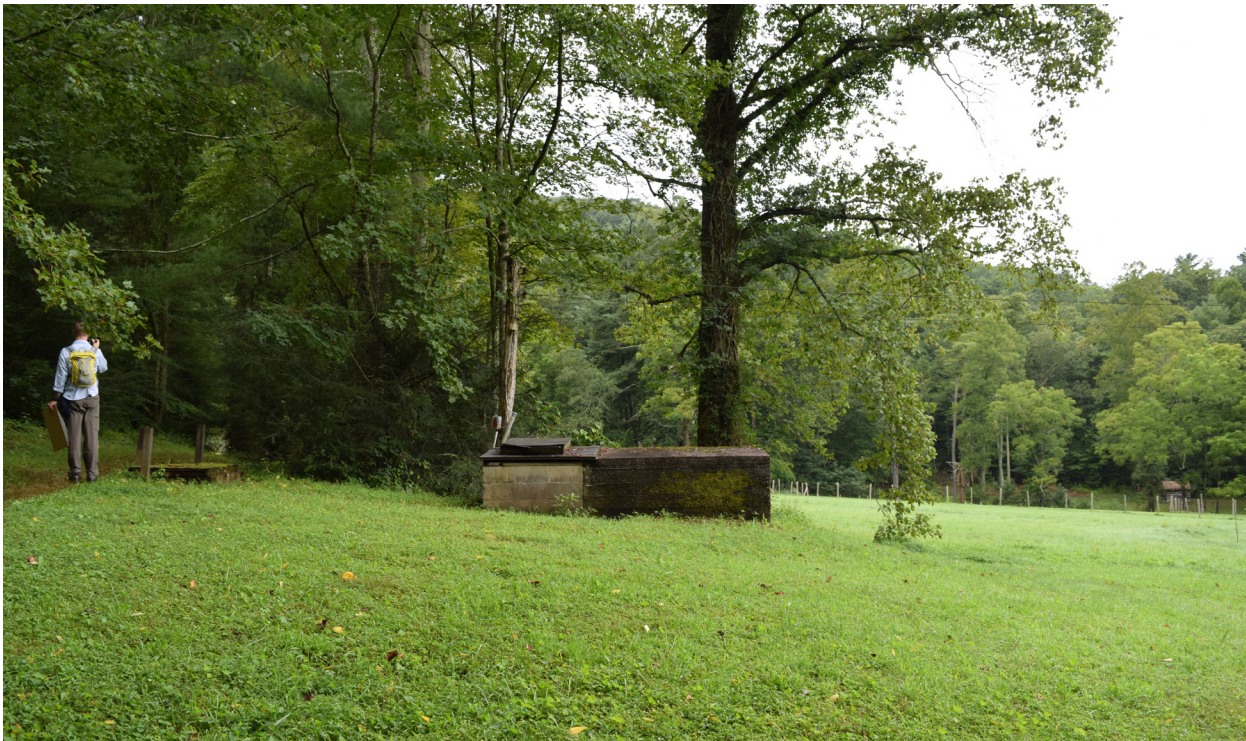
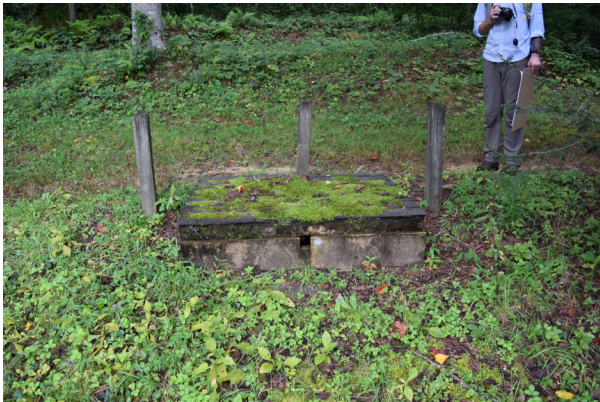
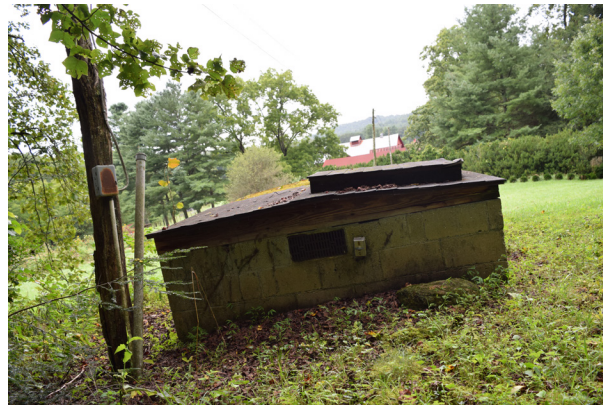
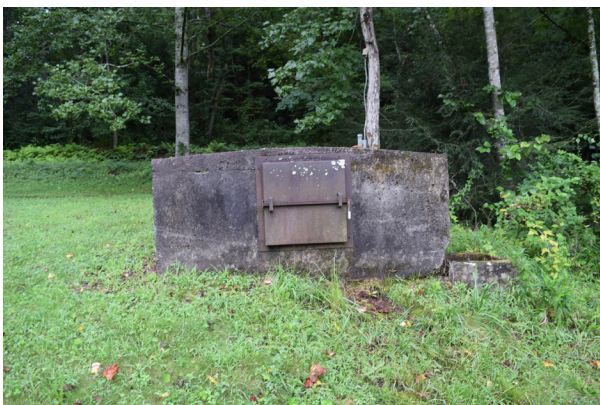
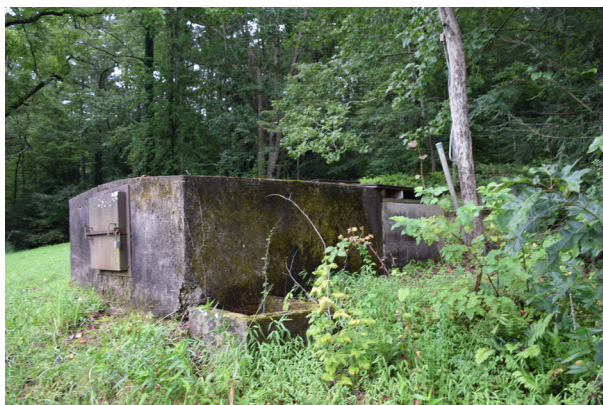
1 **Figure 3. 98.** The Barn Pump House is a two-part small structure. View to the west (Source: WLA Studio).

4 **Figure 3. 99.** The Barn Pump House cistern. View to the south (Source: WLA Studio).

2 **Figure 3. 101.** The Barn Pump House. View to the north (Source: WLA Studio).

6 **Figure 3. 100.** The Barn Pump House. View to the south (Source: WLA Studio).

8 **Figure 3. 102.** The Barn Pump House has an outlet point on the east side (Source: WLA Studio).

33 This is a low, two-part rectangular cistern
34 structure approximately 30 inches above grade and
35 constructed in two parts: one is concrete block
36 with an asphalt roof and the other is board-formed
37 concrete with a concrete roof. The structure
38 appears to have been constructed circa 1900-1945
39 (Figure 3. 98 - Figure 3. 102). The pump house has
40 a locked steel access panel on the north façade.
41 Water enters the structure below grade and exits
42 via a PVC pipe on the west side, which then dives
43 below grade. This structure aided in supplying
44 water to the other buildings in the Farm Core
45 area. There is also an associated board-formed
46 concrete access hatch (with asphalt-shingled roof)
47 approximately 10 feet south of the structure.

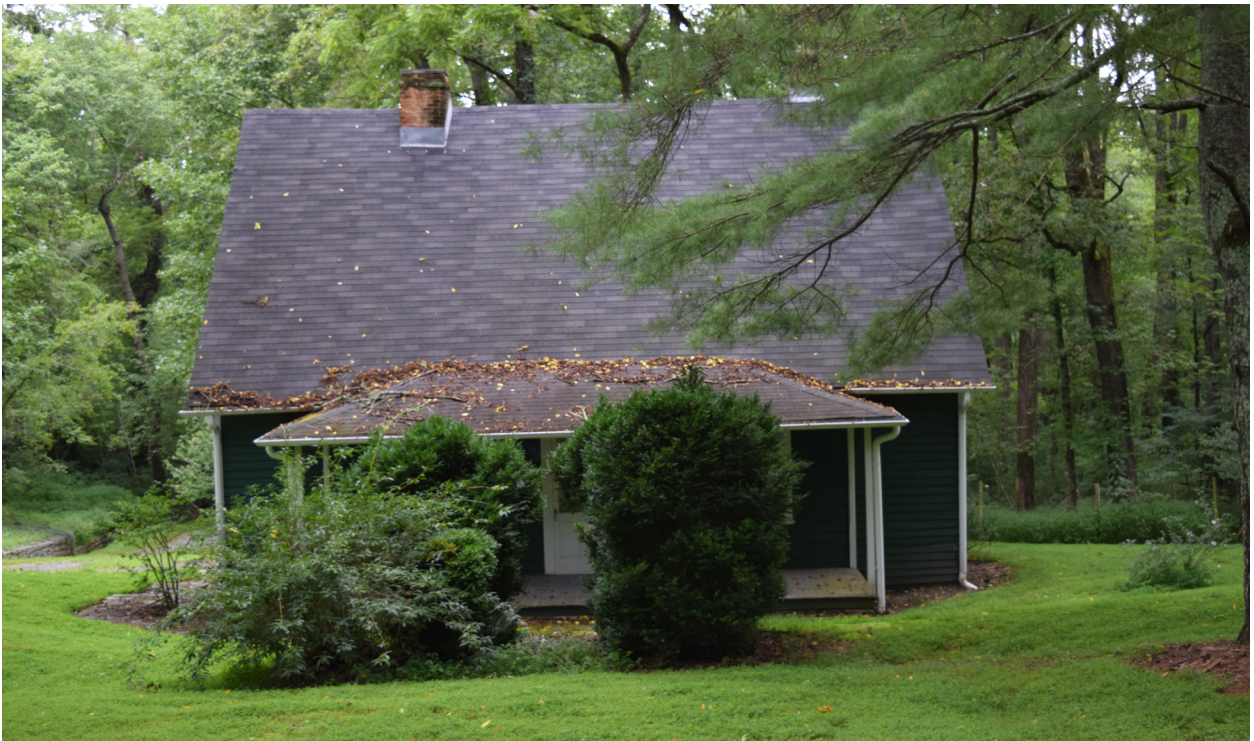
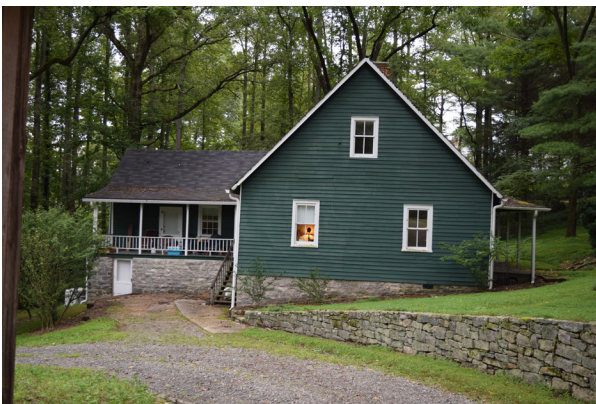
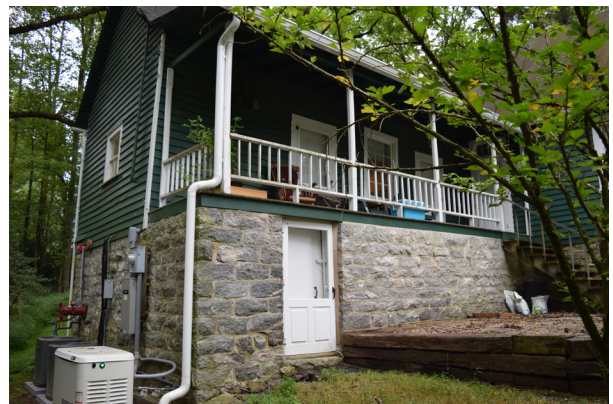
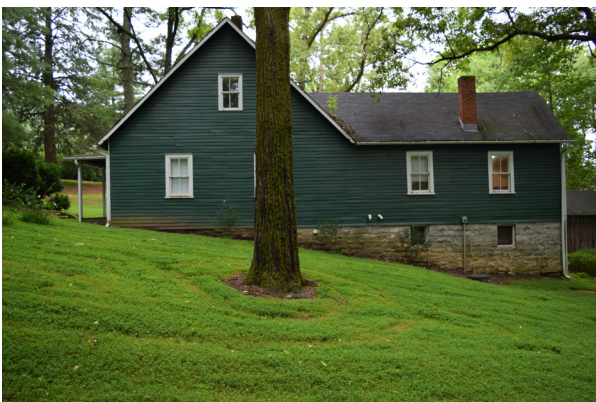
1 **Figure 3. 103.** The south façade of the Farm Manager's House (Source: WLA Studio).

2 **Figure 3. 104.** The west façade of the Farm Manager's House (Source: WLA Studio).
3

4 **Figure 3. 106.** The northwest façade of the Farm Manager's House (Source: WLA Studio).
5

6 **Figure 3. 105.** The east façade of the Farm Manager's House (Source: WLA Studio).
7

8 The Farm Manager's House, built circa 1912,
9 is a 1½ story, L-shaped, frame building with
10 green wood siding and white trim set on a stone
11 foundation that forms a walk-out basement to
12 the rear of the building (Figure 3. 103 - Figure 3.
13 106). It has an asphalt roof. The Sandburgs' Farm
14 Manager used the building as a residence, but it is
15 now used to house park staff. The building faces
16 southeast and is axially aligned with other buildings

17 in the main Farm Core cluster. The front entry
18 porch has a hipped roof supported by wood posts
19 set on a wood deck, which covers a front door and
20 two flanking two-over-two windows. There are
21 eight additional windows of this style on the west
22 and east façades, and one single pane window on
23 the north side. The rear porch is covered by a shed
24 roof supported by wood posts on the "L" portion
25 (west side) of the building. The porch is accessed
26 by an unpainted wooden staircase with nine risers
27 and a handrail with plain rectangular balusters.
