Carl Sandburg Home National Historic Site Cultural Landscape Report

85% Draft Submittal
September 2021

Cultural Resources, Partnerships, and Science Division
Interior Region 2 - South Atlantic Gulf

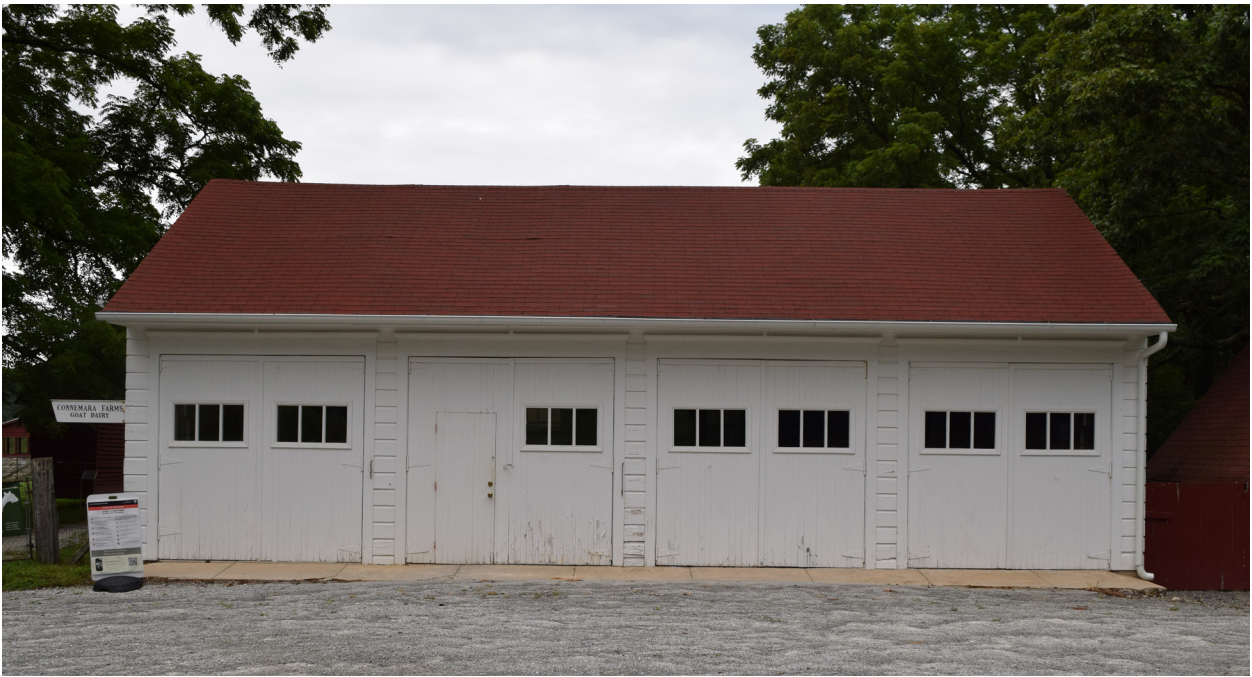
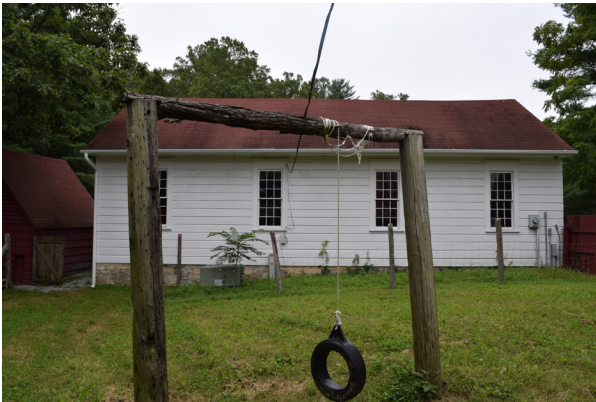
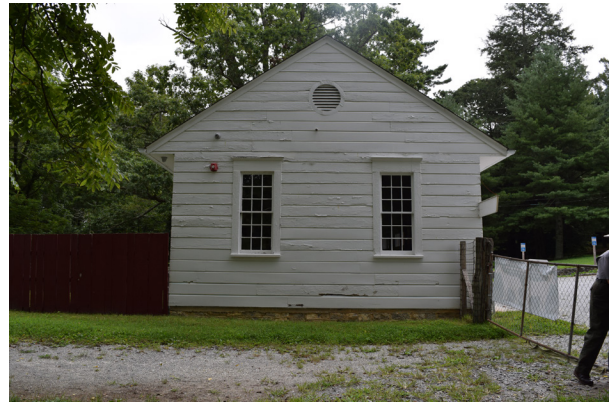
1 **Figure 3. 110.** The south façade of the Barn Garage (Source: WLA Studio).

2 **Figure 3. 111.** The north façade of the Barn Garage. In the
3 foreground is a tire swing used to entertain the goats. View
4 to the south (Source: WLA Studio).

5 **Figure 3. 112.** The west façade of the Barn Garage (Source:
6 WLA Studio).

27 The Barn Garage is a side-gabled, four-bay
28 frame building with a red asphalt roof and wood
29 siding, painted white. It rests on a concrete
30 slab foundation (Figure 3. 110 - Figure 3. 112).
31 Constructed during the Smyth Period in 1925,
32 the Sandburgs later used it as a utility building.
33 It is now used as an exhibit area. The building
34 faces south towards the Back Drive and has four

2 sets of wooden hinged garage doors, each with
 3 a three-light window. One garage door has been
 4 converted to a standard size entry door. There are
 5 four nine-over-nine windows on the north façade,
 6 and two each on the east and west facades. The
 7 siding shows signs of weathering and peeling paint
 8 in some areas. Attached on the west face of the
 9 building is a sign titled “Connemara Farms Goat
 10 Dairy.” The signage is white with black lettering.
 11 The building is equipped with electrical power.

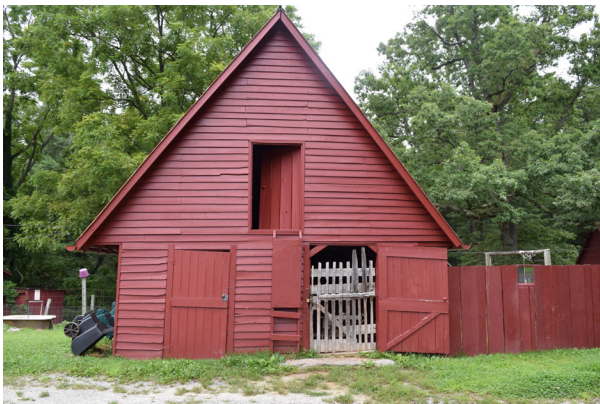
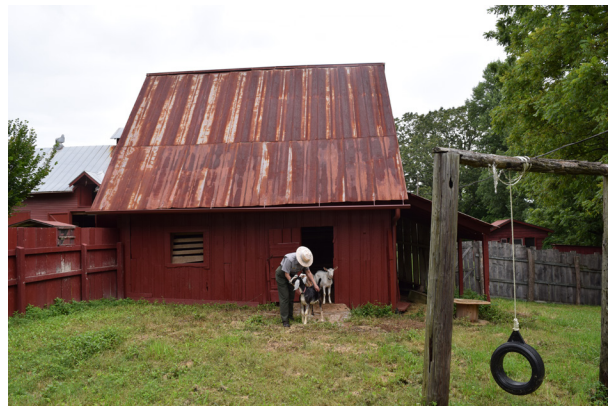
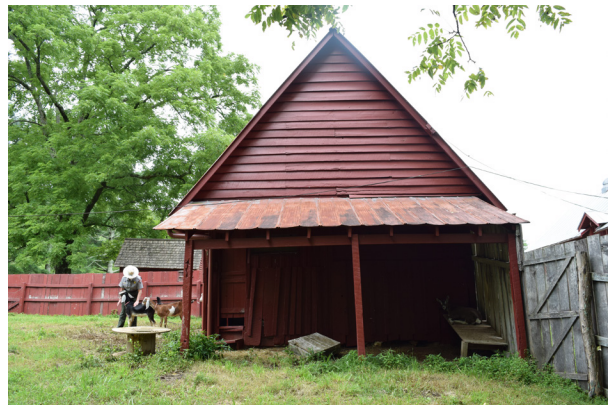
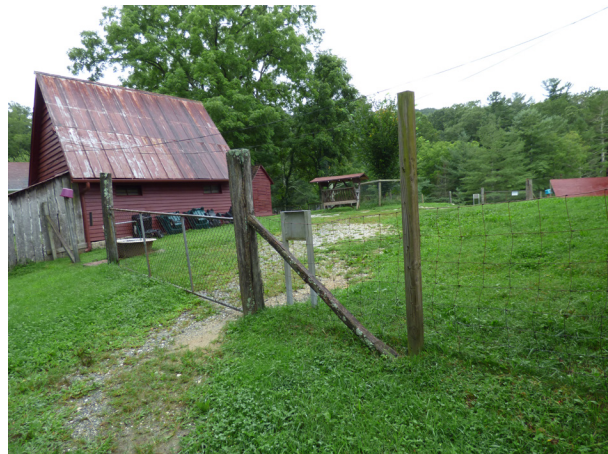
13 **Figure 3. 115.** The west façade of the Buck Kid Quarters;
14 painted picket fencing visible at right (Source: WLA Studio).

1 **Figure 3. 116.** The south façade of the Buck Kid Quarters
2 (Source: WLA Studio).

5 **Figure 3. 117.** The east façade of the Buck Kid Quarters
6 (Source: WLA Studio).

9 **Figure 3. 118.** The north façade of the Buck Kid Quarters.
10 In the foreground is a chain-link vehicular gate and visible
11 repairs to woven-wire fencing. View to the southwest
12 (Source: WLA Studio).

21 The Buck Kid Quarters is a 1 ½ story steep gabled
 22 frame building with red painted wood siding.
 23 The nineteenth century (Memminger Period)
 24 building was modified significantly from its

original construction (Figure 3. 115 - Figure 3. 118). The Sandburgs used it to house male kid goats. The building faces west and is located just south of the Main Barn. The roof is tin, heavily rusted, with overhanging eaves. The building has three doors on the west façade, with a slatted wood gate inside one of the doorways and a ladder to a door on the top story. The south façade has a window opening barred with wood slats from the inside, and a small door. The east façade has one door covered by a lean-to overhang supported by three posts. Enclosed on one side by wood fencing, the building has an integrated bench for the buck kid goats. The north façade has small barred window openings. The building is equipped with electrical power.

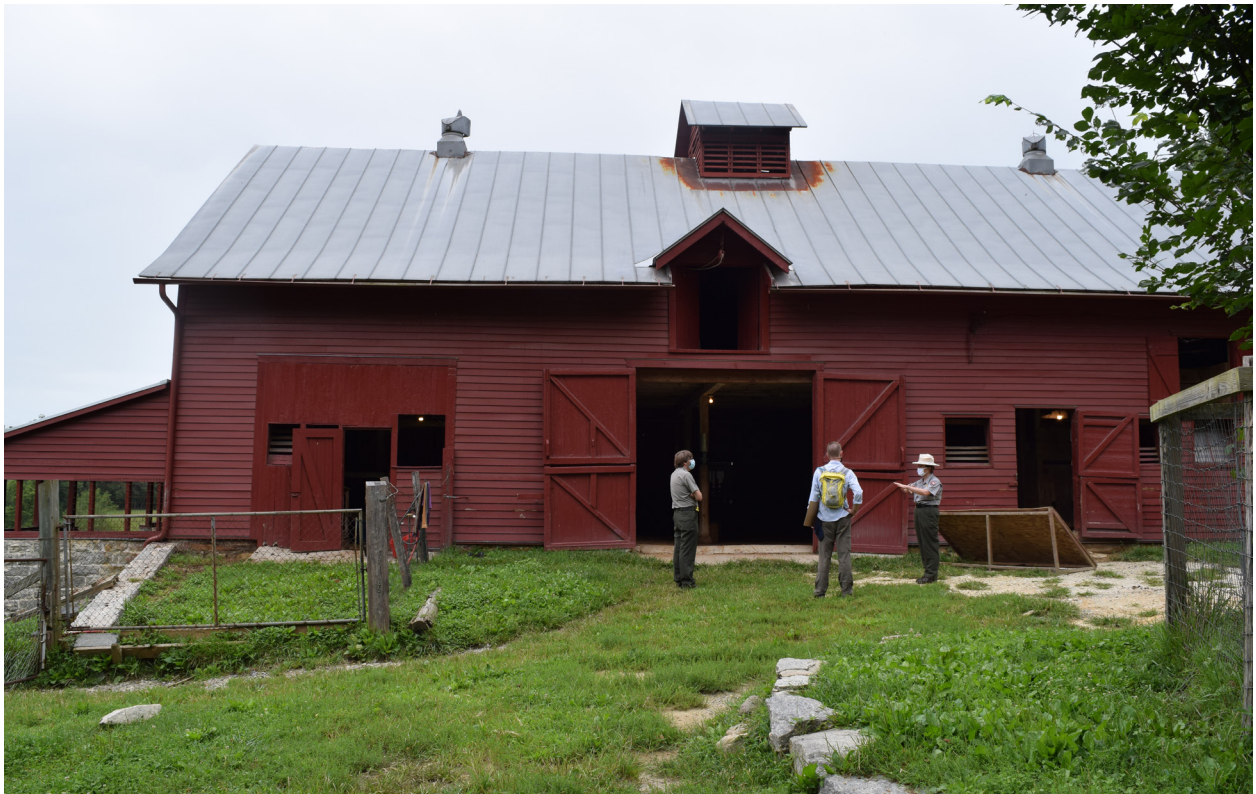
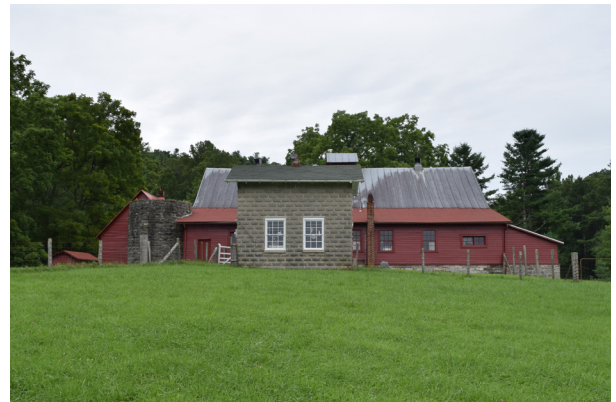
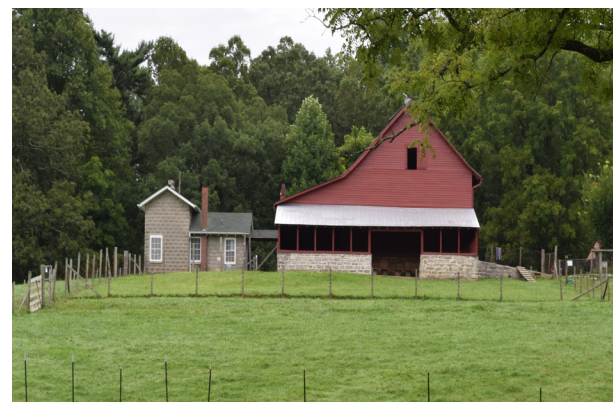
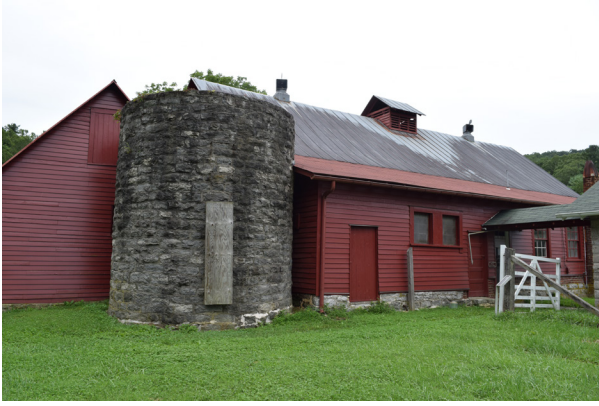
1 **Figure 3. 119.** The south façade of the Main Barn (Source: WLA Studio).

25 **Figure 3. 120.** The north façade of the Main Barn (Source:
 26 WLA Studio).

27 **Figure 3. 121.** The west façade of the Main Barn (Source:
 28 WLA Studio).

Figure 3. 122. The northeast corner of the Main Barn is connected to the Silo structure. At left is the north façade of the Horse Barn (Source: WLA Studio).

The Main Barn is a two-story side-gabled rectangular frame building with red wood siding, a metal roof, and a central cupola spanning the peak, which is flanked by two ventilators. The barn is set on a fieldstone foundation (Figure 3. 119 - Figure 3. 122). The building dates to the Smyth Period but was heavily altered by Mrs. Sandburg for her goat dairy operation. The building faces south towards the Back Drive, serving as the central building to which other buildings in the Farm Core cluster are oriented. The south face has a central double door with a hay loft above and flanking doors on either side. There are square barred window openings and a second hay loft access door. The west façade has a shed roof extension supported by a fieldstone foundation wall. The east side is closely abutted to the neighboring Horse Barn, with a small walkway between. Interior openings provide access to the Silo. The north façade is an asphalt-shingled shed

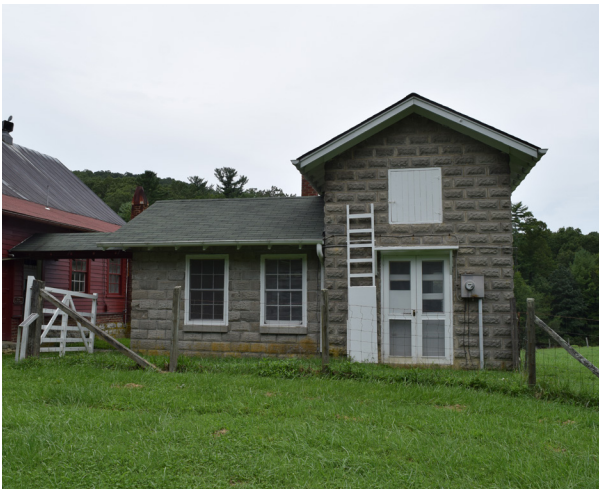
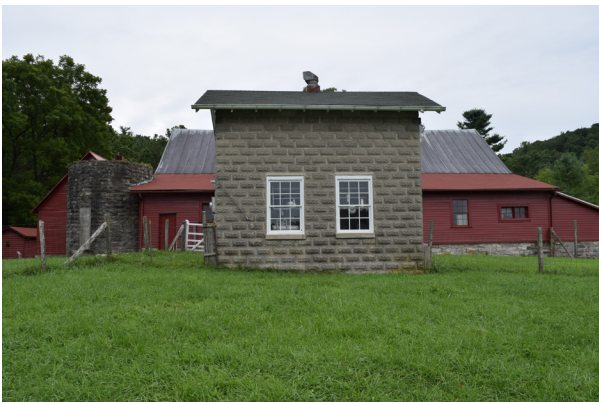
Figure 3. 125. The west side of the Milk House (Source: WLA Studio).

Figure 3. 123. The east side of the Milk House behind the Main Barn (Source: WLA Studio).

Figure 3. 124. The north side of the Milk House (Source: WLA Studio).

8 Paula Sandburg designed the Milk House to
9 process and bottle milk. The first portion was built
10 around 1947 and the second part after 1951 (Figure
11 3. 123 - Figure 3. 125). The first portion faces the
12 Main Barn and is aligned 7 feet from the rear barn
13 door. The 1947 portion is a one story, front-gabled
14 building; the connected 1951 portion is 1½ stories,
15 also front gabled, but with the front door facing
16 east. Both portions of the building are textured
17 concrete block construction with an asphalt
18 shingle roof and six-over-six windows, seven in
19 total, and three doors (one double French door),
20 and a brick chimney. A hatch over the east side
21 door is accessible by a wood ladder. The building
22 is equipped with water, electrical power, and a
23 restroom.

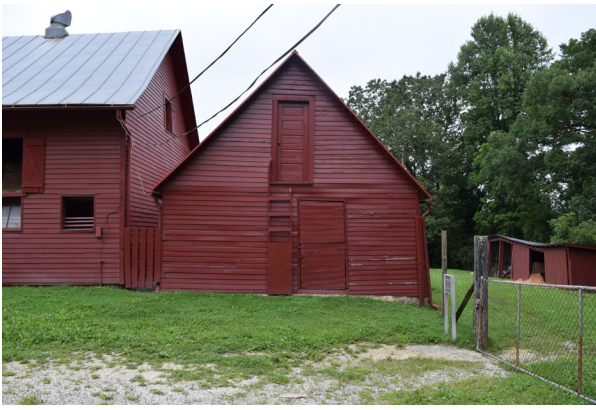
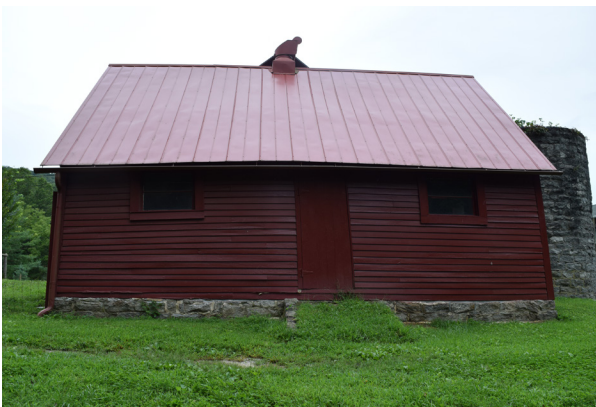
24 **Figure 3. 126.** The south façade of the Horse Barn (Source:
25 WLA Studio).

26 **Figure 3. 127.** The east façade of the Horse Barn (Source:
27 WLA Studio).

10 The Horse Barn was built during the Smyth era
11 as horse stables. The Sandburgs used the building
12 for both horses and tack. The building has been
13 modified heavily since its construction (Figure
14 3. 126 - Figure 3. 127). The 1 ½-story, steep front
15 gabled metal roofed frame building has wood
16 siding, painted red, and is located adjacent to the
17 Main Barn on its east side. It faces south. There
18 is a ventilator centered on the gable. The building
19 is supported by a fieldstone foundation, with a
20 stone ramp on the east side. The south façade has
21 a door on each level, with a ladder to the loft door. 28
22 The east side has two windows and a door, with 29
23 another loft door on the north side. The building
24 closely abuts the Silo structure. There are signs
25 of weathering on the siding in some areas, but
26 the building is otherwise in good condition. The
27 building is equipped with electrical power.

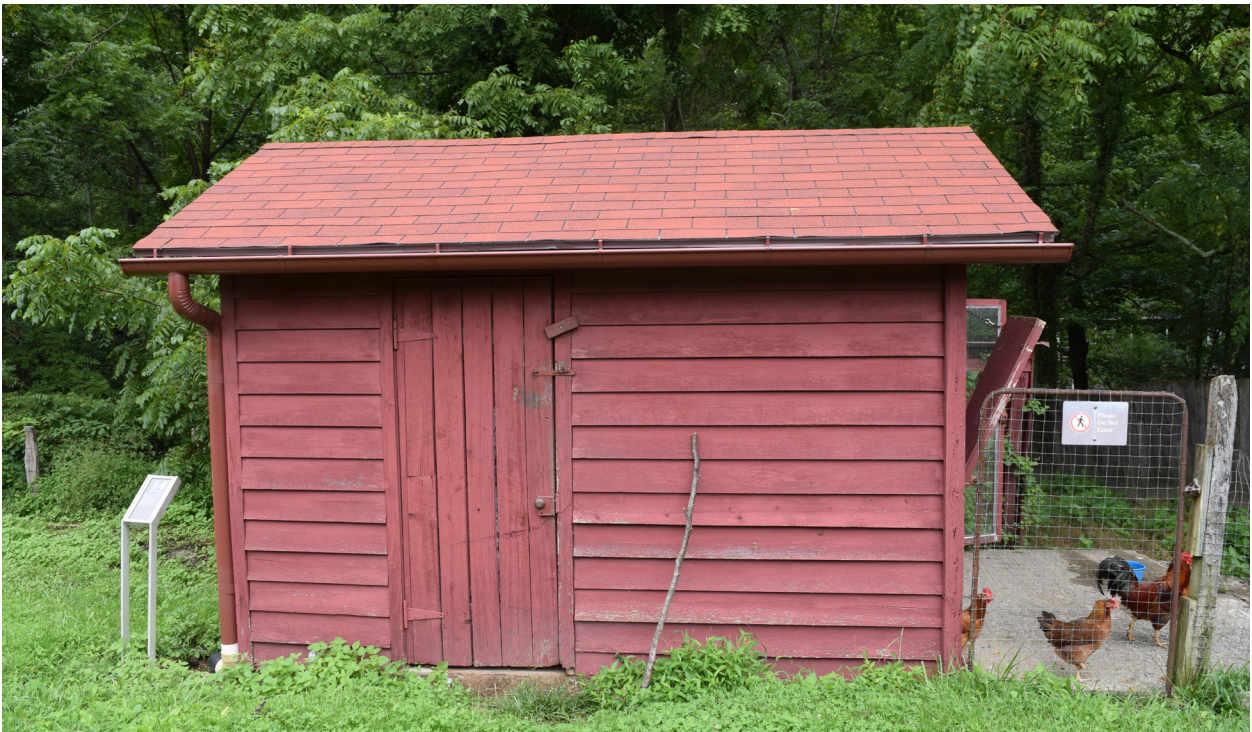
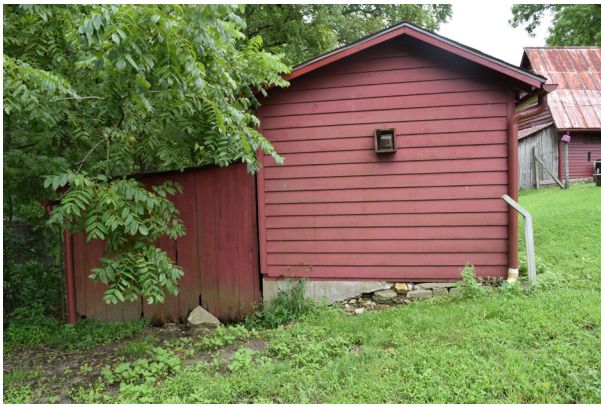
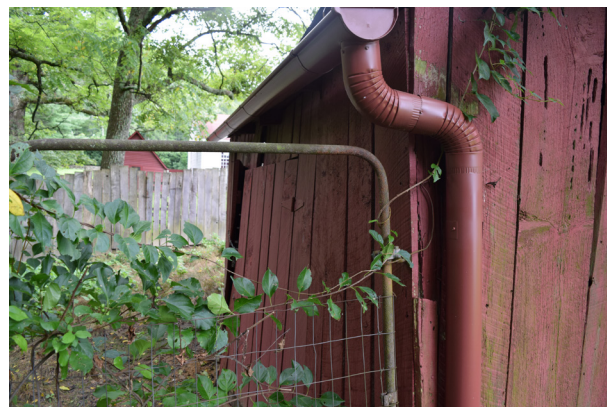
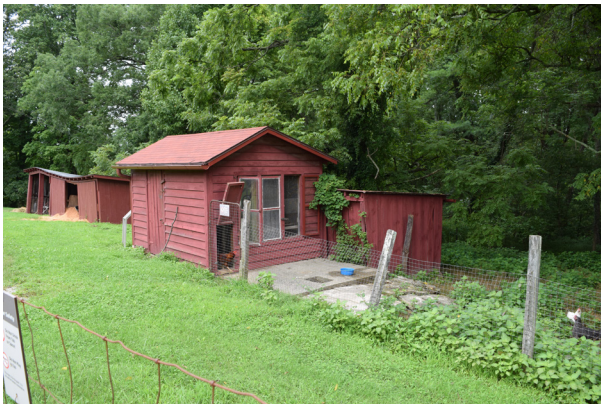
28 **Figure 3. 128.** The west side of the Cow Shed (Source: WLA Studio).

1 **Figure 3. 129.** The north side of the Cow Shed (Source: WLA 3
2 Studio).

3 **Figure 3. 131.** The east side of the Cow Shed (Source: WLA
4 Studio).

5 **Figure 3. 130.** The south side of the Cow Shed. The fencing 7
6 is chicken-wire with square wood posts (Source: WLA Studio). 8

2 The cow shed is a small frame building with wood
3 siding, an asphalt-shingled gable roof outfitted
4 with gutters, and a lean-to addition (Figure 3.
5 128 - Figure 3. 131). The shed dates to the Smyth
6 Period and was intended as a turkey shed but
7 was modified by the Sandburgs to milk cows and
8 house chickens. The building has a full-size door, a
9 chicken hatch, and three windows, and the lean-
10 to is open to the east to house one or two cows
11 at most. The windows are screened with chicken
12 wire. The shed sits on a concrete slab foundation,
13 which is cracked in some areas. Portions of the
14 lean-to are set directly on the ground and some
15 boards are rotting at the ends. The building is
16 supported by stacked granite blocks on the south
17 elevation. Vegetation is growing over some parts
18 of the building. The building is equipped with
19 electrical power.

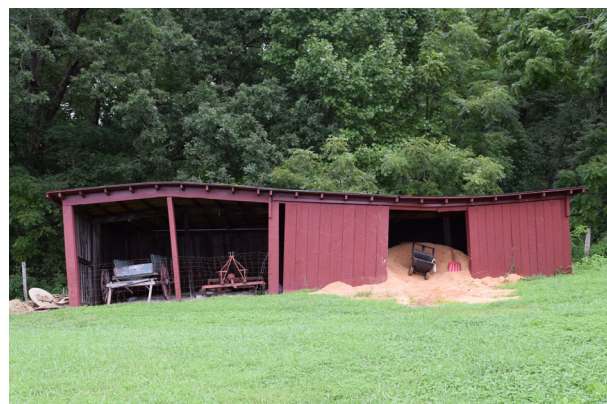
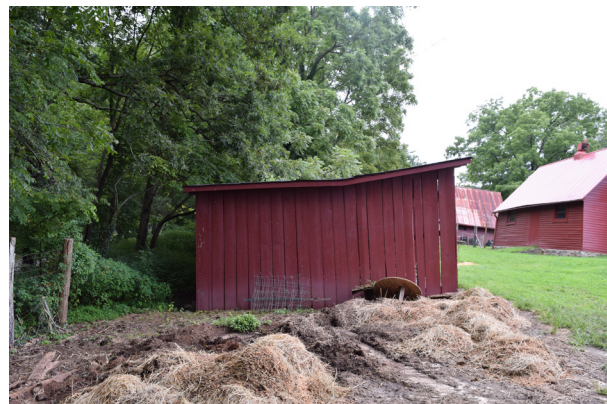
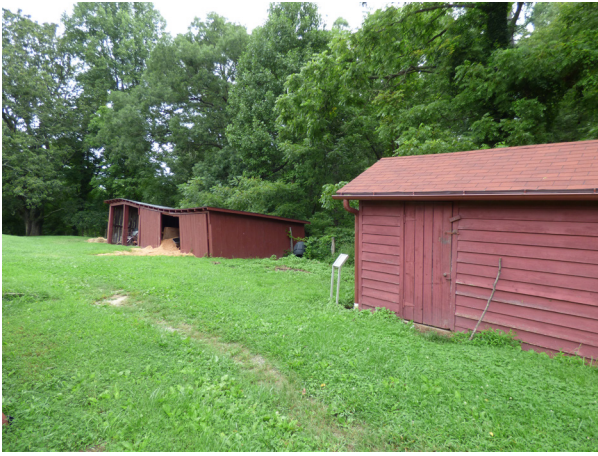
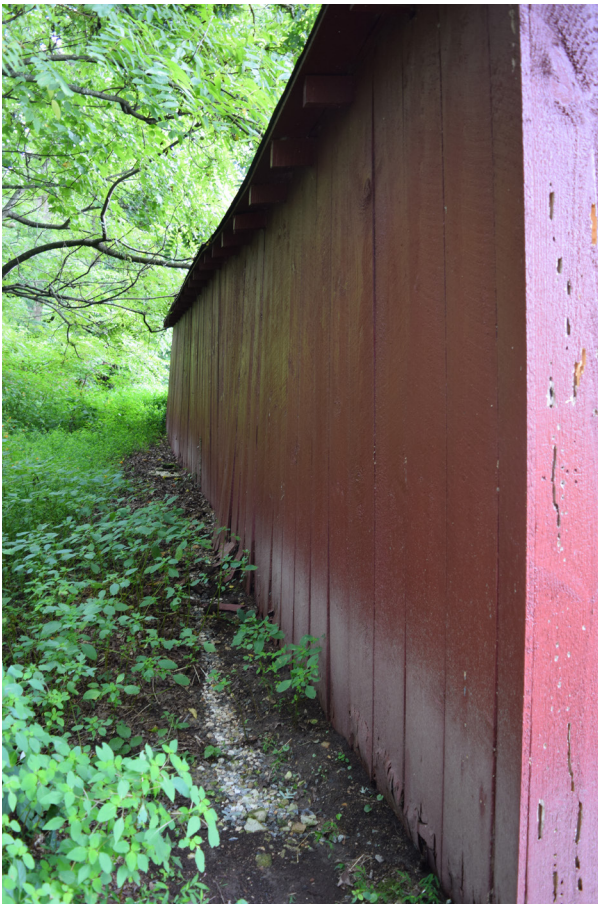
Figure 3. 132. The west side of the Hay Equipment Storage
Shed (Source: WLA Studio).

Figure 3. 133. The north side of the Hay Equipment Storage
Shed (Source: WLA Studio).

47 **Figure 3. 134.** The south side of the Hay Equipment Storage
48 Shed (Source: WLA Studio).

49 **Figure 3. 135.** The east side of the Hay Equipment Storage
50 Shed (Source: WLA Studio).

21 The Sandburgs built the Hay Equipment Storage
22 Shed during the late 1950s to store farm equipment
23 and the wood shavings used for goat bedding
24 (Figure 3. 132 - Figure 3. 135). The storage building
25 is just north of the Cow Shed, facing west towards
26 the Milk House. The building has a low-angled
27 composite shingled roof, pitched higher towards
28 the west side, and no foundation. The open west
29 side has five bays, with an S-curved roofline due to
30 insufficient framing for the load and spans. Sliding
31 doors are kept open to provide access to the wood
32 shavings. Two bays are open with farm equipment
33 stored inside. The building has a fire suppression
34 mechanism but no power. The building is showing
35 signs of deterioration on weathered vertical boards
36 in places where the boards meet the ground
37 surface.

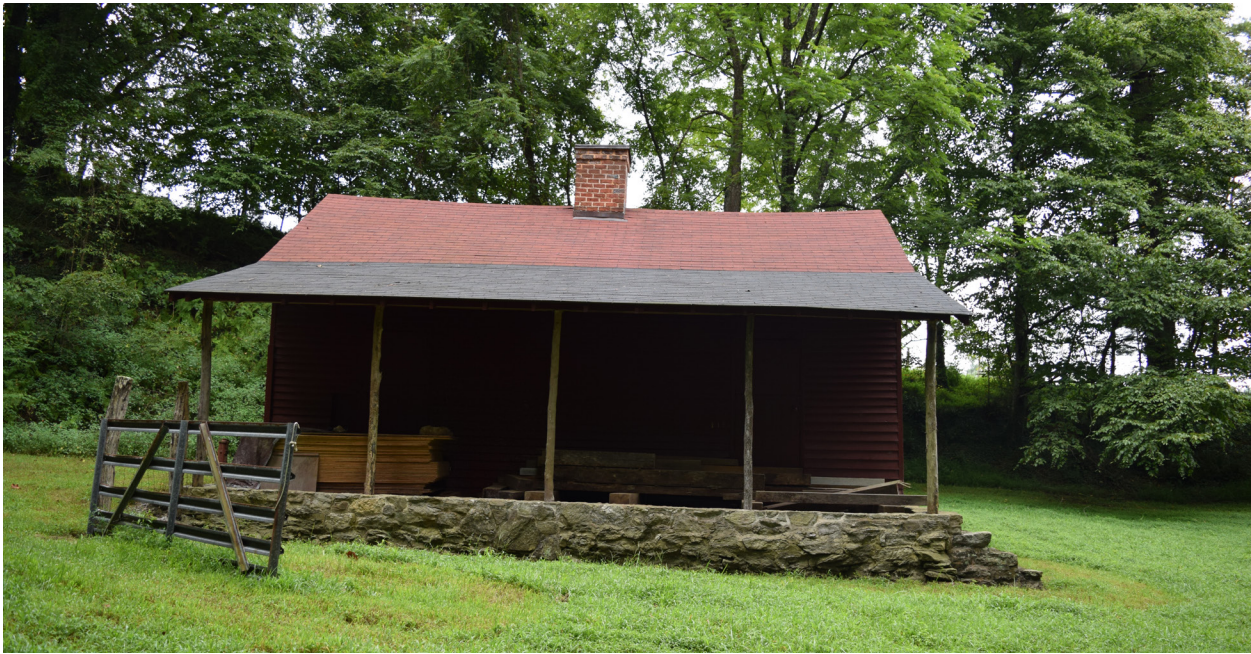
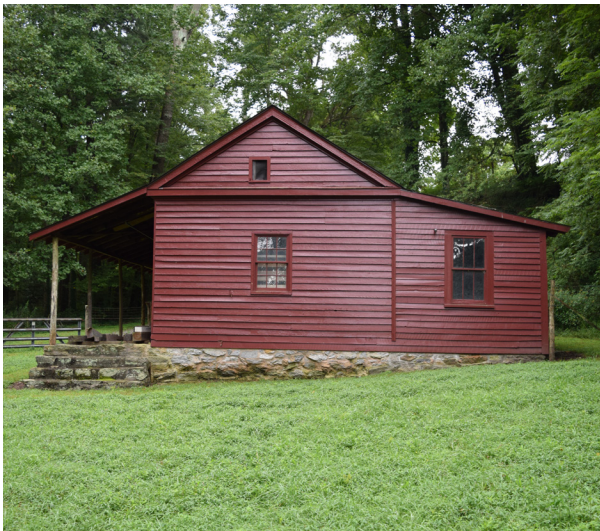
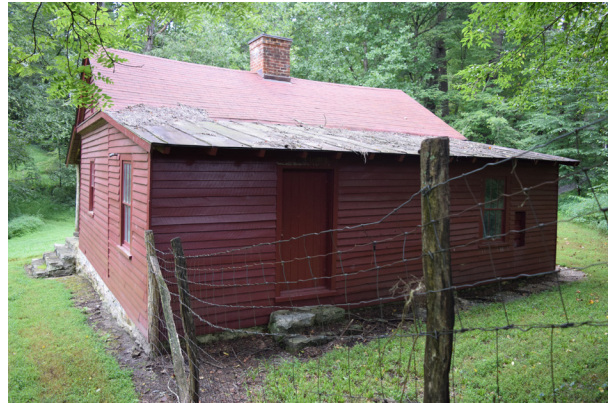
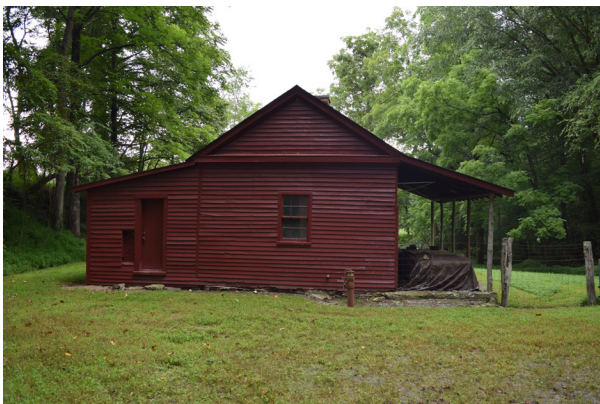
1 **Figure 3. 136.** The east façade of the Buck Kid House (Source: WLA Studio).

4 **Figure 3. 137.** The north façade of the Buck Kid House
5 (Source: WLA Studio).

2 **Figure 3. 139.** The west façade of the Buck Kid House
3 (Source: WLA Studio).

8 **Figure 3. 138.** The south façade of the Buck Kid House
9 (Source: WLA Studio).

3 This building is a former residence dating to
4 the Memminger Period, potentially during the
5 1830s-1850s, though exact date is unknown
6 (Figure 3. 136 - Figure 3. 139). It is possible that it
7 may predate the Memminger ownership of the site.
8 Located outside of the main Farm Core complex,
9 the building is set down into the landscape abutting
10 a bluff on the west side, at the end of a service
11 drive that begins by the Isolation Quarters. The
12 Sandburgs modified the building to house adult
13 male goats. The building is 1 ½-story, side gabled,
14 with composite shingle and metal roof portions.
15 It is a rectangular frame building with wood
16 siding, painted red, and has a central interior brick
17 chimney. It rests on a fieldstone foundation. A shed
18 roof extension supported by locust posts forms a
19 front porch the length of the east façade, protecting
20 two doorways. The building and its porch are

21 currently being used as covered storage. The porch
22 has large wooden beams and lumber stacked atop
23 beams set between the foundation walls but is
24 missing a floor. There is a set of four stone stairs to
25 the porch on the north façade, which suggests this
26 may have been the primary entrance direction. A
27 second shed roof addition projects from the west
28 side and is enclosed on all sides with two additional

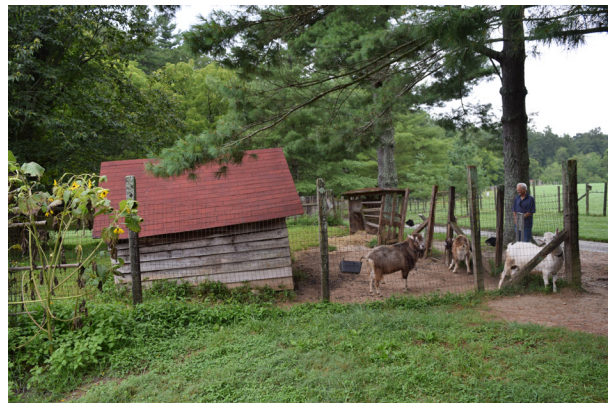
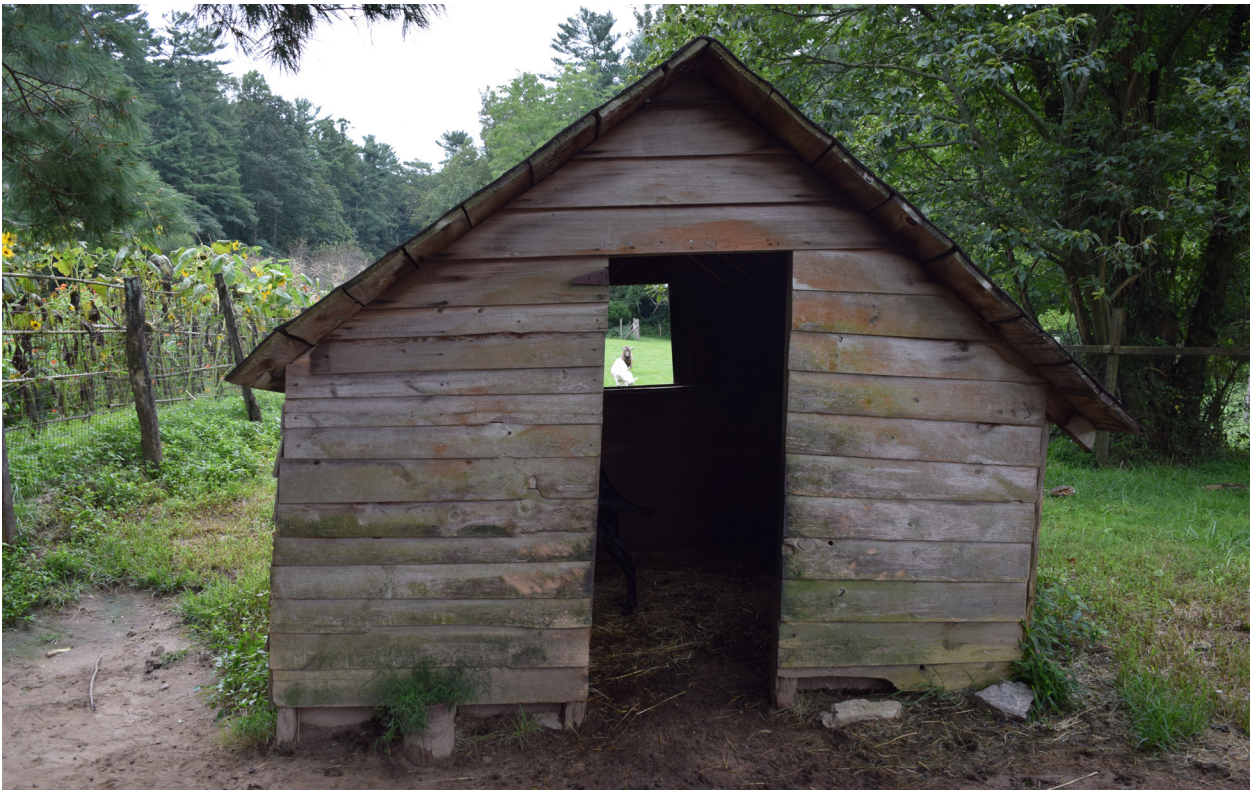
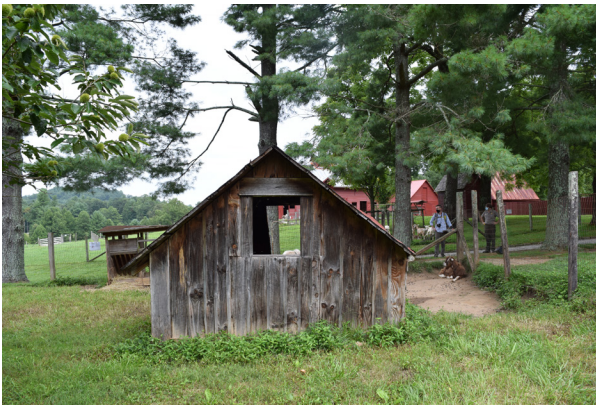
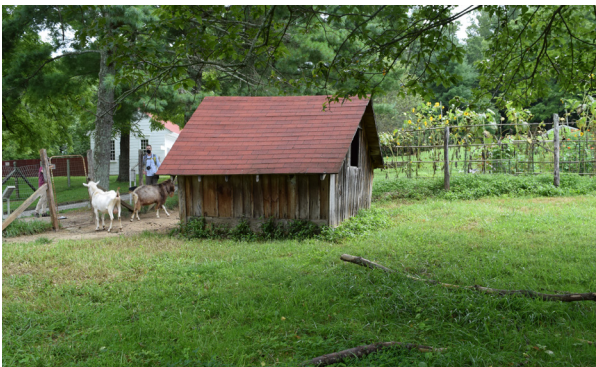
6 **Figure 3. 140.** The east side of Jennifer's House HS-24
7 (Source: WLA Studio).

1 **Figure 3. 141.** The north side of Jennifer's House HS-24 (Source: WLA Studio).

29 **Figure 3. 142.** The south side of Jennifer's House HS-24
30 (Source: WLA Studio).

31 **Figure 3. 143.** The west side of Jennifer's House HS-24
32 (Source: WLA Studio).

8 This building is adjacent to HS-25, across the main
9 service drive from the main Farm Core complex
10 near the vegetable gardens, facing north (Figure
11 3. 140 - Figure 3. 143). Named for a prize-winning
12 goat, the building is a small gabled building used
13 by the Sandburgs and today to house goats. It was
14 constructed circa 1945-48. It is comprised of frame
15 construction with red composite roofing, board-
16 and-batten and weatherboard siding, unpainted.
17 There is an open doorway on the north side and a
18 windowless opening on the south side. Adjacent to
19 the building is a wooden feeding stand with a shed
20 roof.

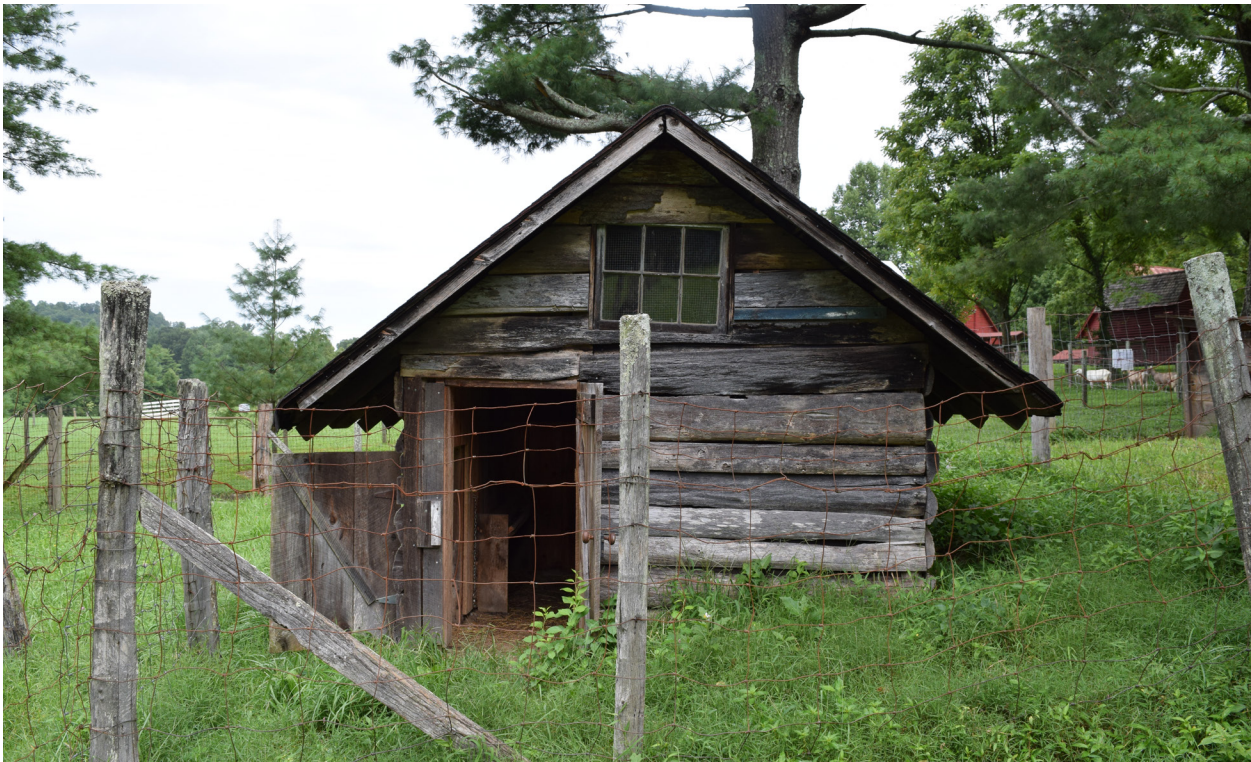
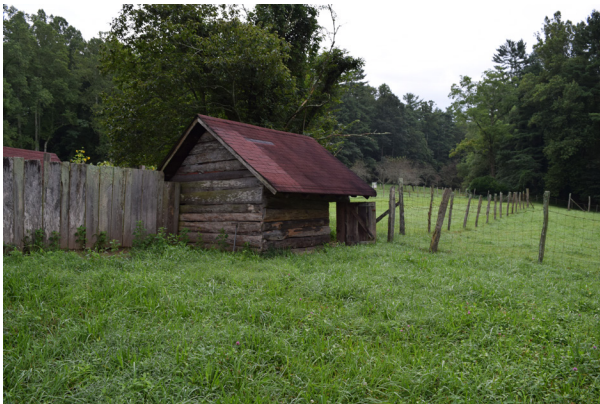
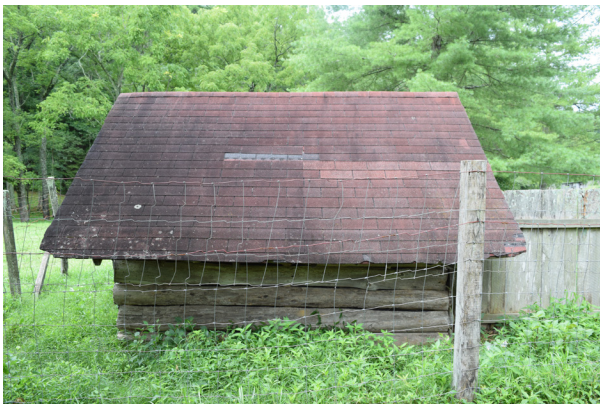
1 **Figure 3. 144.** The south side of Breeding Pen HS-25 (Source: WLA Studio).

27 **Figure 3. 145.** The northwest corner of Breeding Pen HS-25
28 (Source: WLA Studio).

29 **Figure 3. 146.** The east side of Breeding Pen HS-25 (Source:
30 WLA Studio).

22 This building is adjacent to HS-24, facing south
23 away from the main service drive (Figure 3. 144
24 - Figure 3. 146). The small gabled building was
25 used by the Sandburgs and is used today to house
26 goats. It is a frame construction with red composite

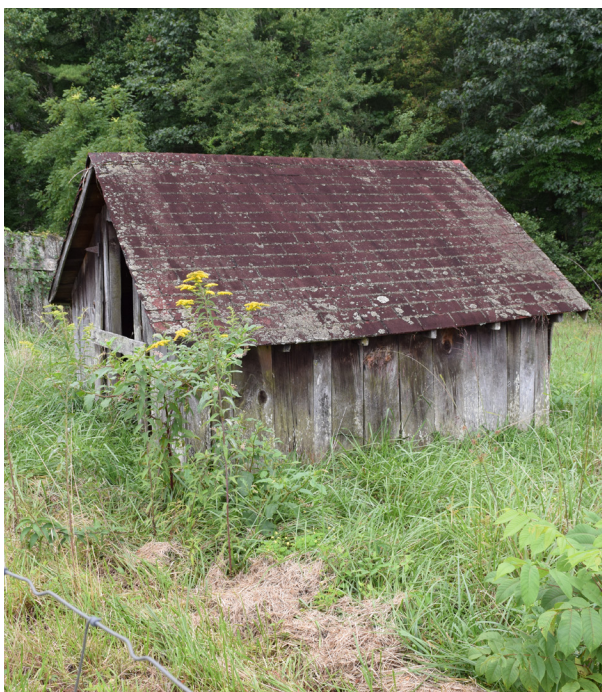
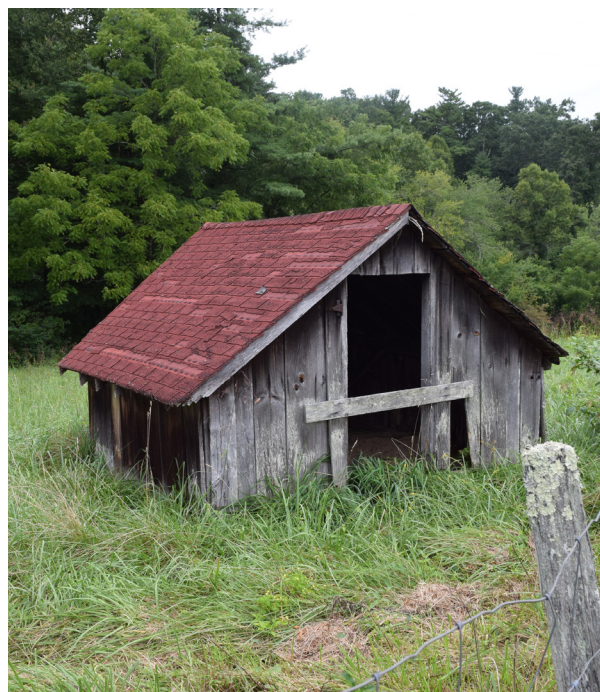
1 **Figure 3. 147.** The northeast corner of Manley's House HS- 26 (Source: WLA Studio). 2

3 **Figure 3. 148.** The southeast corner of Manley's House HS- 26 (Source: WLA Studio). 4

6 Manley's House is a small gabled frame building
7 with vertical wood siding used to house goats and
8 is located in a pasture northwest of the main Farm
9 Core cluster, near HS-27 (Figure 3. 147 - Figure
10 3. 148). The building has red composite roofing,
11 which is in poor condition, and a single open
12 doorway on the east face with a window opening
13 (missing sash) on the west face. The building,
14 constructed in the mid-to-late 1940s, is open-air
15 and was named for a special goat, Manley.

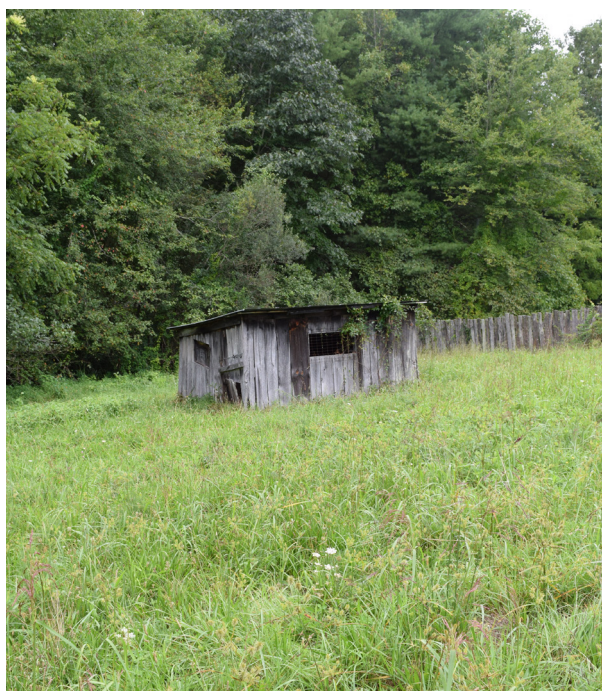
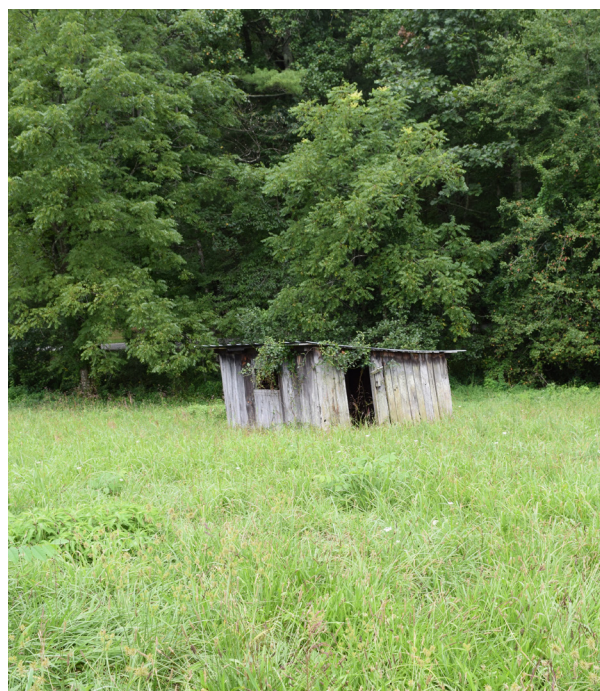
5 **Figure 3. 149.** The southeast corner of Buck House in Pasture 6 #3 HS-27 (Source: WLA Studio). 7

8 **Figure 3. 150.** The northeast corner of Buck House in Pasture #3 HS-27 (Source: WLA Studio).

17 The Buck House in Pasture #3 is a small shed-roof
18 frame building with vertical wood siding and is in
19 fair-to-poor condition (Figure 3. 149 - Figure 3.
20 150). Located south of HS-26, near the Duck Pond,
21 the building has two window openings, a small
22 goat door on the south side, and larger door on the
23 north side. It was constructed in the mid-to-late
24 1940s.

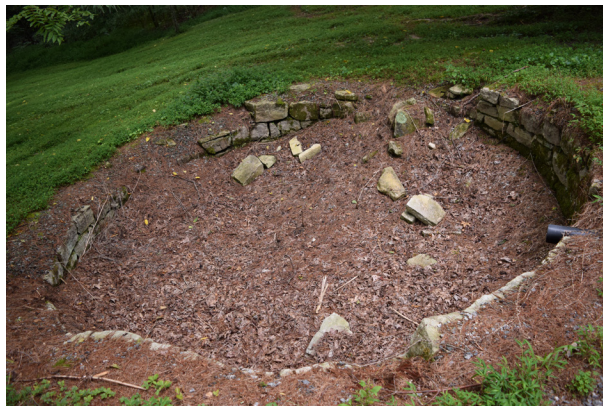
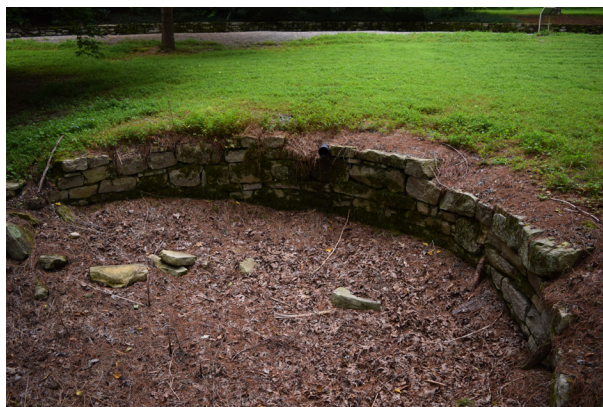
27 **Figure 3. 151.** Some areas of the stone Ice House foundation
28 have collapsed. View to the northeast (Source: WLA Studio).

29 **Figure 3. 152.** The stone Ice House foundation is south of,
30 the Farm Managers House. View to the southwest (Source: WLA Studio).
31

6 The Ice House is a ruin now and is only identifiable
7 by the extant stone foundation (Figure 3. 151
8 - Figure 3. 152). The subterranean cylindrical
9 stone foundation wall is approximately 4 feet
10 deep. The wall creates an open pit and is located
11 south of the Farm Manager's house near the main
12 drive. Built by Memminger in 1847, the structure
13 fell in significant disrepair during the Sandburg
14 period and was demolished by 1950. The existing
15 foundation wall is in poor condition, with failing
16 sections, and the pit is filled in with leaves and

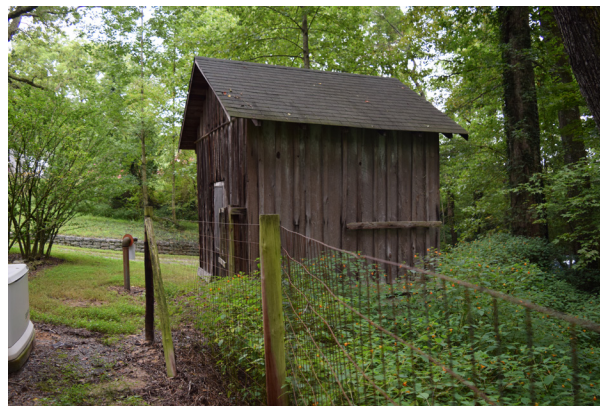
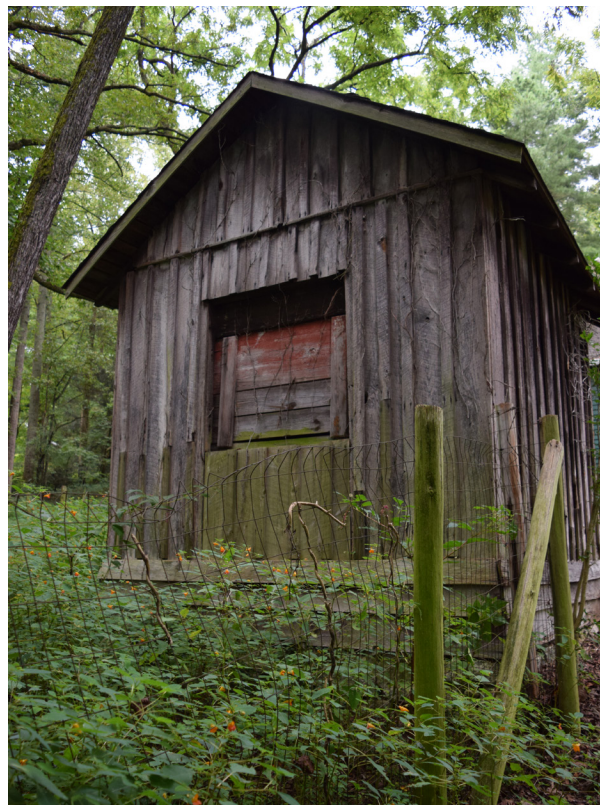
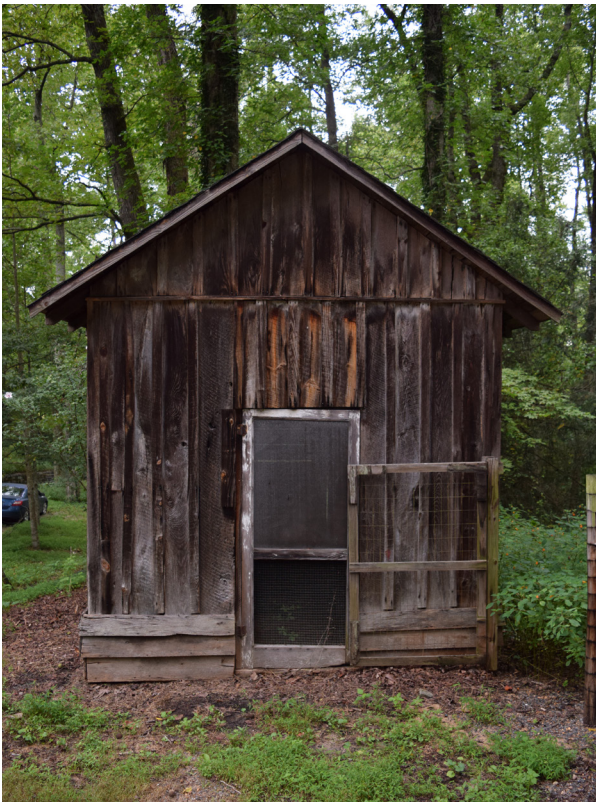
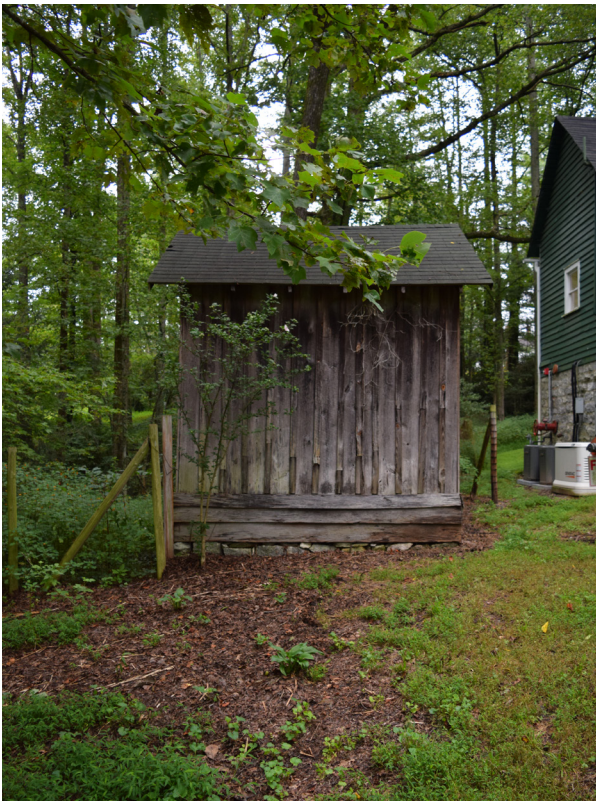
Figure 3. 153. The east side of the Farm Manager's Chicken House (Source: WLA Studio).

Figure 3. 154. The north side of the Farm Manager's Chicken House (Source: WLA Studio).

3 **Figure 3. 155.** The south side of the Farm Manager's Chicken
4 House (Source: WLA Studio).

7 **Figure 3. 156.** The west side of the Farm Manager's Chicken
8 House (Source: WLA Studio).

21 The Farm Manager's Chicken House is a small
22 gabled frame shed just northwest of the Farm
23 Manager's House and faces south (Figure 3.
24 153 - Figure 3. 156). The shed has a screen door
25 on the south face, board-and-batten unpainted

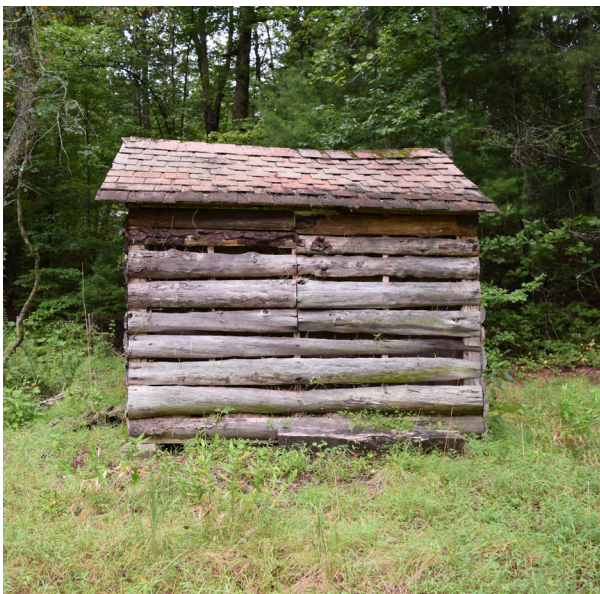
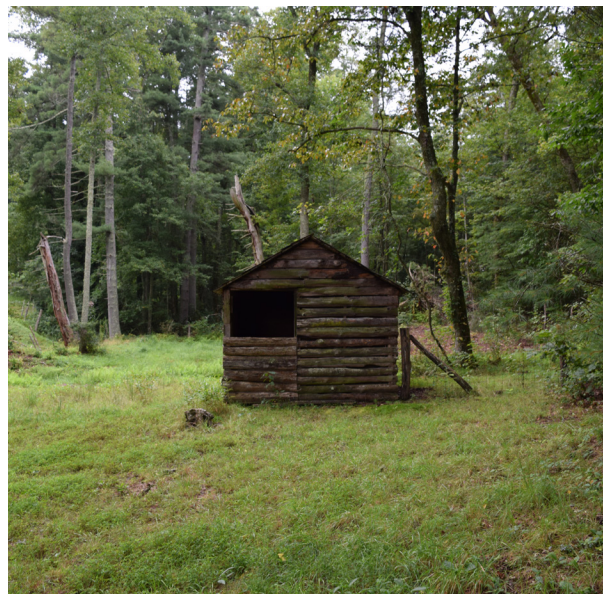
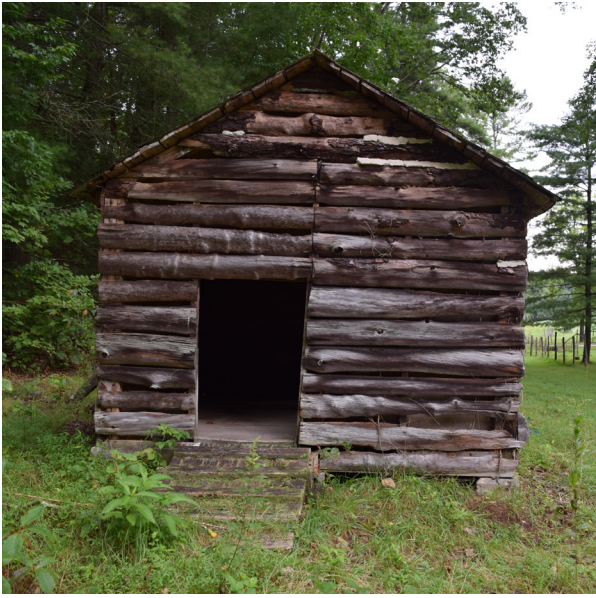
26 **Figure 3. 161.** The east side of the Hog Pen (Source: WLA
27 Studio). 28

Figure 3. 162. The north side of the Hog Pen (Source: WLA
Studio). 29

1 **Figure 3. 163.** The south side of the Hog Pen (Source: WLA 3
2 Studio).

17 The Hog Pen is a small, rustic, gabled frame
 18 building enclosed by split logs, which are
 19 unpainted, and has a shingle roof (Figure 3. 161
 20 - Figure 3. 164). Located along the treeline away
 21 from other buildings in the Farm Core, the Hog
 22 Pen is approximately 65 yards southwest of the
 23 Breeding Pen HS-25 and faces south. An open
 24 doorway with a log ramp on the south side and
 25 an open window on the north side are the only
 26 openings. The pen was constructed circa 1950-
 27 1967.

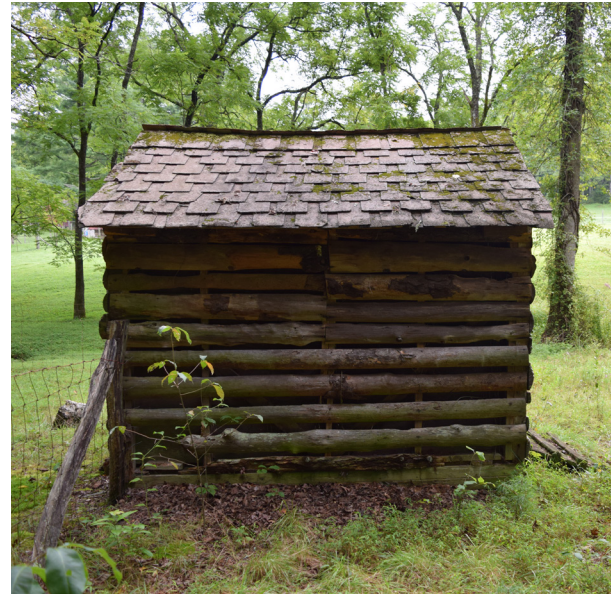
3 **Figure 3. 164.** The west side of the Hog Pen (Source: WLA
4 Studio).
