Carl Sandburg Home National Historic Site Cultural Landscape Report

85% Draft Submittal
September 2021

Cultural Resources, Partnerships, and Science Division
Interior Region 2 - South Atlantic Gulf

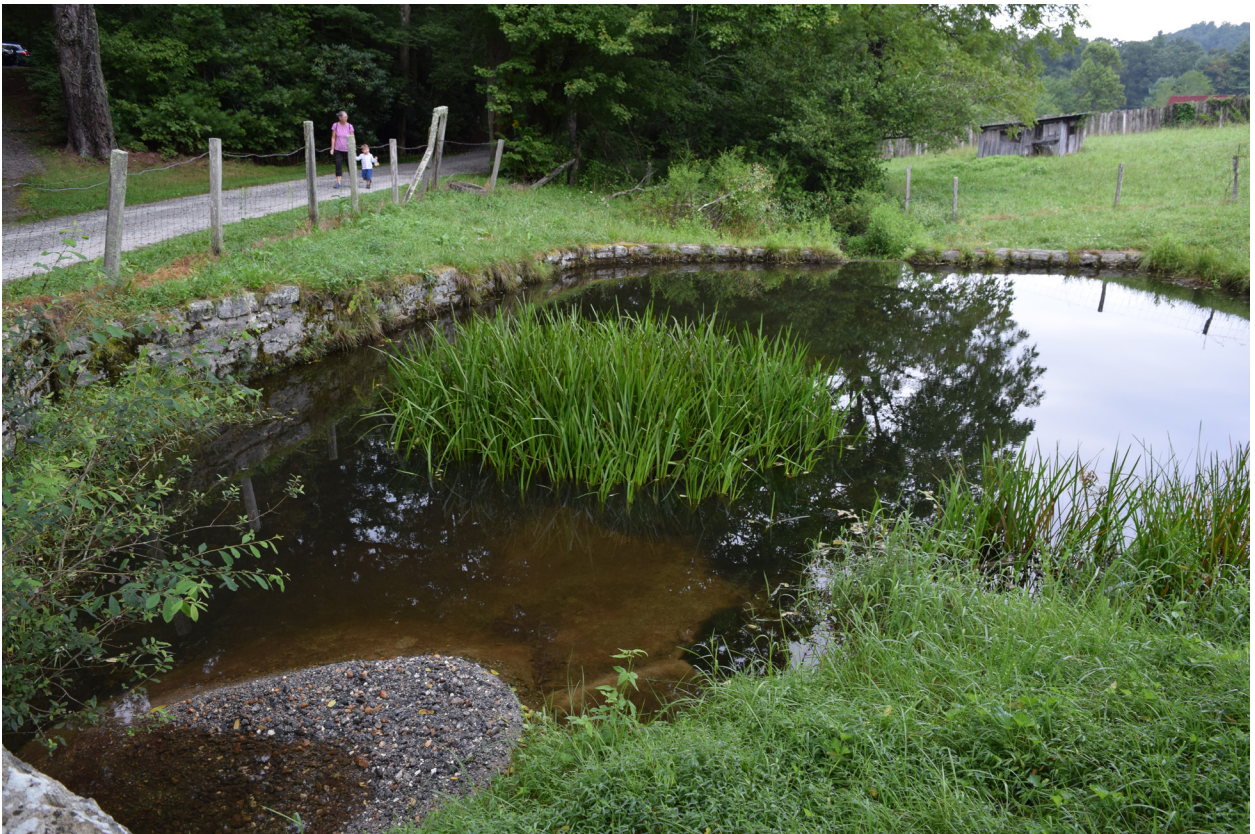
5 **Figure 3. 165.** The Duck Pond is lined with a stone retaining wall on the south side that becomes a low dam at the western
6 edge. View to the west (Source: WLA Studio).

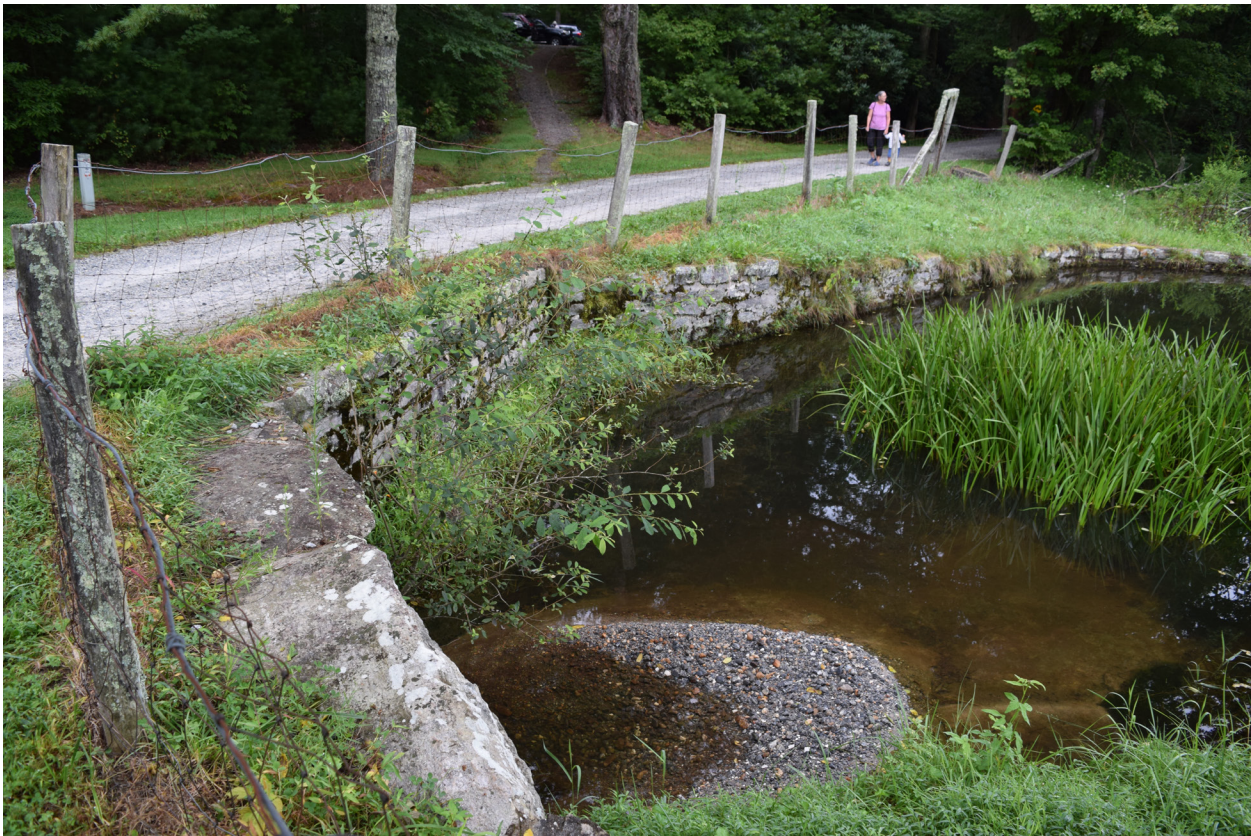
1 **Figure 3. 166.** The Duck Pond receives flow from Trout Pond Spring via a culvert that passes under Back Drive into the stone
2 retaining wall. View to the southwest (Source: WLA Studio).

Some stone headwalls are historic features. Stone headwalls approximately 9 feet high support the entrance to the original Entry Drive, while a tunneled opening in the wall with a stone lintel allows water to pass through. In the Pasture and Fields area a badly degraded stone headwall with a culvert is located where Trout Pond Spring crosses the dirt drive near the Cow Shed in Pasture #2. Another stone headwall conveys water from Trout Pond Spring beneath Back Drive, conveying water to Duck Pond.

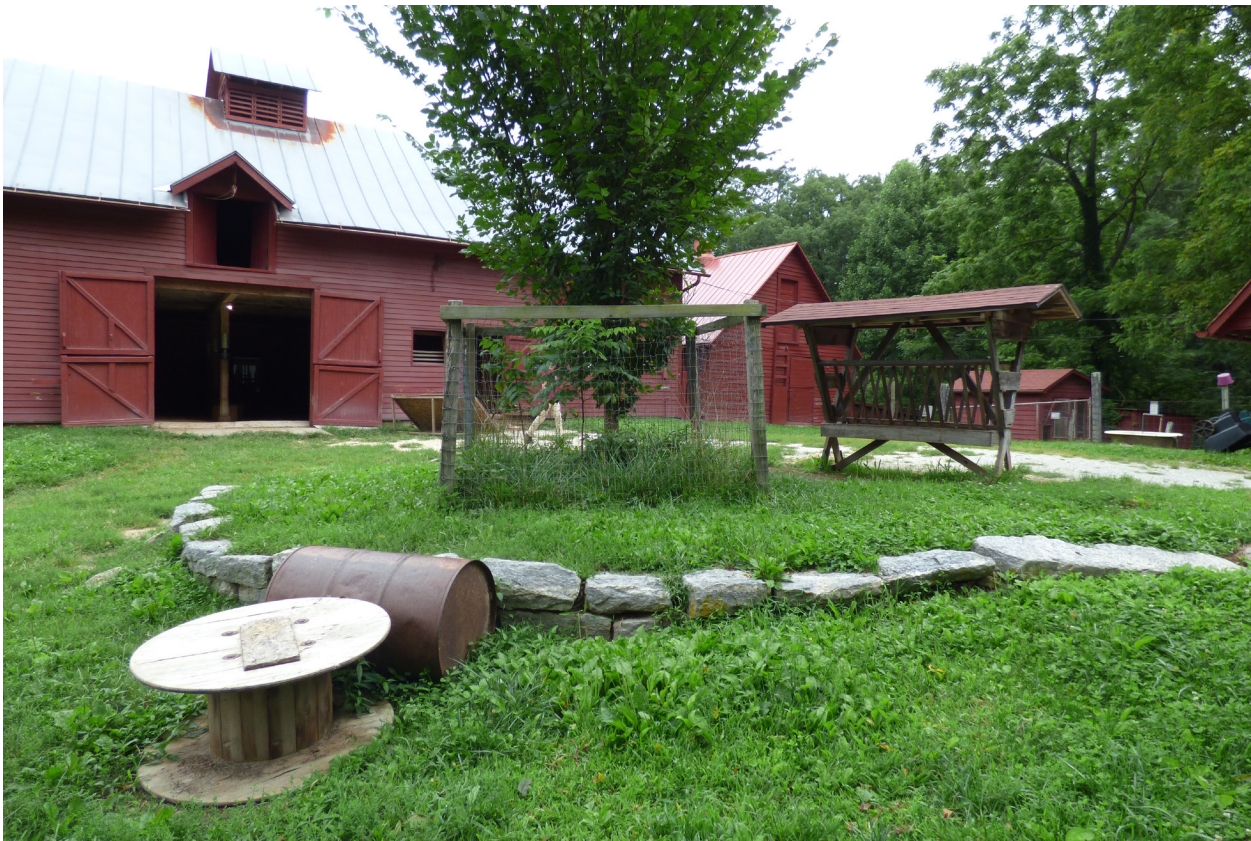
3 **Figure 3. 167.** A low stone wall curves around an elm tree by the Main Barn area that was recently replanted. Also visible are
4 a goat hay manger and objects for the goats to play on (Source: WLA Studio).

11 A curved, 2-foot-tall, stone retaining wall that
12 is approximately 22 feet long is located in the
13 main barnyard area (Figure 3. 167). The structure
14 formerly surrounded a mature elm tree, which has
15 been replanted.

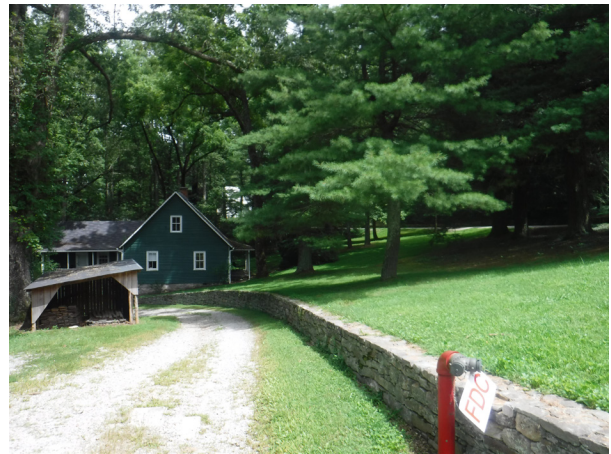
28 **Figure 3. 168.** A 2 to 3-foot-tall stone retaining wall runs
 29 along the north side of the hill by the Farm Manager's house.
 30 View to the east (Source: WLA Studio).

2 There are several stone retaining walls in the Farm
 3 Core character area. Beginning at the intersection
 4 of Back Drive and the driveway to the Farm
 5 Manager's House, a 2-foot-tall wall curves around
 6 the bend continuing approximately 73 feet to the
 7 Farm Manager's House, gradually becoming 4 feet
 8 tall (Figure 3. 168). North past the Farm Manager's
 9 House a stone retaining wall holds the grade for
 10 approximately 60 feet on the west side of the drive,
 11 expanding from 1 foot high at the south end to 5
 12 feet high at the north end, before turning west to
 13 terminate into the grade (Figure 3. 169). Another
 14 2 to 3-foot-tall wall begins by the path to the
 15 vegetable garden, following along the south side of
 16 Back Drive, approximately 156 feet east (Figure 3.
 17 170).

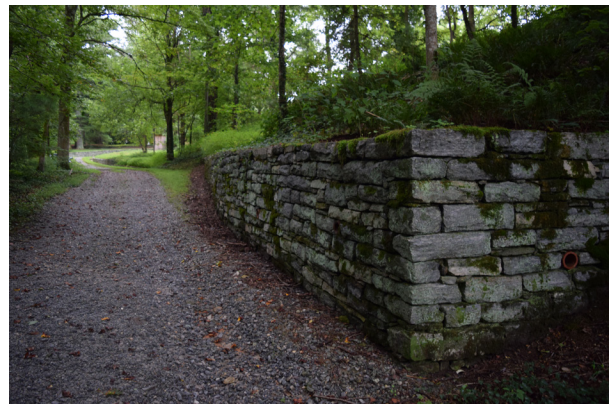
31 **Figure 3. 169.** A 2 to 5-foot-tall stone retaining wall
 32 holds back the ridgeline along the road between the Farm
 33 Manager's house and the Buck House. View to the south
 34 (Source: WLA Studio).

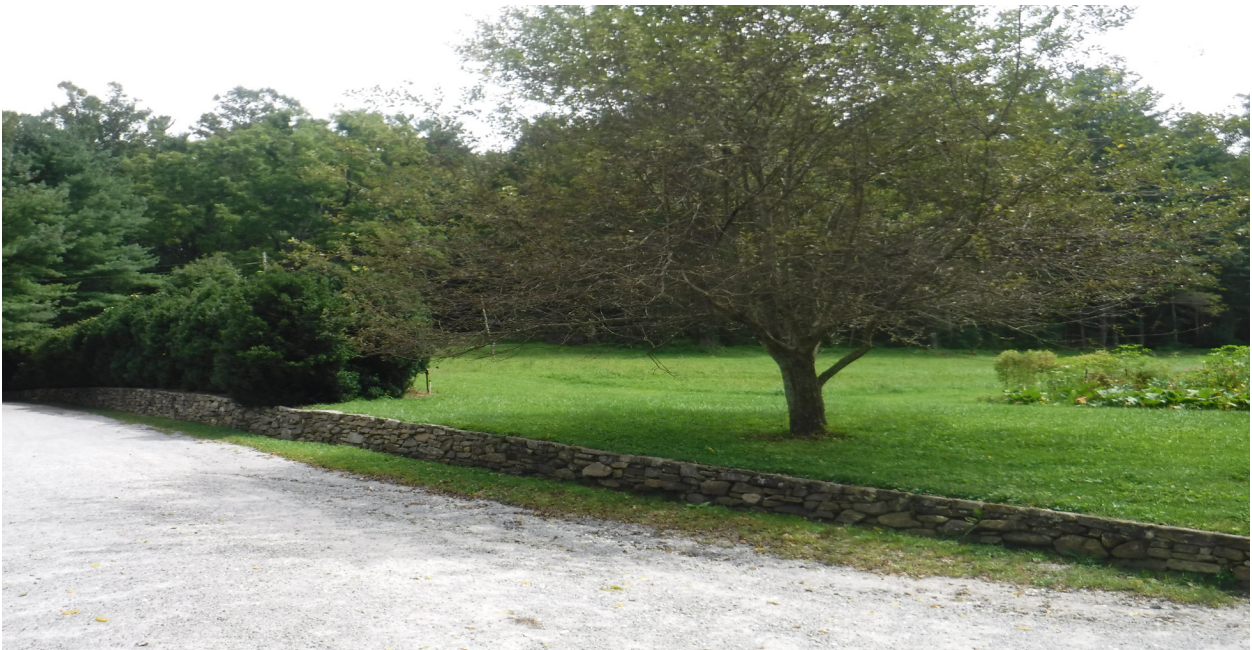
35 **Figure 3. 170.** A 2-foot stone retaining wall runs along the southern edge of Back Drive. View to the southeast (Source: WLA
 36 Studio).

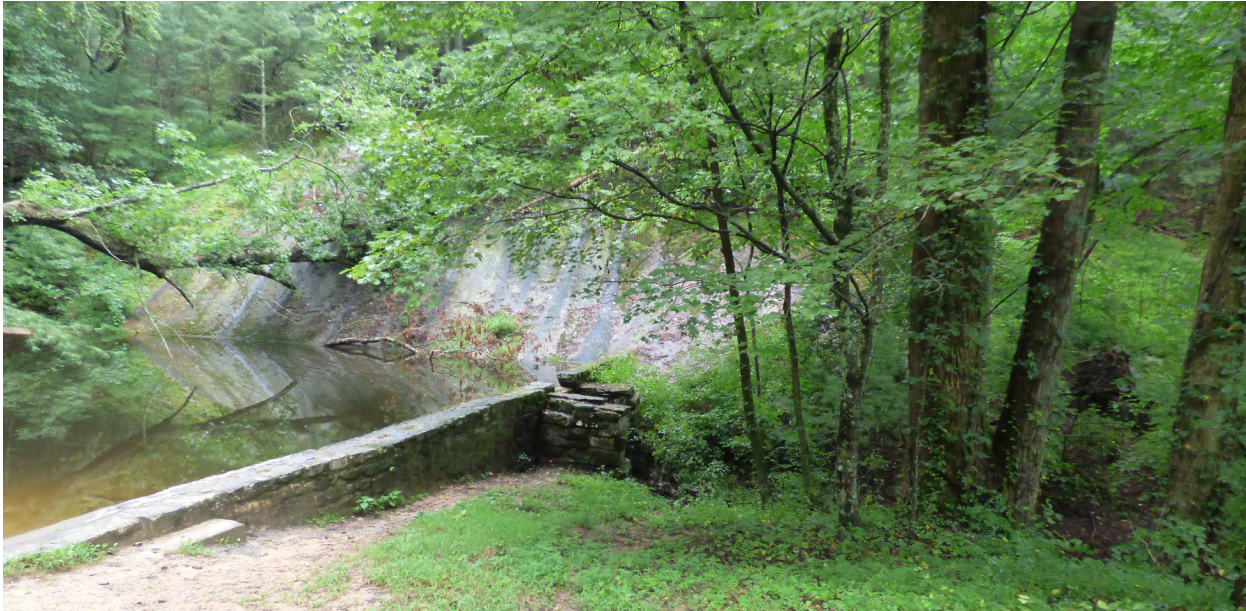
16 **Figure 3. 171.** A low stone dam creates a reservoir at Trout Pond Spring, meeting an exposed granite face on the west side of
17 the reservoir (Source: WLA Studio).

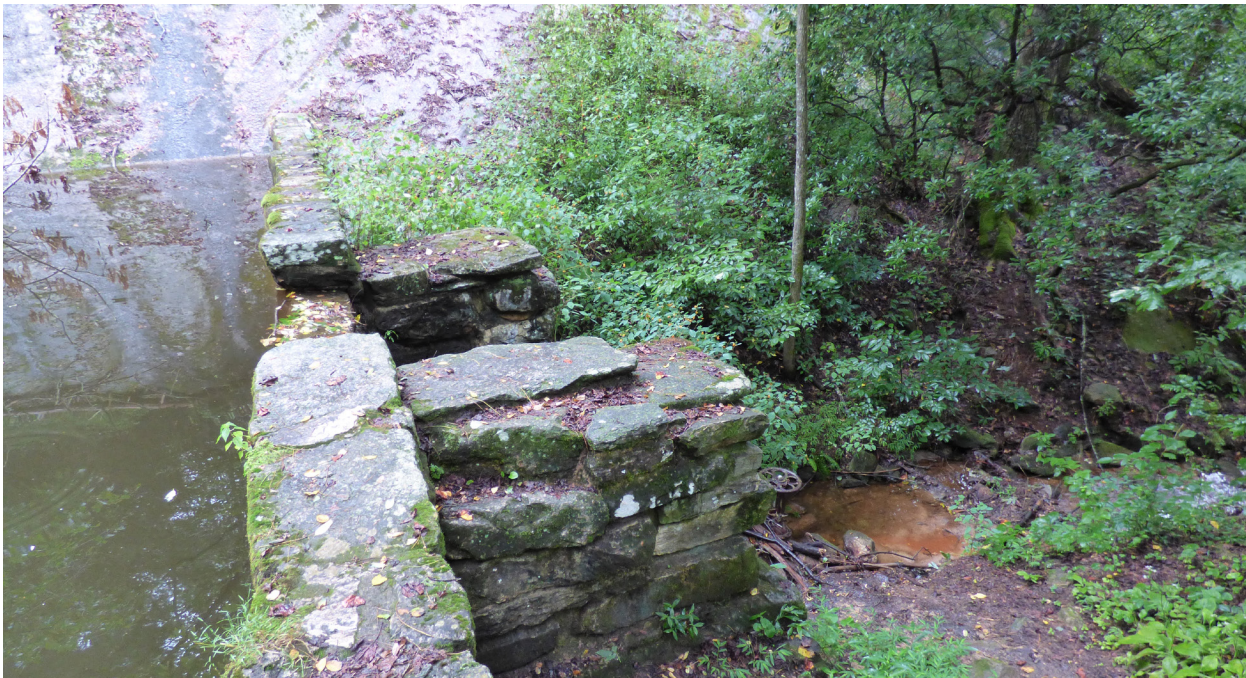
18 **Figure 3. 172.** The outlet in the dam at Trout Pond Spring (Source: WLA Studio).

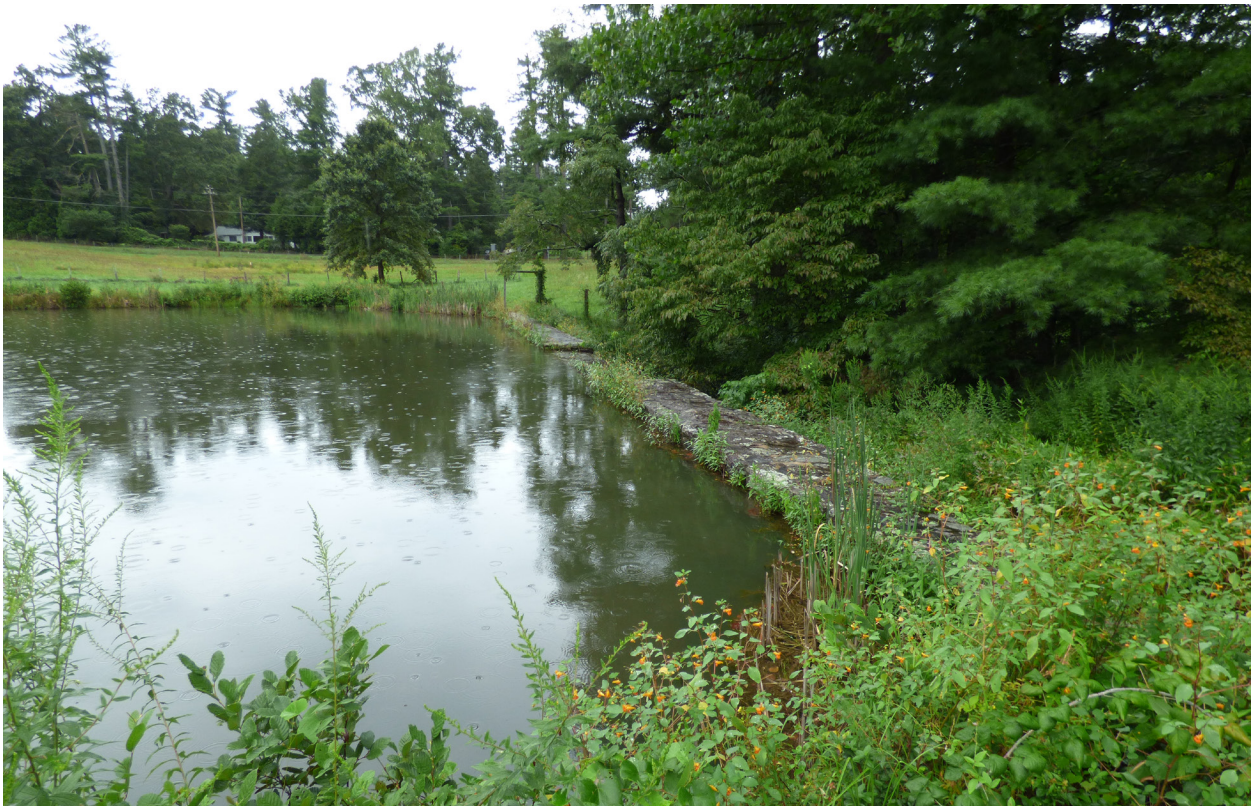
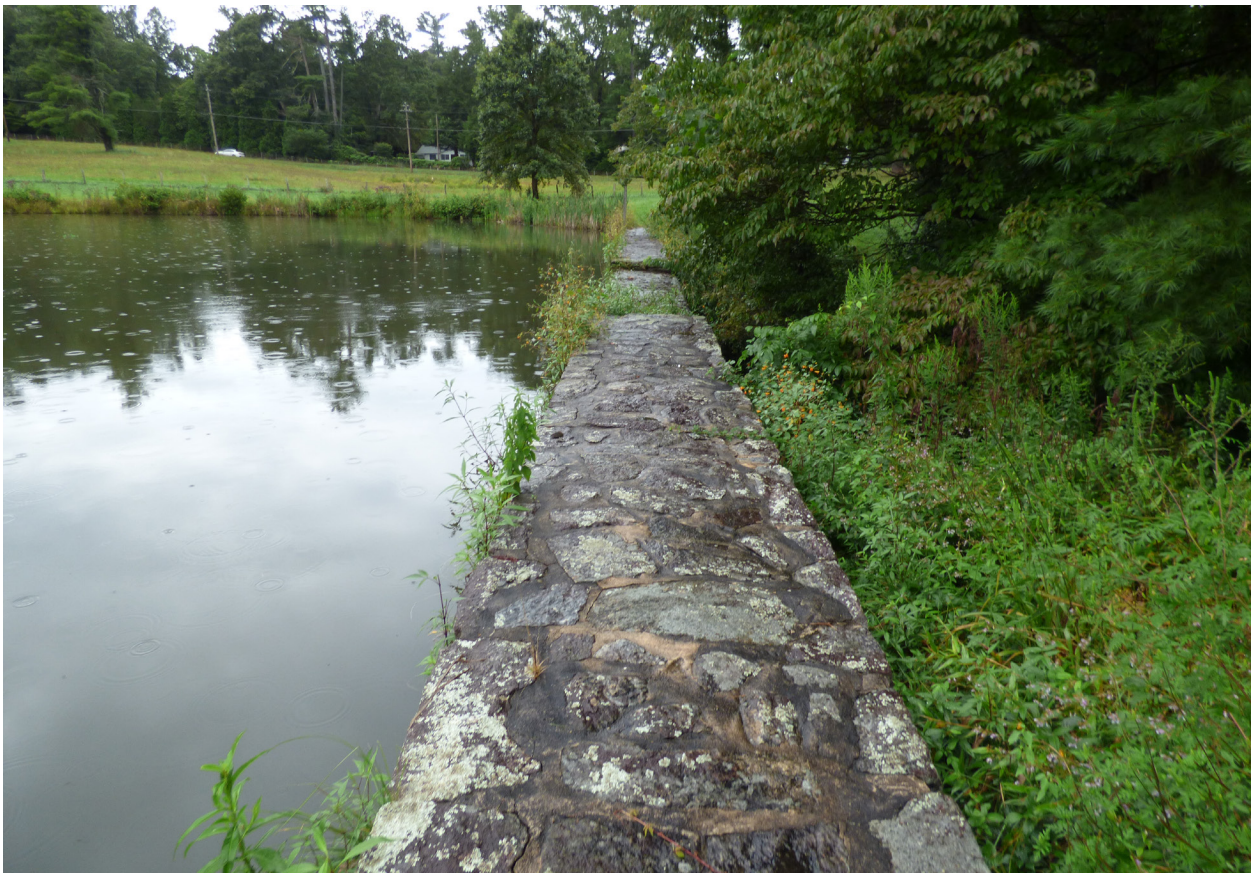
1 **Figure 3. 175.** Side Lake stone dam. View to northeast (Source: WLA Studio).

2 **Figure 3. 176.** Side Lake stone dam and spillway. View to the north (Source: WLA Studio).

20 There is a mortared stone dam on the east side of
21 Side Lake which is approximately 6 feet wide by
22 130 feet long (Figure 3. 175 - Figure 3. 176). The
23 dam is in good condition.

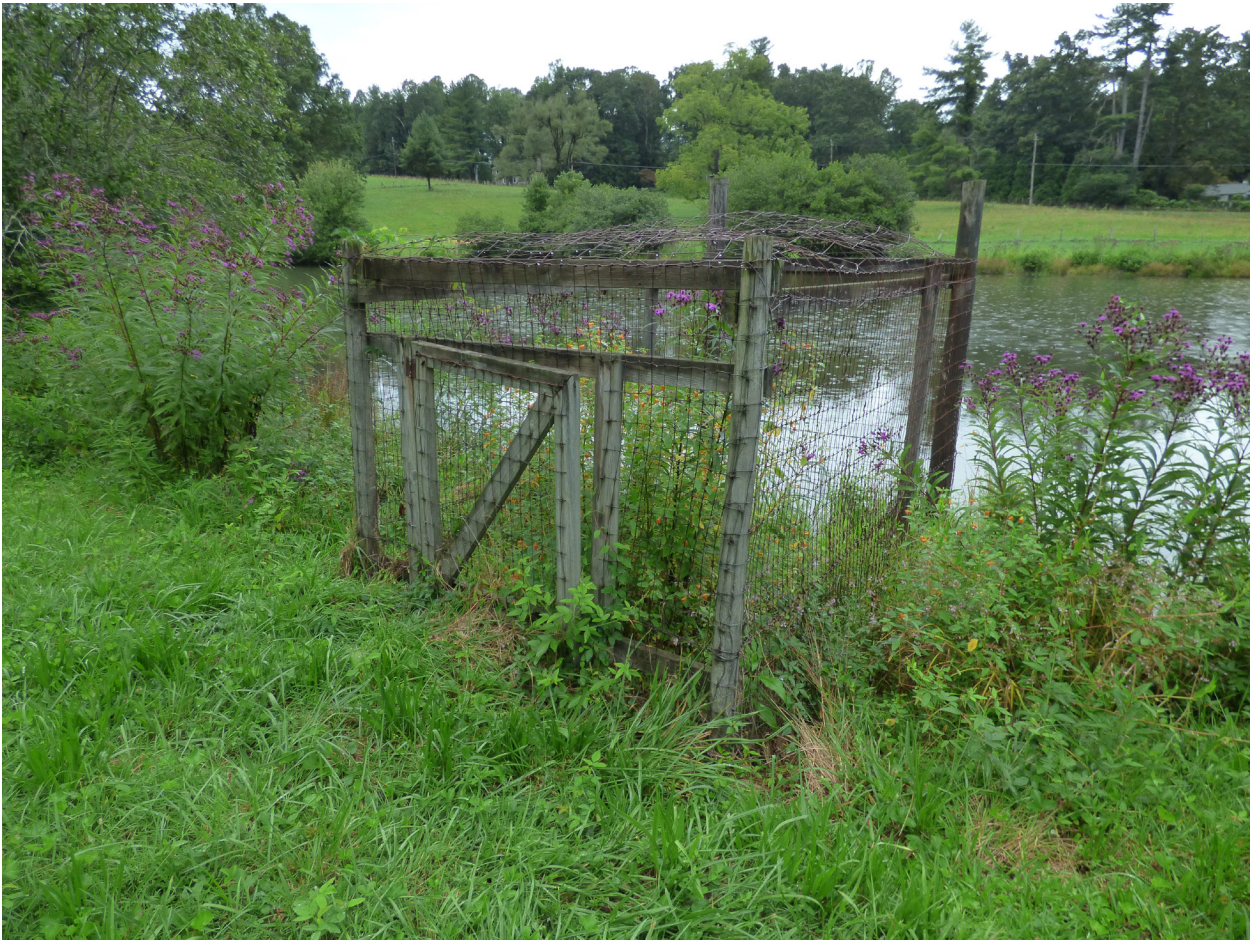
1 **Figure 3. 177.** Duck Cage at Side Lake. (Source: WLA Studio).

25 The Duck Cage is a small rectangular enclosure
26 constructed in the 1950s to protect the Sandburg's
27 ducks from predators (Figure 3. 177). The structure
28 is a wood framed box, approximately 6 feet by
29 12 feet wide and 6 feet tall with a hinged door
30 opposite the lake. The structure is enclosed on the
31 top and sides with woven wire mesh on a 2"x4"
32 grid, fastened with wire. Situated at the edge of the
33 lake with four posts in the water and two on land,
34 the ducks could enter and exit the structure from
35 the lake underneath the structure.

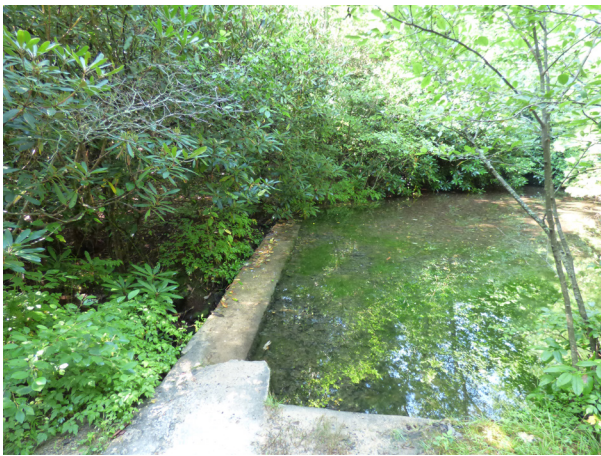
35 **Figure 3. 179.** The concrete wall at Mountain Reservoir.
36 View to the south (Source: WLA Studio).

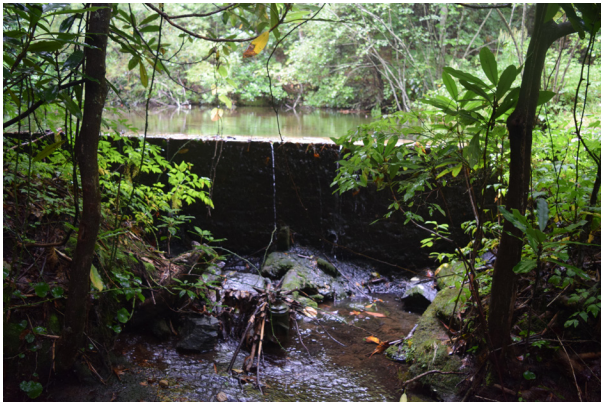
37 **Figure 3. 180.** The spillway and low concrete dam at
38 Mountain Reservoir. View to the west (Source: WLA Studio).

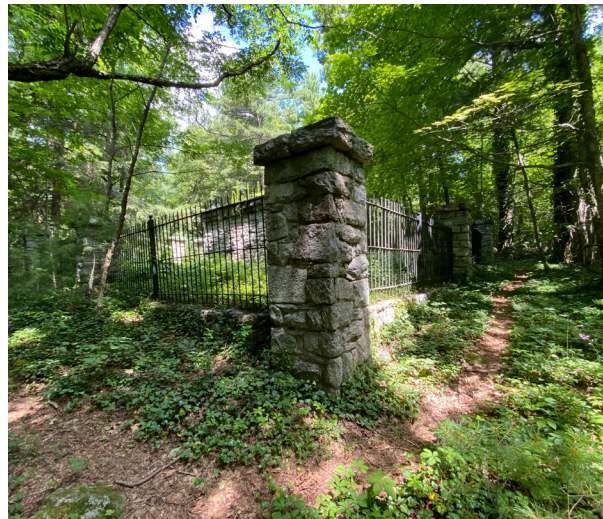
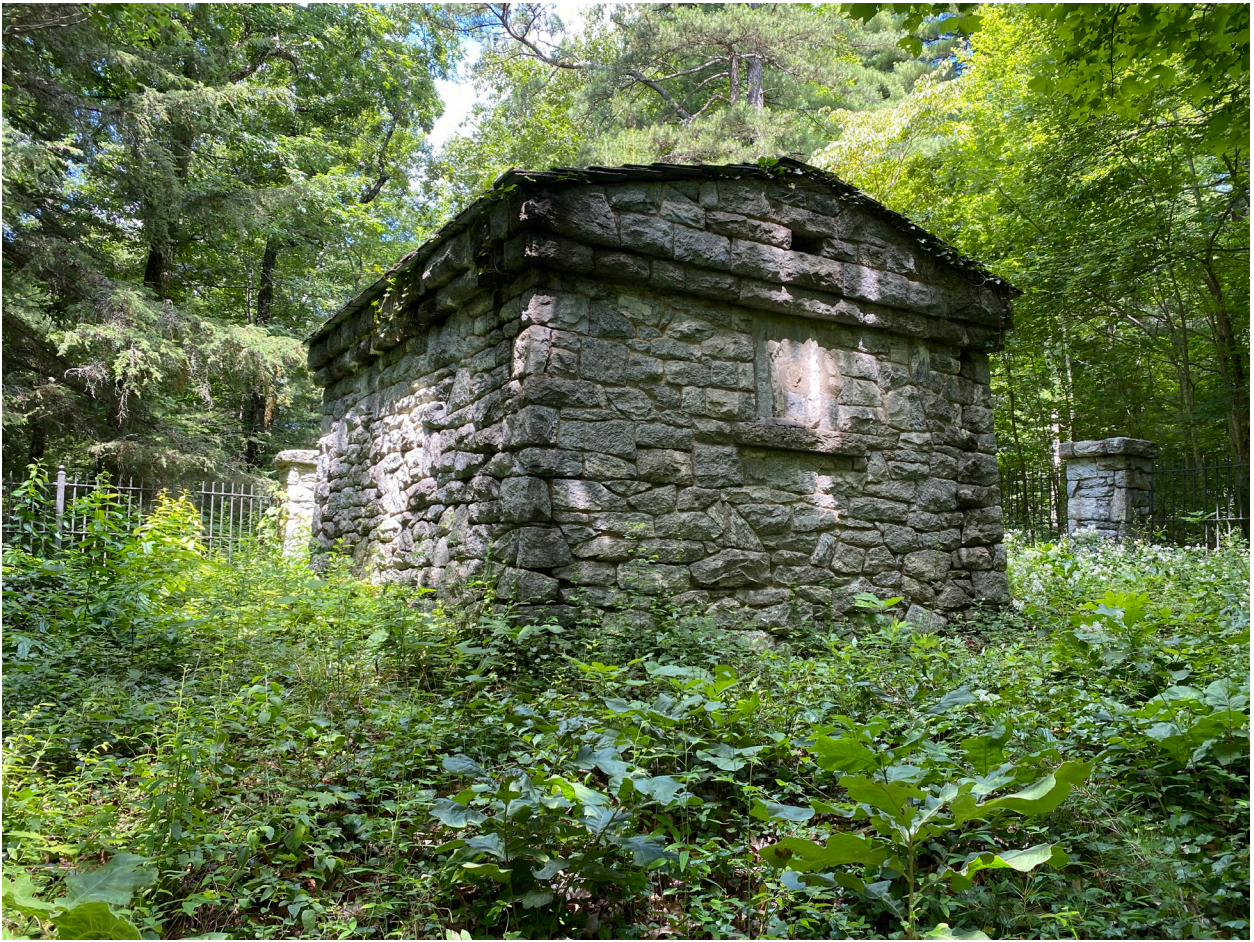
3 **Figure 3. 181.** The mausoleum stands in the southwest
4 corner of the site, on the recently acquired Hill Tract. The
5 NPS does not interpret the mausoleum and limits its access
6 (Source: WLA Studio).

31 The Mausoleum is a front gabled, rectangular
32 building with simple massing. It is constructed
33 of uncoursed, rusticated granite (Figure 3. 181 -
34 Figure 3. 182). The building has a slate roof and

1 **Figure 3. 182.** The mausoleum is surrounded by a large stone wall and fence (Source: WLA Studio).

2 corbelled cornice. There are two infilled openings;
 3 one in the front façade that was the primary
 4 entrance. The second opening was a small window
 5 with a granite sill; it is also infilled. There are small
 6 vent openings along the cornice and in the gable
 7 ends. The front entrance features a large, rough
 8 shaped lintel with the name “HILL” engraved. A
 9 small bronze plaque is fixed to the front façade.
 10 The mausoleum measures 16 feet by 14 feet and
 11 stands 10 feet high. The building is in overall good
 12 condition, but vegetation is growing on the slate
 13 roof and evidence of efflorescence. A wrought iron
 14 fence surrounds the site. The fence panels are on a
 15 continuous granite base. Large granite piers mark
 16 the corners and entrance gate.

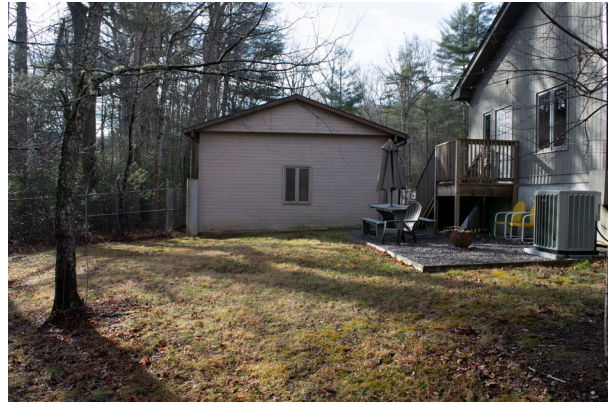
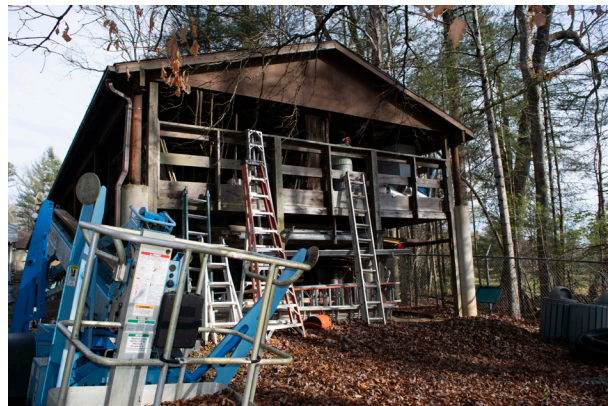
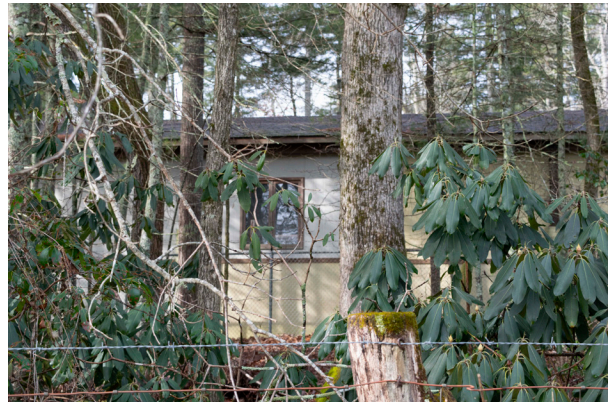
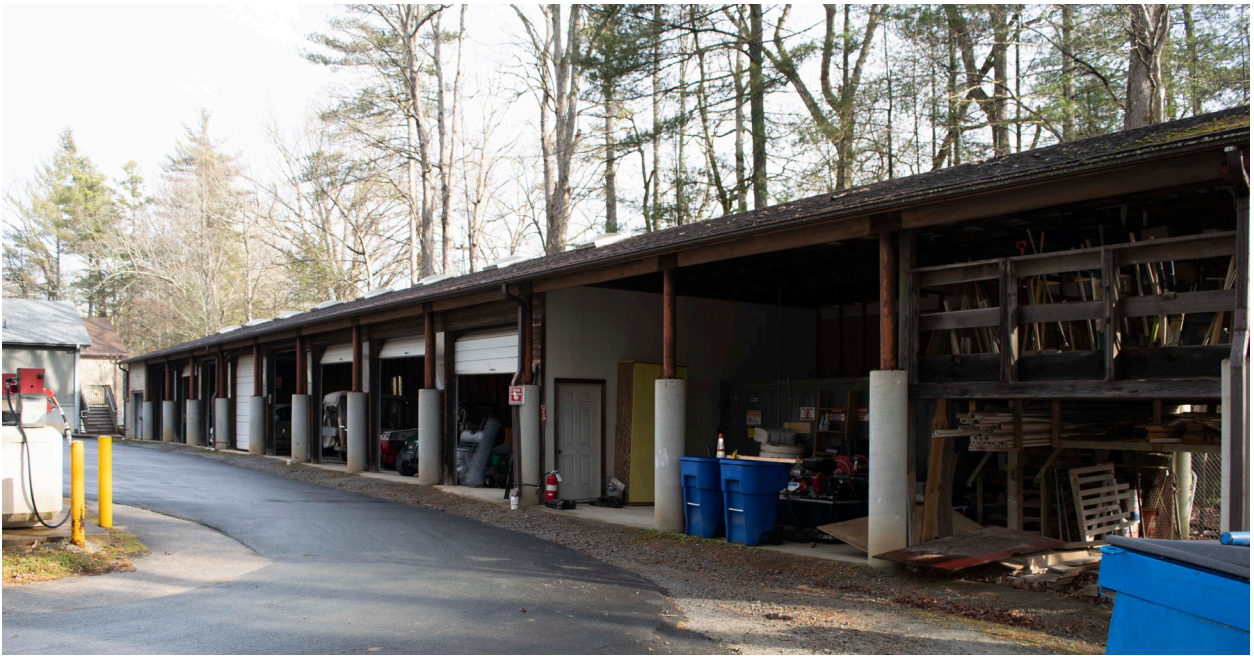
3 **Figure 3. 187.** The north side of the Maintenance equipment
4 Storage Shed (Source: WLA Studio).

8 **Figure 3. 188.** The south side of the Maintenance equipment
9 Storage Shed (Source: WLA Studio).

12 **Figure 3. 189.** Windows on the east side of the Maintenance
13 equipment Storage Shed (Source: WLA Studio).

1 **Figure 3. 190.** The west side of the Maintenance equipment Storage Shed (Source: WLA Studio).

17 The Maintenance Equipment Storage shed mirrors
18 the Maintenance Shop in form (Figure 3. 187 -

5 Figure 3. 190). It is a rectangular, gabled building
6 with a composite shingle roof. The building has
7 twelve bays on the west façade and one pedestrian
8 entrance bay, eight garage bays, and three open
9 bays for covered storage.

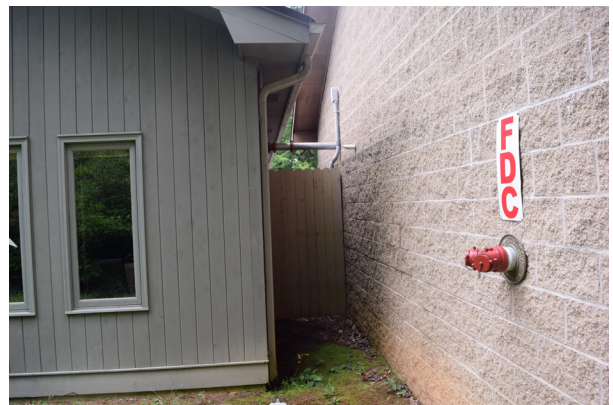
19 **Figure 3. 193.** The south side of the Park Headquarters
20 building and the north side of the Maintenance Shop are
21 less than 5 feet apart (Source: WLA Studio).

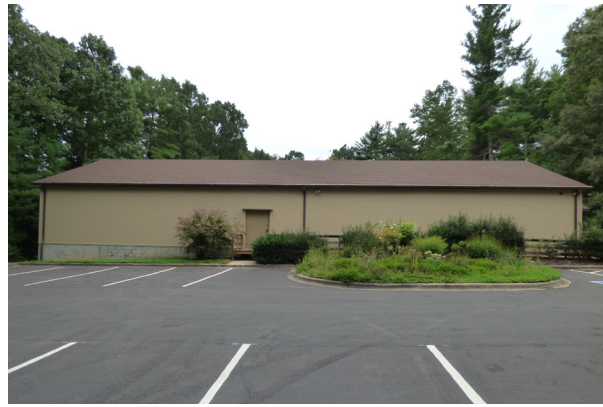
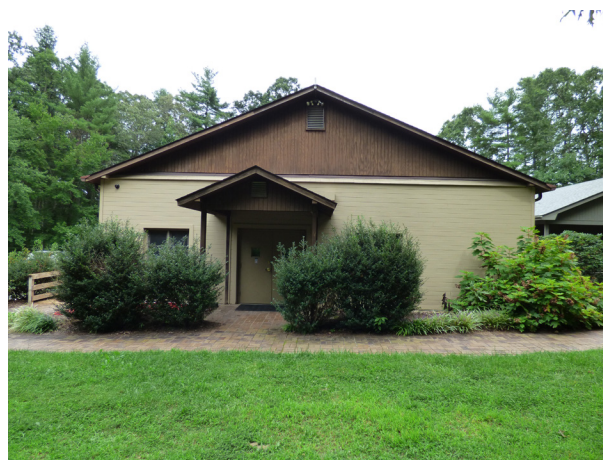
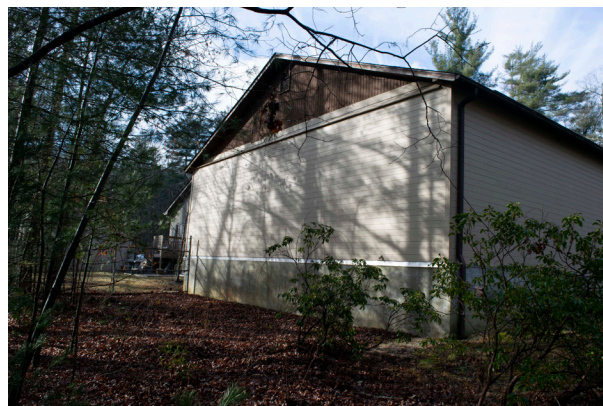
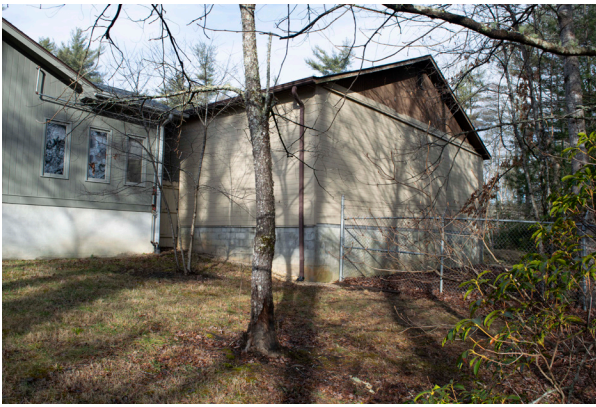
3 **Figure 3. 195.** The north façade of the Preservation Center,
4 from the Administrative Parking lot (Source: WLA Studio).

26 The Preservation Center is a rectangular gabled
27 building that abuts the administrative parking area
28 and Park Headquarters (Figure 3. 195 - Figure
29 3. 198). The building faces west and has a gabled
30 entry alcove at the center of the west face, which is
31 flanked by two sets of two single-hung windows.
32 The building has a brown composite shingled
33 roof with stained vertical wood panel on the
34 upper portion of the gabled end and horizontal
35 composite siding, all of which is painted a cream
36 color. There are no windows on the north side
37 but there is one door with an unpainted wooden
38 accessible ramp leading from the parking area.

39 **Figure 3. 196.** The west façade of the Preservation Center
40 (Source: WLA Studio).

41 **Figure 3. 197.** The east façade of the Preservation Center.
42 View to the southwest (Source: WLA Studio).

1 **Figure 3. 198.** The south side of the Preservation Center
2 closely abuts the north side of the Headquarters building.
3 View to the northwest (Source: WLA Studio).

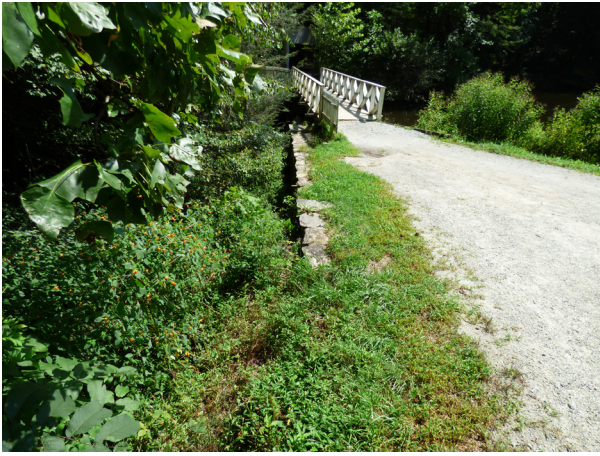
3 **Figure 3. 209.** The approach to the Front Lake Dam Bridge, 1
4 view to the east (Source: WLA Studio). 2

The Front Lake Dam Bridge is a wooden footbridge approximately 55 feet in length and 80 inches wide, built atop the Front Lake Dam (Figure 3. 209 - Figure 3. 210). The bridge has slat flooring with a 40-inch-tall handrail on both sides. The handrail is supported by 1 × 4 posts with decorative cross-bracing. The sides of the bridge are lined with metal screen for child safety. The bridge structure is steel framing set on a mortared stone foundation atop the dam spillway.

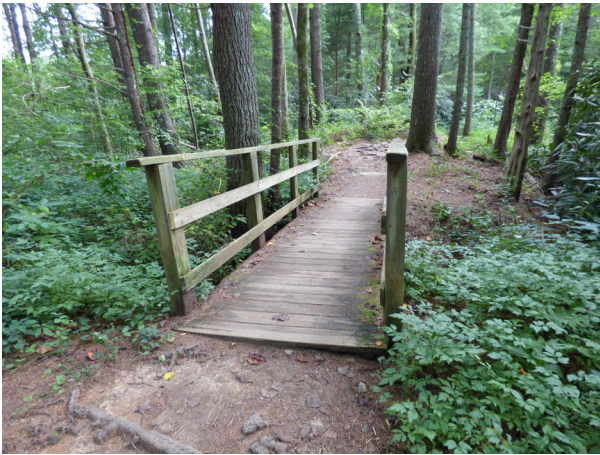
11 **Figure 3. 211.** Wooden footbridge along the Front Lake 9
12 Trail (Source: WLA Studio). 10

There are five wooden footbridges that cross small drainages feeding into Front Lake (Figure 3. 211). The footbridges range from 52 to 103 inches wide and 12 to 22 feet in length, with 37-inch-tall wooden handrails. One bridge crossing a shallow drainage does not require a handrail. The structures are set flush with the grade.

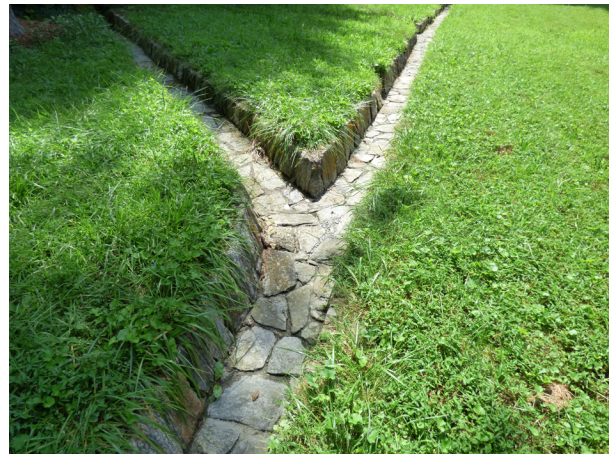
46 **Figure 3. 215.** Stone gutter in the Residential Core CA,
 47 northwest of the Main House (Source: WLA Studio).

39 Stone gutter features were located in four areas in
 40 the landscape (Figure 3. 215 - Figure 3. 218). The
 41 gutters likely date to the Memminger or Smyth
 42 Periods, though exact construction dates are
 43 unknown. The features are likely located in areas
 44 where erosion was occurring during storm events
 45 due to grading and construction of the farmstead.

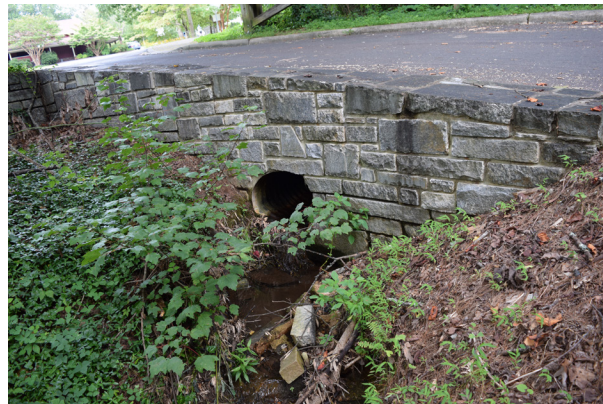
Figure 3. 219. Stone headwall at the vehicular entrance to the Main Visitor Parking area. View to the northeast (Source: WLA Studio).

Mortared stone headwalls are located at the inlet and outlet points of culvert pipes (Figure 3. 219 - Figure 3. 220). Stone headwalls in and around the Main Visitor parking lot date to the NPS ownership period. Headwalls are located in the Main Visitor Parking area where drainage travels beneath the parking lot. There is a section of headwall with a culvert at the parking lot entrance, approximately 22 feet in length and 52 inches in height. An approximately 6-foot-tall stone retaining wall supports the parking area at the south end of the lot and also has a culvert. There is a 20-foot-long, 16-inch-wide, and 27-inch-tall headwall towards the center of the parking area. Small eyelet-shaped headwalls along the south side of Little River Road also date to the NPS Period. The mortared stone structures built during the NPS Period blend stylistically with historic retaining and freestanding walls found in other areas of the site.

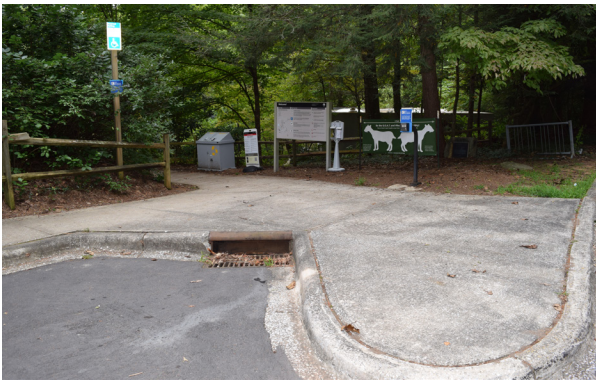
Figure 3. 221. Curb Inlets at the Main Visitor Parking Area. View to the west (Source: WLA Studio).

Drain inlets and curb inlets are underground concrete structures with a metal grate flush with the ground surface that convey stormwater from a gutter or low point in the landscape to an underground catch basin where it is then conveyed underground (Figure 3. 221 - Figure 3. 222). Curb inlets, found in the Visitor Parking area, convey runoff from the impervious parking area. Drain inlets, found in multiple areas of the site, convey water to underground pipes.

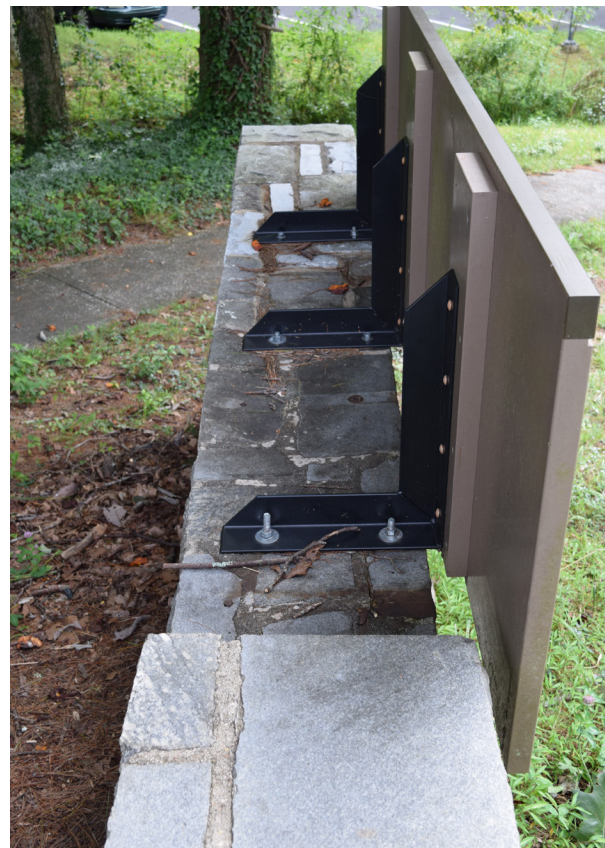
Figure 3. 224. The Park Identity Sign on Little River Road is installed with metal “L” brackets to a stone base. View to the south (Source: WLA Studio).

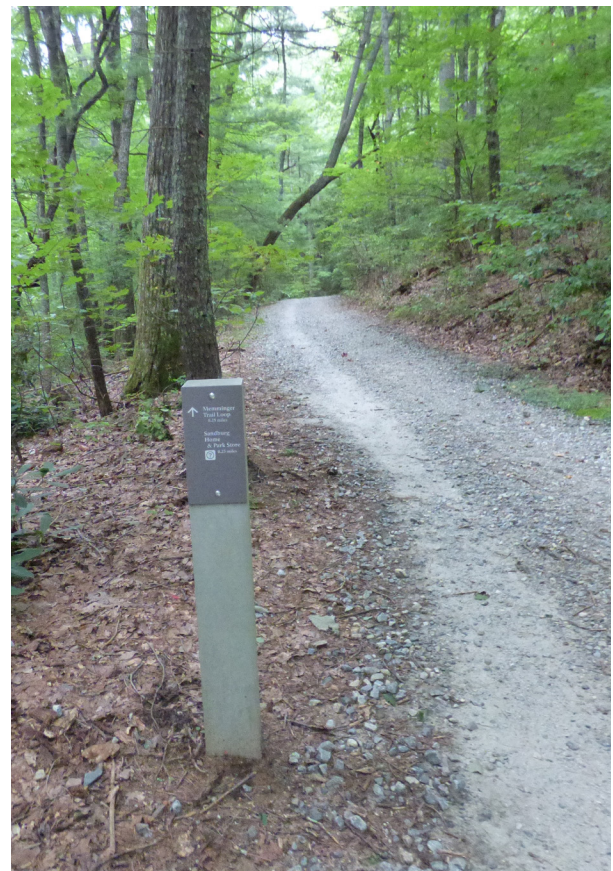
10 **Figure 3. 227.** Pedestrian wayfinding sign along a trail in the park, bollard style (Source: WLA Studio).
11

2 There are also 25 pedestrian wayfinding signs
3 that direct visitors to historic features and identify
4 hiking trails within the park (Figure 3. 227 - Figure
5 3. 228). There are two sign types: a bollard style and
6 a post-and-panel type. Both types are composed
7 of 3-foot-tall light gray aluminum posts with
8 in-line, flush-mounted, medium-gray aluminum
9 signage bolted to the posts. The sign information

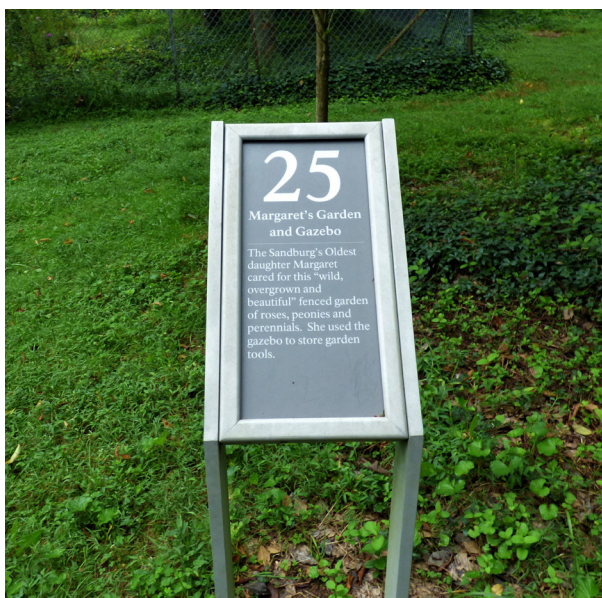
Figure 3. 230. Example of Self-Guided Tour Interpretive Signs identifying historic features within the park (Source: WLA Studio).

There are 17 self-guided tour interpretive signs in the park. These signs are approximately 3 feet in height and have gray painted aluminum with white lettering (Figure 3. 230). Each sign is numbered to correlate with the Park Visitor Map. Eight

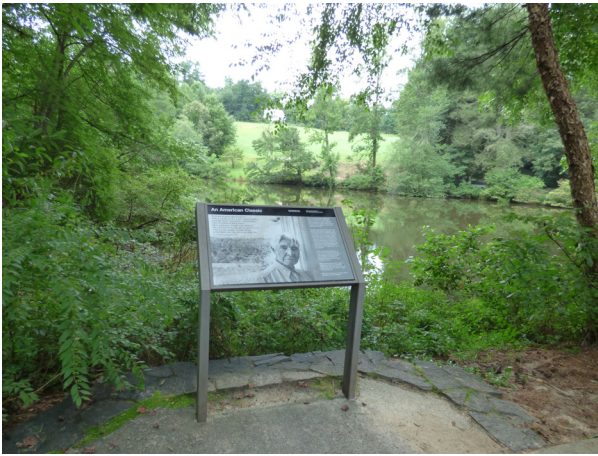
3 **Figure 3. 232.** Interpretive Wayside signage is located at
4 strategic points in the park (Source: WLA Studio).

In addition to the Visitor Contact Station, there are three wayside signs that provide information regarding the history and significance of the Carl Sandburg landscape (Figure 3. 232). The wayside signs interpret significant features including Carl Sandburg’s chair in the granite dome area, Mrs. Sandburg’s goat breeding activities in the farm area, and Carl Sandburg’s life and work in the Entrance area. The wayside signs are in color, mounted on gray rectangular aluminum posts.

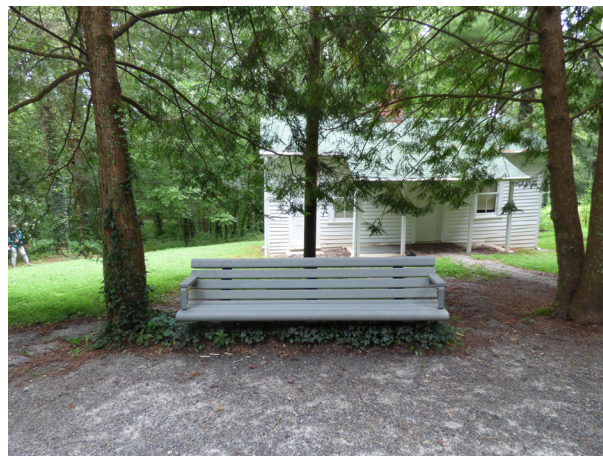
48 **Figure 3. 237.** Typical composite bench in the park (Source:
49 WLA Studio).

32 Multiple styles of seating were identified
33 throughout the site (Figure 3. 237 - Figure 3.
34 239). There are twenty-five gray recycled plastic
35 benches, some with armrests, some without. A
36 few benches show signs of damage from wildlife.
37 The contemporary bench style is noticeably
38 distinct from other site features. Near the visitor
39 parking area, a set of four picnic tables is located
40 behind the Visitor Contact Station. The picnic
41 tables are composite plastic construction with
42 seating on two sides. The tables are in good-to-fair
43 condition. By the Visitor Contact Station are two
44 wooden benches and a movable plastic bench. The
45 Amphitheater also provides seating during events.

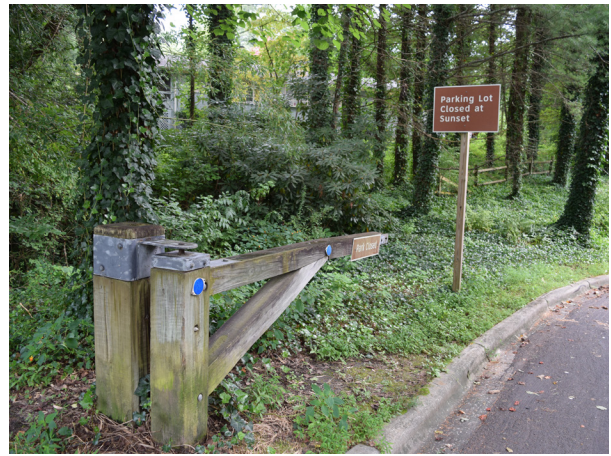
3 **Figure 3. 241.** Wooden swing gate at the entrance to the
4 main visitor parking area. View to the south (Source: WLA
5 Studio).

44 Metal-frame woven-wire, five-slat wood, and
45 aluminum chain-link vehicular gates are found in
46 pastures and goat pen areas (Figure 3. 241 - Figure
47 3. 246). Some of these gates are in fair condition
48 or are no longer functional, with chain-link gates
49 appearing to be modern replacements. A 3-foot-tall
50 manual swing, chain-link aluminum gate affixed to
51 mortared stone columns provides vehicular entry
52 to the Park Headquarters. It is in good condition.
53 A metal, key-coded automatic entry double gate is
54 located just beyond the administrative parking lot
55 and is in good condition. Manual double-swing
56 metal entry gates are located at the vehicular
57 entrance to the Hikers' Parking Lot and are in

6 good condition. Manual double-swing wood
7 entry gates are located at the vehicular entrance
8 and exit to the Main Visitor Parking Lot. They
9 are in fair condition. A single-swing decorative
10 wood vehicular entry gate is located near the Main
11 House and is in good condition. A five-slat wooden
12 entry gate surrounded by mortared fieldstone
13 columns and walls is located at the entrance to the
14 historic serpentine drive along Little River Road.
15 Pedestrian-sized gates are metal with woven wire
16 (some with a decorative top), as well as wood
17 picket styles. These are from the historic period
18 and are in fair condition.

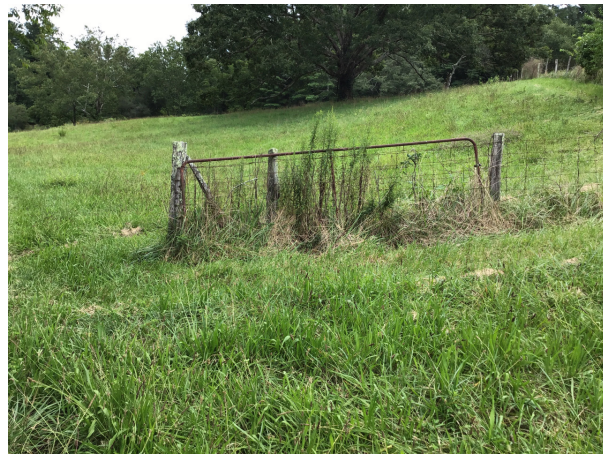
3 **Figure 3. 246.** Woven wire vehicular gate in poor condition
4 in the Pasture and Fields area. View to the west (Source: WLA
5 Studio).

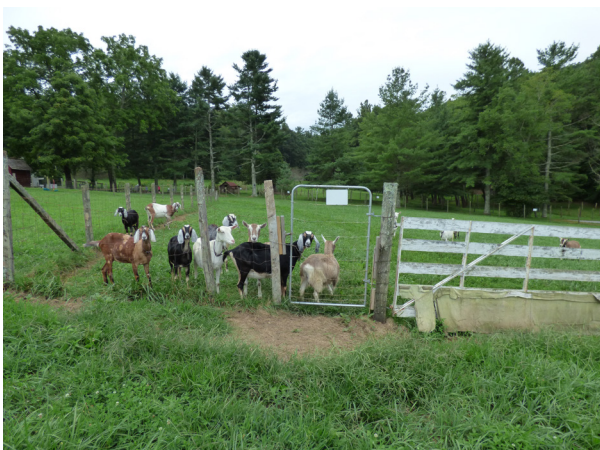
37 **Figure 3. 245.** Woven wire pedestrian gate in the Farm Core
38 area. View to the south (Source: WLA Studio).
