Carl Sandburg Home National Historic Site Cultural Landscape Report

85% Draft Submittal
September 2021

Cultural Resources, Partnerships, and Science Division
Interior Region 2 - South Atlantic Gulf

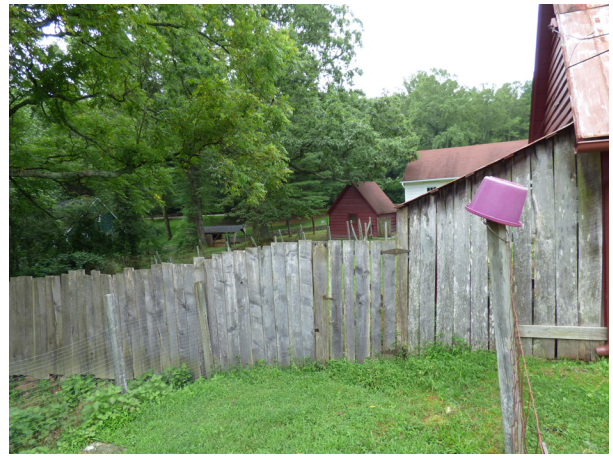
49 **Figure 3. 247.** Unpainted picket fencing in the Farm Core
 50 area. View to the south (Source: WLA Studio).

20 Fencing around pastures and goat pens is generally
21 4-foot-tall woven wire goat fencing with either
22 locust or metal posts, or a hybrid design (Figure 3.
23 247 - Figure 3. 252). Woven-wire fencing is found
24 throughout the Farm Core and Pasture and Fields
25 areas of the park. Specific areas of note include in
26 the Vegetable Garden, behind the Farm Manager's
27 House, and dividing the pastures. Additionally,
28 a section of 4-foot-tall woven-wire fencing with
29 wood posts was recently installed around the
30 Amphitheater area. Conditions range from good
31 to poor, and in some areas only remnant fencing
32 remains. The style of woven-wire fencing is not
33 uniform, with slight variations from decades of
34 patches and repairs by the Sandburgs and park
35 managers. The fenced areas actively used for goat
36 pasture are in good condition.

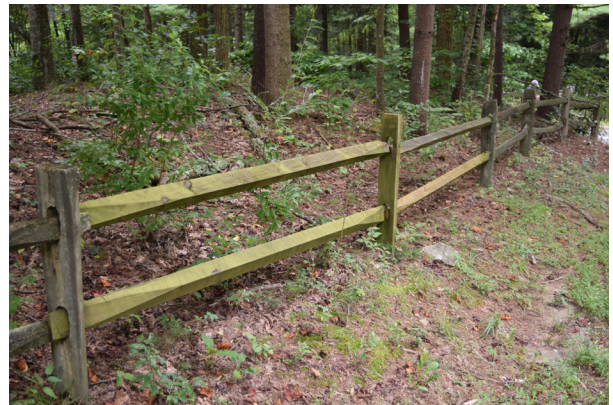
51 **Figure 3. 248.** Split rail fencing in the Entrance area (Source:
 52 WLA Studio).

16 Double split-rail wood fencing lines the northern
 17 and eastern property boundaries near the Main
 18 Visitor Parking Area, as well as along the south side
 19 of the parking area and along the paved pedestrian
 20 path to the Visitor Contact Station. This provides
 21 a safety barrier for pedestrians. These wooden
 22 fences are of a standard design that consists of
 23 vertical timbers with mortise holes that receive the
 24 horizontal rails. The posts are set directly into the
 25 ground. The split-rail fencing is in good condition.

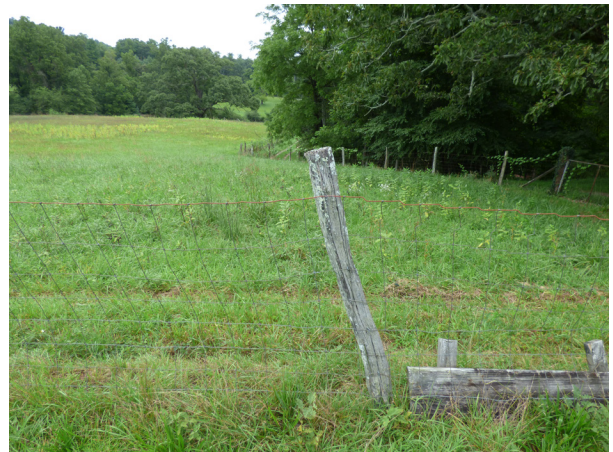
53 **Figure 3. 249.** Woven wire fencing with locust posts in the
 54 Pasture and Fields area (Source: WLA Studio).

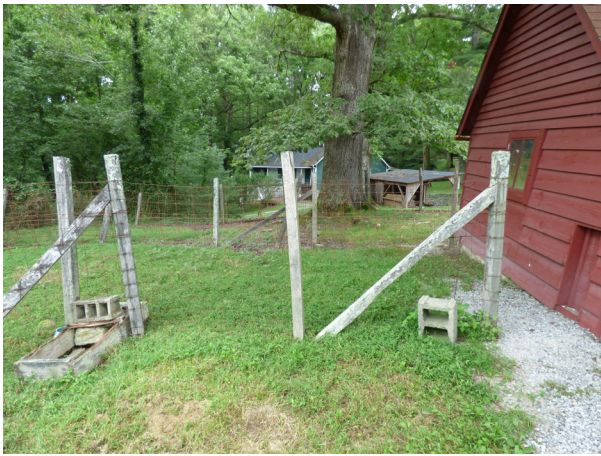
1 **Figure 3. 250.** Woven wire fencing with square wood posts
2 in the Farm Core area (Source: WLA Studio).

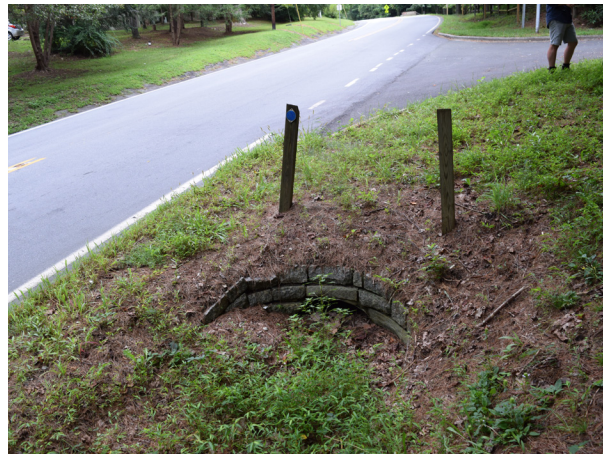
3 **Figure 3. 253.** Bollards by the driveway in the Entrance
4 Character Area (Source: WLA Studio).

37 There are simple wood and metal bollards to
 38 indicate vehicular hazards and prevent damage to
 39 site features (Figure 3. 253). Bollards are located
 40 surrounding the propane tank, generator, and near
 41 culverts and headwalls in the Administrative Area.

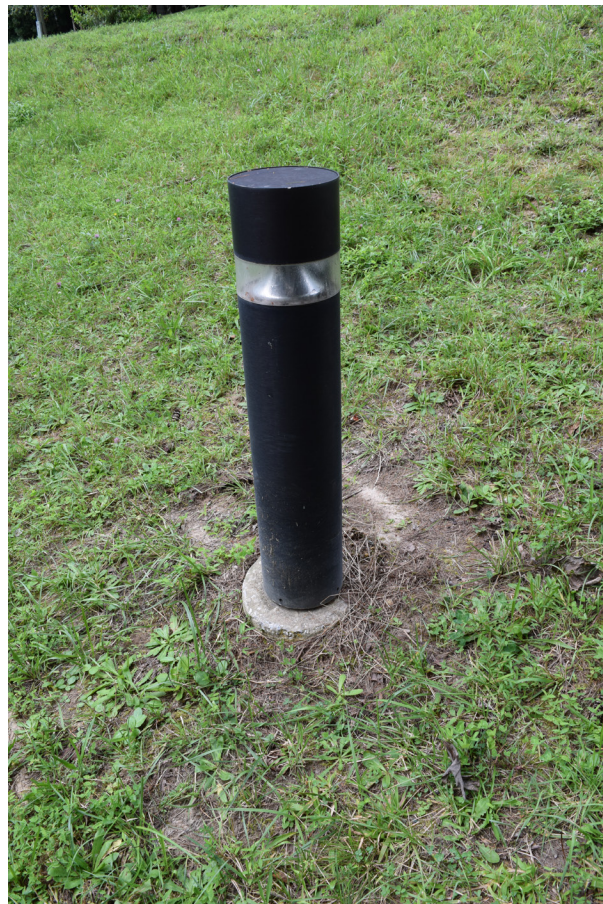
8 **Figure 3. 254.** Bollard-style lighting in the Entrance
9 Character Area (Source: WLA Studio).

There are 3-foot-tall metal bollard-style pedestrian lights, painted brown, that lead from the Park Identity Sign to the Main Visitor Parking area (Figure 3. 254). They are in fair condition. The only outdoor overhead lighting features in the landscape are in the Main Visitor Parking Lot, which is illuminated at night with tall overhead light fixtures on steel poles (Figure 3. 255). These are 3-foot-tall metal bollard-style pedestrian lights, painted brown, that lead from the Park Identity Sign to the Main Visitor Parking area. They are in fair condition. Other lighting features include security flood lights installed on the administrative and maintenance buildings.

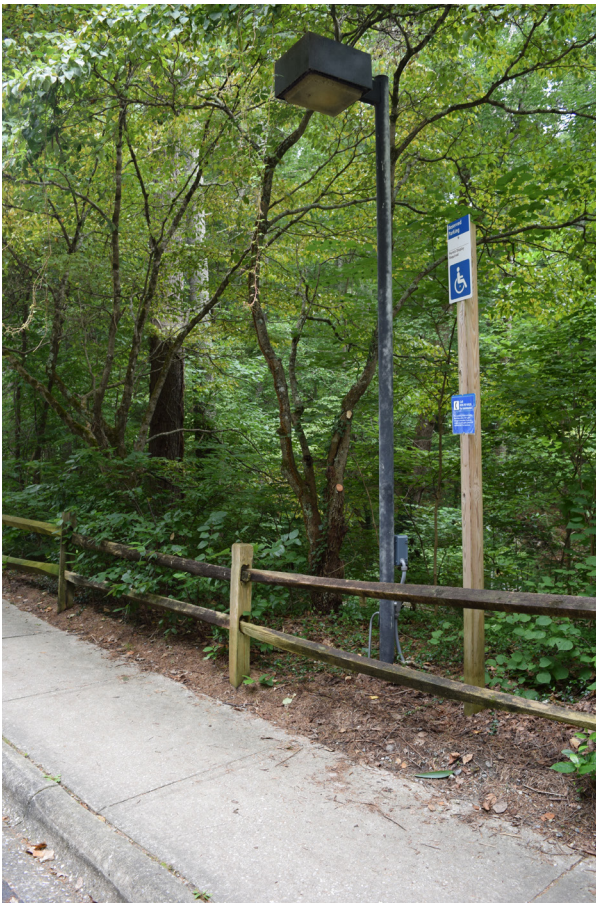
Figure 3. 255. Overhead lighting in the Entrance Character Area (Source: WLA Studio).

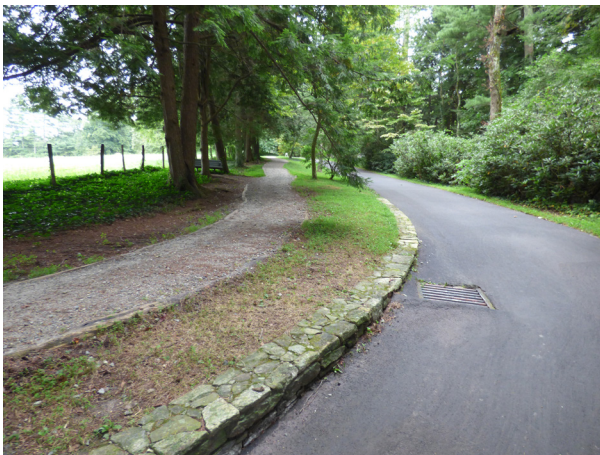
61 **Figure 3. 256.** Timber edging lines the gravel walkway
62 approaching the Main House. View to the south (Source: WLA Studio).
63

46 Natural logs and railroad ties are used for edge
47 reinforcement and trail stabilization throughout
48 the site (Figure 3. 256 - Figure 3. 257). Natural logs
49 are used to line the edge the gravel pedestrian
50 path following the Entry Drive. Natural logs are
51 installed across hiking trails throughout the park to
52 direct stormwater runoff away from the trail during
53 storm events. Deteriorating railroad ties retain
54 the gravel walkway on the west end of Front Lake
55 Bridge.

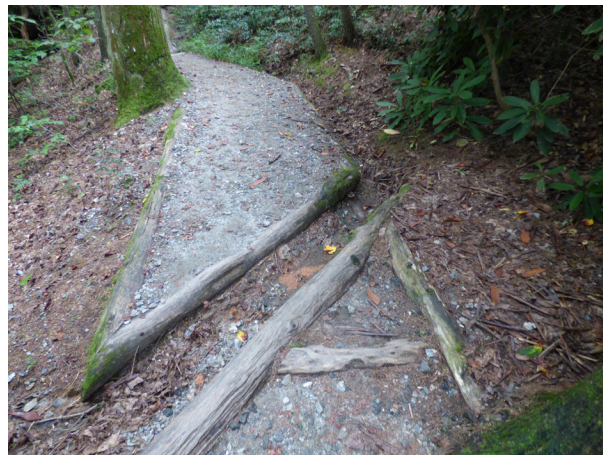
Figure 3. 257. Natural log construction is used to divert
stormwater runoff away from trails (Source: WLA Studio).

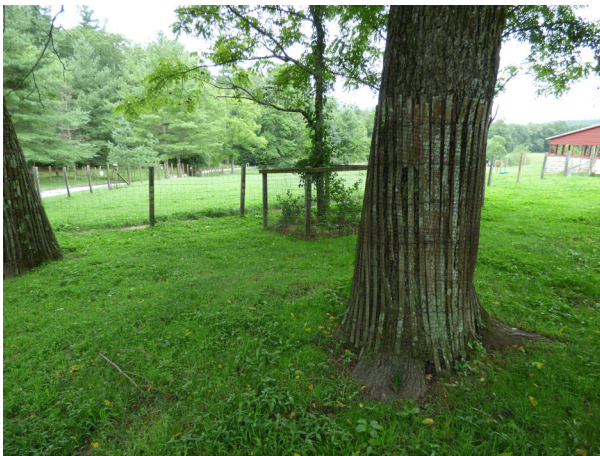
6 **Figure 3. 264.** Constructed protection from the goat herd
7 surrounds some trees in the Farm Core Character Area
8 (Source: WLA Studio).

1	<i>Residential Core Area</i>	44	• Waste receptacles
2	Miscellaneous features in the Residential Core area	45	• Mailboxes
3	include Carl Sandburg's rattan chair, a stone basin,	46	• Goat watering, feeding, and play features
4	birdhouses, a bird bath, a burn barrel, and a dinner	47	• Birdbath
5	bell (Figure 3. 258 - Figure 3. 262).	48	• Birdhouses
		49	• Carl Sandburg's rattan chair
		50	• Flagpole
6	<i>Farm Core area</i>	51	• Burn barrel
		52	• National Historic Landmark plaque
7	Miscellaneous features associated with the Farm	53	• Stone curbs
8	Core area include two goat feeding troughs, tree	54	• Concrete curbs
9	protection wrapping and barriers in the goat pen,	55	• Timber edging
10	an oil drum, two wooden spools and goat watering	56	• Fences
11	stations, a bathtub with a spigot, and a tire swing	57	• Gates
12	with wood supports (Figure 3. 263 - Figure 3. 265).	58	• Bollards
		59	• Power and light poles

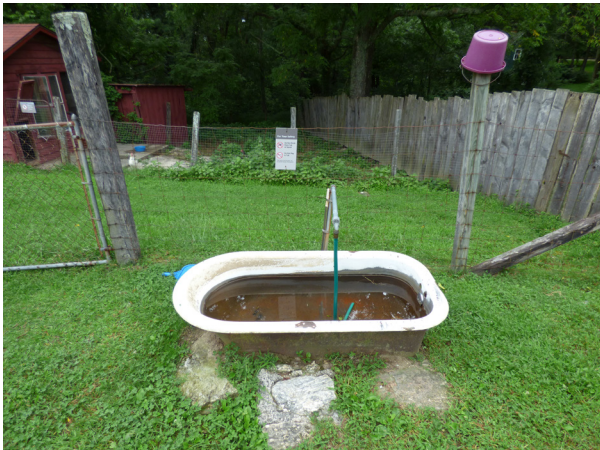
11 **Figure 3. 265.** Bathtub used as a goat water source in the
12 Farm Core Character Area (Source: WLA Studio).

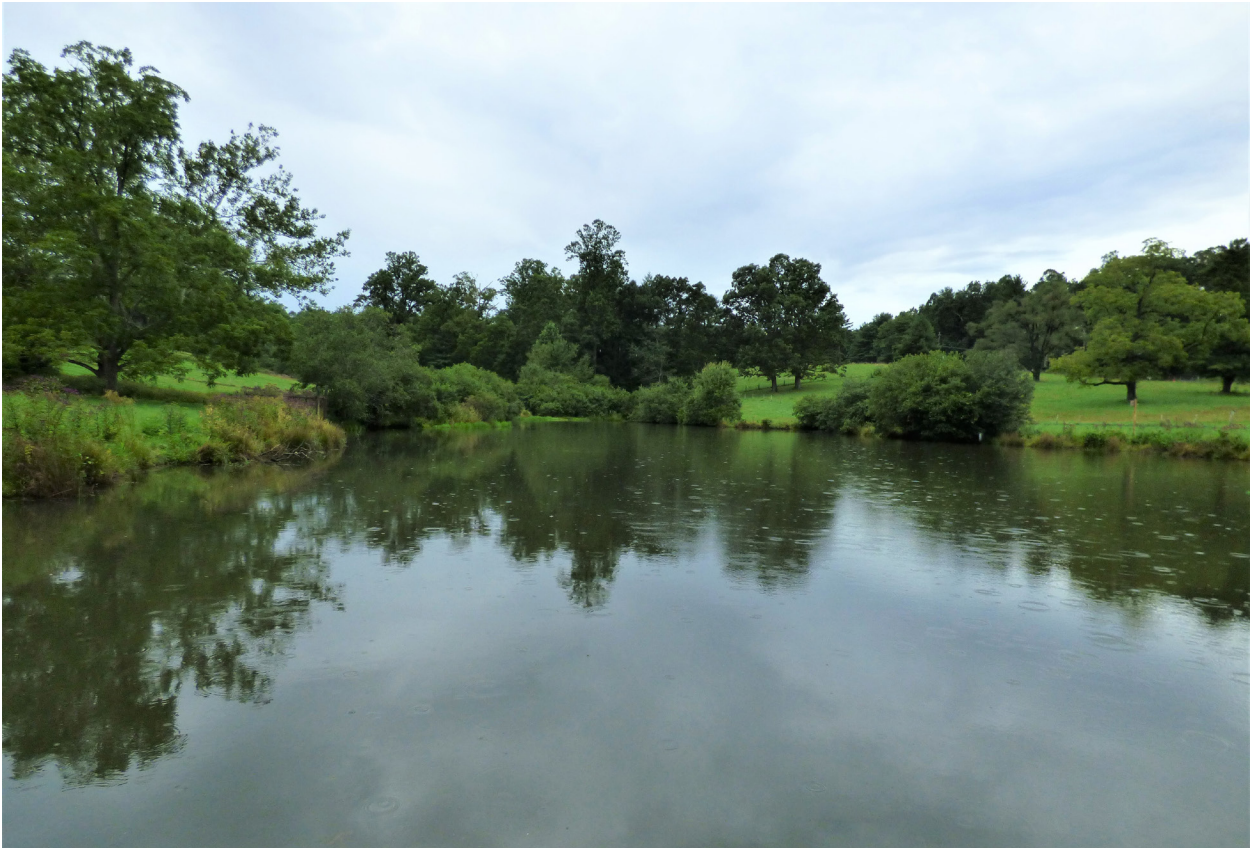
1 **Figure 3. 268.** Side Lake in the Pasture and Fields Character Area. View to the west (Source: WLA Studio).

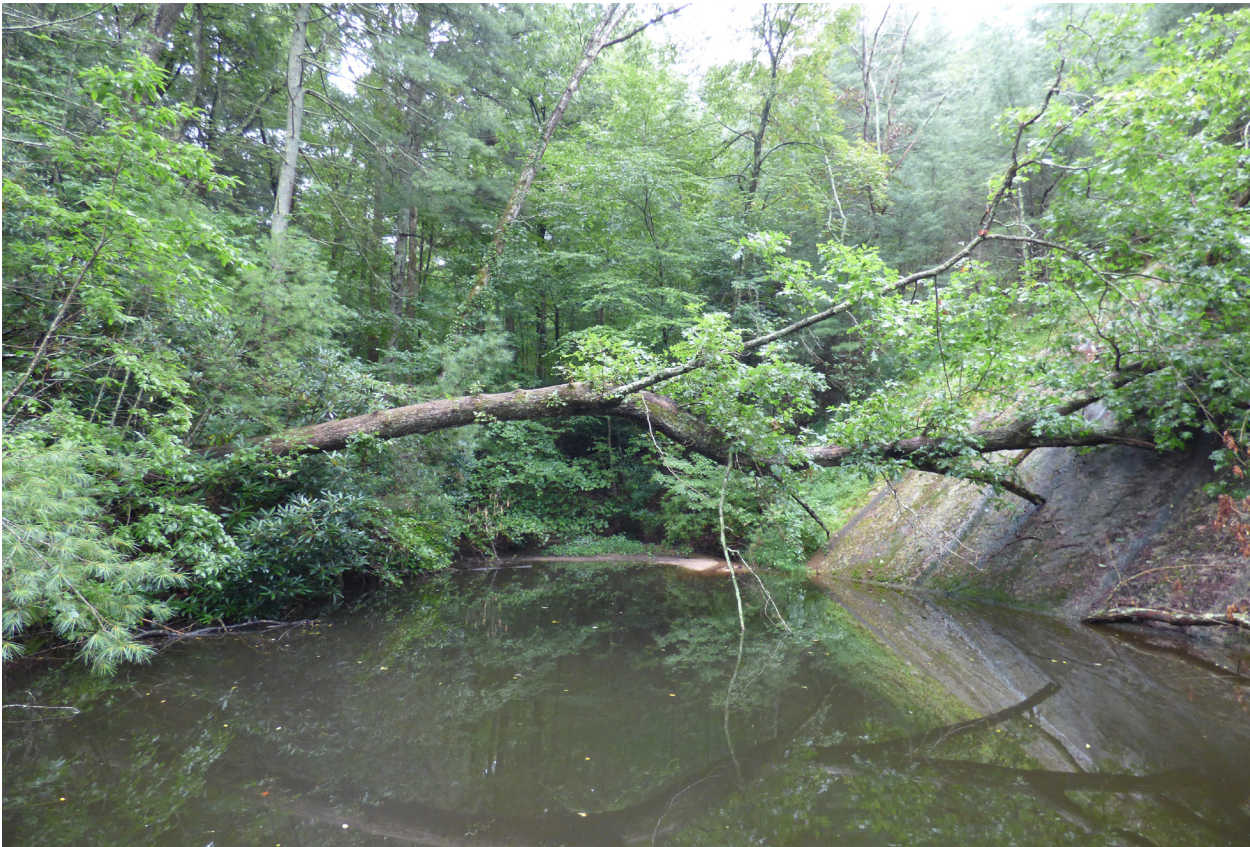
2 **Figure 3. 269.** Trout Pond is a small reservoir at the southern end of the Farm Core Character Area (Source: WLA Studio).

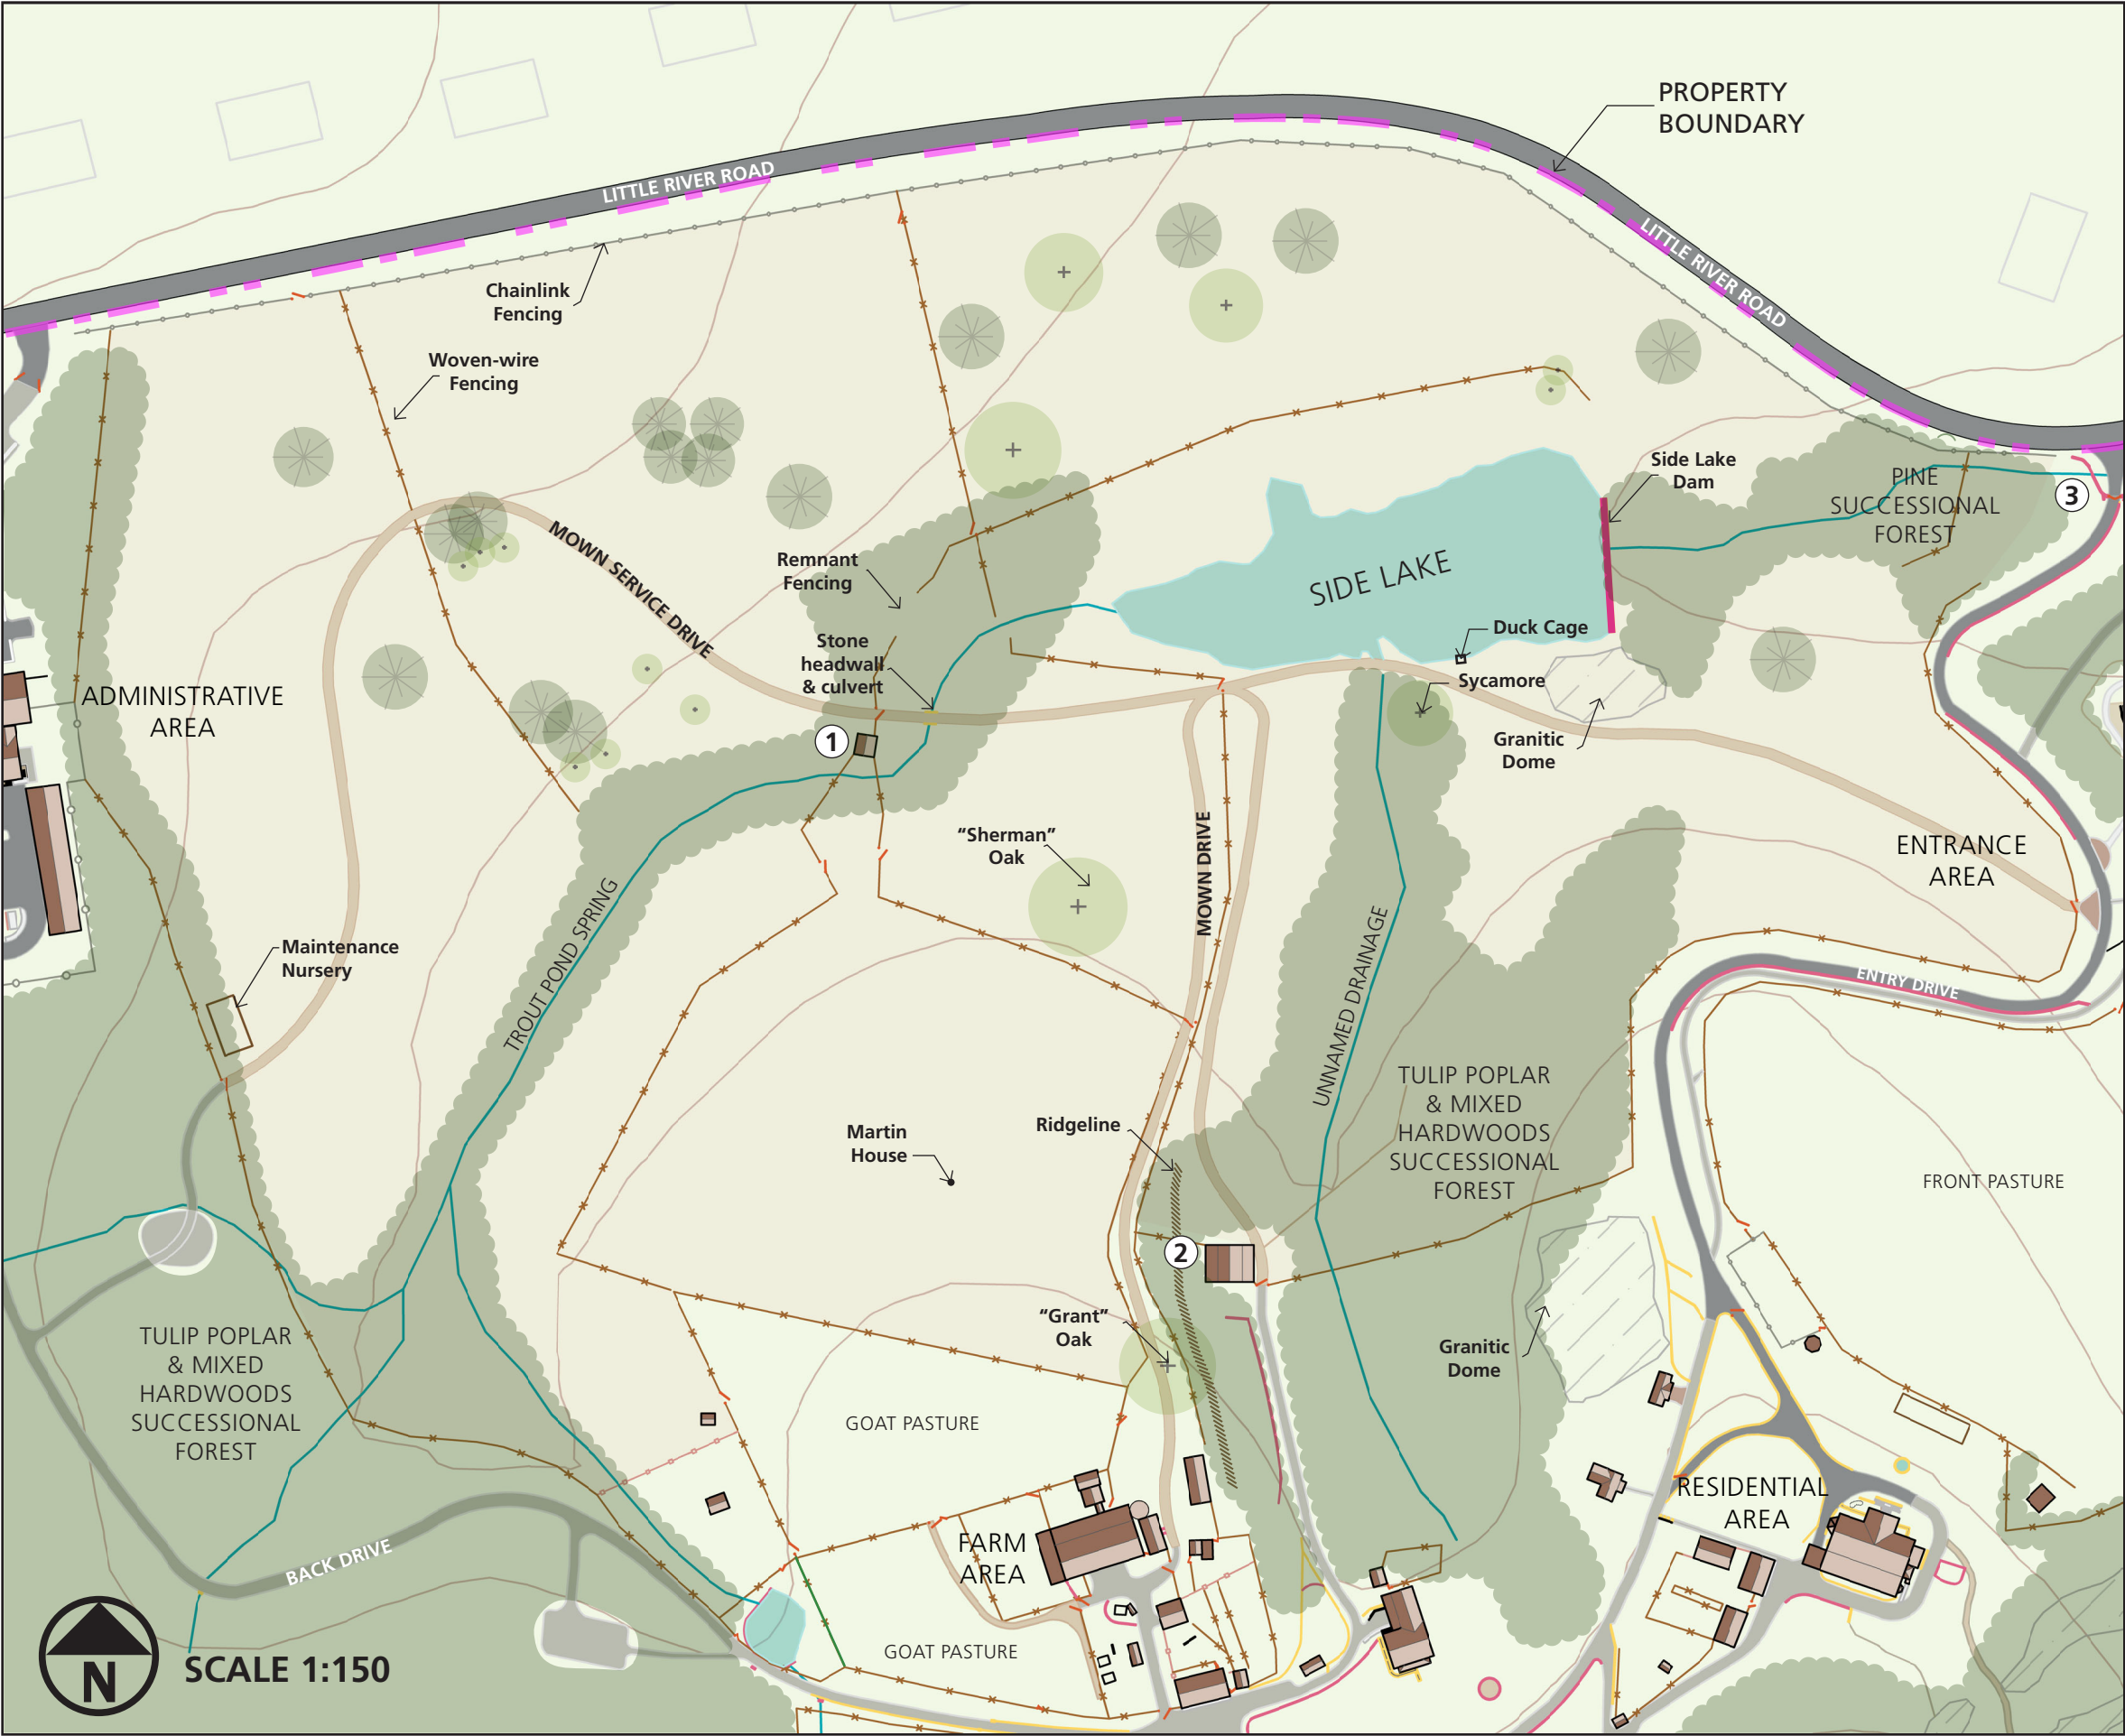
Illustration 3.5
Existing Conditions:
Pasture and Fields Character Area

- 1 HS-31 Cow Shed
 - 2 HS-21 Buck House
 - 3 HS-48 Main Entrance Gate
-
- Picket Fence
 - Woven Wire Fence
 - Chainlink Fence
 - Stone Wall
 - Stone Drain & Gutter
 - Hayed Pastures

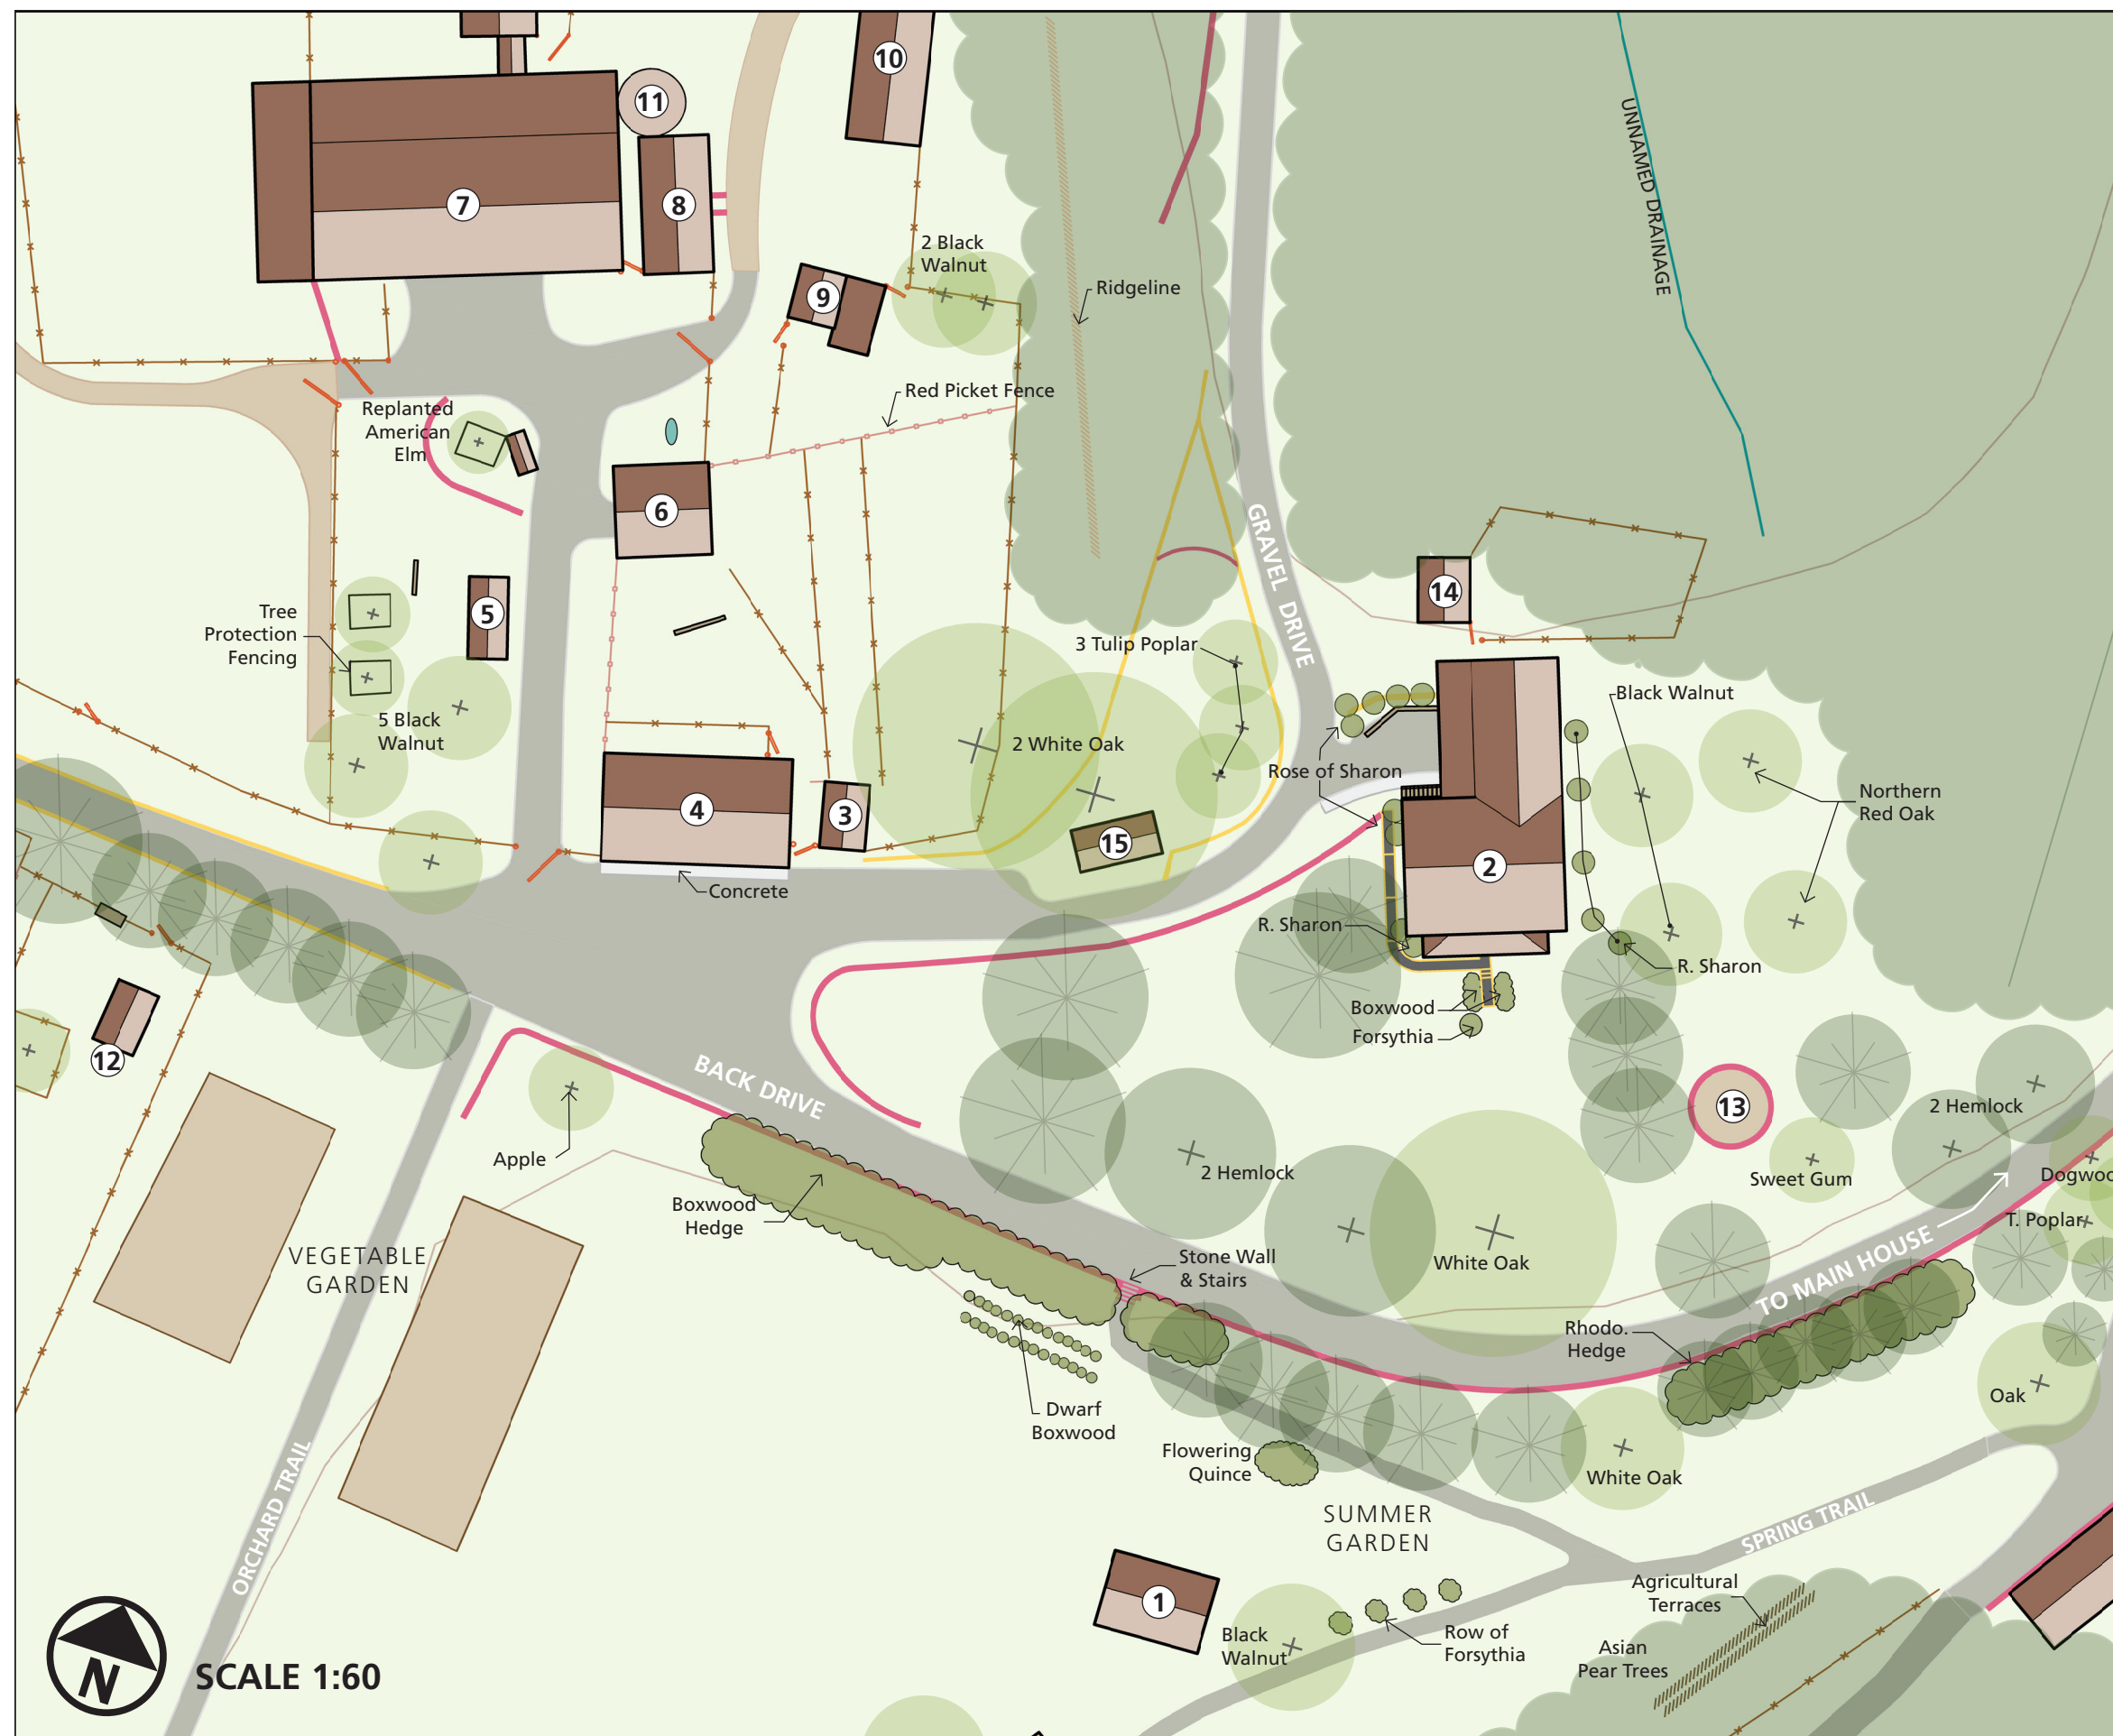
Illustration 3.12
Existing Conditions: Vegetation
Farm Core Character Area

- 1 HS-09 Greenhouse
- 2 HS-11 Farm Manager's House
- 3 HS-12 Isolation Quarters
- 4 HS-13 Barn Garage
- 5 HS-14 Corn Crib
- 6 HS-15 Buck Kid Quarters
- 7 HS-16 Goat Barn
- 8 HS-17 Horse Barn
- 9 HS-18 Cow Shed
- 10 HS-19 Farm Equipment Storage
- 11 HS-20 Silo
- 12 HS-24 Jennifer's House
- 13 HS-28 Ice House Ruins
- 14 HS-29 Farm Manager's Chicken House
- 15 HS-30 Farm Manager's Woodshed

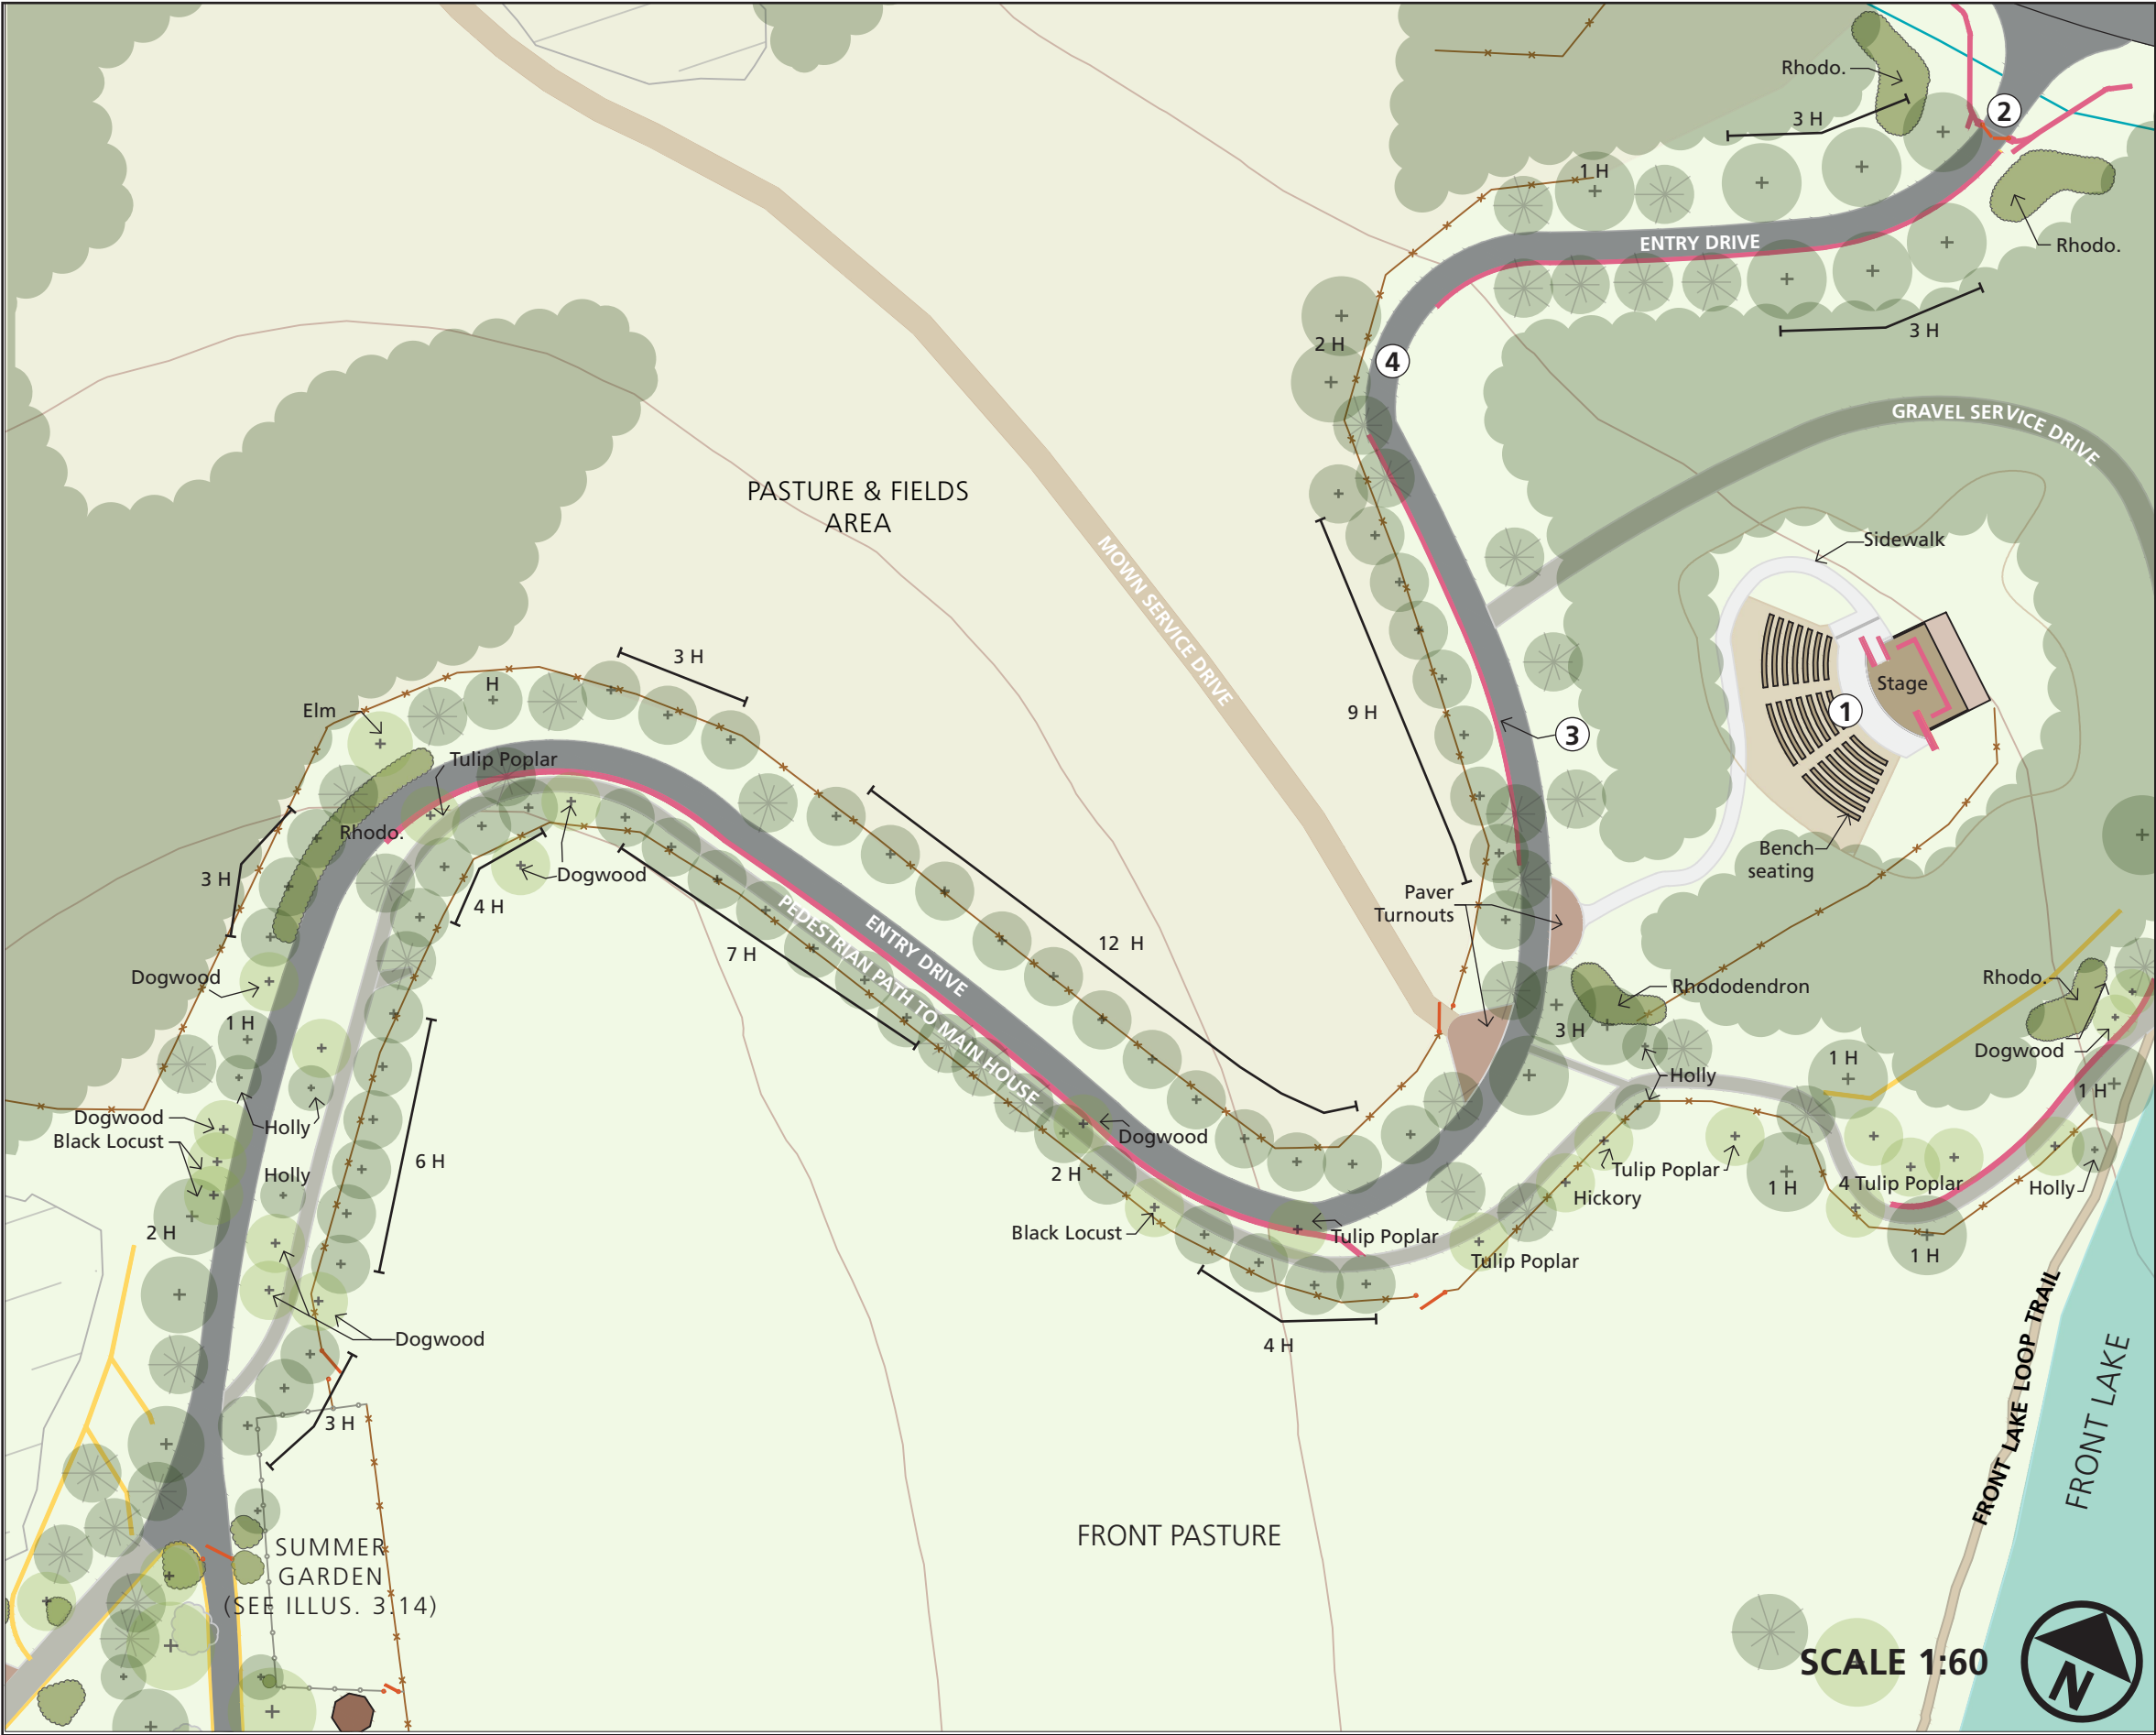
Illustration 3.13
Existing Conditions: Vegetation
Entry Drive

- 1 Amphitheater
- 2 HS-48 Main Entrance Gate
- 3 HS-36 Serpentine Drive Retaining Walls
- 4 HS-45 Serpentine Entrance Drive

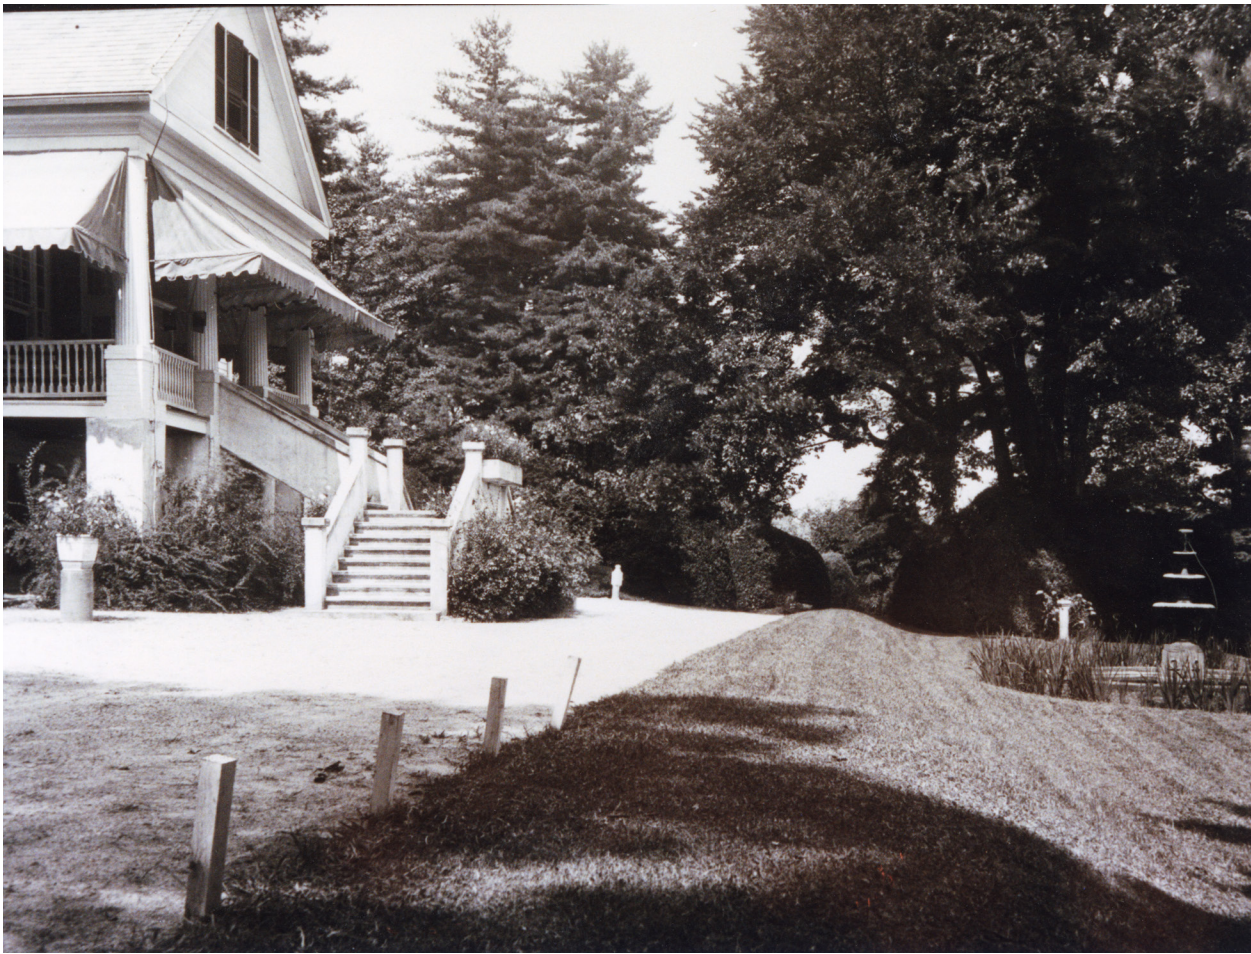
1 **Figure 4. 1.** Circa 1930s image of the front lawn landscape showing terracing. The image also shows the various small-scale
 2 features, including bollards, the sundial, wood posts, and plant pots. Note the vegetation surrounding the fountain and house
 3 foundation, as well as the boxwoods along the drive in the background. (Source: CARL archives, 3001-0006).

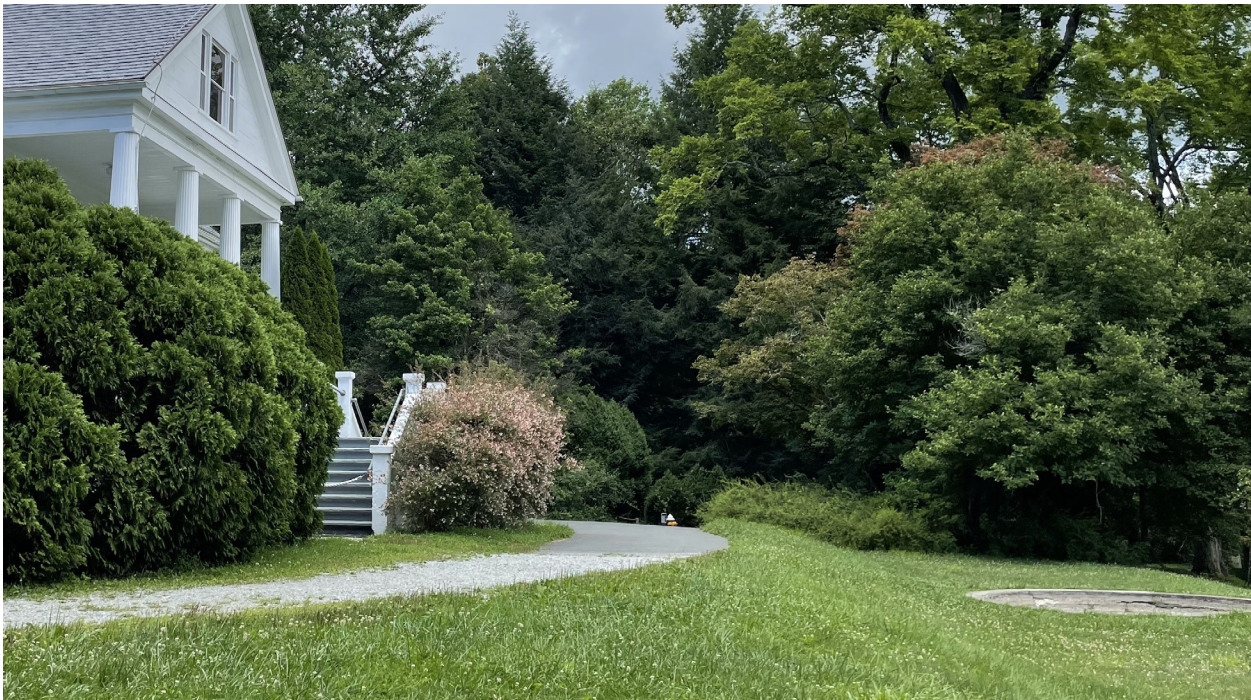
3 **Figure 4. 2.** This photograph provides a comparison between the existing conditions of the front lawn area with that of the
 4 1930s. (Source: WLA Studio).

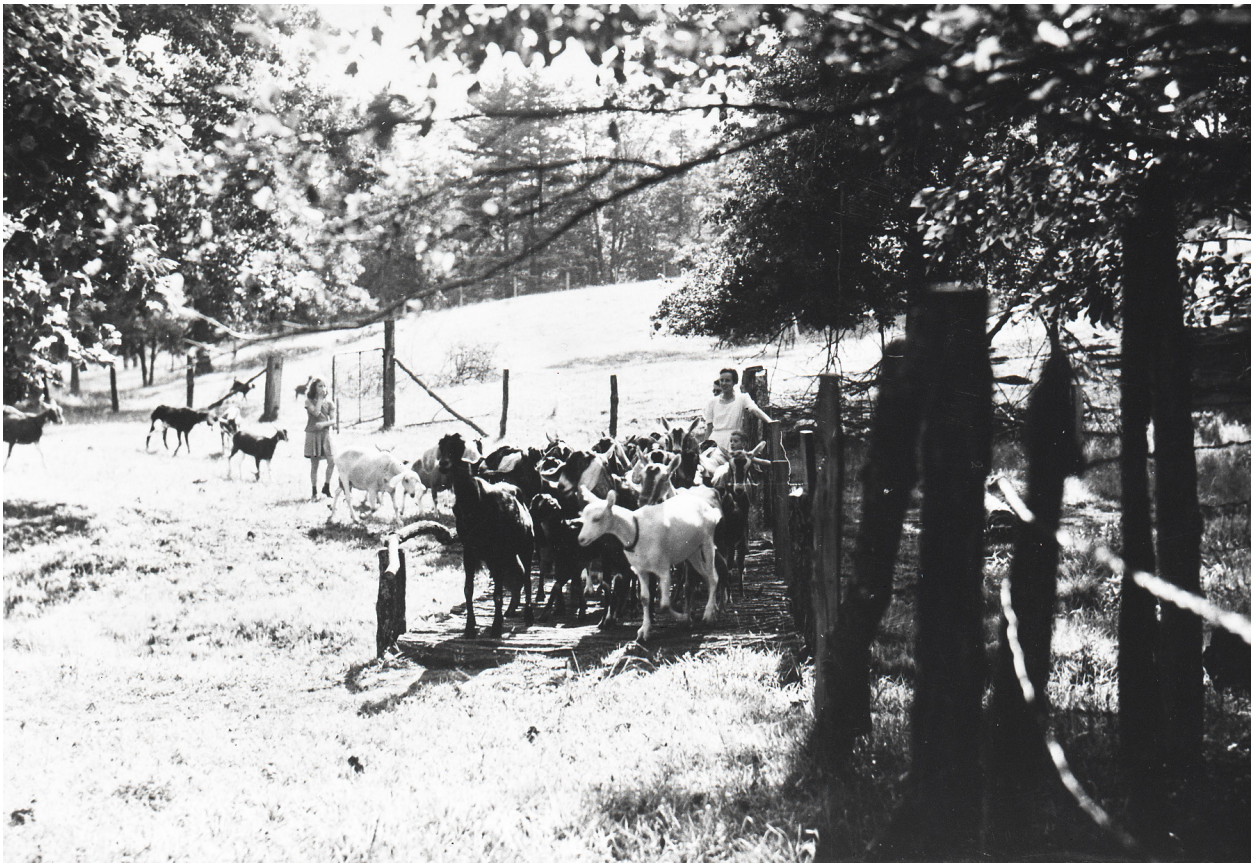
1 **Figure 4. 3.** Late 1940s photo of the Sandburgs' goats being led into the lower pastures, likely near Side Lake. Note the
2 wooden bridge over the creek, post-and-rail fencing, and vegetation diversity. (Source: CARL archives, 3000-0513).

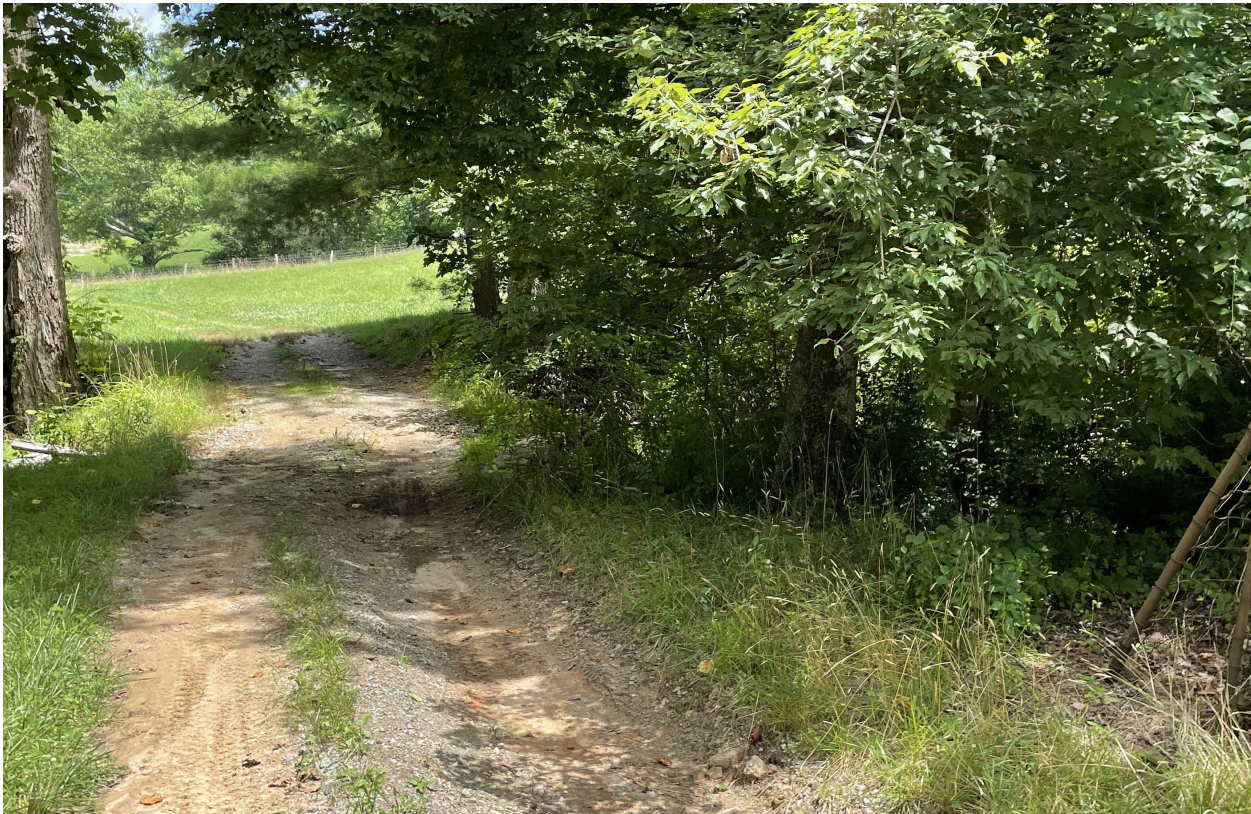
3 **Figure 4. 4.** Compare this photograph with Figure 4.3. This image is thought to show the location of the wooden bridge used
4 to move goats across the stream. (Source: CARL archives, 3000-0513).
