Carl Sandburg Home National Historic Site Cultural Landscape Report

85% Draft Submittal
September 2021

Cultural Resources, Partnerships, and Science Division
Interior Region 2 - South Atlantic Gulf

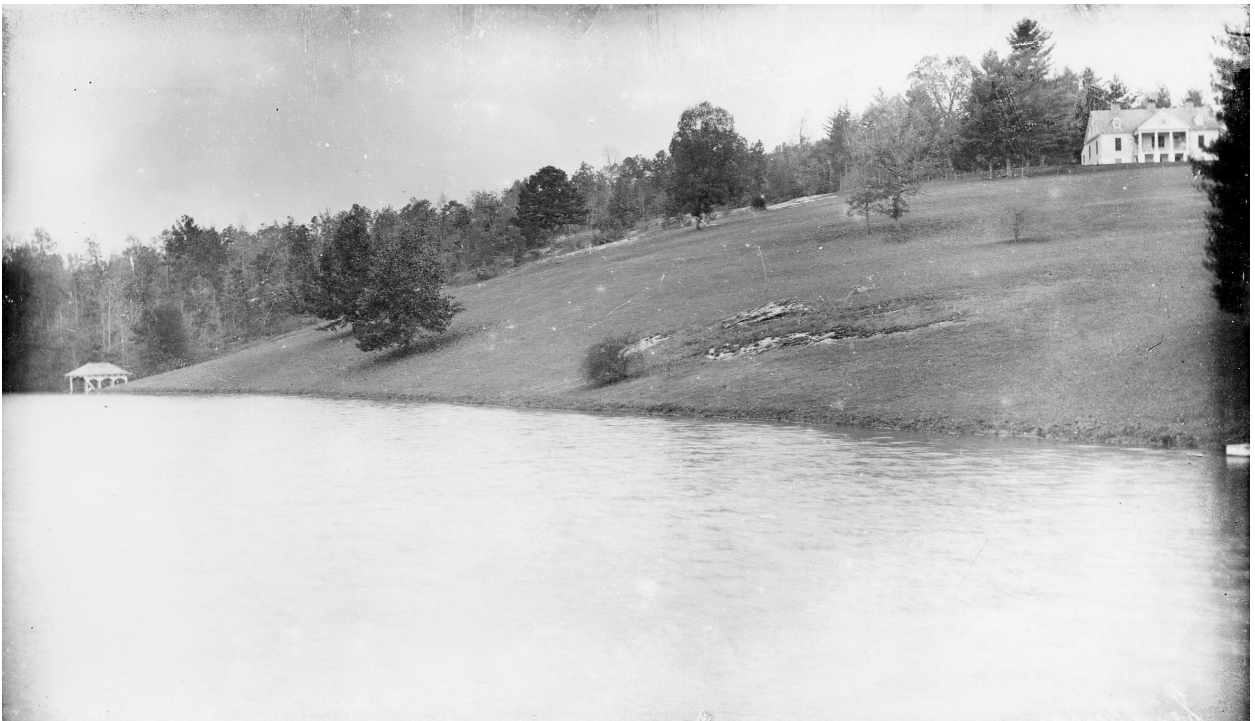
1 **Figure 4. 8.** Circa 1900 image showing Front Lake, the boat house, Front Pasture, and the Main House. Note fence along upper
 2 edge of pasture, scattered specimen trees, the granitic domes, and the manicured edge of the lake. (Source: Carl archives,
 3 3001.01.48P).

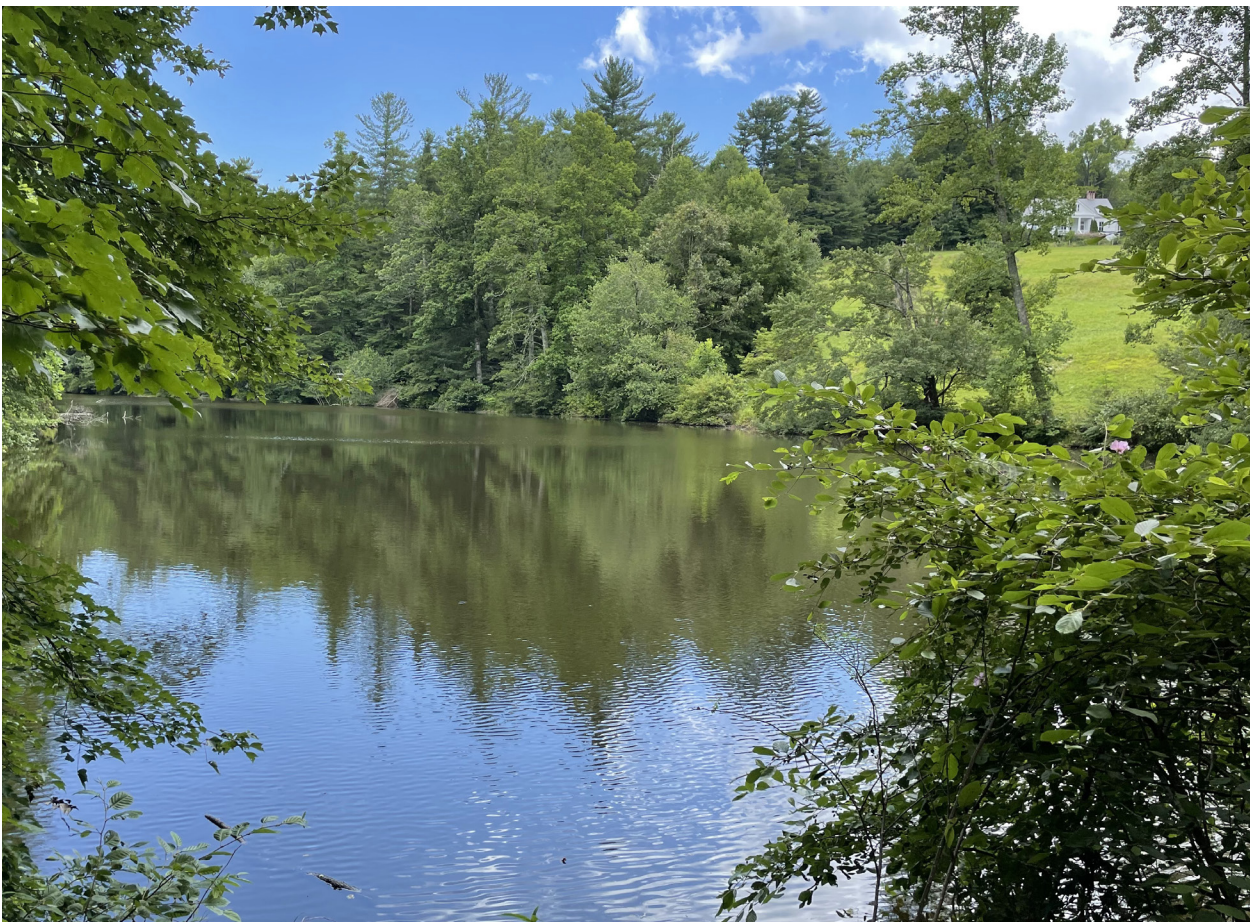
4 **Figure 4. 9.** Compare this image to Figure 4.8. Note the differences in vegetation, with existing conditions containing far
 5 more vegetation in the vicinity of Front Lake. Also note the removal of the boat shed from the edge of the lake. (Source: WLA
 Studio).

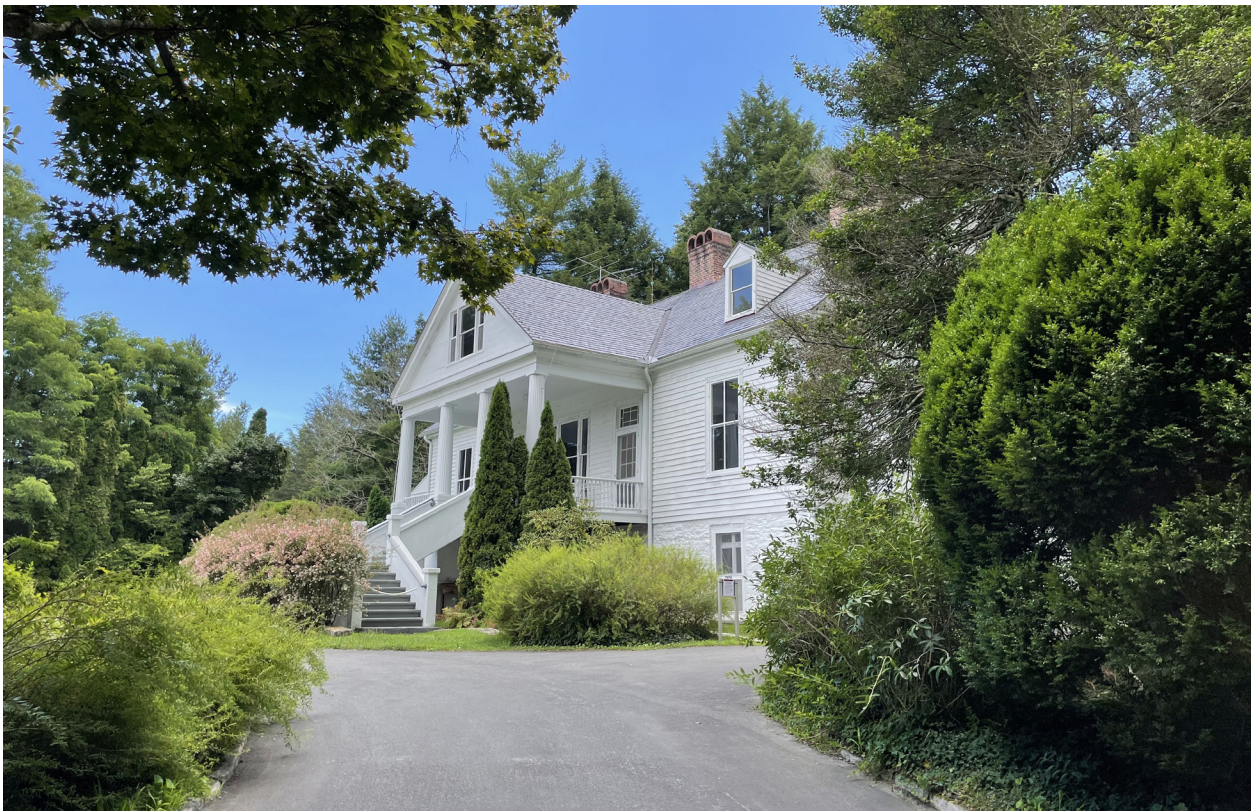
2
3 **Figure 4. 11.** Compare this image to Figure 4.10. Note, despite some differences in plant material, the landscape is reflective of the historic period. (Source: WLA Studio).

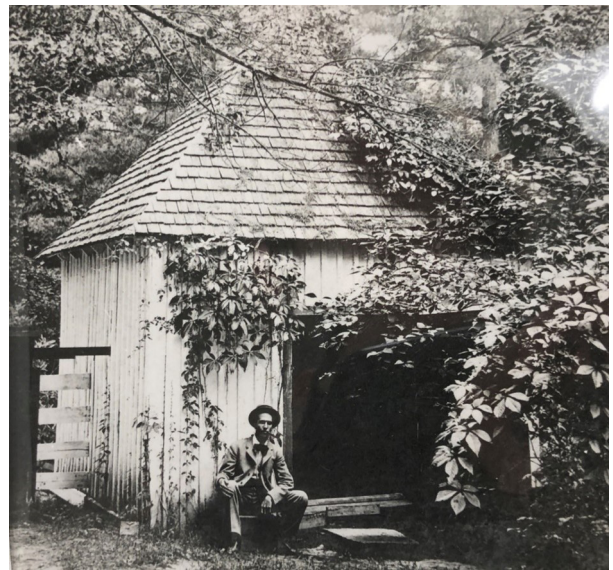
Figure 4. 12. Undated Smyth Period photograph of the Spring House. Note the lush vegetation and fence with gatepost on the left side of the image (Source: CARL archives, 3001-03-01p).

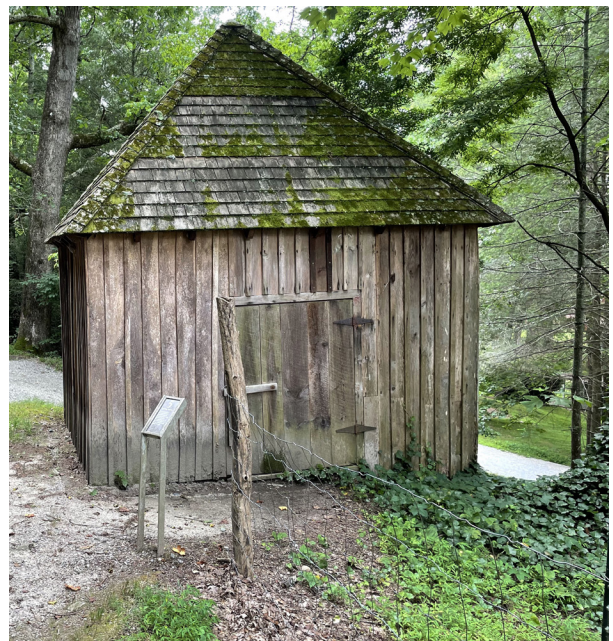
Figure 4. 13. Compare this image to Figure 4.12. Note the difference in vegetation between existing conditions and those during the Smyth Period. Other differences pertain to fencing and the grade adjacent to the door. (Source: WLA Studio).

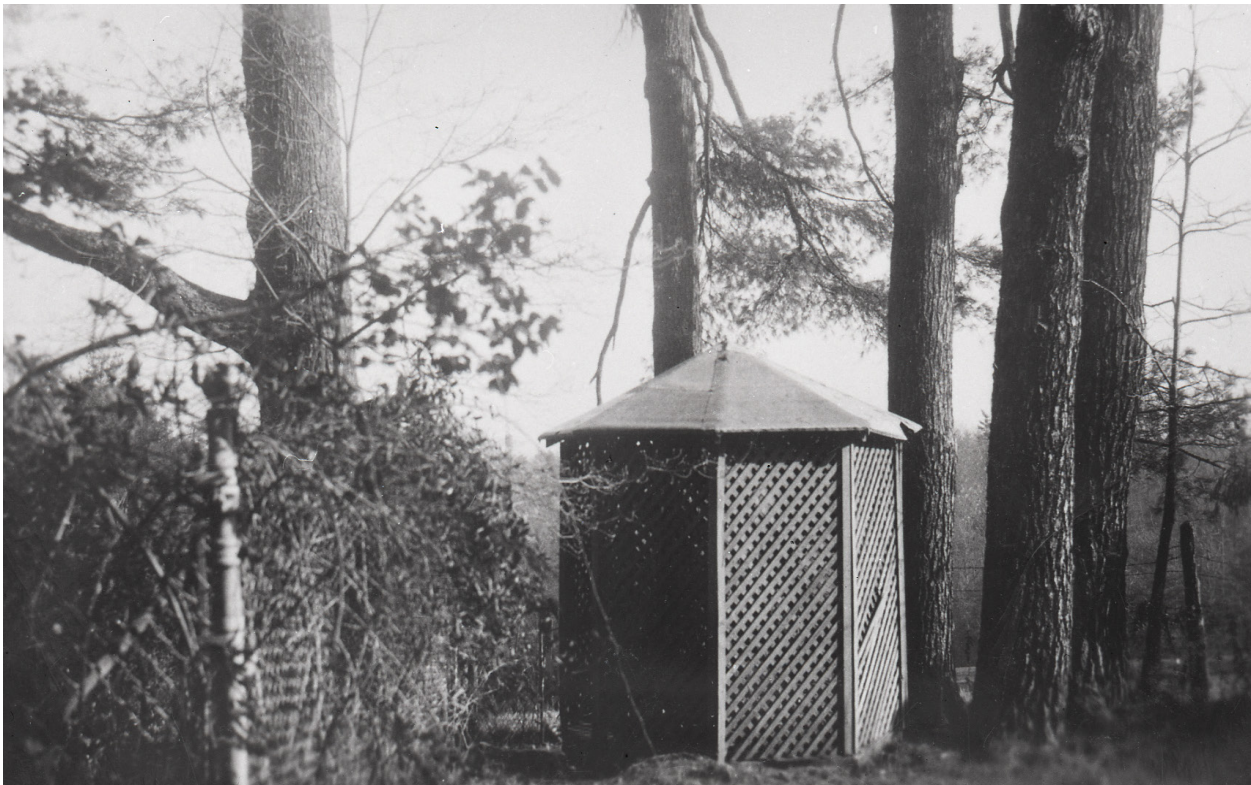
1 **Figure 4. 15.** Image of the Smyth Period Gazebo next to the Summer Garden. The Sandburgs called this the Summer House.
 2 Note the unkempt nature of the vegetation along the fence line. (Source: Carl archives, 3000-0378).

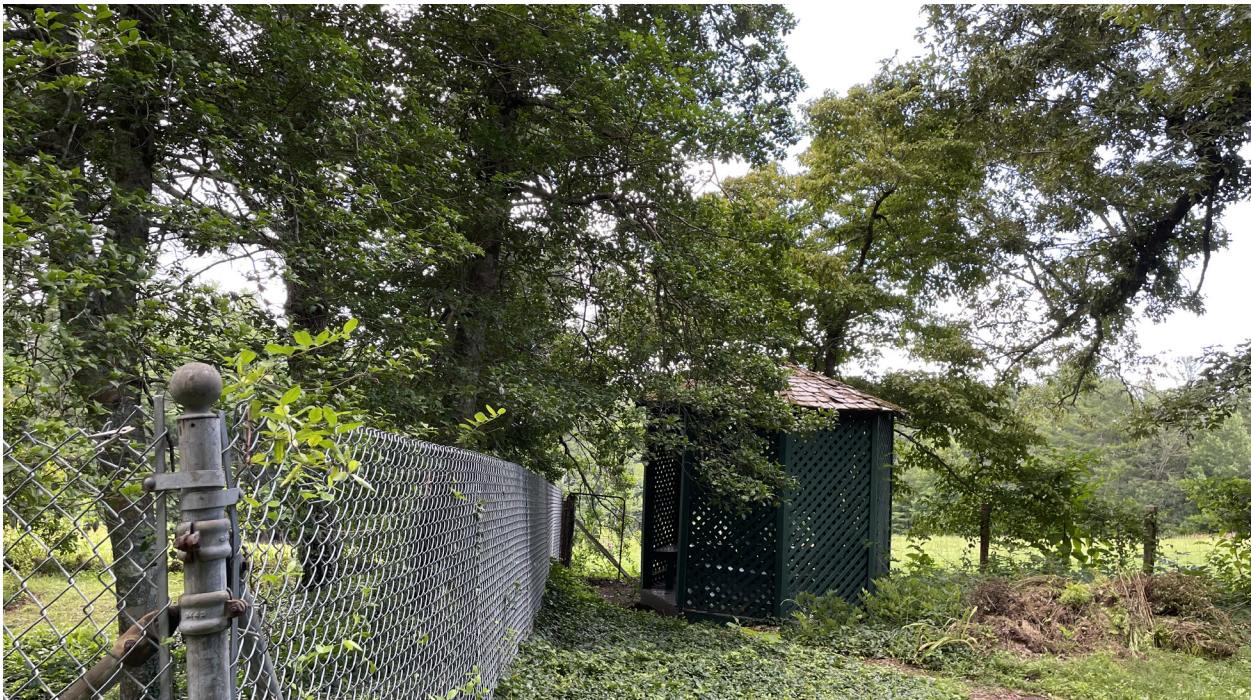
3 **Figure 4. 16.** Compare this image to Figure 4.15. The most obvious difference is the absence of the large trees that surrounded
 4 the gazebo during the Sandburg Period. (Source: Carl archives, 3000-0378).

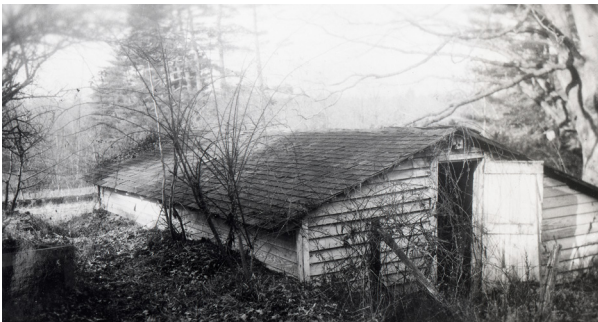
Figure 4. 17. Circa 1960 image of the deteriorating Greenhouse in the Farm Core Character Area. Note the section of fencing in foreground, large oak to the right, and the pumphouse to the left of the image. (Source: CARL archives, 3000-0365).

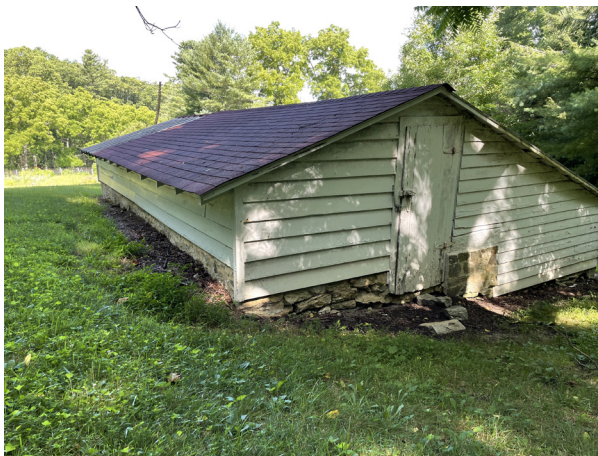
Figure 4. 18. Compare this image of the Greenhouse in 2021 to Figure 4.17. Note the absence of vegetation and fencing today, as well as the depth of left litter against the sides of the building. (Source: WLA Studio).

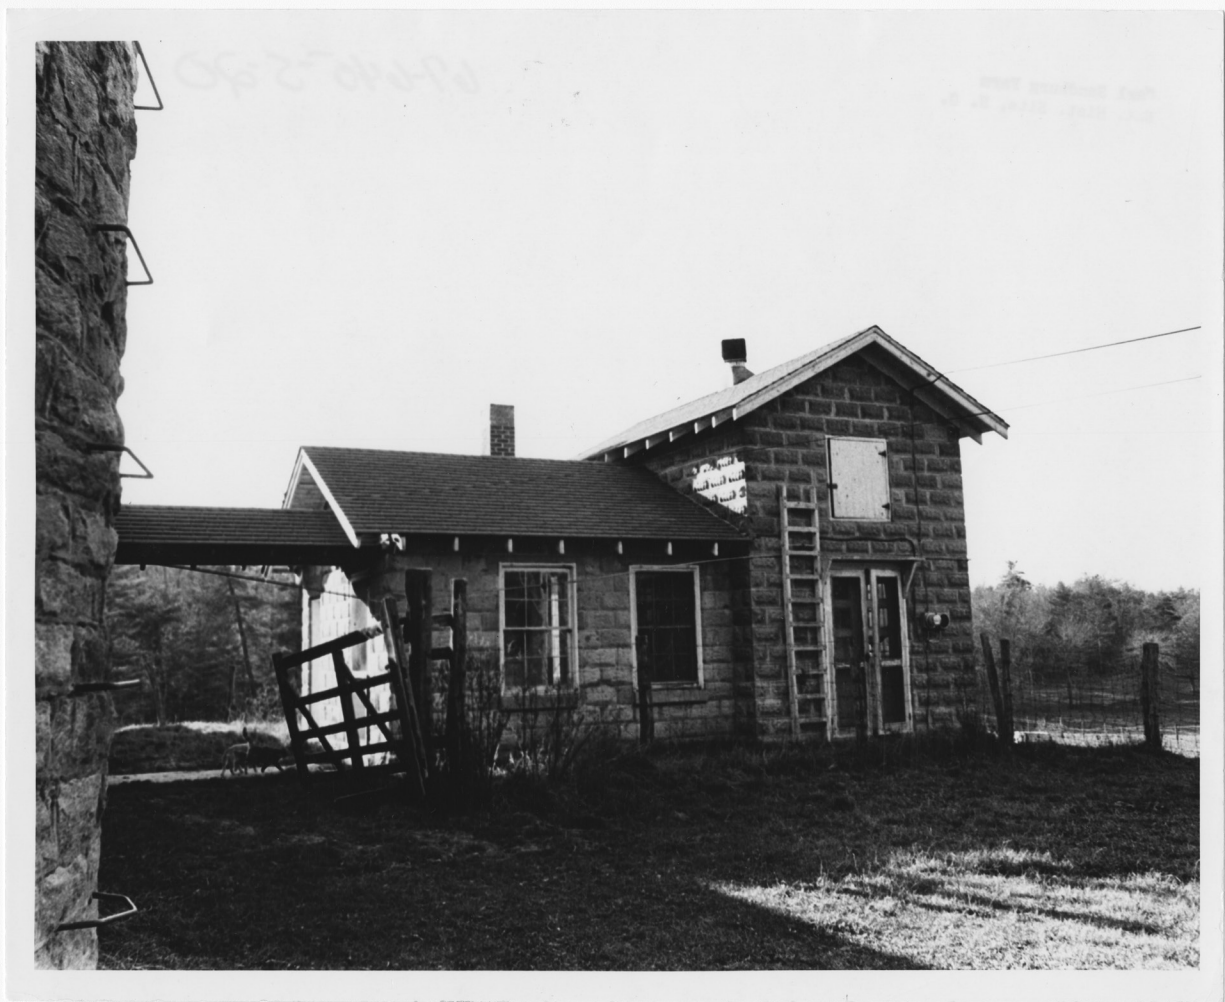
Figure 4. 20. Circa 1970 image of the Milk House taken shortly after NPS acquisition. A portion of the silo is on the left side of the picture. Note the fencing and gate. The path from the barnyard to the pastures went through this area. (Source: CARL archives, 4011-series 1-010-010).

1 but the front door faced east (Figure 4. 20). The
2 entire building was constructed of “rusticated
3 concrete blocks as an aid to sanitation.”²³³

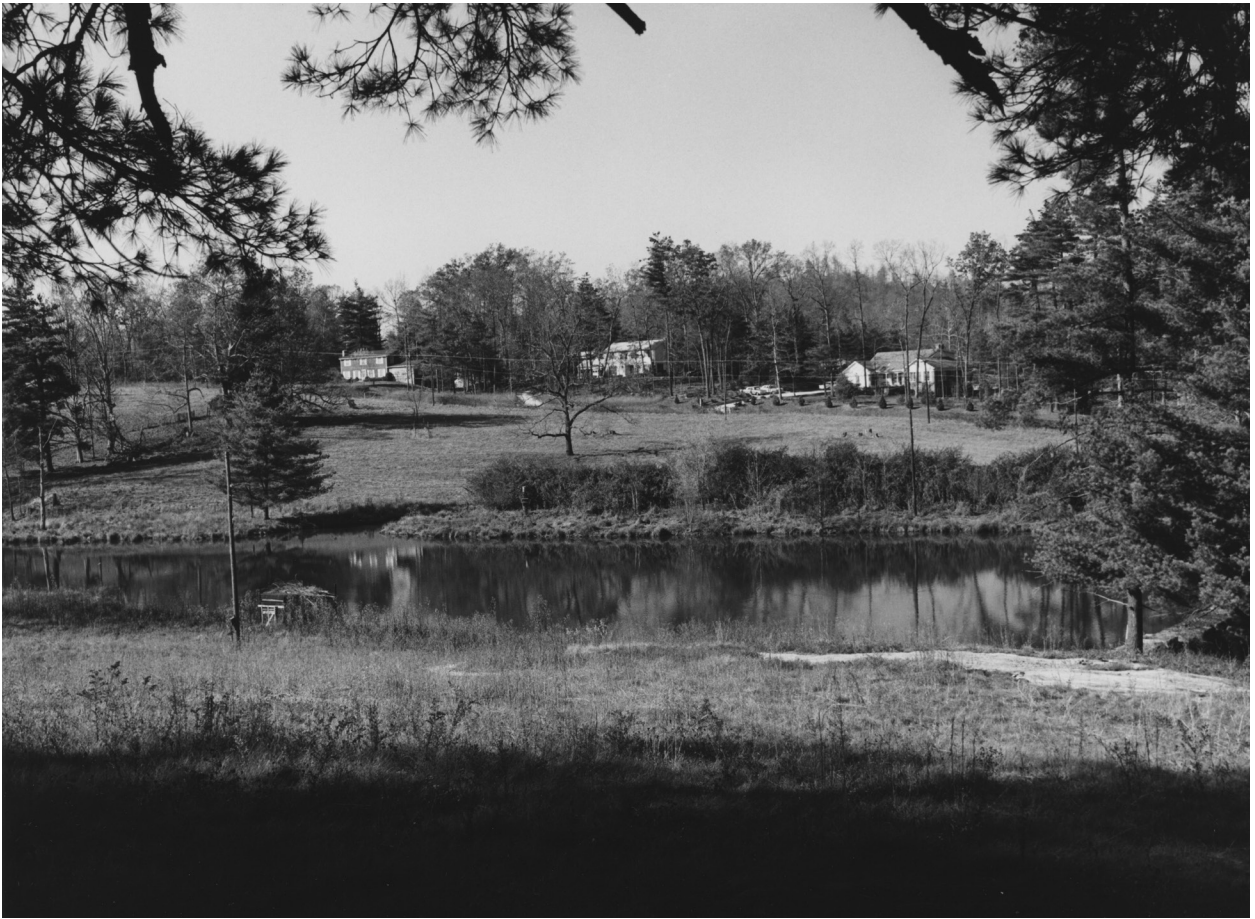
75 **Figure 4. 22.** Late Sandburg Period image of Side Lake looking north towards neighboring properties, with Side Lake dam on
 76 the right side of the image. Note the Duck Cage at the lake's edge, towards the left side of the image. (Source: CARL archives,
 77 4011-series1-011-009).

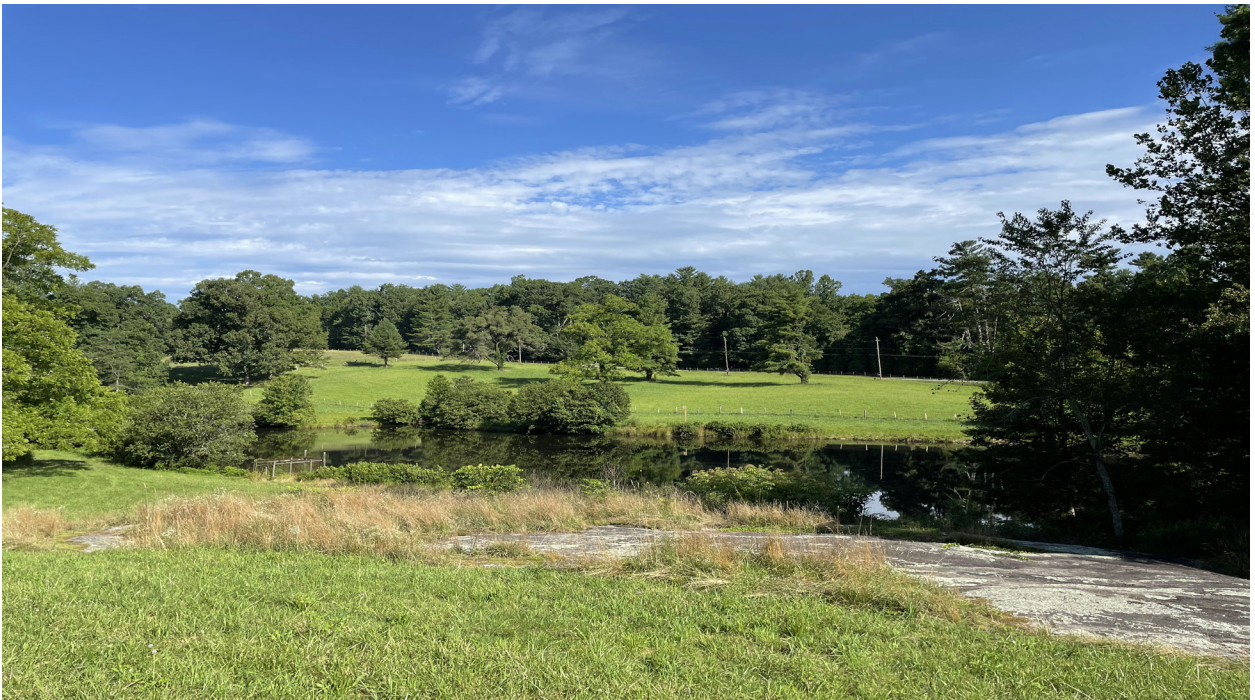
78 **Figure 4. 23.** Compare this 2021 image of Side Lake and the pastures to its north with that in Figure 4.22. Note the differences
 79 in vegetation along the lake's edge, as well as how similar the images are (despite being taken in different seasons). (Source:
 80 WLA Studio).

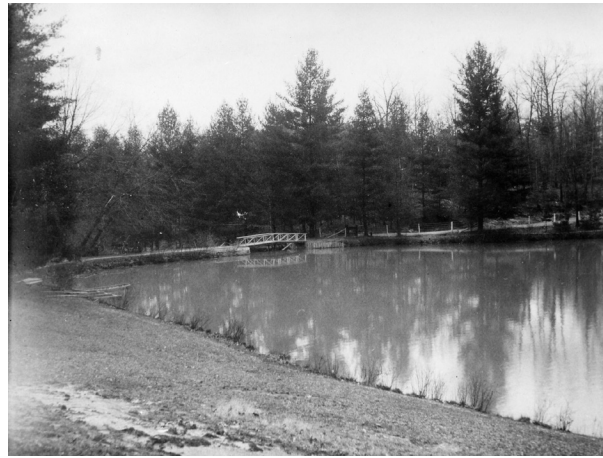
38 **Figure 4. 24.** Circa 1910s image of Front Lake, Front Lake
39 Dam, and an iteration of the bridge over the dam. Also note
40 the fencing along the (now relocated) Little River Road.
41 (Source: CARL archives, 3001.09.07p).

43 Ellison Smyth had a bridge constructed over Front
44 Lake dam during his ownership of the property
45 (Figure 4. 24). The simple wooden bridge featured
46 two handrails on either side flanking a wooden
47 boardwalk. It was painted white. The bridge
48 deteriorated within the Sandburg Period, and the
49 family removed the structure.

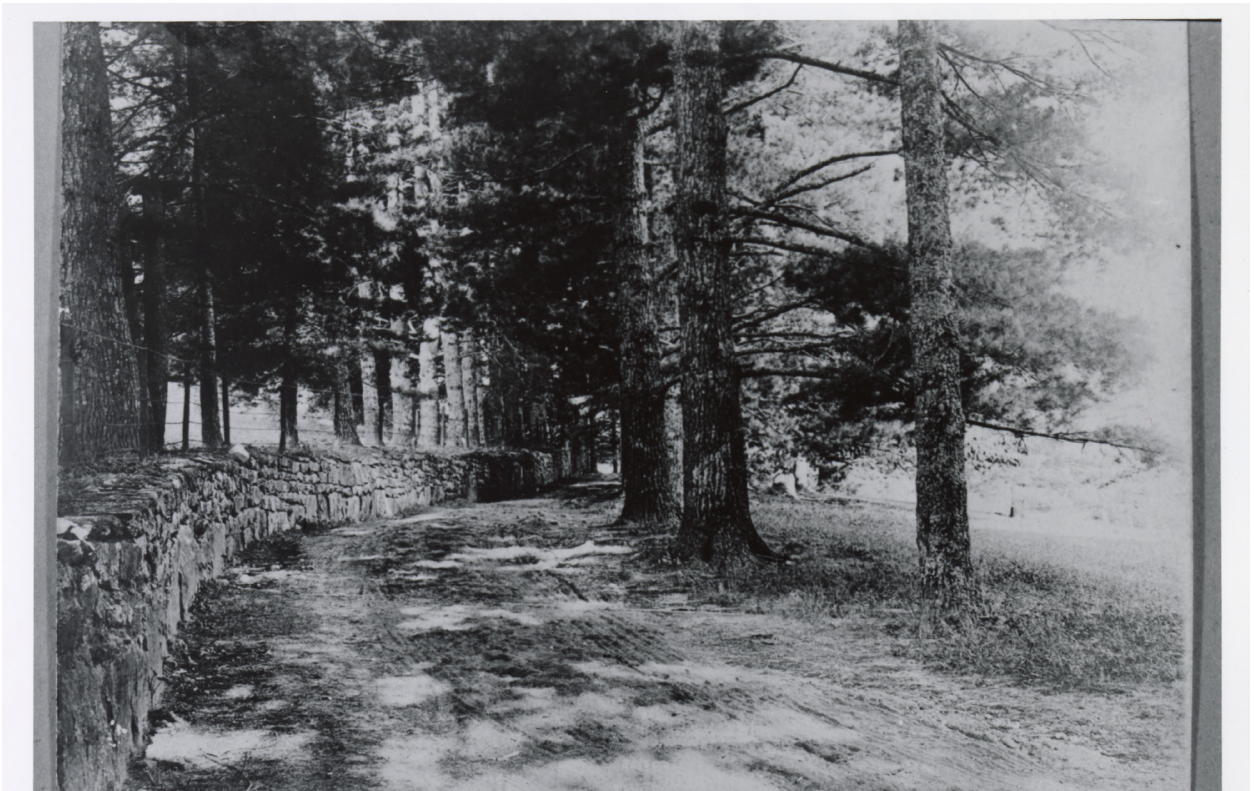
1 **Figure 4. 25.** Smyth Period image the Entry Drive with the recently constructed stone walls and planted white pines. Behind
2 the wall is the post-and-wire fencing that Smyth installed (Source: CARL archives, 3002-0002).

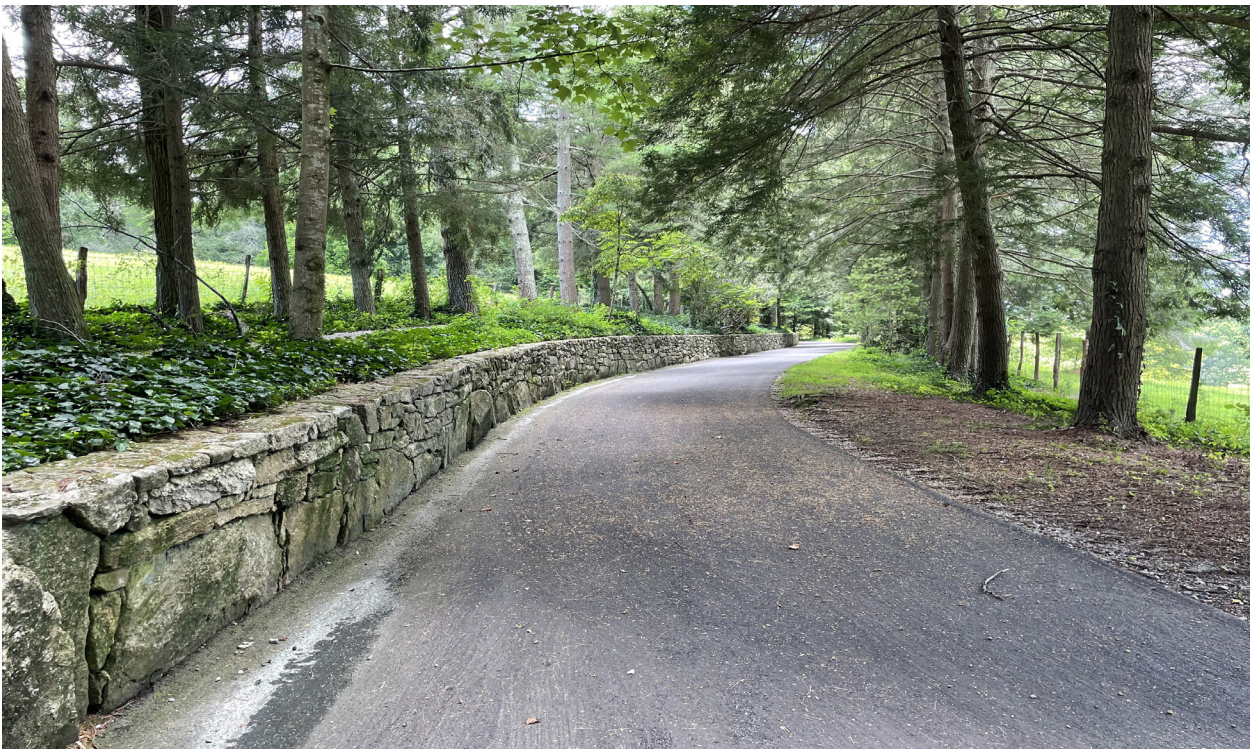
3 **Figure 4. 26.** Compare this image taken in 2021 to Figure 4.25. Note the continued presence of the stone wall and its similar
4 appearance to early 20th century conditions. Also note the absence of white pines along the drive, the paved surface, and the
5 increased shoulder width. (Source: WLA Studio).

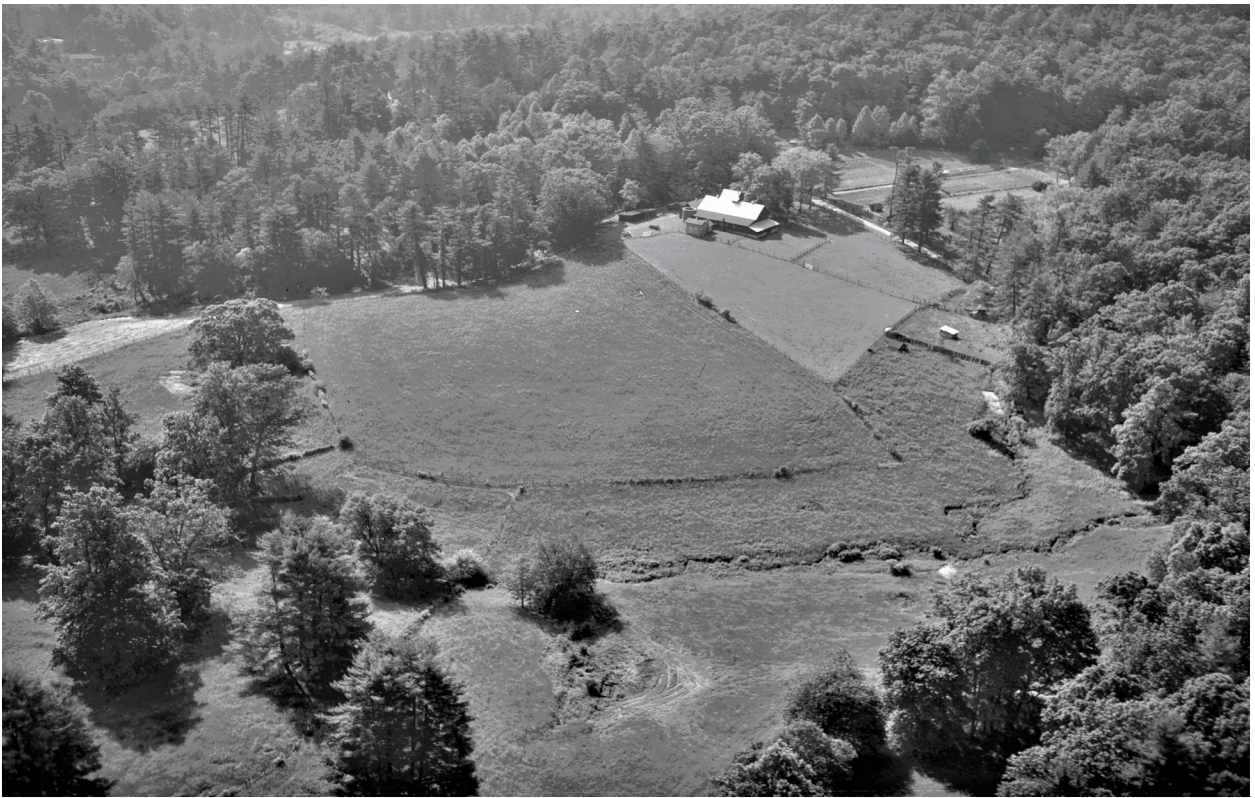
1 **Figure 4. 28.** 1974 aerial image of the Farm Core Character Area, looking southeast. Note the barnyard complex, field patterns, drainage features, and vegetative character of the area. (Source: CARL archives, 4004-0521).
2

77 Initial plans for the park included reviving the
78 goat operation and making it a working farm for
79 interpretation purposes. However, the farm’s
80 buildings and landscape were in poor condition
81 after several years of deferred maintenance. As
82 such, like the Residential Core, the Farm Core
83 Character Area underwent extensive repairs and
84 modifications after the period of significance.
85 These repairs were in general keeping with
86 preservation protocols, balanced with the needs
87 of making the farm area accessible and safe for the
88 public (Figure 4. 28 and Figure 4. 29).

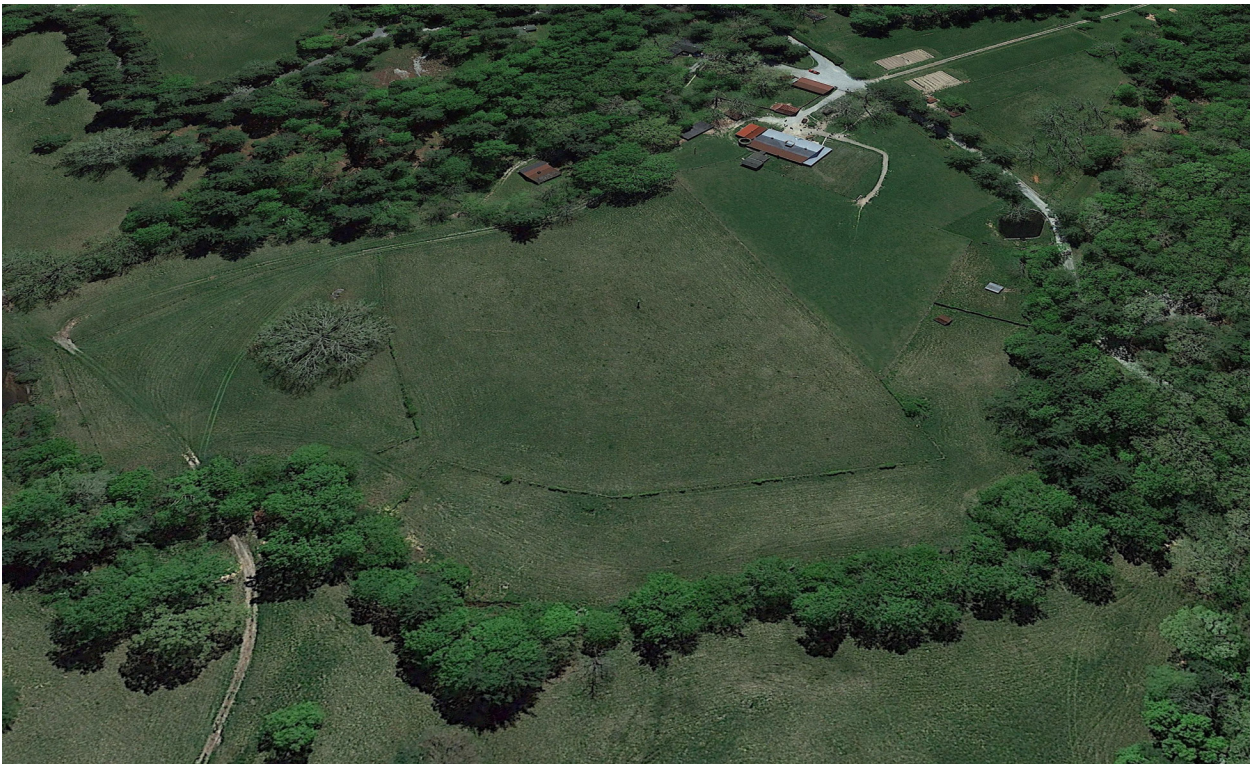
3 **Figure 4. 29.** Compare this 2020 aerial image to the one in Figure 4.27. While the angle is not exact, note the continued
4 presence of the barnyard complex. Also note the changes in vegetation, especially along the creek drainage. Slight differences
5 in fencing are also seen near Duck Pond. Finally, note the presence of recent NPS Period circulation features in the pastures.
6 (Source: Google Earth).

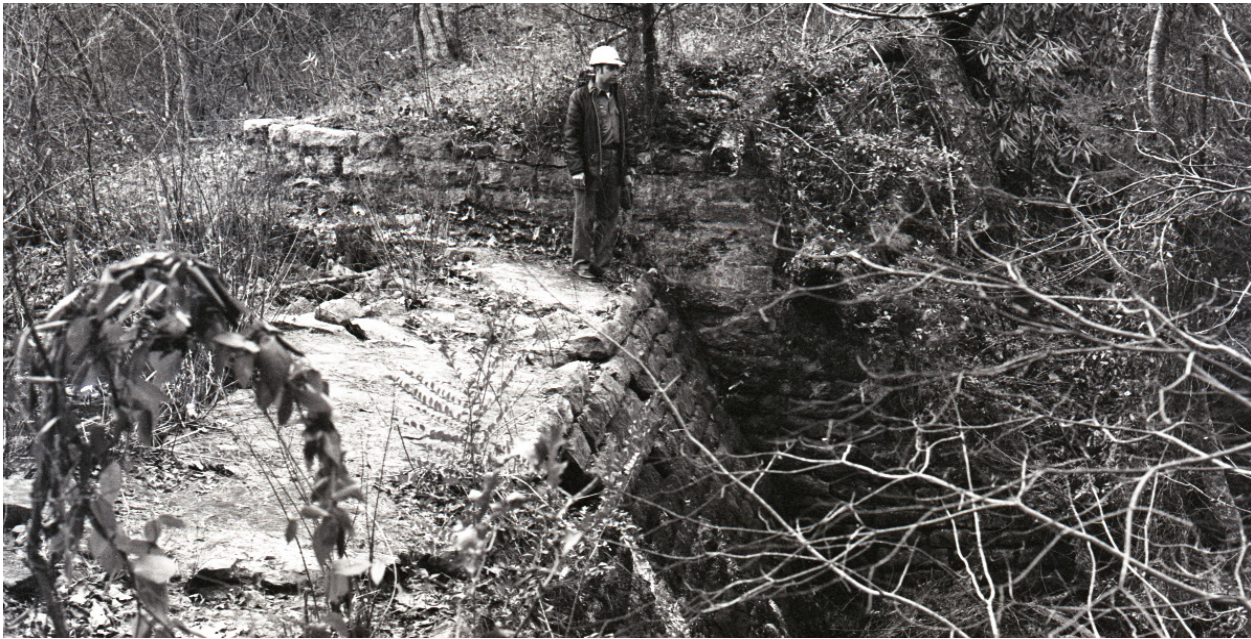
Figure 4. 30. This 1974 photograph shows the condition of Front Lake Dam prior to later restoration efforts. Note the missing bridge, overgrown vegetation, and general disrepair (Source: CARL Archives 4008_0258).

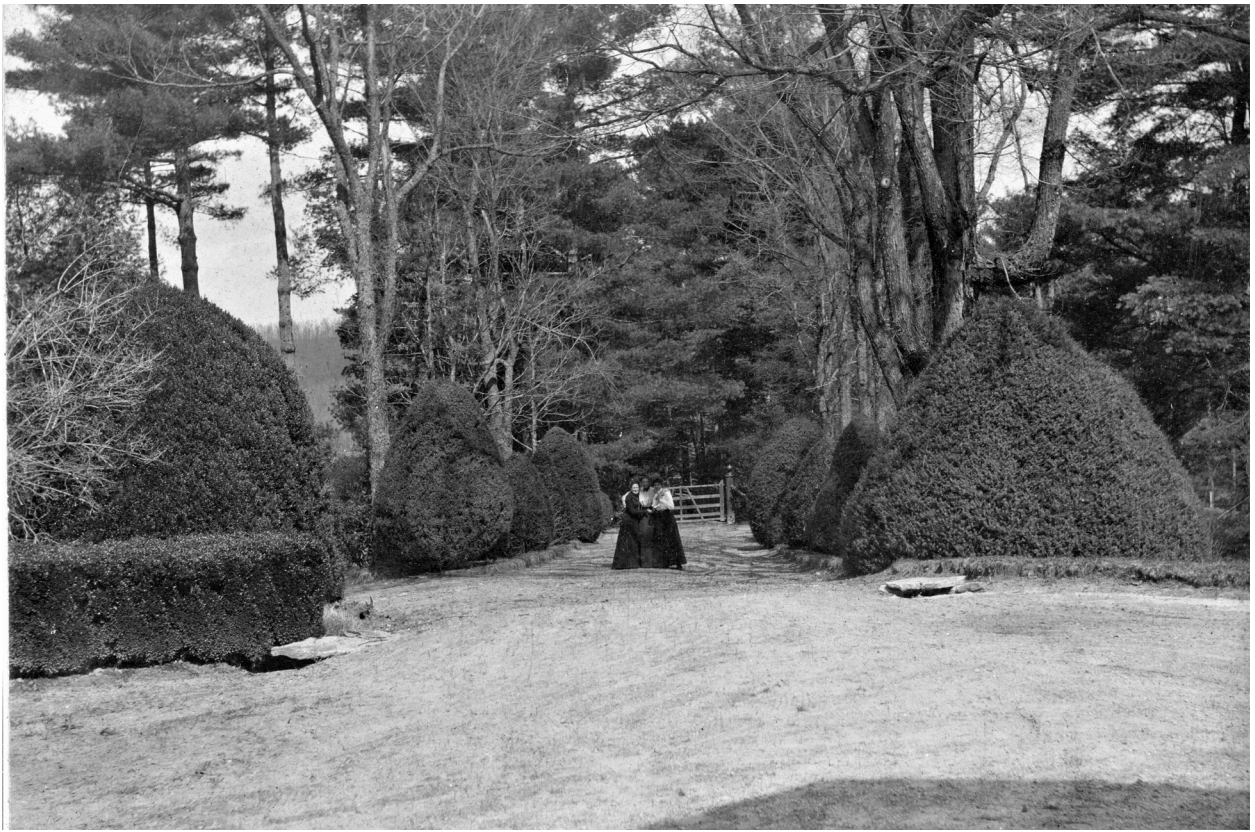
1 **Figure 4. 33.** This 1901 photo from the Smyth Period shows a gate along the Entry Drive in the Residential Core of the
2 landscape. Compare this photo with Figure 4.34. (Source: CARL Archives).

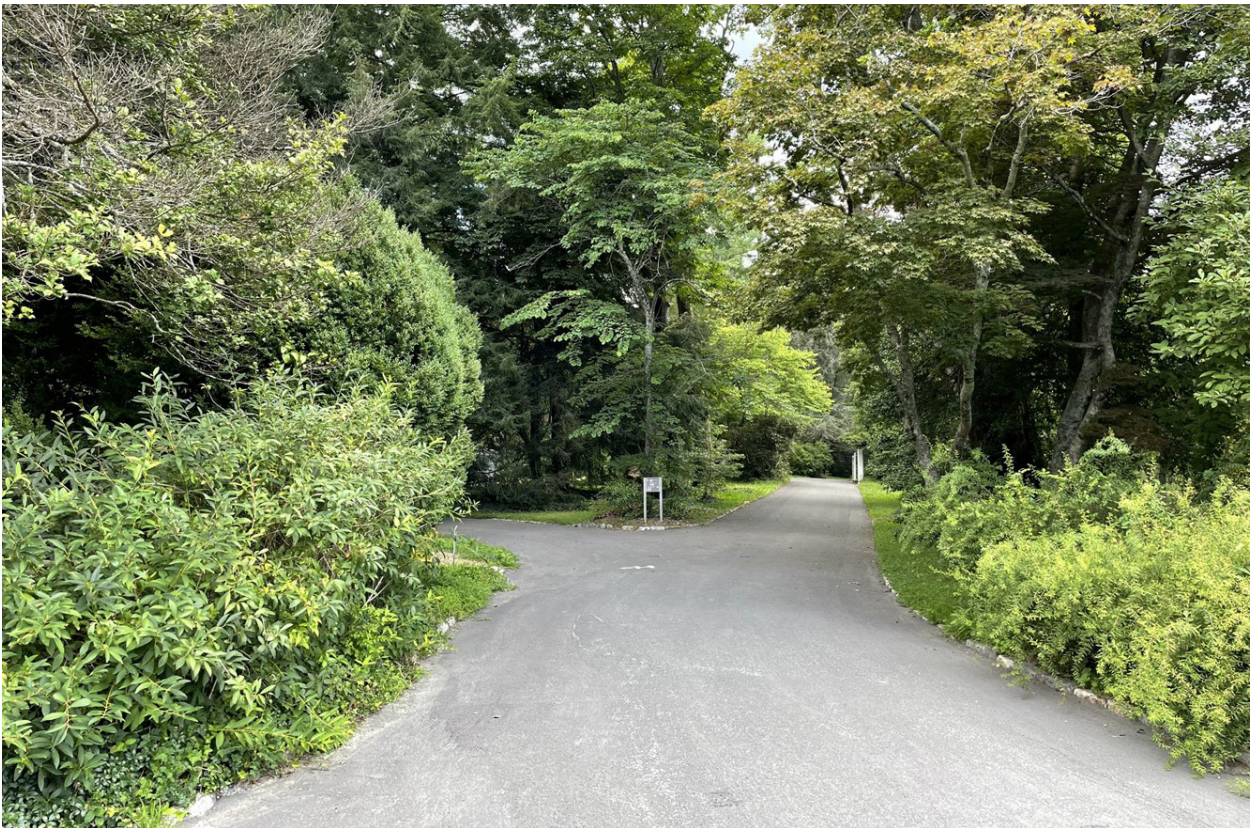
3 **Figure 4. 34.** Compare this image to Figure 4.33. Note the gate (open) in the background of this photo. Also note the
4 differences in vegetation, with the 1901 image containing a much more formal appearance. (Source: WLA Studio).

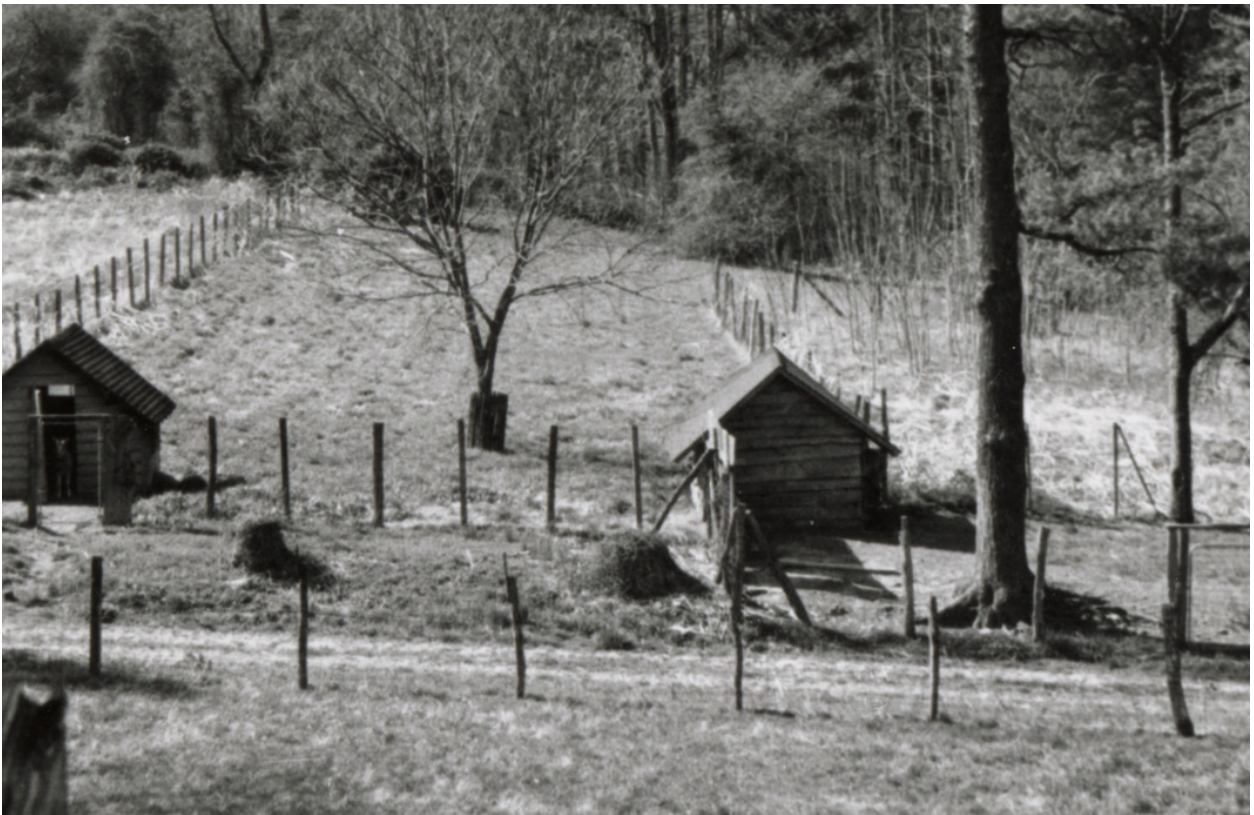
Figure 4. 37. This 1968 photograph shows the Back Drive along with adjacent fencing and goat pens and illustrates the way in which Paula Sandburg had enclosed various areas throughout the Farm Core Character Area the pastures. (Source: CARL Archives, 3000-0606).

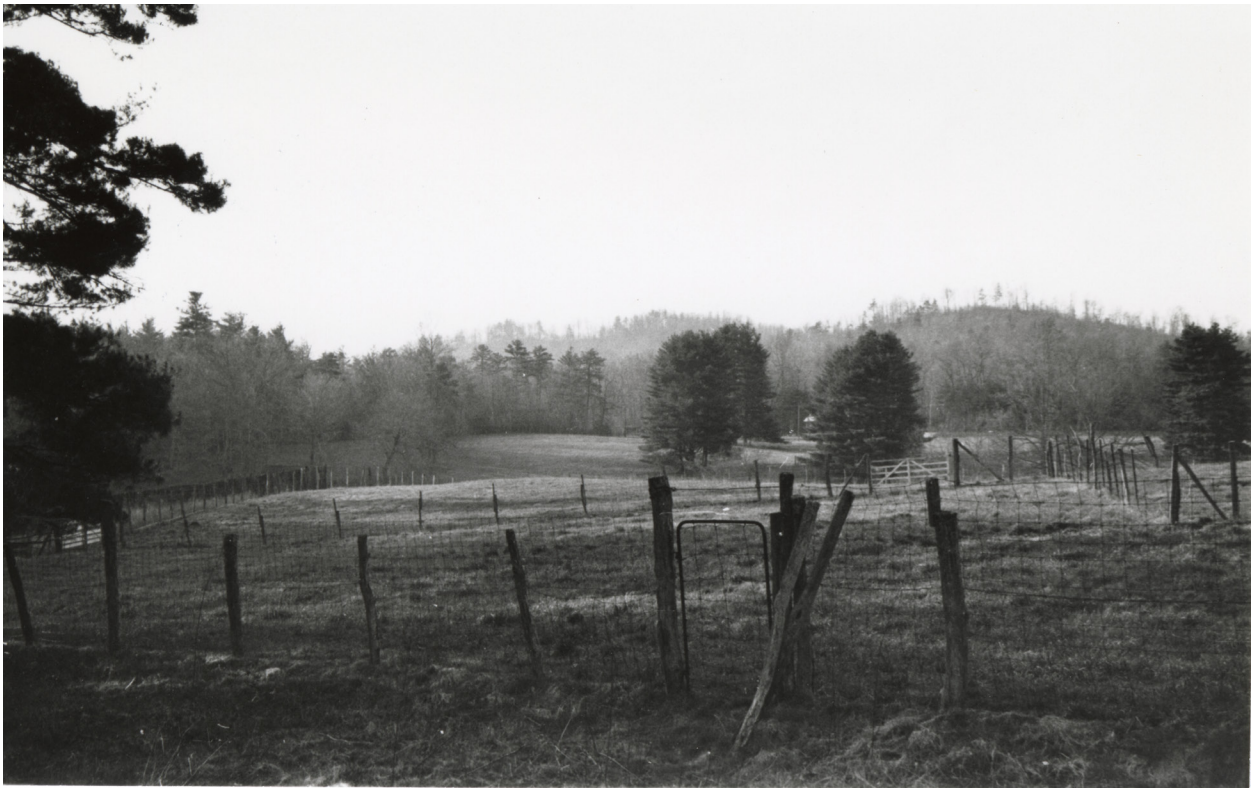
99 **Figure 4. 38.** 1968 image of the fencing and gates in the Farm Core. Note the two types of gates used here: a white wooden
100 swing gate in the background and a smaller metal gate in the foreground. (Source: CARL archives, 3000-0605).

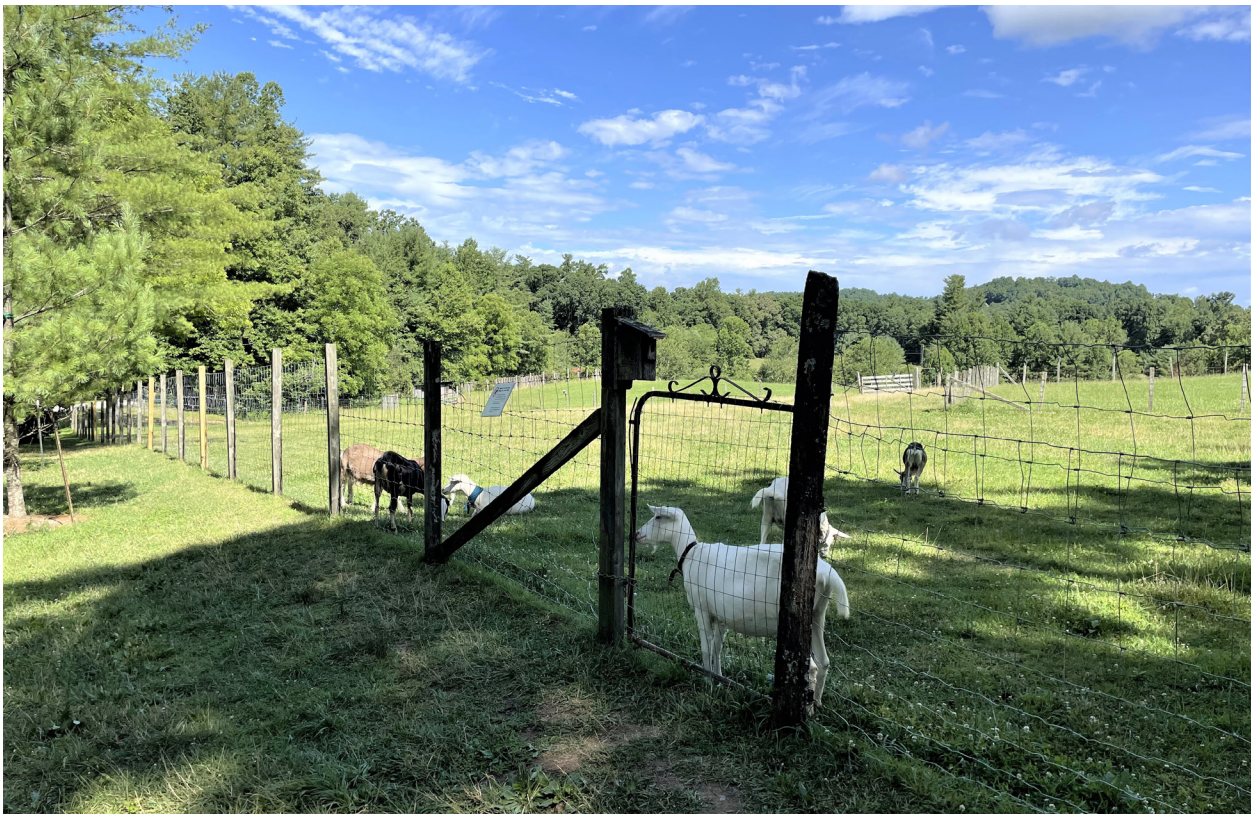
101 **Figure 4. 39.** While the angle is slightly off (in order to show background fencing), compare this image to Figure 4.38. Note
102 the different gate type in foreground, as well as the more uniform post dimensions. It is hard to see in the background, but the
103 fencing around the gate has been altered since the historic period. It appears the gate seen in the foreground in Figure 4.35
104 was relocated to the side of the larger swing gate in the background, indicating changes made after the period of significance.
105 However, it still appears the fence orientation has remained consistent. (Source: WLA Studio).

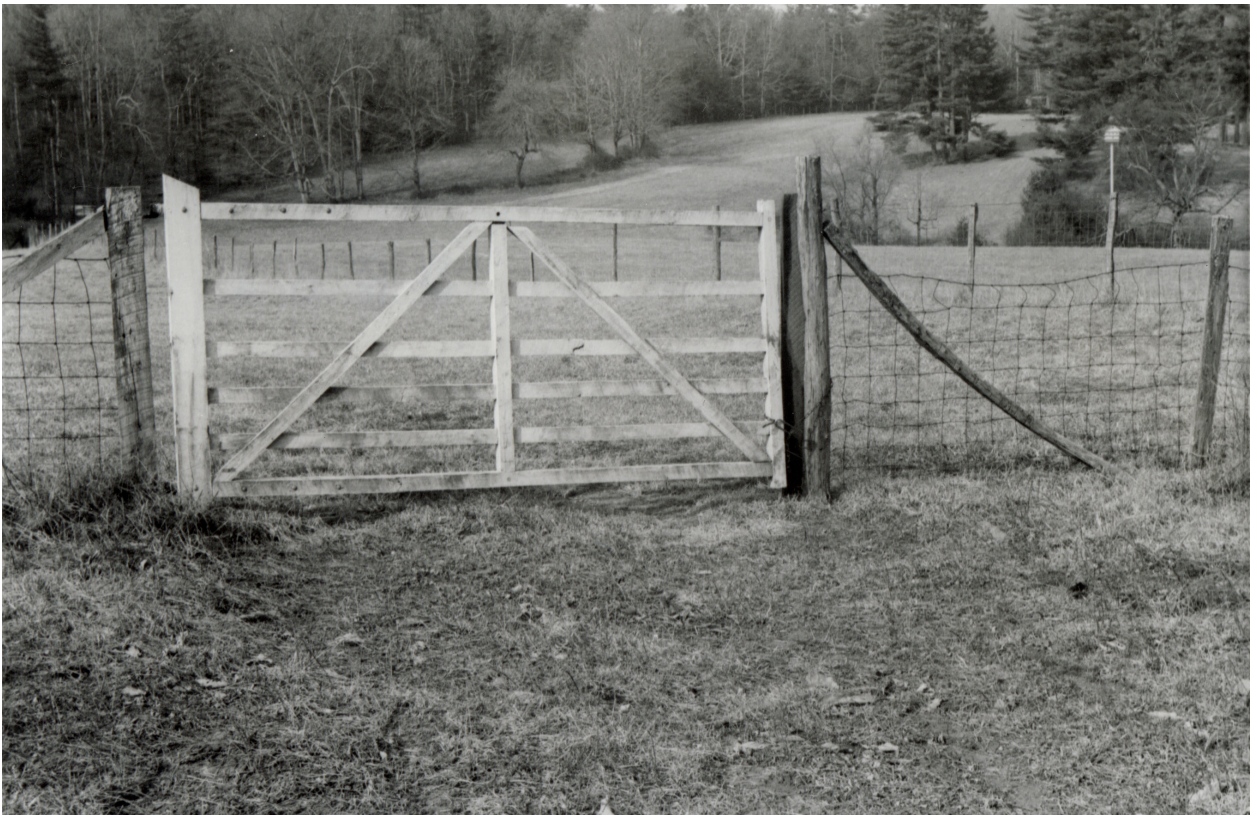
87 **Figure 4. 40.** 1981 image of the gate leading out to the Martin House pasture. Note the condition of the fencing. While it is
88 unknown if this image shows NPS replacement or original Sandburg fencing, its character is in keeping with historic conditions.
89 (Source: CARL archives, 4008-1212).
