Carl Sandburg Home National Historic Site Cultural Landscape Report

85% Draft Submittal
September 2021

Cultural Resources, Partnerships, and Science Division
Interior Region 2 - South Atlantic Gulf

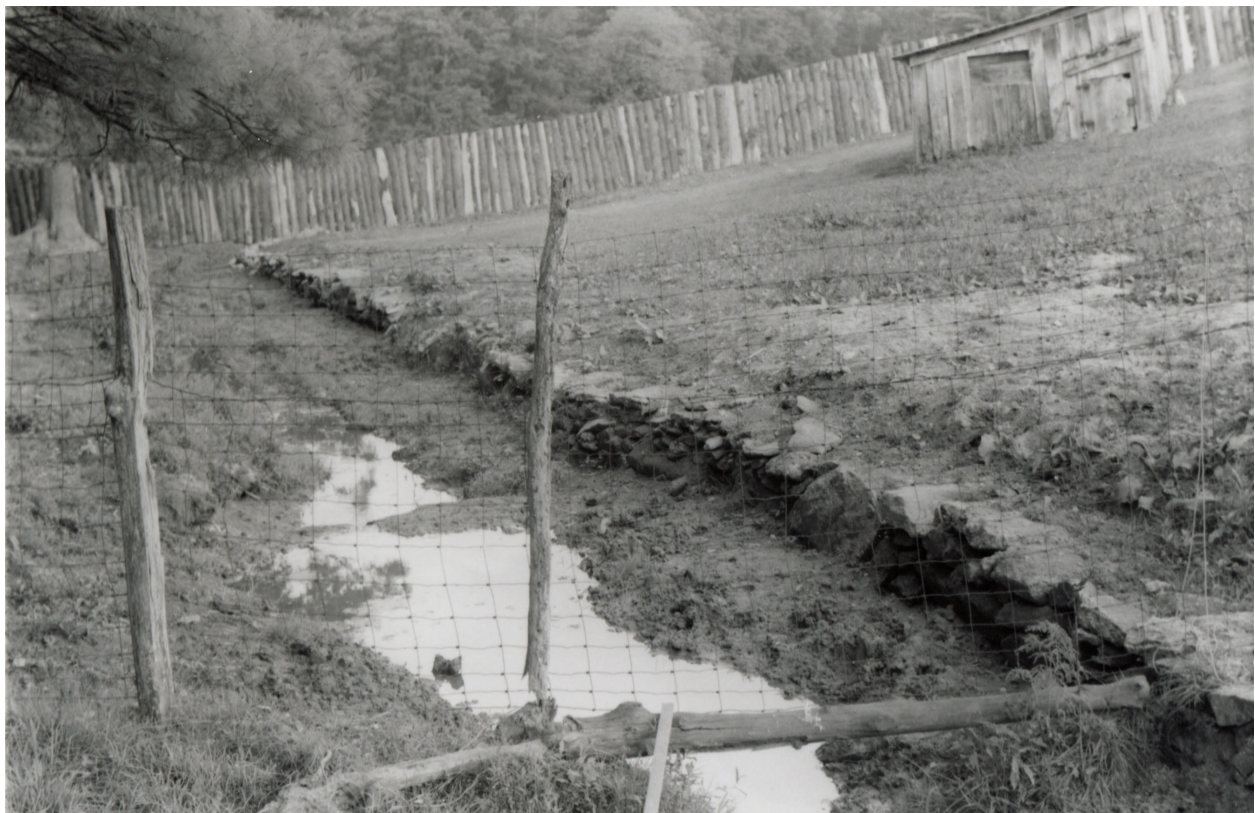
90 **Figure 4. 41.** August 1977 image of a wood post-and-wire fence spanning across the drainage leading from the Duck Pond.
91 Note the board fence in the background. (Source: CARL archives, 4008-1210).

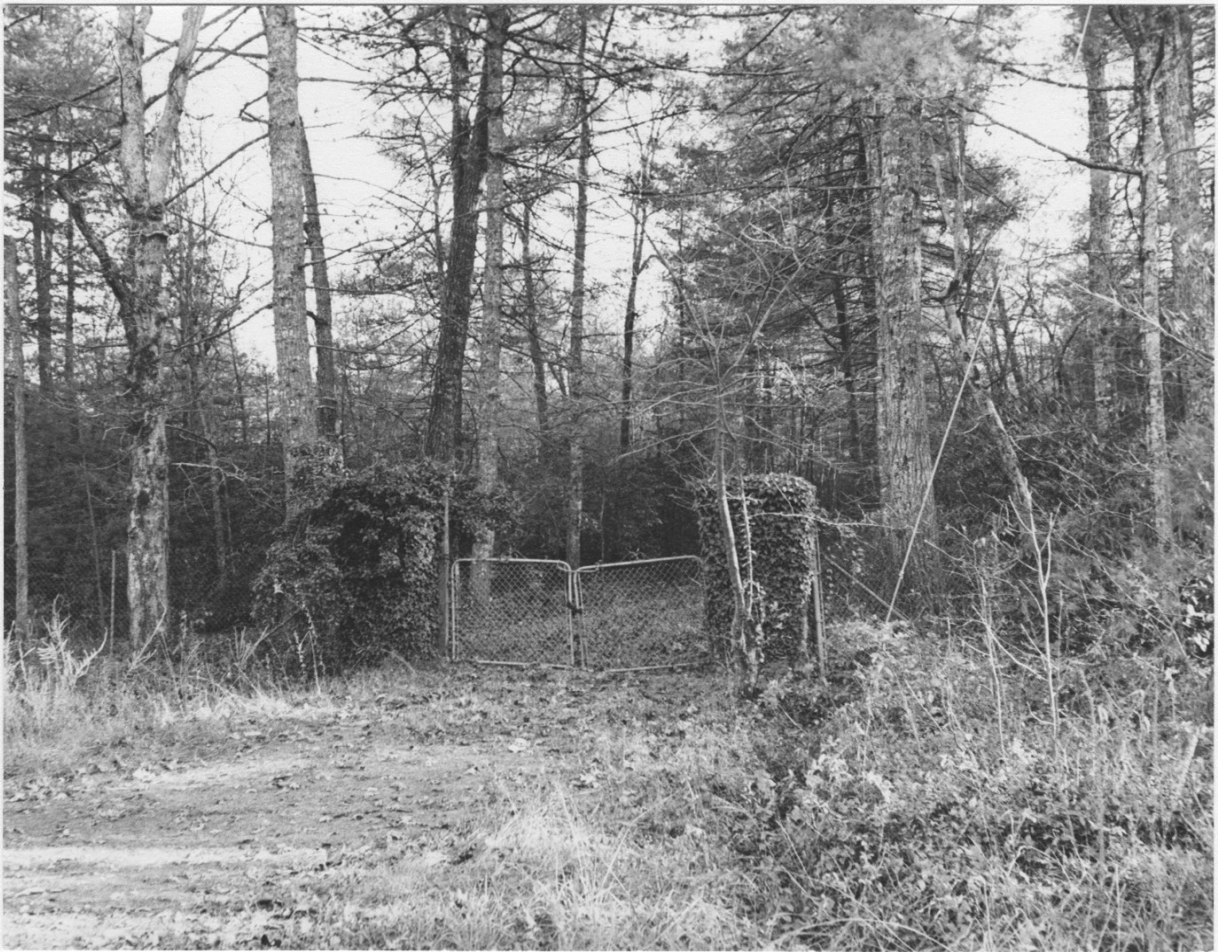
Figure 4. 42. Circa 1968 image of the Back Drive entrance gate circa 1968. Note the overgrown character of the landscape and how vines have completely covered the stone pillars. (Source: CARL archives, 4011-series1-010-011).

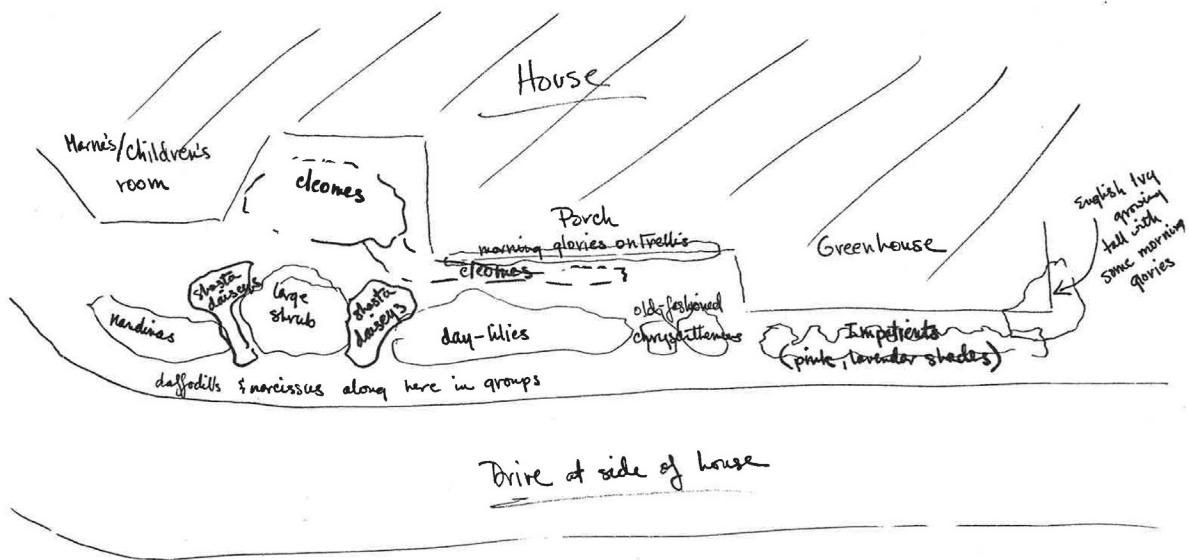
1 **Figure 4. 46.** Paula Steichen Polega's plan for the plantings in the east foundation bed. (Source: CARL archives).

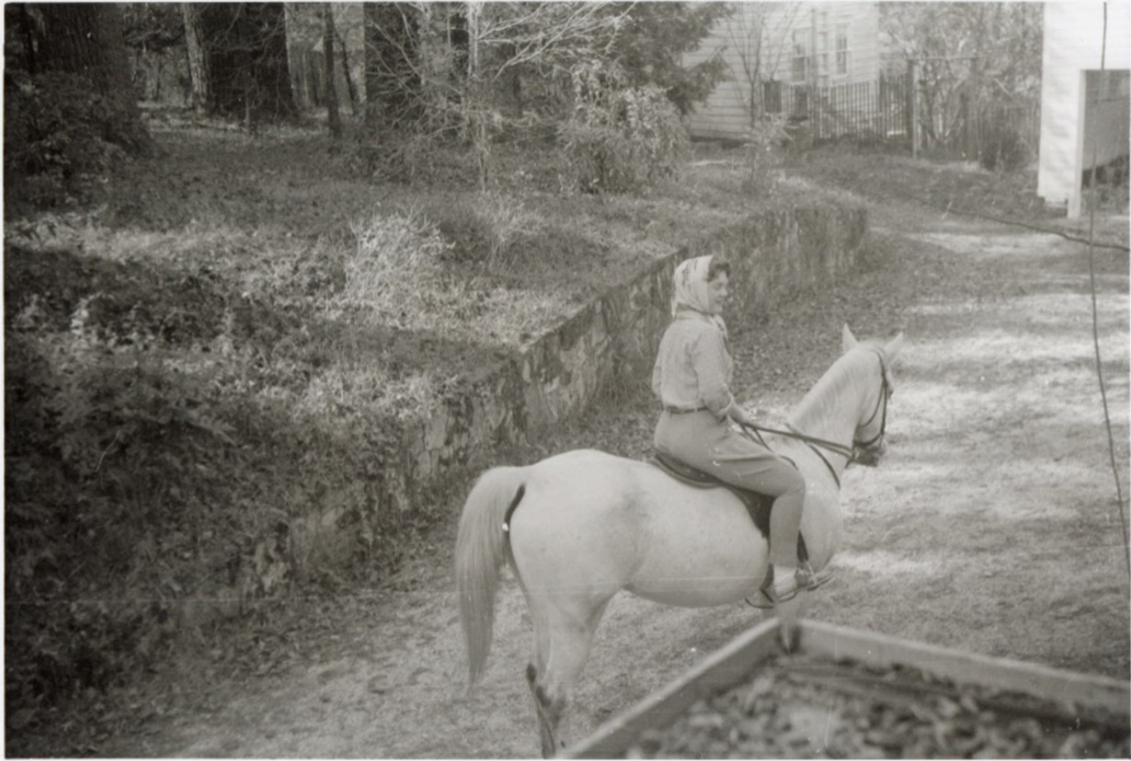
Figure 4. 52. Circa 1950 image of the south side of the Main House showing the circular drive, as well as natural vegetation and stone retaining wall. (Source: CARL archives, 3000-0599).

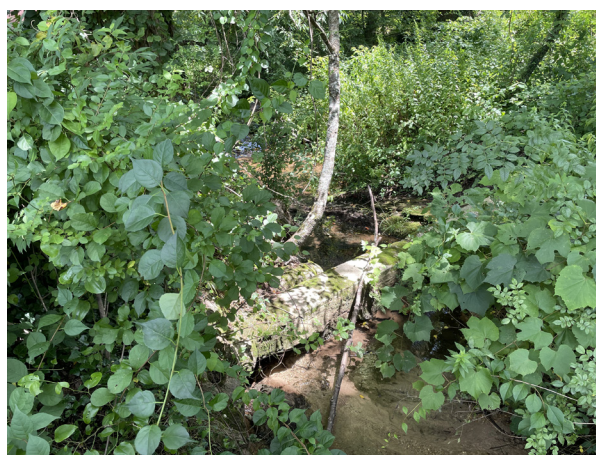
Figure 5.1: Check dam (in center) along a park drainage. These NPS-installed check dams are impeding the movements of fish in the park and are ineffective at controlling silt accumulation in Side Lake (Source: WLA Studio).

Presently, three check dams are located within the drainages that cut across the Pastures and Fields Character Area (Figure 5.1). These simple concrete dams were installed by the NPS in the 1980s in order to stop silt accumulating in Side Lake. They are not historic resources. The dams have since failed, with water going around, under, and during storm events, over them. While the failed dams do not stop silt from moving along the streams, they do restrict upstream migration by fish that reside within Side Lake.²⁸⁰

This report recommends the removal of the three check dams after photo-documentation for the park resource management records. This work could be done in conjunction with the thinning of vegetation along the drainages, as discussed in the Vegetation section to follow.

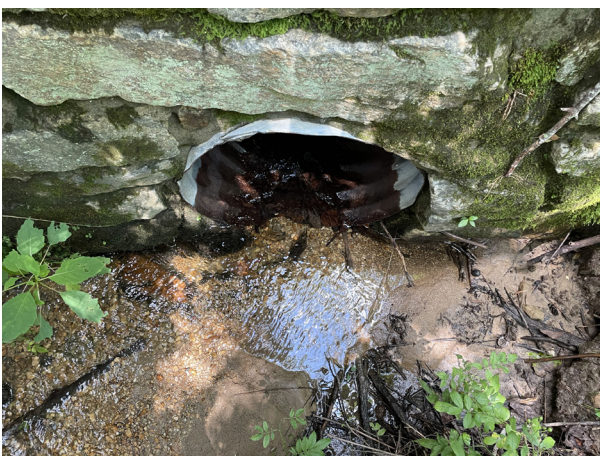
Figure 5.2: The culvert over the earthen bridge adjacent to the Cow Shed is undersized. Its replacement is recommended. (Source: WLA Studio).

An NPS-installed culvert is currently located on the drainage adjacent to the Cow Shed. The non-historic culvert is too small to handle stormwater flow (Figure 5.2 and Figure 5.3). Over time, this has caused its failing. This report recommends replacing the culvert and specifies the installation of an open-bottom arch culvert. This design would allow for increased stormwater flow as well as the expanded use of the drainage by fish and other aquatic wildlife.

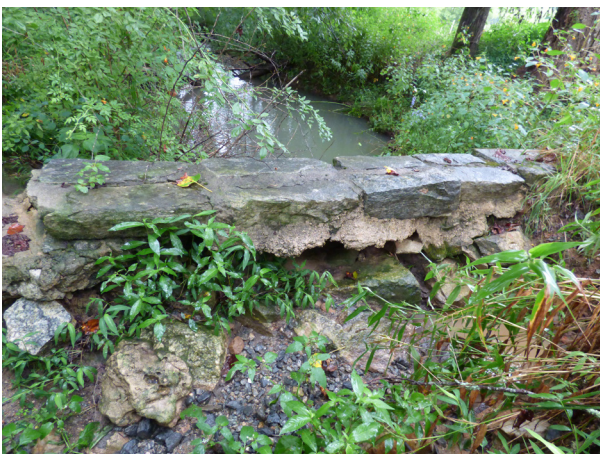
Figure 5.3: The discharge side of the culvert is in poor condition and does not function as intended during significant rain events. (Source: WLA Studio).

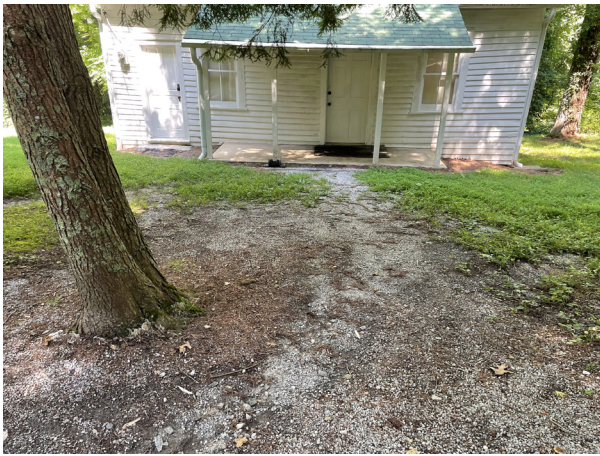
Figure 5.4: The Tenant House receives a problematic sheet flow of stormwater during rain events. It appears the water flows over Back Drive and down the slope to the front landing of the building. (Source: WLA Studio).

9 The Tenant House sits on a downslope. During
10 heavy rain events, stormwater flows onto the front
11 landing and against the foundation of the building
12 (Figure 5.4). While no significant damage has
13 occurred yet, the issue should be addressed. It is
14 recommended the NPS fix the issue with a multi-
15 faceted approach.

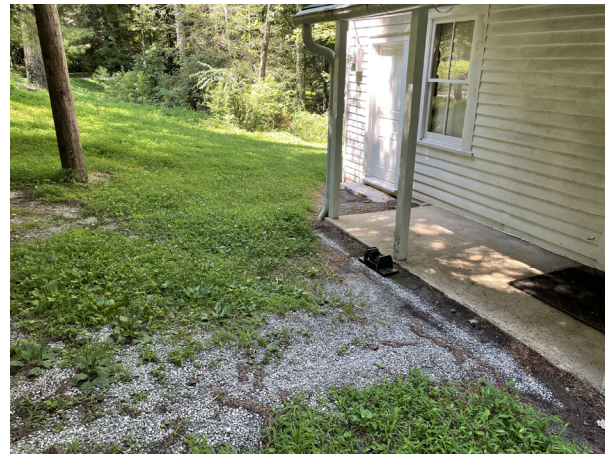
Figure 5.6: A solution to the stormwater issue at the Tenant House includes excavating a subtle swale a few feet out from the landing, which will direct the flow of water away from the building. (Source: WLA Studio).

29 Third, excavate a slight swale approximately 2 feet
30 out from the concrete landing of the Tenant House
31 (Figure 5.6). Feather the depression so that any
32 sheet flow that collects there will drain west and
33 away from the building.

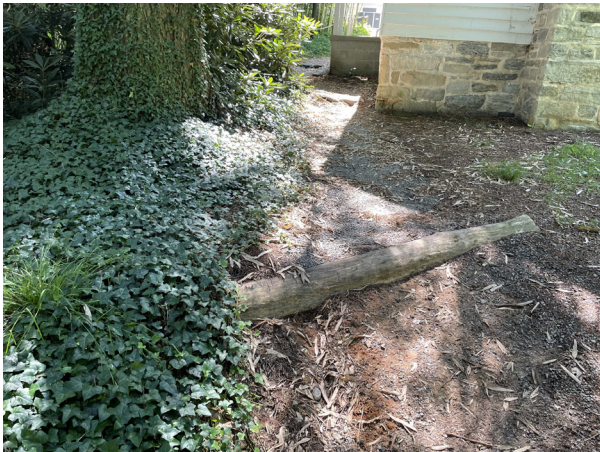
Figure 5.5: An additional intervention to resolve the stormwater issue at the Tenant House includes the addition of water breaks on the path adjacent to the Swedish House. (Source: WLA Studio).

16 First, check the flow of water before it reaches the
17 west edge of the Back Drive by diverting the water
18 as it flows along the path beside the Swedish House
19 (Figure 5.5). Installing additional water bars along
20 the path is recommended.

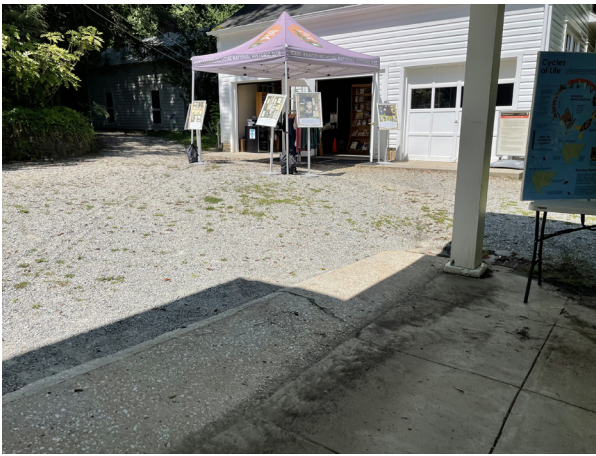
Figure 5.7: The carport area experiences ponding during rain events due to improper drainage. The water line shown in this photograph shows the location. (Source: WLA Studio).

evidence the issue. A Sandburg Period photograph even shows John Steichen with a shovel, appearing to dig out the concrete swale that edges the south side of the carport slab. The flow of water in the area can be read in the gravel of in front of the Garage and shows that stormwater drains almost directly to clogged drains at the corner of the carport (Figure 5.7 and Figure 5.8).

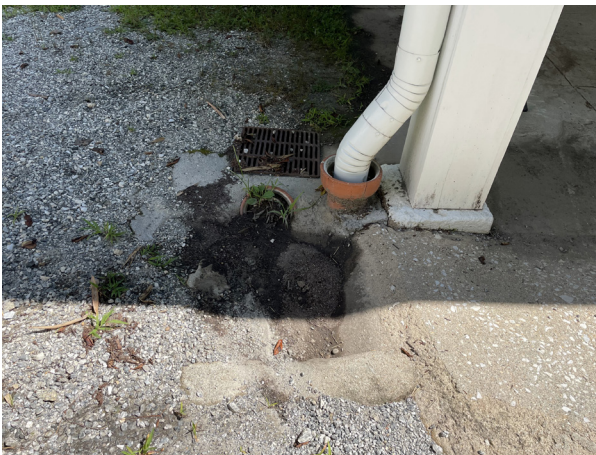
Figure 5.8: The ponding of water at the carport is caused in part by clogged drains at the corner of the structure. It is recommended the NPS excavate and clear the drain grates and drain lines. (Source: WLA Studio).

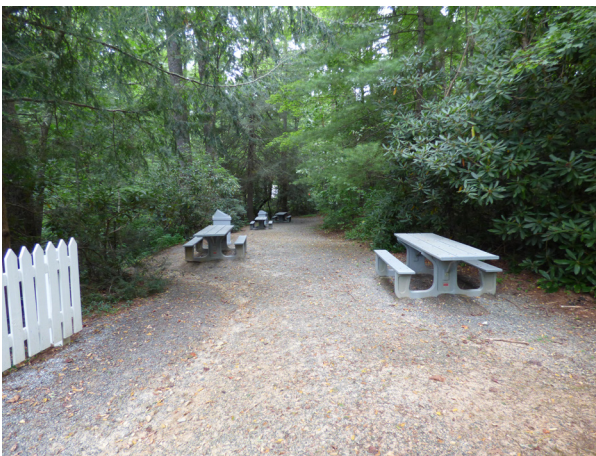
Figure 5.9: Stormwater impacts the picnic area, as sheet flow pushes aggregate against the picnic tables. Using a reinforced grid to hold the aggregate in place is a potential solution. (Source: WLA Studio).

The picnic area adjacent to the Visitor Contact Station experiences wash out during storm events (Figure 5.9). It sits in a slight depression between the elevated walkway beside Front Lake Dam and Little River Road. Most water appears to come from the walkway however, and the treatment recommendation focus on this area.

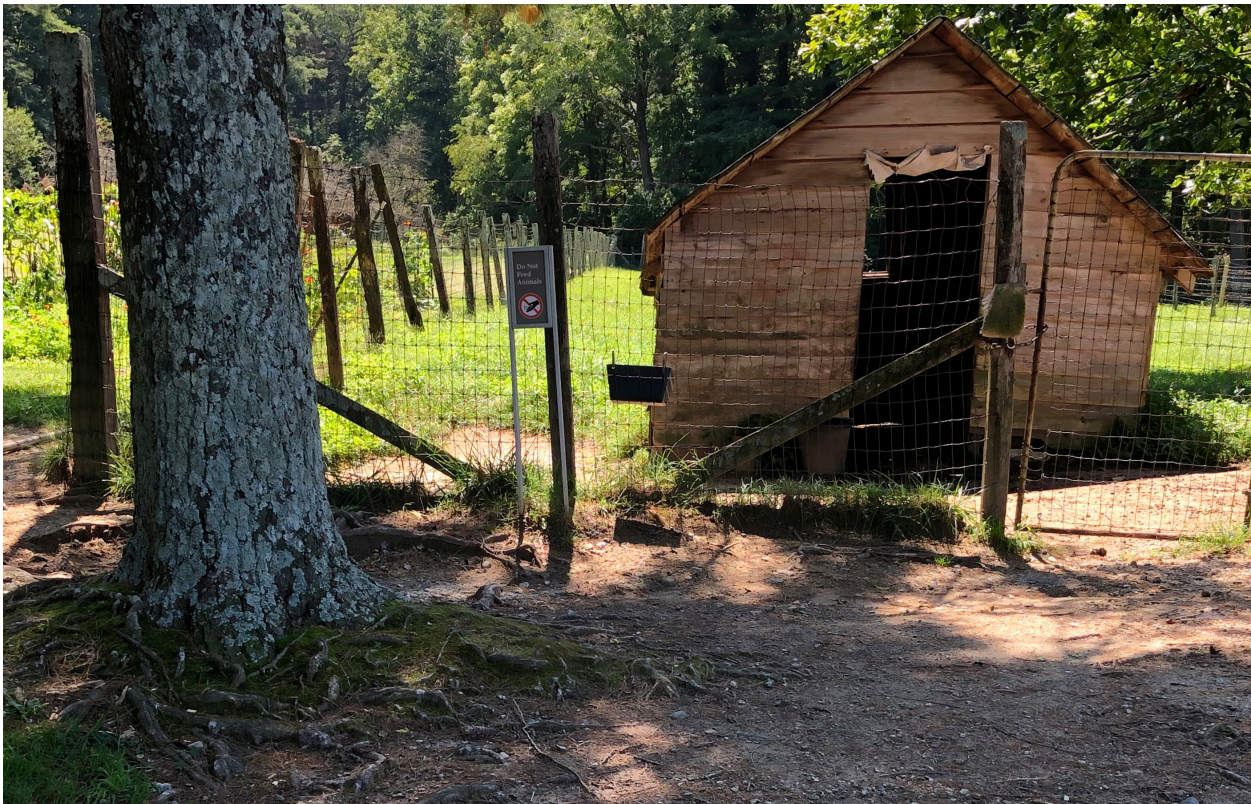
1 **Figure 5.10:** The bare earth in front of the Buck House evidences the stormwater issue in this area. Water discharges here
 2 from the swale seen in Figure 5.12. (Source: National Park Service / CARL).

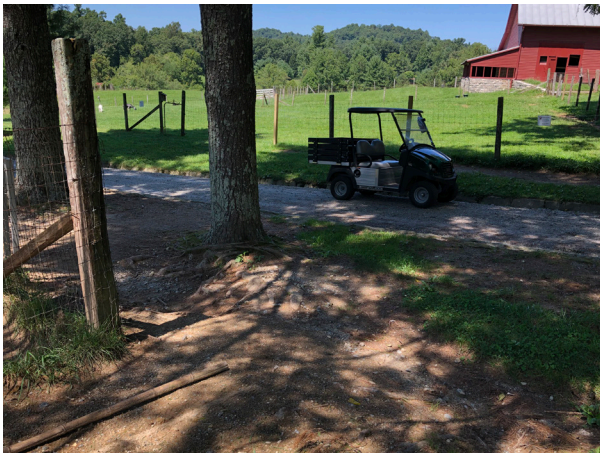
3 **Figure 5.11:** This image shows the washed-out Buck House
 4 area from the south. (Source: WLA Studio).

A significant stormwater issue is located in the vicinity of the Vegetable Garden and Buck House (Figure 5.10 - Figure 5.13). The water originates in

1 the swale that runs parallel to the west vegetable
2 bed. From here, stormwater flows downslope
3 through the swale, turns to the west behind the
4 benches, and runs across the top of the ground
5 toward the Buck House. During heavy rain events,
6 the water washes out the pen area, creating an
7 unsanitary condition for the goats and public.
8 Additionally, the roots of the white pines lining the
9 drive are being exposed by erosion and heavy foot
10 traffic.

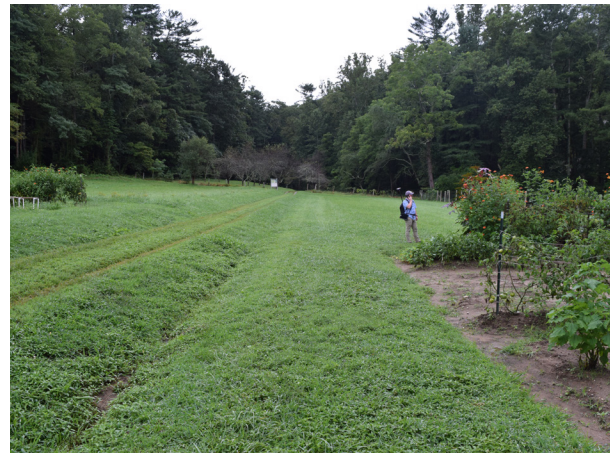
5 **Figure 5.12:** This photograph shows the swale alongside
 6 the western vegetable bed. From here the swale bends west
 7 and empties out at ground level. (Source: WLA Studio).

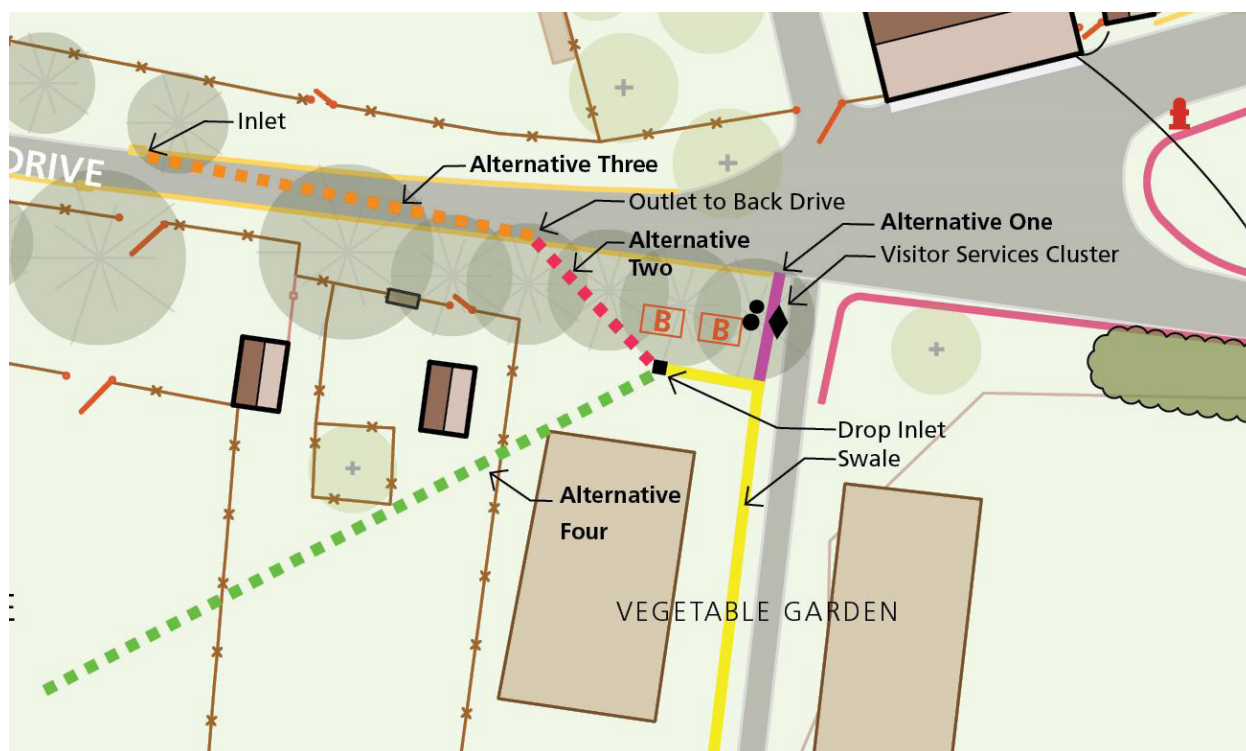
1 **Figure 5.13:** There are various alternatives for fixing the drainage issue here. This image shows four alternatives, with
 2 Alternative Two being the preferred option. (Source: WLA Studio).

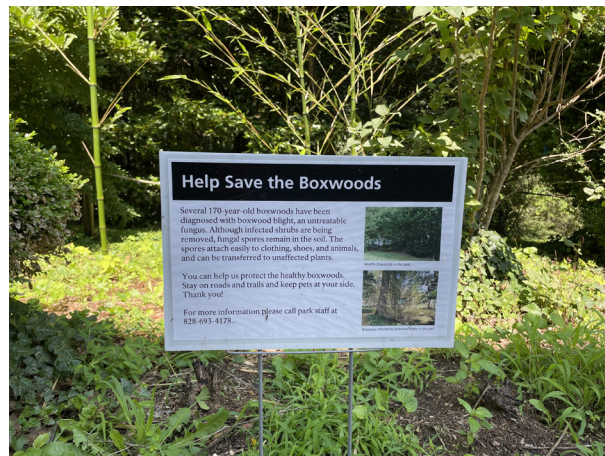
Figure 5.14: Photograph showing one of the public education signs informing visitors of the boxwood blight issue. (Source: WLA Studio).

Boxwood blight (*Calonectria pseudonaviculata*) is currently infecting the site's historic boxwoods (Illustration 3.10 and Figure 5.14 and Figure 5.15). Despite the quick actions of park staff, the blight continues to spread, resulting in the removal of many infected plants. Below is a summary of actions necessary to help stop the blight from infecting more plants and suitable replacements.

1. Remove all infected plants and plant debris (fallen leaves and stems) from site as soon as blight is observed.

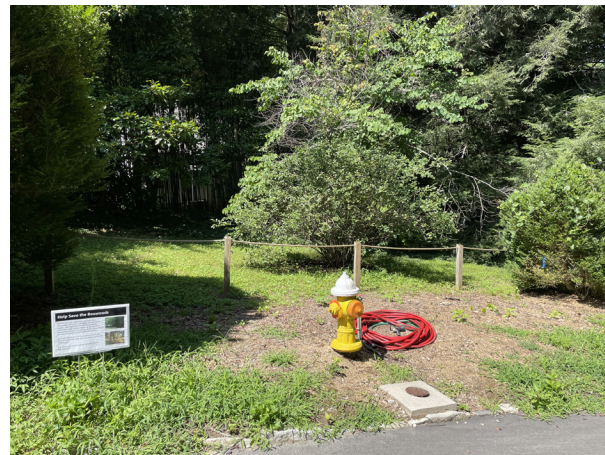
Figure 5.15: This area in the vicinity of the American elms lost several historic boxwood. (Source: WLA Studio).

39 As such, site management should consider
 40 replacement plants that serve a similar role and
 41 function as the already-removed and soon-to-
 42 be-removed boxwoods, but that also exhibit
 43 resistance to blight. Unfortunately, identified blight
 44 tolerant cultivars do not reach the same stature
 45 as *B. sempervirens* (5-15 feet tall). Future research

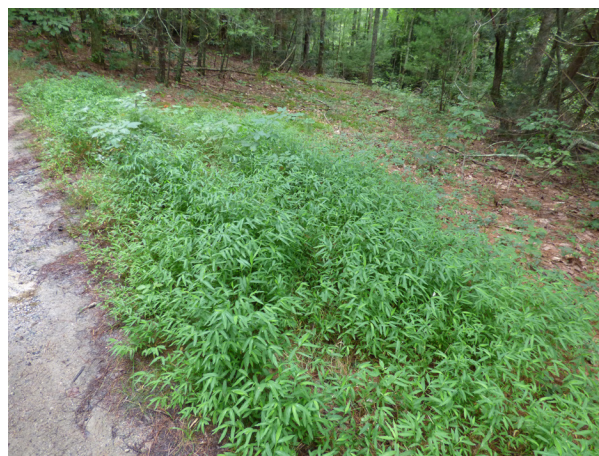
46 **Figure 5.16:** Stiltgrass is an increasing problem in the
 47 park, as it is easily transported on tires and shoes. This
 48 photograph shows a stand on the granitic dome behind the
 49 Main House. (Source: WLA Studio).

78 Major concerns pertain to Japanese stilt grass
 79 (*Microstegium vimineum*). The stiltgrass does well
 80 in high-traffic areas, often where other native

1 plants cannot gain a foothold (Figure 5.16). The
2 seeds of stiltgrass are transported throughout
3 the park on the shoes of staff and visitors, vehicle
4 tires, and other means. Once established, it is
5 extremely difficult to remove. The amount of
6 pesticide required for its removal is untenable.
7 Recommendations include:

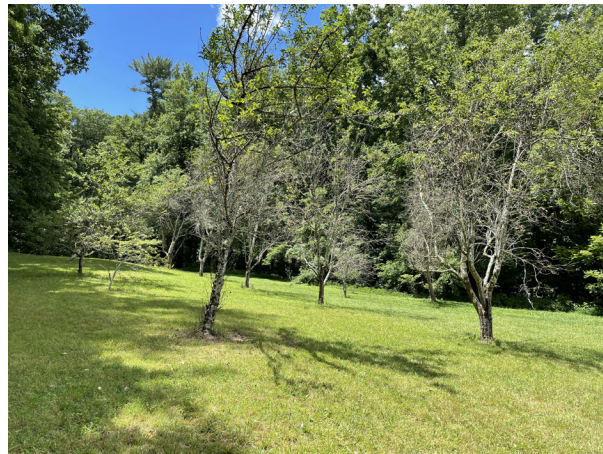
Figure 5.18: The Orchard exists in fair to poor condition. Most trees exhibit deadwood, and some were evidently grafted onto dwarf root stocks. This photo is looking south into the Orchard. (Source: WLA Studio).

rows of trees reflects the Sandburg Period, as the spacing between two rows is anchored by two of the oldest trees. The apple trees are in fair to poor condition (Figure 5.18 and Figure 5.19). All the trees have deadwood in their canopies. Some trees dating from the 1990s have grown very little in stature, indicating they were grafted to dwarfing rootstocks, a non-historic characteristic.

This CLR, as opposed to the 1993 report, recommends "resetting" the Orchard to the date of initial planting, so that in 30 years, the orchard will reflect Sandburg Period conditions. While this approach will result in a more managed appearance to the garden for several years, the trees that the Sandburgs inherited more than likely underwent such treatment at establishment. The present orchard did not receive the same level of initial care, and as such, does not likely reflect the condition of the trees as the Sandburgs experienced them. This approach would provide CARL with a healthy and productive orchard that in time will better reflect Treatment Period goals.

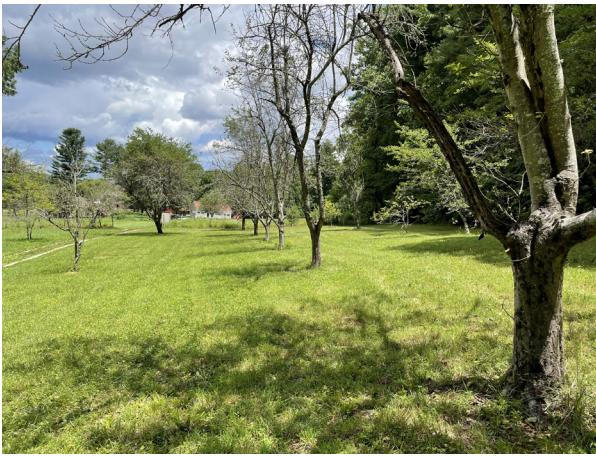
Figure 5.19: The Orchard exists in fair to poor condition. Most trees exhibit deadwood, and some were evidently grafted onto dwarf root stocks. This photo is looking north out of the Orchard. (Source: WLA Studio).

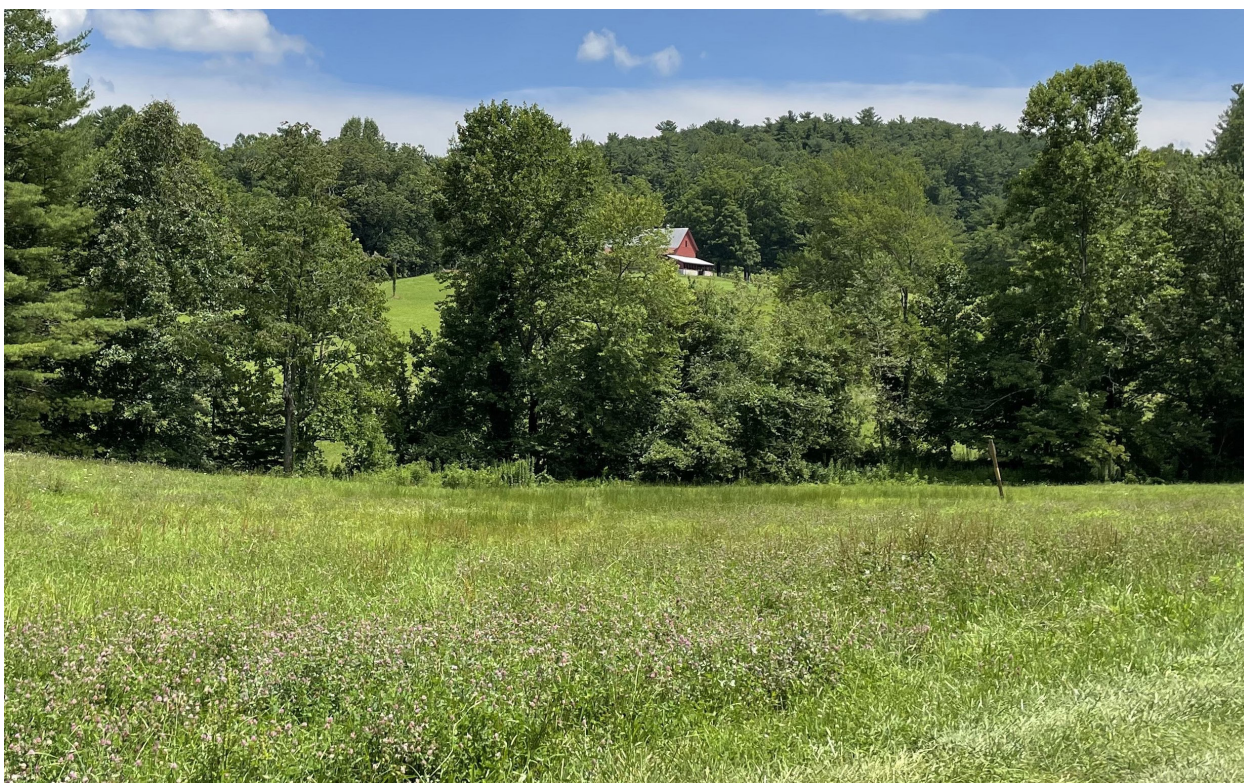
1 **Figure 5.22:** Compare this photo to Figure 5.23. Note the amount of vegetation that now exists along the creek drainage.
 2 (Source: WLA Studio).

- First, the minimum amount of vegetation removal as necessary to achieve the objective of maintaining the viewshed of the barn and pasture from Little River Road is recommended.

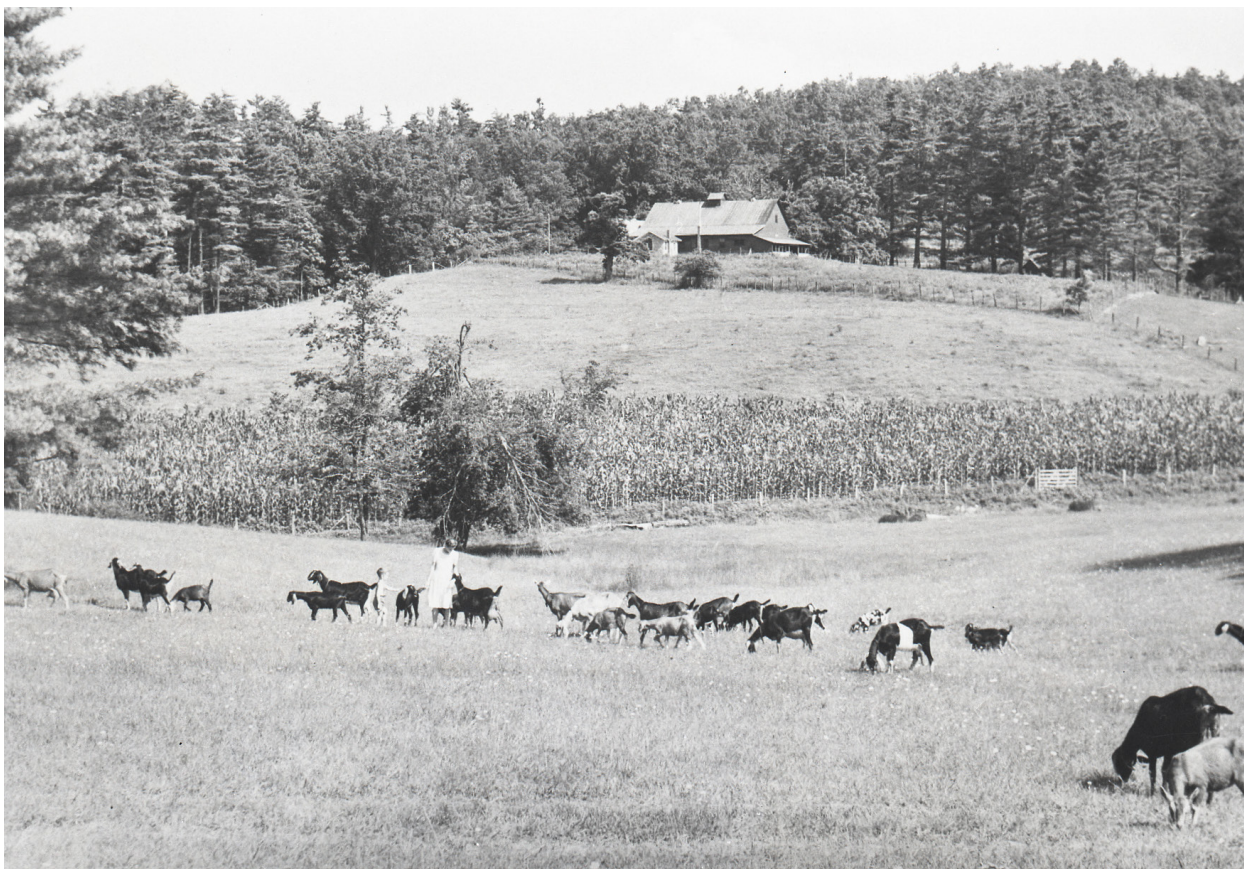
3 **Figure 5.23:** This photograph shows the goat pastures and corn field north of the barnyard. Compare to Figure 5.22 for how
 4 vegetation has impacted this view. (Source: CARL Archives CARL3000-0529).

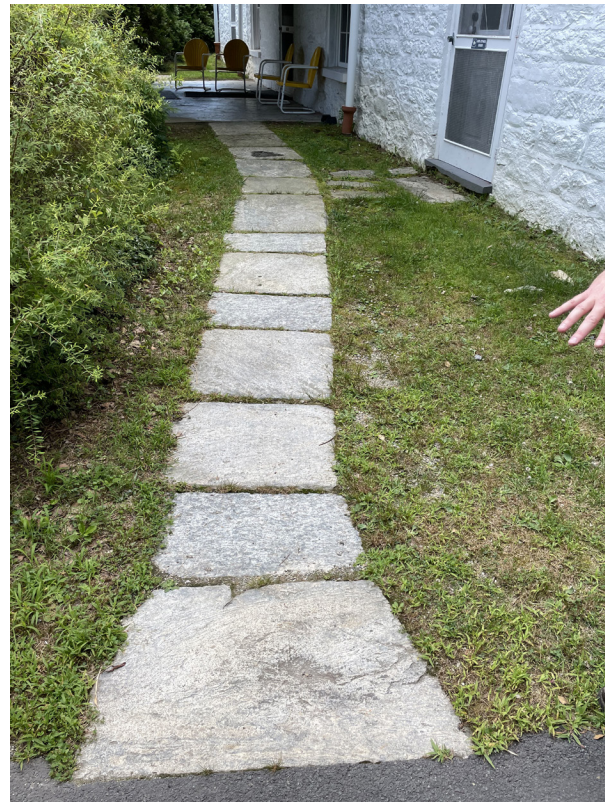
Figure 5.24: This photograph shows the walkway next to the Main House that is in need of accessibility improvements. (Source: WLA Studio).

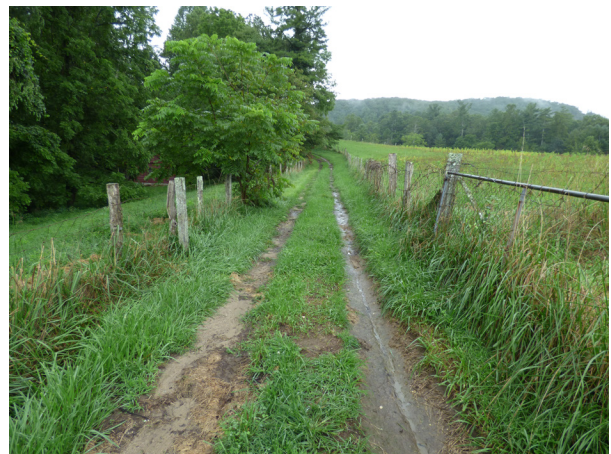
77 **Figure 5.25:** The pasture lane stretches from the barnyard
78 area north into the pastures area. The chainlink gate seen
79 on the right can be closed to deter visitors from venturing
80 further, should this circulation feature be incorporated into
81 site interpretation. (Source: WLA Studio).

75 With this in mind, one option that was discussed
76 by park staff—and recommended by this CLR—is
77 to provide limited access to the “entrance” of the
78 pastures via the Pasture Lane (Figure 5.25). This
79 would allow visitors to walk north through the
80 barnyard and generally get a sense of what the
81 pasture area was like during the historic period.
82 Access would end at the chain link gate halfway to
83 Side Lake. From this point, visitors would have a
84 good vantage of the Martin House, specimen oaks,
85 the rolling hills of the pasture area, and a glimpse of
86 Side Lake. An interpretive wayside could be located
87 at the gate. The panel could contain information
88 about the pastures’ history, including its use for
89 both recreation and agriculture.

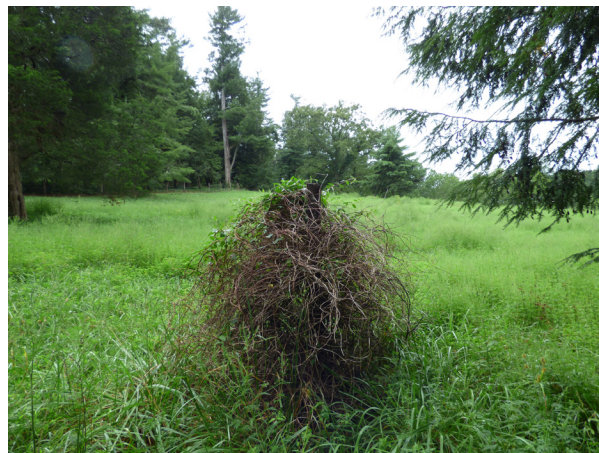
Figure 5.26: There are various remnant fence posts and spans of fencing throughout the site. This solitary pole is covered in vines along the edge of a pasture. (Source: WLA Studio).

During discussions with park staff the issue of restoring remnant or unused sections of fencing was addressed (Figure 5.26 - Figure 5.27). The conditions of these sections range from dilapidated to ruinous.²⁹⁴ The full extent of remnant fencing is currently unknown because much of it is covered with vegetation. It can be assumed that much of

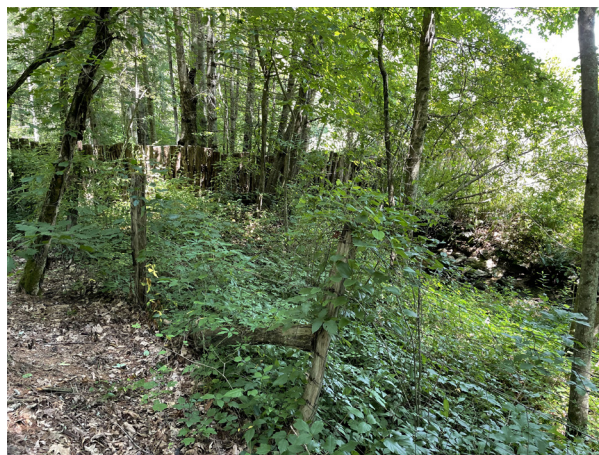
Figure 5.27: The section of fence in this photo is hard to see, as it has been obscured by vegetation. It is recommended the park let these remnants remain as-is. (Source: WLA Studio).

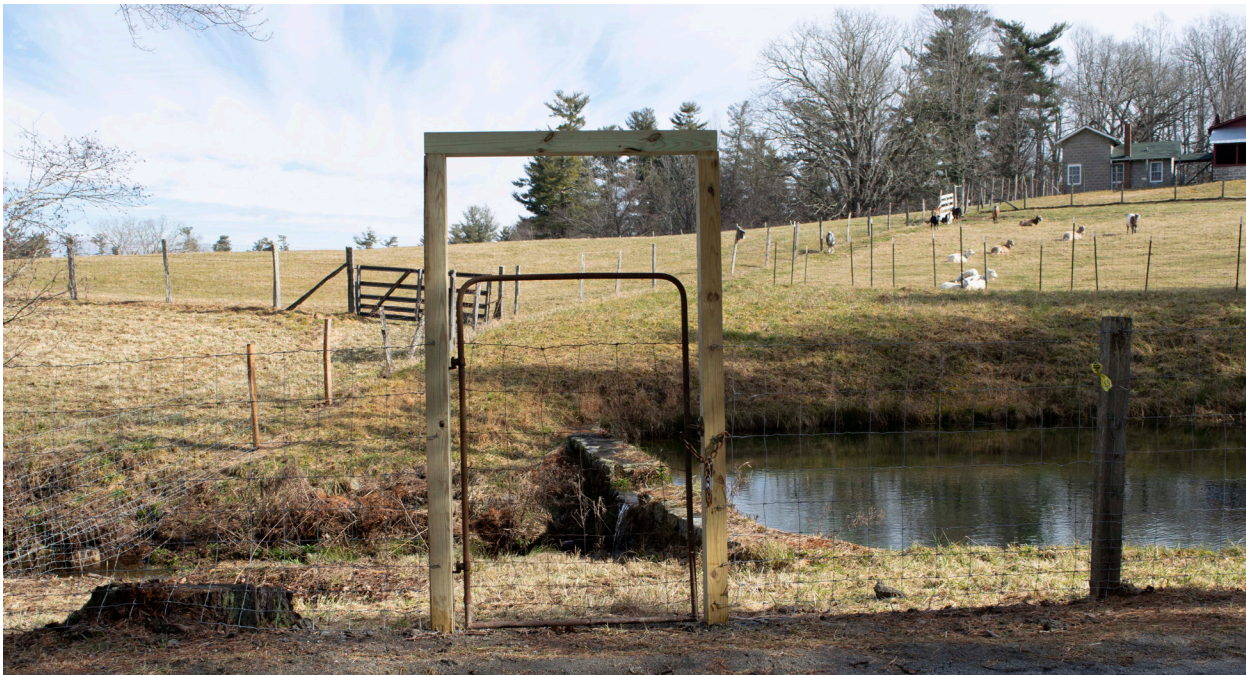
1 **Figure 5.28:** This gate by the duck pond was recently replaced with in-kind materials. Weathering will help the new wood to
 2 better blend in with the site. (Source: WLA Studio).

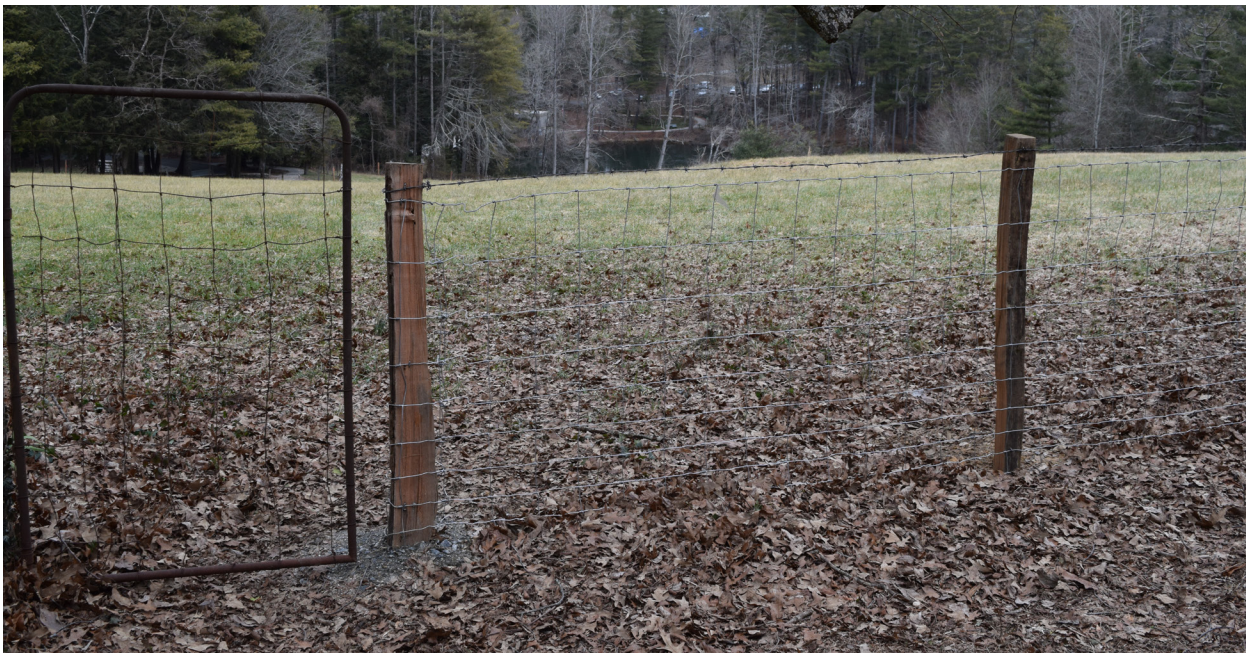
3 **Figure 5.29:** This section of fencing also shows appropriate replacement of fence materials on site. (Source: WLA Studio).

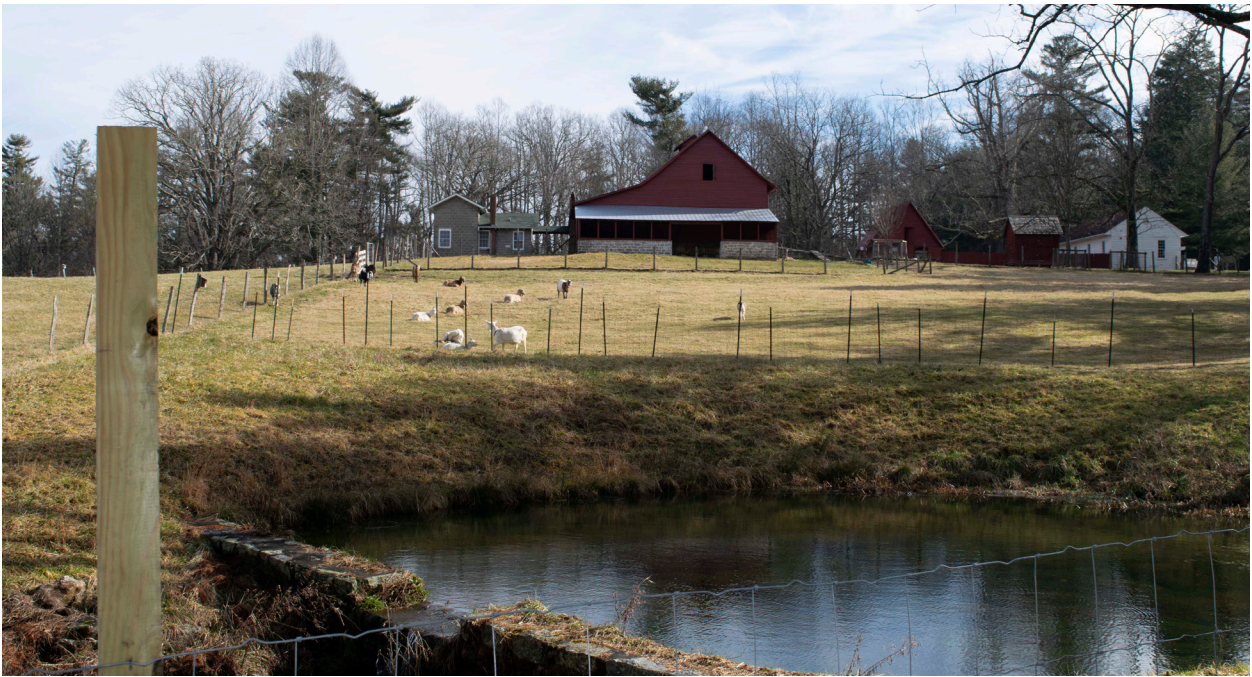
Figure 5.30: The non-historic T-post-and-wire fence is located near the duck pond. Its removal should be considered by the park. (Source: WLA Studio).

Currently, a non-historic fence blocks access to the Duck Pond area, which falls within the Historic Interaction Zone (Figure 5.30). This metal T-post and wire fence was installed to limit erosion on the bank of the small pond caused by goat traffic. It is recommended the park remove this section of fencing and restore the historic field pattern in this area. There is a shade tree adjacent to the pond that could provide relief for goats, as referenced in the “shade for goats” section. Park staff should monitor for any erosion issues, as well as any other safety concerns.

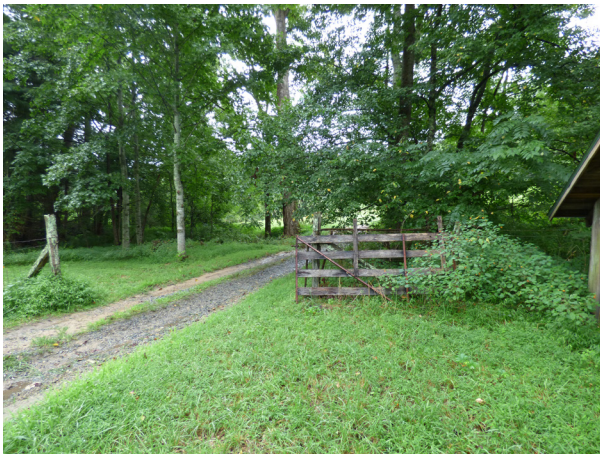
Figure 5.31: Some gates are no longer attached to a post and have been propped up against the fence. The gates in the non-interpreted areas of the site need not be mounted, but photo documentation of gates should occur prior to release or storage. (Source: WLA Studio).

The pasture area in particular has a number of gates. While some are functional, others are left permanently open either due to gate condition or ease for maintenance work (Figure 5.31 - Figure 5.32). The pasture area is presently not interpreted to the public. While the gates are

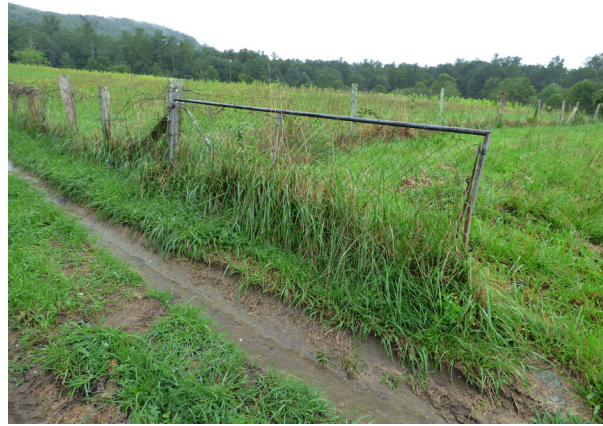
Figure 5.33: This aluminum gate can withstand weathering better than wood gates and can still function for park purposes. This gate is located at the end of the pasture lane. (Source: WLA Studio).

part of the historic landscape and are within the Historic Discovery Zone, this report recommends prioritizing maintenance of gates within the Historic Interaction Zone (Figure 5.33 - Figure 5.34).

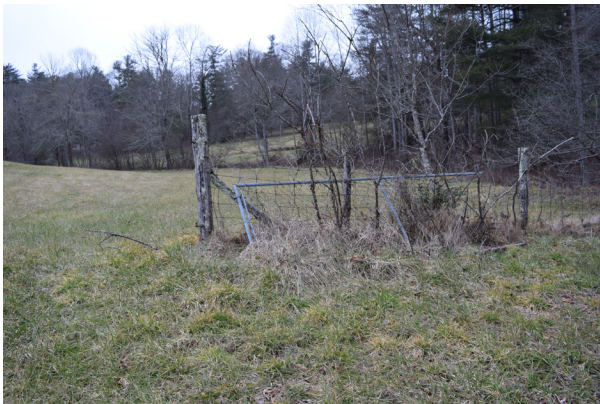
Figure 5.32: This photograph shows another fence that is no longer used, and is getting overgrown with vegetation, posing a maintenance issue. (Source: WLA Studio).

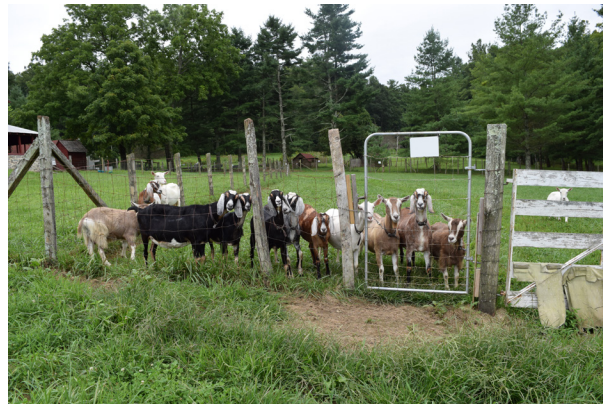
Figure 5.34: This photo shows two types of gates used in the farm area. In general, gates should be used as long as possible and replaced in-kind when the need arises. (Source: WLA Studio).
