# The Road Inventory of Capulin Volcano National Monument CAVO – 7160

Prepared By:  
Federal Highway Administration  
Eastern Federal Lands Highway Division  
Cycle 3

# Capulin Volcano National Monument in New Mexico

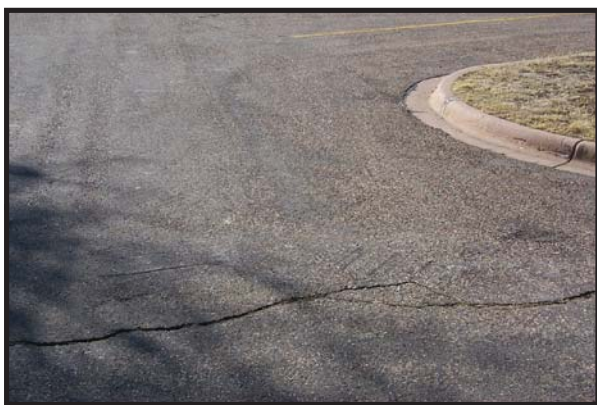
## Route 0901

Route	Public / NonPublic	Date Visited	Area (sq ft)	Lane Miles *	Surface Type	Condition / PCR
0901	Public	3/11/2003	15685	0.27	OC	POOR / 45

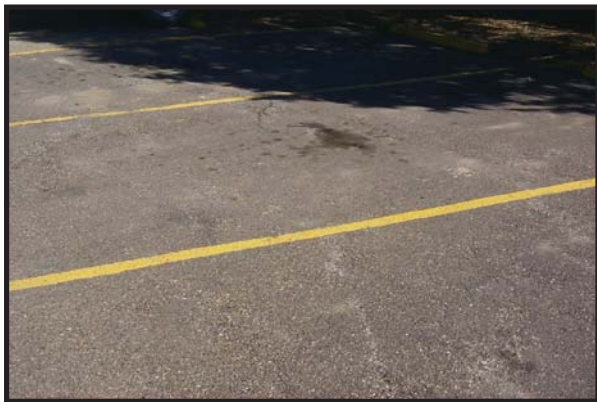
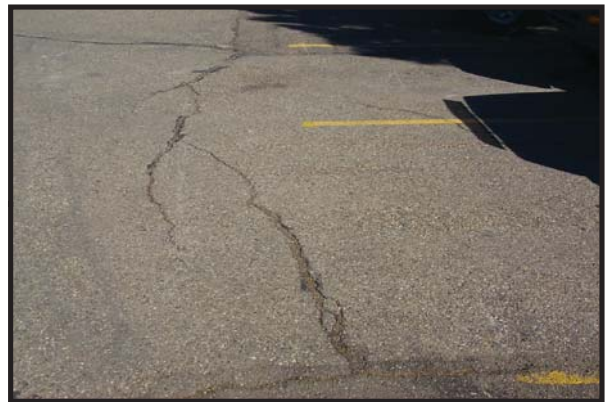
## Route 0903

Route	Public / NonPublic	Date Visited	Area (sq ft)	Lane Miles *	Surface Type	Condition / PCR
0903	NonPublic	3/11/2003	1209	0.02	OC	POOR / 45

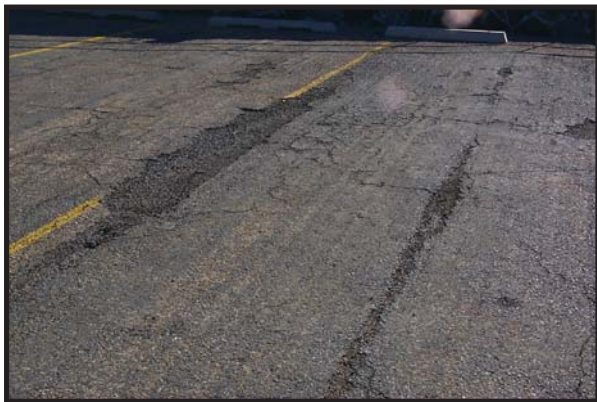
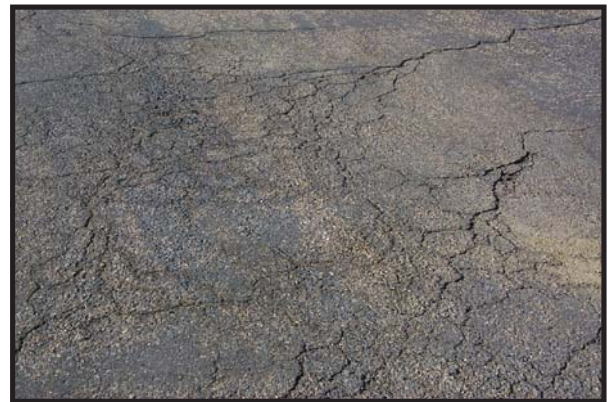
Route	Public / NonPublic	Date Visited	Area (sq ft)	Lane Miles *	Surface Type	Condition / PCR
0905	Public	3/11/2003	12470	0.21	OC	POOR / 45

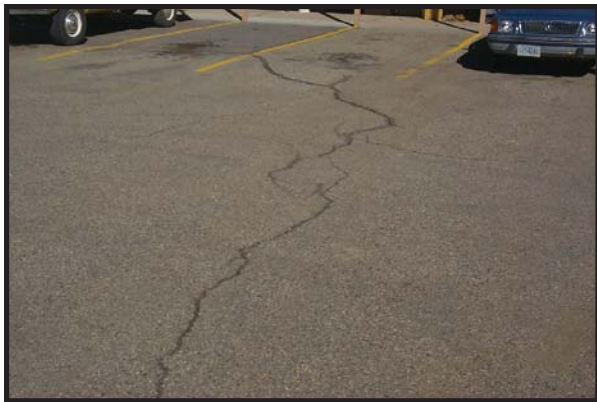
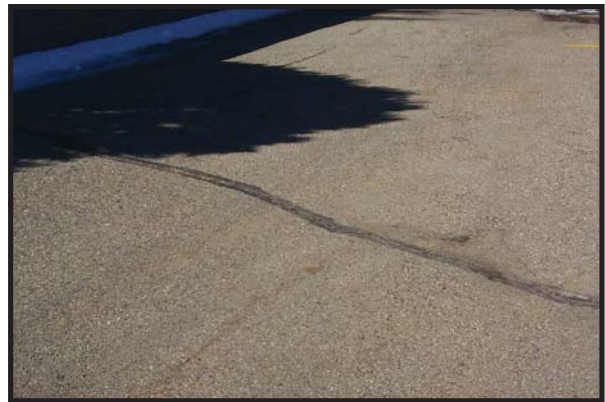
## Route 0906

Route	Public / NonPublic	Date Visited	Area (sq ft)	Lane Miles *	Surface Type	Condition / PCR
0906	NonPublic	3/11/2003	11538	0.20	OC	POOR / 45
