Lower Vine Ranch
Death Valley National Park

CULTURAL LANDSCAPES INVENTORY (CLI) PROGRAM
2010 Condition Assessment Update for:

Cultural Landscape Inventory: Lower Vine Ranch

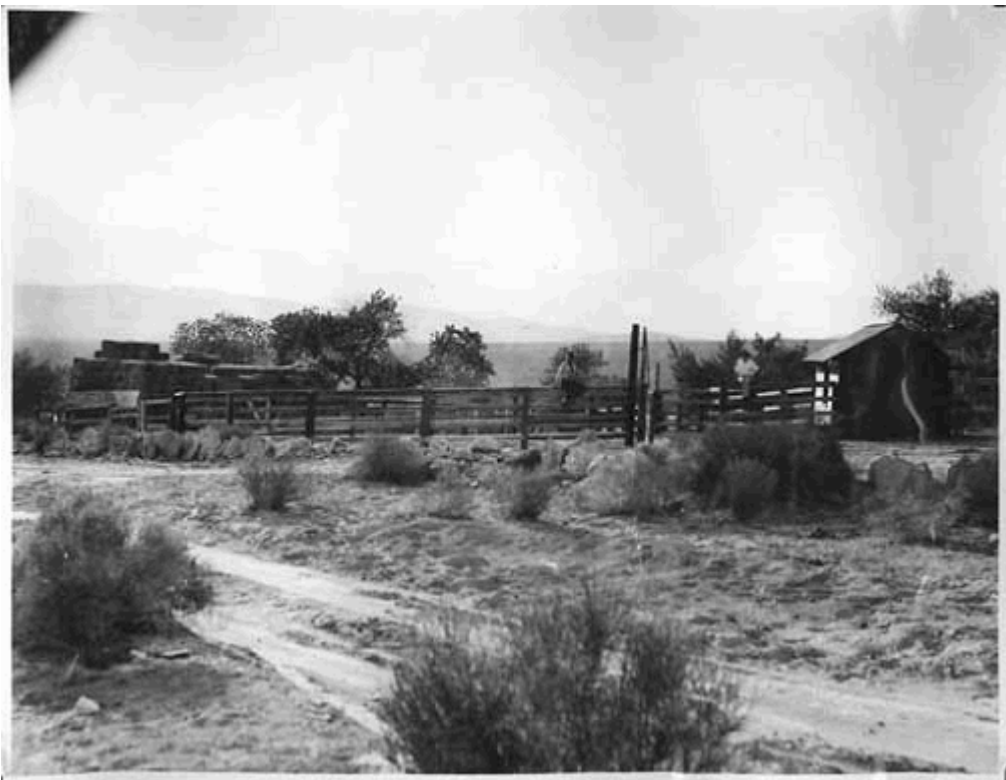
Photograph of the corrals circa 1930, view south. This structure was built in 1927, two years prior to the construction of Scotty's ranch house (DEVA 41344).

The corrals at Lower Vine Ranch must be stabilized to prevent further damage. A carpenter and crew of one will be necessary to stabilize this structure.

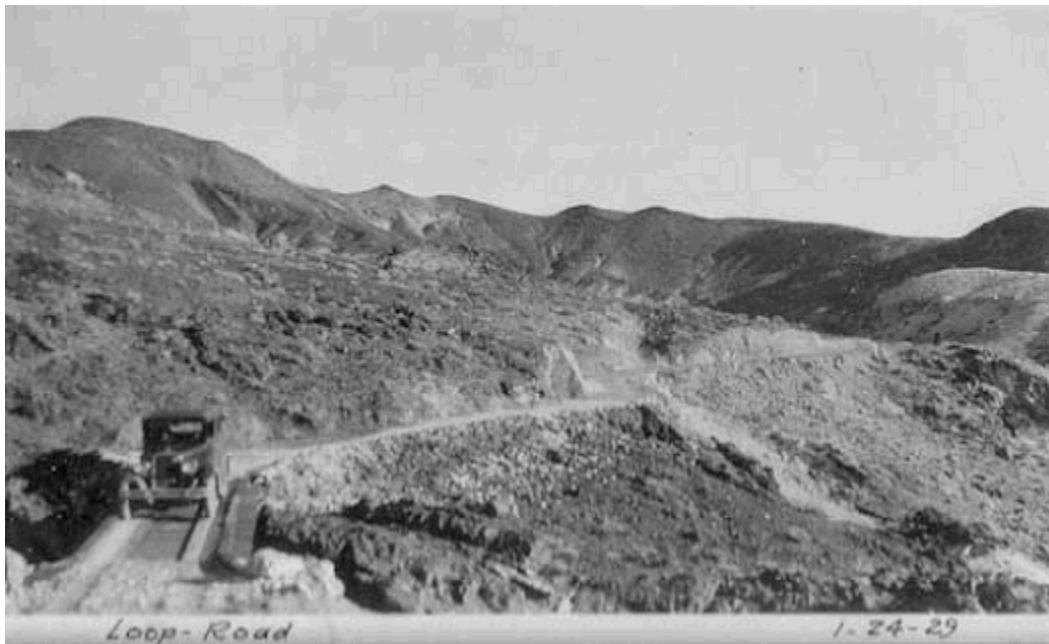
Photograph of the loop road and the wooden bridge, view north. The bridge was built on the northeast portion of the Lower Vine property in 1926 (Album 13732 DEVA 40674).

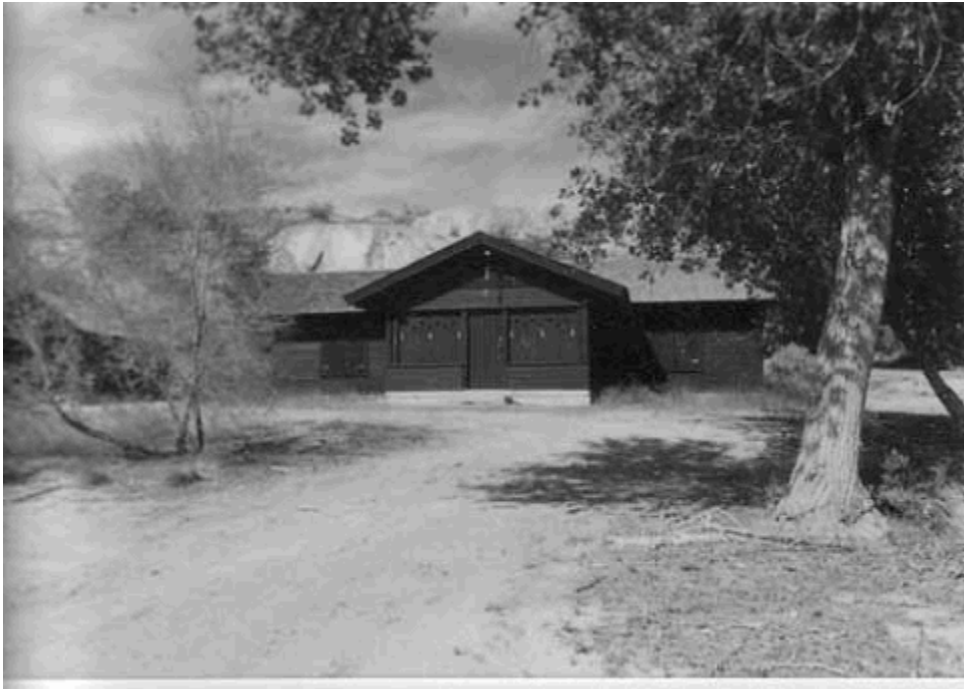
Photograph of Scotty's ranch house in the mid-1970s, view north. The residence was mothballed after 1954 and has been in this state since (Album 60670 DEVA 2099 78).

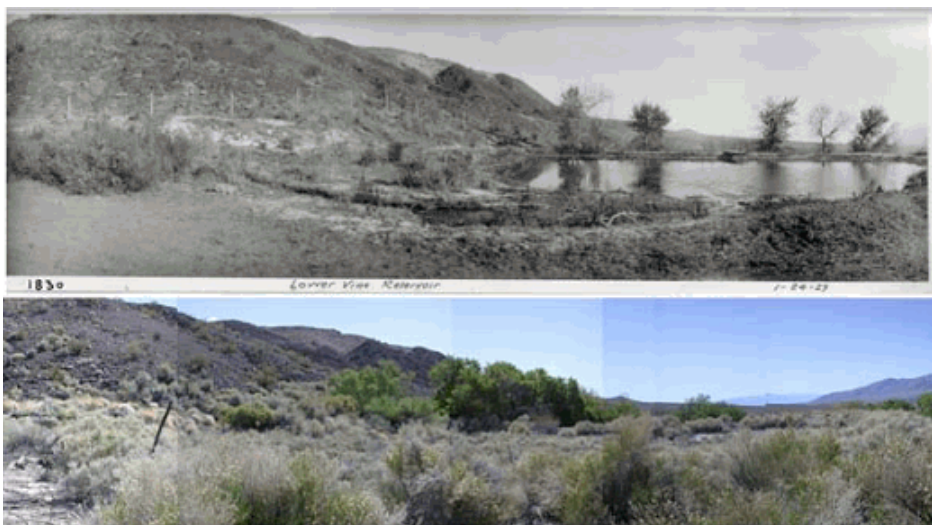
Images of the reservoir located approximately one mile west of Scotty's ranch house, view east. Although the structure remains intact, it is no longer in use (Top: Album 17372 DEVA 40721 Bottom: PWR 2004).

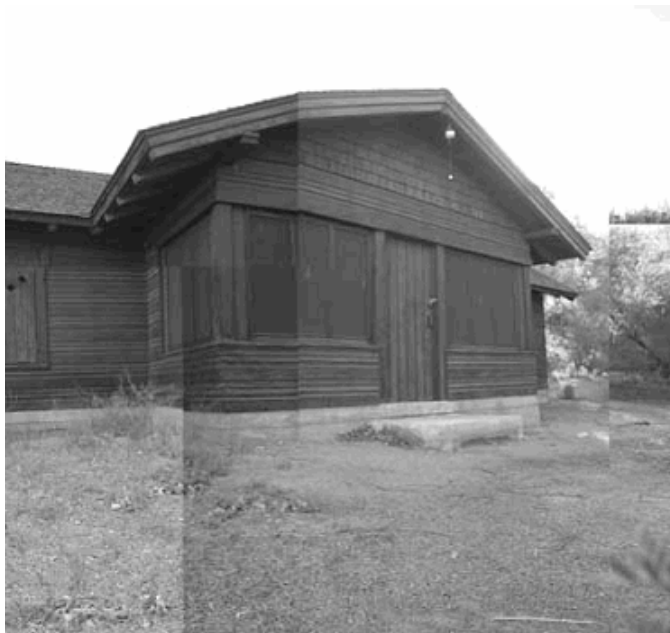
Contemporary image of Scotty's ranch house, view northeast. Today, the residence remains mothballed (PWR 2004).

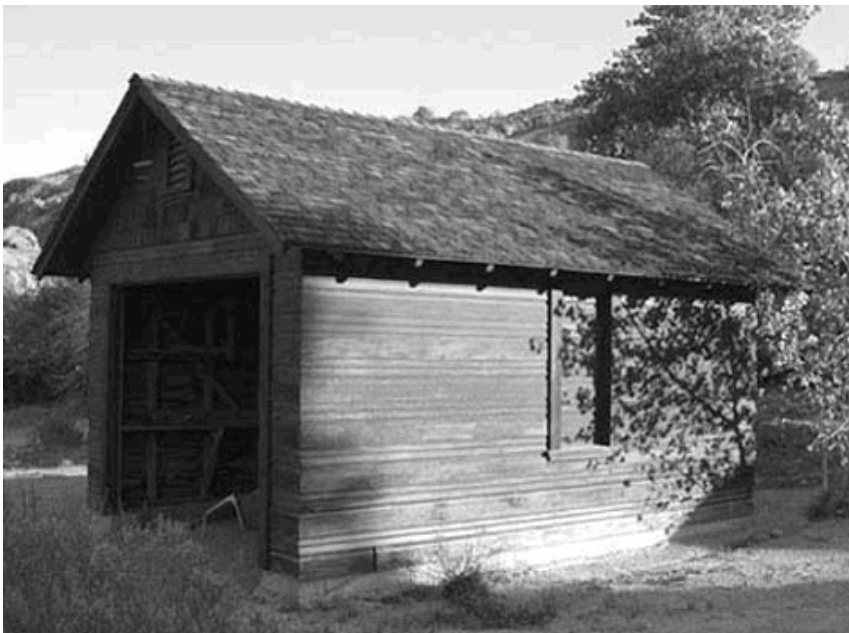
Image of the garage, view northwest. This building once housed Scotty's car. It is located west of Scotty's ranch house (PWR 2004).

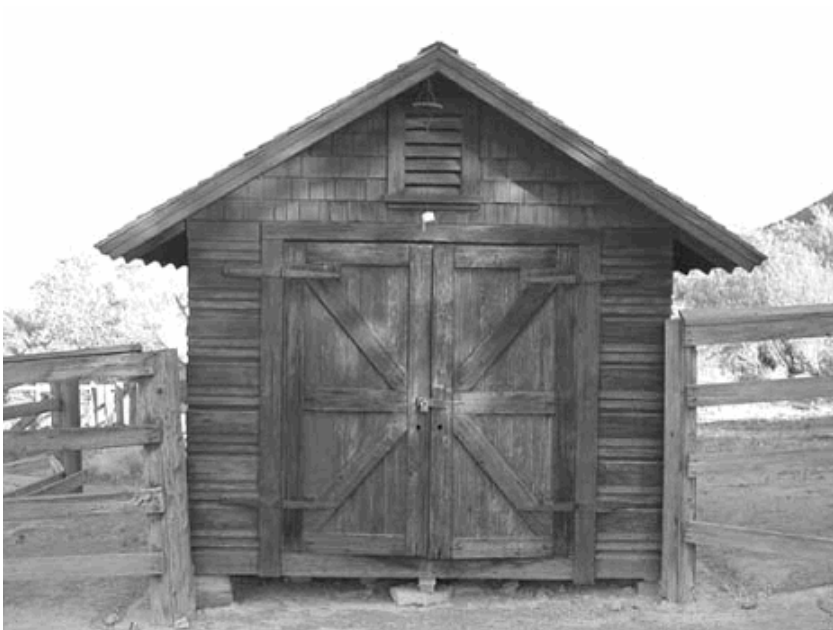
Image of the grain shed, view west. This building is located south of Scotty's ranch house (PWR 2004).

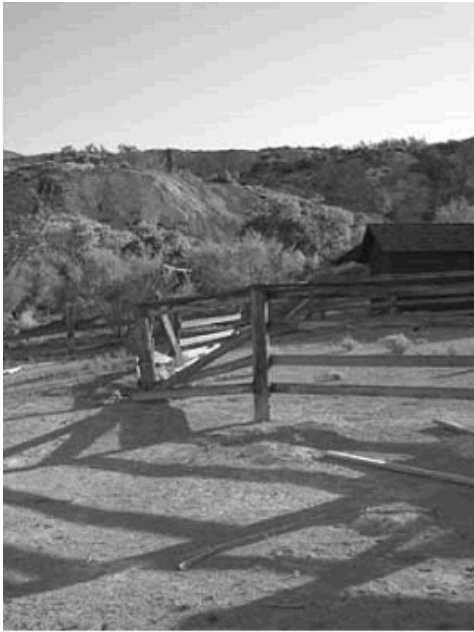
Image of the corral at Scotty's Castle, view north. This structure was constructed in 1927 (PWR 2004).

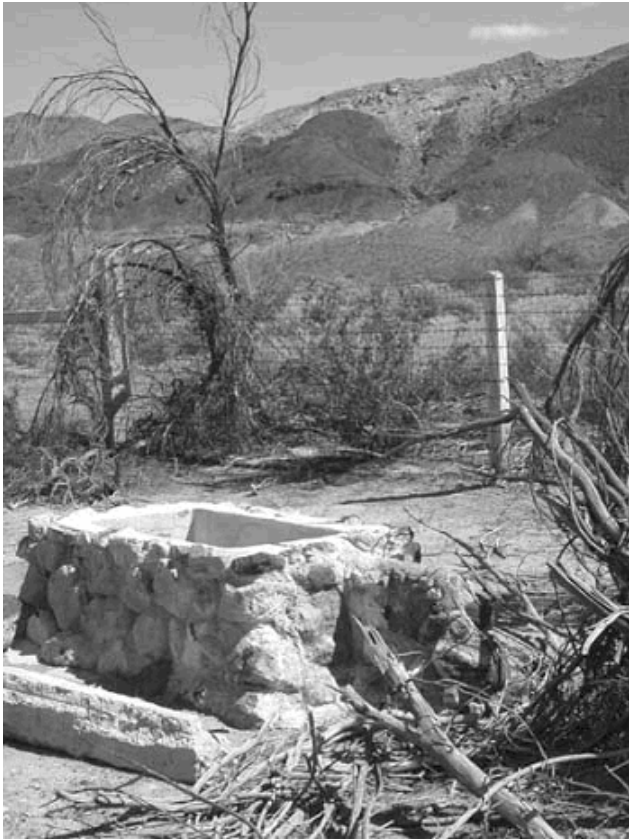
Image of the Lower Vine ranch trough, built by Johnson to maintain the water rights of his property, view northwest (PWR 2004).

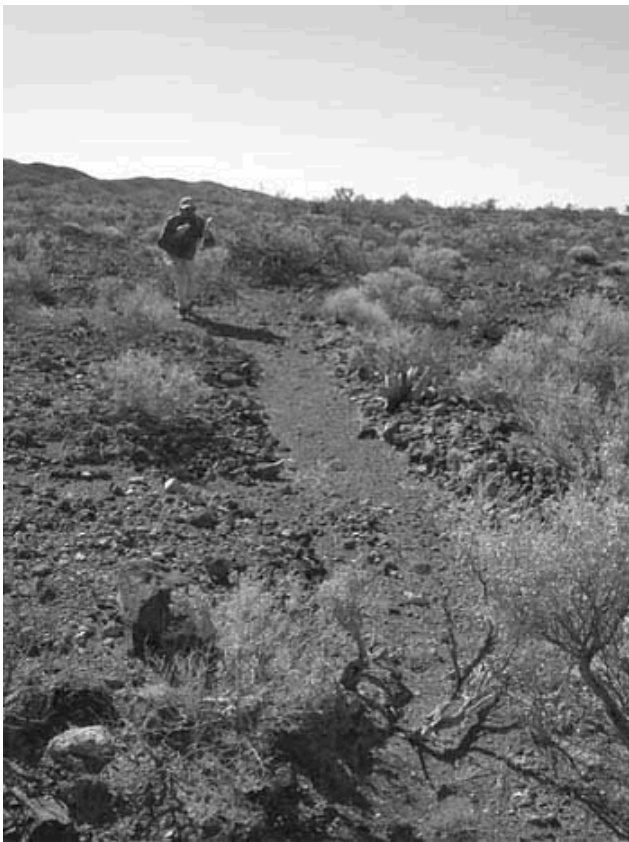
Faint traces of a trail aligned between Scotty's ranch house and the reservoir, view east. This trail was probably aligned by Scotty to provide access between the two sites during the historic period (PWR 2004).

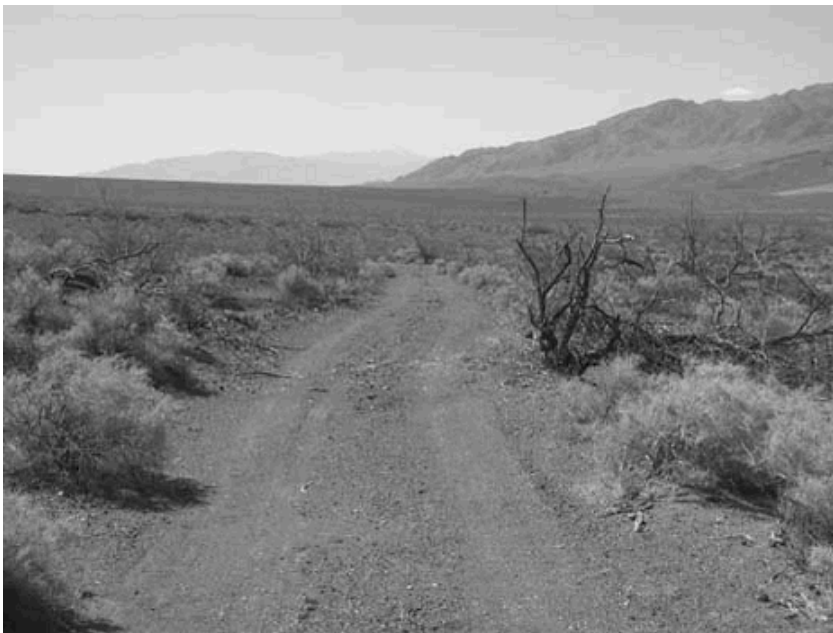
Image of the single-lane road aligned between the entrance gate and reservoir, view east. The rural character of the road is typical of other roads found on the Lower Vine Ranch (PWR 2004).
