UNITED STATES DEPARTMENT OF THE INTERIOR
NATIONAL PARK SERVICENATIONAL REGISTER OF HISTORIC PLACES
INVENTORY -- NOMINATION FORM

Fort Laramie National Historic Site

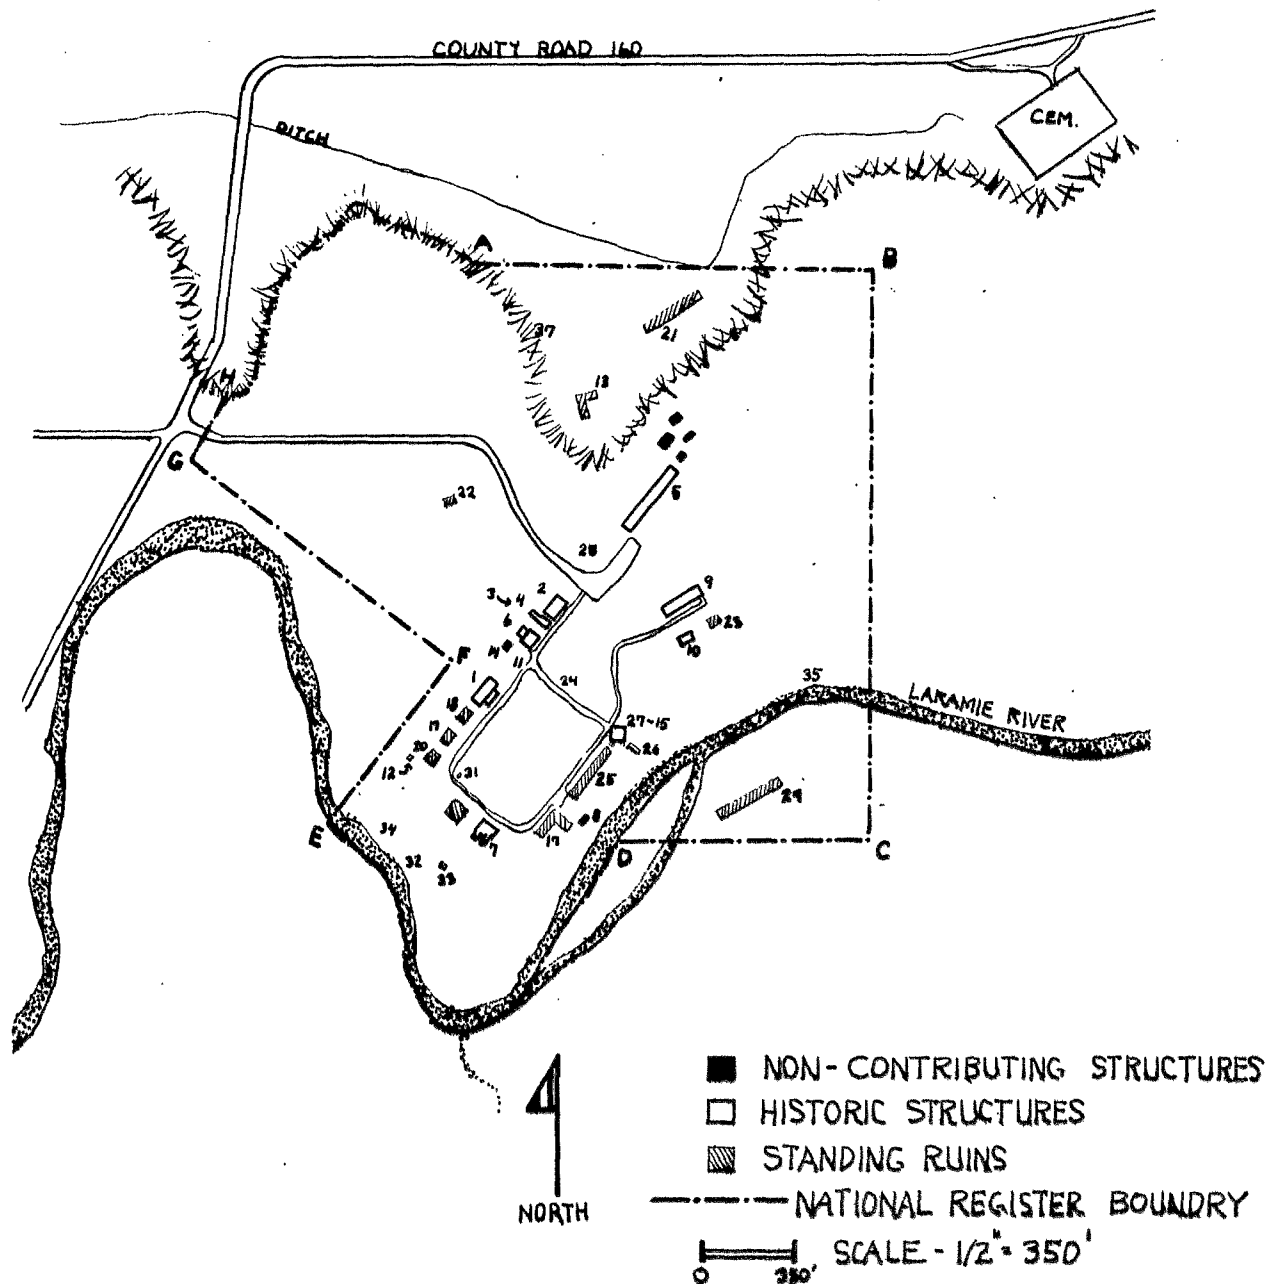
Historic Structures

- 01 - Old Bedlam
- 02 - Sutler's Store
- 03 - Historic Privy
- 04 - Officer's Quarters F
(Burt House)
- 05 - Cavalry Barracks
- 06 - Officer's Quarters E
- 07 - Officer's Quarters A
- 08 - Old Guard House
- 09 - Commissary Storehouse
- 10 - Old Bakery
- 11 - Officer's Quarters Ruins
- 12 - Chicken House
- 13 - Hospital
- 14 - Magazine
- 15 - New Guardhouse
- 17 - Administration Building
- 18 - Officer's Quarters D
- 19 - Officer's Quarters C
- 20 - Officer's Quarters B
- 21 - Married NCO Quarters
- 22 - Powerhouse/Sawmill
- 23 - New Bakery
- 24 - Three Company Barracks
- 25 - Two Company Enlisted
Men's Barracks
- 26 - General Sink
- 27 - 1850 Guardhouse
- 28 - Sutler's Residence
- 29 - Married E.M. Quarters
- 30 - 1850 Officer's House
- 31 - Birdbath
- 32 - Icehouse
- 33 - Outbuilding
- 34 - Outbuilding
- 35 - Footbridge
- 37 - Earthwork Trench

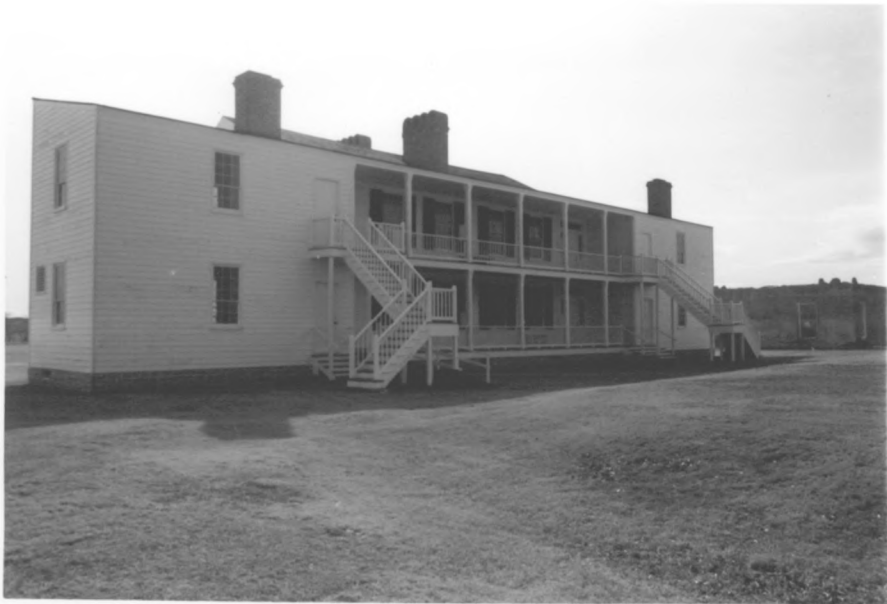
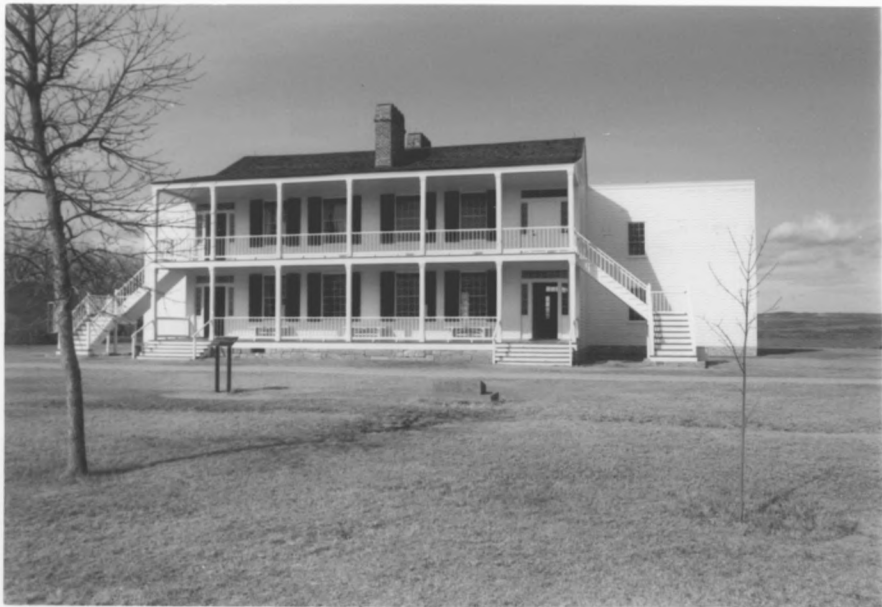
NAME: Old Bedlam (HS-001)

- HS-001 Old Bedlam-----Constructed in 1849. The vernacular Greek Revival structure is the oldest standing military structure in Wyoming. It is a two-story central block with symmetrical wings. It measures 55'8" x 3' with 9' veranda and 26' x 16' kitchen wings. It has a sandstone foundation and a crawl space basement. The wall construction is frame on masonry and lime concrete. The white weatherboard is in excellent condition. It has a two-story porch. There are two brick center chimneys on a central block; one is on the rear slope and the other is on the front slope. Both chimneys have a crown of semi-circle arches. Two other chimneys, one offset right and the offset left, have slightly corbeled caps. Each of the four doors in the front and the four in the back have four rectangular panels with a transom and side lights on both sides. The windows on the kitchen wings are nine over six lights double hung sash with a plain exterior trim. The main structure windows are 12 over 12 lights double hung sash with plain exterior trim and green louvered shutters. The covering of the roof is wood shingles. The roof shape of the kitchen wings is the shed roof type, whereas the central block is shaped like one half of a bellcast gable. The flooring of Old Bedlam is random width, tongued, and grooved boards. The building is in good condition. The building retains its architectural and historical integrity.

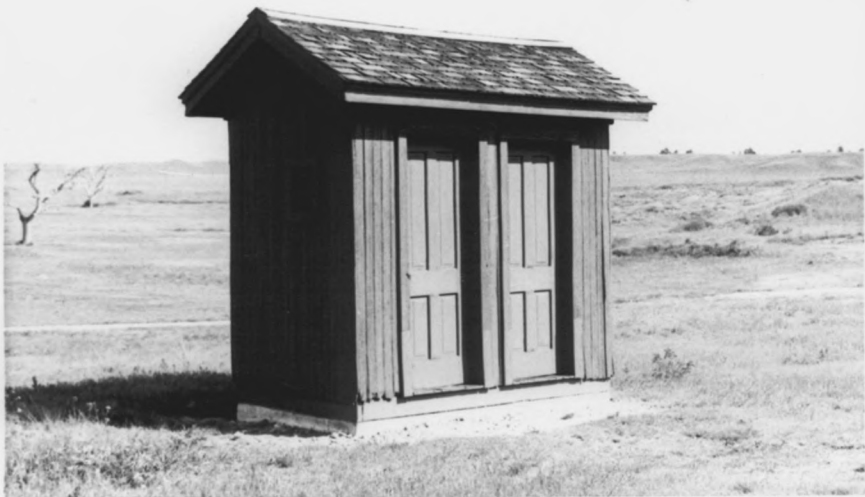
NAME: Historic Privy (HS-003)

HS-003 Historic Privy-----It is assumed that the privy was constructed about 1884 since the Lt. Col's. Quarters (HS-4) just in front of the privy was constructed in that year. It was built by the Corps of Engineers of the U.S. Army. The Historic Privy is a one-story rectangular frame construction building measuring 9'2" x 5'1 1/2". The wall construction is maroon wooden vertical planking. There was an attempt to restore the foundation with concrete, but it is falling apart. On the southeast side, there are two rectangular four paneled doors next to each other. There are two vents, one on the northeast side and one on the southwest side. The wood shingled roof is medium gabled with boxed cornices. The building is in good condition. It retains its architectural and historical integrity.

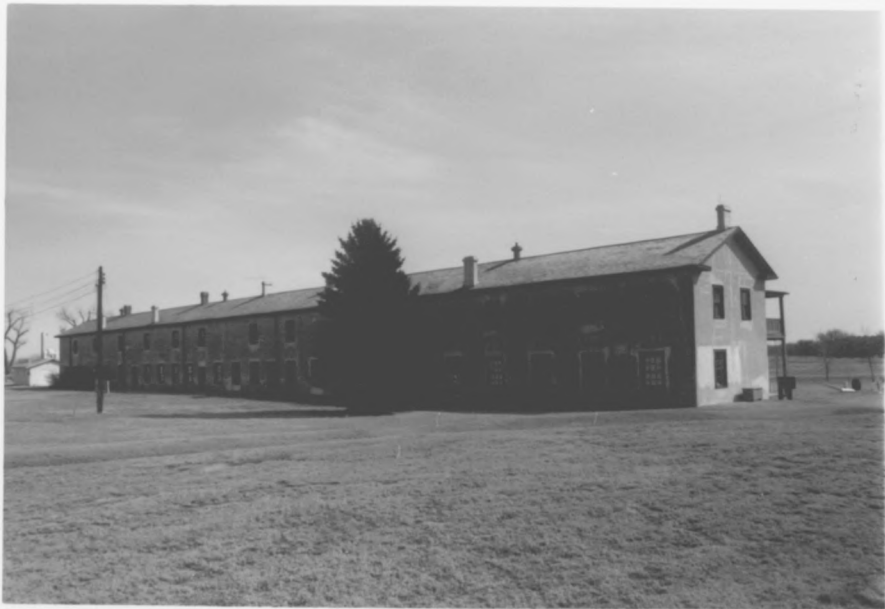
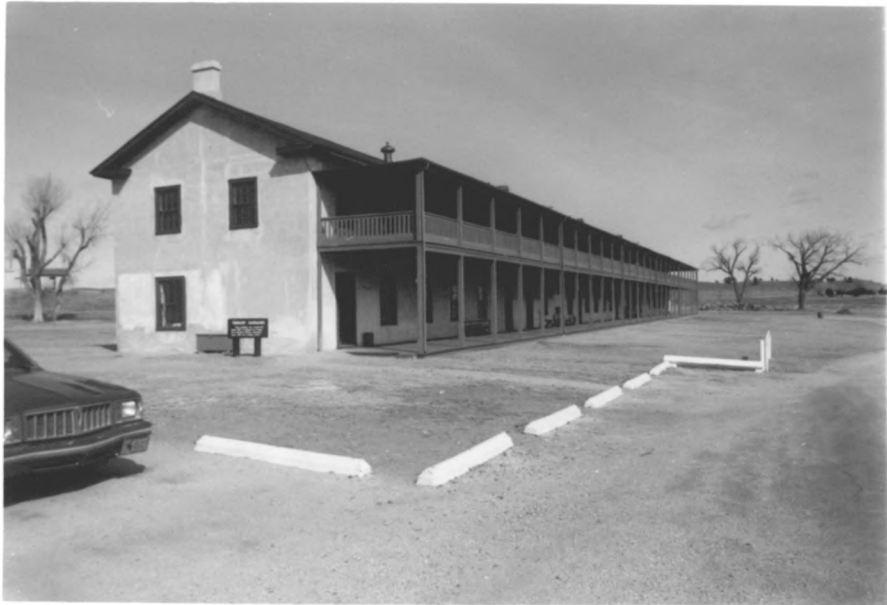
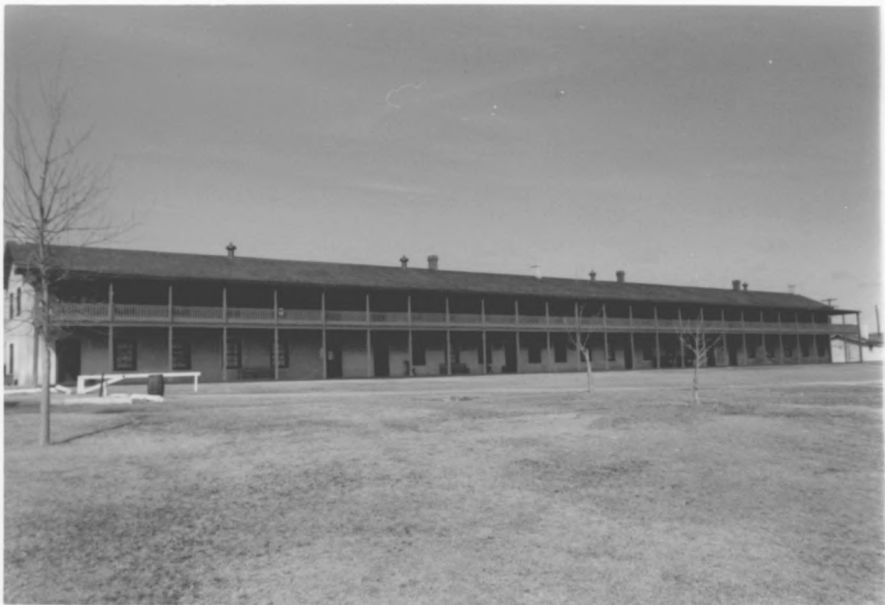
NAME: Cavalry Barracks (HS-005)

Cavalry Barracks-----Cavalry Barracks was built in 1874 by the Engineer Corps of the U.S. Army. The lime grout cavalry barracks for two companies of soldiers measures 270' x 26'. This two-story rectangular shaped structure had 18" thick, 10' high walls on the lower story and 14" thick, 9' high walls on the upper story. During the winter of 1882-83, a veranda, 275' long, 12' wide, and 21'6" high was added to the front. These barracks were used by cavalry troopers from 1874-1883, and by infantrymen from 1883 to 1890. Presently, the lime grout on the cavalry barracks is deteriorating faster than maintenance can patch it. The building has a lime grout foundation and a lime grout wall construction. There are six chimneys in the front of which three of the chimneys are brick with corbeled caps. Four chimneys are on the front slope in the back of the cavalry barracks and are lime grout with corbeled caps. There are seven doors on the first floor on the front side of the cavalry barracks as follows: to the extreme left is a four paneled door with a plain trim; to the right of the four paneled door is a door with a window and a plain trim; the next two doors have plain trim; in the middle of the cavalry barracks is a four paneled door with plain trim; to the right of this four paneled door is a six paneled door with plain trim; and to the right of the six paneled door is a plain trim door with two vertical panels. The second floor in the front of the cavalry barracks has two doors with plain trim. Four doors on the backside of the cavalry barracks have plain trim and one of these doors has a three paneled horizontal window above it. The northeast side of the building has a door with plain trim. All the windows are six lights

over six lights double hung sash. The cavalry barracks has a gabled roof with shingles. The two story front porch covers the entire length of the building. Nailing blocks were put in for trim and windows. Inside the cavalry barracks, the partitions are frame construction, wood lath, and smooth finish plaster. Interior of exterior walls is wood lath and smooth sand finish. Various partitions are papered. Ceilings were originally lathed and plastered, but in 1900 were replaced with 3/8" x 4" and 3/8" x 6" matched and beaded ceiling. The interior flooring is wood. Some restoration work was done 1953-59 and 1973. Complete restoration remains to be done. The cavalry barracks is significant because of its unique style and it is one of a few, if not the only, example of its kind extant. The building is in poor condition because of the deteriorating lime grout, the rotting window sills, and is in dire need of restoration.

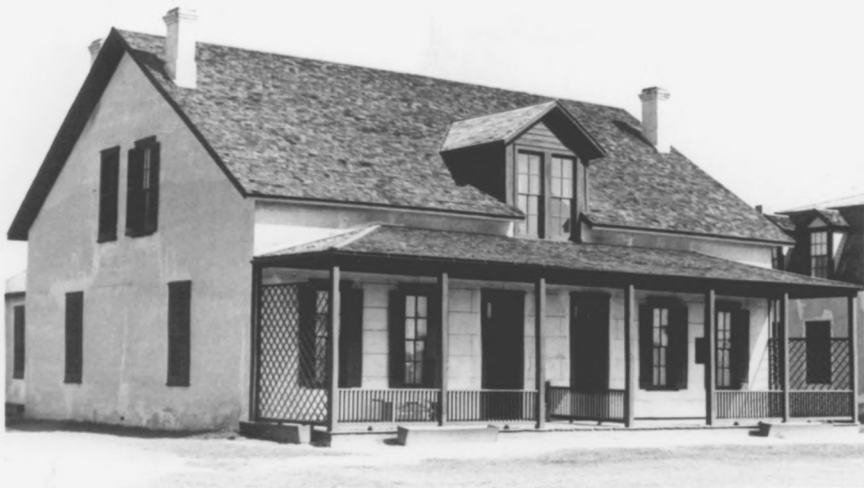
NAME: Officer's Quarters E HS-006

HS-006 Officer's Quarters E--This 1875 house was built and designed by the Engineer Corps of the U.S. Army. The front portion of the house is 1 1/2 stories. The rear portion is one story. The house is shaped as a 1 1/2 story central block with a one story wing. The foundation is lime grout and the exterior walls are lime grout with nailing blocks put in for the trim, windows, etc. There is a three bay one-story front porch with a wooden floor. On the southwest side is a two bay one-story side attached porch with a wooden floor. The exterior doors and windows, trim, cornice, front and rear porch columns, dormers, rear entrance vestibule are

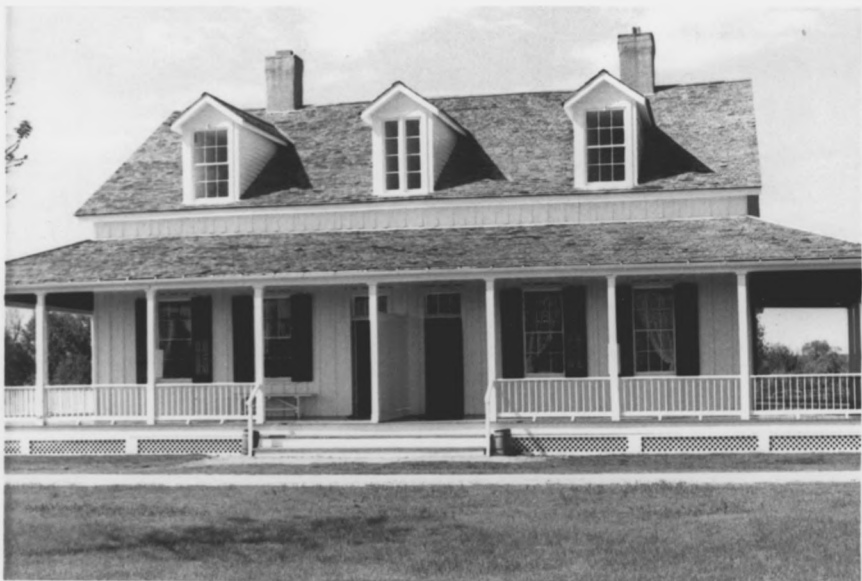
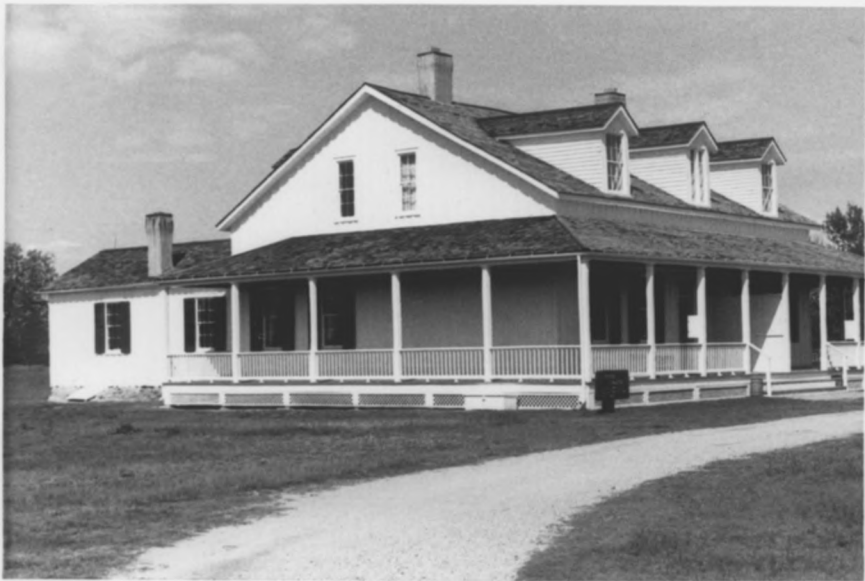
NAME: Quarters A (HS-007)

- HS-007 Officer's Quarters A---Quarters A was built approximately in 1873 by the Corps of Engineers of the U.S. Army. It was erected as a single residence, but eventually a center partition was put up to make it a double dwelling. There is a porch on three sides of the house. The foundation under the main part of the house and rear (east) wing are of stone. The porch rests on wood posts set on stone footings. A basement exists under the rear (east) wing. To the rear of the house, on the west side, is a storage cellar. Construction of the house is wood frame and the exterior walls are filled with adobe brick. Windows are double hung, with divided sash and are operated with spring catches. It is a 1 1/2 story U-shaped building with a one-story rear section. The right side has slightly offset chimney on the front slope and a chimney straddling the ridge offset right. The left side has the same positions for its two chimneys, but the one on the front slope is slightly offset to the right. All the chimneys are made of lime grout. Both front doors have four rectangular panels with a three light transom above them. The two doors at the backside have four rectangular panels each. The first floor has six lights over six lights double hung sash windows with marron louvered blinds. The medium gabled roof of the 1 1/2 story roof for the one-story rear section has a overhang for the back entrances. Inside, the interior walls are of a smooth plaster applied over wood lath. There is interior sill work. There is a single flight open staircase facing the rear that originally had been one staircase, but was divided when the house was converted into a duplex. The building is in good condition. The building retains its architectural and historical integrity.

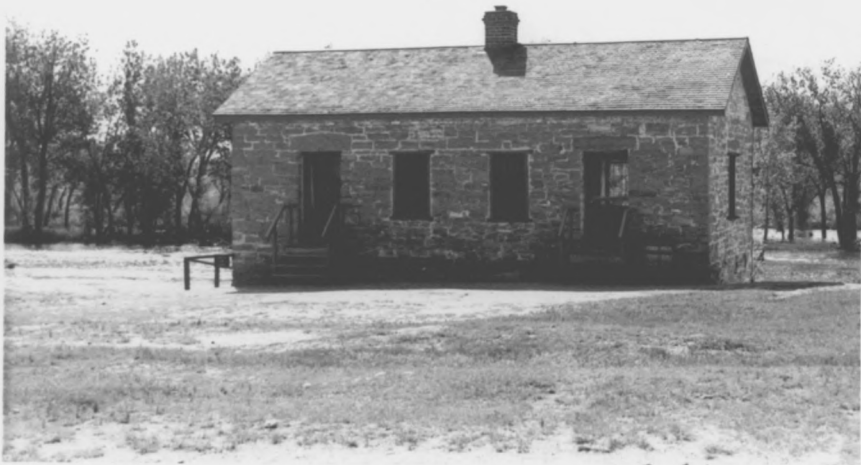
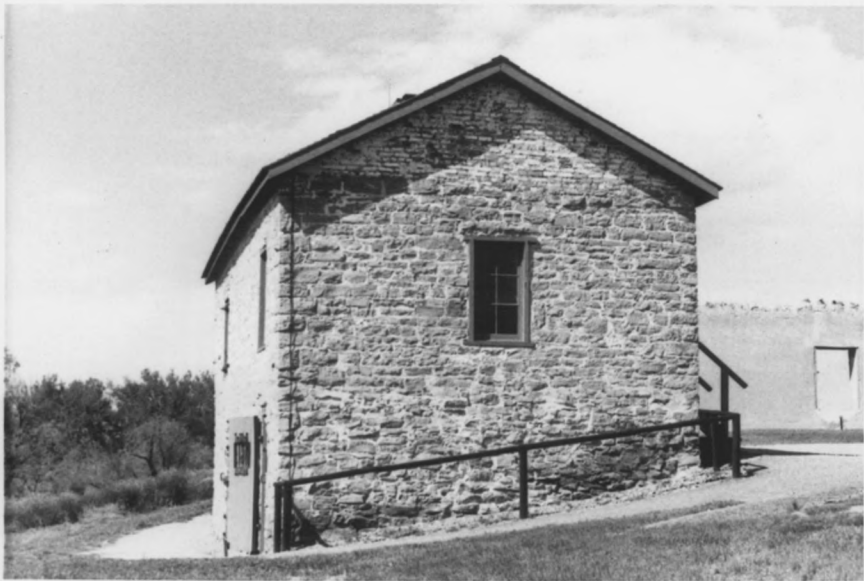
NAME: Old Guardhouse (HS-008)

- HS-008 Old Guard House-----The Old Guard House was erected in 1866. It was both designed and built by the Corps of Engineers of the U.S. Army. It measures 20' x 36' and was "capable of containing forty prisoners and a guard of forty men." The upper story was partitioned into two rooms, one for the officer of the guard and the other for the guard. The front facing the parade ground is one-story, whereas the grade in the rear drops down to be approximately level with the basement floor. The foundation wall is approximately 25" thick and consists of sandstone laid up with lime grout. The wall construction is coursed rubble mixed with lime grout. On the northeast and southwest sides near the top are some weathered stretcher bond brick. On the southeast side of the first floor are

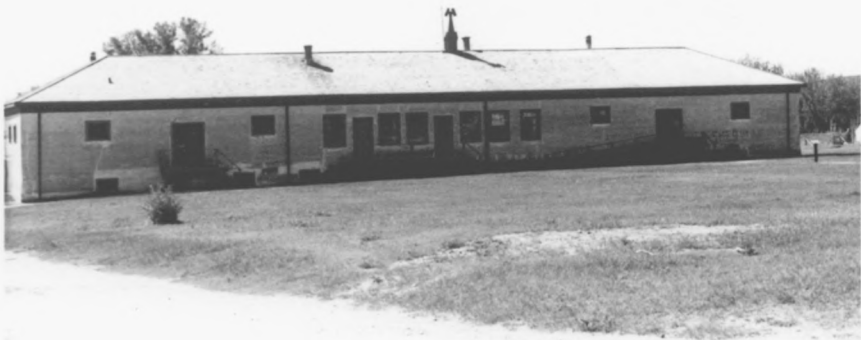
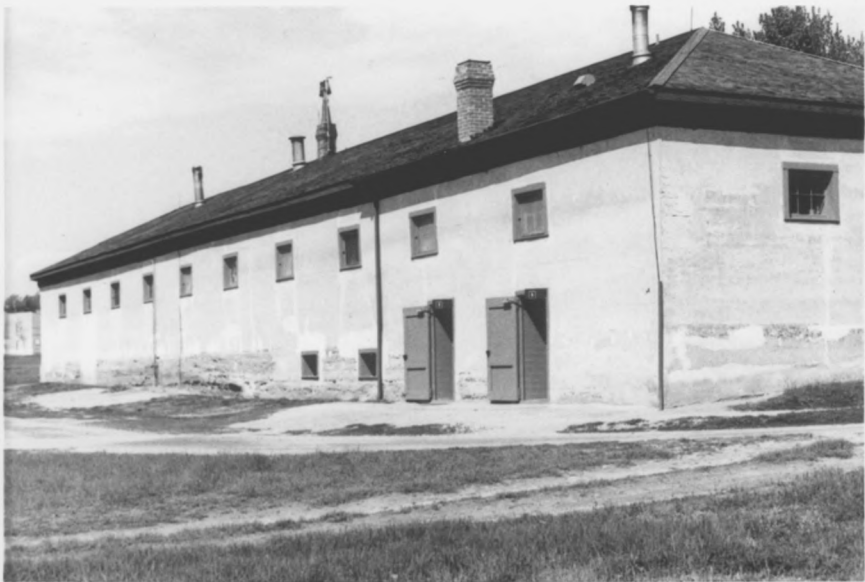
NAME: Commissary Storehouse (HS-009)

HS-009 Commissary Storehouse---The Commissary Storehouse was constructed in 1883. This lime grout structure measures 32' x 135'. The structure housed numerous foodstuffs that made up the soldiers' diet from 1883 until 1890. The rectangular shaped building has a lime grout foundation and two brick chimneys with corbelled caps. One chimney straddles the ridge in the middle of the building and the other one is on the east backside. There is a partial basement which covers approximately 1/3 of the building on the east side. The backside of the building has ten rectangular casement windows and two basement windows with gray plain trim. There are two, two paneled doors on the east side with plain trim. The paneled doors on the east side have plain trim. The front of the building has four basement windows, four doors with plain trim and steps leading up to them, four rectangular vertical windows with six panes, and six over six lights double hung sash horizontal rectangular windows. Each of the sides of the building has two rectangular vertical windows with six panes. All the windows have gray trim. The roof is low hipped with wooden shingles. There are dark Venetian red painted eaves. The building is in fair condition, as the lime grout is deteriorating faster than it can be patched. The building retains its architectural and historical integrity.

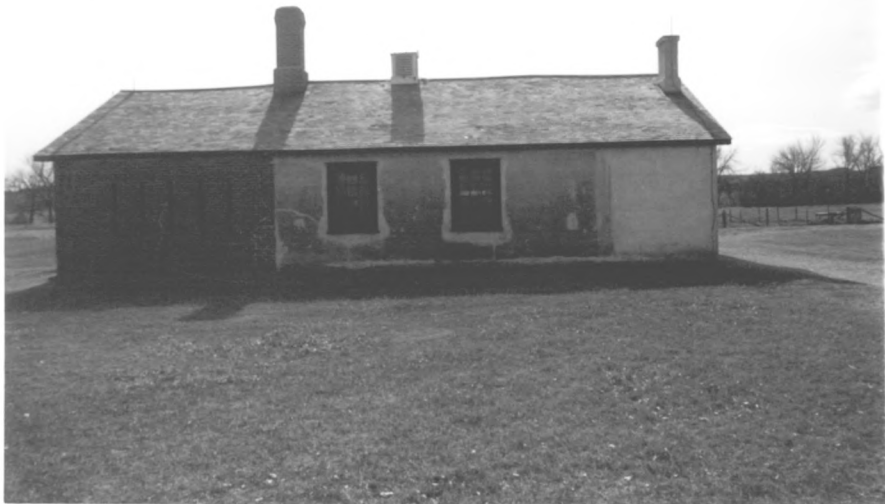
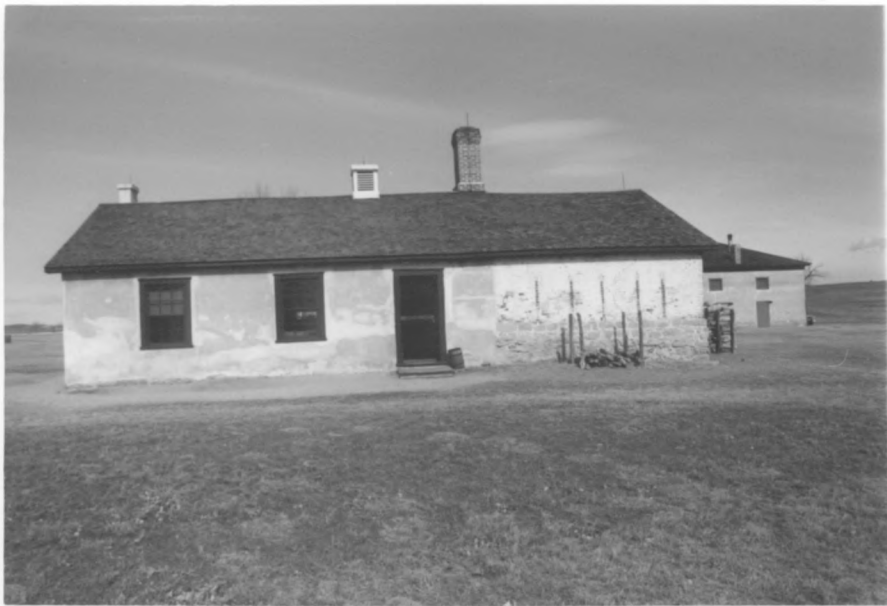
NAME: 1876 Bakery (Back) HS-010

CONTINUATION SHEET	DESCRIPTION	ITEM NUMBER	PAGE
HS-010	Old Bakery-----		7
	The Old Bakery was constructed in 1876, and is rectangular shaped with a lime grout foundation. The building is made of lime grout, except where the baking oven is located. Therefore, the northeast side of the front and back and the northeast side itself are made of brick. There are two chimneys, both on the north-west side. One is a brick chimney with a corbelled cap and the other is a lime grout chimney. The trim around the doors and windows is maroon. The door is of plain trim with plexiglas. The windows are six lights over six lights with plain trim. The medium gabled roof is made of wood shingles. The slightly overhanging eaves are maroon. There is a white cupola on top of the roof. The building is in fair condition and retains its historical and architectural integrity.		
HS-011	Officers' Quarters----- Ruins		
	Sometime between 1880 and 1882, this officers' quarters was built from the existing ordnance storehouse, gunshed, and powder magazine. Construction was of frame adobe, concrete and stone. All that remains today is part of a standing concrete wall.

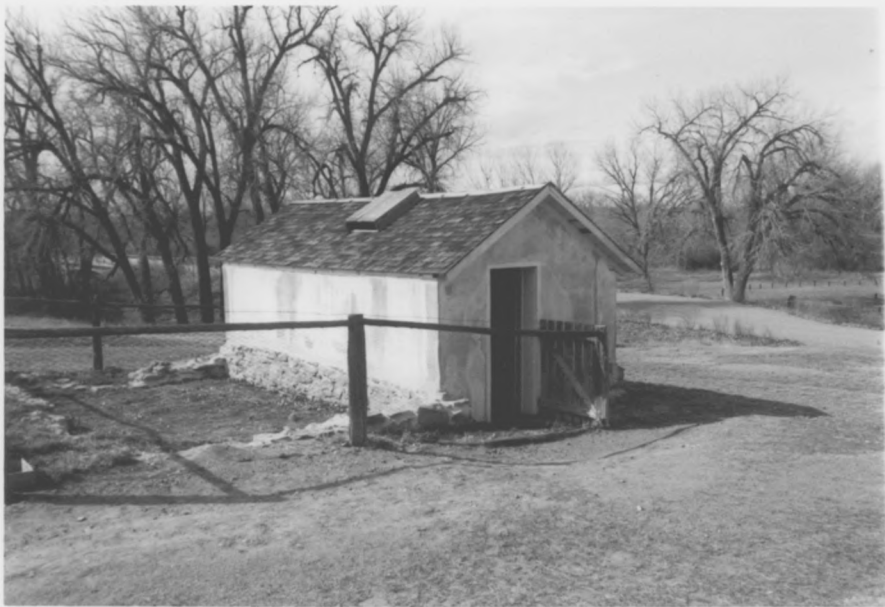
NAME: Chicken House (HS-012)

HS-012	Chicken House-----		
	The Chicken House was built about 1881 by the U.S. Army. It appears to have been designed for special use by the C.O. and was used both as a stable and later as a chicken house. It measures 19'7" x 10'8". It has a limestone foundation laid with lime grout and it is apparent that the lime grout was poured on top of the stone foundation in such a manner to indicate that stone may have been the remains of a former building. On the northeast side of the building is a rectangular six paneled wooded door with plain trim. The south-west side has a square shaped opening that is covered with chicken wire. The roof is medium gabled with wooden shingles and eaves on the northeast and south-east sides. The roof has a projecting airvent on the southeast front slope. The inside ceiling is exposed wooden rafters. There are the remains of a foundation of a former building adjoining the chicken house on the southeast side. The building is in good condition. The building retains its architectural and historical integrity.

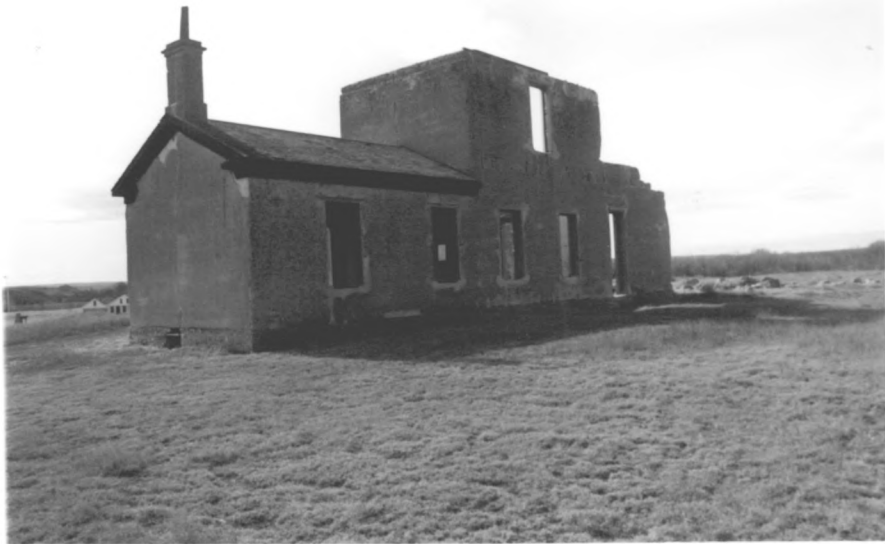
NAME: Hospital (HS-013)

CONTINUATION SHEET	DESCRIPTION	ITEM NUMBER	PAGE	
HS-013	Hospital-----	Begun in 1873 and completed a year later, this two-story lime grout hospital had a capacity of 13 beds, but often times held as many as 20. In 1878 and 1880 verandas were added. The hospital was in use from 1873 until March of 1890. Within 10 years of abandonment most of the structure had been stripped and deterioration had set in. Stabilization was begun in 1958 and eventually completed in 1963-64. The foundations and basement are lime grout, as are the exterior walls. Parts of the exterior wall are plastered with a white sand finish plaster. This ruin has a medium gabled roof over the one-story portion, surmounted with a large louvered vent on the ridge. The lime grout chimney has a brick top with an 8-inch diameter stove pipe extending 2'3" above the top of the chimney. The chimney is on the ridge of the gabled roof.	7	8

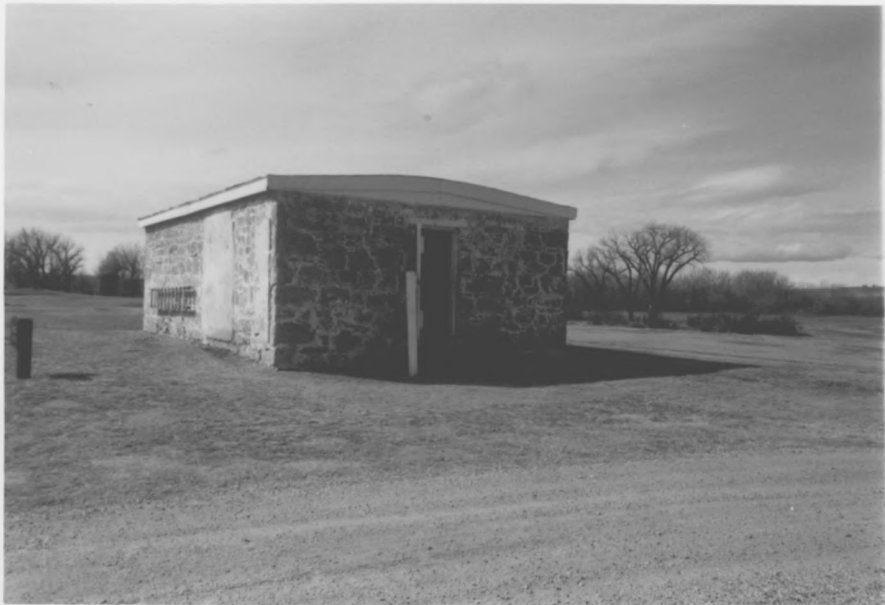
NAME: Magazine (HS-014)

HS-014	Magazine-----	The magazine was constructed in 1850. It is a one-story rectangular building. The foundation had concrete stabilization done in 1950. The wall construction is uncoursed fieldstone and lime grout. There are large patches of lime grout on the southeast side. A temporary stoop leads to a rectangular door with vertical planks. The door is always open, but the opening is covered with plexiglas. In the early 70s, new boards were put along the sides of the roof with tin to help the water run off. The low gabled roof is made of crushed rock, layers of plastic, tar, and bricks. The southwest side has wooden shutters covering the only window, which is one light over one light double hung sash. The building retains its architectural and historical integrity and is in fair condition.		
HS-015	New Guardhouse----	Constructed in 1876, this lime grout New Guardhouse measures 50' x 36'. In 1882-83, a 50' x 20' porch was added. The interior of this one-story guardhouse was partitioned to provide areas for the officer of the guard, the guard room, and the cells for the prisoners. It is the only building at the fort oriented on a true north-south grid. The foundation is coursed rubble and lime grout and it extends above the ground approximately 2" to 4". The building has a five bay, one-story front porch with a wood shingled roof. There are two stone masonry chimneys, one on the east side and one on the west side, with a plain concrete base. The building is in good condition and it retains its architectural and historical integrity.

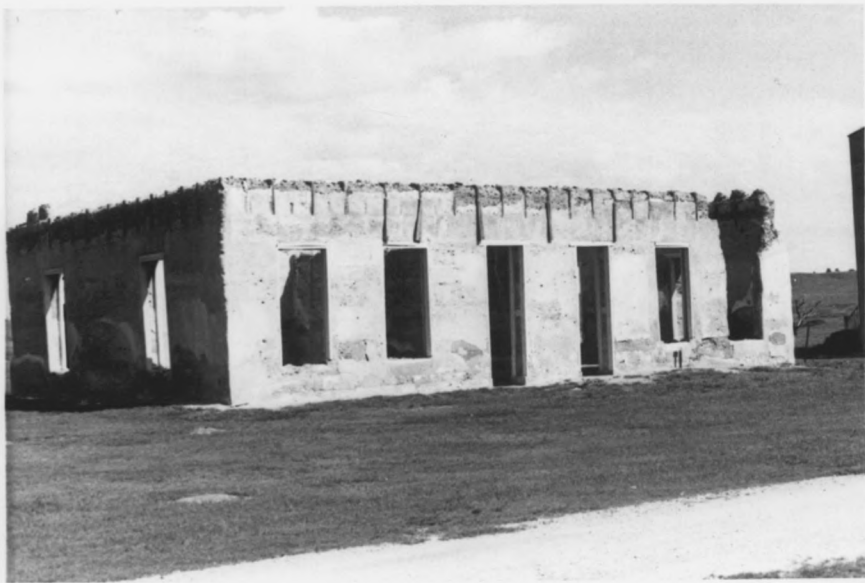
NAME: Officer's Quarters D (HS-018)

HS-018	Officers'-----This double officers' quarters was constructed around an Quarters D earlier adobe officers' quarters in 1881. Built of lime concrete and with a mansard roof, this 1 1/2 story structure served as quarters for two officers and their families. As one of the first buildings stripped by homesteaders who purchased the fort property in 1890, it soon deteriorated. The National Park Service stabilized this structure in 1954 and 1956. The ruin is a gutted shell of a building. There are ten openings for windows, one of which is a ruin and does not have a lintel. Wood bucks and wood lintels similar to the original work have been reinstalled. The partition dividing the duplex still exist. There are four openings for entrance into the ruin. Lime grout was used to fill in walls around all the openings.		
HS-019	Officers'-----This double officers' quarters was constructed around an Quarters C earlier adobe officers' quarters in 1881. Built of lime concrete and with a mansard roof, this 1 1/2 story building served as quarters for two officers and their families. As one of the first buildings stripped by homesteaders who purchased the fort in 1890, deterioration soon set in. This ruin received stabilization treatment in 1954 and 1965. The ruin is a gutted shell of a building.

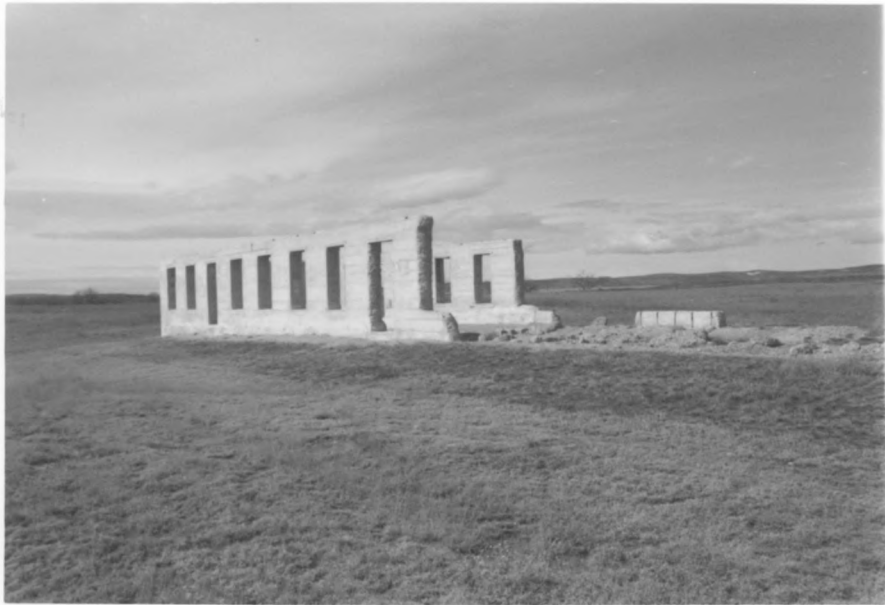
NAME: NC Officer's Quarters-Ruins (HS-021)

- HS-021 Married NCO-----This structure, constructed in 1884-85 of lime grout,
Quarters consisted of six sets of quarters for the NCO married staff. It was in use until the fort was sold at public auction in 1890. The building was approximately 225' x 27.5'. Through the years it has steadily deteriorated, after being stripped of lumber by the homesteaders who bought it in 1890. Some stabilization was accomplished in 1950 and 1956. There are now only two end walls, 34 or 64 wall piers connected on top with only 10 masonry lintels. The walls average 11 feet high and 1.5 feet thick connected together with a base or wainscot from 2 to 4 feet high.

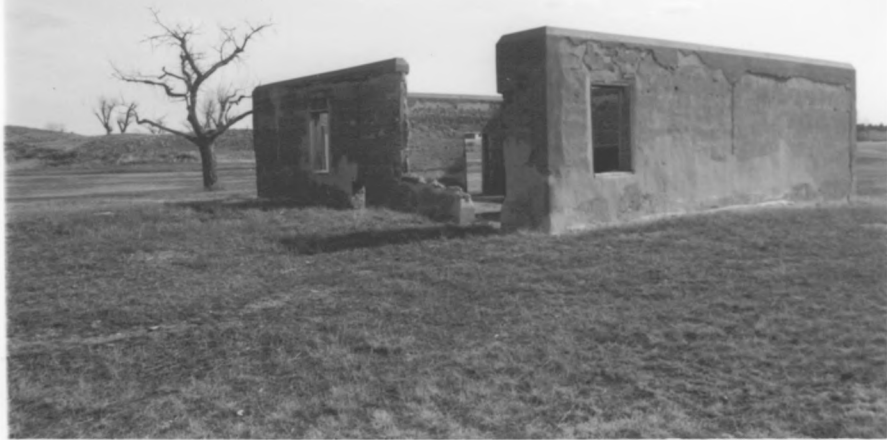
NAME: Sawmill (HS-022)

- HS-022 Powerhouse/-----Apparently built in 1887-88 at a cost of \$400 to replace
Sawmill an earlier frame sawmill that burned. This lime concrete structure measured 28' x 38'. Stabilized by the NPS in 1959. Currently, this site is a lime grout ruin.

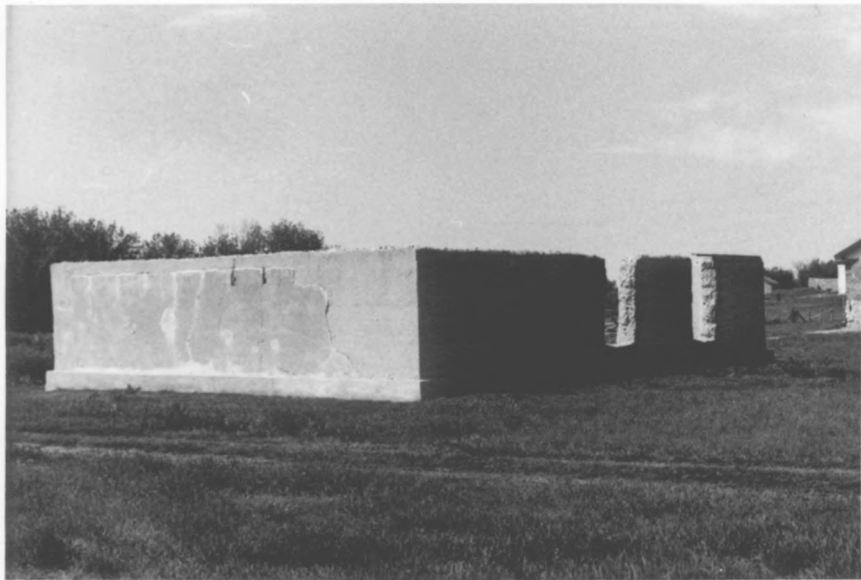
NAME: New Bakery (HS-023)
LOCATION: Fort Laramie National Historic
Site, Wyoming
DATE: June 1983
PHOTOGRAPHER: T. Canaday
LOCATION OF NEGATIVE: National Park
Service, Rocky Mountain Regional Office,
Denver, Colorado
VIEW: Facing southeast and northeast

- HS-023 New Bakery-----Built in 1883-84 of concrete (lime grout) to replace the
1876 Bakery (HS-10). The new bakery measured 34' x 46'. After the fort was sold at public auction in 1890, the building was used among other things by homesteaders as a barn. Burned to the ground in 1923. Ruins were stabilized in 1971.

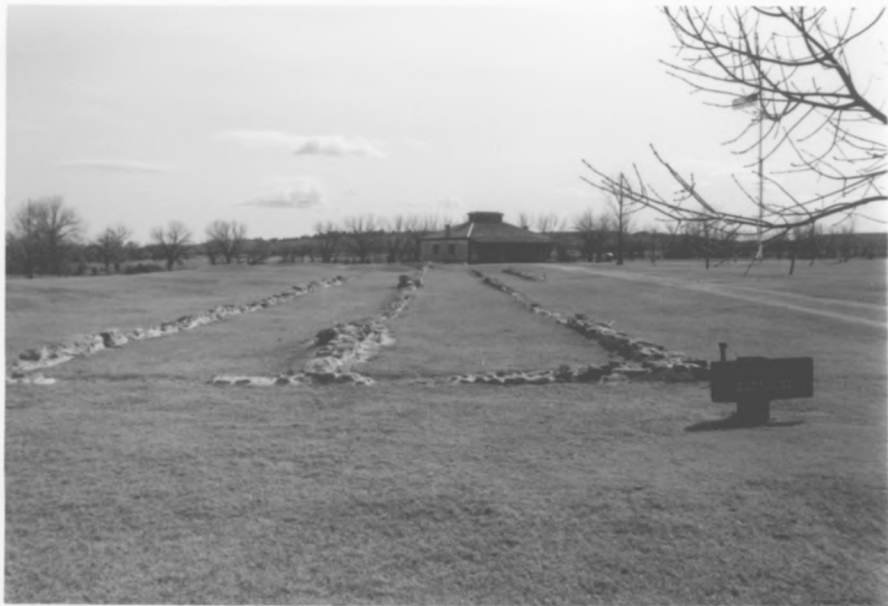
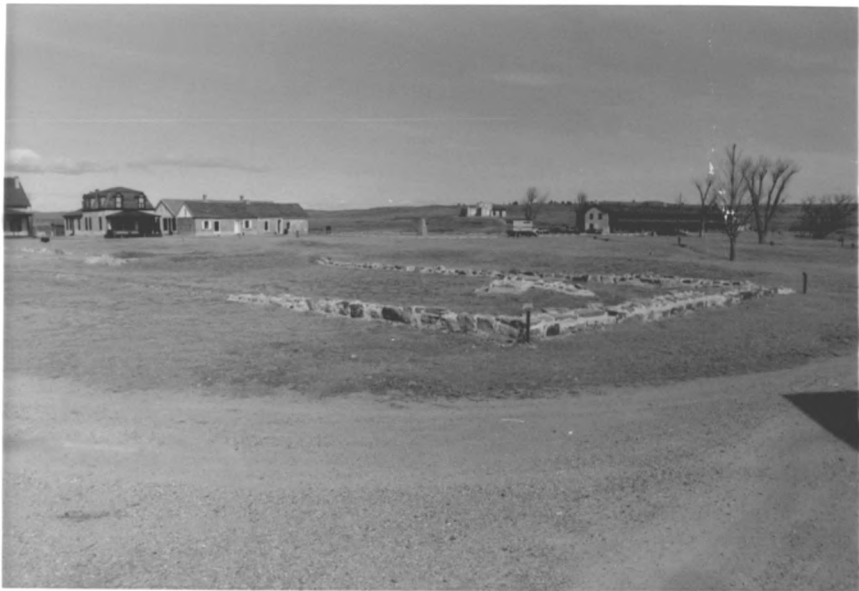
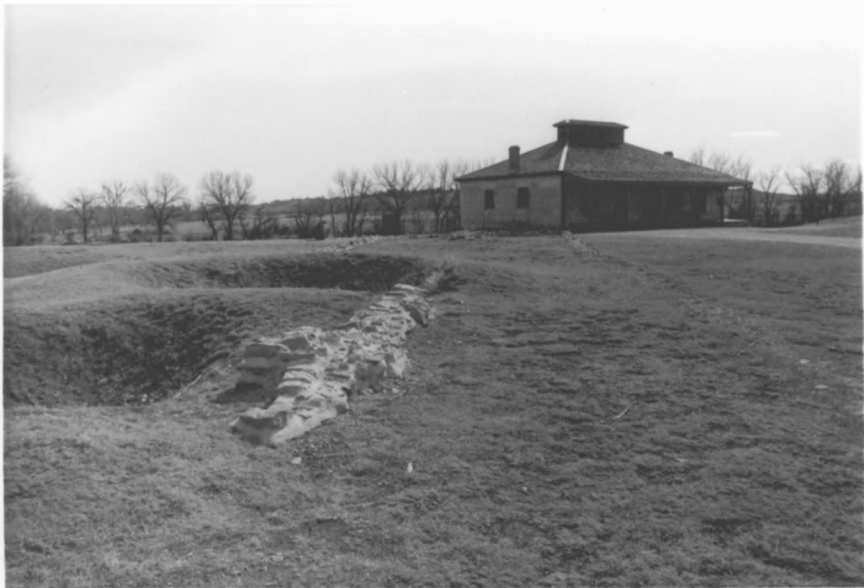
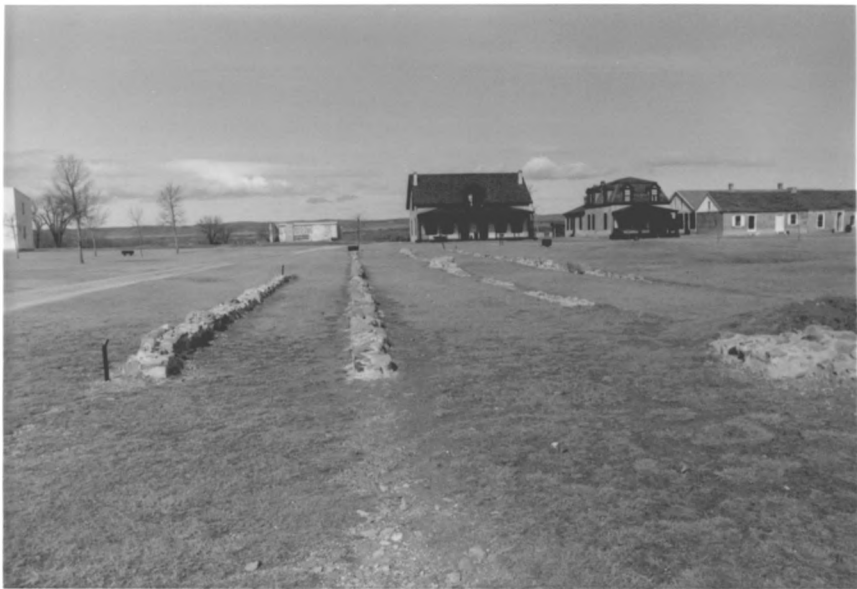
NAME: Three Company Barracks - Ruins
(HS-024)

Continuation sheet	DESCRIPTION	Item number	Page
HS-024	Three-Company ----- Barracks	Built in 1867, this one-story frame building held three companies of soldiers. The 30' x 286' building was built using frame boards upright battened, adobe-lined with a singled roof, Nothing remains but visible foundation ruins.	7
HS-025	Two-Company ----- Enlisted Men's Barracks	Built in 1866, this building held two companies and consisted of two rooms. The 30' x 286' building was built using adobe and it had a shingled roof. Nothing remains but visible foundation ruins.	11
HS-026	General Sink -----	Constructed in June 1886, this concrete general sink was of vault construction with necessary pipes for daily flushing into the adjoining Laramie River. Built for the use of the Band, Guardhouse, and Companies A, F, H, and K, 7th Infantry, as an improved sanitary measure. All that remains is some of the structural ruins.

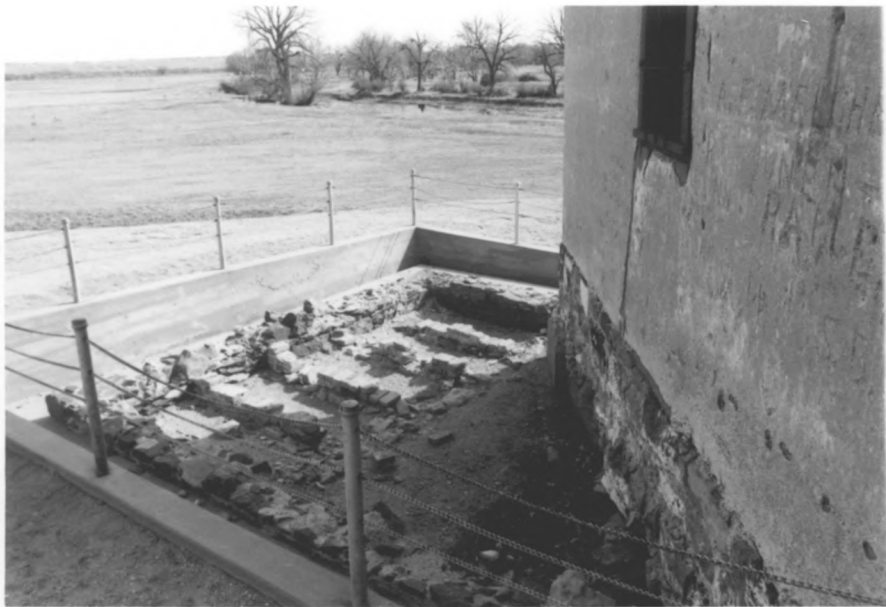
NAME: Ruins of 1850 Guardhouse (HS-027)

HS-027	1850 Guardhouse --	This first of three Guardhouses was built in 1850 and was utilized until 1866, when it was replaced by the second Guardhouse. This first Guardhouse was torn down in 1867. The original structure was two-story, the upper story being of frame construction with a shingle roof and the lower story of stone. The approximate size of the building was 31 1/3' x 17'. The stone basement was divided into two sections, one for a general lockup and the other containing five solitary confinement cells. The upper story contained a courtroom and the guard room. In 1958 while restoring the 1876 Guardhouse, NPS workers discovered the foundation of the 1850 Guardhouse partially beneath the 1876 Guardhouse. A decision was made to expose the entire foundation, a portion of which contained the outlines of the tiny solitary confinement cells outside the 1876 Guardhouse. The new Guardhouse has half the floor removed to show the 1850 Guardhouse foundations. These foundations were treated and stabilized.

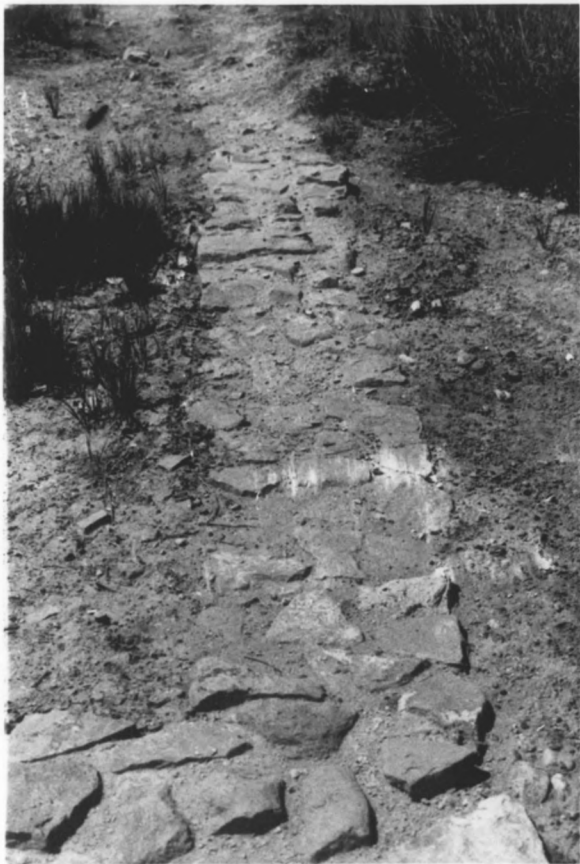
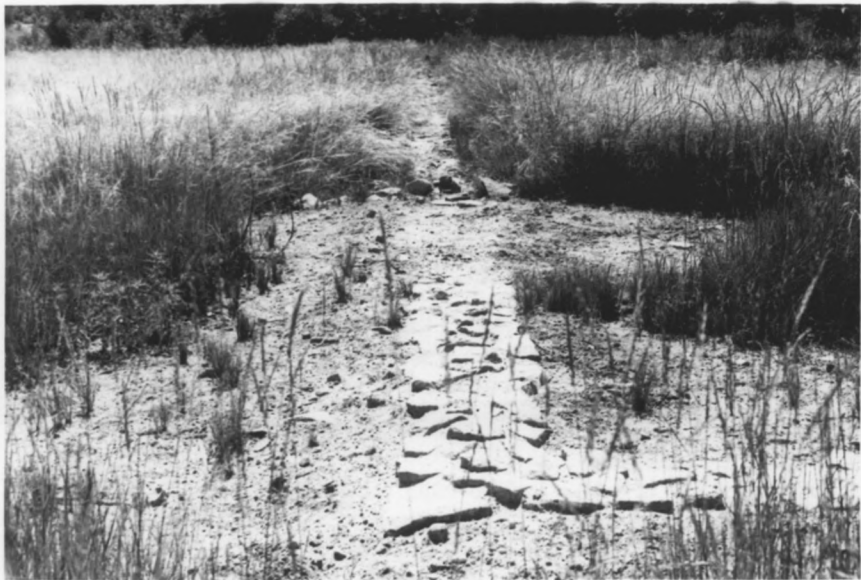
NAME: Married EM Quarters (Soapsuds) HS-029

Continuation sheet	DESCRIPTION	Item number	Page
		7	12
HS-029	Married E.M.----- Quarters	Originally built in 1872, this frame structure was used as a Cavalry Barracks for about eight months. It was then used as laundresses' quarters and finally as married enlisted men's quarters. The structure was shingled, adobe, lined and floored with boards. The 30' x 300' building has a 6' porch and contained 20 sets of quarters. Nothing remains but visible foundation ruins.	
HS-030	1858 Officers'----- Quarters	The House was of a framed construction lined with adobe. It was a one-story duplex with a shingled roof. Each side had four rooms. The main part measured 16' x 166'. One wing measured 24' x 58'. Nothing remains but visible foundation ruins.	
HS-031	Birdbath-----	The parade ground was beautified during the 1880s. As part of this project three brick birdbaths were built, one on each of three corners of the parade ground. The ruins of the one on the southwest corner remain..

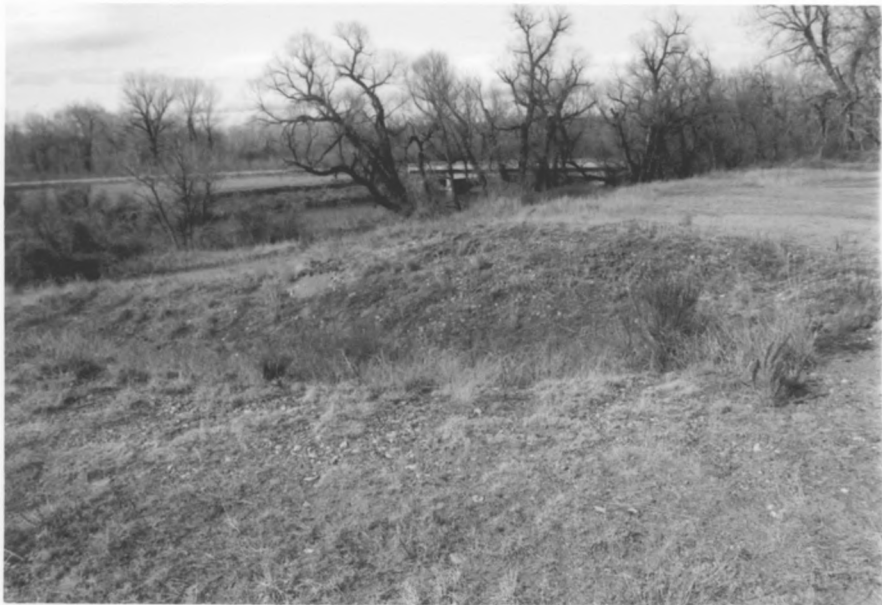
NAME: Ice House (HS-032)

HS-032	Icehouse-----	Apparently built near the river on the south end of the parade ground in the 1880s. In 1881 it was described as a 16' x32' frame icehouse. A large hole and a few foundation ruins are all that remain. A wire fence keeps visitors from falling in.	
HS-033	Outbuilding-----	Nothing is known of this structure. It may be the ruins of a root cellar, an icehouse, or some other building. The hole and existing foundation ruins are enclosed by a wire fence to keep visitors from falling in. The date of construction is unknown for this resource.	
HS-034	Outbuilding-----	Nothing is known of this structure. It may be the ruins of a root cellar, an icehouse, or some other building. The hole and existing foundation ruins are enclosed by a wire fence to keep visitors from falling in. The date of construction is unknown for this resource.	
HS-035	Footbridge-----	Nothing remains of this wooden structure except some foundation ruins and rip-rap. The date of construction is unknown for this resource.
