UNITED STATES DEPARTMENT OF THE INTERIOR
NATIONAL PARK SERVICENATIONAL REGISTER OF HISTORIC PLACES
INVENTORY -- NOMINATION FORM

Fort Laramie National Historic Site

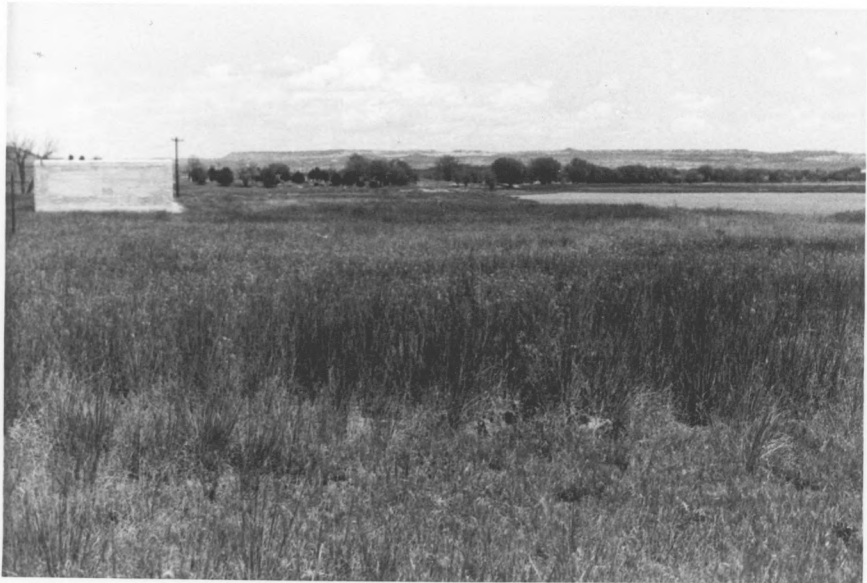
NAME: Earthworks Trench (HS-037)

earthworks system was altered. The third "lunette" was replaced by an adobe walled quartermaster corral with two hexagonal blockhouses. The only remains of this system of earthworks are some faint trenches behind the 1873 hospital ruins and near the married NCO quarters' ruins, and the outline of the first "lunette" behind the hospital ruins.
