## Modeling of Historic Structures

### Simulation-Based Structural Analysis of Fort Sumter Considering Foundation Settlement

By Sez Atamturktur, Ph.D. and Saurabh Prabhu

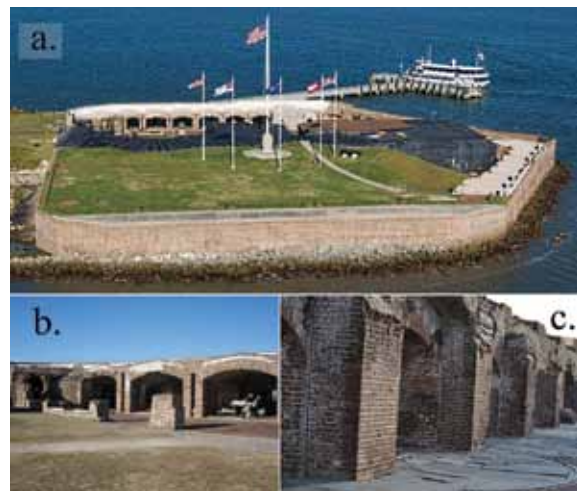
Figure 1: The current state of Fort Sumter National Monument: (a) aerial view, (b) barrel vaulted casemates, and (c) degradation of brick and mortar piers.

Fort Sumter, in Charleston harbor, SC, is a 19<sup>th</sup> century brick masonry coastal fortification. Declared a national monument in 1948, it is best known as the site where the first shots of the American Civil War were fired in 1861. According to archival documents, construction began in 1829 with the foundation, a man-made island filled with nearly ten thousand tons of granite and over sixty thousand tons of assorted rocks and aggregate. By 1860, the pentagonal-shaped structure (Figure 1a) rose nearly 50 feet high, with three tiers built with locally made bricks and Rosendale mortar. After several devastating bombardments between 1861 and 1865 and reconstruction efforts lasting into the early 20<sup>th</sup> century, only the lower first tier of the original fort stands with major portions reconstructed. The walls are made up of barrel vaulted casemates (Figures 1b and 1c) that once held guns and artillery. Each casemate has a gun embrasure opening in the exterior scarp wall allowing artillery to fire from the fort in all directions. The scarp wall, is adjacent to the casemate piers and vault, but

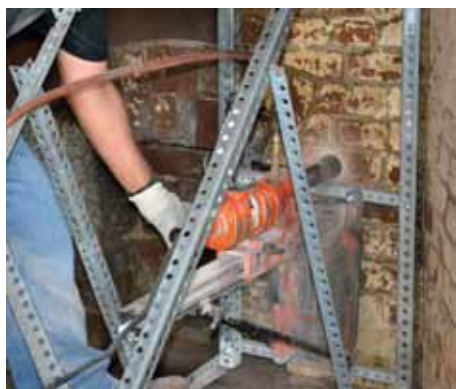
Figure 2: Coring of material samples revealed that although the construction drawings indicate a brick wall across the width, the construction of the fort is composite with tabby concrete infill.

During our studies on Fort Sumter, a prism sample along with 2.5-inch diameter cored samples were obtained on site (Figure 2, page 28). The compressive strength and modulus of elasticity were determined according to ASTM standard tests parallel and perpendicular to the mortar bed joints. The tensile strengths of the brick and mortar samples are determined via three-point flexural tests. The tensile capacity

of the brick-mortar assembly is taken as the volumetric average of a representative cell. The properties of the tabby concrete infill are determined via diametral tests on the cored samples. Lastly, the densities of the materials are measured by taking a ratio of weight to volume of the specimen.
