Reference: Emergency Deconstruction for Parade Grounds Flagpole, Determination of Eligibility, Fort Union National Monument.

# Determination of NRHP Eligibility for Flagpole on Parade Grounds

**Structure ID Number:** HS-10

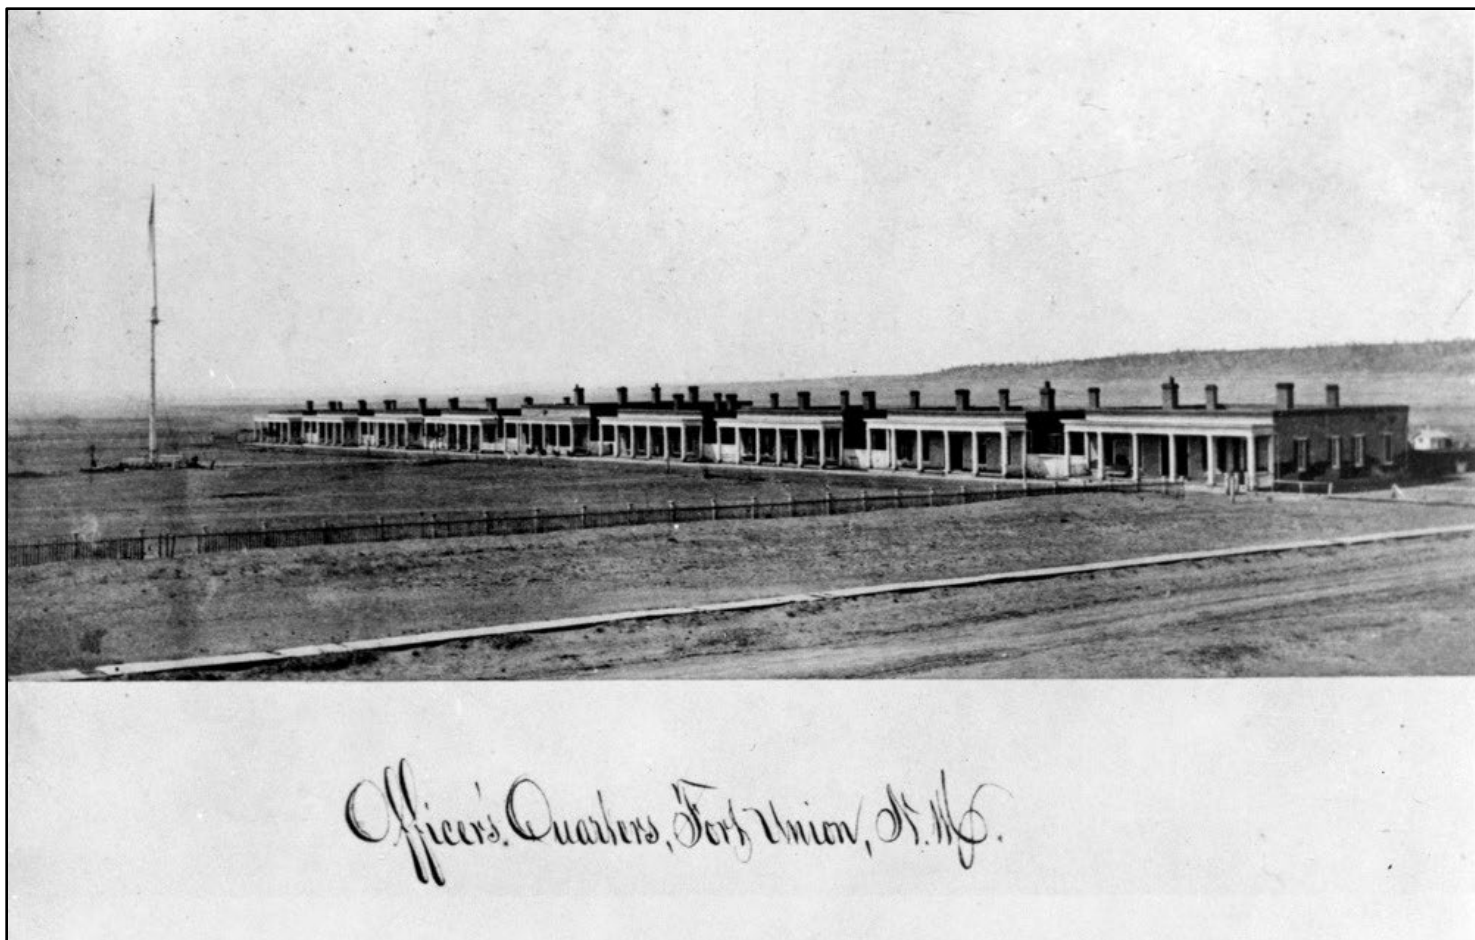
Figure 5 – Third Fort Union, Officers Row, 120-ft Historical Flagpole.

The U.S. Army built the original 120-ft flagpole on the Third Fort’s parade grounds as historical photographs and records show (*Figure 4-5*). It was erected circa June 1862 during the initial building phase of the third (and largest) fort. It was built tall like a ship’s mast using joined poles with supporting shroud lines and underground base structure, so it could be seen for miles along the Santa Fe Trail. Military flagpoles were built like ship masts to achieve extreme height, structural stability in high winds, and easier maintenance using traditional maritime joinery and rigging. The original pole remained at the fort until it was abandoned in the 1890s.

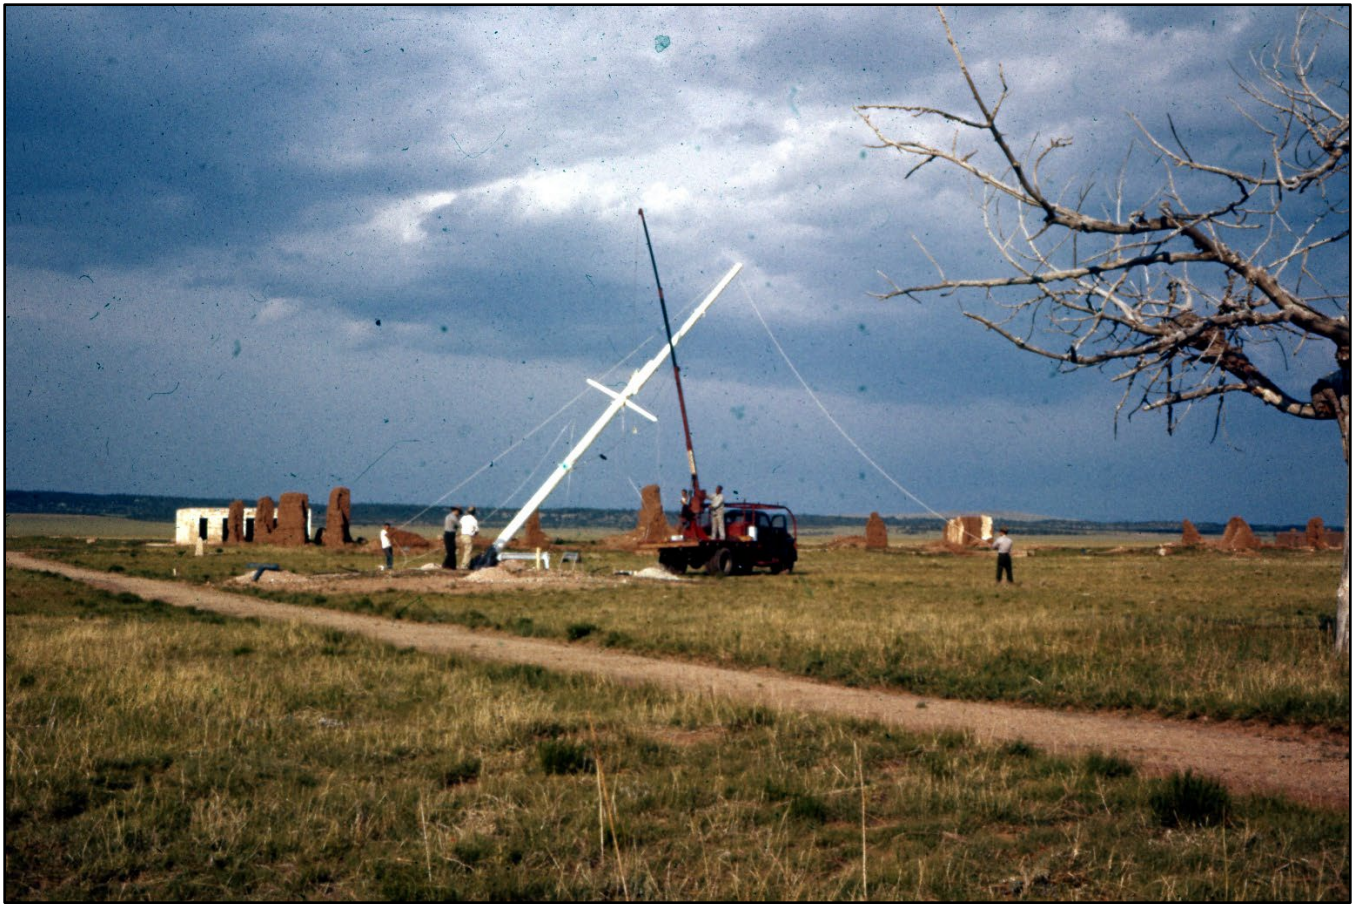
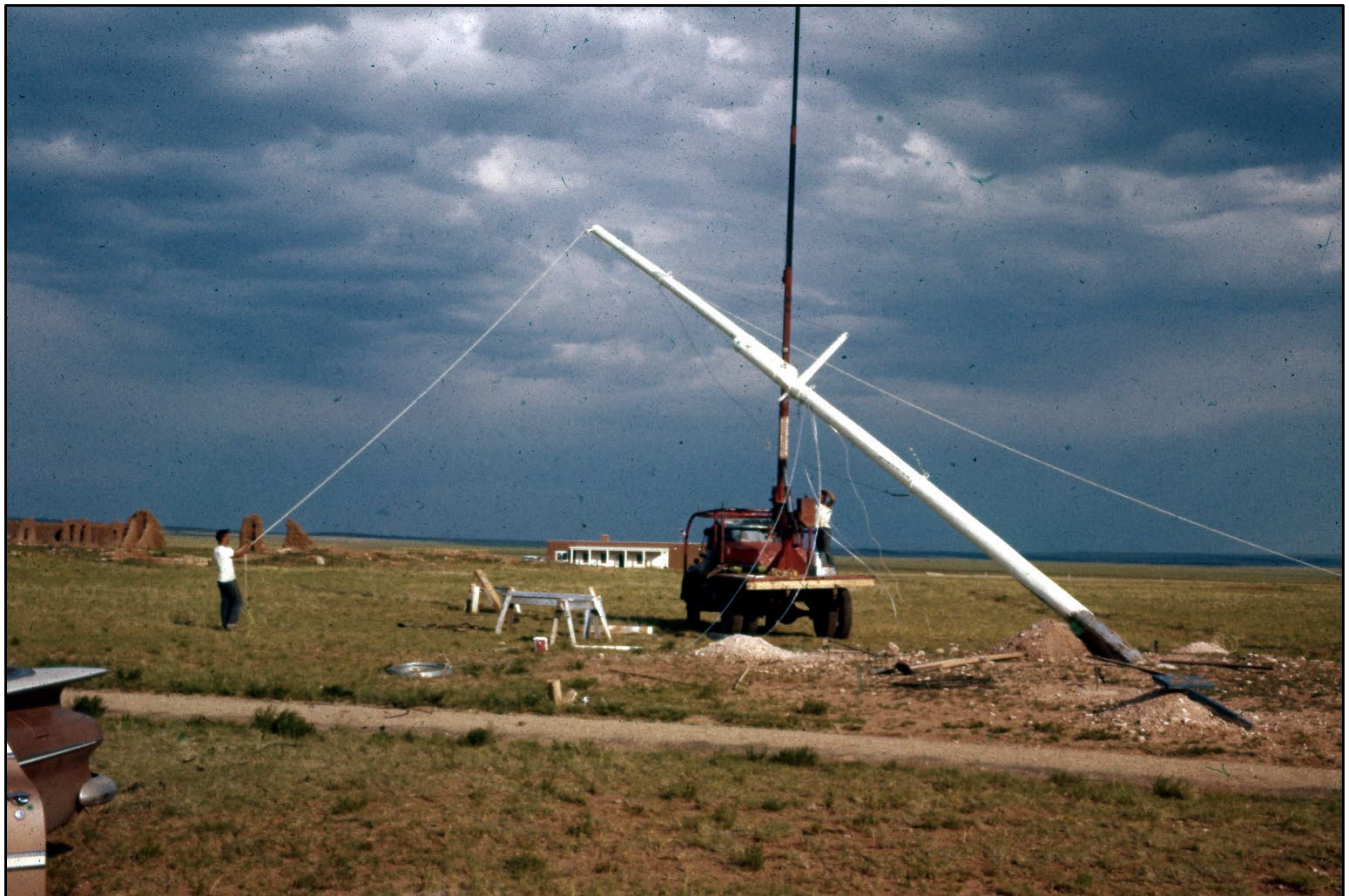
Figure 6 – Erection of replica 62-ft flagpole, 1959.

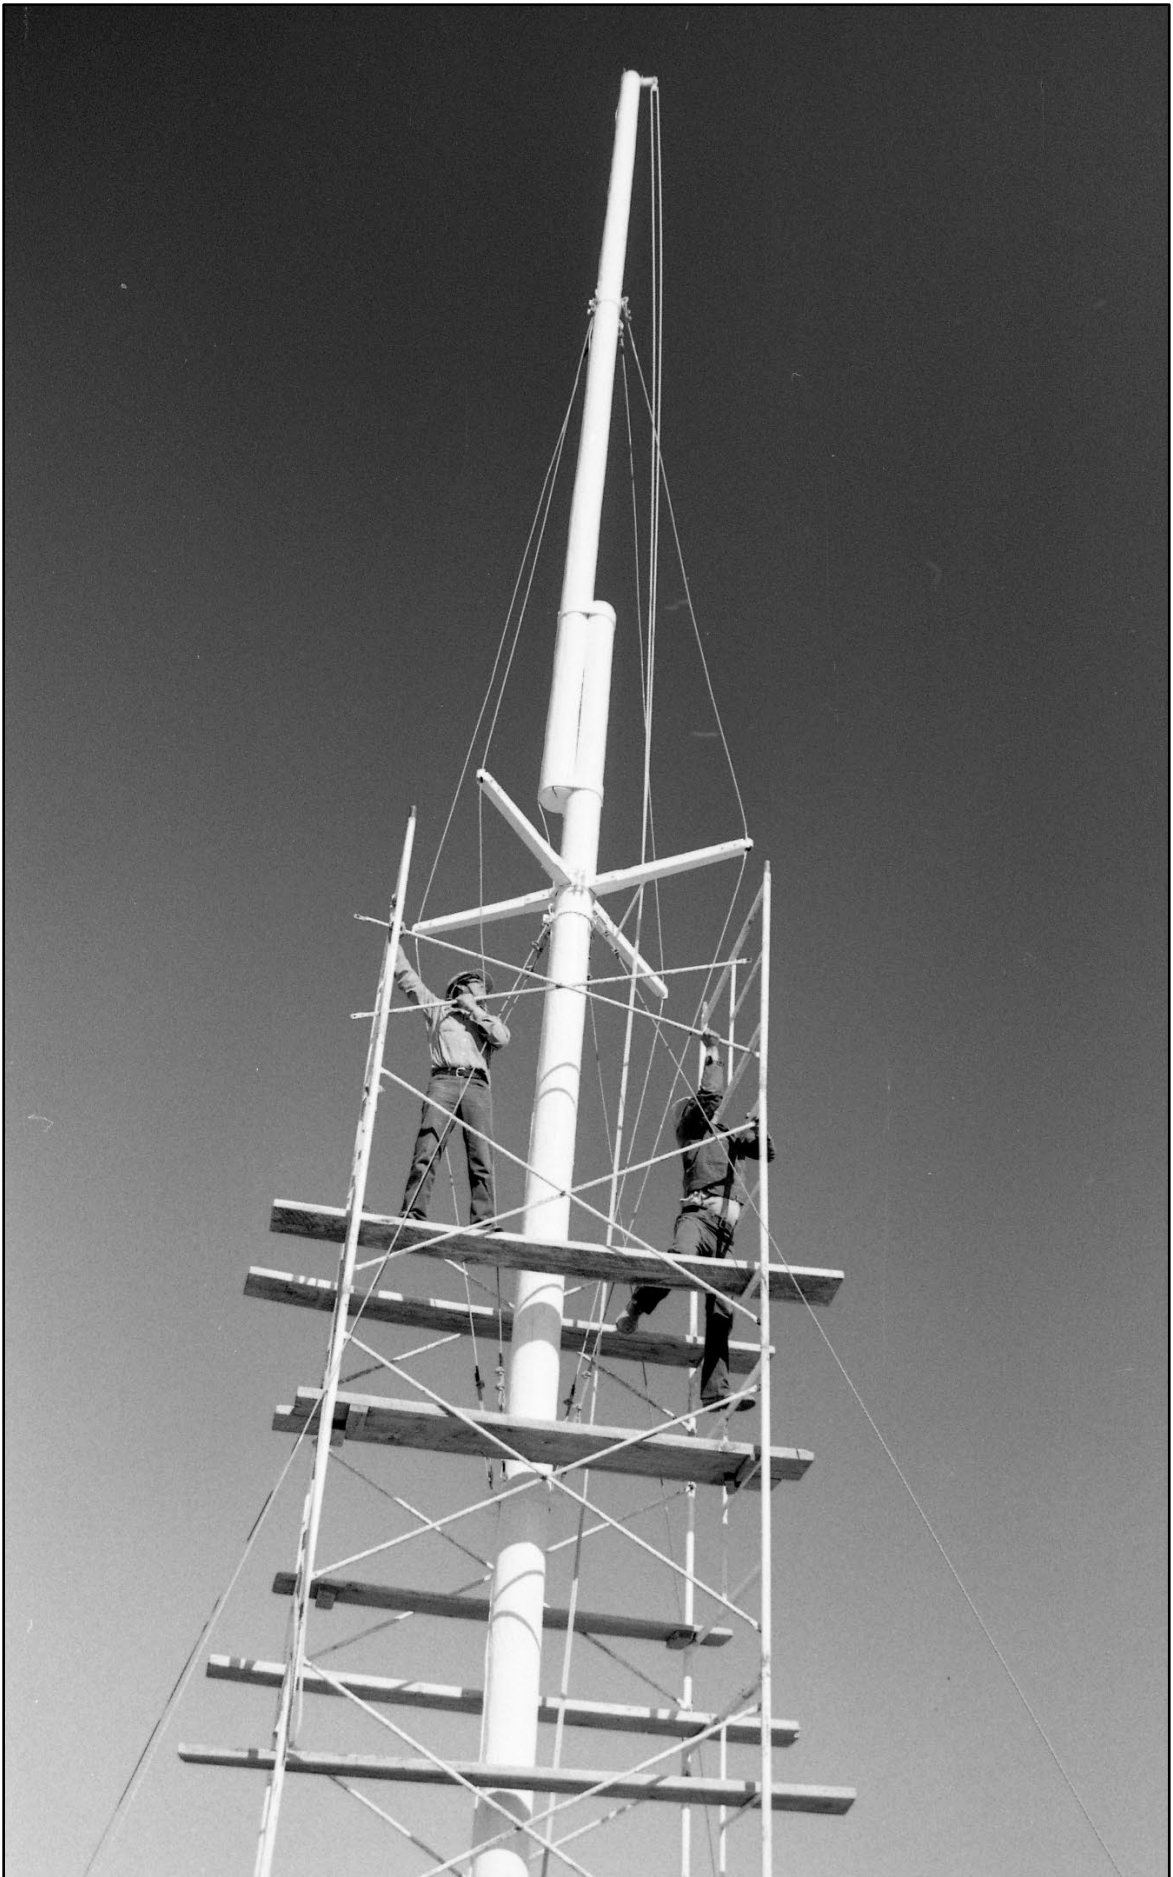
Figure 8 – Flagpole repairs and paint, 1986.

Park records do indicate the reconstructed flagpole underwent repair projects in 1986, that involved scaffolding around the flagpole and park staff was maintaining upkeep in painting the flagpole, (*Figure 8-9*). There is maintenance record of project budget, *A01 Paint Historic Flagpole*, with estimated budget cost of \$4000. The proposed work statement included scraping off old paint, prime coat and repainting the existing “historic replica.” Work had to be accomplished from a scaffold or bucket truck to avoid causing further damage to the pole. (FOUN FY1985 maintenance record, *Paint Historic Flagpole*, August 5<sup>th</sup>, 1985). Another similar project was undertaken in 2001, in painting and repairing the reproduction flagpole in a Section 106 compliance letter, to Elizabeth Oster, New Mexico State Historic Preservation Officer. (FOUN, FY2001, H4217, compliance documentation).

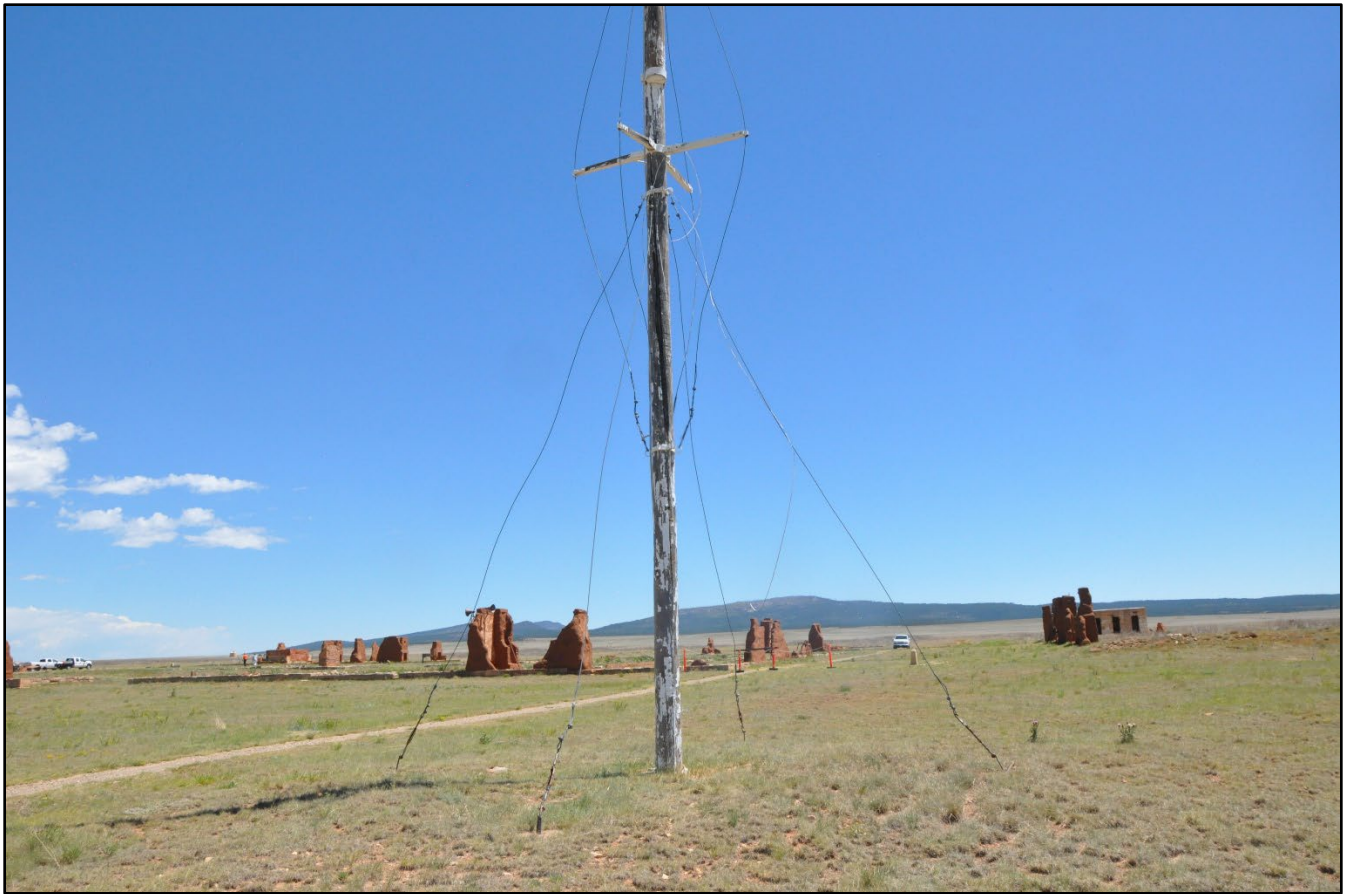
Figure 14 – Flagpole, Large structural crack on lower mast, facing north-east. July 10, 2026.

Most flagpoles have a 20-30 year lifespan, and this structure has significant deterioration. The lower pole contains an elongated split crack, estimated to be 12 feet in length, indicating structural compromise. Both poles display surfaces of weathered timber and evidence of internal wood rot, with paint peeling and flaking, which has spread onto the parade grounds. The flagpole features paired crosstrees and multiple guard wires, arranged symmetrically but are now very loose, which diminishes their ability to stabilize the mast. The gradual taper of the topmast is marked by a secondary elongated split crack near the junction of two joined poles and horizontal spreaders, suggesting the damage is extensive and affects the core structure. Because of these challenges, the flagpole has exceeded its lifespan. (*Figure 12-15*).

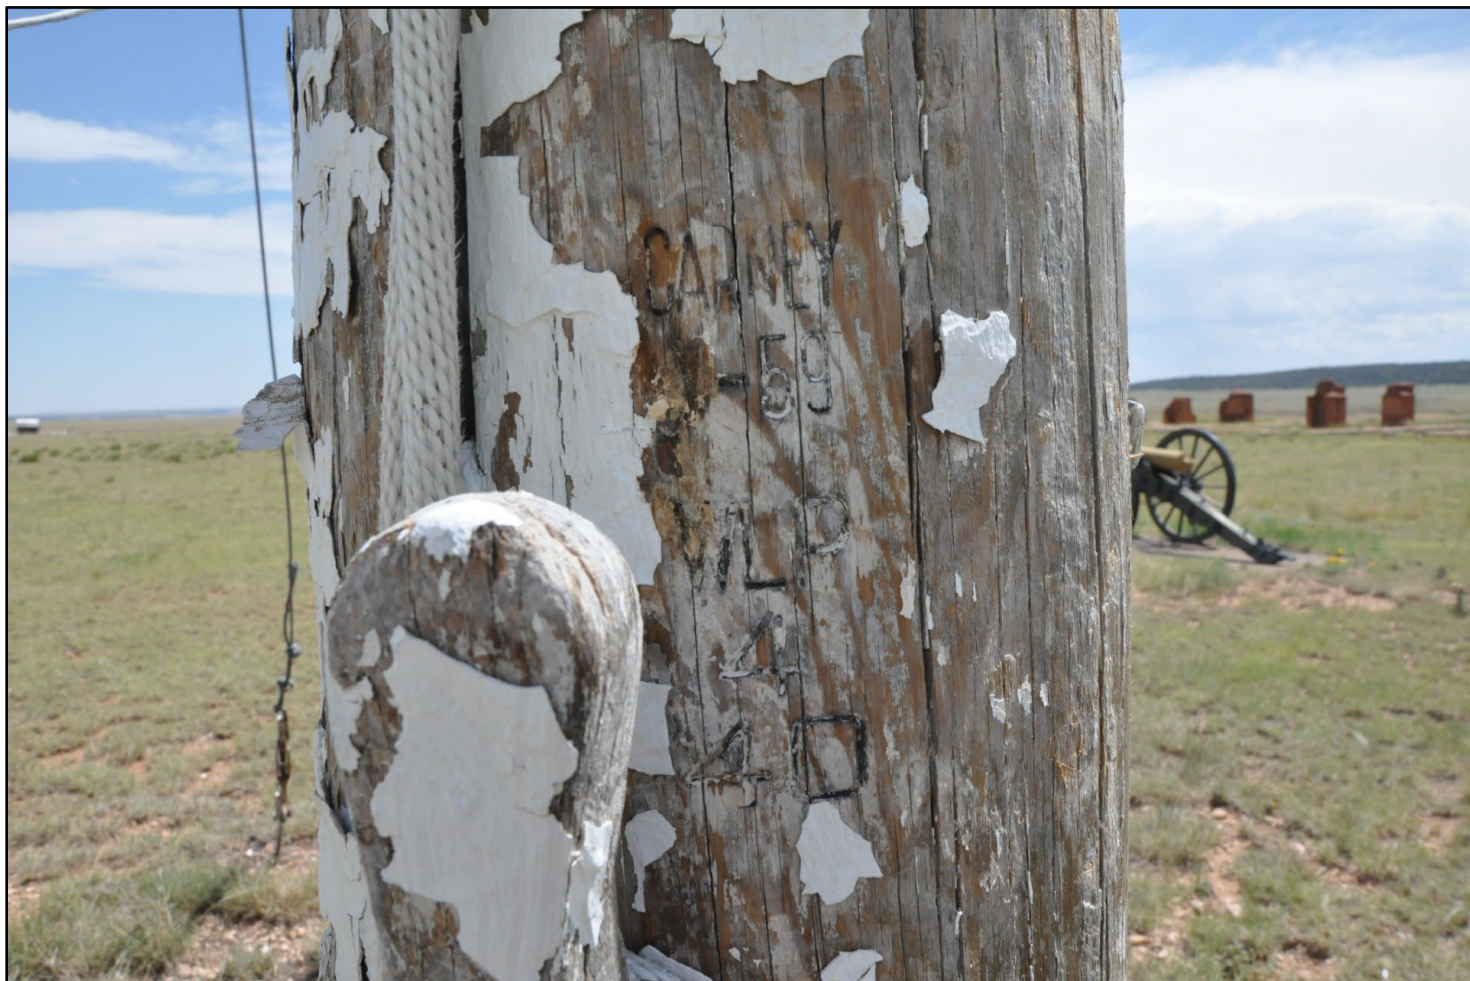
Figure 16 – Above wooden cleat on lower mast, stamp, “Carney / (dash) – 59 / WLP / 4 / 4D”.

Above the wooden cleat on the lower mast, the pole is stamped "Carney / (dash) - 59 / WLP / 4 / 4D". This type of stamping was used in the mid-twentieth century for commercial supplies. "Carney" indicates that it was manufactured by B.J. Carney & Company. "[19]59" is the year the timber was harvested, chemically treated, and branded. WLP is the botanical species code "Western Larch Pole," highly favored for heavy structural poles due to its incredible straightness and natural decay resistance. "4" refers to the ANSI Pole Class, its strength

rating. Class 4 is a standard, robust thickness used for load-bearing utility structures. “4D”- The specific plant or treatment batch code, mapping back to its facility, where the timber underwent its preservation process (*Figure 16*).
