National Park Service  
Cultural Landscapes Inventory  
2012

Fort Union Trading Post National Historic Site  
Fort Union Trading Post National Historic Site

## **Inventory Unit Summary & Site Plan**

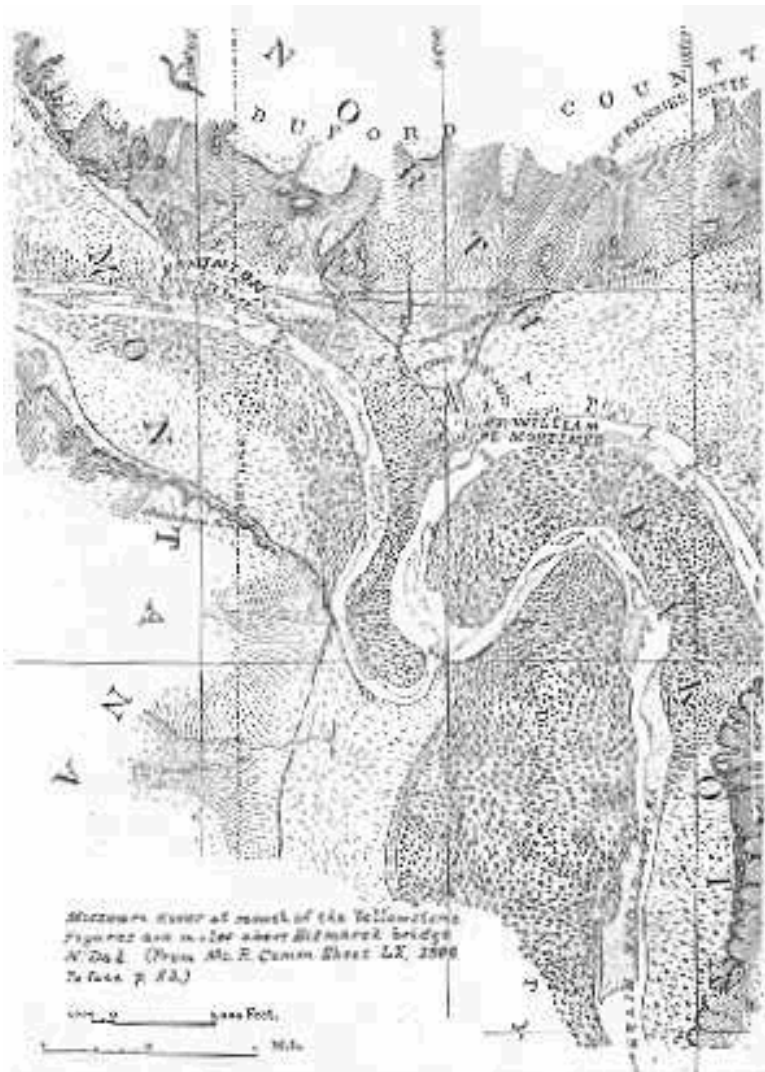
*Map of the confluence of the Missouri and Yellowstone Rivers. (MO. R. Comm. Sheet, 1894)*

The confluence of the Yellowstone and Missouri Rivers occurs in northwestern North Dakota three miles east of the Montana-North Dakota boundary. Their valleys are carved from the clays and gravels of the glaciated portion of the Missouri Plateau section of the Great Plains province. Between the two rivers, moderately prominent bluffs up to 300 feet high indicate the plateau, while the valley of the Missouri is flanked on the north by rolling hills. The flood plain of the Missouri is only a mile and a half wide, while that of the Yellowstone is twice that and shows more evidence of meandering and flooding. Both floodplains are now protected by levees and subject to cultivation and irrigation. Flood channels, old sandbars, and cottonwood groves still occupy a considerable part of the floodplains. North of the Missouri and south of the hills, is a gravel bench two to five thousand feet wide and about thirty feet above the low water of the river.

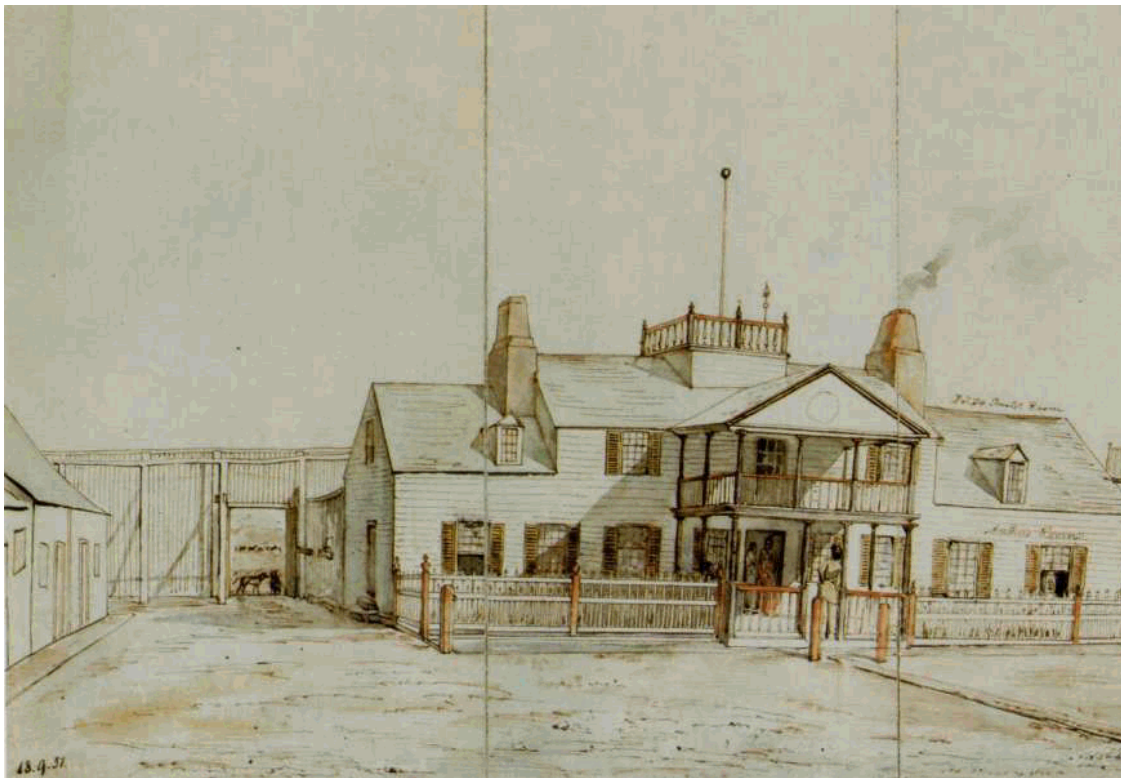
*Bourgeois House sketched by Rudolph Kurz in 1851. This is the earliest representation showing a full second floor, a two story porch and a widow's walk. (The Jesuit Missouri Province Archives, St. Louis, MO)*

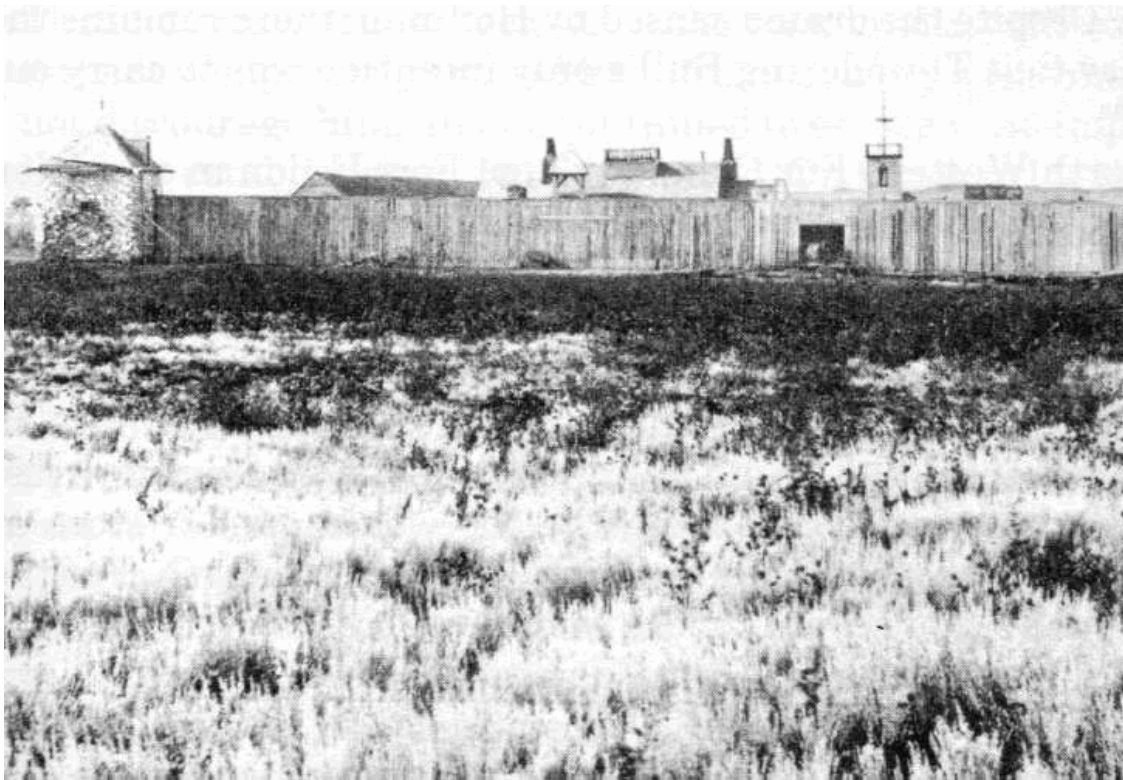
*View of the North Palisade, 1866. Deterioration is becoming evident, especially the northeast (left) bastion. (Fort Union Trading Post, A Pictorial History, MWRO. Original is with the Montana Historical Society)*

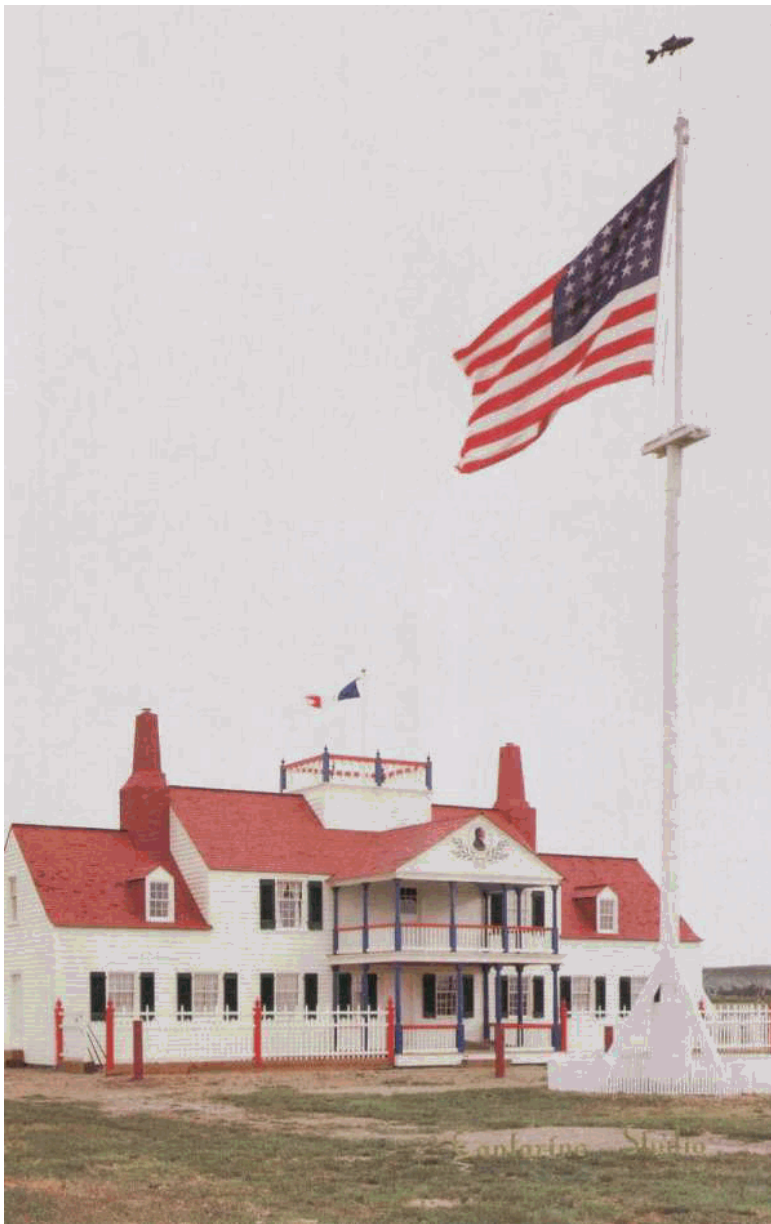
*The completed reconstruction of the Bourgeois House and the flagpole. (Fort Union Trading Post, A Pictorial History, MWRO. Photo by Richard Cronenberger, NPS.)*

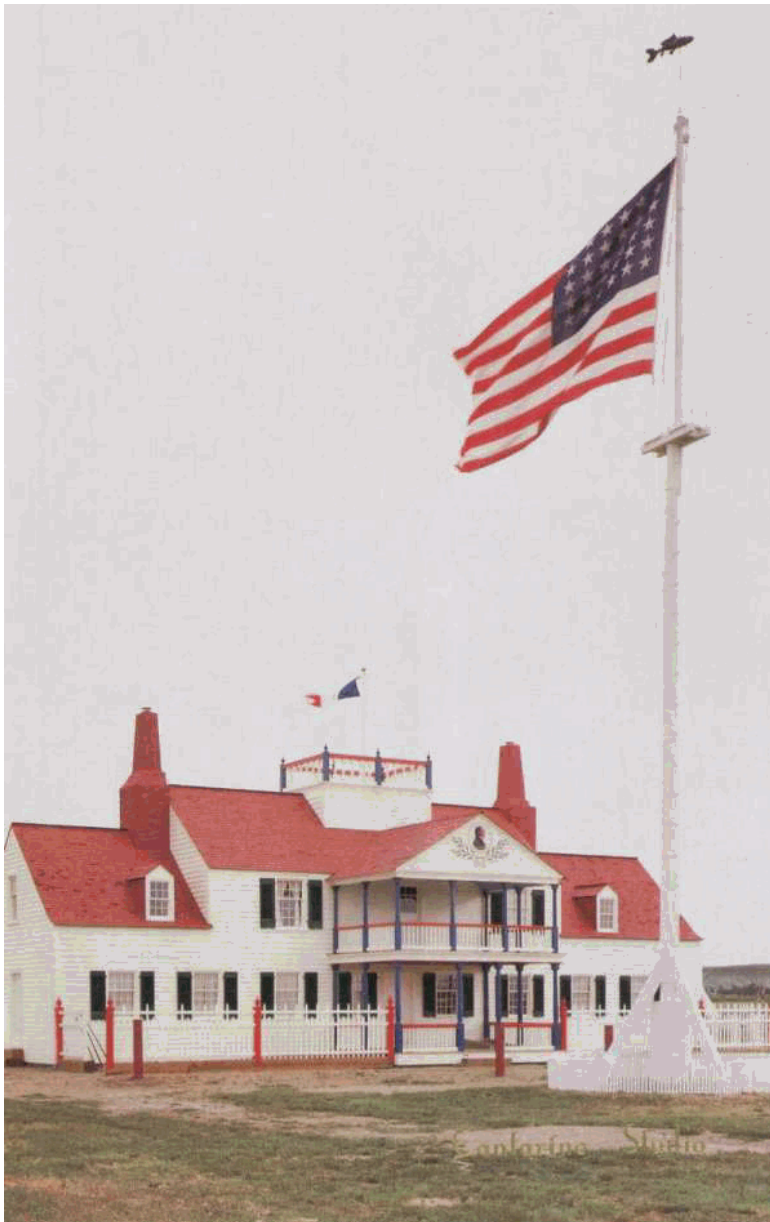
*Bourgeois House and flagpole, 1987. (Fort Union Trading Post, Photographic History, 1987. Photo by Richard Cronenberger, NPS.)*

Between 1986 and 1991 Fort Union was partially reconstructed based on historic and archaeological evidence. The palisade, two stone bastions, flagstaff, bourgeois house, and Indian/Artisan House were reconstructed. The structural members of the fort's kitchen were "ghosted" to interpret the site and to protect the exposed foundation. The dairy floor was roofed to protect the exposed flagstone flooring. Major unexcavated sites and unreconstructed buildings were outlined with ten-by-ten inch timbers to identify the sites and more fully define interior spatial relationships. Historic stones remain in original configuration at the main gate and north gate.
