National Park Service  
Cultural Landscapes Inventory

Revised: 1/2025

Gloria Dei (Old Swedes') Church NHS Landscape  
Gloria Dei (Old Swedes) Church National Historic Site

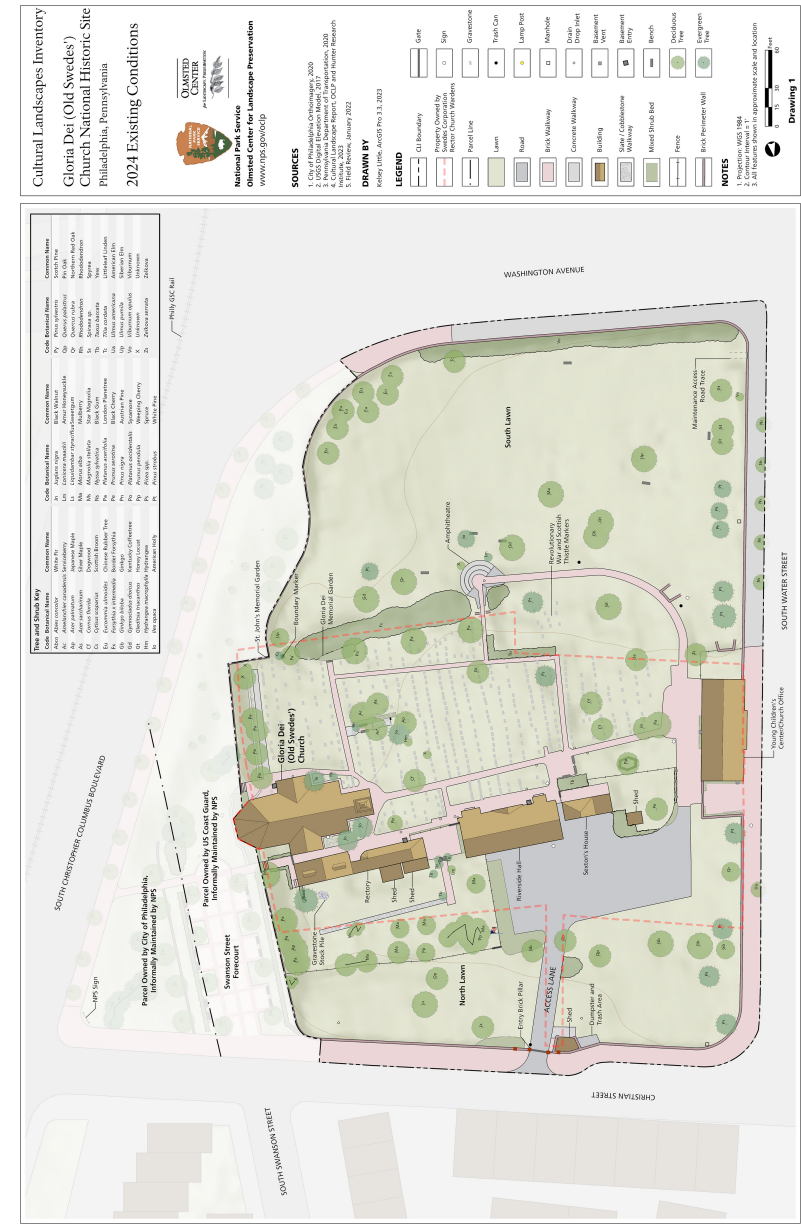
Site Plan

Site map, 2024.

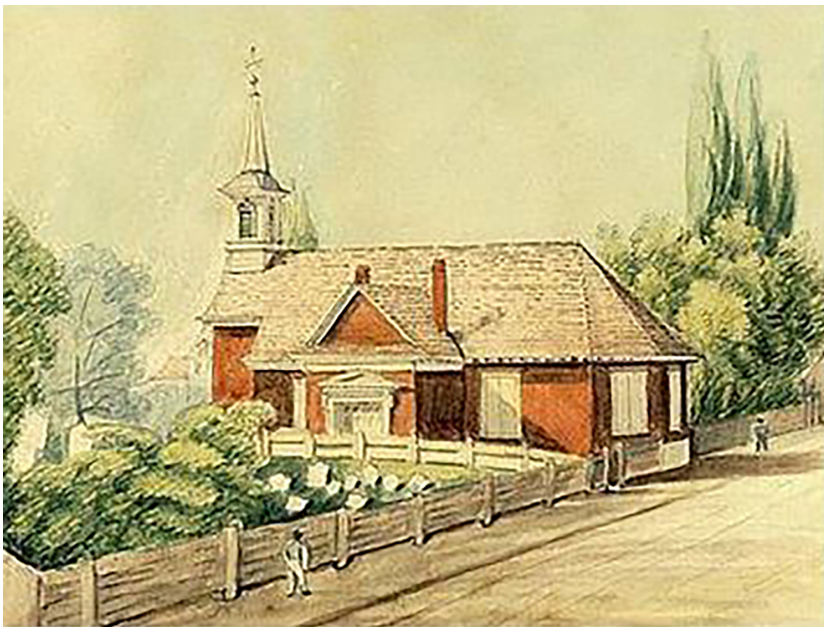
Figure 8. William L. Breton, "The Swedes Church, Southwark," 1828. This view shows vegetation, fencing, and sidewalks. The gate from Swanson Street is evident but there do not appear to be steps up into the graveyard because Swanson Street is at a higher elevation than it is today. (The Athenaeum of Philadelphia, from CLR 2022: 45)

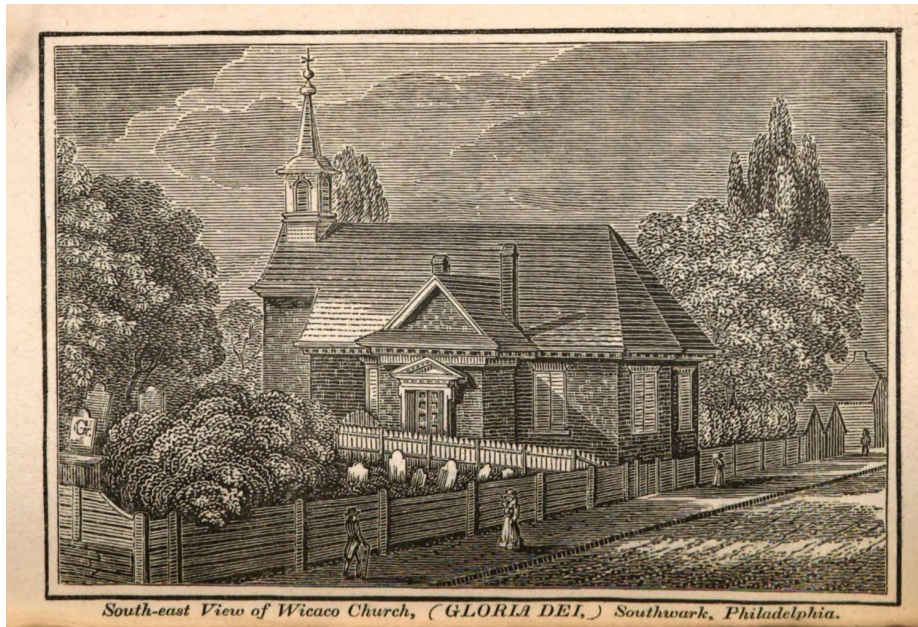
Figure 9. Jehu Curtis Clay, “South-east View of Wicaco Church, (GLORIA DEI,) Southwark, Philadelphia,” 1835. This view appears to show a low stone wall (bottom left) similar to one that survives today serving as a foundation for the brick perimeter wall instead of a wood fence as shown here. (The Athenaeum of Philadelphia, from CLR 2022: 45)

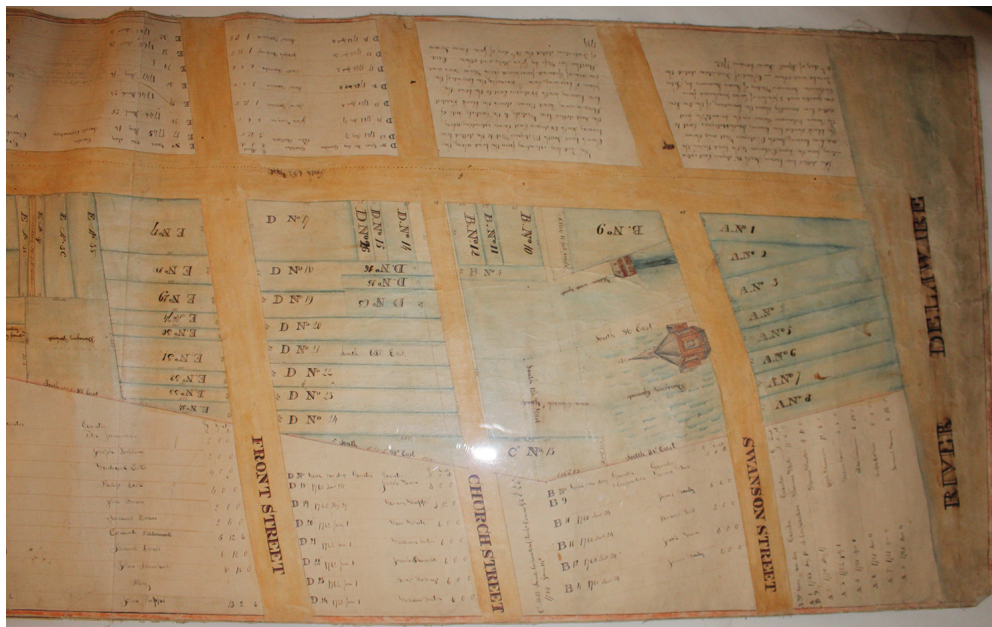
Figure 10. Detail of the eastern section of “Survey and Draught of Church Lands,” David Coombs, 1828. The map documents early colonial church lands (in green), the eastern aspects of the church (center right) and the old parsonage (small building north of the church). (Gloria Dei Church Archives, from CLR 2022: 50)

Perhaps the most critical cartographic source for understanding the disposition of church property from the mid-18th century through 1845 when Gloria Dei formally merged with the Protestant Episcopal Church, is a survey map produced by David Coombs in 1828 at the request of William Jones on behalf of the congregation (Figure 10). The map references the three principal deeds for the church’s land acquisitions extending as far west as the future Ninth Street and indexes the various parcels that the church subsequently leased and sold off. While the only two buildings depicted are the church and the parsonage, the map delineates the many subdivisions of the land, the vast majority of which supported the building of homes, commercial premises and industrial uses. The accompanying data show periods when the process of subdivision was most active – in the mid-1740s and mid-1750s, the 1760s, 1812 and the mid- to late 1820s, this last burst of activity involving property between Third and Fourth Streets and perhaps providing the impetus for the Coombs survey. (CLR 2022: 47)

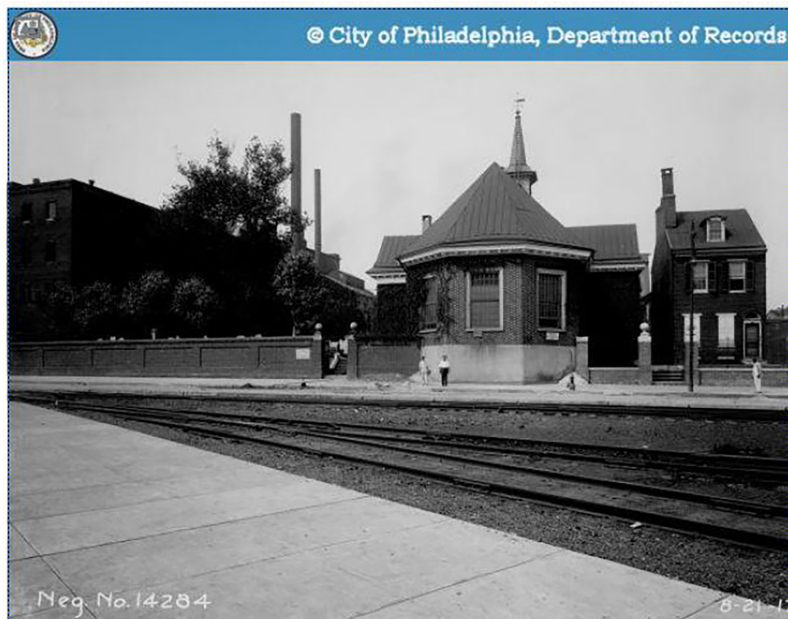
Figure 19. View west-southwest from South Delaware Avenue (present-day Columbus Avenue), 1917. Note proximity of the railroad tracks to the brick wall, gates, and fence erected along the church's Swanson Street frontage in 1898. Four young trees are growing on the burial ground side of the wall, apparently the four London plane trees extant today. (City of Philadelphia, Department of Records, #8401, from CLR 2022: 65)

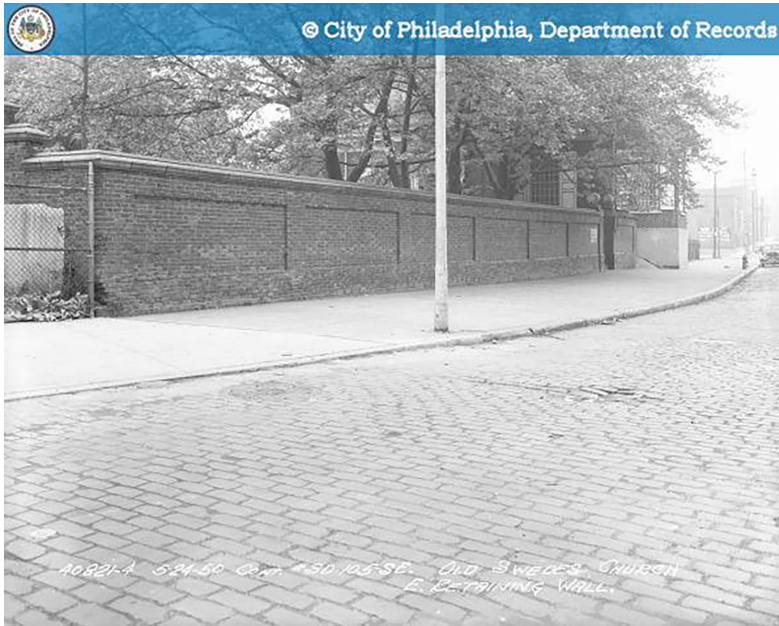
Figure 22. View looking northwest along South Swanson Street showing the brick wall enclosing the eastern end of the Gloria Dei churchyard, 1950. (City of Philadelphia, Department of Records, from CLR 2022: 72)

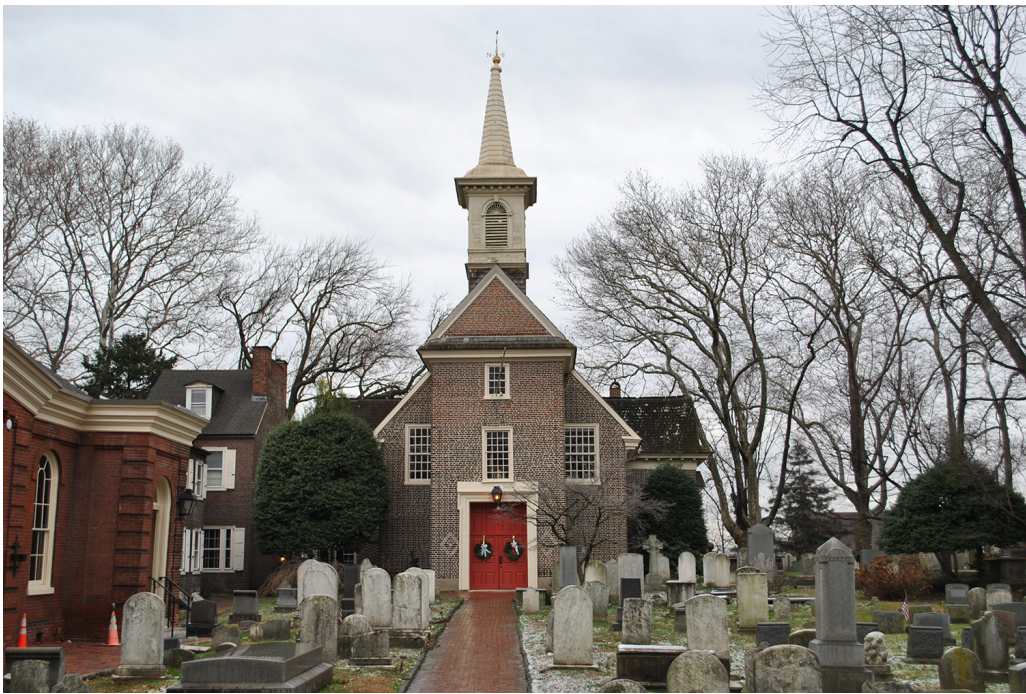
Figure 26. The churchyard and main east/west brick path, view looking east from the burial ground to the west elevation of the Gloria Dei Church and its tower and steeple. The rectory and Riverside Hall are at image left. (CLR 2022: 109)

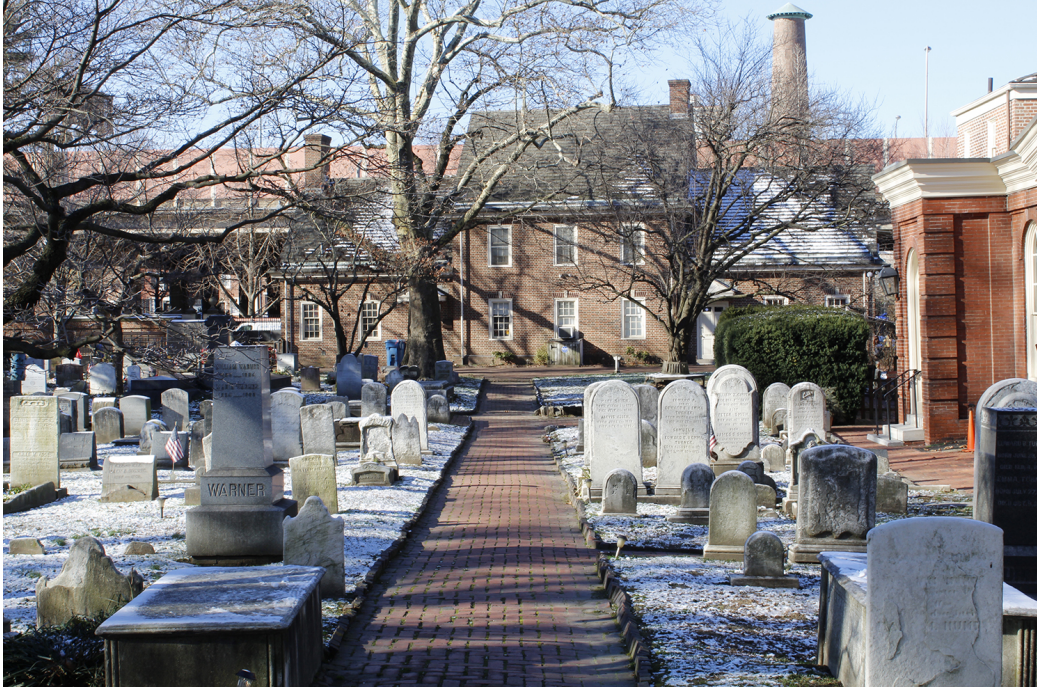
*Figure 27. The churchyard and main east/west brick path, view looking west from the Gloria Dei Church west facade to the Young Children's Center/church office. (CLR 2022: 145)*

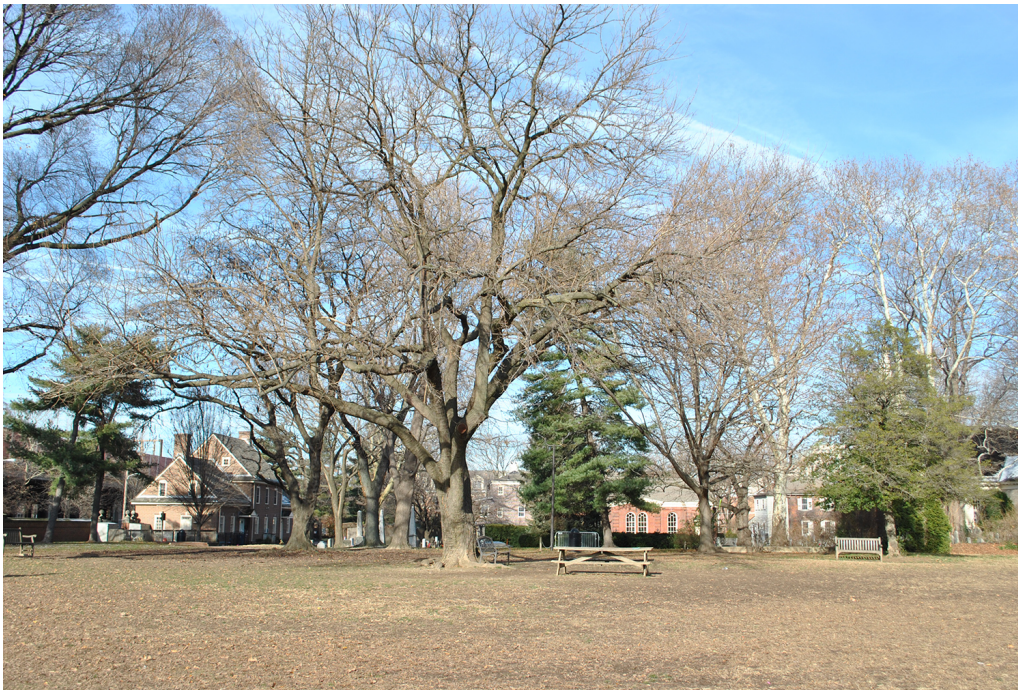
*Figure 28. View looking north from center of the South Lawn, illustrating noncontributing spatial organization of the area outside of the churchyard. (CLR 2022: 136)*

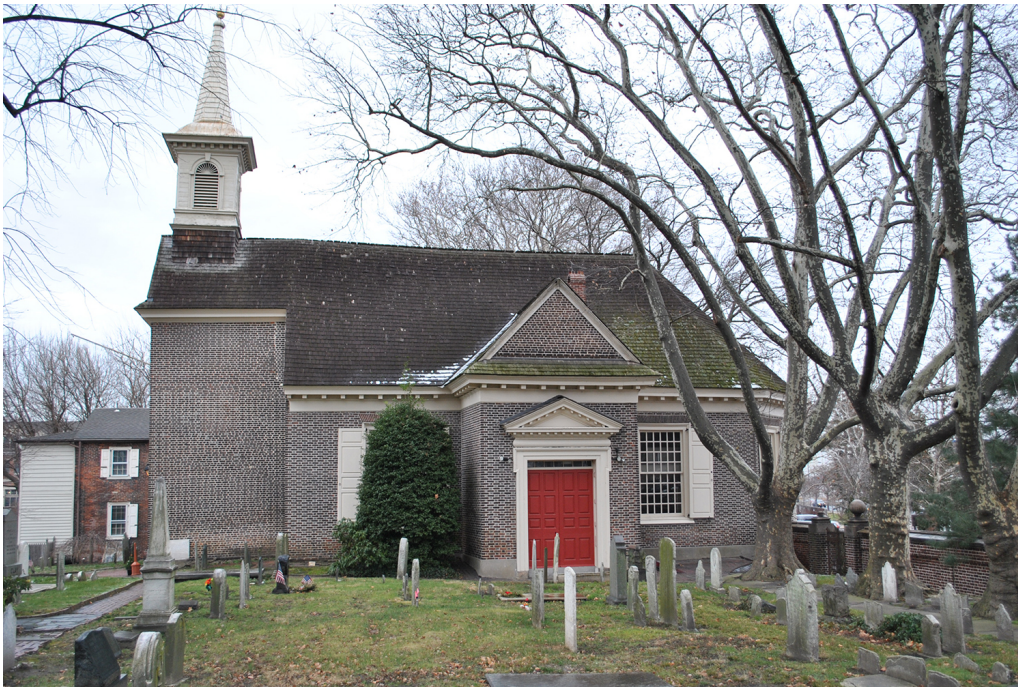
*Figure 29. Gloria Dei Church, south elevation, view looking north from the burial ground. The south porch entrance was historically the main entrance and cloak room. Parishioners and visitors entered from the gate on South Swanson Street at right. This entrance is now seldom used. (CLR 2022: 110)*

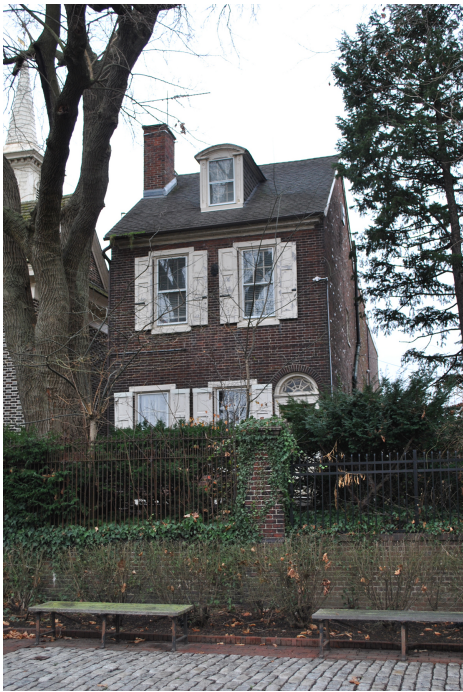
*Figure 30. Rectory, east elevation, view looking west from the Swanson Street Forecourt. The rectory is set back from the forecourt plaza, historically South Swanson Street, making it less prominent in the original streetscape than the church, which is to the left of this view. It is now used as office space. (CLR 2022: 111)*

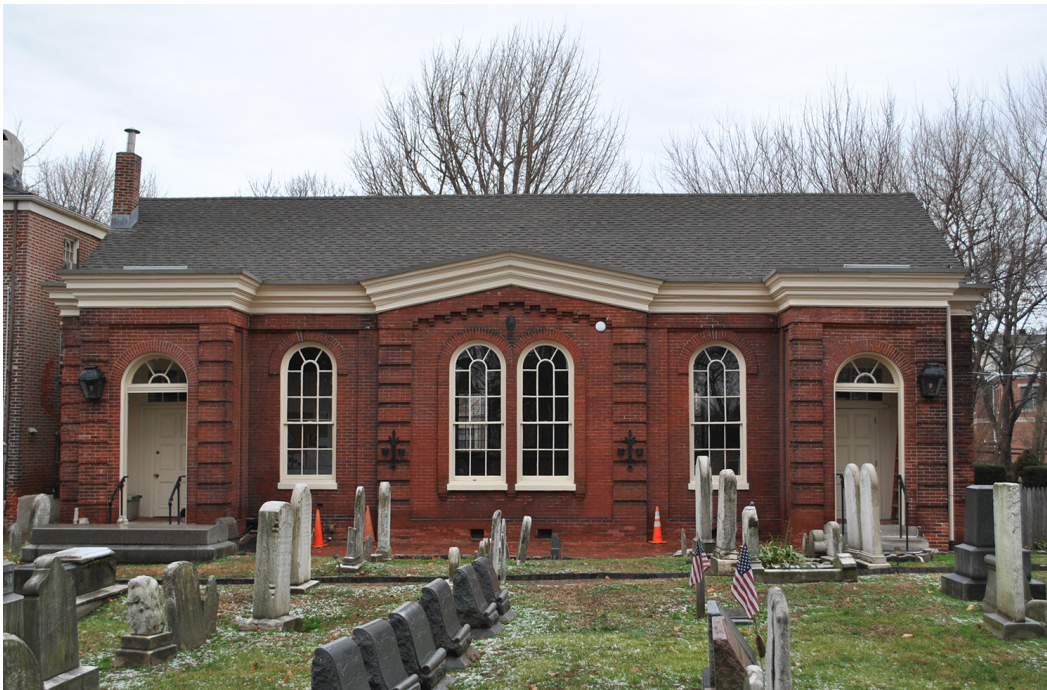
*Figure 31. Riverside Hall, south (front) elevation, view looking north from the burial ground. The Victorian architectural aesthetic is evident in the brick corbelling, pilasters, and window and door arches. (CLR 2022: 113)*

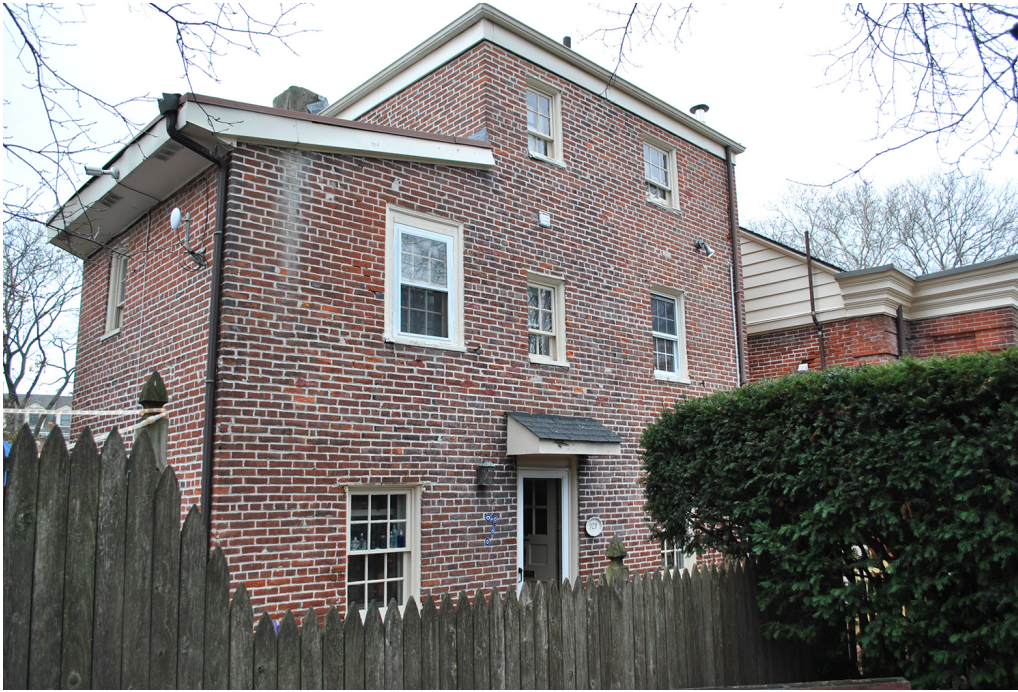
*Figure 32. Sexton's House, south (front) and west (side) elevations, view looking northeast from west end of the burial ground. Note its asymmetrical architecture and varied window sizes and placements. It has the appearance of a less formal caretaker's residence compared to the rectory. (CLR 2022: 115)*

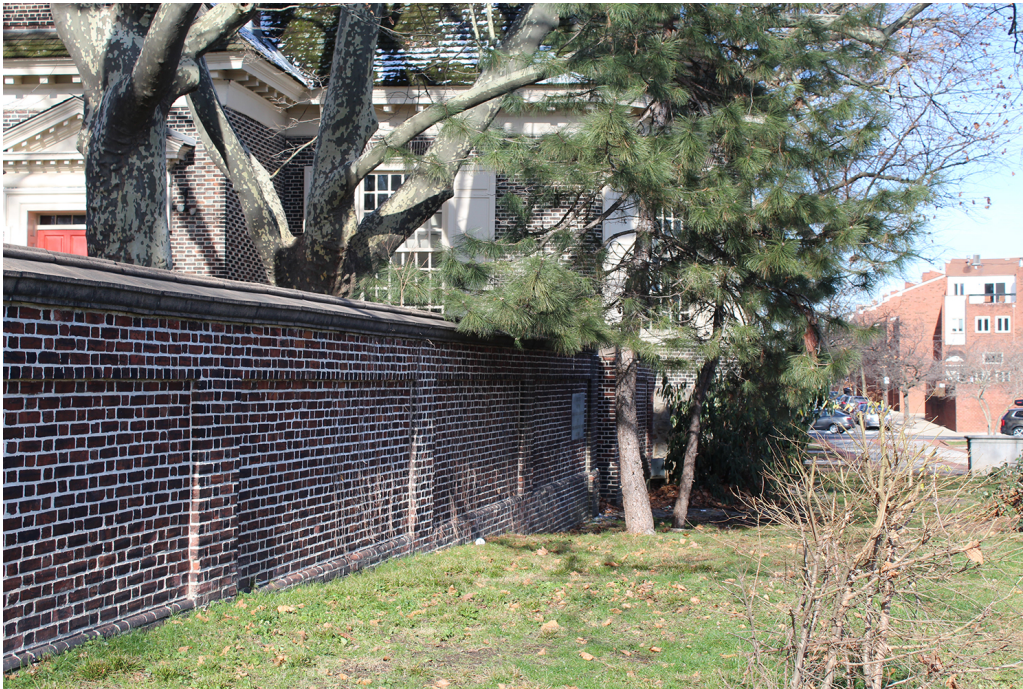
*Figure 33. Original section of the 1898 brick perimeter wall, east elevation, extending south of Gloria Dei Church, view looking northwest. This segment of wall originally fronted South Swanson Street, which was vacated and landscaped as a park in the mid-1980s. (CLR 2022: 125)*

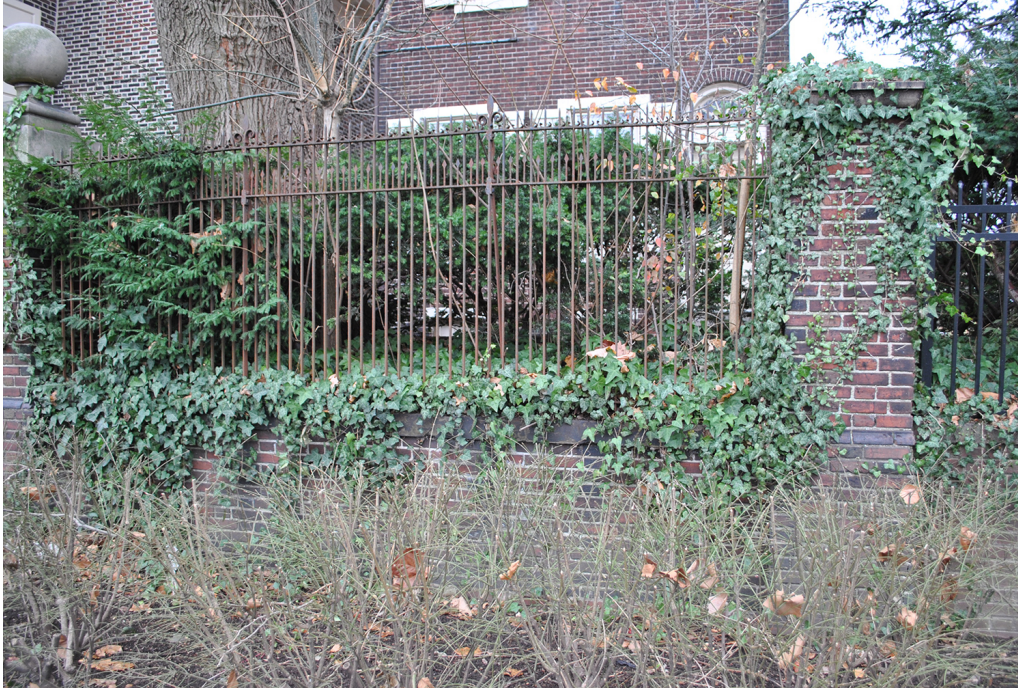
Figure 34. Original section of the 1898 perimeter wall and iron picket fence, north of Gloria Dei Church, view looking west with the rectory in the background. This wall and fence also originally fronted on South Swanson Street. (CLR 2022: 125)

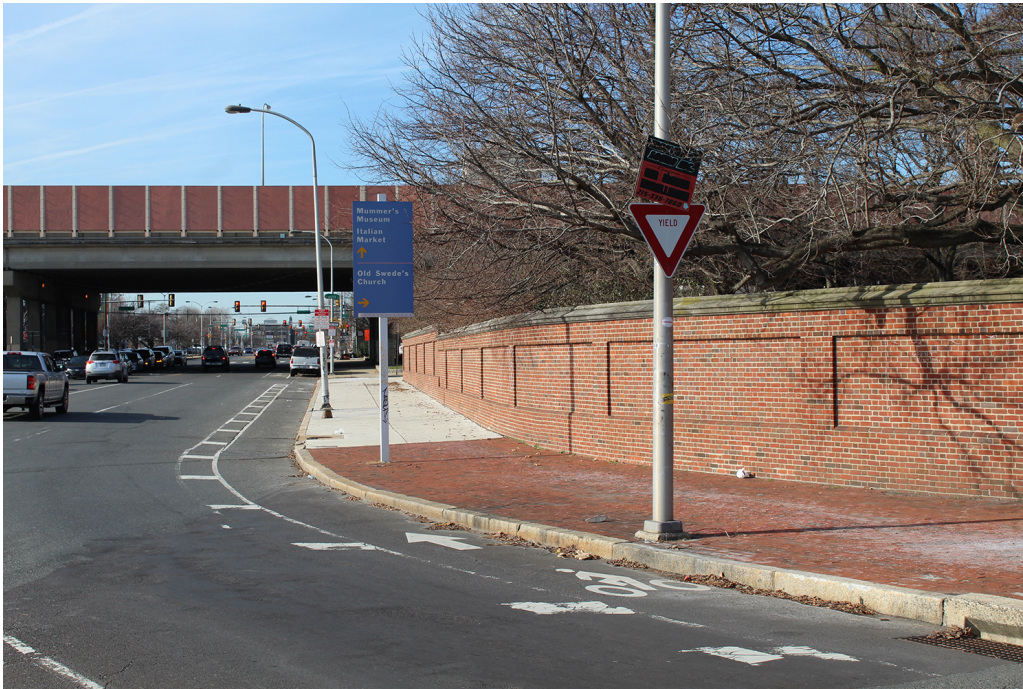
Figure 35. Perimeter wall section that is noncontributing, view looking west on Washington Avenue from Christopher Columbus Boulevard. Built in 1978-1979 by the National Park Service to enclose the property. Its design was intended to be compatible with an earlier wall of 1898 east of the burial ground (see Figure 33). (CLR 2022)

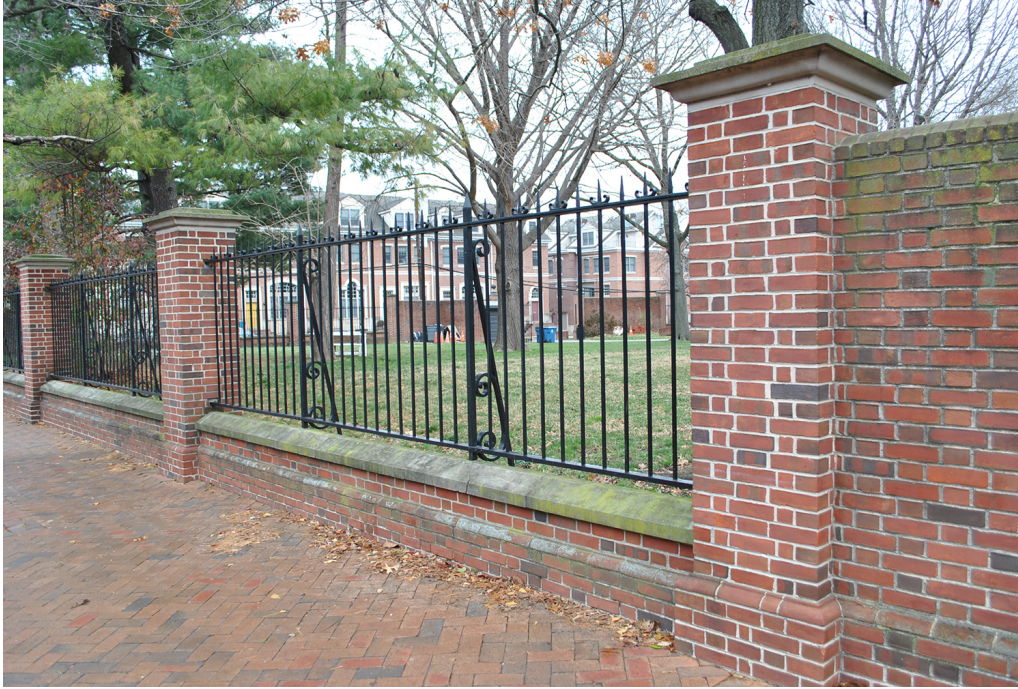
Figure 36. Perimeter wall and fence, view looking southeast on Christian Street from near South Water Street, built in 1978-1979 by the National Park Service to enclose the Gloria Dei property. Its design was intended to be compatible with the 1898 section east of the rectory (see Figure 34). (CLR 2022: 126)

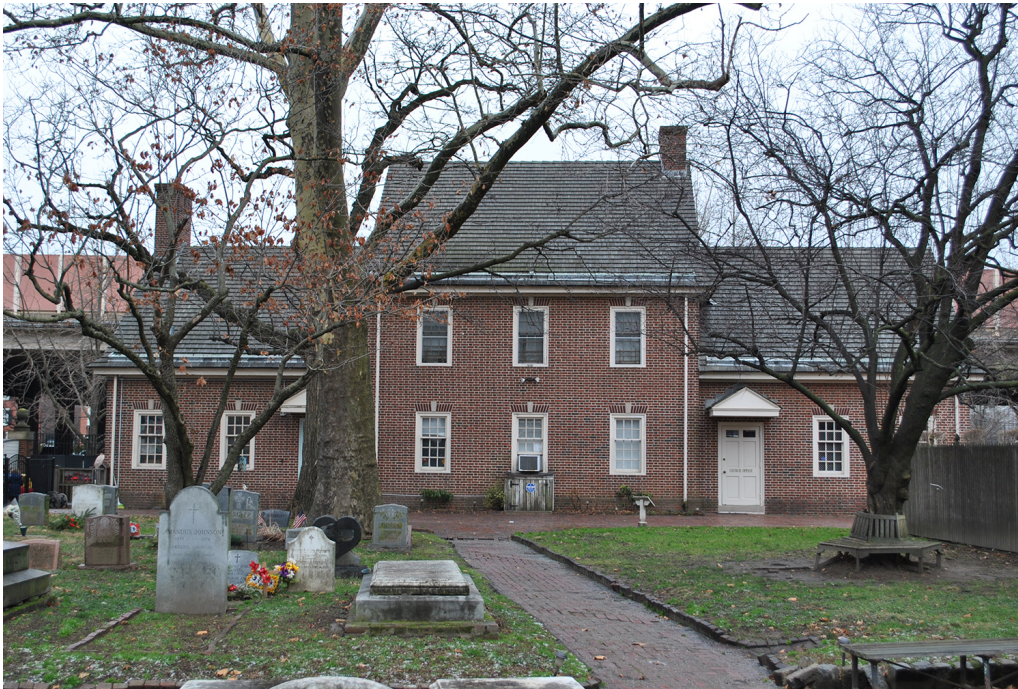
Figure 37. The 1971 Roak Building, housing The Young Children's Center for the Arts, east elevation, view looking west from the burial ground. It encloses the western end of the burial ground and replaced a two-story ca.1840 brick Sunday school, which was smaller but similarly oriented. (CLR 2022: 116)

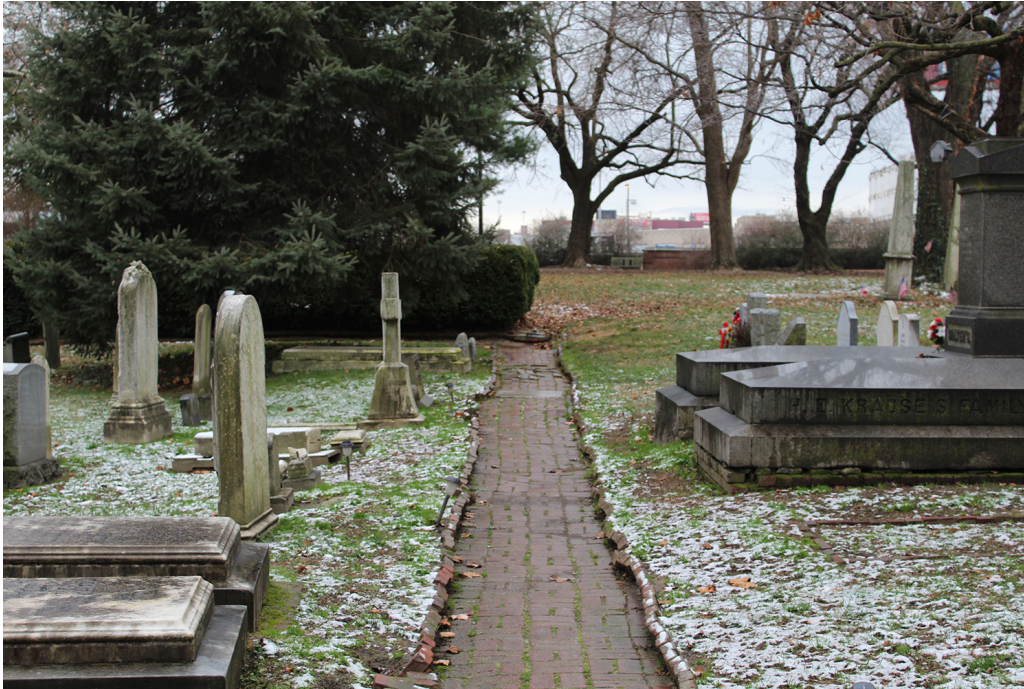
Figure 38. Burial ground, typical brick path conditions, view looking south from south of the sexton's house. (CLR 2022: 145)

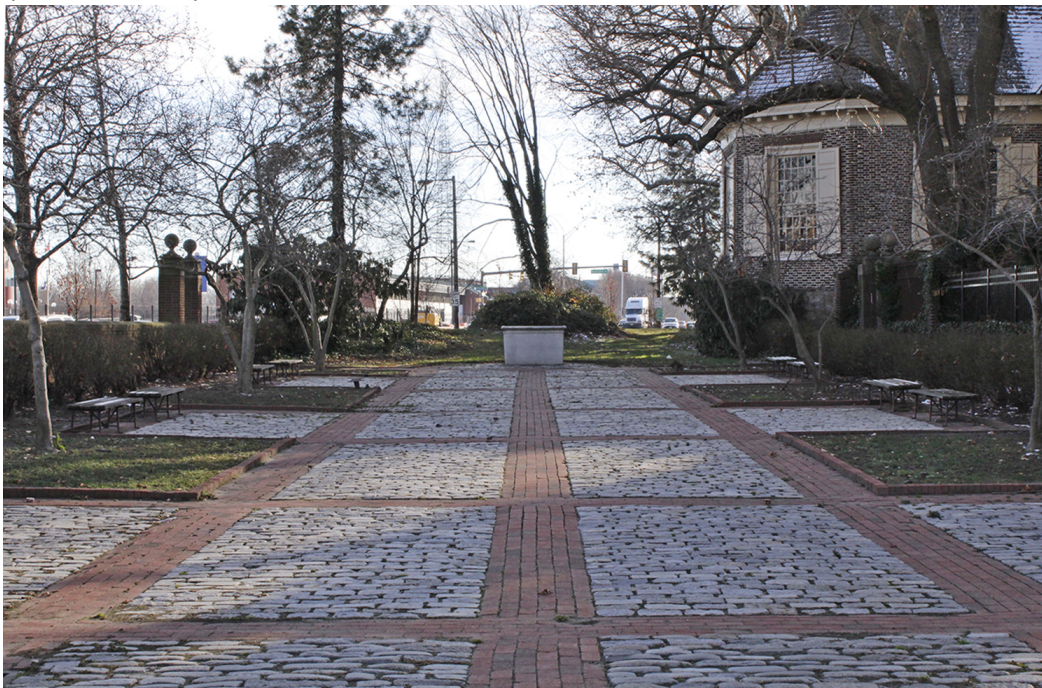
Figure 39. Swanson Street Forecourt, view looking southeast. The stone sett and brick pavers were installed in the mid-1980s. The plaza is on the footprint of old South Swanson Street, historically the front entrance to Gloria Dei. (CLR 2022: 143)

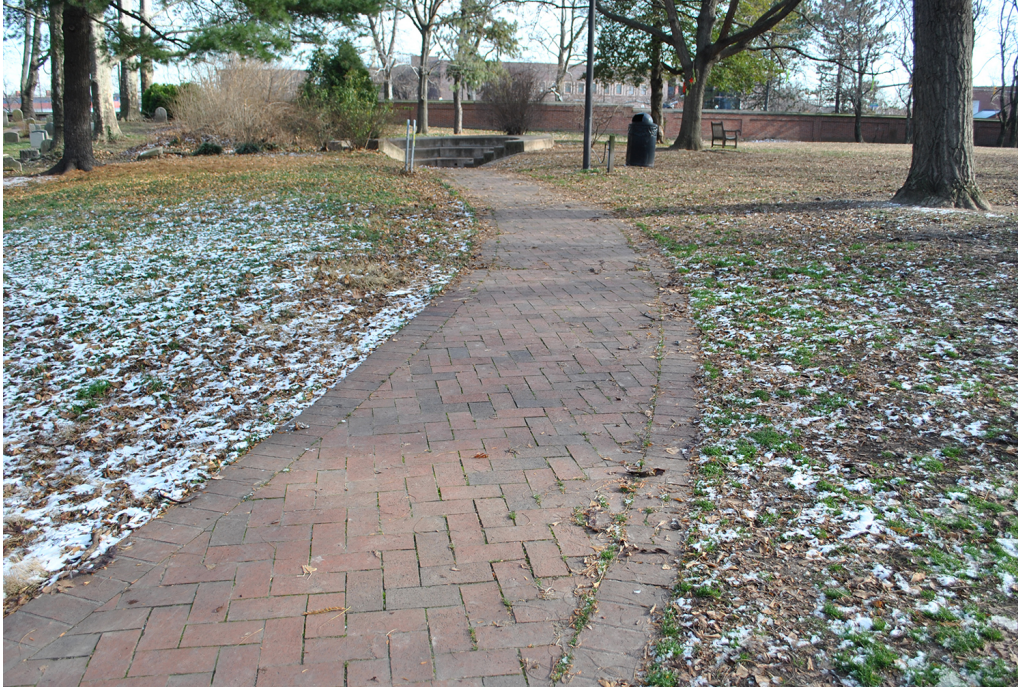
Figure 40. South Lawn, curved brick path, looking east toward the amphitheater. This path was installed in the late 1970s as part of National Park Service landscape improvements. (CLR 2022: 146)

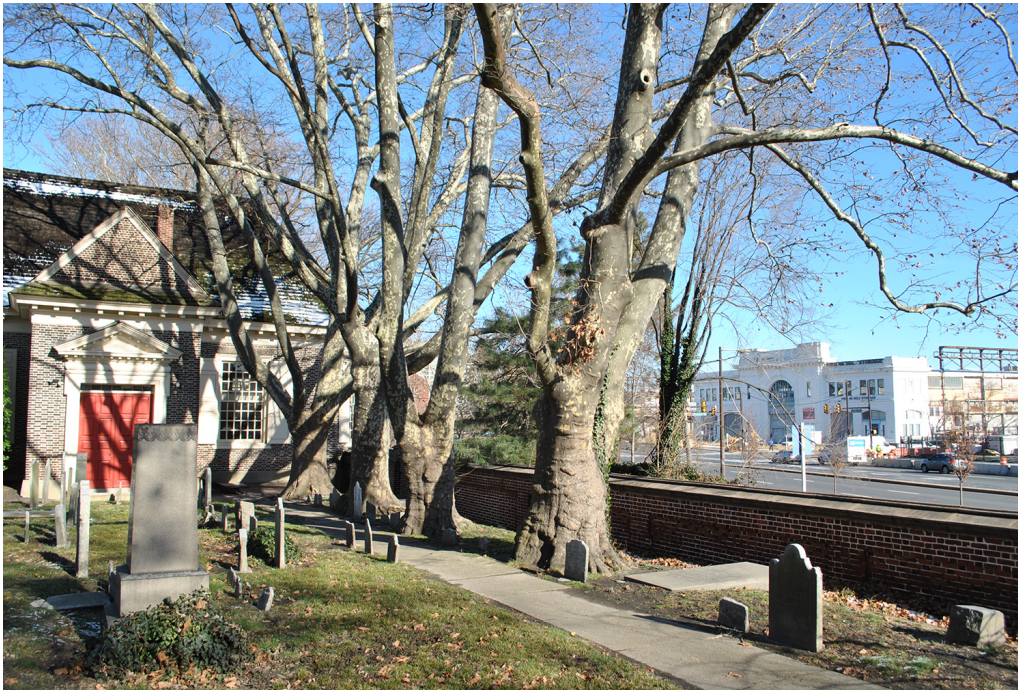
*Figure 41. View looking northeast from the burial ground at the closely spaced London plan trees next to the perimeter wall. These trees are believed to be the oldest extant at Gloria Dei and appear in images as early as the 1910s. (CLR 2022: 132)*

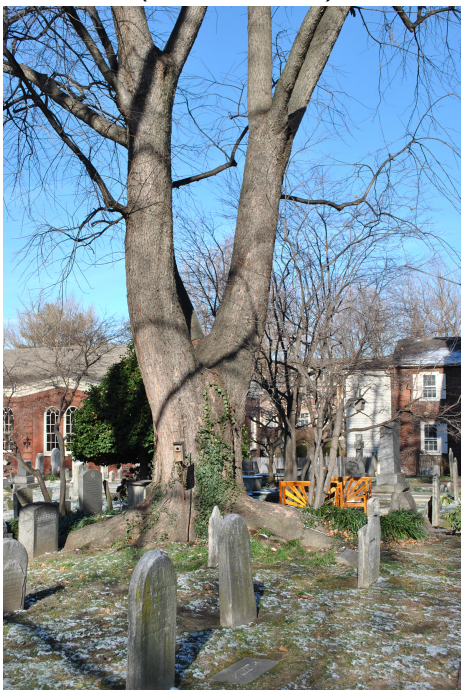
*Figure 42. Silver maple tree in front of a smaller ornamental serviceberry and American holly tree, view looking northwest in the churchyard, with Riverside Hall and rectory in the background. This tree is visible as a young tree in photographs from the 1930s. It is approximate to a location where there has been a singular tree in the burial ground as documented in a view as early as 1759. (CLR 2022: 131)*

A comparison of existing vegetation with documentary evidence has identified 23 trees, mostly within the churchyard, and some in the South Lawn and Swanson Street Forecourt, that were present at the end of the 1958 period of significance (Figures 41, 42, see 2022 "Cultural Landscape Report for Gloria Dei (Old Swedes') Church" for locations). Contributing species include London plane (*Platanus acerifolia*), white pine (*Pinus strobus*), honey locust (*Gleditsia triacanthos*), sycamore (*Platanus occidentalis*), silver maple (*Acer saccharinum*), and mulberry (*Morus alba*) (see 2022 CLR for a complete list). Most of these trees were planted between 1930 and 1958, although the London plane trees on the eastern edge of the burial ground could date to the early 1900s. The existing vegetation in the North Lawn and South Lawn is based on a master landscape plan. The plantings in the Swanson Street Forecourt date from the mid-1980s, while the street trees of the perimeter are a more recent introduction. No small trees, shrubs, or planting beds have been identified in existing photography or landscaping plans that predate 1958. The two flowering dogwoods in the churchyard appear old enough to predate 1958 as saplings; however, they are insufficiently visible in photographs to document that they are that old. (CLR 2022: 190-195; Review comments, M. Ehrler, 9 May 2024)

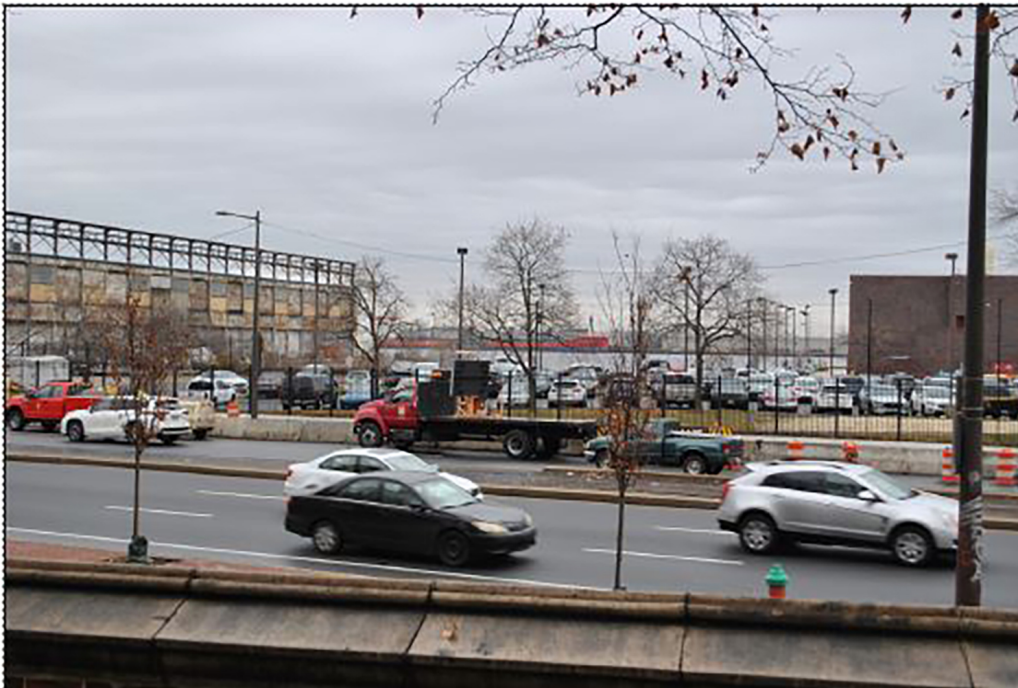
*Figure 43. View looking east from the east end of the burial ground over the brick perimeter wall (bottom of view). From this vantage point the Delaware River can be seen in the distant background, mid-view. (CLR 2022: 204)*

photographers have turned to again and again over the past 200 to 250 years (see Figure 26). Due to the limitations posed by the perimeter wall, only an eastward view from the high point at the east end of the burial ground reveals the Delaware River and the site's historic spatial relationship to the river (Figure 43). The key view outside the perimeter wall is from the former alignment of South Swanson Street where the Gloria Dei Church is visible above the perimeter wall (see Figure 39). Some of the plantings in the forecourt that were overgrown and obscured this view have been addressed. (CLR 2022: 200-205; Review comments, M. Ehrler, 9 May 2024)

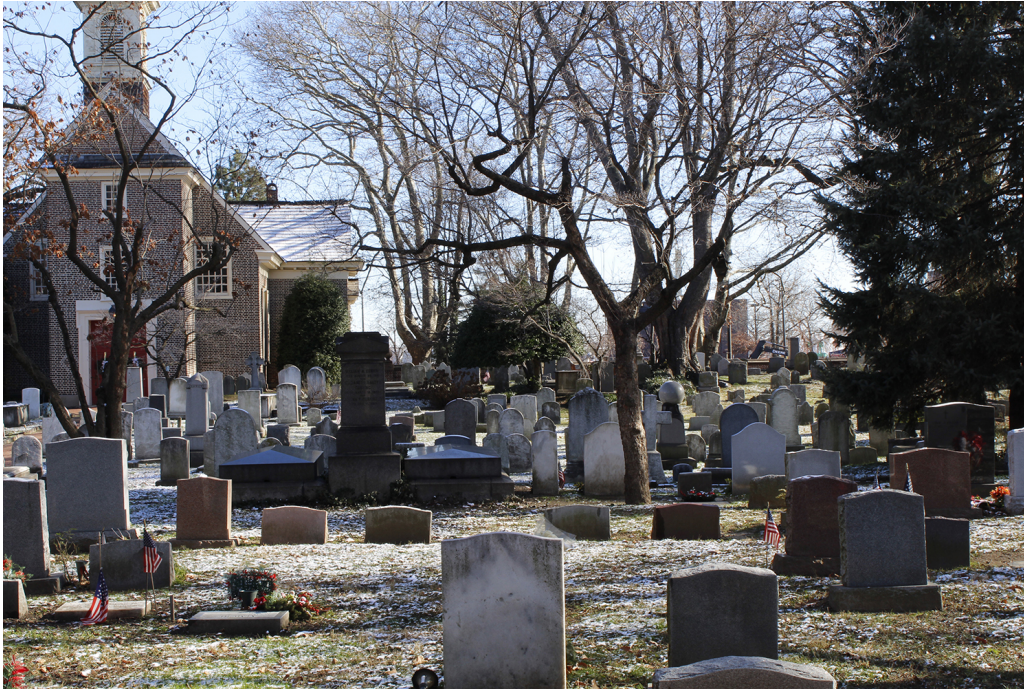
Figure 44. Burial ground, view looking east. Note the ground elevation rising to a high point to the right of the church. This is interpreted as being the location of the original blockhouse/church of circa 1677, as well as the oldest section of the graveyard. (CLR 2022: 117)

The Gloria Dei burial ground occupies a roughly rectangular plot of ground that measures 275 feet east/west and 125 feet north/south. The burial ground is on church-owned property with the exception of the Revolutionary War monuments placed at the southwest corner. The topography slopes gently down from east to west with a visible highpoint immediately south of the church, in the oldest part of the burial ground (Figure 44). The markers here are for the most part arranged within 30 rows that extend north/south across the entire burial ground. The rows are uniformly arranged with the engraved sides of many of the upright headstones facing to the east, which would be a typical practice in a Christian graveyard; however, it should be noted that the oldest known drawings and photographs of the burial ground from the late 1750s to the 1850s, suggest that some gravestones have been moved and reoriented over time, perhaps to create this more orderly arrangement, especially in the older eastern sections of the burial ground where many original stones are believed to have deteriorated and been lost. (CLR 2022: 117-118; CLR Part 1 Addendum, S.Kosovych, 13 March 2024)

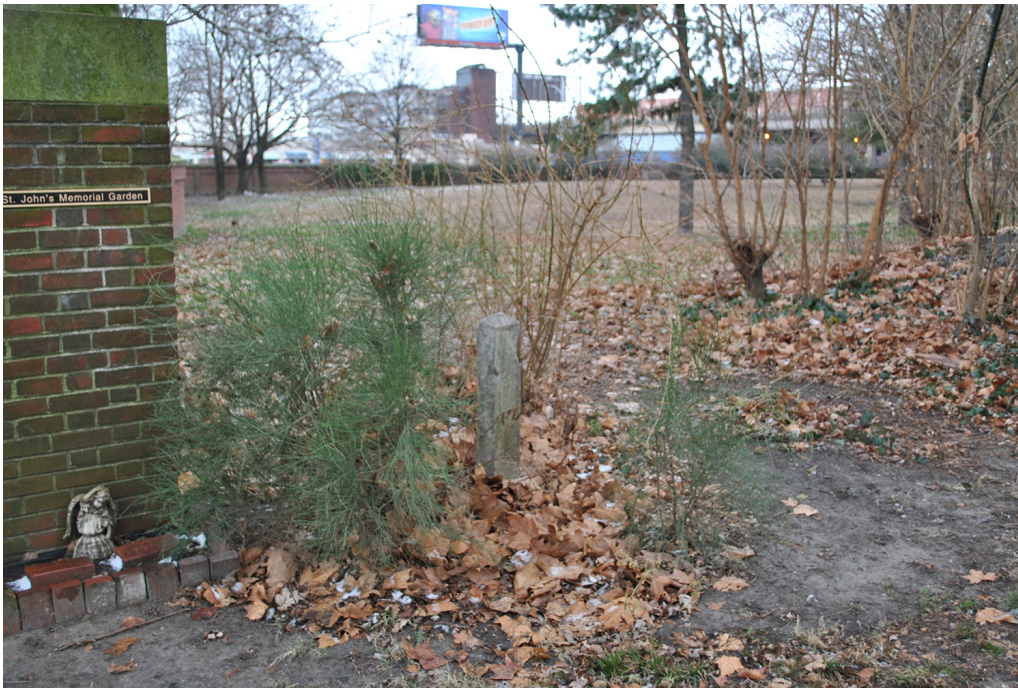
Figure 45. A stone boundary marker (image center), view looking southwest. The perimeter wall and St. John's Memorial Garden are to the left of view. (CLR 2022: 148)

Church records document wood fences at Gloria Dei by the early 1700s were used to define the boundaries of the church tract, as well as to enclose the burial ground, pastures, and garden. Historic illustrations document wood vertical picket fences from the 1750s to the 1830s and horizontal wood board fences from the 1820s to the 1890s. The wood fences on the South Swanson Street frontage were replaced by brick walls and iron picket railings in 1898, but wood fences continued to be used to separate the north and south boundaries of the church tract from neighboring properties into the middle of the 20th century. Stone boundary markers may have once existed for all corners of the church tract. These were likely placed around the 1820s, which was the last major subdivision of the land that the church had acquired in the early 18th century. The only remaining visible stone boundary marker is located near the southeast corner of the perimeter wall (Figure 45). As the stone boundary marker dates to the period of significance, it is contributing. (CLR 2022: 146-147)

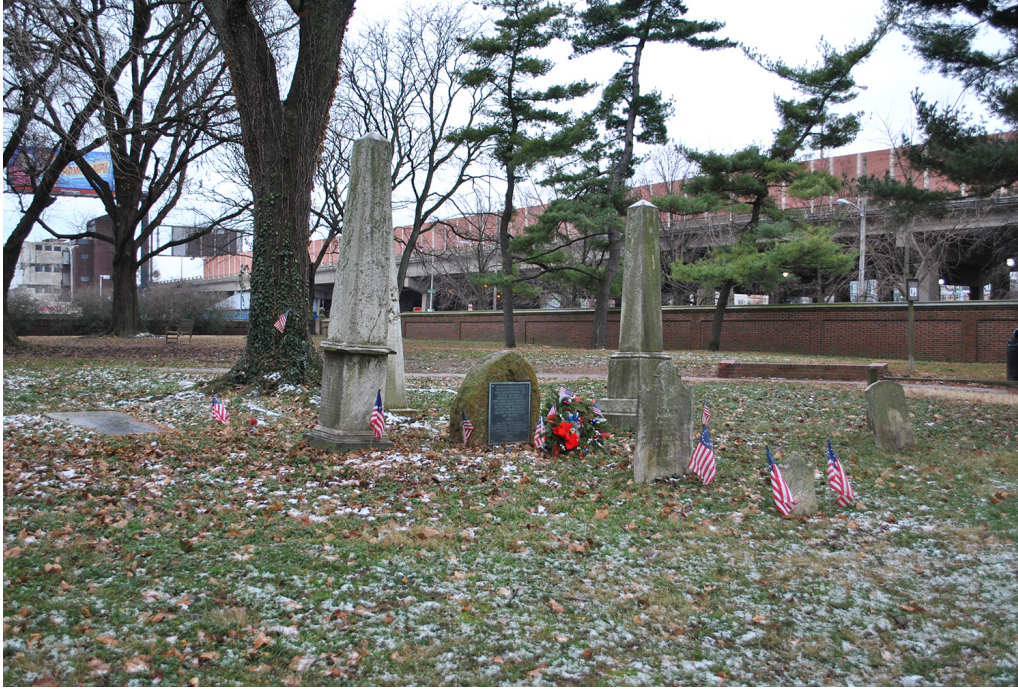
*Figure 46. The Revolutionary War and Scottish Thistle Society Markers, relocated to the burial ground in 1950, view looking southwest. The associated human remains were relocated elsewhere. (CLR 2022: 122)*

1950, on federal property just beyond the church-owned tract (Figure 46). They were moved here after the Philadelphia downtown cemeteries where they were previously located were redeveloped. The associated human remains were relocated elsewhere. Although moved from their original location, both markers date to the period of significance and are contributing. (CLR 2022: 122,207)

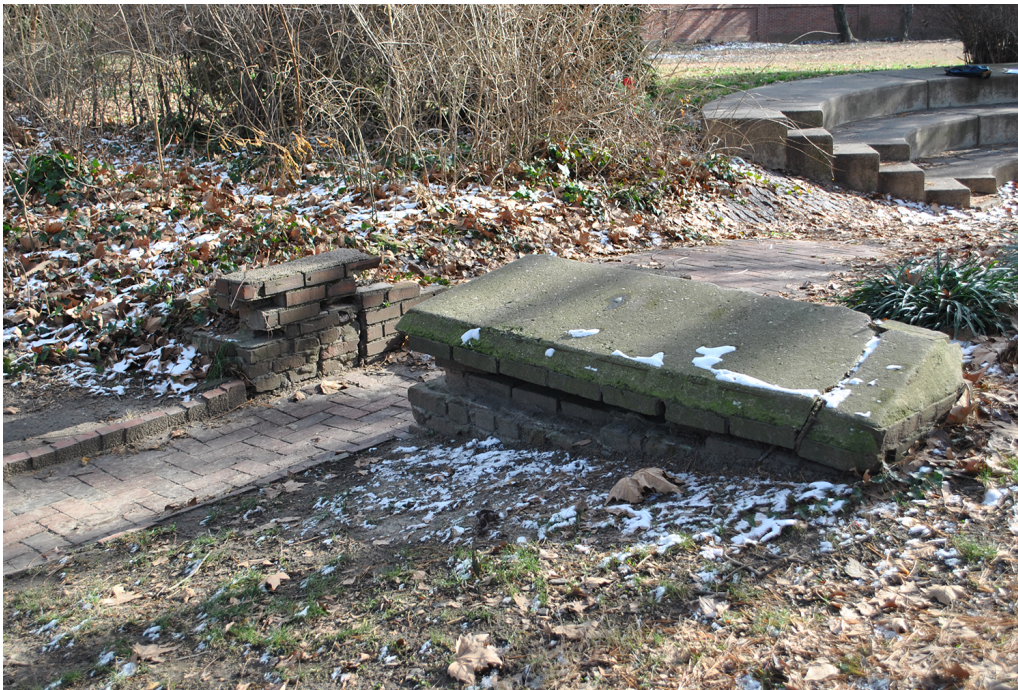
*Figure 47. Remnant of low brick wall between the churchyard and the South Lawn, view looking southeast with the amphitheater in the background. The origin of this wall is uncertain. (CLR 2022: 148)*

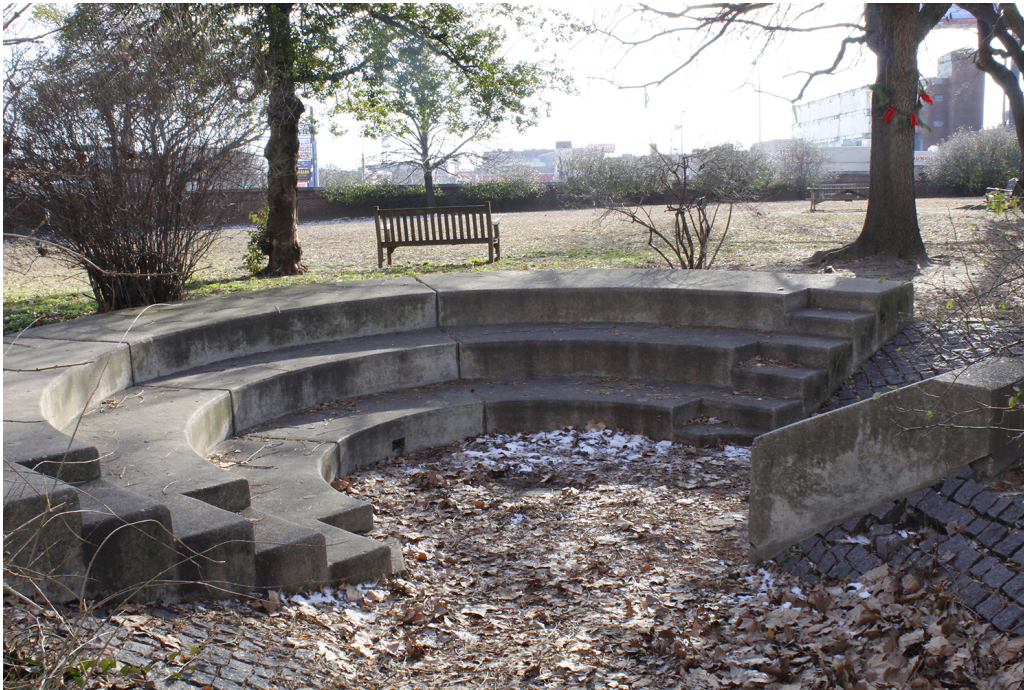
Figure 48. Amphitheater, view looking south, built by the NPS in late 1970s. Slatted seat boards, light sconces, and a memorial plaque on the plinth (image right) are missing, and leaf litter likely clogs the floor drain. A bench is visible in the background. (CLR 2022: 152)
