National Park Service  
Cultural Landscapes Inventory

Revised: 1/2025

Gloria Dei (Old Swedes') Church NHS Landscape  
Gloria Dei (Old Swedes) Church National Historic Site

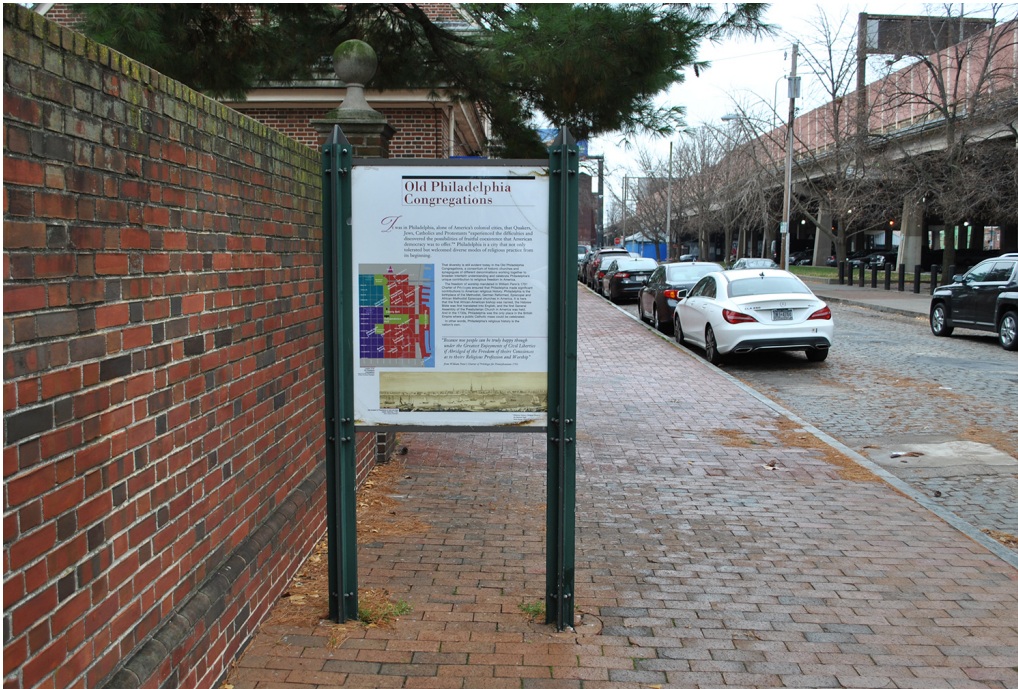
Figure 49. Interpretive sign on South Water Street, view looking south. (CLR 2022: 153)

A two-sided vertical interpretive panel is located on the South Water Street perimeter, north of the Roak Building. This sign has a history of Gloria Dei Church on the south side of the panel, and a history of Philadelphia's religious congregations on the north side of the panel (Figure 49). A low-profile cantilevered interpretive sign is located in the parking lot to the north of Riverside Hall. It interprets the history of Gloria Dei Church and is situated to attract the attention of visitors arriving by motor vehicle and parking in the lot. The sign's fiberglass panel has faded and checked. A Pennsylvania Historical and Museum Commission cast-metal marker on a metal post is located in the churchyard in the passage between Gloria Dei Church and the rectory. The signs are collectively compatible with the property's historic character. (CLR 2022: 151; CLR Part 1 Addendum, S.Kosovych, 13 March 2024)
