Presidio Gate, Broadway Gate and Vicinity

Cultural Landscape Report

Presidio of San Francisco

October 1996

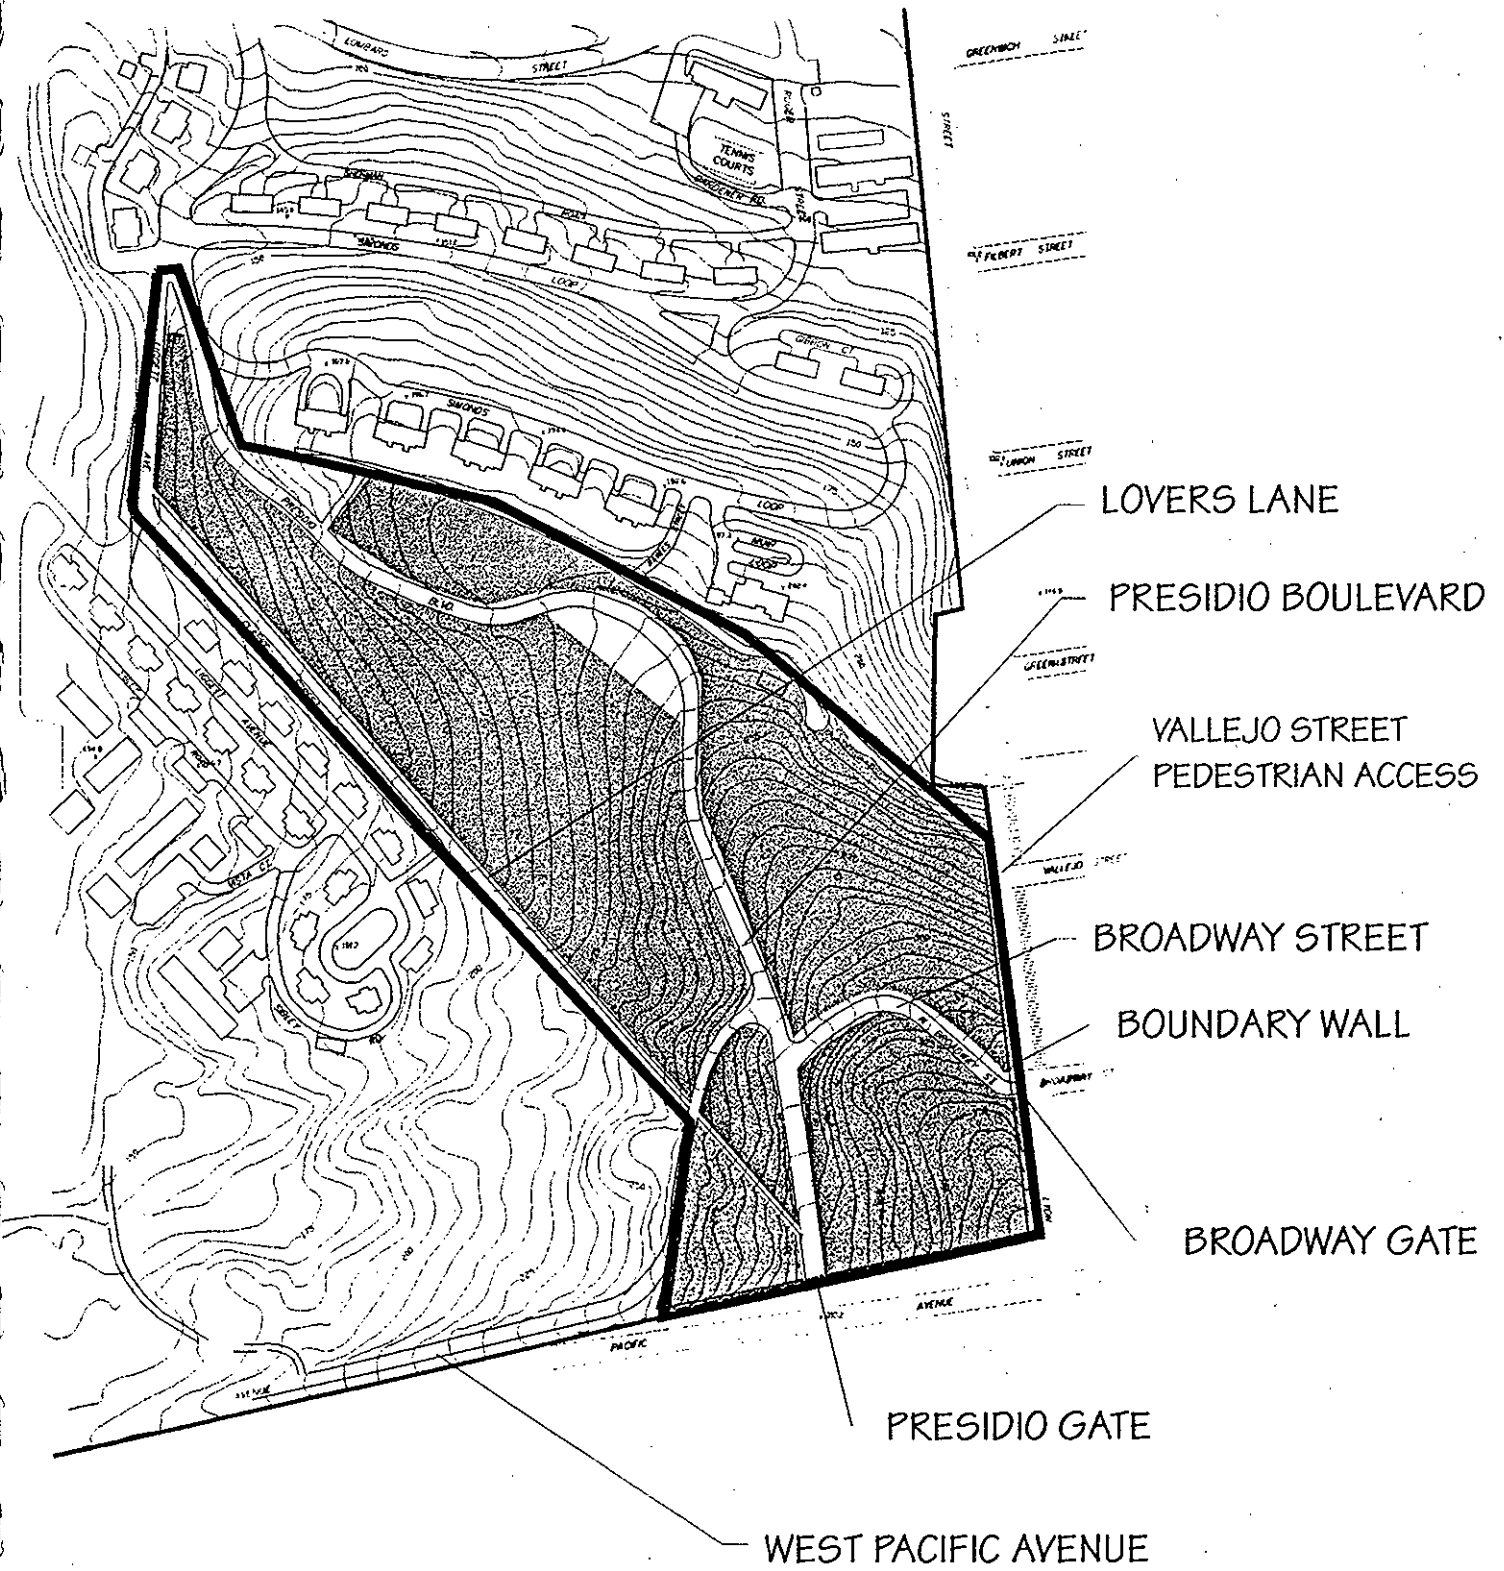
FIGURE 1

This project study area covers the southeastern most corner of the Presidio, it covers approximately 30 acres, figure 1. Beginning at the southeastern most point of the Presidio, near the intersection of Lyon Street and Pacific Avenue, heading north to Vallejo Street, heading north and east to Shafter Road, heading north and east along Shafter Road to Presidio Boulevard, heading north along Presidio Blvd. to Liggett Avenue, heading south and west along Liggett Avenue to Lovers Lane, heading south and east along Lovers Lane to West Pacific Avenue to Walnut Street, heading east along boundary wall to the southeastern most point of the Presidio, near the intersection of Lyon Street and Pacific Avenue.

PROJECT STUDY AREA

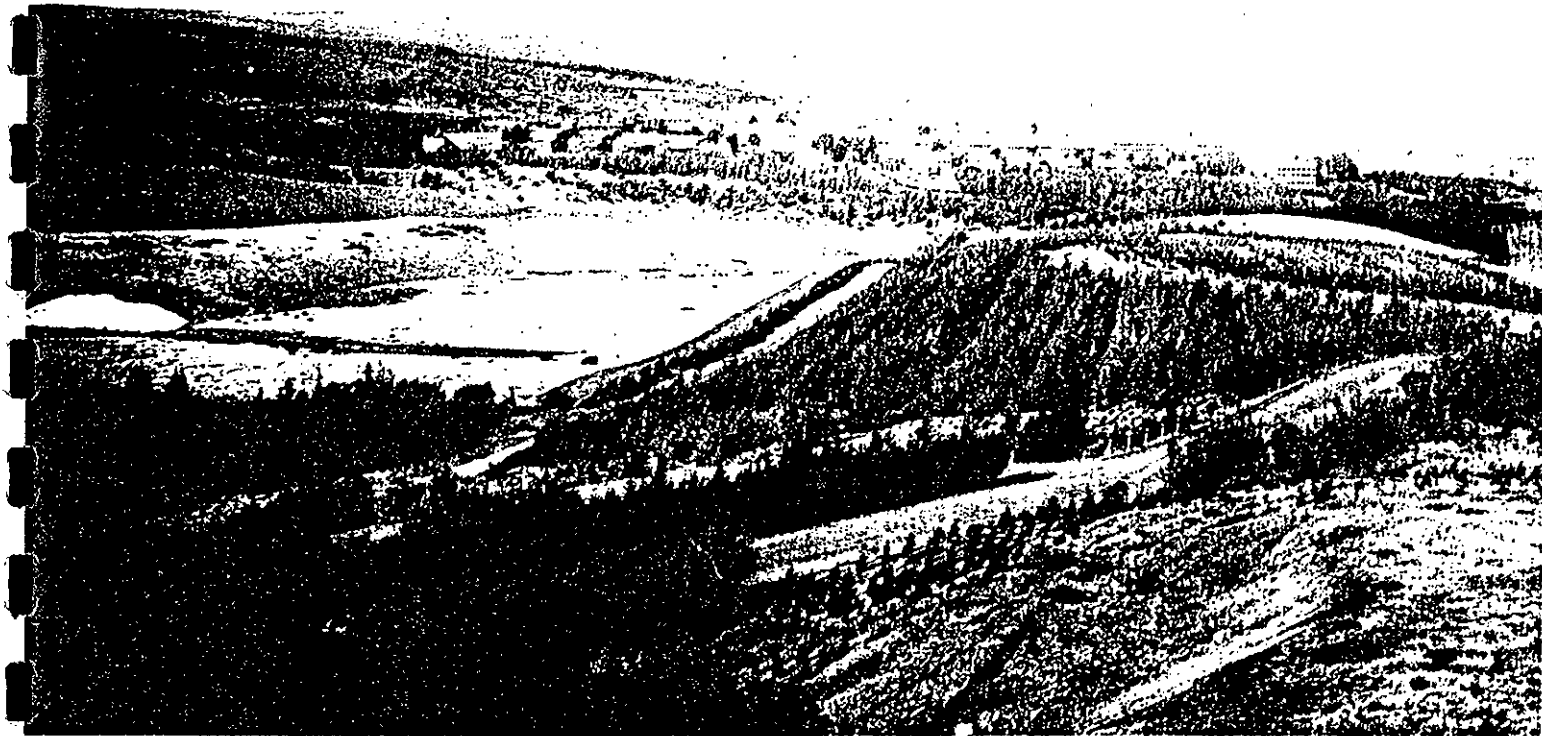
Figure 2 - 1893 Photograph of the Presidio from southeast corner

information from 1893 photo:

- * Alley of trees lining Presidio Blvd already in place; trees are a@ 5' to 10' tall;
- * the West Pacific Street intersection at Presidio is visible;
- * Broadway Street is not yet formally defined; it may not yet be paved; perhaps its just currently a footpath and/or a social trail.

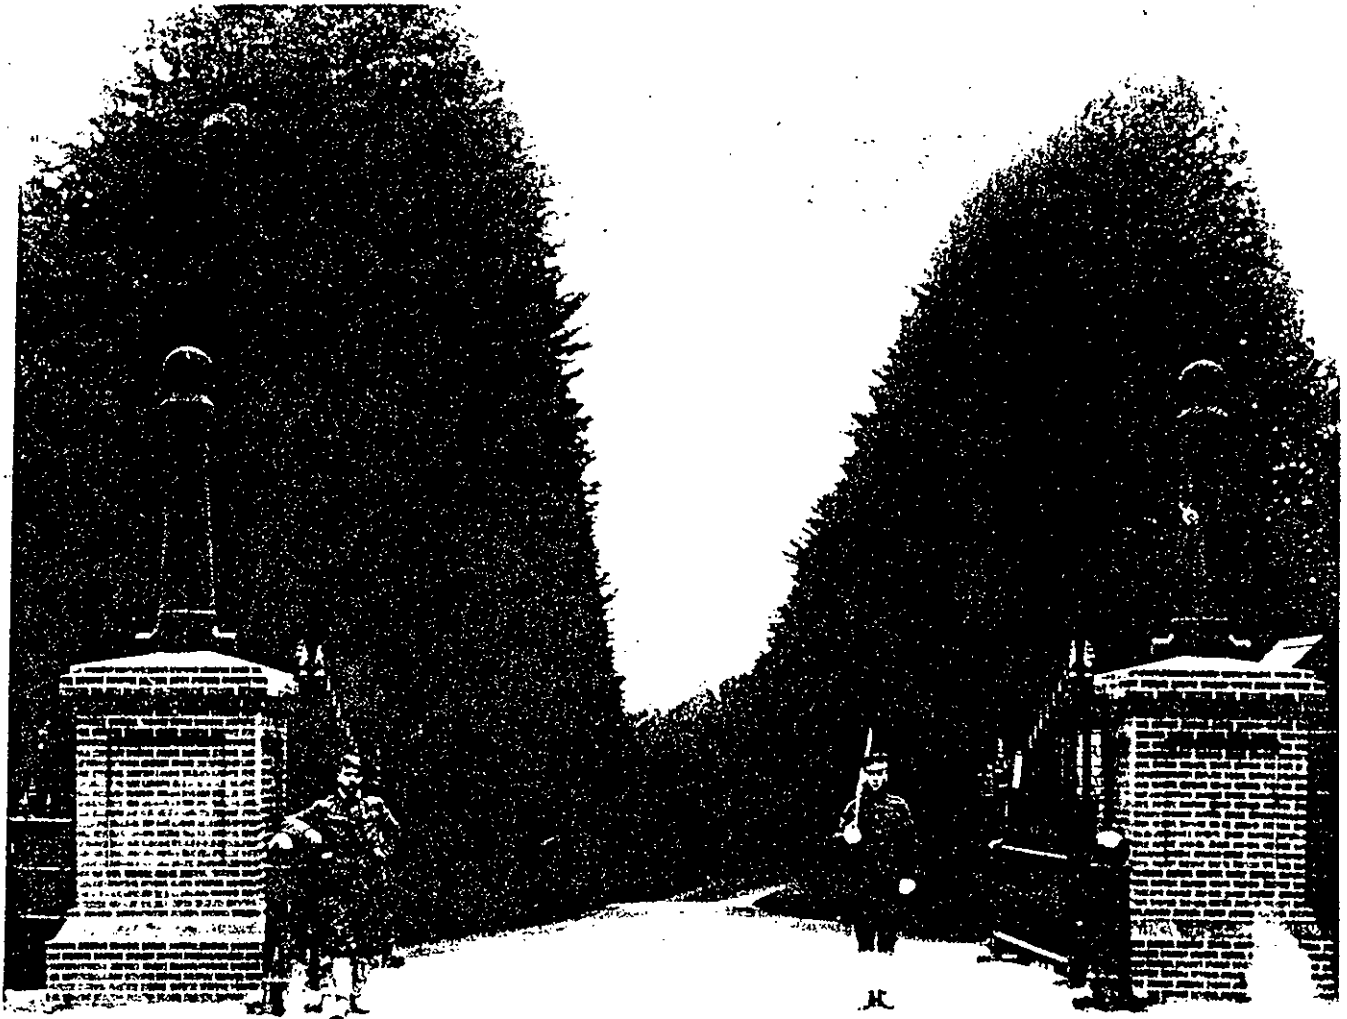
Figure 3 - 1906 Photograph of Presidio Gate

(information from historic photo, dated 1906)

- * pedestals now constructed in common bond brick work with very clean-looking mortar (when was the light tan parging removed?)
- * narrow, white wood-frame sentry box with gable roof is located in the rear, behind the eastern pedestal;
- * trees appear to be @ 20' to 25' tall (they appear to be @ 10' taller than the gatekeeper's house)

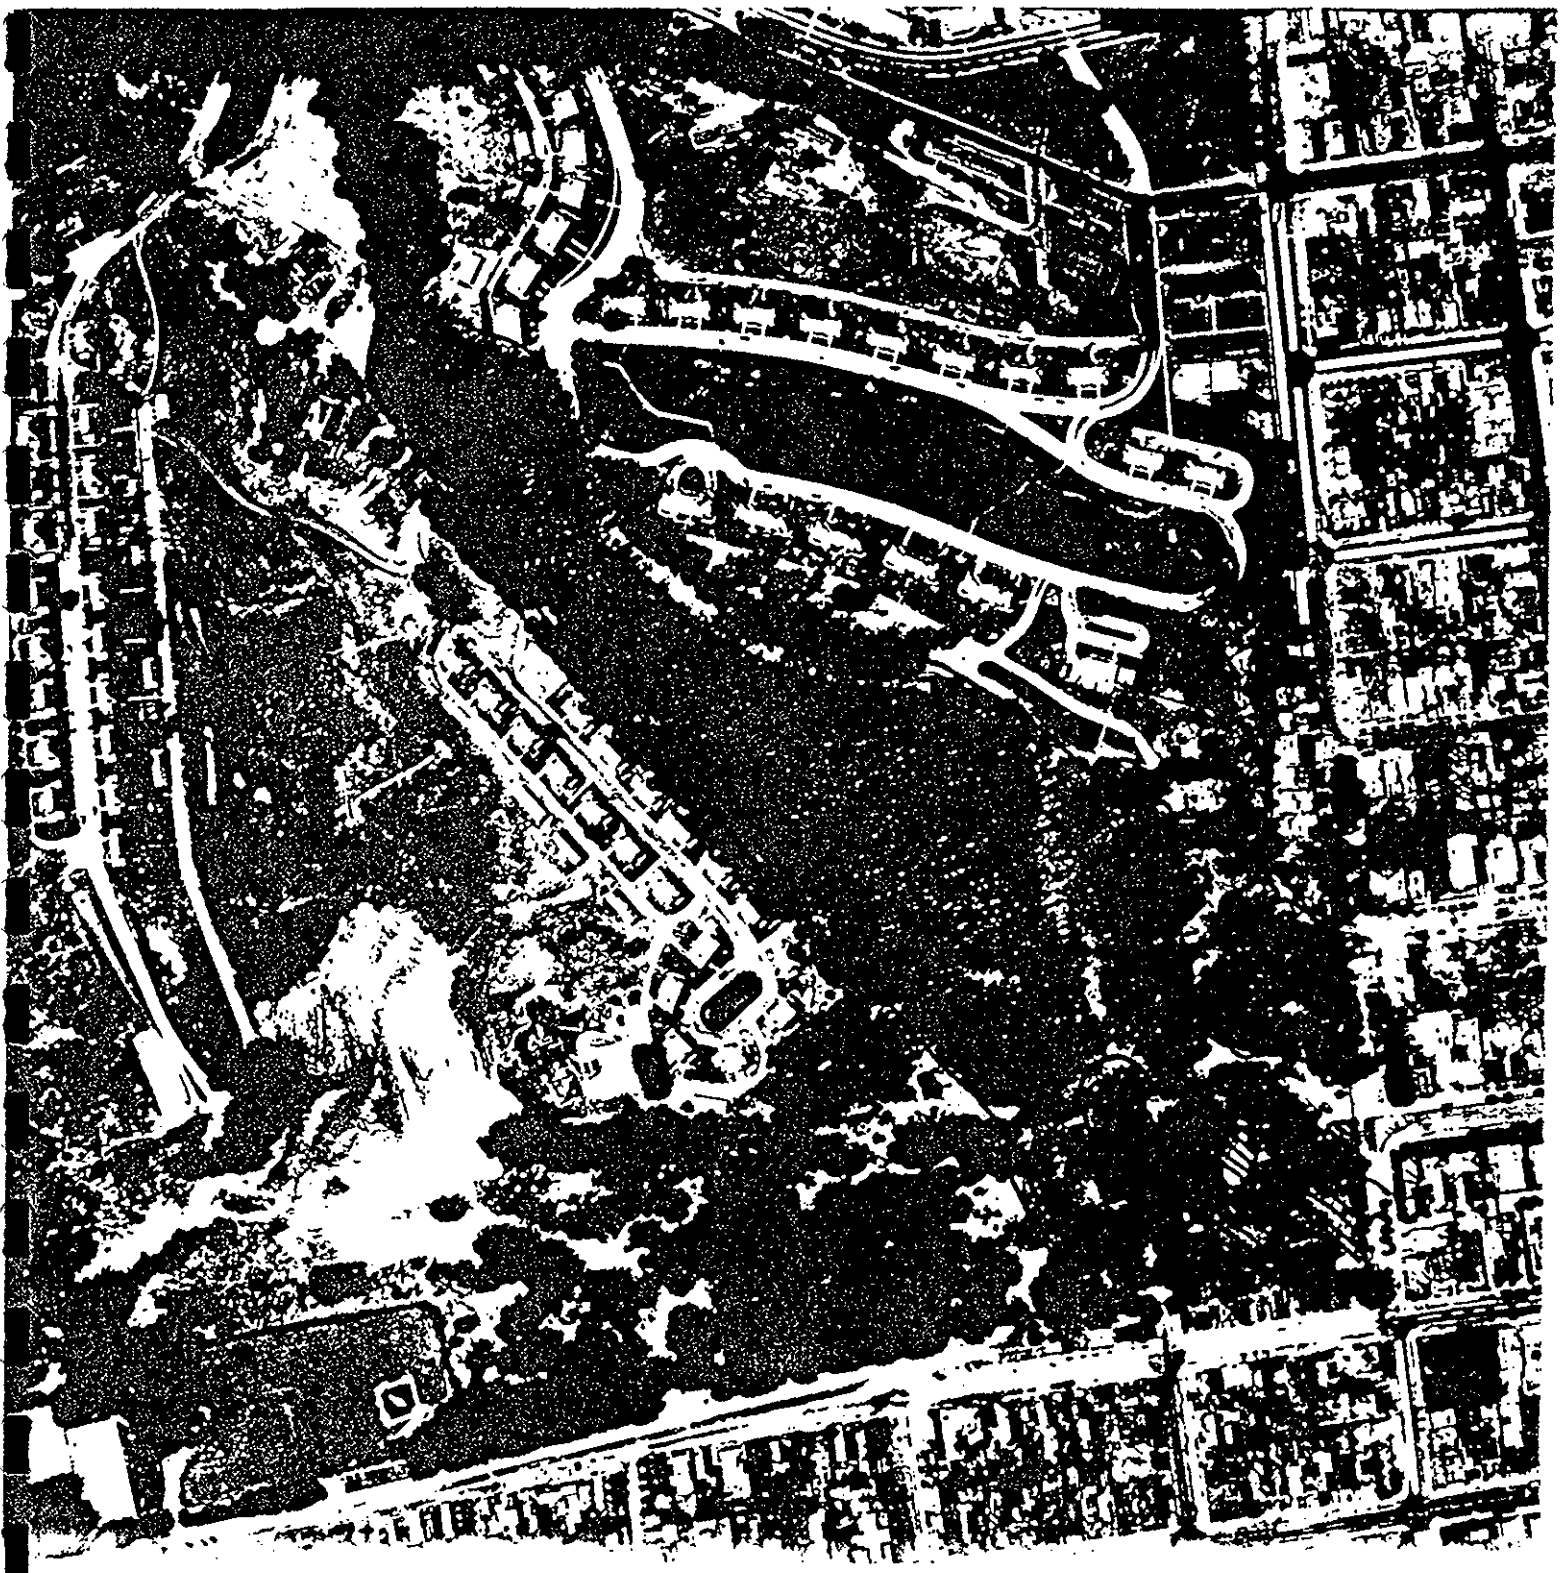
Figure 5 - 1948 Aerial photograph

description from 1948 aerial photograph:

Presidio Gate

* overhead vegetation growth now obscures the visibility of the paved road.

Broadway Gate

* the previously clear paved road has become less clear (vegetation overgrowth?);

* the clearly defined elliptical shape has lost its shape (due to vegetation overgrowth?);

* whole area looks like it has suffered from a lack of landscaping attention;

* the vegetation along the Presidio Blvd has overgrown so that it overshadows the Broadway/Presidio Blvd intersection.

There is a pedestrian access point via stone/concrete stairs at the end of Vallejo Street and a remnant log retaining wall and trail between Vallejo St. and the end of Shafter Road. This access is cut off by a chain link fence on top of the boundary wall, however, there is some use by people crawling under the fence and heading uphill from this point causing moderate erosion to the slope. The log retaining structure is in poor condition, the cross members are broken or damaged. The date of this pedestrian connection is unknown, the steps appear to be added on to the boundary wall. The trail shows up clearly in the 1948 aerial map, figure 5.

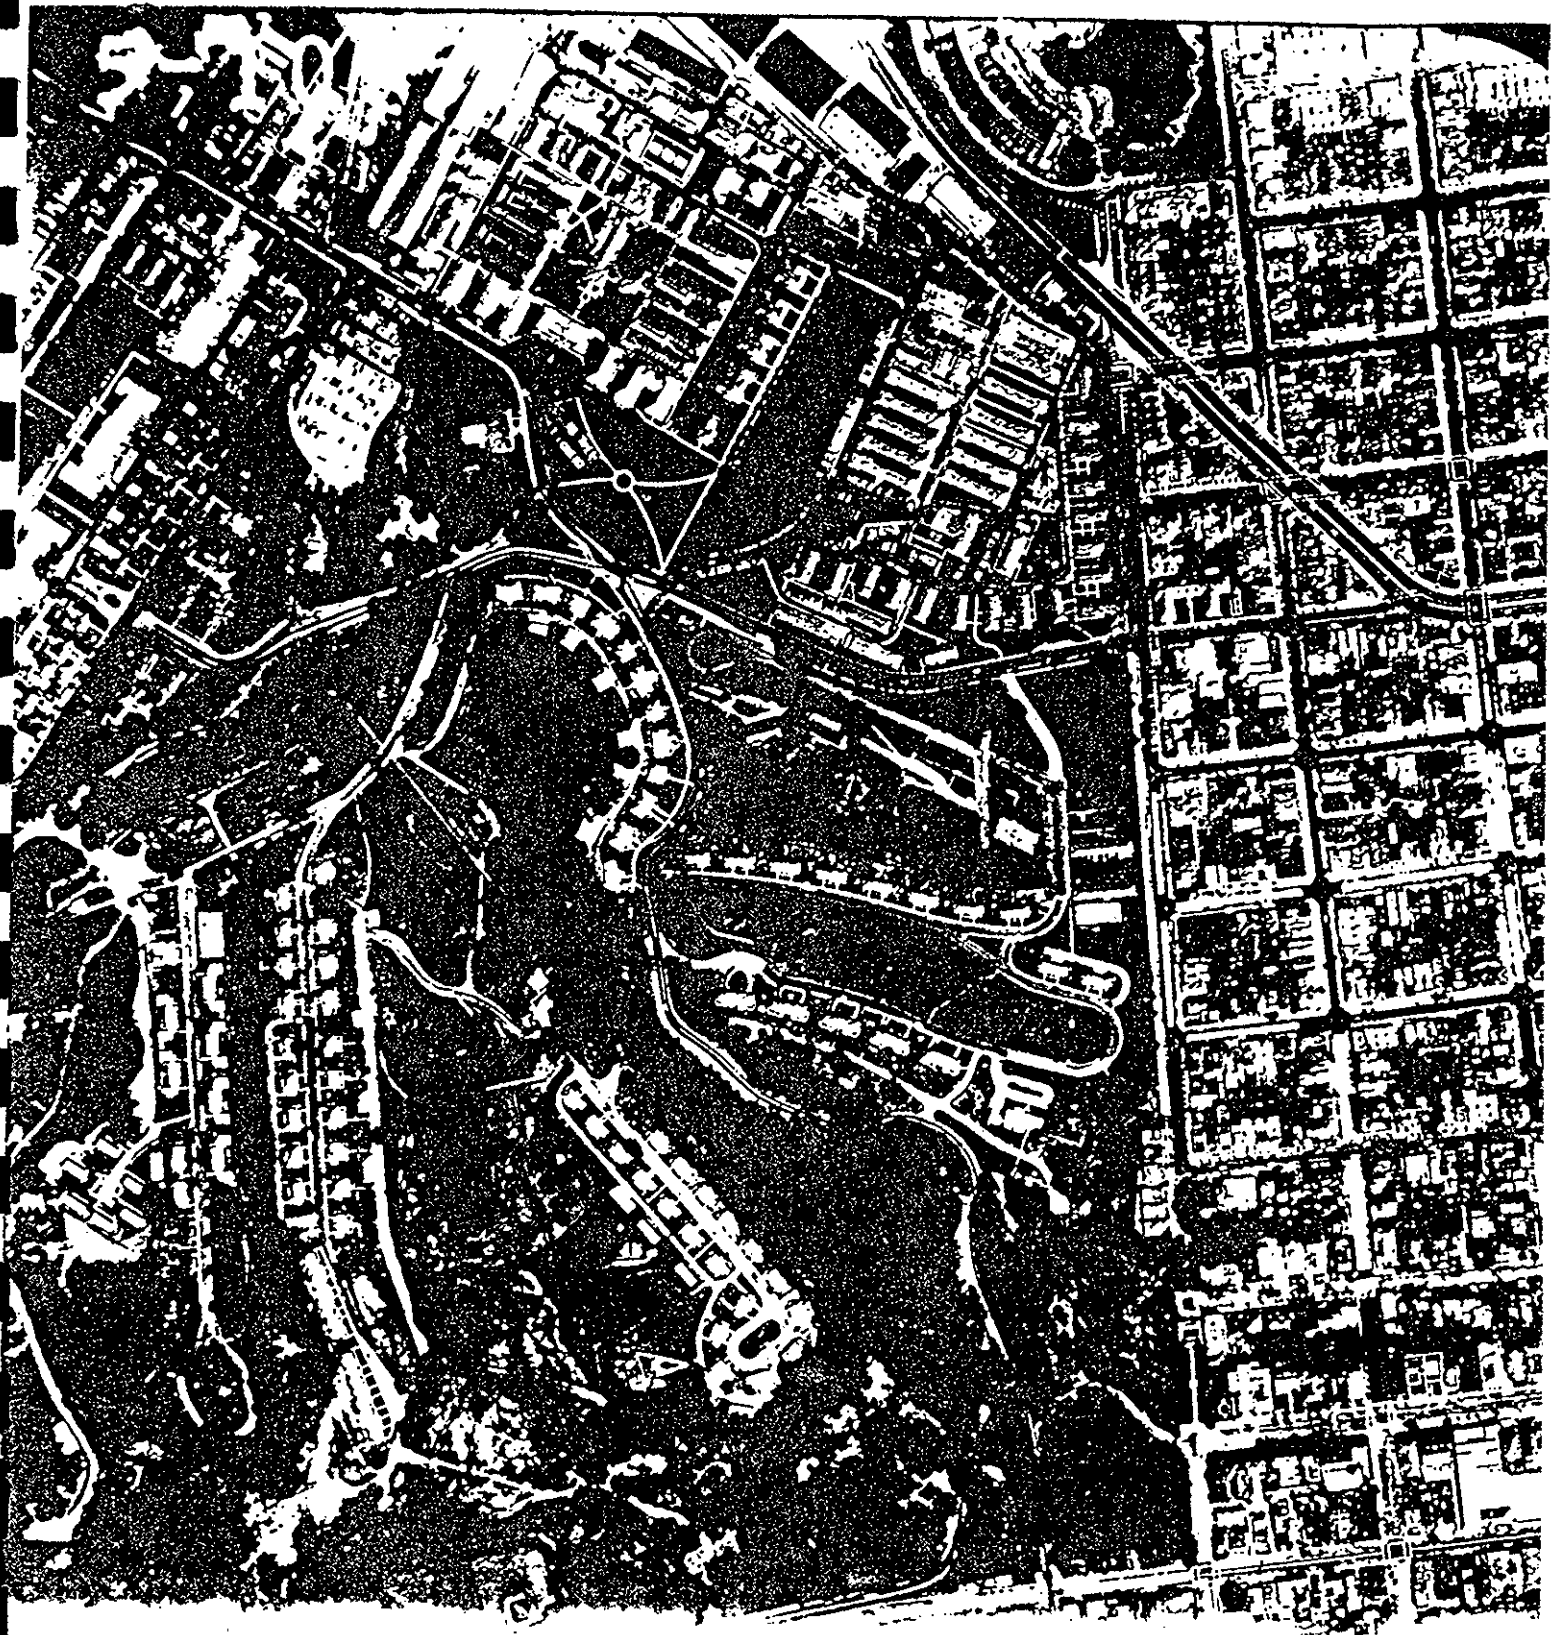
Figure 6 1955 Aerial photograph

description from 1955 aerial photograph:

Presidio Gate

* no visible change from previous aerial

Broadway Gate

* paved road is more clear and better defined again;

* vegetation cluster adjacent to the eastern edge of boundary wall (along Lyon St.) has been cleared; * cleared area is still grassy, with some small vegetation;

* a clearly visible social trail from Broadway Gate cuts across hill down to the Presidio Gate entrance; (this social trail may be visible on the 1948 aerial but not sure; perhaps this was established as an informal dog run)

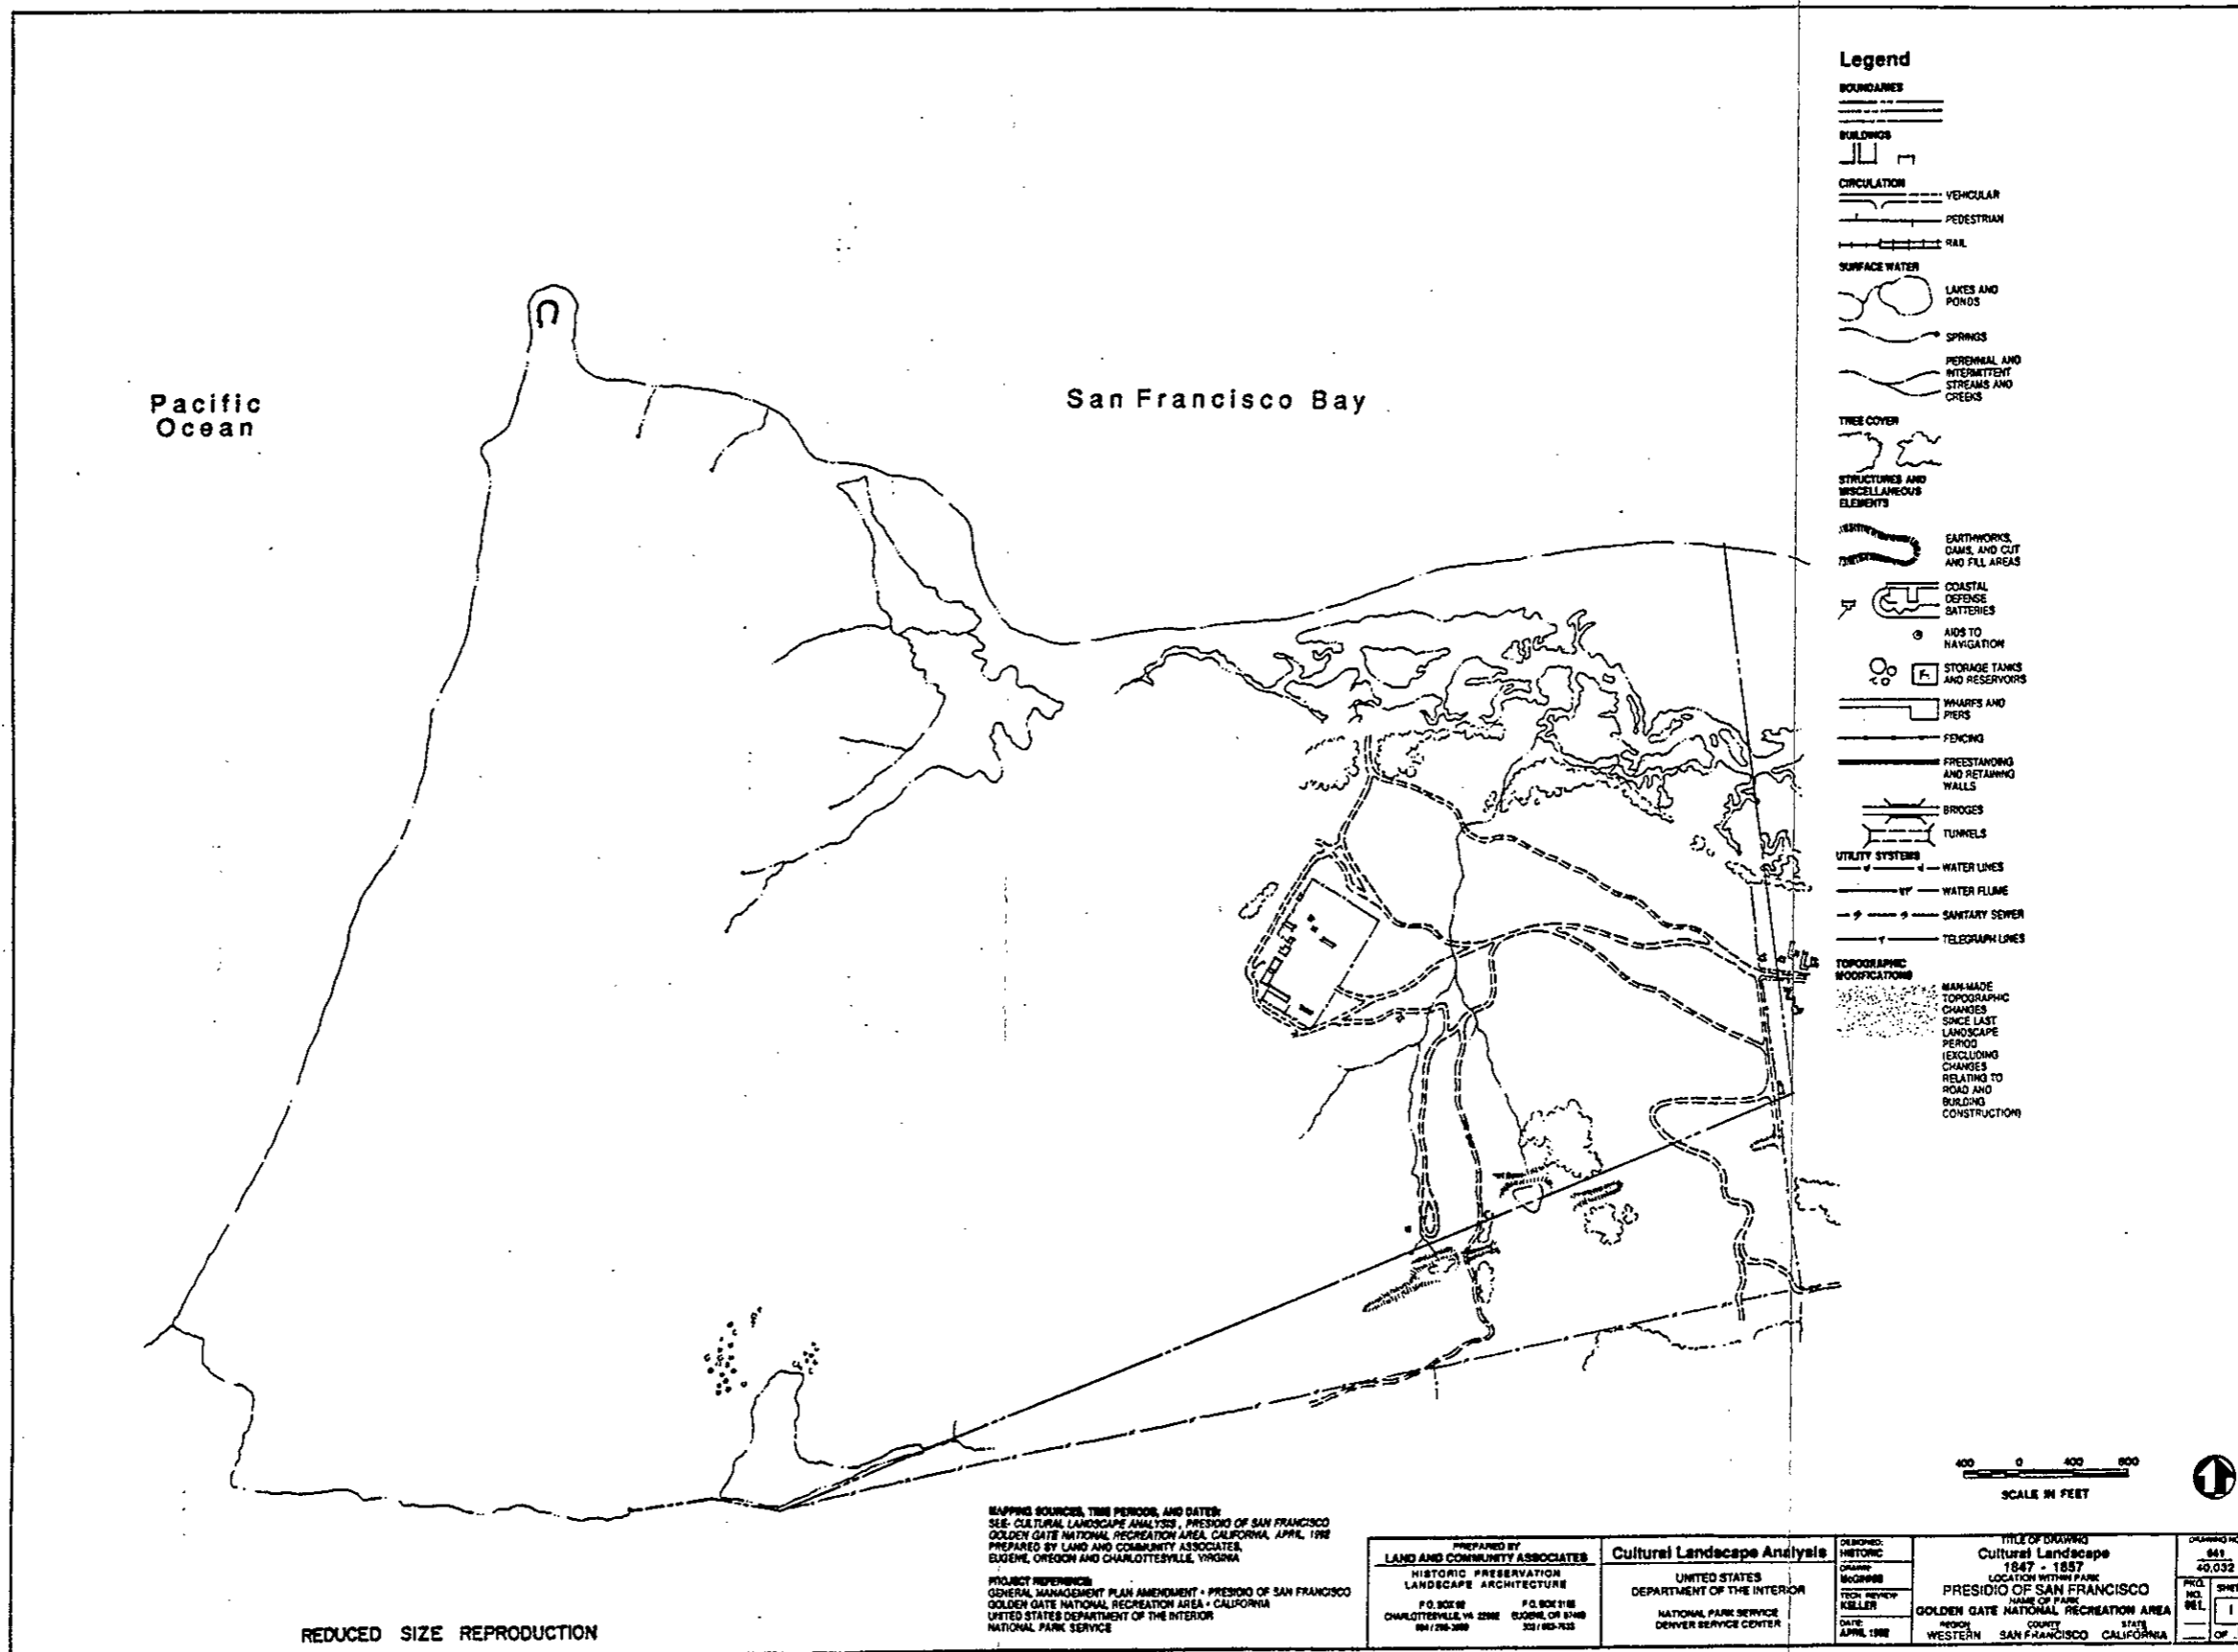
Figure 7 - 1847-1857 map of the Presidio

- * 1847 - Figure 7 Presidio Boulevard is unnamed and appears as an informal trail.
- * 1895 - Figure 8 Presidio Boulevard, West Pacific Avenue and Lovers Lane are clearly identified in present day locations.
- * 1907 - Figure 9 Broadway Street is shown in present day location, Shafter Road (including connection to Presidio Boulevard), and Liggett Avenue are shown.

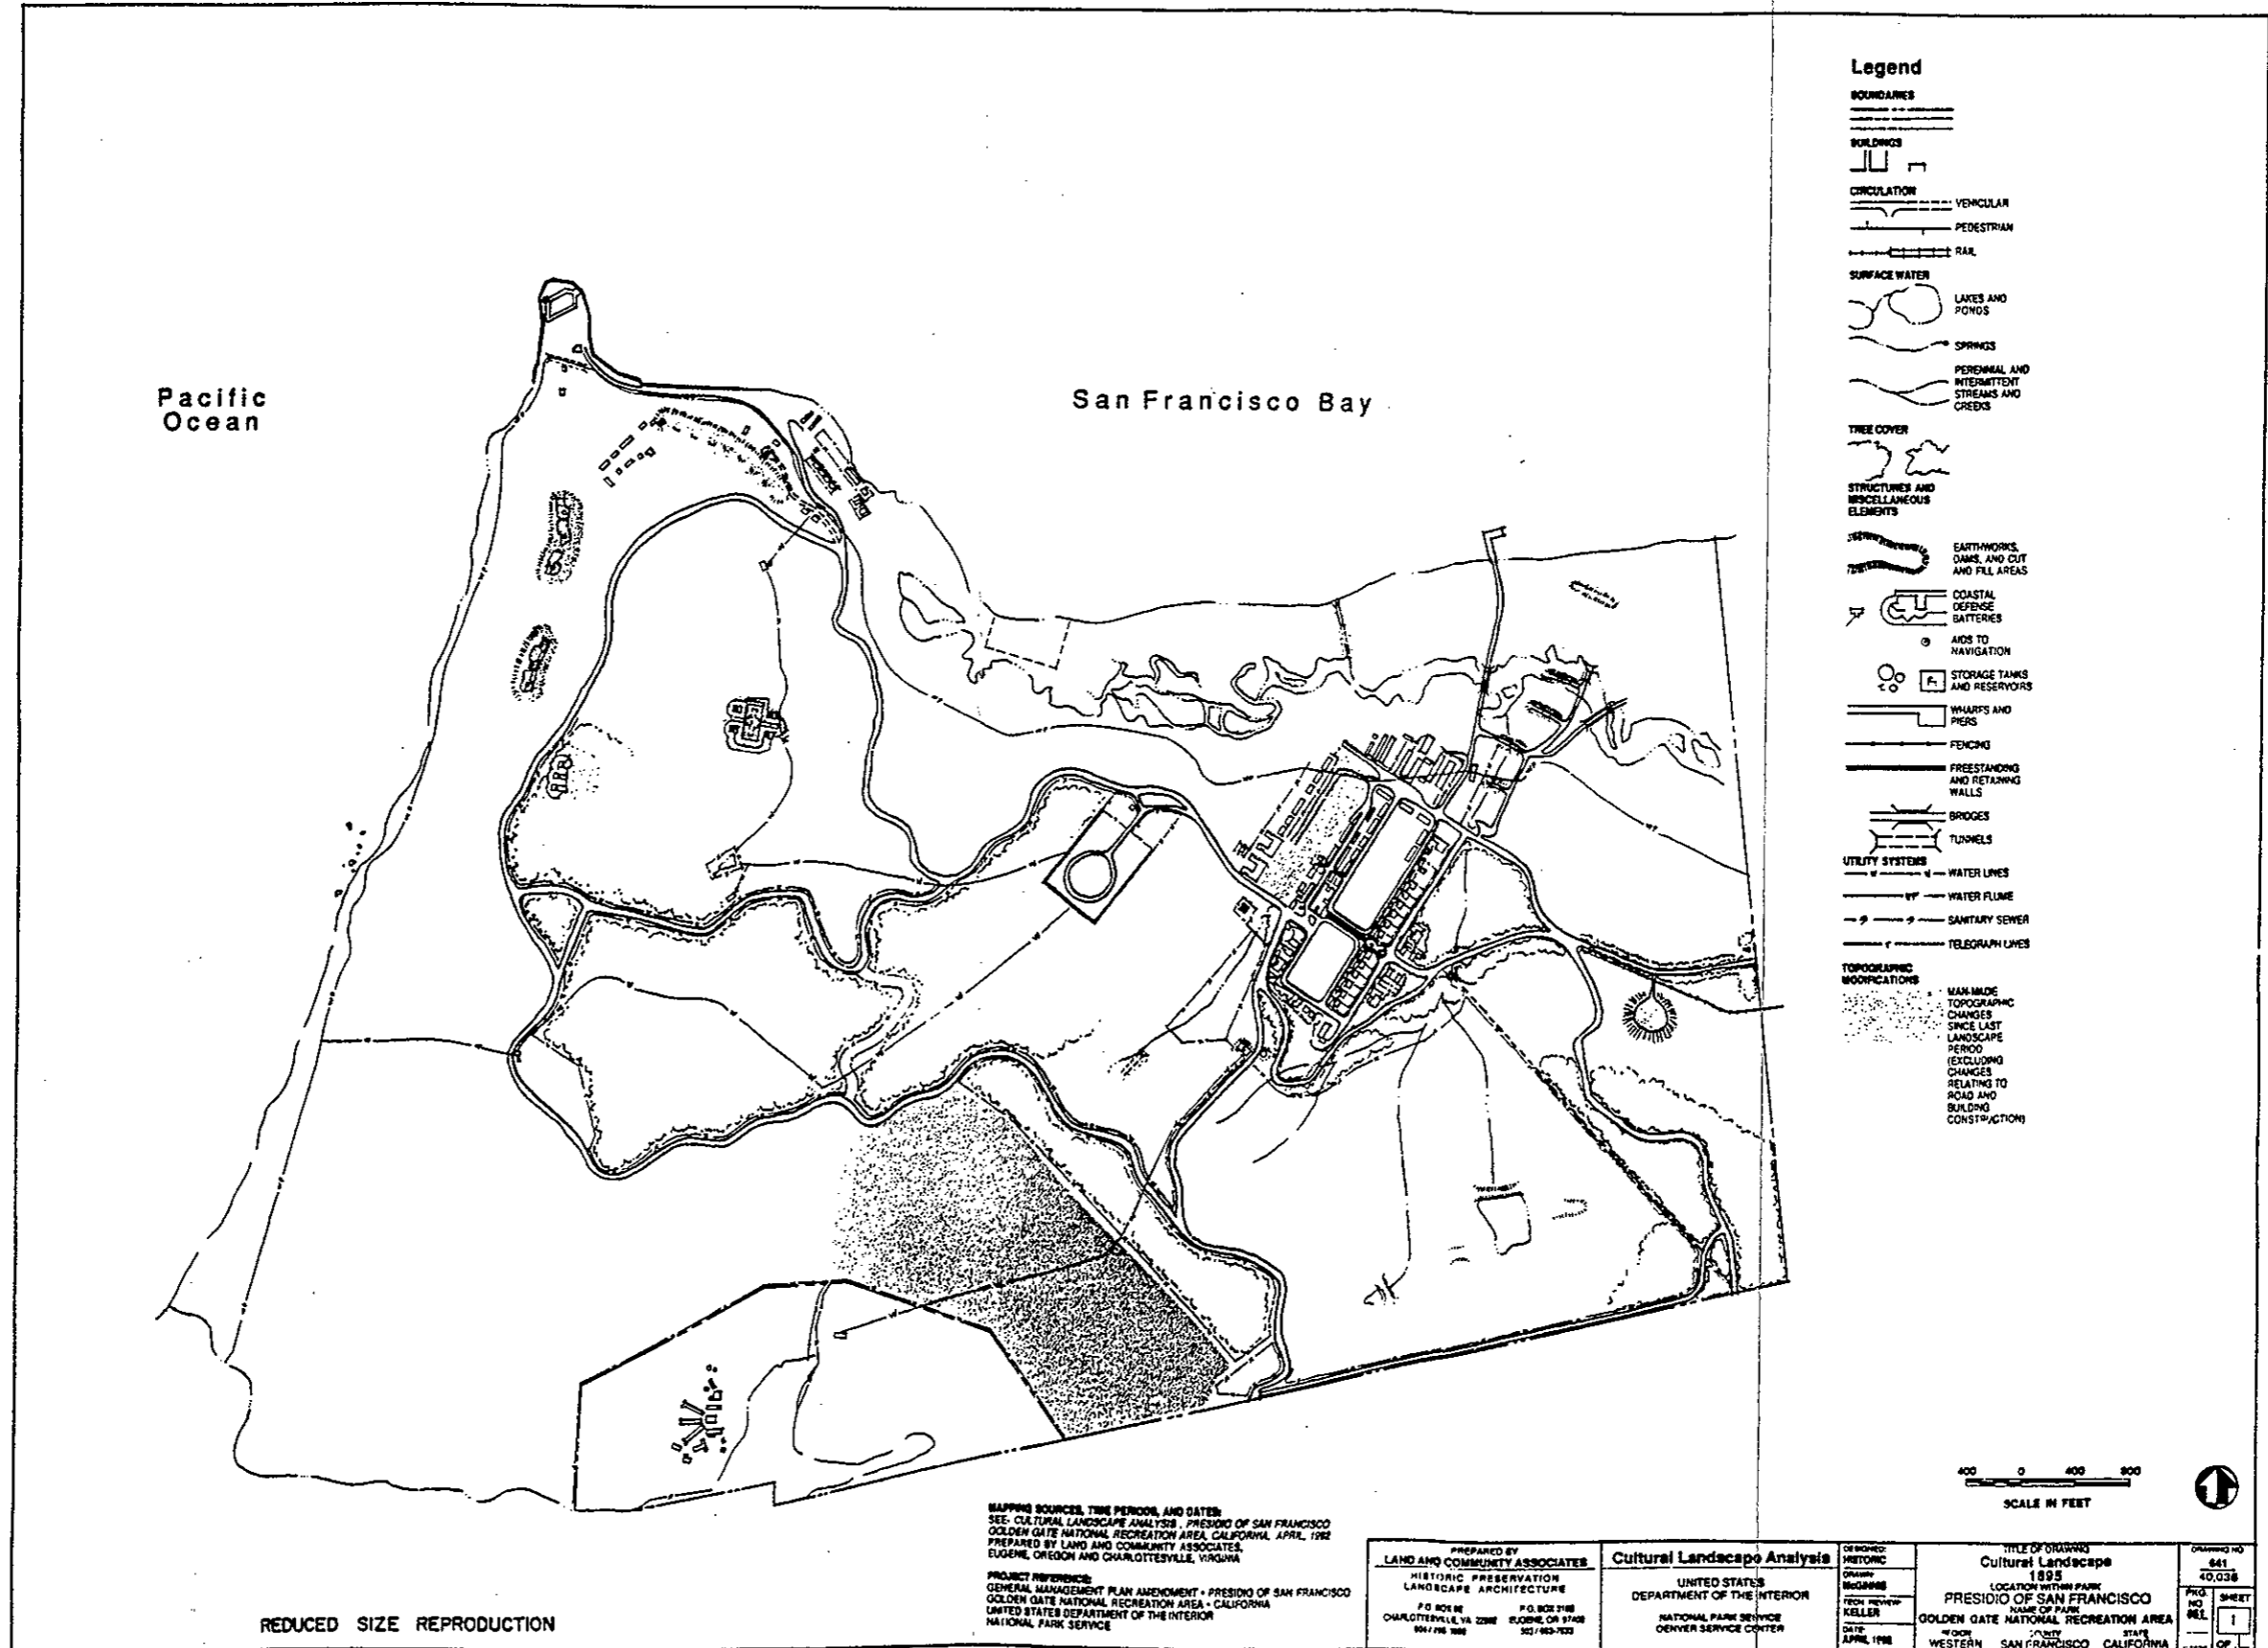
Figure 8 - 1895 map of the Presidio

Presidio Boulevard was one of three entrances into the Presidio in the late 19th century (shown with Lombard and Arguello entrances in the 1895 map of the Presidio). Lovers Lane footpath is also shown in this early plan.

West Pacific Avenue is a paved 22' wide connection between Arguello Boulevard and Presidio Boulevard. The avenue shows on maps as early as 1895, figure 8. The intersection with Presidio Blvd. has poor sight distance for vehicles turning onto Presidio Blvd. from W. Pacific Ave. Due to steep slope of intersection and stand of mature trees on the southwest corner. The side slopes along the north side of W. Pacific between Presidio Blvd. and Lovers Lane are eroded due to steepness of the slope and pedestrian crossing.

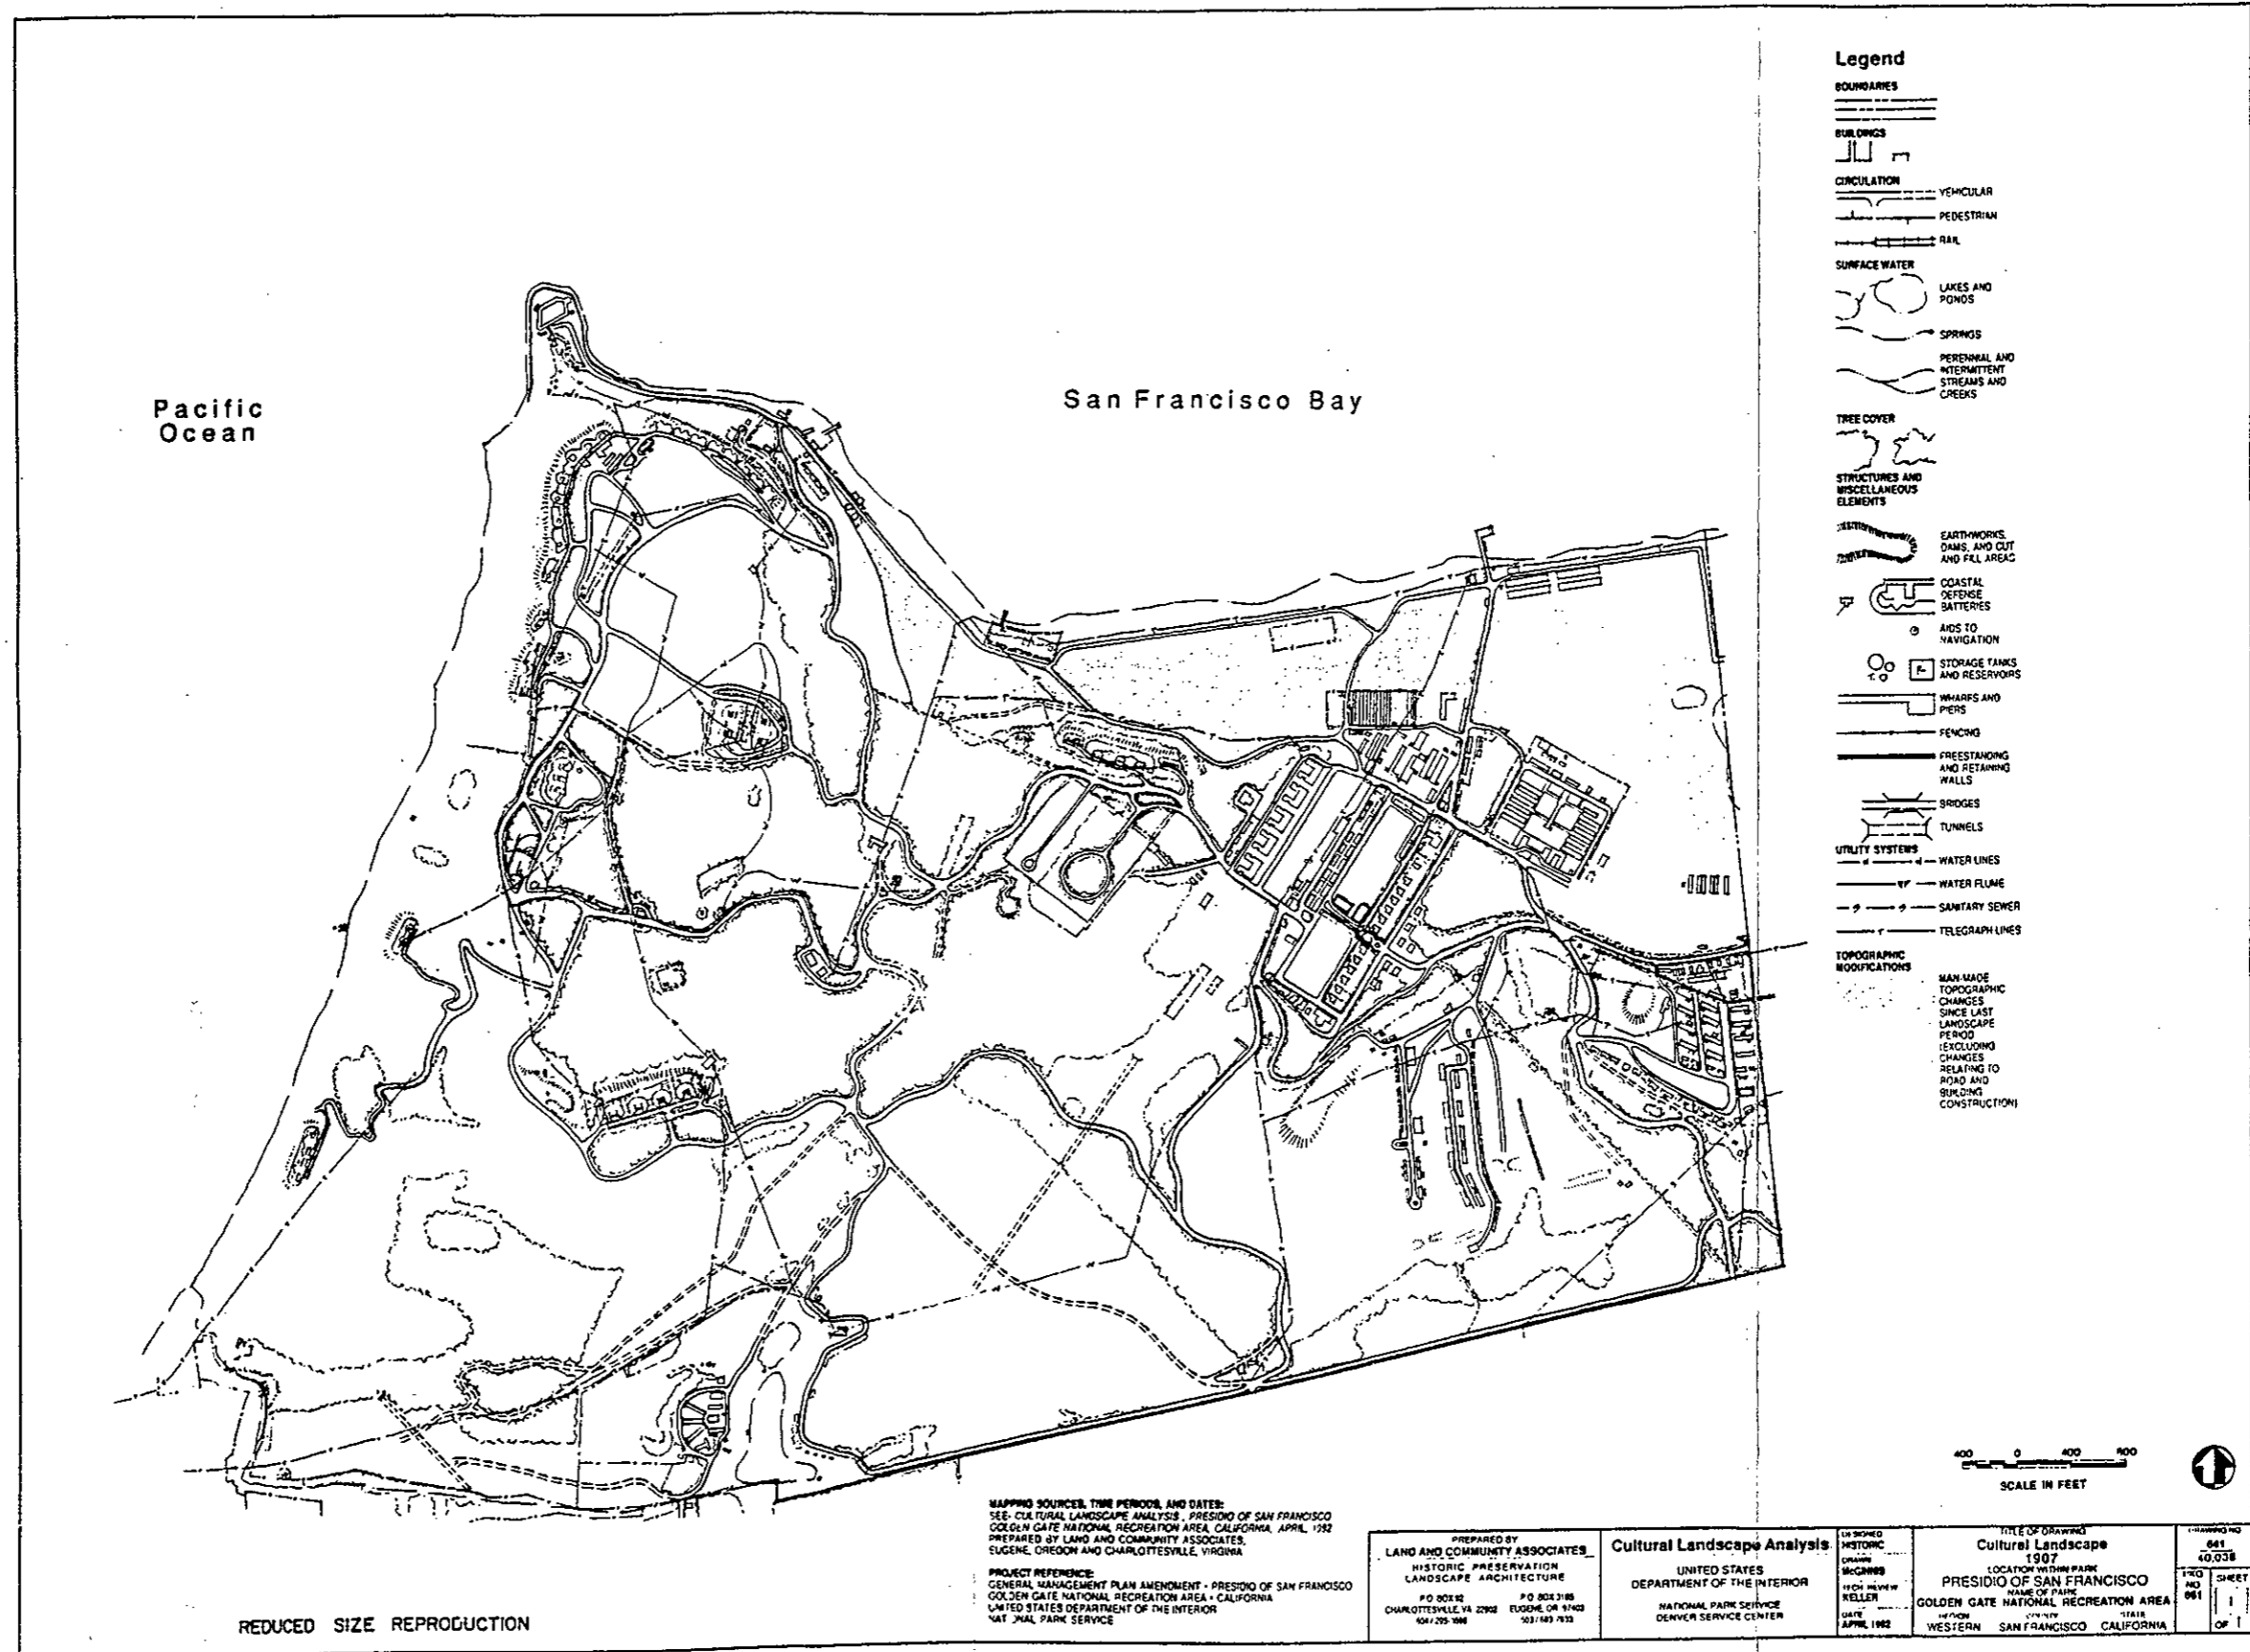
Figure 9 - 1907 map of the Presidio

Broadway Street is closed to vehicular traffic, the street is used by pedestrians and bicyclists, the street is shown on the 1907 map of the Presidio, figure 9. The street is approximately 20' wide and has a wide parking pull-off northwest of the Broadway Gate. A non-historic pipe gate blocks the entrance at Presidio Boulevard.
