Presidio Gate, Broadway Gate and Vicinity

Cultural Landscape Report

Presidio of San Francisco

October 1996

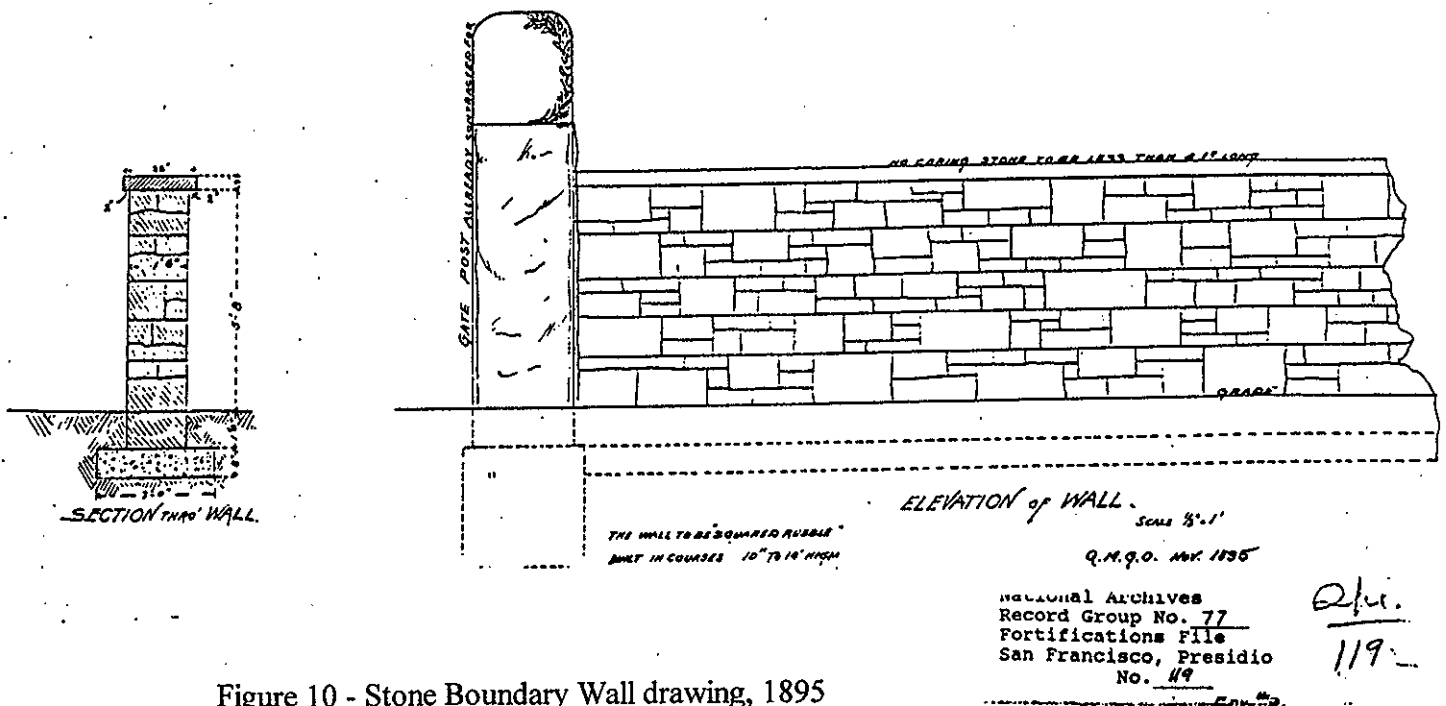
Figure 10 - Stone Boundary Wall drawing, 1895

The boundary wall is typically in good condition, an area on the east wall is missing, the coping and mortar joints need to be repaired in several areas.

The boundary wall is a key element to the historic landscape, for its definition of the Presidio, and for its quality of material and design. The stone boundary wall was constructed to "*prevent trespass by unauthorized persons and the unauthorized departure of soldiers of the post*" Major Wm. W. Harts, 1907. The walls should be repaired following the original design in form and materials.

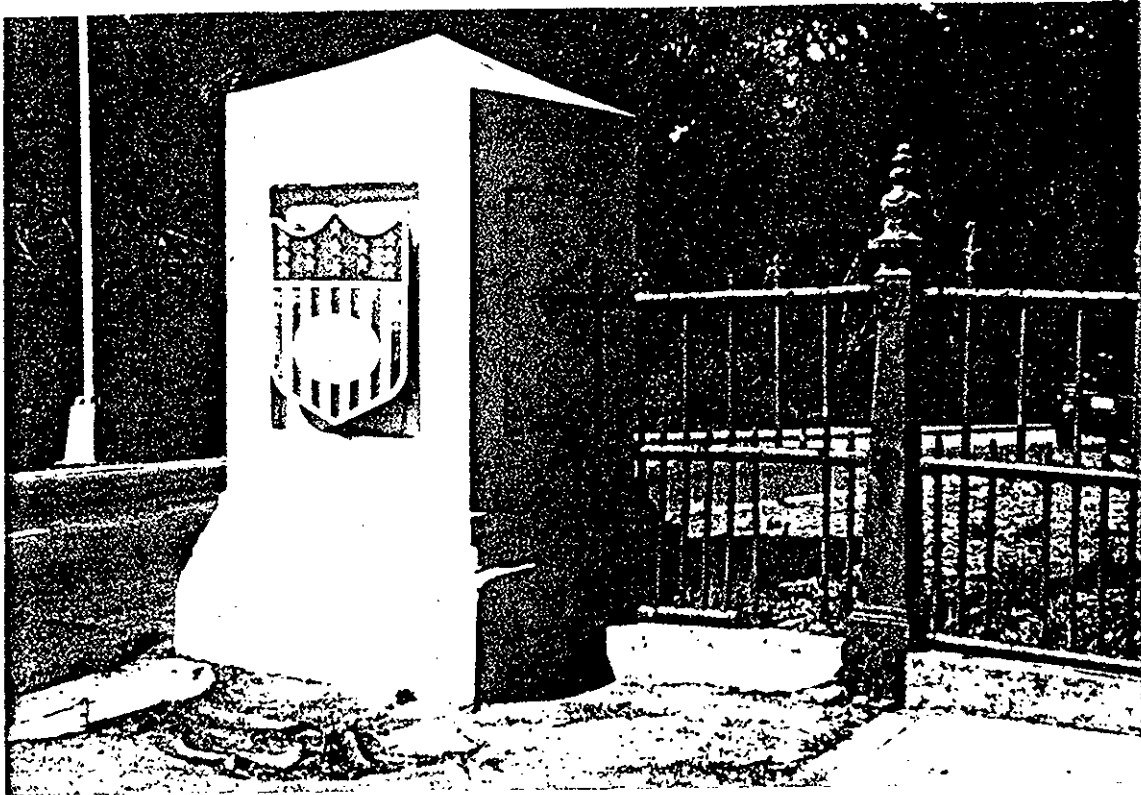
Figure 11 - Presidio Gate Masonry Pedestal

The Presidio entrance gate is the last gate (Broadway Gate?) in its original location. The cannons on top of the masonry pedestals and the cannon bollards were removed in 1942. The vehicular iron gates were removed, date is unknown.

Today, the masonry pedestals have a thick stucco finish, buses are hitting the easternmost pedestal causing moderate damage to the base. The masonry pedestals are 19' apart at the base, extremely narrow for two buses to maneuver. The ornamental iron fence is moderately deteriorated, several pickets are missing, many of the finials are missing, decorative moldings from the iron posts are missing, many of the iron stringers are rusted away from the posts. The pedestrian gate is not the same gate as shown in the 1906 photograph, figure 3, it is unknown when this gate was replaced. The gate is moderately deteriorated, the connection to the masonry pedestal is missing. There is only one pedestrian gate, which is located on the west side of the entrance. Pedestrian and bicycle access from the east side is extremely dangerous, visitors must either cross Presidio boulevard or enter in the vehicular lanes. In either case view is obstructed by the masonry pedestals.

The road through the gate is 19' wide, minimum road width for buses to pass is 20'. The damage buses are causing to the pedestals is moderate at this time. As more vehicular traffic goes through the gate, the damage will become more severe. Design alternatives to reduce damage to the pedestals:

- A. Move the eastern pedestal to widen road to 22', the design standard for Presidio Boulevard. This solution would allow buses to pass and maintain the historic character of the gate. This solution would move the pedestal from its historic location.
- B. Keep the pedestals in existing locations, restore the cannon

bollards and iron vehicular gates, sign the gate as a narrow entrance. This solution would maintain the historic character and location of the gate. The width of the road would be less than 18', only one bus could pass through the gate. At this width, the gate becomes essentially a one lane gate.

C. Keep the pedestals in existing locations, add narrow curbs to both sides of the road, against the pedestals. This would add non-historic curb to the gate structure. The road width would be reduced to 18.5', extremely narrow for urban setting.

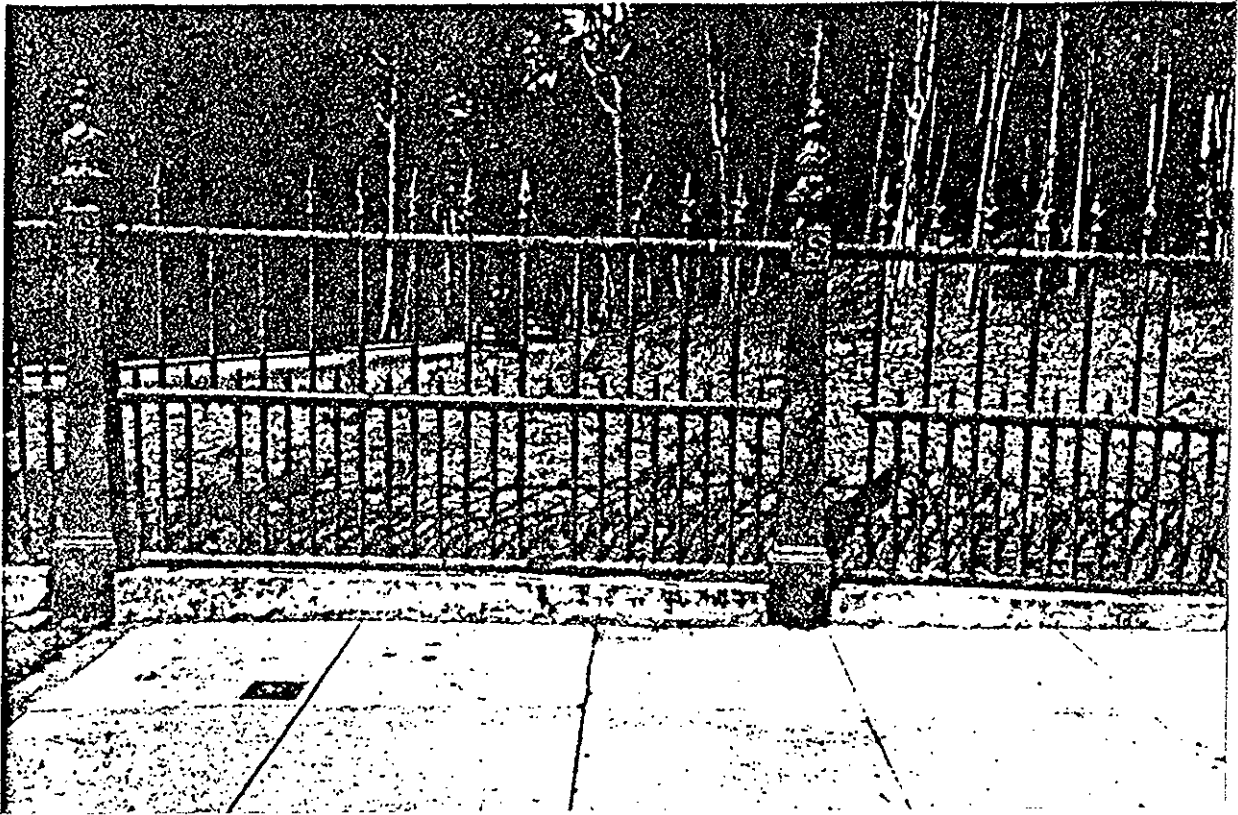
Figure 12 - Iron fence at the Presidio Gate, 1996

" At four of the entrances to the Presidio, handsome, ornamental iron gates have been erected with stone gate posts of fine design. These are of excellent appearance. It is believed, however, that in order to render the wall and gates suitable for the purposes for which constructed, to prevent trespass by unauthorized persons and the unauthorized departure of soldiers of the post, it will be necessary to place along the wall, an iron fence." Major Wm. W. Harts, 1907

The iron fence and pedestrian gate should be repaired following the original design and materials, using the existing fence and historic photographs to reproduce missing details.
