HABS No. WYO-26

T. A. MOULTON RANCH

Location: 3 miles south of Antelope Flats Road on the west side of Mormon Row Road, Kelly Vicinity, Teton County, Wyoming.  
Universal Transverse Mercator Coordinates: (USGS Moose Quadrangle Map) 12.527120.4833970.

# T.A. MOULTON RANCH

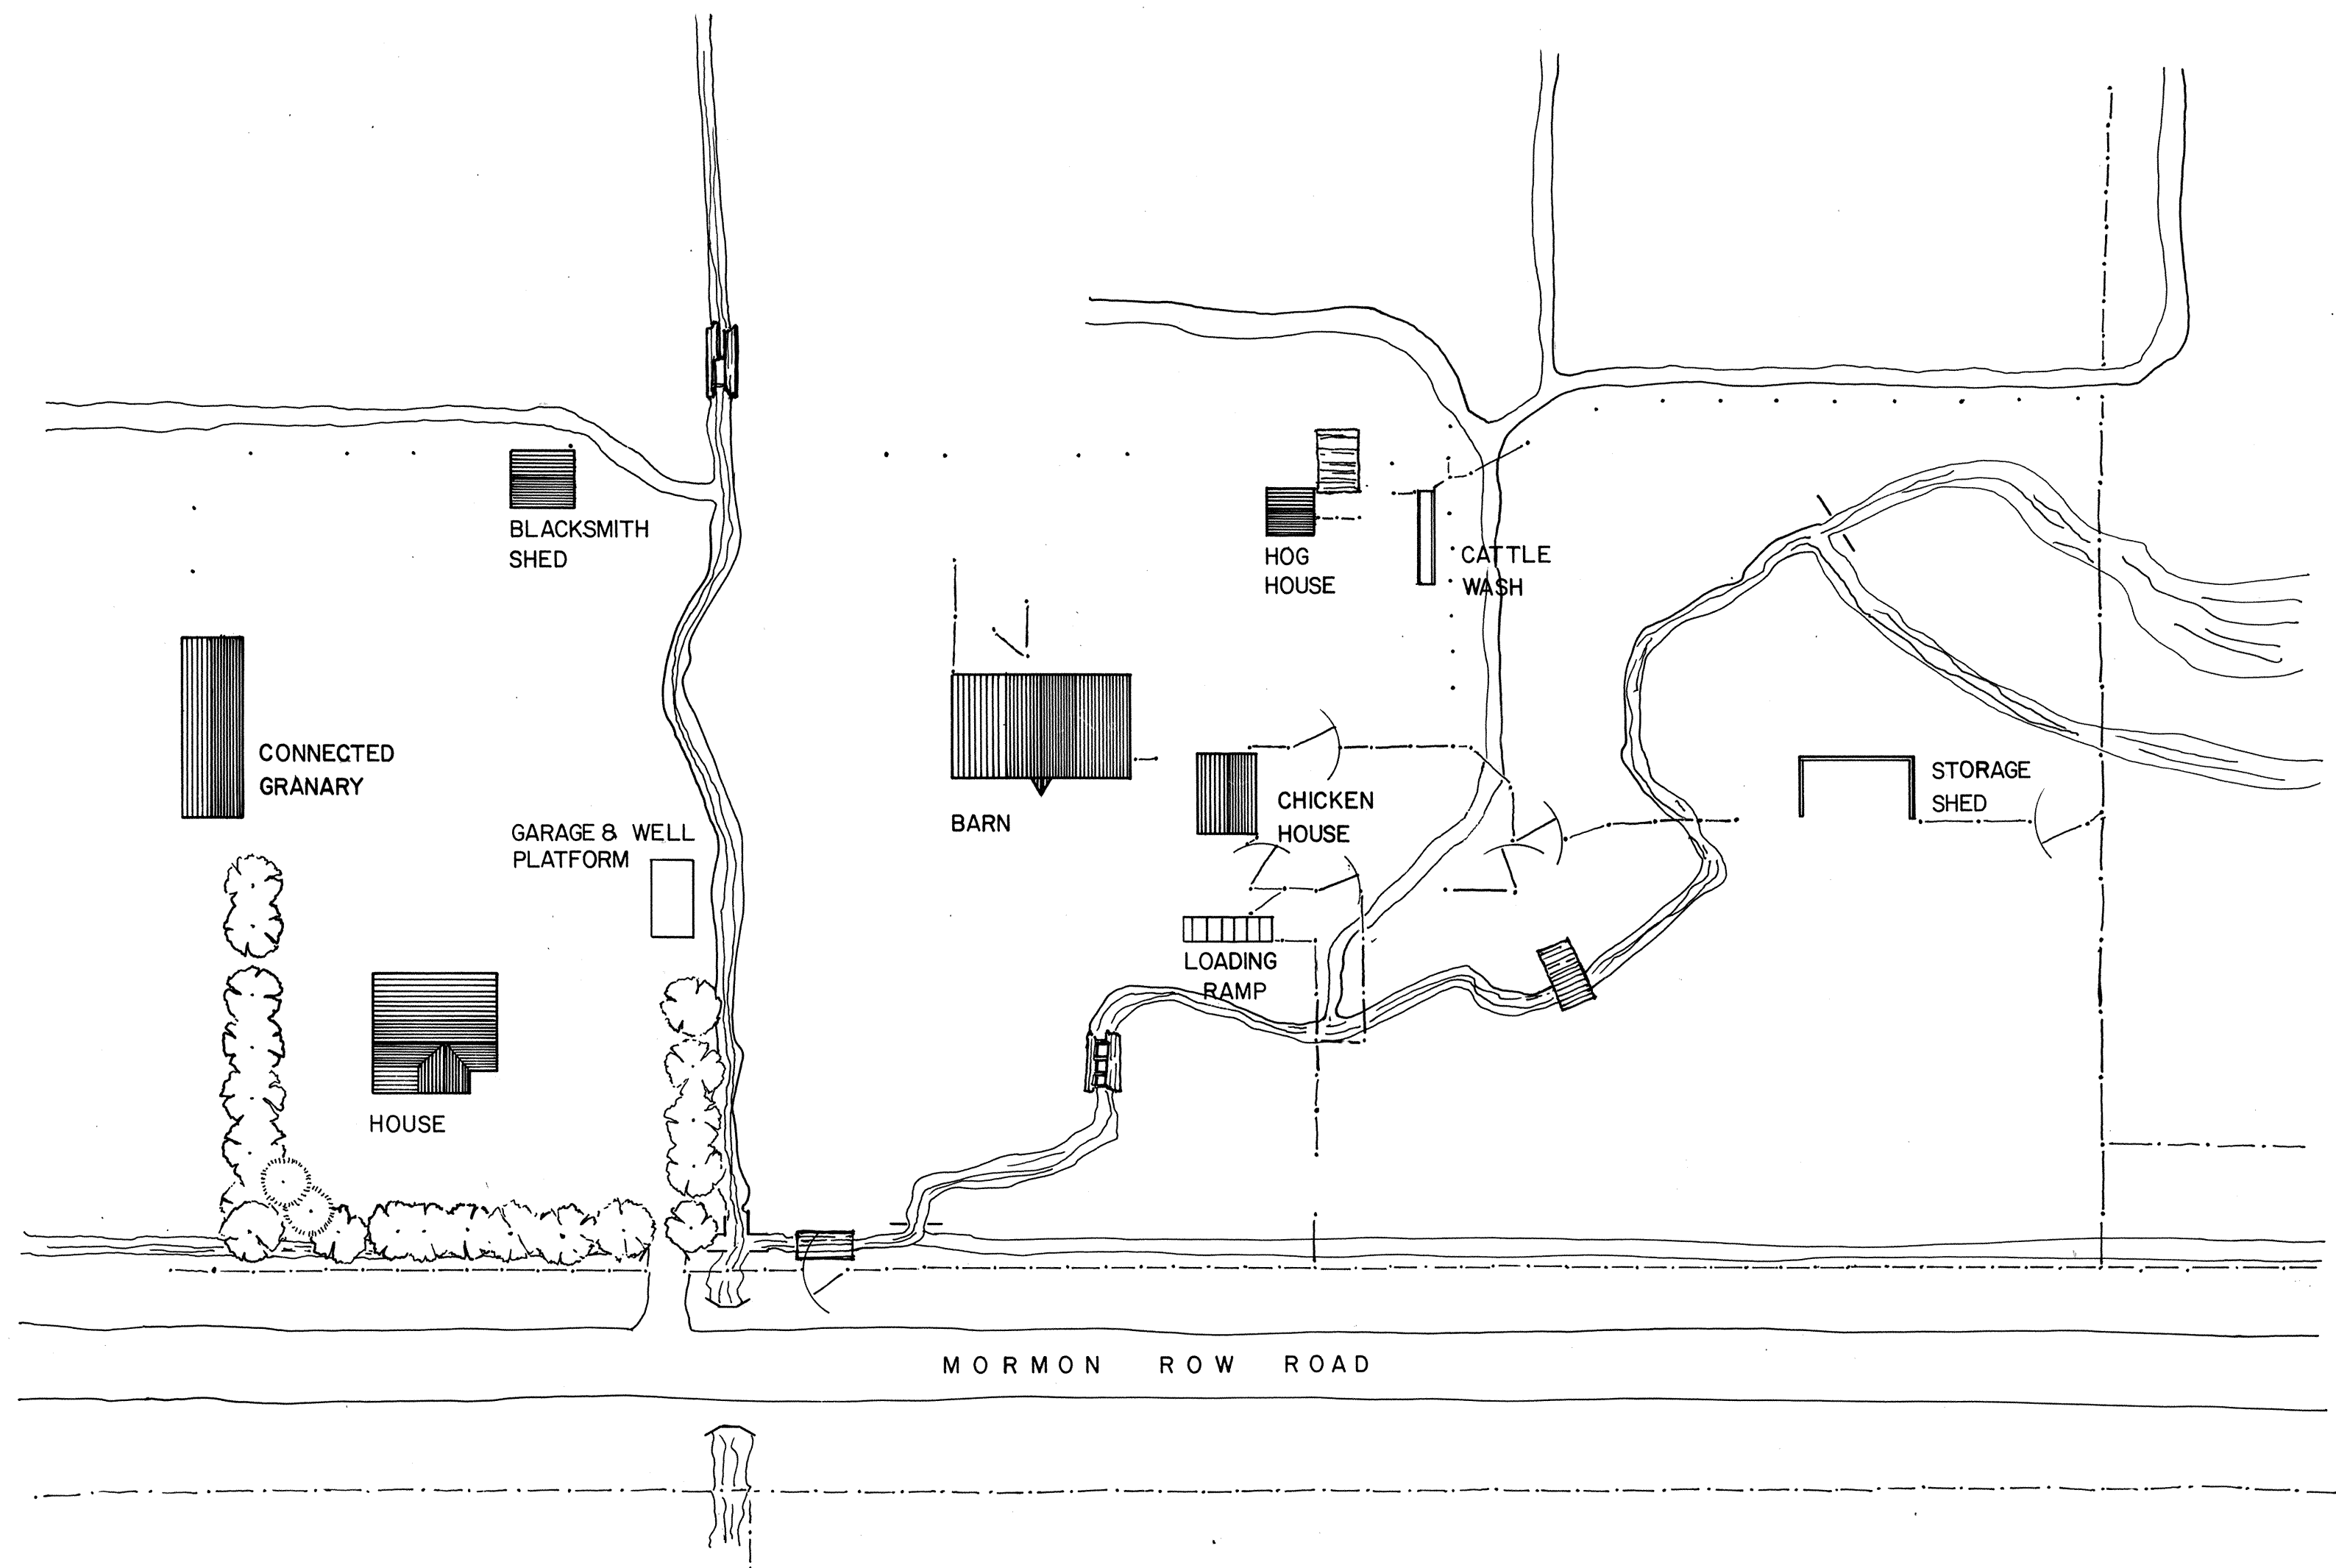
**SITE PLAN**

2. Outbuildings: In addition to the house there are several other buildings and structures associated with the Ranch. These include a barn, a connected granary, blacksmith shed, garage and well platform, loading ramp, chicken house, cattle wash, storage shed, and various wooden flood gates and bridges for irrigation.

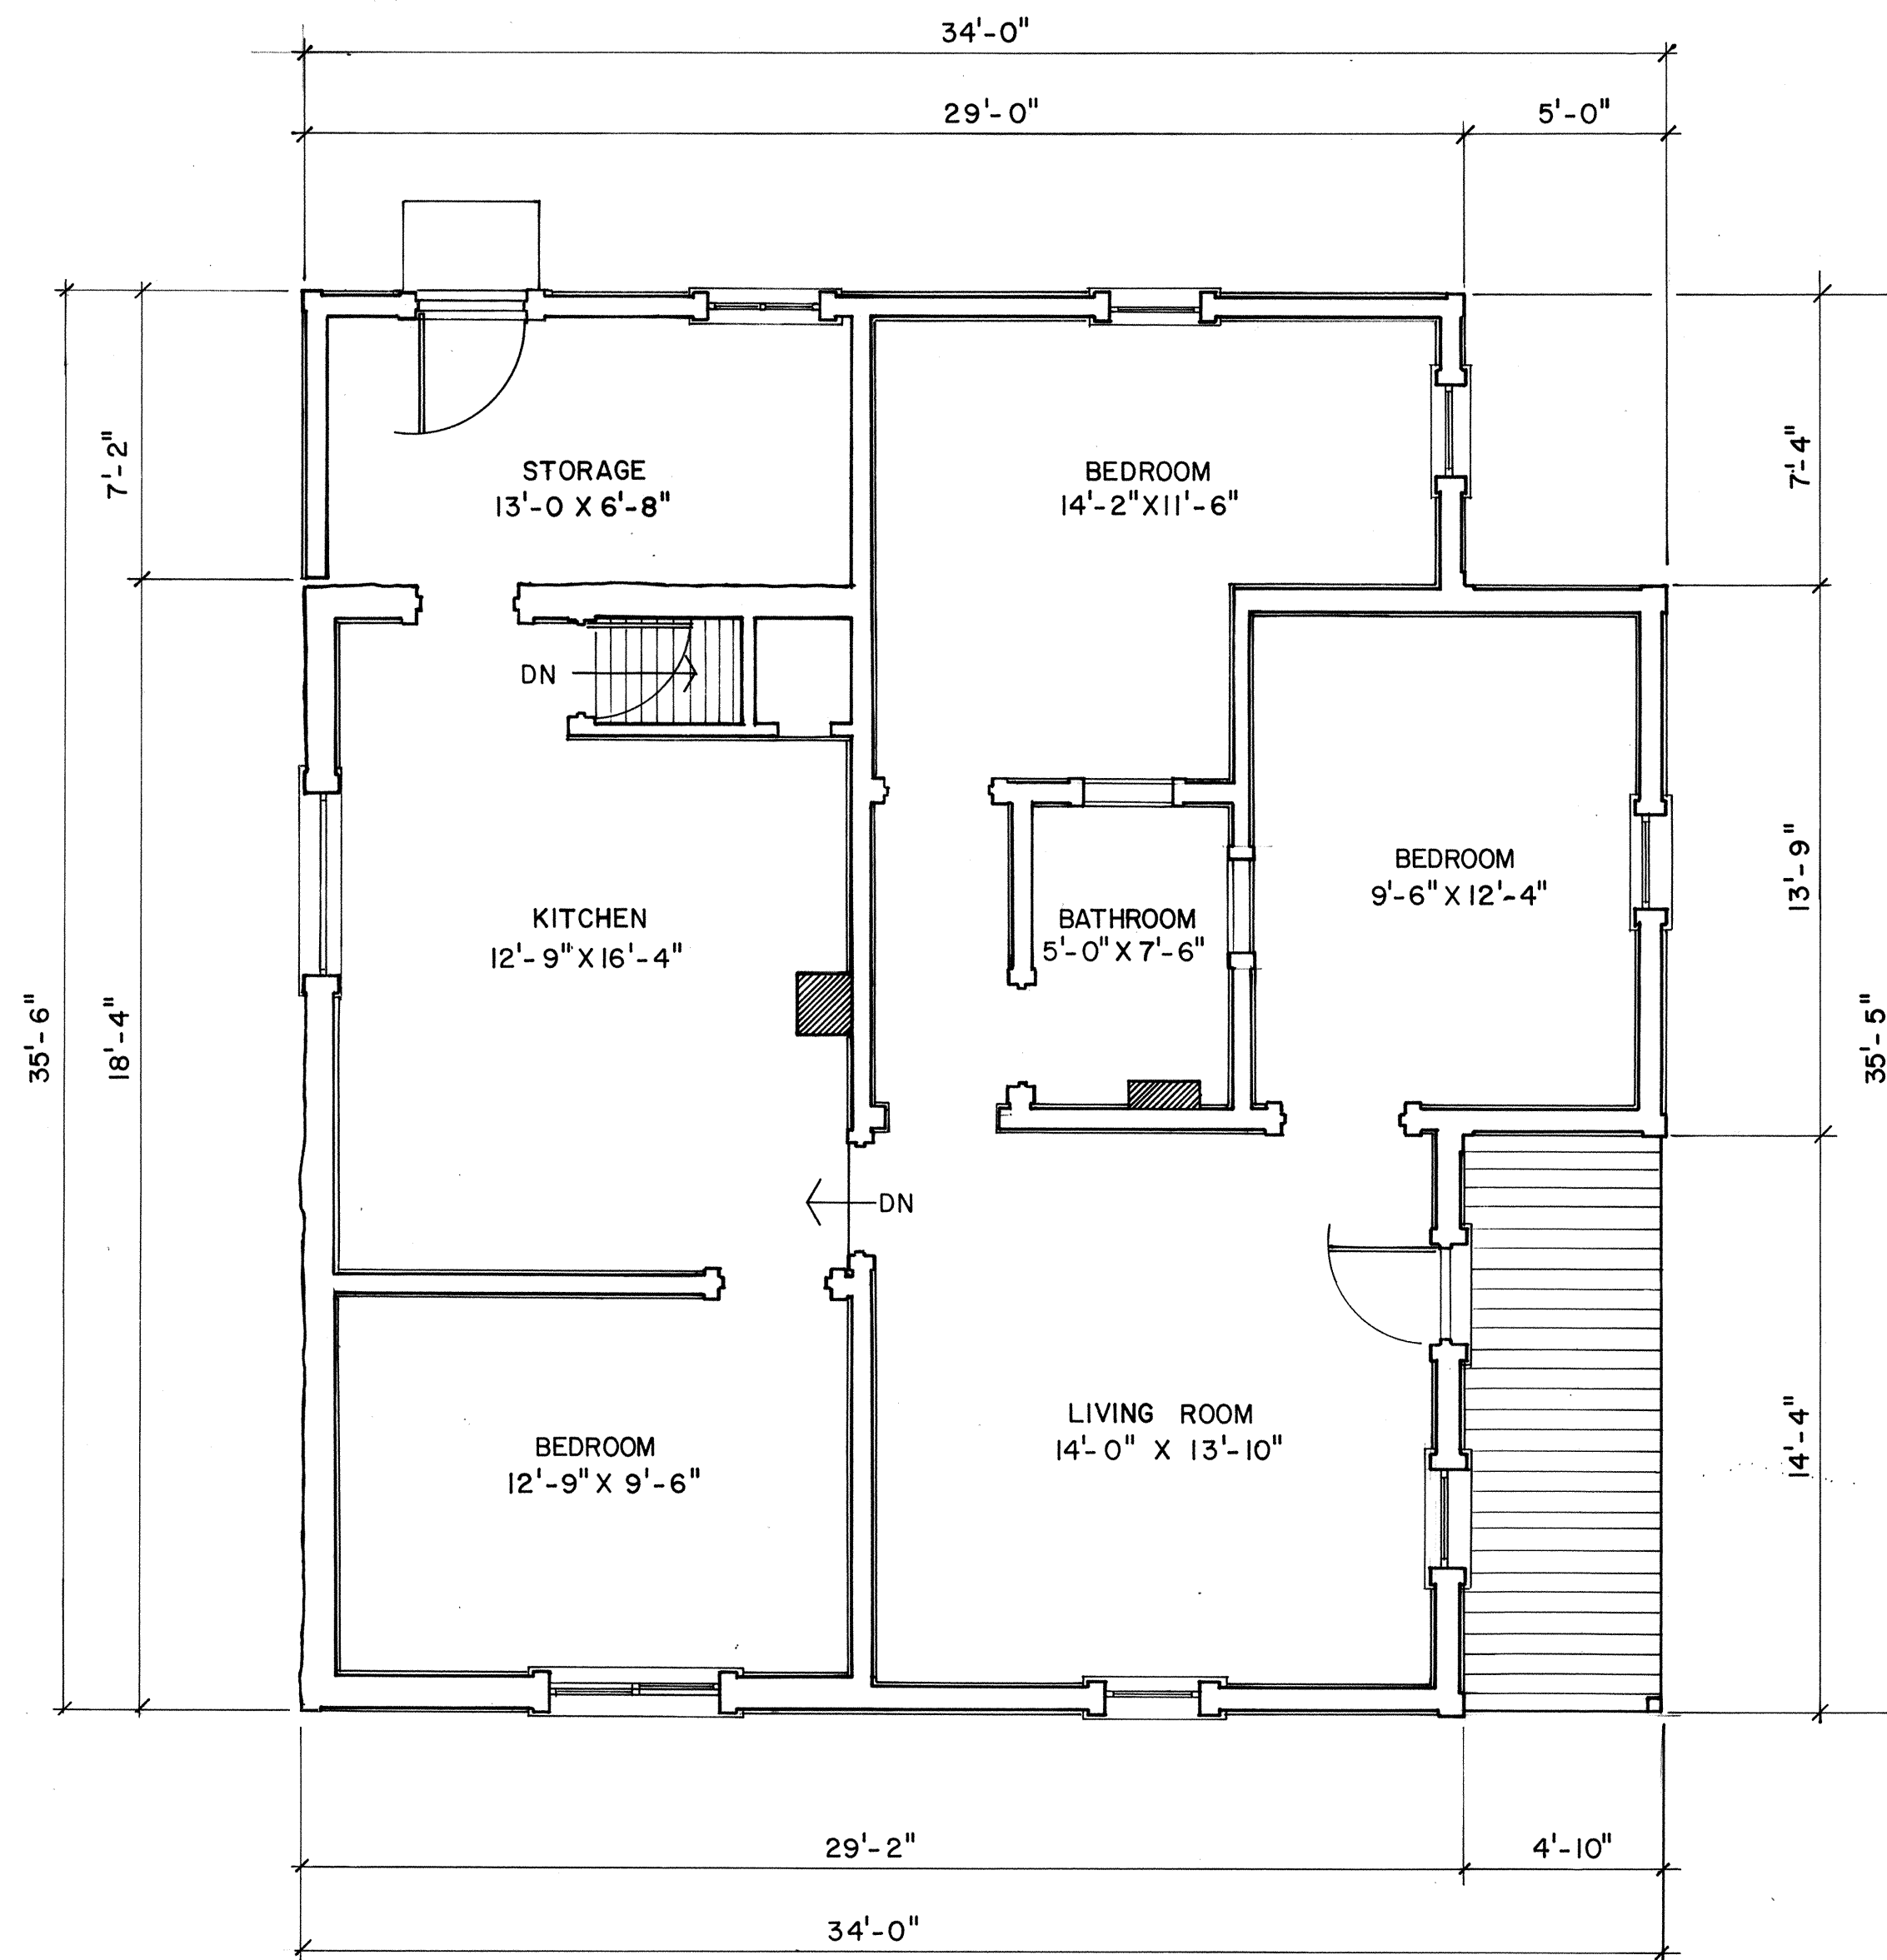
FLOOR PLAN

1. Over-all dimensions: 35'-5" (4 bays) x 34'-0" (2 bays), 1 1/2 stories, rectangular with bay and porch protruding.
2. Foundations: Concrete and stone foundations, wooden support piers used at intermediate points.

1. Floor plans:
  - a. Basement: Partial basement with interior access.
  - b. First floor: The first floor has been remodeled. The present plan includes a kitchen storage room, one bathroom, a living room and three bedrooms.
  - c. Attic: The attic is closed off and accessible through a hatch door in the central portion of the house.
2. Stairways: An open stair with exposed stringers descends from the kitchen to the partial basement beneath the central part of the house.

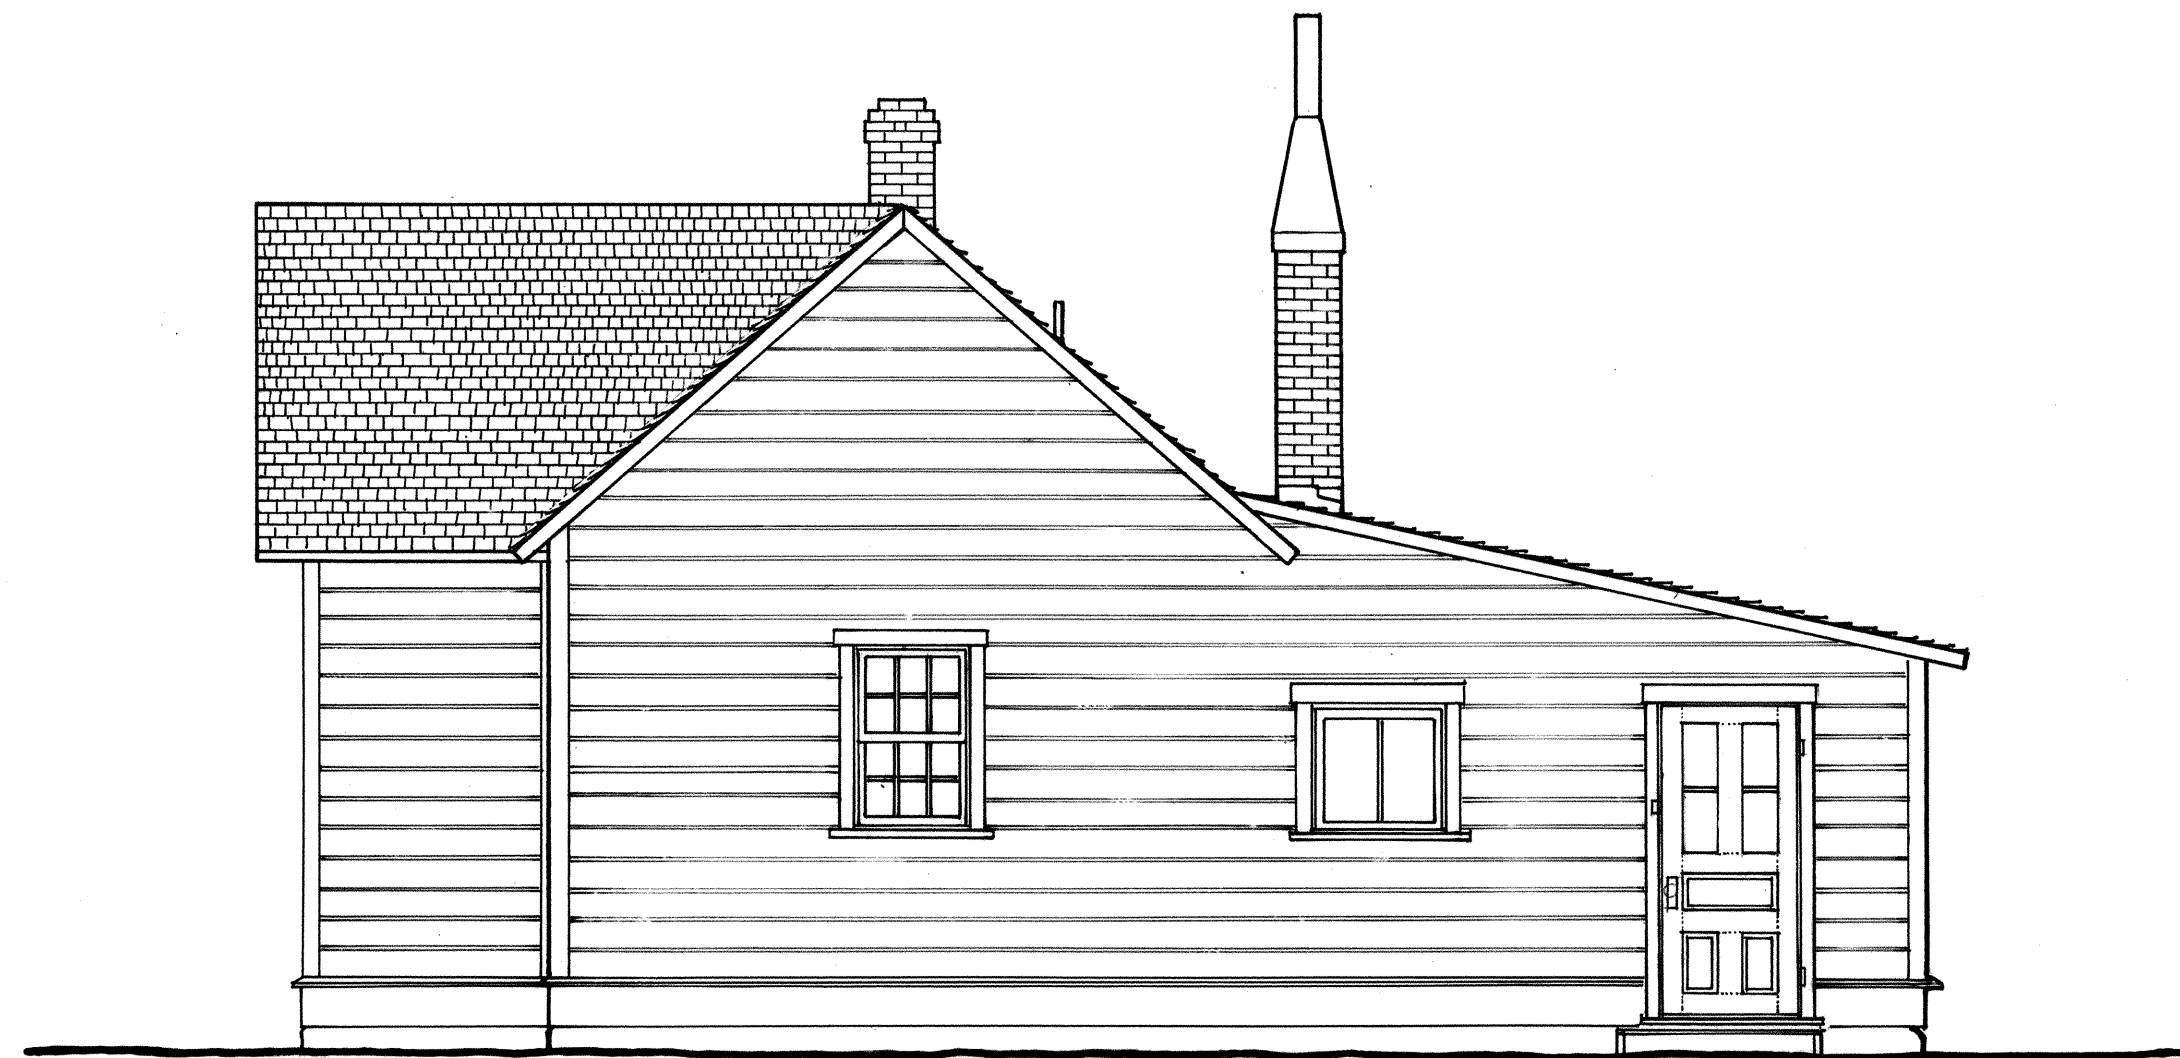
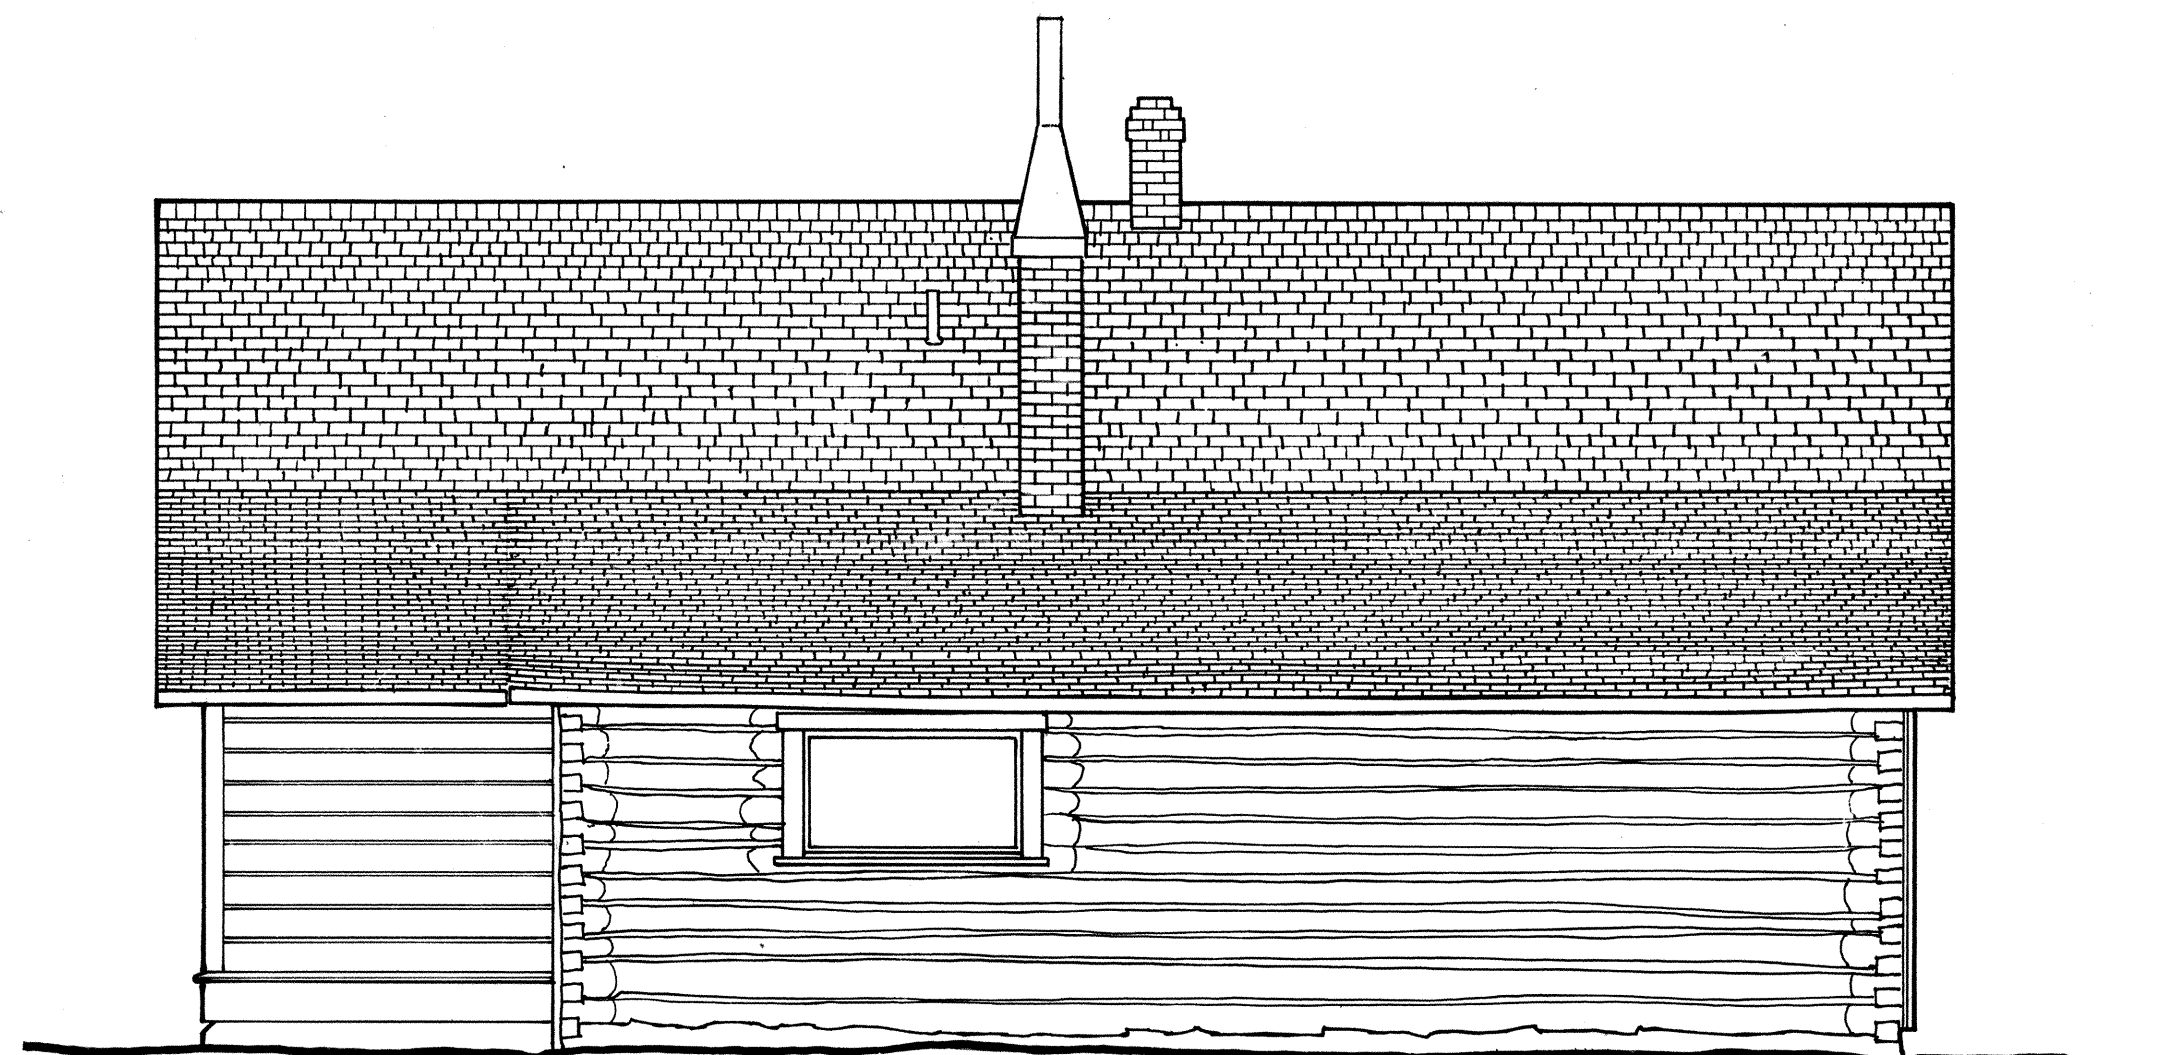
NORTH ELEVATION

6. Alterations and additions:
- House: A porch on the north facade was enclosed by a frame addition providing storage space and enlarging one of the bedrooms. No date has been established for the addition.

3. Wall construction, finish and color: The original log structure, a simple system of stacked logs, is tenant notched and spiked together at the corners; one original log wall is exposed on the west elevation. The modern part of the ranch house is frame with wooden shiplapped siding and painted white.

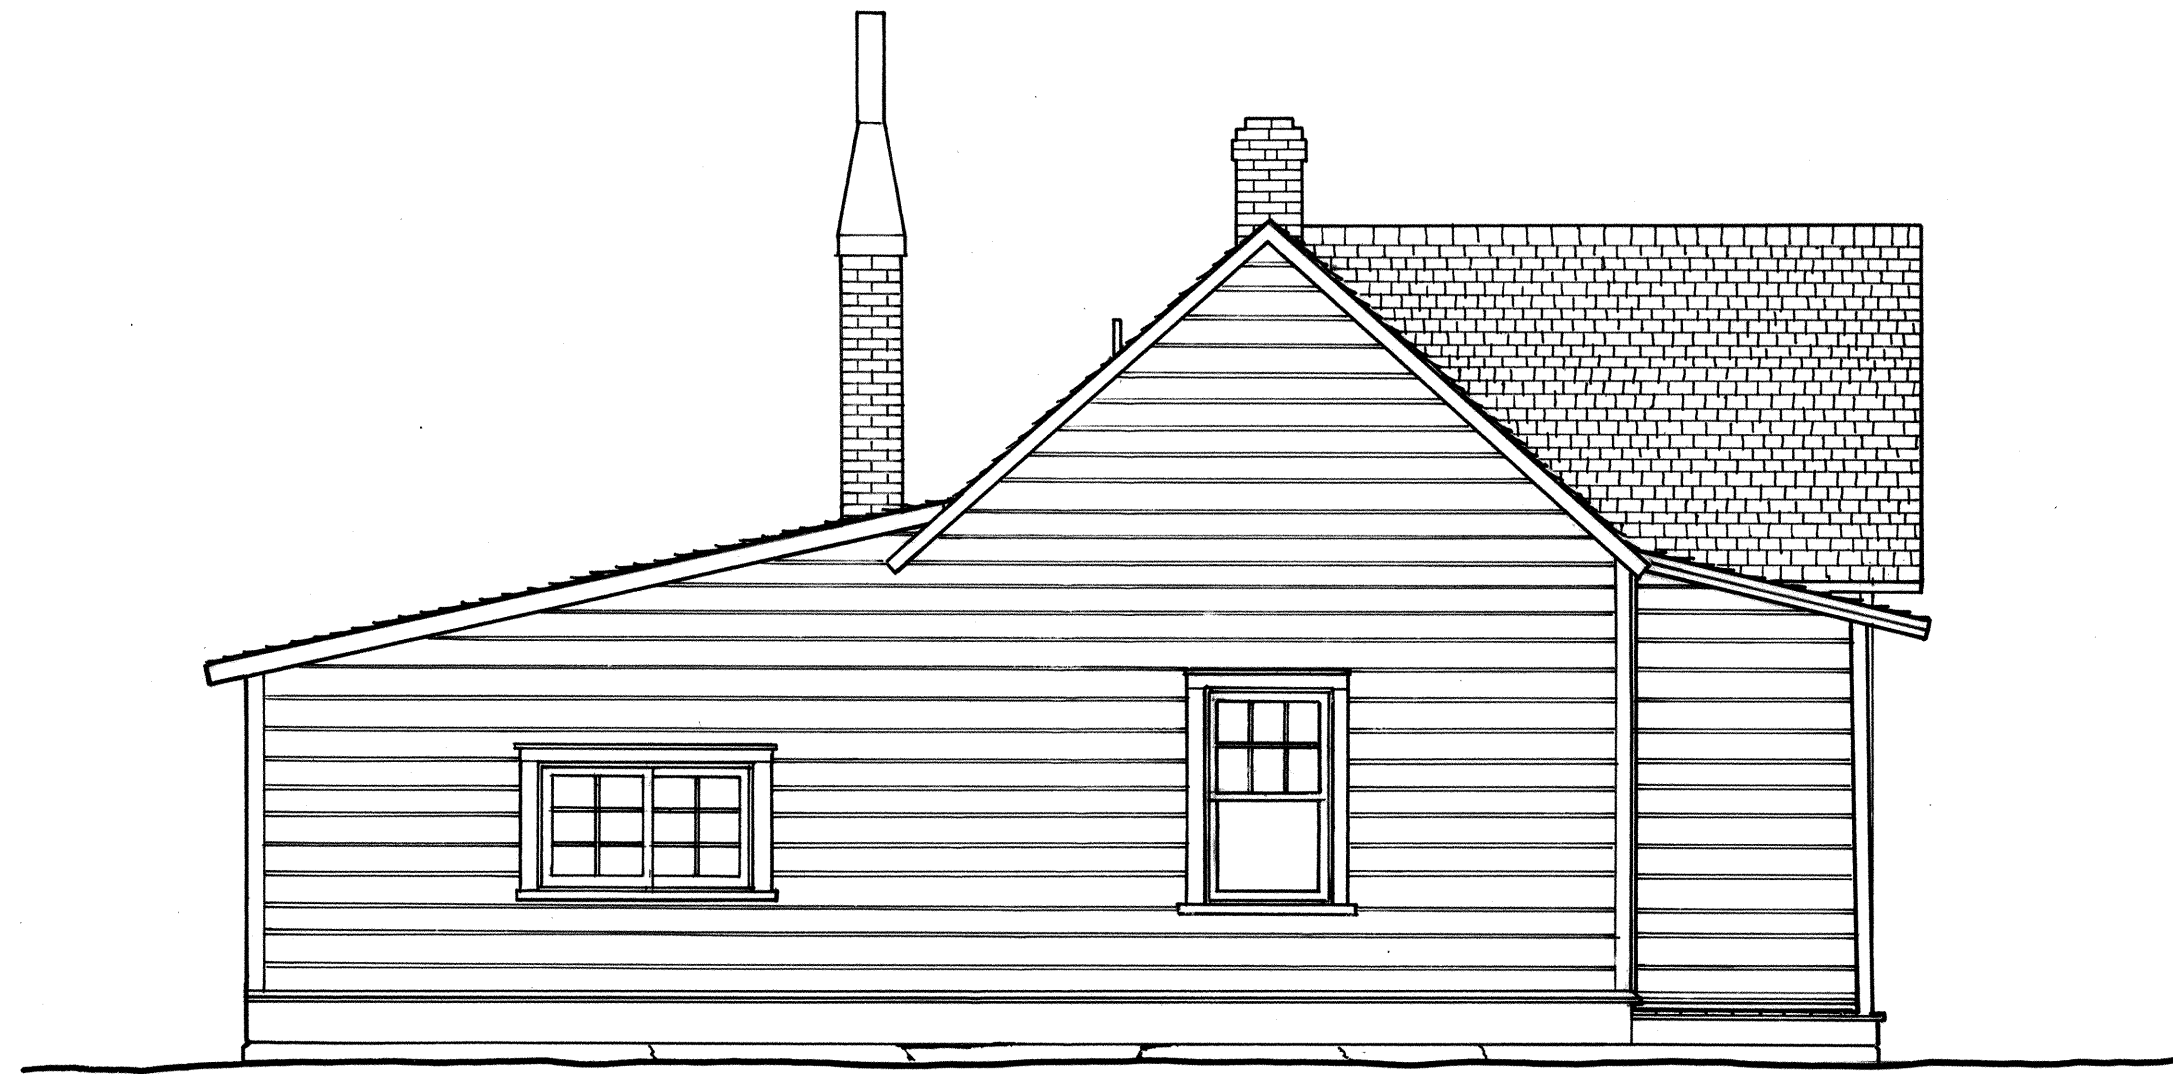
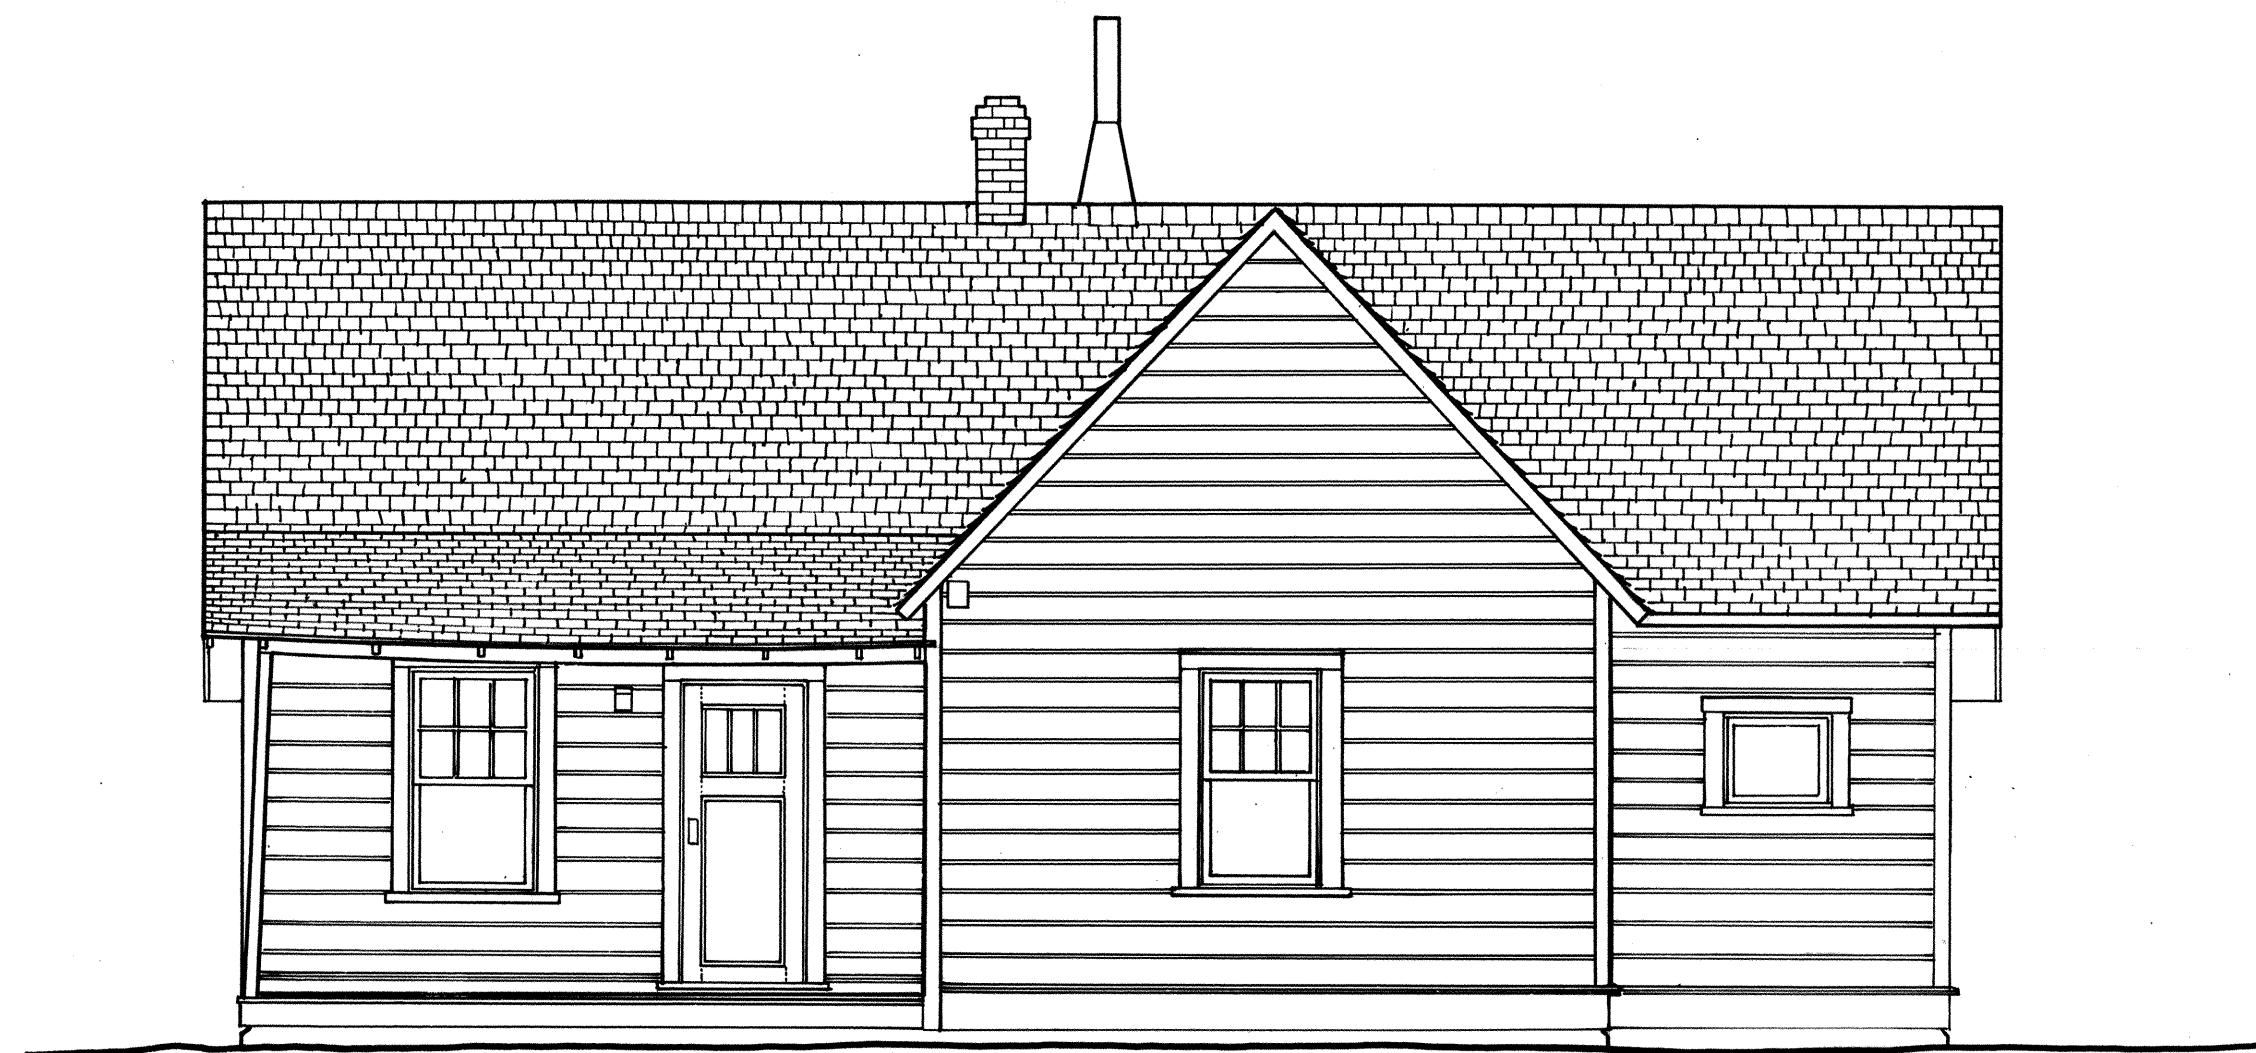
EAST ELEVATION

4. Structural system, framing: Log and frame bearing walls.
5. Porches: Open wooden porch on east elevation gives access to front entry.
6. Chimneys: Two masonry chimneys, one capped by sheet metal extension.

7. Openings:
  - a. Doorways and doors: There are doorways on the east and north sides of the building. Openings are framed with dimensioned lumber. Wooden doors are paneled and the two upper panels are windows.

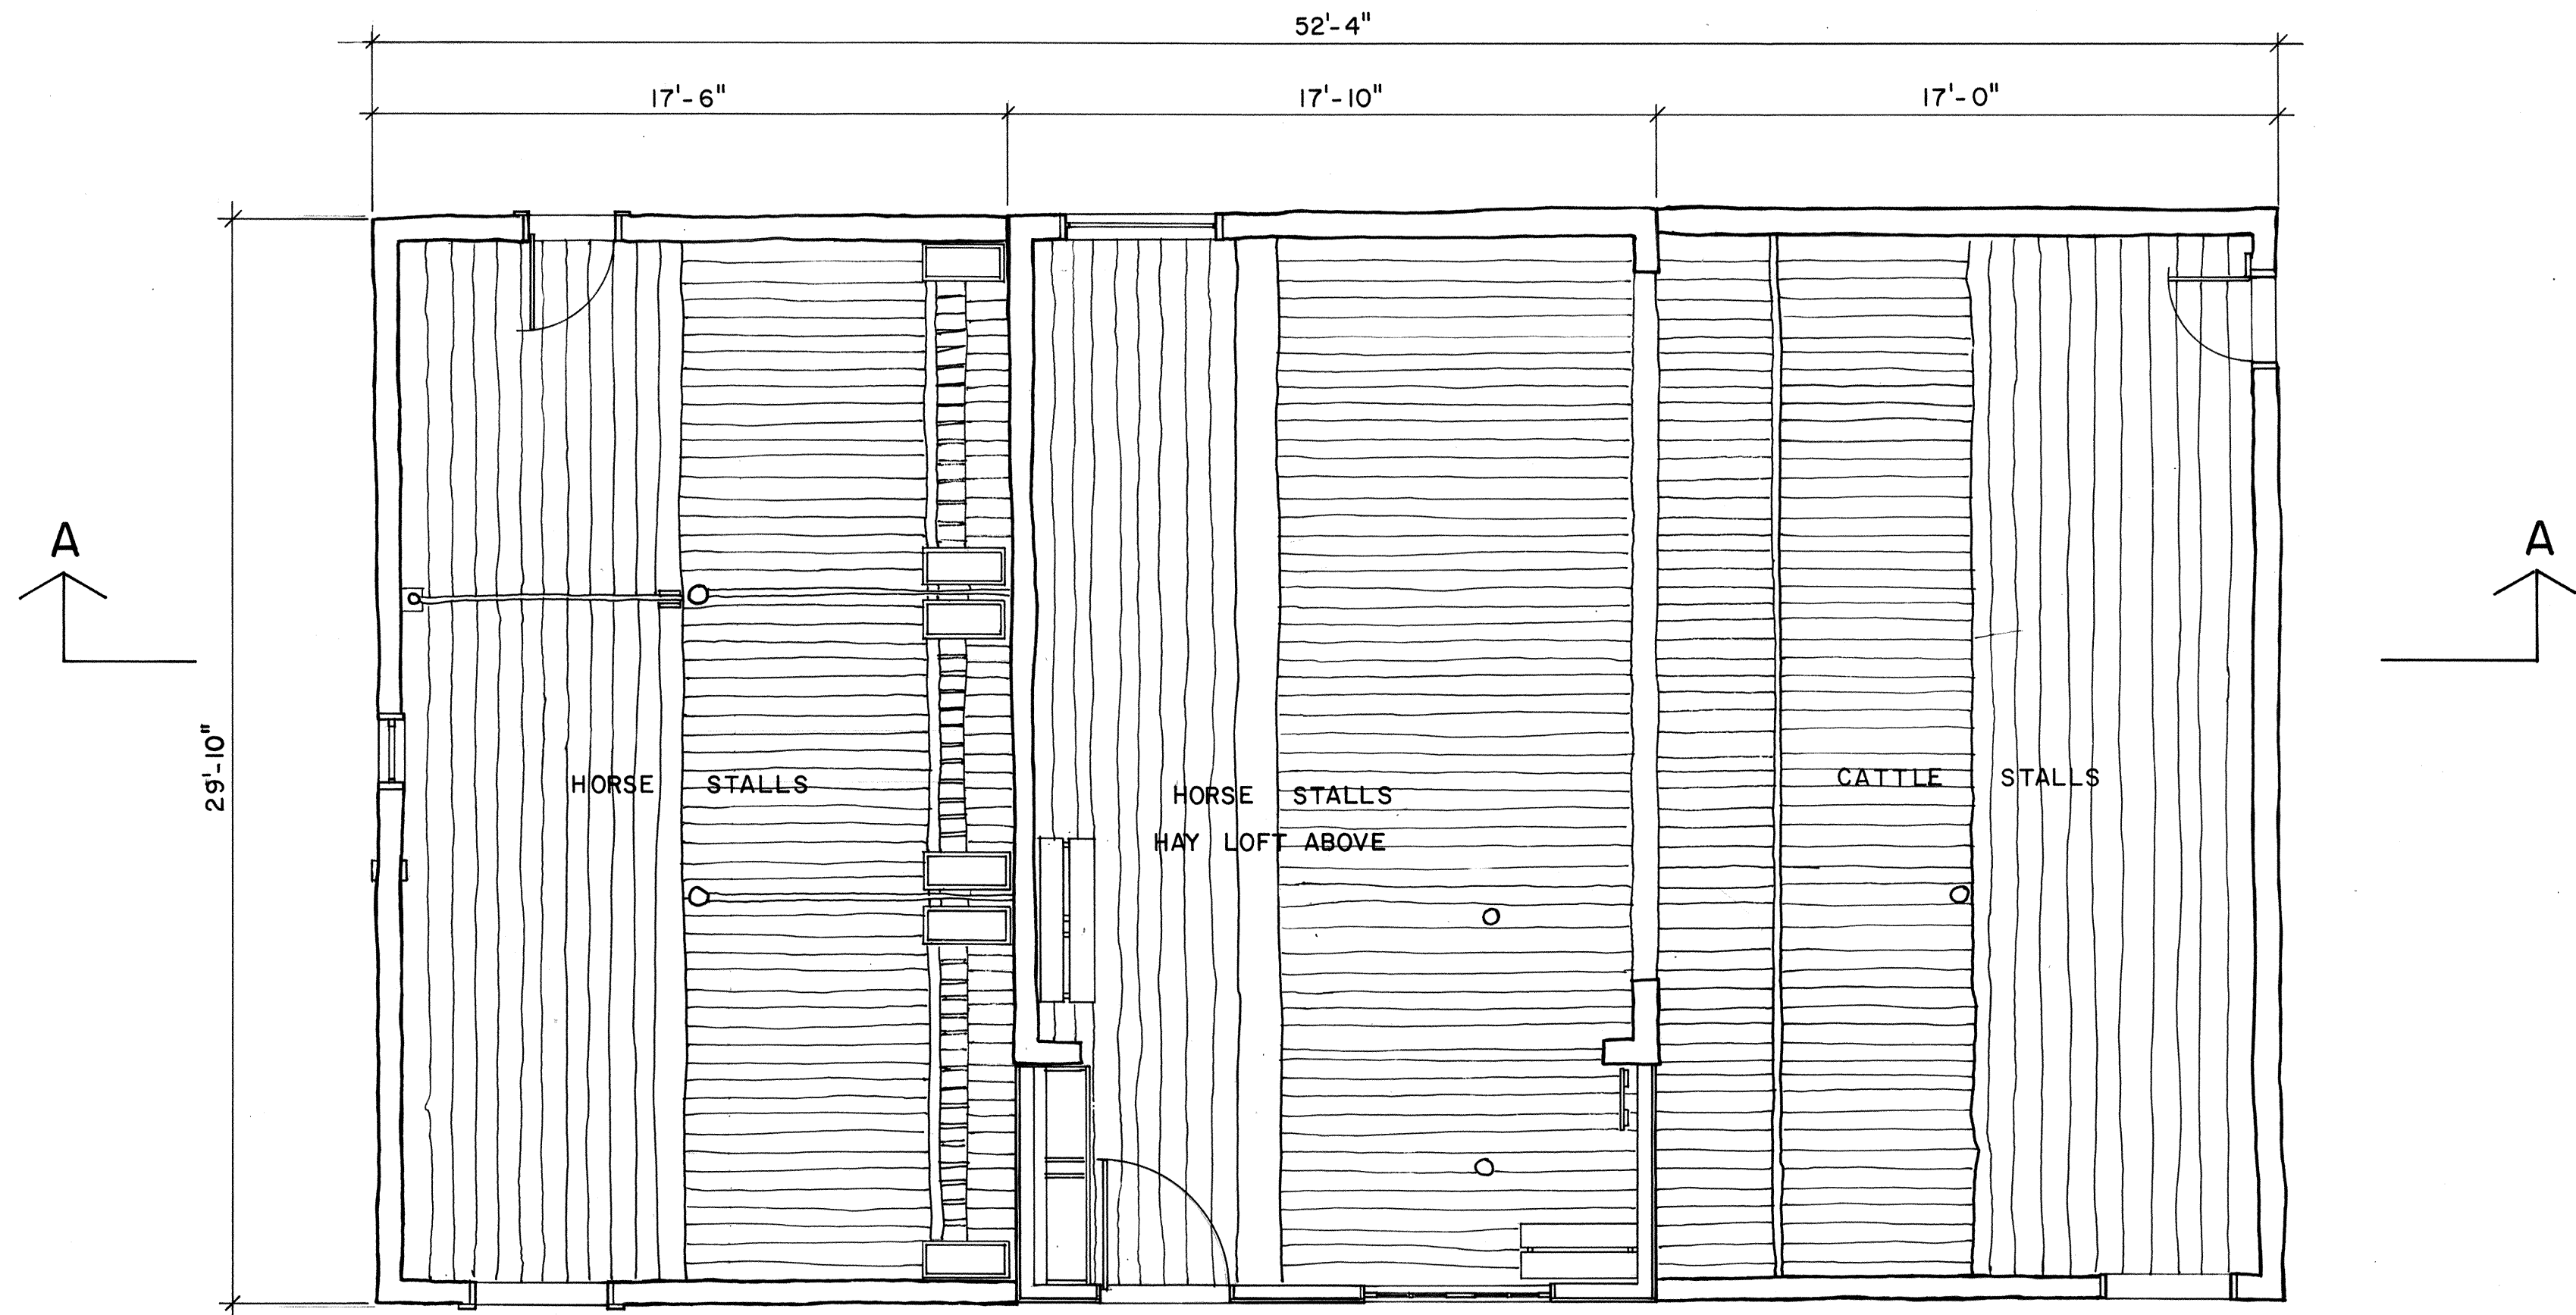
FLOOR PLAN

1. Floor plans:
  - a. First floor: Divided into three bays, north, central, and south. The north bay is 17'-0" x 29'-10". Essentially bare, there are remains of a feed trough. This bay was apparently used by cattle. The central bay is 17'-10" x 29'-10" and originally was used for horses. There are two wooden benches built into the east and south walls, and a grain bin built on the south wall. A 1' x 1' gutter runs east and west the width of the barn. The south bay, 17'-6" x 29'-10", has three horse stalls built against the interior wall. A large trough for hay is attached to the interior wall.

- b. Second floor: There is a hayloft over the central bay, accessible through a large door located above the hay trough in the south bay. In the central bay a crude wooden ladder on the north wall leads to the hayloft via a hatch in the northeast corner.
