HABS No. WYO-26

T. A. MOULTON RANCH

Location: 3 miles south of Antelope Flats Road on the west side of Mormon Row Road, Kelly Vicinity, Teton County, Wyoming.  
Universal Transverse Mercator Coordinates: (USGS Moose Quadrangle Map) 12.527120.4833970.

# T.A. MOULTON RANCH

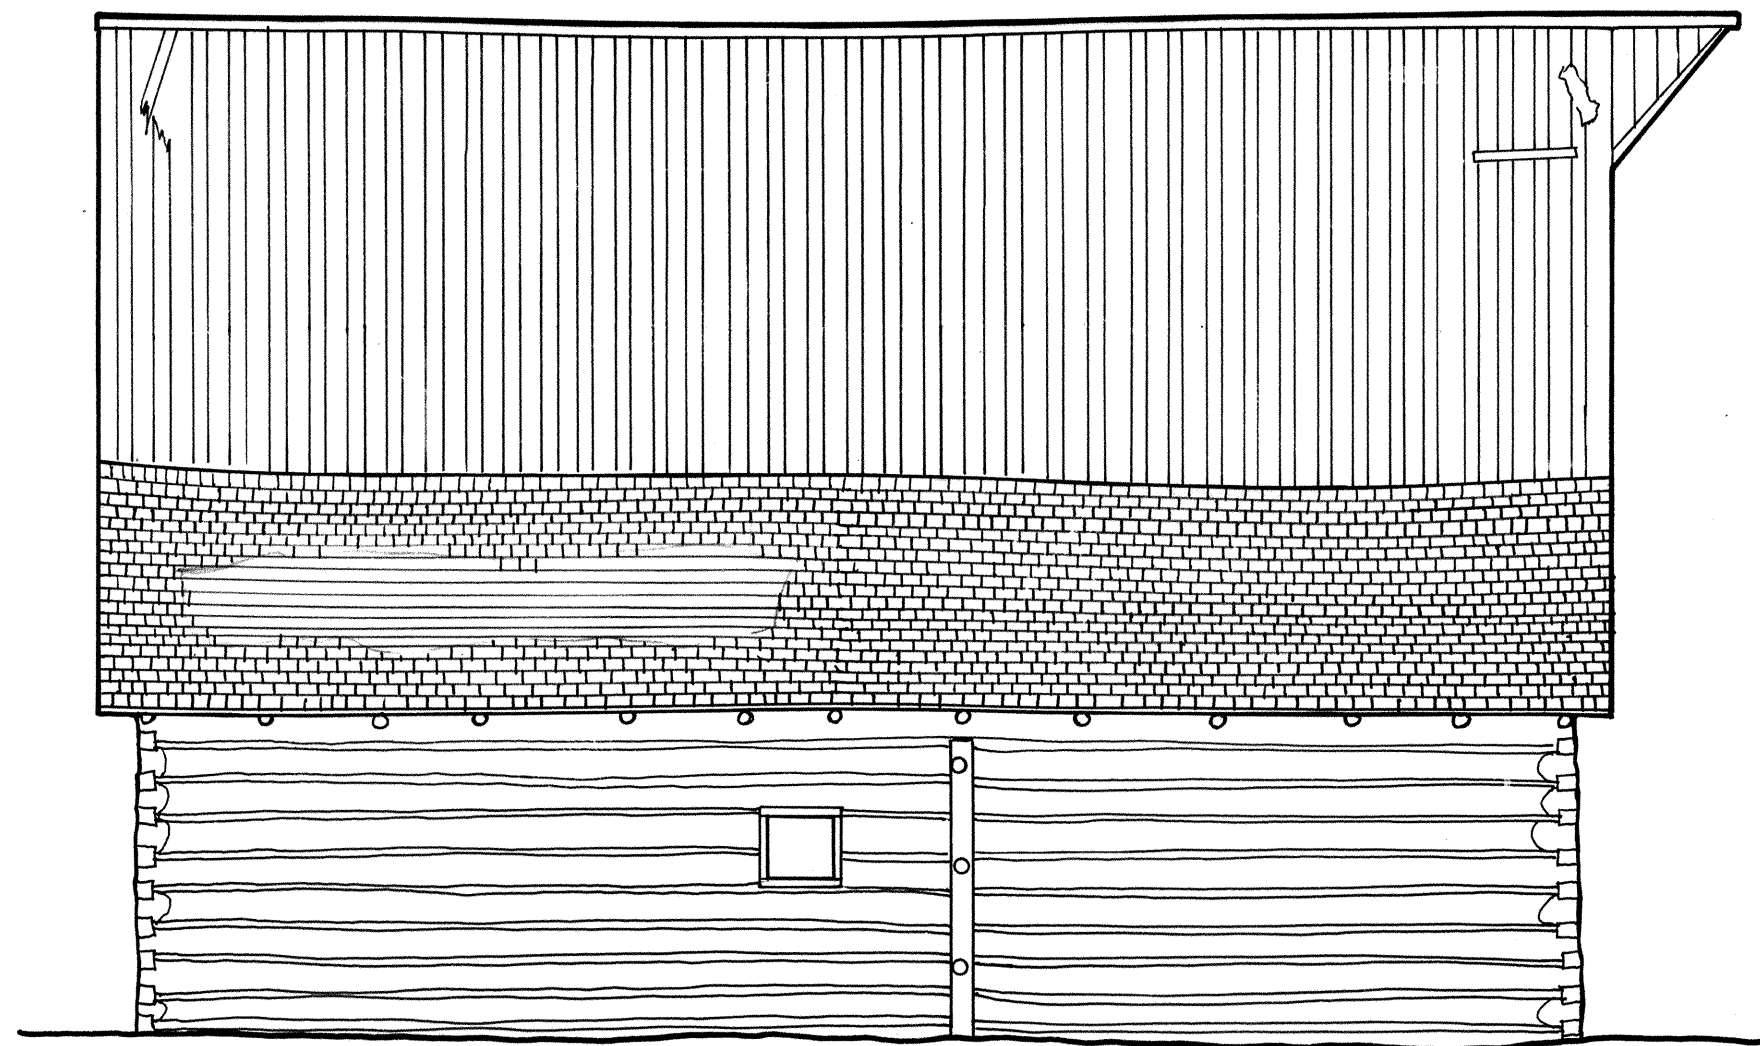
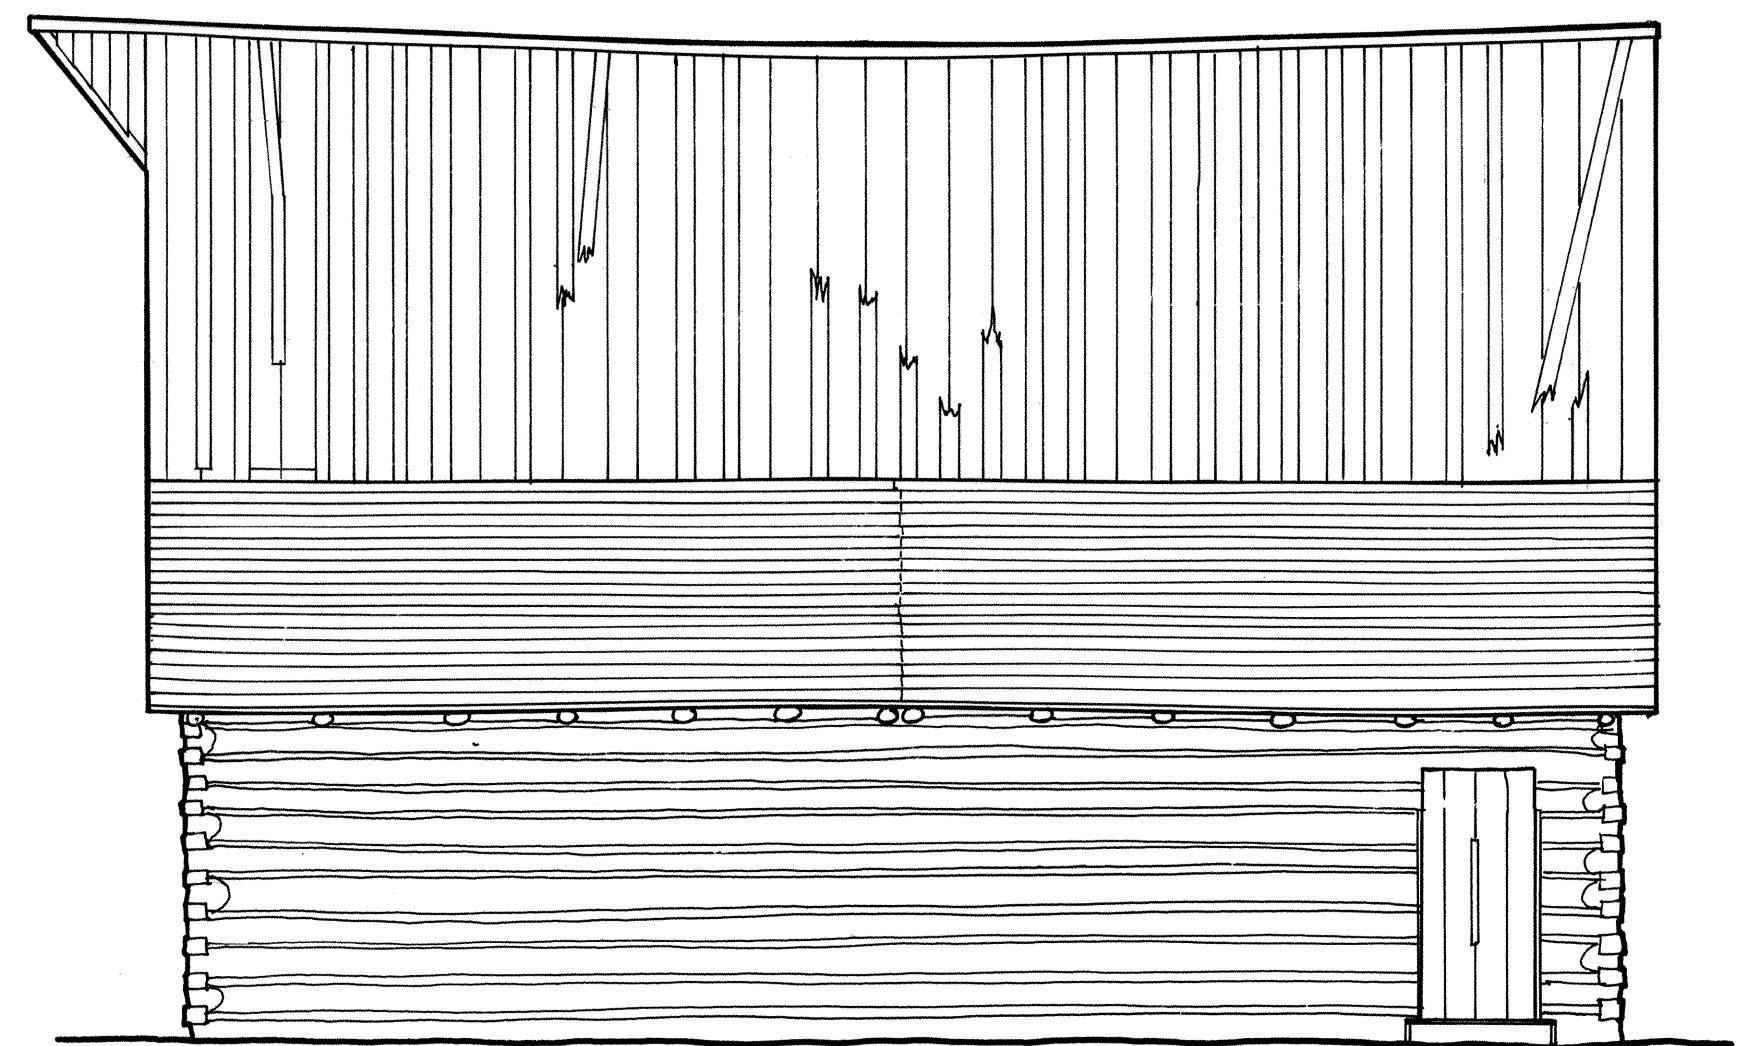
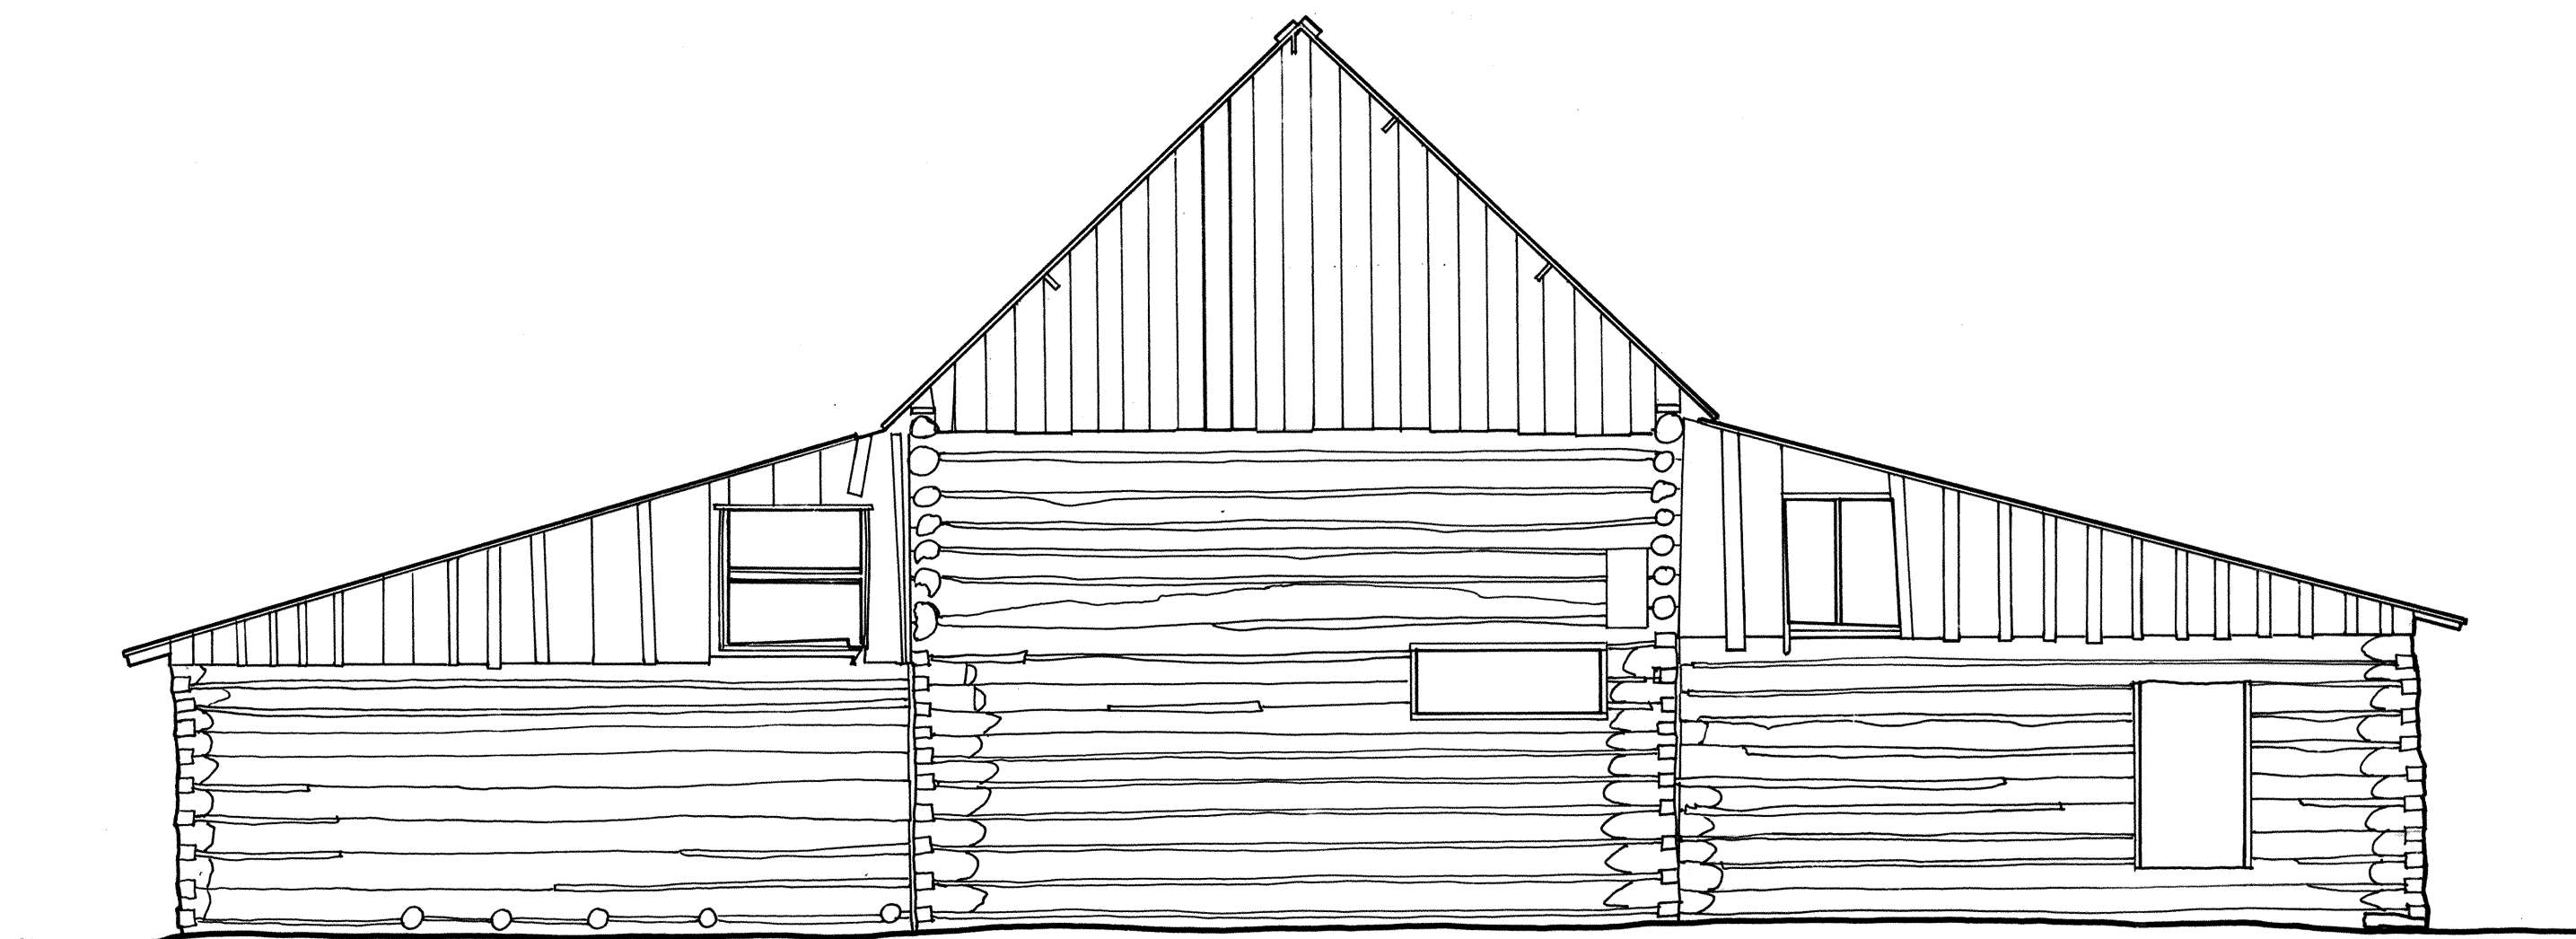
SOUTH ELEVATION

- Barn: Built ca. 1916 it was enlarged with the addition of a hayloft and a lean-to addition on the south facade (no date). A lean-to addition was added to the north facade (no date).

1. Over-all dimensions: 52'-4" (4 bays) x 29'-10" (1 bay), central portion has two stories, flanked by one story lean-to additions, rectangular.
2. Foundations: Loose stone on grade.

3. Wall construction: Log bearing walls, with wood and mortar chinking, and tenant notching at the corners; left unfinished to weather. The second story as well as the east wall on the central bay are frame construction with board and batten siding.

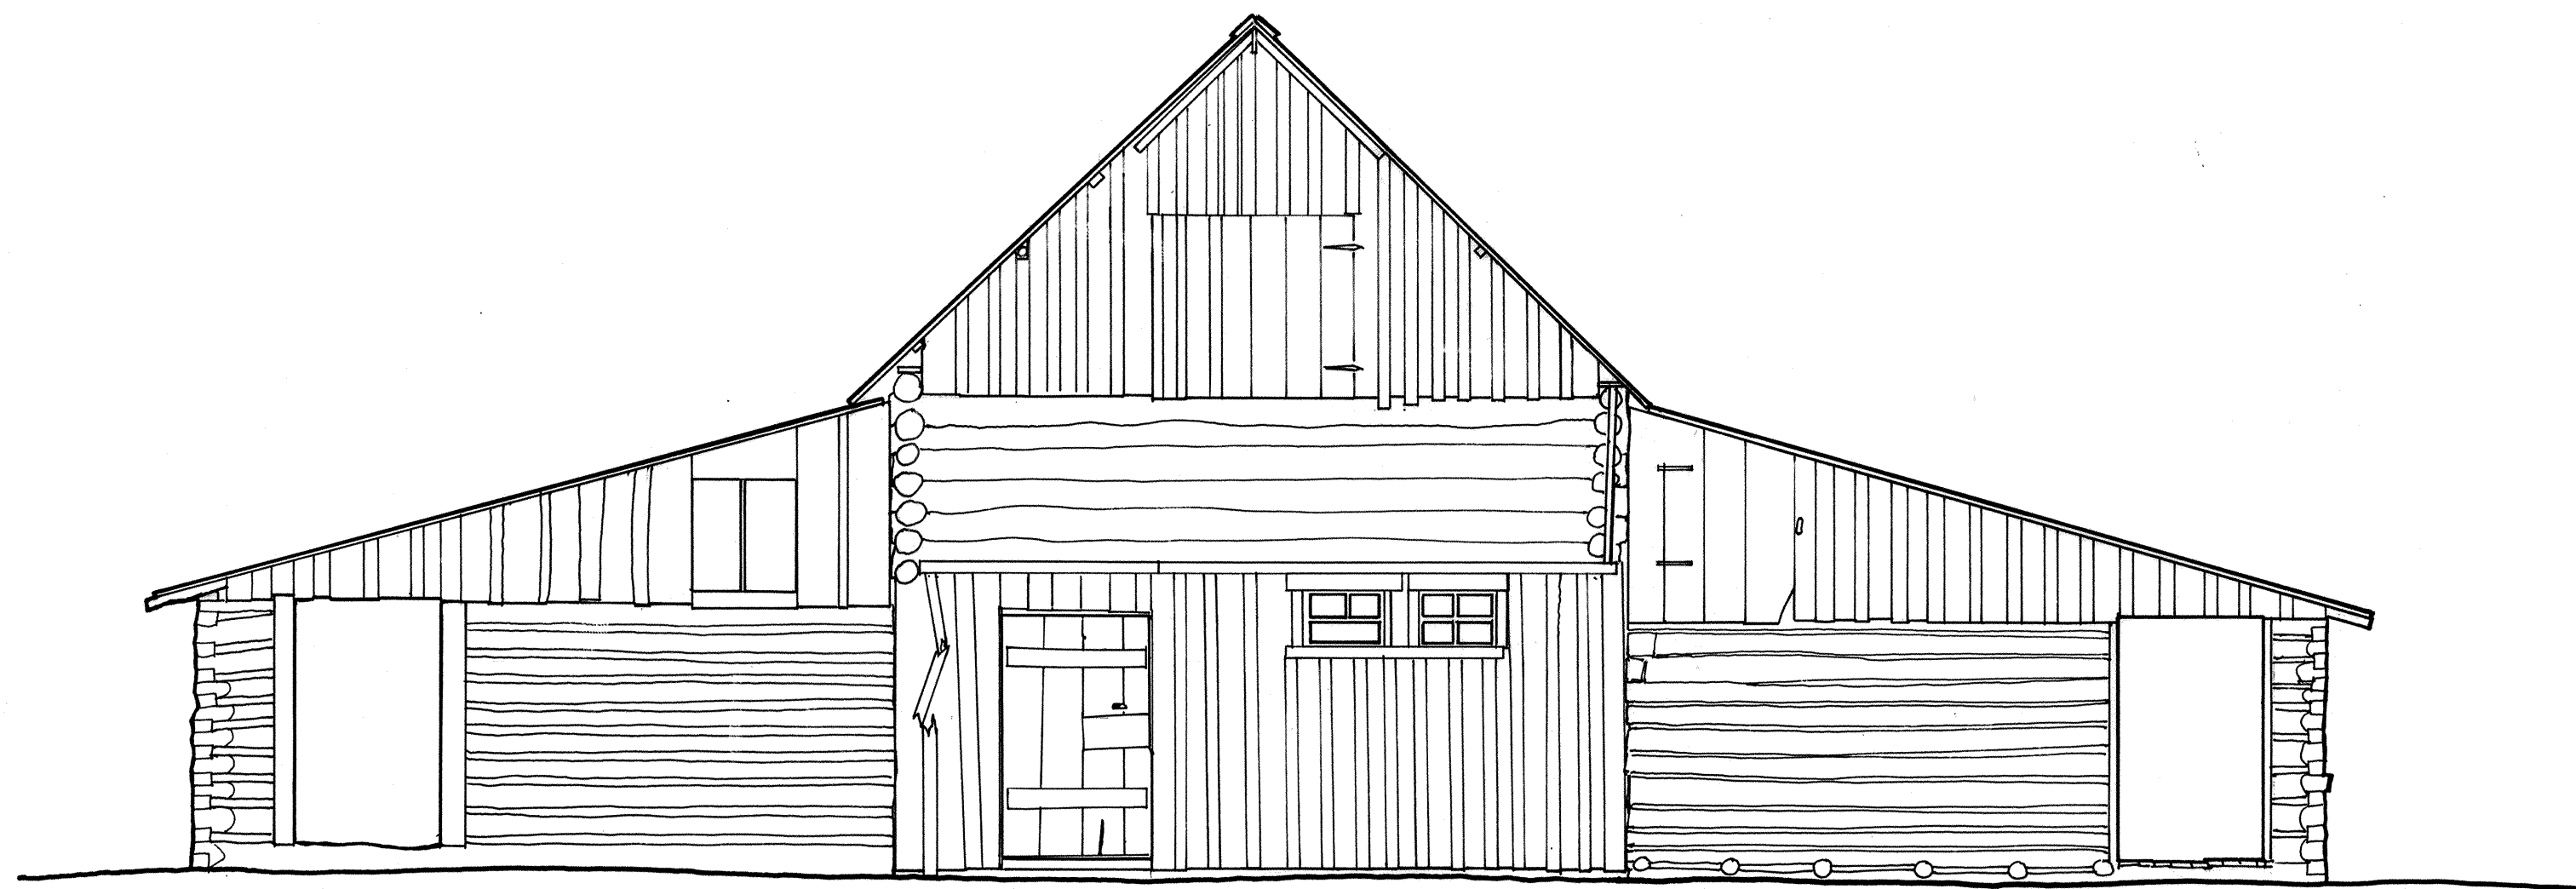
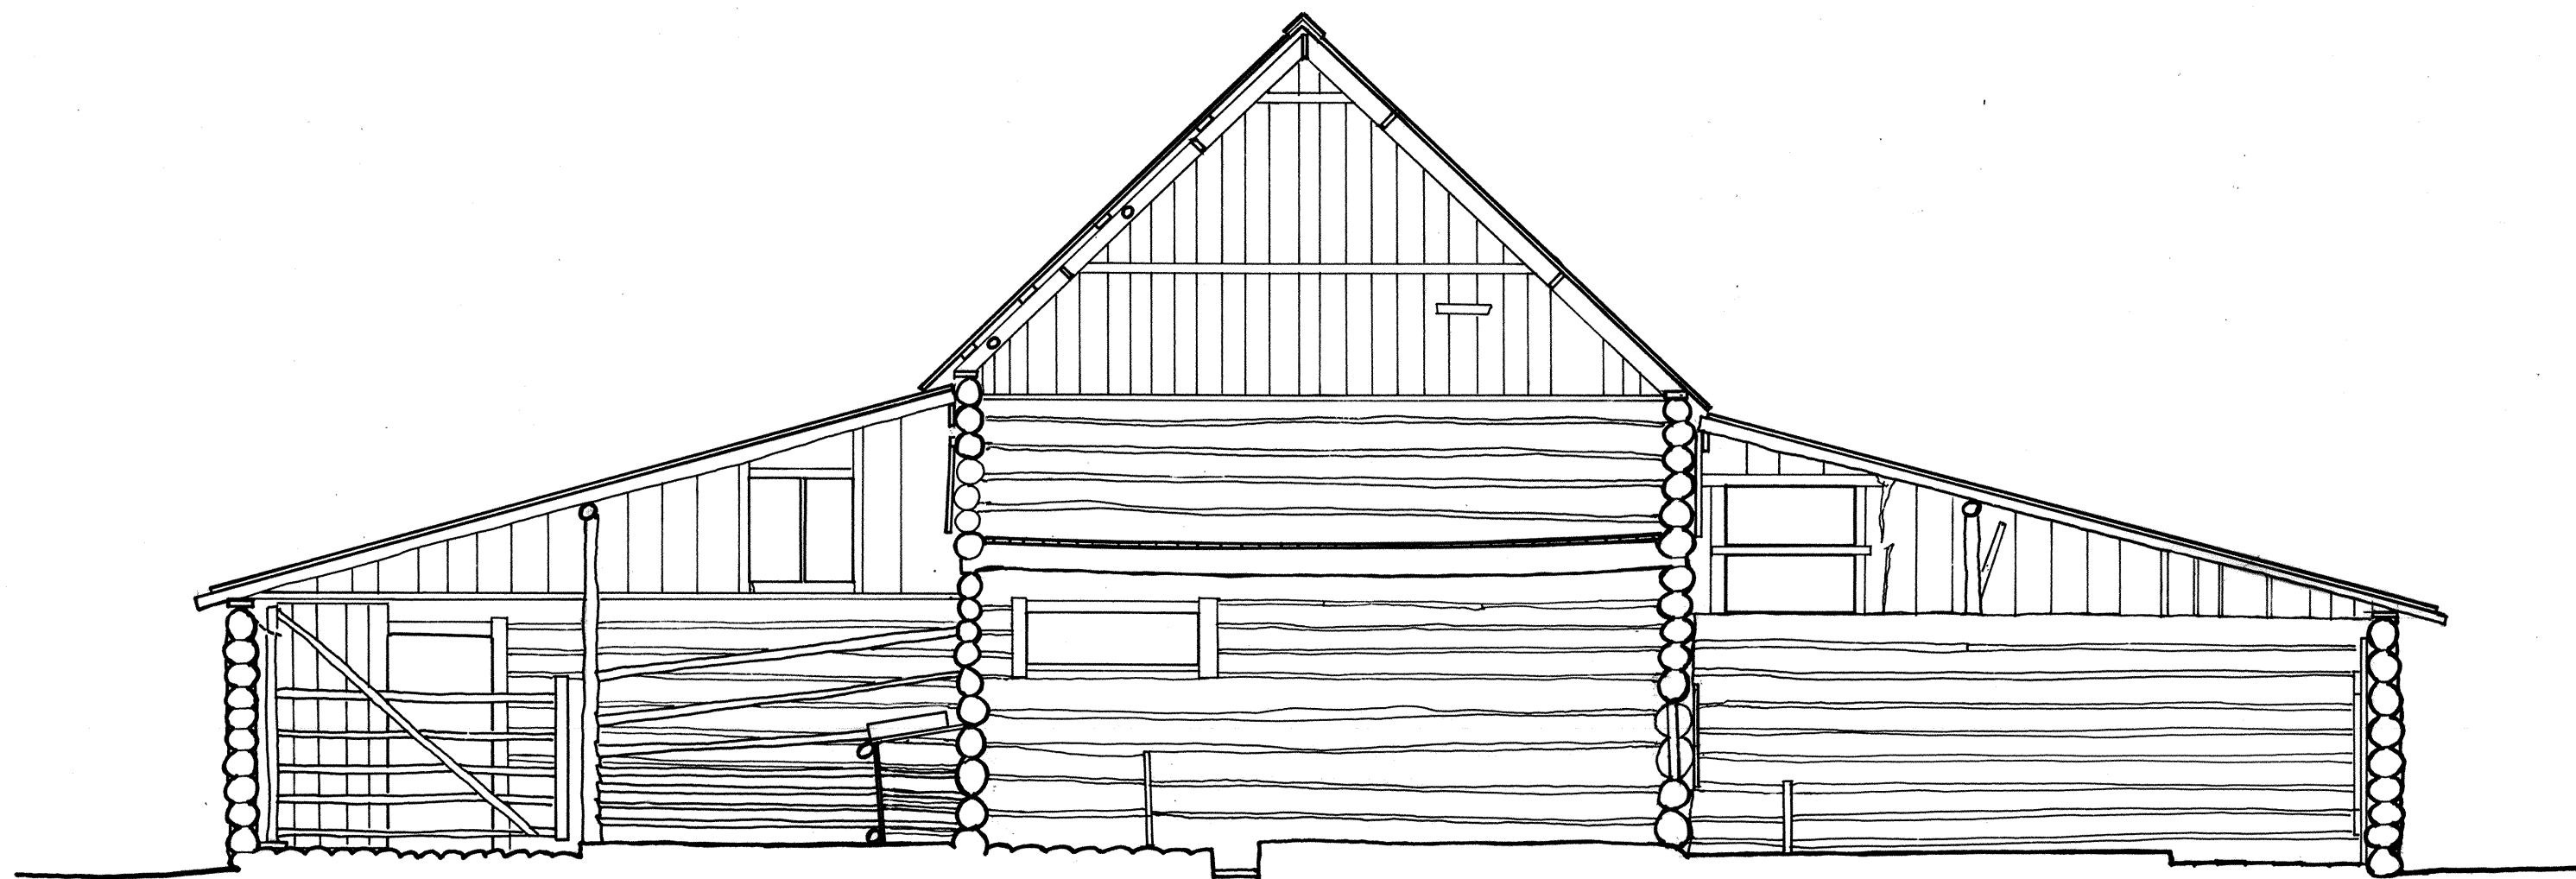
EAST ELEVATION

- b. Cornice, eaves: Eaves are projected with exposed rafters.
  - c. Dormers, cupolas, towers: The ridge beam extends out about 2'-6" on the east elevation and is supported by two diagonal members. This was used to hoist hay to the second-story loft.

3. Flooring: Log flooring is used in all bays; wooden plank-  
ing is used in parts of the central and northern bays and  
for the floor of the hayloft.
4. Wall and ceiling finish: The logs and rough-cut lumber  
framing have been left exposed. Wooden chinking is used  
on some of the outside walls.
5. Doorways and doors: Horizontal openings with wooden flap  
doors used between bays.
6. Hardware: Crude surface strap hinges.

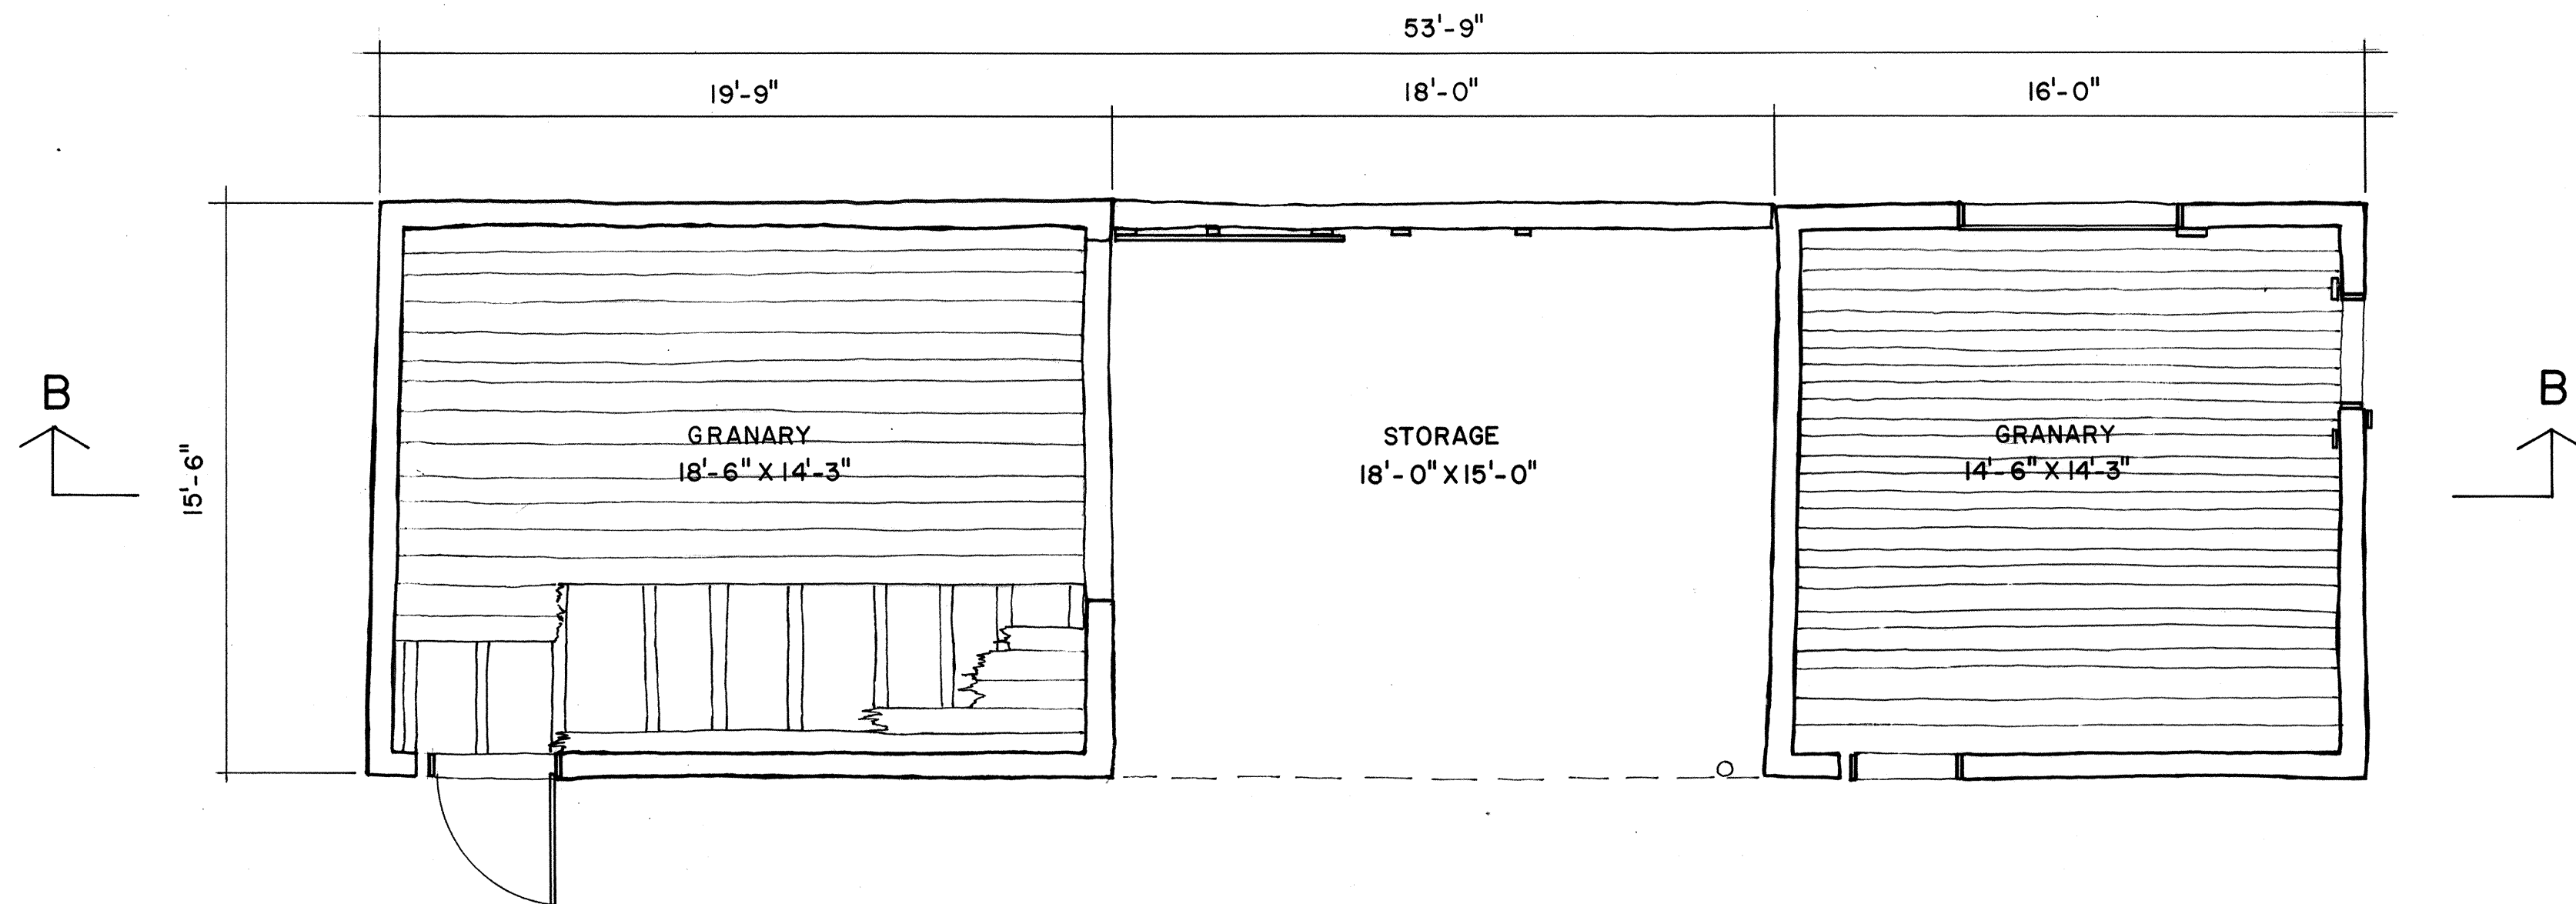
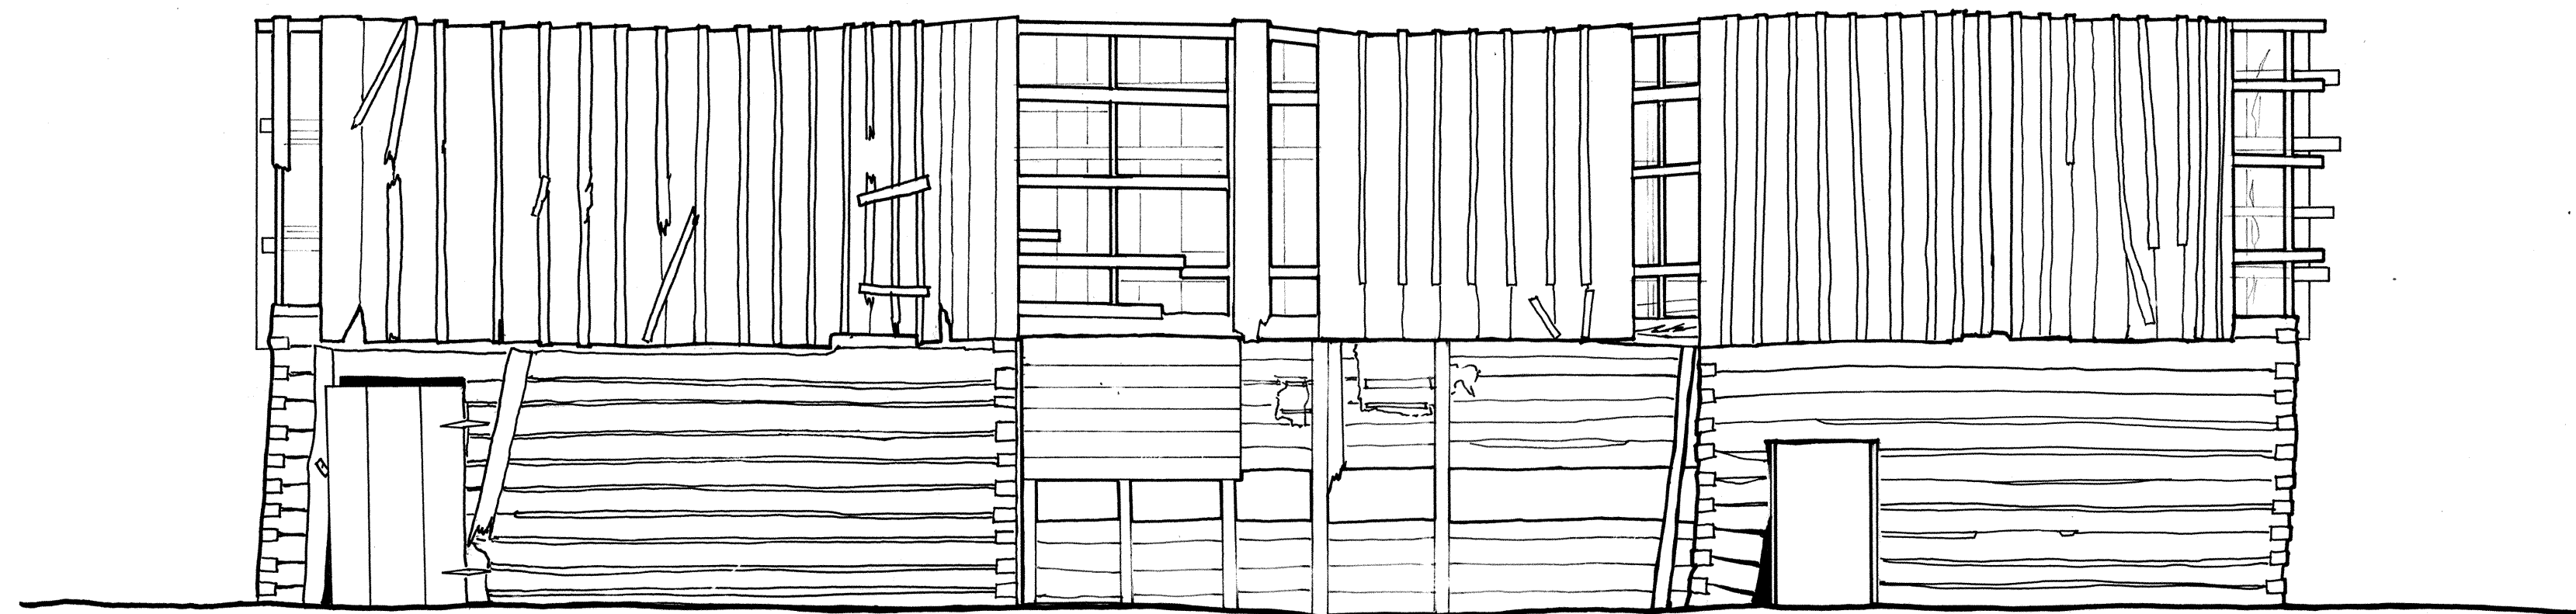
FLOOR PLAN

- Connected Granary: Two square log granaries were connected (no date) by a log wall on the south side to create a storage shed between the granaries.

1. Floor plan: This one-story building has three distinct bays.
  - a. East bay: A granary room 18'-6" x 14'-3" is entered  
through a low wide door on the north wall. A large hori-  
zontal opening has been cut into the central (west) wall,  
probably for feeding. Gable opening in central (west)  
wall.

- b. Central bay: A three-sided storage room, open on the north;  
log wall with a large horizontal opening on the south wall.
  - c. West bay: A granary room 14'-6" x 14'-3" with a large  
opening on the north and west walls. A large opening on  
the south wall has been boarded up.

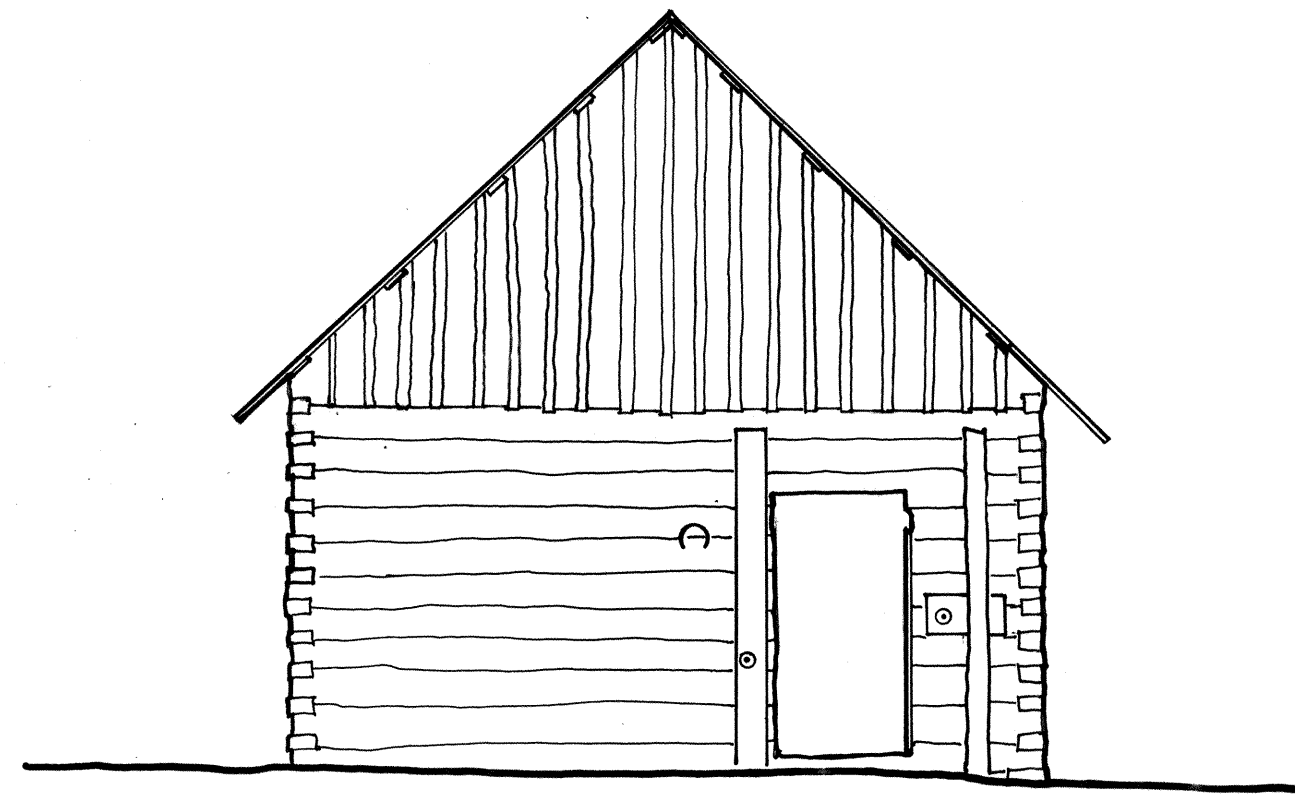
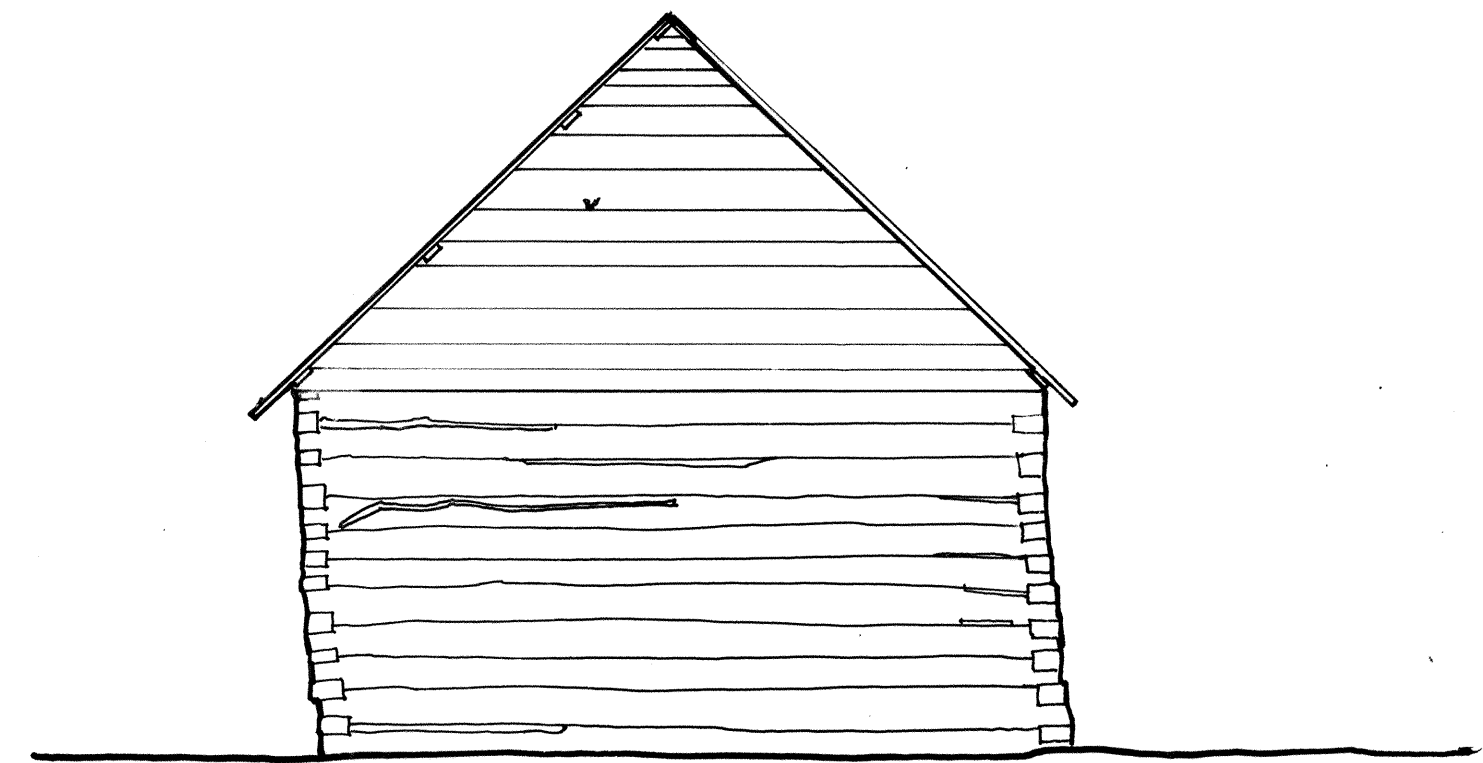
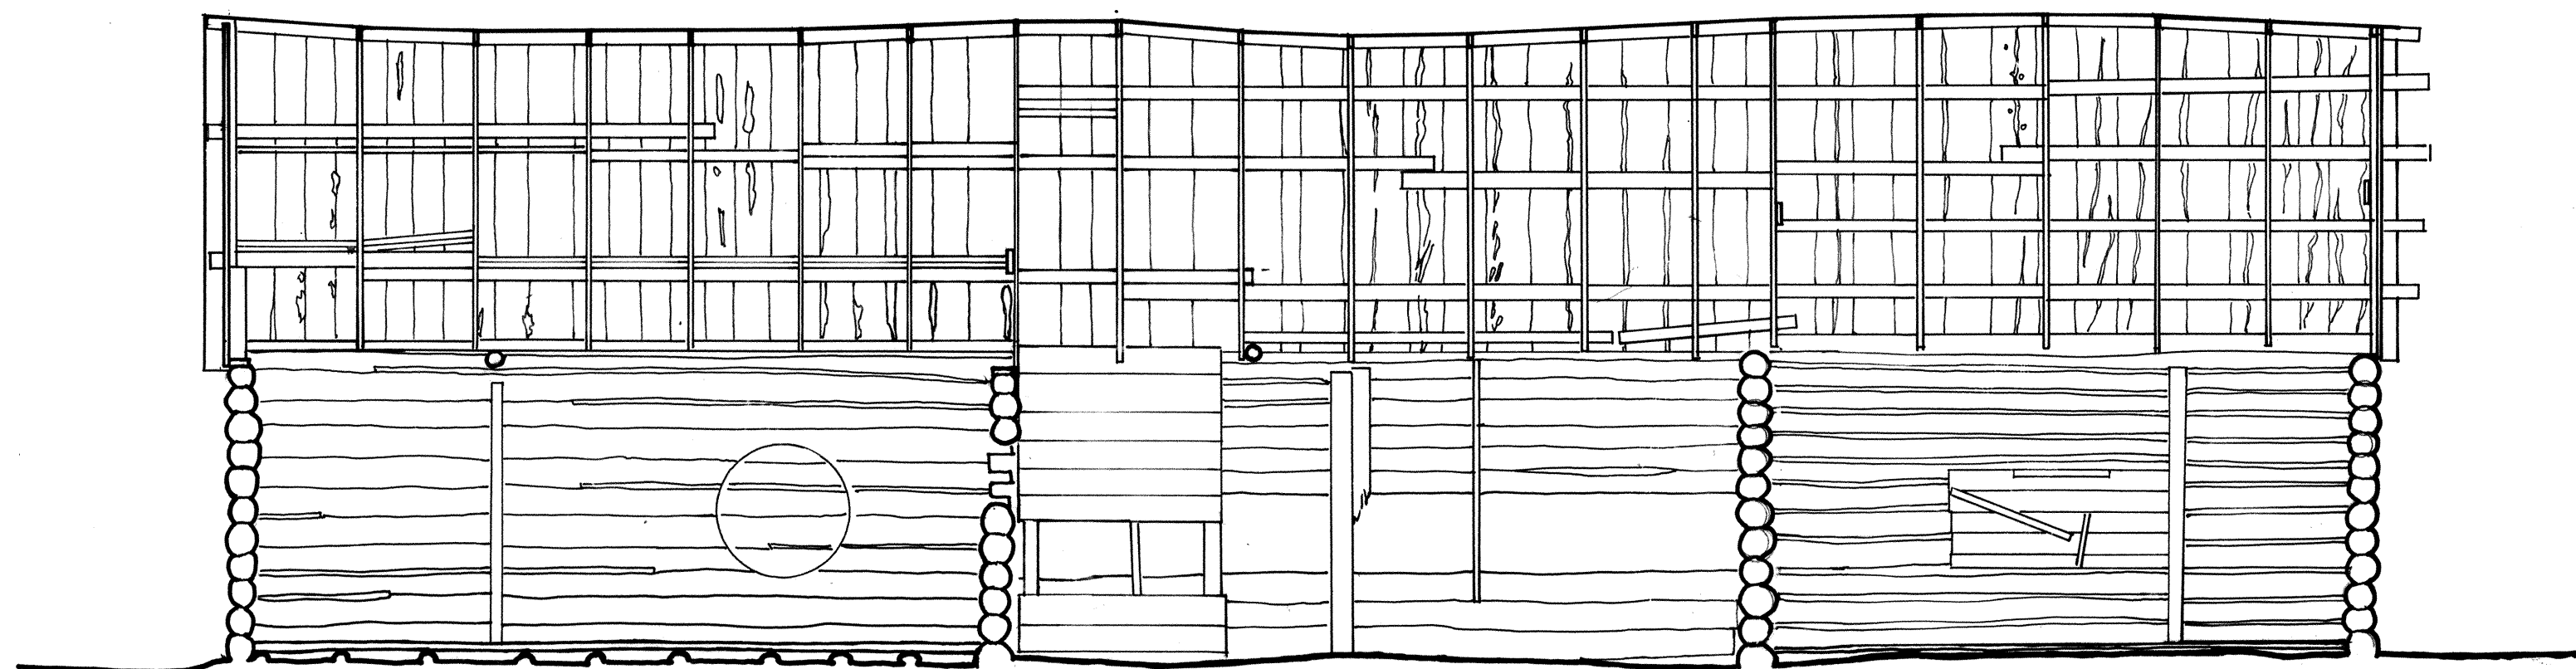
SECTION B-B

1. Over-all dimensions: 53'-9" (2 bays) x 15'-6" (1 bay), one story rectangular plan.

3. Wall construction, finish and color: Log construction with "tenant" notching at corners and spiked to each other with a large iron nail. Cracks between logs are sealed with wood and mortar chinking. The logs have been left unfinished and are their natural color.
4. Structural system, framing: Log bearing walls with "tenant" notched ends which form inter-locking corners.
5. Openings:
  - a. Doorways and doors: Hewn logs were used for the lintels, and rough-cut lumber shaped the door jambs and sills. Doors are rough-cut board and batten. The doors have metal strap hinges and crude wooden latches.
6. Roof:
  - a. Shape, covering: Steep pitch gable roof of rough-cut lumber purlins covered by board and batten roofing.
  - b. Cornice, eaves: Eaves are projected with exposed rafters.
