HABS No. WYO-26

T. A. MOULTON RANCH

Location: 3 miles south of Antelope Flats Road on the west side of Mormon Row Road, Kelly Vicinity, Teton County, Wyoming.  
Universal Transverse Mercator Coordinates: (USGS Moose Quadrangle Map) 12.527120.4833970.

# T.A. MOULTON RANCH

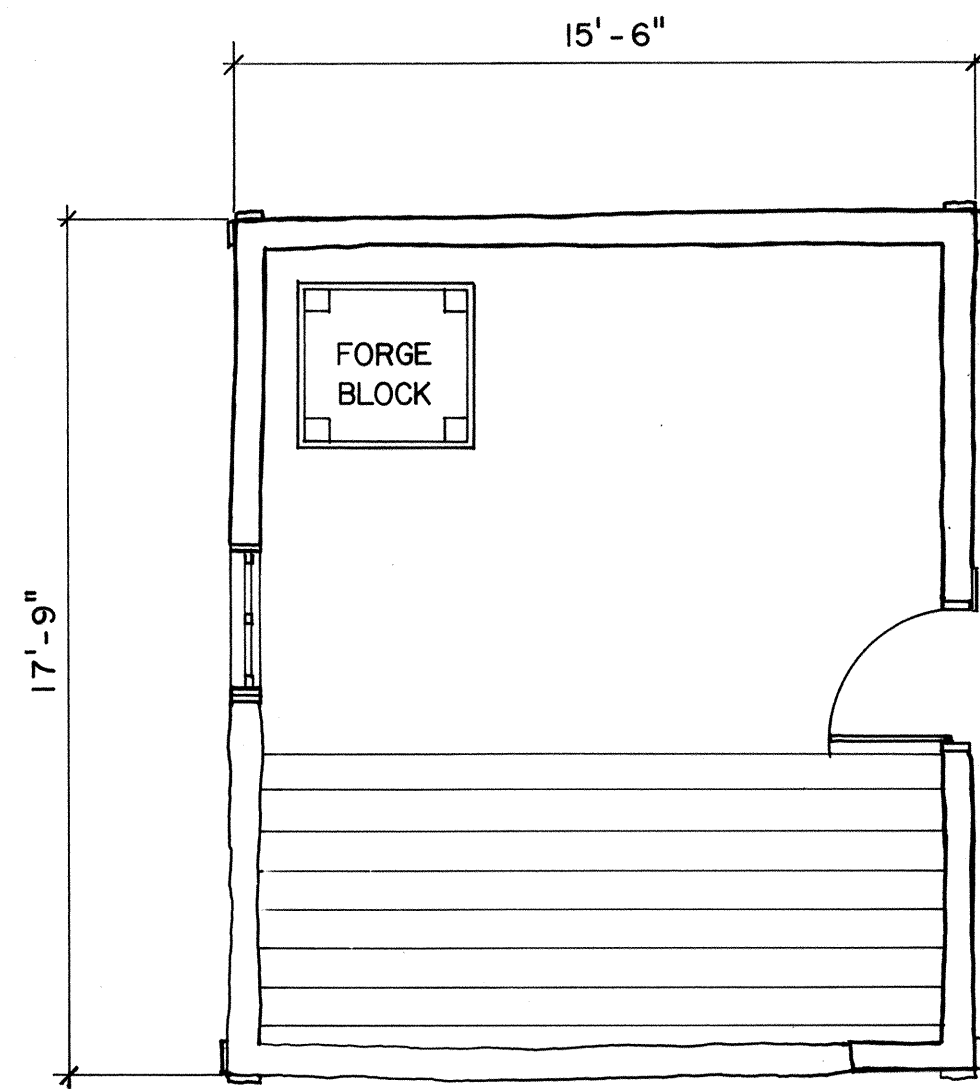
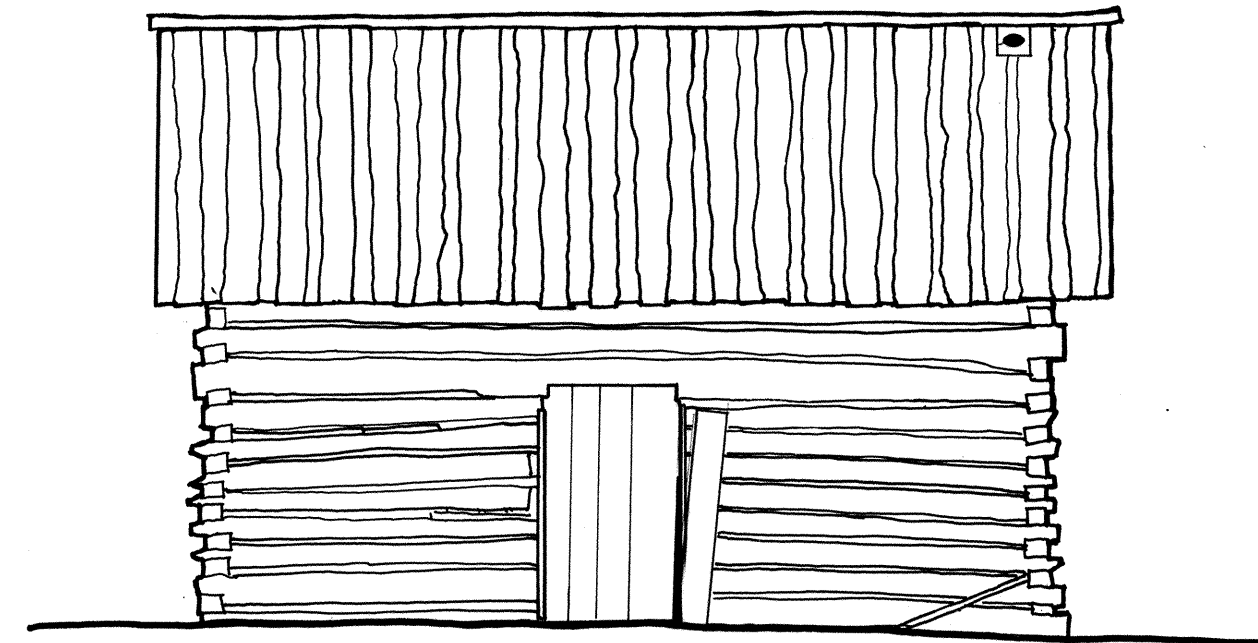
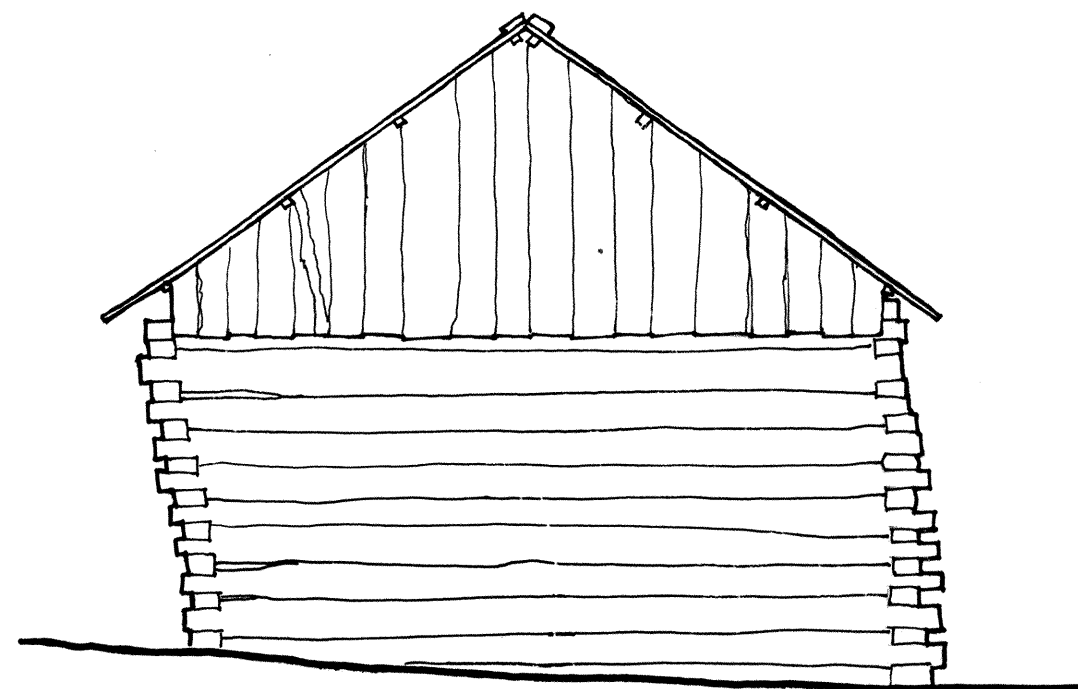
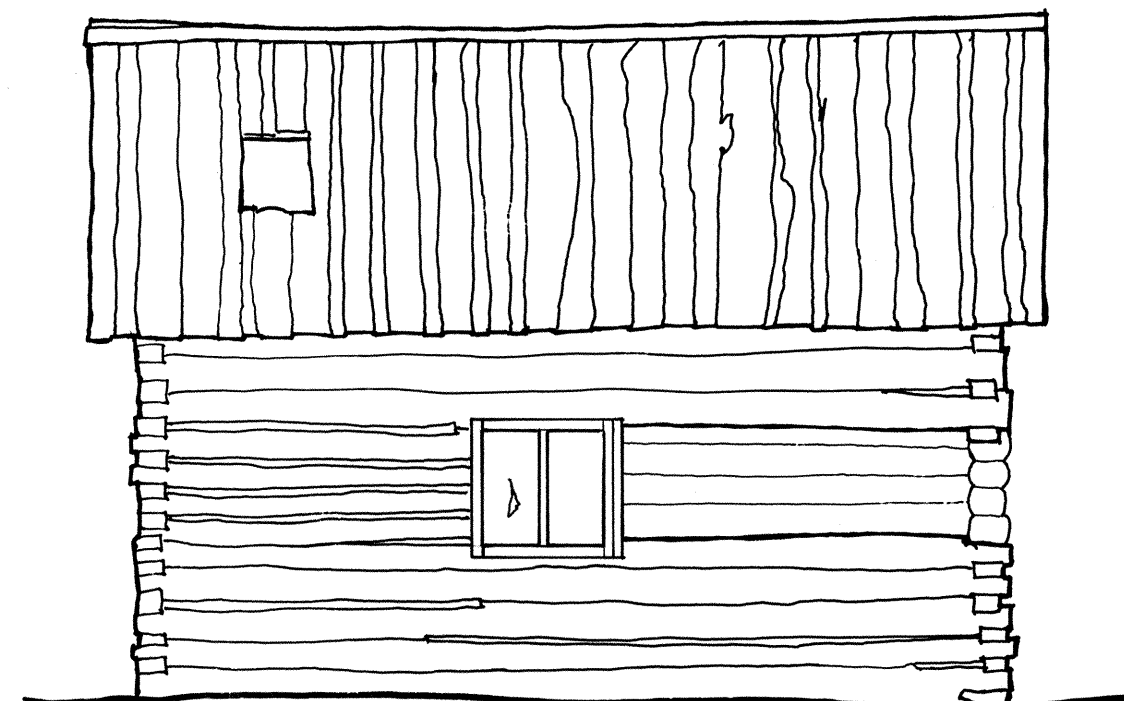
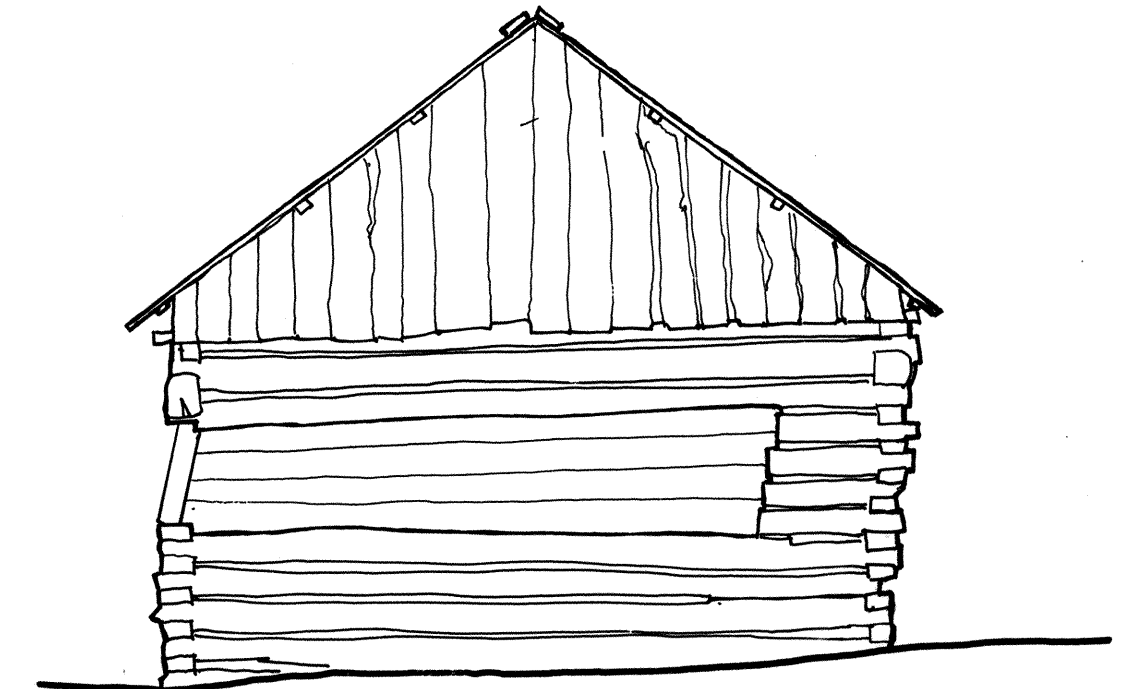
**BLACKSMITH SHED**

1. Architectural character: This is a simple log structure.
2. Condition of the fabric: The logs around the window have been knocked out, and this has caused significant damage to the structure.

1. Over-all dimensions: 17'-9" (1 bay) x 15'-6" one story, rectangular.
2. Foundations: Stones on grade with base logs laid directly on the stones.
3. Wall construction, finish and color: Log construction with "tenant" notched corners. Wood and mortar chinking between the logs. Natural finish and color.
4. Structural system, framing: Log bearing walls with wooden framing in the gable ends.
5. Chimneys: Hole in roof surrounded by sheet metal. Apparently there was a round stack at one time to exhaust smoke.
6. Openings:
  - a. Doorways and doors: Hewn logs used for the lintels and sills and rough cut lumber for the door jamb. The doors are composed of vertical cut lumber tied together with two horizontal members; they are hung by metal strap hinges.

1. Floor plan: This is a simple rectangular one-room structure  
with a door on the east side, window on the west side, and  
a large hole where the window and adjacent logs were on the

south side. There is a heavy table 3' square in the north-west corner. There is a trap door in the roof above the table.

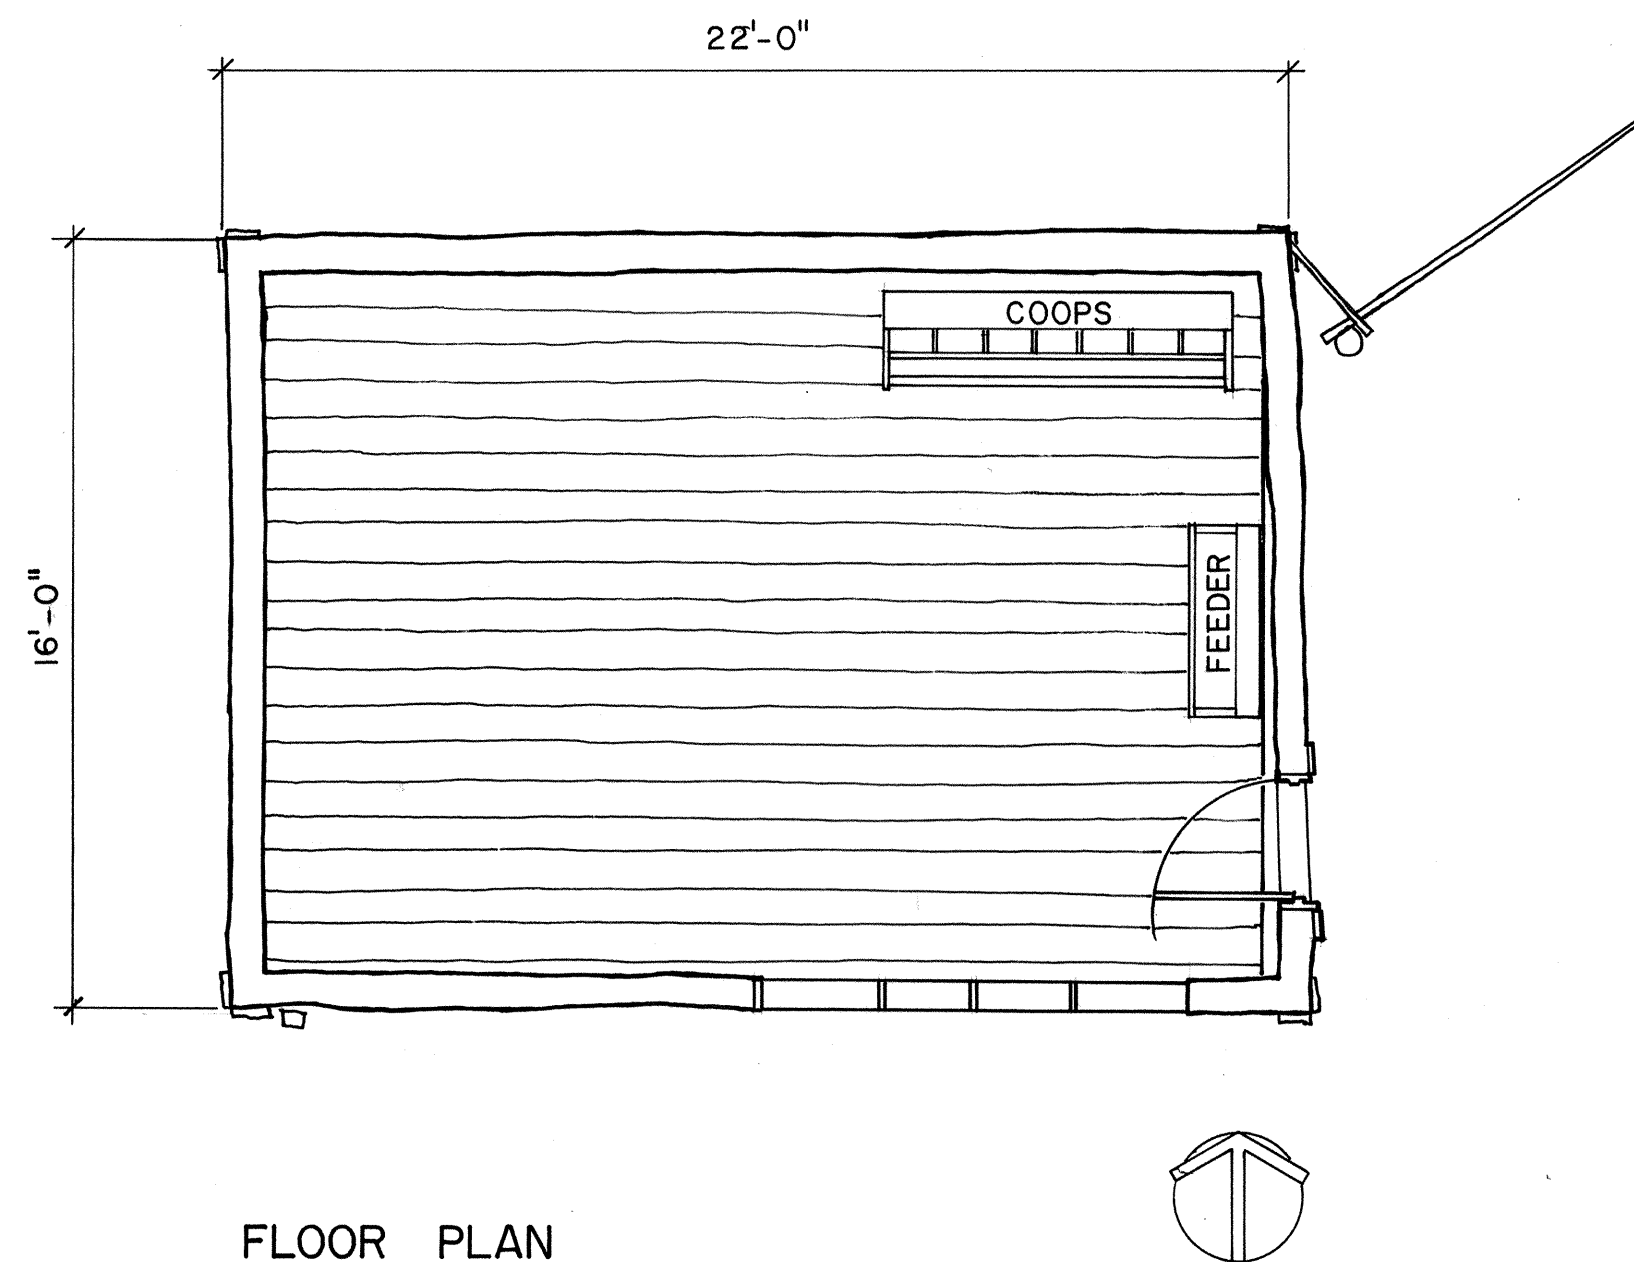
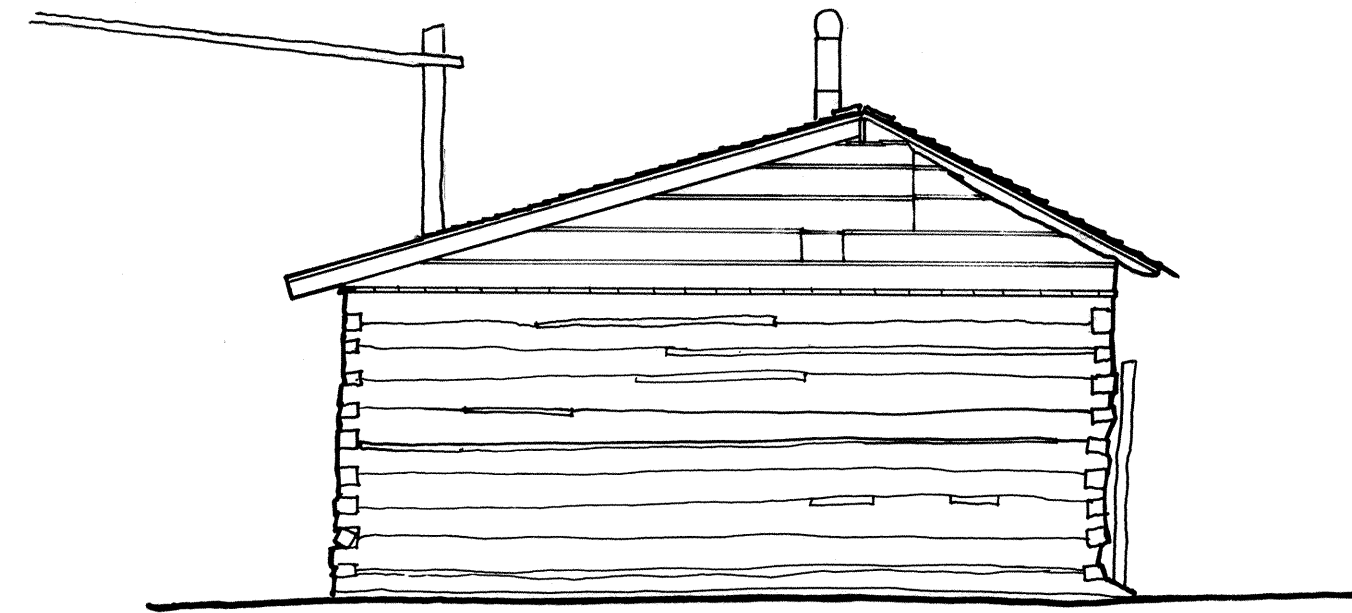
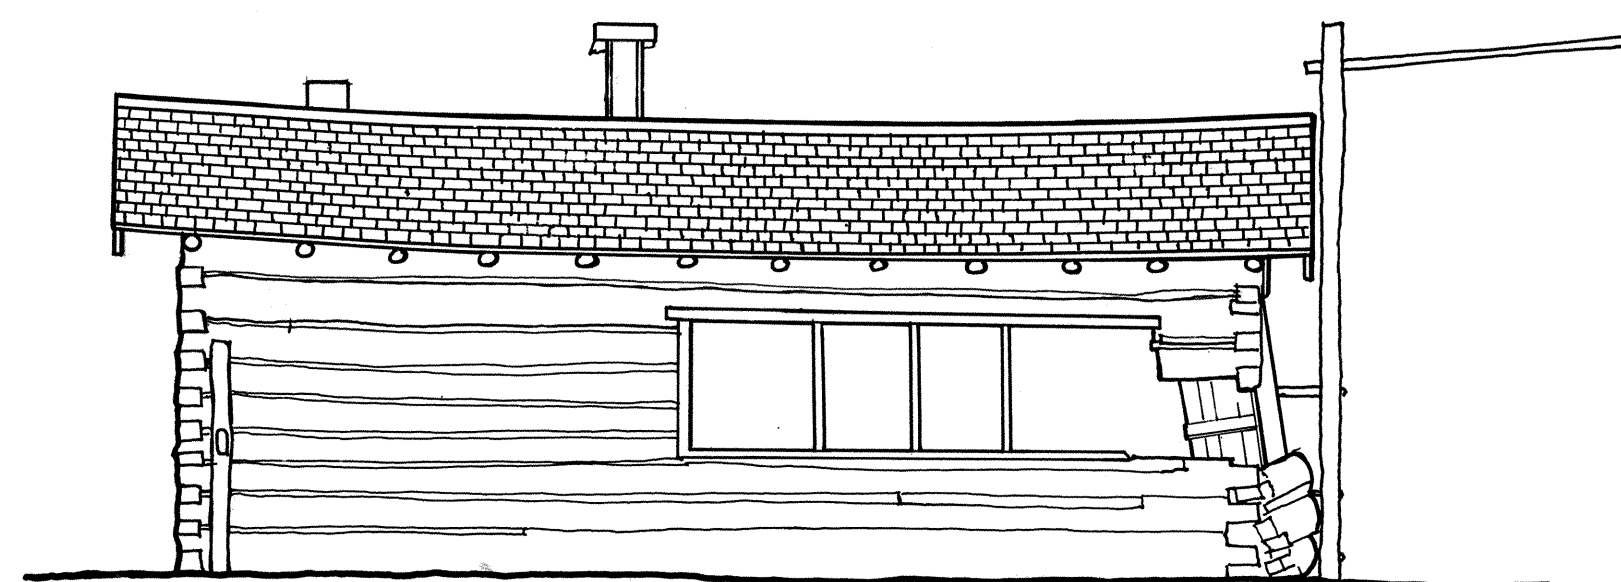
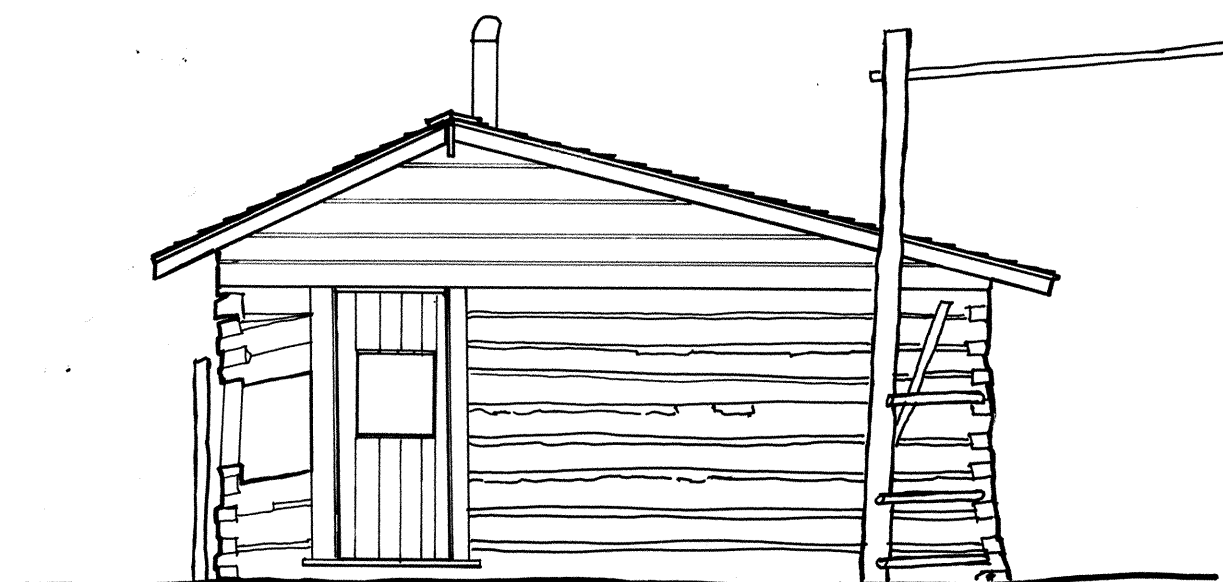
## CHICKEN HOUSE

1. Architectural character: This simple log structure is a typical form of chicken coop in the Mormon Row area.
2. Condition of fabric: The southeast corner has been pulled out and some logs are missing.

1. Over-all dimensions: 22' x 16' (1 bay) one story, rectangular.
2. Foundations: Stones on grade with base logs laid directly on the stones.
3. Wall construction, finish and color: Log bearing wall construction, "tenant"-notched at the corners; logs spiked to each other at the corners with a large iron nail. Cracks between logs are sealed with wood and mortar chinking. The logs have been left unfinished and are their natural color.

1. Floor plan: This is a rectangular one-room structure with chicken coops built into the north wall. There is also a large feeder on the east wall. The chimneys are located along the ridge line on the west side. It is probable that the heater and incubators were located underneath the chimney locations.

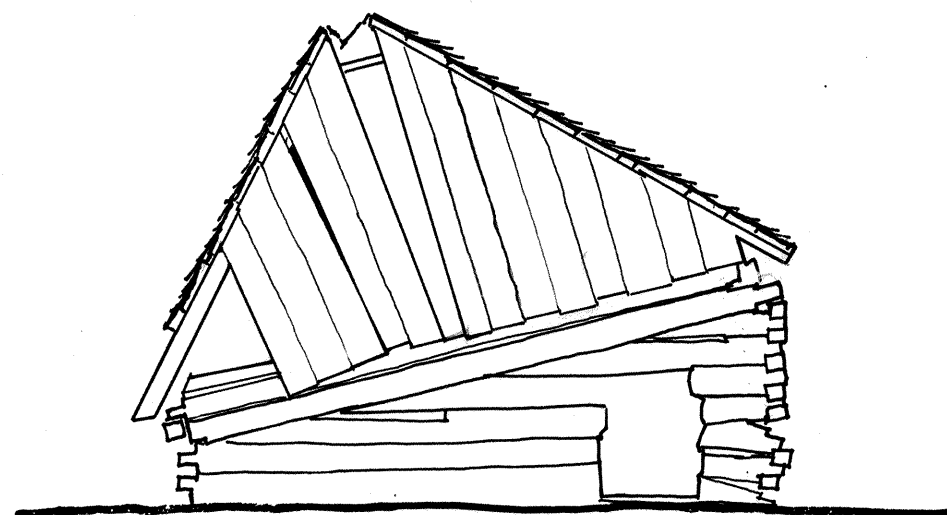
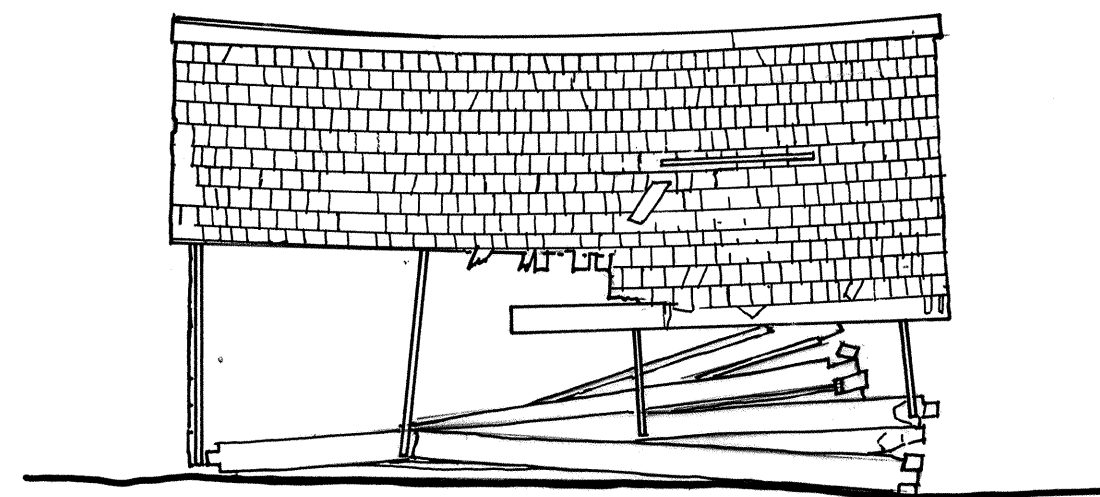
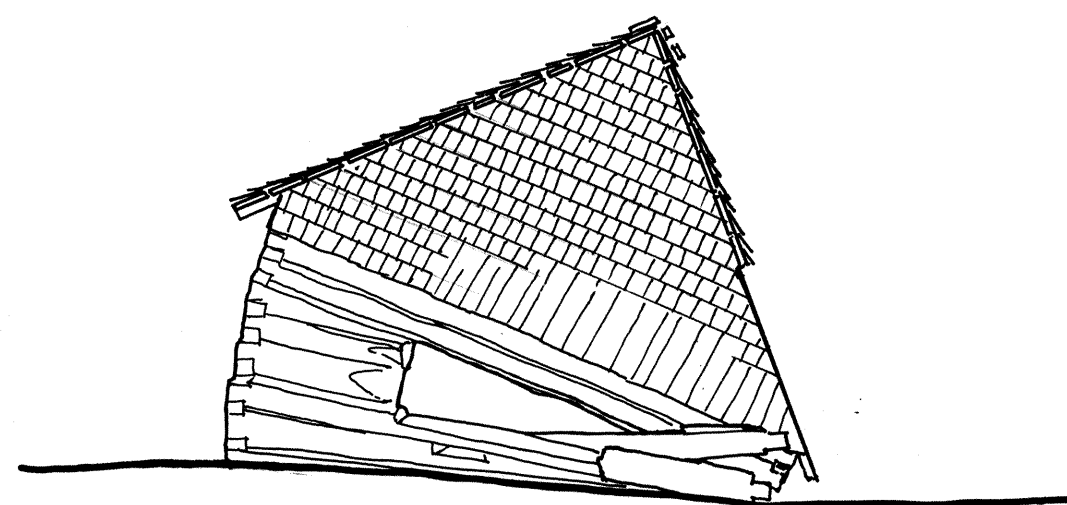
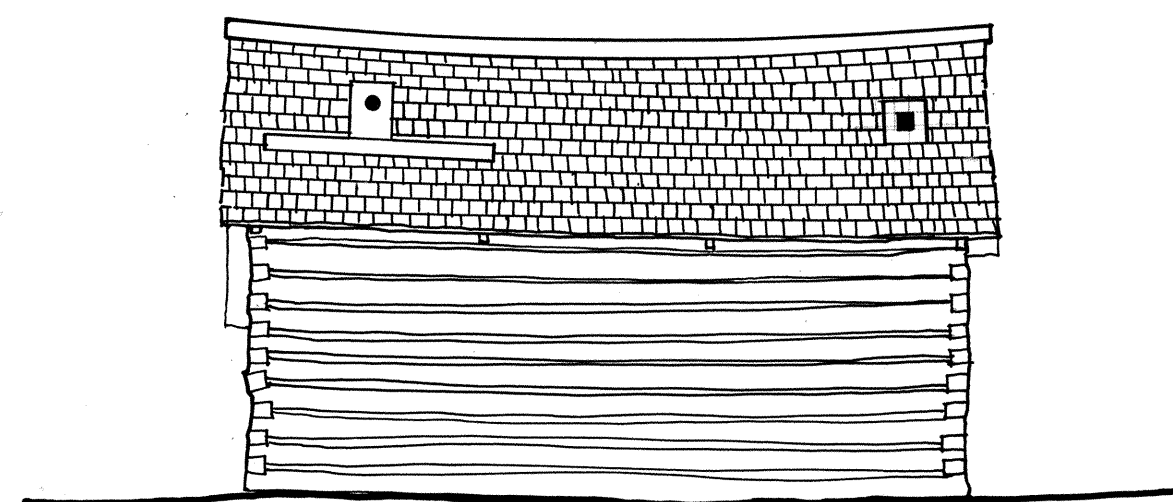
## HOG HOUSE

1. Architectural character: This is a simple log structure.
2. Condition of the fabric: Poor condition. The building has fallen down.

1. Over-all dimensions: 16' x 12' (1 bay) one story, rectangular.
2. Foundations: Stones on grade with base logs laid directly on the stones.
3. Wall construction, finish and color: Log construction, "tenant"-notched at corners and spiked to each other by a large iron nail. Cracks between logs are sealed with wood and mortar chinking. Logs have been left unfinished and are their natural color.
4. Structural system, framing: Log bearing walls with "tenant"-notched corners which are spiked to each other by a large iron nail. Gable ends are framed and shingled.
5. Openings:
  - a. Doorways and doors: Although there are openings cut on the east and north walls, neither of the openings are framed or contain doors or windows.
6. Roof:
  - a. Shape, covering: Moderate pitch gable roof, covered by cedar shakes.

1. Floor plan: This is a simple, rectangular, one-room structure, with openings on the north and east walls.
2. Flooring: Dirt floor.
