# NATIONAL REGISTER OF HISTORIC PLACES REGISTRATION FORM

Historic name Honouliuli Internment Camp

Other names/site number Civilian Internee Stockade, POW Compounds 6, 8, and 9, Jigoku-Dani

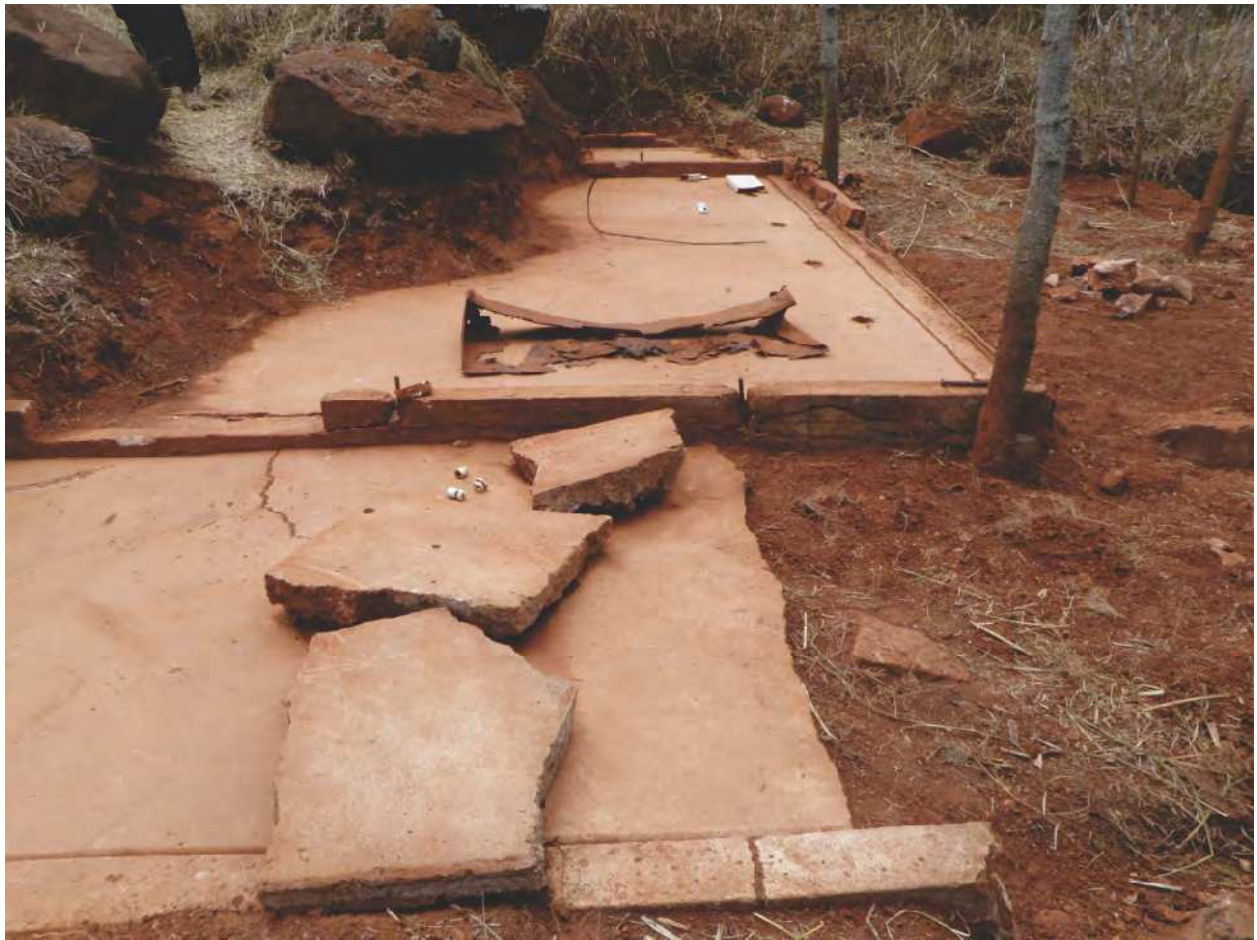
Photograph 35 of 77

Latrine/shower building foundation in Compound V (Feature V-7)

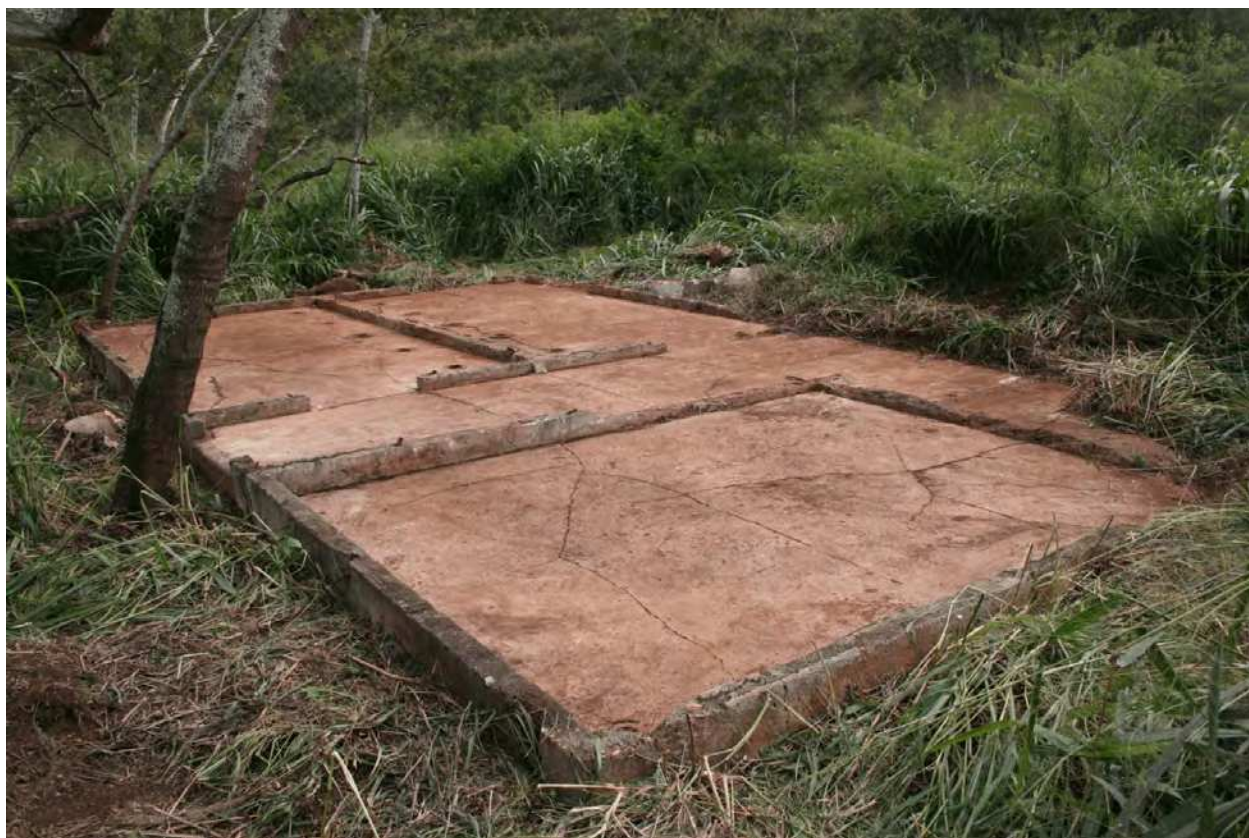
Photograph 36 of 77

Latrine/shower building foundation in Compound V (Feature V-26), view to south

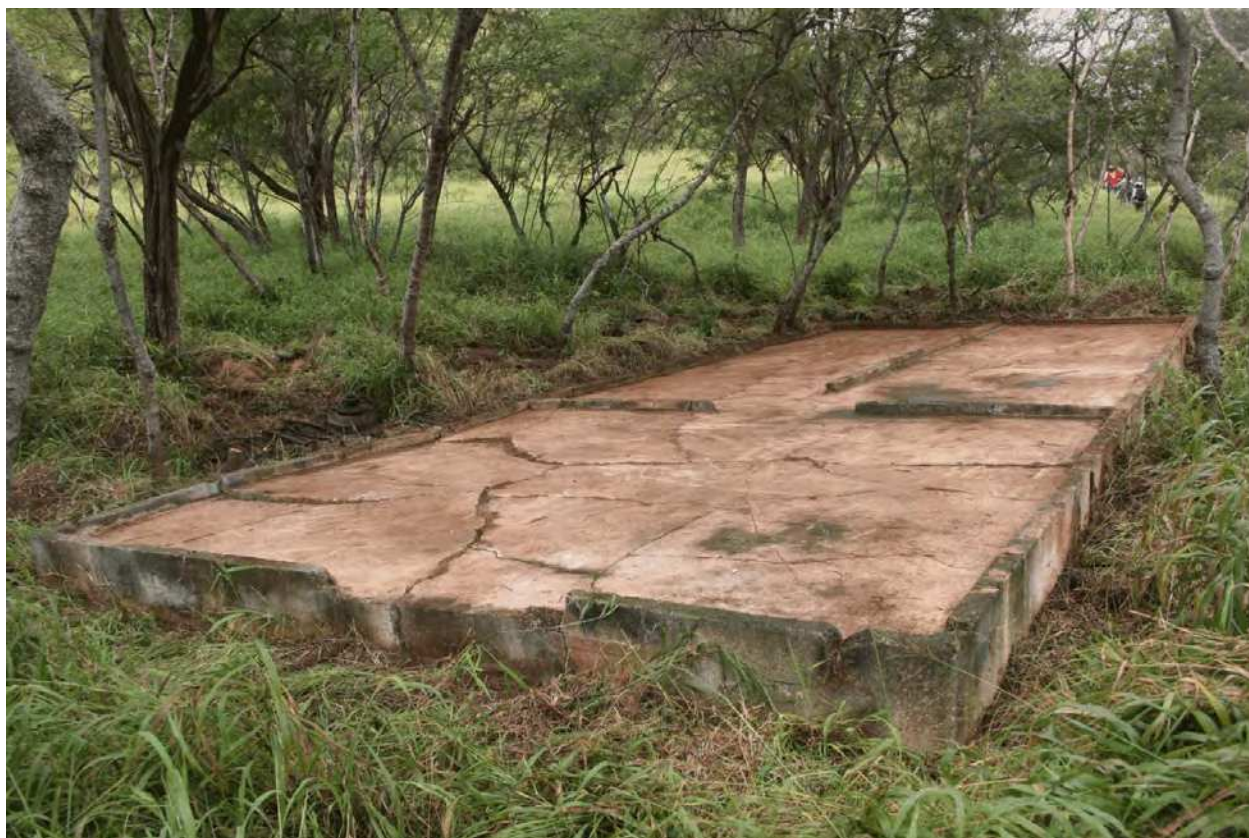
Photograph 37 of 77

This feature is a shower building foundation, composed of a concrete slab 40 ft long by 16 ft 9 inches wide (670 sq ft). Like the other shower foundations recorded, the building was divided into three rooms by stem walls 3 inches to 3½ inches high above the slab floor. An exterior doorway on the southeastern end provides entry into a dressing room measuring approximately 14 by 16 ft. A 4-ft-wide doorway in the center of the interior wall of the dressing room provides access to two long narrow shower rooms, each with a drain near the far end. Vehicle parts, including truck and car rear axles, wheels, a steering wheel, gears, and tire chains, are located on and adjacent to the slab. Also found on the slab and probably related to the vehicle parts is a brass hand-pump carbon tetrachloride (CTC) fire extinguisher.

Shower building foundation in Compound III (Feature III-4), view to northwest

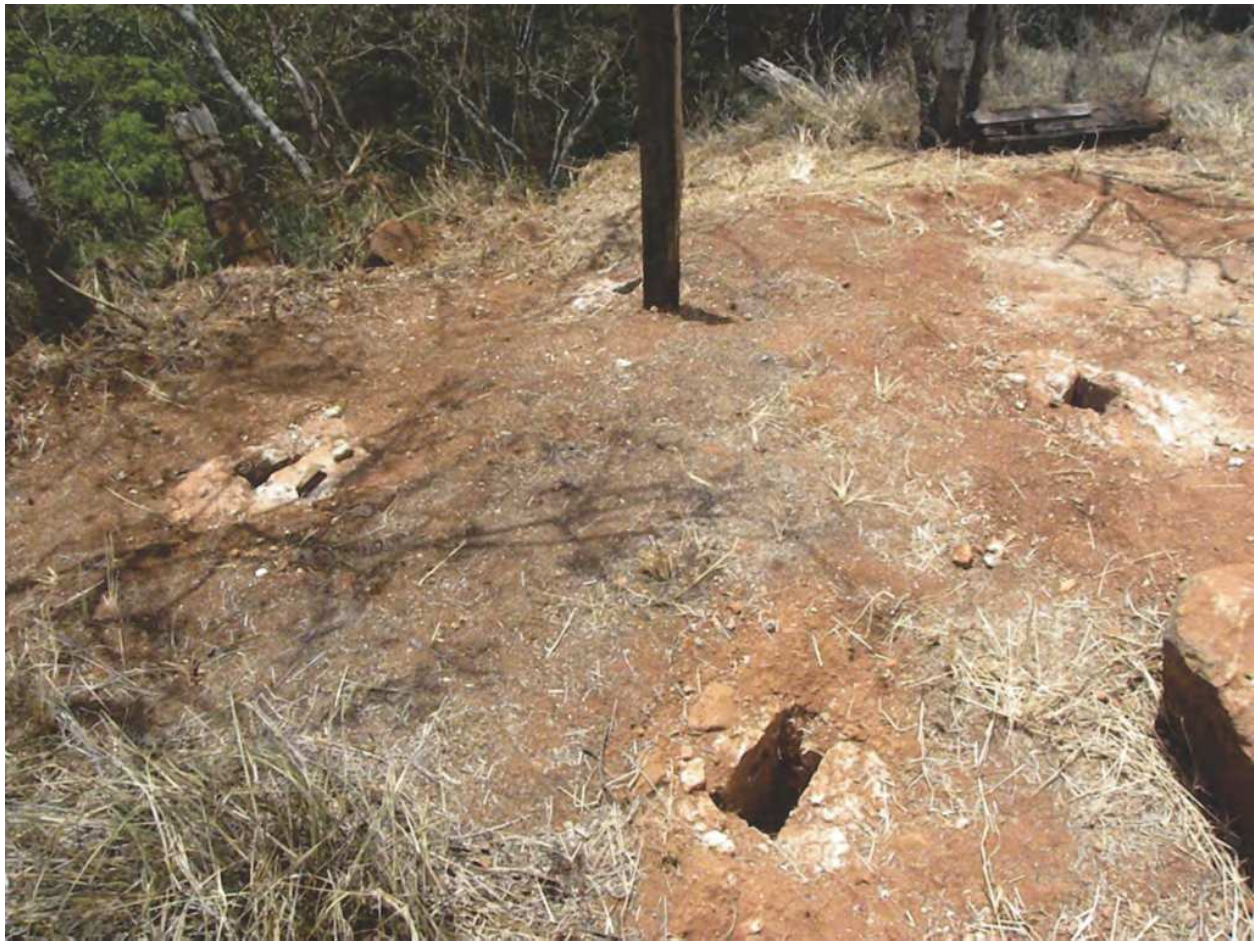
Honouliuli Internment Camp  
Honolulu County, Hawaii  
Jeff Burton  
July 2010  
University of Hawai'i - West O'ahu  
Guard Tower footings in Compound IV (Feature IV-2)  
Photograph 41 of 77

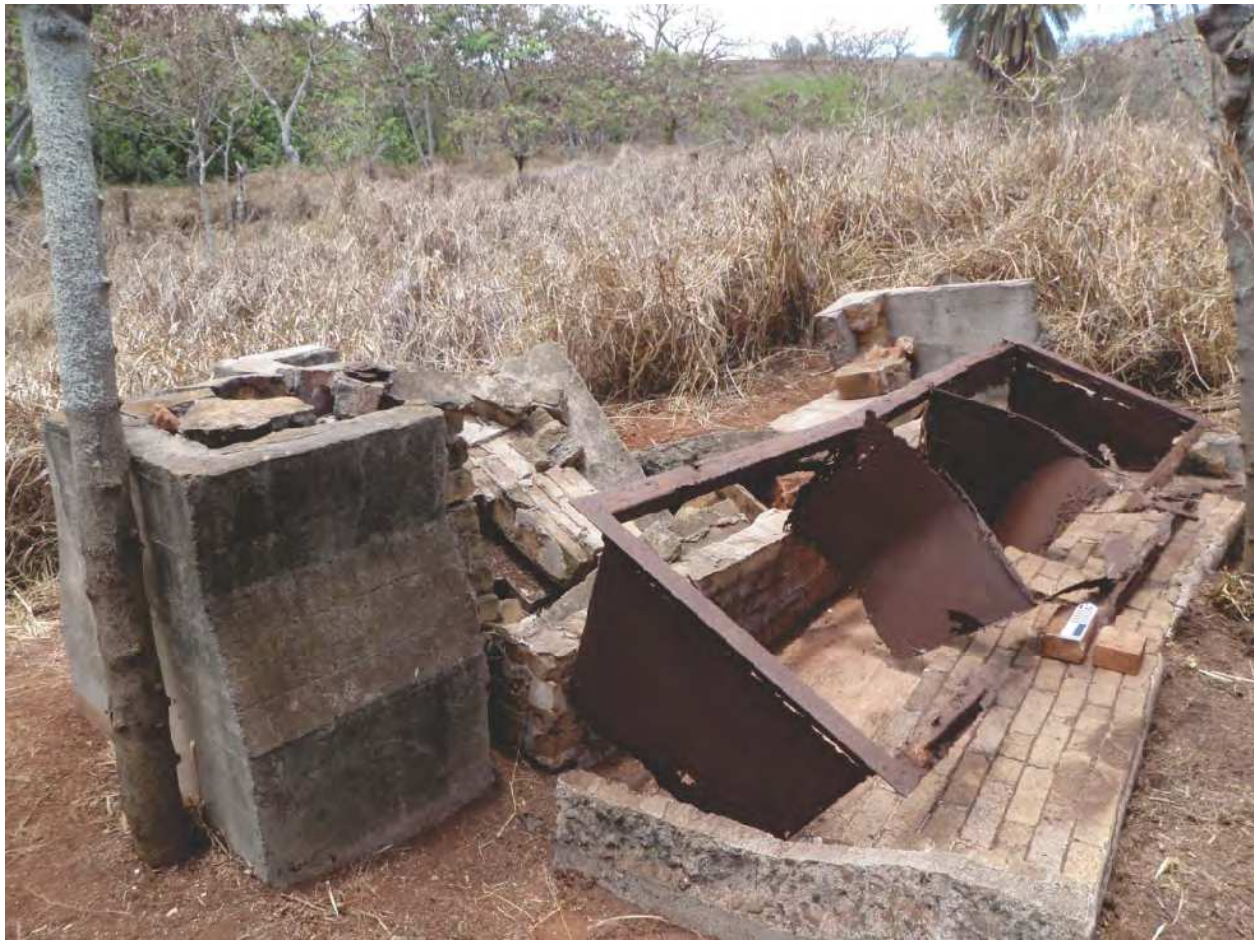
The Compound I incinerator is about 12 ft in length and over 4 ft wide and 3 ft tall, with walls of poured concrete about 4 inches thick. The concrete is broken in several places so that the brick-lined combustion chamber lies in pieces on the ground, probably from purposeful demolition at the end of the camp occupation. A heavy-gauge sheet metal frame lies alongside the concrete; it appears to have functioned as a liner for the combustion chamber, dividing the chamber into three sections. The chimney end is still lined with fire bricks, and a broken and cracked concrete collar holds a remnant of the stove pipe. Several fire bricks are stamped “DIABLO,” a brand made by the Stockton Fire Brick Company of Stockton, California, from 1935 to 1942.<sup>21</sup> At least one is stamped with “STOC[KTON],” made by the same company from 1927 to 1942.<sup>22</sup> Although this incinerator is not depicted in the available historic photographs or blueprint, it appears to be similar to the two south of the Compound III mess hall photographed by R.H. Lodge.

Honouliuli Internment Camp  
Honolulu County, Hawaii  
Jehan Sinclair  
July 2010  
University of Hawai'i - West O'ahu  
Incinerator in Compound I (Feature I-5)  
Photograph 49 of 77
