National Park Service  
Cultural Landscapes Inventory  
2004

John Muir National Historic Site  
John Muir National Historic Site

# Cultural Landscape Inventory: John Muir National Historic Site

CONDITION ASSESSMENT: **Fair**

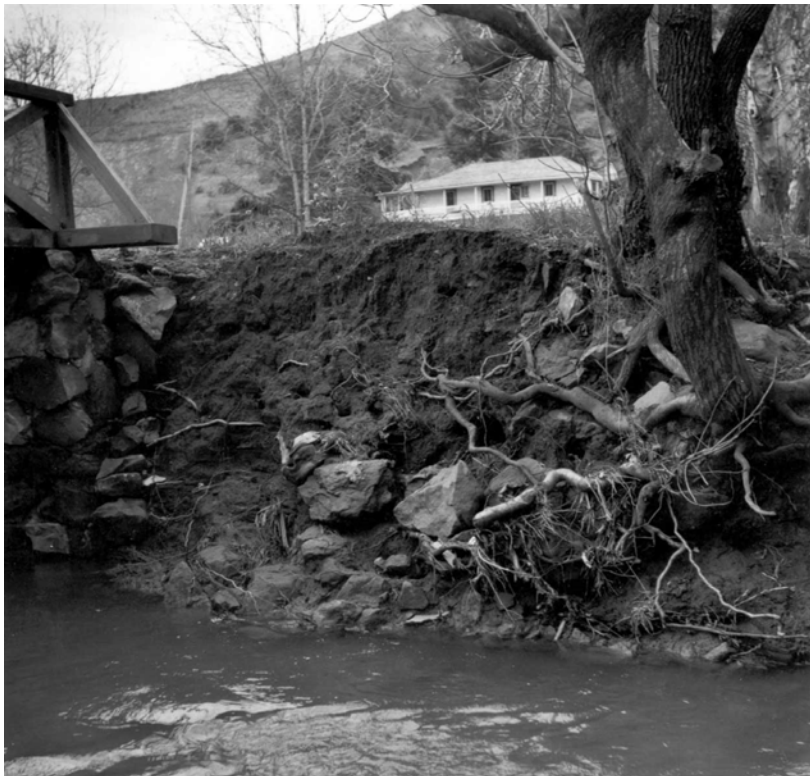
*History #19: Flood damage along Franklin Creek in 1970. (Photographer and catalog number unknown. From Historic Structures Report: Franklin Creek Bridge. JOMU)*

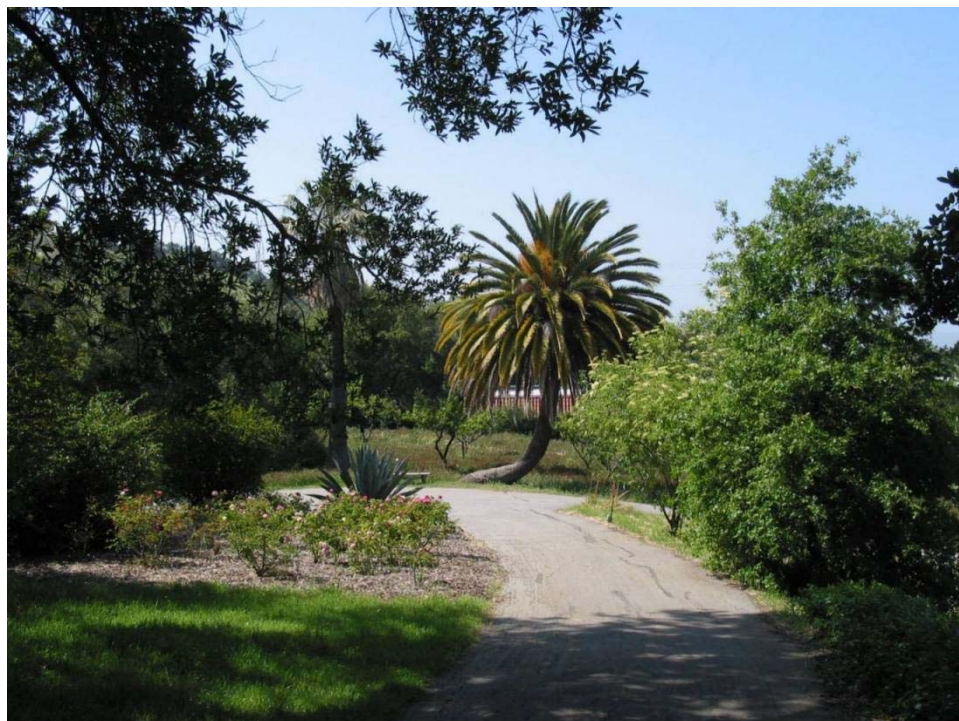
*Vegetation #2: View toward the contributing Canary Island palm and plantings along the north side of Carriage Drive-Loop. The non-contributing vegetation in the loop is in the foreground. (OCLP, 2003)*

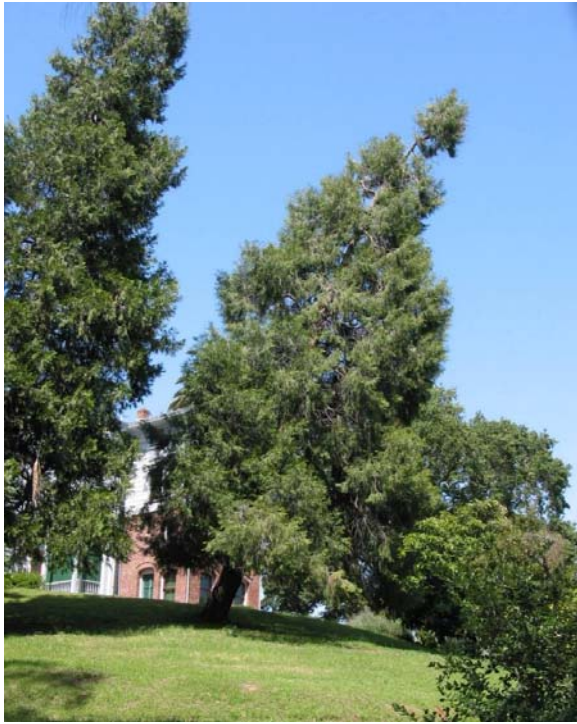
*Vegetation #3: View of the contributing incense cedars, particularly the leaning specimen, on the west slope of the Muir House. (OCLP, 2003)*

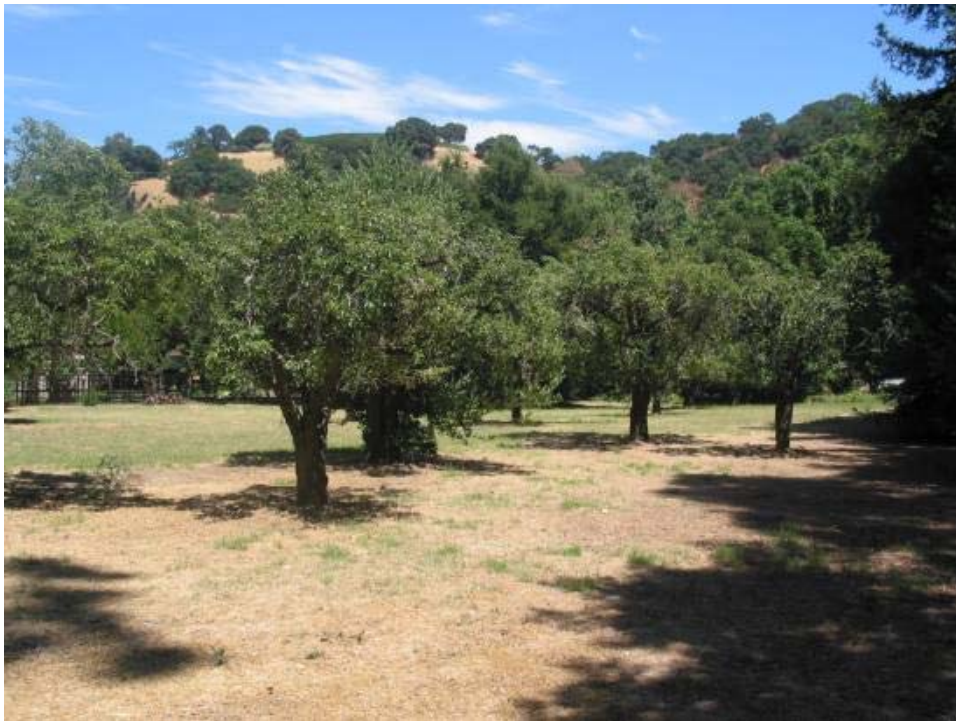
*Vegetation #4: View of the contributing pear orchard remnants at the Gravesite Unit. (OCLP, 2003)*

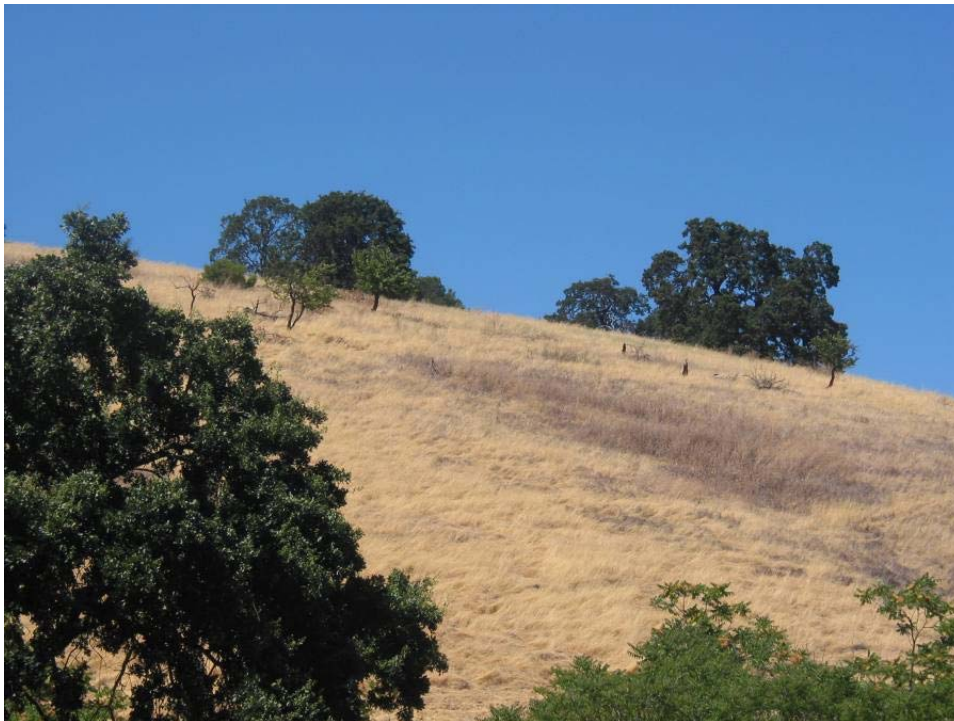
*Vegetation #6: View of the contributing remnant apricot orchard on Mt. Wanda. (OCLP, 2003)*

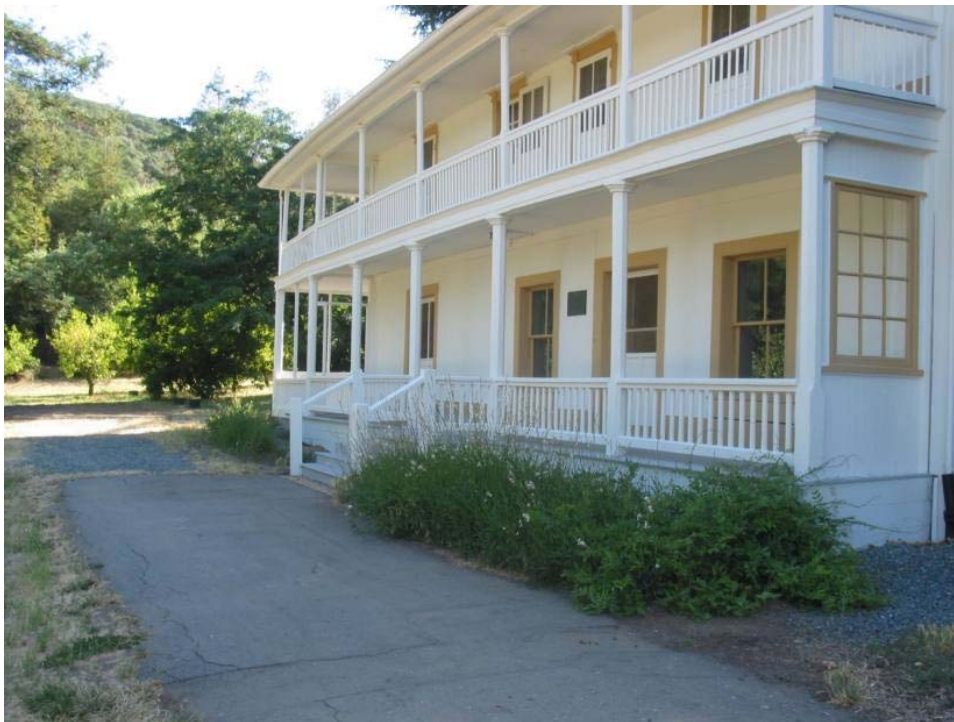
*Circulation #6: The remains of the Martinez Adobe driveway. Just past the stairs, the paving is replaced with gravel. (OCLP, 2003)*

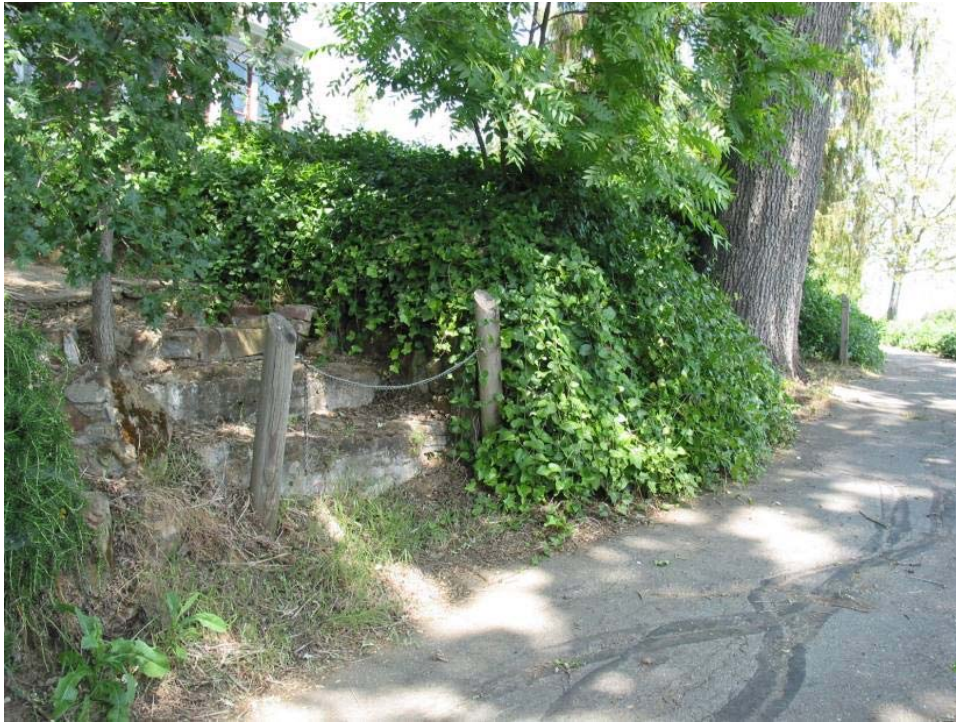
*Circulation #7: View of the stone/brick walls and stone steps southeast of the Muir House. (OCLP, 2003)*

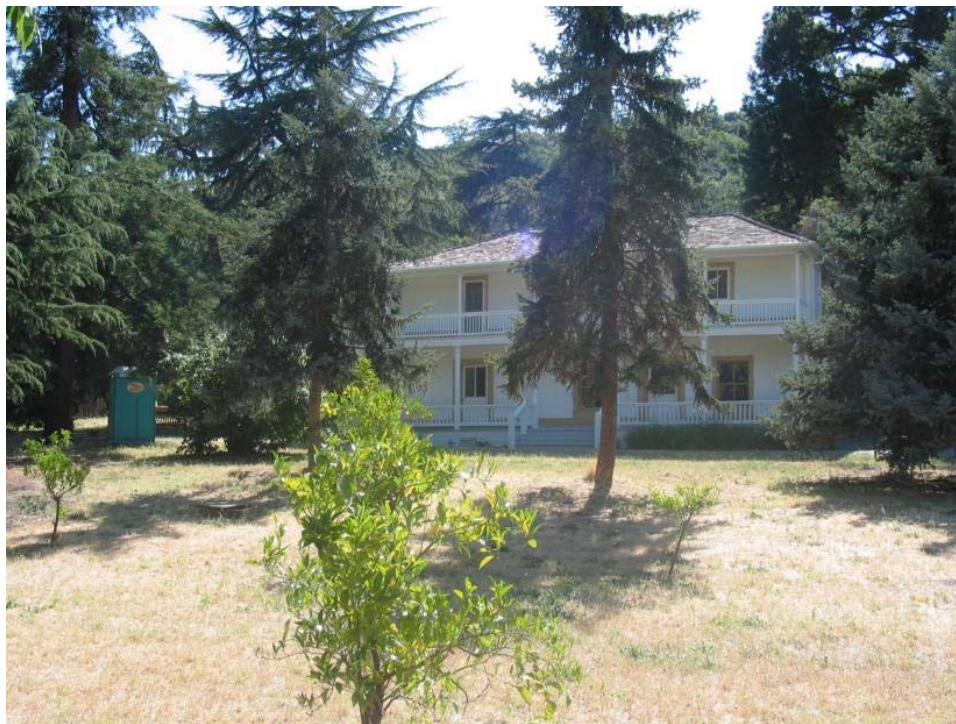
*Buildings and Structures #1: View of the Martinez Adobe from the front, including several spruce trees, a redwood, and a quince. (OCLP, 2003)*

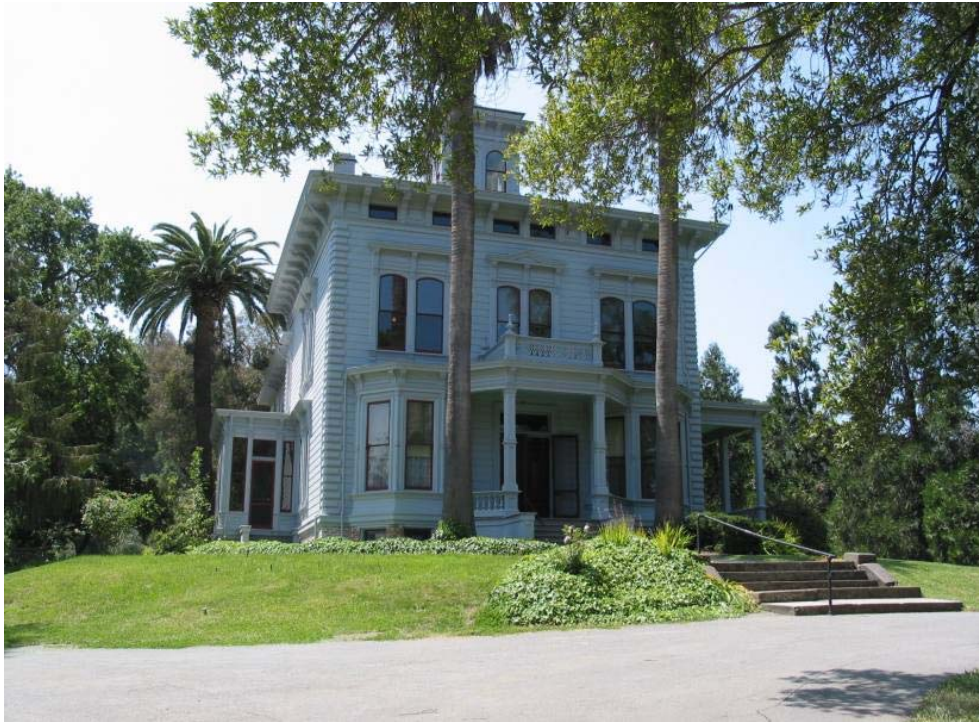
*Buildings and Structures #2: Front view of the Muir House, including two California fan palms flanking the entrance and the southern part of the Carriage Drive-Loop. (OCLP, 2003)*

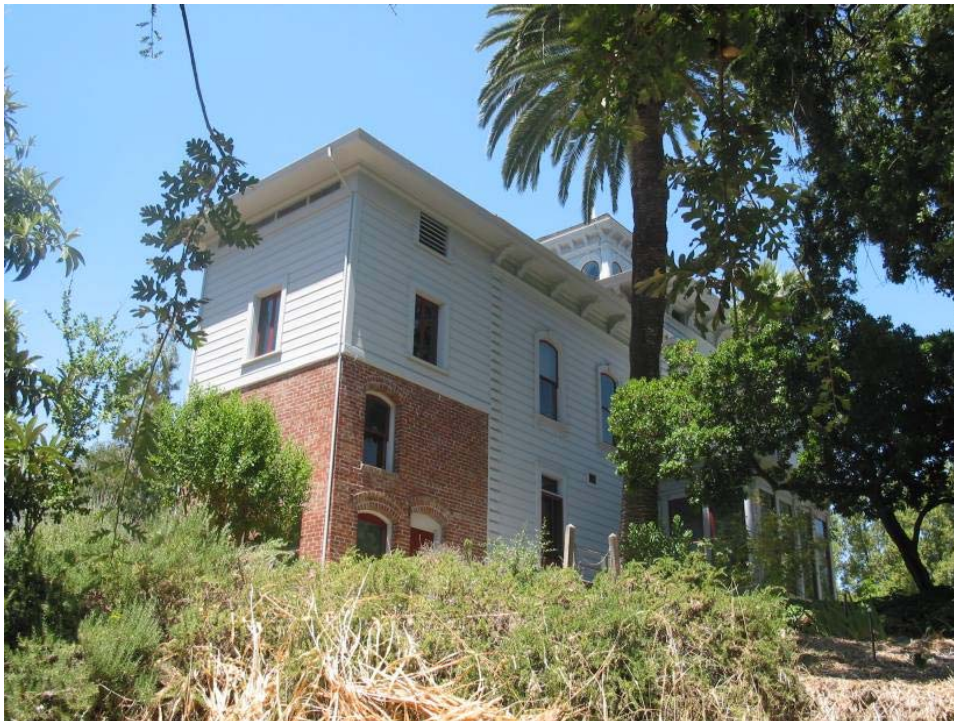
*Buildings and Structures #3: A view of the kitchen addition at the rear of the Muir House. A Canary Island palm is located right of center. (OCLP, 2003)*

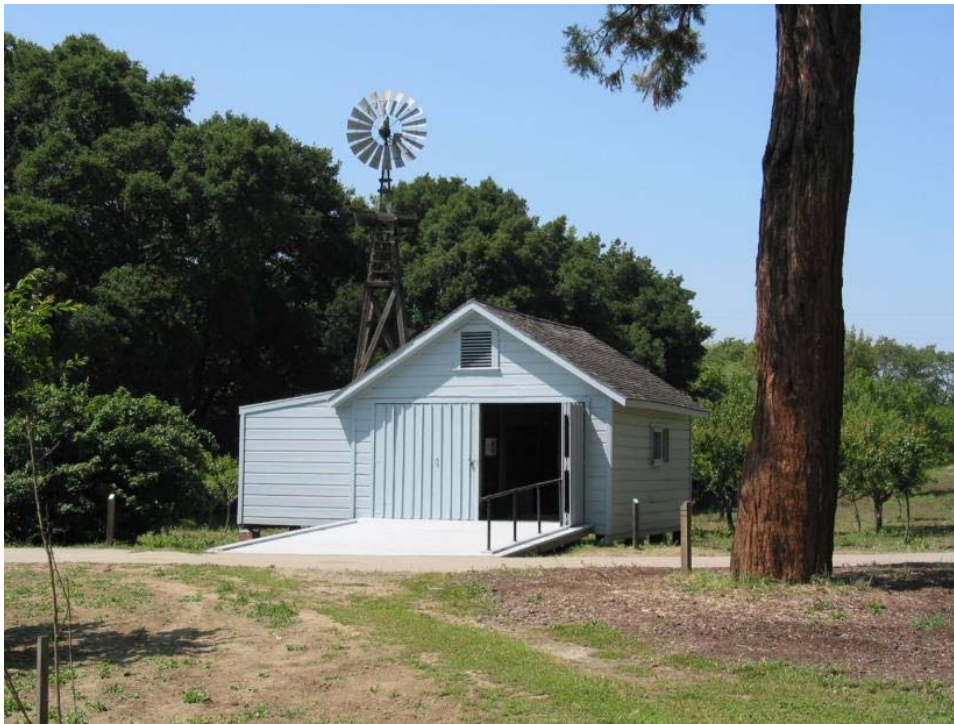
*Buildings and Structures #4: View of the Carriage House. The Franklin Creek windmill and the orchard in the fish pond area are located behind the structure. (OCLP, 2003)*

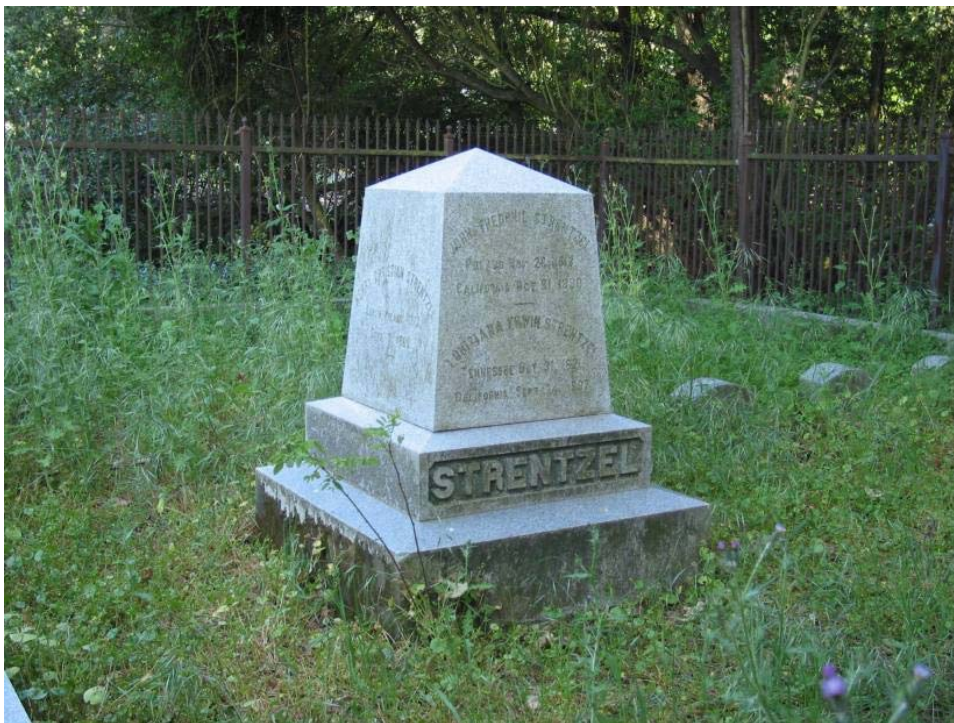
*Buildings and Structures #5: A view of the Strentzel family monument. The smaller Strentzel gravemarkers are located to the right. Granite coping and an iron picket fence surround the site. (OCLP, 2003)*

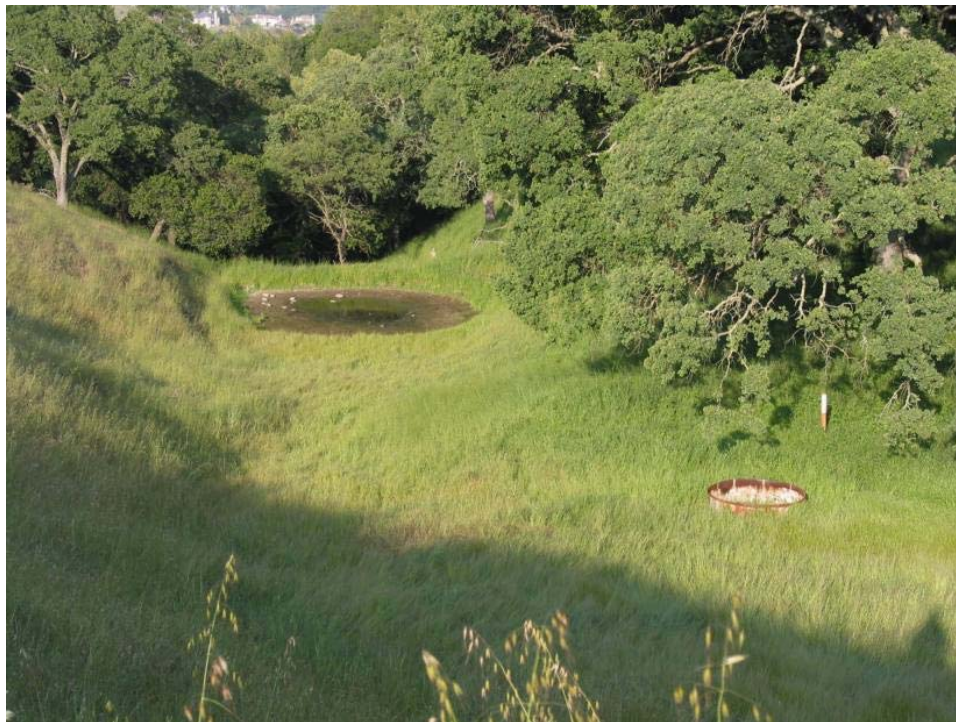
*Buildings and Structures #7: View of the remains of the stock pond at Mt. Wanda. (OCLP, 2003)*

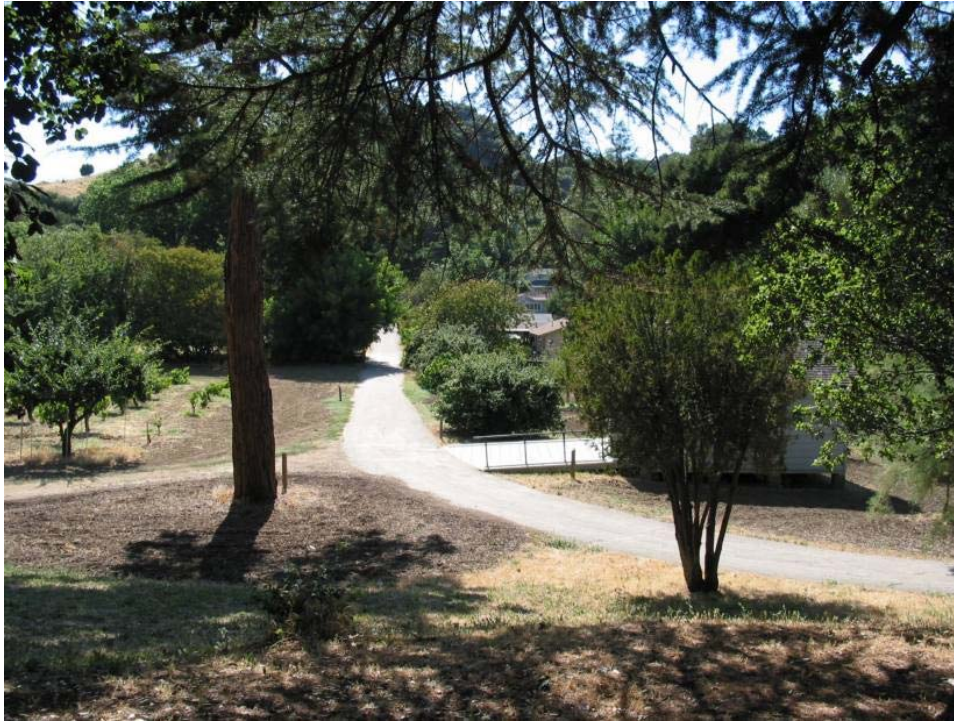
*Views and Vistas #1: View down the main farm road from the remains of the triangle intersection. The view once continued across Franklin Creek to the west orchard and the Martinez Adobe. (OCLP, 2003)*
