Kalaupapa and Kalawao Settlements Cultural Landscape Report

Kalaupapa National Historical Park

Cultural Landscape Report

Prepared by:
Wiss, Janney, Elstner Associates, Inc.
2000 Powell Street, Suite 1650
Emeryville, California 94608

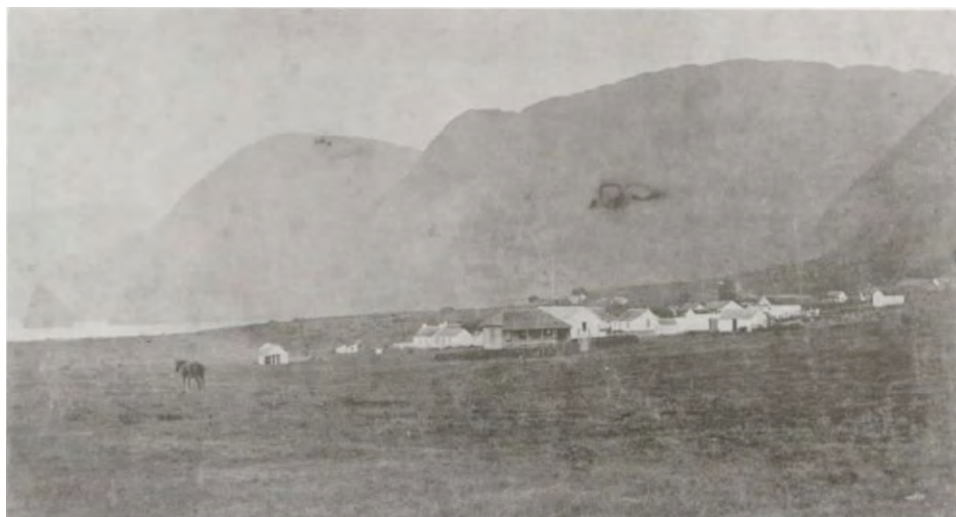
Figure 9. Hospital compound at Kalawao looking east, undated. (Source: Bishop Museum, Honolulu; Greene, Figure 8)

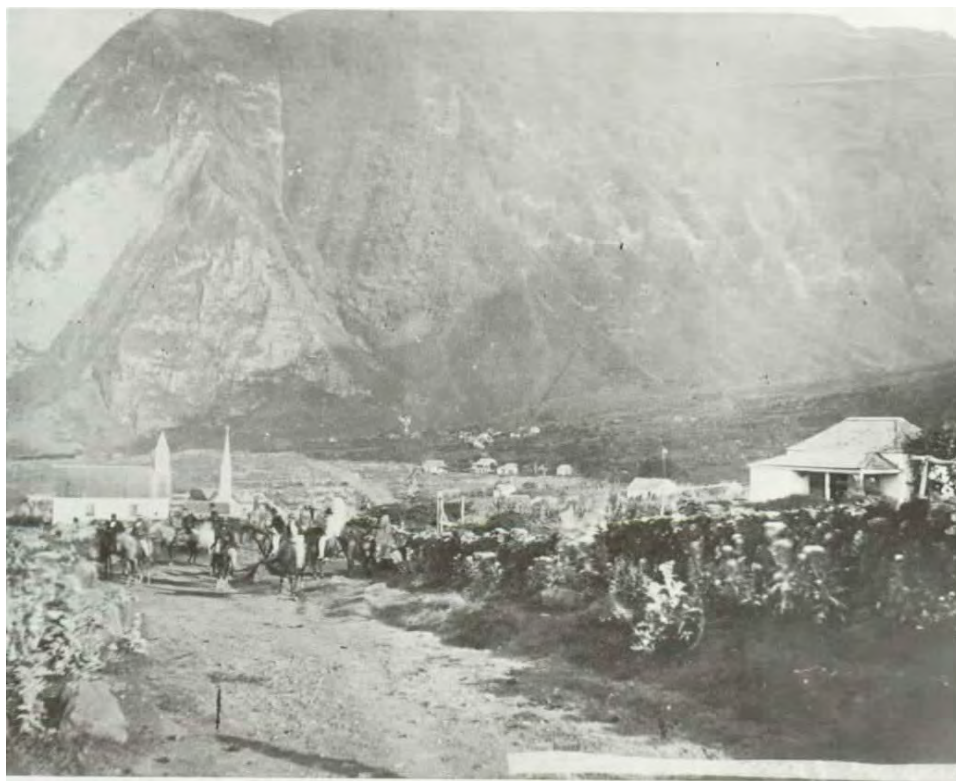
Figure 12. Kalawao settlement, 1884, showing Siloama Church prior to alterations of 1885, and St. Philomena with the new nave and steeple built by Saint Damien, and what is likely the rectory (between the two structures). (Source: Hawai'i State Archives, Honolulu; Greene, Figure 14)

The people of Kalawao soon began to organize their own institutions to handle the emotional and physical hardships of confinement. The Old Stone Church was built at Kalaupapa by Protestant missionaries in 1853 as a meeting house. (Figure 10 and Figure 11). In July 1871, the Congregational Siloama Church of the Healing Spring was built at Kalaupapa, established by a group of thirty-five Congregationalists who had requested of the Hawaiian Evangelical Association that they be released from their former churches and be allowed to form a new church (Figure 12).⁴⁹ In addition to housing religious services, the Siloama Church served as a platform to present demands to the Board of Health.⁵⁰ The church was named Siloama in memory of Jesus's healing of a blind man when he anointed his eyes with clay and bid him wash in the pool of Siloam.⁵¹ When the residents had collected sufficient funding for lumber, a bell, and a carpenter, the Hawaiian Board of Missions brought the material to Kalawao, where they were dumped overboard, floated ashore, and transported to the building site.⁵² A Catholic Church, St. Philomena, was built in 1872 after Brother Victorin Bertrant (sometimes Bertrand) transported a wooden chapel from Honolulu (refer to Figure 12).⁵³

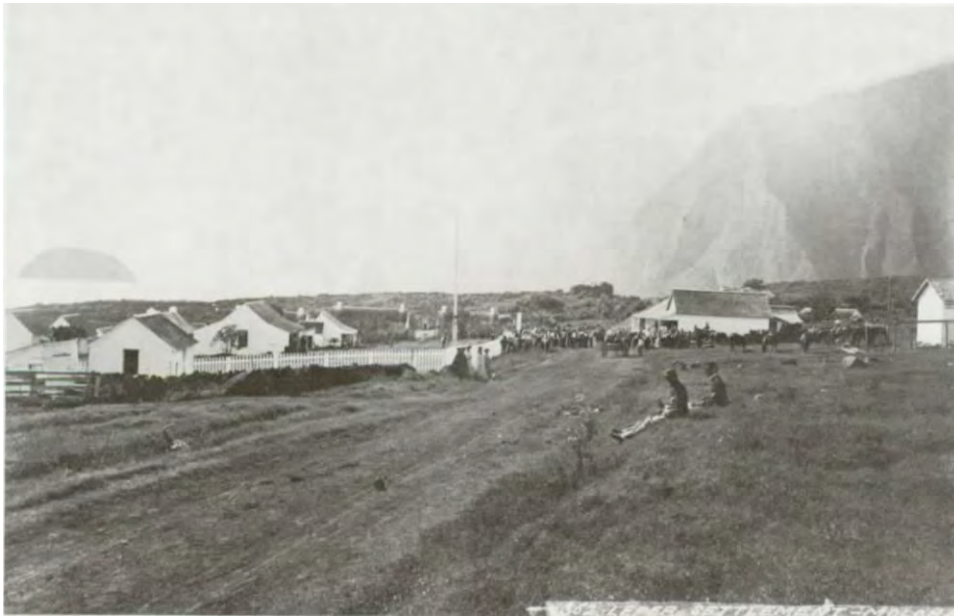
Figure 14. Kalawao, undated, post-1893. The store is visible at the right, and the circular stone cistern visible in the background may be the reservoir built circa 1886. The Hospital compound is visible at the left. (Source: Bishop Museum, Honolulu; Greene, Figure 22)

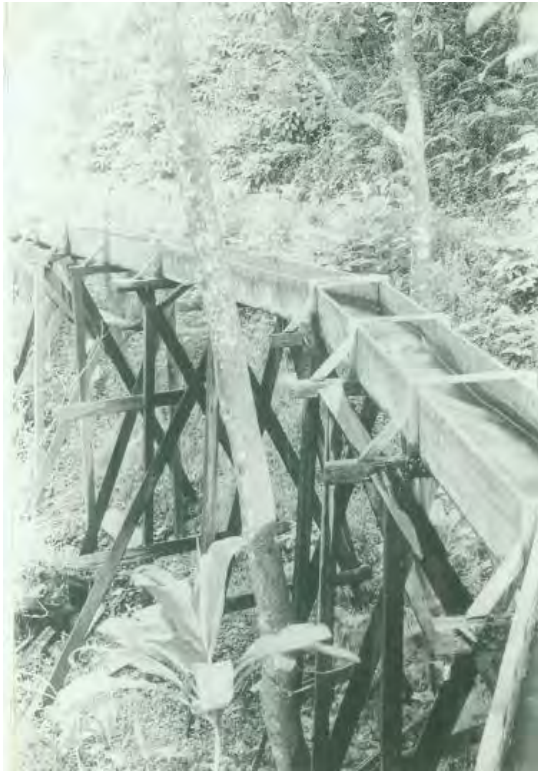
Figure 16. One of the flumes used to transport water to the settlement. (Source: Kalaupapa Historical Society)

In 1888, work began on two larger dormitories to expand the children’s home built to house orphans, replacing earlier buildings. At this time, new dining halls were also constructed, and a concrete baking oven was constructed for the home.⁷⁷ Also in 1888, work was completed on a new water system, which included a wooden flume carrying water from a diversion ditch off the main Waikolu stream, and cast iron pipes running to a 750,000 gallon storage tank above Kalaupapa (Figure 16).⁷⁸

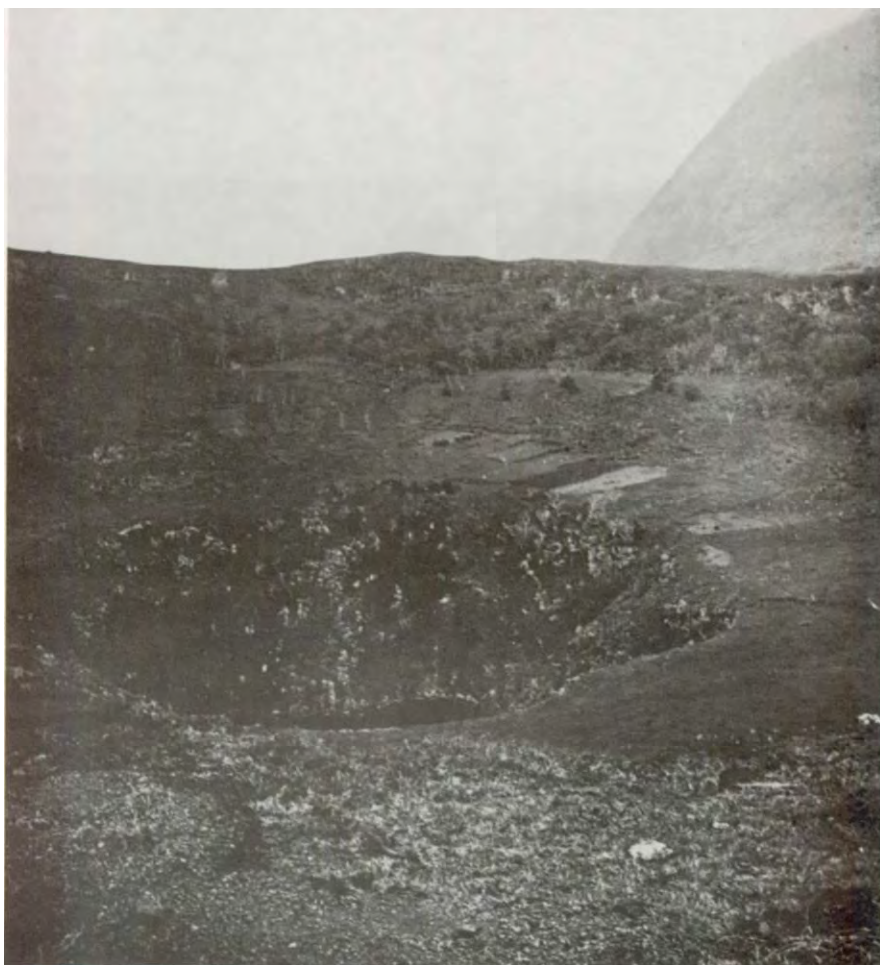
Figure 20. View inside Kauhakō Crater, circa 1890, showing terraced fields and house. (Source: Bishop Museum, Honolulu, Department of the Interior, USGS; Greene, Figure 24)

Cultivation within Kauhakō Crater was observed prior to establishment of the leprosy settlement, and by 1888 this resource was adapted by patients and kōkuas for growing purposes as well (Figure 20).⁸³ Also during this time, breeding cattle were stocked in the peninsula's pastures by the Board of Health, and fences were erected to create paddocks.⁸⁴

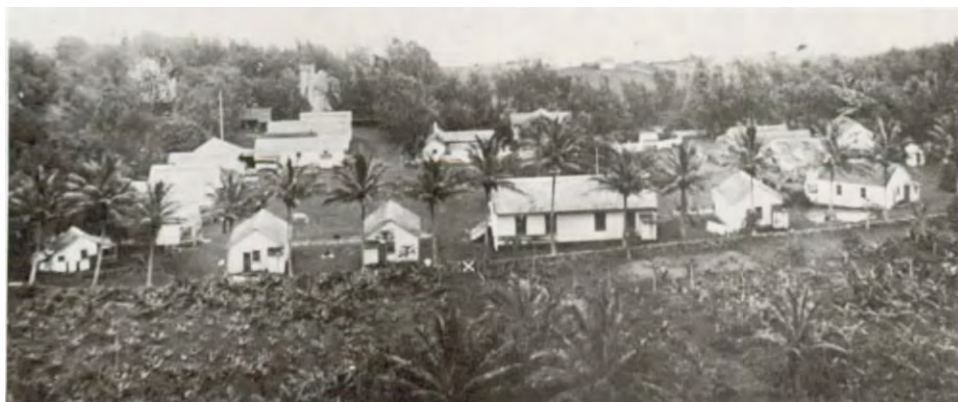
Figure 21. Baldwin Home, Kalawao, looking north circa 1900. Dutton's office is at left, facing the flagpole, with his cottage at the left bottom corner of the photograph. (Source: Bishop Museum, Honolulu; Greene, Figure 40)

Henry Baldwin, a wealthy sugar planter and philanthropist donated funds to construct four new buildings to comprise the Baldwin Home for Boys and Men at Kalawao. The home was constructed on a formerly treeless, rocky area.⁸⁶ When it opened in May 1894, the Baldwin Home consisted of twenty-nine structures, some newly constructed and others moved across the road from St. Philomena. The complex was initially managed by Saint Marianne Cope and the Sisters of Charity, before disciplinary problems led Saint Marianne to lobby for a group of Sacred Heart brothers to serve the residents. The brothers ran the home under the direction of Brother Dutton beginning in late 1895 (Figure 21).⁸⁷

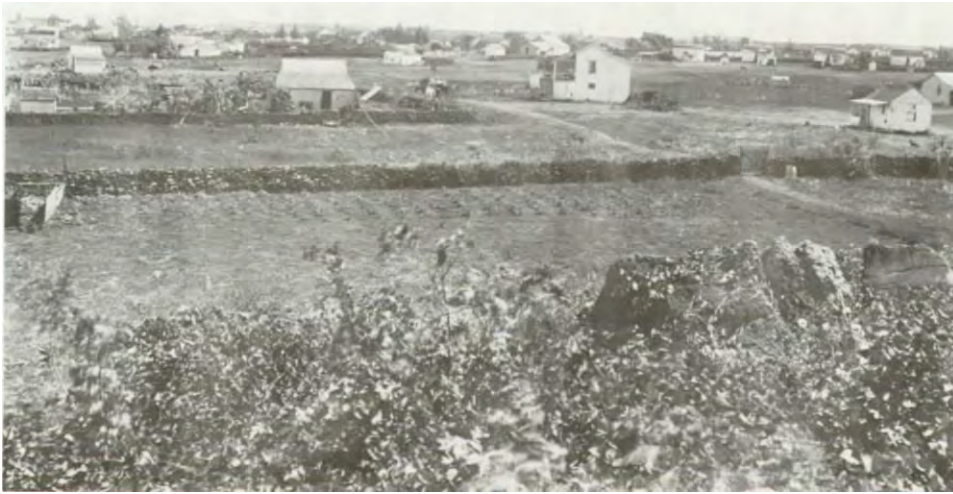
Figure 26. Kalaupapa settlement, undated, pre-1906, showing typical whitewashed houses and enclosed fields. The early St. Francis Church is seen in the distance at the far left. (Source: Hawai'i State Archives, Honolulu; Greene, Figure 23)

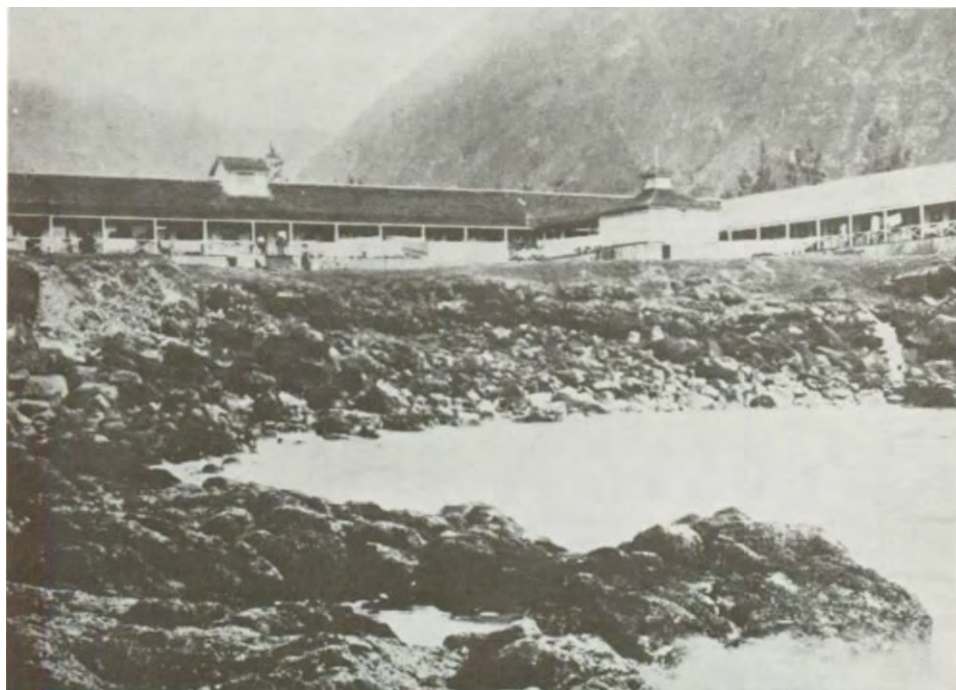
Figure 28. Bay View Home for the Aged and Blind, circa 1907. (Source: Greene, Figure 53)

The second major development at Kalaupapa, after the construction of the Bishop Home in 1888, was the construction of the Bay View Home for the Aged and Blind. This facility, which opened in 1900–1901, provided for both male and female patients needing additional care and included a full-time nursing staff (Figure 28). In the summer of 1901, new visitor quarters were constructed at Kalawao. Two dormitories providing additional visitor quarters were constructed at Kalaupapa (Figure 29).⁹⁵

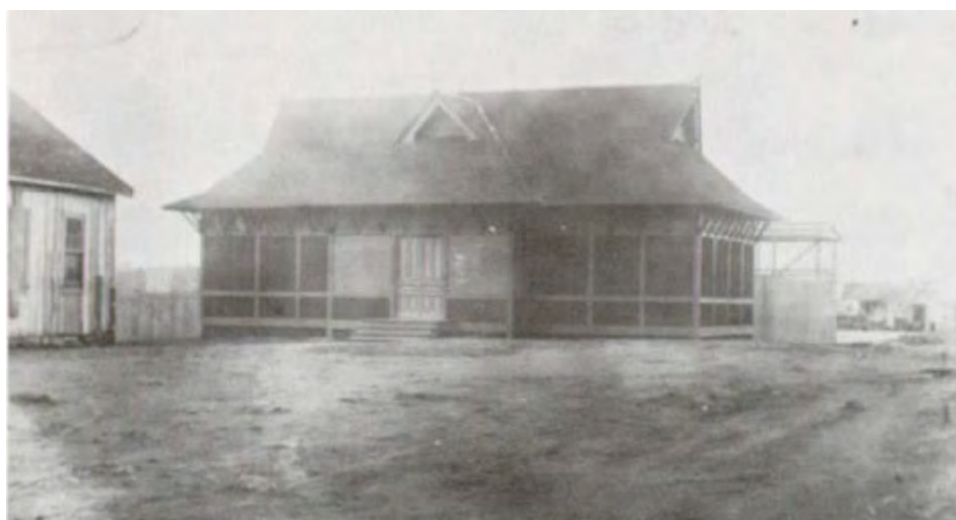
Figure 29. Guest house constructed in 1906 near the landing. (Source: Hawai'i State Archives, Honolulu; Greene, Figure 30)

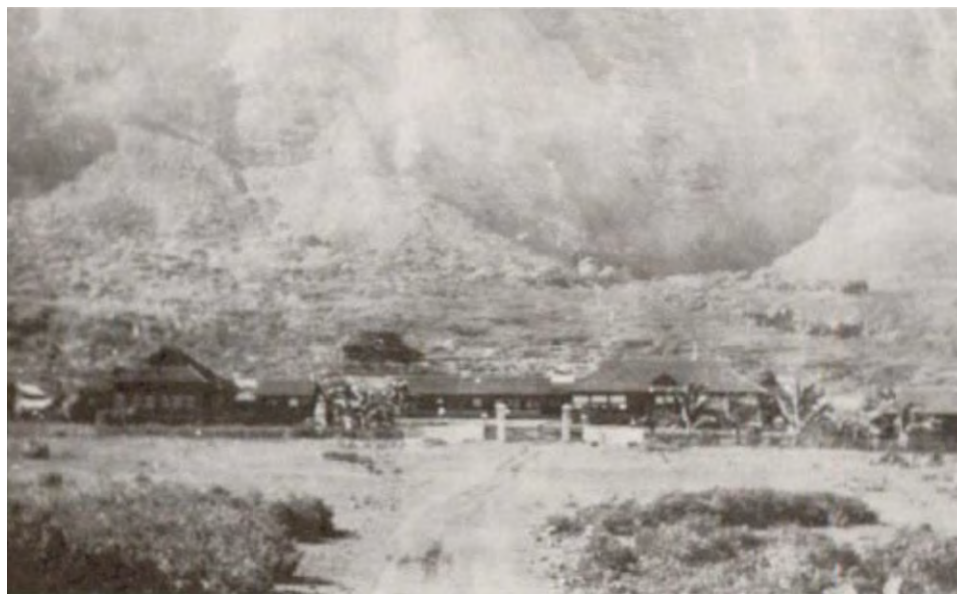
Figure 35. View toward the pali, showing the old general hospital buildings, likely prior to 1935–1936. (Source: Greene, Figure 108)

The first Kalaupapa Hospital opened in 1908. Located at the base of the cliffs, the hospital complex included two general and four private wards, an operating room, drug room, nurse's quarters, dressing rooms, dining room, and a kitchen (Figure 35). A ward for patients with other contagious diseases was located in a separate building. The hospital also included a nursery for babies born to patients in the

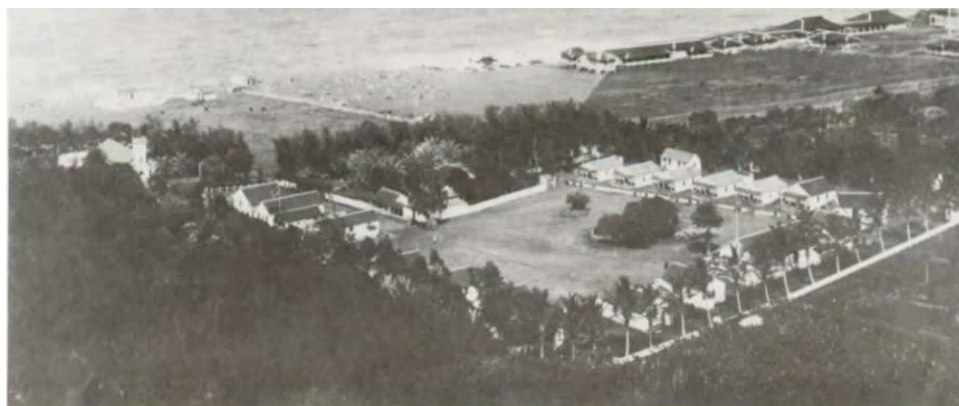
Figure 37. U.S. Leprosy Investigation Station, circa 1913. The Baldwin Home is in the foreground with pasture and clothes washing and drying houses visible near the sea. (Source: National Archives, Washington, D.C.; Greene, Figure 51)

The facility closed in 1913 and remained vacant until 1929, when it was demolished and materials salvaged (Figure 37).¹⁰⁷

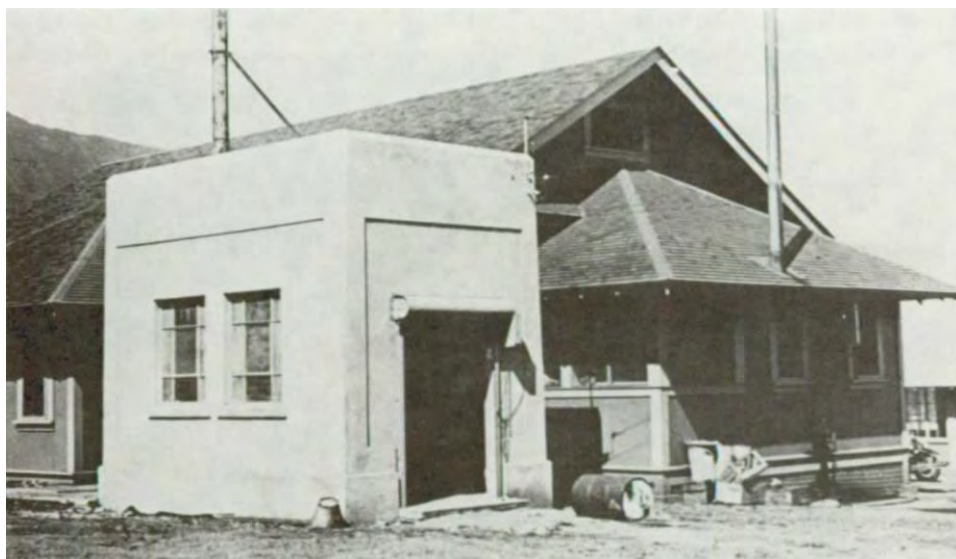
Figure 46. Heating plant, McVeigh Home, 1931–1932. (Source: Kalaupapa Historical Society, Kalaupapa; Greene, Figure 95)

In 1930–1938, the McVeigh Home, which had been destroyed by fire in 1928, was rebuilt. In 1930, plans were developed for two new eleven-room dormitories to replace the facilities destroyed during the November 1928 fire. Work also included construction of fourteen additional cottages, which were completed in 1931–1932.¹²¹ The new facility contained two twelve-room dormitories, twenty-one two-room cottages, two four-room cottages, one older cottage, a central kitchen/dining room, laundry, hot water plant, recreation pavilion, and garages (Figure 43 through Figure 47). All quarters had electricity, indoor plumbing and hot water.¹²²

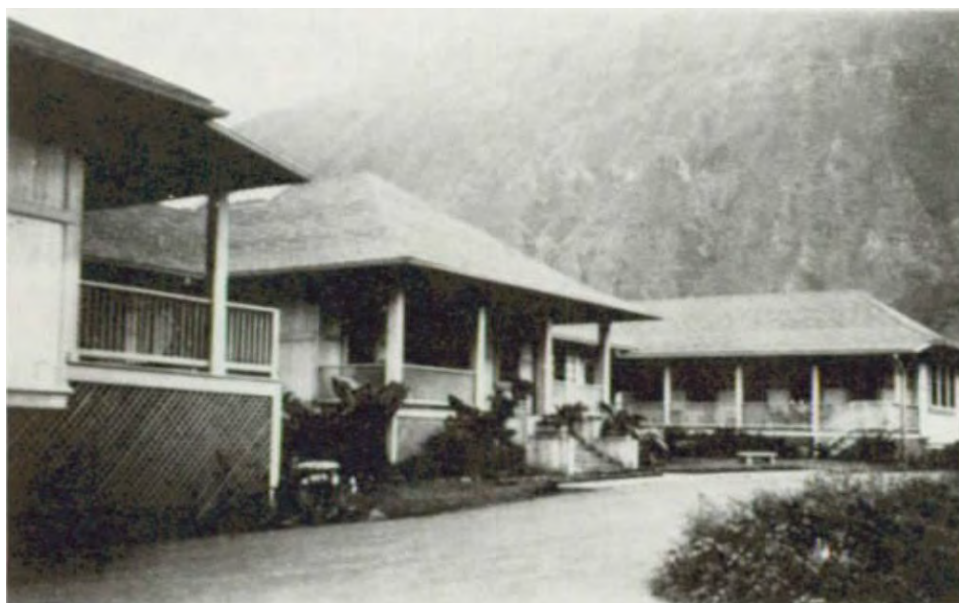
Figure 48. General Hospital, opened 1931, undated. (Source: Hawai’i State Archives, Honolulu; Greene, Figure 106)

A new Kalaupapa Hospital opened on July 1, 1931, displacing twelve cottages and numerous outbuildings which were demolished (Figure 48). The hospital had a capacity of 50 beds, maternity ward, operating room, x-ray room and laboratory, dining room, kitchen, storeroom, staff offices, boiler room, incinerator and laundry. The new hospital modernized the medical treatment capabilities of the settlement. With the construction of the hospital, all residents from Kalawao were moved to Kalaupapa, ending Kalawao’s time as a settlement for patients.¹²⁴ A mental ward was added to the Kalaupapa Hospital complex in 1935–1936 (Figure 49).¹²⁵

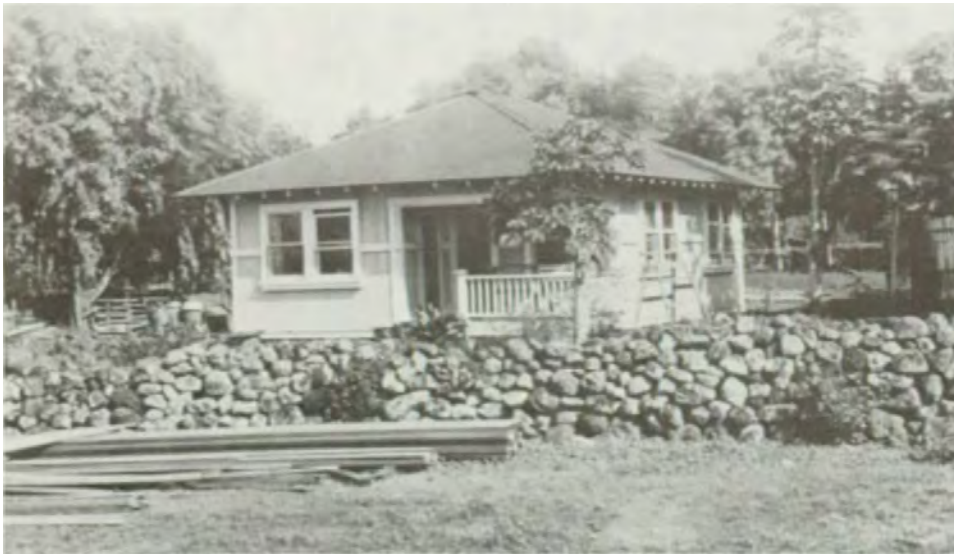
Figure 58. An example of house style 4A, soon after construction in 1931. (Source: Kalaupapa Historical Society; Greene, Figure 104)

In 1934–1936, four more cottages were built, and another twenty-three cottages were remodeled.¹³² Beginning in the 1930s and continuing into the 1940s, many houses were updated by the Department of Health. Improvements included increased accessibility so that residents could be more self-sufficient. Typical changes included replacing door knobs with levers and installing wheelchair ramps where necessary.¹³³ This work continued through 1937–1938 (Figure 57 and Figure 58).

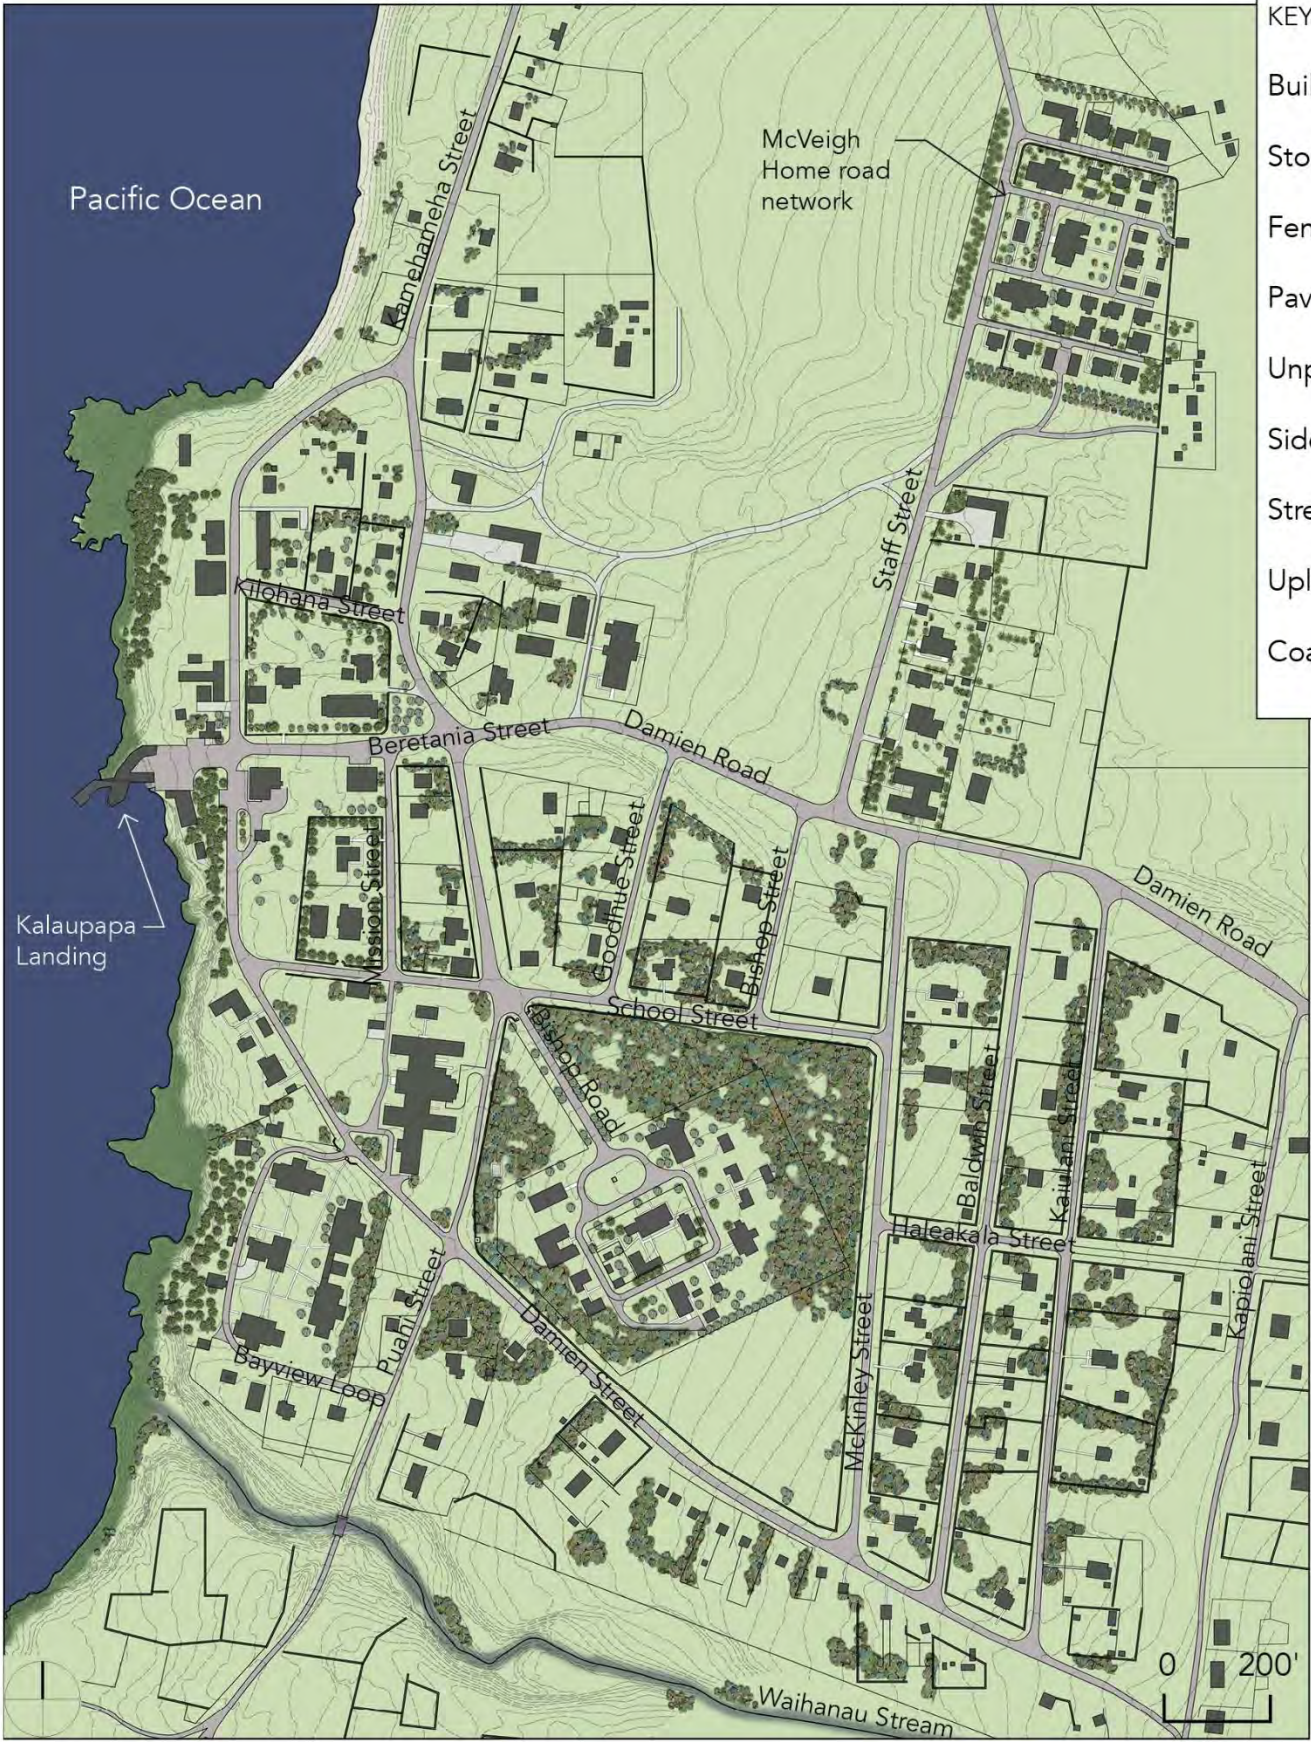
Figure 59. Kalawao, 1909-1942

KEY	
Buildings	
Stone Walls	
Fences	
Paved Roads	
Unpaved Roads	
Sidewalks	
Stream	
Upland Vegetation	
Coastal Vegetation

Source material:
-Aerial orthoimagery, 1938 (<http://miles.giscenter.isu.edu/kalaupapa/overview.html>)
- "Bay View Home Kalaupapa," Governor's Advisory Committee on Leprosy. H.A. Kluegal, C.E., August 1930.
- "Bishop Home for Girls, Kalaupapa," Governor's Advisory Committee on Leprosy. H.A. Kluegal, C.E., August 1930.
- "Industrial Center Kalaupapa," Governor's Advisory Committee on Leprosy. H.A. Kluegal, C.E., August 1930.
- "Kalaupapa Settlement – 1939. Kalaupapa National Historical Park," U.S. Department of the Interior, National Park Service. Adapted from map titled

For a map of Kalawao and Kalaupapa during this time period, refer to Figure 59 Kalawao, 1909–1942, and Figure 60, Kalaupapa Settlement, 1909–1942.

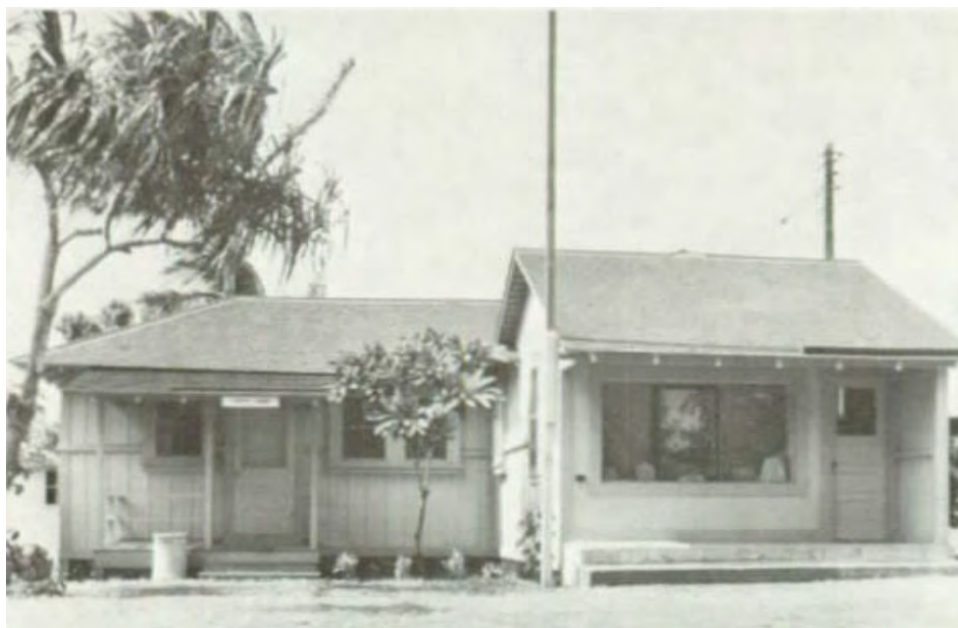
Figure 62. Craft shop, formerly the bakery, 1949. (Source: Hawai'i State Archives, Honolulu; Greene, Figure 166)

In 1948, the craft shop/bakery/beauty shop at the corner of Beretania and Kamehameha Streets was destroyed by a fire (Figure 62). The building was reconstructed the following year, at which time it was used as a craft shop, complete with looms, worktables, sewing machines, and ceramic kiln. The shop soon had twenty-seven

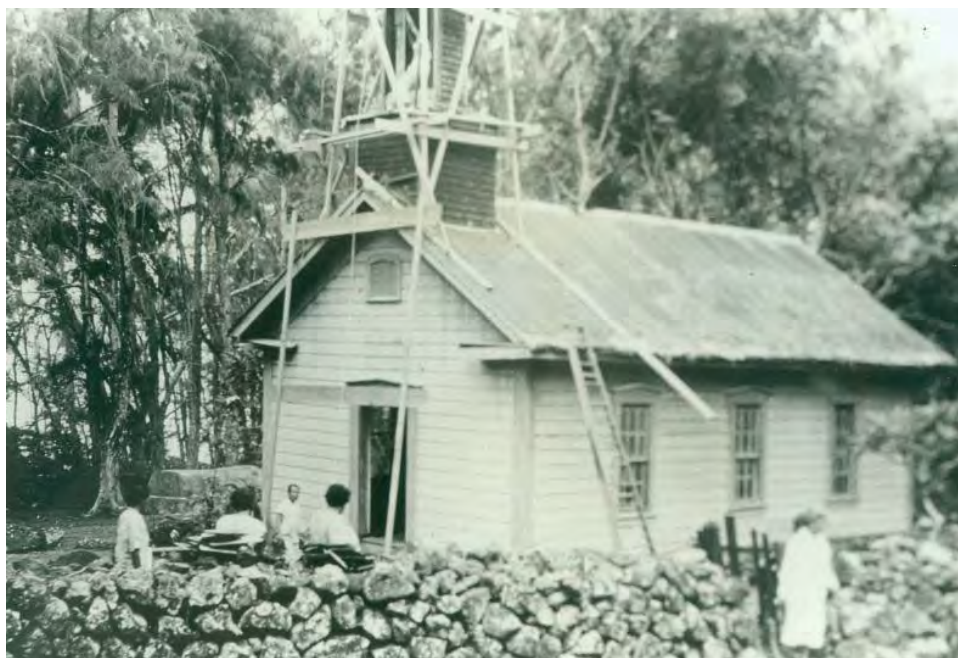
Figure 63. Siloama Church in Kalawao undergoing repair work, 1948. (Source: Kalaupapa Historical Society)

employees, with a craft club also organized.¹⁵² In 1948, repairs were also implemented at Siloama Church (Figure 63).

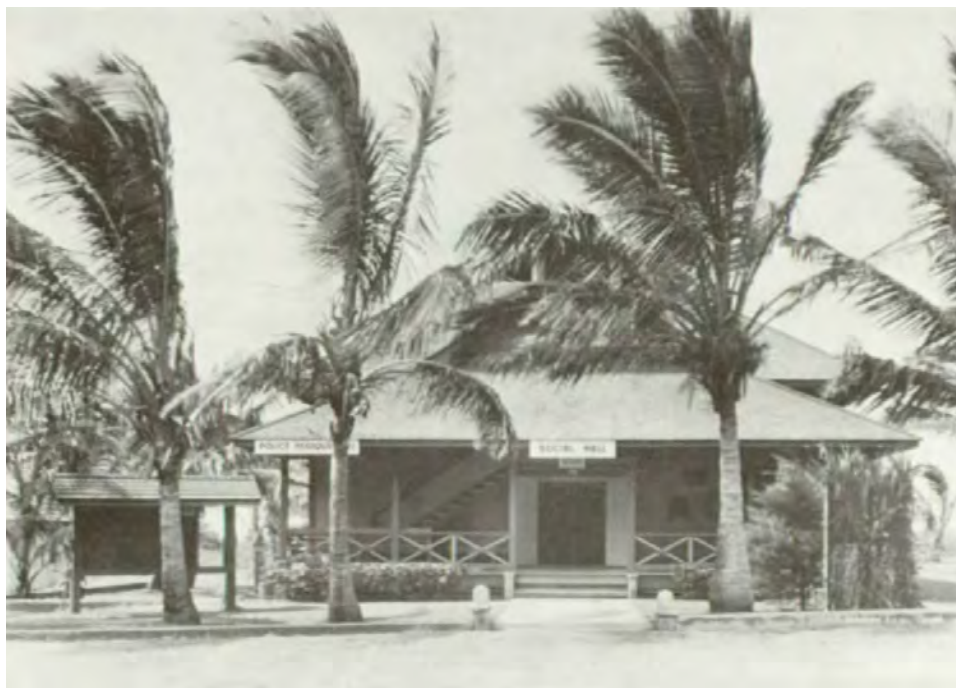
Figure 65. Social hall, 1949. The building was renamed Paschoal Hall in 1958. Note the sign for the Police Headquarters at the left end of the building. (Source: Greene, Figure 165)

new cottages were constructed at McVeigh Home in 1956.¹⁵⁵ Of the eighty-one separate cottages that were available at the time, forty were occupied by married couples.¹⁵⁶ Additional street paving was completed in 1956 and 1958.¹⁵⁷ In the 1950s, a new picnic pavilion for the use of residents and their families—named for Lawrence Judd— was constructed at Kalawao near the site of the former US Leprosy Investigation Station.¹⁵⁸ The social hall was renamed Paschoal Community Hall in 1958, after Manuel G. Paschoal, a longtime proponent for the people of the Kalaupapa settlement (Figure 65).

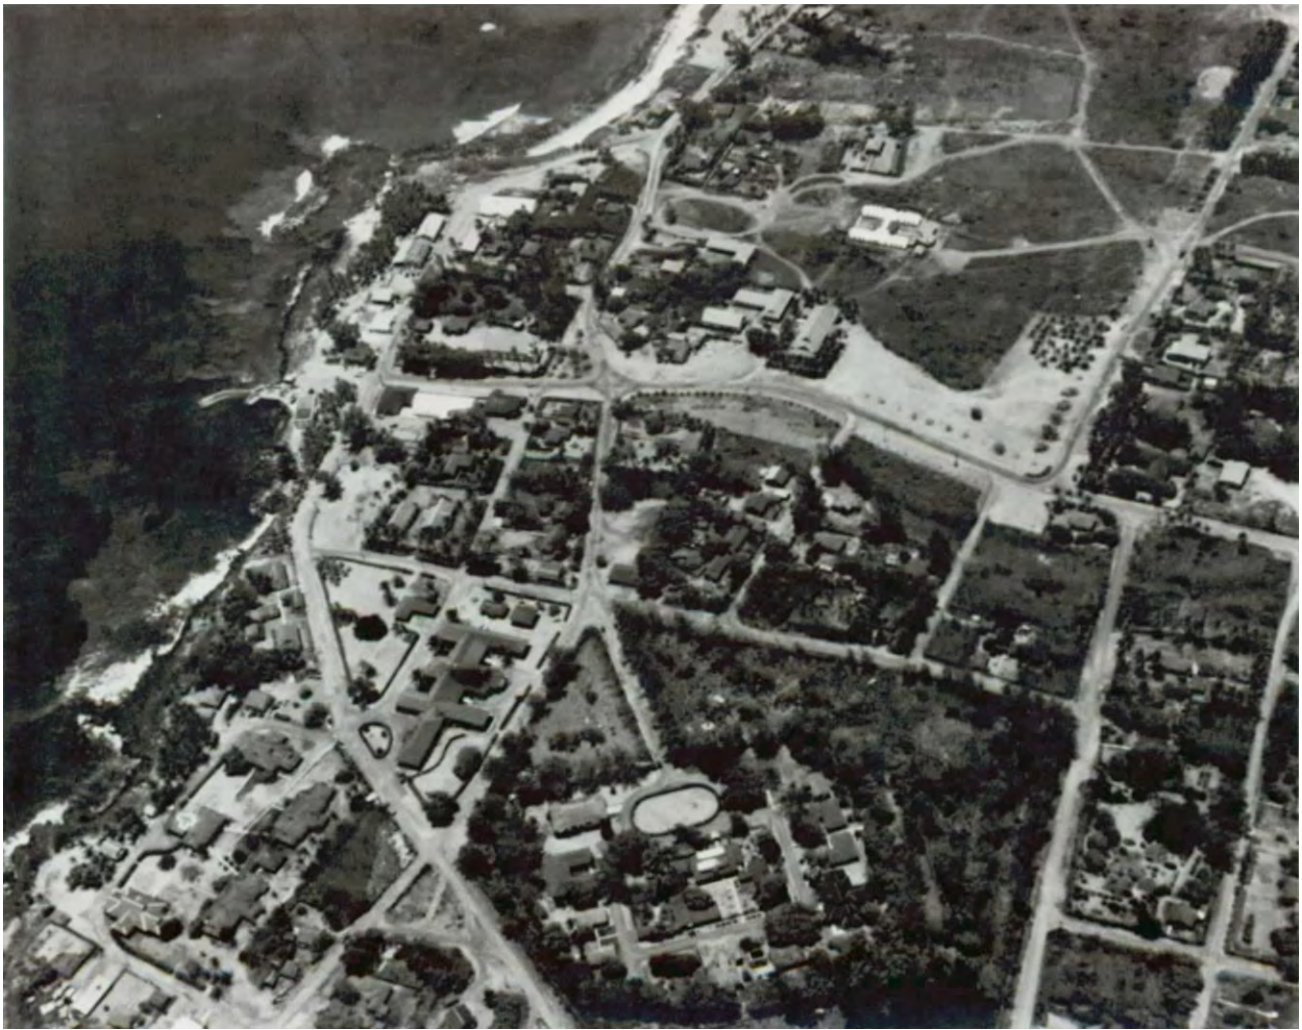
Figure 66. Aerial view of Kalaupapa settlement, 1950. (Source: U.S. Army photo, Bishop Museum, Honolulu; Greene, Figure 167)

With the number of new residents declining, and the current population aging, a number of physical changes were made to Kalaupapa during the 1950s and 1960s (Figure 66). With the population continuing to decline through the 1950s, a number of facilities were closed or converted to different uses, with several residences altered in order to meet modern standards. In 1951, residents of the New Baldwin home were relocated to the Bay View Home. At the same time, a surplus Quonset hut from Pu‘u nēnē Maui Naval Air Station was reconstructed adjacent to the Bay View Home to serve as a dormitory. Other surplus Quonset huts brought from the Naval Air Station were reconstructed at the settlement for use as warehouses and housing for staff. Following the relocation of residents, building materials were salvaged from the New Baldwin Home, while entire sections of the building were also moved in 1951.¹⁶⁰ By 1951, non-patient dormitories were moved to five Quonset huts obtained from the Navy in 1950 (Figure 67). Evaluation of the residential structures at the settlement revealed that about one-third of the homes were beyond repair.

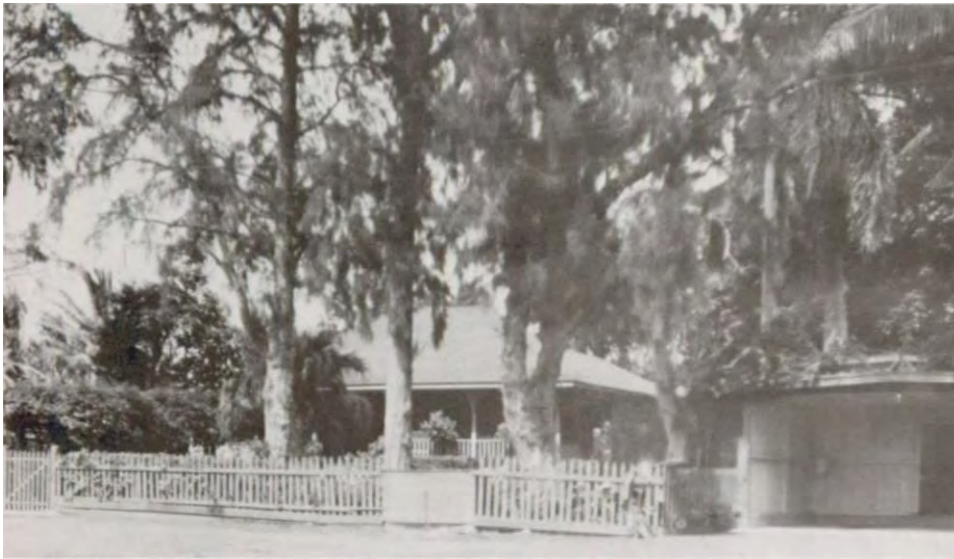
Figure 68. Superintendent's residence on Staff Row, 1949. (Source: Hawai'i State Archives, Honolulu; Greene, Figure 111)

In response to an increase in patients calling for the end to the policy of isolation, the Superintendent's Residence was converted into a dining room and kitchen for the settlement's residents (Figure 68).

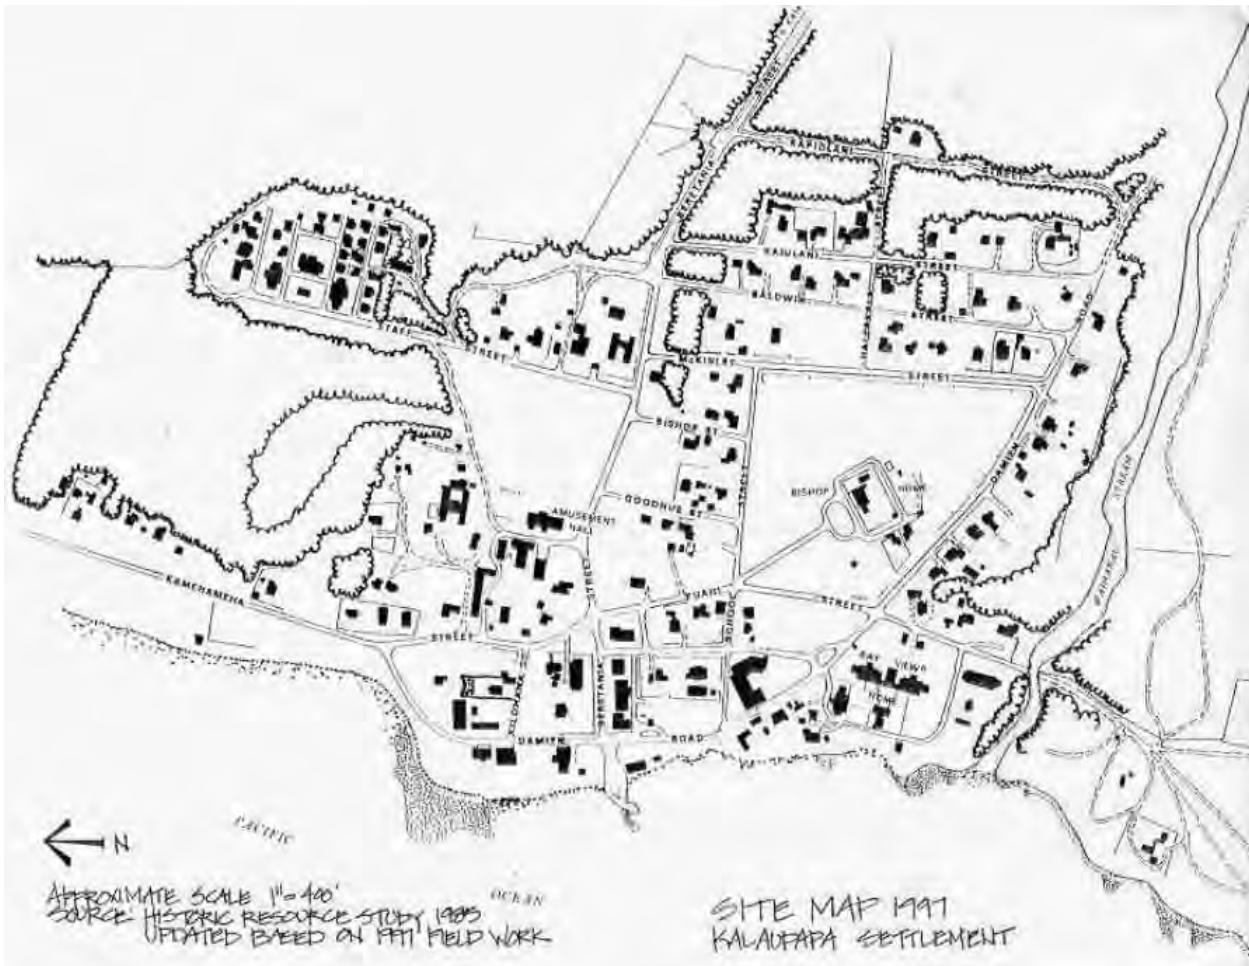
Figure 70. A site plan showing the Kalaupapa Settlement in 1997. (Source: *Cultural Landscape Inventory*, 41, adapted from Greene)

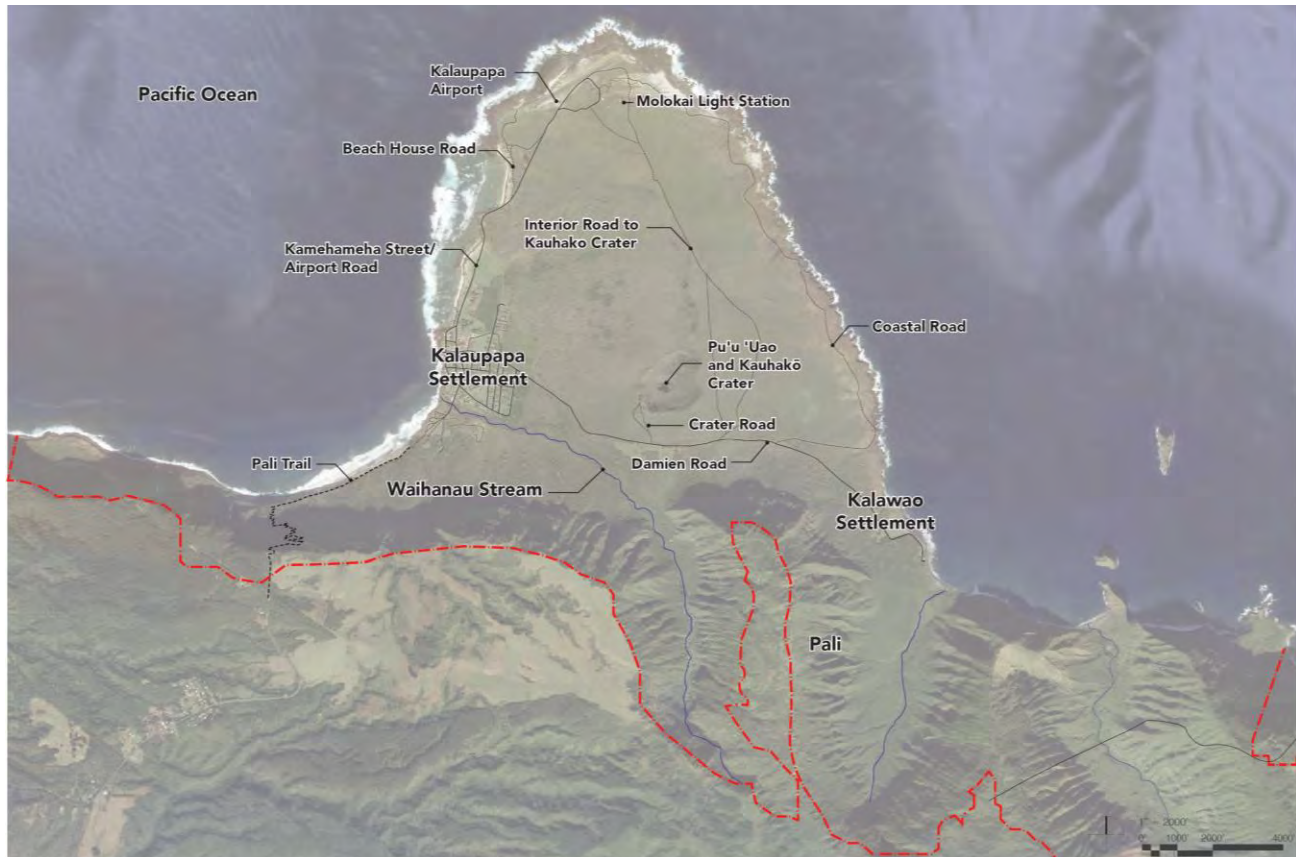
Figure 73. Overview map of Kalaupapa and Kalawao Settlements and Kalaupapa Peninsula. (Source: LSHLA)

Kalaupapa National Historical Park encompasses the remote northern peninsula of Molokai Island that serves as the physical setting for the Kalaupapa and Kalawao Settlements study area (Figure 73). The Kalaupapa and Kalawao Settlements comprise the developed portions of Kalaupapa Peninsula where those presenting with Hansen's disease, also known as leprosy, were separated from Hawaiian society in an effort to control the feared disease. The way in which the removal of individuals who had contracted Hansen's disease to the Kalaupapa Peninsula affected the people and families of Hawai'i continues to be felt today. Kalaupapa

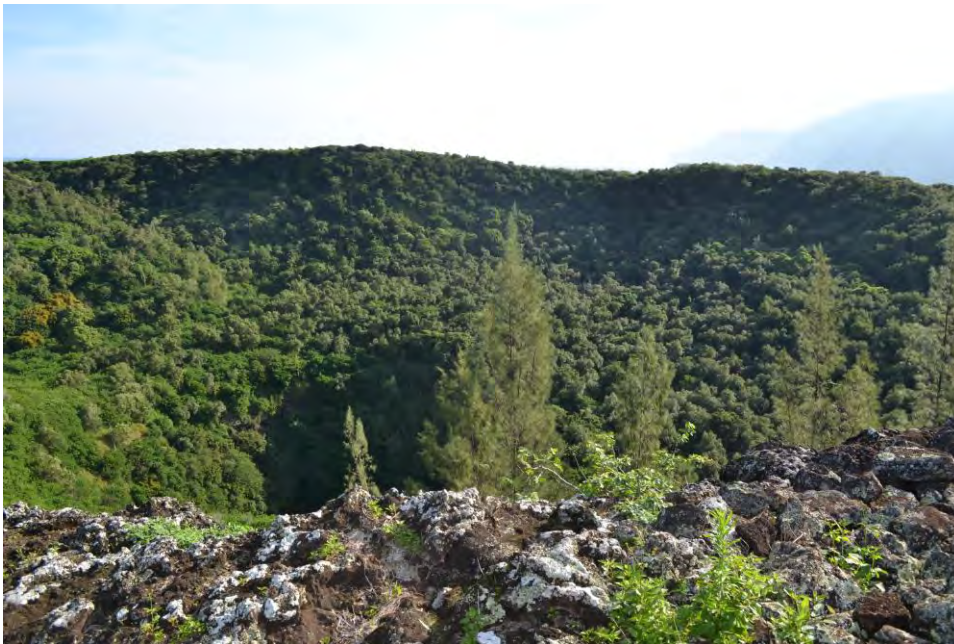
Figure 78. View east across Kauhakō Crater from the rim of Pu‘u ‘Uao, 2017.

One of the notable natural features of the peninsula is Kauhakō Crater (Figure 78), the primary vent of Pu‘u ‘Uao volcano that contains a prominent lava channel and tube system and trench and cave formations.¹⁹⁰ The interior of the crater features one of the deepest volcanically-formed freshwater lakes in the world, while rare native plant communities are found on both the interior and outer slopes. Rock outcroppings that have served as a source for the dry stacked stone walls found in many developed areas of the peninsula are also present, along with evidence of earlier agricultural terracing, residential structures, and some burials, which are distinct from the marked graves along the road that leads to the top of Pu‘u ‘Uao overlooking the crater. The western rim of Pu‘u ‘Uao affords sweeping views of the Kalaupapa Settlement to the west, the pali to the south, the level topography of the peninsula to the north, Molokai Light Station, and the Pacific Ocean to the west, north, and east. The top of Pu‘u ‘Uao and Kauhakō Crater holds special meaning for Kalaupapa residents. For many, it is sacred space with splendid views, considered “a beautiful place . . . a nice place to

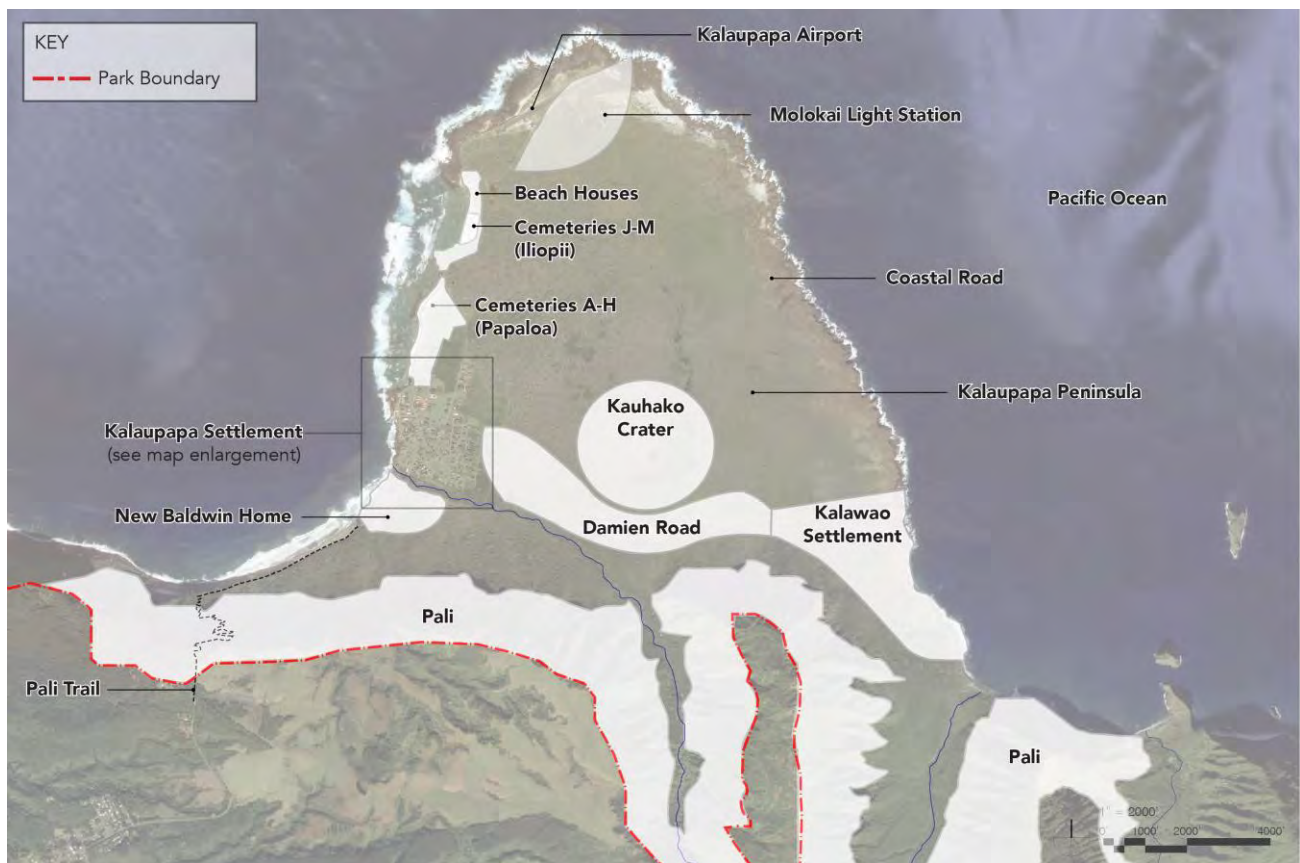
Figure 80. Map of Peninsula-wide Spatial Organization. (Source: LSHLA)

Refer to Figure 80, Map of Peninsula-wide Spatial Organization.

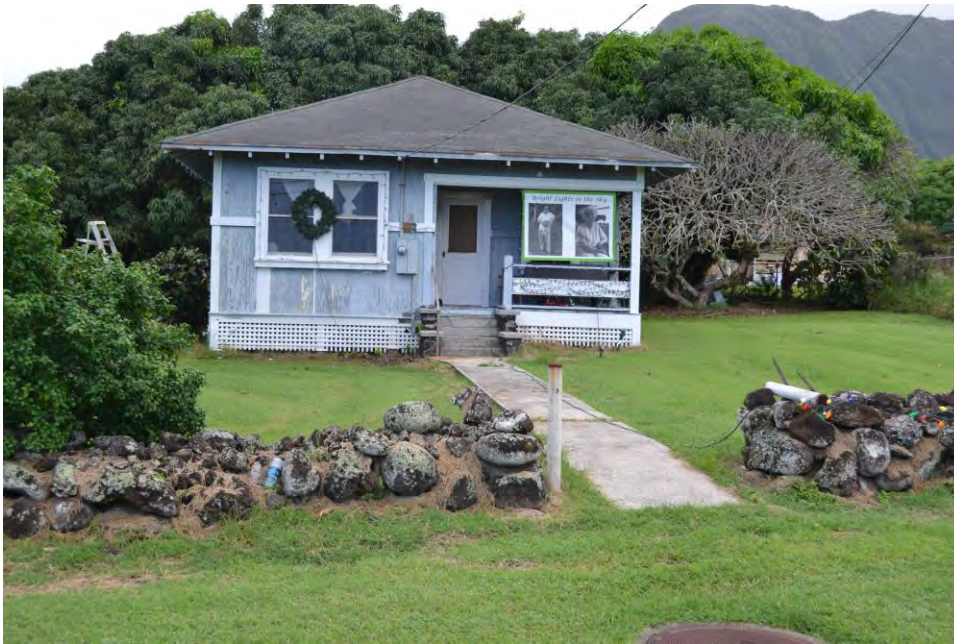
Figure 83. A residential property at Kalaupapa, 2017. The property is characteristic of many residences within Kalaupapa Settlement for the Hawaiian Plantation style of architecture of the dwelling, the marking of the property along the road with a dry stacked stone wall, the paved walk leading to the front entrance through an open front yard, and the presence of ornamental plantings behind the house.
