Kalaupapa and Kalawao Settlements Cultural Landscape Report

Kalaupapa National Historical Park

Cultural Landscape Report

Prepared by:
Wiss, Janney, Elstner Associates, Inc.
2000 Powell Street, Suite 1650
Emeryville, California 94608

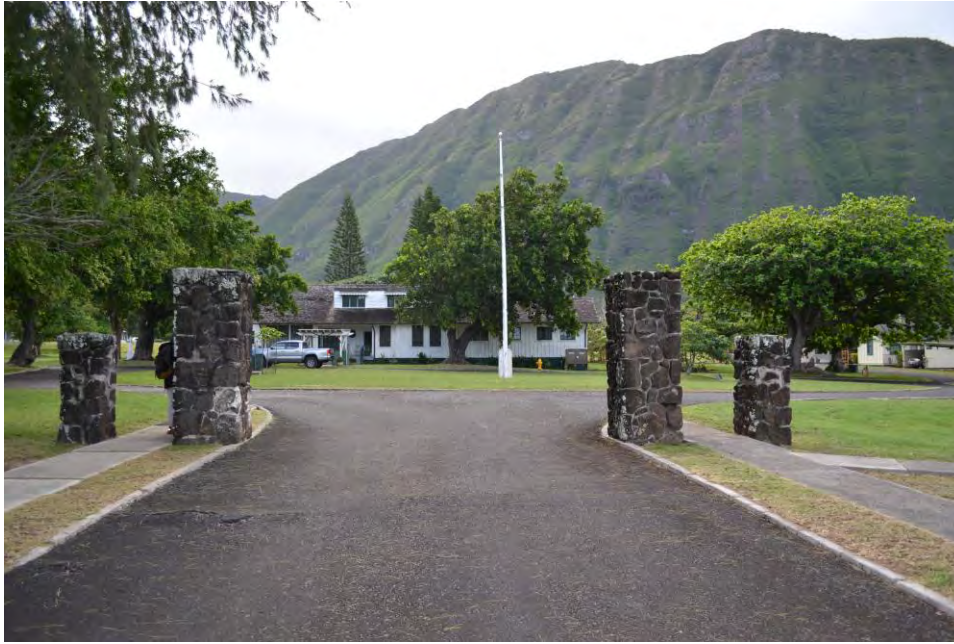
Figure 84. View along Bishop Road, the entrance drive, edged by stone piers, that leads to the Bishop Home property from the intersection of School and Puahi Streets, 2017.

To the south of the administrative area are two additional group homes—Bay View and Bishop Home—both of which served distinct populations. Bishop Home for Girls was established for younger women in 1888. It also served as a convent for the nuns who cared for the girls and is currently in use by nuns who are in residence. It occupies one of the largest blocks within Kalaupapa Settlement and has one of the most formal landscape plans. The complex is centered on an elevated knoll, with all of the buildings sited around a central oval. Although many of the original buildings are no longer present, the original road system and other landscape features highlight the formal arrangement of the internally-focused built precinct set within the center of the property (Figure 84), which was also marked by a perimeter dry stacked stone wall system.

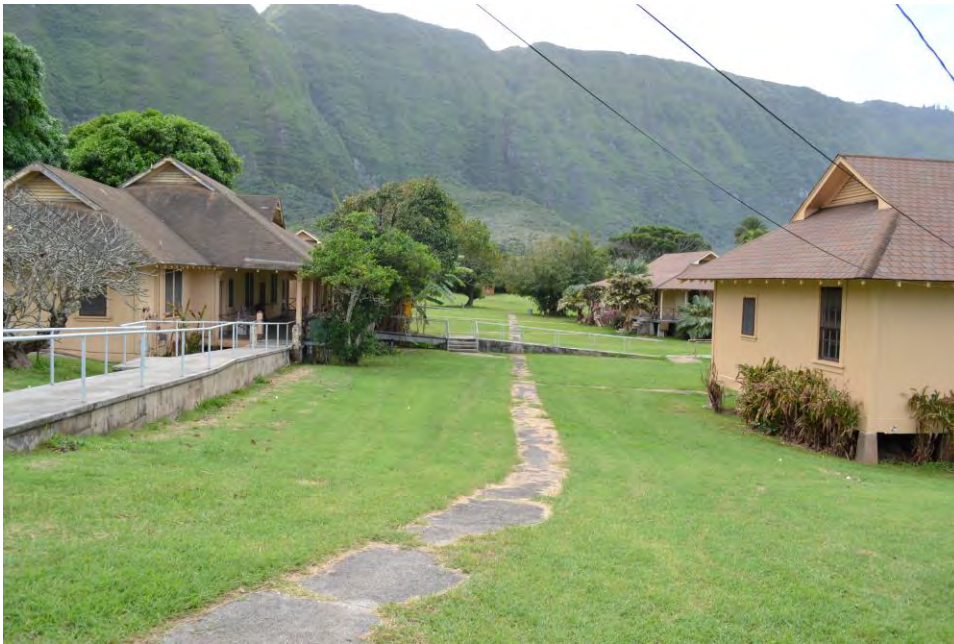
Figure 85. Bay View Home buildings edging the central open space, 2017.

Bay View Home is another internally-focused group home complex. Originally designed with five similarly-scaled buildings arranged to form a central open space, Bay View is comprised of a cluster of dormitories, a kitchen, and a dining hall centered around a central open space (Figure 85). As with Bishop Home, paired piers mark the entrance into the group home precinct. Additional residences edge the cluster along a perimeter road. To the north of Bay View Home is a cluster of buildings that edge Damien Street associated with the Visitor Quarters developed area that house and otherwise address the needs of visitors.

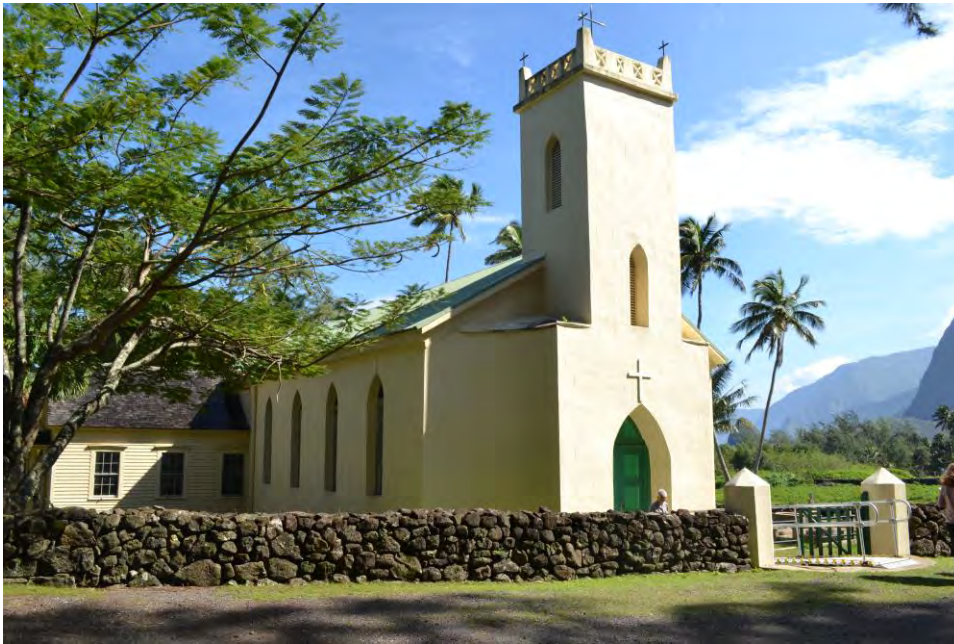
Figure 87. View east of St. Philomena Church and the dry stacked stone wall that edges the property along Damien Road, 2017.

Kalawao was a linear community that followed the alignment of Damien Road. Clusters of built features that edged the road were surrounded by open areas used for cultivation and livestock pasture and recreation. Several churches were built at Kalawao; two survive today—St. Philomena Catholic Church (Figure 87) and Siloama Protestant Church. Both are set within precincts formed by dry stacked stone walls that contain burial grounds and plantings. Also in evidence are the structural remains of buildings and walls associated with the 1909 U.S. Leprosy Investigation Station, located along Damien Road near the eastern end of the peninsula, and the original Baldwin Home, located across Damien Road from St. Philomena Catholic Church.

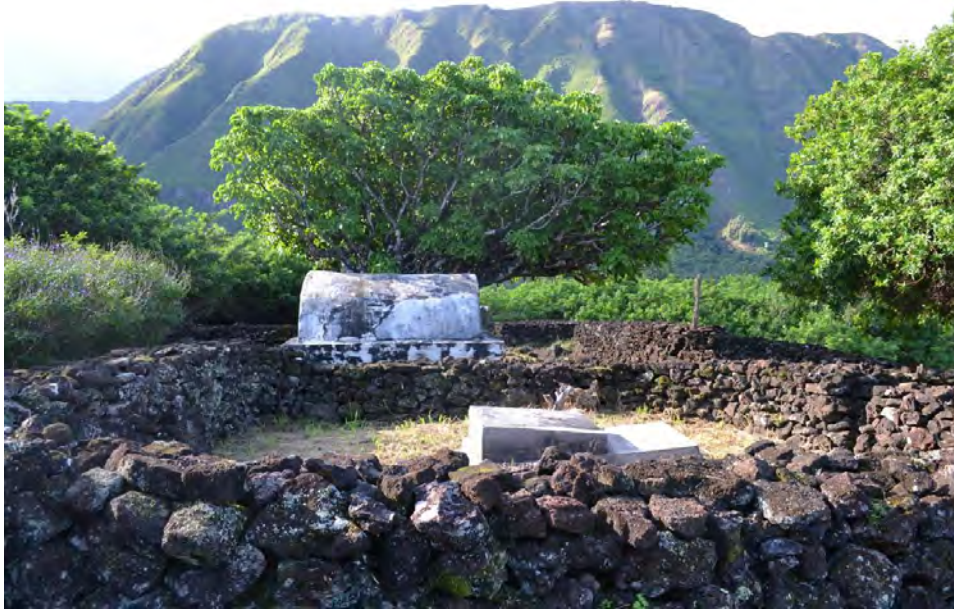
Figure 88. View south toward the dry stacked stone walls that enclose a series of burial ground plots along the road leading to the western rim of Kauhakō Crater on Pu'u 'Uao, 2017.

As noted the volcanic cone of Pu'u 'Uao is the highest point on the peninsula. It rises dramatically within the south-central portion of the peninsula to the north of Damien Road. An unimproved access road leads north from Damien Road to the western rim of the peak which overlooks Kauhakō Crater. The road margins along the slope and the apex of the rim are edged by dry stacked stone wall enclosures that surround graves (Figure 88). A large concrete cross stands atop the western rim of the crater that is visible from the Kalaupapa

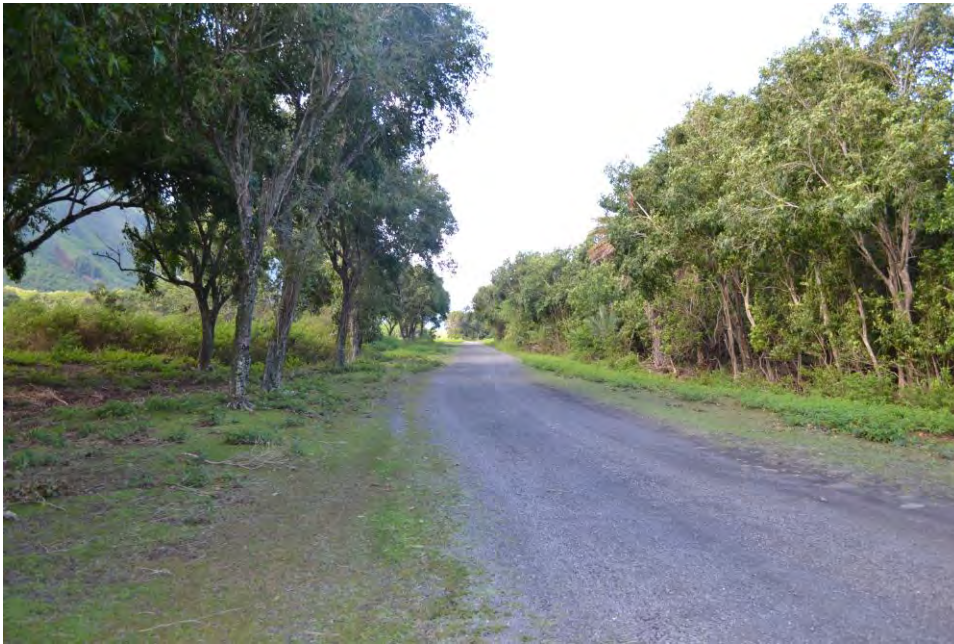
Figure 89. View west along the Damien Road corridor, 2017.

Damien Road connects Kalawao and Kalaupapa Settlements along the southern margin of the peninsula.²¹¹ Damien Road, itself a historic feature, passes several historic features, including the road that leads to the western rim of the crater, water tanks associated with the original water supply system, the site of Settlement Superintendent Ambrose Hutchison’s House, a tsunami preparedness area, a stone cistern, numerous dry stacked stone walls, a heiau, wall-enclosed Kahaloko Cemetery, and evidence of the extensive traditional Hawaiian habitation and agricultural landscape that underlies the present built environment. The road is variously edged by woodland, clearings, and periodic stone cultural feature remains. The road corridor varies from being open along the margins to being heavily wooded (Figure 89).

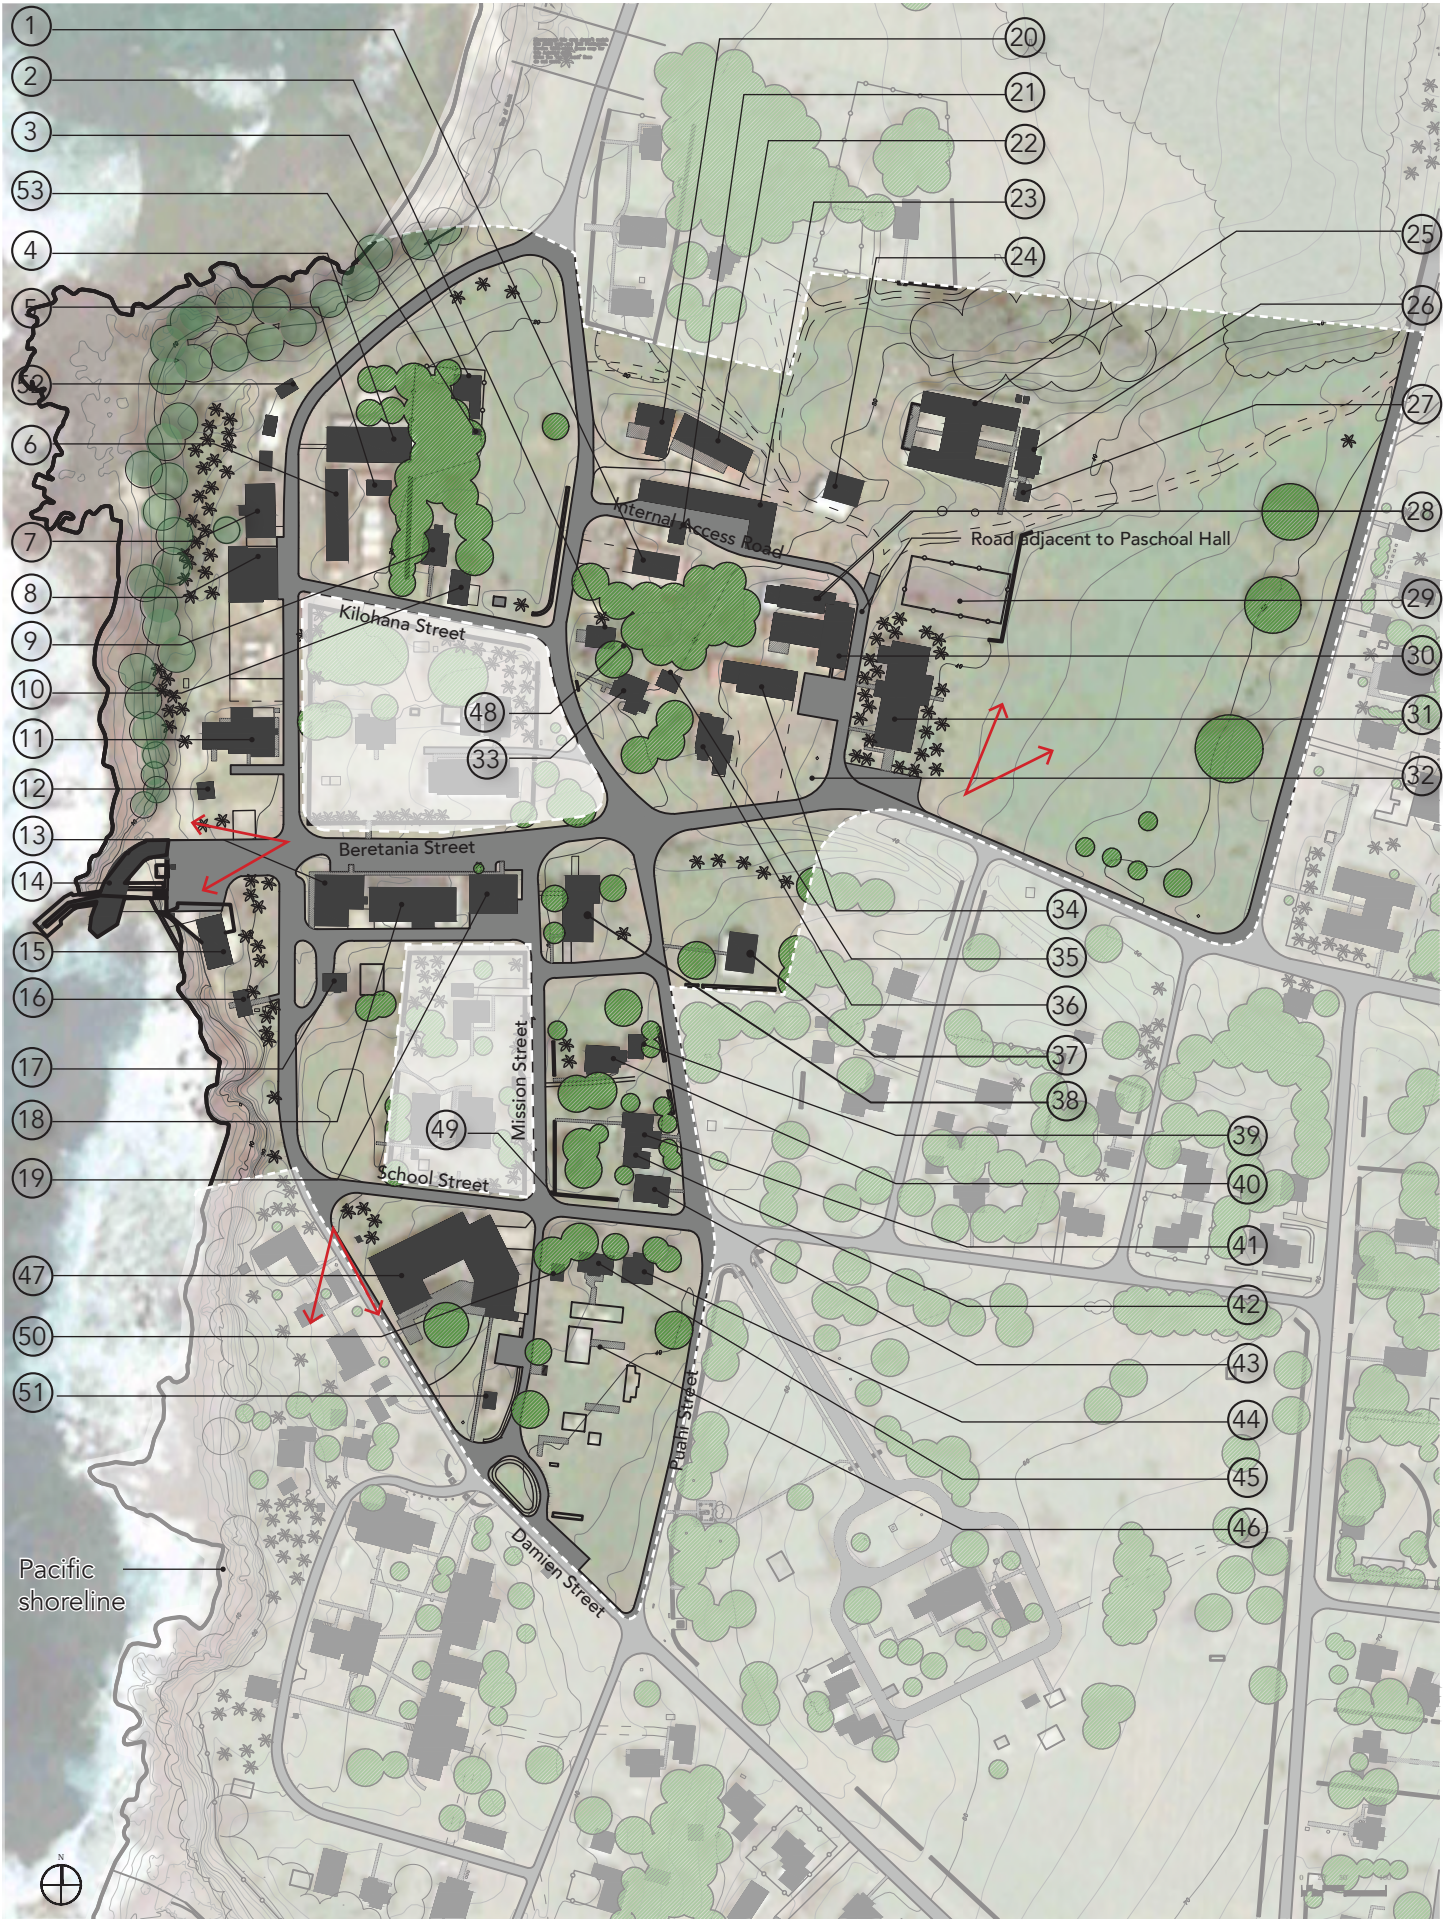
Figure 90. Administrative Character Area - Existing Conditions

- Character area boundary
- Primary roads
- Secondary roads
- Buildings
- Foundations
- Sidewalks
- Walls (C)
- Fences (NC)
- Trees
- Key views

Refer to Figure 90. Administrative Area – Existing Conditions

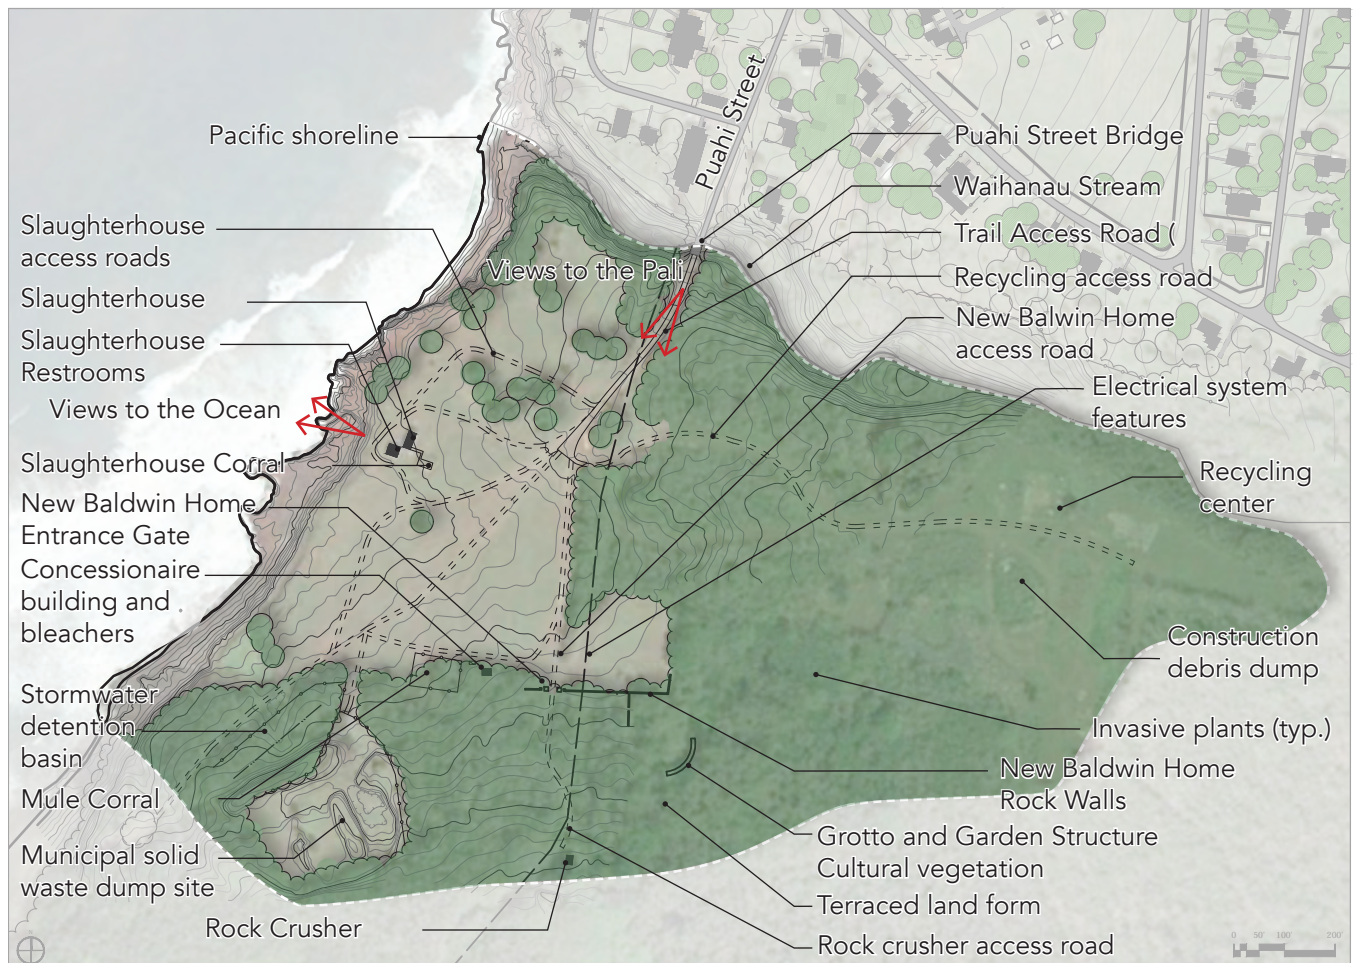
Figure 97. New Baldwin Home Character Area - Existing Conditions

KEY	
	Character area boundary
	Primary roads
	Secondary roads
	Buildings
	Foundations
	Sidewalks
	Walls (C)
	Fences (NC)
	Trees
	Key views

Refer to Figure 97, New Baldwin Home Character Area - Existing Conditions.

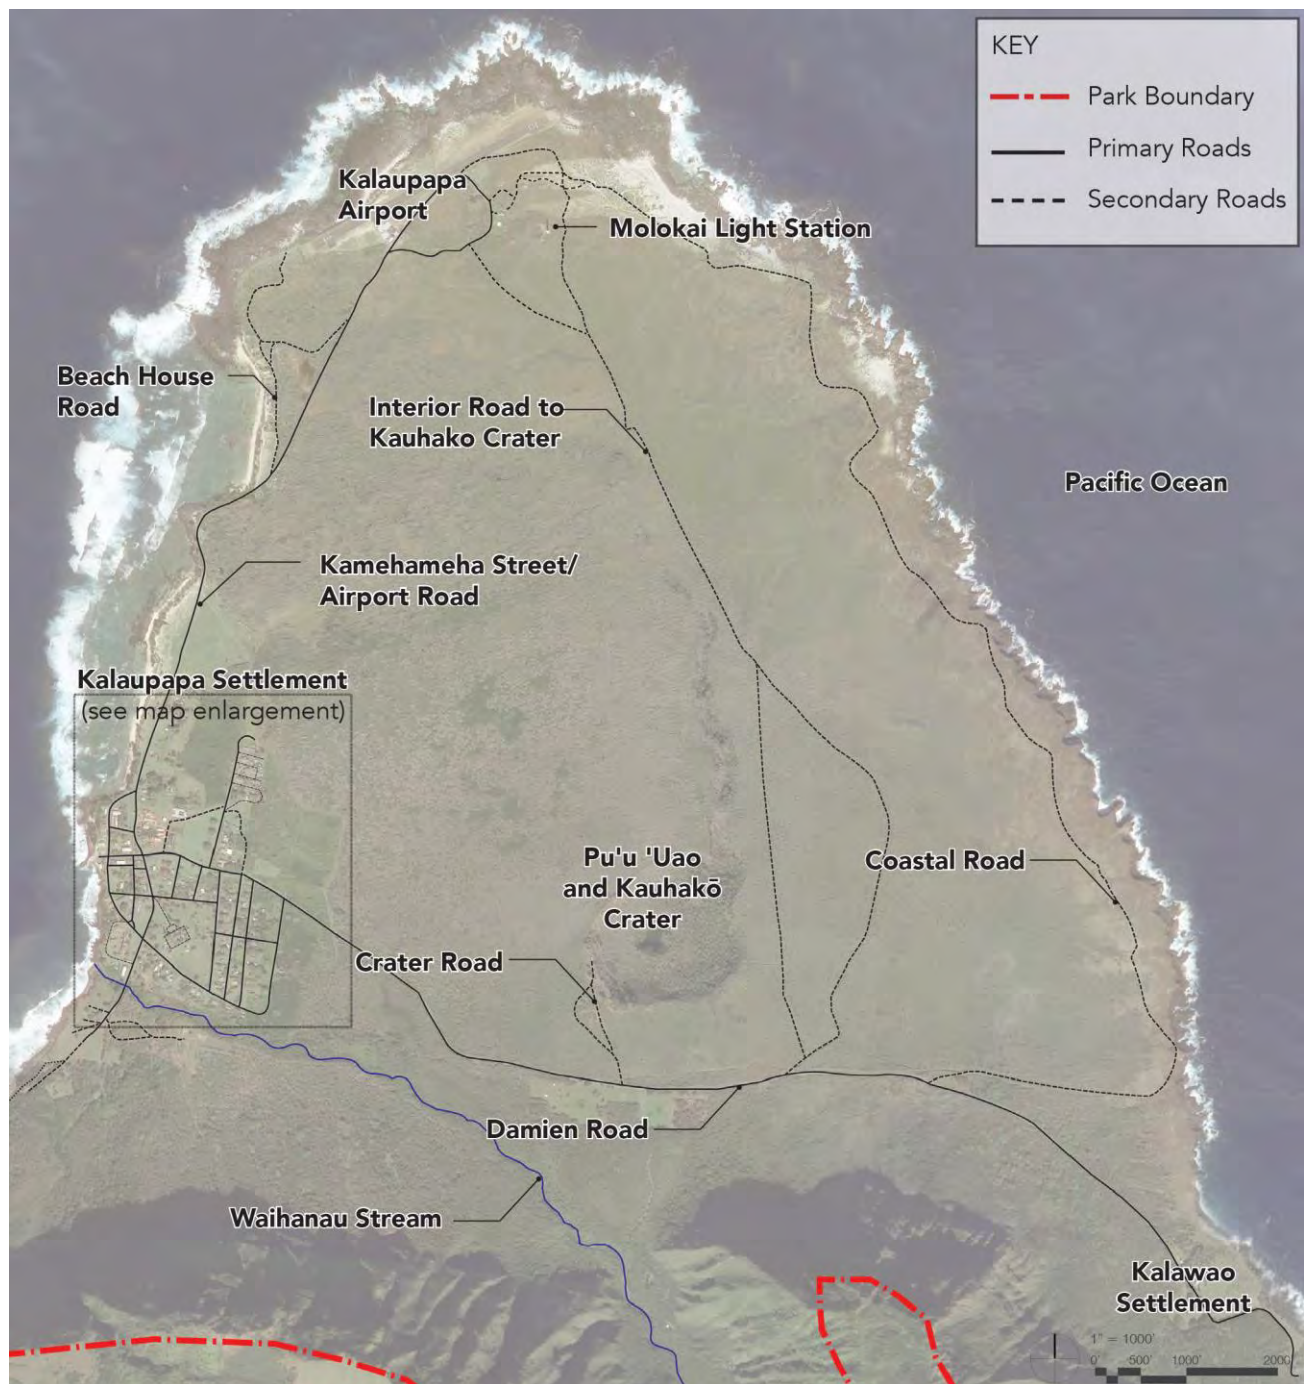
Figure 111. Peninsula-wide circulation features. (Source: LSHLA)

Refer to Figure 110, Kalaupapa Settlement circulation features, and Figure 111, Peninsula-wide circulation features.

The gridded network of primary roads at Kalaupapa Settlement contrasts with the linear arrangement of Kalawao Settlement, where most of the built features were historically oriented to a single central road corridor—Damien Road—with interior access roads formerly arising from the route (Figure 111).

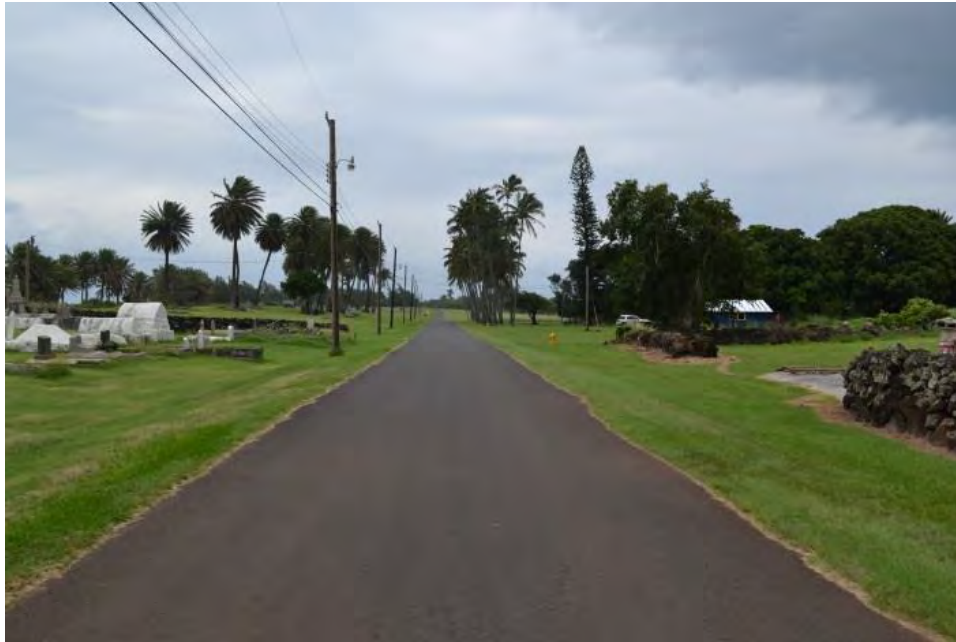
Figure 112. View northeast along Kamehameha Street, with the West Coast Cemeteries at Papaloa to the left, and residential properties to the right, 2017.

The primary road that leads north from Kalaupapa Settlement is known as Kamehameha Street/Airport Road. It is asphalt-paved (Figure 112). Damien Road, which connects Kalaupapa and Kalawao Settlements, is the only primary road corridor that is gravel-surfaced.

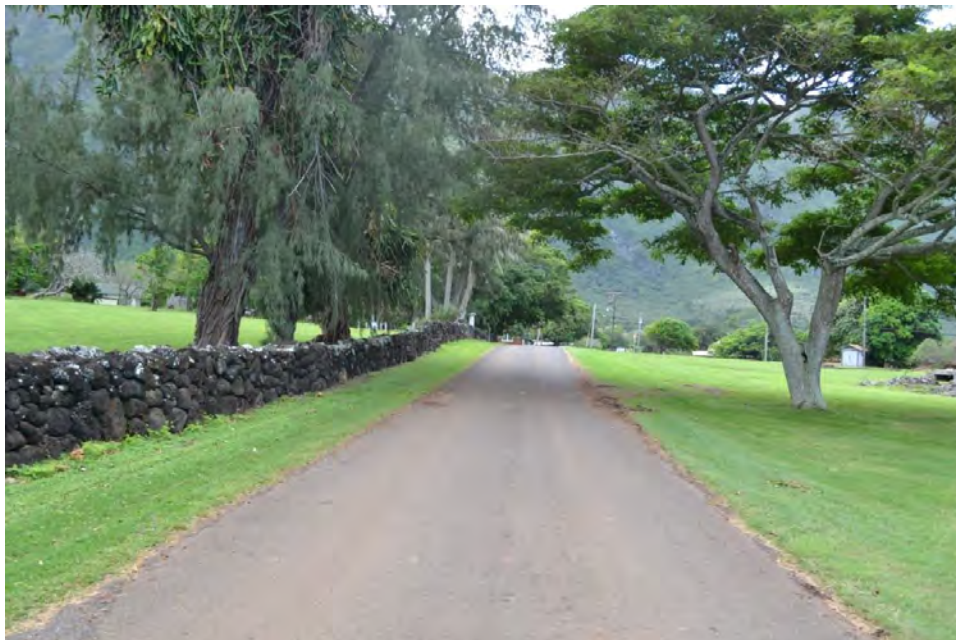
Figure 113. View south along Puahi Street, one of the primary roads within Kalaupapa Settlement, 2017.

North-south primary roads in Kalaupapa Settlement include Kamehameha Street, Mission Street, Damien Street, Baldwin Street, Bishop Street, Goodhue Street, Kaiulani Street, Kapiolani Street, McKinley Street, Staff Street, and Puahi Street (Figure 113).

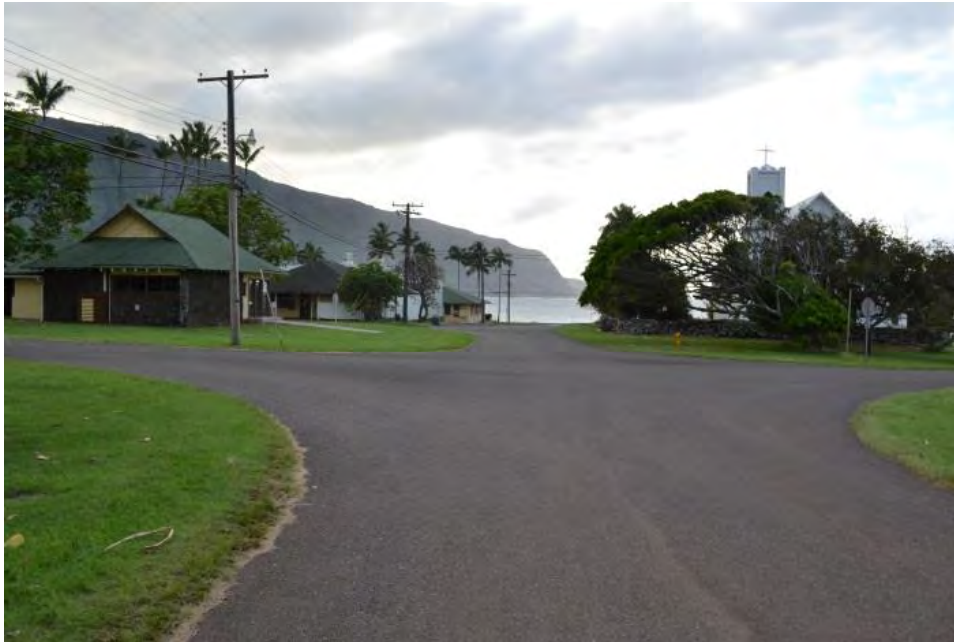
Figure 114. View west along Beretania Street near its intersection with Puahi Street (left), and Kamehameha Street (right), 2017. Also visible are the DOH administration building to the left and St. Francis Catholic Church to the right.

East-west primary roads in Kalaupapa Settlement include Beretania Street, School Street, Haleakala Street, and Kilohana Street. Beretania Street extends from Kalaupapa Landing to Damien Road, and provides views of St. Francis Catholic Church (Figure 114) and Paschoal Hall.

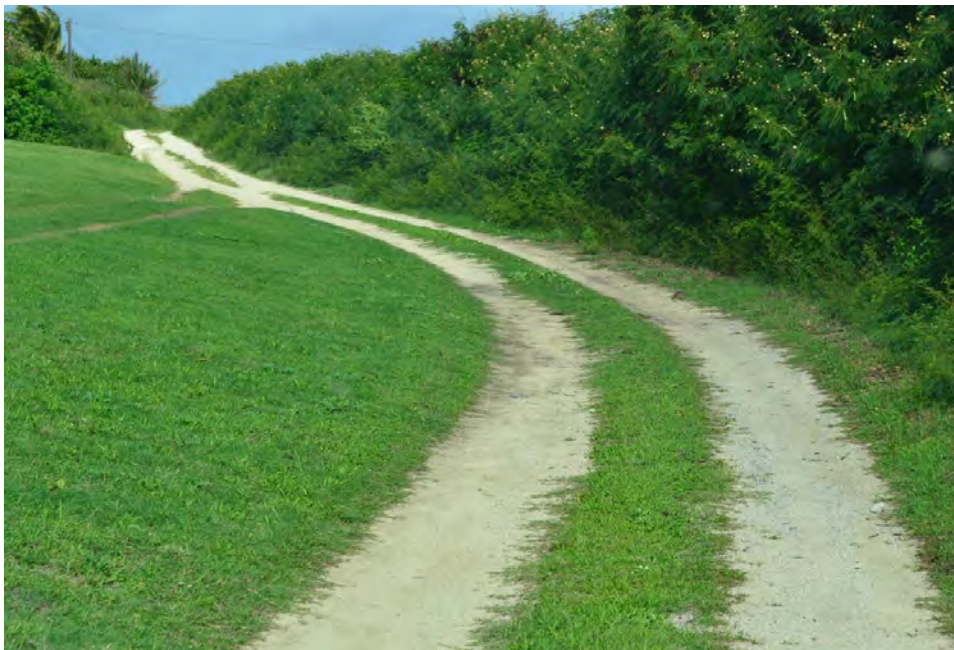
Figure 115. Beach House Road is an example of a secondary road within Kalaupapa Settlement, 2017.

Secondary Roads. Secondary roads that occur within the Kalaupapa and Kalawao Settlements are narrower than primary roads, measuring approximately 12 to 15 feet in width, and surfaced with gravel, hard-packed earth, or sand. Edge conditions associated with secondary roads vary, and include woodlands, herbaceous and woody vegetation, and fencing. The secondary roads located within Kalaupapa and Kalawao Settlements include the Trail Access Road that leads to the Pali Trail, Beach House Road (Figure 115), Crater Road, Coastal Road, and the Interior Road to Kauhakō Crater.

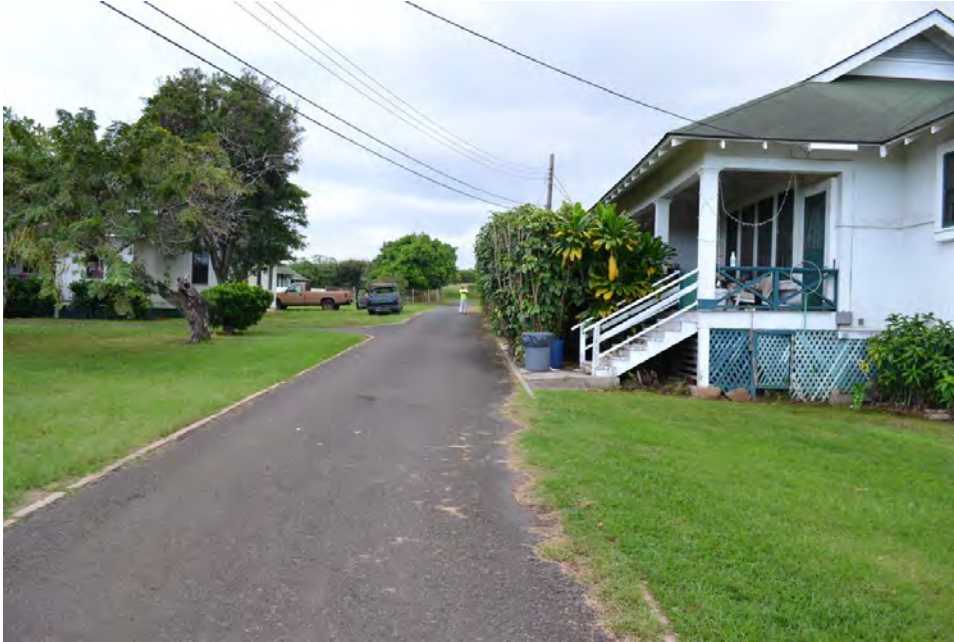
Figure 116. One of the interior roads associated with McVeigh Home, 2017.

Interior Access Roads. Interior access roads lead into Bay View Home, Bishop Home, and McVeigh Home in Kalaupapa Settlement (Figure 116). Improved interior access roads are asphalt-paved, and narrower than primary roads. At McVeigh Home, the interior roads are narrow and range from 10 to 12 feet in width, while those at Bay View and Bishop Home are wider, ranging from 12 to 15 feet in width. Many of the interior access roads are edged by concrete curbs.

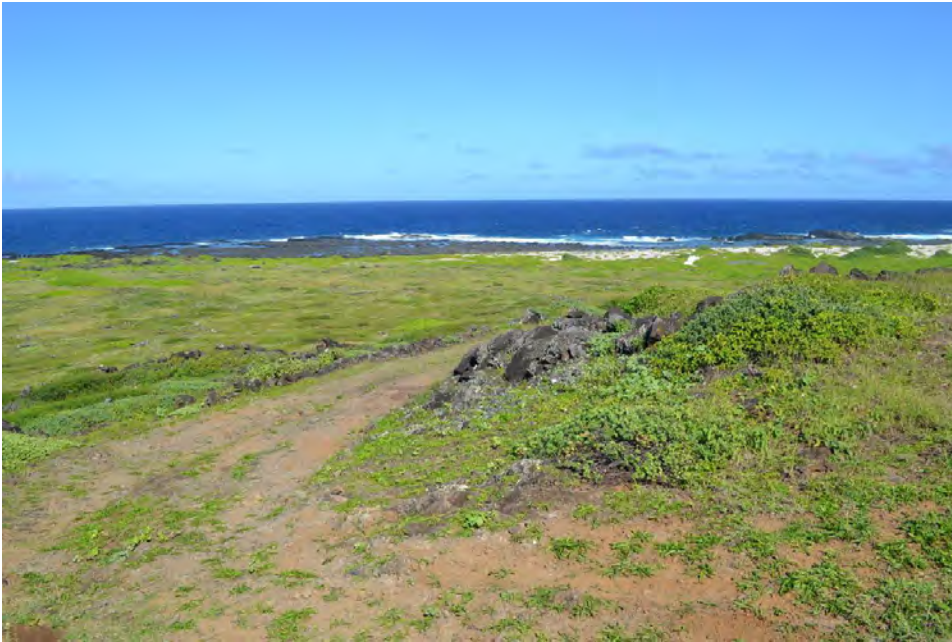
Figure 117. One of the unimproved access roads at the Molokai Light Station, 2018.

Unimproved Access Roads. Unimproved access roads are associated with service routes for maintenance and other utility functions, and lead to isolated buildings, parking areas, service and maintenance facilities, and remote storage areas. Unimproved access roads are generally single-lane, two-track routes surfaced with grass and hard-packed earth wheel ruts. Examples include three access roads associated with Molokai Light Station (Figure 117), Staff Row Loop, roads connecting Barrel Field and McVeigh Home, and leading through the West Coast Cemeteries.

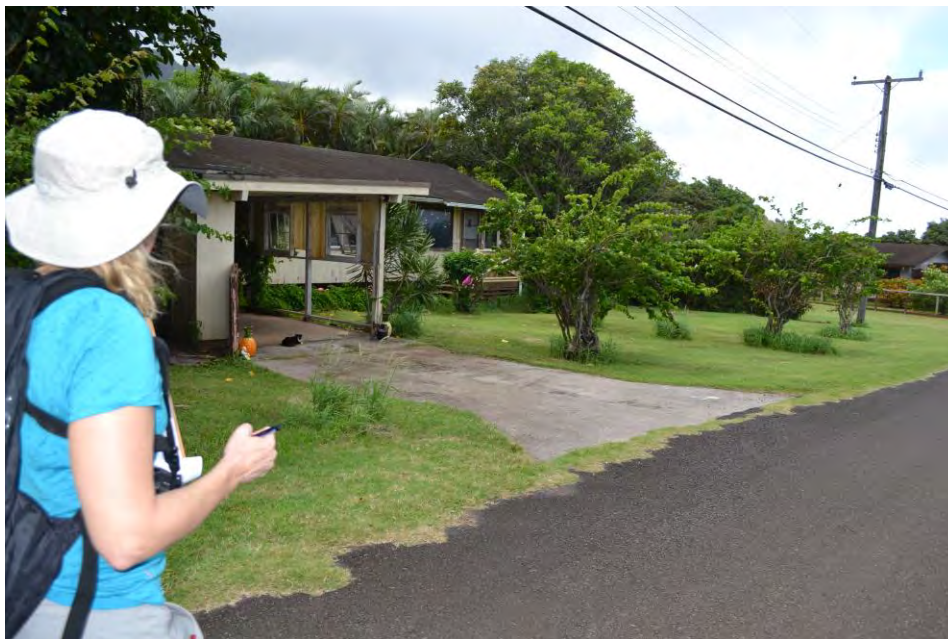
Figure 118. A concrete-paved residential driveway, 2018.

Driveways. Driveways are associated with individual dwellings within the Residential Area as well as several other properties within the Administration Area. Driveways within the Residential Area often lead to garage structures or carports. Driveways are generally narrow—approximately 10 to 12 feet in width—and

vary in surfacing from concrete (Figure 118) or asphalt paving to grassy two-tracks or hard-packed earth roads.

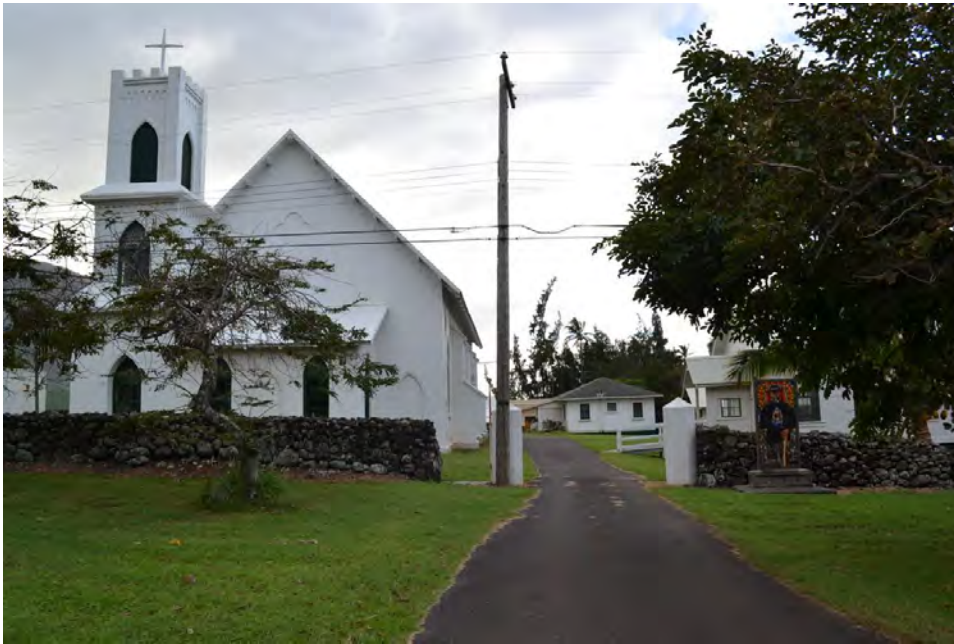
Figure 119. Driveway leading into the St. Francis Catholic Church property, 2017.

Within the Administrative Area, driveways are associated with Craft Shop/Storage Building and Old Stone Church; St. Francis Catholic Church (Figure 119); Ice Plant; Kana‘ana Hou Church; Kalaupapa Memorial Hospital; Bay View Home Building 10A; Bay View Dining Hall; Administrative Building; McVeigh Home Residence 12; Dentist’s Residence and Freezer building; and the Assistant Resident Physician’s Residence.

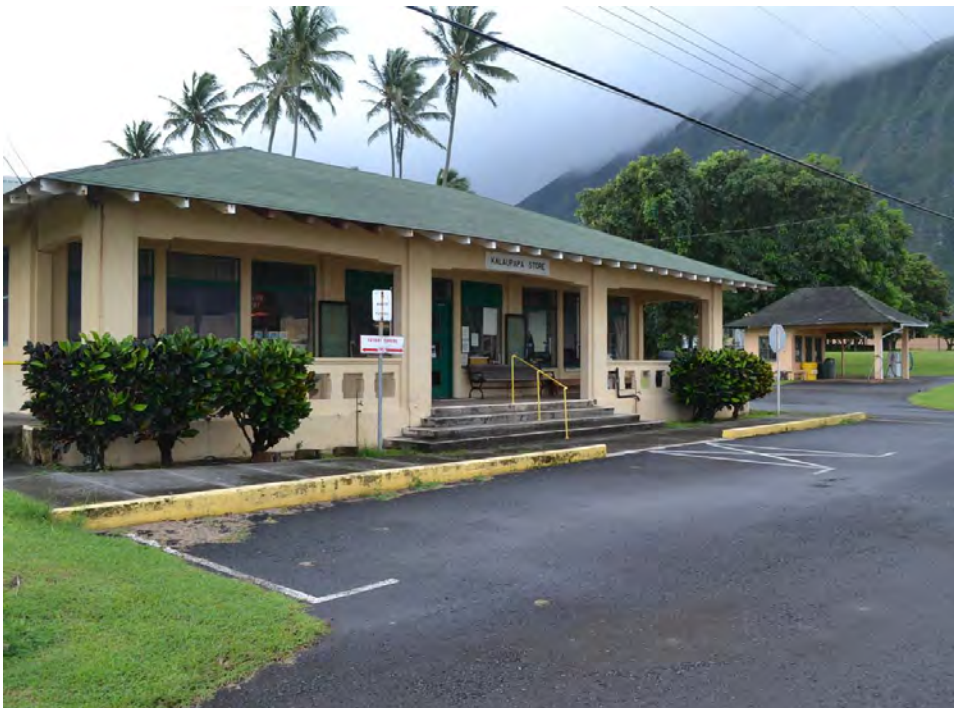
Figure 120. Paved parking area in front of the Patient Store, 2018.

Parking Areas. Parking areas occur throughout Kalaupapa and Kalawao Settlements as both formal and informal circulation features located near institutional, recreational, administrative, health services, and commercial buildings, as well as group home complexes. Parking areas within the Administration Area are typically asphalt paved and arranged for head-in parking along the adjacent primary road. Examples include the Patient Store (Figure 120), Paschoal Hall and the DOH Administration Building. Parking also occurs within areas with a larger footprint, such as outside Kalaupapa Memorial Hospital.

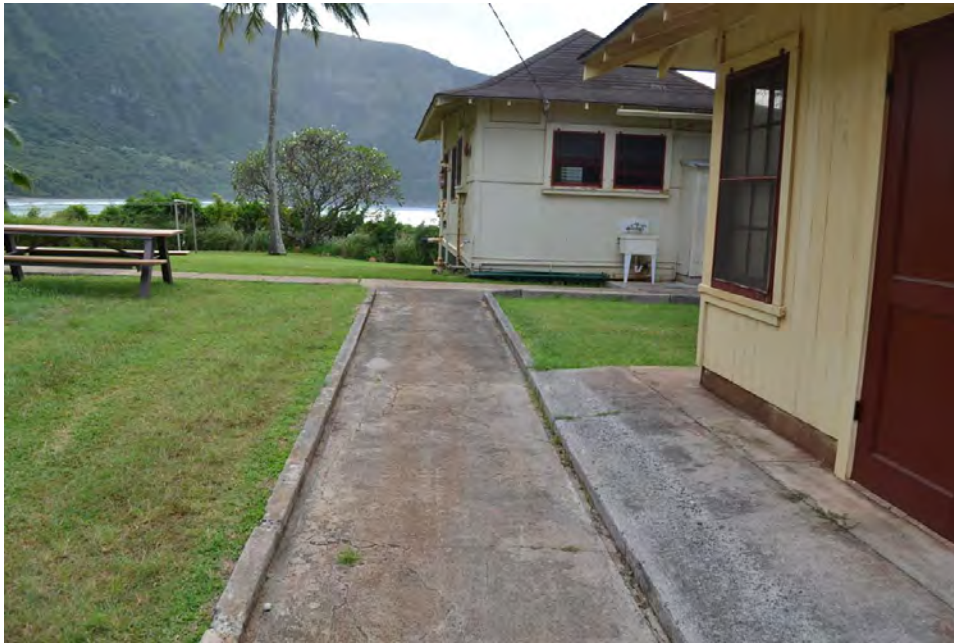
Figure 121. Visitor Quarters sidewalks, 2018.

Paved Walks. Paved walks lead to individual buildings within the Administration Area, the church properties, Molokai Light Station, many of the residences, and buildings associated with the group homes and the Visitor Quarters (Figure 121). The walks that lead from public roads to residences and other properties do not extend all the way to the road, but typically end well short of the pavement, potentially indicating where rock walls once marked the property boundary. In some locations, such as near the DOH Administrative Building, an asphalt extension has been added to the original concrete walk to enhance the accessibility of the walk. Some of the walks are elevated above the adjacent turf grass. Walks present on otherwise vacant lots illustrate the locations of former buildings. Walks are often marked at the street by gate piers and posts historically associated with fence and wall systems that are sometimes no longer present.

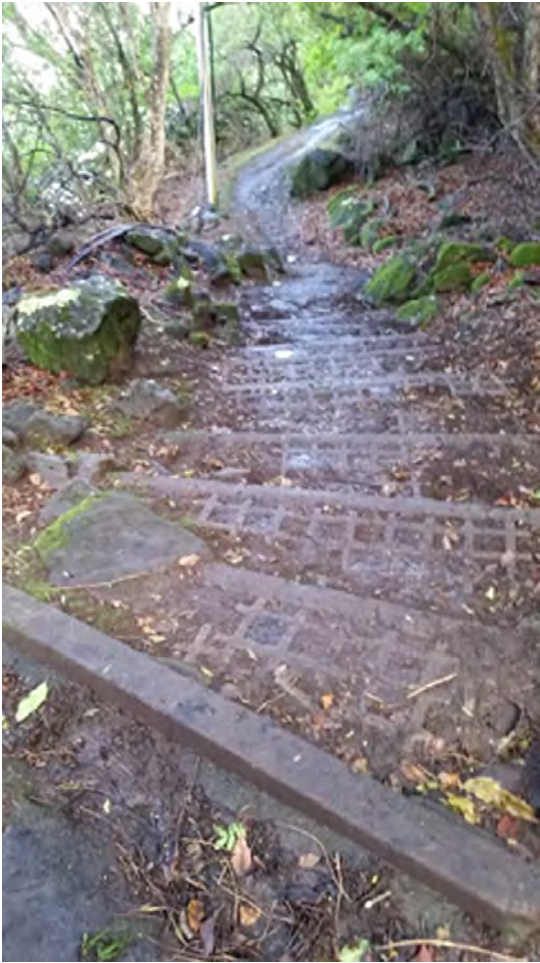
Figure 122. View of the Pali Trail, 2017.

The Pali Trail. The Pali Trail (also known as the Kalaupapa Trail) is a steep and challenging route that traverses the cliffs that overlook the peninsula to the south and connects the peninsula with topside Molokai. Slightly less than 3 miles in length, the trail climbs approximately 1800 feet in elevation, and features twenty-six switchbacks along its length. It is surfaced with earth and stone, and reinforced with concrete block and metal rebar. The trail is edged in places by dry stacked stone retaining walls (Figure 122). Stone water bars drain portions of the trail. Three bridges are associated with the trail. One is located near the upper end of the trail between switchbacks 2 and 3, while the other two are located at the lower end. Pedestrians as well as mules associated with concessionaire-led tours use the trail. The lower portion of the Pali Trail traverses through a traditional Hawaiian agricultural complex of approximately 780 features, including walls, enclosures, terraces, heiau, and habitation sites.

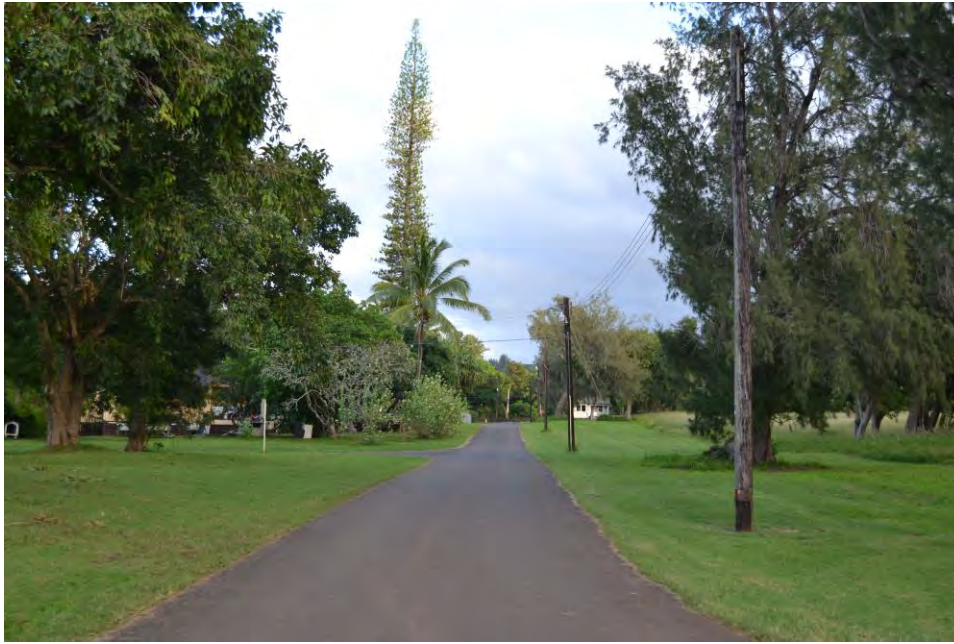
Figure 123. View south along McKinley Street of the turf grass edging road corridors, shade trees, ornamental trees, and shrub plantings typical of Kalaupapa Settlement, 2017.

Within the developed areas, turf grass is a dominant cultural vegetation feature. Lush verdant turf grass serves to unify the sense of place within the settlement; mown turf edges most primary roads within the right of way to either side (Figure 123) and is characteristic of most institutional and residential properties. Tree and shrub plantings are also associated with residential and institutional properties throughout the settlement. Trees provide shade, serve as windbreaks, and continue to reflect institutional design and development from the 1930s in the form of rows and groves of coconut palm (*Cocos nucifera*) and ironwood pine trees. Ironwood pine plantings form an alleé along the Primary Access Road leading to the keeper's complex and windbreaks

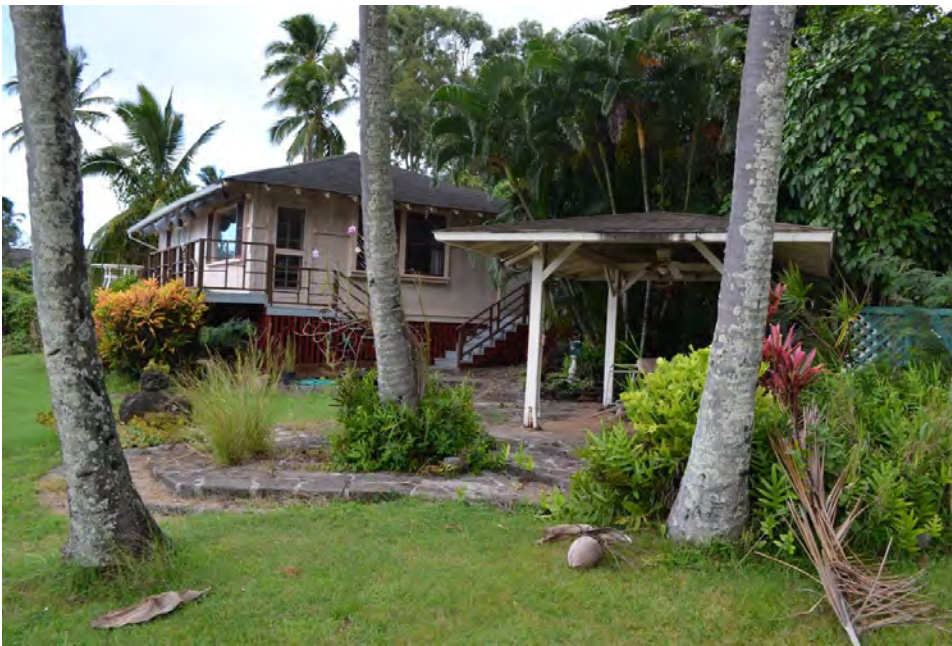
Figure 124. View of a residential garden located near Bay View Home, 2018.

Residential gardens. Within the Residential Area and around homes throughout Kalaupapa Settlement, residents have traditionally planted gardens that provided both emotional and physical sustenance, as well as pleasure (Figure 124). The government agencies involved in administering the settlement supported gardening as a way to promote community health and well-being. At one time, prizes were offered at Kalaupapa on a yearly basis for the best gardens.²¹⁷ The gardens propagated by individual residents offer an

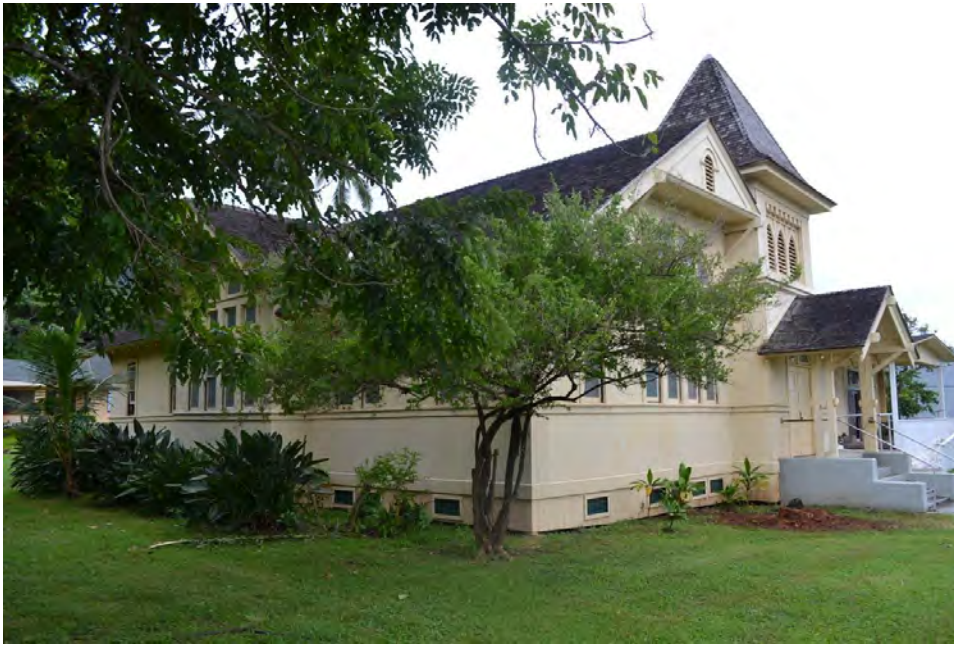
Figure 125. View of plantings associated with Kana'ana Hou Church, 2018.

Church gardens. Ornamental and symbolically-referenced plant materials have been used within church properties as part of their role as haven and sanctuary (Figure 125). At Kana'ana Hou Church, rows of coconut palms and other trees edge the dry stacked stone wall that frames the churchyard and parsonage precinct. Ornamental trees and shrubs form a linear border that helps to separate the parsonage from the church itself. The northwest corner of the parcel contains a grove of trees and shrubs that provides a cool shady area. At St. Francis Catholic Church, a row of coconut palm trees edges the southern wall, while shade trees and ornamental plantings provide a cool space to the north of the church that enhances use of the grotto. Foundation plantings edge the rectory. At the Church of Jesus Christ of Latter-day Saints, bougainvillea trained on the wall that fronts the property along Kamehameha Street adds a decorative touch. Inside the wall are several individual shade trees. Foundation plantings edge the residence and parish hall. The eastern edge of the property is also framed by trees.

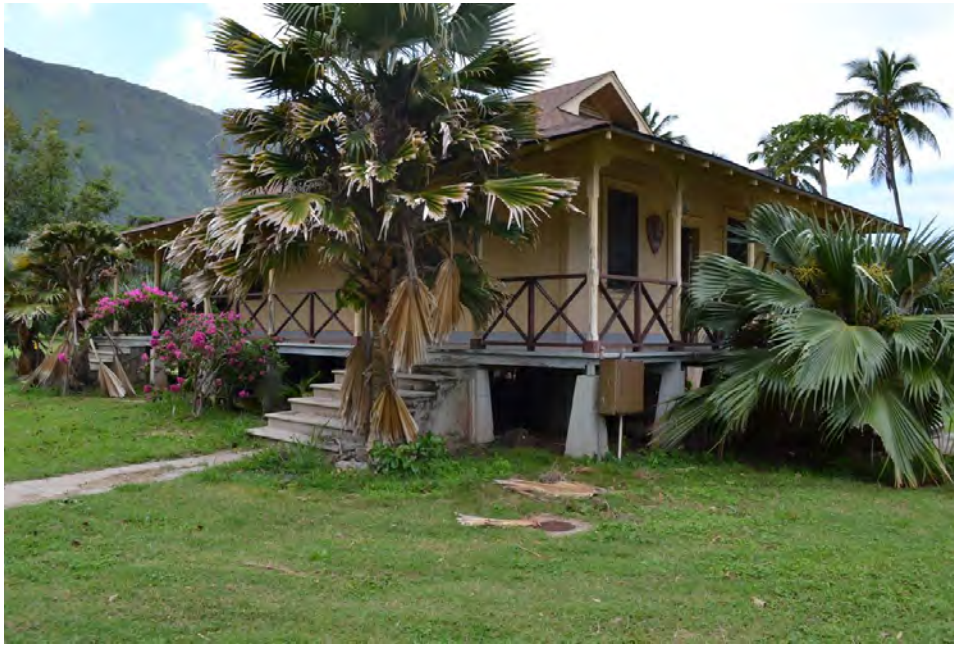
Figure 126. View of foundation plantings around one of the buildings at Bay View Home, 2018.

Foundation plantings. Many of the residences, as well as the buildings associated with group homes, and some institutional and administrative buildings are edged by foundation plantings (Figure 126). The plantings range from lower groundcover species to shrubs and trees. Foundation plantings are typically informal, with a diversity of species, and no recognizable order of spacing or sense of designated planting beds. Foundation plantings often occur as widely spaced shrubs or small trees that emerge within the turf grass. Many times, the shrubs become overgrown and leggy at the base. Trees are also often found growing up against buildings where foundation plantings might otherwise be located.
