Kalaupapa and Kalawao Settlements Cultural Landscape Report

Kalaupapa National Historical Park

Cultural Landscape Report

Prepared by:
Wiss, Janney, Elstner Associates, Inc.
2000 Powell Street, Suite 1650
Emeryville, California 94608

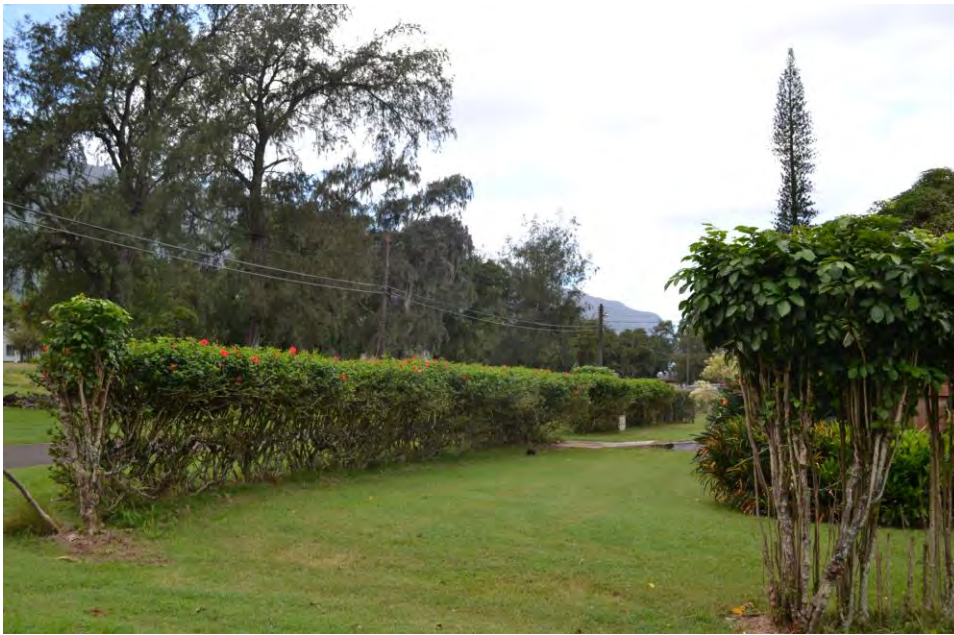
Figure 127. View of a residential hedge along School Street, 2018.

Hedges and hedgerows. Hedges are planted along property lines in front of some of the dwellings within the Residential Area and are used to create a sense of privacy by some residents. While some hedges are maintained through pruning and shearing at a height of 3 to 4 feet, allowing the residence behind to remain visible from the street (Figure 127), others are taller and block views of the property beyond. One species used for tall hedges is panic (*Adenanthera pavonia*). A pruned and sheared hedge is also present at the intersection of Damien and Mission Streets between Bay View Home and Kalaupapa Memorial Hospital (Figure 128). There are few other examples of hedges of this type, although they formerly existed at Bishop Home. Hedgerows that edge some open space and property boundaries are composed of mixed plantings that might include wiliwili, panax, and croton.

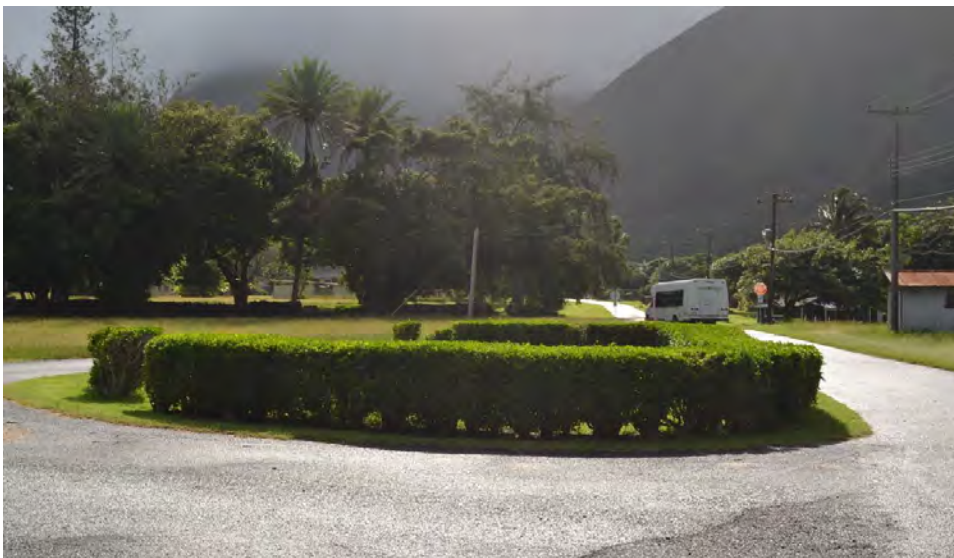
Figure 128. View of the hedge that marks the intersection of Damien and Mission Streets near Bay View Home, 2018.

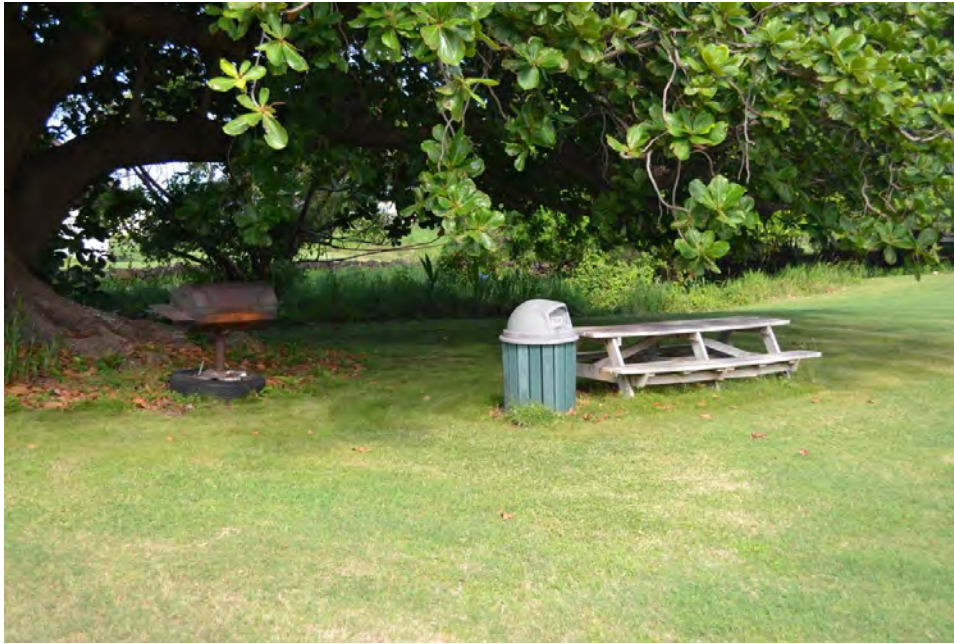
Figure 129. View of a shade tree used for picnicking near the volleyball court, 2018.

Shade trees. Shade is a valued commodity within Kalaupapa Settlement that is sought to protect cars from the sun, in outdoor use areas (Figure 129), and at the western sides of buildings for passive cooling. Tree species that have been planted for shade within the Settlement include banyan (*Ficus microcarpa*), kamani, kukui, mango, heliotrope (*Tournefortia argentea*), sea grape (*Coccoloba uvifera*), and ironwood pine. Ironwood pine trees along the western shoreline are appreciated for the way they cut the sun's glare off the ocean, especially during the afternoon. Heliotrope, another problematic invasive species, formerly provided shade for picnicking and resting near Ho'olehua Point Beach, a favorite place for finding drift wood, shells, and other items washed up by the waves.²²² Removal of these most of these trees to address invasive species control by NPS, which was decried by the patient population, is an example of the challenges posed by the management of traditional cultural vegetation.

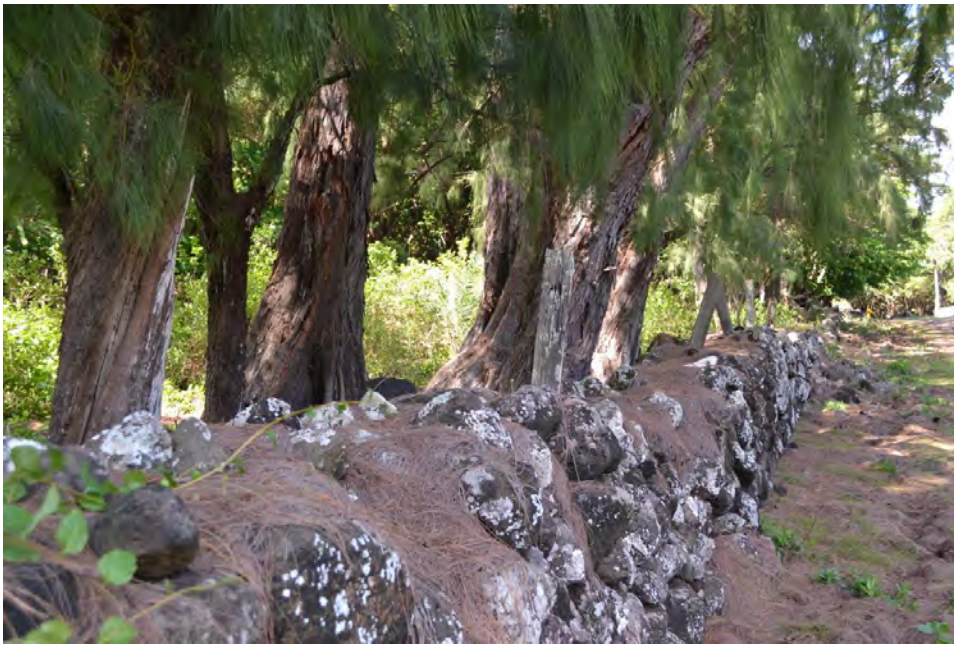
Figure 130. View of ironwood pine trees planted along the dry stacked stone wall at Baldwin Home in Kalawao, 2017.

Boundary markers. In addition to providing shade and wind protection, trees and shrubs are also used to delineate boundaries, sometimes in conjunction with dry stacked stone walls. Ironwood pine trees, for example, line the dry stacked stone wall at Baldwin Home (Figure 130), as well as the western boundaries of the West Coast Cemeteries. Vegetation also appears to be purposefully employed in articulating the boundaries of many individual residential yards, as well as the outdoor living areas associated with the residences at McVeigh Home and Staff Row. Plantings used to define property boundaries include trees, shrubs, hedges, windbreaks, panic, croton, and hibiscus hedges, ironwood pine plantings, bougainvillea (*Bougainvillea glabra*, *B. spectabilis*), shower trees (*Cassia* spp.), and a variety of palms.²²³ Hedges once marked boundaries that defined patient use areas at Bay View Home and the Visitor Quarters; a remnant of the hedge survives at Bay View Home.²²⁴

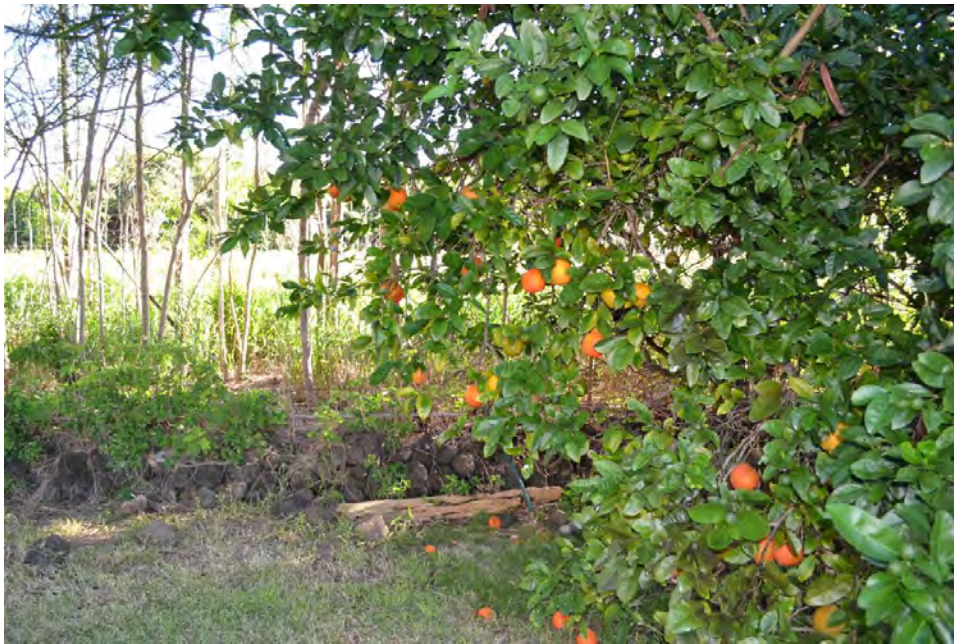
Figure 131. Orange tree at McVeigh Home, 2018.

Fruit trees and other food plants. Quality fruit trees and home-garden-grown foods have played an essential role in life in the Settlement and are cherished by the community. Key fruit and nut trees present within the Settlement include avocado, orange (*Citrus sinensis*) (Figure 131), breadfruit, lilikoi (passionfruit)(*Passiflora edulis*), guava, date palm, lemon (*Citrus limon*), mountain apple (*Syzygium malaccense*), papaya, kukui nut, tangelo (*Citrus grandis* x *C. nobilis*), and tamarind. Home gardens also contain additional popular food plants as noted above.²²⁵

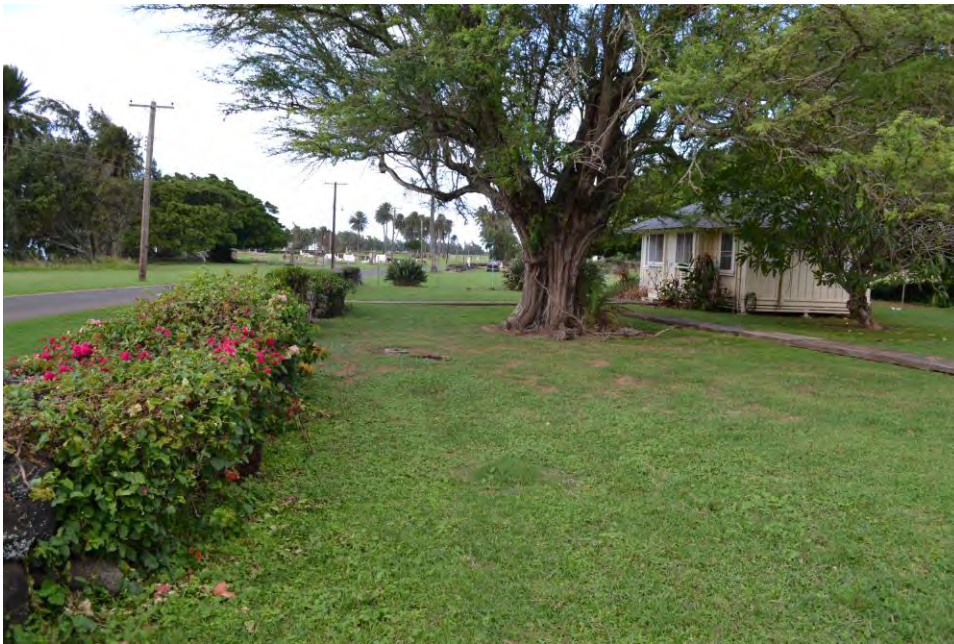
Figure 132. Flowering plants such as bougainvillea [*Bougainvillea spectabilis*] have traditionally been common along the roads at Kalaupapa. Today, bougainvillea is growing on the wall that fronts the Church of Jesus Christ of Latter-day Saints shown here along Kamehameha Street, 2017.

Flowering trees and shrubs. Although less prevalent today than during the early to mid-twentieth century, flowering trees and shrubs have traditionally edged some of the road corridors in Kalaupapa Settlement. Interviews with patients have described the use of bougainvillea to add color and texture within the Administrative Area. In general, ornamental plants have been highly valued by residents of the Settlements. Some of the species that have been planted for their aesthetic qualities include bird of paradise (*Strelitzia reginae*), heliconia (*Heliconia* spp.), and plants with tropical foliage. Today examples of flowering shrubs remain along Beretania and Staff Streets, with bougainvillea continuing to be maintained along some property boundaries, such as the dry stacked stone wall at the Church of Jesus Christ of Latter-day Saints (Figure 132).

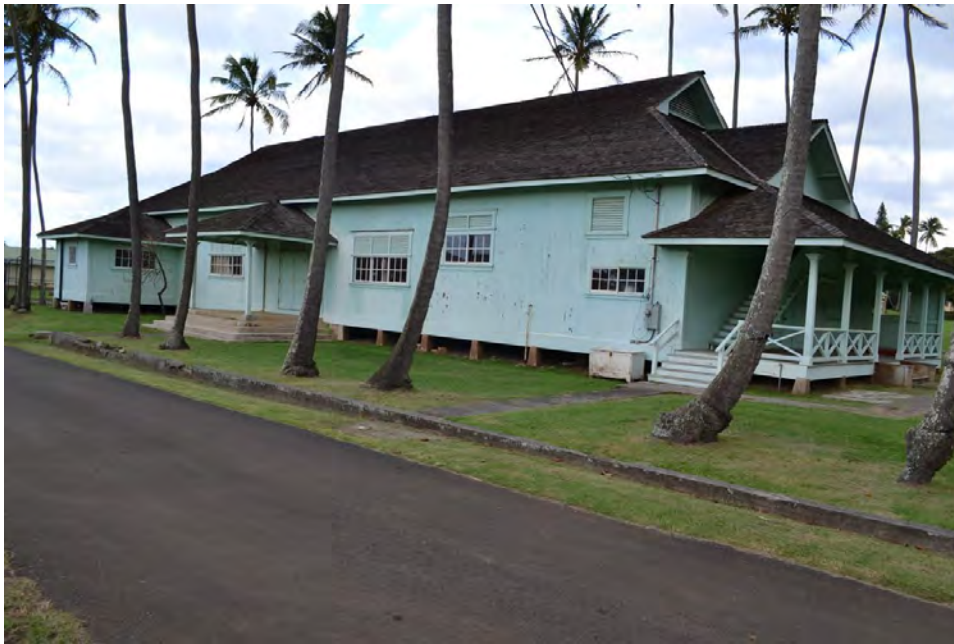
Figure 133. View of Paschoal Hall and associated coconut tree plantings, 2017.

Coconut palm rows and groves. Stands of coconut palms arranged in rows and groves occur in several locations around the settlement, including along Kamehameha Street east of Papaloa Cemetery, within Cemetery G, west of McVeigh Home, around Paschoal Hall (Figure 133), along the western shoreline at Bay View Home, at St. Francis Catholic and Kana‘ana Hou Churches, and around the ruins of the U.S. Leprosy Investigation Station. These plantings form striking groupings that generally reflect institutional design efforts. At least 300 coconut trees were planted along road corridors and around government-administered buildings in the 1930s when a large investment in the settlement was made. The coconut palms along Damien Road near the U.S. Leprosy Investigation Station ruins were planted by Lions Club members in the 1950s.

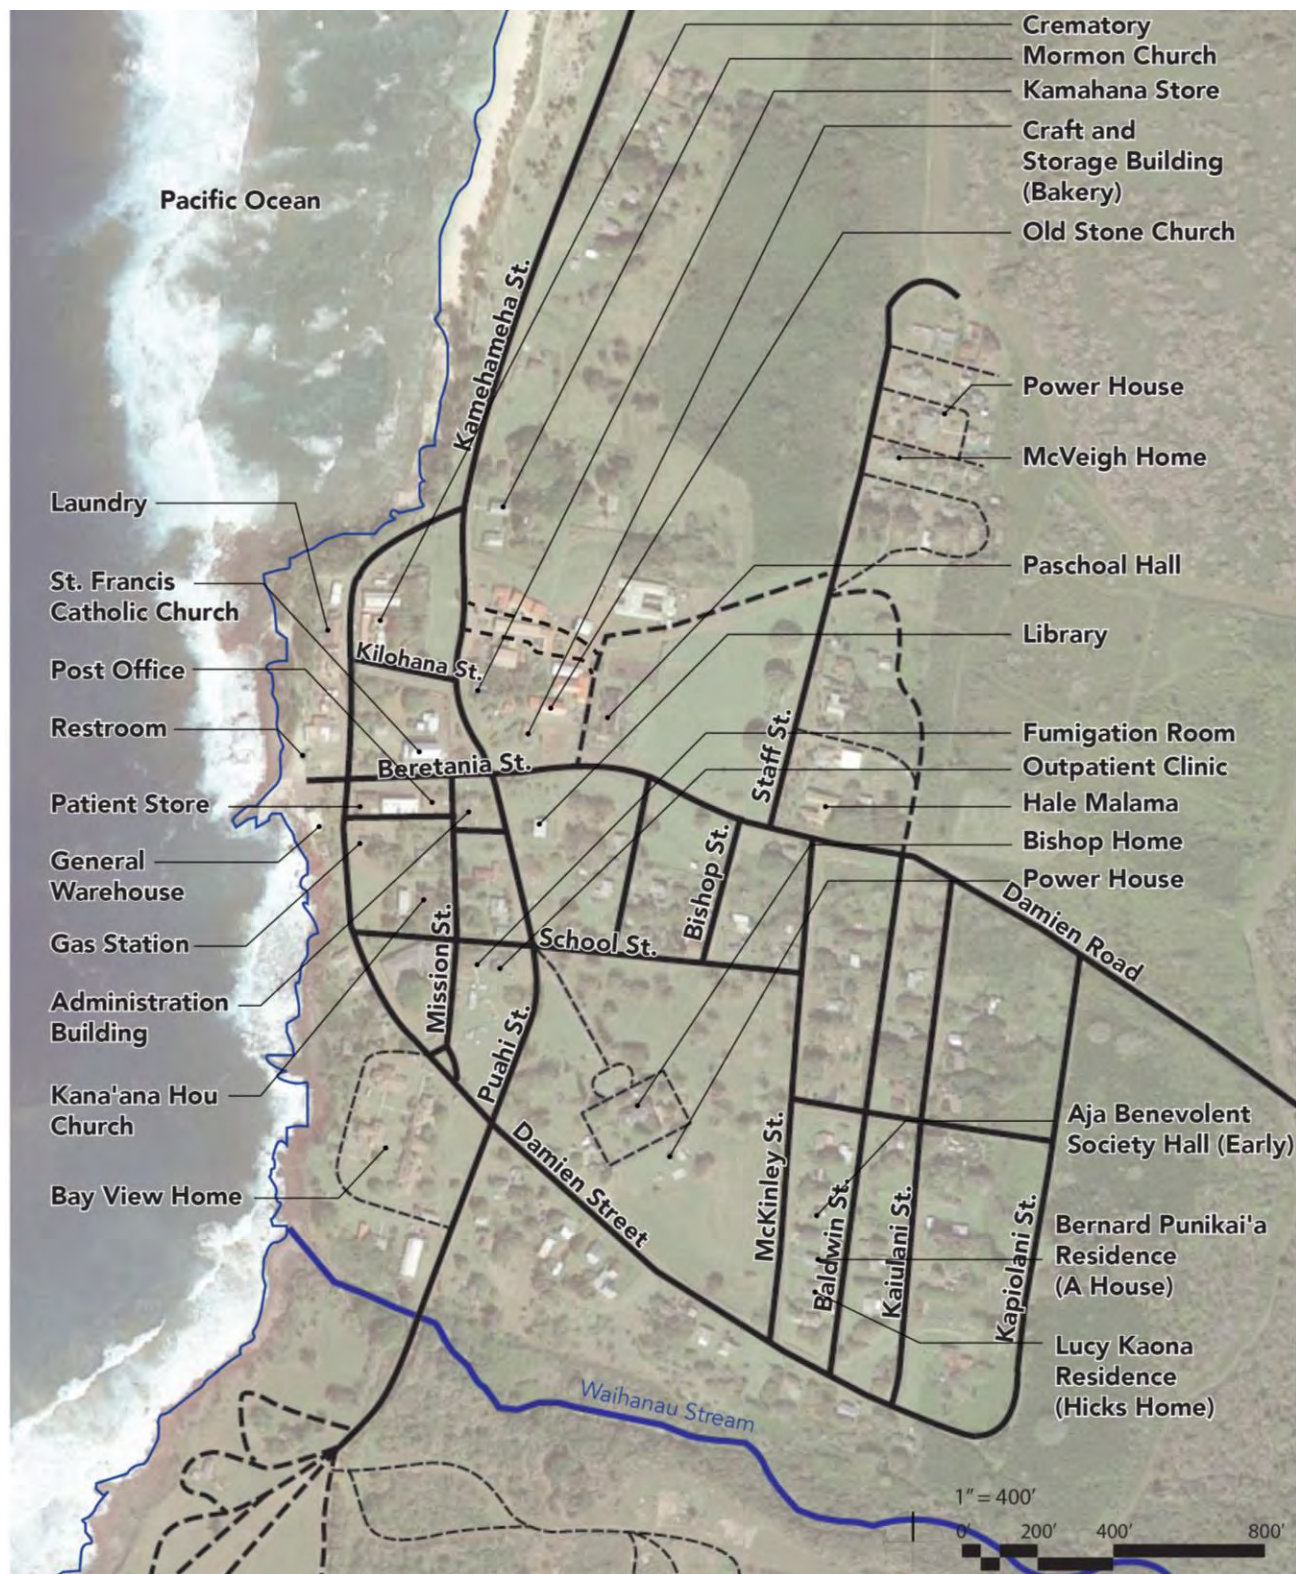
Figure 134. Map of representative buildings, Kalaupapa Settlement. (Source: LSHLA)

Refer to Figure 134, Map of representative buildings, Kalaupapa Settlement.

The Kalaupapa and Kalawao Settlements contain more than 250 buildings and structures. Most are located within Kalaupapa Settlement, although there are also historic buildings present at Kalawao Settlement and Molokai Light Station. The majority of the buildings present today were constructed prior to 1969, although there are also several examples of later additions, as well as modifications that have been made to historic buildings to address the ongoing needs of the community and adaptive use.

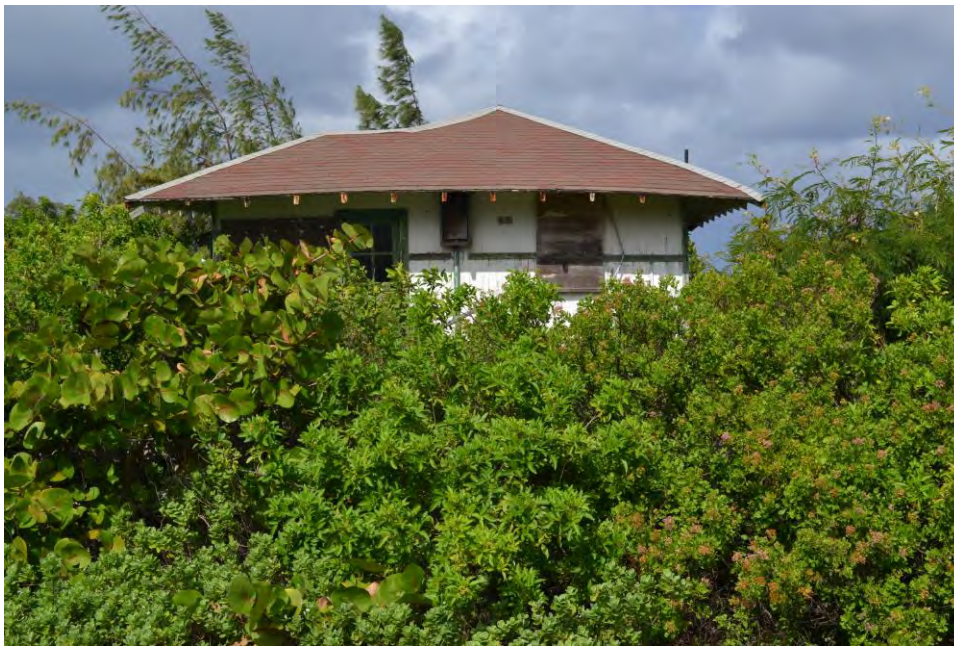
Figure 135. View east toward one of the beach houses at 'Īliopi'i from the shoreline, 2017. Beach houses were built by settlement residents, often using salvaged material.

Another interesting element of the settlement reflected in the architecture is the interplay between built features that clearly reflect the institutional nature of the settlement, and the way in which residences have been customized over time to reflect individual self-determination, ownership, and independence. The best example of this is the cluster of 'Īliopi'i Beach Houses, built by residents from salvaged materials at a distance from the administrative core of Kalaupapa Settlement (Figure 135).

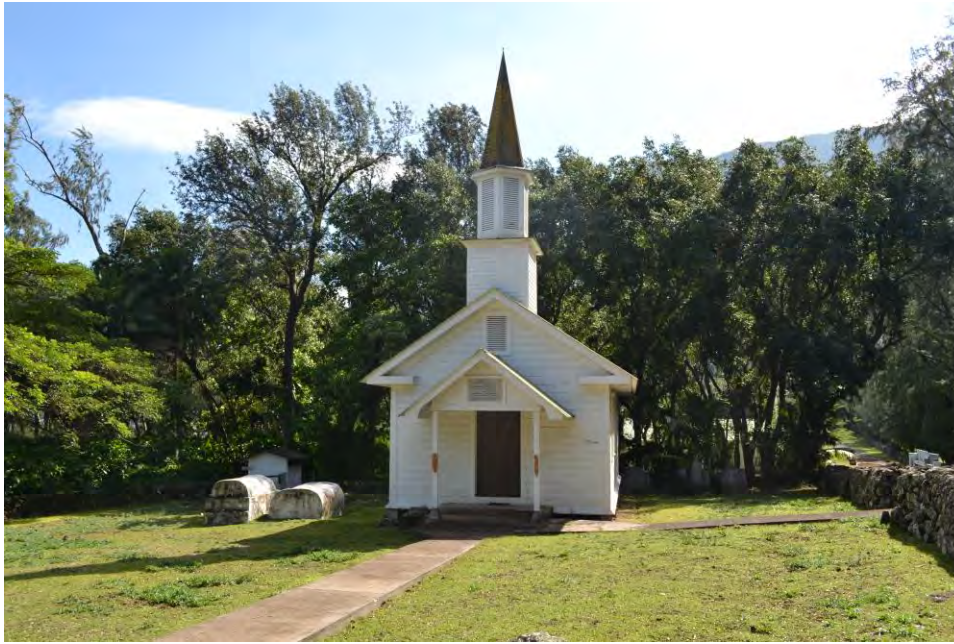
Figure 136. View southeast toward Siloama Church at Kalawao in 2017. The building, although a twentieth century replacement for the original structure built in 1871, is an example of Mission architecture.

Mission Architecture. Missionaries introduced new architectural styles to traditional Hawaiian building practices during the early nineteenth century. The earliest missionaries were Congregationalists and Presbyterians. Missionaries built the first frame dwellings in Hawai‘i. Many were similar in style to the simple Congregational meeting houses and vernacular farmhouses found in New England, and featured high-pitched roofs, and siding composed of overlapping weatherboards, or clapboards. The simplicity of the buildings reflected the puritan ethic of the missionaries. Over time, the Mission style architecture brought to the islands from New England evolved through local building practices and materials into a distinctive style referred to as Hawaiian Mission architecture. At Kalawao, the original Siloama Congregational Church, constructed in 1871, was an austere structure representative of Hawaiian Mission architecture (Figure 136). The Old Stone Church was built by Protestant missionaries in 1853 as a meeting house. This plain rectangular structure is the only standing building that precedes establishment of the settlement at Kalawao (Figure 137).

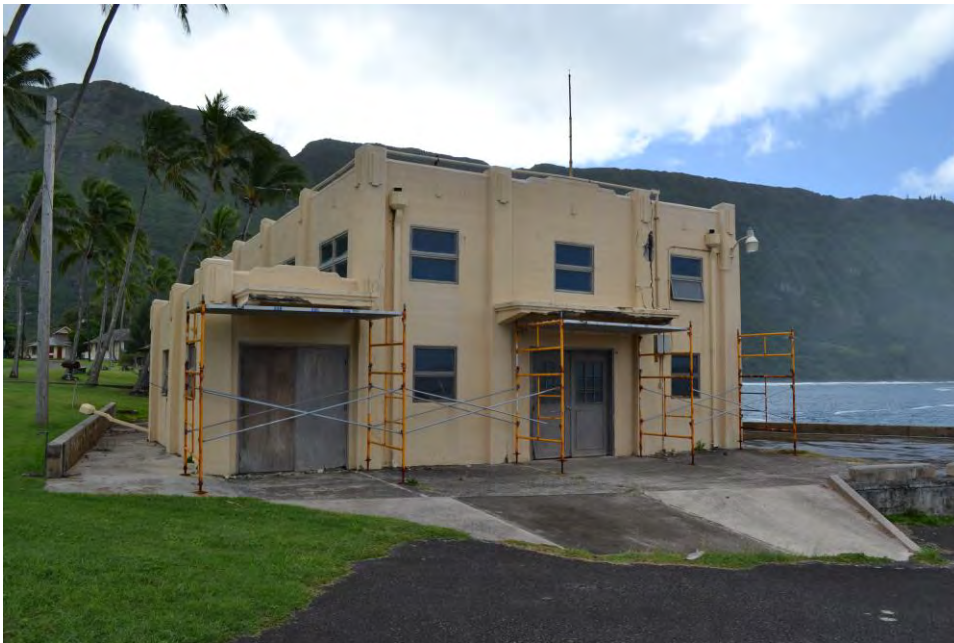
Figure 138. View southwest toward the General Warehouse, 2017, one of several Art Deco buildings at Kalaupapa.

Art Deco Architecture. The Art Deco style was introduced to Hawai‘i in the 1920s, and became a popular style for institutional structures.²²⁶ The style emerged in France in the late nineteenth century as part of the Beaux Arts tradition that combined elements of ancient Greek and Roman architecture into a modern neoclassical style. Art Deco is considered to reflect a broader movement toward modernization in architecture and the use of materials, such as concrete, during the early twentieth century. Like other styles imported to the islands, aspects of the Art Deco style were modified in Hawai‘i to reflect local traditions, motifs, and available construction materials. The result is referred to as Hawaiian Beaux Arts and Art Deco architecture. The Waikiki Natatorium War Memorial on Oahu is an example of Hawaiian Beaux Arts architecture. At Kalaupapa there are several examples of Art Deco architecture. These include Boiler Rooms at McVeigh Home and Bishop Home, and the General Warehouse at Kalaupapa Landing (Figure 138).

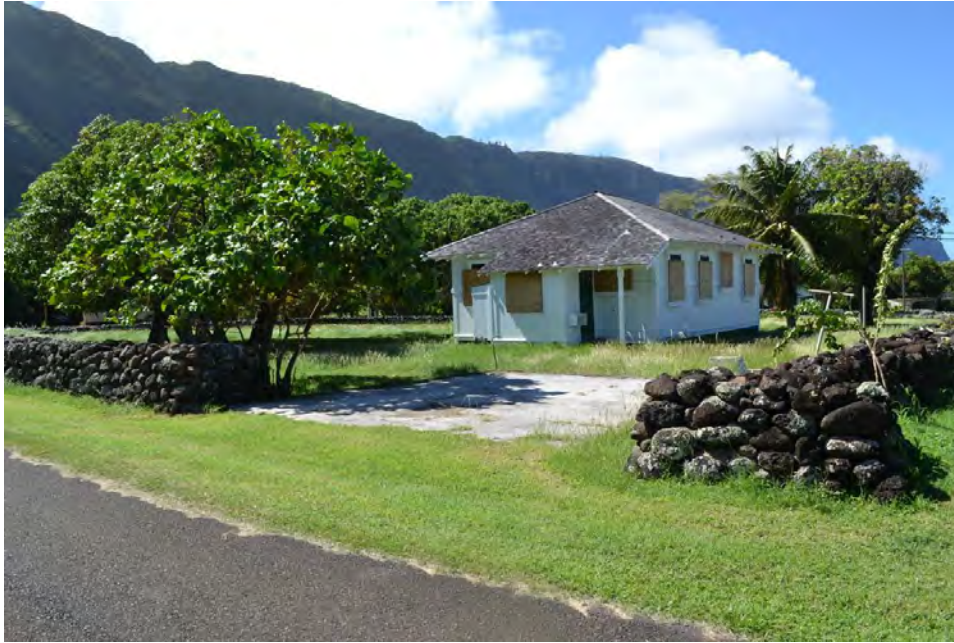
Figure 139. View of one of the Kalaupapa residences within the Residential Area representative of the Hawaiian Plantation style of architecture, 2018.

Hawaiian Plantation Architecture. One of the most prevalent architectural styles within the Hawaiian Islands is Hawaiian Plantation architecture. The style was used primarily in residential buildings but can also be seen in many other building types. The style derives its name from the housing constructed for workers on the sugar cane and pineapple plantations during the boom in production that occurred during the early to mid-twentieth century. The style quickly became popular for the way it blends with the surrounding landscape. Buildings constructed in the style are often described as bungalows (Figure 139) that feature low-profile, wood frame construction, vertical plank siding, large porticos, and porches or lanai. Roofs, which are highly characteristic of the style, are typically wide-hipped or bellcast, split pitch, with deep bracketed eaves and exposed rafters.

Many of the residences present at Kalaupapa are representative of the Hawaiian Plantation style of architecture, including the individual houses in the residential area and McVeigh Home. The A Homes built at Kalaupapa Settlement in the 1930s are also representative of the style. Many of the institutional buildings at Kalaupapa reflect the style, but at a larger scale.

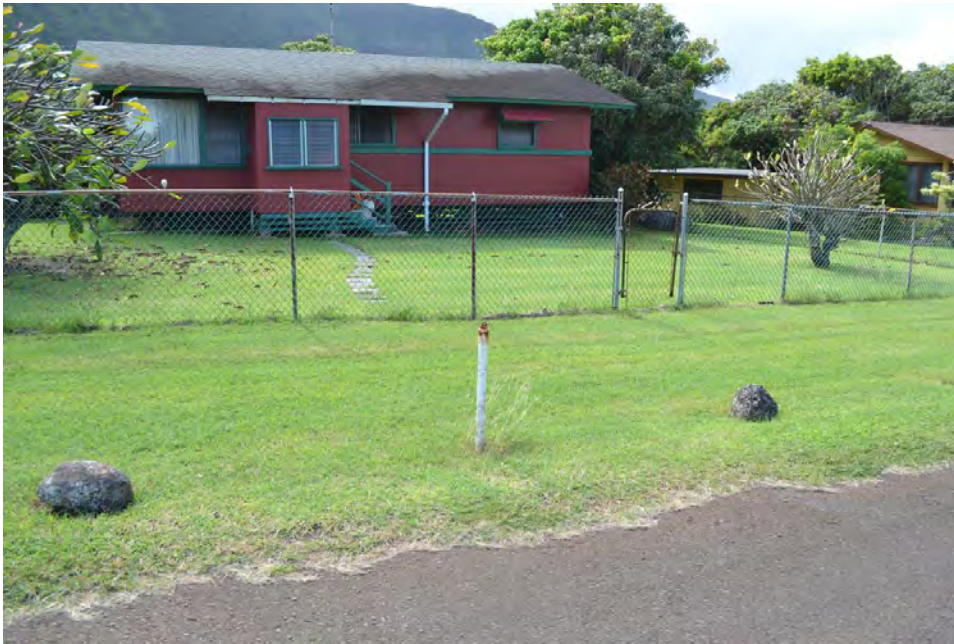
Figure 140. View of one of the ranch style Kalaupapa residences (Hicks Home Type #2) associated with construction during the modern era, 2018.

Mid-Twentieth-Century Modern Architecture. Numerous prefabricated homes were erected within the settlement in the 1950s and 1960s. These are known as Hicks Homes. They are representative of mid-twentieth-century Modern architecture and are a local variation on the ranch-style house built throughout the United States at the time (Figure 140). Other examples of the style within Kalaupapa Settlement include the Church of Jesus Christ of Latter-day Saints Meetinghouse.

Three different floor plans were used in the Hicks Homes models constructed at Kalaupapa. These include Type #1, a single-story two-bedroom style built in 1956 that is oriented so that the main entrance porch is at one gable end, and a shed roof is tacked above the entrance porch to shelter it from the elements (Figure 144);²²⁹ Type #2, a single-story two-bedroom style built in 1962 that features a corner picture window, a small wood porch, sheltered by a small extension of the gable roof that provides access to the front door, and a rear carport; and Type #3, a single-story two-bedroom style built in 1964 that features a central picture window and otherwise random fenestration, as well as a gable roof. This type also featured a carport with a nearly flat roof. There are nine examples of Type #1 and Type #2 Hicks Homes within Kalaupapa Settlement, and six examples of Type #3 Hicks Homes within the settlement today.

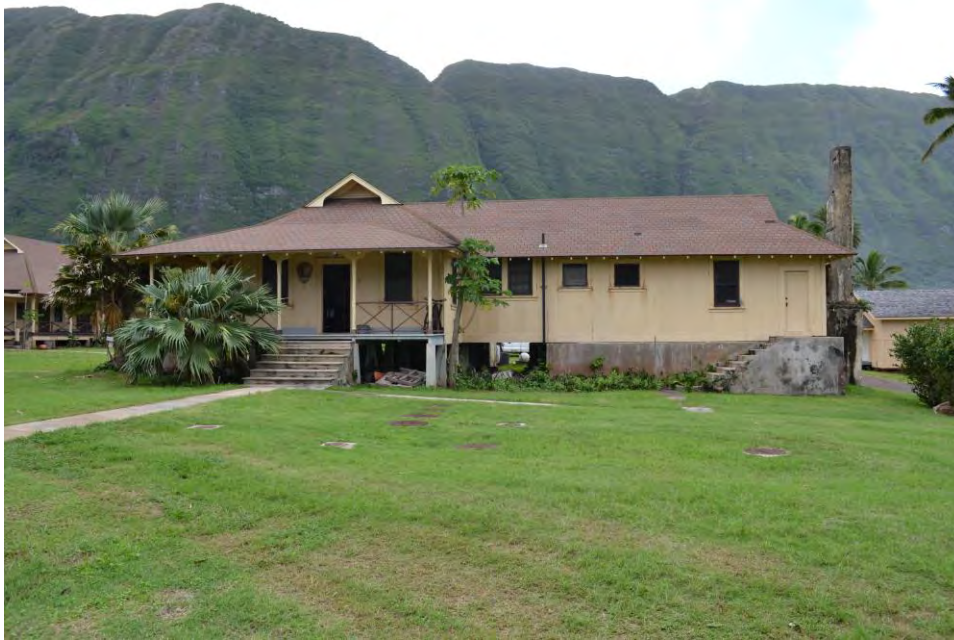
Figure 141. View southwest of the Old Bay View Kitchen and Dining Room at Bay View Home, 2017.

Group homes often feature larger structures, with a construction style similar to the more modest cottages, that support dormitory style living or group functions. These include McVeigh, Bishop, and Bay View Homes (Figure 141). The Bishop Home for Girls is the only building at Kalaupapa with double-wall construction.

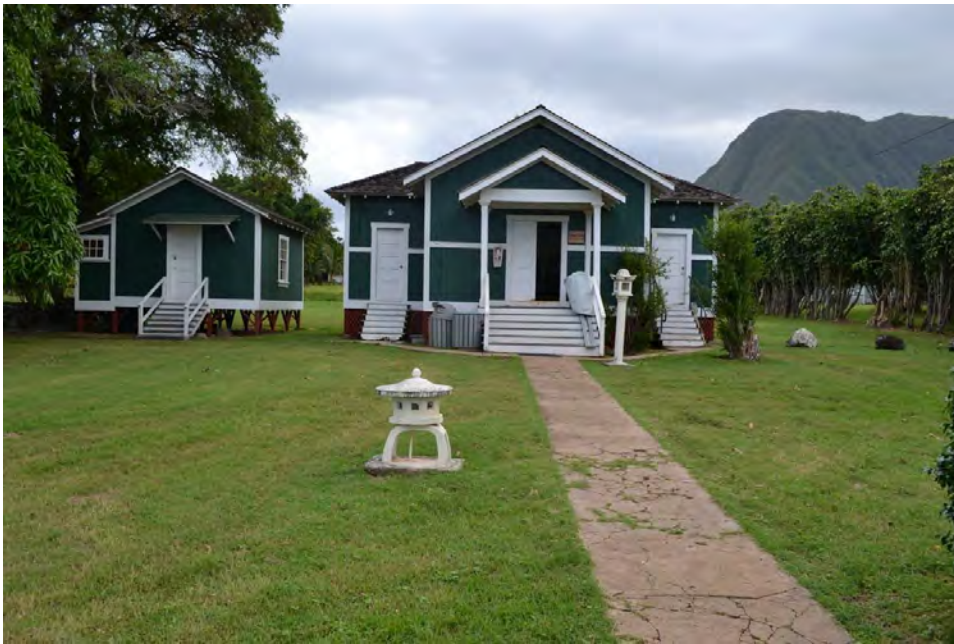
Figure 142. View of an early residence, later the AJA Benevolent Society Hall, 2017.

Residential buildings can also be grouped according to periods of development. Only four residences survive at Kalaupapa that pre-date 1931. These include the AJA Benevolent Society Hall on McKinley Street (Figure 142) the Clarence Naia and Nono Residences on Goodhue Street, and the Cambra Residence on Kamehameha Street. These early twentieth-century residences are typically simple structures. Like many other residences within the settlement, these residences also feature tongue and groove or board and batten walls. Early residences also typically had separate wash houses and privies, few of which survive today. These residences are typically modest buildings, often less than 400 square feet in size, with single-wall, wood-frame construction, 1 inch by 12 inch board and batten details, a central front door and a stoop leading to a lanai, and double-pitched gable roofs that extend the length of the structure with a change in pitch over the front and rear. The interiors of these buildings are divided into two or three living spaces, with kitchen and wash functions accommodated in separate adjacent structures.

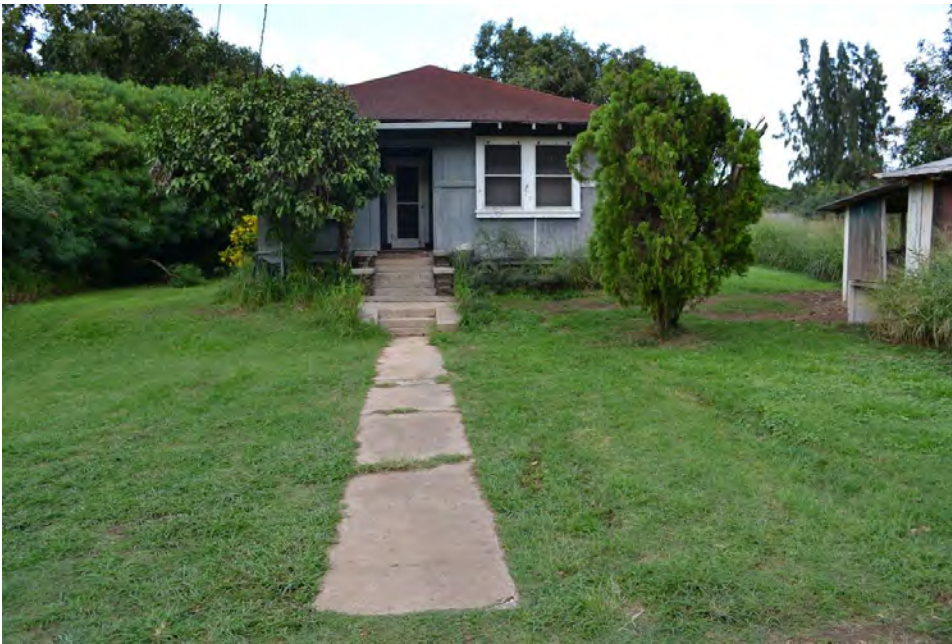
Figure 143. View of one of the A Houses located near the maintenance area, 2017.

A Houses. Twelve patient cottages were built in 1931–1932 by Molokai homestead carpenters with similar floor plans, with four additional structures built in 1934–1936. These residences, known as A Houses, were simple rectangles in plan with a simple hip roof and inset porch that reflected the Hawaiian Plantation style. Some of the A Houses have been modified to enclose the front porch (Figure 143). The walls were tongue and groove. Each had concrete steps leading to the front door, a concrete stoop with stone buttresses, and a lanai on one side. Inside, there was a dining room and living room to one side, and two bedrooms separated by a shared bath. The kitchen was typically in the rear of the house, accessed by a rear stoop.²²⁷ All sixteen A Houses survive within Kalaupapa Settlement.²²⁸

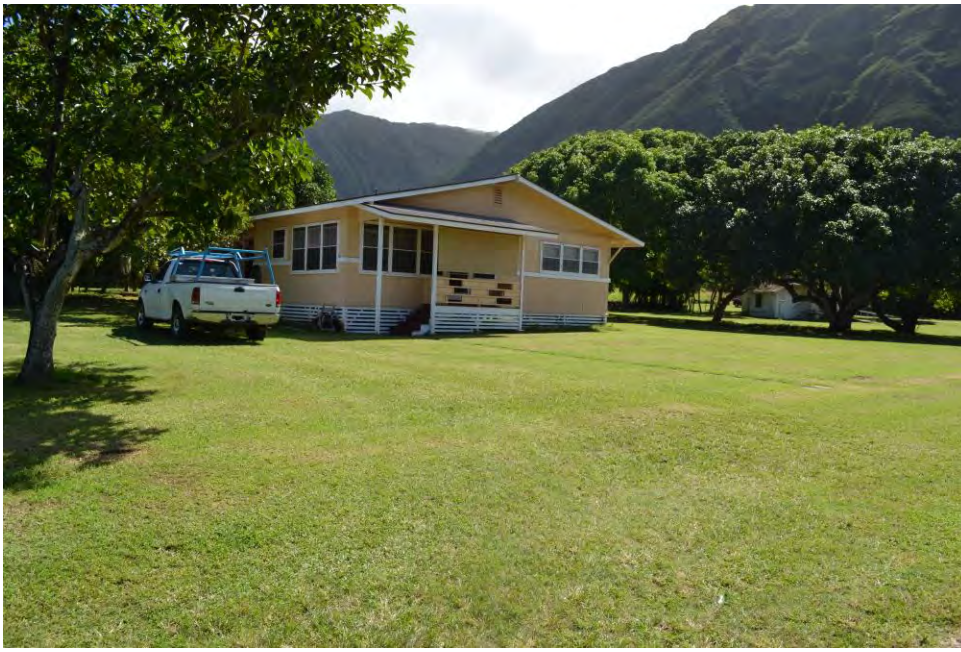
Figure 144. A Type #1 Hicks Home, 2018.

Hicks Homes. Mid-twentieth-century modern residences (circa 1950s–1960s) are generally associated with the prefabricated Hicks Homes. During the later period that followed World War II, residential construction incorporated new manufactured building materials. One of the standardized residential models built throughout Kalaupapa was the Hicks Home, a pre-fabricated housing type popular in Hawai‘i at the time. These wood frame homes feature vertical siding and low-angle gable roofs, plate glass windows, one-over-one windows, or louvered/jalousie windows. Some have aluminum sliding windows. Hicks Homes were also built of cedar or redwood to increase the resistance of the structures to decay and termites.

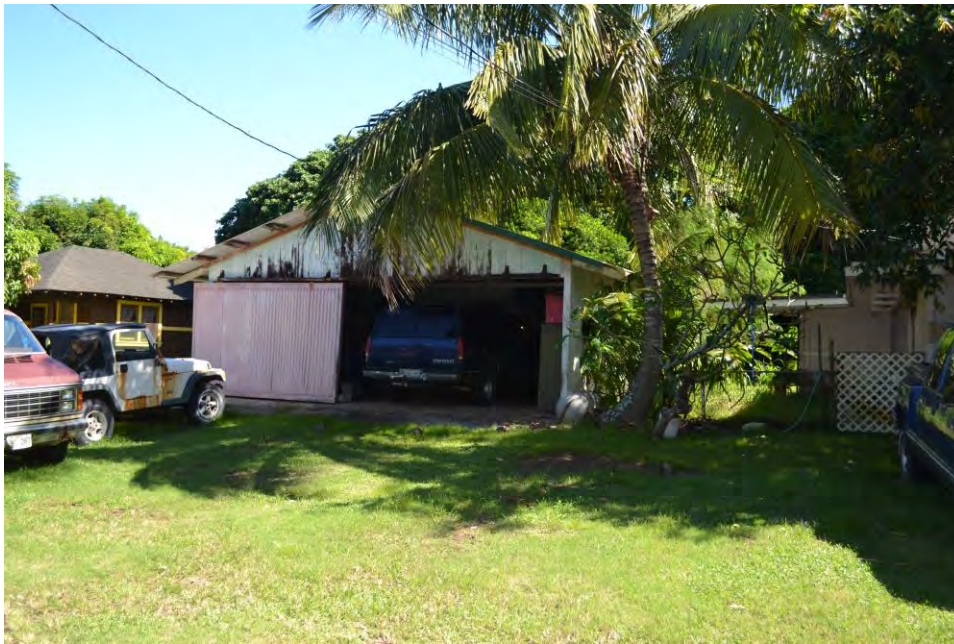
Figure 145. A garage, one of the outbuilding types represented in the Residential Area, 2018.

Outbuildings. Many residences feature associated outbuildings. Outbuilding typologies range from garages (Figure 145), to carports, washhouses, outhouses, hothouses, sheds, poker rooms, garden houses, chicken coops, and pig sties. Most were built by patients to provide shelter for their vehicles, tools, supplemental food, and recreational activities and are vernacular expressions that represent the initiative of the individuals to provide for themselves and establish a unique identity in terms of their home place.²³⁰ They are considered to be the private property of residents. Many residential outbuildings were constructed using salvaged or recycled materials, including corrugated metal. The majority of the residential outbuildings are modest in size, single-story, simple wood-frame structures with gable or shed roofs clad with a wide range of materials. The roof coverings are asphaltic rolled roofing, wood or asphalt shingles, corrugated metal or plastic, or plywood. Siding is board and batten, tongue and groove, plywood, or corrugated metal. Foundations are concrete or stone, while interior floors are concrete or earth. Many outbuildings are in poor condition and are at risk of being lost.

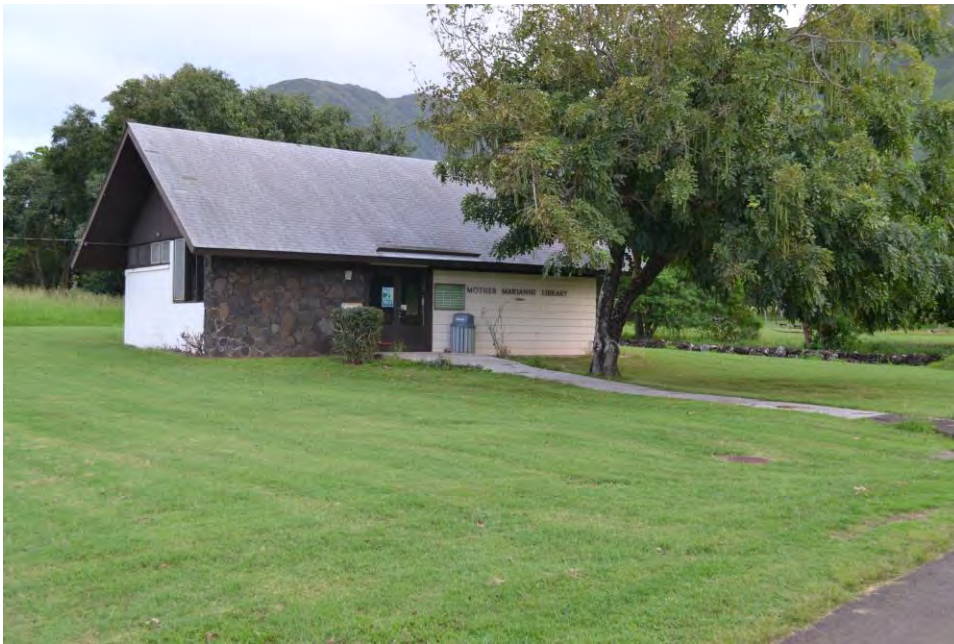
Figure 146. View southeast of the Saint Marianne Library from the intersection of Beretania and Puahi Streets, 2017. The Library is one of the community buildings located within the Administrative Area at Kalaupapa.

Buildings that afford services for residents also count among the list of community buildings. These include the Library (Figure 146), which is an example of mid-twentieth-century Modern architecture with stone masonry siding at the front, and the Craft Shop and Storage Building, a modest structure with elements of Hawaiian Plantation architecture that was initially built as a house and bakery and later adapted for community use.

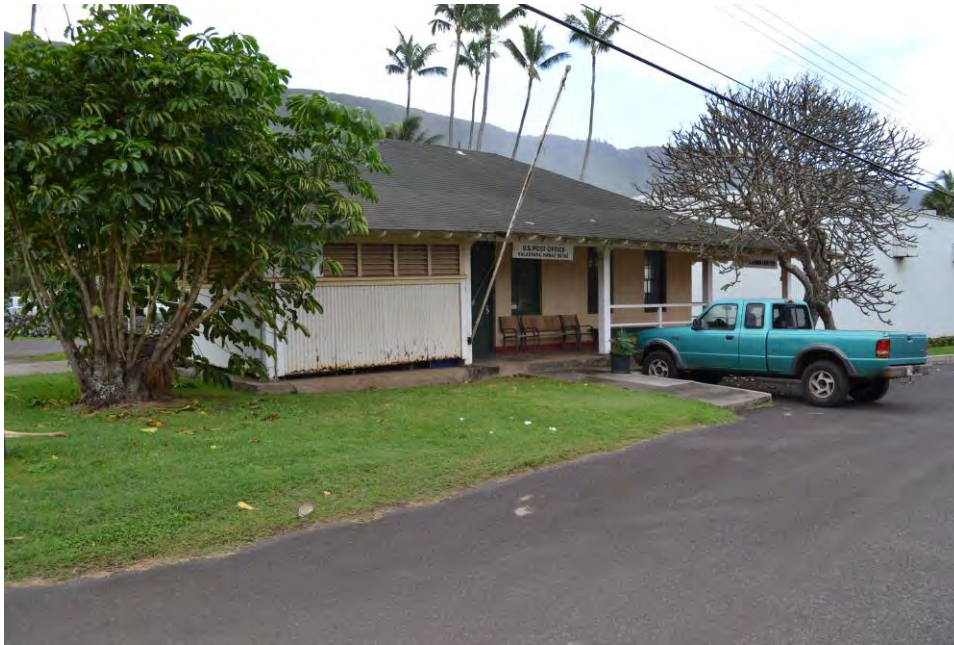
Figure 147. View southwest of the Post Office, 2017.

Institutional buildings. Several institutional or civic buildings are also present within the Administrative Area of the settlement, including the Post Office (Figure 147), Laundry, Restroom at the Visitor Quarters, Patient Store, and Gas Station. Many of these are residential in scale, and consistent with other examples of Hawaiian Plantation style architecture.

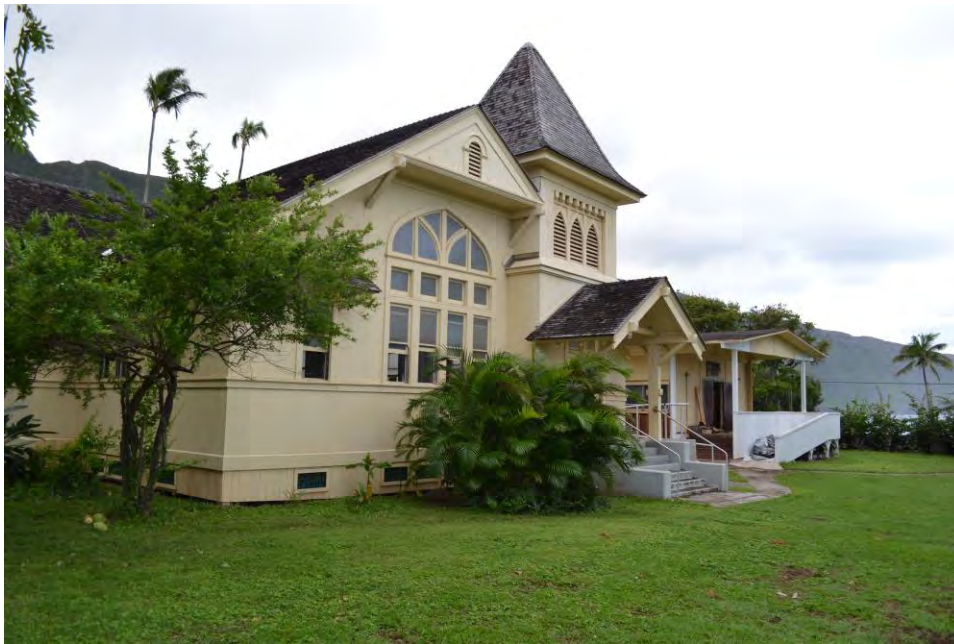
Figure 148. View southwest toward the principal façade of Kana'ana Hou Church, 2017.

Kana'ana Hou Church was constructed by the United Church of Christ in 1915 in a modified Arts and Crafts Stick Style of architecture. In plan, the church is in the shape of a Greek cross (Figure 148). The building is a beige wood-frame structure that rests on wood post, stone, and concrete foundations. It features a large bell-tower, gabled portico, numerous windows, tongue and groove siding, and a cross-gable wooden shingle roof. The architectural detailing also includes Gothic arched louvers and large dentils in the bell tower, as well as numerous chamfered buttresses.

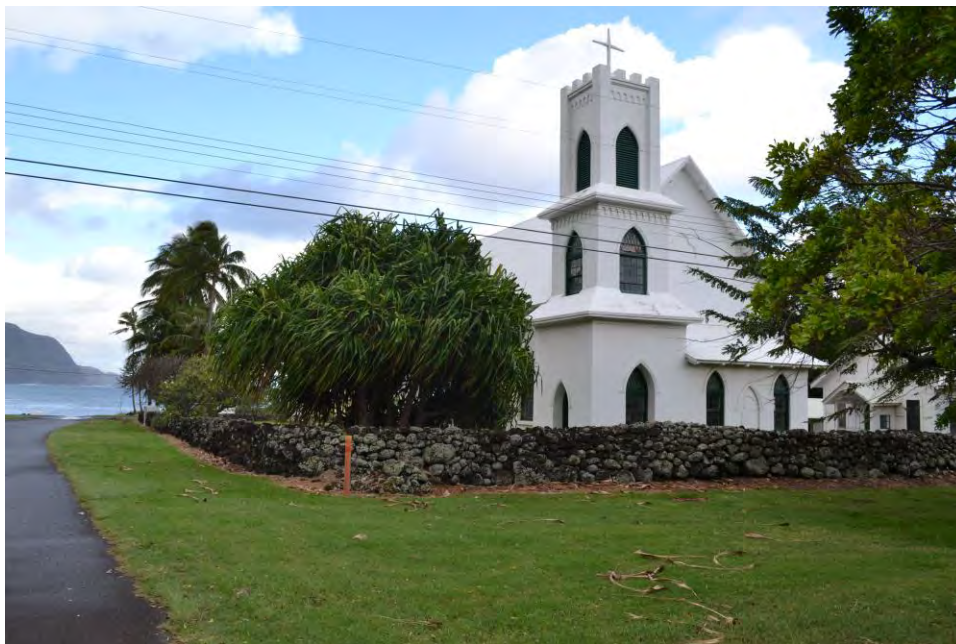
Figure 149. View west toward the rear facade of St. Francis Catholic Church, 2017.

A second Catholic church—St. Francis—is located within the Administrative Area at Kalaupapa. St. Francis Catholic Church is an Italian Gothic-style building of reinforced concrete rebuilt in 1908 (Figure 149). It replaced an earlier church lost to fire in 1906. St. Francis features a corner bell tower with kicked eaves, Gothic arches with double-hung windows, quatrefoil windows, side buttresses, and a large corrugated metal gable roof. The use of “ferro-concrete” (early reinforced concrete) to build this church is considered an early example by the State of Hawai‘i’s Register of Historic Places.²³³

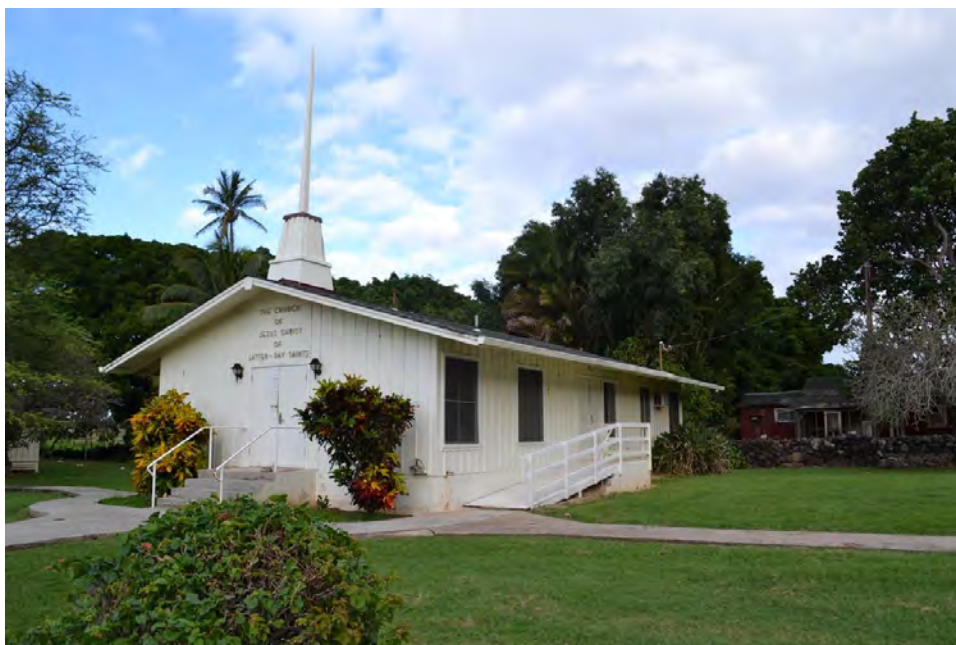
Figure 150. View northeast toward the entrance to the Church of Jesus Christ of Latter-day Saints meetinghouse, 2017.

Church of Jesus Christ of Latter-day Saints. The Church of Jesus Christ of Latter-day Saints congregation was established in the early years at Kalawao. Today, there are no known members of the congregation. Within Kalaupapa Settlement the church administers a complex that includes a residence, parish hall, meetinghouse, and monument to Jonathan Napela. The meetinghouse (Figure 150) was constructed in 1965 to replace an earlier structure lost to the 1946 tsunami. The current church is reflective of the mid-twentieth-century Modern style of architecture. It features a low gable roof of composition shingles, plywood and batten siding, and jalousie/louvered windows.

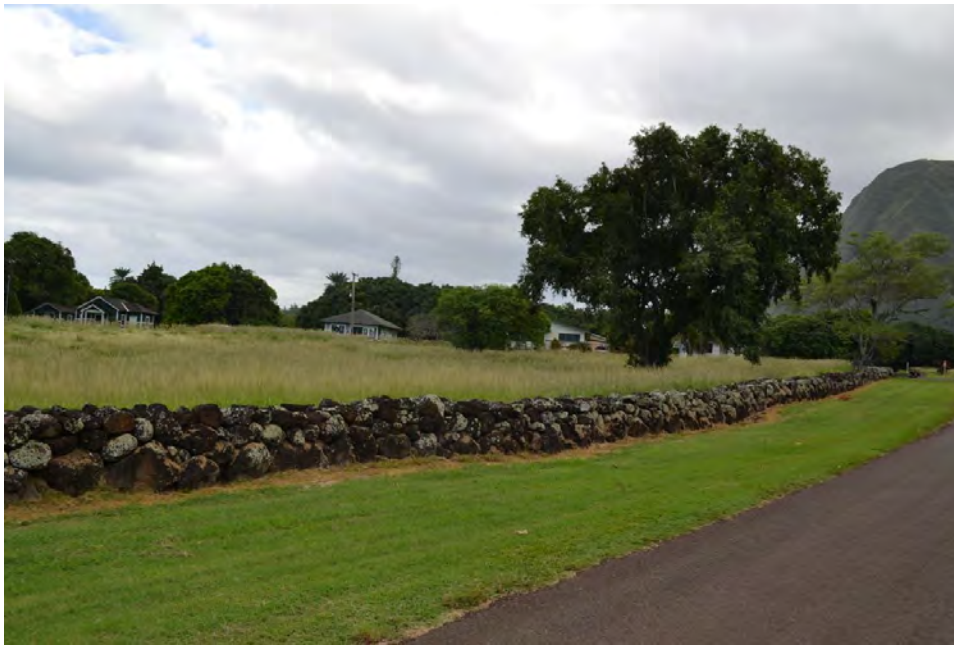
Figure 151. View east of the dry stacked stone wall that demarcates the boundary of the Bishop Home property along Damien Street, 2017.

Dry stacked stone walls. One of the character-defining structures of the Settlements is the dry stacked stone wall. Walls occur throughout the settlements to mark property boundaries (Figure 151). Rock walls built as part of settlement development co-exist within certain areas of the peninsula with earlier walls and wall systems. Traditional Hawaiian rock walls denote former ahupua'a (Hawaiian land division) boundaries, corrals, garden plots, and agricultural field systems, as well as heiau, also known as Hawaiian temple platforms. Rock walls constitute one of the elements that connects life before and after establishment of Kalawao Settlement. They also serve a dynamic place in the perpetuation of cultural traditions today and are symbolic of the "living resources" of the settlement.

The walls surrounding structures in the settlement are maintained through a hapai pohaku (carry rock) program that includes traditional Hawaiian masons within the NPS repairing the rock walls utilizing the traditional skills of dry set masonry, or ho'oniho. These "Hapai Pohaku" workshops are events characterized by cooperation between the NPS and the masons, many of who now work for the NPS at parks throughout the islands. This movement began at Pu'ukohola Heiau National Historic Site after the earthquakes of 2006, which required the NPS to seek masons to repair the damage and resulted in a program currently termed the "Hawaiian Legacy" program. The movement to continue cooperating in this way to perpetuate this traditional cultural skill of ho'oniho and continue caring for cultural sites cooperatively is ongoing and an important part of recognizing the significance of a living cultural landscape today. The workshops happen almost annually and are gatherings that are celebrated within the community, characterized by cooperation, hard work, food, and celebration.²³⁵
