Kalaupapa and Kalawao Settlements Cultural Landscape Report

Kalaupapa National Historical Park

Cultural Landscape Report

Prepared by:
Wiss, Janney, Elstner Associates, Inc.
2000 Powell Street, Suite 1650
Emeryville, California 94608

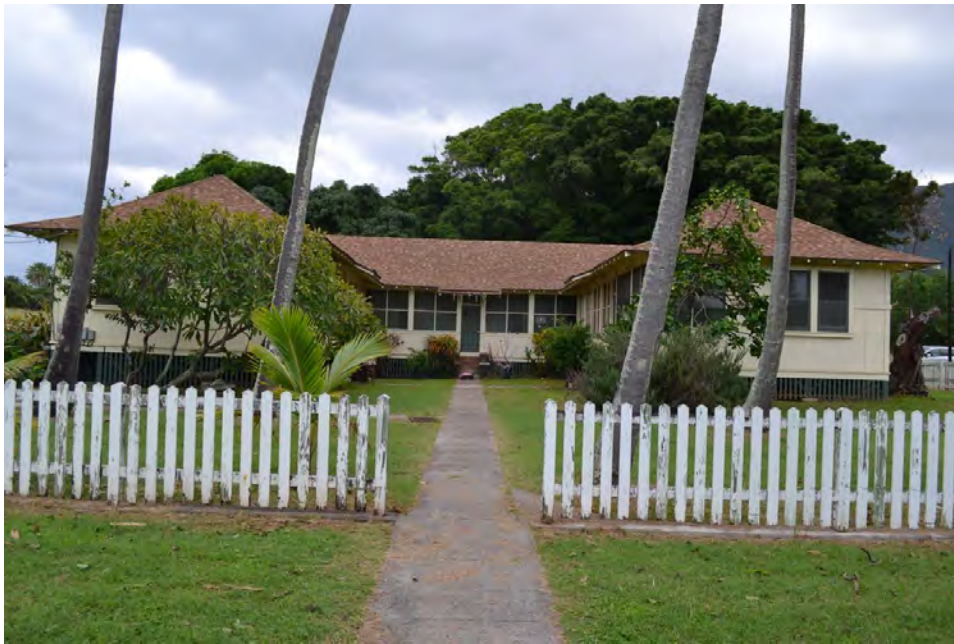
Figure 152. View southeast of the fencing outside the Residence for Single Women, 2017. This fence is a replacement of historic fencing that edged properties fronting Staff Street at Staff Row prior to the 1940s.

Fences and railings. Fences have also been used historically to delineate property ownership. Fences were traditionally wooden. Picket fences were once found around many group home complexes, staff residences, and community structures; the majority were removed in the 1940s to reduce the separation between patients and other community members. A wooden picket fence that frames two sides of the yard associated with the Residence for Single Women (Figure 152) along Staff Row follows the alignment of one of these historic fences, but is a later replica used for interpretation.

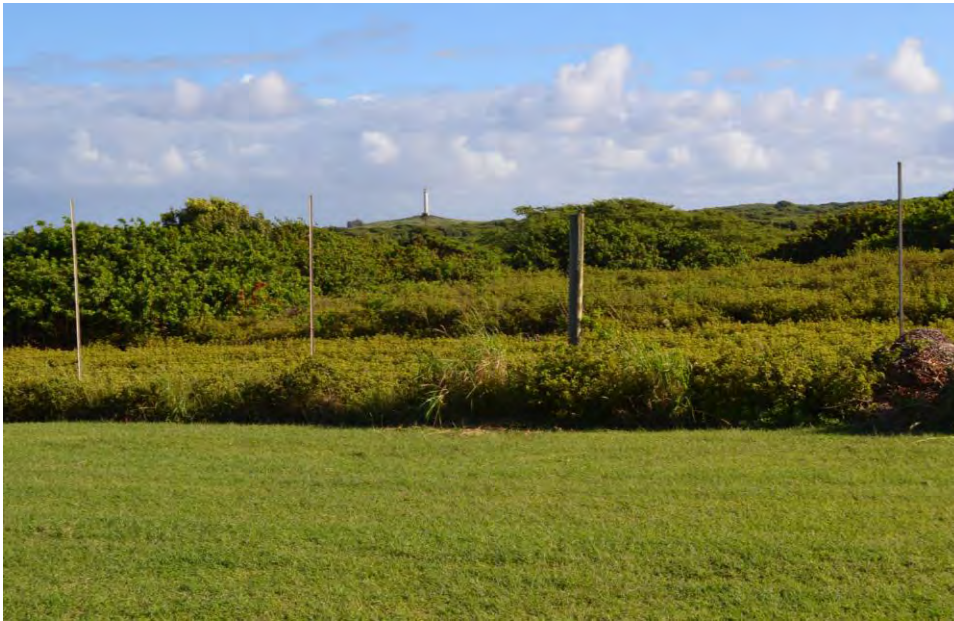
Figure 153. View north of deer fencing near McVeigh Home, 2018.

The NPS and DOH have erected taller metal fencing to exclude axis deer and hogs from Kalaupapa Settlement, Kalaupapa Airport, the pali, and Kauhakō Crater. Approximately 6 feet in height, the deer fencing is composed of metal or wood posts and a several strands of thin metal wire (Figure 153).

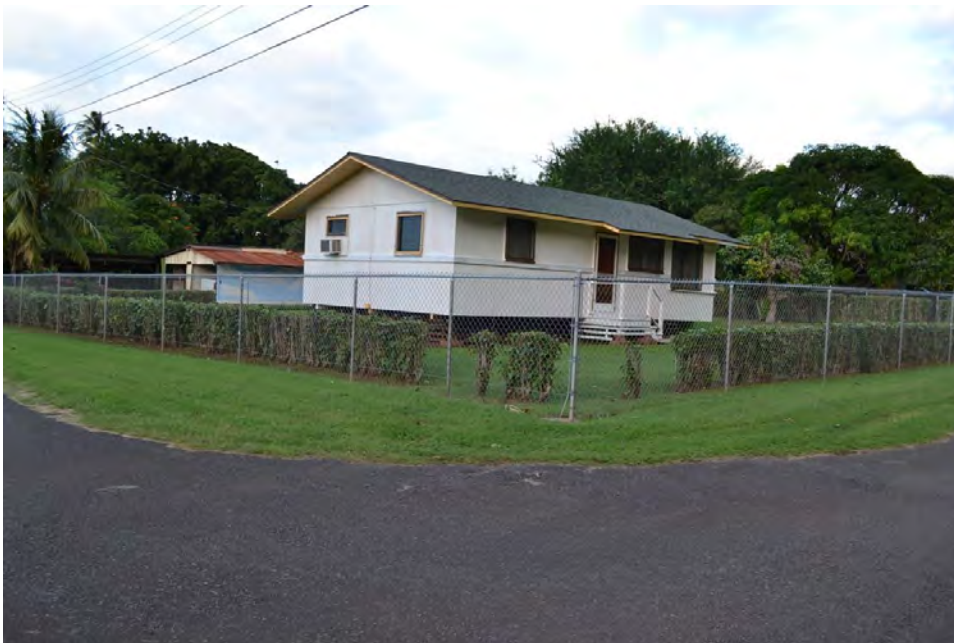
Figure 154. View of one of the chain link fences used to mark some residential properties within Kalaupapa Settlement, 2017.

Chain link fencing edges several residential properties (Figure 154), including the Paul and Winifred Harada Residence along School Street, the Olivia Breitha Residence along Puahi Street, and behind the Barbara Marks Residence at Bishop Home, and several properties at McVeigh Home. Black-coated chain link fencing surrounds much of the sports court to the north of Paschoal Hall, except where the presence of a block retaining wall in poor condition precluded the use of fencing. The stormwater management basin near the Pali Trail trailhead is surrounded by a woven wire fence supported by metal poles.

Metal and chain link fencing has also been used to enclose livestock pasture, maintenance areas, and some residential and institutional properties (Figure 154). Cattle were traditionally grazed to the north and south of Kalaupapa Settlement in areas enclosed by post and wire fencing, the evidence of which survive today. The metal wire is often referred to as hog wire, formed of 4-to-6-inch squares. Hog wire fencing is also present in association with some institutional and residential properties, such as the rear yard of the Bernard Punikai’s Beach House, the northern end of the Church of Jesus Christ of Latter-day Saints property (in combination with chain link fencing), and around a garden at the Norbert Palea Residence. Hog wire fencing forms a portion of the perimeter of the nursery area. Remnants of a historic strand wire fence also survives at Molokai Light Station, including hog wire fencing that extends between the lighthouse and residential complex. A contemporary metal mule corral is located along the Trail Access Road near New Baldwin Home site used in association with park tours. Nearby at the Slaughterhouse is a metal cattle corral.

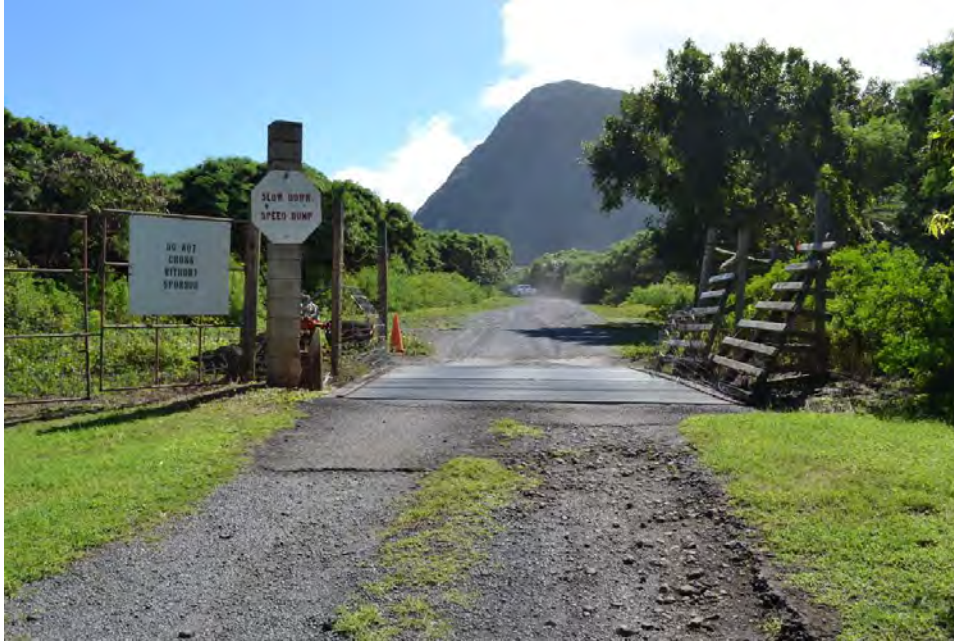
Figure 155. View of the cattle guard at the end of Beretania Street, 2018.

Cattle guards are used where roads pass through the deer fences to keep animals from crossing into the Settlements. Cattle guards are located at the east end of Beretania Street (Figure 155), at the north end of the West Coast Cemeteries along Kamehameha Street, on Crater Road, within the bridge across Waihanau. There are also two on the roads leading to the light station. The gates at the entrances to the New Baldwin Home site and Bay View Home formerly included cattle guards as evidenced by the pipes at the bases of the piers. The cattle guards are composed of metal slat surfacing edged by angled wooden guards that are tied to the fence posts to either side.

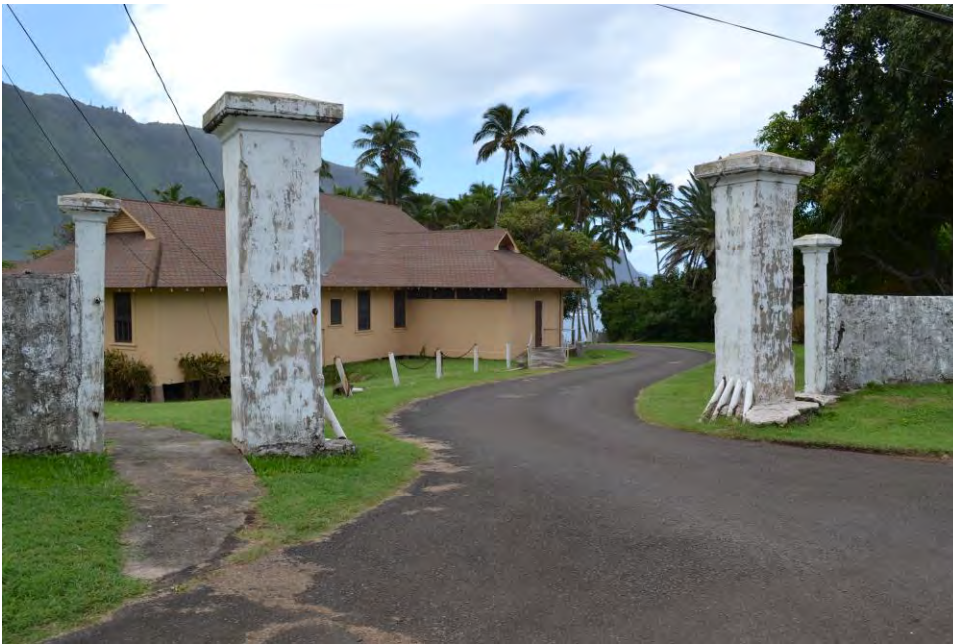
Figure 156. View southwest of the gate posts that mark the entry into the Bay View Home complex, 2017.

Gate and Entry Posts. Gate and entry posts are another character-defining element of Kalaupapa Settlement. Gate posts or piers mark the entry into several group homes—Bishop Home, New Baldwin Home, Old Baldwin Home, and Bay View Home—as well as properties along Staff Row—the Electrician’s Residence, Resident Physician’s Residence, and Residence for Single Women—the West Coast and Kahaloko Cemeteries, along Beretania Street, the churchyards, and several individual residences, including Residence 22 and the Norbert Palea Residence. Although the gates themselves do not survive, the gate posts and remnant rusting hardware attachments survive to mark former gated vehicular and pedestrian access routes. The gate posts vary in height, materials, and finish. Many are square concrete columns with peaked caps that were historically whitewashed or painted. The posts at Bay View and New Baldwin Home site are supported by pipe buttressing elements at the base that likely relates to former cattle guards (as noted above). Other gate posts are constructed of mortared lava rock covered with stucco or lime wash. The gate posts at Bishop Home are mortared lava rock inset with bronze plaques. The front faces are inset with bronze plaques noting “Bishop Home” to the left and “1888–1931” to the right. One of the piers is in need of repair. The gate posts are often located at openings in rock walls that mark a property boundary. Others are free-standing and likely once were associated with picket fences that have since been removed. The gate posts at Bay View Home (Figure 156) as well as New Baldwin Home are edged by curvilinear concrete walls that extend to either side. Both of these examples include a buttressed taller post at the central vehicular entrance and a smaller, lower post to either side where a pedestrian entrance occurs.

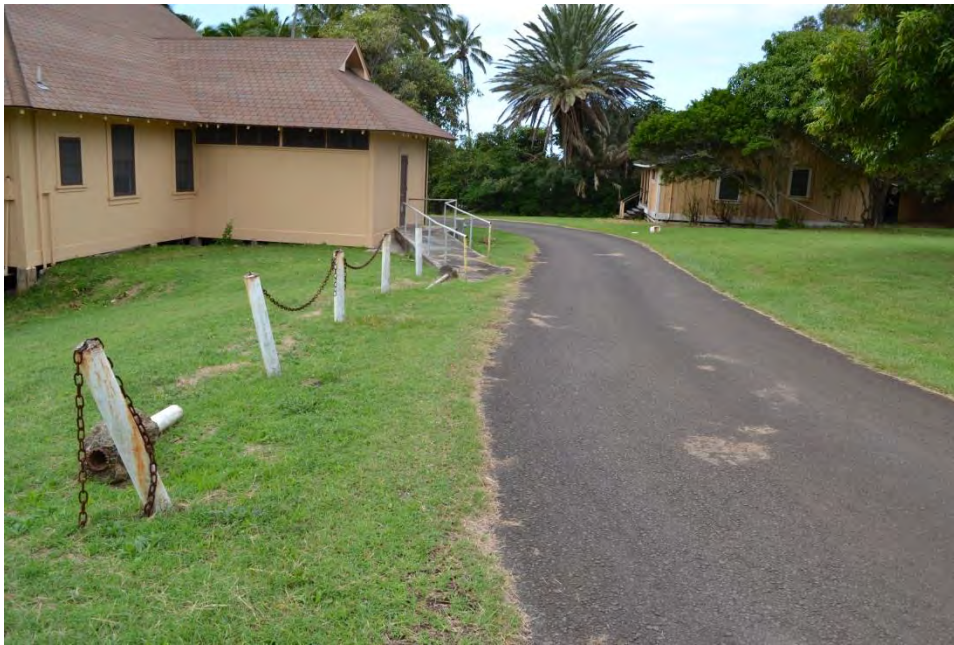
Figure 157. View of metal bollards and chains along Bay View Loop, 2017.

Edging Materials. Edging materials present along road margins to limit vehicular access to turf lawn, septic fields, buildings, and cliff margins include bollards and chains (Figure 157), concrete bollards, boulders, and painted rocks.

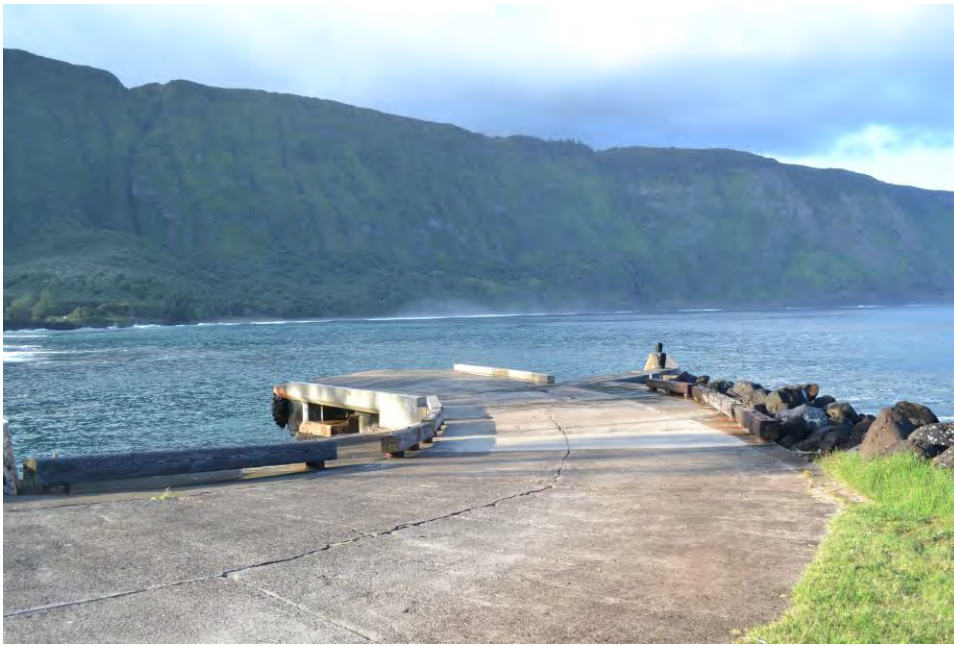
Figure 158. View southwest of the Kalaupapa Landing wharf, 2017.

Kalaupapa Landing, Bulkhead, and Breakwater. Kalaupapa Landing features a wharf, pier, and dock structure (Figure 158) that extends into the Pacific Ocean from the shoreline at the western edge of Kalaupapa. The wharf is used to dock boats at the settlement, principally the barge that delivers goods annually. The pier is irregularly shaped with a 10 foot high concrete dog-leg shaped breakwater extending 50 feet into the bay. A metal leveling deck covers a portion of a U-shaped reinforced concrete dock built over an earlier stone wharf accessed by steps. There is a winch associated with the pier, as well as bollards, railroad ties, and rubber tires. Associated with Kalaupapa Landing is a 105 foot long, 20 foot high bulkhead/sea wall composed of cast-in-place concrete and mortared volcanic rock set in concrete (Figure 159). The wall protects the Kalaupapa Landing area from wave action, along with a breakwater composed of formed concrete and stacked volcanic rock, approximately 200 feet long, located within the water near Kalaupapa Landing.

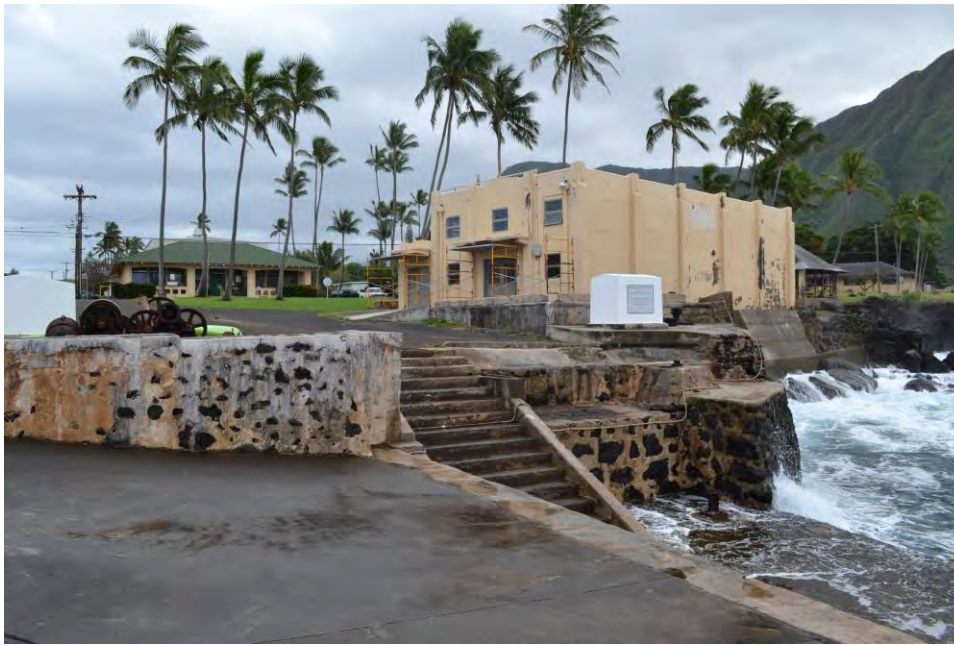
Figure 159. View east of the bulkhead/sea wall from the wharf, 2017.

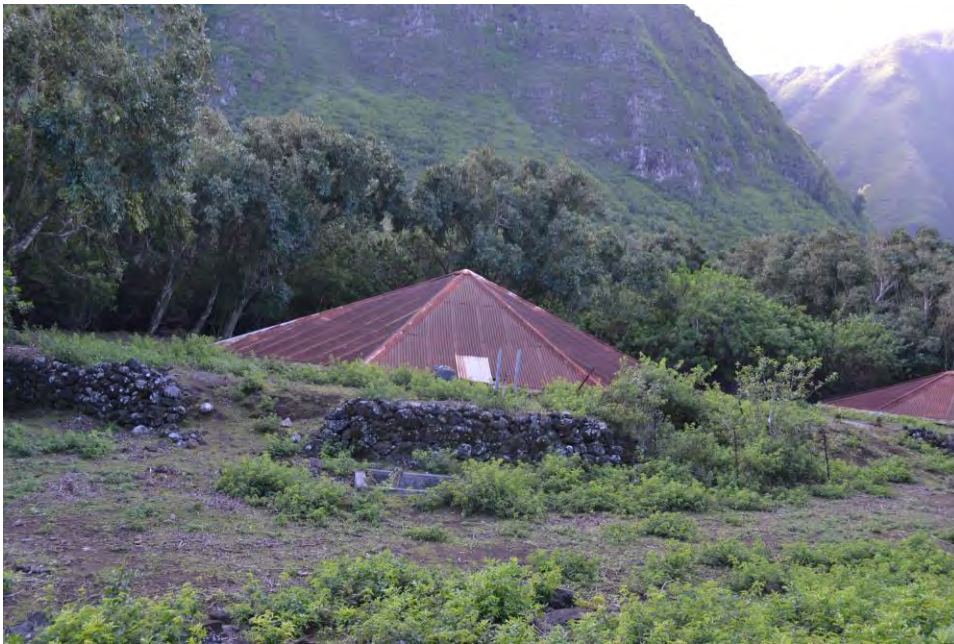
Figure 160. View south of underground water tanks located along Damien Road that were associated with the historic water supply system, 2017.

Water System Infrastructure. Evidence of the historic water system, which preceded contemporary use of a well-established by NPS, includes water tanks, a water reservoir, a Filter Building, and a Chlorinator Building. All of these features are located along Damien Road. The water tanks are partially buried in the ground with metal roofs to the south of the road (Figure 160), while the Filter and Chlorinator buildings are located to the west, also to the south of the road. The water reservoir, sometimes referred to as the Damien Reservoir, is located to the north of Damien Road as it approaches Kalawao. There is also a cistern located at the Bishop Home behind a former dormitory site that is an underground structure 8 feet in diameter, with a 3-foot opening at ground level. The water system supports fire suppression needs within the Settlements. Fire suppression features include fire hydrants and nearby fire hose boxes located in proximity to buildings and structures.

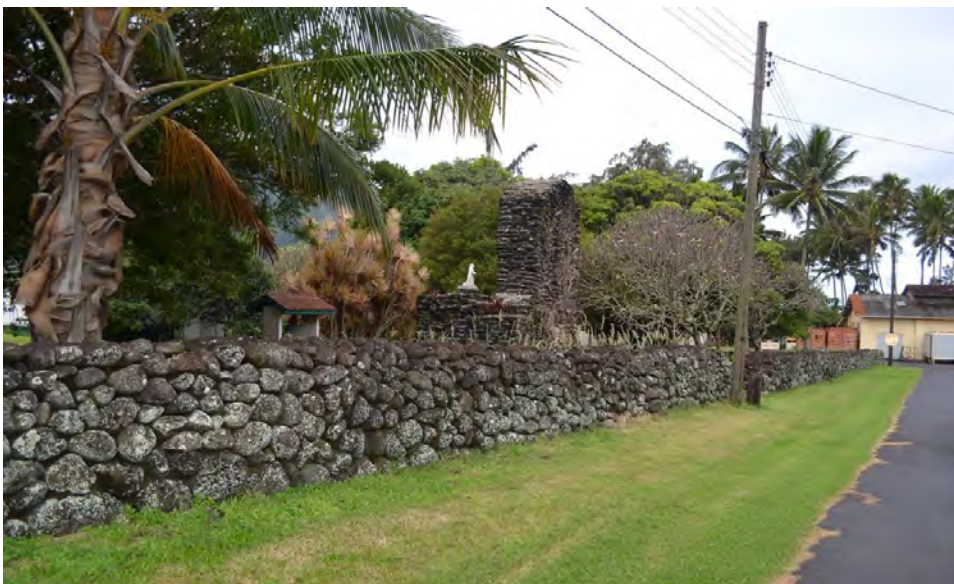
Figure 161. View of electrical poles and lines north of St. Francis Catholic Church, 2018.

Electrical and Telephone System Infrastructure. The electrical system at Kalaupapa reflects several eras of power generation and distribution, including 1909, 1932-1933, and 1962. The electrical system is one of the Settlement features that represents early twentieth century modernization efforts and coincided with the construction of new housing and other facilities. Elements of the system include wood poles strung with lines (Figure 161), crossbars, wiring, insulators, and transformers.²³⁷ The electrical poles are known to have been used by patients with poor eyesight to navigate the Settlement. Electrical lines and utility poles are used to support street lighting within Kalaupapa. Lines extend throughout Kalaupapa Settlement, with power supplied from topside via lines that traverse the pali and continue through New Baldwin Home site. Electrical lines continue north along Kamehameha Street to the airport, beach houses, and light station. Located south of Kalaupapa Memorial Hospital along Mission Street is a contemporary block structure that houses an electric generator to support hospital needs during a power outage. Telephone lines are also strung from dedicated telephone poles, but were sometimes strung on power poles.²³⁸ A small wood-frame structure located near the Visitor Quarters complex along Damien Street, referred to as a Telephone Station, relates to the telephone line infrastructure.

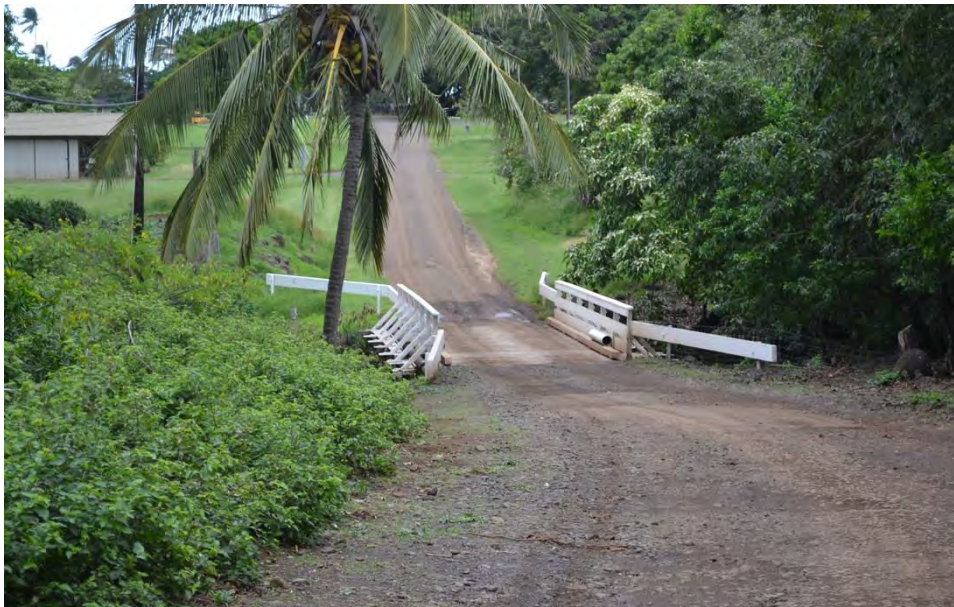
Figure 162. View north of the Puahi Street bridge, 2017.

Bridges. Puahi Street crosses Waihānau Stream via a single-lane wood and concrete bridge (Figure 162). This bridge replaced an earlier cattle guard and bridge at the crossing of Waihanau that has since been filled. Three bridges are associated with the Pali Trail, two at the lower end of the trail and the other between switchbacks 2 and 3 near the top. The bridge near the top is at the second switchback. It is a 65-foot high-grade aluminum structure, while the lower bridge is wood set on stone abutments.

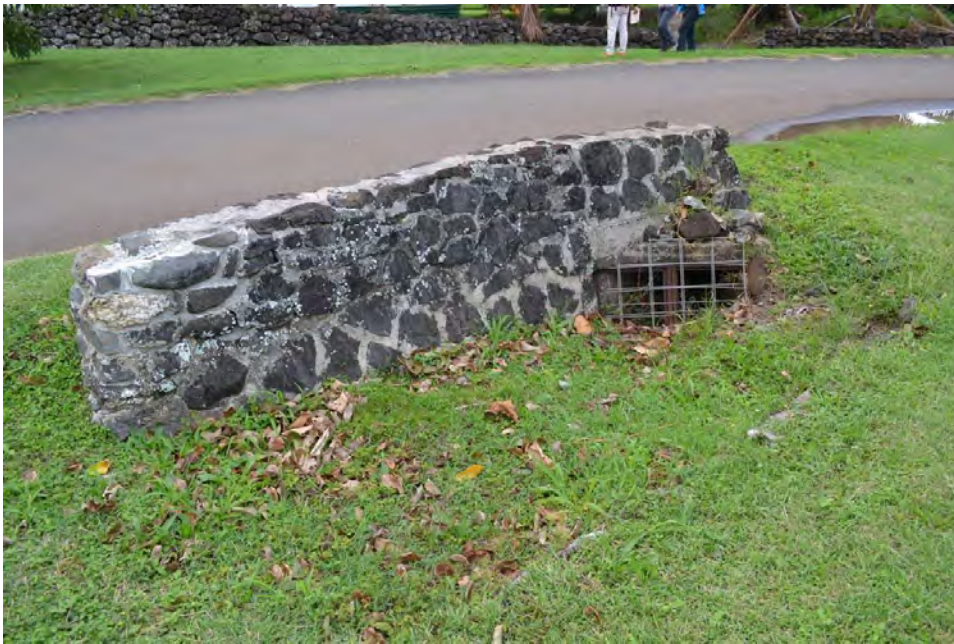
Figure 163. View north of the culvert that carries stormwater beneath Kamehameha Street near St. Francis Catholic Church, 2017.

Culverts. Five culverts are present within Kalaupapa that convey storm water flow beneath elevated road corridors (Figure 163). Two are associated with the St. Francis Catholic Church property and convey stormwater beneath Kamehameha Street to the east and Damien Street to the west, emptying at a culvert on the beach. Two others extend beneath streets within the Residential Area. The fifth passes beneath the Staff Street west of McVeigh Home.

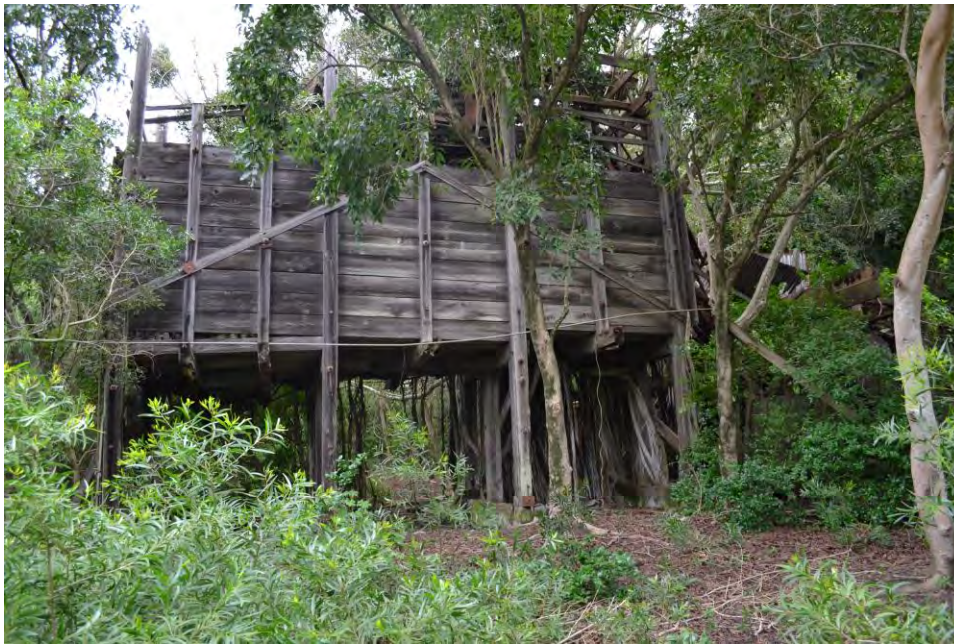
Figure 164. View southeast of the Rock Crusher, 2017.

Rock Crusher. As discussed above, a Rock Crusher was brought to the settlement to pulverize stone for road surfacing in the 1950s. The rock crusher is currently located near the New Baldwin Home site and overgrown with vegetation. It is a timber frame structure that measures 20 by 50 feet in plan and features external frame walls, diagonal braces, and a corrugated metal roof (Figure 164). It contains an engine shelter and compartments for three separators for processing different sized gravel.

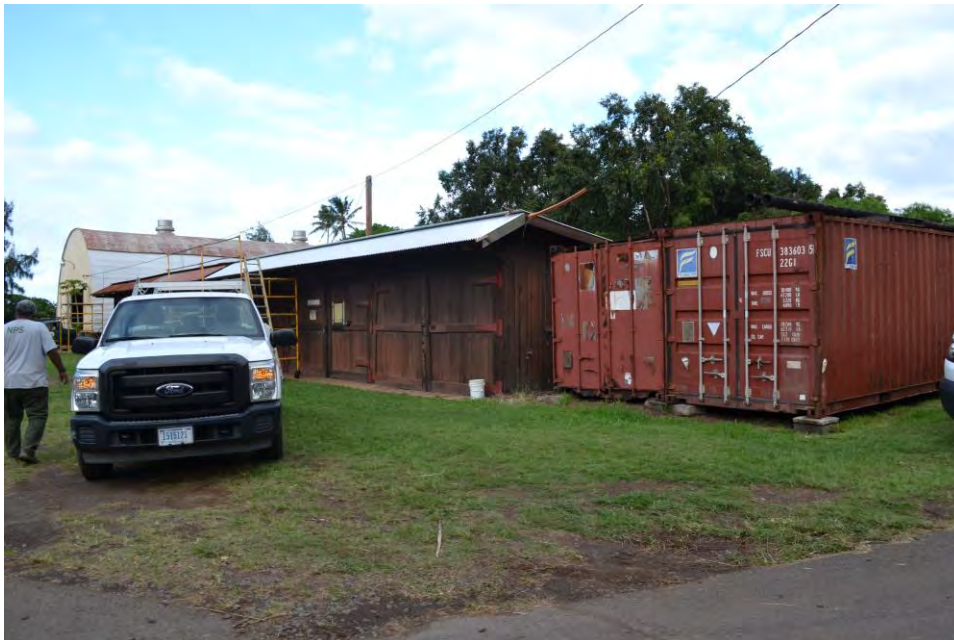
Figure 165. View northeast of one of the containers near the maintenance area, 2017.

Containers. There are several 20 foot by 8 foot shipping containers located in and around the industrial area used for storage, including items ready to be loaded on the summer barge (Figure 165). These prefabricated metal structures are located within a cluster of maintenance buildings near Kalaupapa Landing, east of Paschoal Hall, and along Damien Street.

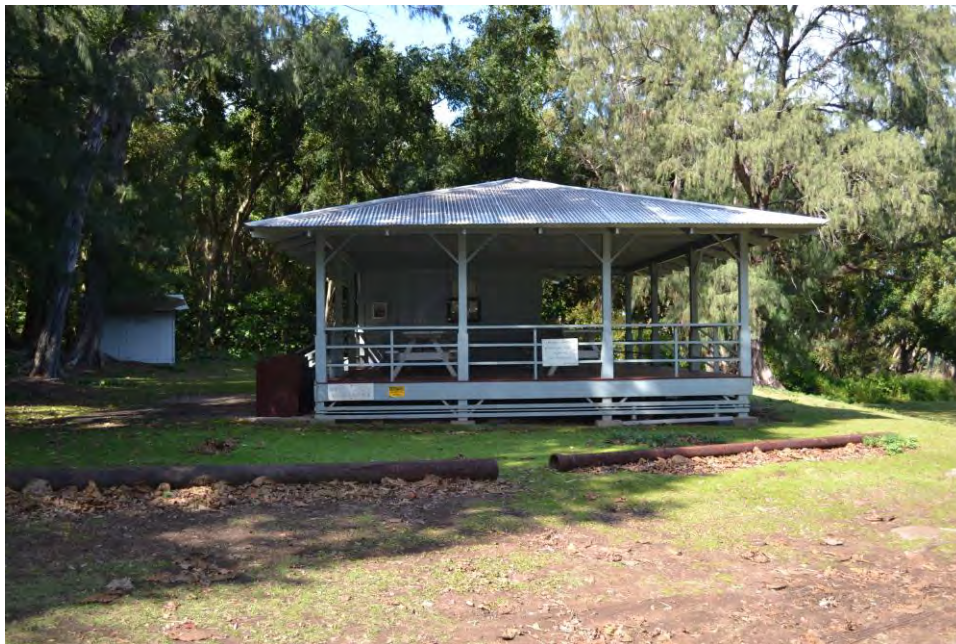
Figure 166. View southwest of the Judd Park Pavilion, 2017.

Picnic shelters and pavilions are located at Judd Park in Kalawao (Figure 166), and along the western shoreline in Kalaupapa. The Judd Park Pavilion, built in 1950, is located at the southeastern end of Kalawao. It is wood frame construction with a wood post and concrete foundation and a corrugated metal roof. One corner of the structure has been walled-in and converted to a restroom. The remainder is open.

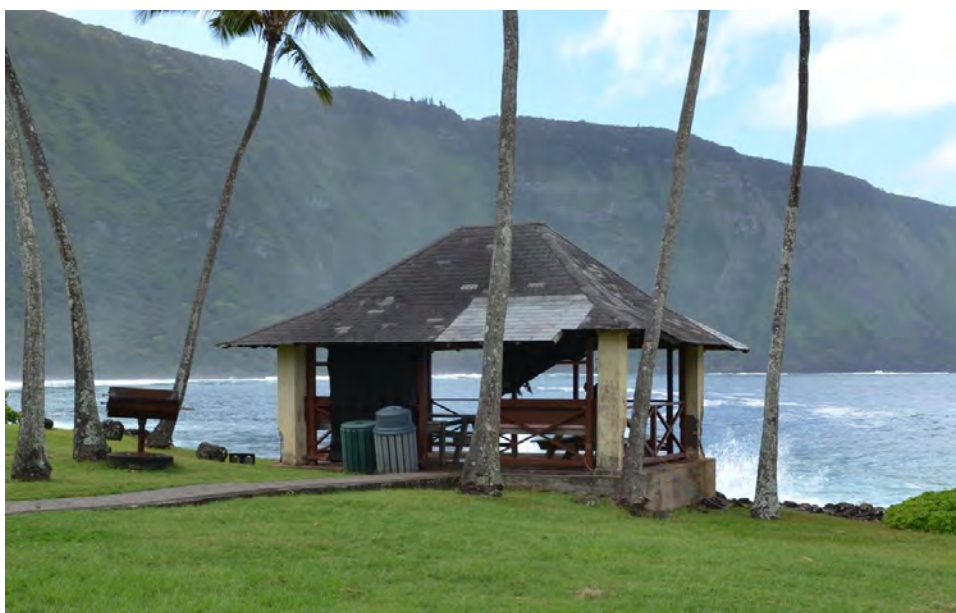
Figure 167. View southwest toward the Oceanside Pavilion located near Kalaupapa Landing, 2017.

An open-air picnic shelter is located near the beach houses along Kamehameha Street. The Lions Pavilion, also referred to as Ocean View Pavilion, was built in 1965 by the Lions Club, and later modified and expanded in 1970, 1984, and 1996. Restrooms associated with the pavilion are located across Kamehameha Road. A second shelter, known as Oceanside Pavilion, is located south of Kalaupapa Landing and overlooks the ocean (Figure 167). These two pavilions are both simple open-air structures with seating and other amenities inside. The Lions Pavilion has a sink with running water and electric lights, while the Oceanside Pavilion also has electric lighting.

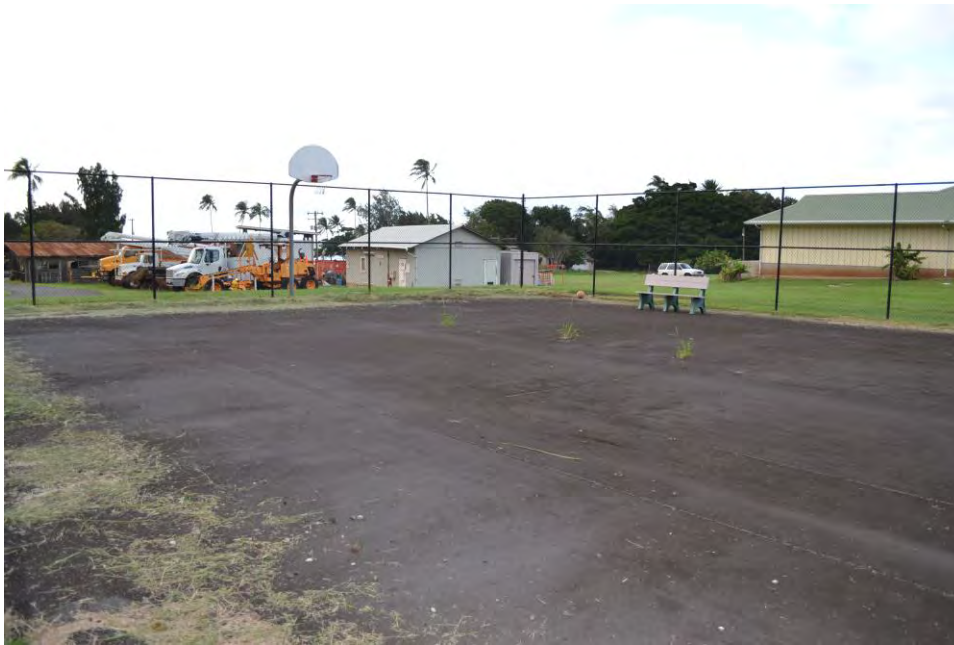
Figure 168. View northwest across the multi-purpose court north of Paschoal Hall, 2017.

A multi-purpose recreation court is located behind Paschoal Hall (Figure 168). The court measures approximately 60 by 120 feet and is enclosed on three sides by a chain link fence. The fourth side is edged by a concrete block wall that is failing. The asphalt-paved court is striped for tennis and one basketball hoop is located along the west edge. There is also a volleyball court set up in a level grassy area across Puahi Street from Fuesaina's Bar.

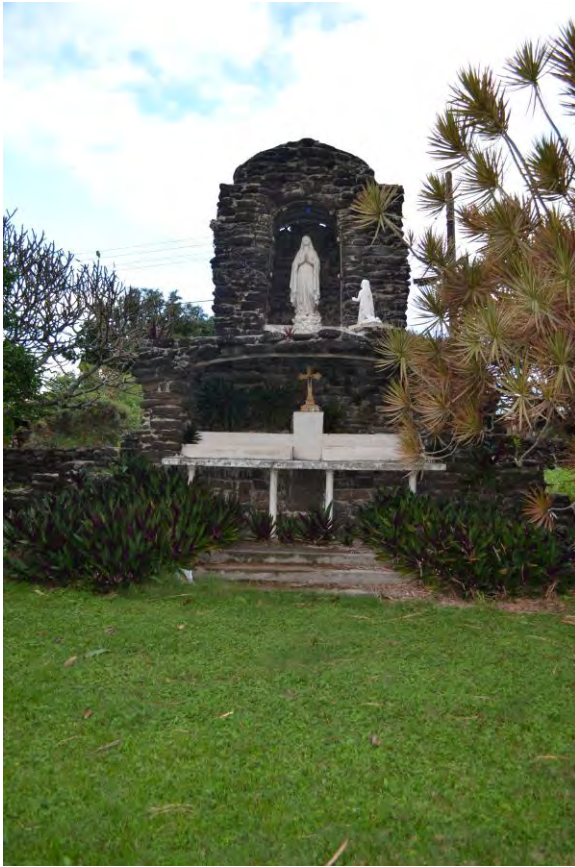
Figure 169. View north of the Grotto for Our Lady of Lourdes and St. Bernadette at St. Francis Catholic Church, 2017.

Religious Features. There are two grottoes located within Kalaupapa. One is at New Baldwin Home and the other is located at the northern edge of the St. Francis Catholic Church property (Figure 169). Both are substantial stone structures with a vertical orientation, and niches that feature statuary.

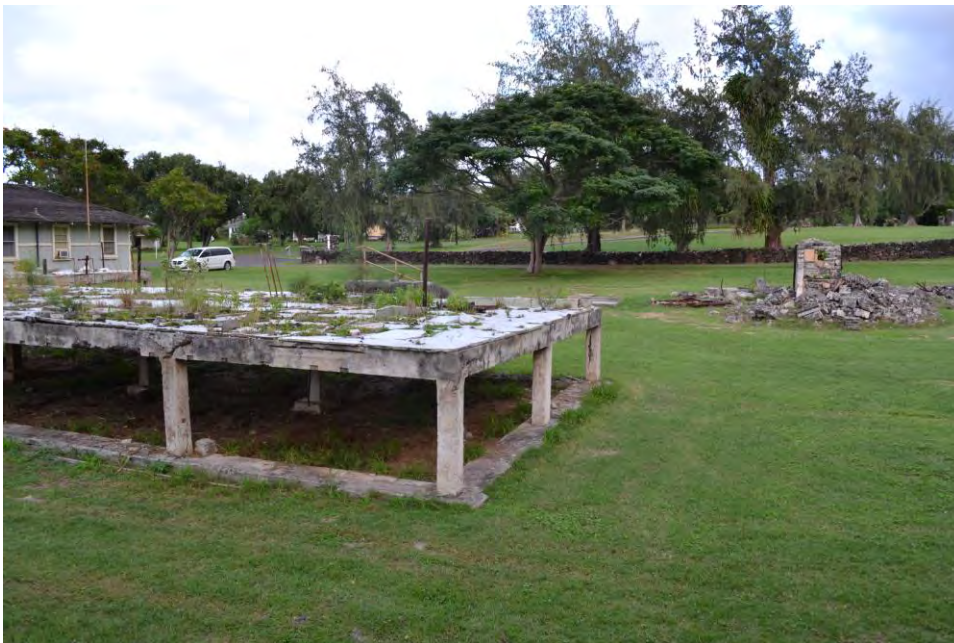
Figure 170. View northeast of the Hospital ruins, 2017.

Building Foundations and Ruins. Former building sites are often marked by foundations and other types of structural ruins that are visible aboveground. Such features are considered as part of the cultural landscape due to their visual impact and the manner in which they mark missing historic features and patterns of spatial organization. They may also indicate the locations of potential archeological resources with a high sensitivity to change and disturbance. Several building foundations and ruins are scattered throughout the settlements, including at the Old and New Baldwin Home sites, Bay View Home, McVeigh Home, individual residential properties, in the beach house area, and at Kalawao, including the U.S. Leprosy Investigation Station, and the second Kalaupapa Hospital (Figure 170). The first was located south of the Waihanau Bridge near where New Baldwin Home was later established. The Superintendent's Residence at Staff Row is also marked by foundation ruins.

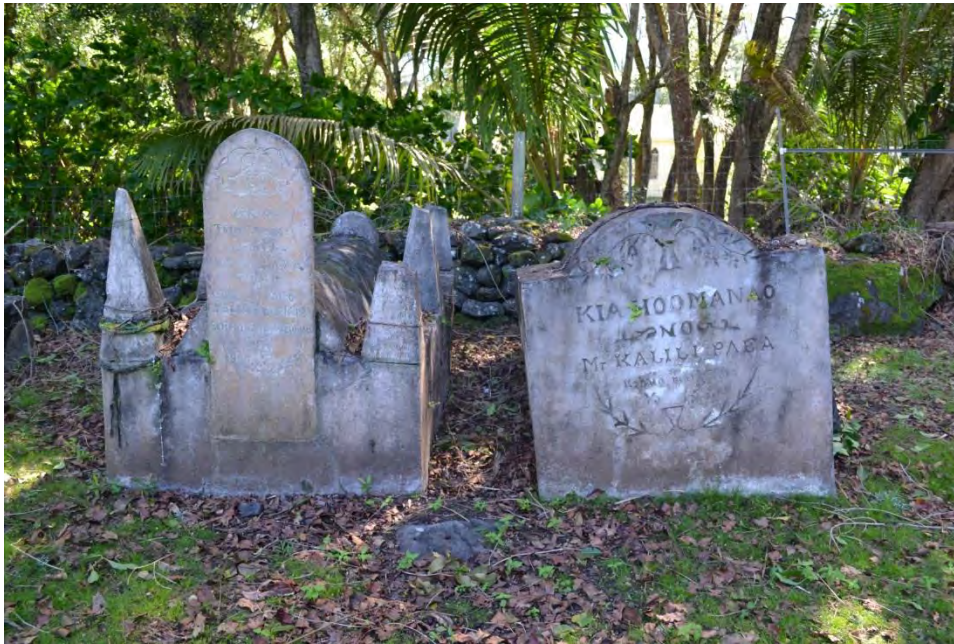
Figure 171. View southeast of grave markers associated with the Siloama churchyard, 2017.

Grave Markers and Cemetery Objects. Grave markers of a variety of styles, sizes, and materials are present within the twenty documented cemetery properties at Kalaupapa and Kalawao, including West Coast Cemeteries at Papaloa and ‘Īliopi‘i; St. Francis Catholic Churchyard, the Siloama (Figure 171) and St. Philomena Catholic Church churchyards and adjacent burial grounds, Kauhakō Crater, Kahaloko Cemetery along Damien Road, as well as graves located at Bishop Home, near New Baldwin Home, near one of the beach houses, near the lighthouse, and south of Damien Road. Overall, there are more than 1,300 grave markers associated with these cemeteries. The grave markers vary in terms of materials, scale, shape, and markings. Marker types include upright, raised, cross, flat or flush with the ground, mausoleum, tomb/vault, obelisk, post, pillow, slab, hakka or urn house, and temporary sign. Materials associated with the grave markers range from wood, to rough lava stone, concrete, cast-iron, iron pipe, bronze plaque, granite, marble, and sand as part of a mortar mix, or any combination thereof.²³⁹ A large majority of the grave markers are composed of mortared lava rock covered with a lime wash on stucco.²⁴⁰

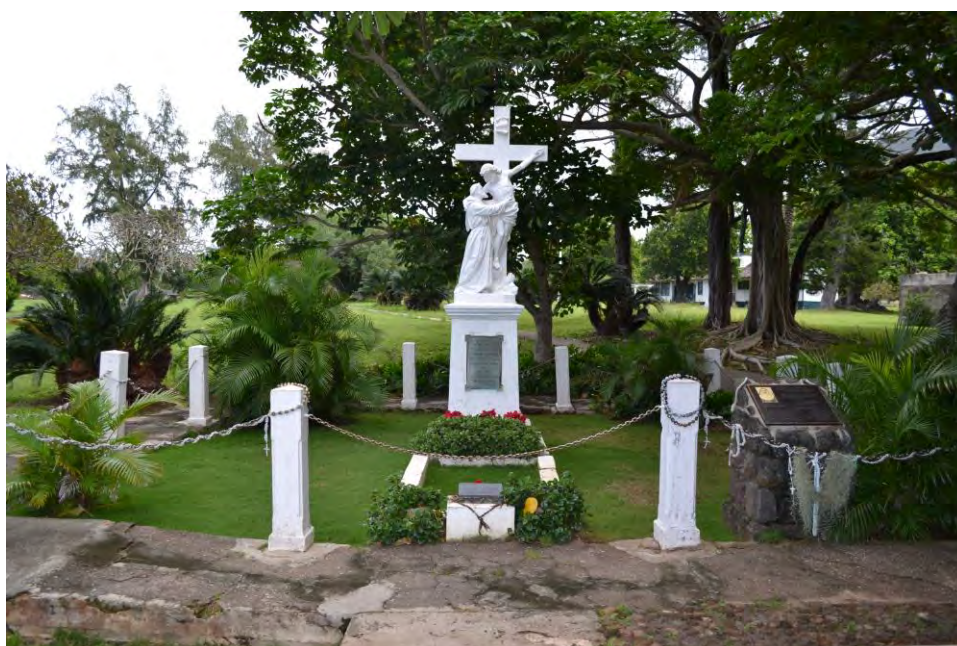
Figure 172. View east toward the Saint Marianne Cope grave marker, 2017.

Among the most visited grave sites at Kalaupapa are the Saint Marianne Cope Grave at Bishop Home, and the Saint Damien and Joseph Dutton graves at St. Philomena Church. The grave of Saint Marianne Cope, who helped establish and then later ran the Bishop Home for Girls between 1888 and 1918, features a white statue of Jesus and John the Baptist surrounded by a formal walk, concrete posts and chains, and plantings (Figure 172).

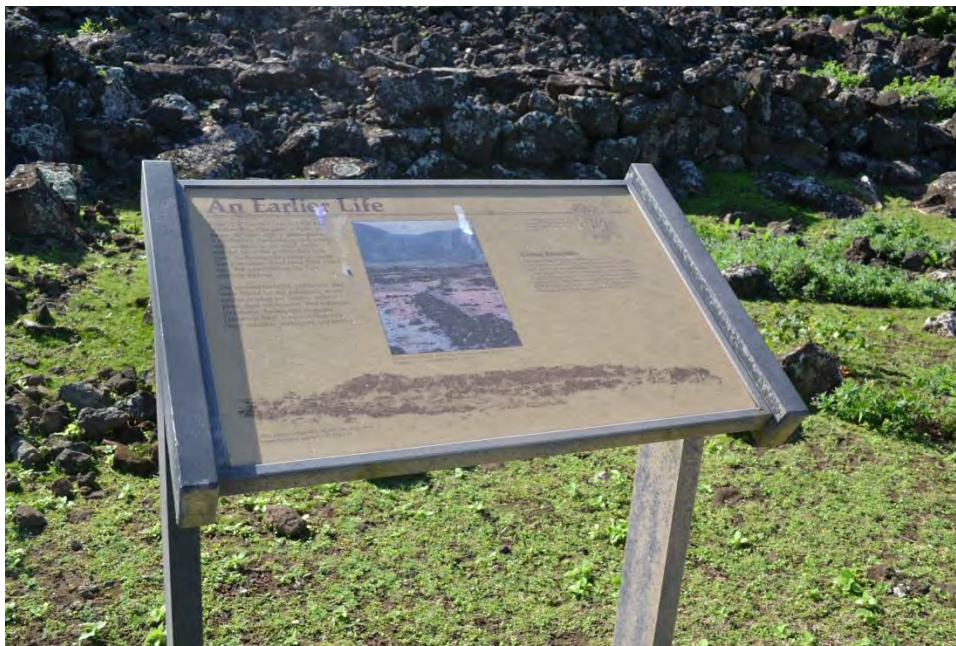
Figure 174. View southeast of the wayside exhibit that interprets a heiau along Damien Road, 2017.

Several NPS standard wayside exhibits are located within the peninsula. These exhibits mark and interpret several features within the settlements including a heiau along Damien Road (Figure 174), St. Francis Catholic Church, Bishop Home, St. Philomena Catholic Church, Baldwin Home, and Staff Row.

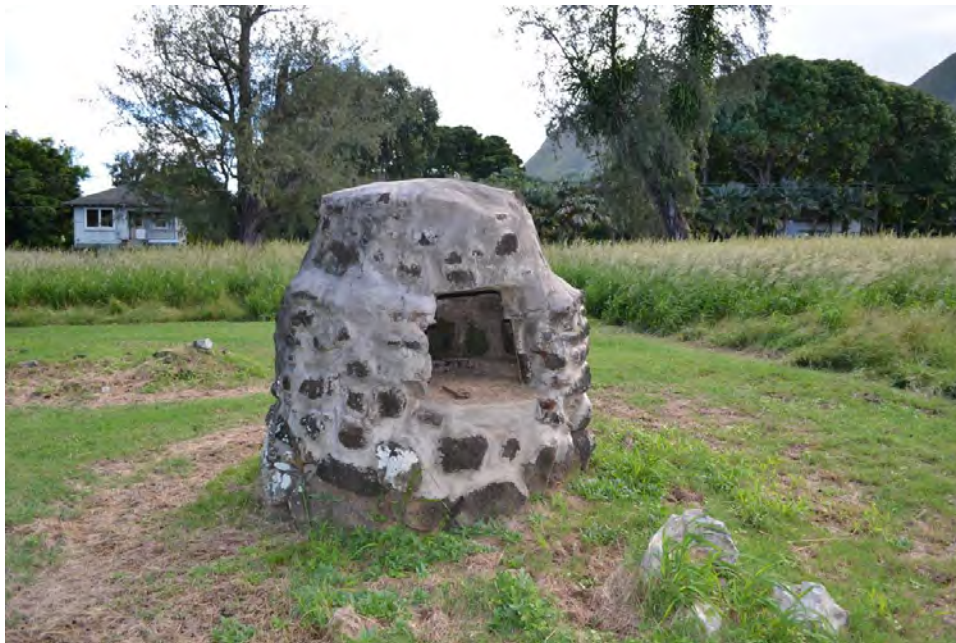
Figure 175. View northeast of the bake oven at Bishop Home, 2017.

Site Furnishings. Site furnishing present throughout the Settlement includes picnic tables and benches located near Fuesaina's Bar and near administrative buildings for staff, two flagpoles—one at Bishop Home and the other at the Post Office—food delivery boxes and trash can boxes, and an informational chalkboard and planters outside Paschoal Hall. At Bishop Home there is a mortared masonry feature in the open grassy field at the northeastern corner of the property referred to as a beehive-shaped bake oven (Figure 175). The oven is associated with the introduction of Portuguese baking practices in Hawai'i.

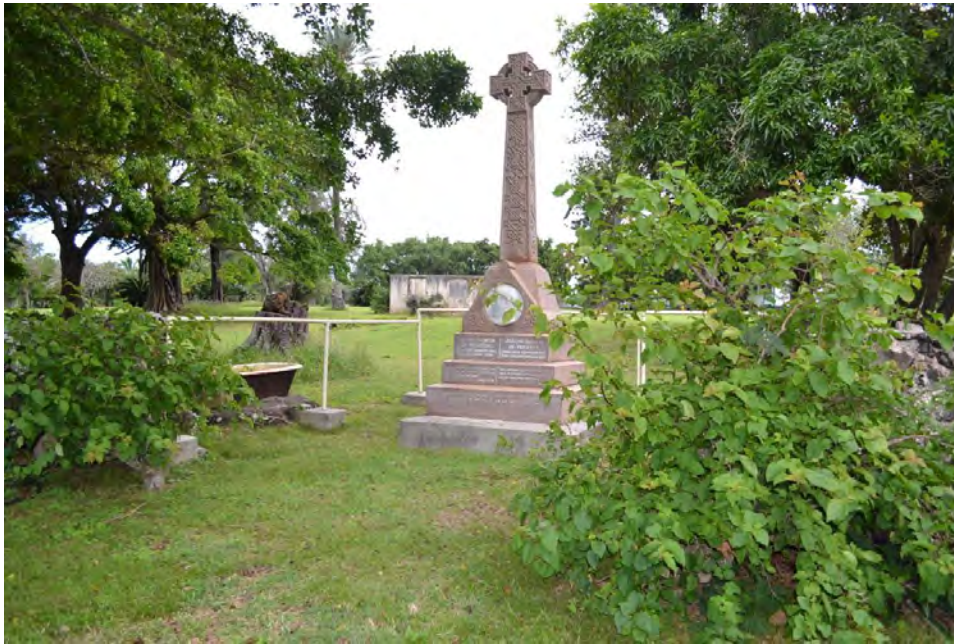
Figure 176. View northeast of the Saint Damien Monument, 2017.

Monuments. Examples of monuments present within the Settlements include the concrete cross erected in 1956 atop Pu‘u ‘Uao near the rim of Kauhakō Crater used for religious ceremonies and visible from many locations on the western coast of the peninsula, the Saint Damien Monument, a red granite Celtic cross located along Puahi Street erected in 1893 by the people of England (Figure 176). A third monument honors Jonathan Napela at the Church of Jesus Christ of Latter-day Saints. The concrete obelisk monument was erected in 1938. The fourth and final monument located within the CLR study area is the Mother Clinton Monument located at the southeastern corner of Damien and Puahi Street. The monument consists of a 2 by 8 foot concrete base inlaid with a plaque. The monument was erected in 1945 to honor Bessie Clinton, an administrator at the Kalihi Hospital from 1918 to 1946.

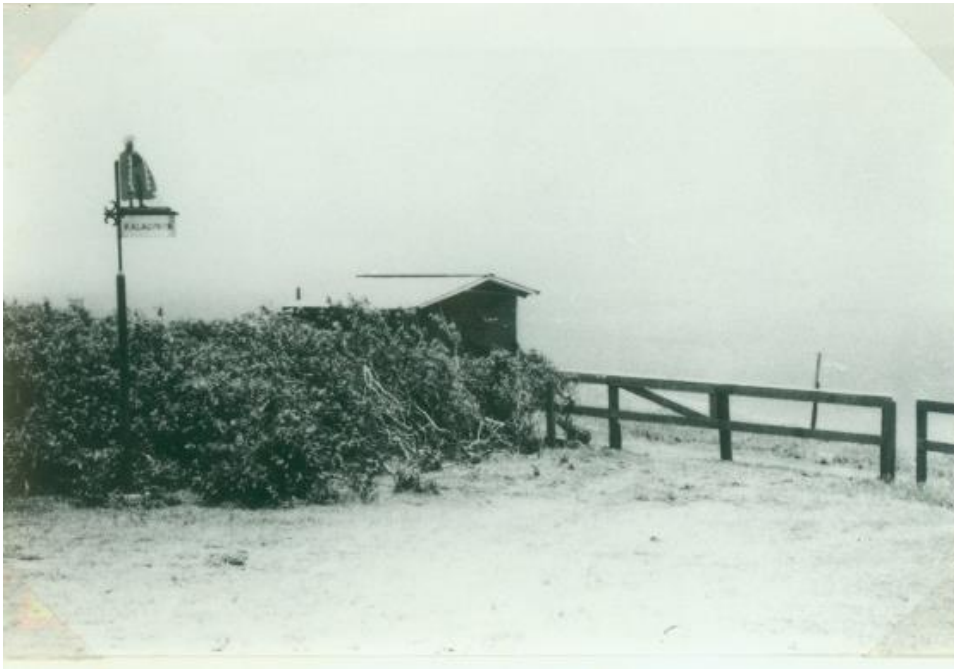
Figure 183. View of the guard house at the top of the pali trail used by a caretaker who policed those coming and going, circa 1930s. (Source: KALA Kalaupapa Historical Society Album E PG 4 #446-448)

In 1936, a gate and watchman station were built at the entrance to the trail topside to control access (Figure 183). The watchman station was removed in 1946 after the first successful medicinal treatment of leprosy with sulfone drugs.²⁷⁴ Despite restrictions on travel and the presence of the watchman station, many patients did find ways to sneak off topside for a day or two before the rules were relaxed. If their absences were noticed, they were punished when they returned by being put in the Kalaupapa jail.²⁷⁵ Kōkua regularly traveled the pali to visit with others topside, bringing back news to the patients.

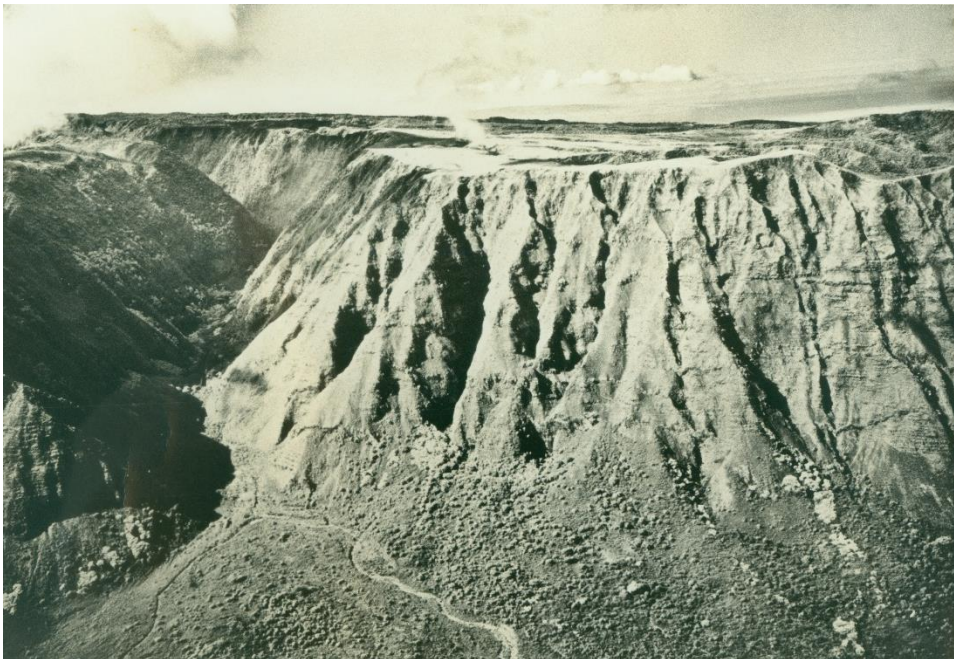
Figure 184. View of the pali and Waihānau Valley, circa 1950. (Source: KALA Kalaupapa Historical Society Album E PG 2 #442)

Over time, they reduced the pali into a denuded barren hillside (Figure 184), described by some as resembling a prison wall. Cathrine Puahala noted the appearance of the pali when she arrived at Kalaupapa in 1942:

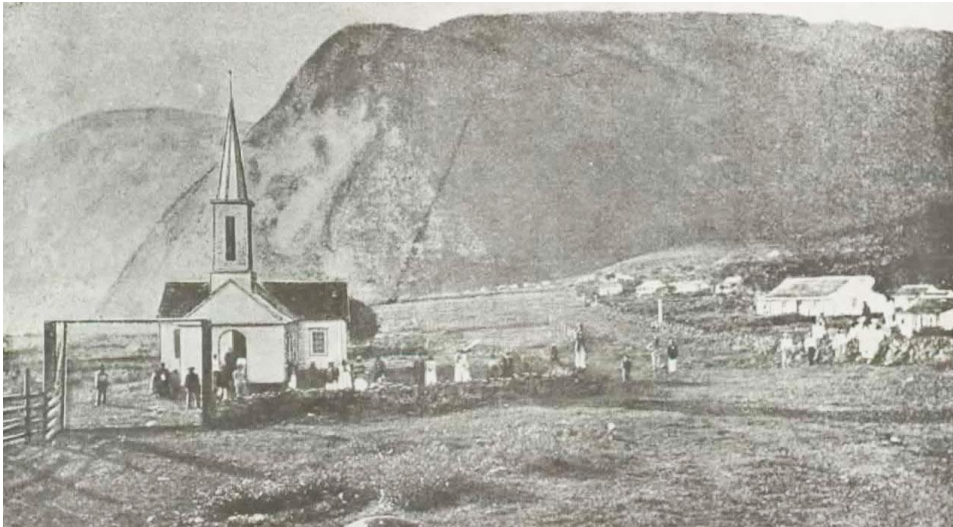
Figure 187. St. Philomena Catholic Church in 1886 showing the nave and steeple added to original chapel by Saint Damien. View looking east. (Source: KALA Kalaupapa Historical Society Album A PG 2 #176)

Vernacular in character, the Settlement slowly grew along the existing road leading to the western shoreline and the fishing village at Kalaupapa, with community services sited along the central road and houses and makeshift shelters scattered nearby. A hospital was soon added to the development, while by 1872, two churches—the Congregational Siloama Church of the Healing Spring (Figure 186) and St. Philomena Catholic Church—also edged the northeast side of the road (Figure 187).
