Kalaupapa and Kalawao Settlements Cultural Landscape Report

Kalaupapa National Historical Park

Cultural Landscape Report

Prepared by:
Wiss, Janney, Elstner Associates, Inc.
2000 Powell Street, Suite 1650
Emeryville, California 94608

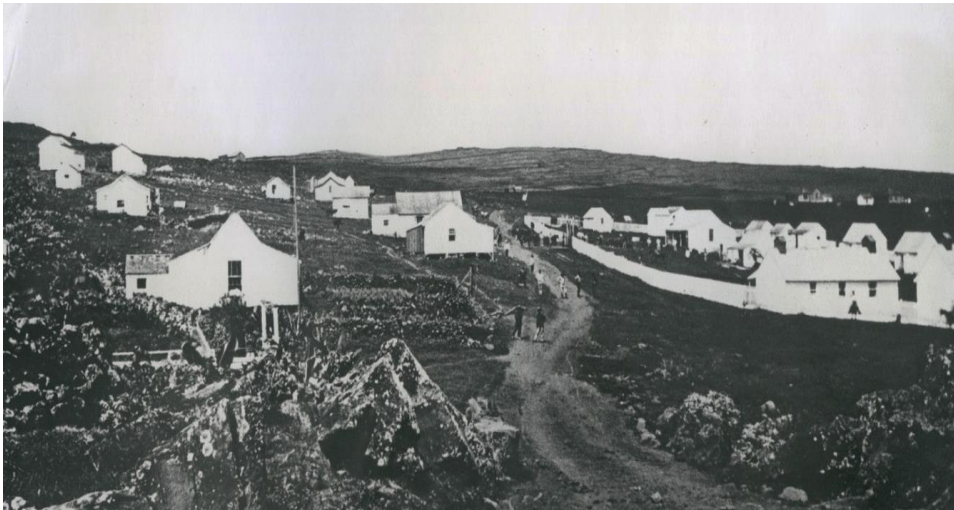
Figure 188. Kalawao, with the hospital complex on the north side of the road enclosed by picket fence, and the store on the south side of the road, circa 1880s–1890s. View looking west. (Source: KALA Bruce Doneux_00372_Box 01_007, Hawaii State Archives)

By the 1880s, much of the settlement was concentrated along the central road corridor, with patient services creating a center, and individual houses generally to the east and scattered along the base of the pali, reflecting a blend of Hawaiian and western construction styles and spatial ordering (Figure 188). The land supporting Kalawao Settlement extended over a large area. Much of the land was open in character as a result of extensive use for agriculture and grazing.²⁹³ Kōkua raised fowl and pigs, and managed all varieties of gardens, growing sweet potatoes, banana, onions, beans, and cabbage. Large portions of the surrounding landscape supported the growth of seashore rush grass (*Sporobolus virginicus*) that offered fodder for settlement horses.²⁹⁴

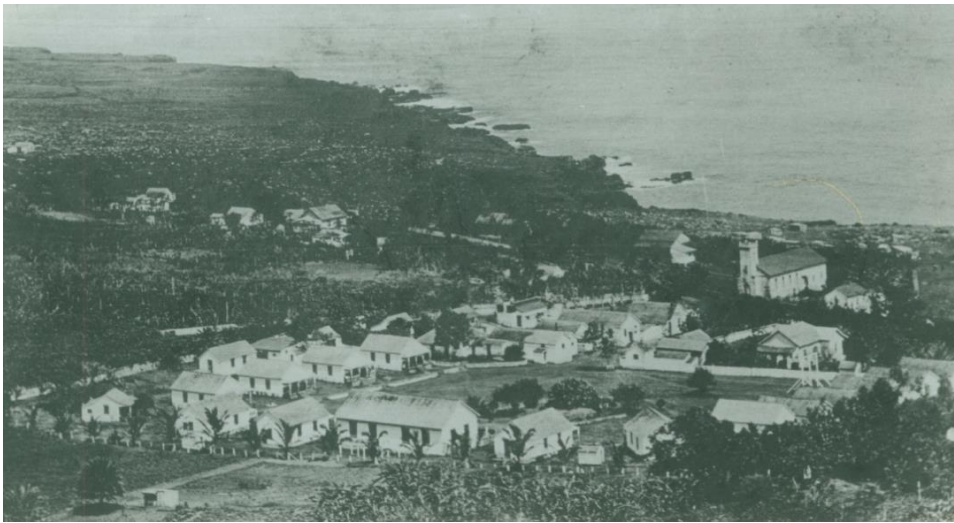
Figure 189. Bird's eye view looking northwest of Baldwin Home for Boys located across Damien Road from St. Philomena Catholic Church, undated. (Source: KALA Kalaupapa Historical Society Album A, page 7, #181)

The site selected for construction of the Baldwin Home for Boys was an open rocky area across from St. Philomena Catholic Church. The group home was designed with a relatively formal site plan that organized the twenty-nine buildings around a large central open area marked by a small garden and water fountain in the center sited near a large hala tree. Baldwin Home extended over approximately 2 ½ acres and was enclosed by a whitewashed fence. Large buildings were sited on the west and east sides of the built cluster. The large building located to the west was set apart and enclosed by a wood fence. The large building to the east had an open porch that faced onto the open central yard. A wooden walkway, also whitewashed, wrapped around the open yard, connecting the individual buildings. A single row of palm trees was planted along the east perimeter the fence. Over the years, the grounds were landscaped with Java plum, eucalyptus (*Eucalyptus spp.*), avocado, date palm, and croton trees, as well as pomegranate (*Punica granatum*) and hibiscus shrubs. By 1899 a large vegetable garden and plantation of 2,000 banana trees were growing behind the complex near the pali, and there was a windbreak along with fruit trees planted nearby. These plantings, along with the orderly arrangement of the buildings and formal layout of the complex, made the Baldwin Home for Boys one of the most cohesive and richly landscaped areas in Kalawao Settlement (Figure 189).²⁹⁶

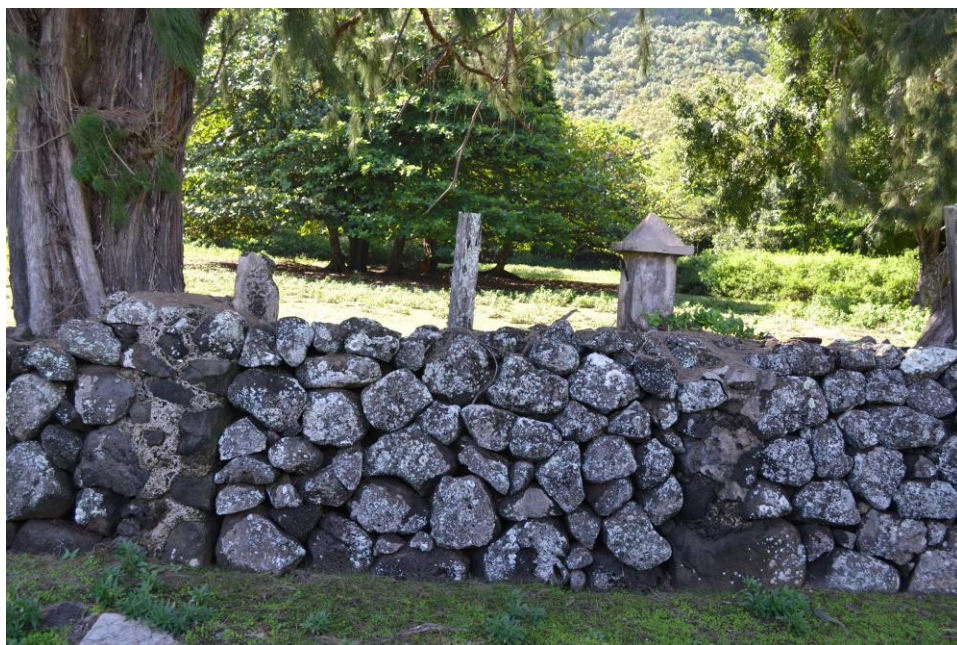
Figure 193. View south into the Baldwin Home site across the perimeter dry stacked stone wall, 2017.

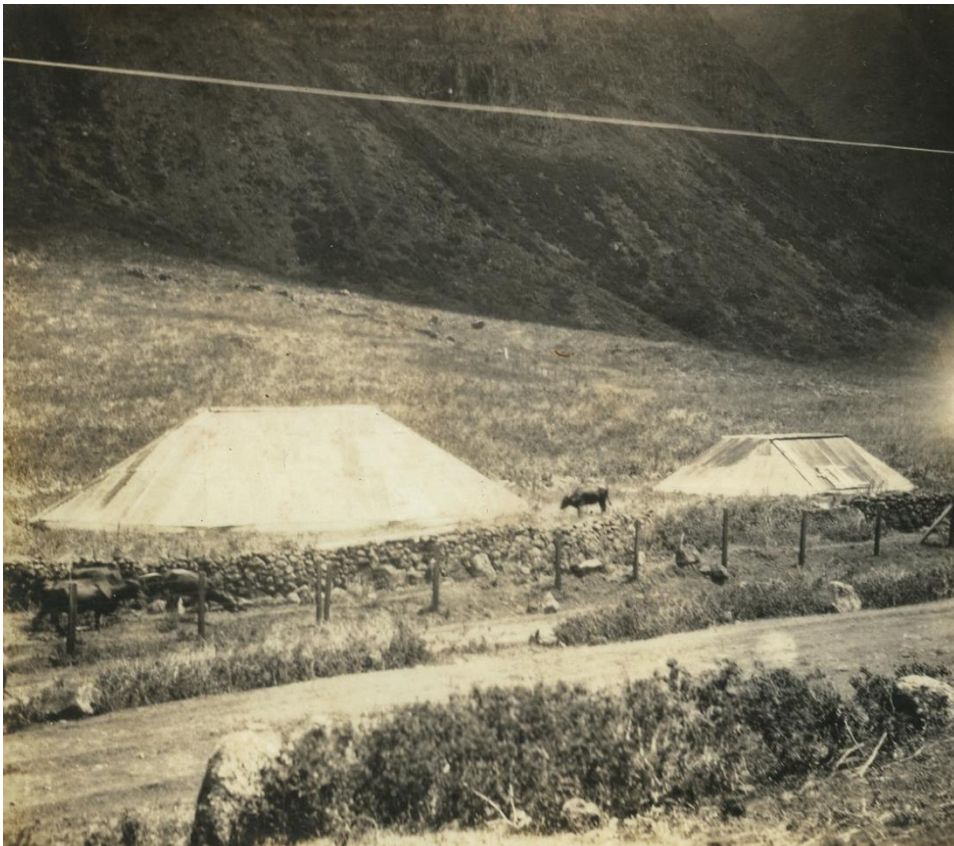
Figure 197. Water tank reservoirs along Damien Road, undated, circa 1900. (Source: KALA Helen Keao_00373_Album 045)

Another feature developed along Damien Road during the nineteenth century was the water supply system. In 1894, the Board of Health added a water collection reservoir on the saddle between Kalawao and Kalaupapa to improve the supply available to the Settlements. In 1904, the Board added a second underground stone and concrete water reservoir nearby. Both extended aboveground for several feet and featured hipped corrugated metal roofs (Figure 197).³⁰⁵ Later, in 1908, the Board of Health built another 10,000-gallon water storage tank at Makanalua.³⁰⁶ These systems proved sufficient until the 1930s when the Board decided to modernize the Settlement infrastructure by expanding the power plant, power distribution system, and water supply system. In 1931, a new 750,000-gallon steel tank was added to replace the use of the older storage reservoirs, which were left in place. In the 1950s and 1960s, chlorinator and filter buildings were added to treat the water for Settlement use.

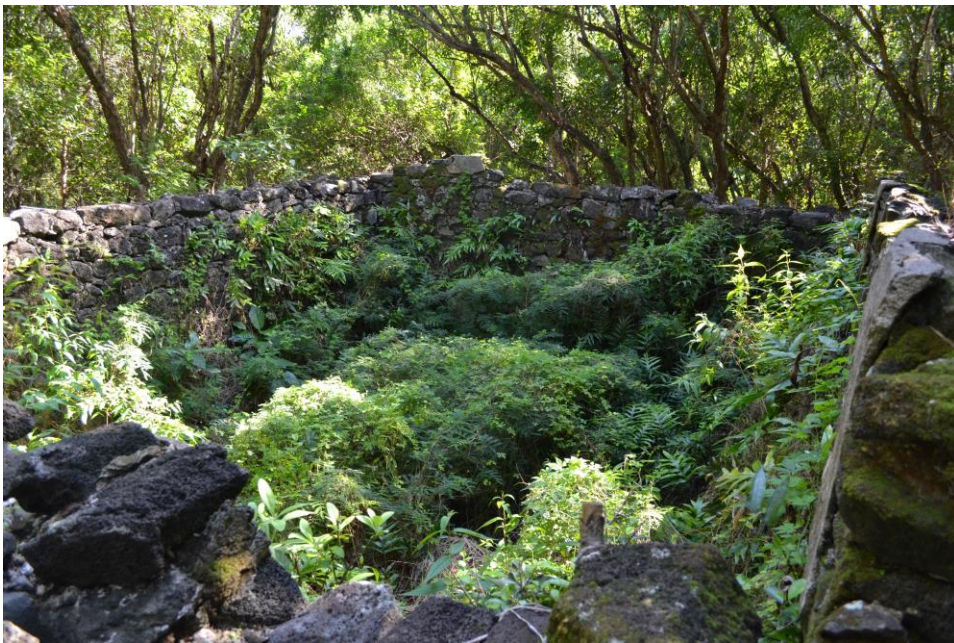
Figure 201. View northeast of the stone water reservoir built in the 1880s to supply water to the Kalawao hospital along Damien Road, 2017.

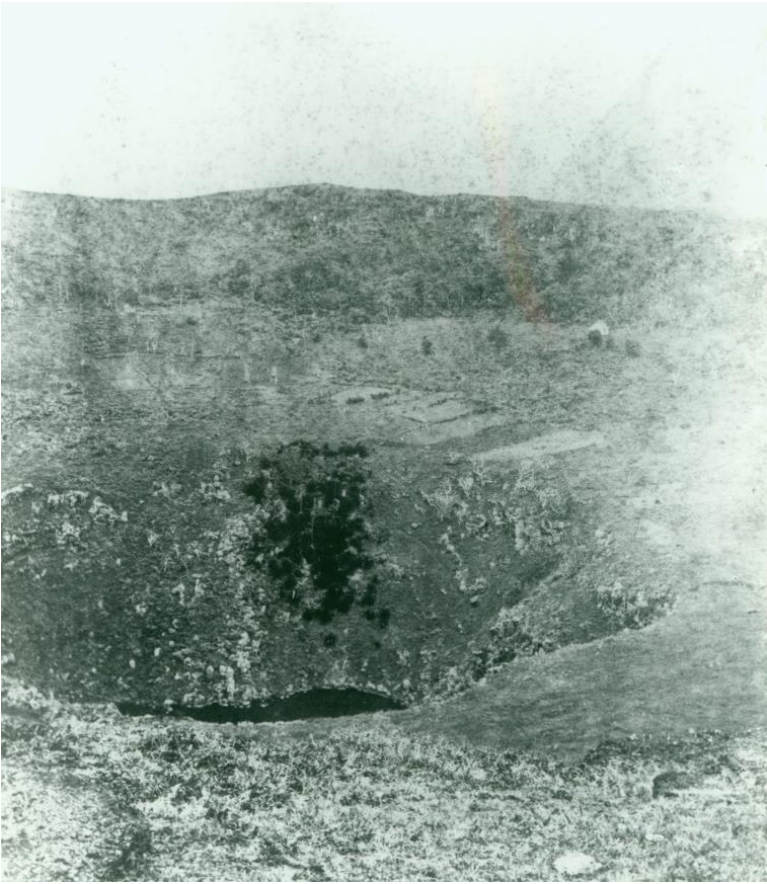
Figure 204. View of the Kauhakō Crater interior, 1886. Terracing and rock walls are visible. (Source: KALA Kalaupapa Historical Society Album C PG 31 #407)

Historic Conditions. Prior to establishment of the settlement at Kalawao, Polynesian settlers established sweet potato farms inside the crater using a method of terracing that remains evident today (Figure 204). Evidence of various traditional Hawaiian habitation sites, rock shelters, and storage enclosures have been documented within the crater by archeologists.³¹⁰ The crater also appears to have been used as a burial place. According to one patient, “just going in there you feel the presence” of those earlier peoples.³¹¹

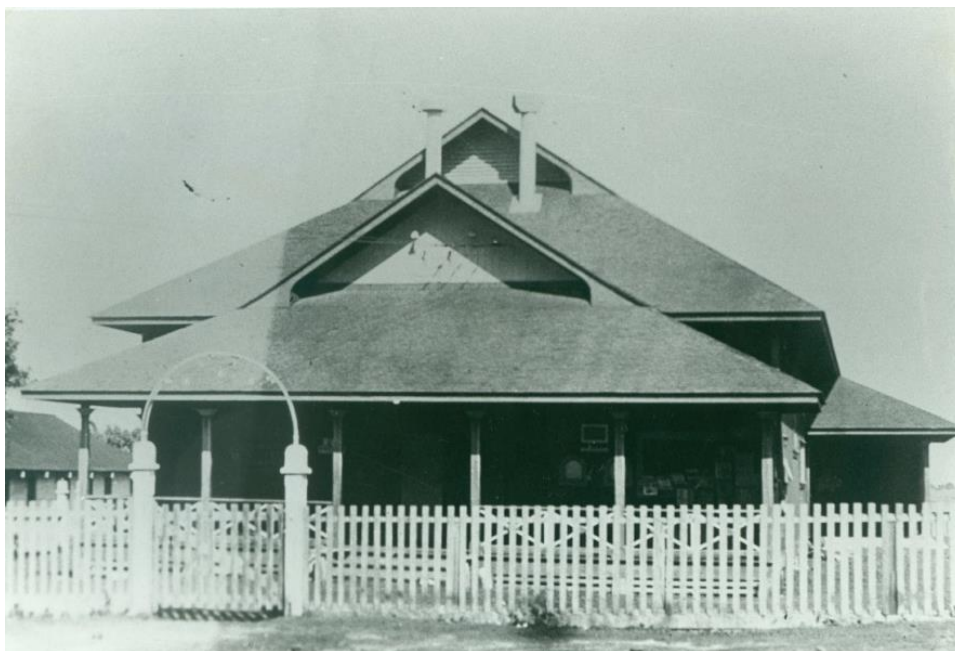
Figure 213. Paschoal Hall circa 1930s, showing the original picket fence and gate that surrounded the structure, before the coconut palm trees were planted. (Source: KALA Kalaupapa Historical Society Album G, page 33, #731)

the patients in the area east of the warehouses. The 2-½ story structure, measuring 120 by 40 feet in plan, was constructed using concrete pier and wood post foundation. It was one of the largest buildings in the settlement. Like many other early buildings in the settlement, the social hall had tongue and groove siding, wood sash windows, and a hip and gable roof with asphalt shingles. A lanai was added on the front with diamond-patterned railings and chamfered posts and pilasters. A picket fence and gate fronted the building (Figure 213).

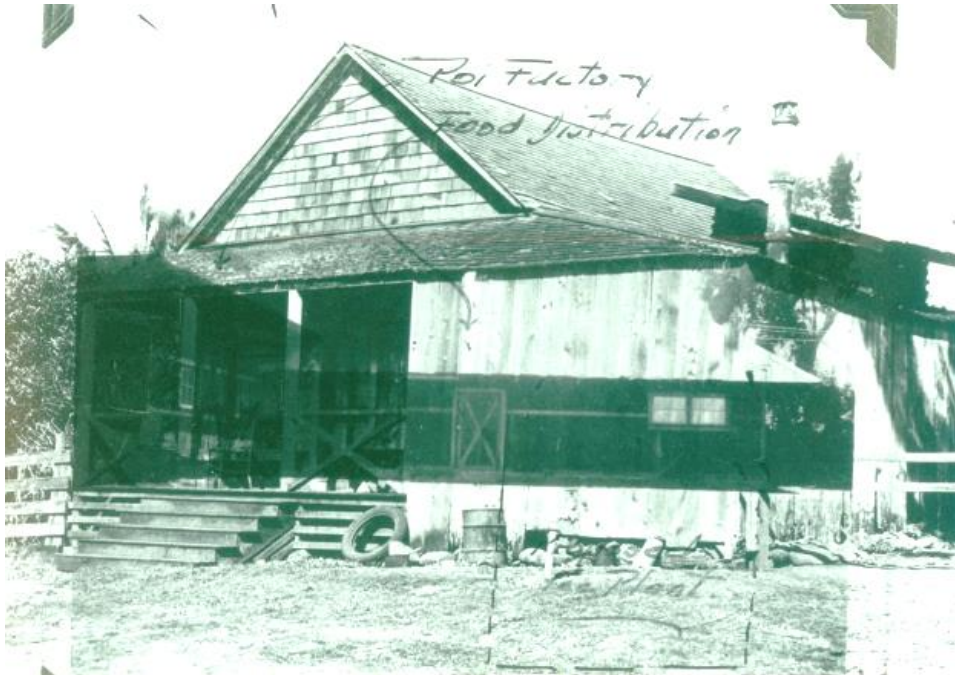
Figure 214. Kalaupapa poi factory/food distribution building constructed in 1931–1932. (Source: KALA Kalaupapa Historical Society Album G, page 15, #674)

Prior to major redevelopment in the 1930, the administrative center included several residences and more than a dozen primary structures including a Visitor Quarters near the landing, and a poi factory and provision room, an electrical plant, carpenter and blacksmith shops, paint shop, Patient Store, Gas Station, and Laundry (Figure 214).

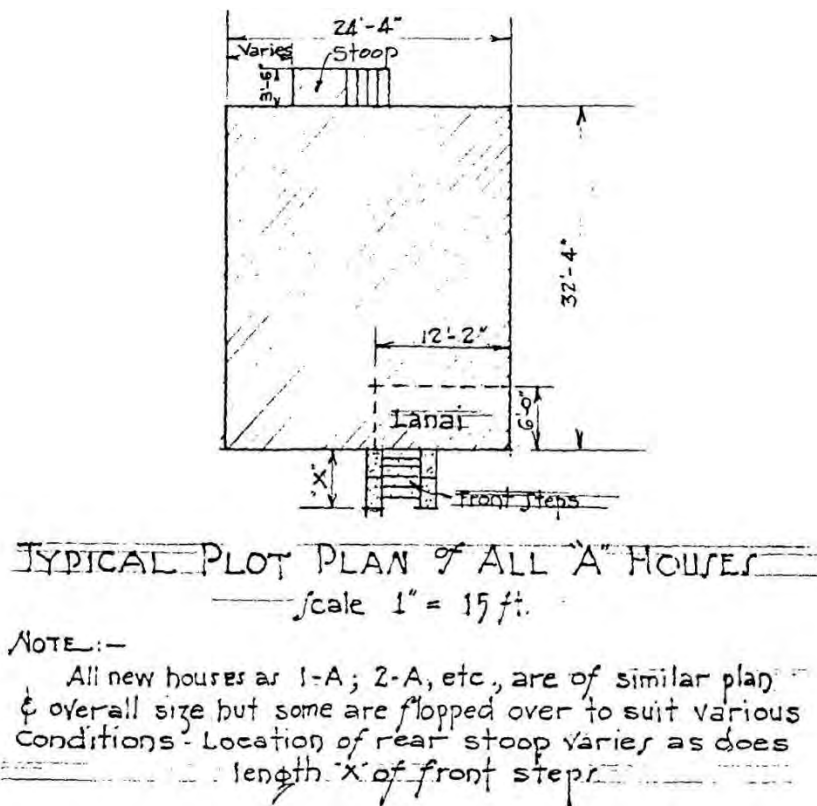
Figure 225. Typical plot plan of A Houses by the Board of Hospitals and Settlement. (Source: Greene, 405)

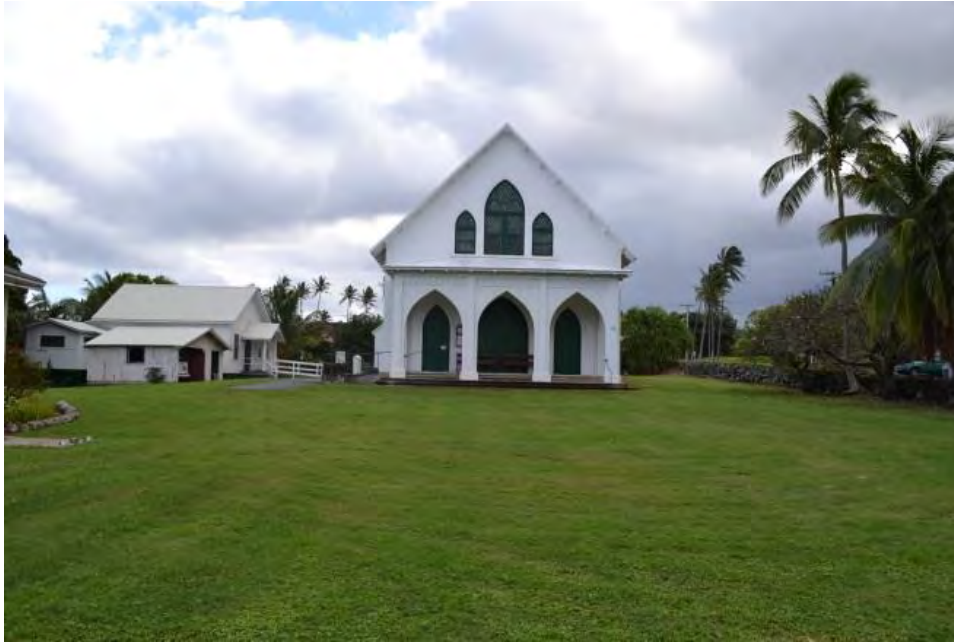
Figure 238. View of St. Francis Catholic Church, looking east, with the garage and Damien Hall located to the left, 2017.

Existing Conditions. St. Francis Catholic Church is an iconic feature of Kalaupapa Settlement, and prominently visible from the adjacent roads Beretania and Kamehameha Streets to the east and south, as well as Damien and Kilohana Streets that edge the parcel to the north and west. Services continue to be held in the church, which retains an active congregation. The five buildings clustered in the southern half of the property within a level area characterized by mown turf are all historic features, as are the coconut palm and other tree species that edge the perimeter walls to the south and east (Figure 238). Of the five buildings, the church and rectory are more formal, while the other three buildings are more vernacular in character. The grave of Father Maxime André, priest at the church from 1902 until his death in 1927, is marked by a statue of the Sacred Heart of Jesus and serves as a focal point at the western end of the open space. The northern half of the parcel is set topographically below the rest of the property and is heavily planted. A large historic stone grotto edges the space to the north. The primary circulation features associated with the property include a paved entrance drive, and stone stairs. Other circulation is informal. Colorful tile murals, added in the 2010s, flank the entrances into the property through the perimeter rock walls from the adjacent streets.

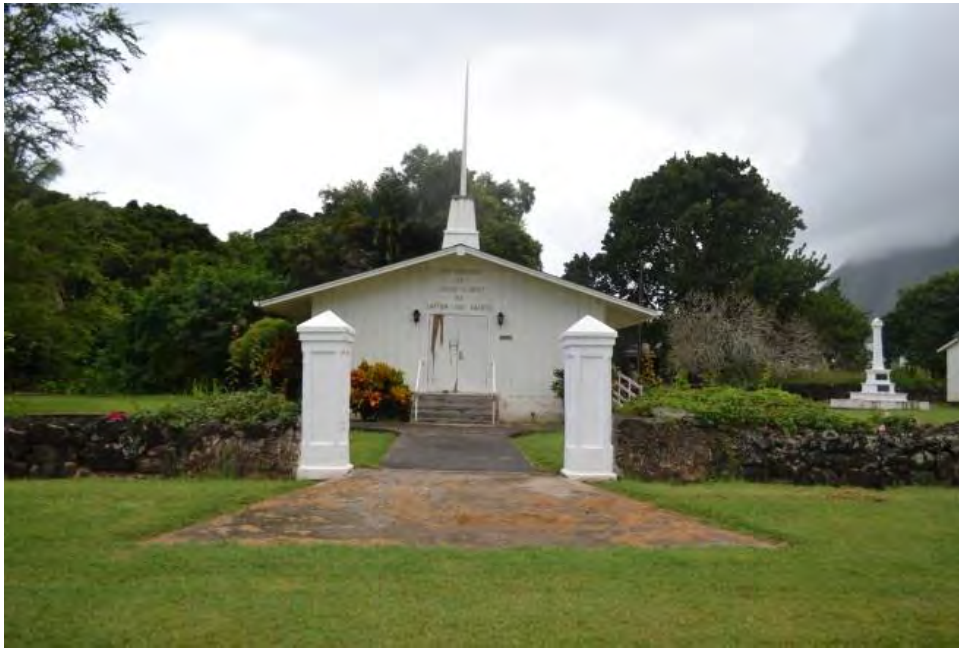
Figure 239. Views of the Church of Jesus Christ of Latter-day Saints meetinghouse complex, including the meetinghouse, walkway, gated entrance through the perimeter rock wall, and scattered plantings, 2017.

The Church of Jesus Christ of Latter-day Saints parcel is located to the north of St. Francis Catholic Church along Kamehameha Street. The Church of Jesus Christ of Latter-day Saints no longer supports an active congregation at Kalaupapa.³⁴¹ The church, set within a linear parcel, contains three historic buildings oriented to face Kamehameha Street and sited with a consistent set-back. A dry stacked stone wall frames the churchyard precinct on three sides; the fourth is marked by contemporary chain link fencing. The meetinghouse, built in 1965 as a replacement for an earlier building, is modern in architectural style (Figure 239), and thus incongruous with the other buildings that were designed in the Hawaiian Plantation style. Shade trees and foundation plantings edge the walls and buildings. Circulation occurs in the form of concrete walks that lead into the property through a pair of historic gates from Kamehameha Street, and provide access to the meetinghouse and the other buildings. Located between the meetinghouse and the parish hall, centered within a level green space, is an early twentieth century monument that adds a degree of formality to the site plan. Ramps have been added to enhance accessibility at building entrances.

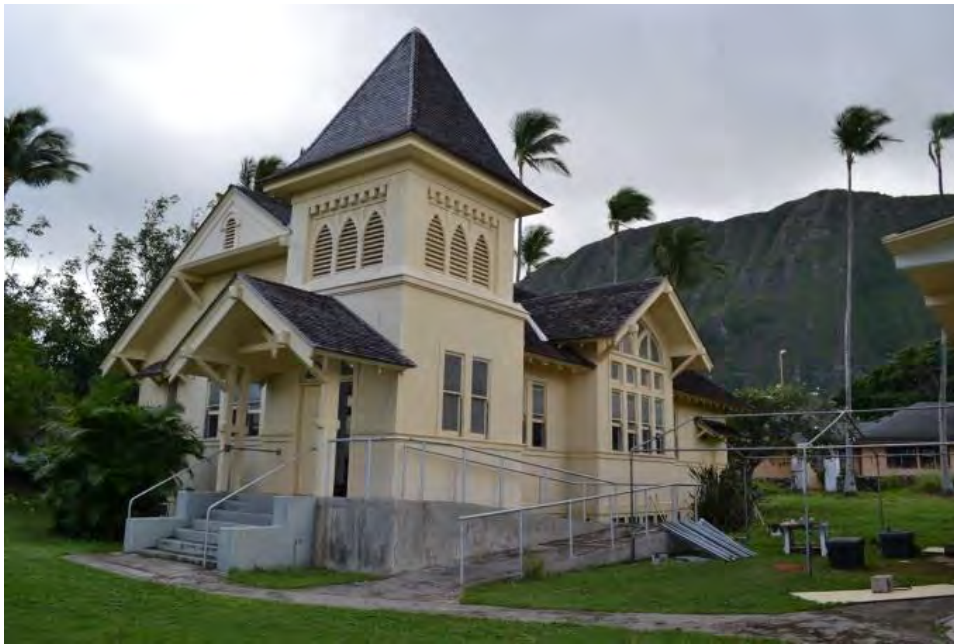
Figure 240. Views of Kana'ana Hou Church, with the parish hall beyond, 2017.

The Kana'ana Hou Church parcel is located to the south of St. Francis Catholic Church between School, Damien, and Mission Street. Services continue to be held at Kana'ana Hou Church, which retains an active congregation. Like the other two church parcels, Kana'ana Hou is edged by a perimeter wall composed of dry stacked stone, with gate piers marking four openings for access. Narrow concrete walks lead to some of the buildings from the gates. The parcel is heavily planted with ornamental, shade, and fruit trees and shrubs. Plantings around the church include golden shower (*Cassia sp.*) trees, an octopus (*Schefflera actinophylla*) tree, golden cane palm (*Dyopsis lutescens*) and croton shrubs near the entrance, and plumeria (*Plumeria spp.*), African tulip, and coconut palm trees, along with bougainvillea, cacti, noni, and bird of paradise shrubs. Plantings associated with the parsonage landscape include an allamanda (*Allamanda cathartica*) hedge, mock orange (*Murraya paniculata*) shrubs, and borders featuring coconut palms, royal pioncianna (*Delonix regia*), cane palm, dracaena (*Dracaena sp.*), lichi (*Litchi chinensis*), croton, breadfruit, mango, Philodendron (*Philodendron sp.*), and snake plant (*Sansevieria trifasciata*) and kamani. Views of the church are often limited due to the extent of the plantings. The church, constructed in 1915, is closely edged by a modern style parish hall constructed in 1968 to the west (Figure 240). Set behind a screen planting to the north is the 1935 parsonage, an associated garage, and a driveway. Directly behind the church near the south boundary wall is a small maintenance building erected circa 1950, and a hot house used to grow flowers for church services. The vast majority of the landscape features date to the period of significance. Ramps have been added to enhance accessibility at building entrances.

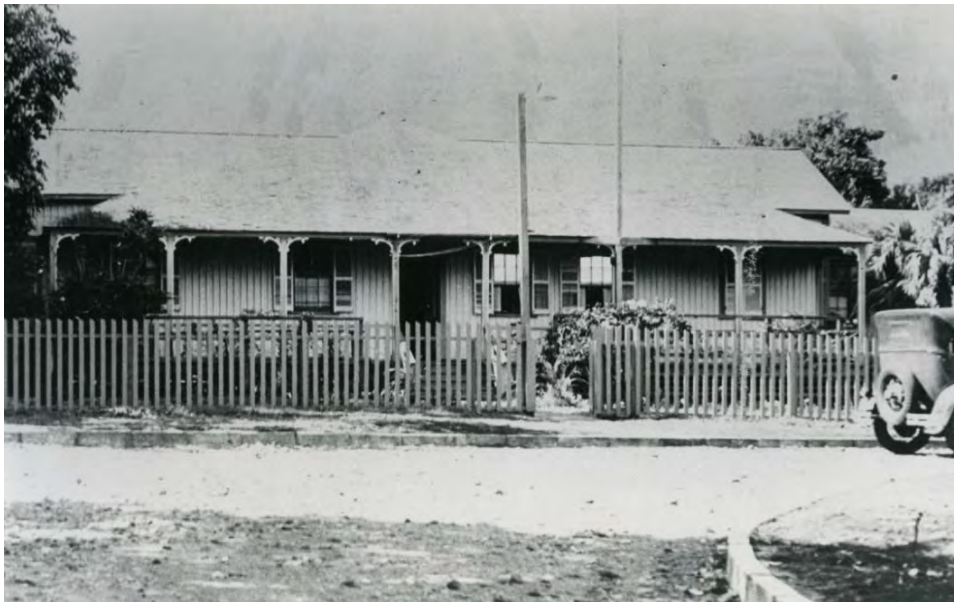
Figure 242. The original convent built on the top of the knoll at the center of the Bishop Home for Girls, undated. View looking southwest. (Source: KALA Bruce Doneux 00372, Box 02_014_label 013)

Early buildings at the site included a one-story convent with a large veranda, and four small cottages for women residents (Figure 242). Two of these were used for sleeping quarters, one was for cooking, and the fourth was for medical services. Within two years, twelve additional buildings were added to the group home, including four dormitories, a cookhouse, a schoolhouse and assembly or recreation room, a carriage shed, a bathroom. By 1890, the entire complex was fenced.

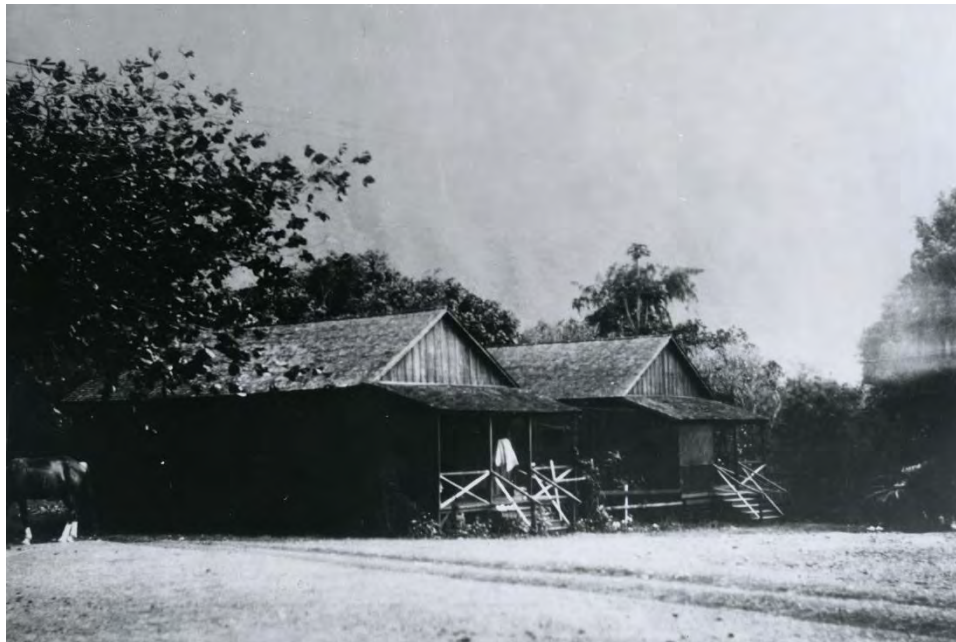
Figure 244. Two of the early cottages/dormitories at the Bishop Home for Girls, undated. (Source: KALA Bruce Doneux 00372, Box 02_028_label 027)

In 1922, electric lights were added to the property. By this time, the Bishop Home contained as many as nineteen buildings, including a chapel and convent, an infirmary, several cottages (Figure 244), a dining room/kitchen, a dormitory, a heating plant, and a laundry, primarily clustered around the central developed core atop the knoll. A wood picket fence enclosed the convent, while a more extensive picket fence surrounded the entire central building complex, and a perimeter dry stacked stone wall edged the property as a whole, creating a series of physical transitions that served as reminders of the rules separating patients and visitors.³⁴⁵

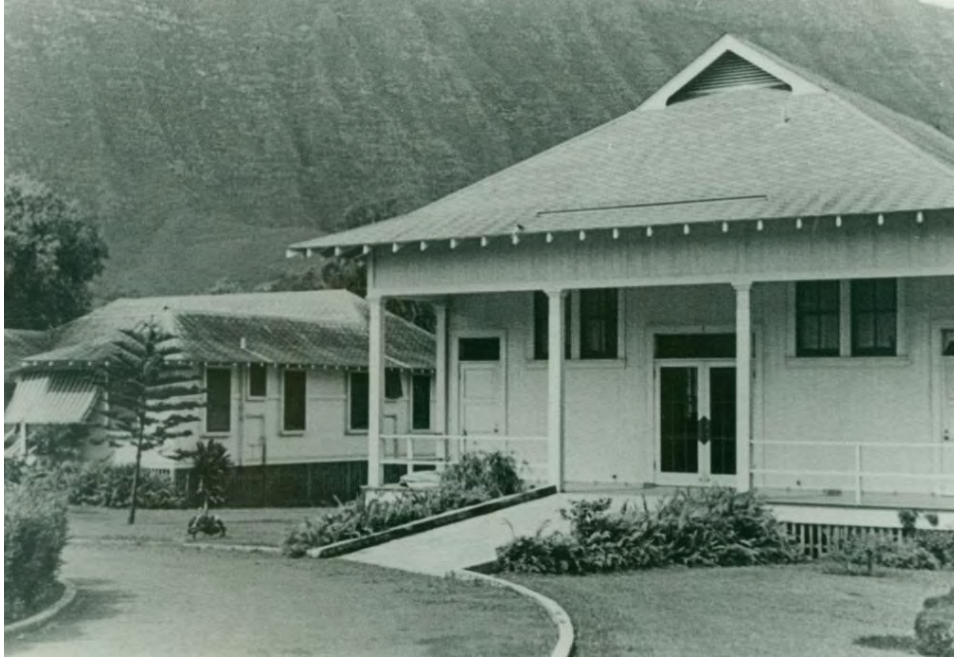
Figure 247. The new Social Hall built at the Bishop Home for Girls was completed in 1932 along the west side of the entrance drive oval at the top of the knoll. View looking south. (Source: KALA Kalaupapa Historical Society Album D PG 37 #137)

The Bishop Home complex was almost entirely rebuilt during the early 1930s (Figure 245 and Figure 246). Twelve of the original buildings were demolished by 1932. New buildings included a kitchen/dining room, dormitory, social hall (Figure 247), laundry room, and central boiler plant. Improvements were made to other

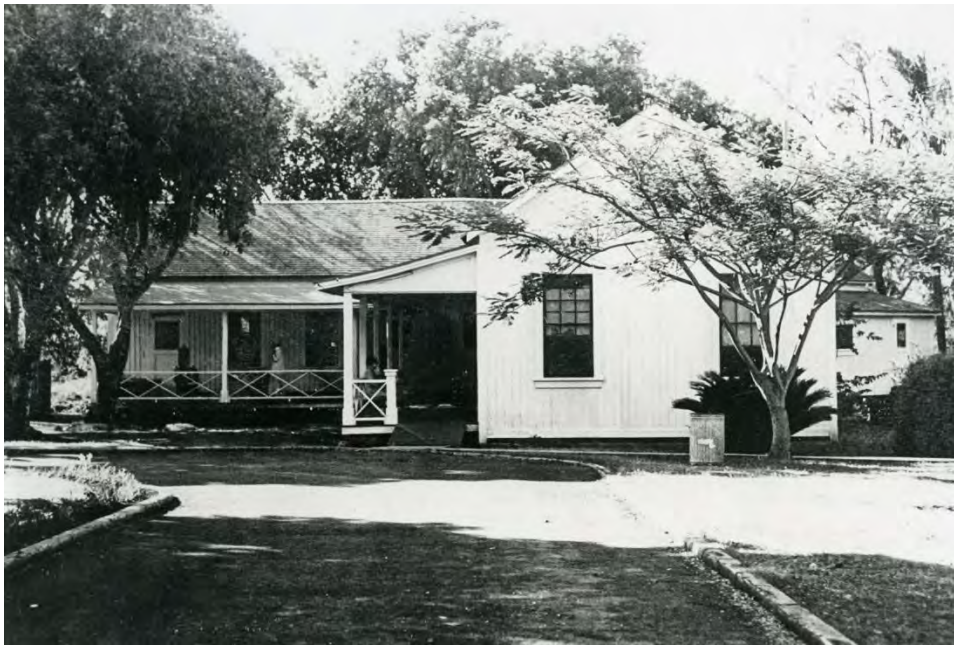
Figure 250. The Bishop Home Infirmary built in 1938 on the east side of the oval was removed in 1951. (Source: KALA Bruce Doneux 00372, Box 02_011)

With the introduction of sulfone drugs in 1946, the number of new patients arriving at Kalaupapa began to decline. Throughout the 1940s and 1950s, buildings that were no longer needed at Bishop Home were removed. Among these buildings was the 1938 infirmary (Figure 250), demolished in 1951. As part of Superintendent Lawrence Judd's initiative to diminish the use of barriers throughout the Settlement during the late 1940s, the outer fence at Bishop Home was removed.³⁴⁸

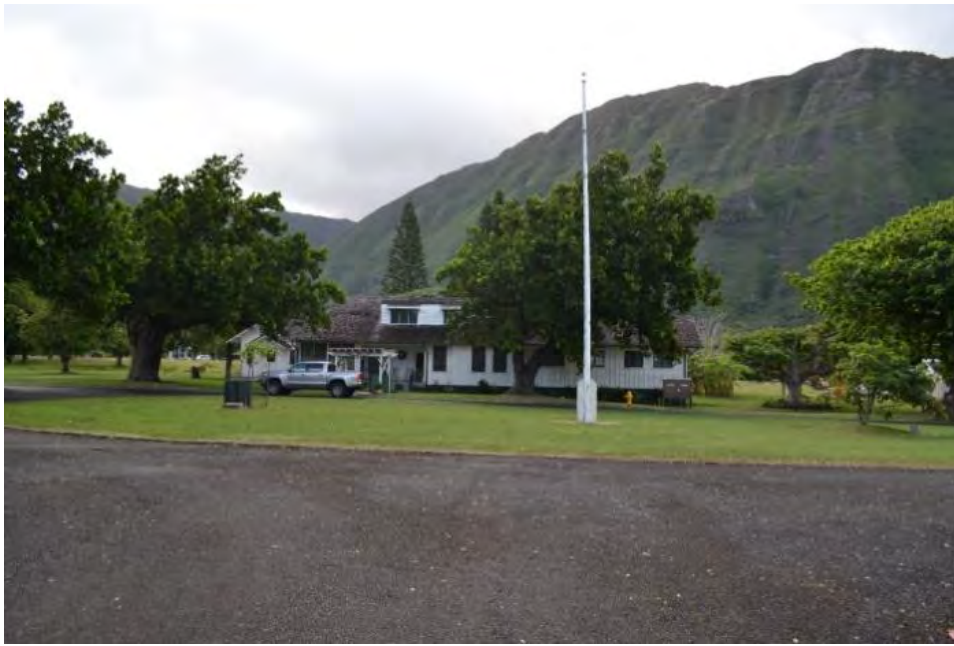
Figure 251. View southeast toward the cottage built for the nuns now referred to as the Bishop Home for Girls, 2017.

Existing Conditions. The Bishop Home character area continues to command a prominent visual and spatial position within Kalaupapa Settlement due to its large block size and siting atop a knoll. The historic buildings sited atop an elevated knoll on the property include the Bishop Home for Girls, built as housing for the nuns (Figure 251), Elizabeth Chapel, Barbara Marks Residence, Bishop Home Residence 4, and a Boiler Plant (Figure 252). Three of the property boundaries are demarcated by historic dry stacked stone walls, while the fourth is lined with an informal row of shade trees. The historic entrance drive leads into the property on an angle from the corner of School and Puahi Streets. The entrance is marked by a pair of historic lava stone masonry piers located to either side of the Bishop Home Road, which is asphalt paved and edged by concrete curbs. Smaller pylons sit to either side of concrete walks providing access to the central core of the property (Figure 253). Surviving evidence of a historic linear planting of ironwood pine trees edges the entrance road, along with two grave markers (Figure 254). The central developed area occupying the top of the knoll features the circular terminus of the entrance drive, centered on the Bishop Home for Girls and the adjacent St. Elizabeth Chapel, several memorials and monuments, statuary, a flagpole, a covered entrance walk, and a variety of tree and shrub plantings. In front of the Bishop Home for Girls is a large wooden trellis with two wooden benches and a short section of picket fence and gate provide pedestrian access to both the Bishop Home for Girls and St. Elizabeth Chapel. A statue of St. Anthony, added after the period of significance, is located near the entrance in front of the chapel. Concrete walkways link the convent and the chapel, and areas on the south side. A commemorative plaque honoring Saint Damien, metal hand pumps for water, and a variety of foundational plantings and ornamental garden areas surround the convent. In these areas, vegetation continues to focus on fruiting trees such as mango, Kamani, banana, and avocado, as well as perennials, shrubs, and ornamentals that yield flowers and foliage for cutting such as bird of paradise, ferns, croton, ti, slipper flower, heliconia, and aloe.

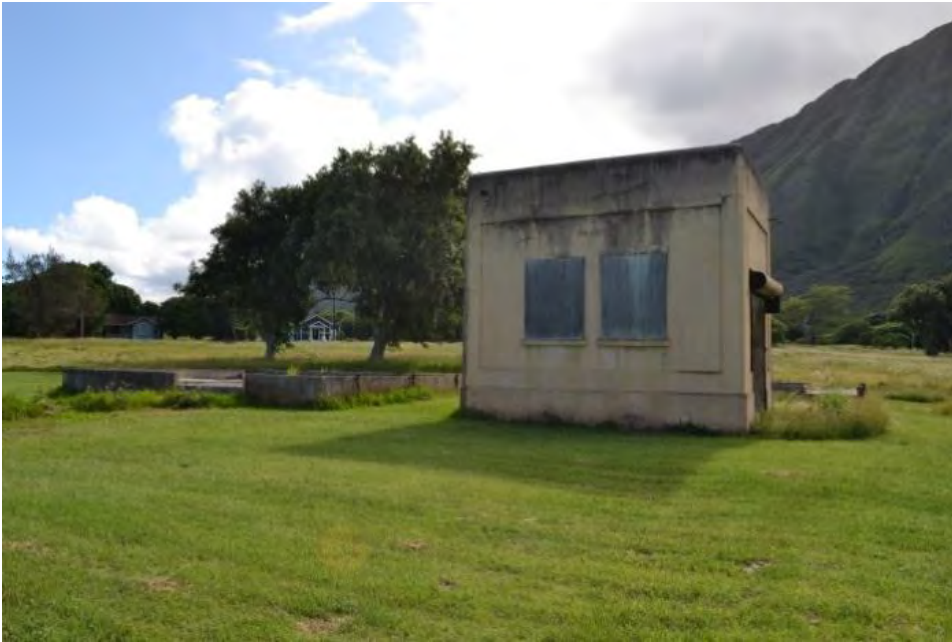
Figure 252. View east of the Boiler House along the secondary loop road at Bishop Home for Girls, 2017.

Behind the Bishop Home for Girls is a secondary loop road system provides access to the two surviving cottages and the Art Deco style Boiler Plant. The foundation ruins of several former buildings edge the secondary loop road system. Beyond the central core, the expansive property is generally maintained in turf and field grasses with scattered woody plants and informal rows of trees along School Street. Species include banyan trees, Norfolk Island pine (*Araucaria heterophylla*), royal palm (*Roystonea regia*), ironwood, tamarind, golden shower tree, plumeria, and Java plum. Set within the field grasses within the northeast corner of the property is a mortared stone oven feature thought to have been built by a Portuguese resident, while to the south near McKinley Street is a grave marker.

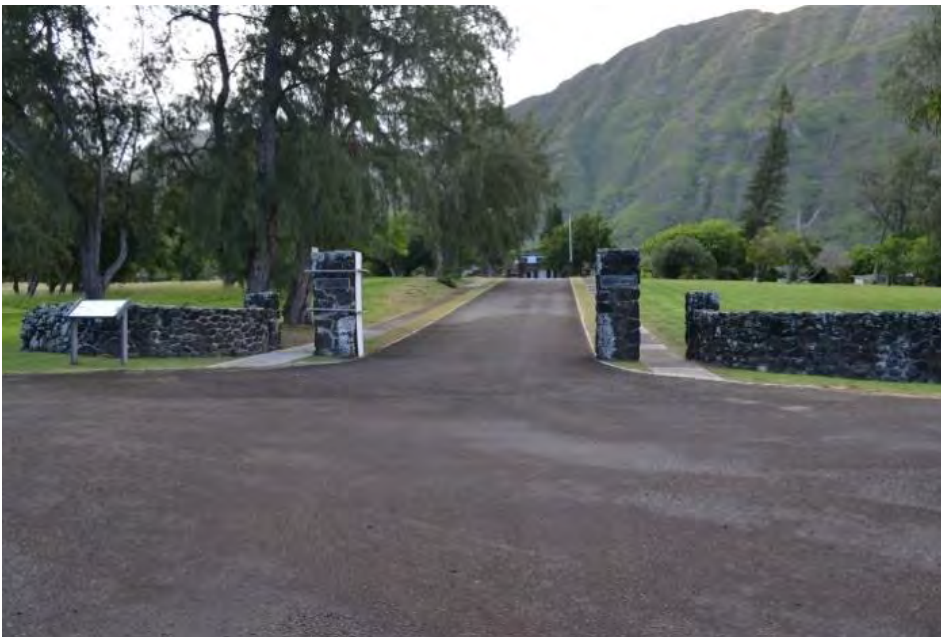
Figure 253. View southeast of the entrance drive, walls, and pylons at the corner of Puahi and School Streets marking the road and walks leading to the Bishop Home for Girls, 2017.

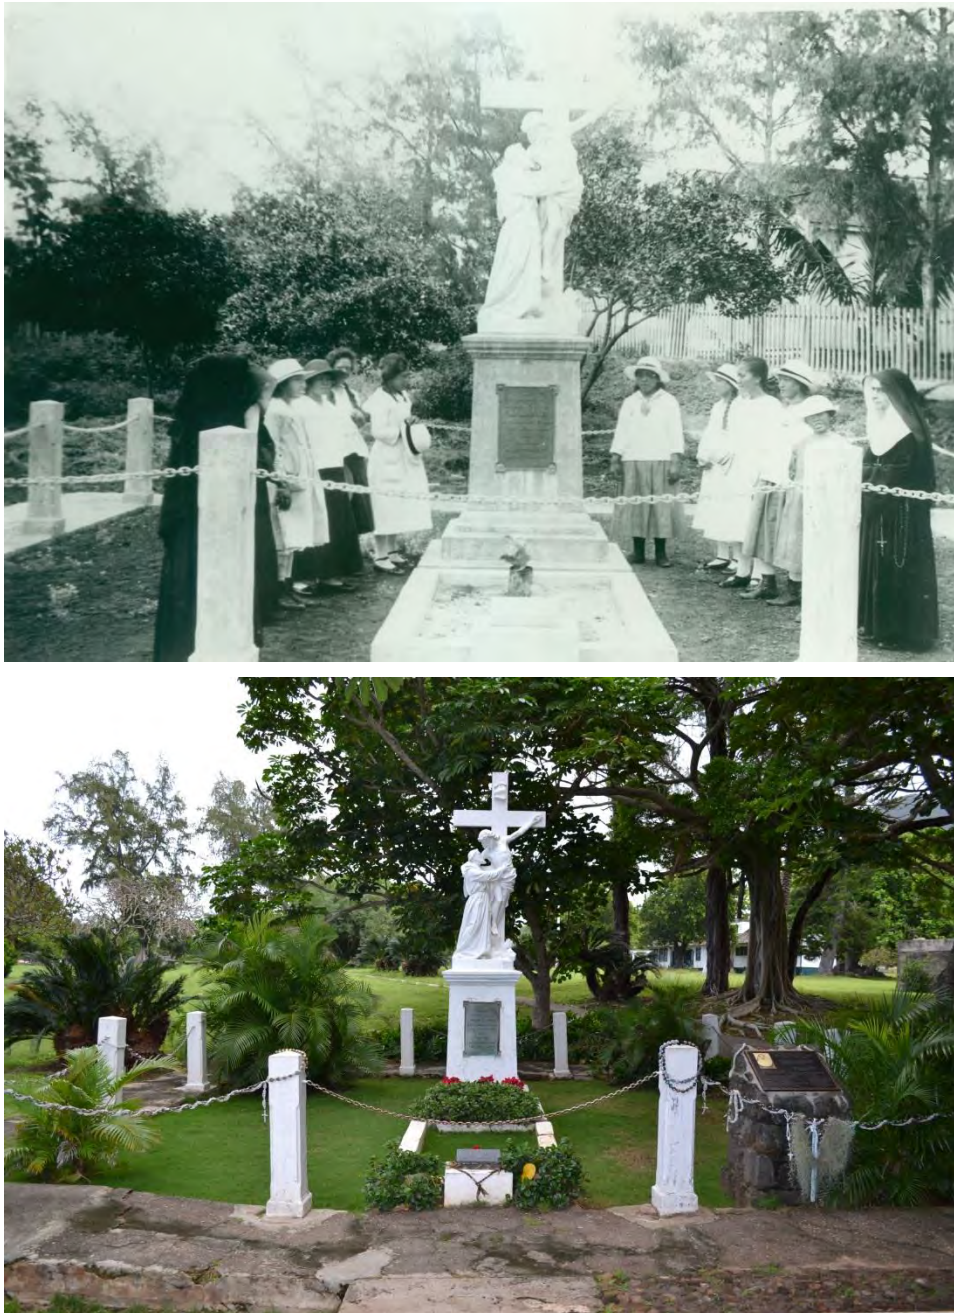
Figure 255. Saint Marianne's grave, undated (top) and 2017 (bottom). (Source: KALA Kalaupapa Historical Society Album D PG 14 #085)

Small-scale features also survive from the historic period, such as the beehive shaped bake oven, the three grave markers, and elements of the Saint Marianne Grave site such as the concrete piers and chain surrounds (Figure 255). Small-scale features that post-date the period of significance and diminish the integrity include the wayside exhibit near the entrance drive, and chain link fencing around the Barbara Marks Residence yard. The painted rocks, representative of the work of Ed Kato, are reproductions. The original painted rocks began to fade and are now in the park collections.

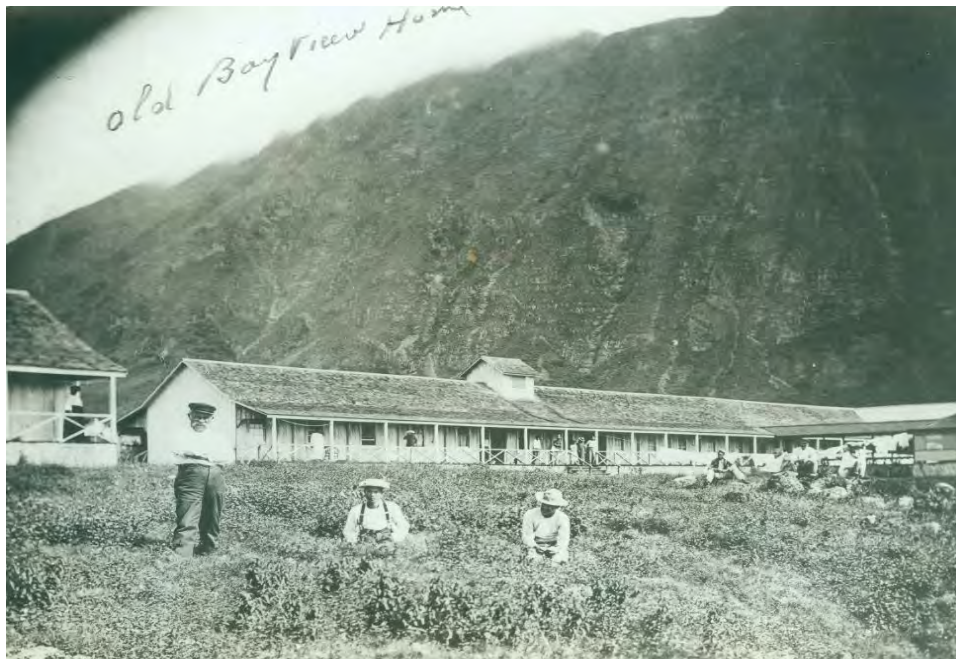
Figure 257. The first Bay View Home complex, circa 1907. View looking southeast. (Source: KALA Kalaupapa Historical Society Album G PG 43 #764)

the building was enlarged to twenty-six rooms and whitewashed (Figure 257). Fire, however, destroyed both Bay View Home buildings in 1915.

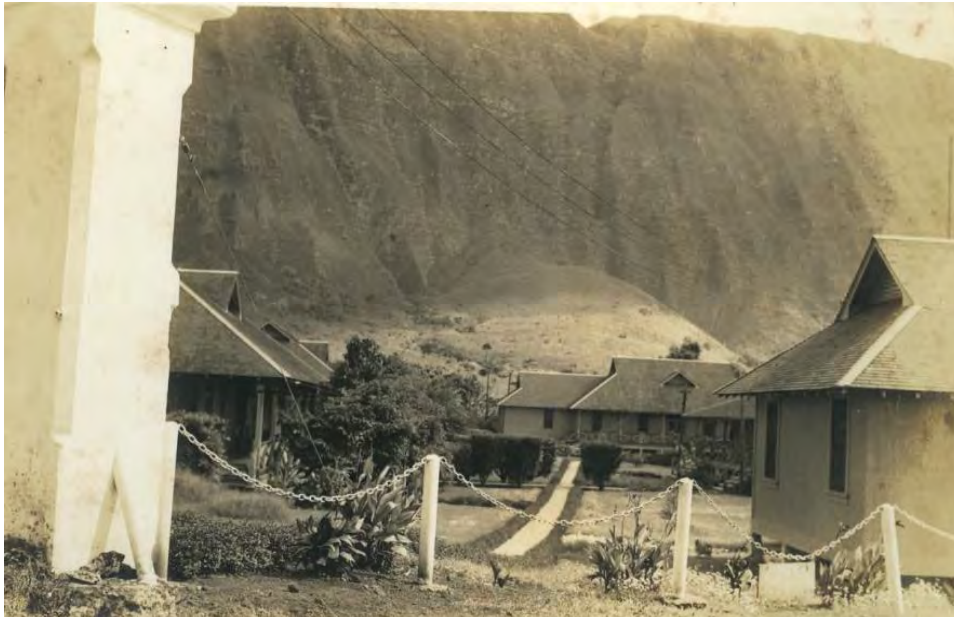
Figure 258. Bay View Home, view south showing a concrete walkway leading from the entry on Damien Street to Building 4, now gone, circa 1938. The photograph also shows the concrete pier at the entrance edged by metal bollards and chain. (Source: KALA Helen Keao_00373 Album 023)

foundations, single wall construction, tongue and groove siding, lanais across the front facade with diamond-patterned railings, and low overhanging roofs that were stylistically consistent with Hawaiian Plantation style architecture of the period. In 1918, the grounds at Bay View were graded, seeded with turf grass, and planted with fruit trees and ornamental trees and shrubs. Two large concrete piers were erected at the entrance to Bay View on the north side of the site along Damien Road, and a wood picket fence extended over 600 feet along the east, north, and south sides of the building complex.³⁵⁶ The shoreline of the Pacific Ocean formed the west boundary. In the 1920s, concrete walkways were added to connect the buildings (Figure 258 and Figure 259).

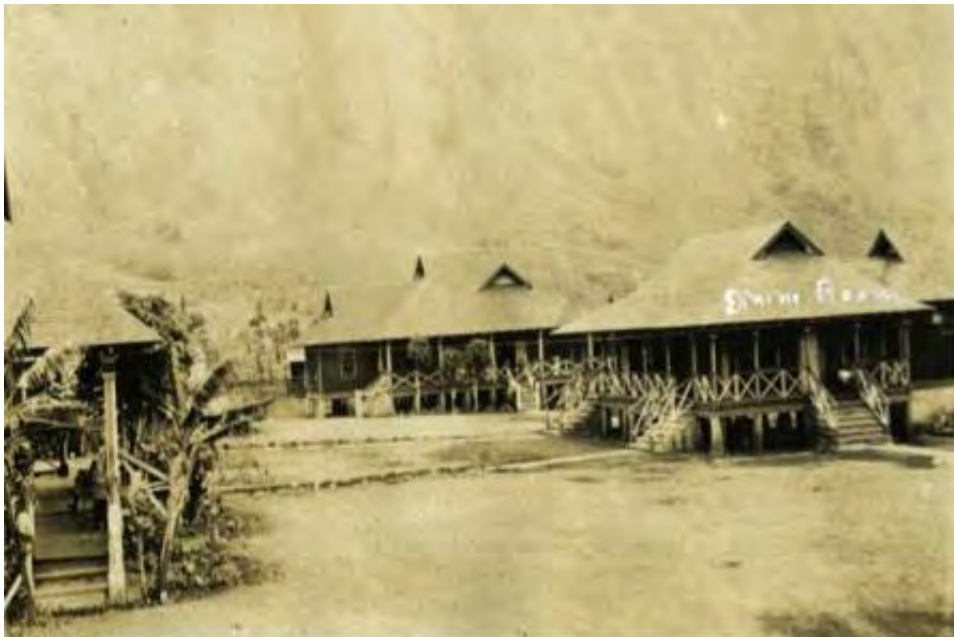
Figure 259. Bay View Home, view looking south showing layout of the buildings and walkways connecting the wards with the dining room in the center of the cluster, and the generally open character of the early landscape, undated. (Source: KALA Potter Collection KALA 17429)

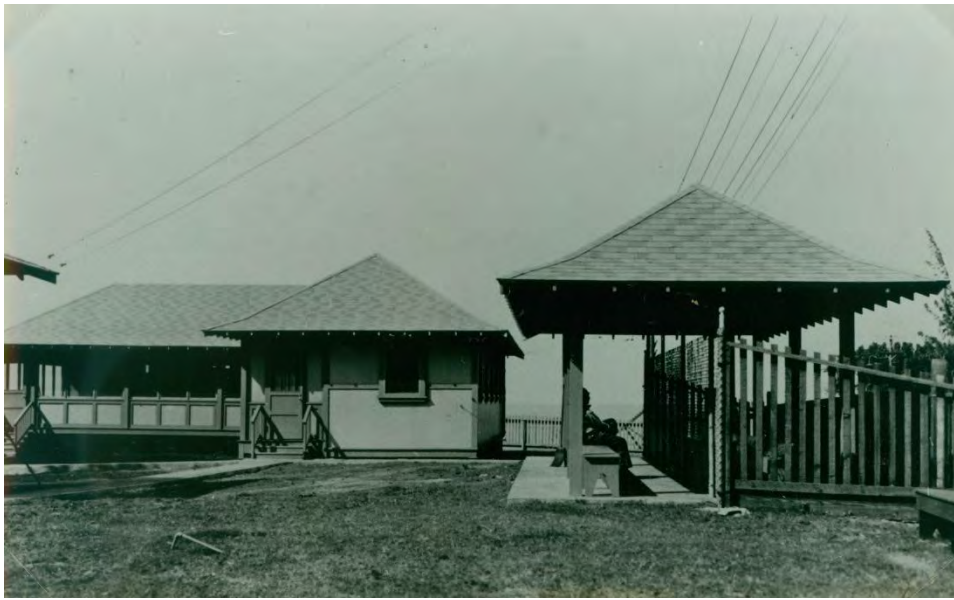
Figure 261. Visitors' Pavilion, with fence and screen system to separate patients and visitors. View looking west, undated. (Source: KALA Kalaupapa Historical Society Album G, page 12, #667)

To the north, a cluster of visitor services facilities designed to accommodate friends and families traveling to the Settlement to visit with patients also emerged during this period. These buildings joined the existing Wilcox Dispensary (now Wilcox Memorial Building), constructed in 1906. They included the Visitors' Quarters, Visitors' Quarters Kitchen, and Visitors' Pavilion completed in 1933.³⁵⁸ The Visitors' Pavilion was an L-shaped building, 28 by 45 feet in size, and designed with different entrances for visitors and for patients (Figure 261). A long counter and wire screen extended the full length of the interior to maintain physical separation between patients and visitors. A double fence enclosed the buildings and a hedge was planted between the fences. Under the direction of Superintendent Judd, barriers between patients and staff and visitors began to be removed throughout the Settlement. At the Visitors' Pavilion, the fence was removed in the late 1940s.

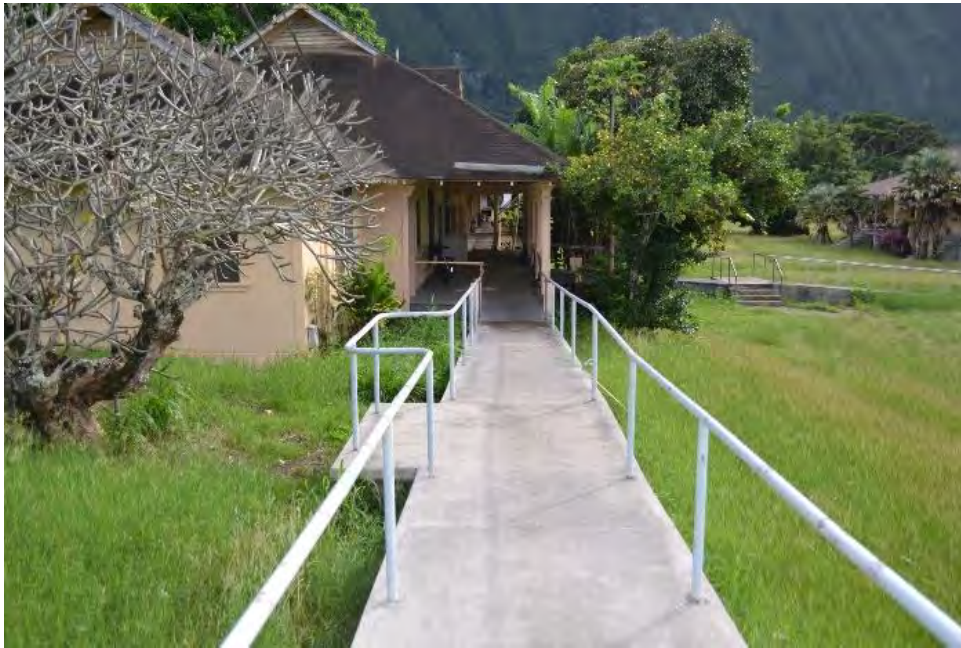
Figure 264. View southwest along the concrete walk and ramp system providing access to Bay View Home Residence 2, Bay View Home Dining Hall, and Bay View Home Residence 3, 2017.

altered to accommodate wheelchairs through the addition of concrete ramps. Some of the ramps were constructed over the original sidewalks, cutting off the route of the original walkway.³⁶⁴

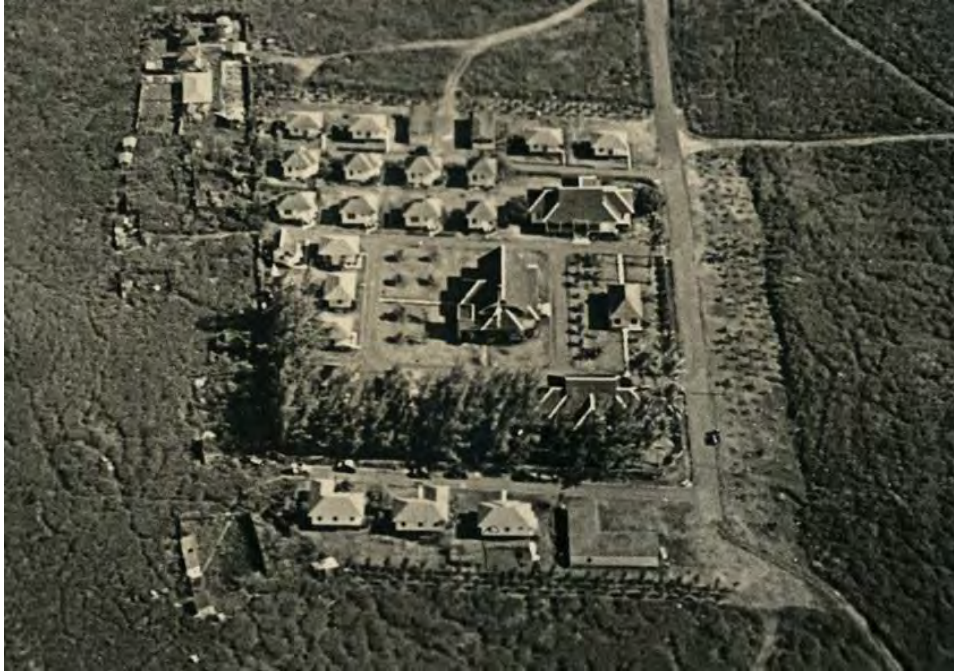
Figure 271. Aerial oblique view of the McVeigh Home, circa 1933, showing the formal spatial organization, circulation, building complex, and newly planted trees defining the edges of the development. View looking south. (Source: KALA Boland 015)
