Kalaupapa and Kalawao Settlements Cultural Landscape Report

Kalaupapa National Historical Park

Cultural Landscape Report

Prepared by:
Wiss, Janney, Elstner Associates, Inc.
2000 Powell Street, Suite 1650
Emeryville, California 94608

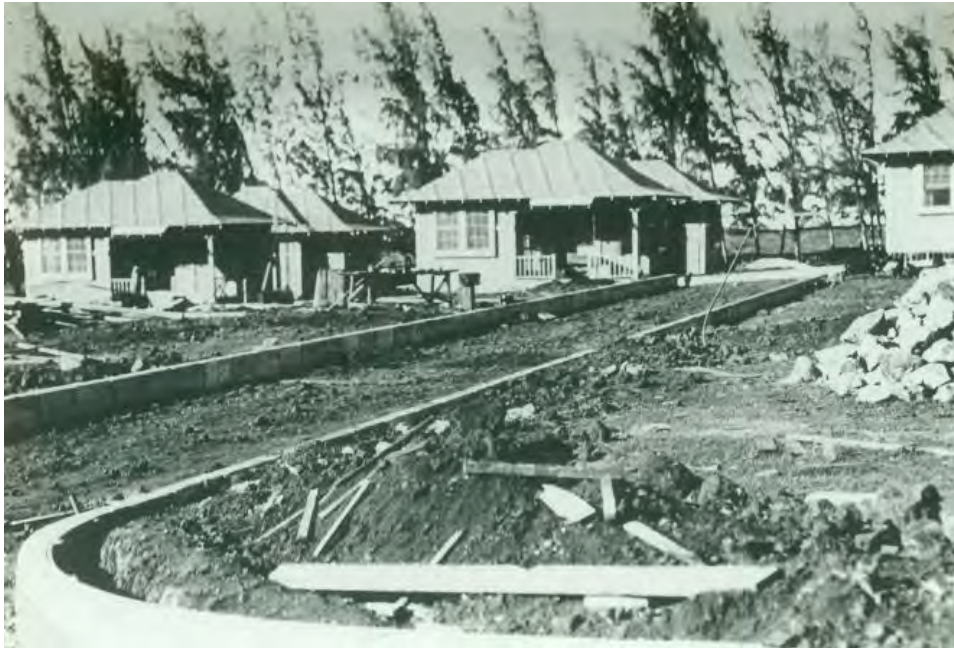
Figure 272. McVeigh Home under construction circa 1931, showing new roads and curbing, typical cottage styles, and ironwood pine windbreak behind. View looking southeast. (Source: KALA Kalaupapa Historical Society Album, G PG38 #745)

homes, the extent of the McVeigh Home complex was defined with a combination of dry-laid stone walls and vegetation. Stone walls marked the boundary on the north and east sides of the complex. The roads were laid out in a simple grid, graded, paved with asphalt macadam, and edged with concrete curbing in 1931. Windbreaks of ironwood pines was planted along the northern and southern margins of the complex (Figure 270 and Figure 271). On the west side along Staff Street, coconut palm trees were planted extending south across the full length of the development. An area dedicated to raising chickens was located just outside the precinct, separated by the wall system, to the southeast.

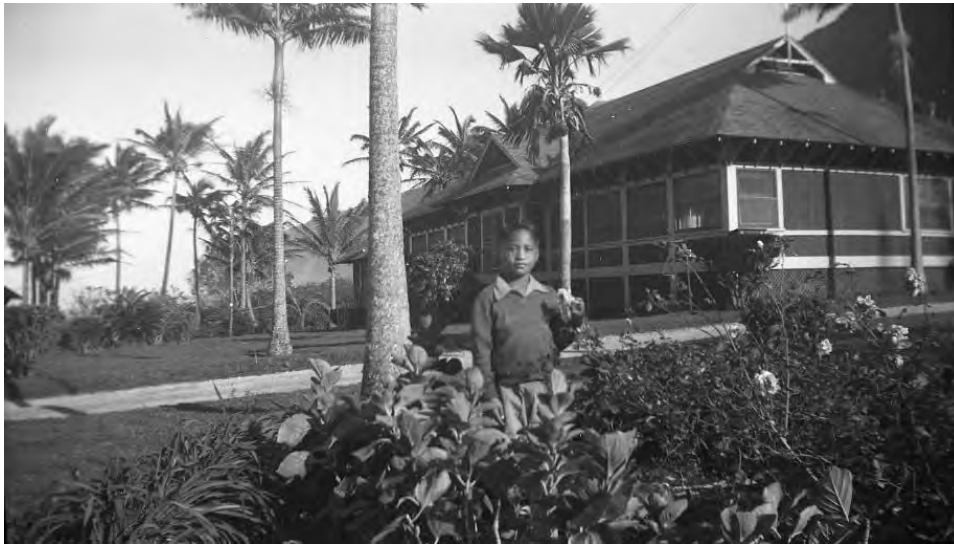
Figure 273. View of McVeigh Home showing well-established shrub plantings and palm trees planted around the dormitory building. View looking northeast. (Source: KALA Kenso Seki_KALA 12600_858)

Formal vegetation patterns defined the communal areas of McVeigh Home during the 1930s through the 1950s. In addition to the double row of coconut palms to the west, formal plantings existed around the dining hall, kitchen, and pool hall. The private cottages, in contrast, were planted by the residents, especially in the later years and featured more individual preferences and a varied use of shade trees, fruit trees, plantings for windbreaks and privacy hedges, and foundation plantings, especially around the front facades of the cottages (Figure 273).³⁷¹

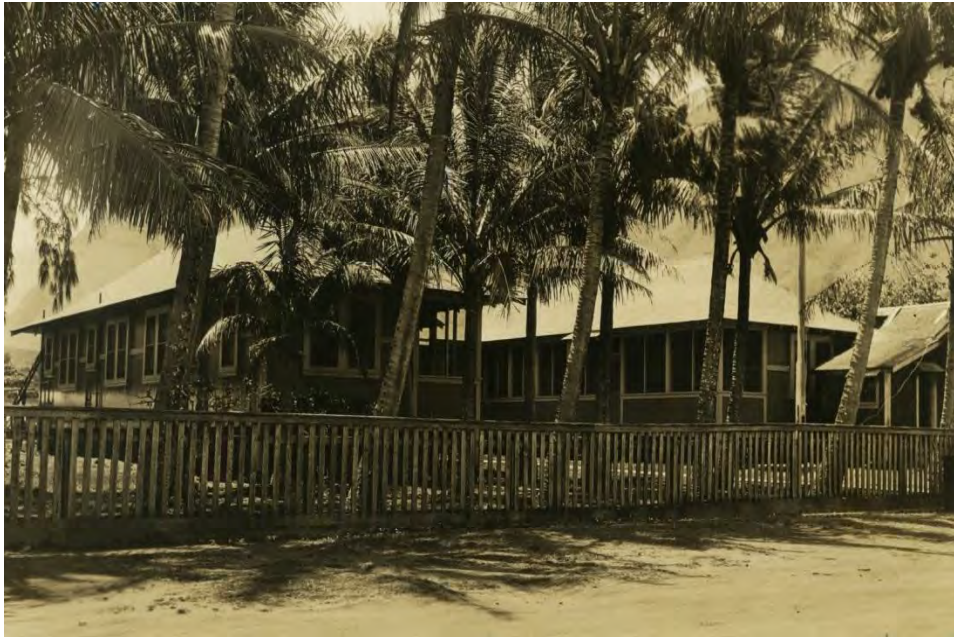
Figure 280. The new cottage for nurses and single women, referred to as the Residence for Single Women, was built in 1932 at the south end of Staff Row. Coconut palm trees were planted along the fence. View looking southeast, circa mid-1930s. (Source: KALA Potter Collection KALA17429_A)

No additional development occurred at Staff Row until the 1930s when upgrades were made to existing buildings; new buildings were constructed, and significant improvements were made to the grounds. In 1932, a new building was added to staff row to provide housing for the nurses and single women working with the medical staff. Located along Beretania Street, the new building was a large H-shaped structure, 60 by 70 feet in plan with eleven bedrooms, shared baths between the rooms, a dining room, and a kitchen. Like many of the buildings in the settlement the Residence for Single Women was designed with elements of the Hawaiian Plantation style architecture, including tongue and groove siding, wood battens, and a hip roof. The building included a screened lanai that wrapped around the facade on the west side of the building creating a small interior courtyard with entrances to each wing of the building. A concrete walkway, 3 feet wide, extended from this interior courtyard all the way to the road (Figure 280).

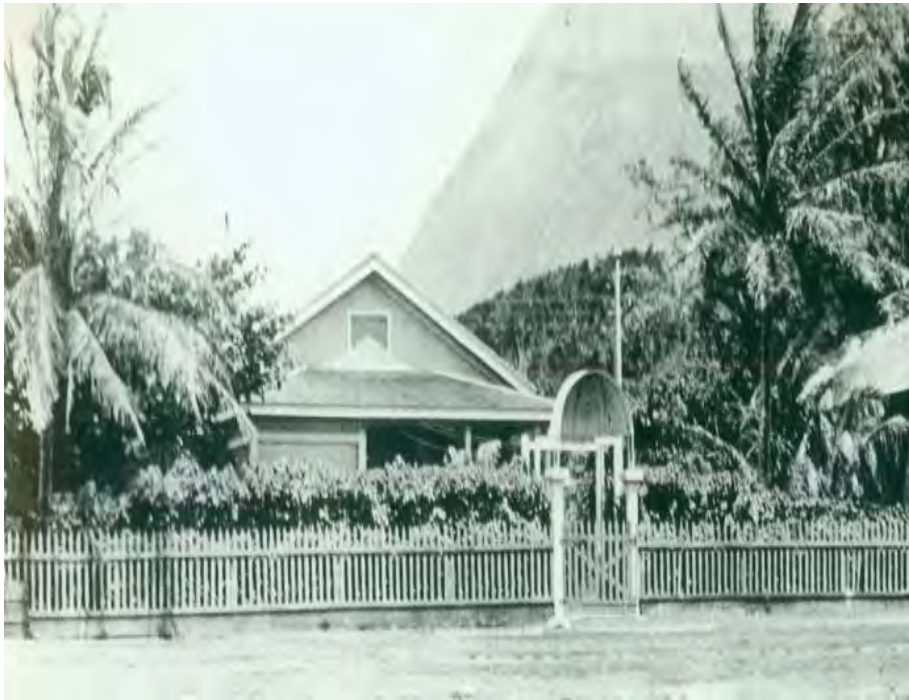
Figure 281. The Resident Physician's Residence, July 1, 1932. Note the wood picket fence and gate, hedges against the fence, and vegetation surrounding the house. View looking southeast from the road. (Source: KALA Kalaupapa Historical Society Album F PG 49 #612)

In 1934, the Resident Physician's Residence received a new kitchen, bathroom, and laundry (Figure 281). Over the following years other residences were improved with additions and upgrades. New structures including two garages, servants' quarters, a laundry, and a small cottage, known as the Electrician's Residence, were added. With the exception of the new garages, all of these additions were sited behind and to the east of the residences in small yards.

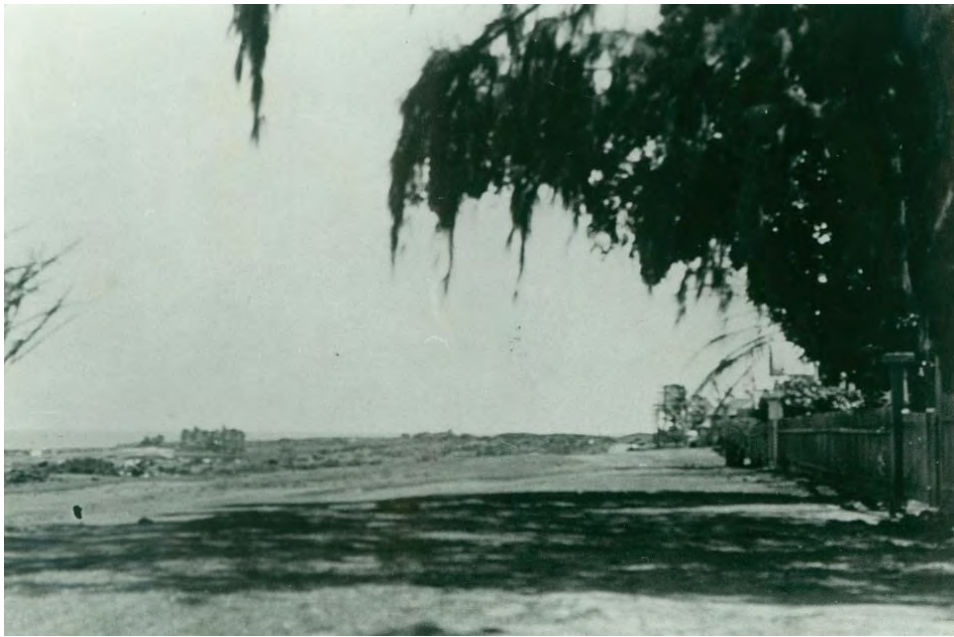
Figure 283. View of Staff Street prior to paving in 1935. Note the fences along Staff Row to the right, and the open character of the landscape west of the road that is now heavily impacted by tree cover. View looking north. (Source: KALA Kalaupapa Historical Society Album E PG 16 #479)

Internal circulation at Staff Row was minimal and limited to 3-foot-wide concrete walkways that provided access through the fenced gates on the west side. Concrete posts with chamfered edges and cap stones marked the entrances to the Superintendent's Residence and the Resident Physician's Residence through the picket fence, giving both a more formal and institutional character. Vehicular circulation to Staff Row was limited to Staff Street on the west side and short access roads and driveways leading to the garages along the road. Staff Street was paved along with most primary roads within the settlement in 1935–1936 (Figure 283).

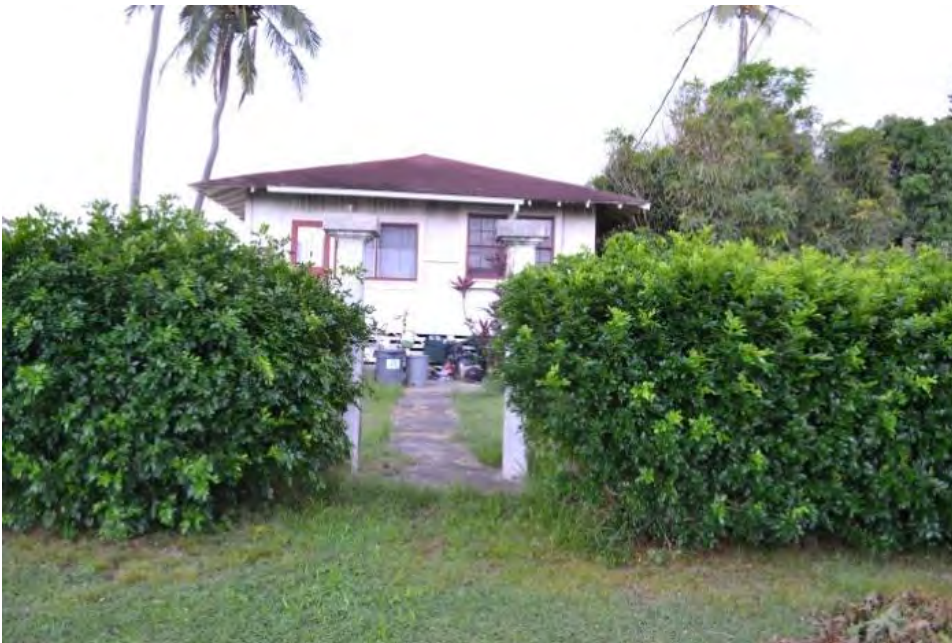
Figure 286. View east of the Assistance Resident Physician's Residence, gate posts, and hedges that follow the historic alignment of former picket fencing, 2017.

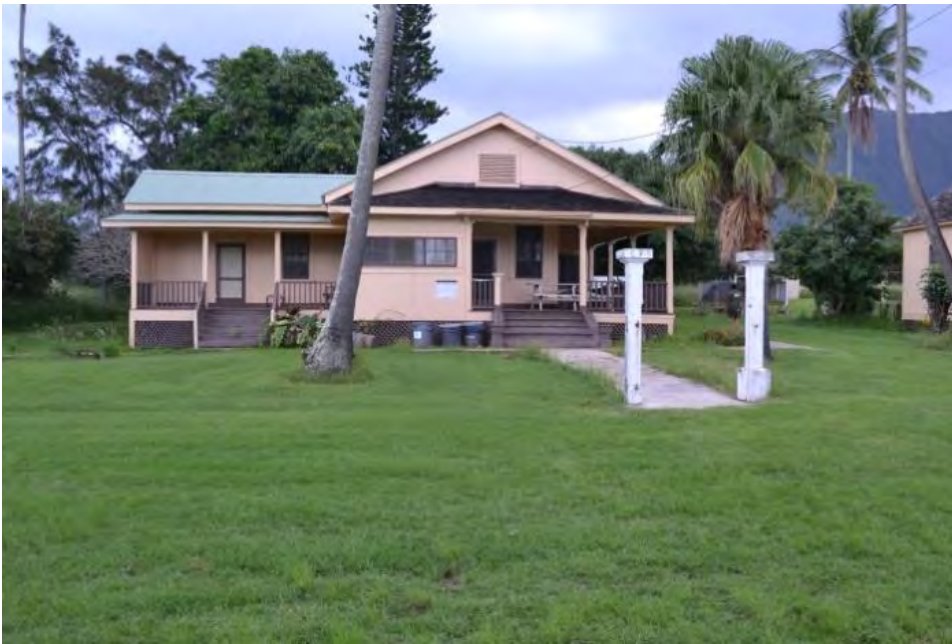
Figure 287. View east of the Resident Physician's Residence, gate posts, and concrete walk, 2017.

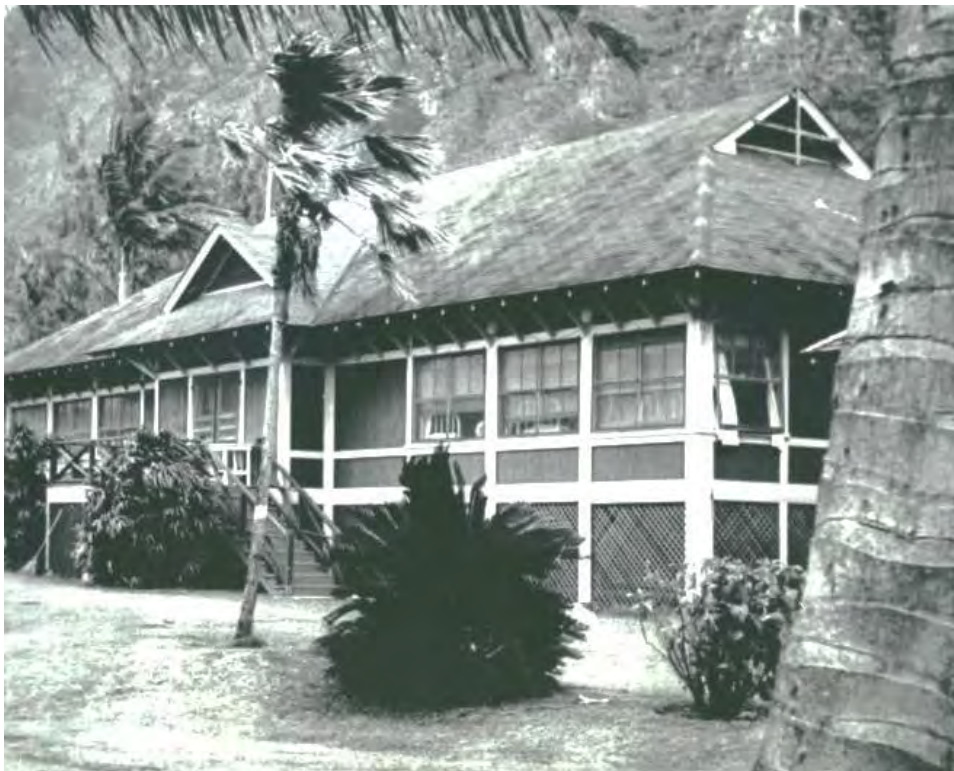
Figure 289. The boy's dormitory at New Baldwin Home, undated. (Source: KALA Bruce Doneux_00372 Box 02_042_label 041)

The New Baldwin Home was comprised of a large dormitory (Figure 289), recreation room, cottages, a chapel, a playground and a grove of papaya and banana trees. Marking the entrance to New Baldwin Home were tall concrete fence posts and a wooden fence. A cattle guard prevented livestock from entering the complex. There was also an outdoor recreation area associated with New Baldwin Home that included a swing set (Figure 290). The favorite outdoor recreational pursuits of the boys living at New Baldwin Home included ‘daredevil’ horseback riding and volleyball; these activities may have taken place in the open area north of the entrance gate.

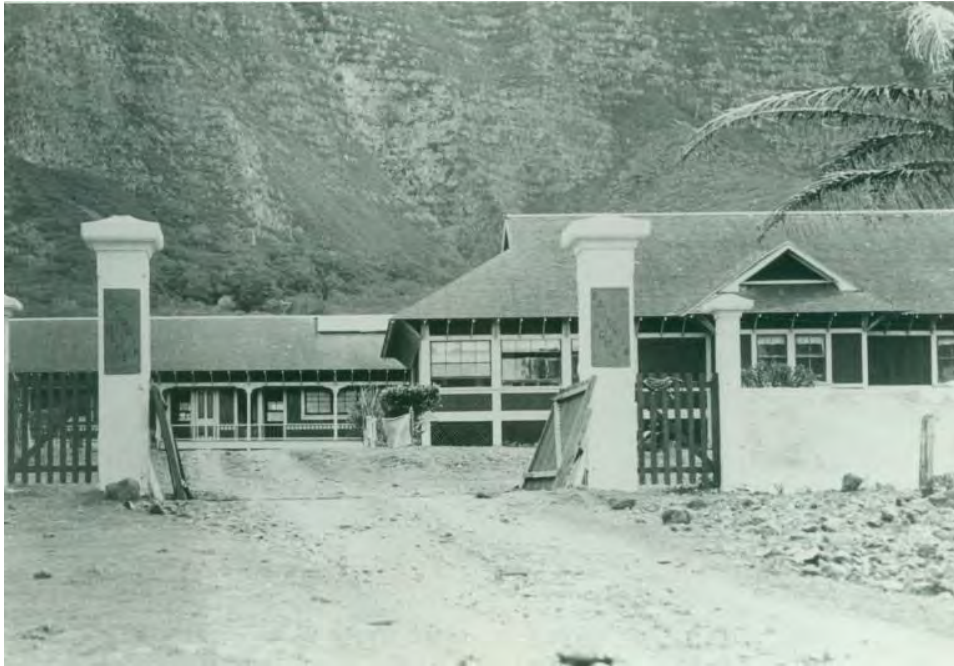
Figure 292. The entrance to the old hospital and new Baldwin Home, circa 1949 just before it closed. (Source: KALA Kalaupapa Historical Society Album B PG 41 #316)

A plot plan was prepared in 1938 to illustrate the features and their arrangement within the complex. The plot plan indicates the extent of the walls, fences, and tree plantings marking the boundary of the complex, as well as the road system, building arrangement, and hedge and other garden plantings (Figure 291). The extant rock wall that marks the northern perimeter of the complex appears to have replaced the original fencing after 1938. By the late 1940s, the New Baldwin Home for Men and Boys was a well-established, carefully kept complex maintained in open cover with ornamental plantings (Figure 292).

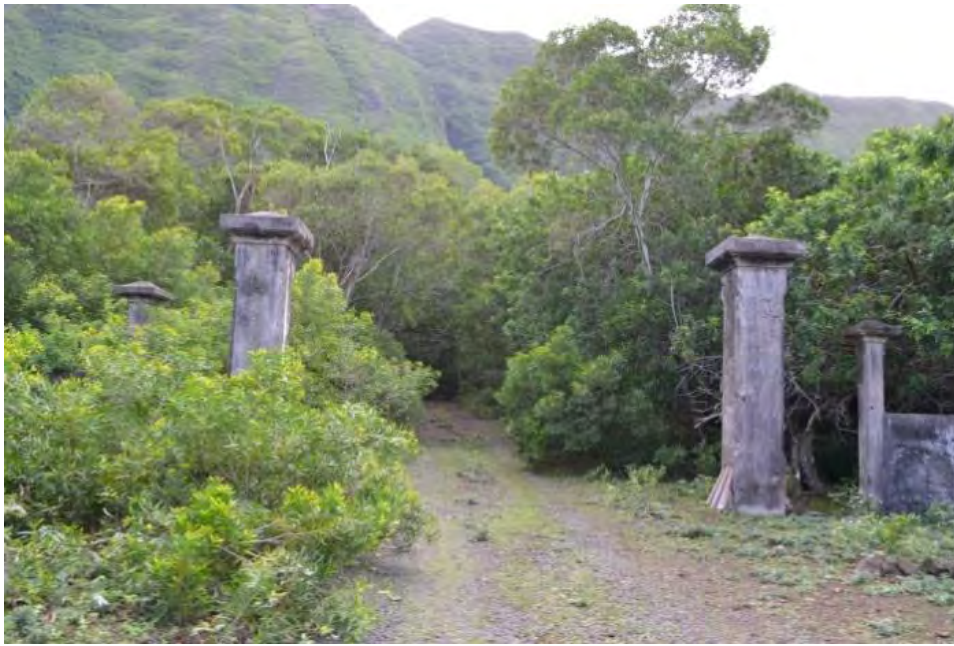
Figure 293. View south of the gate posts at the New Baldwin Home entrance, 2017.

Existing Conditions. The New Baldwin Home character area extends over a relatively large land area south of the intermittent Waihānau Stream corridor. The character area is composed of several developed nodes. Most important among them is the site of New Baldwin Home, marked by dry stacked stone walls and an entrance gate feature (Figure 293), a stone grotto (Figure 294), and evidence of cultural vegetation associated with the former group home. The remnants of worship spaces at New Baldwin Home include a grotto featuring with white cross that is a relic of a chapel that stood next to a kukui nut tree northeast of New Baldwin Home. The grotto is believed to have been built during the mid-twentieth century by Brother Laschet.³⁸⁶ Before the proliferation of woody invasive species, there was a clear view of the Pacific Ocean from the grotto. Also located within the New Baldwin Home site is a wooden Rock Crusher used to develop paving material for Kalaupapa Settlement roads in the 1950s. West of the New Baldwin Home site is a broad, level open space that overlooks the western Pacific Ocean shoreline. The Trail Access Road passes through this open area as an extension of Puahi Street. The road crosses a wooden bridge that spans the intermittent Waihānau Stream. Unimproved two-track roads crisscross the open space. Arising from the Trail Access Road are spurs leading to a cluster of two buildings and corral fencing. The buildings include a Slaughterhouse and an adjacent restroom (Figure 295). Also located along the edge of the open space is a small cluster of features that support tour operations. A mule corral, aluminum seating stand, and small building comprise the cluster. Northeast of the New Baldwin Home site, set within a dense stand of volunteer woody, invasive vegetation is a contemporary recycling center and construction debris dump.

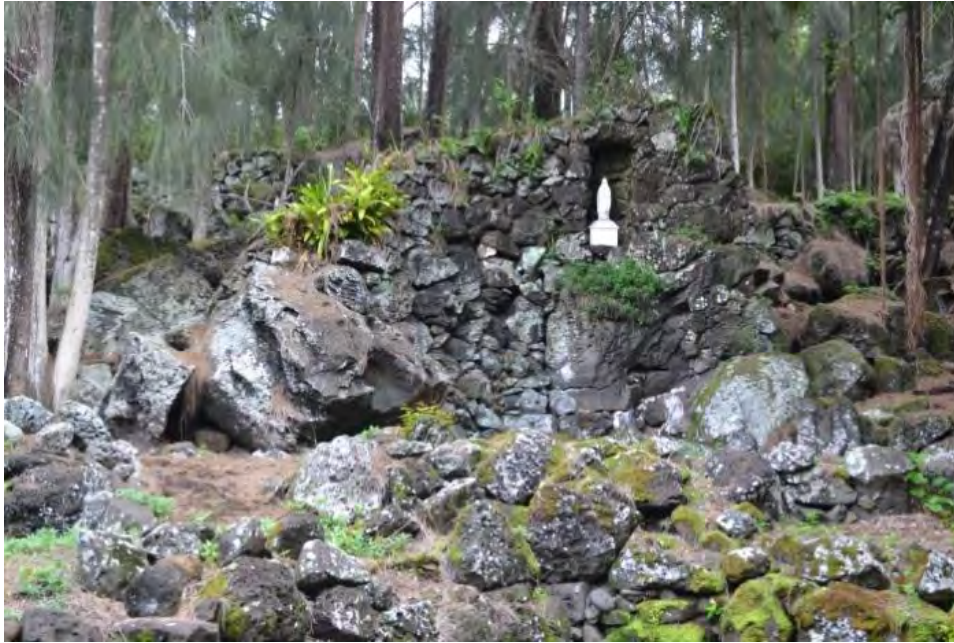
Figure 294. View of the grotto at New Baldwin Home site, 2017.

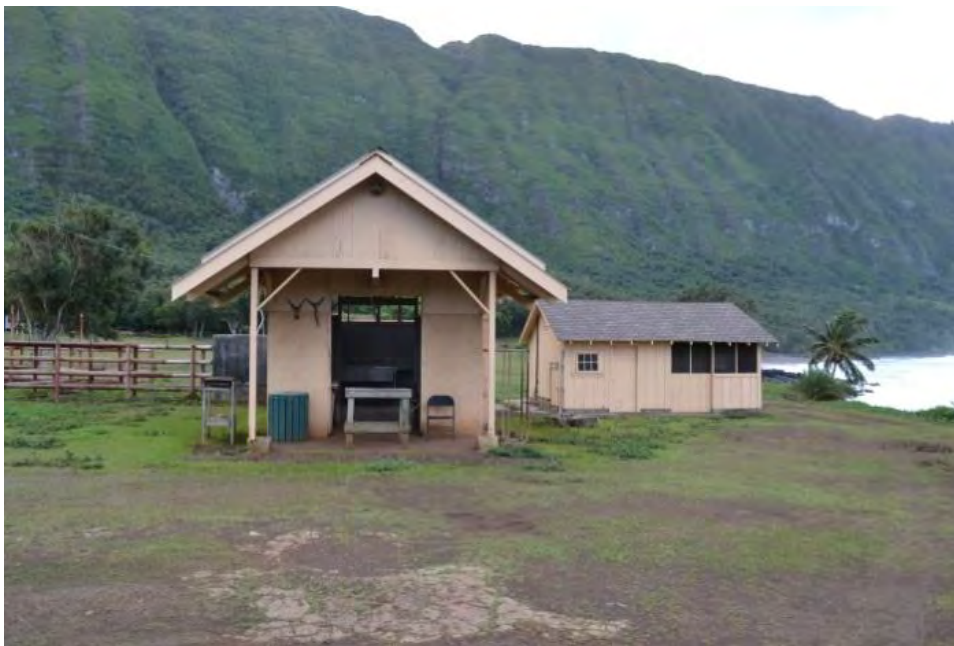
Figure 295. View of the Slaughterhouse (left), Slaughterhouse Restroom (right), and corral fencing, 2017.

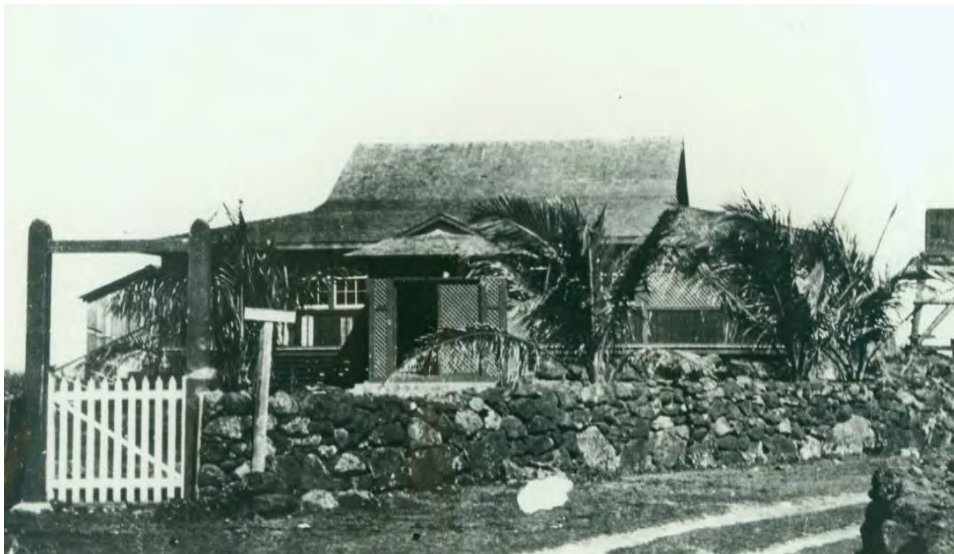
Figure 297. Jack McVeigh's beach house. (Source: KALA Kalaupapa Historical Society Album J PG1 #916)

Historic Conditions. For some residents, the control and constraint on activities, and supervised living at Kalaupapa Settlement was too restrictive, and some sought more autonomy away from this authority. During the 1920s and 1930s, several individual residents constructed their own beach houses along the west coast of the peninsula. Some of the beach houses were located on the north side of the peninsula, and some along the east side, but by far, the majority were located at ‘Īliopi‘i Beach north of the settlement (Figure 297).³⁸⁷

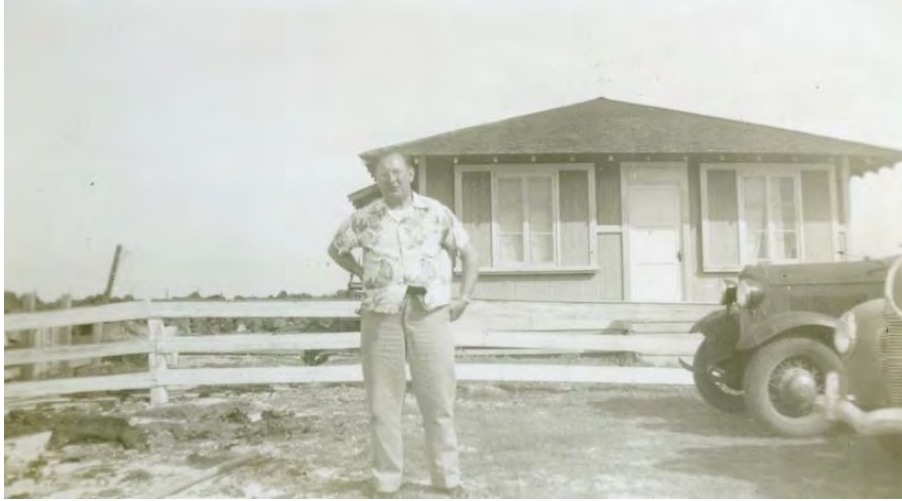
Figure 298. Unidentified beach house. (Source: KALA Kenso Seki_KALA 12600_712)

The beach houses were far enough away from the settlement that they allowed patients to not only feel more autonomy, but also to form a different, and more familiar community, even as they remained separated from their homes, families, and society as a whole.³⁸⁸ Most of the early beach houses were built from recycled materials salvaged from elsewhere on the peninsula.³⁸⁹ They were edged by fences and plantings and often featured planted yards (Figure 298).

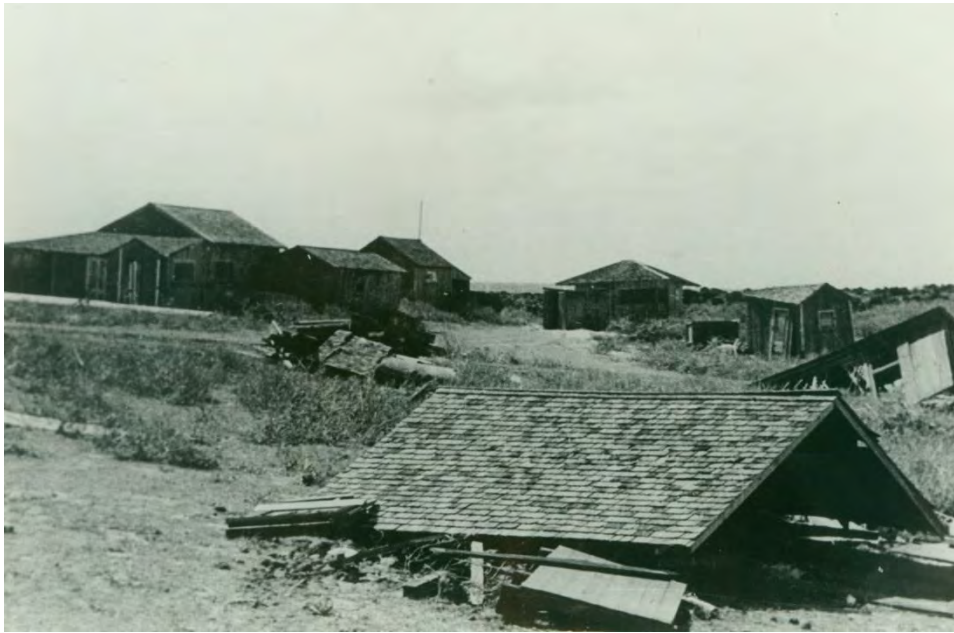
Figure 299. The beach house area following the 1946 tsunami. (Source: KALA Kalaupapa Historical Society Album J PG 2 #914)

The 1946 tsunami that struck the west shore of the Kalaupapa Peninsula damaged several of the beach houses in the ‘Īliopi‘i area, and totally destroyed twelve homes (Figure 299). Some of damaged houses were repaired, while others were rebuilt; all of the beach houses have either been repaired or remodeled since 1946. After World War II, the availability of Quonset hut materials led to the use of recycled corrugated metal in repair and construction of the beach homes and outbuildings.³⁹²

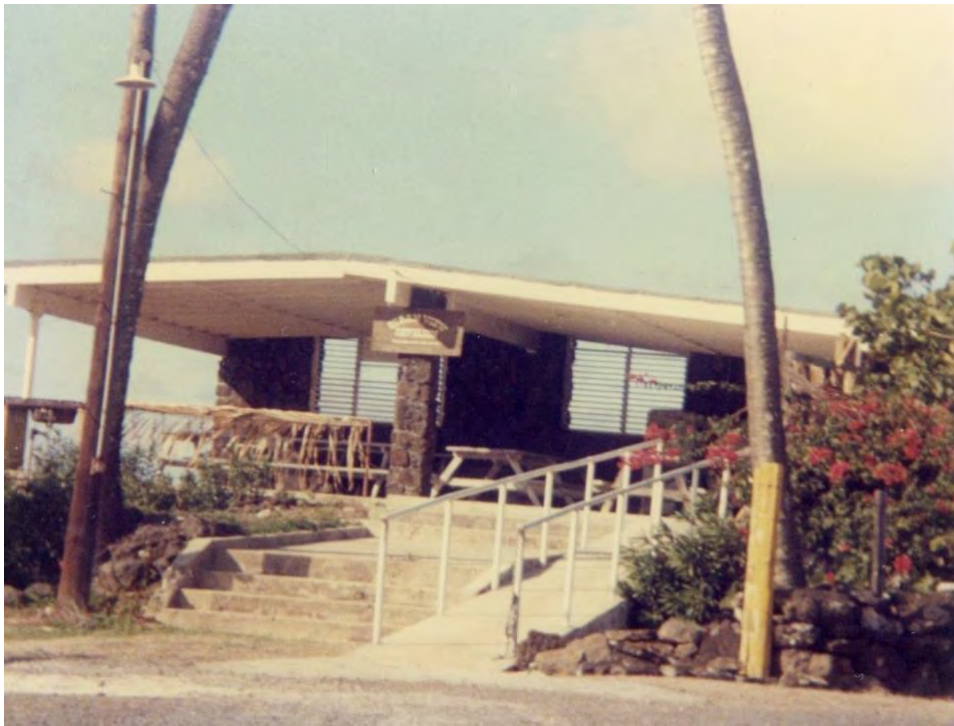
Figure 300. The Lions Pavilion along Kamehameha Road, circa 1970s, view looking north. (Source: KALA Kenso Seki_KALA 12600_495)

In 1965, the Lions Club built a picnic pavilion along Kamehameha Road near the beach houses to provide a place for family gatherings, picnics, and beach access (Figure 300). The structure came to be known as ‘Ocean View’ following a naming competition. The pavilion and its role as a gathering place and picnic area played an important role in the lives of residents for many years:

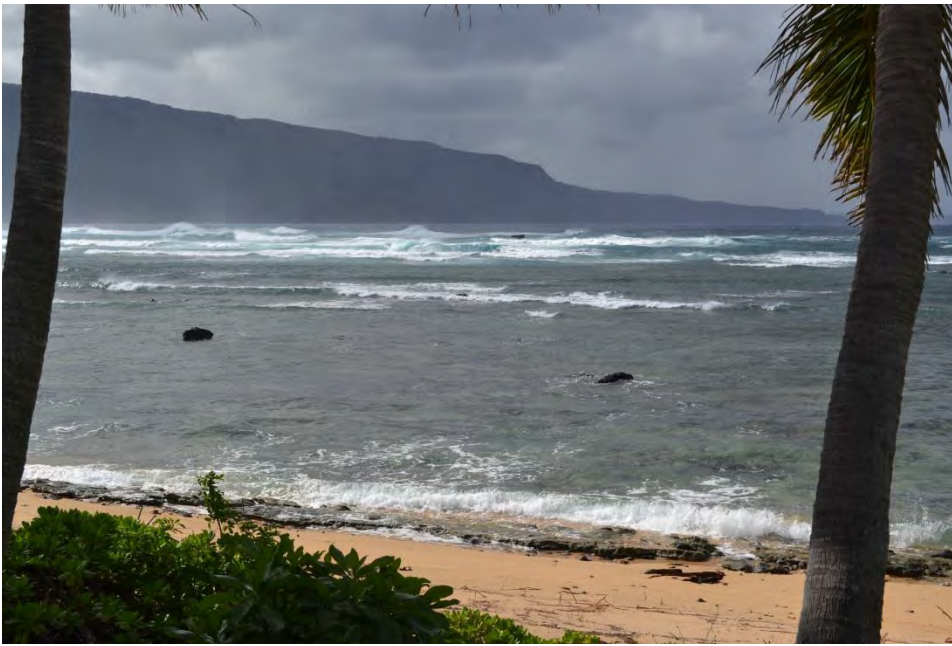
Figure 301. View looking west across 'Īliopi'i Beach from one of the beach houses, 2017.

Existing Conditions. The 'Īliopi'i Beach Houses character area includes a linear collection of eight patient-owned beach houses and associated features sited along the western coastline of the Kalaupapa Peninsula overlooking 'Īliopi'i Beach (Figure 301). Five of the extant beach houses are historic, while three—the Meli and Randall Watanuki Beach House, Richard and Gloria Marks Beach House, and Shoichi Hamai Beach House—are contemporary additions. Although none survive today, several additional beach houses were once located along the eastern coastline of the peninsula north of Kalawao.³⁹⁴ Remnants of these former beach houses survive, such as the steps at the site of the Mormon Beach House. Access to the beach houses on the western shoreline occurs from a sandy two-track known as Beach Road (Figure 302) that arises from Kamehameha Street near the 'Īliopi'i Cemeteries (J, K, L, and M). The beach houses are associated with various landscape features—garages, storage sheds, secondary roads and driveways, walls, fencing (Figure 303), and plantings. Also included within the Beach House character area is the Lions Pavilion complex located north of Cemetery A along Kamehameha Street. The complex features the Lions Pavilion (Figure 304), Lions Club Restroom 687, and two shelters. A dry stacked stone wall edges the cluster along Kamehameha Street.

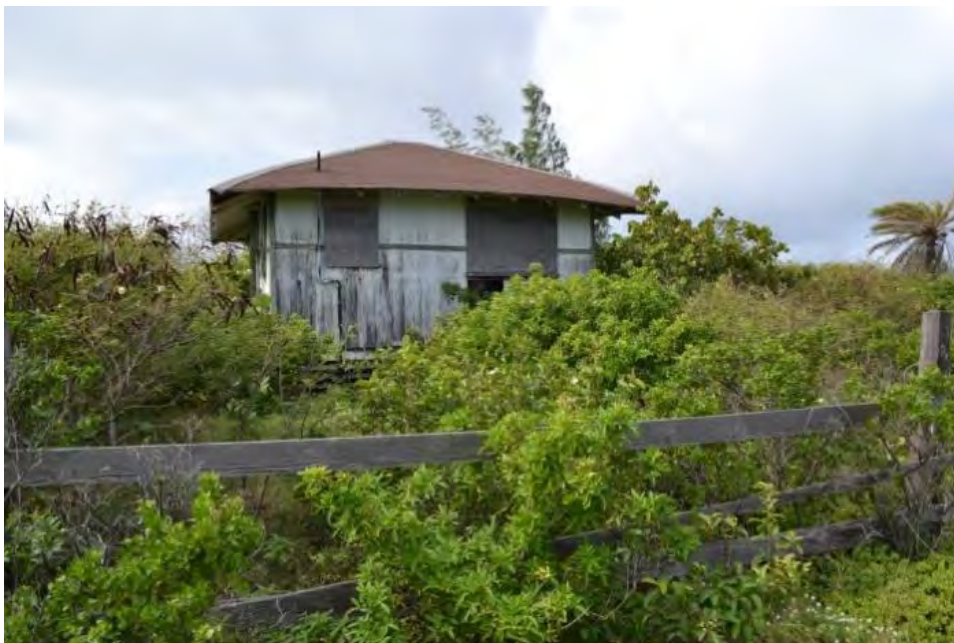
Figure 303. View toward one of the beach houses and associated fencing, 2017.

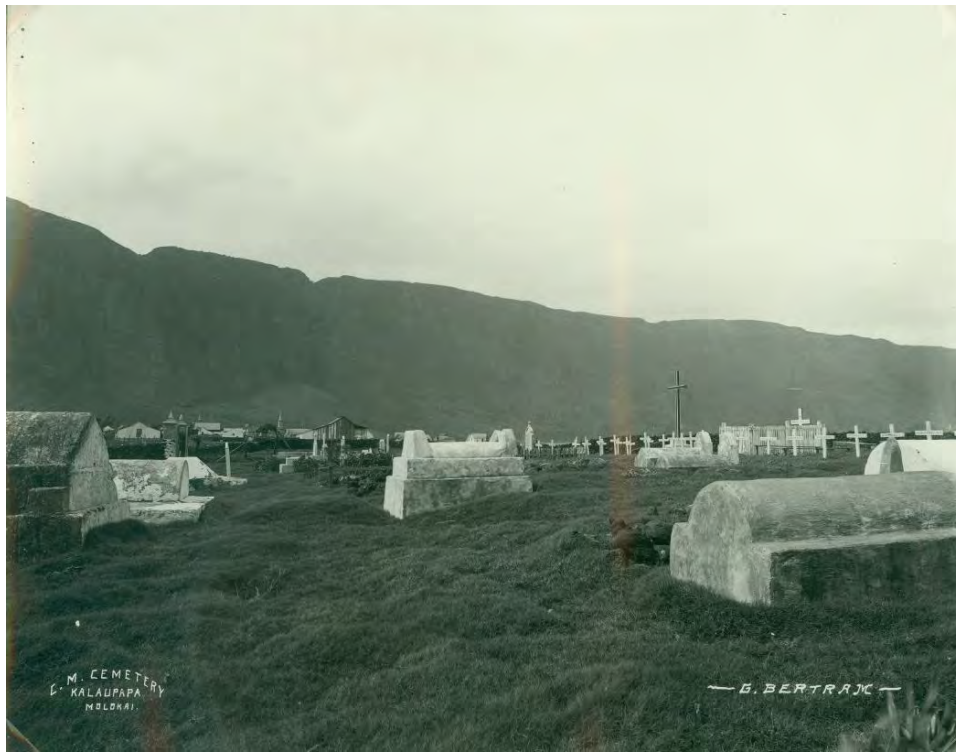
Figure 306. Catholic Mission Cemetery (Cemetery H), prior to 1900. (Source: KALA Kalaupapa Historical Society Album H PG 19 #841)

By the late nineteenth century, designated cemeteries existed both at Kalawao and Kalaupapa. The earliest grave markers associated with the West Coast Cemeteries at Kalaupapa indicate burials dates during the 1890s, particularly within the Catholic Cemetery (Cemetery H) (Figure 306), the adjacent Old Hawaiian and A.J.A. Cemetery (Cemetery G), Church of Jesus Christ of Latter-day Saints Cemetery (Cemetery F), and C.E. Protestant Cemetery (Cemetery E).

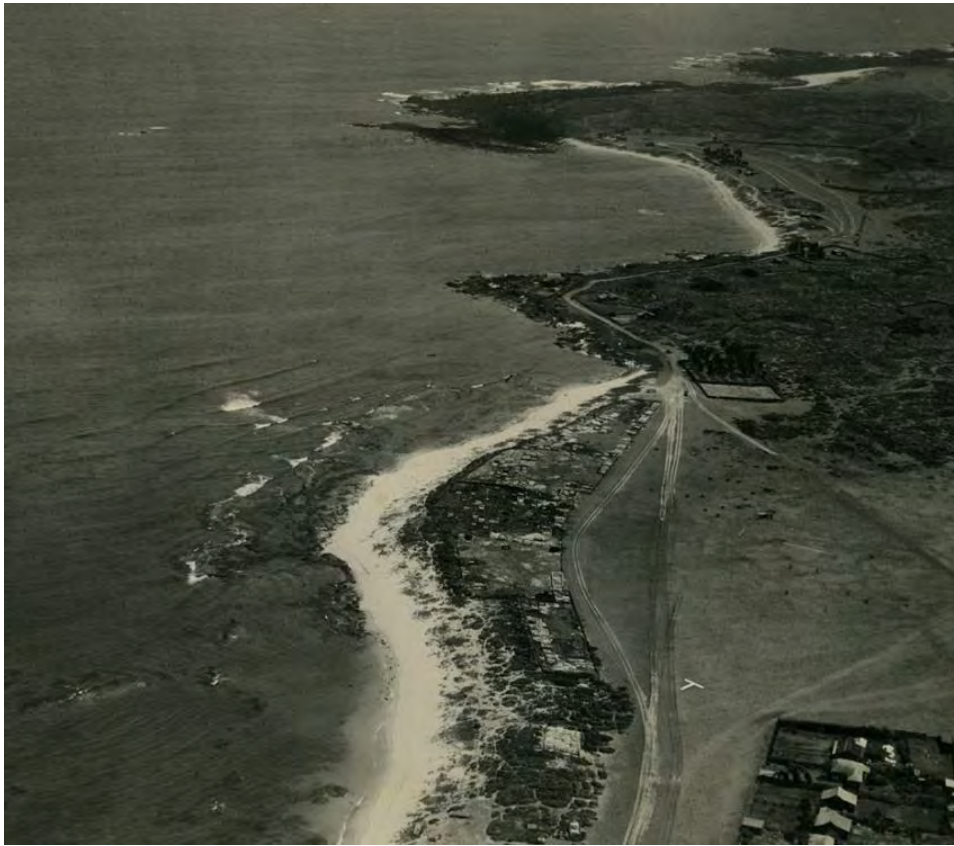
Figure 307. Bird's eye view of Papaloa Cemetery and the residences built along Kamehameha Street, looking north, circa 1930s. (Source: KALA Boland004_Papaloa Cemetery_1930s)

During the 1930s, eight additional residences were added facing Kamehameha Street across from the cemeteries. These residences featured concrete walks leading the front entrances, outbuildings, rock wall enclosures (Figure 307), and plantings. A grove of coconut palm trees was planted along the road in front of many of the houses.

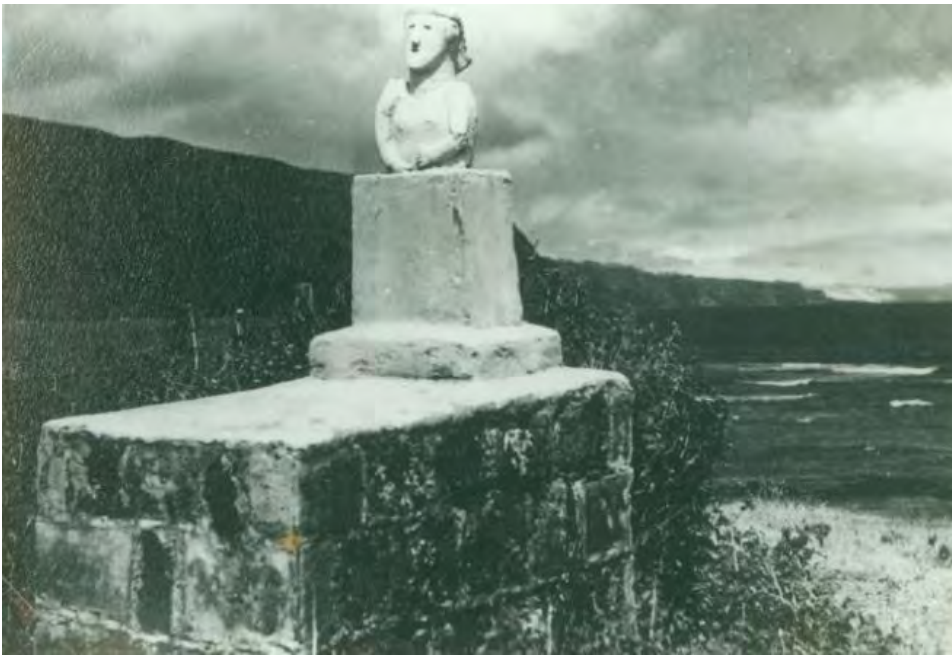
Figure 308. Grave marker carved by a patient prior to 1900. (Source: KALA Kalaupapa Historical Society Album H PG 19 #841)

Markers ranged from upright concrete headstones, to concrete slabs flush with the ground, crosses, mausoleums, elevated tombs and vaults, obelisks, posts, haka or urn houses, and concrete slurry-covered lava rocks configured in geometric forms. Some graves were marked with simple signs or crosses made of wood. Other materials used for grave markers included lava field stone, concrete, iron pipe, bronze plaques, granite, and marble. Patients often helped to fabricate grave markers (Figure 308).

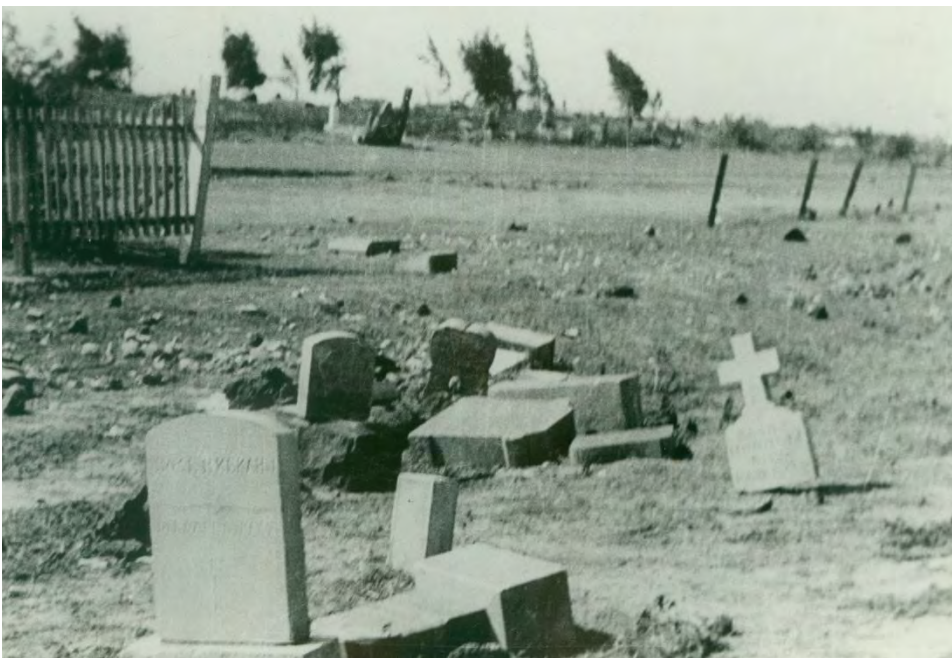
Figure 309. Effects from the 1946 tsunami to Papaloa cemeteries included dislodged and damaged head stones, broken fences, scattered rock associated with walls, and the loss of vegetation. View looking northwest, 1946. (Source: KALA Kalaupapa Historical Society Album J PG 2, 1913)

On April 1, 1946, a tsunami swept over the west coast of the Kalaupapa Peninsula having a significant impact on the settlement and the cemeteries along the shoreline. The waves changed the morphology of the shoreline and washed away or dislodged many headstones, and damaged the fences and rock walls marking boundaries between cemeteries (Figure 309).

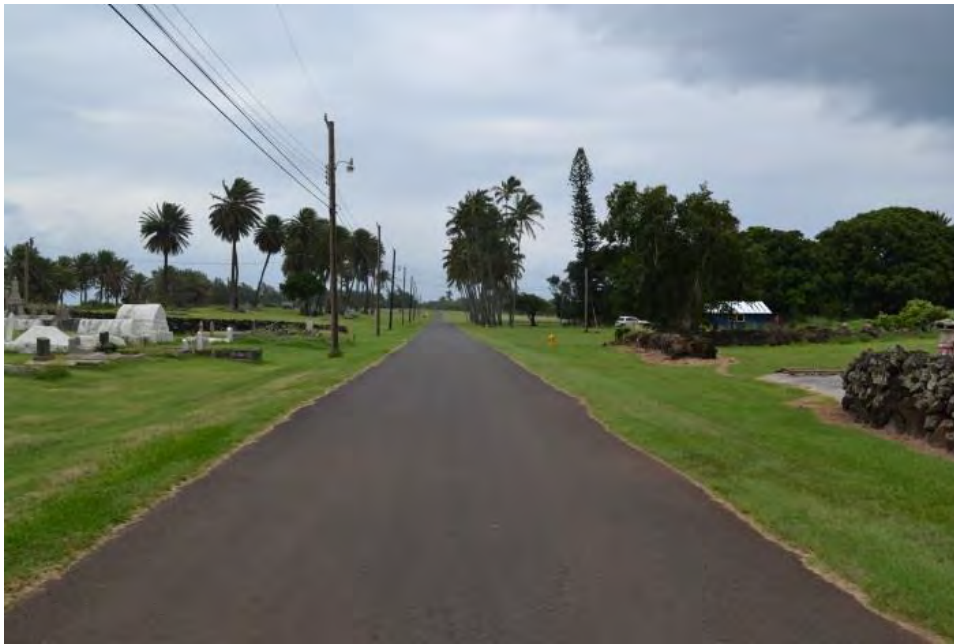
Figure 310. View north along Kamehameha Street of the West Coast Cemeteries character area with graves indicated to the left and residential features to the right, 2017.

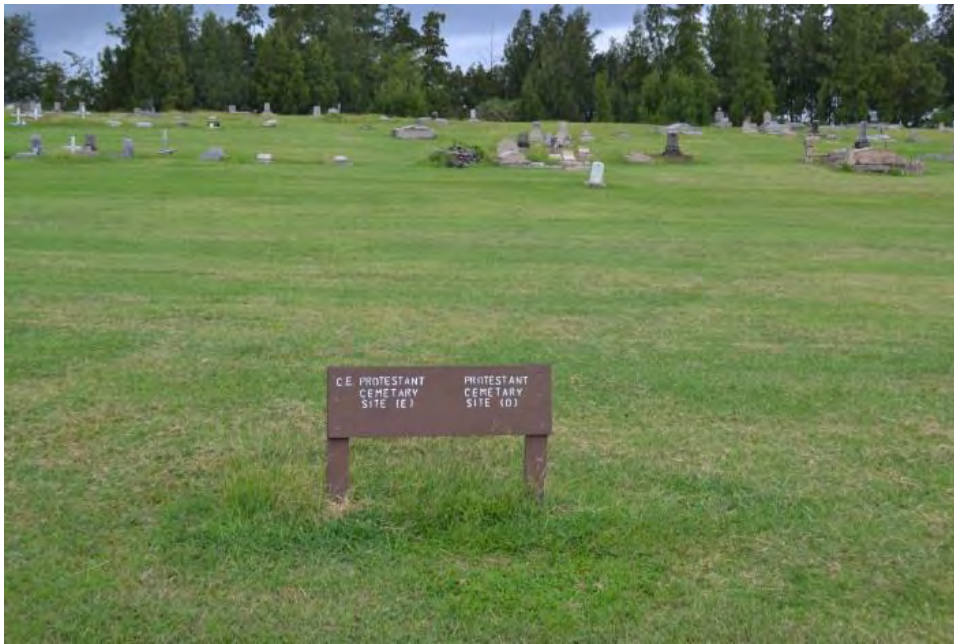
Figure 311. View west of one of the low brown signs serving to identify the individual burial grounds comprising the West Coast Cemeteries, 2017.

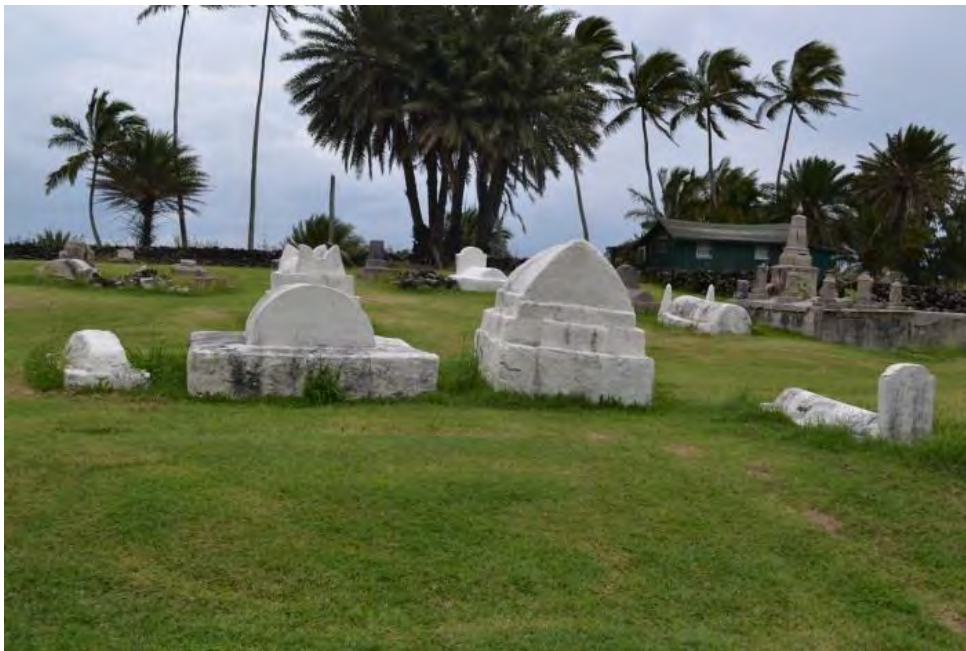
Figure 312. View west of features associated with the West Coast Cemeteries, such as grave markers and plantings, 2017.

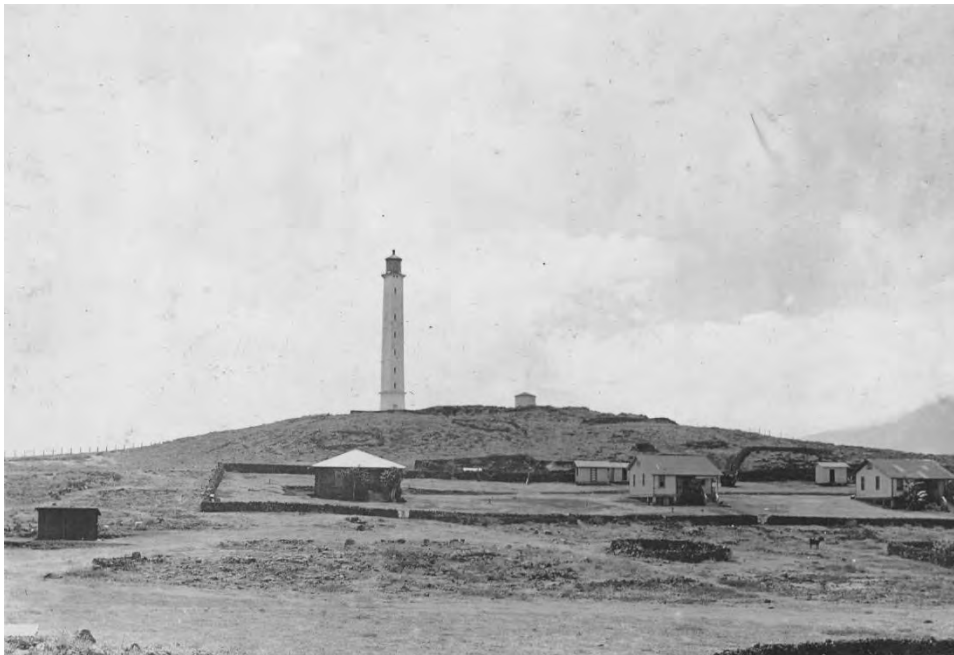
Figure 315. View of the Molokai Light Station complex, undated. (Source: KALA 1925-1928 AB Potter_KALA-17429h-1)

Historic Conditions. The Molokai Light Station was constructed by the U.S. Coast Guard between 1908 and 1909 to provide guidance to mariners traveling through the dangerous Kaiwi Channel between Molokai and O‘ahu (Figure 315). To accommodate construction, a water line was extended to the site from Kalaupapa and a road was built from Kalaupapa Landing to the future complex in 1908.

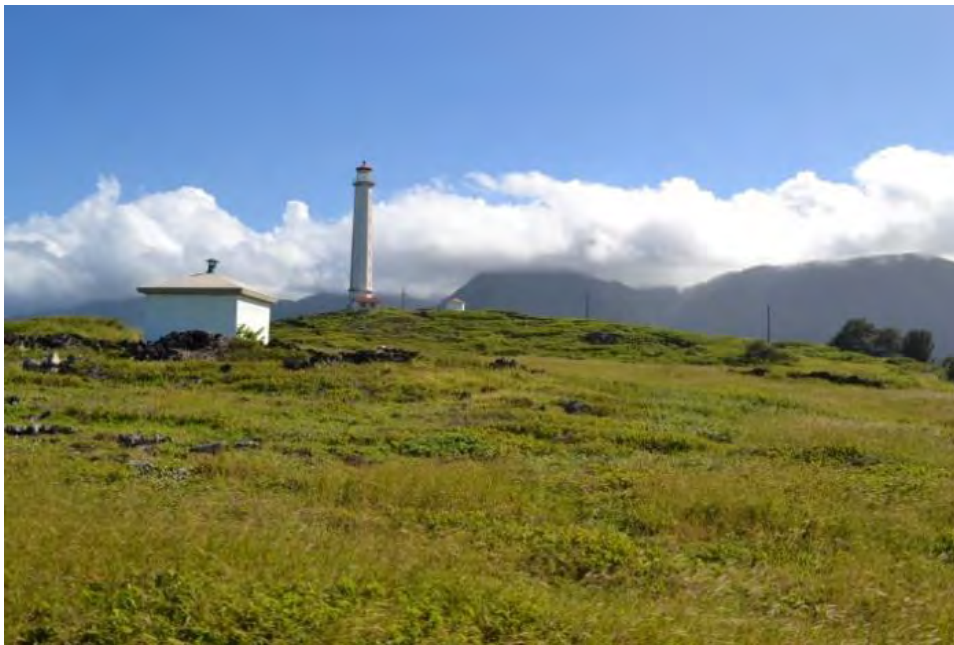
Figure 317. Views of the Molokai Light Station lighthouse with the storage vault in the foreground, 2018.

Existing Conditions. Molokai Light Station occupies a prominent knoll overlooking the Pacific Ocean. The Molokai Light Station character area is composed of two precincts—one that contains the lighthouse and associated support structures atop the knoll (Figure 317), and another built to support the needs of those operating the light house complex. Evidence of the wire fencing strung from redwood posts used to mark the perimeter of the property survives today, along with the dry stacked stone wall that encloses the residential keepers precinct. Historic unimproved access roads lead into the light station property from Airport Road to the west—referred to as the Principal Access Road—and to the lighthouse—referred to as the Internal Access Road. Additional roads lead into the precinct from the peninsula's Internal Road, and Coastal Road to the east

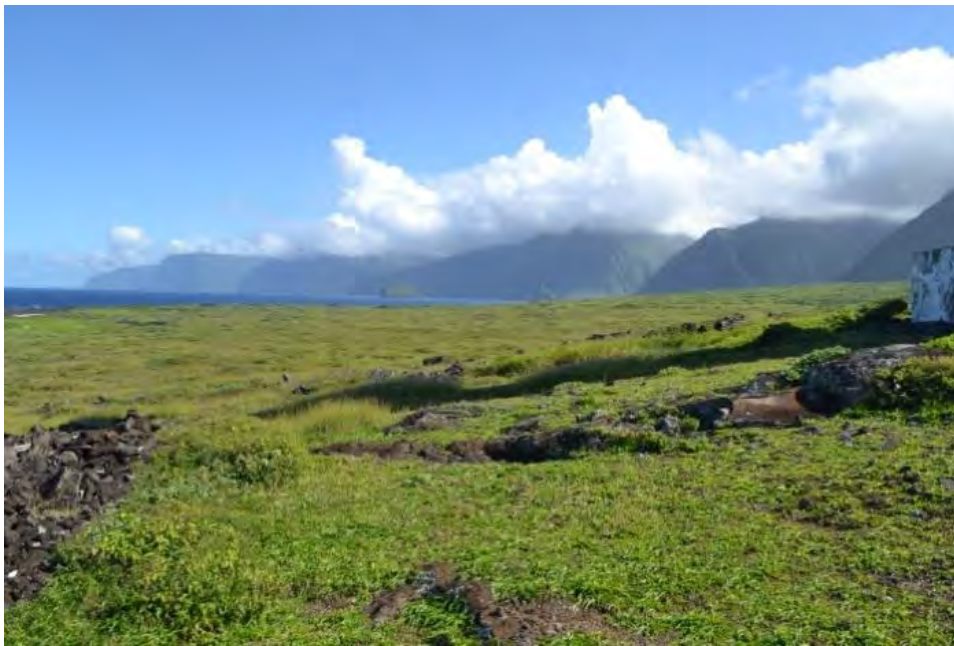
Figure 318. View from the lighthouse environs and stone work associated with the heiau present on the knoll, 2018.

and south, and from the north. The Principal Access Road leading to the residential precinct is edged by an allée of ironwood pine trees planted in the 1910s. Additional ironwood pine trees edge the walls to the north, east, and south that were planted in the 1910s as a windbreak. In addition to the ironwood pine tree allées and windbreak, there are foundation plantings around the residential buildings and evidence of a former residential garden area, as well as date palms that have naturalized. Otherwise, much of the landscape of the northern peninsula is characterized by low-growing vegetation. The elevated terrain and lack of tree covers allows for 360 degree views from the lighthouse and its environs. The residential complex, however, is more contained by the knoll and tree plantings, and views are more limited. The light house precinct was constructed within a traditional Hawaiian landscape and was sited atop a heiau (Figure 318).
