Kalaupapa and Kalawao Settlements Cultural Landscape Report

Kalaupapa National Historical Park

Cultural Landscape Report

Prepared by:
Wiss, Janney, Elstner Associates, Inc.
2000 Powell Street, Suite 1650
Emeryville, California 94608

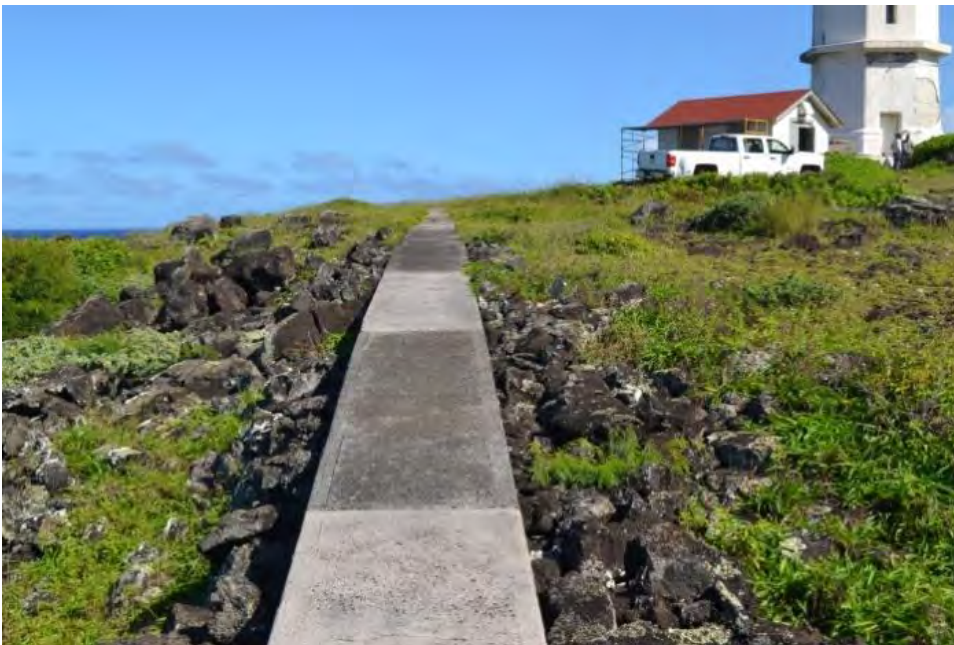
Figure 320. View toward the lighthouse along the concrete walk built circa 1927-1930, 2018.

Historic buildings that comprise the lighthouse precinct include the Molokai Light Station Lighthouse, Molokai Light Station Generator Shed, and Molokai Light Station Storage Vault. Structures at the lighthouse precinct include the Molokai Light Station Water Tank. Structures associated with the residential precinct include the perimeter stone wall. Historic buildings that comprise the residential precinct include the Principal Keeper's Residence, First Assistant Keeper's Residence, and Wash House/Storage Shed (Figure 319). Outside of the walled residential precinct is the historic Molokai Light Station Garage. Pedestrian circulation features include the concrete walk built to connect the residential and lighthouse precincts (Figure 320). There is also a child's grave located near the lighthouse.

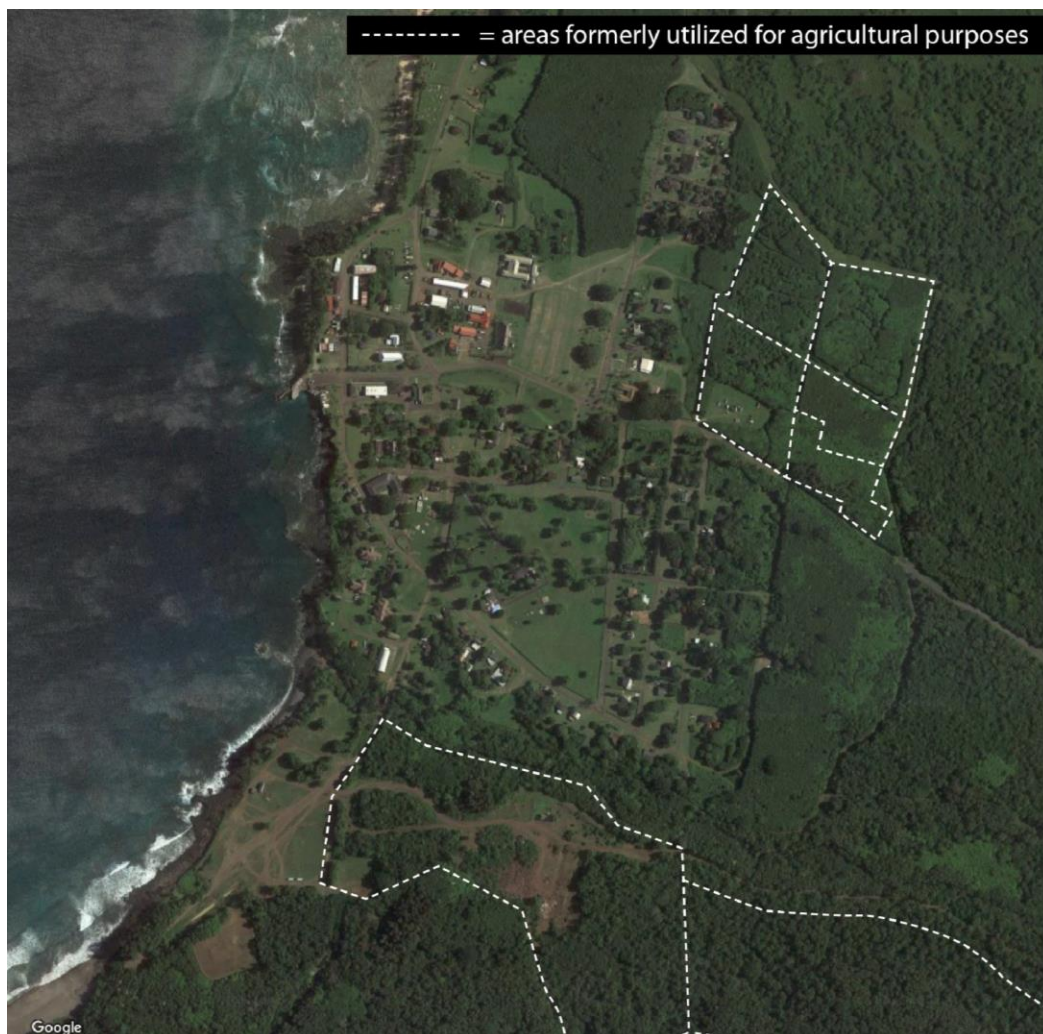
Figure 322. Diagram illustrating former agricultural lands at Kalaupapa Settlement. (Source: LSHLA)

2. Identify areas for potential future agricultural use based on knowledge of areas where agricultural activities occurred during the period of significance (Figure 322).

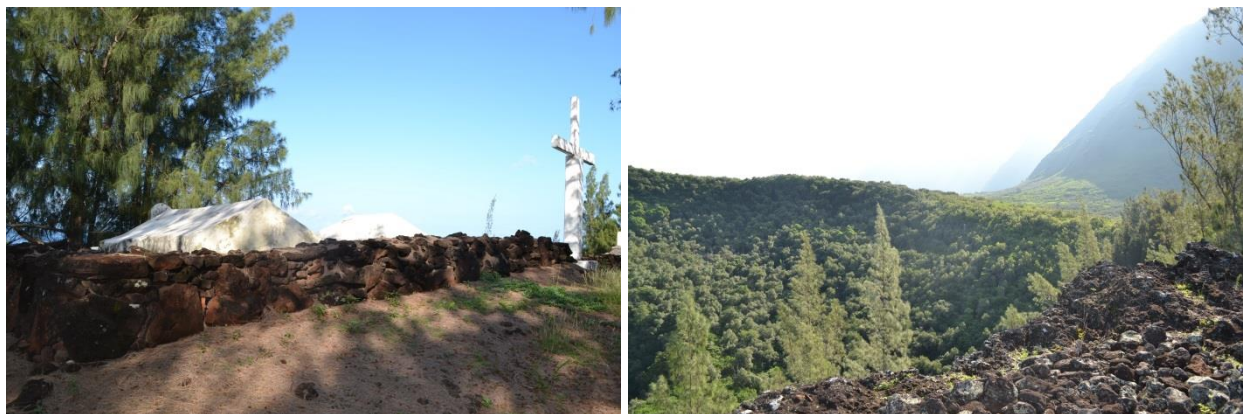
Figure 325. Examples of woody vegetation encroaching on views and altering patterns of spatial organization associated with the western rim of Kauhakō Crater.

- Preserve and maintain the open character of the western rim, Crater Road, the rock wall enclosures that mark the burial grounds, the grave markers, and the concrete cross that comprise historic patterns of spatial organization and have been important to use of the area for Easter Sunday sunrise services.
- Enhance historic spatial patterns and views by thinning volunteer stands of ironwood pine, Java plum, lantana, and other invasive species that are currently encroaching on the burial grounds, western rim, and views of Kalaupapa Settlement, Molokai Light Station, and crater interior (Figure 325).

- Preserve the expansive views from the western rim toward the lighthouse and Kalaupapa Settlement, as well as into the crater.
- Reestablish views in association with the burial grounds west of Crater Road where volunteer ironwood pine trees are encroaching on the view (refer to Figure 325).
- Remove invasives that are encroaching on the views into the crater (refer to Figure 325).

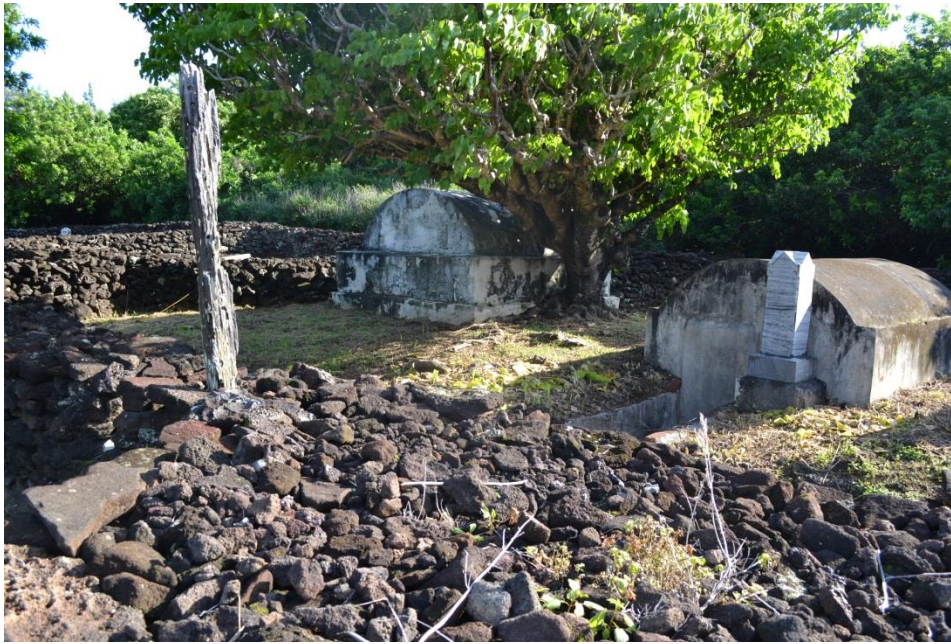
Figure 326. Maintain the burial grounds in low grass cover and mature shade trees as shown. Immediately remove woody volunteer species.

- Manage vegetation within the walled burial enclosures by removing woody volunteer species as identified through monitoring. Otherwise maintain in low grass cover and allow existing shade trees to remain unless they pose a threat to walls and grave markers (Figure 326). See *Settlement-wide Design Guidelines: Vegetation* for guidance.

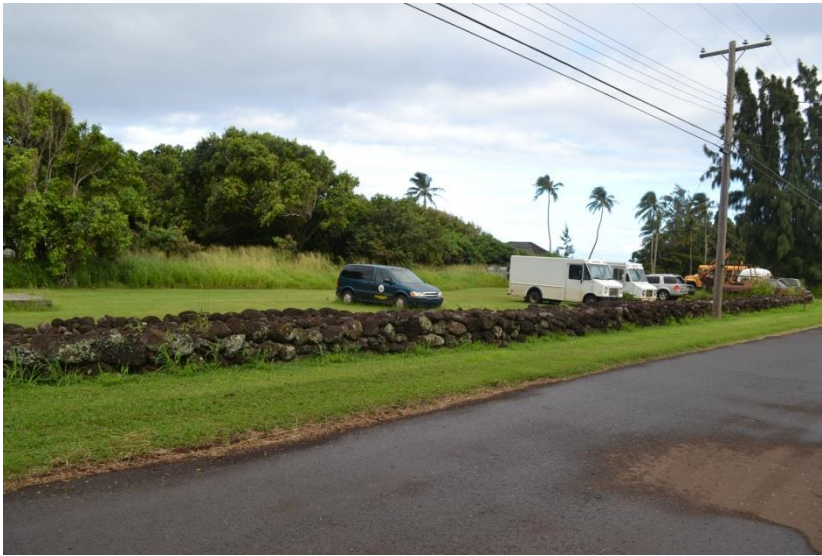
Figure 328. View of row of stored cars, buses, and construction vehicles along Kamehameha Street that should be screened or relocated to enhance the settlement entrance corridor.

- Preserve and maintain the existing circulation patterns that reflect the historic character during the period of significance. Preserve the names of patients and kōkua etched into some of the sidewalks.
- Screen or relocate stored cars, maintenance vehicles, and buses along Kamehameha Street north of St. Francis Catholic Church (Figure 328) to a temporary storage location that can be screened to enhance the viewshed of the entrance corridor.

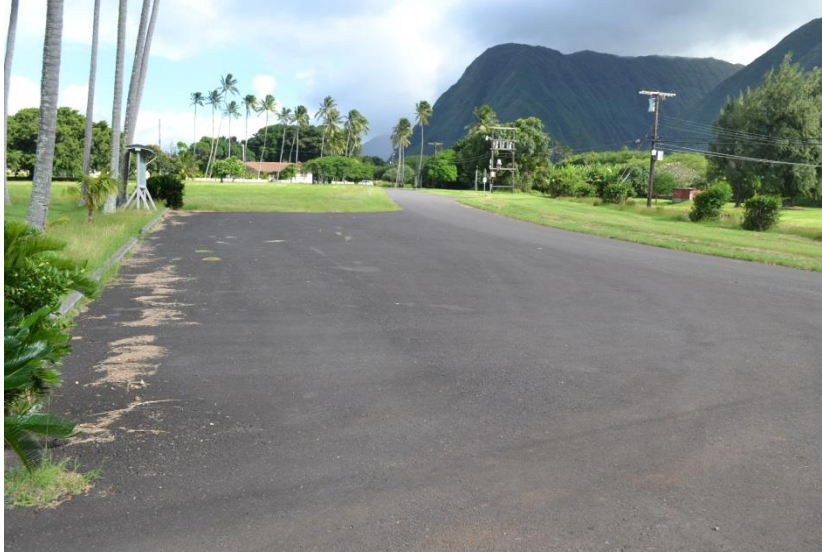
Figure 329. View to row of clipped shrubs that might be replaced with a hedge of flowering shrubs.

- Consider establishing a hedge of flowering plants, using a species selected in consultation with the patients, along Beretania Street to replace current shrubs maintained as sheared globes to recall the historic appearance of the road corridor (Figure 329). Select a shrub that can be maintained at a height of between 4 and 5 feet without excessive pruning and that can retain its original form to the degree possible.

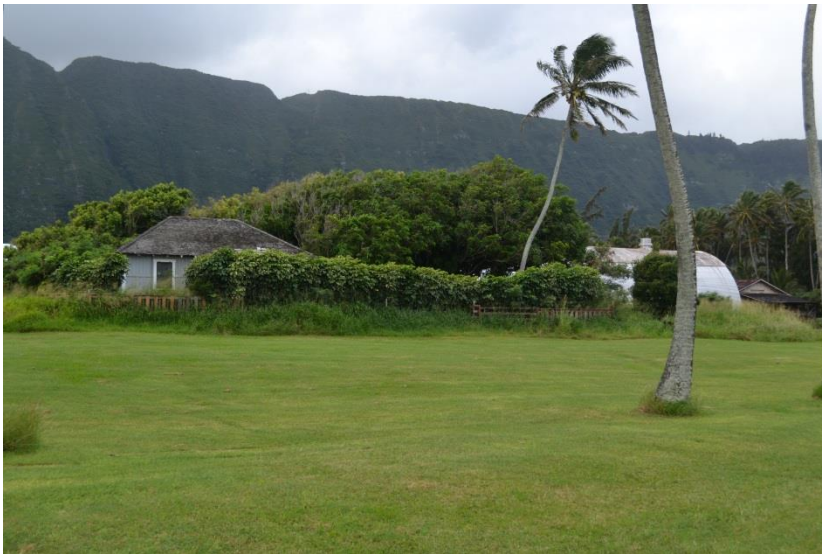
Figure 330. View to the Benjamin Residence that is overgrown and has trash in the yard.

- Clear and thin overgrown volunteer vegetation associated with the Benjamin Residence, and repair the structure. Determine whether it is possible to clear debris and trash from the area around the house (Figure 330).

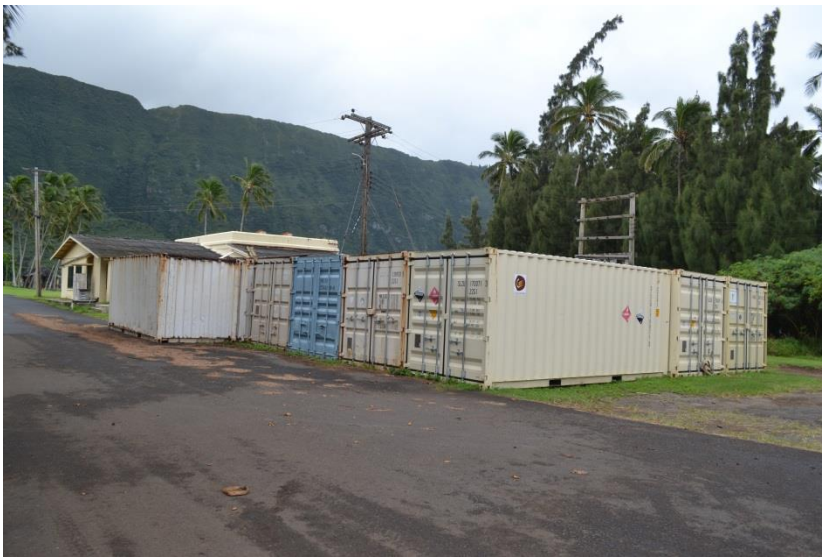
Figure 331. View of some of the containers that line Damien Street near the wharf.

- Begin to return excess storage containers currently sited along Damien Street and elsewhere within Kalaupapa Settlement that are no longer needed via barge. The large number of containers are visually incongruent with the character of the settlement, especially where they are visible near the wharf and St. Francis Catholic Church (Figure 331). Screen in place or relocate storage containers to open fields that can be screened by woody vegetation. Consider shrub and tree plantings to screen the containers in place.

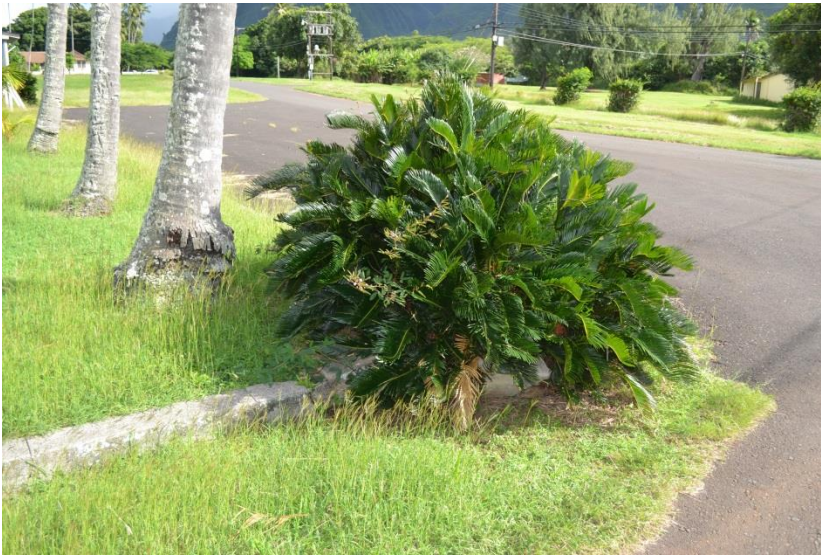
Figure 332. View of one of the two concrete planters in front of Paschoal Hall. Both are cracked and broken.

- Repair or replace in kind the concrete planters in front of Paschoal Hall that are cracked and broken (Figure 332).
- Consider the Oceanside Pavilion, Gas Station, Patient Store, Paschoal Hall, and Library as co-location sites to accommodate benches, water bottle refill stations, orientation and interpretive information, and concession sales.
- Provide additional safety features along the margin of Damien Street where the western shoreline follows a steep cliff and could pose a danger to visitors. Consider alternatives such as bollards, or fencing.

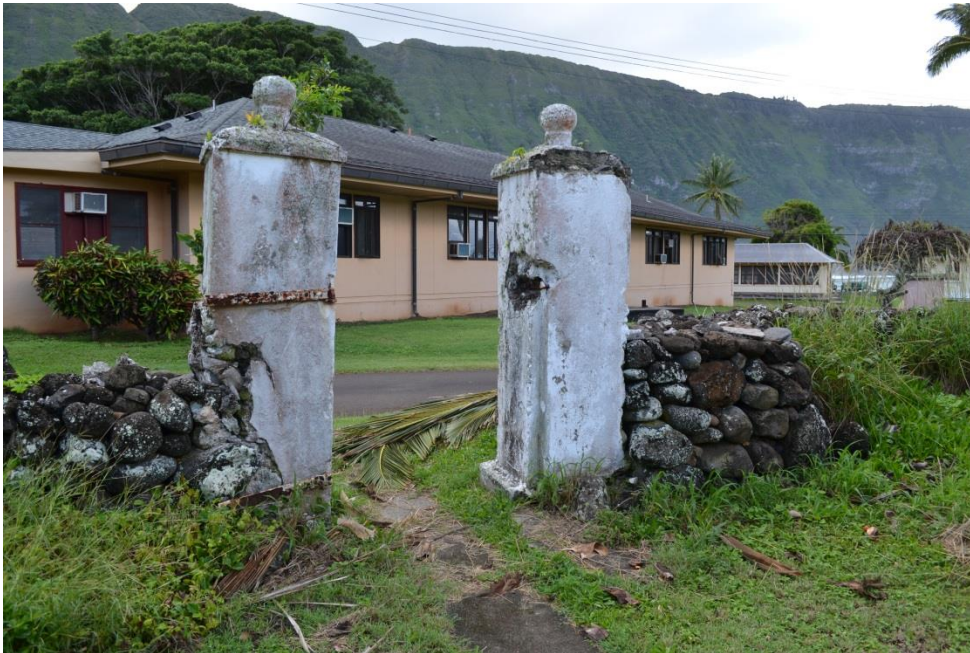
Figure 335. Several of the entry piers as well as the dry stacked lava rock walls at Kana'ana Hou Church are in need of repair.

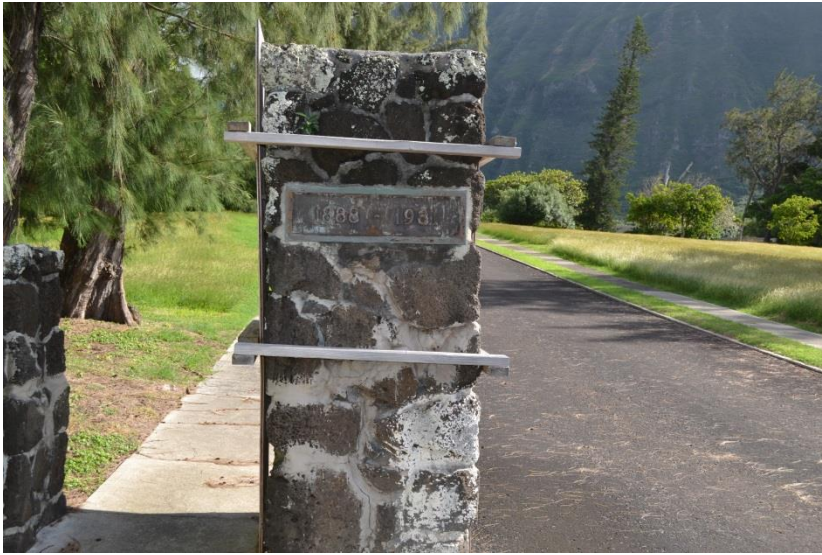
Figure 337. View of the stone pier that requires repair at the entrance to Bishop Home.

- Preserve and maintain the contributing buildings and structures within Bishop Home character area.
- Repair the stone masonry gate pier at the entrance to Bishop Home that is currently protected with plywood and a metal clamping system (Figure 337).
- Stabilize existing dry stacked lava stone walls along the perimeter of the Bishop Home property where stones have fallen, or sections have collapsed. See *Settlement-wide Design Guidelines: Rock Walls* for guidance regarding care and stewardship of historic rock walls.
- Clean the base of the Saint Damien Memorial.
- Repair and repaint or whitewash the piers at the entrance to the Saint Marianne Cope Grave to match historic conditions (Figure 338).

Repair the mortared rock gate pier at the entrance to Bishop Home that is currently protected with plywood and a metal clamping system

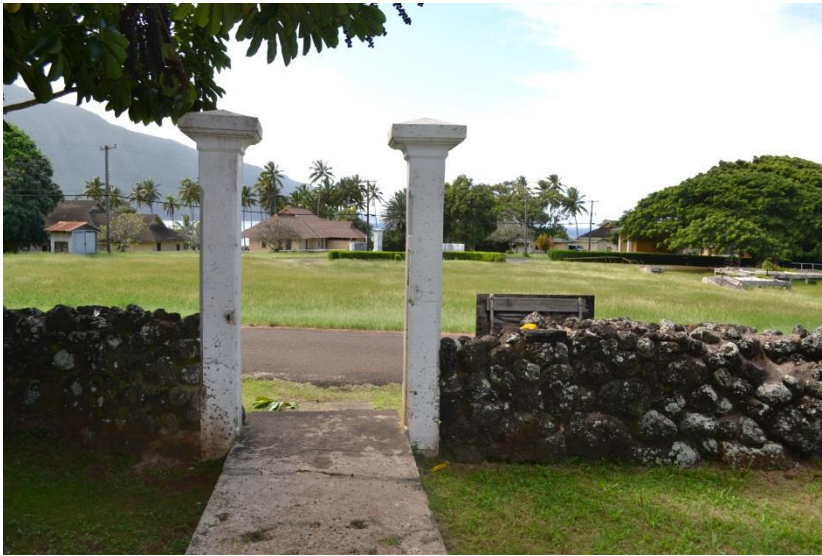
Figure 338. View of the piers at the entrance to the Mother Marianne Grave that require repair and repainting.

Clean the base of the Father Damien Monument and repair and repaint the piers at the entrance to Mother Marianne’s Grave.

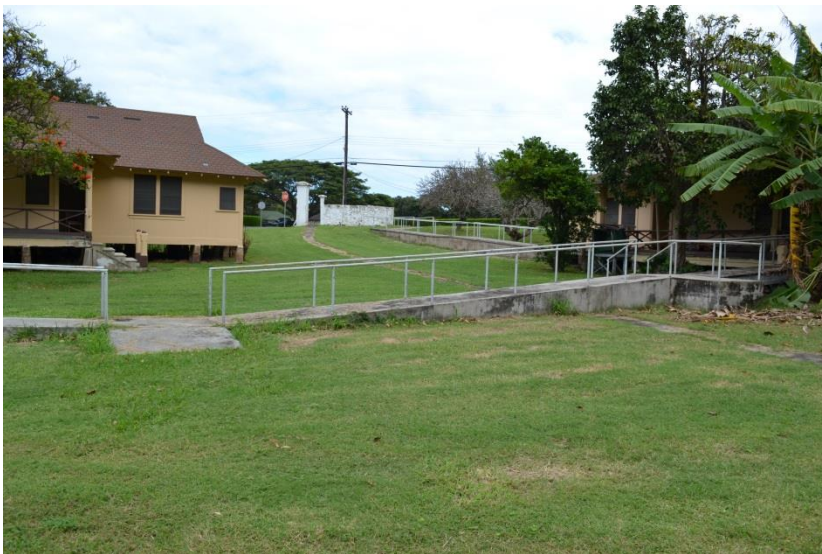
Figure 340. The concrete ramps placed over top of the historic concrete walks at Bay View Home are intrusive.

- Remove the concrete ramps placed over top of the original walks in the 1990s to reestablish historic patterns of circulation (Figure 340). Where concrete ramps are removed, rehabilitate the walks to match historic conditions. Provide an alternate accessible route that minimizes the impact on the historic scene. See *Settlement-Wide Design Guidelines: Accessibility* for guidance.

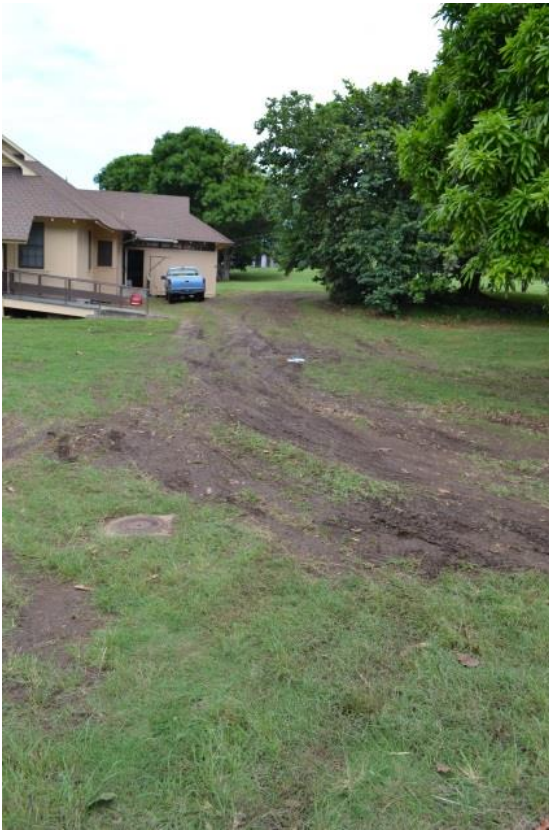
Figure 341. Use of the turf grass along the southern section of Bay View Loop Road has led to erosion.

- Establish designated parking spaces to replace ad hoc use of the turf grass area at the southern end of the complex. Consider siting new parking south of Old Bay View Kitchen and Dining Room where parking was historically located to replace use of the turf grass (Figure 341). See *Settlement-wide Design Guidelines: Parking* for guidance.

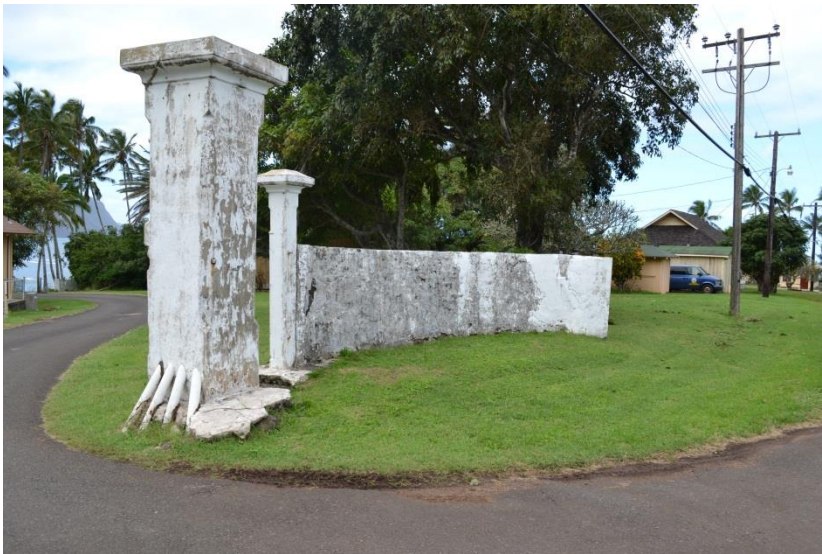
Figure 342. The gate posts at the entrance into Bay View Home are in need of repair and whitewashing or painting.

- Preserve and maintain in good condition contributing buildings and structures within the Bay View Home character area. Consider adaptive reuse or removal of non-contributing buildings and structures. Ensure that maintenance work or activities conducted to rehabilitate or repair the exteriors of historic buildings does not negatively impact landscape resources, including vegetation, planting beds, walks, and other features. Co-locate visitor amenities such as restrooms, concessions, and interpretation within existing buildings as they are adaptively reused.
- Repair and repaint the existing Bay View Home gate posts at the intersection of Damien Road and Bayview Loop Road, which are cracked and chipping (Figure 342).

- Repair, reset, and repaint the metal and concrete posts and chain that edge Bay View Loop Road.
- Repair and repaint the existing Bay View Home gate posts at the intersection of Damien Road and Bayview Loop Road.

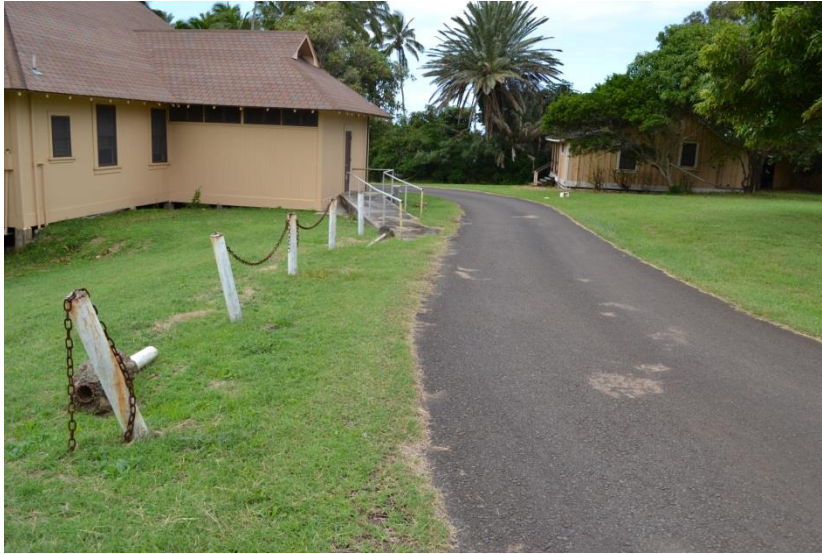
Figure 343. The metal and concrete posts that edge Bay View Loop along the north edge are in need of repair.

- Repair, reset, and repaint the metal and concrete posts and chain that edge Bay View Loop road to reflect historic conditions (Figure 343).
- Provide a bike rack in association with the parking area to promote and support bicycle use by park staff and visitors.

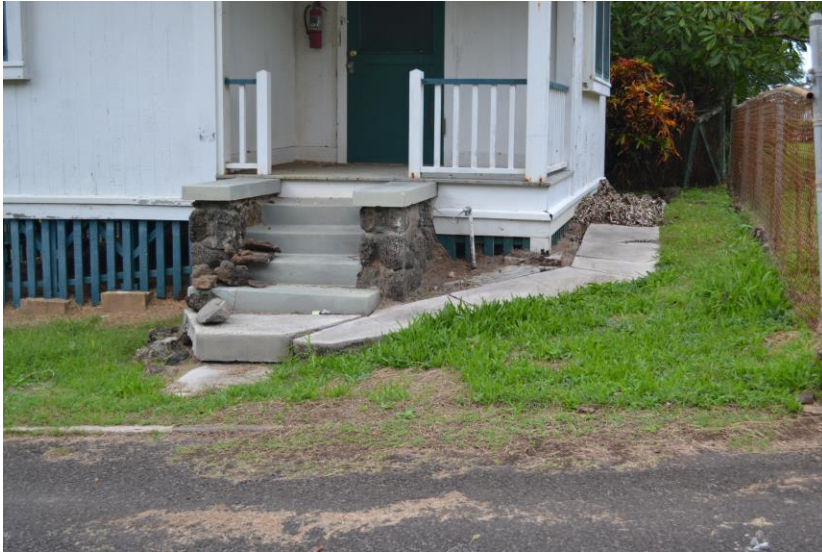
Figure 345. View of one of the McVeigh Home internal road curbs overgrown with turf grass.

- Preserve all historic roads.
- Remove turf grass growing into and over concrete road curbs and reestablish a clean edge between turf grass and the curb (Figure 345). Rehabilitation and repaving of the road surface in the future should include specifications for lowering the finish grade of the asphalt to ensure the historic profile and character of concrete curbing throughout the McVeigh Home is visible. Replace in kind any missing curb sections.

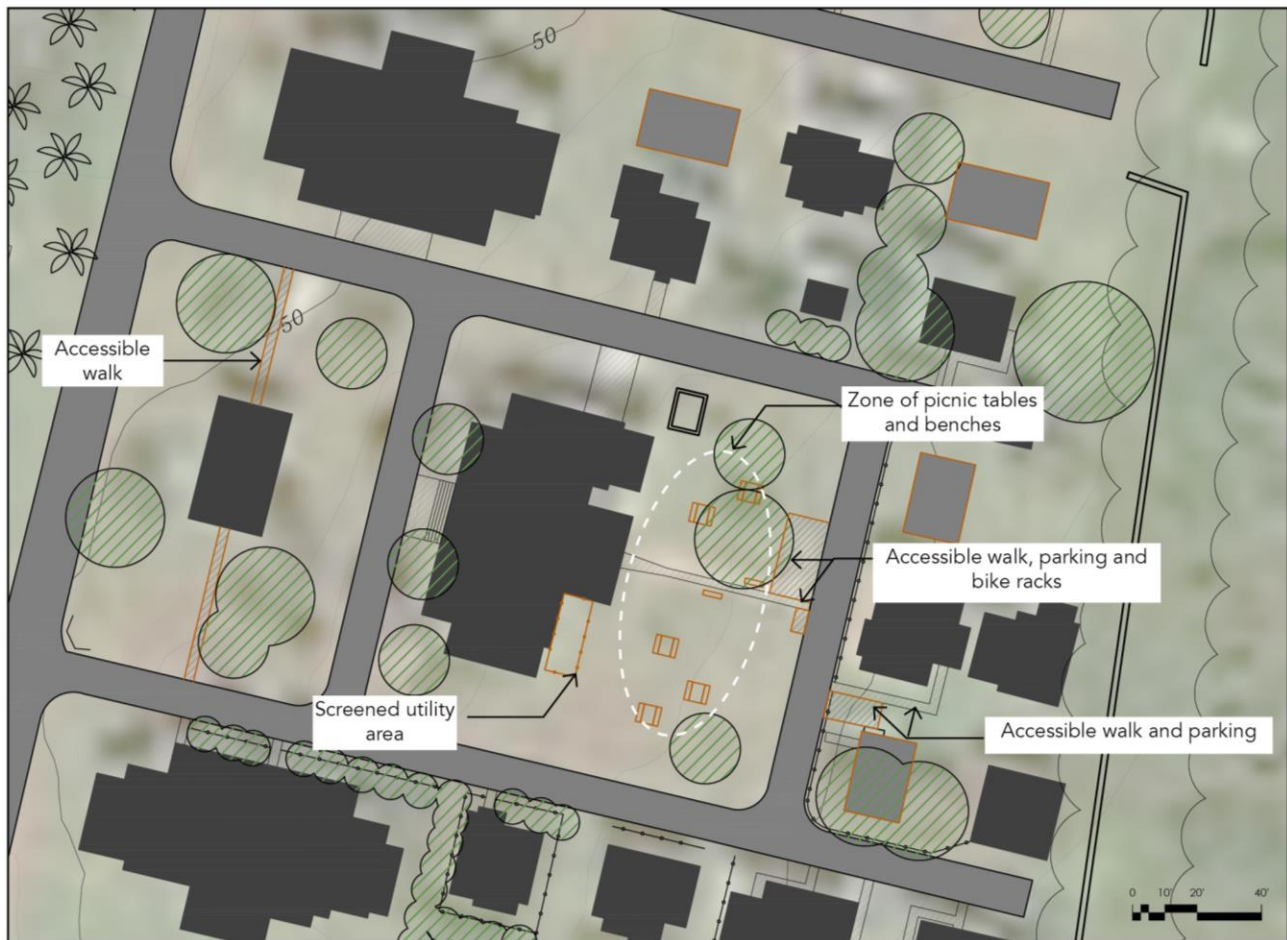
Figure 346. Detail of McVeigh Home showing locations of new accessible walks to the Social Hall and Pool Hall, accessible parking, screened utility features, and picnic tables and benches. (Source: LSHLA)

- Preserve historic walks between the road and individual cottages.
- Rehabilitate circulation throughout the McVeigh Home to address accessibility requirements related to future building and structure improvements following the *Settlement-Wide Design Guidelines: Accessibility* section. Ensure designated parking areas, walks, and access points to buildings create a unified system of access, taking into consideration appropriate design guidelines related to the use of compatible materials, forms, and transitions.
- Reestablish the concrete walk that historically provided access to the McVeigh Pavilion (Pool Hall) as an accessible route (Figure 346).

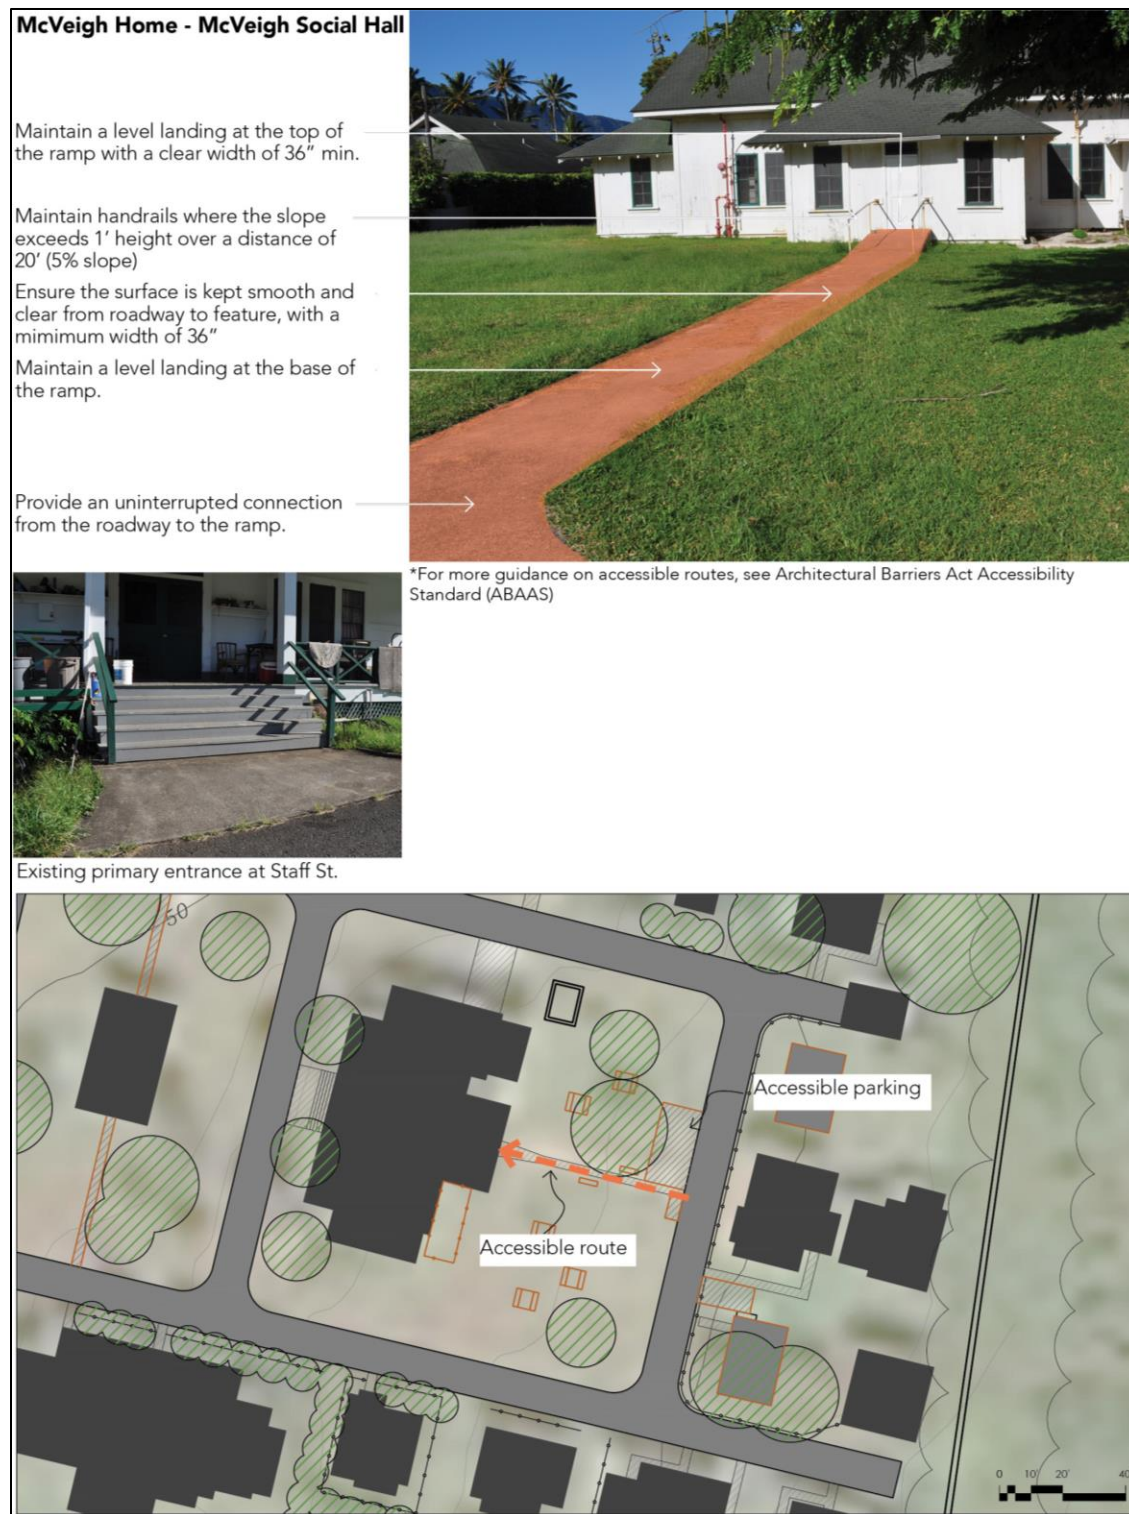
Figure 347. Illustrations indicating the provision of accessible parking and an accessible route for entering the McVeigh Social Hall. (Source: LSHLA)

- Rehabilitate the existing ramp on the east side of the Social Hall to ensure it meets code and provide an accessible parking space in association with the ramp (Figure 347).

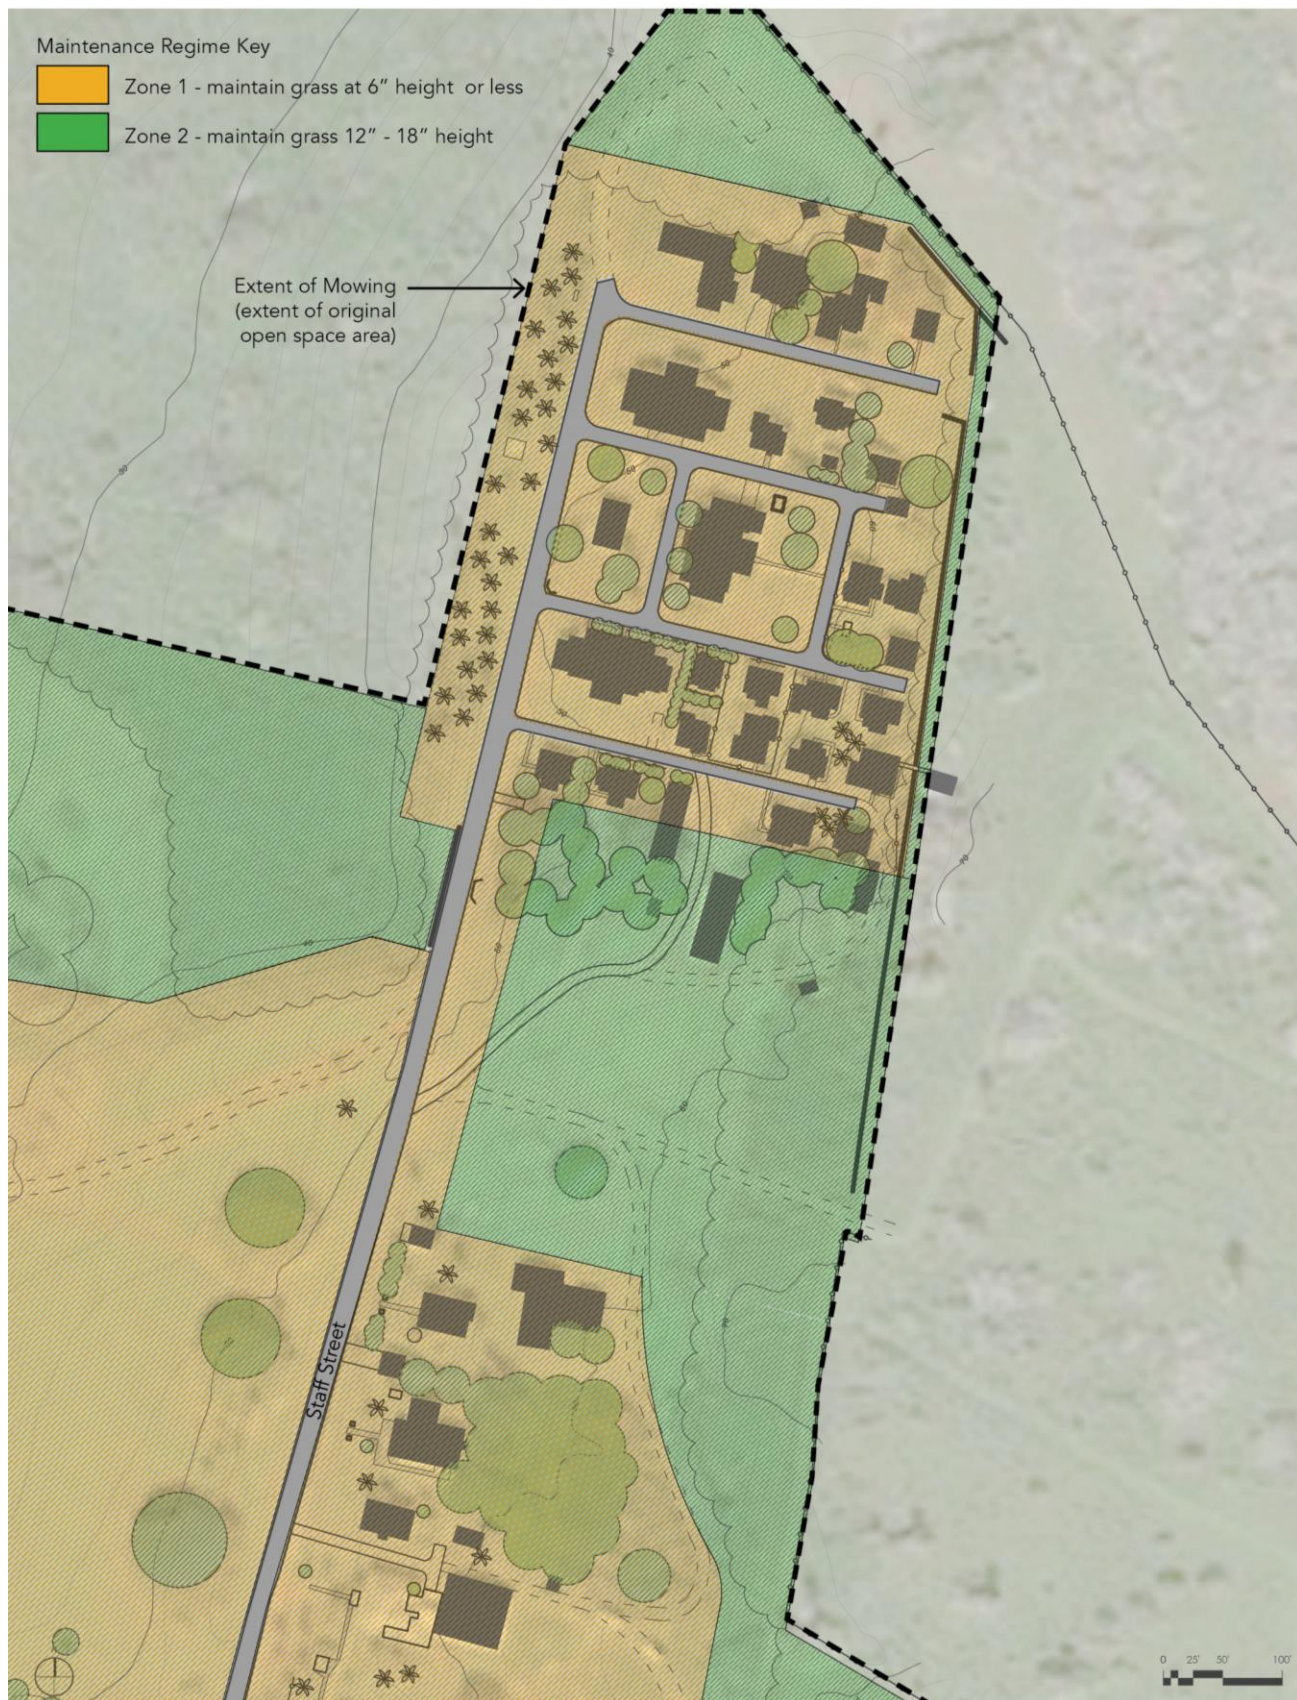
Figure 348. Diagram showing recommended mow height zones. (Source: LSHLA)

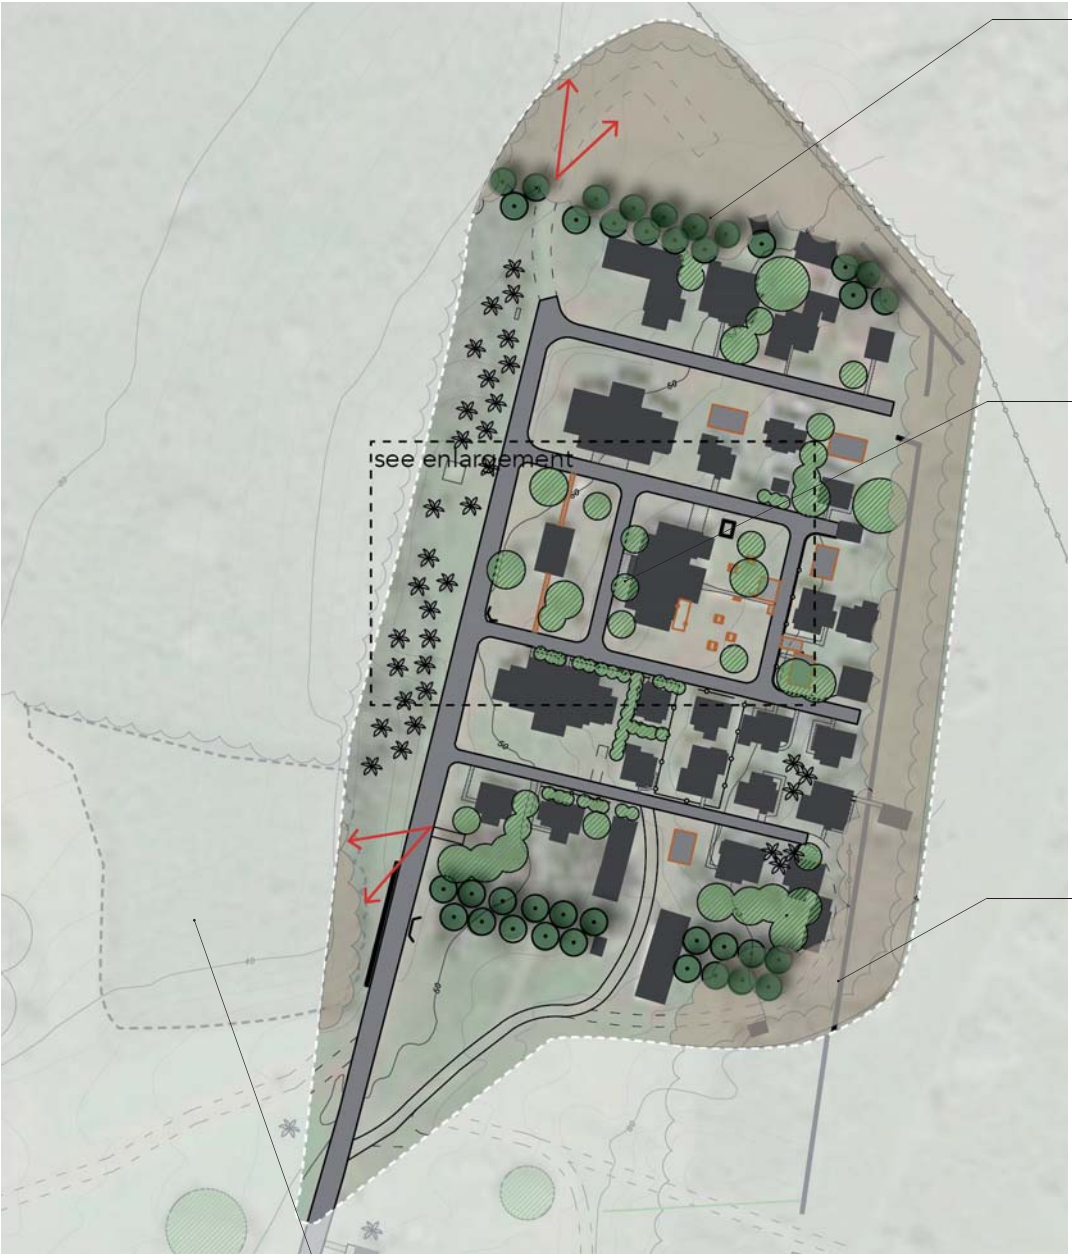
Figure 349

McVeigh Home Character Area
Treatment Recommendations

Refer to Figure 349, Treatment plan for the McVeigh Home Character Area.

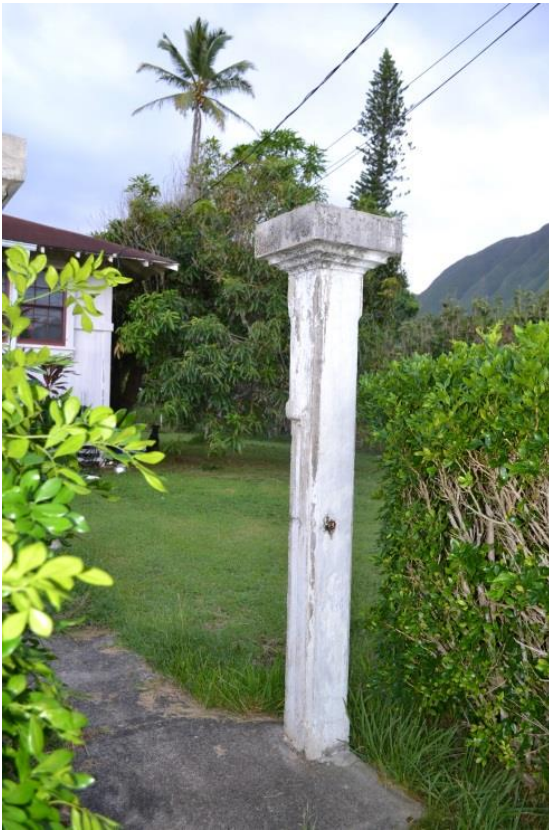
Figure 351. The gate posts associated with entrance walks at Staff Row are in need of repair and whitewashing or repainting.

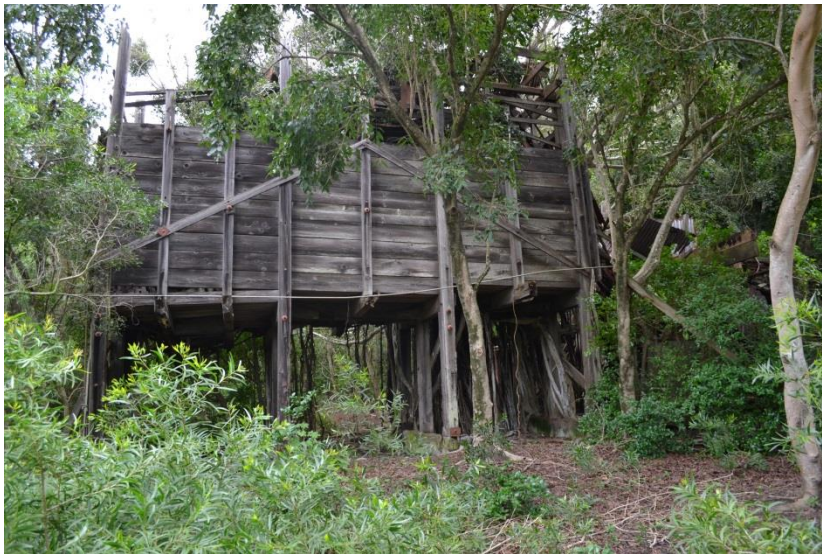
Figure 353. The historic Rock Crusher is currently overgrown with vegetation that poses a threat to preservation of the structure.

- Preserve and maintain contributing buildings and structures within the New Baldwin Home character area that include the Slaughterhouse, Slaughterhouse Restroom, Slaughterhouse Corral, New Baldwin Home Entrance Gate and Rock Walls, Grotto and Garden Structure, and Rock Crusher.
- Provide structural shoring of the rock crusher to allow vegetation removal. Remove vegetation growing on and within the Rock Crusher (Figure 353). Cut trees and other woody species growing through the wall flush with the ground, or as close to the ground as can be reached. Apply a systemic herbicide to the cut end to avoid regrowth. Stabilize the structure and interpret it for visitors. If the Rock Crusher can be stabilized, consider opening it up for visitor interpretation, after adding signage that asks visitors to refrain from accessing the Rock Crusher.

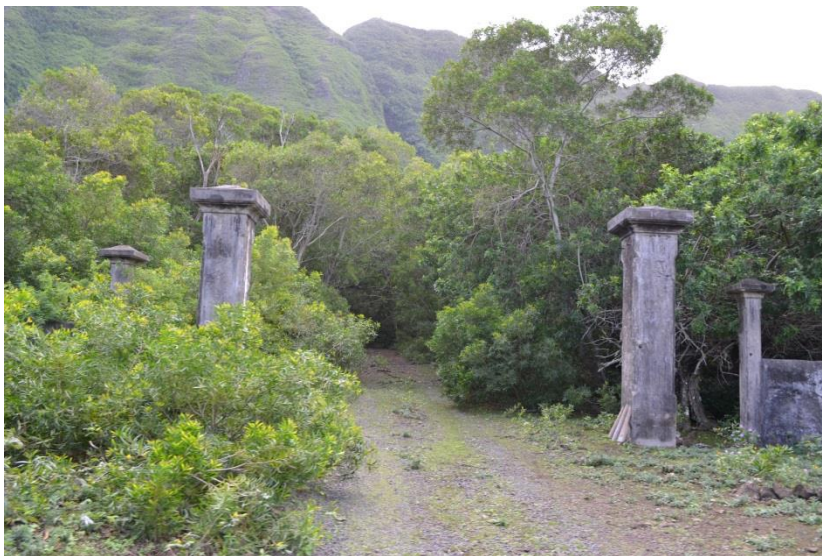
Figure 354. The gate piers and rock walls at New Baldwin are overgrown with vegetation and in need of repair.

- Repair the dry stacked lava rock wall and concrete wall segments and repair and repaint the gate piers at the entrance to New Baldwin Home (Figure 354). Maintain the wall free of vegetation. See *Settlement-wide Guidelines: Rock Walls* for guidance.

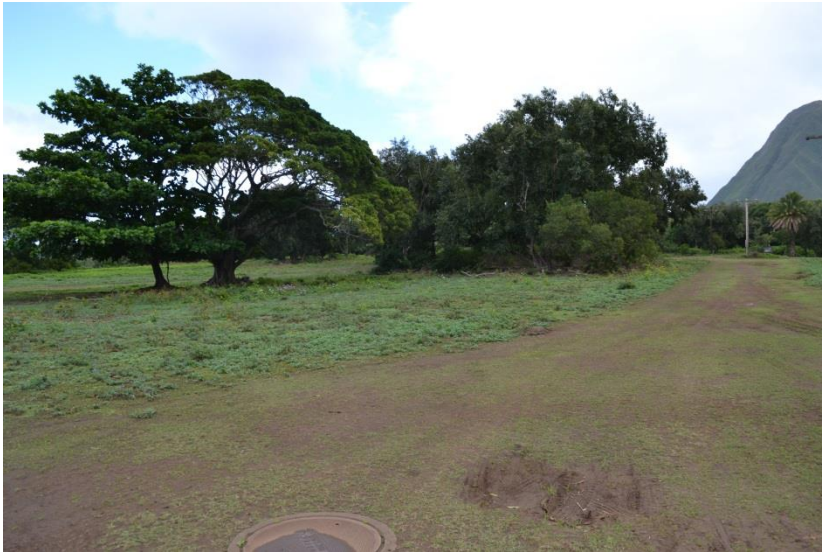
Figure 355. The open space northwest of New Baldwin Home is rutted and eroded, with numerous roads in use. Repair of the road and establishment of a grass and forb field would enhance the appearance of this Settlement entrance corridor.

appearance and prevent further erosion (Figure 355). Work with the community to determine their interest in implementing this recommendation. Establish new fencing to exclude axis deer and feral hogs in the least intrusive manner possible.
