Kalaupapa and Kalawao Settlements Cultural Landscape Report

Kalaupapa National Historical Park

Cultural Landscape Report

Prepared by:
Wiss, Janney, Elstner Associates, Inc.
2000 Powell Street, Suite 1650
Emeryville, California 94608

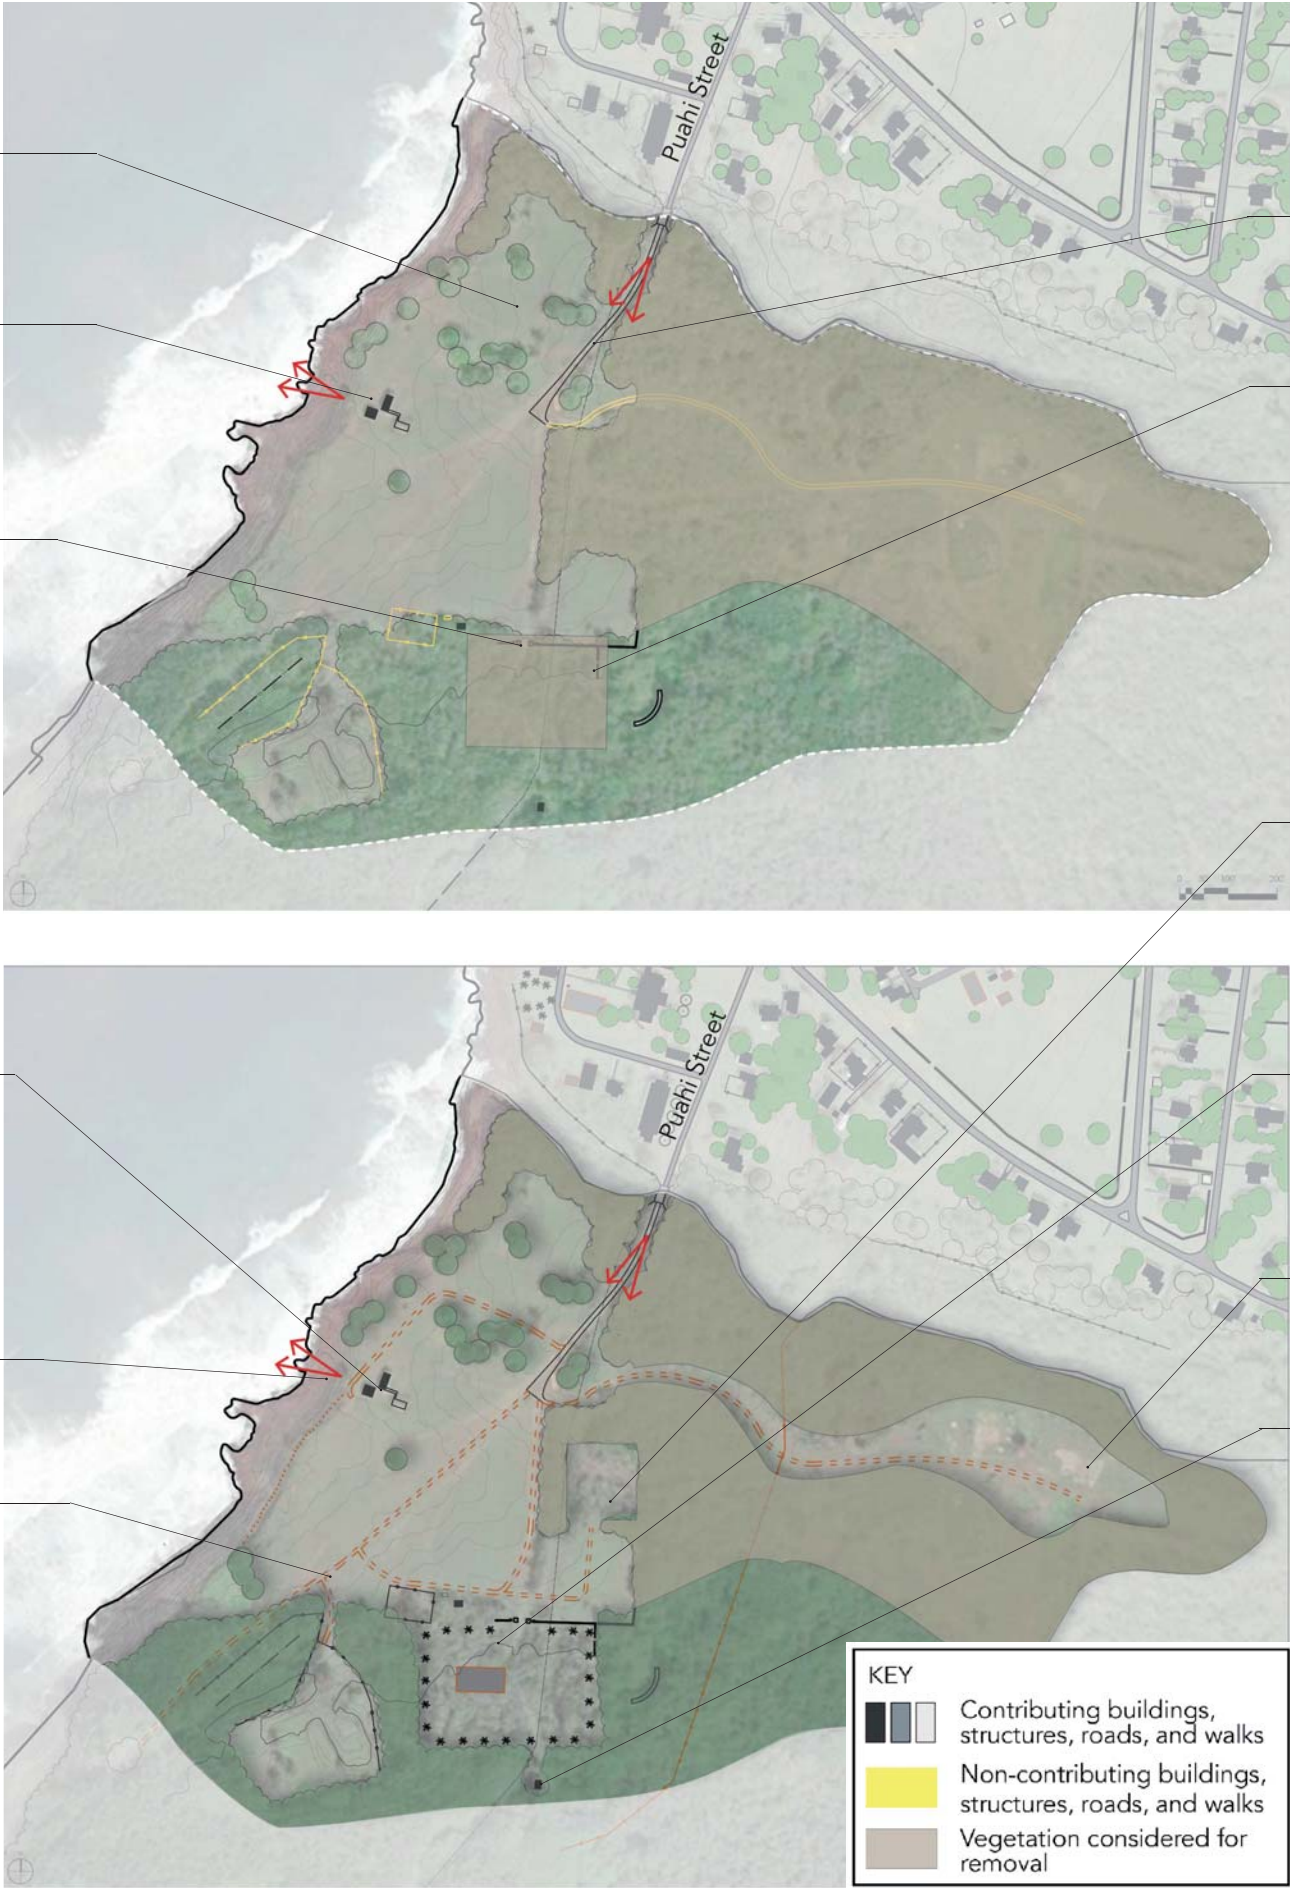
Figure 356

**New Baldwin Home Character Area
Treatment Recommendations**

Refer to Figure 356, Treatment plan for the New Baldwin Home Character Area.

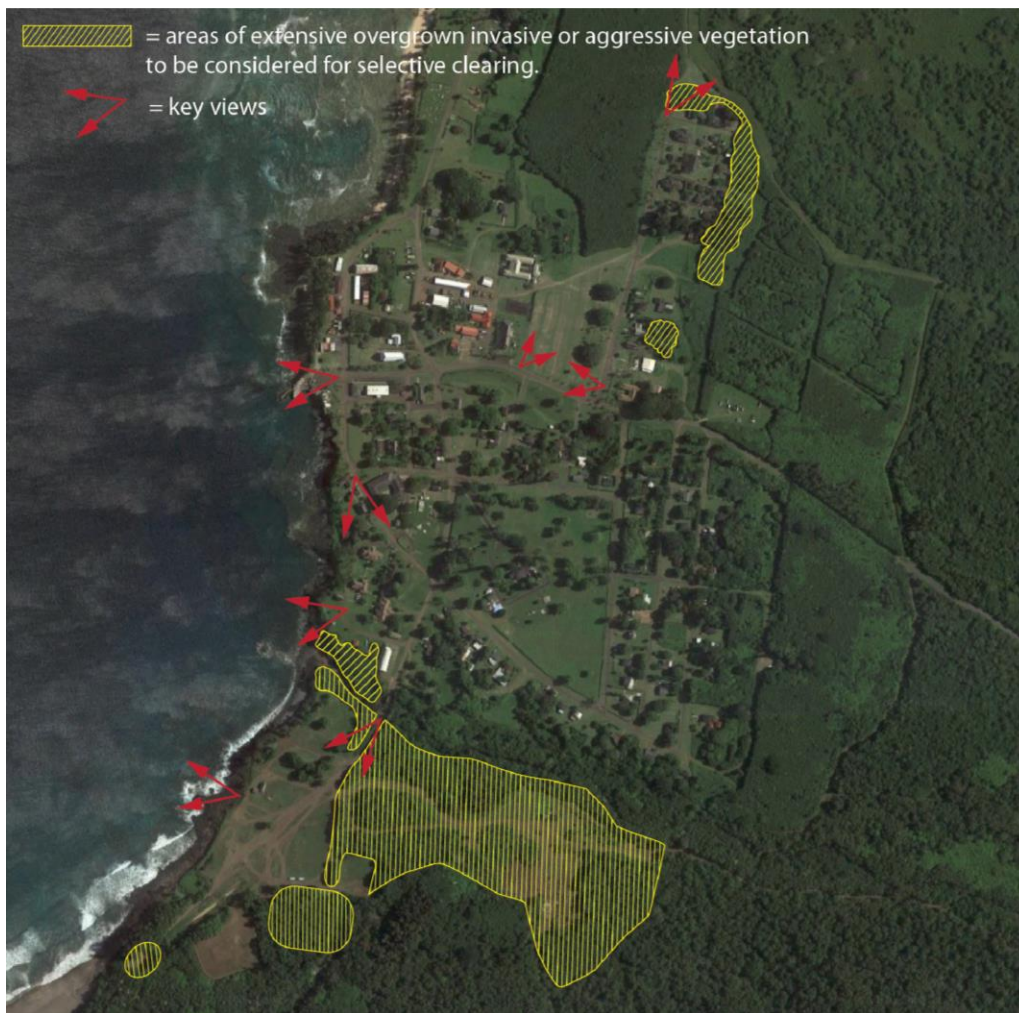
Figure 360. Diagram indicating the relationship between key views and proposed areas recommended for selective clearing at Kalaupapa. (Source: LSHLA)

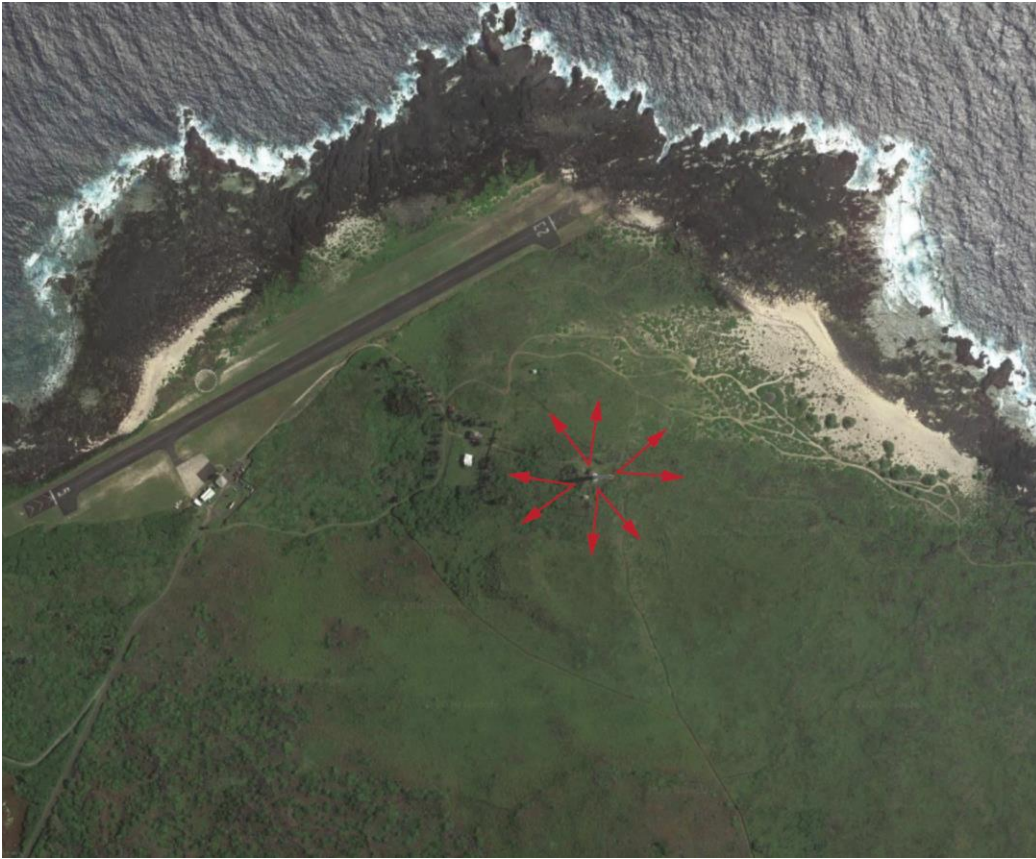
Figure 361. Diagram indicating the key views (red arrows) at Moloka'i Light Station. (Source: LSHLA)

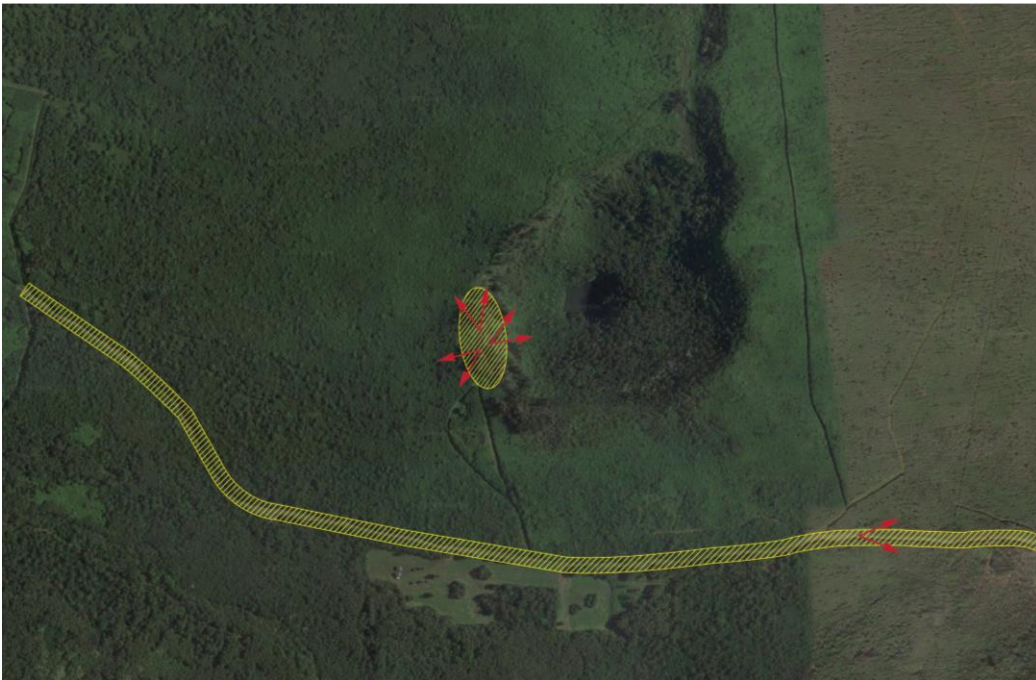
Figure 362. Diagram indicating the relationship between key views (red arrows) and proposed areas recommended for selective clearing (yellow hatching) at Damien Road corridor and Kauhakō Crater. (Source: LSHLA)

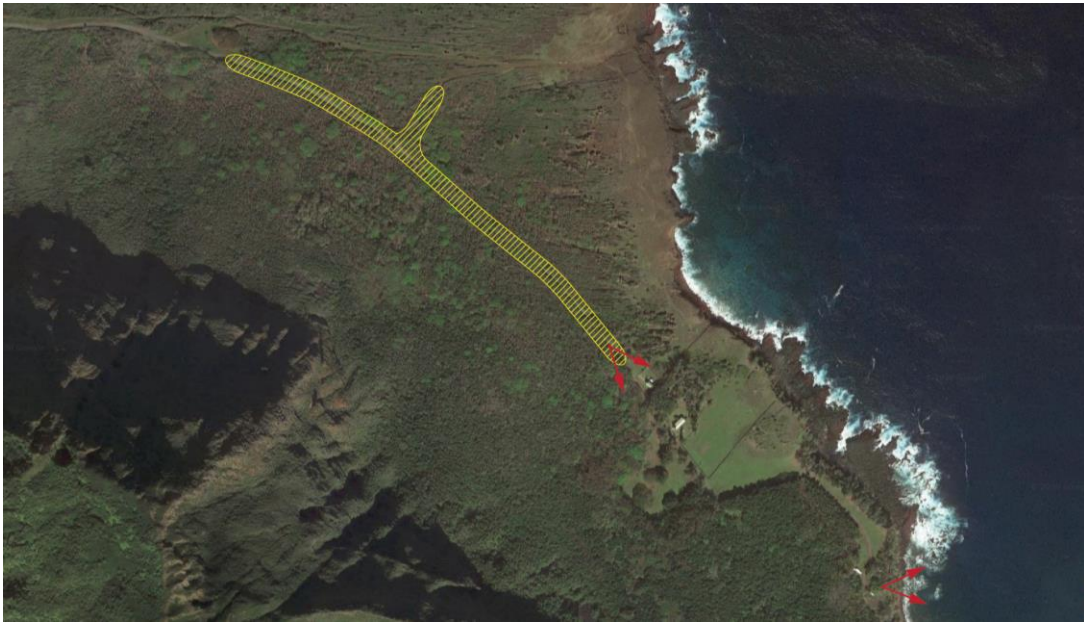
Figure 363. Diagram indicating the relationship between key views (red arrows) and proposed areas recommended for selective clearing (yellow hatching) at Kalawao. (Source: LSHLA)

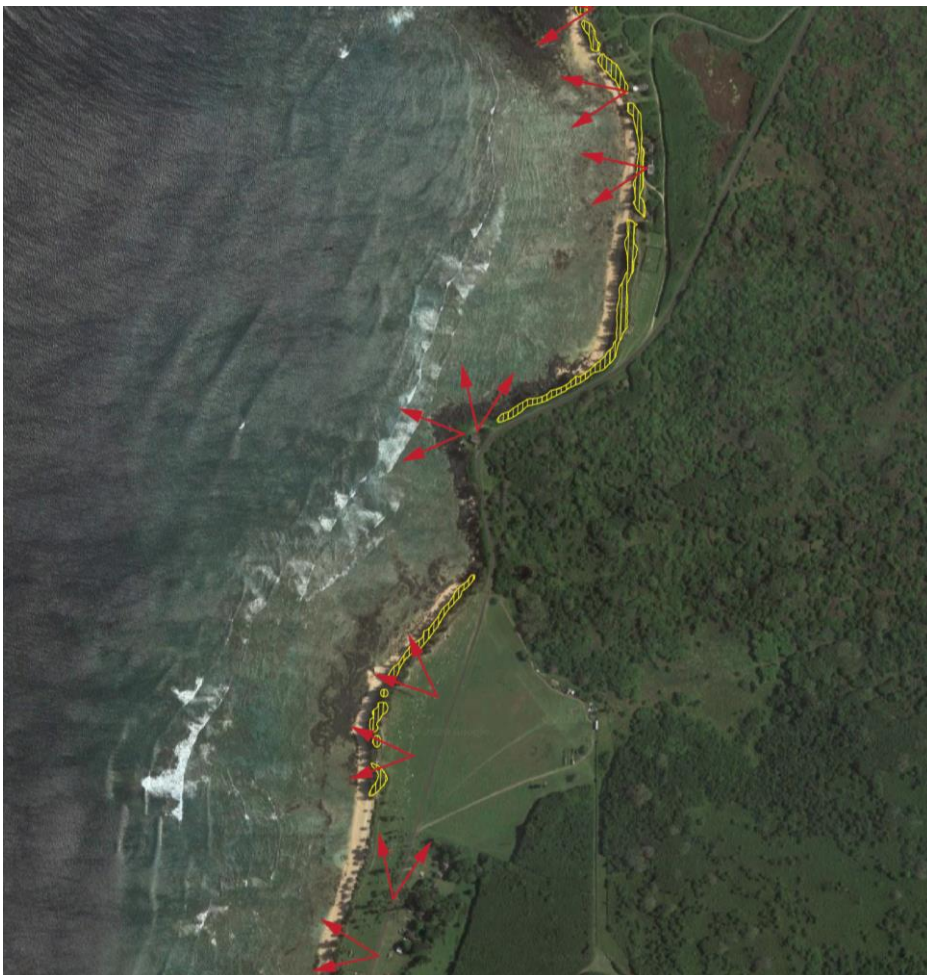
Figure 364. Diagram indicating the relationship between key views (red arrows) and areas recommended for selective thinning and clearing along the western shoreline (yellow hatching). (Source: LSHLA)

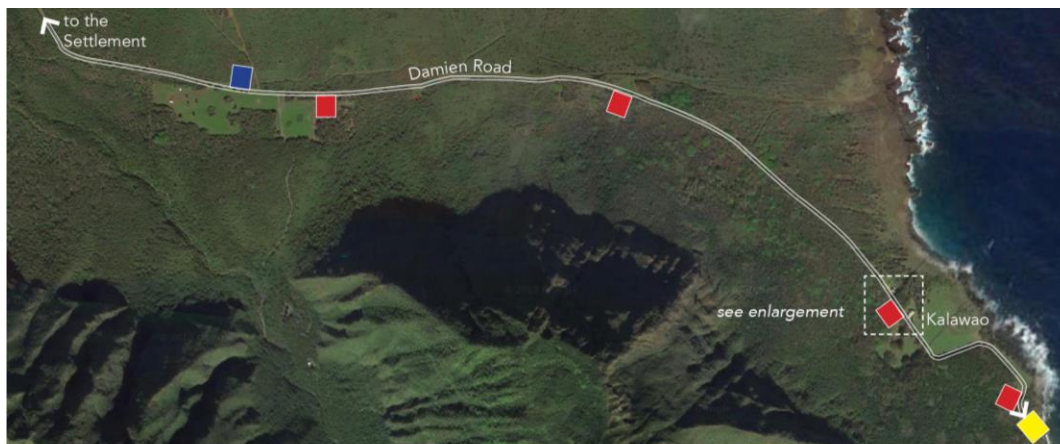
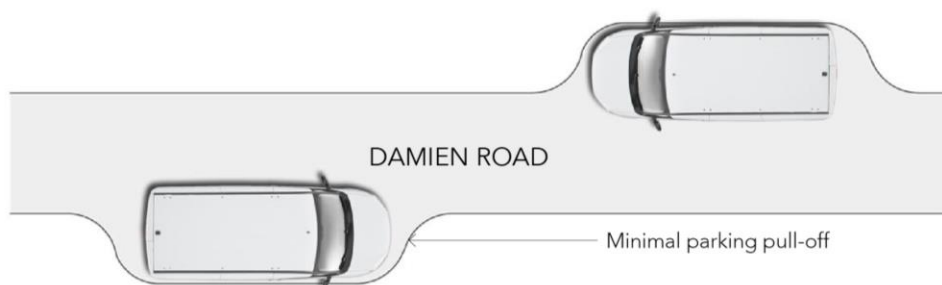
PARKING PULL-OFFS AT DAMIEN ROAD

- Single allocated accessible van space added on north side of Damien Road
- Single allocated accessible van space added on south side of Damien Road
- Existing parking area improved to allow up to 5 vehicles with potential spillover parking options during larger events

Figure 366. Diagrams indicating the proposed locations (top) and form (bottom) of parking pull-offs recommended for Damien Road. (Source: LSHLA)

- Establish accessible parking along Damien Road between St. Philomena and Siloama Churches that meets ABAAS scoping requirements. Evaluate the most suitable grade and conditions for creating a level pull-off. Provide accessible surface conditions for the parking and an accessible aisle, and connect it to the churchyards and entrances into the buildings with an accessible route (Figure 367).

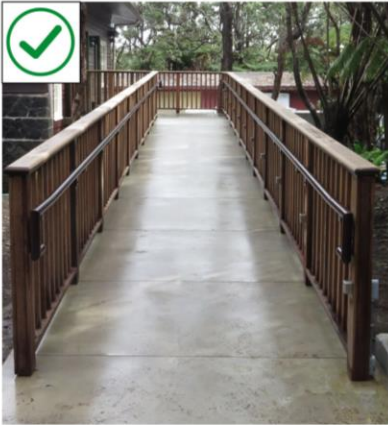
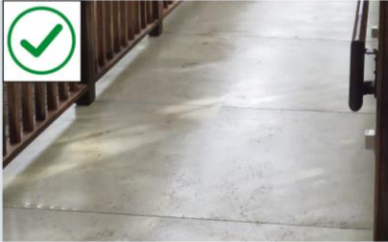
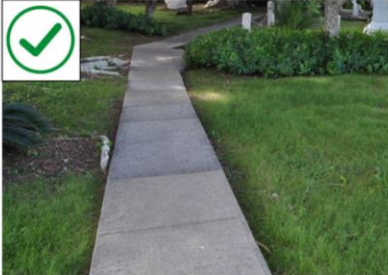
CLEAR WIDTH
Provide a minimum clearance of 36" for all walks and ramps, and an ideal width of 60" where possible at primary building entries. Maintain a consistent width except where ramp landings may be required to be wider. If a walk leads to a ramp, the ramp should be the same width as the walk. Vegetation and other impediments should be kept off all surfaces.

MATERIAL CONSISTENCY
Construct walks and ramps entirely of concrete to access public buildings and features, unless unachievable based on site conditions. Maintain a smooth, clean and consistent surface.

On ramps over 5%, utilize handrails painted or powder-coated grey to match the color palette of the concrete ramp.

VISUAL COHESION & MAINTENANCE
Retain concrete in its natural color to maintain visual cohesion and avoid unnecessary maintenance that would be required for painted surfaces. Maintain a clean surface and repair when needed to maintain the surface color and consistency.

EASE OF ACCESS
Maintain shallow slopes where possible to provide ease of access.

Avoid placing ramps on top of existing stairs that provide public access unless building or site conditions exclude other options for an accessible entry. Consider, instead, ramps that are adjacent to stairs and utilize the same landing.

HANDRAILS
Handrails should be added on all slopes over 5%. Handrails should be provided on both sides of ramps over 36" wide and maintain a consistent rail profile.

CONTIGUOUS CONNECTION
Provide an accessible route to a primary entrance or a public entrance that is visible from the adjacent roadway. Ensure an uninterrupted connection from adjacent road or driveway to the walk or ramp utilizing a consistent material.

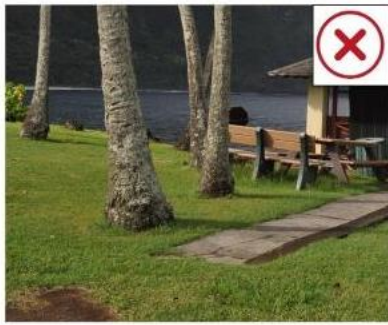
< ISSUE: Path does not connect to an adjacent roadway.

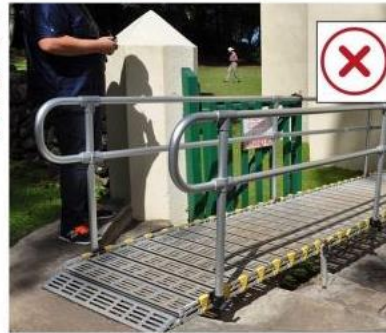
> ISSUE: Ramp material is visually incompatible, ramp is set on top of existing public access stair, slope isn't accessible.

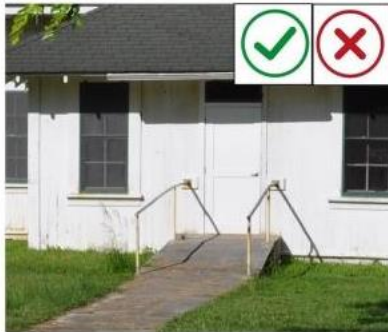
< Handrails are provided on both sides of ramp

ISSUES:
A landing is required at the top and bottom of the ramp. The ramp should not exceed a 1:12 slope. Handrails should extend 12 inches minimum beyond the bottom of the ramp run.

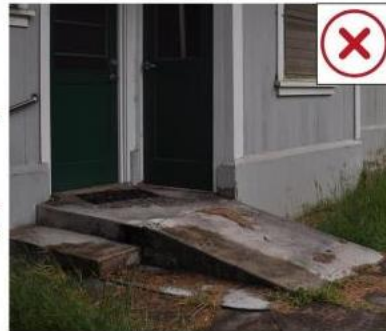
> ISSUE: Missing handrail.

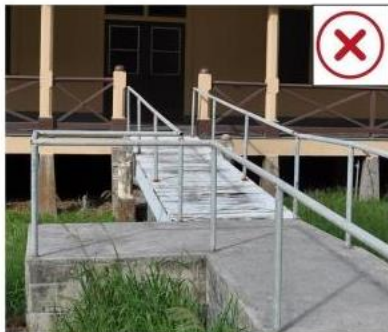
< ISSUE: Surface changes from concrete to wood.

ISSUE: Lower landing is inconsistent with adjacent ramp and roadway.

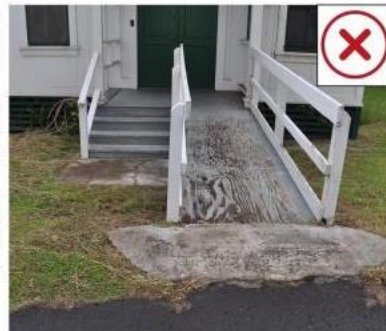
> ISSUE: Ramp placed on top of existing stair.

ISSUE: Ramp is missing appropriate handrails and a landing at the bottom that meets requirements.

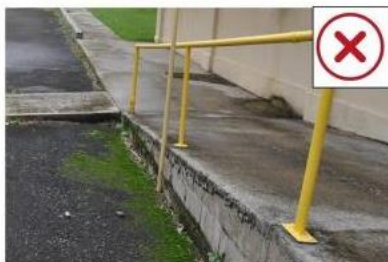
< ISSUE: Handrail is painted yellow.

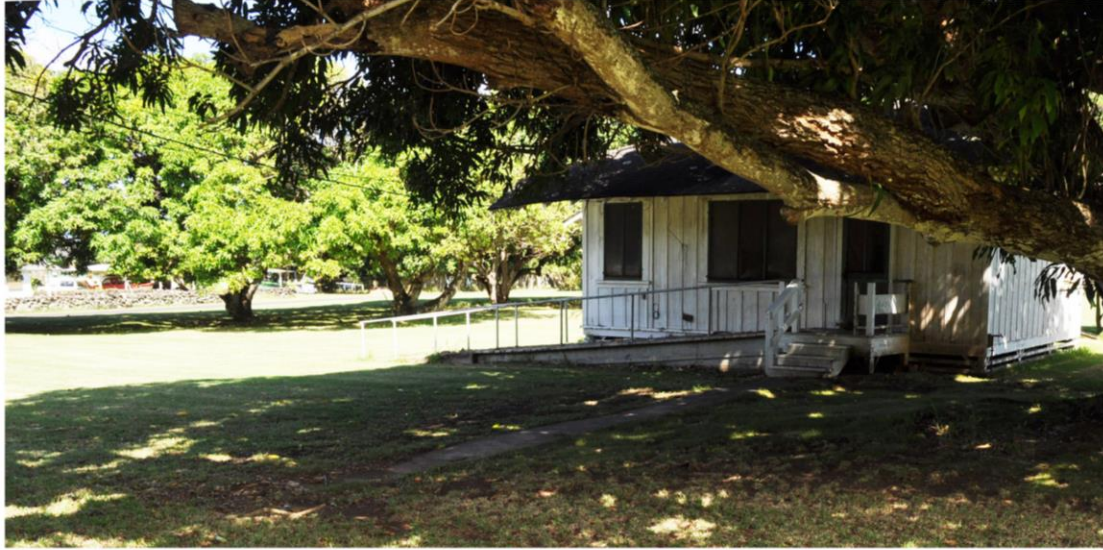
- If an accessible route to the primary entry isn't feasible, provide an accessible route to a secondary entrance.
- Provide an uninterrupted connection from the adjacent road to the ramp.
- Provide a clear width of 36" minimum.
- Provide a level landing at the top and bottom at least as wide as the ramp leading to it.
- Maintain a smooth, clear and consistent surface - suggested surfaces include concrete and wood.
- Provide a handrail along both sides of the ramp - suggested material is steel, powder coated a dark color. Maintain consistency of rail profile and color.

Wooden plank ramp with metal handrails
Kalaupapa Settlement - photo by LSHLA

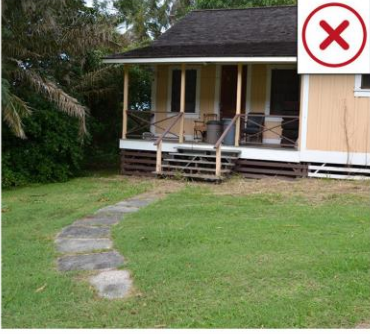
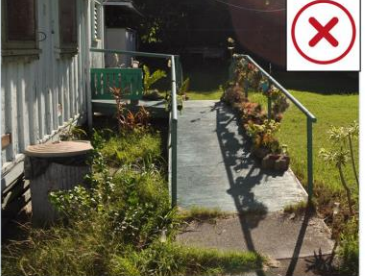
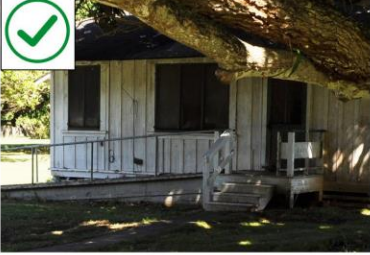
CONSISTENCY
Maintain consistency from access route to walk or ramp ensuring width is maintained at a minimum of 36". Maintain a consistent width for entire length except where landings may be required to be wider. Where possible, maintain material consistency.

MATERIALITY
When needed, construct ramps out of wood boards to access private residences and other buildings.

VISUAL COHESION
Paint wood light grey to provide visual cohesion. Maintain a clean and smooth surface. Utilize galvanized tube steel handrails painted or powder-coated light grey to match the color of the wood ramp.

CLEAR WIDTH
Provide a minimum clearance of 36" for all ramps. If a walk leads to a ramp, the ramp should be the same width as the walk, with a minimum width requirement of 36". Vegetation and other impediments should be kept off all surfaces. Provide a level landing at the top and bottom at least as wide as the ramp leading to it.

PLACEMENT
Avoid placing ramps on top of existing stairs that provide access. Instead, place ramps adjacent to utilize the same landing.

HANDRAILS. Handrails should be added on all slopes over 5%. Handrails should be provided on both sides of ramps over 36" wide and maintain a consistent rail profile.

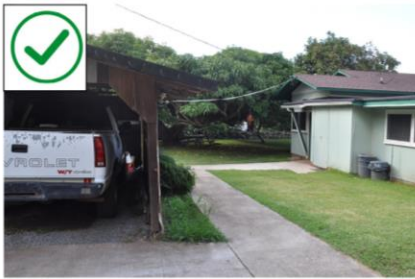
<
Direct accessible route provided
from adjacent carport to
secondary entry.

Path is minimum 36" wide

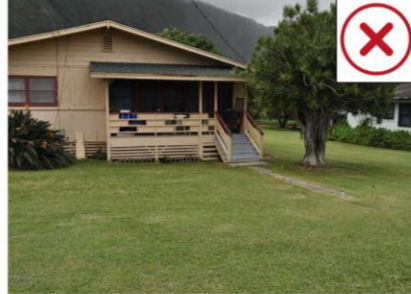
>
ISSUE: Path is too narrow
and doesn't connect
to adjacent roadway or
driveway.

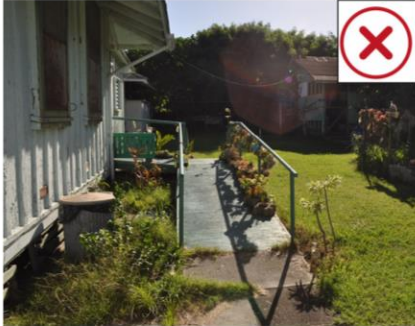
<
ISSUES:
Ramp surface material changes.

Ramp surface and handrail are
painted green.

Ramp width is not clear with
impediments and vegetation
growing on it.

Handrails should extend 12
inches minimum beyond the
bottom of the ramp run.

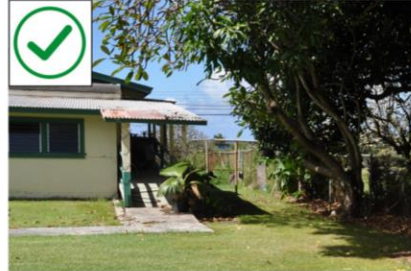
>
Ramp and path is provided
to secondary entrance.

Path and ramp are same
width, minimum 36"

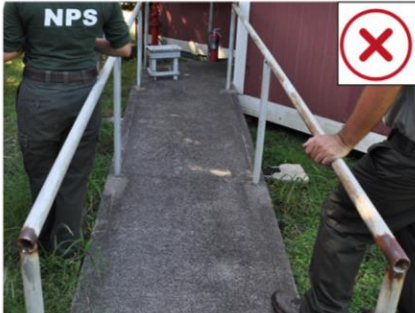
<
ISSUE: Handrail is in need of
repair.

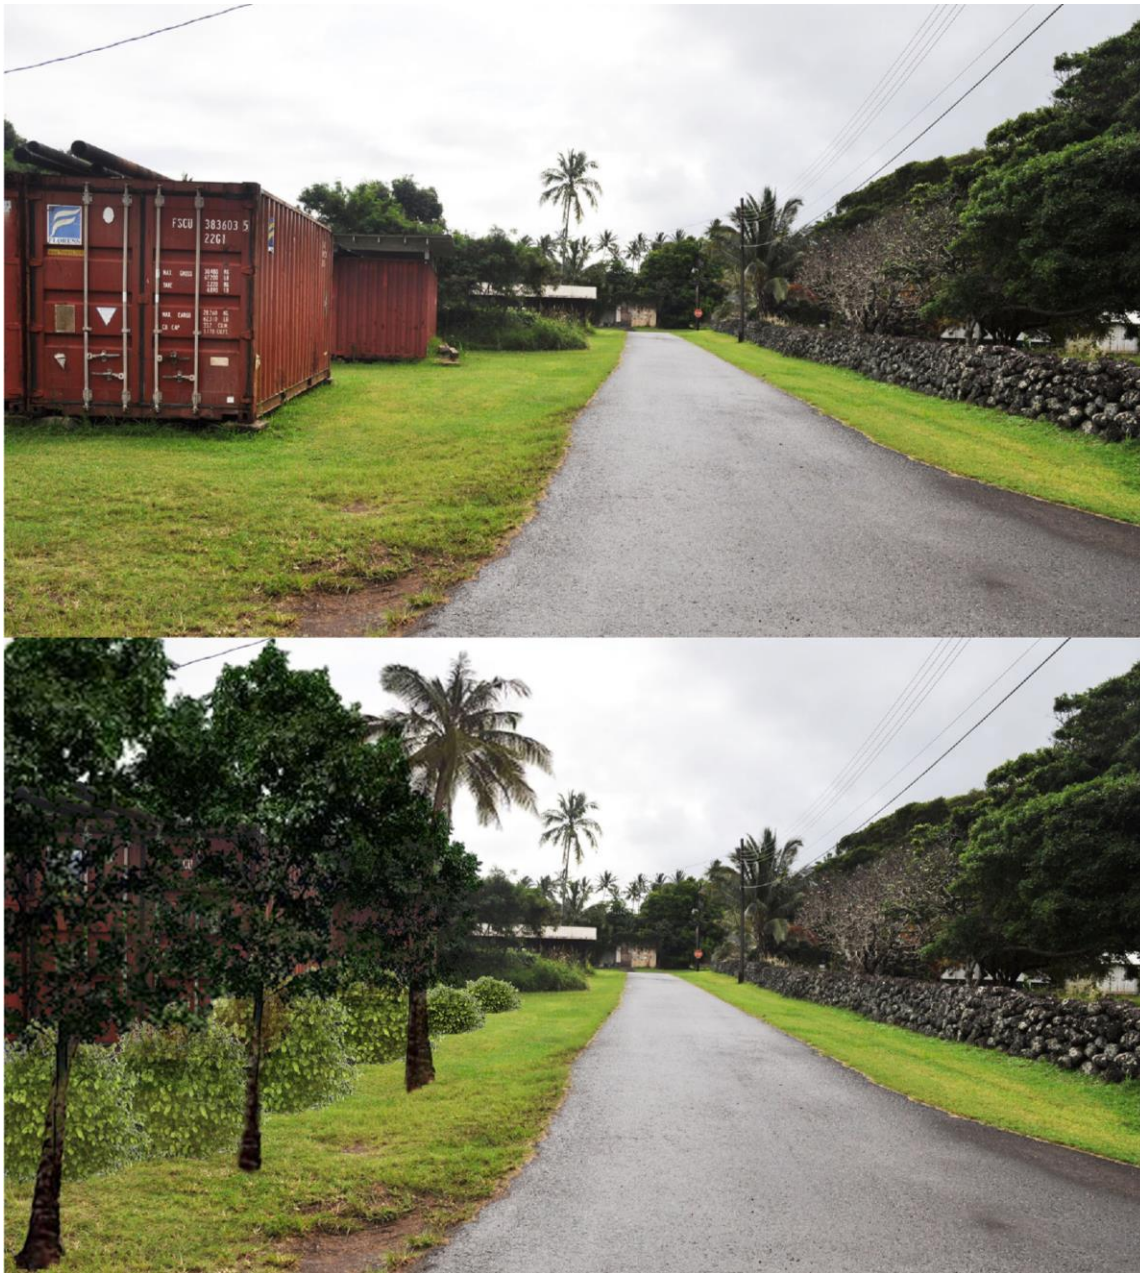
Figure 377. Diagram illustrating the character of screen plantings to limit views of incompatible features from primary roads. (Source: LSHLA)

- Consider using trees and shrubs to screen views of incompatible features from primary roads. Consider species that are effective in limiting views, but are of themselves attractive to look at and compatible with the plant palette already present within the Settlements (Figure 377).

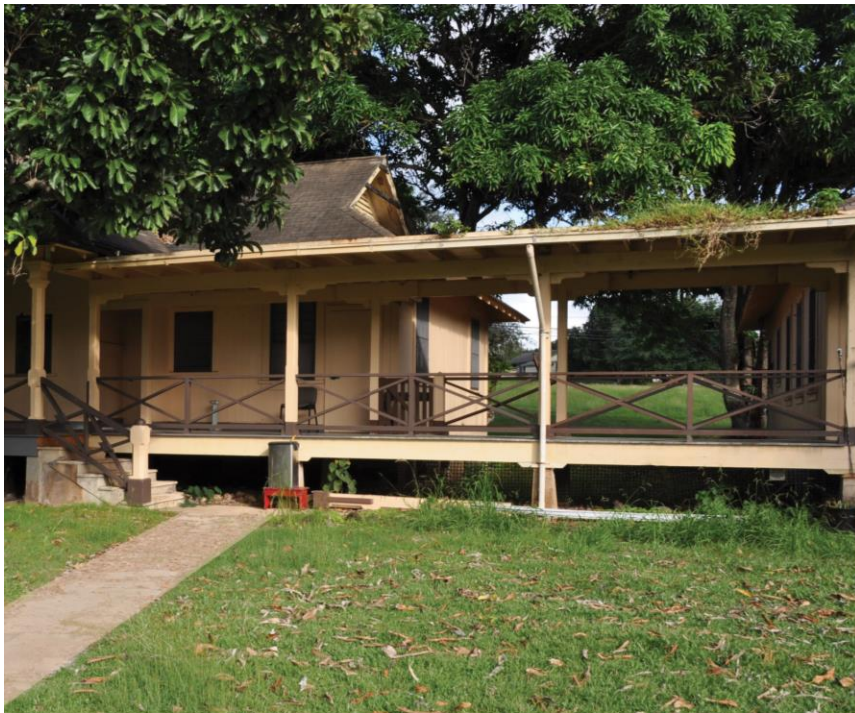
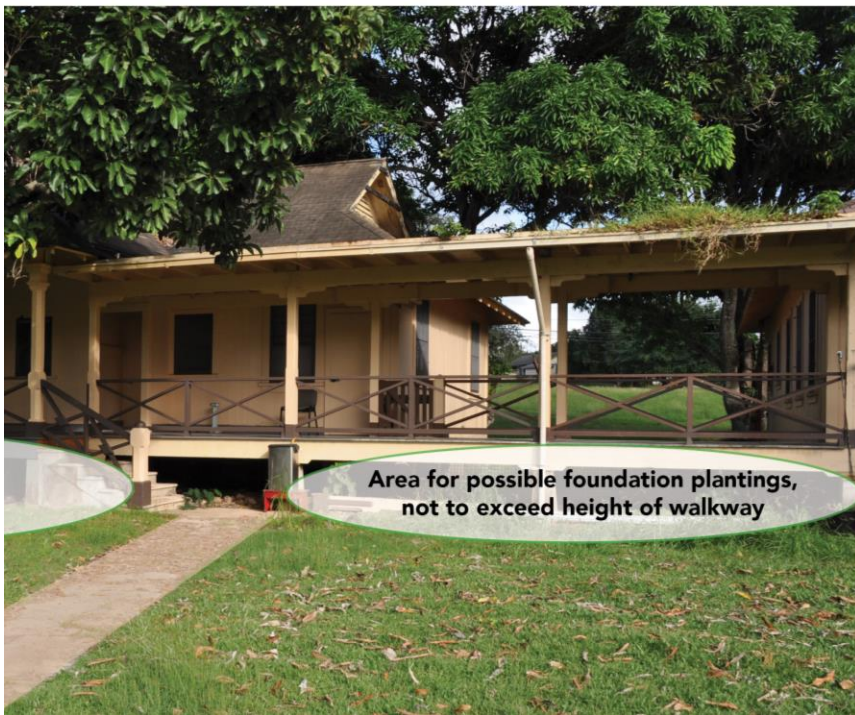
Figure 379. Example of how to implement recommended foundation planting rehabilitation. (Source: LSHLA)

- Select plants for inclusion in individual foundation plantings based on the character of the plants designed to complement the historic setting and architecture (Figure 379).

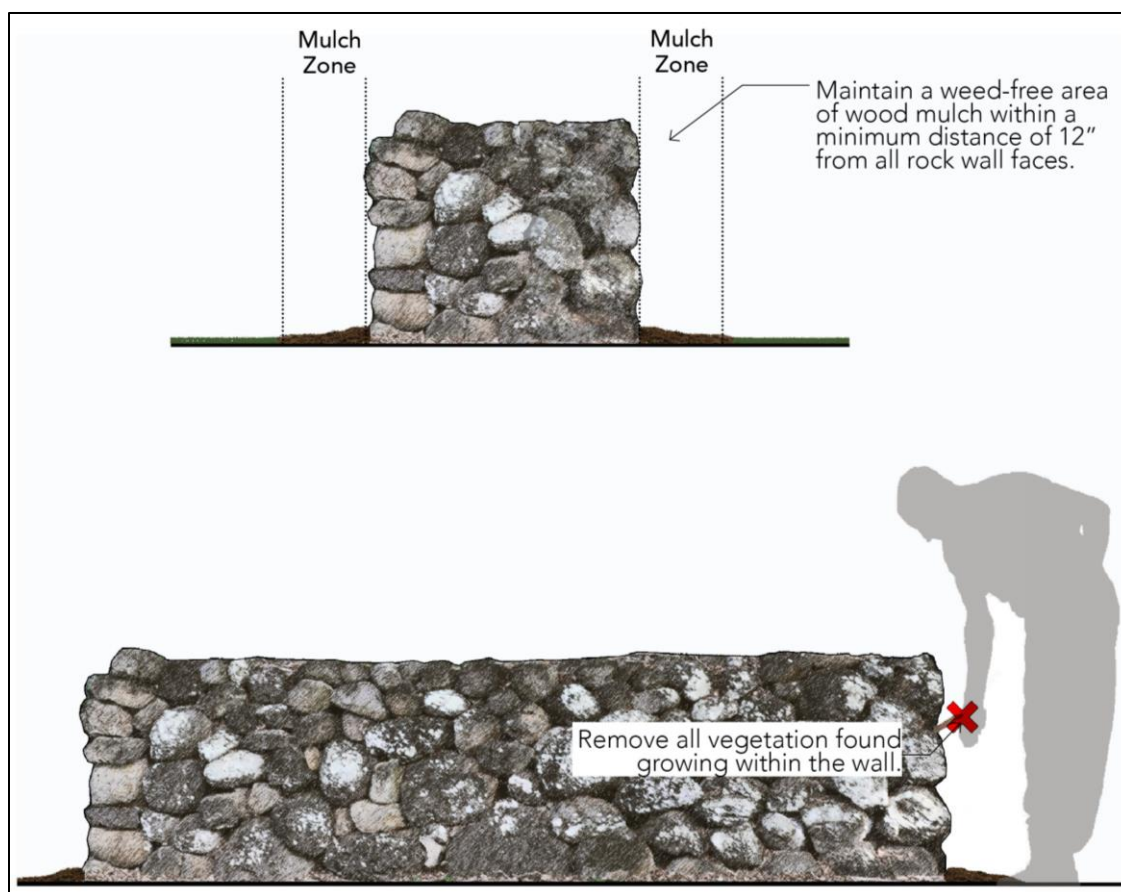
Figure 381. Diagram illustrating vegetation management related to rock walls. (Source: LSHLA)

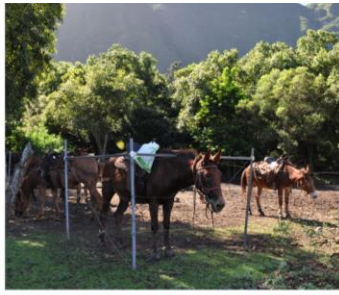
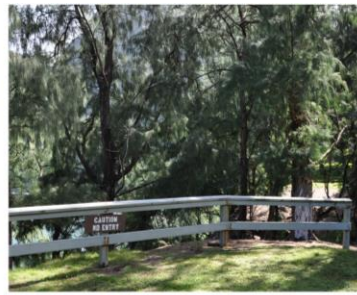
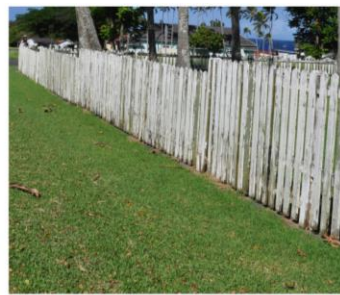
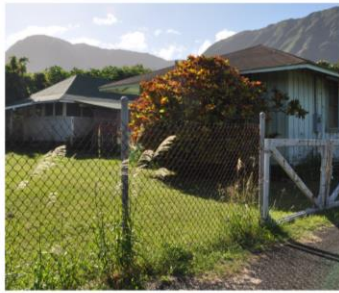
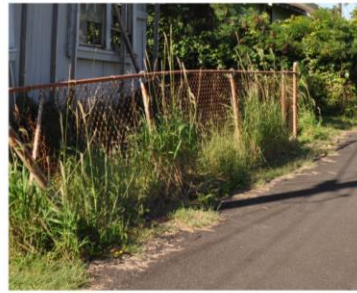
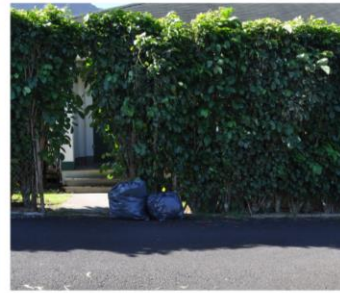
Figure 382. Fence typologies at Kalaupapa and Kalawao Settlements, 2018. (Source: LSHLA)

Fence typologies observed at the Settlements are shown in Figure 382.

- Based on review of the fencing typologies (refer to Figure 382), the fence styles shown in Figure 383 through Figure 385 are recommended for proposed new fencing, including safety fencing along the shoreline margins.

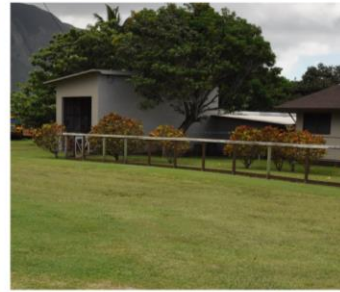
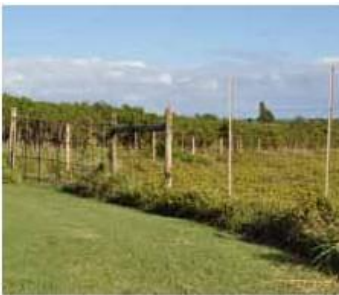
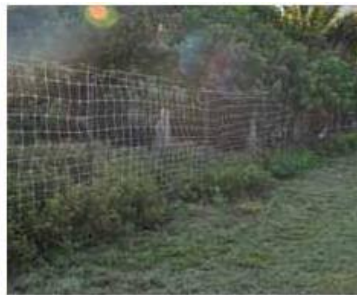
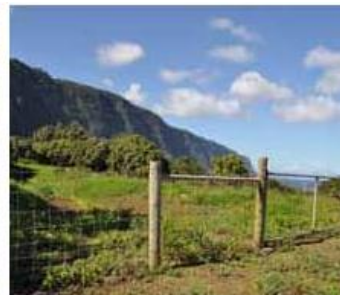
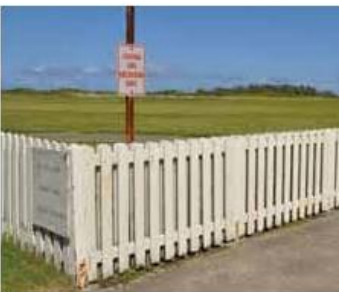
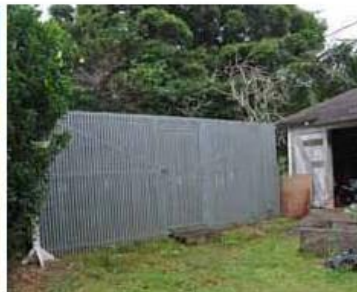
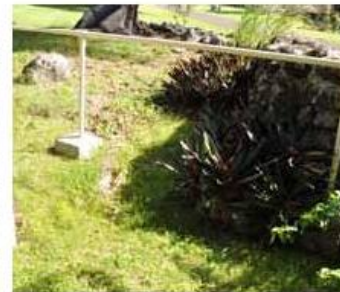
fencing at residence

deer fencing near McVeigh Home

deer fencing along Kamehameha St.

deer fencing near New Baldwin Home

fencing at airport

fencing at Kana'ana Hou

fencing at Father Damien Monument

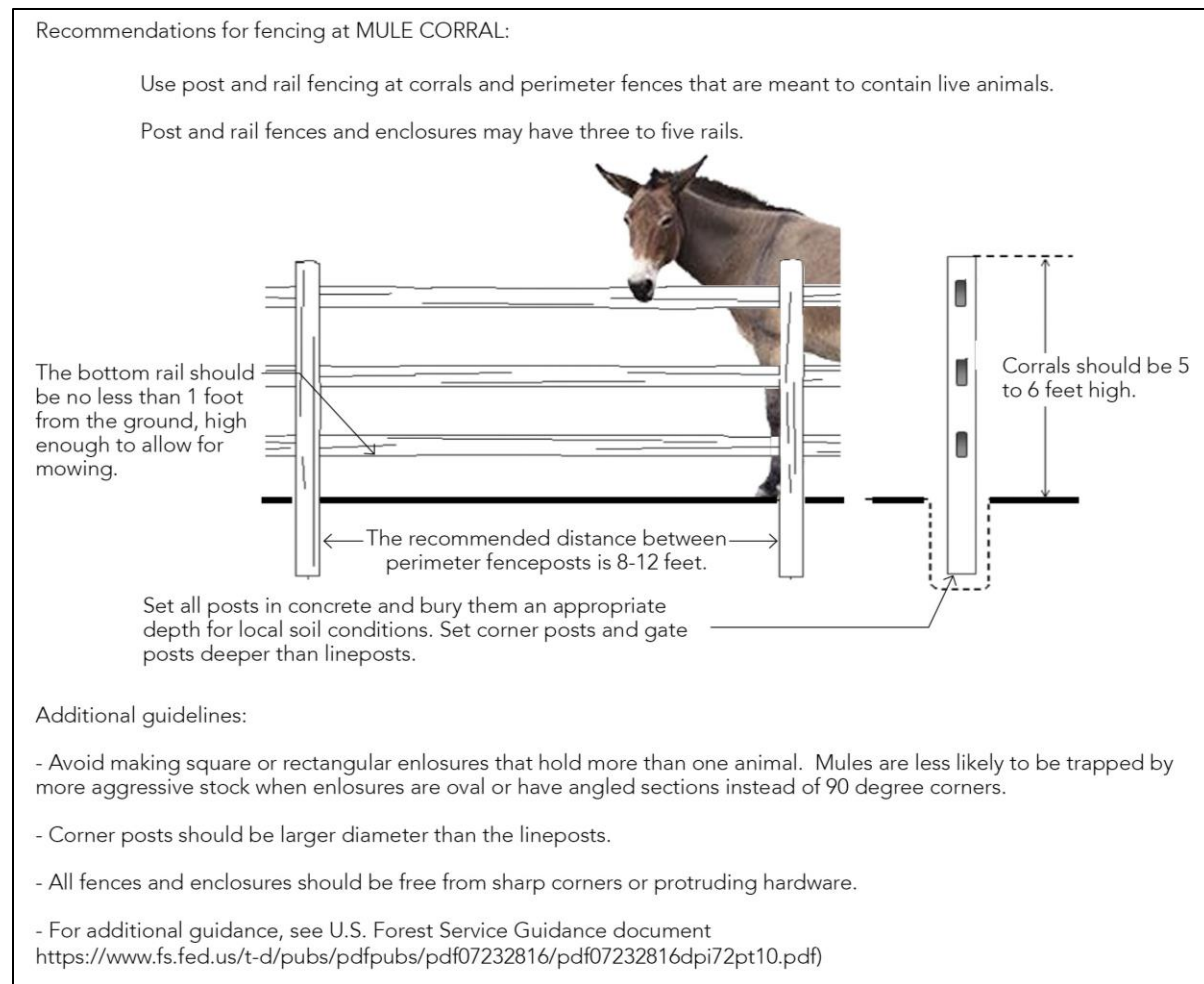
Figure 385. Fence style recommendations for contemporary additions within Kalaupapa and Kalawao Settlements. (Source: LSHLA)

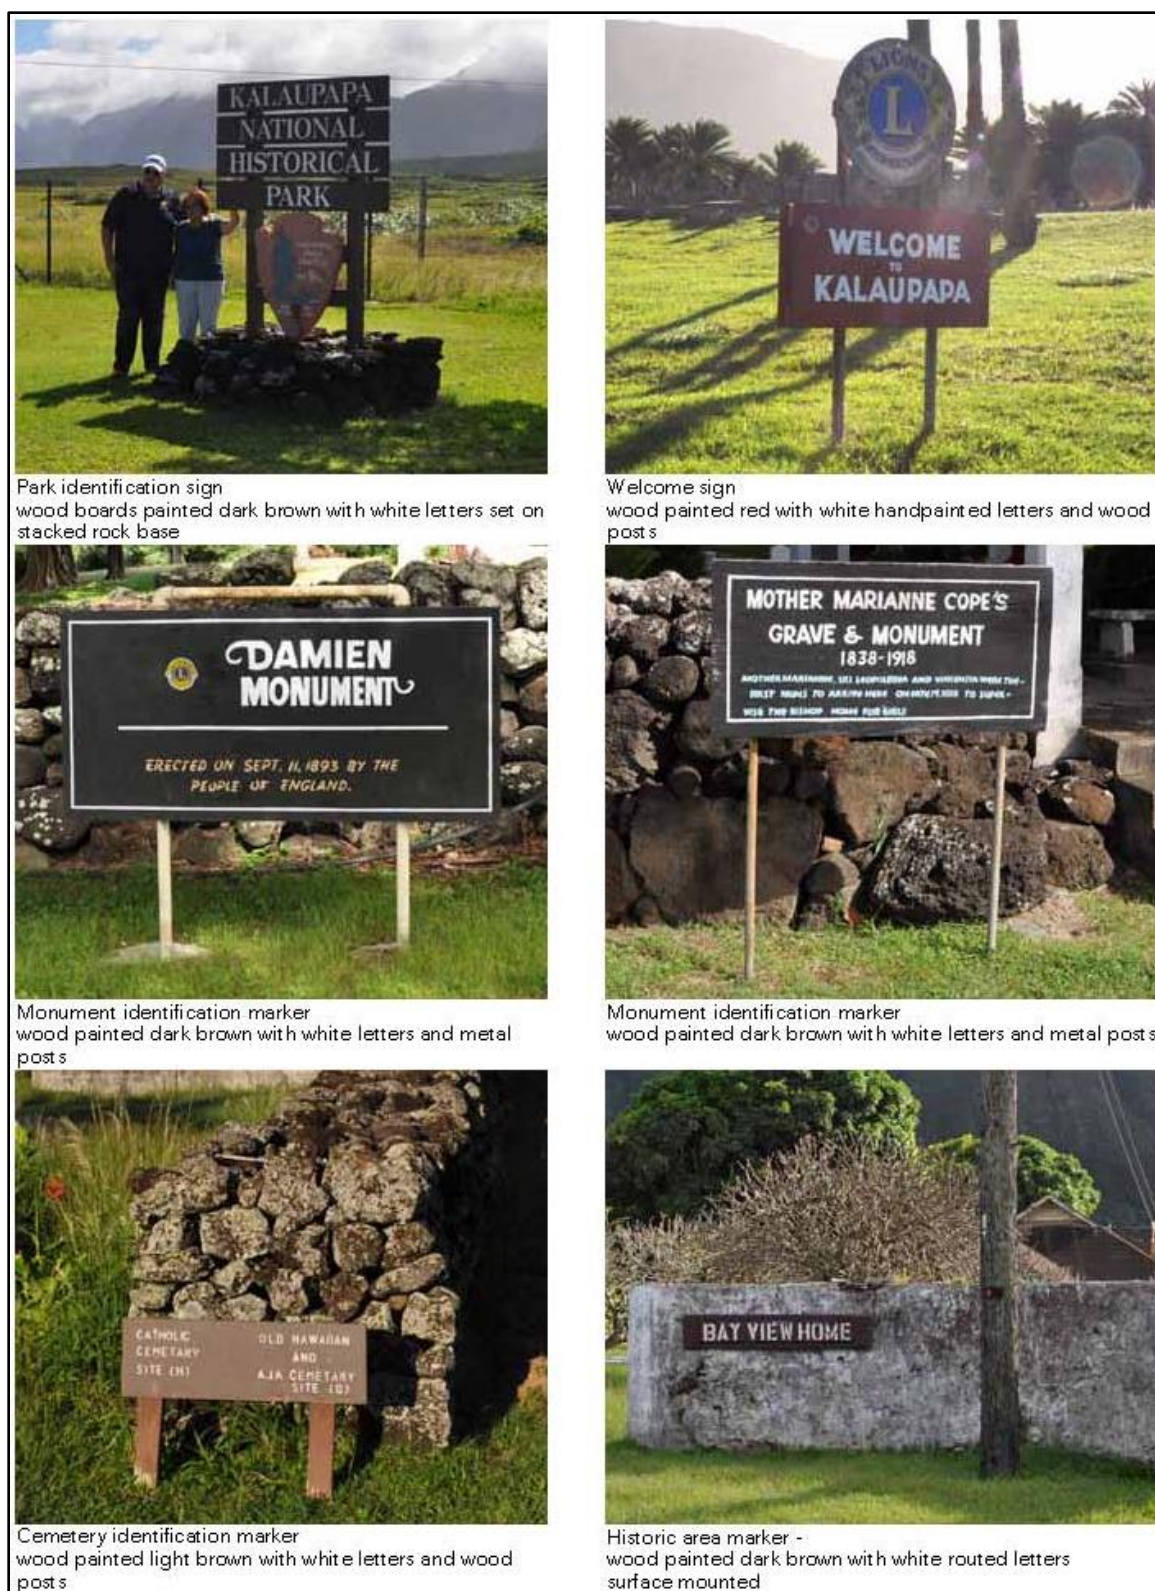
Figure 386. Sign typologies at Kalaupapa and Kalawao Settlements, 2018. (Source: LSHLA)

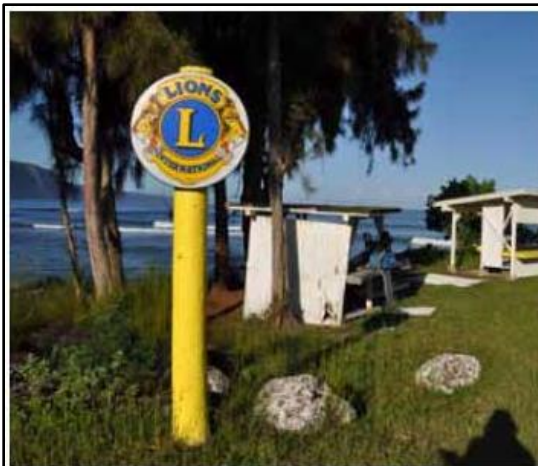
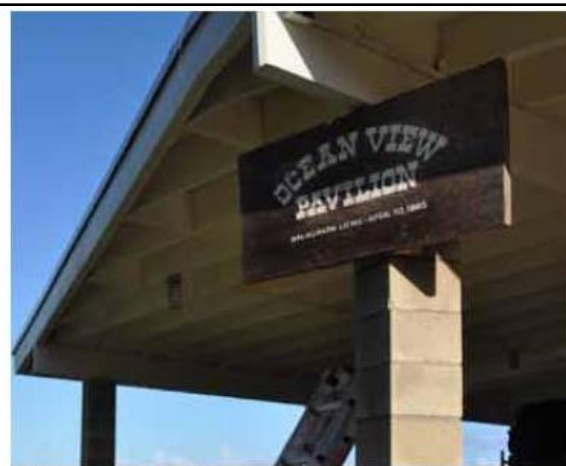
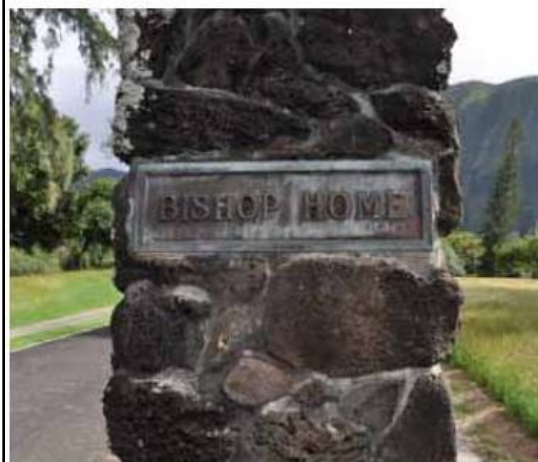
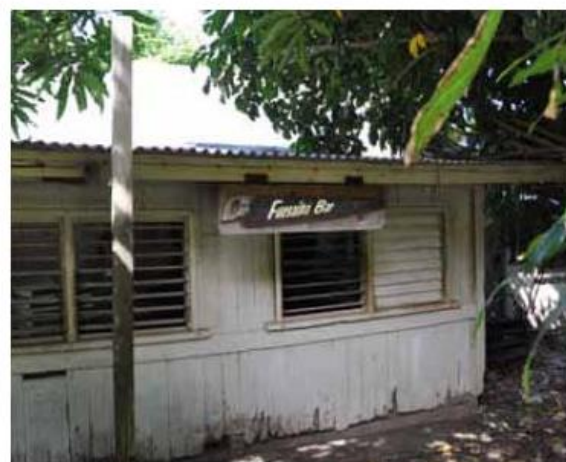
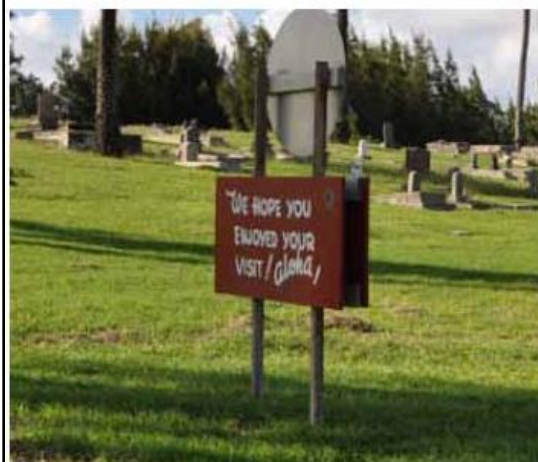
Figure 387. Sign typologies at Kalaupapa and Kalawao Settlements, 2018. (Source: LSHLA)

Lion's Club International sign - acrylic with wood post painted yellow

Ocean View pavilion sign - wood with natural with white stenciled letters

Bishop Home identity sign - bronze inlaid in stone column

Firewood sign - wood and metal with white handpainted letters

Welcome sign - wood painted red with white handpainted letters and wood posts

Sign typologies observed at Kalaupapa and Kalawao Settlements are shown in Figure 386 through Figure 389.
