Kalaupapa and Kalawao Settlements Cultural Landscape Report

Kalaupapa National Historical Park

Cultural Landscape Report

Prepared by:
Wiss, Janney, Elstner Associates, Inc.
2000 Powell Street, Suite 1650
Emeryville, California 94608

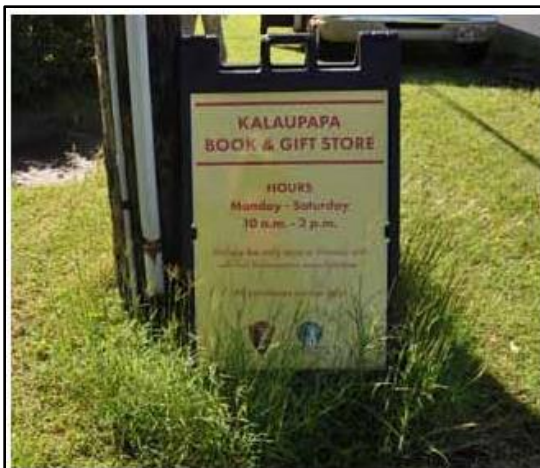
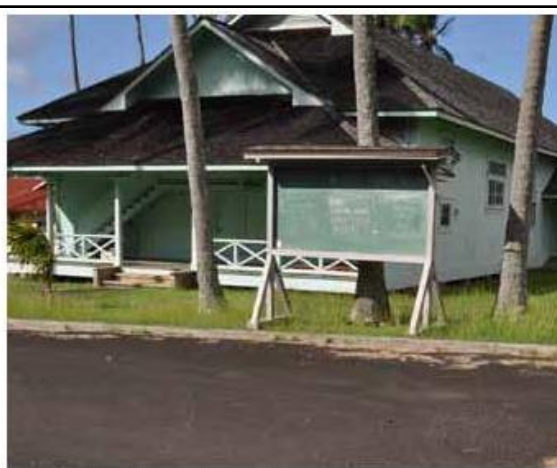
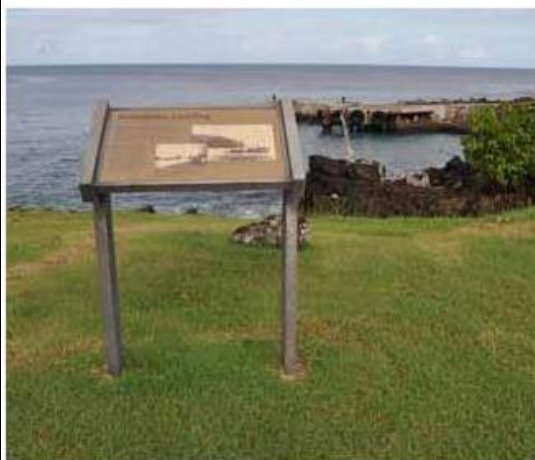
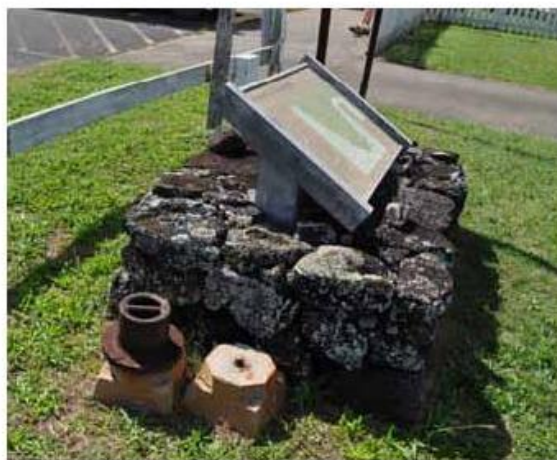
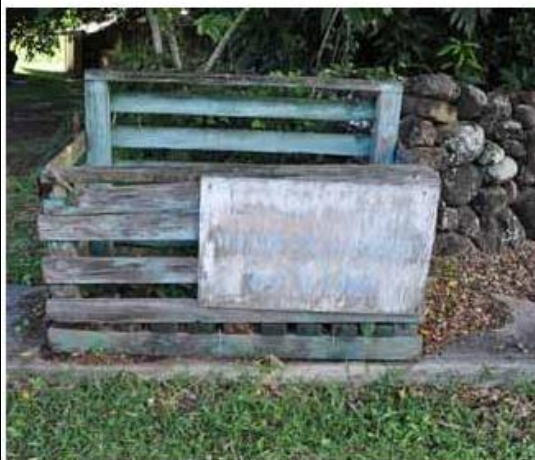
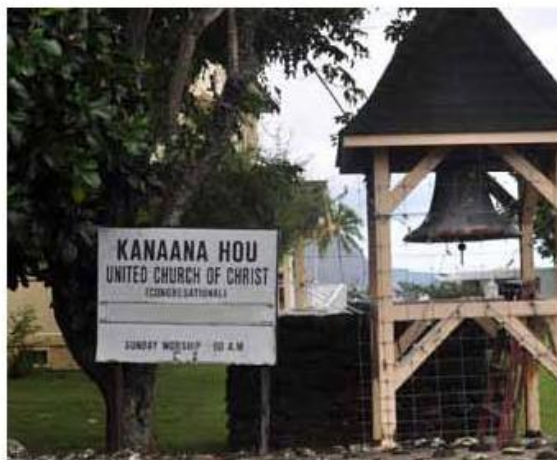
Figure 388. Sign typologies at Kalaupapa and Kalawao Settlements, 2018. (Source: LSHLA)

Book and gift store sign
plastic sandwich board with inlaid yellow/red poster

Community information sign
wood framed chalkboard

NPS wayside
unpainted steel frame with inlaid sign

NPS wayside
unpainted steel frame set on stone base.

Firewood sign

Church identity sign

Sign typologies observed at Kalaupapa and Kalawao Settlements are shown in Figure 386 through Figure 389.

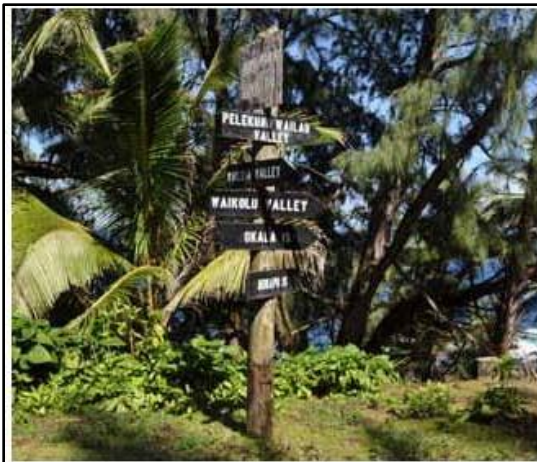
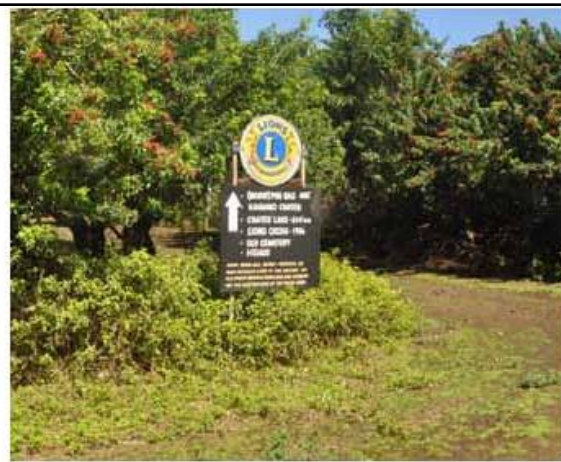
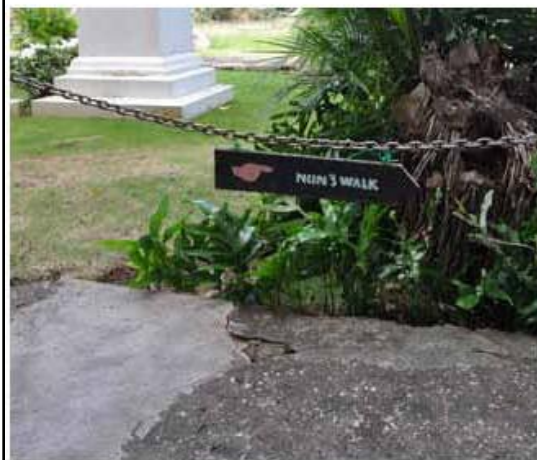
Figure 389. Sign typologies at Kalaupapa and Kalawao Settlements, 2018. (Source: LSHLA)

Book and gift store sign
plastic sandwich board with inlaid yellow/red poster

Community information sign
wood framed chalkboard

NPS wayside
unpainted galvanized steel frame with inlaid sign

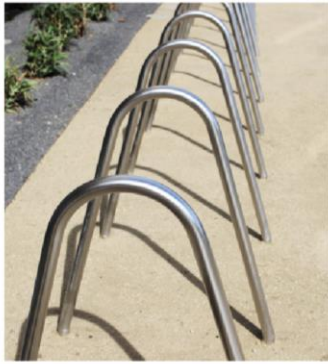
Figure 392. Illustrations of an appropriate bike rack style. (Source: Bola)

Single, ground mounted:

- Consider adding a limited number of simple contemporary metal bike racks in association with existing parking areas within the Administrative Area and the group home complexes (Figure 392).

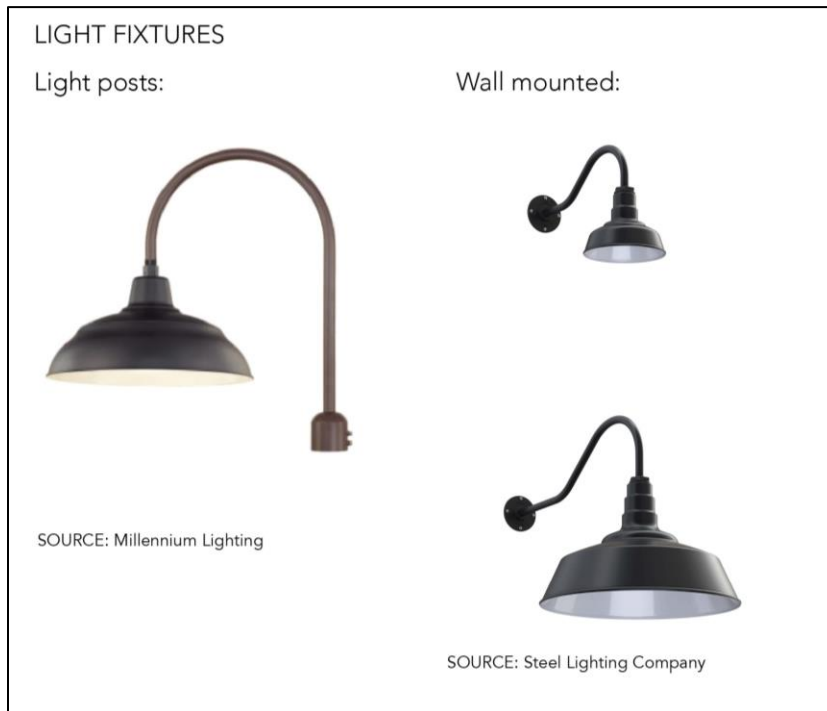
Figure 393. Illustrations of appropriate light fixtures. (Source: Millennium Lighting and Steel Lighting Company)

- Motion-activated lighting may be needed in the future at public paths and select parking areas. Lower bollard-style path lighting may be needed in the future as well. Ensure that lighting is dark sky compliant (Figure 393).
