CULTURAL LANDSCAPE REPORT FOR MARTIN VAN BUREN NATIONAL HISTORIC SITE

VOLUME II: UPDATED TREATMENT PLAN AND RECORD OF TREATMENT

KINDERHOOK, NEW YORK

Olmsted Center for Landscape Preservation
National Park Service, Boston, Massachusetts, 2016

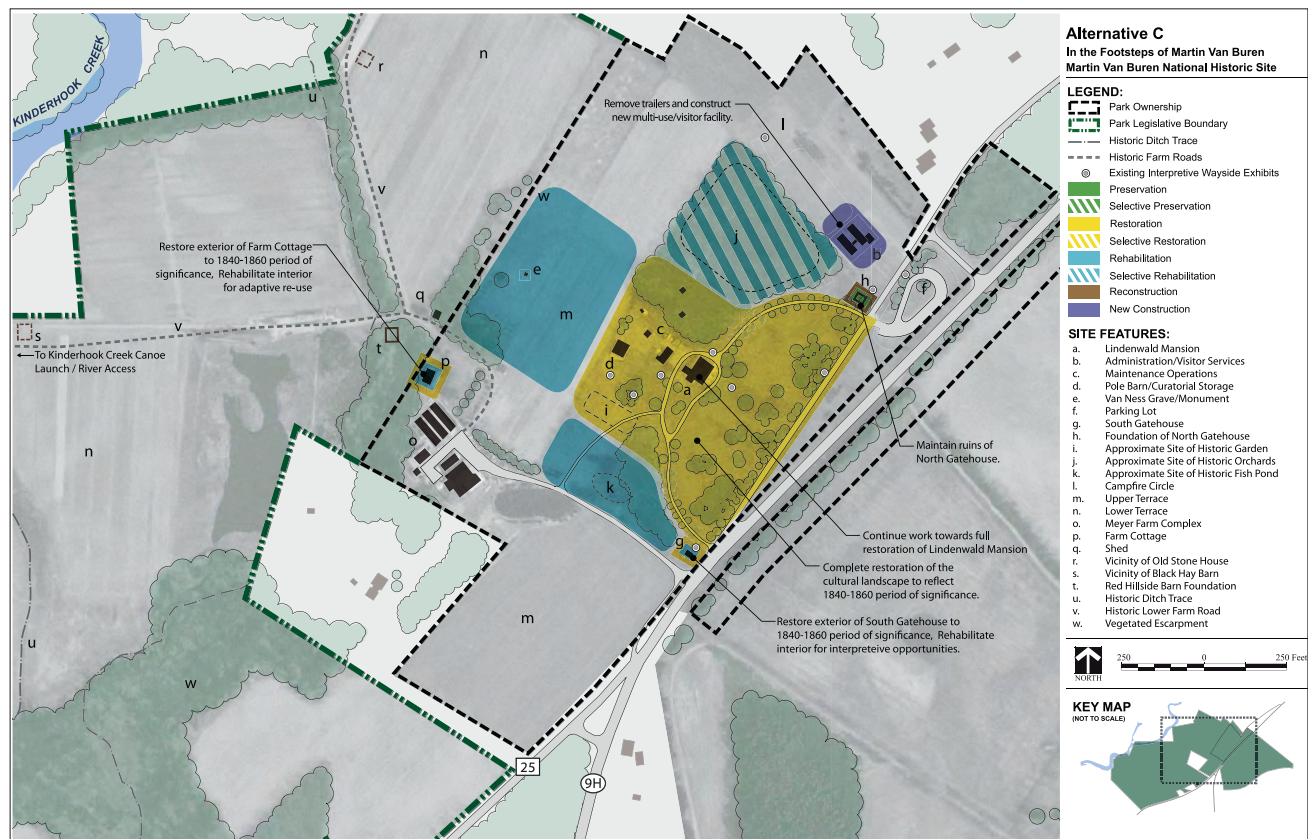
Figure 1.2. The *General Management Plan* identifies restoration as the treatment approach for the Historic Management Zone, encompassing the historic core, mansion, formal landscape, and Farm Cottage structure. Rehabilitation is identified for select areas surrounding the Historic Management Zone, 2015 (GMP).

The *General Management Plan* identifies two treatment approaches for Martin Van Buren National Historic Site. Restoration is identified as appropriate for the Historic Management Zone, including the Lindenwald mansion, historic outbuildings, entry drive, and formal landscape dotted with specimen trees. Rehabilitation is identified for the surrounding land owned in fee by the National Park Service, consisting primarily of the upper terrace field, an agricultural field immediately south of the historic core, the former Meyer agricultural complex, visitor parking lot, and the north field and visitor center. In this report, we have expanded this treatment approach to provide guidance for all land (primarily Agricultural Zone) included within the National Park Service 2009 boundary adjustment (Figure 1.2).

Figure 1.2 illustrates the rehabilitation and restoration zones for the landscape within Martin Van Buren National Historic Site.

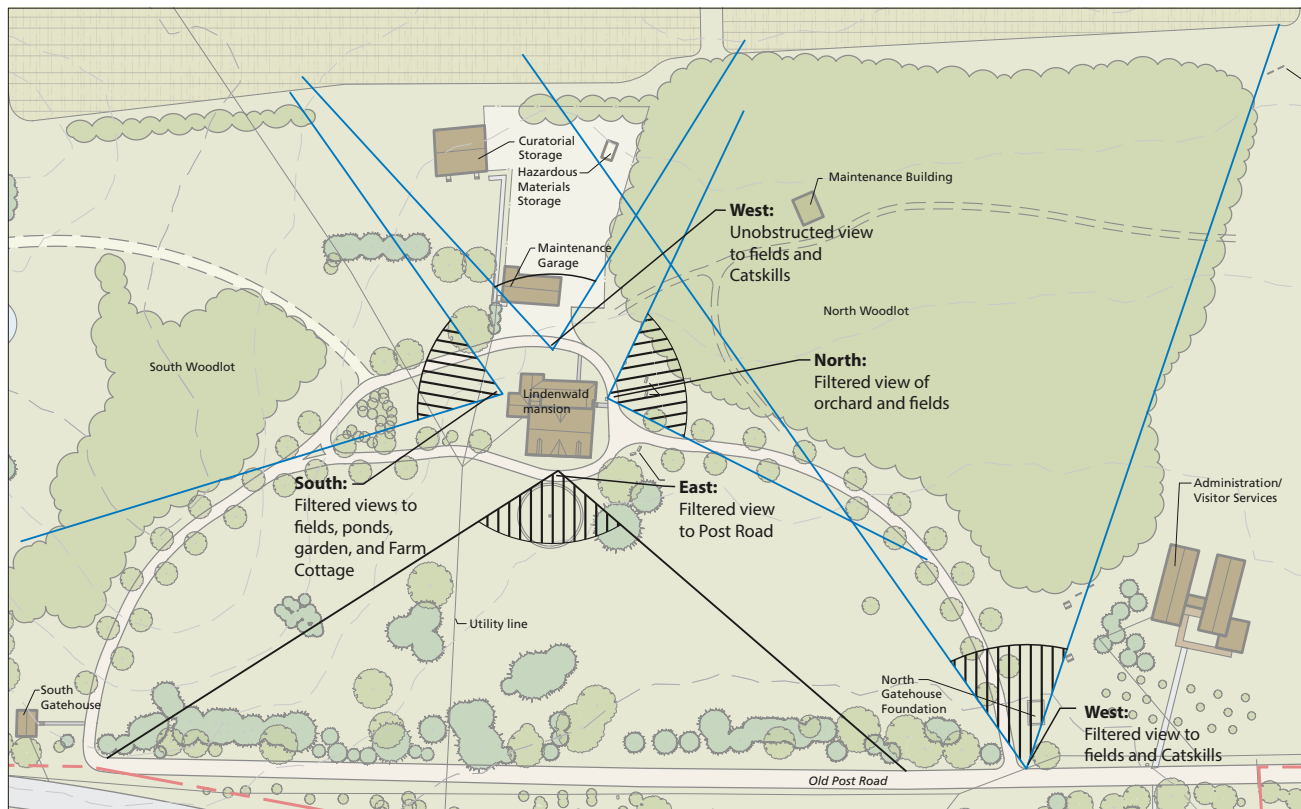
Figure 3.1. Diagram of historic views from the formal Lindenwald landscape overlaid on existing conditions. Blue view cones require treatment and black cones should be maintained. Views diagrammed with striped cones should be filtered views, view cones without stripes represent unfiltered views, 2016 (OCLP).

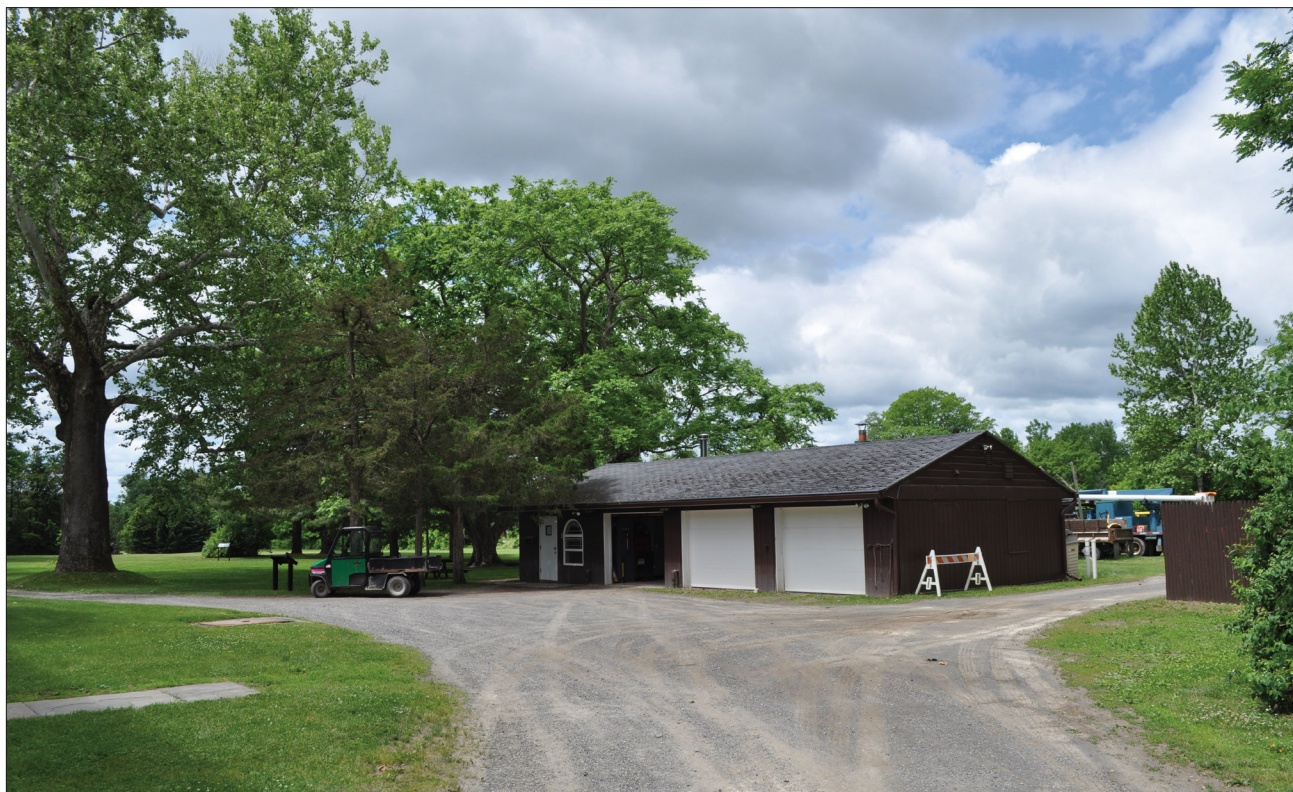
Figure 3.2. Located in close proximity to the historic Lindenwald mansion, park maintenance facilities, including a garage, vehicles, equipment, and fencing detract from site's historic character and obscure views to the west, 2015 (OCLP).

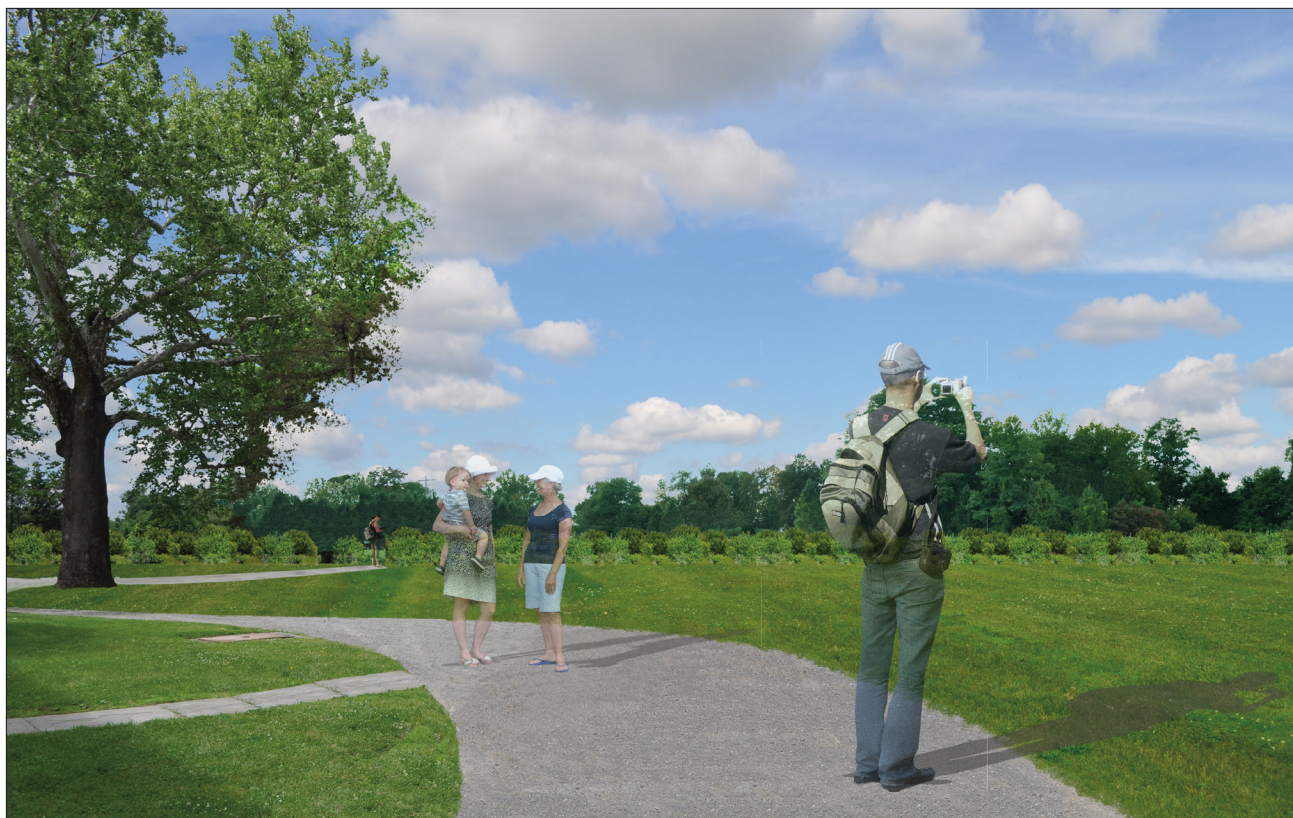
Figure 3.3. This photo simulation illustrates restoration of the open character and views of agricultural lands west of the mansion through the removal of contemporary buildings and structures. The proposed interpretive trail expansion evocative of the south farm road can be seen to the rear of the historic sycamore tree at image left, 2015 (OCLP).

obscure views west. Maintain a low hedgerow along the boundary between the rear mansion lawn and the cultivated fields (Figure 3.3). As detailed in Task PW-VG-1, the hedgerow will benefit wildlife and farm operations, provide filtered and unfiltered views at ground level, and offer unobstructed views from the mansion tower. To further reestablish views to the Catskills, reduce the vegetation on the escarpment as described in Task AG-VG-1.

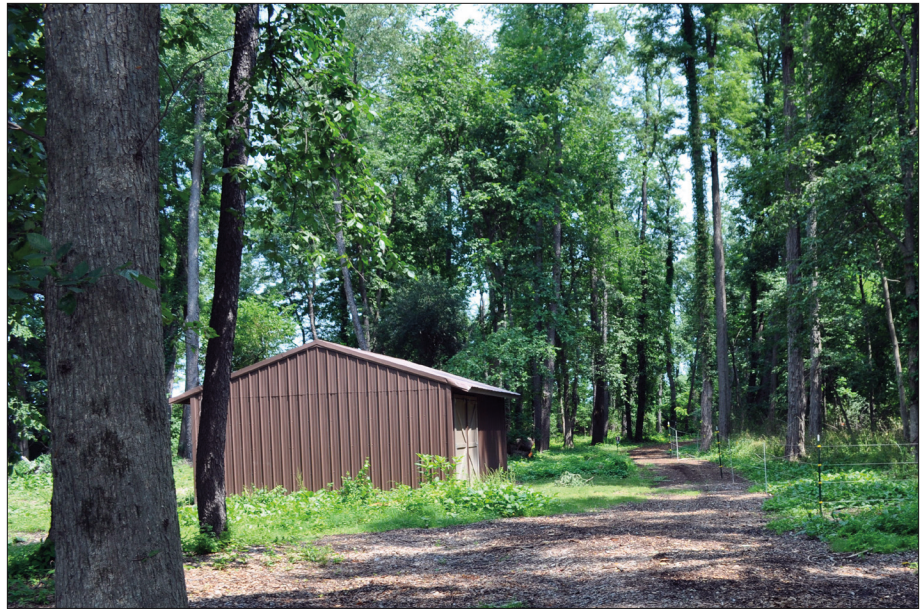
Figure 3.4. Historically an orchard, the area north and northwest of the mansion, presently referred to as the north woodlot, consists of mature trees and underbrush, which obscure filtered views to agricultural surroundings. The character and massing of the north woodlot differs from the character of the orchard during the historic period which consisted of trees planted in neat rows approximately thirty feet apart, 2014 (OCLP).

of the farmland and Catskill Mountains beyond, and disrupt the hierarchy of vegetation, buildings, and open space characteristic of the historic period (Figure 3.4 and 3.5).

To reestablish views to the northwest and north, remove the north woodlot and plant orchard trees or preferred alternative treatment as further described in Task HT-VG-1.

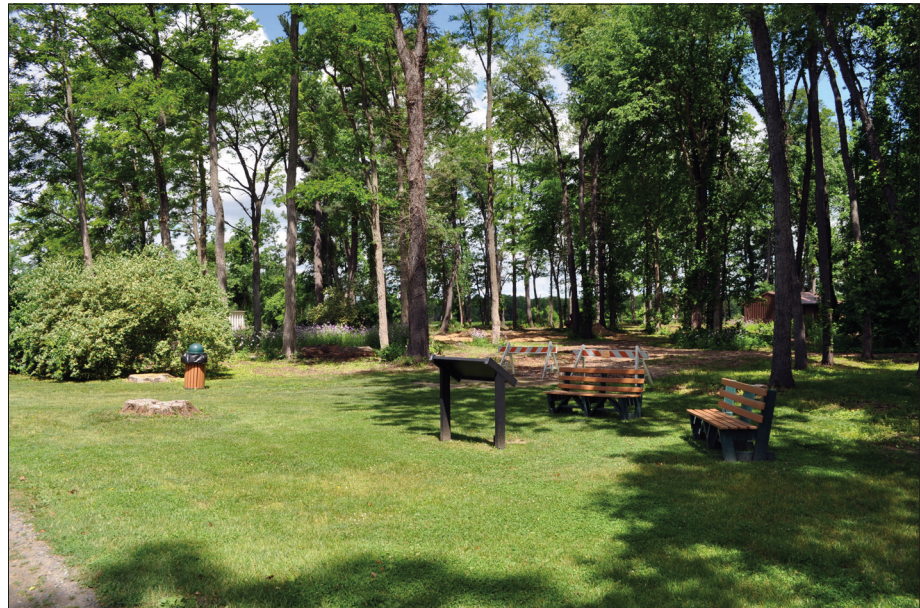
Figure 3.5. An effort to clear underbrush and invasive plants in the north orchard using leased goats began in summer 2014. Note the decrease of vegetation on the woodlot floor in this photo compared to Figure 3.4, taken before clearing efforts began, 2014 (OCLP).

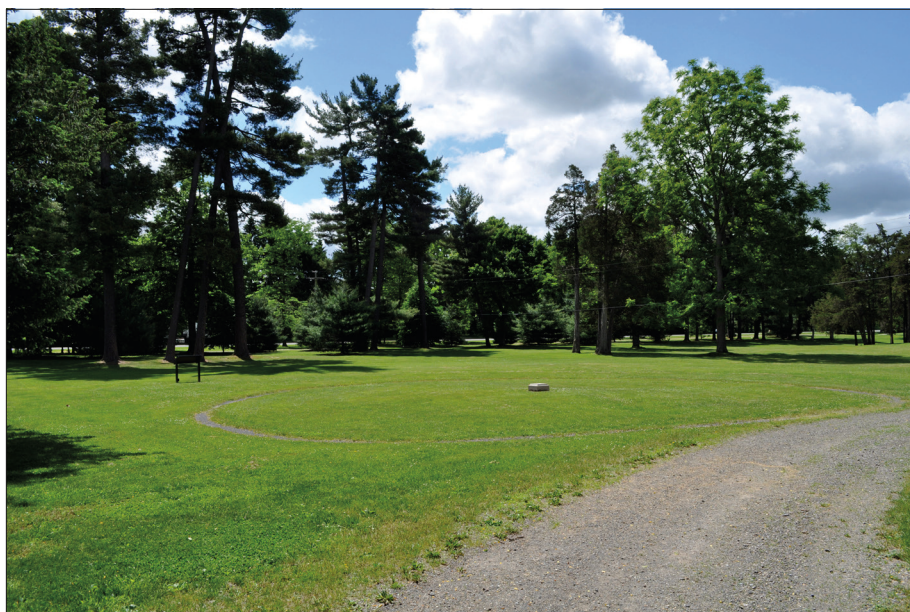
Figure 3.6. View east toward the Old Post Road from the entry drive near the front entrance to the Lindenwald mansion. Note the front garden in the foreground, specimen trees dotting the front lawn in the middle ground, and the white pine screen in the background, 2014 (OCLP).

Views to the east from the mansion: During the historic period an assortment of trees grew along the eastern edge of the front lawn and created a filtered view of the Old Post Road and agricultural fields to the east. Pines, cedars, cherries, linden, and additional specimen trees grew in the manicured lawn. Today, the filtered view from the mansion to the Old Post Road and fields beyond remains, though many of the original trees have died and been replaced (Figures 3.6, 3.7 and 3.8). To preserve the filtered views, continue to manage the specimen trees

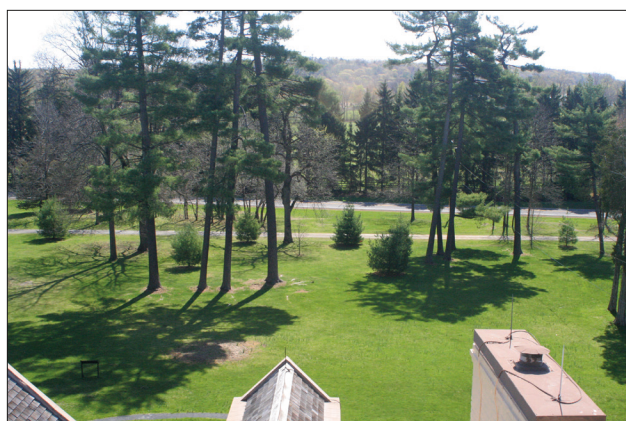
Figure 3.7. View east c. 2010 from the Lindenwald tower. Note the recently planted replacement white pines along the Old Post Road, (OCLP).

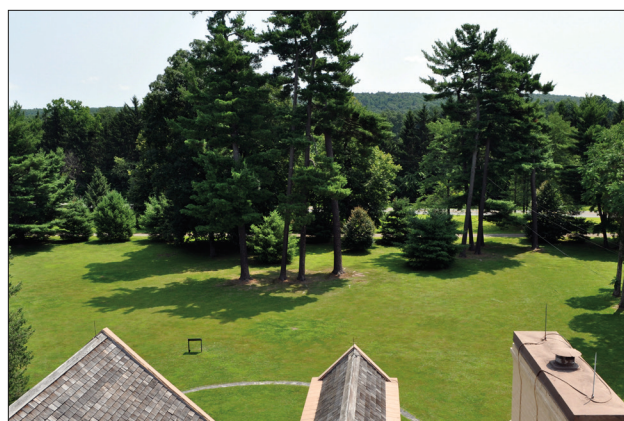
Figure 3.8. View east from the Lindenwald tower. Note the replacement white pine trees along the Old Post Road which have begun to mature and screen the roadway, 2014 (OCLP).

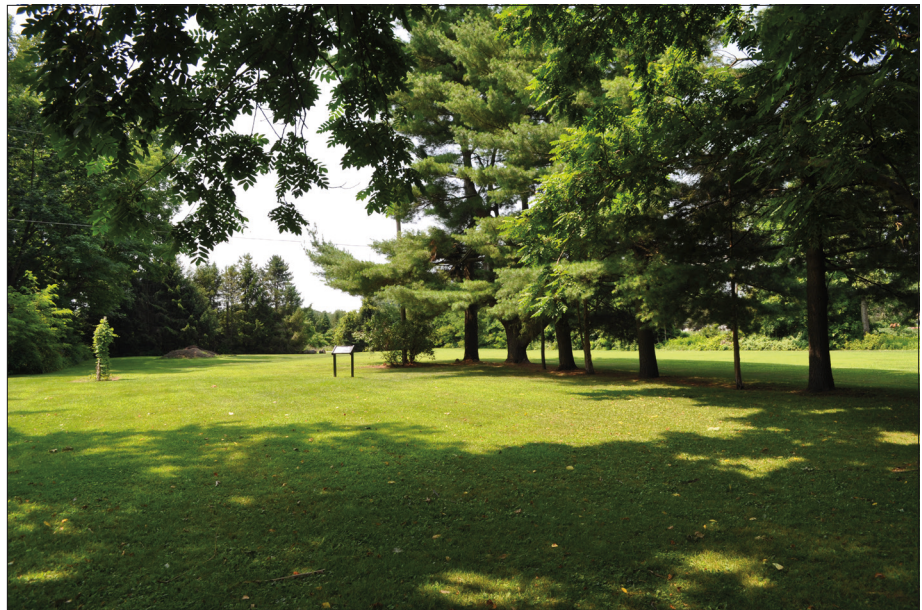
Figure 3.9. Views south of the mansion are obscured by non-historic vegetation. A row of conifers blocks views to the upper terrace agricultural fields. At image left, volunteer vegetation surrounds a wetland and spring area, blocking views of the remaining spring and upper pond, 2014 (OCLP).

grounds (Figure 3.9). To reestablish views to the south and southwest, remove volunteer vegetation surrounding the wetland and spring area (as feasible) to the south of the mansion and thin vegetation around the single remaining upper pond. The non-historic row of white pine and cedar to the southwest of the mansion should be removed (see Figure 3.9). Removal of vegetation to the south and southwest of the mansion should be done with consideration of the need to screen contemporary development and agricultural operations/ equipment (Figure 3.10). Removal or thinning of the extant overgrown hedgerow between the rear mansion lawn and the upper terrace agricultural field should not be undertaken until preparations for replanting have been made. Removal of vegetation within the south woodlot should be undertaken, as feasible, based on the findings of natural resource experts. Visual impacts of contemporary development including roadways and buildings should be considered prior to the removal of the south woodlot. Removal of portions of the south woodlot may necessitate installation of hedgerows or other screening methods.

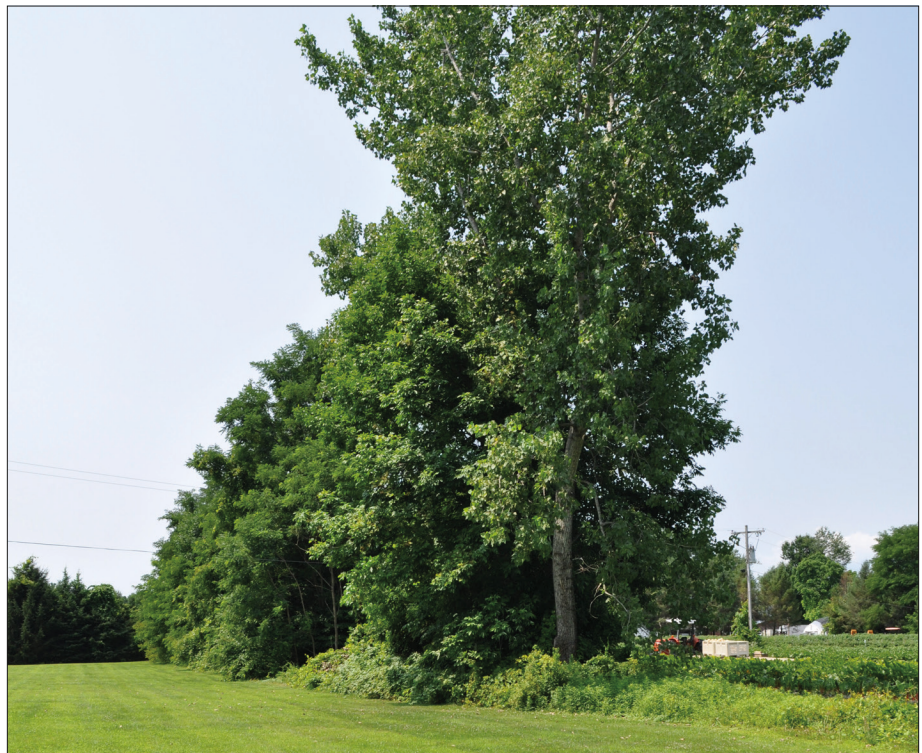
Figure 3.10. View from southwest lawn behind the mansion to the contemporary farm complex and historic Farm Cottage. A hedgerow defines the western edge of the formal landscape and the eastern edge of the upper terrace agricultural field. The hedgerow is composed of a mixture of native and invasive species, including grasses, shrubs, and trees. A portion of the hedgerow has been cleared, and is intermittently mowed to maintain views between the formal and agricultural landscape, 2014 (OCLP).

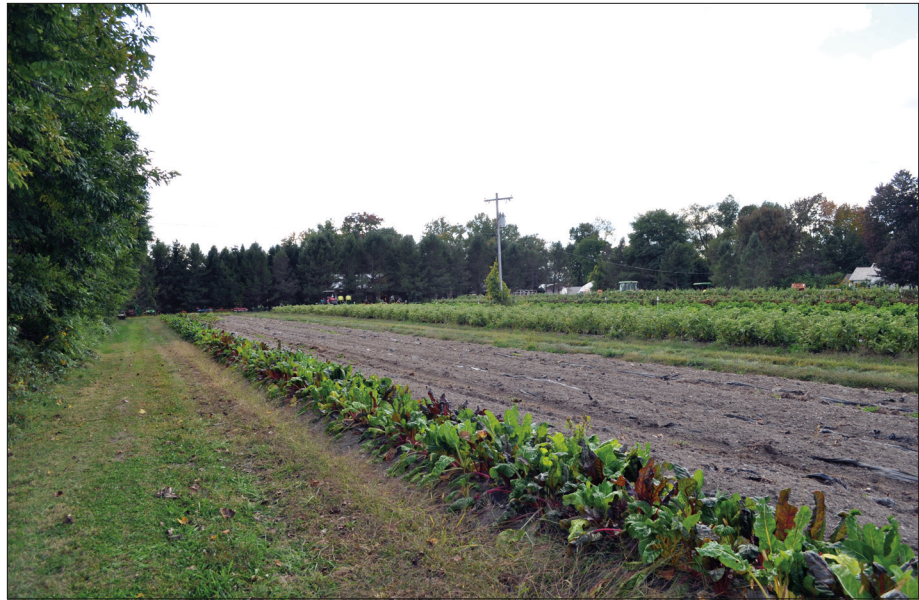
Figure 3.11. View southwest from the western edge of the formal landscape toward the Meyer farm complex and Farm Cottage. Note the utility lines that cross the agricultural field. A row of evergreens (visible in the distance) screens the majority of the contemporary farm complex and supporting infrastructure, 2014 (OCLP).

Screen incongruous views to the west. To enhance the historic character of the landscape, submerge utility lines that bisect the upper terrace as illustrated in Drawing 3.7 and described in Task HM-UT-1. Maintain the existing screen of evergreen trees between the non-historic farm buildings and the mansion (Figure 3.11). As these evergreens mature, lower branches will continue to die back reducing the screening effect of this tree line. As feasible, establishment of a shade tolerant hedgerow parallel to this tree line should be considered (Drawing 3.8).

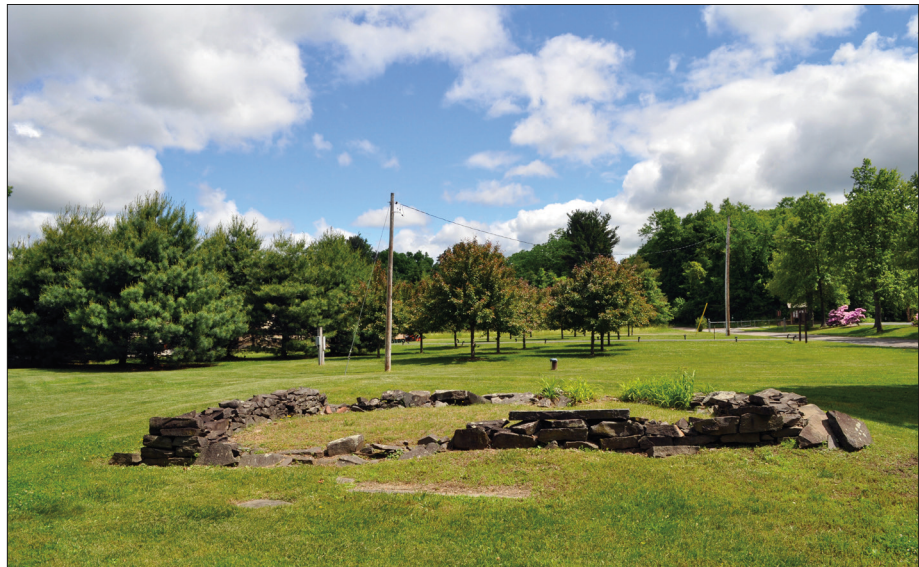
Figure 3.12. View north from the formal grounds toward the non-historic parcel containing the visitor center and administrative offices. A dense screen of vegetation reduces the visual impact of the visitor center on the historic core, although utility lines detract for the historic character. The foundation of the North Gatehouse is in the foreground, 2014 (OCLP).

Screen incongruous views to the north. Maintain the existing screen between the mansion grounds and the temporary visitor center until the extant structure is removed from the site (Figure 3.12). Construction of the new visitor services/administrative building will be done in a manner to minimize impact to the setting and views from the mansion, although it is likely that some form of screening will be necessary to reduce impact. Removal of the extant non-historic screening in this area should be predicated on the design and installation of additional screening to minimize impact of proposed new construction in this area. Screening of new construction with a hedgerow following the north boundary of Van Buren's estate should be explored once construction plans are finalized (See PW-VG-1).

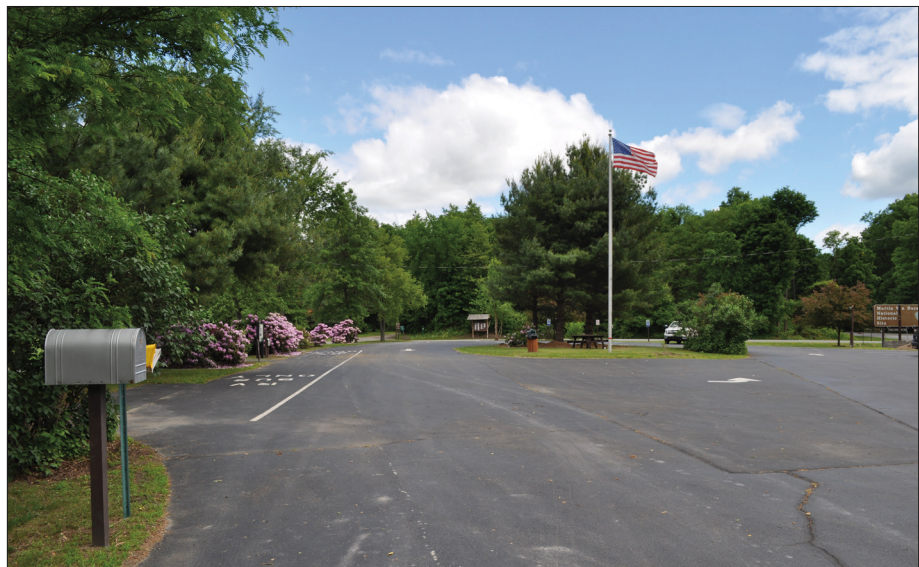
Figure 3.13. View north of the visitor parking lot. A mixture of trees and shrubs (at left) screen the parking lot east of the historic core. Replacement plants should be chosen from a historically appropriate palette, 2014 (OCLP).

Screen incongruous views to the east. Maintain existing screening vegetation between the visitor parking lot and the historic core (Figure 3.13). As existing vegetation declines or no longer effectively screens the parking area, replant the screen with species that were present on the site during the historic period as described in Task AD-VG-1. If the existing parking lot is relocated in conjunction with the construction of a visitor orientation building, non-compatible plantings should be removed.

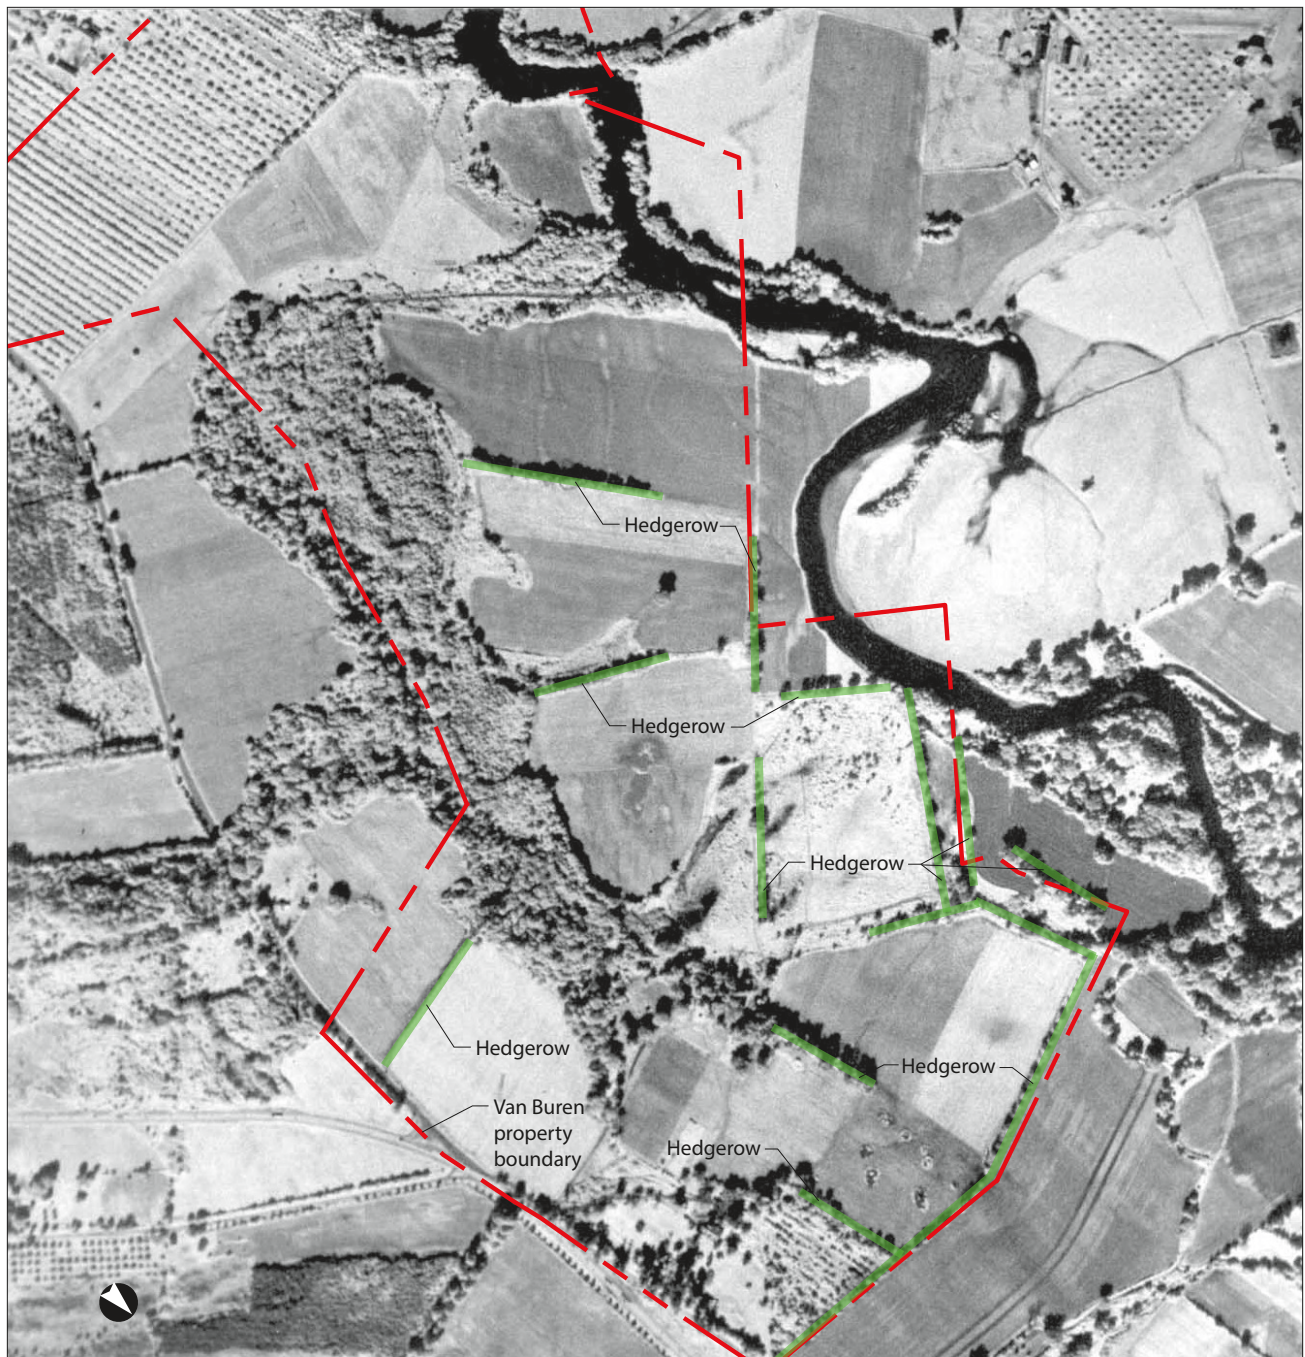
Figure 3.14. Several hedgerows (highlighted in green) are discernible in this 1948 aerial photo. Note that hedgerows divide the lower terrace. Others correlate with historic property lines, like the north boundary of the Van Buren Farm. The Van Buren's period property boundary is delineated with a dashed red line, 1948 (MAVA archives, NY-A-9 55; annotated 2016, OCLP).

Hedgerow along north property line: Historic vegetation patterns, remnant vegetation, and typical landscape patterns indicate that a hedgerow delineated the north boundary of the Van Buren farmland (Figure 3.14 and 3.18). Historic documentation indicates the presence of the Dingman Fence along this property line. Vegetation surveys completed in 1980 and 1993 indicate the presence of

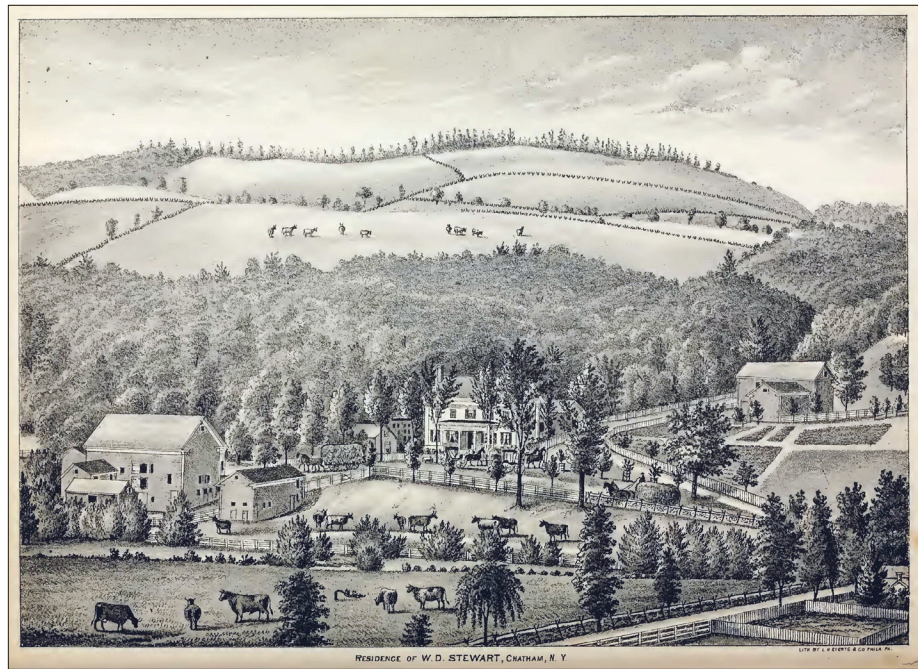
Figure 3.15. This pen and ink drawing of the residence of W. D. Stewart illustrates the prevalence of hedgerows in nearby Chatham, New York in 1878. Many of the depicted hedgerows are located along fence lines and walls, 1878 (Ellis, History of Columbia County).

areas of mutual agreement between the National Park Service and Roxbury Farm. Additional sources of information include known and approximate locations of other agricultural features during the historic period (Drawings 3.2 and 3.3), regional trends documented in drawings (Figure 3.15), and existing landscape features and patterns (Drawings 3.4 and 3.5). In addition to enhancing historic landscape character, replanted hedgerows will offer valuable ecosystem services including: wildlife corridors, hosts for pollinators, reduction in surface runoff and erosion, buffering of crops from winds, and habitat for insects and birds.² Replanting missing historic hedgerows aligns with the *General Management Plan* which supports the perpetuation of contemporary sustainable agricultural practices including soil fertility and ecosystem health as well as increased opportunity for visitors to experience how Van Buren's farming practices relate to contemporary farming practices.³

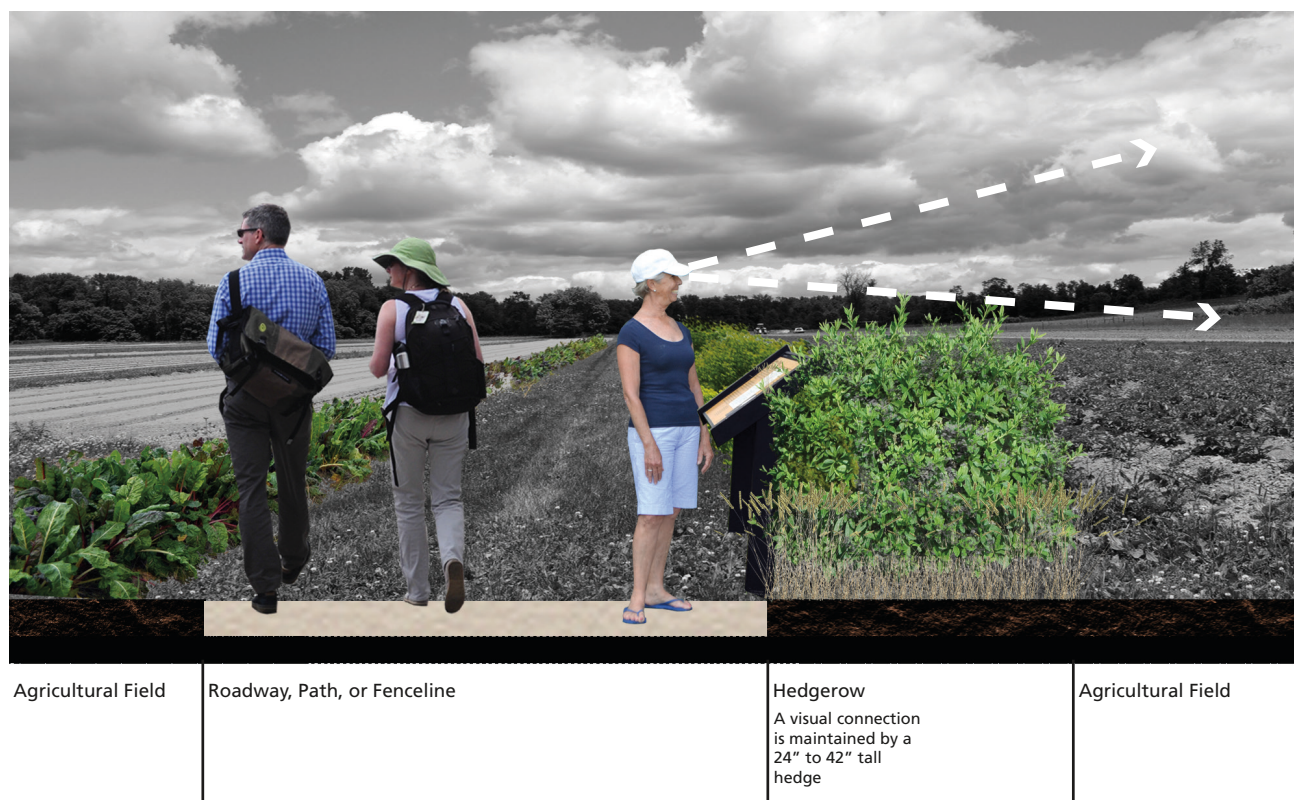
Figure 3.16. Hedgerows two to four feet tall will maintain visual connections between fields while evoking historic landscape patterns, 2016 (OCLP).

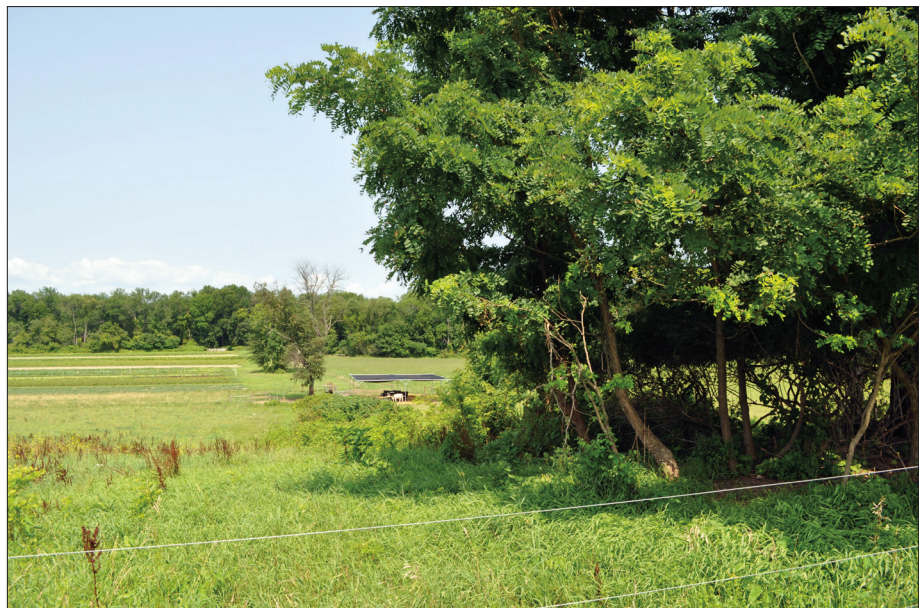
Figure 3.18. View west from northwest corner of the upper terrace field along the north boundary of the historic Van Buren property. Remnants of the hedgerow documented in Figure 3.14 are visible in the landscape today. Documentation indicates the historic boundary with the Dingman property was delineated with a fence. It is likely that a volunteer hedgerow was present during the historic period, a pattern in the landscape that persists today, 2014 (OCLP).

black locust stumps in a linear form extending west along the northern property line from the proximity of the North Gatehouse foundation to the eastern edge of the historic north orchard. A slight indentation left by a decayed root system is perceptible today. These trees could have been part of the hedgerow, or planted along the boundary line. It is probable that a hedgerow paralleled the northern boundary line and Dingman fence, correlating with the north boundary of Van Buren's north orchard, and likely extended west toward Kinderhook Creek. The hedgerow likely framed the northern edge of the lower terrace agricultural fields. The eastern end of the hedgerow may have ended at the eastern extent of the orchard, marking the transition to the formal landscape and domestic area surrounding the North Gatehouse. The northern property boundary directly north of the North Gatehouse was likely delineated by a fence that extended to intersect a front fence along the Post Road.

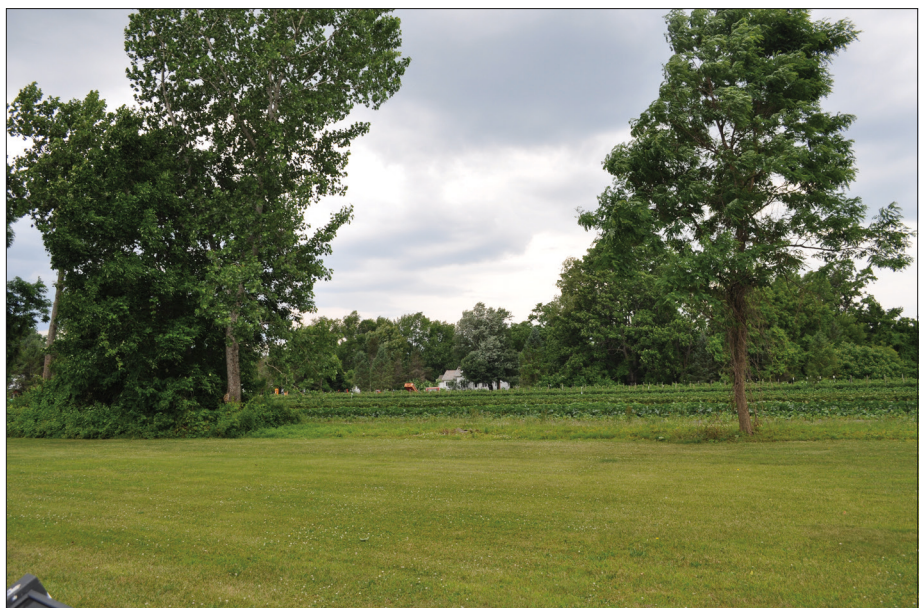
Figure 3.19. View west from the mansion rear lawn to the Farm Cottage. The hedgerow between the manicured mansion grounds and upper terrace should be managed to perpetuate the visual connection between the two areas, 2014 (OCLP).

Hedgerow between the mansion grounds and upper terrace: After the 2009 boundary expansion, the park removed a portion of the overgrown hedgerow dividing the mansion grounds and upper terrace farmland, revealing the visual connection between the western edge of the mansion grounds and the agricultural landscape beyond (Figure 3.19). To reestablish the hedgerow and improve the visual connection between the mansion and farmland, selectively remove additional vegetation to create a more transparent hedge character, and encourage the growth of shorter vegetation, like small shrubs, grasses, wildflowers, or an edible hedgerow like raspberries (see Appendix B for more information). The current practice of mowing a portion of the hedge to ground level provides a visual connection to the upper terrace field, however it creates a sharp contrast between the mowed section and the mature hedge (Figure 3.19). Selected viewpoints should be managed for visual quality and connection, while the remainder should be managed for hedgerow and ecosystem health. As other tasks are completed, the importance of the visual connection between the historic

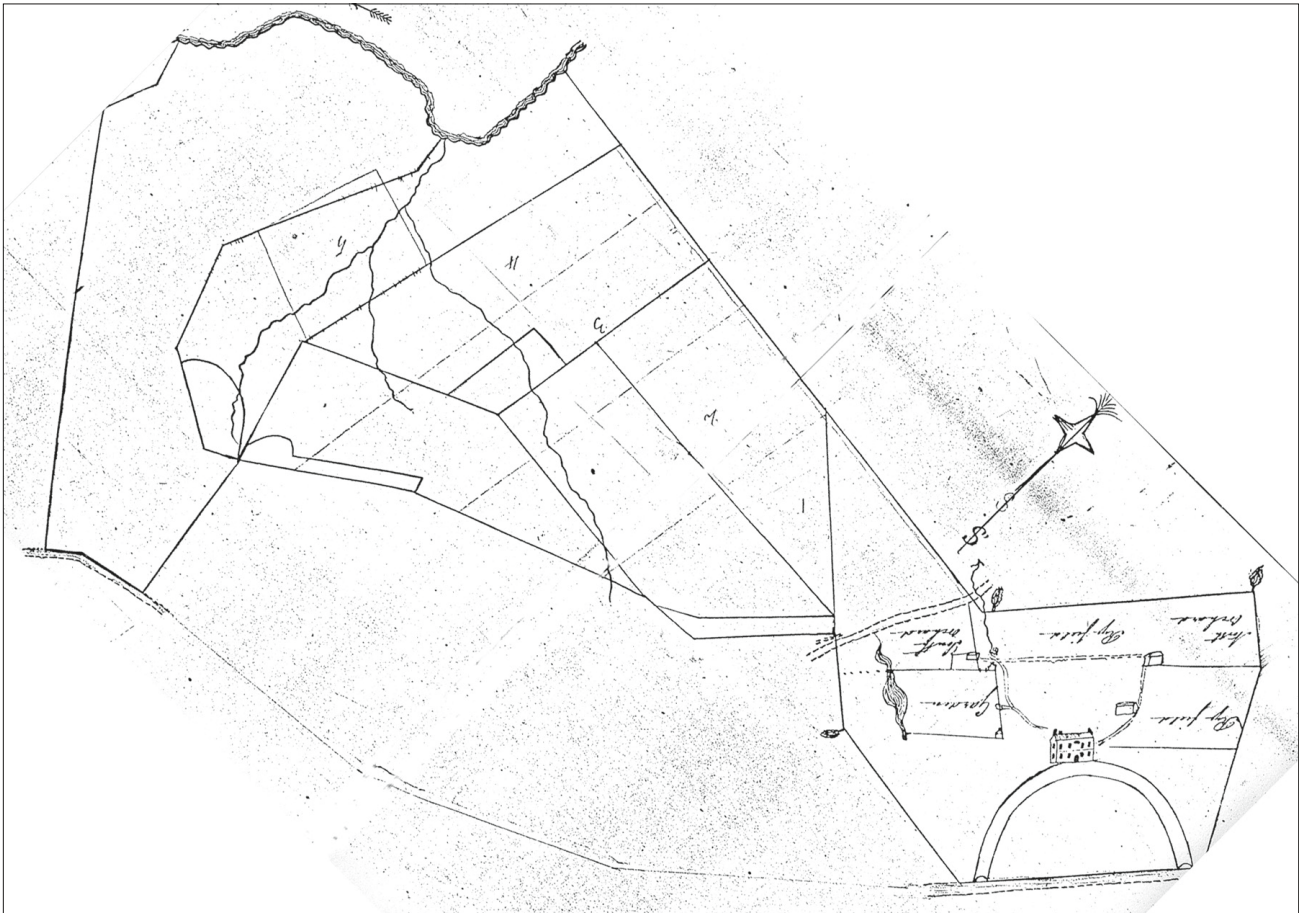
Figure 3.20. The c. 1841 sketch map of Lindenwald, documents the entry drive, location of the mansion, and the north and south farm roads that head toward the outbuildings and lower terrace. The upper and lower pond, garden, and fields are depicted, (Van Buren Papers, Pennsylvania State University; photocopy on file, MAVVA).

The c.1841 sketch map of Lindenwald depicts the Van Buren period circulation system, including the north and south farm roads (Figure 3.20). Although fragmented today, during the historic period the north and south farm roads originated near the mansion and provided access to the agricultural fields and outbuildings of the upper and lower terraces. While the historic location and alignment of the Van Buren period network of roads is only partially known, historic documentation and physical evidence in the landscape provide sufficient information to reestablish sections of these historic circulation routes, which will be repurposed as an interpretive trail. Geophysics or conventional archeology will likely confirm road alignment and provide information regarding historic construction materials. Photographs dating to the late 1800s and early 1900s and archeological surveys conducted in 2010 suggest the farm roads were surfaced with compacted soil and gravel. The two-track earthen roadway visible in Figure 3.21 is likely a remnant of the south farm road. Drawing 3.2 illustrates the circulation system during the Van Buren period.

South farm road: During the Van Buren period the south farm road originated near the southwest corner of the mansion, led west past the Farm Office, the garden, and the south orchard before heading south toward the Farm Cottage (Figure 3.20 and 3.22). Today a portion of the south farm road continues to follow the historic alignment from the Farm Cottage past the Red Barn site before descending the escarpment to the lower terrace and extending west past the Black Hay Barn site toward Kinderhook Creek. A branch road extends northwest and connects to the north farm road in the vicinity of the Old Stone House site.

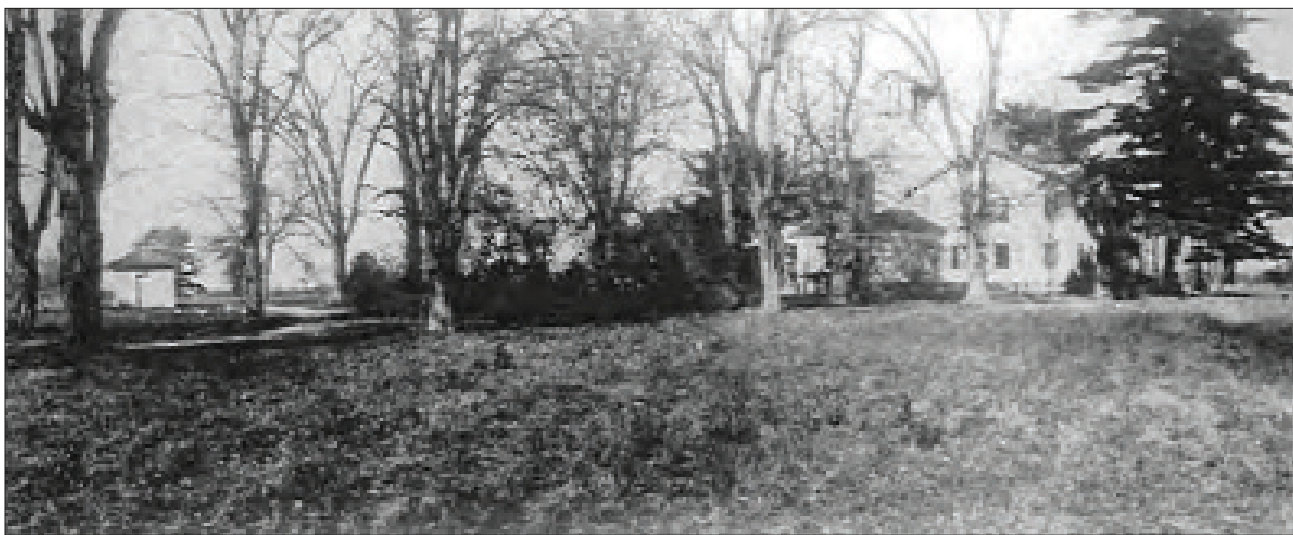
Figure 3.22. The south entrance drive and accompanying black locust allée, white pines framing the front garden, the mansion, farm office and south farm road are documented in this photo taken during Wagoner ownership, c. 1913 (MAVA archives).

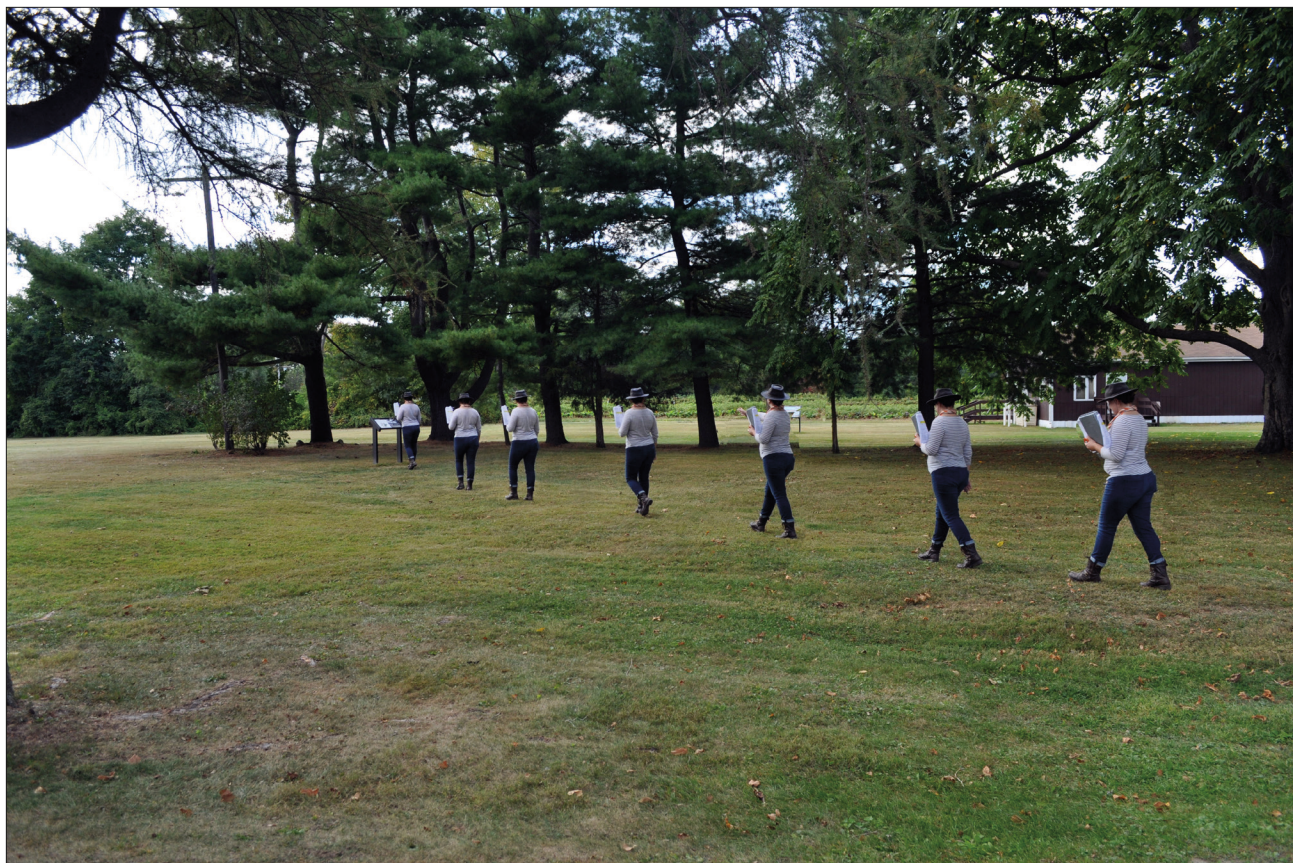
Figure 3.23. This layered photo simulation documents a faint linear rise detected during fieldwork southwest of the mansion and historic sycamore tree. The anomaly may indicate remnants of the south farm road. The figure walks the raised route which corresponds closely to the documented location of the south farm road. This area should be investigated using geophysics or traditional archeology, 2015 (OCLP).

The easternmost portion of the south farm road, located in the historic core in close proximity to the Lindenwald mansion, should be reestablished as part of an interpretive trail (Drawing 3.7 and Figure 3.21). Historical documentation provides sufficient information to locate portions of the road and understand its general form. During the field work and documentation process for this report a faint linear rise was detected in the suspected location and orientation

of the south farm road (Figure 3.23). Archeological investigation could yield additional information and has potential to confirm the rise as the road alignment. Figure 3.72 depicts a portion of the south farm road interpretive trail in a photo simulation. The portion of the south farm road that bisected the upper terrace, now within an active farm operations area, is unsuitable for visitor use.

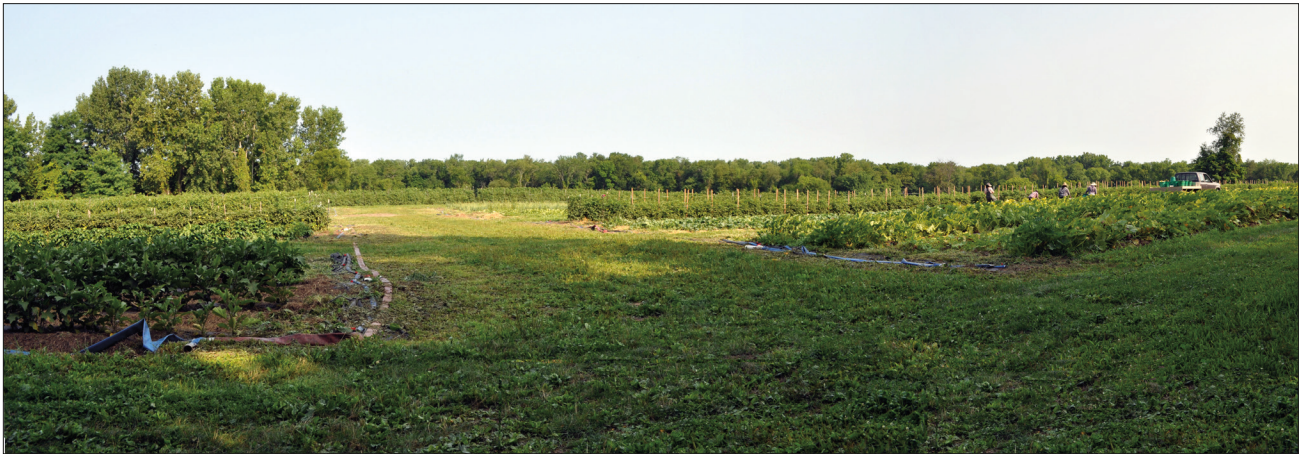
Figure 3.24. View west across the upper terrace farm field from just south of the carriage barn site. The north farm road extended from the rear of the mansion west past the carriage barn and through the upper terrace toward the Old Stone House on the lower terrace. The approximate location of the north farm road through the upper terrace is currently uncultivated land, 2015 (OCLP).

(Drawings 3.6 and 3.7). The eastern portion of the north farm road, located in the historic core in the proximity to the Lindenwald mansion, should be reestablished as part of the interpretive trail, evoking the historic character and alignment by arching west from the Lindenwald mansion toward the lower terrace. Based on current agricultural use and planting practices, this trail could bisect the upper terrace in an area currently not used for crop production that correlates with the approximate historic route, before descending to the lower terrace (Figure 3.24).
