CULTURAL LANDSCAPE REPORT FOR MARTIN VAN BUREN NATIONAL HISTORIC SITE

VOLUME II: UPDATED TREATMENT PLAN AND RECORD OF TREATMENT

KINDERHOOK, NEW YORK

Olmsted Center for Landscape Preservation
National Park Service, Boston, Massachusetts, 2016

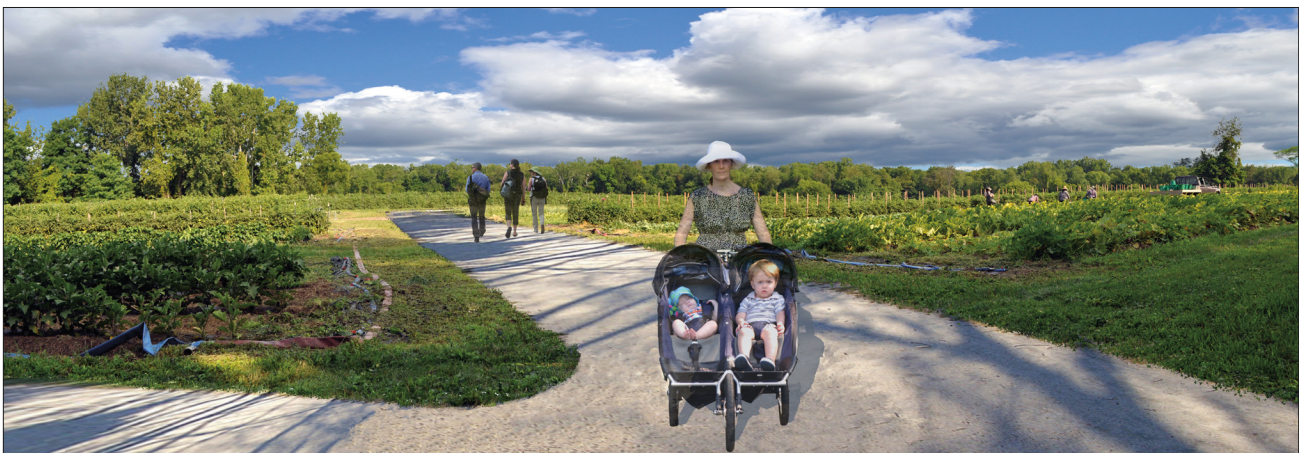
Figure 3.25. Photo simulation depicting an accessible interpretive farm trail through the historic Van Buren farmland. The trail would follow historic circulations routes whenever possible, such as the portion of the north farm road depicted here, 2016 (OCLP).

The location of the trail within the escarpment and lower terrace will be discussed and mutually agreed upon by partners. The proposed interpretive trail would extend onto actively farmed land both within and beyond land owned in fee by the National Park Service. A proposed width and surface treatment is illustrated by a photo simulation (Figure 3.25).

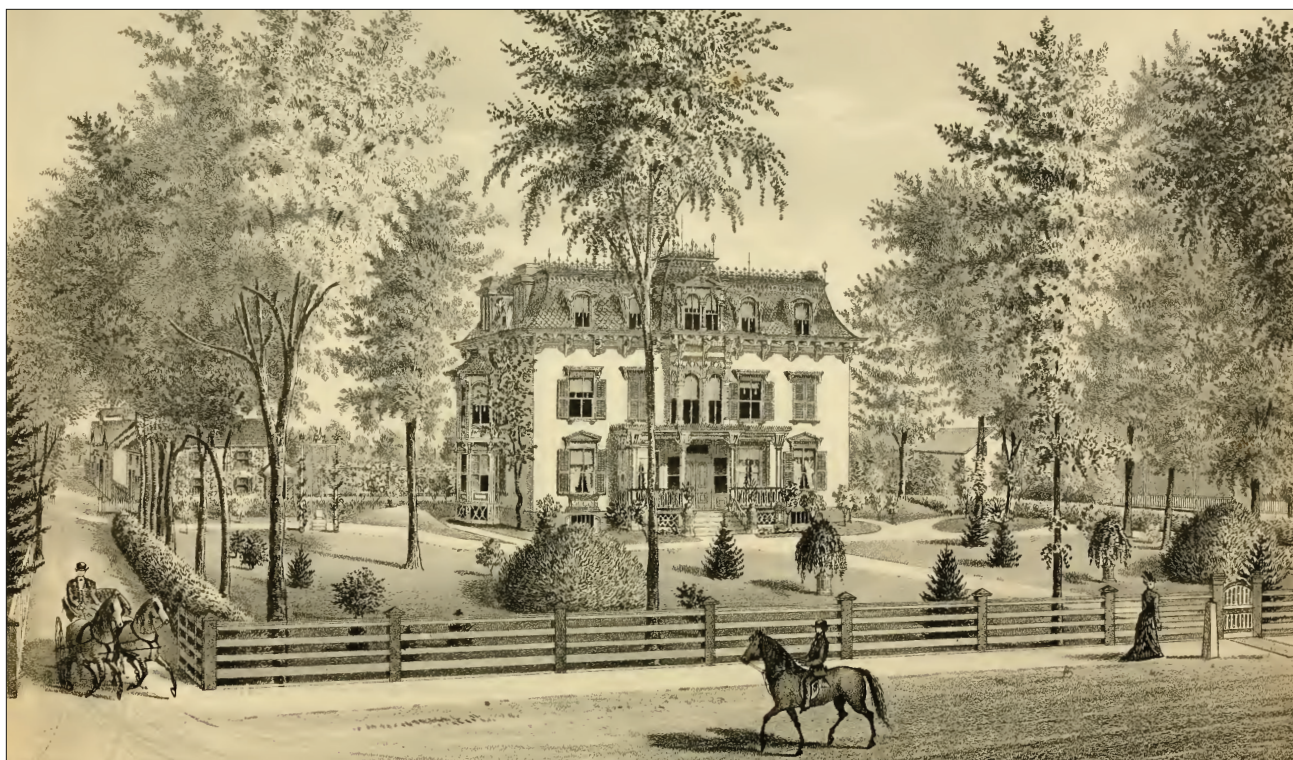
Figure 3.31. This pen and ink drawing, published in 1878 depicts the Kinderhook, New York home of James Mix, a prominent jeweler and president of the local bank. Similarities to the Lindenwald property include a manicured front lawn dotted with specimen trees, decorative urns, and an interconnected circulation system. Note the board fence that lines the roadway, 1878 (Ellis, History of Columbia County).

Figure 3.31. The fence at the Mix property is a three board fence with a decorative top rail. The posts are constructed of sturdy square wood topped with a decorative pyramidal cap. A c.1900 photograph of Lindenwald, Figure 3.34, shows a well-maintained post and wire fence along the Old Post Road, with an ornate wooden gate at the entrance to the north entry drive. Interestingly, the style of the gate in the 1909 photograph closely resembles the arched entry gate depicted in the 1878 ink drawing of the Mix property. Figure 3.32 depicts a wooden fence lining the front of the Bushnell Residence in Claverak, New York. Like the Mix property, the landscape exhibits qualities similar to Lindenwald's during the historic period, including a manicured lawn, specimen trees, an arched entry drive, and a circular front garden. The fence depicted at the Mix Property is a simple wooden picket fence with a kickboard.

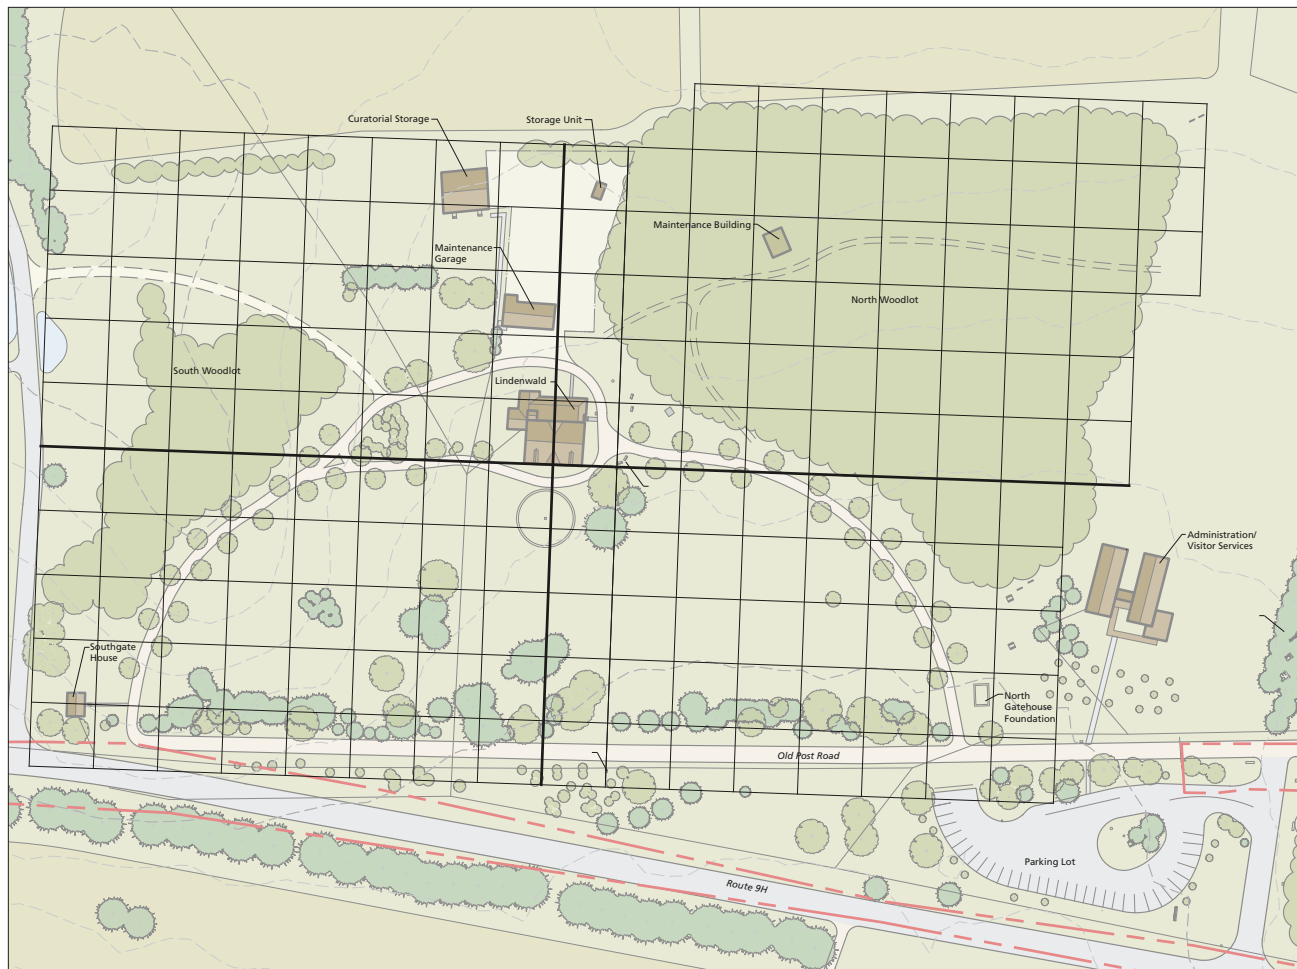
Figure 3.35. Diagram illustrating a sample geophysics collection grid established from fixed base points (east facade and centerline of mansion). Establishment of a grid system will allow data collected through multiple projects and investigations to be linked for comprehensive analysis, 2016 (OCLP).

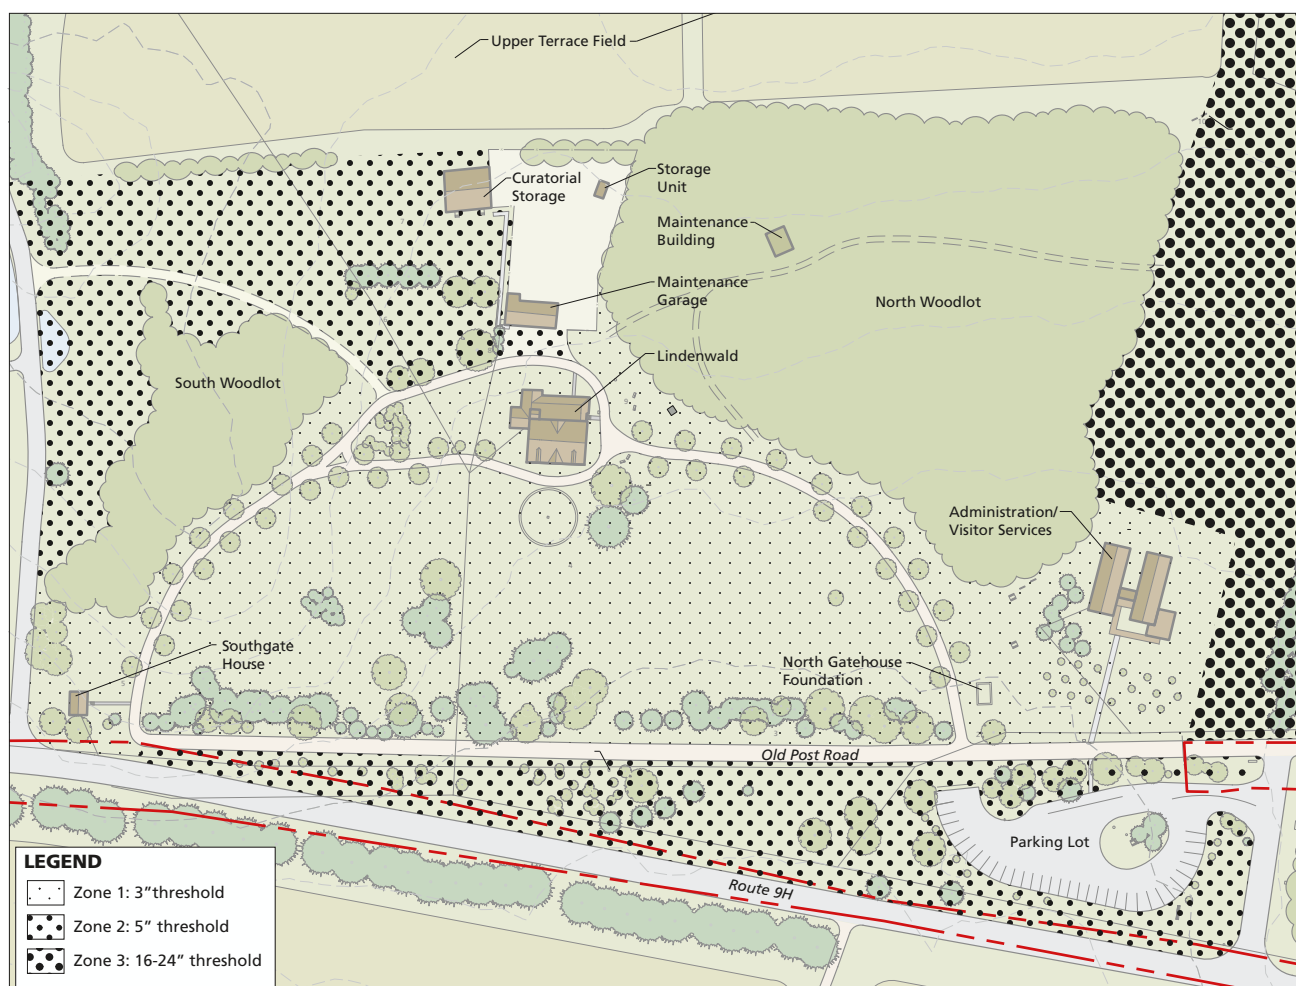
Figure 3.36. The Turf Management Plan (2010) divides the formal Lindenwald landscape into three turf management zones based on recommended mowing height. This report updates turf zones and mowing recommendations based on park feedback and recommendations, 2016 (OCLP).

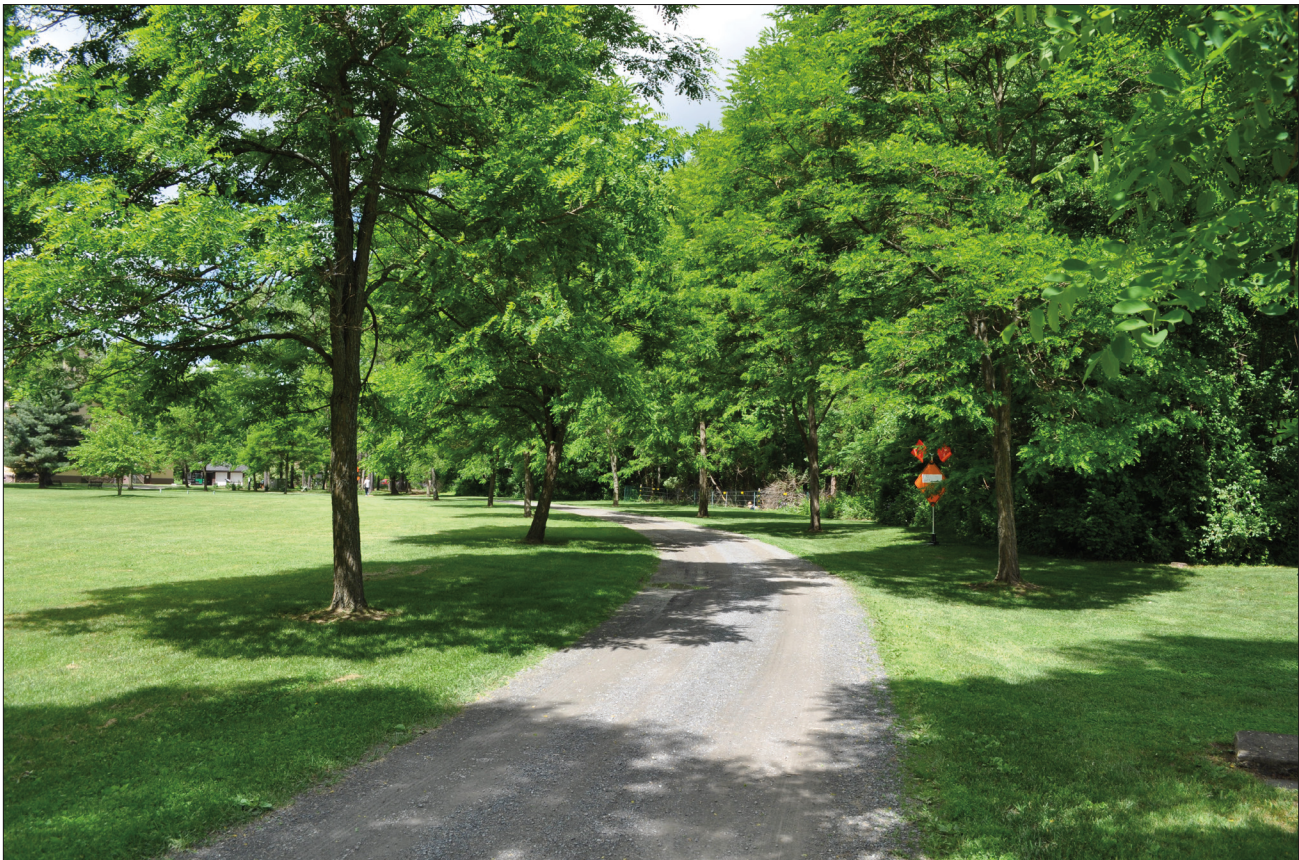
Figure 3.37. View southwest toward the mansion along the entry drive. The park replanted the black locust allée in 2002. Now over a decade later, the maturing trees are beginning to evoke the historic character of the entry drive, 2014 (OCLP).

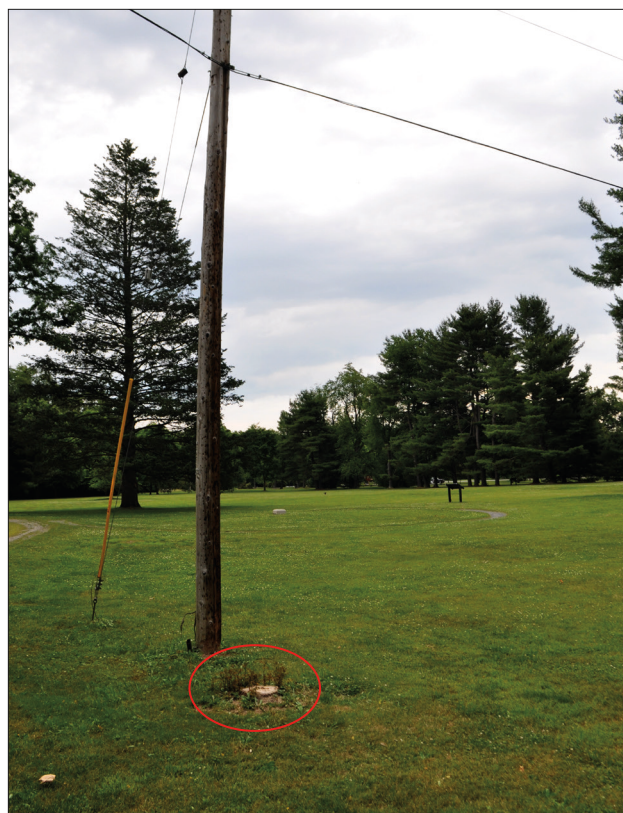
Figure 3.38. View north across the front lawn and circular front garden. Overhead utility lines that bisect the mansion's formal landscape necessitated the removal of one of the replanted black locust in 2014, when the trees crown reached the wires. Overhead utility lines should be buried or relocated, 2014 (OCLP).

Tree #112, part of the original allée is located at the end of the north allée, closest to the house, and should be preserved. Black locust #272, (formerly #R22 *Volume II: Treatment Plan*), was removed in 2014 because of safety threats presented as its canopy grew into overhead utility lines (Figure 3.38). Tree #272 should be replanted when overhead utility lines are removed as recommended in Task HM-UT-1. Tree #282 (formerly #R32), part of the replacement allée, is missing and should be replanted. However, prior to replanting, the extant stump should be ground and removed. All attempts should be made to maintain the locusts in uniform size and character. The trees should be monitored by an arborist for signs of diseases and pests, dead and decayed wood, and structural deficiencies.

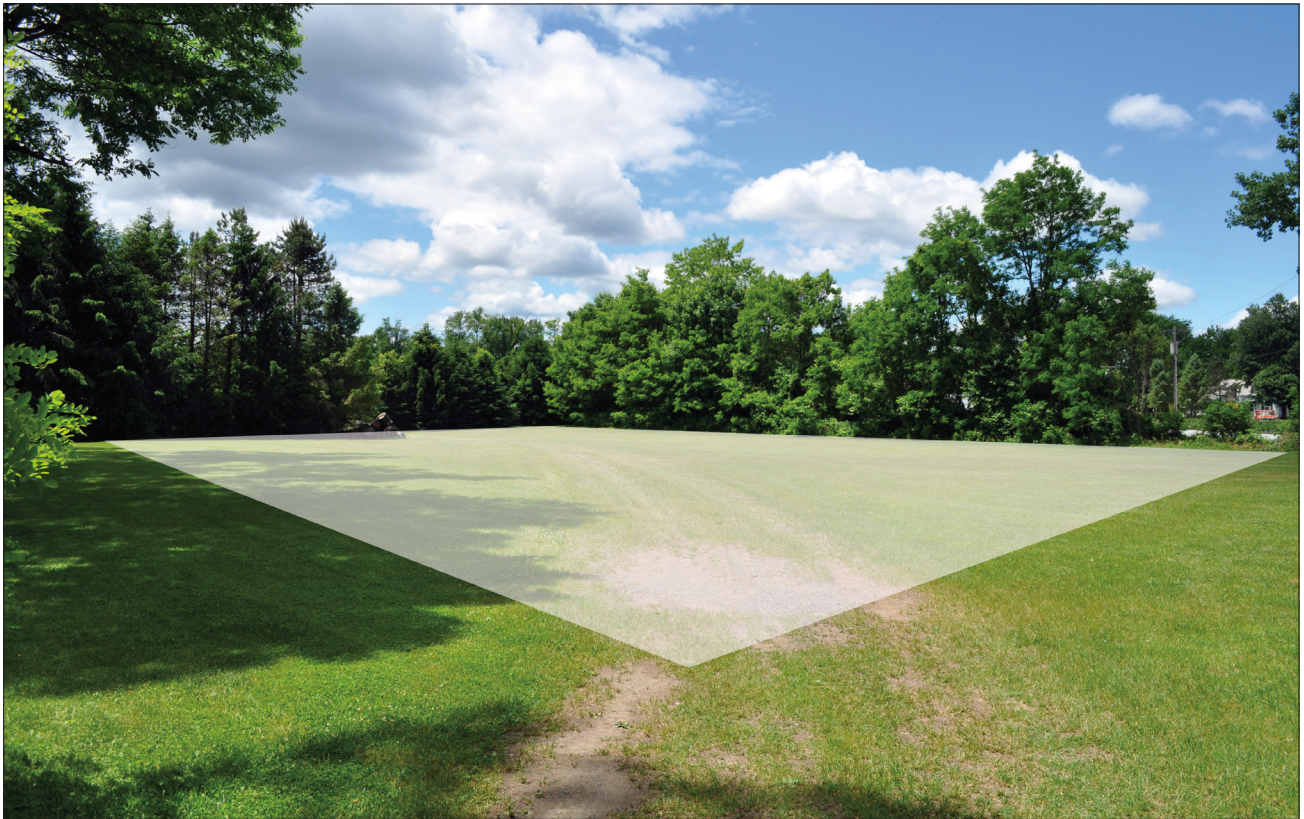
Figure 3.39. View southwest across the rear lawn from the entry drive south of the mansion. The white rectangle overlaid on the photo illustrates the approximate footprint of the Van Buren garden. A portion of the Farm Cottage is visible at image right, 2015 (OCLP).

Shortly after purchasing the property, Van Buren described the dilapidated state of Van Ness's garden, in an 1841 letter, writing that it consisted of "a corn field with only here and there a poor tree."³² Van Buren began a campaign to rebuild and enlarge the garden plot southwest of the house, hiring a gardener to "revive and prepare the old Van Ness plot" in the fall of 1839.³³ No longer extant today, it is likely that Van Buren's garden extended from the Farm Office to the upper fishpond.³⁴ General descriptions of the garden indicate that it was approximately 150 feet wide and 300 feet long and included vegetables, flowers, fruit trees, and vines enclosed by fences. Should the Van Buren garden be redeveloped, the location of historic features and descriptions of the garden during the historic period should guide the garden plan and layout. Sources include Van Buren's letters and descriptions by visitors, both of which describe the garden walls, greenhouse, and the variety of flowers, herbs, vegetables, and fruits that grew in the garden. The general form and location of the garden is depicted on the 1840 sketch map (Figure 3.20) and the approximate historic footprint is overlaid on a contemporary photo in Figure 3.39.

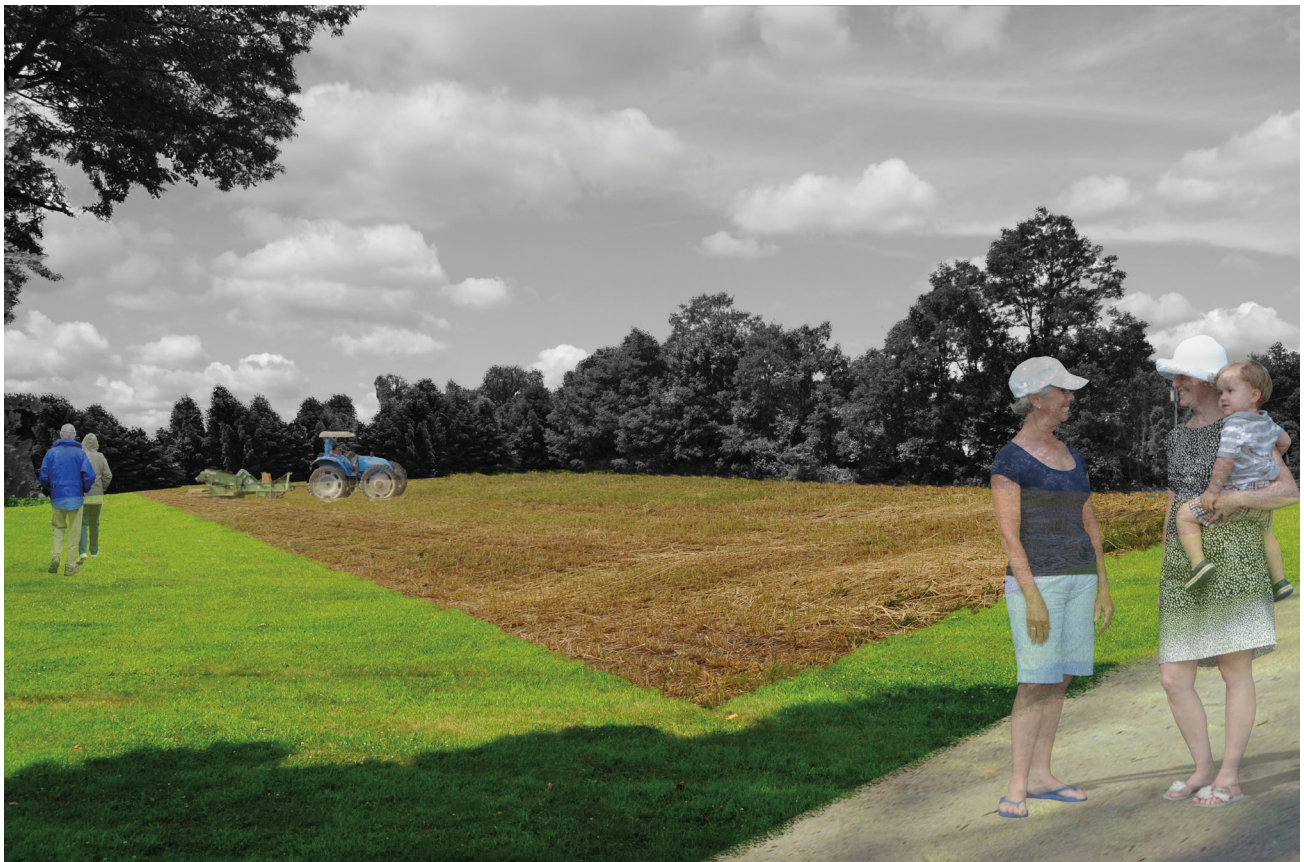
Figure 3.40. Photo simulation depicting the Van Buren garden footprint represented through the planting of a single cover crop, 2015 (OCLP).

crop, weeding, mulching, and harvesting. The crop planted could rotate annually or biannually. This treatment alternative is depicted in Figure 3.40.

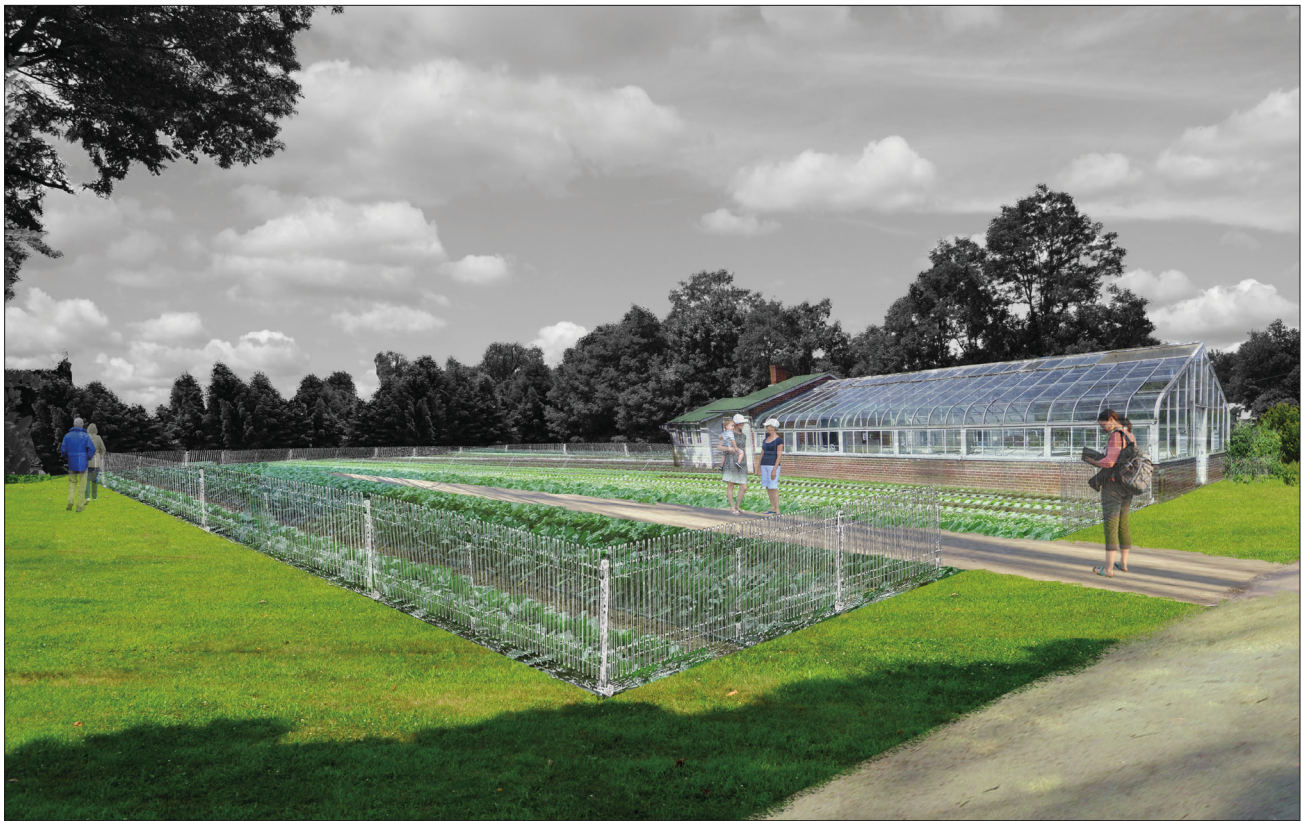
Figure 3.41. Photo simulation depicting the Van Buren garden footprint represented through planting a diversity of crops. Construction of a greenhouse would extend the growing season and offer additional interpretive opportunities, 2015 (OCLP).

Greenhouse structures extend the growing season and can be heated or unheated. The addition of a greenhouse would enhance the historic character of the garden area, and provide useful growing space for local produce. In addition, the garden plot described above can serve as a garden plot for flowers, vegetables, and a tree crop described by Martin Van Buren and his guests. This treatment alternative is depicted in Figure 3.41.

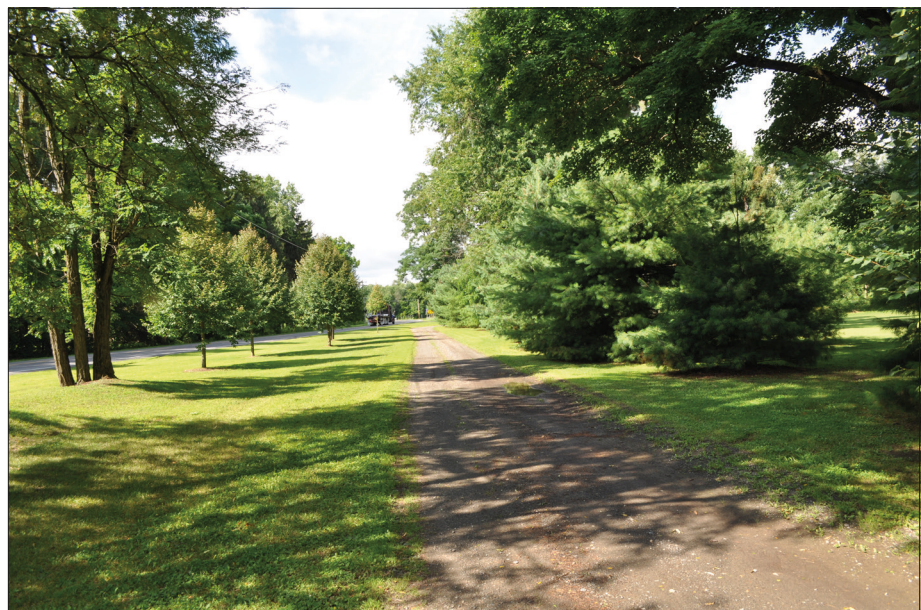
Figure 3.42. View south along the Old Post Road. Note the replanted white pines at image right. Non-historic littleleaf lindens have been planted in the triangular median between the Old Post Road and Route 9H, 2014 (OCLP).

(Figure 3.42). Some portions of the tree row consist of a densely-planted double-row of white pines, planted one to three feet apart and ranging in diameter from approximately eight inches to over twenty inches.

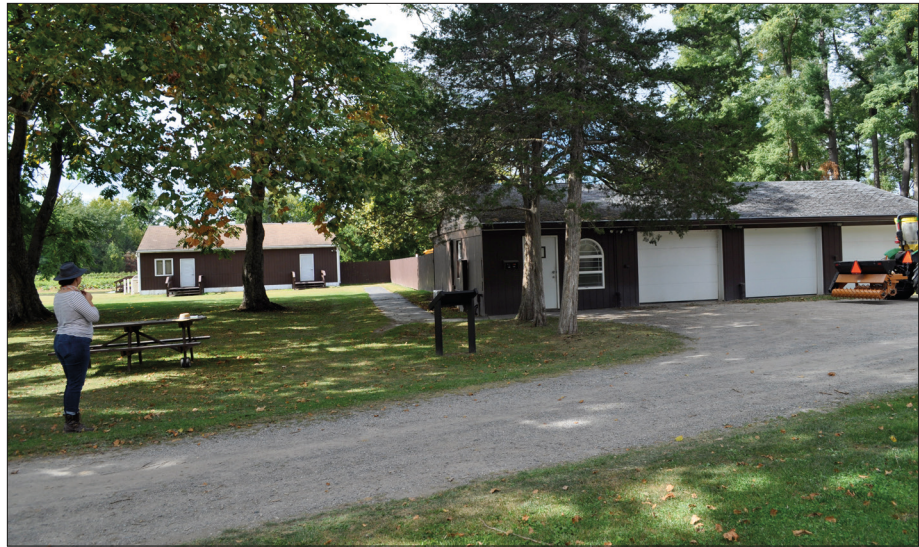
Figure 3.44. View west from the rear of the mansion. The open character of the rear pasture has been altered by the growth of non-historic trees and the construction of several NPS buildings and supporting infrastructure, including an asphalt path and stockade fencing, 2014 (OCLP).

The pasture located behind the mansion during the historic period now contains contemporary park archives and maintenance buildings, park vehicles and equipment, and is surrounded by a privacy fence (Figure 3.44 and 3.45). These non-historic buildings, associated paths, and fencing should be removed, and the open character of the historic pasture should be restored. Removal of non-historic elements should be carried out in a manner sensitive to archeological resources within the site. After the removal of contemporary elements the area should be reseeded and maintained in a manner consistent with surrounding turf, until

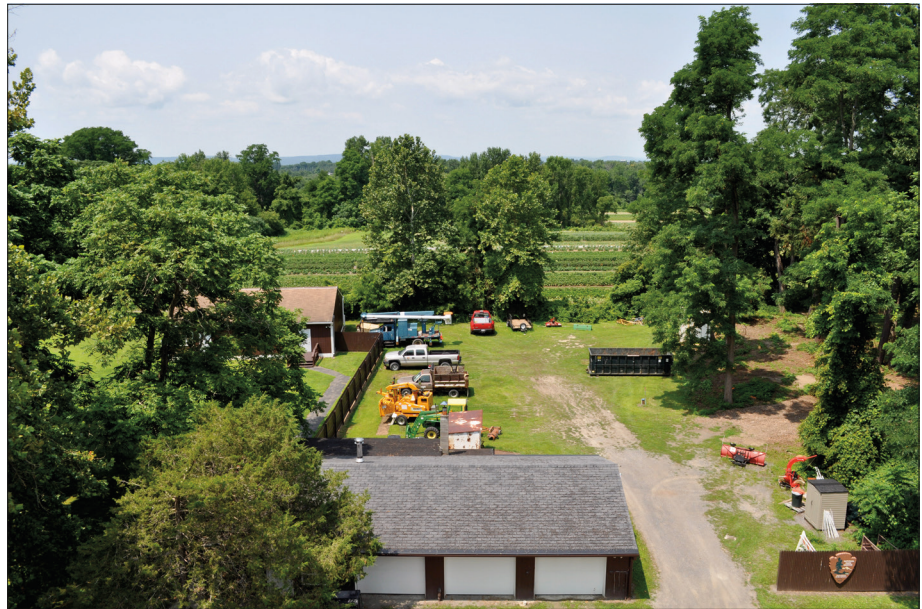
Figure 3.45. View west from the Lindenwald tower, illustrating the intrusion of contemporary NPS infrastructure in close proximity to the mansion. Note the agricultural fields and Catskill Mountains beyond, 2014 (OCLP).

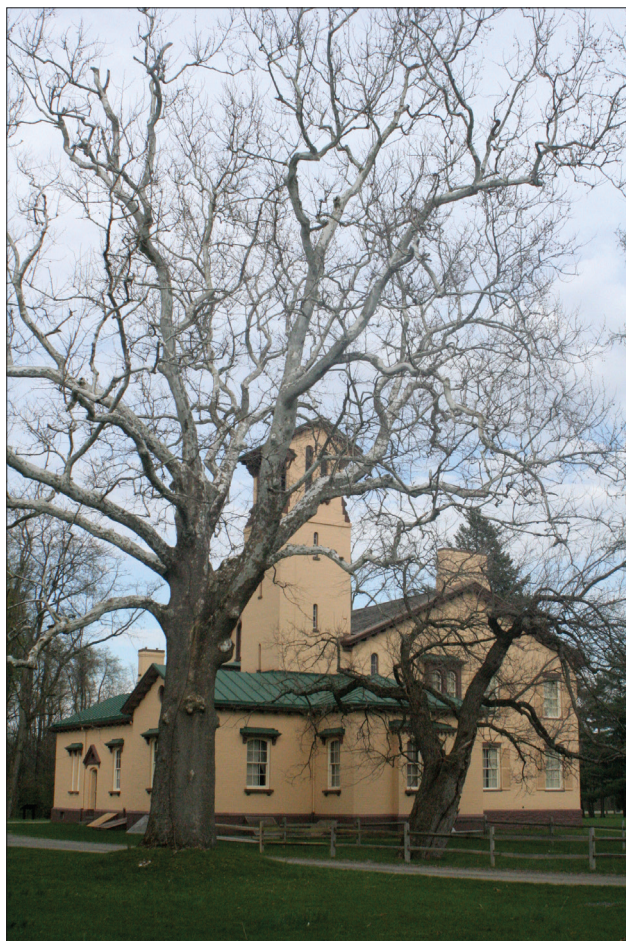
Figure 3.46. View c. 2010 northeast to the mansion. Note the historic sycamore in the foreground and white mulberry, in declining health, closer to the house. The mulberry has since been removed, c. 2010 (OCLP).

Replacement in-kind: The missing white mulberry tree should be replaced in-kind from propagated stock (Figure 3.46 and 3.47). Three white pines surrounded the front garden during the historic period (Figure 3.48). One was lost by a storm in 1937, and the final two were removed in the 1990s.⁴⁹ These three white pines should be replanted (Figure 3.49).

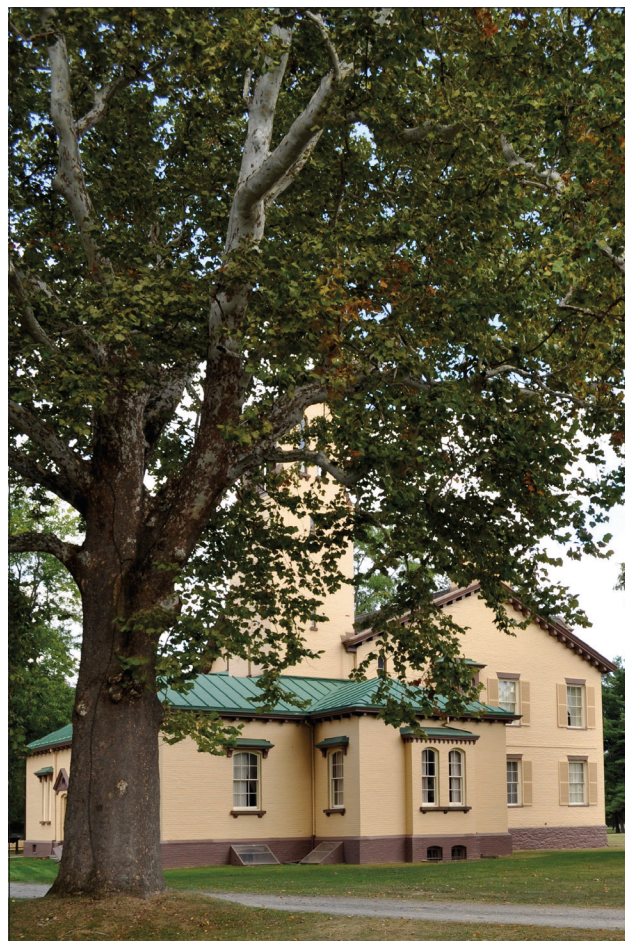
Figure 3.47. View northeast to the mansion. The historic sycamore remains, however note the white mulberry documented in Figure 3.53 has been removed. This missing historic tree has been propagated and should be replanted, 2014 (OCLP).

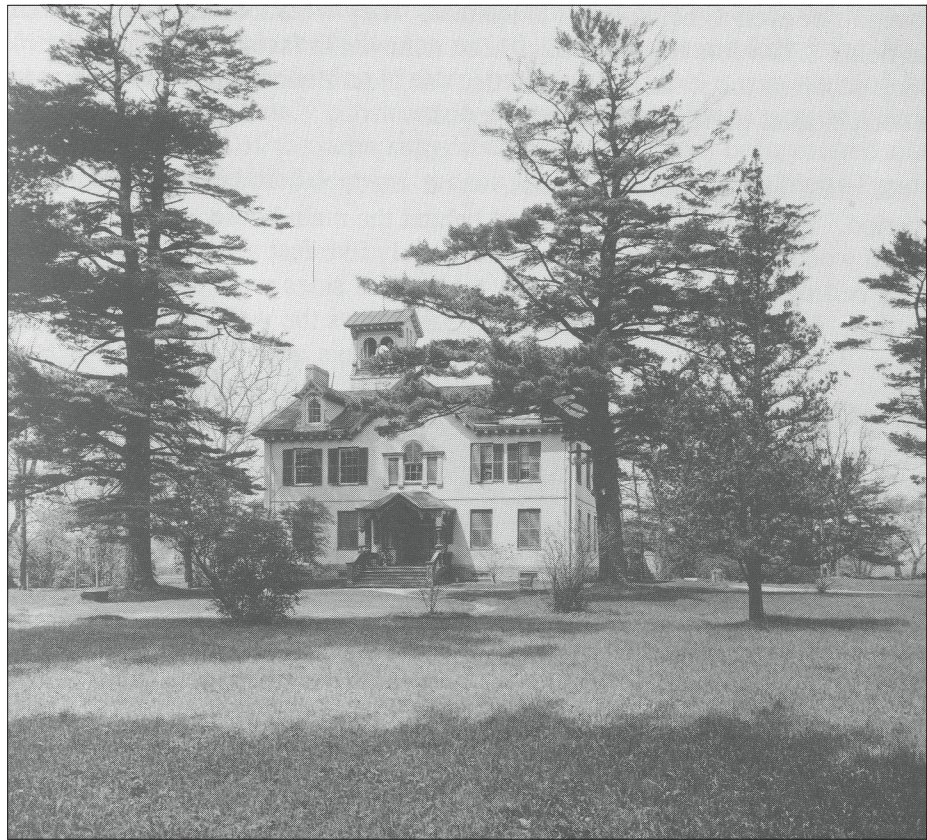
Figure 3.48. Taken during Wagoner ownership, this photo shows two mature white pines framing the front garden. A young Douglas fir can be seen at image right. Several shrubs border the front garden, c. 1913 (MAVA archives).

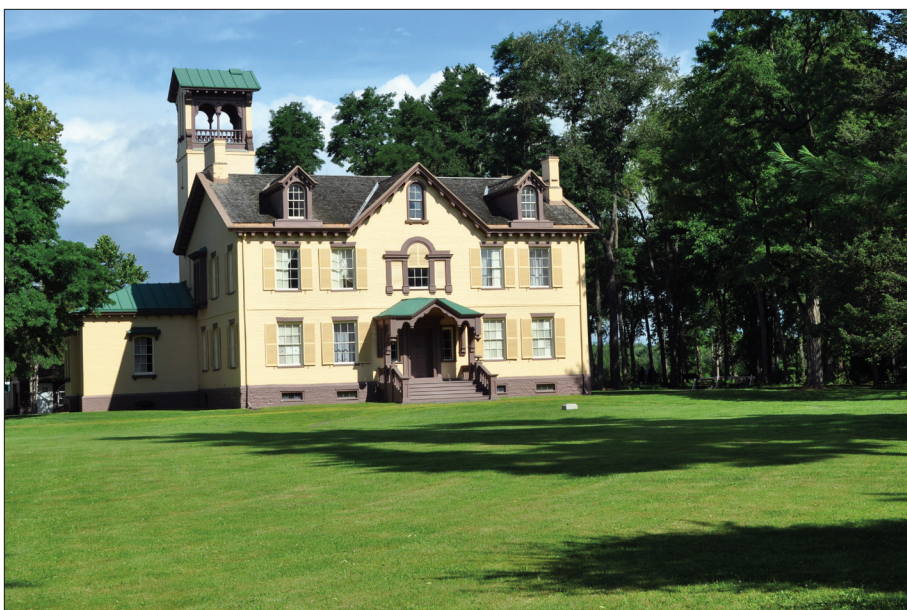
Figure 3.49. View west to the mansion from the front lawn. Note missing white pines framing the front garden that are depicted in Figure 3.56, 2014 (OCLP).

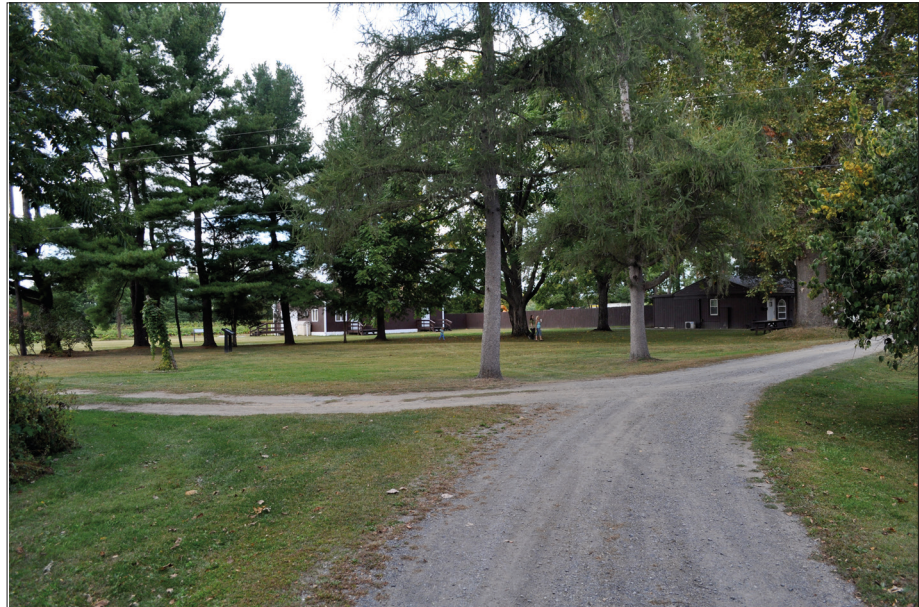
Figure 3.50. View northwest from entry drive to the rear lawn, historical open pasture. The non-historic trees south and west of the mansion's formal landscape obstruct historically open views and bisect the site of historic farm roads. Completion of related treatment tasks will necessitate the removal of non-historic vegetation to more accurately evoke the historic landscape character, 2014 (OCLP).

detract from the historic character of the landscape, obscuring views and altering historic mass and spacing patterns (Figure 3.50). Many of these trees should be removed outright, while others should be retained until replacement trees or screening has matured. This information is presented graphically in Drawing 3.6, 3.7, 3.8, and 3.9 and summarized in the Vegetation Management Table found in Appendix A.

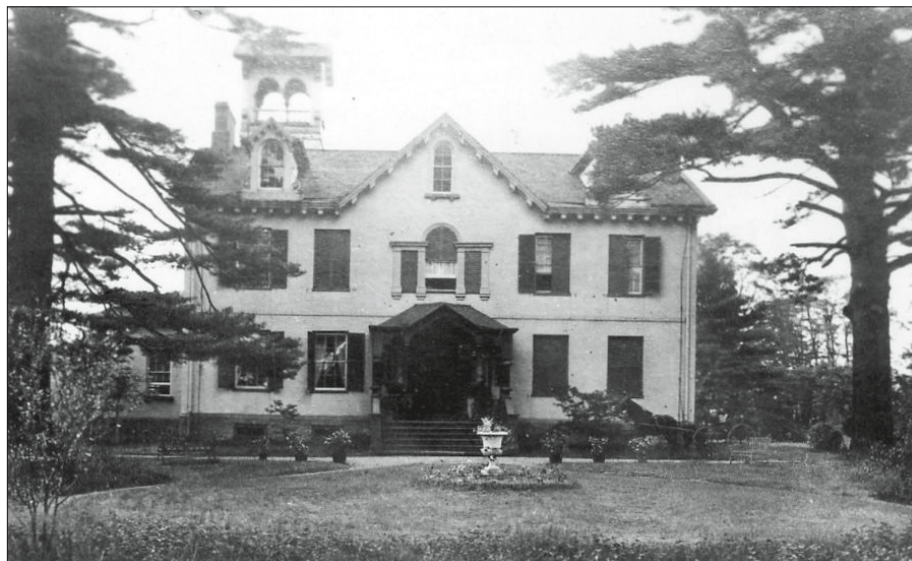
Figure 3.54. View east from the western edge of the front garden. The reproduction urn located in the center of the garden has since been removed. A portion of the replanted white pine screen along the Old Post Road is visible in the background, c. 2010 (OCLP).

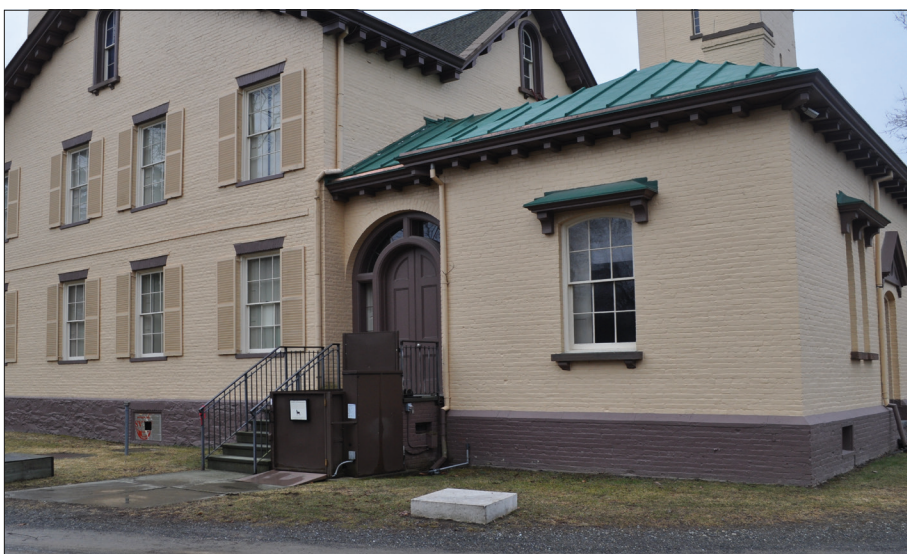
Figure 3.58. View northwest of the woodlot. Contemporary benches and trash receptacles located immediately north of the mansion detract from the historic character of the grounds and should be considered for relocation or modification as associated tasks are completed, such as the restoration of the front garden and the development of a new visitor center, 2014 (OCLP).

Contemporary small-scale features located in close proximity to the north entrance of the mansion detract from the historic character of the site. The wood composite benches and trash receptacle accompany a wayside in an area used for tours to gather before they enter the house. While this staging area for visitors to wait for a tour is an important component of the house tour, these benches should either be relocated or replaced with furnishings that do not detract from the historic setting (Figure 3.58). Alternative locations for tours to gather should be explored, as treatment tasks are accomplished. Alternative locations should be considered in the development of the visitor center (Task AD-BS-1), relocation of the reproduction benches to the center circular garden (Task HM-SSF-3), or north orchard restoration (Task HM-VG-1).

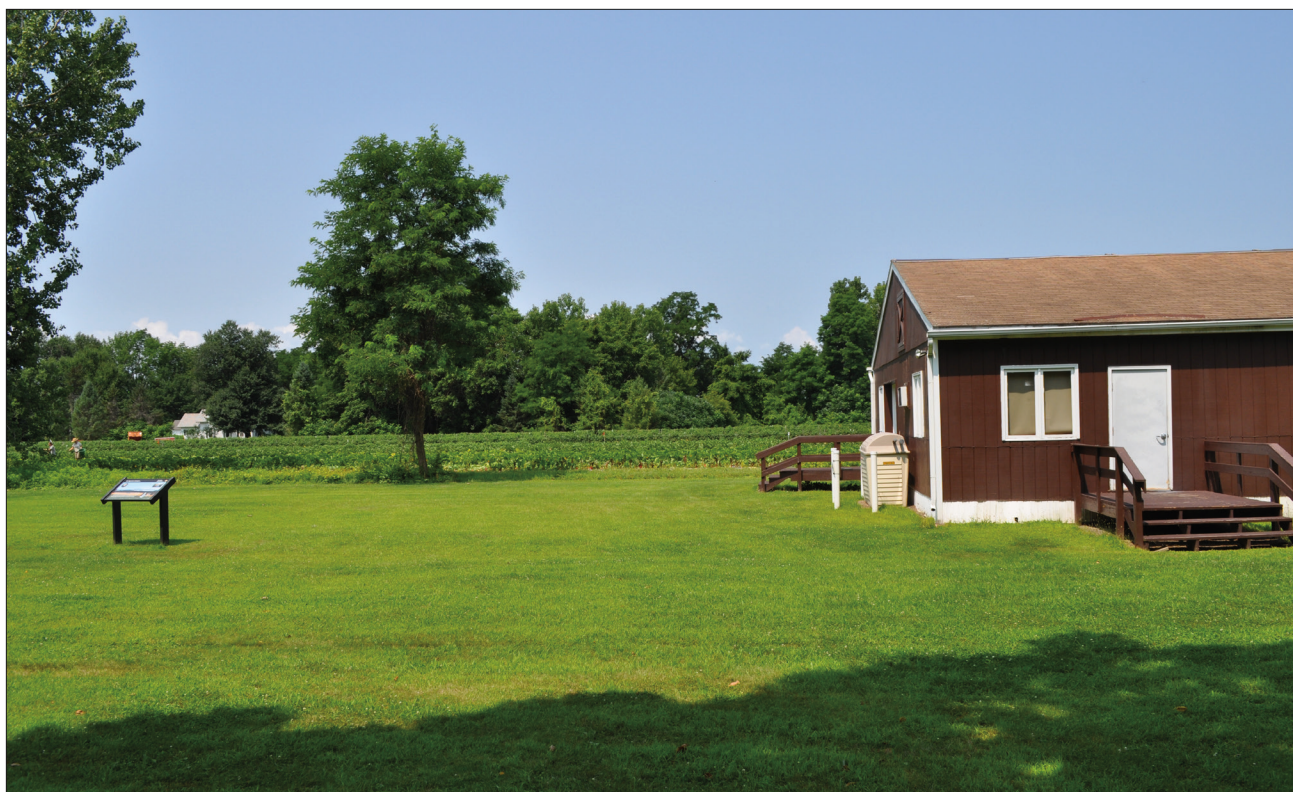
Figure 3.70. View west from behind the mansion toward the upper terrace field. The contemporary archives building (pictured) and a maintenance facility obstruct views to the agricultural landscape beyond. The farm cottage is visible in the background at image left, 2014 (OCLP).

and remains in use. A Campbell era building, used as a park maintenance facility, further detracts from the historic character and view (Figure 3.70). Park vehicles and equipment are stored in a gravel parking lot to the rear of the maintenance facility. A privacy fence surrounding the vehicle storage area further impacts the historic view.

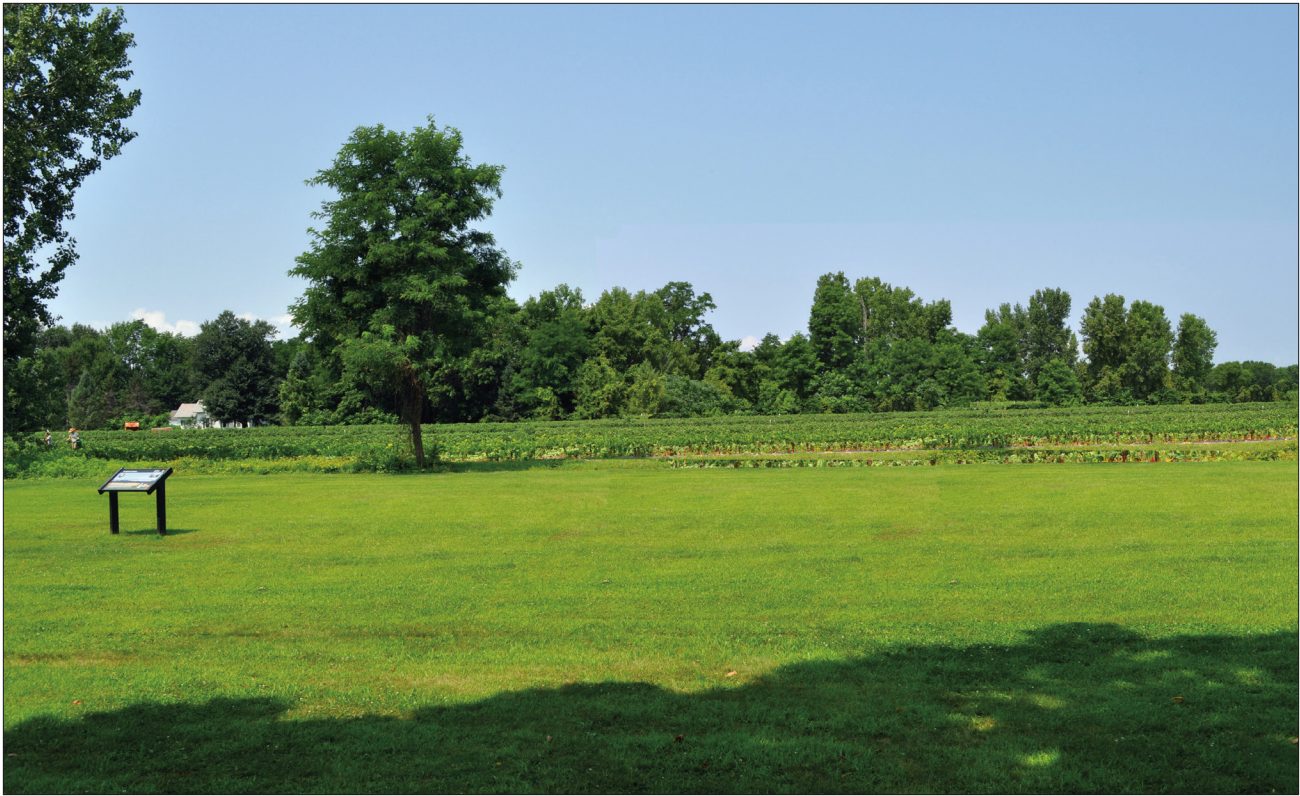
Figure 3.71. Photo simulation depicting the removal of contemporary NPS buildings behind the mansion. Views to the agricultural fields west of the mansion are restored, and the historic character of the site is enhanced, 2015 (OCLP).

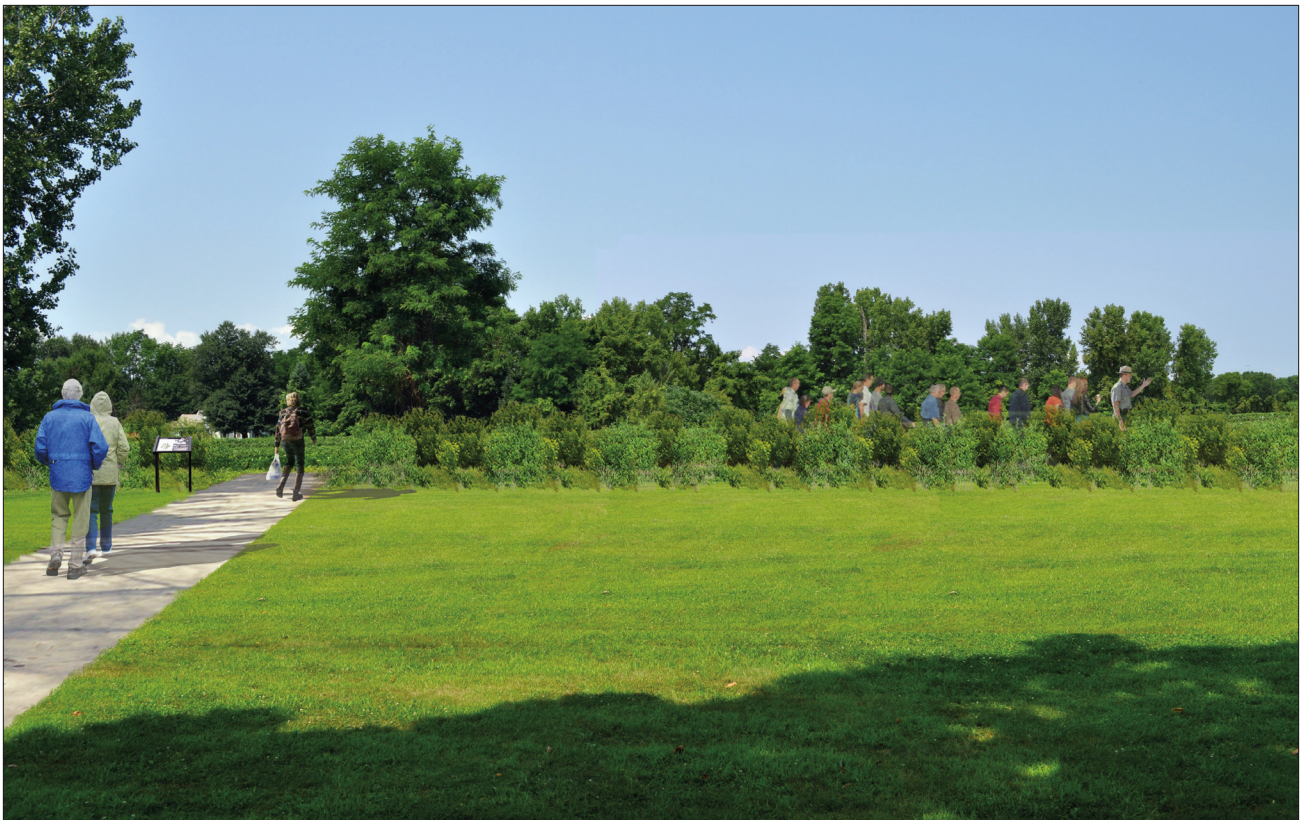
Figure 3.72. Photo simulation depicting the removal of contemporary NPS buildings behind the mansion. A portion of the proposed interpretive trail is visible at image left, and a hedgerow has been established. Views to the agricultural fields west of the mansion are restored, and the historic character and visitor experience is enhanced, 2015 (OCLP).

Figure 3.71, a photo simulation, depicts the removal of contemporary buildings to the rear of the Lindenwald mansion. The area should be returned to open lawn or pasture space as it existed during the historic period. Figure 3.72, a photo simulation, depicts the removal of non-historic park buildings and implementation of treatment tasks to rehabilitate hedgerows (Task PW-VG-1) and represent Van Buren period circulation routes (Task PW-CR-1). Removal of these non-historic buildings will dramatically improve the visual connection between the mansion grounds and its agricultural context as described in Task PW-VV-1.

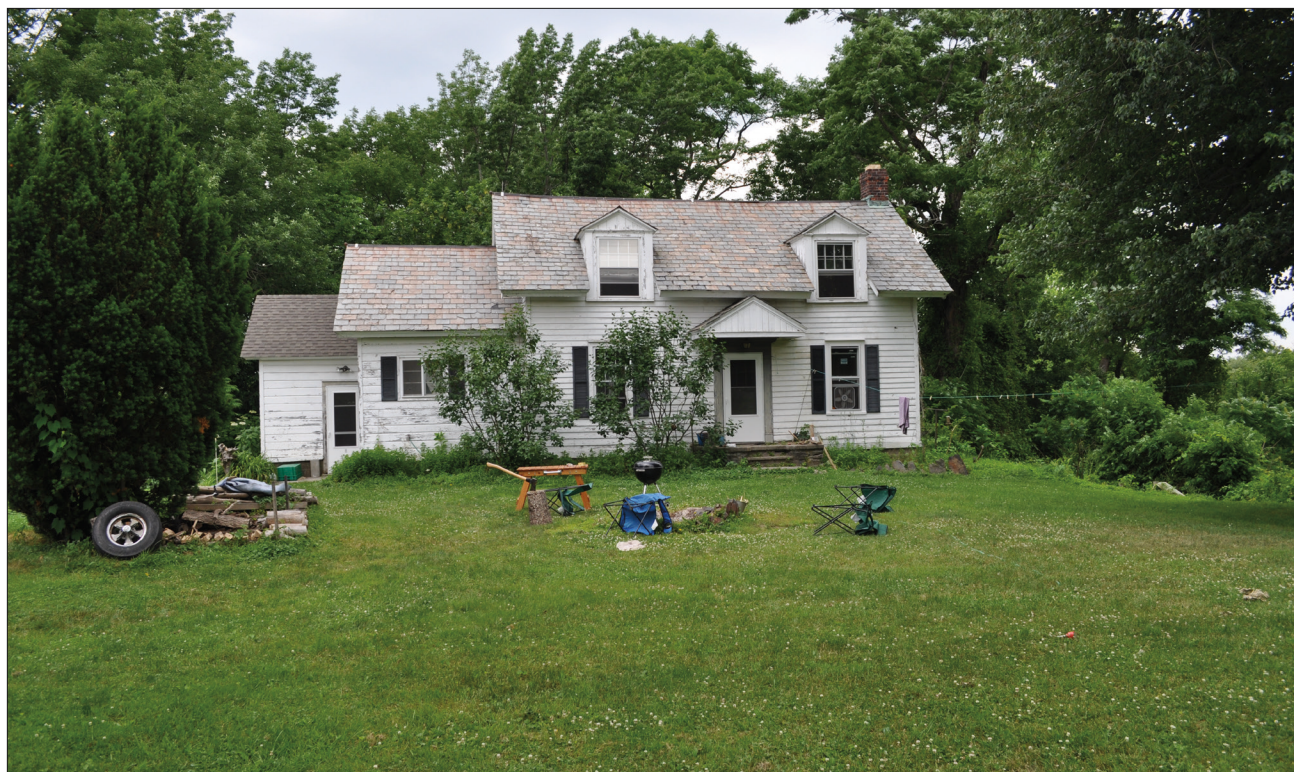
Figure 3.73. View west toward the Farm Cottage, currently used to house Roxbury Farm employees, 2014 (OCLP).

The Farm Cottage, constructed by Van Buren in about 1843, remains in its historic location on the west edge of the upper terrace. Both the interior and exterior have been altered since the end of the historic period and the building is in need of maintenance. Today, consistent with use during Van Buren’s residency, the building houses farm workers (Figure 3.73). The *General Management Plan* prioritizes the Farm Cottage for stabilization treatment under Alternative C to prevent further deterioration. A Historic Structure Report (HSR) was completed in 2016 and provides further direction to develop an appropriate rehabilitation and maintenance plan. The *General Management Plan* indicates a preference for interior rehabilitation and adaptive reuse for park purposes.⁶²
