CULTURAL LANDSCAPE REPORT FOR MARTIN VAN BUREN NATIONAL HISTORIC SITE

VOLUME II: UPDATED TREATMENT PLAN AND RECORD OF TREATMENT

KINDERHOOK, NEW YORK

Olmsted Center for Landscape Preservation
National Park Service, Boston, Massachusetts, 2016

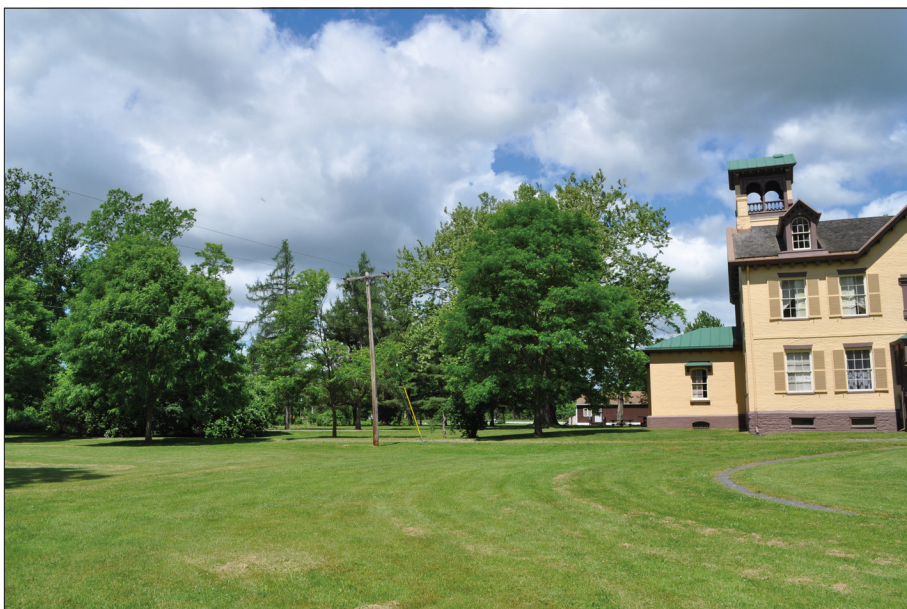
Figure 3.74. View west across a portion of the front lawn, toward the mansion and agricultural fields beyond. Note the utility lines that cross the front lawn, and pole located in close proximity to the mansion. Non-historic vegetation and buildings visible in the background further detract from historic character and obstruct views to the west, 2014 (OCLP).

Overhead utility lines enter the site from the Post Road and extend across the front lawn toward the Lindenwald mansion, crossing through the white pine screen along the Post Road and the replanted black locust allée. Near the mansion, the utility line turns west toward the Roxbury Farm agricultural complex, where it crosses the upper terrace field (Figure 3.74).

The presence and obtrusive location of this utility line impacts the historic character of the site. The line bisects the front lawn, fragmenting the open expanse, and adding an inharmonious contemporary feature. Additionally,

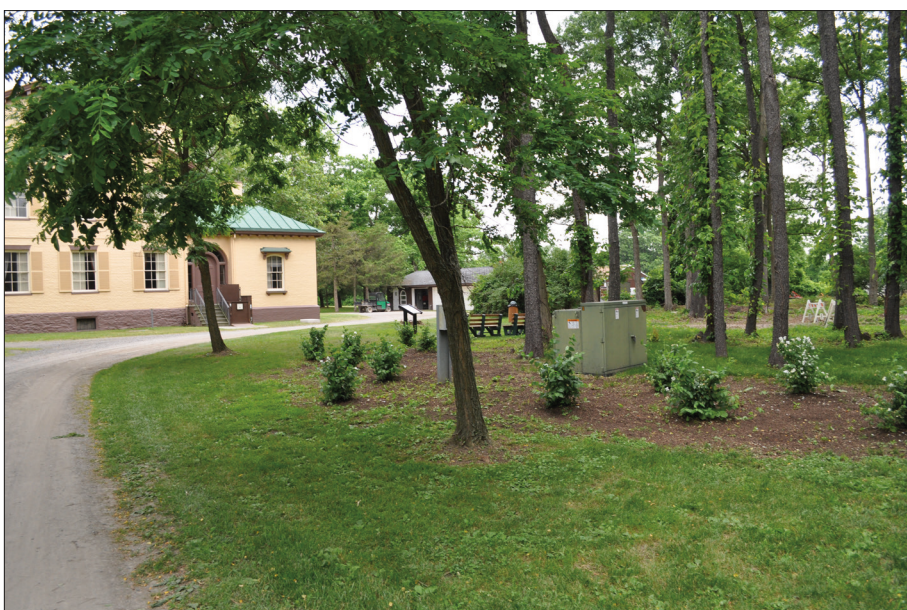
Figure 3.75. View southwest toward the electric transformer located just north of the mansion. Previously the transformer was screened by underbrush in the north woodlot, however today the utility's location is more prominent, 2014 (OCLP).

Planting efforts to screen the utilities was only partially successful. Utilities remain largely visible and detract from the historic character of the core (Figure 3.75). Proper screening is essential to reduce the impact of these necessary but detracting contemporary additions located approximately sixty-feet north of the mansion. Completion of tasks including the restoration of the north orchard (Task HM-VG-1) and restoration of the historic circulation system (Task PW-CR-1) will increase the prominence of the utilities, making adequate screening essential. Recommended species are compatible with the historic character and include common lilacs (*Syringa vulgaris*) and mock orange (*Philadelphus coronarius*). The planting plan developed for *Volume II: Treatment Plan* is included in Figure 3.76. Additional screening of the transformer with appropriate vegetation will reduce the impact of this intrusion in close proximity to the mansion. As feasible the National Park Service should consider relocation of the transformer or other means of reducing impact.

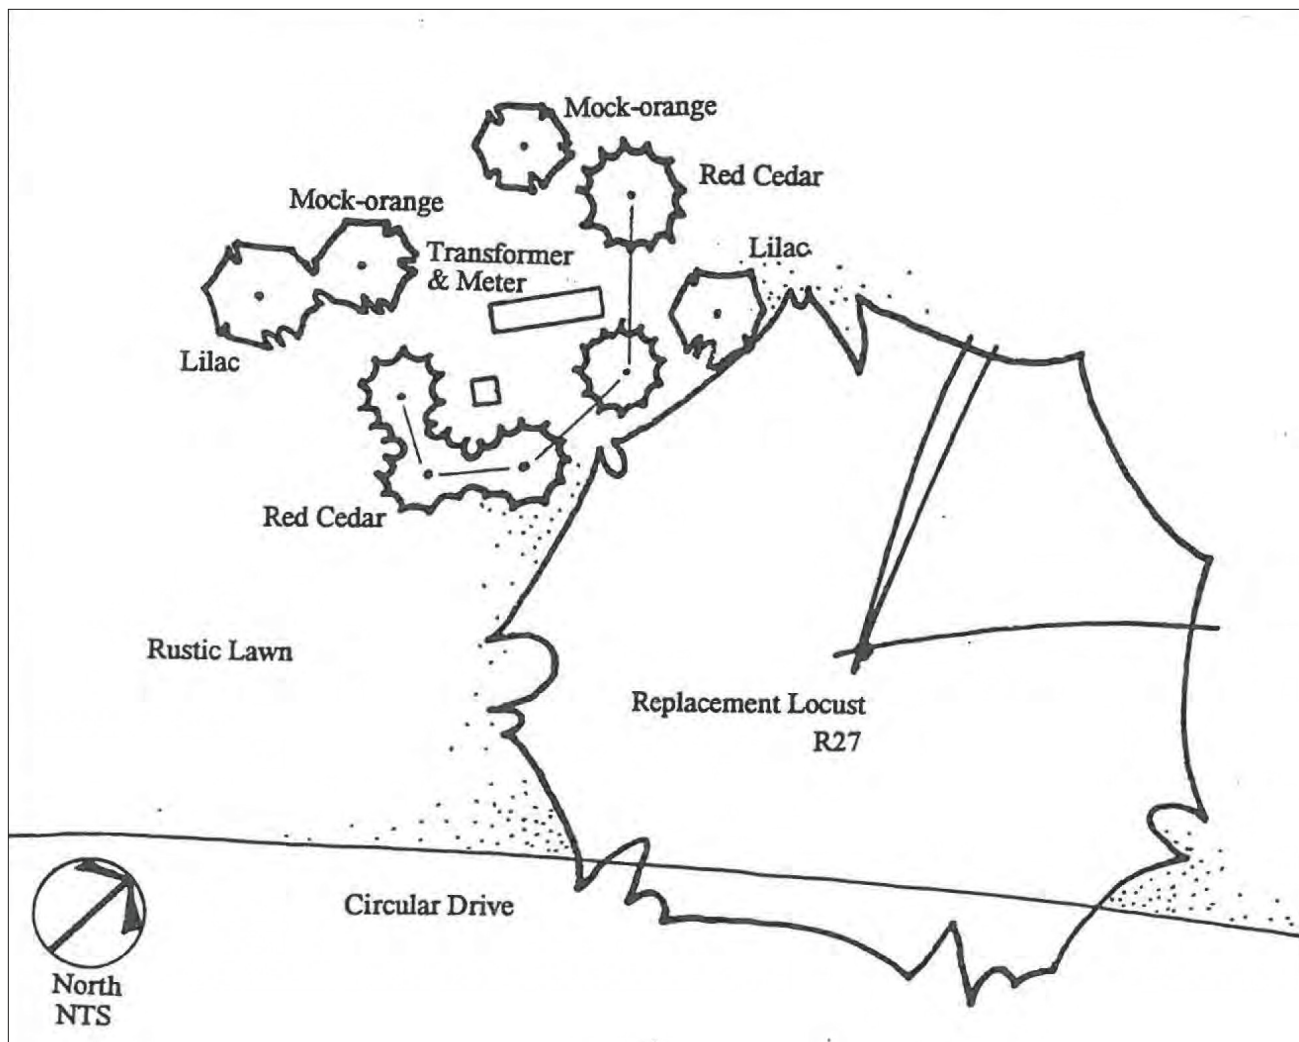
Figure 3.76. Planting plan to screen utilities, 1997 (OCLP/ SUNY ESF).

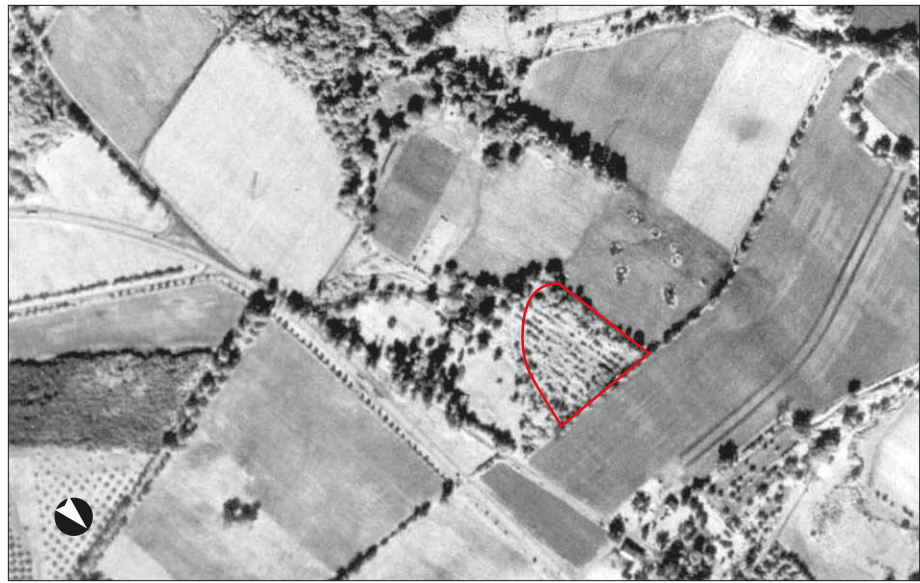
Figure 3.77. This annotated 1948 aerial documents the then surviving remnants of the Van Buren orchard. A 2002 letter from William deProse described it as an “old pear orchard (older than us)... the rows were spaced widely apart so that vegetables and such could be grown in-between. Behind and to the west of the pear orchard there was an equally old apple orchard.” (MAVA archives).

Clear evidence of the remnants of this orchard can be seen in an aerial photograph taken in 1948, (Figure 3.77) and physical evidence of stumps persisted in the landscape through the 1990s. Today little evidence remains in the landscape of Van Buren’s productive orchards. All fruit trees have been removed, and the site of the south orchard is a mixture of cultivated farm fields and an agricultural complex which includes buildings, green houses, parking, and evergreens. The western part of the north orchard has been incorporated into a productive agricultural field, and should remain as such (Figure 3.84). The site of the eastern portion of the north orchard, known today as the north woodlot, is the primary focus for treatment (Figure 3.79, 3.84, 3.86).

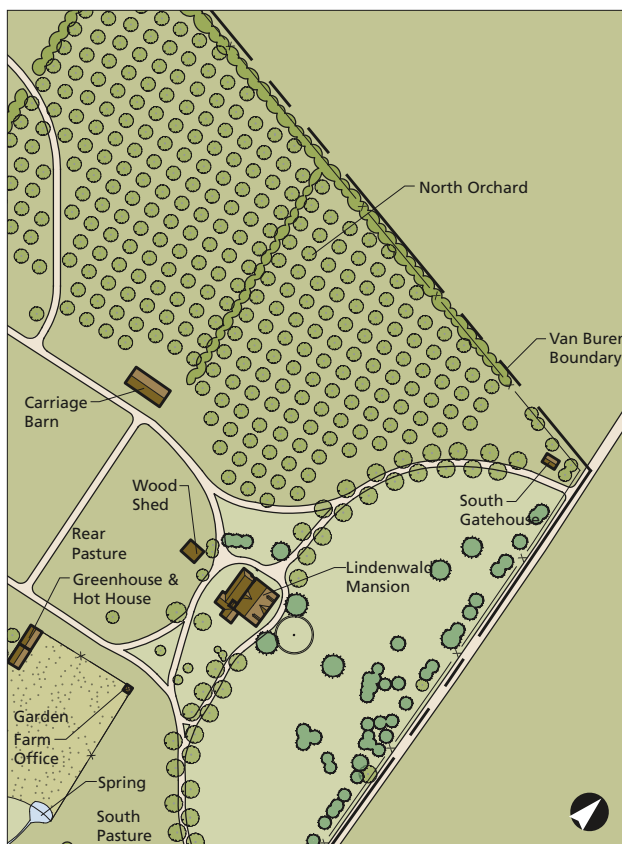
Figure 3.78. Historic Conditions (Van Buren Period). Van Buren's extensive orchards included both apple and pear trees and extended across much of the northern portion of his property, (OCLP).

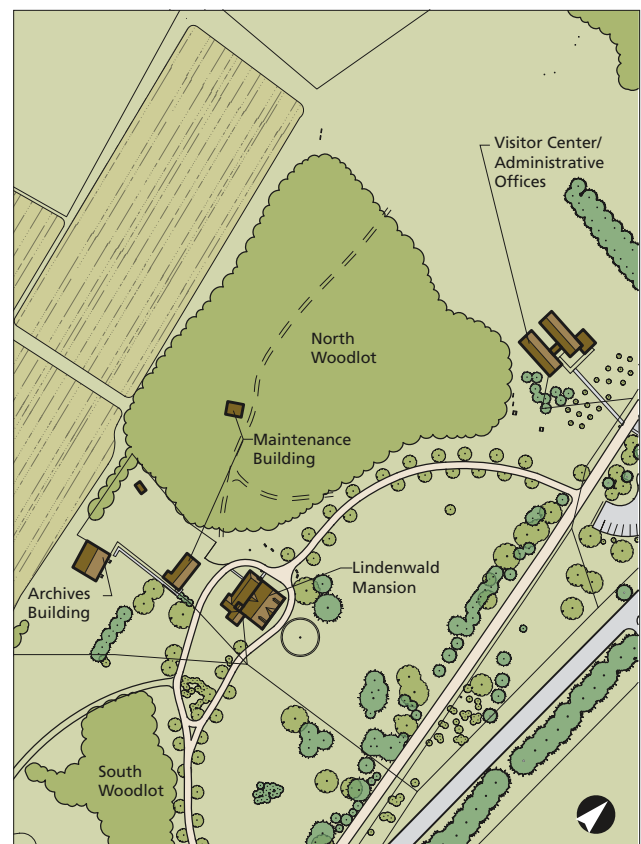
Figure 3.79. Existing Conditions (2015). Van Buren's orchards have been removed. The western portion is actively farmed, the eastern portion has become an overgrown woodlot, (OCLP).

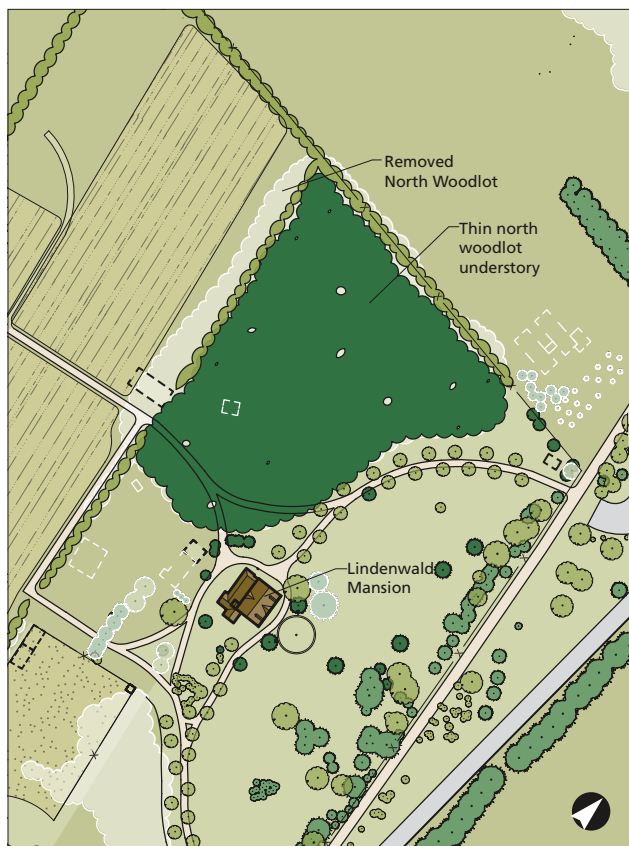
Figure 3.80. Alternative: Transition woodlot to tree grove, (OCLP).

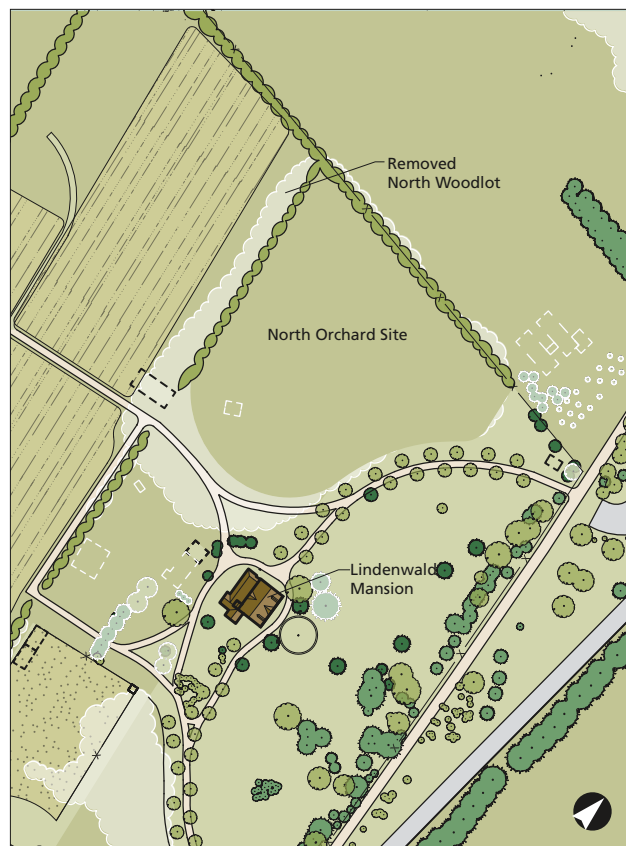
Figure 3.82. Alternative: Partial restoration (eastern part), (OCLP).

A partial restoration of the eastern portion of the former orchard will enhance the historic setting and fabric of the historic period, and eliminate the non-historic woodlot (Figure 3.82). The western portion of the historic orchard would remain in row-crop production, while the eastern portion of the north orchard, now known as the north woodlot, would be cleared, rehabilitated, and partially replanted as an orchard, with trees planted on a thirty-by-thirty-foot grid. This partial restoration would evoke the character of a historic orchard but not necessitate planting of the full grid. For example, the center of the orchard could be more sparsely planted, which would reduce the total number of trees in the orchard, lower long-term maintenance needs and costs. To minimize orchard management practices, trees with a high resistance to pests and diseases are recommended. A smaller number of historic varieties may be planted for interpretation and comparison. The orchard would be managed for the physical characteristics of the orchard, not for fruit production. Trees will be pruned annually and the orchard area will be mowed or grazed seasonally two or three times a year to ensure that woody trees, shrubs and vines do not persist in the orchard area. The remnant orchard visible in the 1948 aerial (Figure 3.77) indicates that Van Buren's orchard was planted in an orthogonal pattern. For

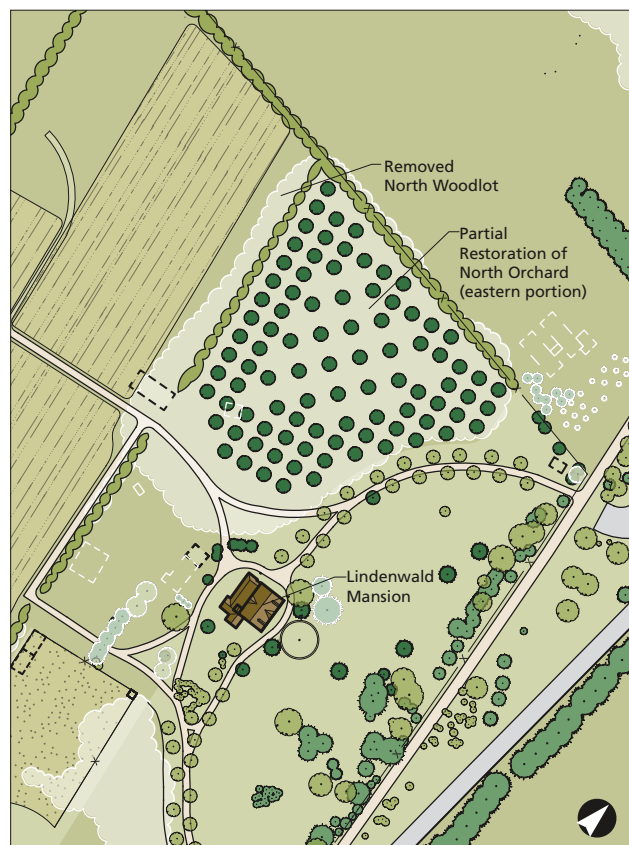
Figure 3.83. Alternative: Full restoration (eastern part), (OCLP).

The eastern portion of the north orchard, now the north woodlot, will be cleared, rehabilitated, and replanted as an orchard (Figure 3.83). Historic fruit tree varieties managed for production will be planted in a thirty-by-thirty-foot grid pattern. The orchard will be managed for fruit production through the use of organic sprays, physical barriers, and other integrated pest management strategies to yield marketable heirloom fruit varieties that were common in the mid-1800s and specifically described by Van Buren. Trees will be pruned annually and the orchard area mowed or grazed seasonally two or three times a year to ensure that woody trees, shrubs and vines do not persist in the orchard area. The western portion of the historic orchard will continue to be actively farmed in row crops. This treatment alternative is depicted in Figure 3.88, 3.90).

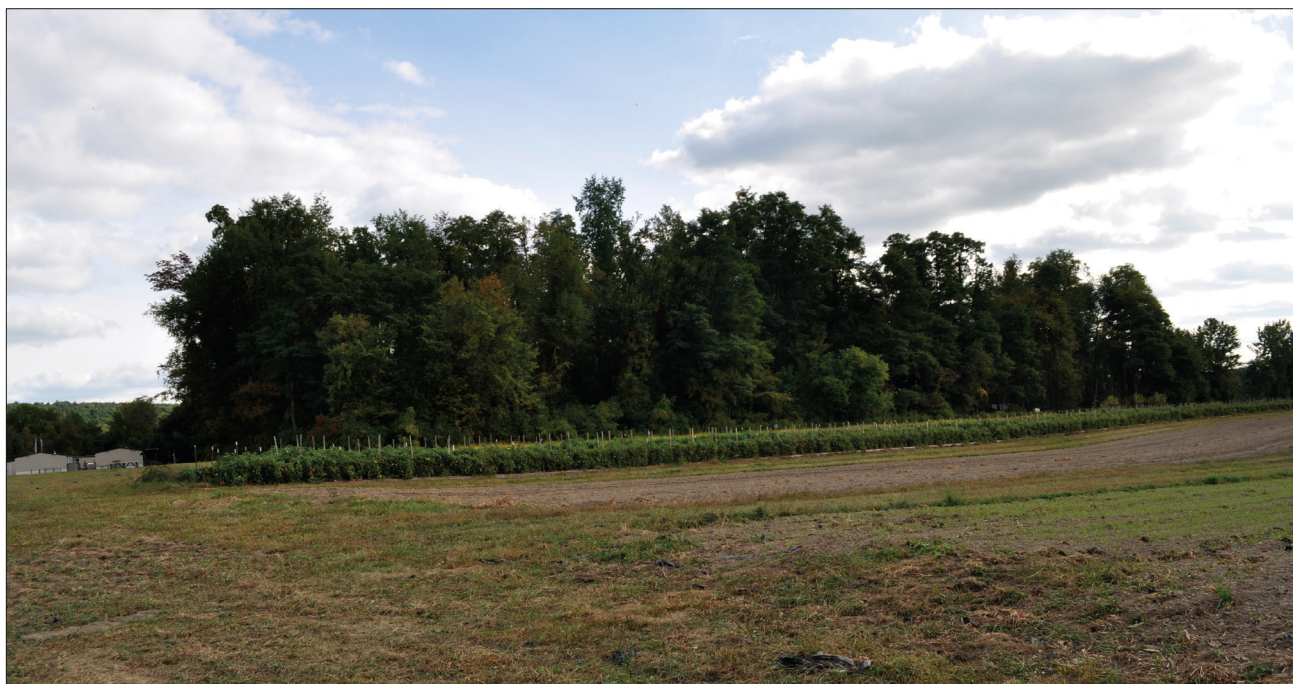
Figure 3.85. View southwest from near the North Gatehouse foundation, illustrating the density of the vegetation within the north woodlot, which obstructs historically open views. In the foreground, the goats leased during the summer of 2014 to clear vegetation are at work, 2014 (OCLP).

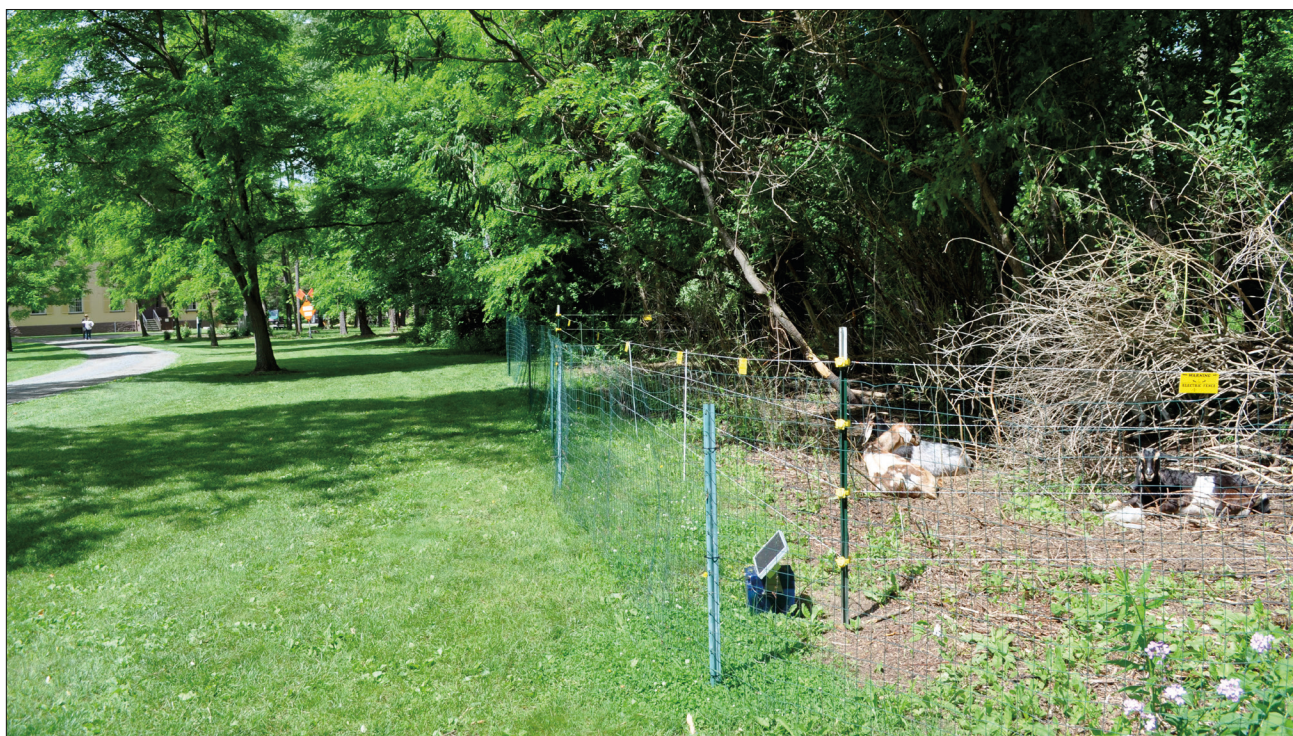
Figure 3.86. Views southwest of the mansion, North Gatehouse foundation, and north woodlot. Views to agricultural fields west and southwest of the formal Lindenwald landscape are obstructed by the north woodlot, 2014 (OCLP).

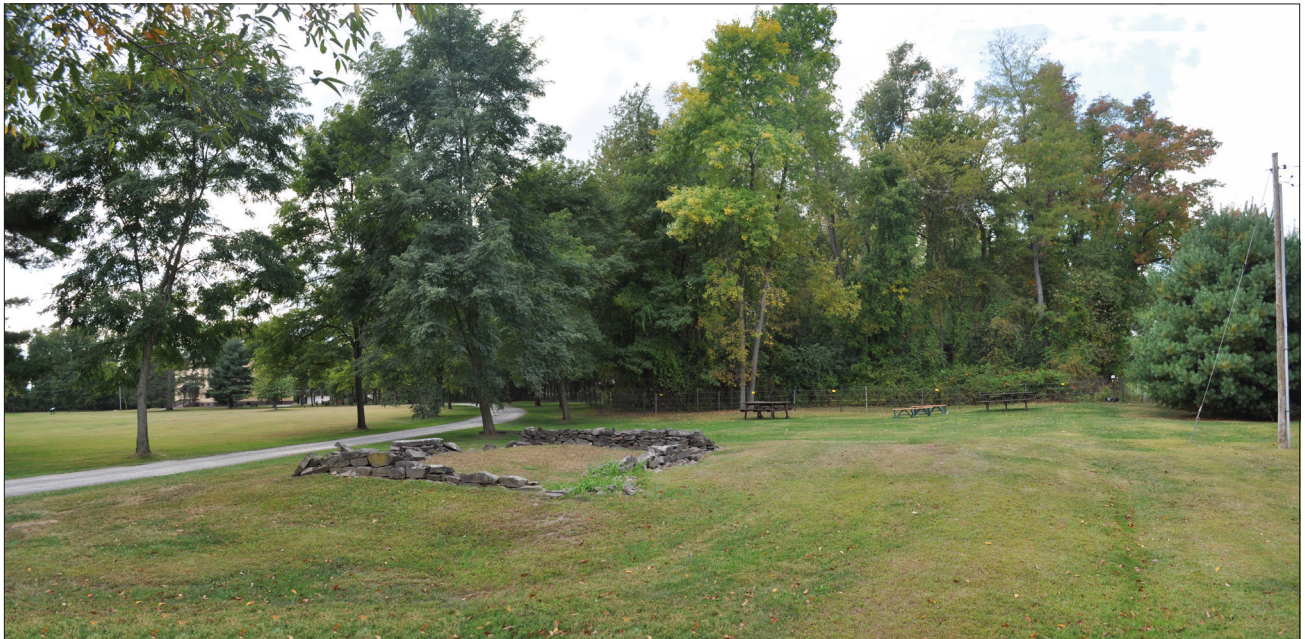
Figure 3.88. Photo simulation illustrating the restoration of historic views through the removal of the north woodlot and a partial replanting of the historic orchard area, 2016 (OCLP).

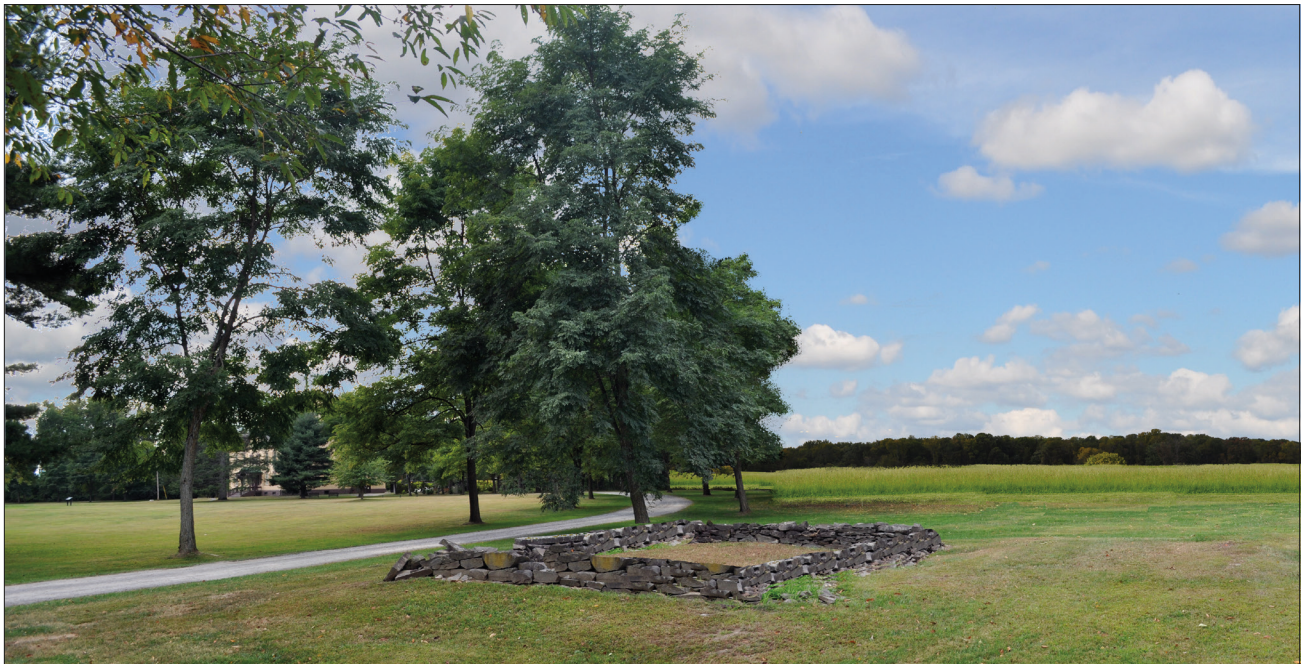
Figure 3.87. Photo simulation illustrating the restoration of historic views through the removal of the north woodlot. The north woodlot area has been cleared and a native meadow grass or hay field mix planted, 2016 (OCLP).

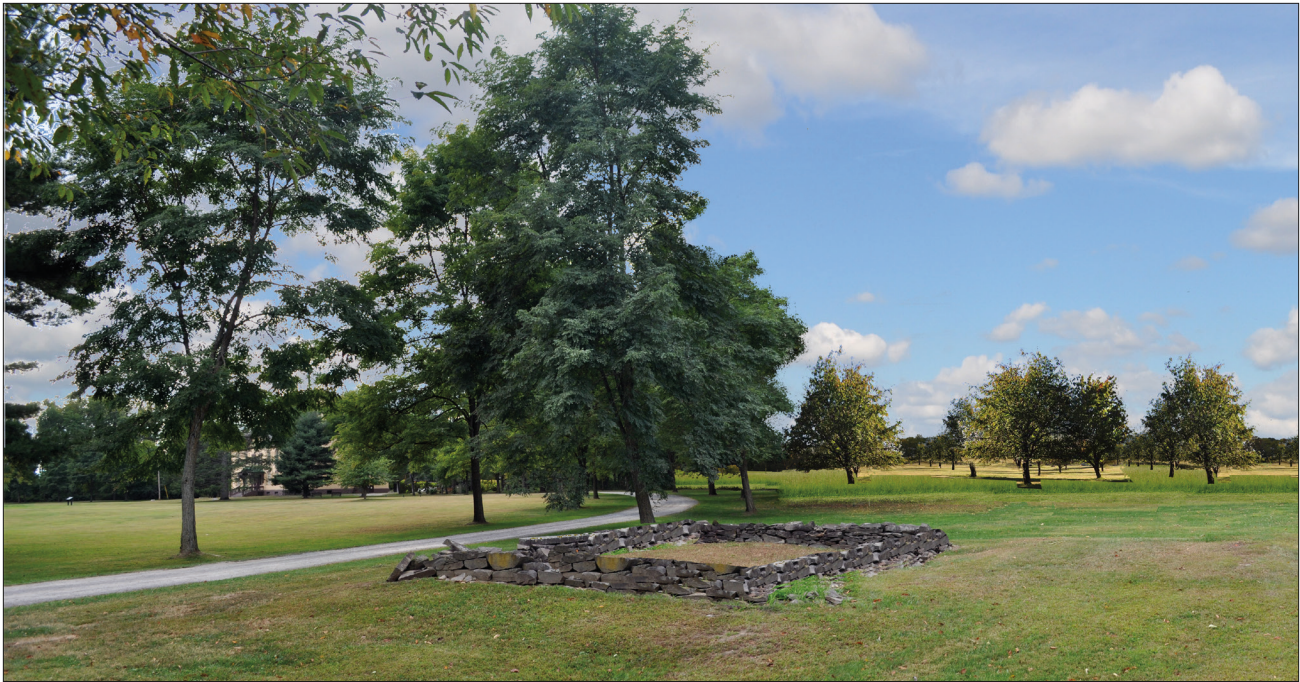
Figure 3.89. The north woodlot acts as a curtain of vegetation behind the restored allée, obstructing views to the south and southwest. Historically, this area was an orchard with widely spaced rows, 2014 (OCLP).

The south woodlot is a non-historic landscape feature, composed of successional woodland growth, which is primarily black locust and black cherry. During the historic period this area was an open pasture that adjoined the historic garden. The woodlot does not reflect the historic character, blocks views of adjacent farm fields, and creates an enclosed feeling not present in the historic period (Figure 3.89).

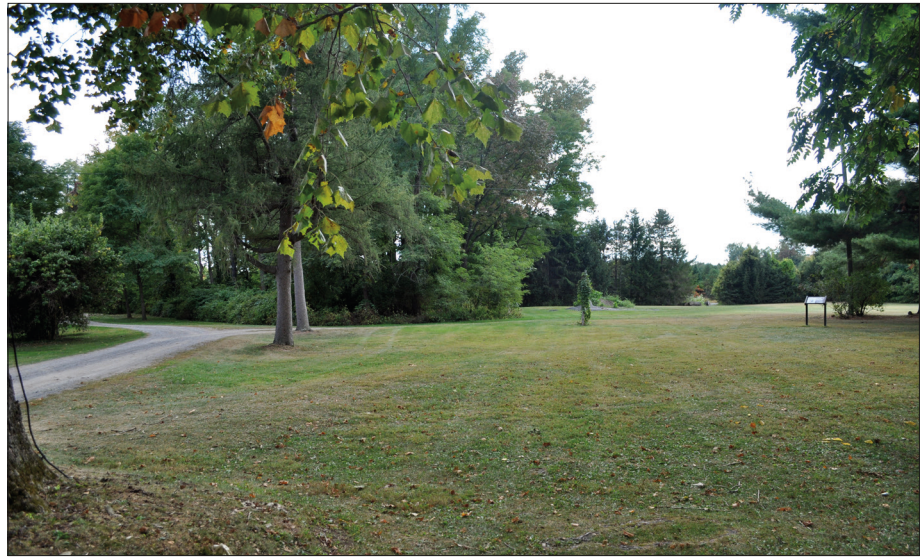
Figure 3.92. View northwest toward the Van Ness grave marker. The grave marker is located on the western edge of the upper terrace field and surrounded by clipped grass, 2014 (OCLP).

Currently, the Van Ness grave marker is surrounded by clipped grass. To the west the trees and successional vegetation of the escarpment form a backdrop. There is surface indication of former stump sites, although it is unknown if these stump locations date to the historic period (Figure 3.92). A photograph from the early twentieth-century depicts a low post and rail fence surrounding the monument (Figure 3.93). This report recommends not replanting trees due to insufficient information about their location. In addition, mature trees would diminish the productivity of the adjacent agricultural field. A low post and rail fence could be constructed to protect the monument; however, an opening should be included to allow maintenance of the turf surrounding the monument. Care should be taken to keep turf mowing and trimming equipment away from the monument surfaces.

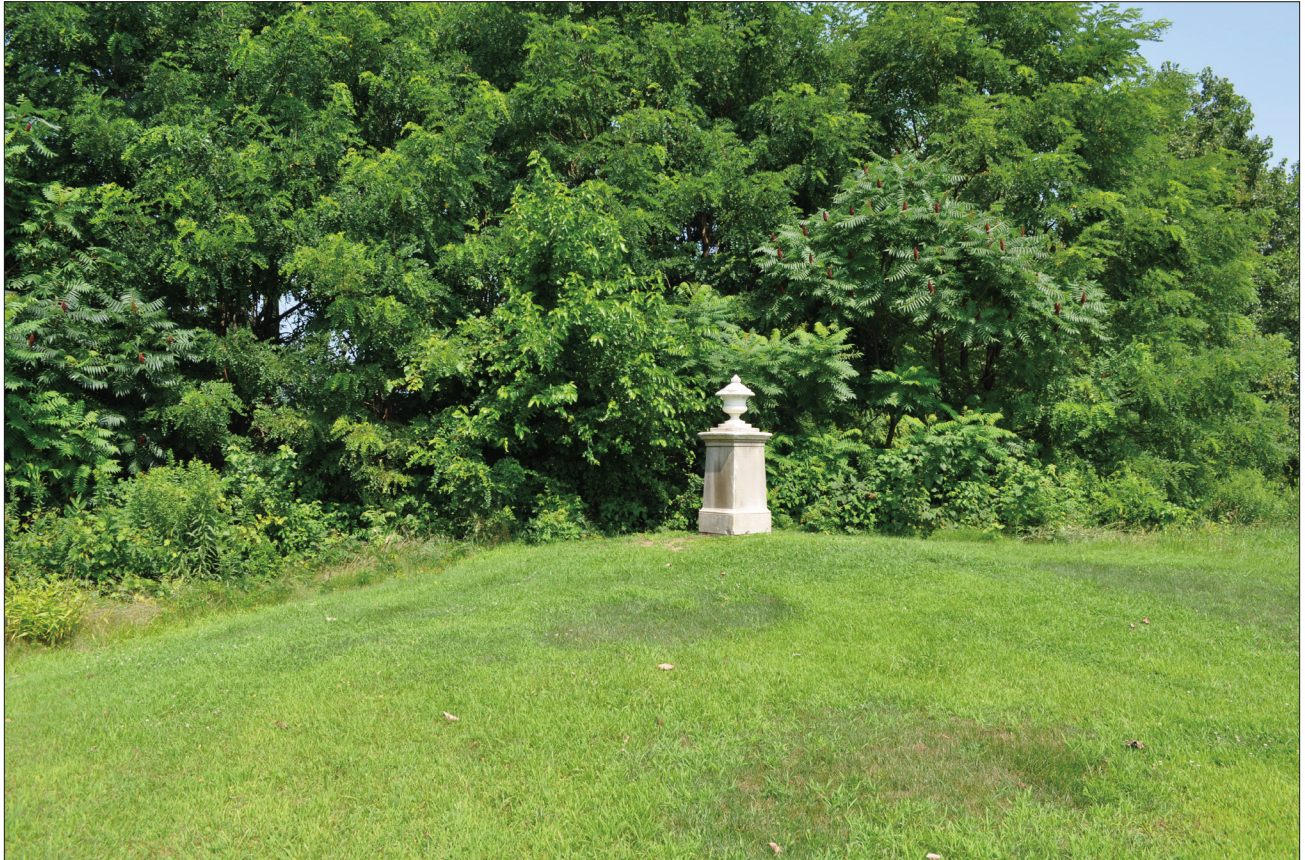
Figure 3.93. View northwest toward the Van Ness grave marker. The grave marker is surrounded by a low fence. Vegetation in the escarpment forms the background, c. early 20th century (MAVA archives).

Historic documentation indicates that a timber fence surrounded the Van Ness grave during the deProsse period, and it is likely that the area was fenced during the historic period (Figure 3.93).⁷³ The grave site should remain undisturbed by contemporary agricultural operations. The stone marker should be evaluated for impacts from natural factors such as weathering and freeze-thaw cycles and repairs made as necessary.

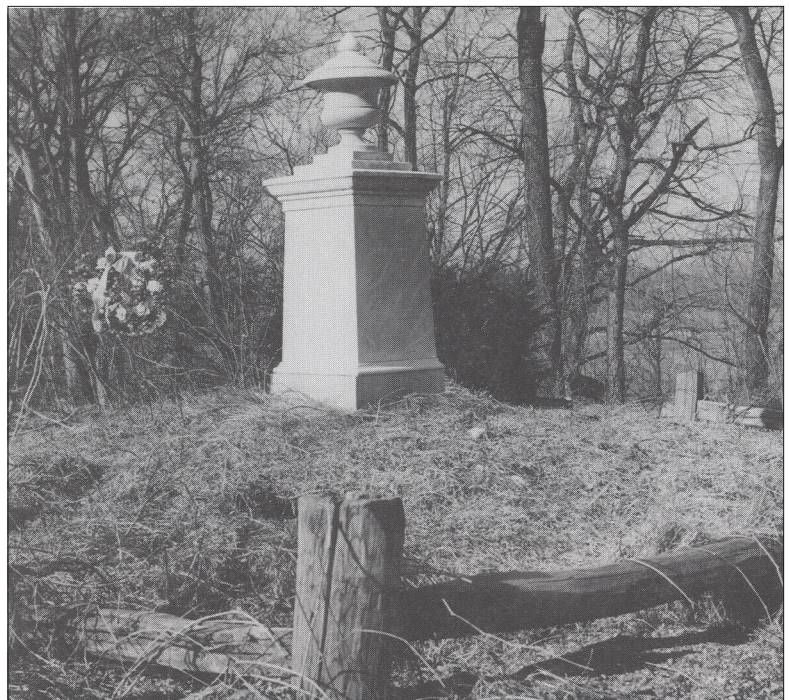
Figure 3.94. View west to the Farm Cottage and Red Barn, c. 1900 (MAVA archives).

though the developing interpretive trail described in Task PW-SSF-1. The approximate location, roof, and orientation of the Red Barn are documented in a c.1900 photograph (Figure 3.94).

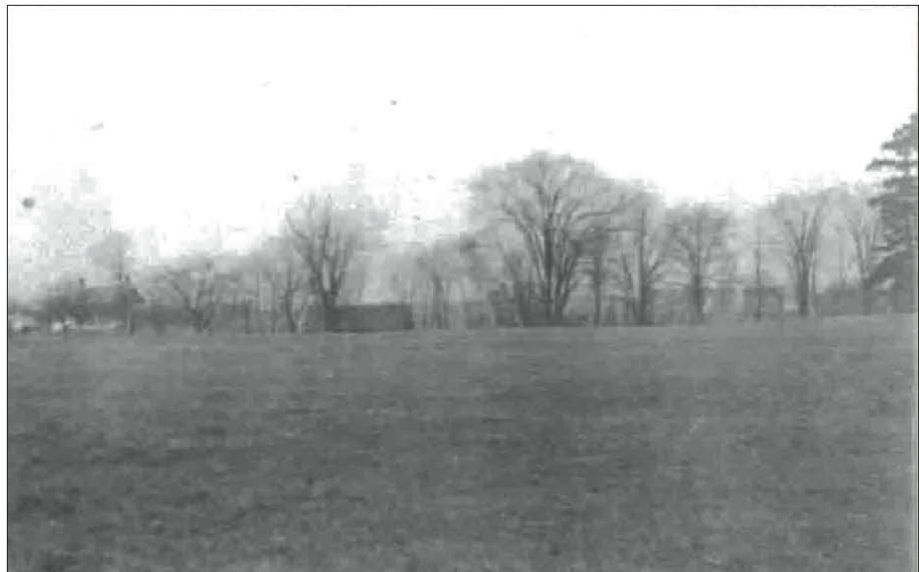
Figure 3.95. View southwest toward the upper fish pond. Note the duckweed covering the water. The access road to the contemporary barn complex is visible at image right, 2014 (OCLP).

As of summer 2014 the upper pond was covered in a dense green layer of duckweed and algae (Figure 3.95). Excessive vegetation is often an indicator of excessive nutrients and ecosystem imbalance. Water quality testing should be done, and alternatives for corrective action examined. If water quality is restored, the upper pond should be stocked with fish and used for special events.

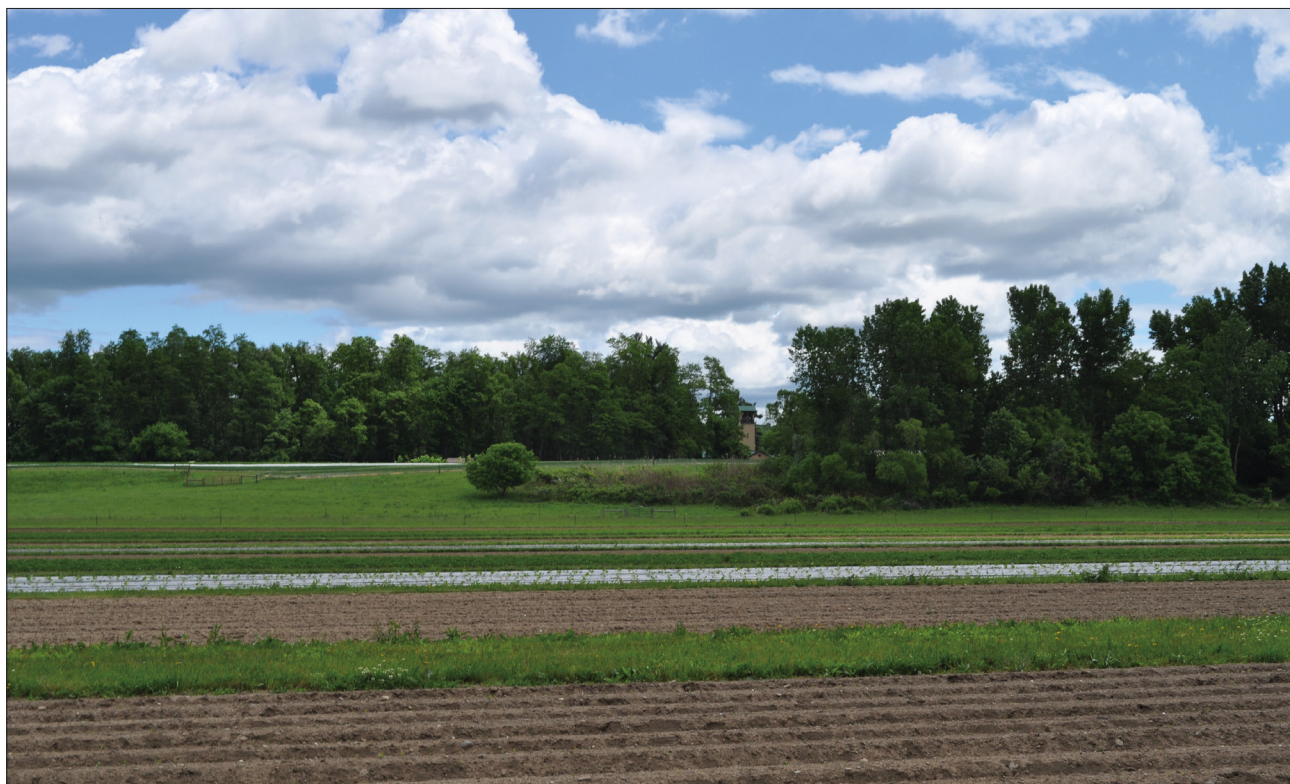
Figure 3.100. View southwest along lower farm road to Kinderhook Creek. The Black Hay Barn, burned in 1948 under Meyer ownership, was located between a cultivated agricultural field and a farm road in the lower terrace. The barn site is in the left foreground of this image, 2014 (OCLP).

Van Buren built the Black Hay Barn in the spring 1844 for crop storage. Meyer burned the barn in 1948 and the site is now situated between cultivated agricultural field and a farm road. The general location of the site can be determined from the slight change in topography and variation in soil color, which is apparent in aerial photographs (Figure 3.100 and 3.101). It is likely that archeological investigation will provide information regarding the precise footprint of the Black Hay Barn. If located, the footprint of this site should be represented above ground in a manner that does not impeded agricultural use.

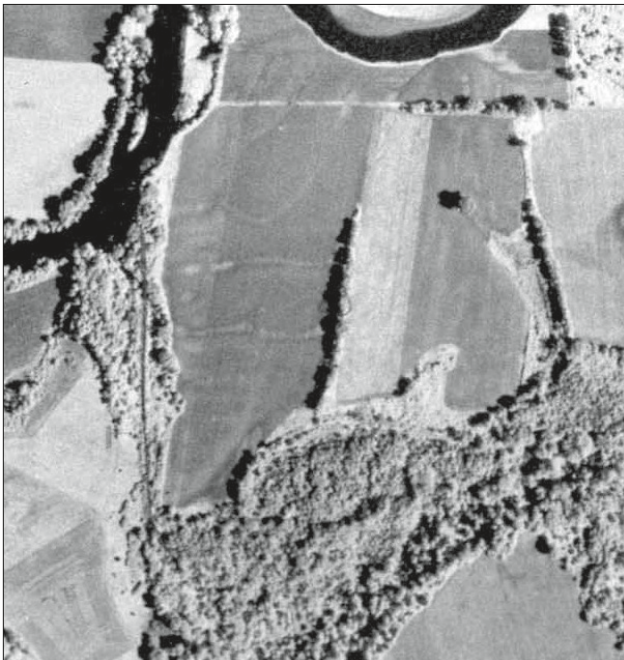
Figure 3.104. Ditch traces dating to Van Buren's ownership of the property can be seen on this 1948 aerial photo within a lower terrace field. Three primary ditches bisect a field, 1948 (MAVA archives).

A network of ditches extends across the lower terrace, some of which date to the Van Buren period of farming. The hand-dug Van Buren ditches are generally not visible to the casual observer, however their linear channels can be clearly identified in aerial photography from 1948 (Figure 3.104) and today (Figure 3.105). The ditches are barely discernible to the eye, but help convey the dedication of Van Buren to cultivating his land. Van Buren's ditches allowed him to farm the fertile soil in the adjacent wet meadows as described by a correspondent for

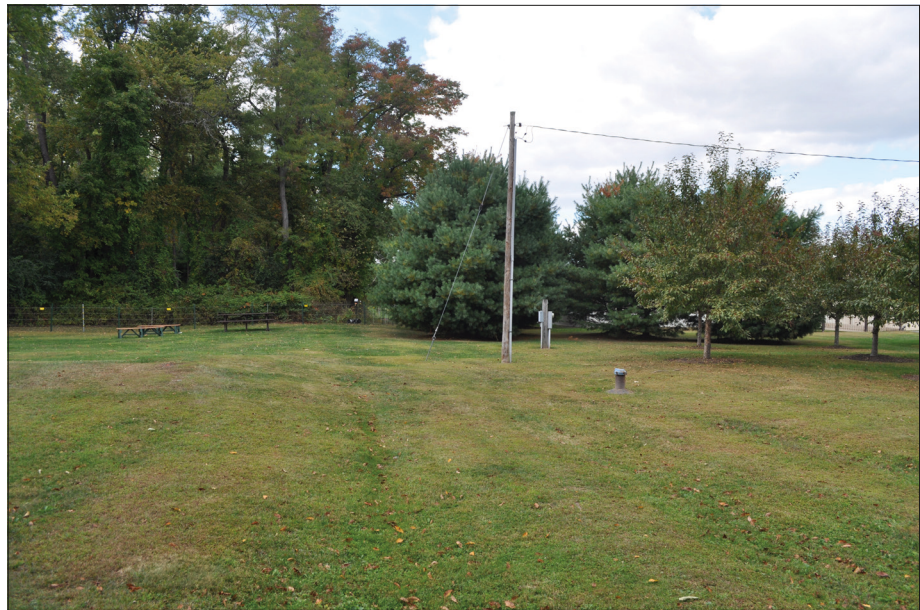
Figure 3.119. The extant visitor center and administrative offices are screened from the historic core by a mixture of evergreen and deciduous vegetation, however unsightly utility poles and wires are not. New construction should be complimented by underground utilities to reduce impact to the historic character of the site, 2014 (OCLP).

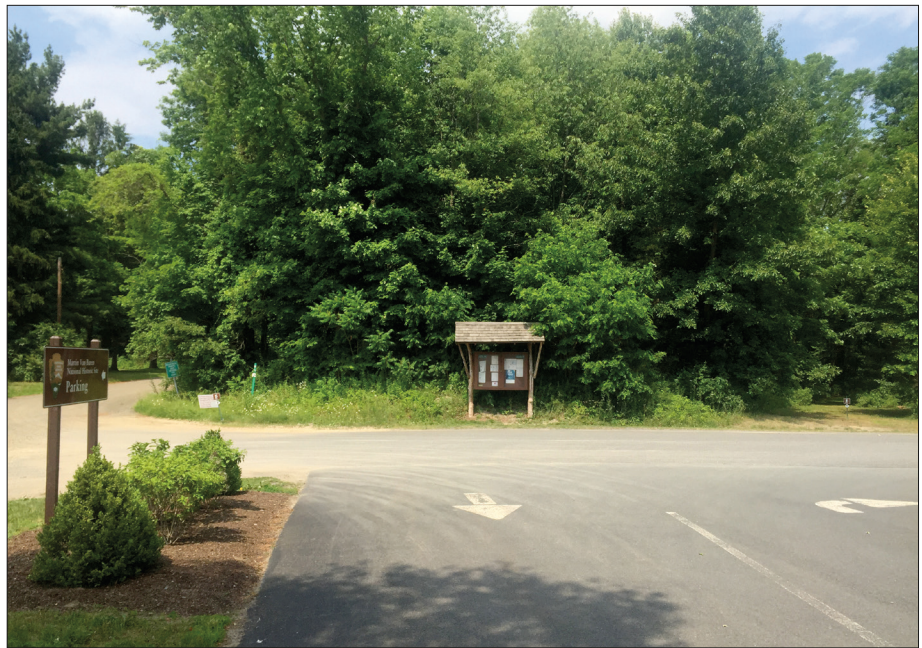
Figure 3.120. The northern portion of parcel 01-107, located west of Route 9H and east of the Old Post Road may be a suitable location for additional parking, 2016 (OCLP).

Create an overflow lot within parcel 01-107, north of the Town access road: North of the Town owned access road, the balance of parcel 01-107 could be developed into an additional parking lot. The new lot would be accessed by the Town owned road to the south. Development of this area would not detract from the historic setting of the Lindenwald mansion and grounds, however this alternative is not preferred because of concerns raised by neighboring landowners and disruption of the Dutch Heritage Trail (Figure 3.120).

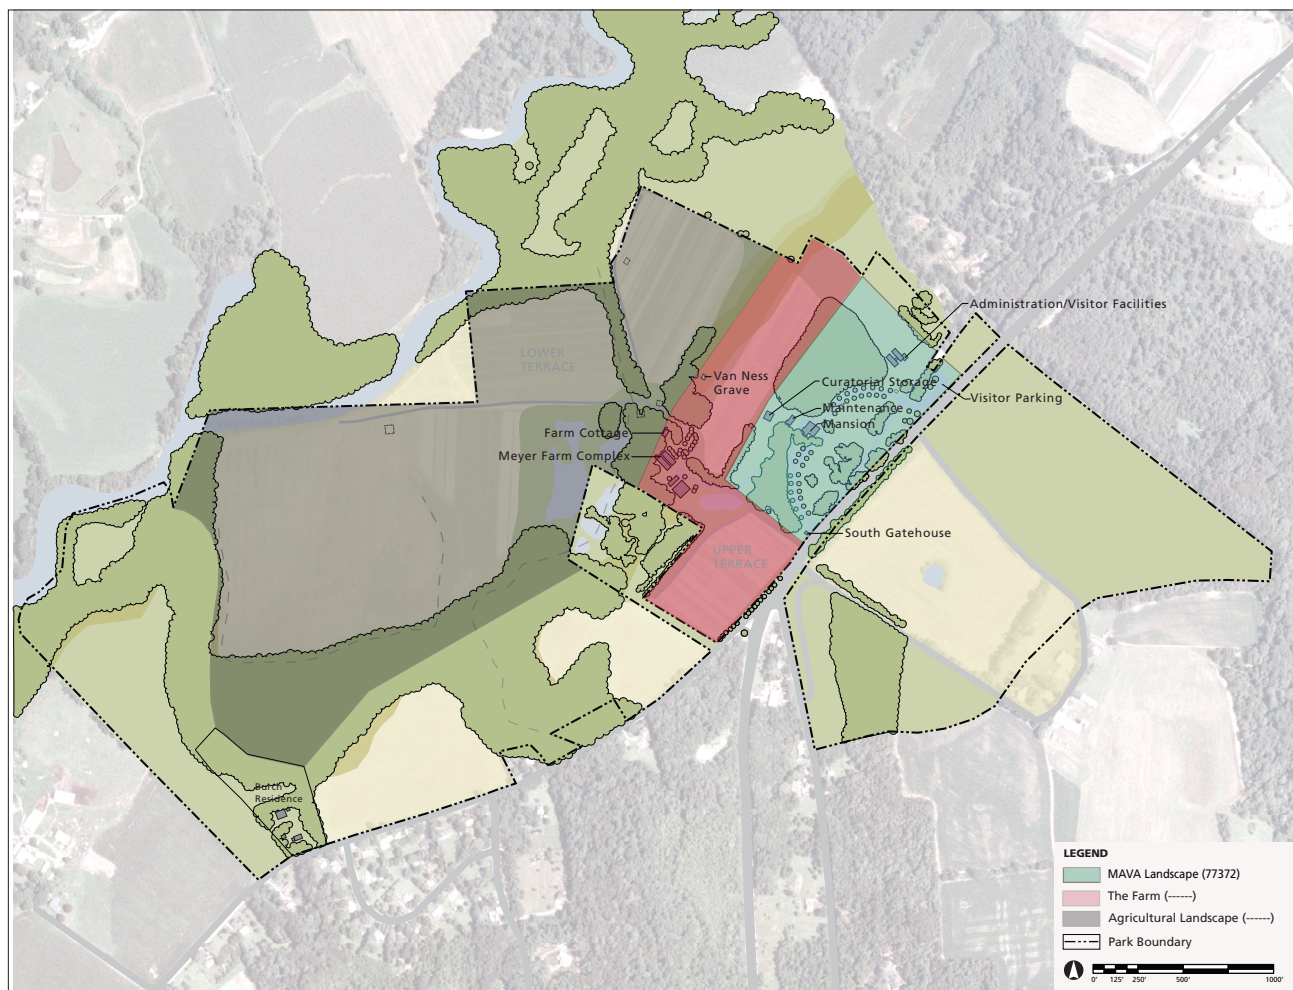
Figure 4.1. Four Locations (3 depicted above) are identified in the FMSS system at Martin Van Buren National Historic Site. Physical boundaries for the Regional Trail Landscape will be determined as planning efforts evolve, 2012, modified 2016 (OCLP).

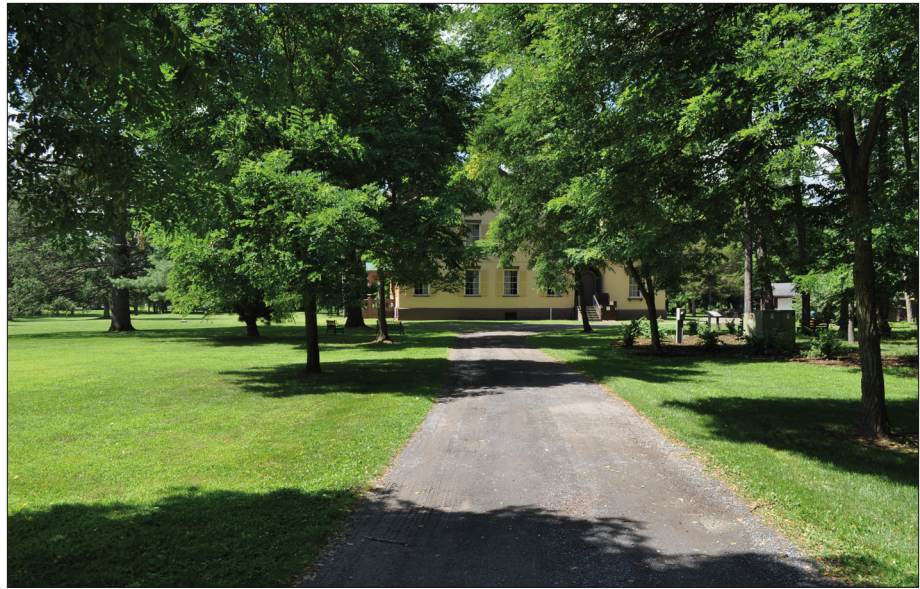
Figure 5.1. View south to the mansion. The entry drive is surfaced in a fine gravel. The replanted black locust allée lines the drive, 2014 (OCLP).

At present, the entry drive is surfaced with fine dark gravel and used by pedestrian visitors and park vehicles to access maintenance facilities (Figure 5.1). The current gravel surface has a finer texture than the surface documented in a 1996 photograph (Figure 5.2). The north half of the drive receives more pedestrian and vehicle traffic than the south half and portions immediately in front of the mansion. Portions of the south drive and near the mansion, seldom used by vehicles or pedestrians have developed two-track characteristics (Figure 5.3). Gravel is added to the Old Post Road and entry drive annually. Potholes are filled and the surface is graded as needed.

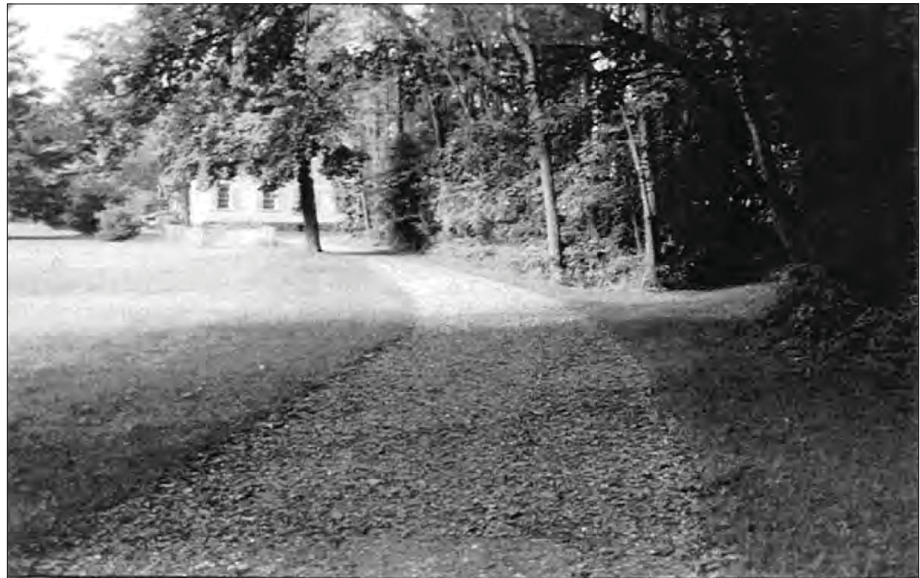
Figure 5.2. In the 1990s, the entry drive had coarse gravel surface. Note the allée has not yet been replanted, 1996 (OCLP).

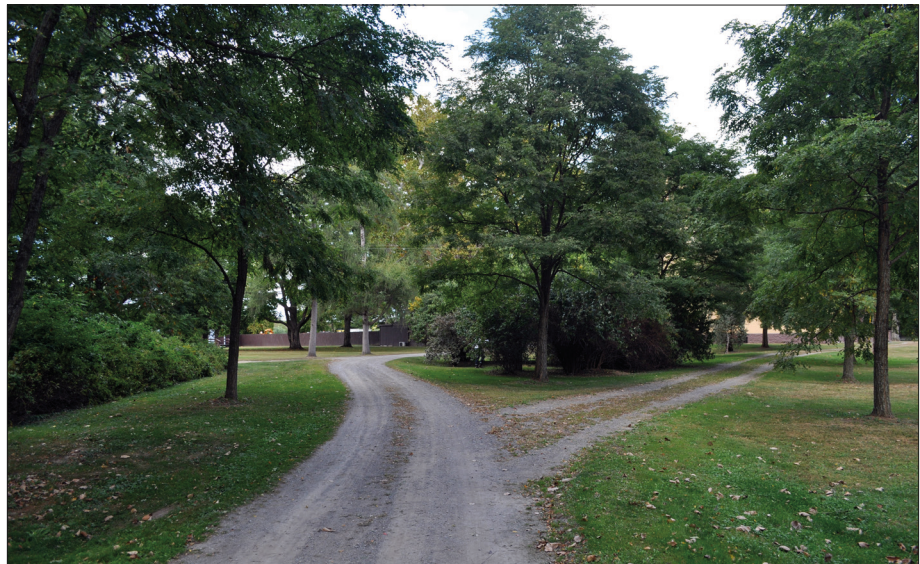
Figure 5.3. The south entry drive is used less frequently by vehicles and pedestrians. Portions of the drive have begun to develop two-track characteristics, 2014 (OCLP).
