CULTURAL LANDSCAPE REPORT FOR MARTIN VAN BUREN NATIONAL HISTORIC SITE

VOLUME II: UPDATED TREATMENT PLAN AND RECORD OF TREATMENT

KINDERHOOK, NEW YORK

Olmsted Center for Landscape Preservation
National Park Service, Boston, Massachusetts, 2016

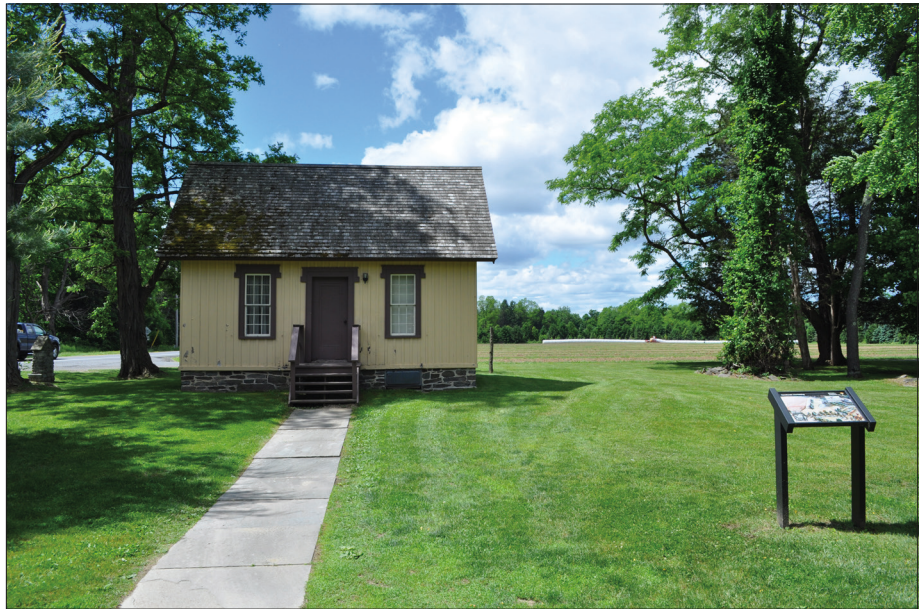
Figure 5.4. A portion of the utility lines near the South Gatehouse were removed, although a pole covered in vines remains (image right), 2014 (OCLP).

Volume II: Treatment Plan recommends removal of overhead utility lines which cross the front lawn and are in proximity to the South Gatehouse.⁴ In the South Gatehouse area, the document recommends removal of the portion of the utility line which extends past the gatehouse toward the site of a removed non-historic structure. Since 1997, the National Park Service has removed overhead wires and poles with the exception of one pole (Figure 5.4). Overhead utility lines crossing the front lawn have not been removed. They continue to detract from the landscape's historic character, and remain a priority for treatment, as described in Task HM-UT-1 (Figure 5.5). The *Volume II: Treatment Plan* recommendation to bury the utility line serving the South Gatehouse has not been completed, and is reemphasized in Task HM-UT-1. Recommendations for feature removal provided in *Volume II: Treatment Plan* are depicted graphically in the Feature Removal Plan (Figure 5.7).

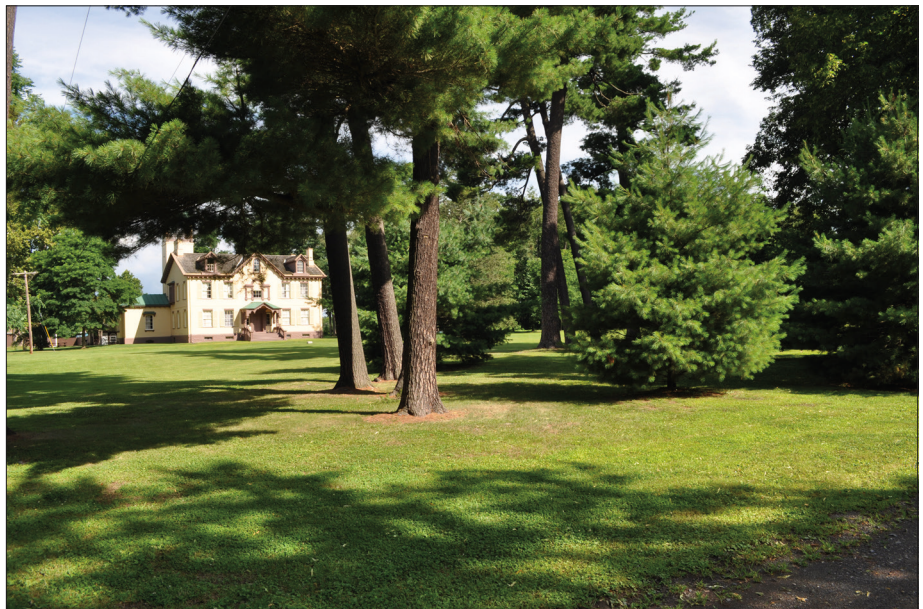
Figure 5.5. Utility lines bisect the front lawn, impacting the historic character and conflicting with vegetation in the front pine row and the allée, 2014 (OCLP).

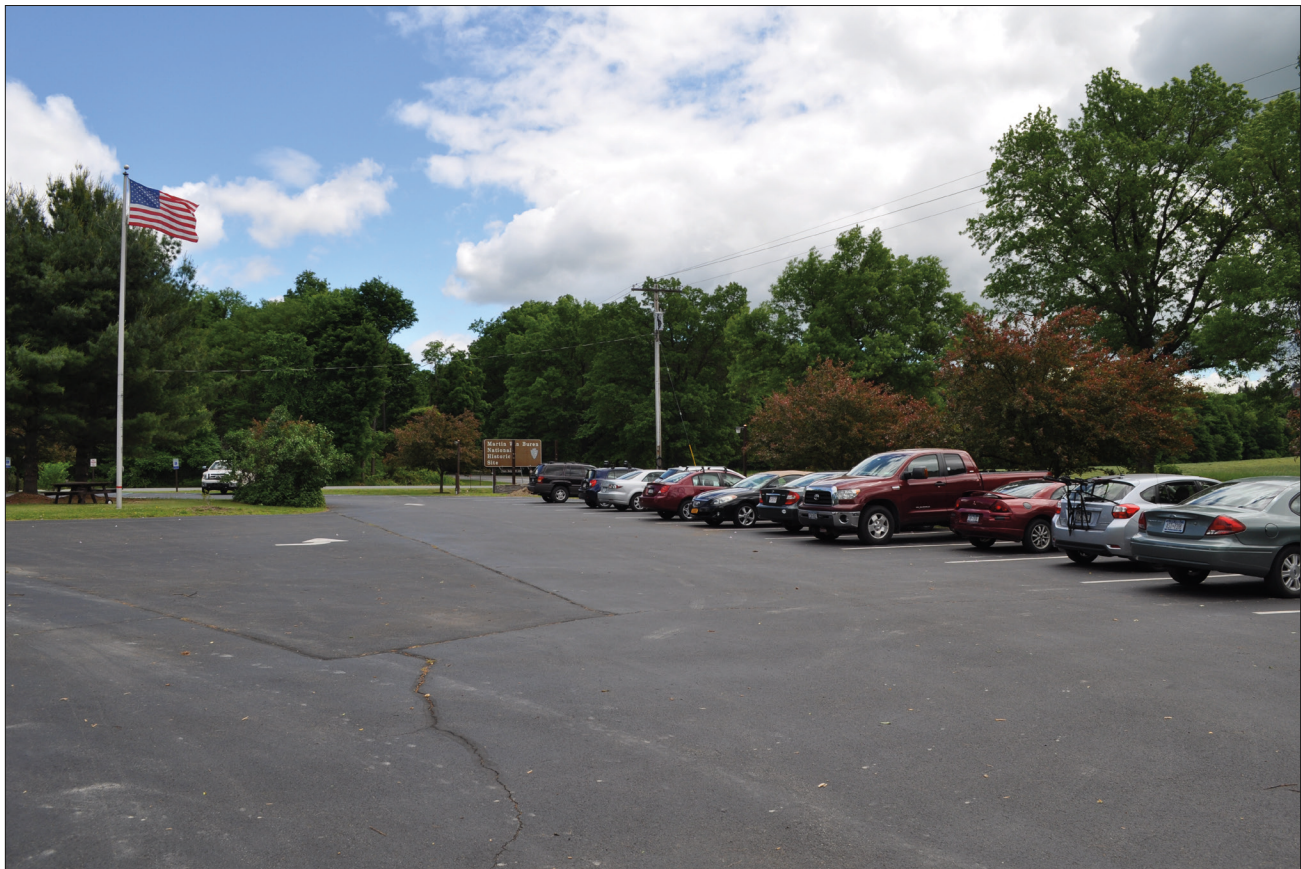
Figure 5.6. The flagpole and NPS sign were relocated to the visitor parking area in 2003, 2014 (OCLP).

In 2003, following recommendations provided in *Volume II: Treatment Plan*, the park relocated a contemporary flagpole and the park sign from the front pine row (see Figure 5.7) to the parking area in the non-historic parcel between the Old Post Road and Route 9H.⁵ Relocation of these features from the historic core

to the parking area enhanced the character of the historic core and increased visibility of park signs to passing traffic on Route 9H. In 2014, the park enlarged and updated the sign to match National Park Service messaging standards. These non-historic features are located in close proximity to the visitor parking area and denote the entry point to the park (Figure 5.6).

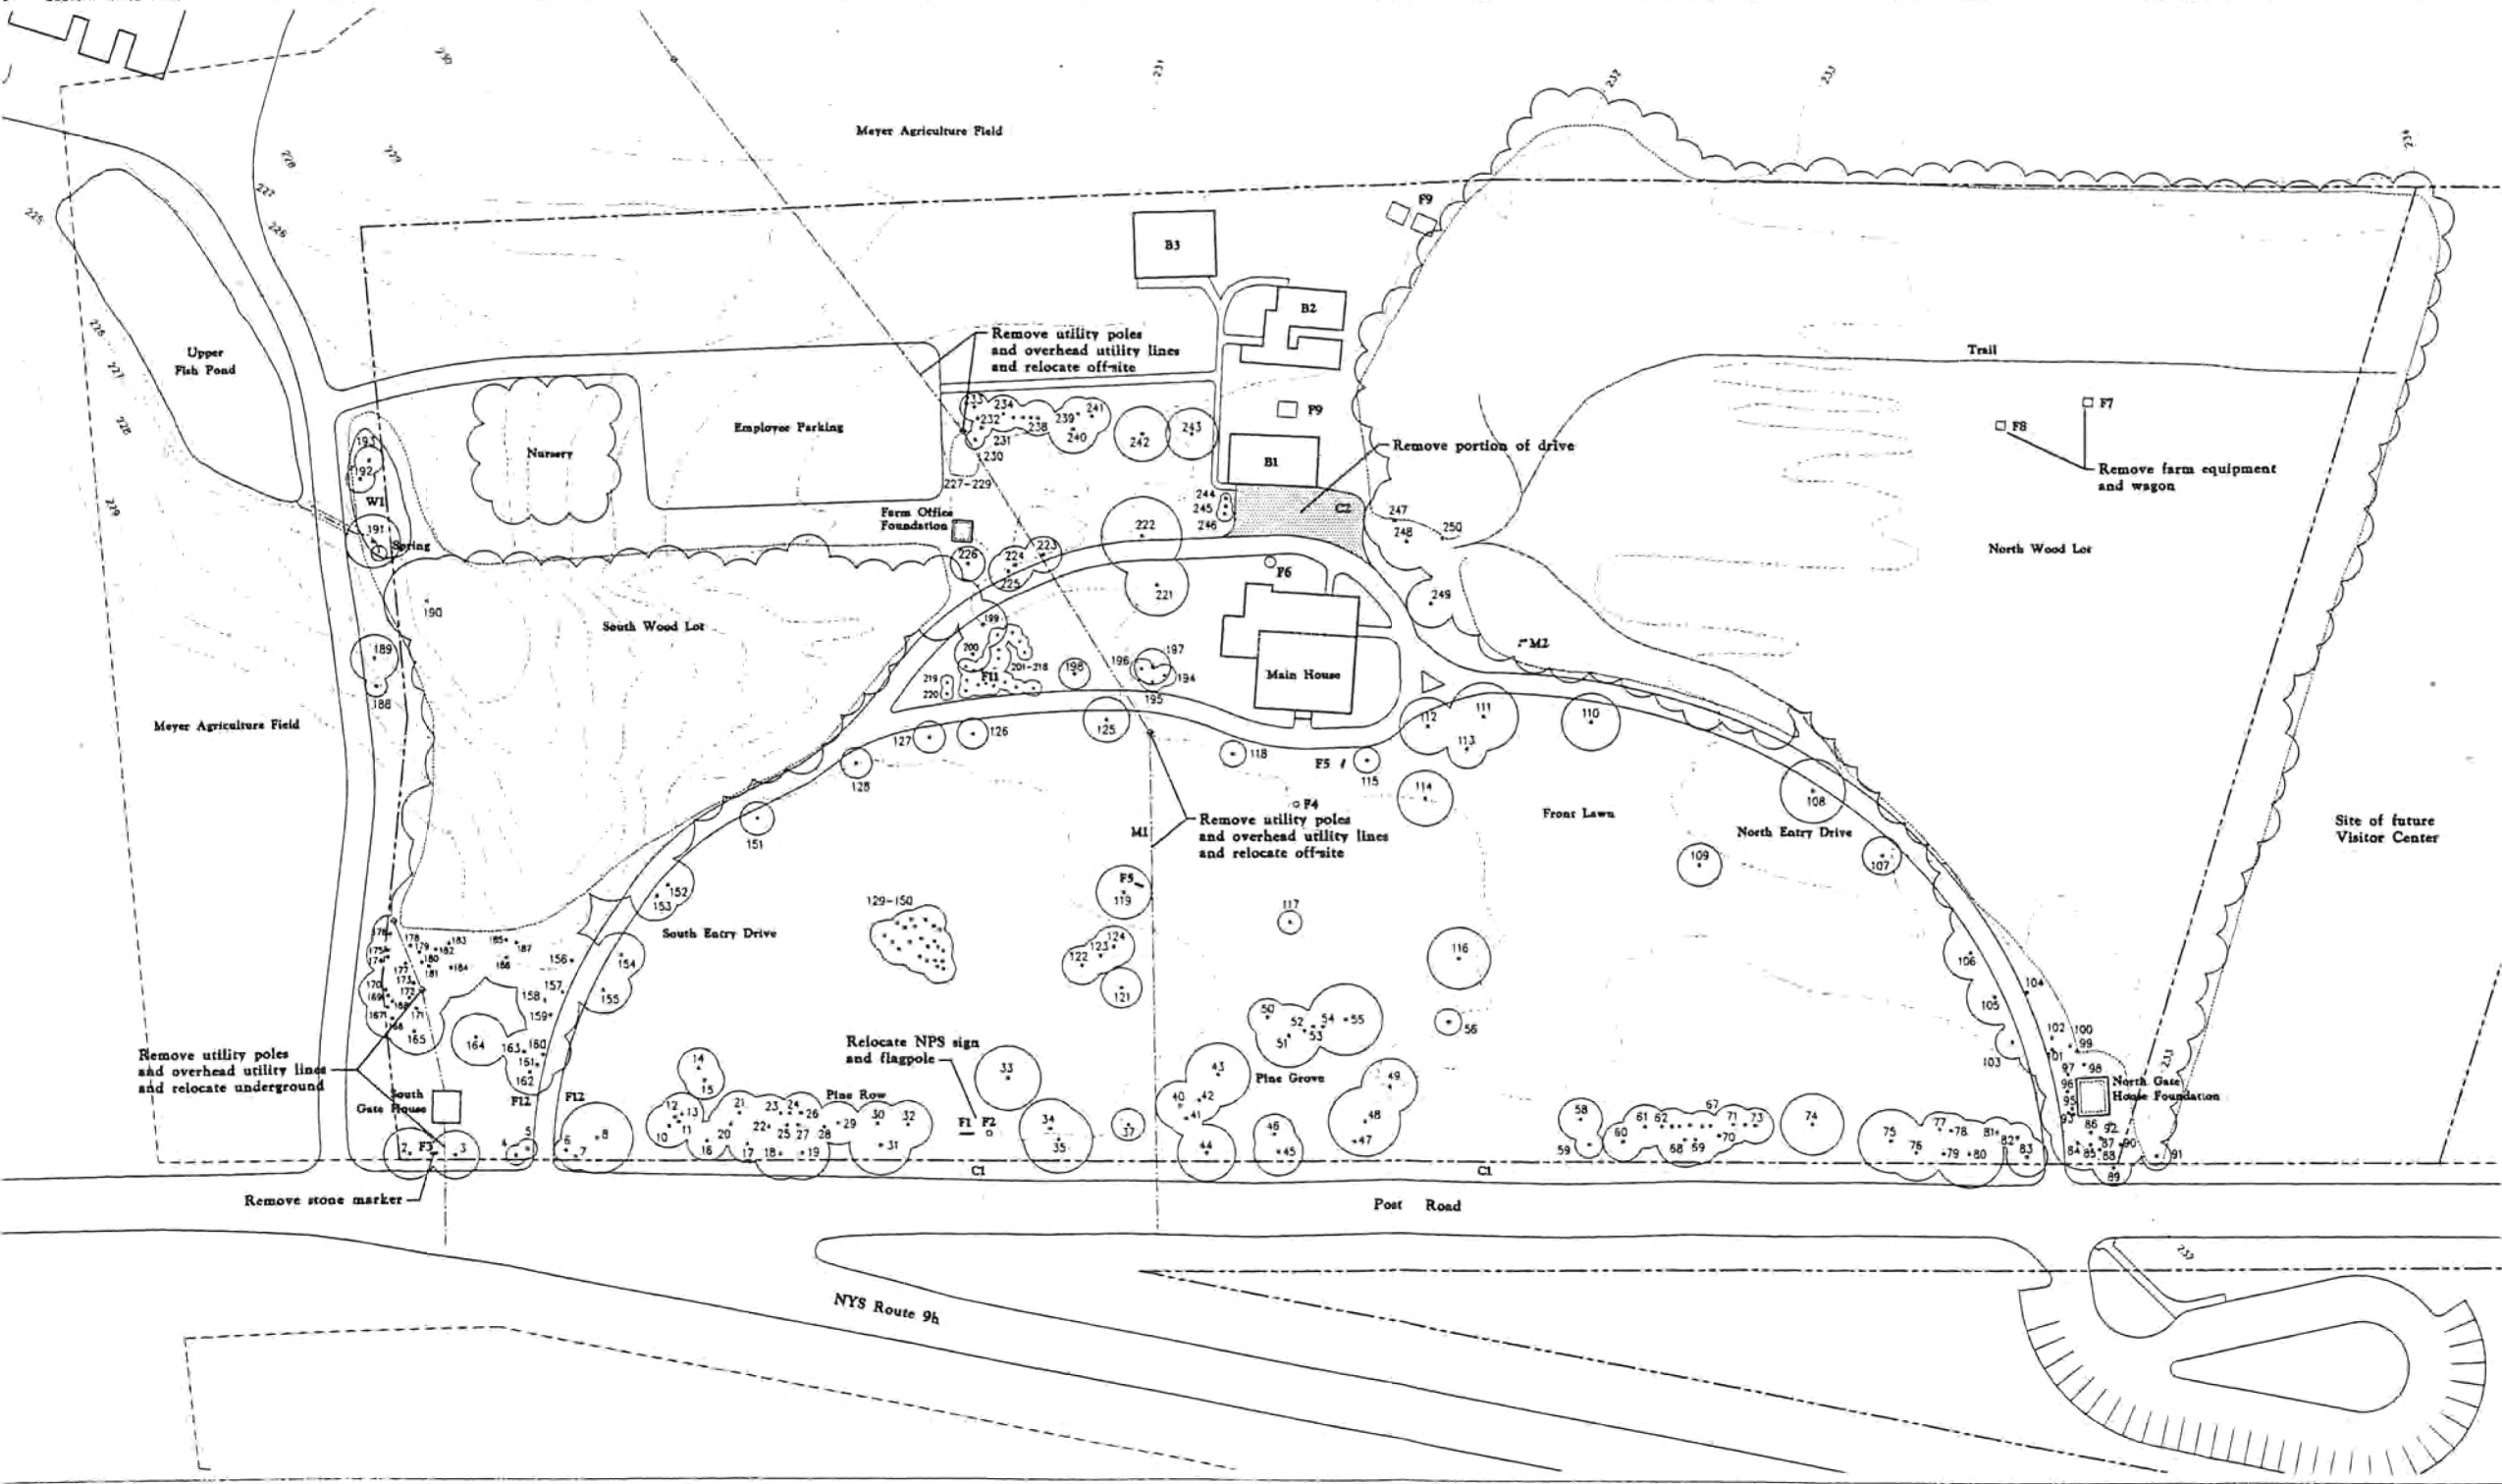
- B1 Maintenance Garage
- B2 Mobile Homes
- B3 Pole Barn
- M1 Farm Complex Electric Lines
- M2 Electrical Transformer
- C1 Visitor Parking
- C2 Universal Access Parking
- W1 Small Pond
- F1 Park Sign
- F2 Flagpole
- F3 Stone Marker
- F4 Urn
- F5 Bench
- F6 Historic Well
- F7 Wagon
- F8 Farm Equipment
- P9 Aluminum Sheds
- F11 Linear Brick Feature
- F12 Circular Brick Feature

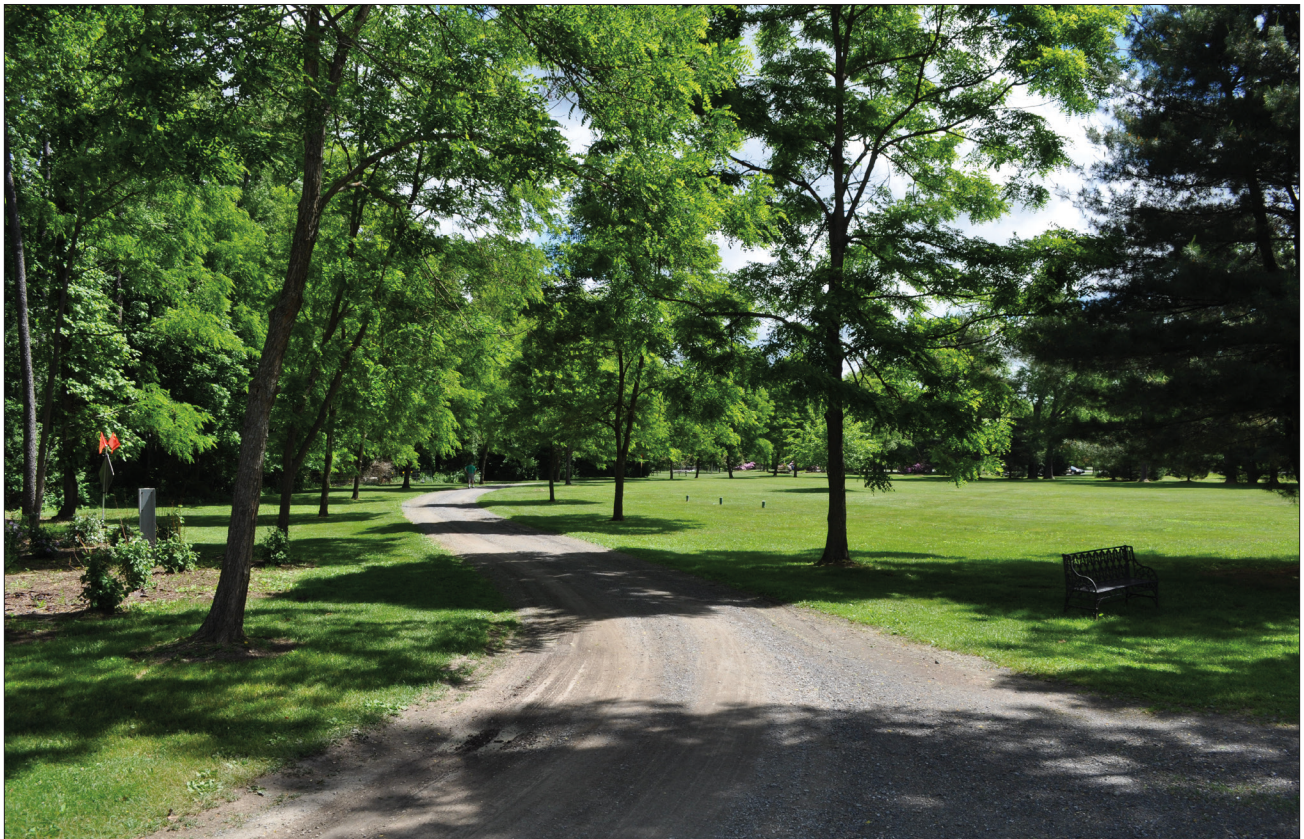
Figure 5.8. View northeast along the entry drive and replanted allée, 2014 (OCLP).

The reestablishment of the black locust allée in 2002 based on recommendations in *Volume II: Treatment Plan* has dramatically enhanced the quality of the historic landscape.⁶ The original allée, planted by Peter Van Ness, lined the two arching arms of the entry drive, and was approximately forty-years-old when Van Buren purchased the property. The declining allée was removed by the deProsse family in the 1930s.⁷ Nearly sixty years passed before the stately landscape feature was replanted. The location, massing, and character of the historic allée is documented in historic photos and narratives (Figure 3.22), which were used to determine the spacing and number of trees to be replanted. Today, nearly fifteen years after the replacement allée was planted, the rapidly growing trees have begun to allude to their mature form. The branches of opposing trees reach toward each other, and have begun to evoke an arched ceiling above the entry drive, offering shade and expressing the stately character present during the historic period (Figure 5.8 and 5.9).

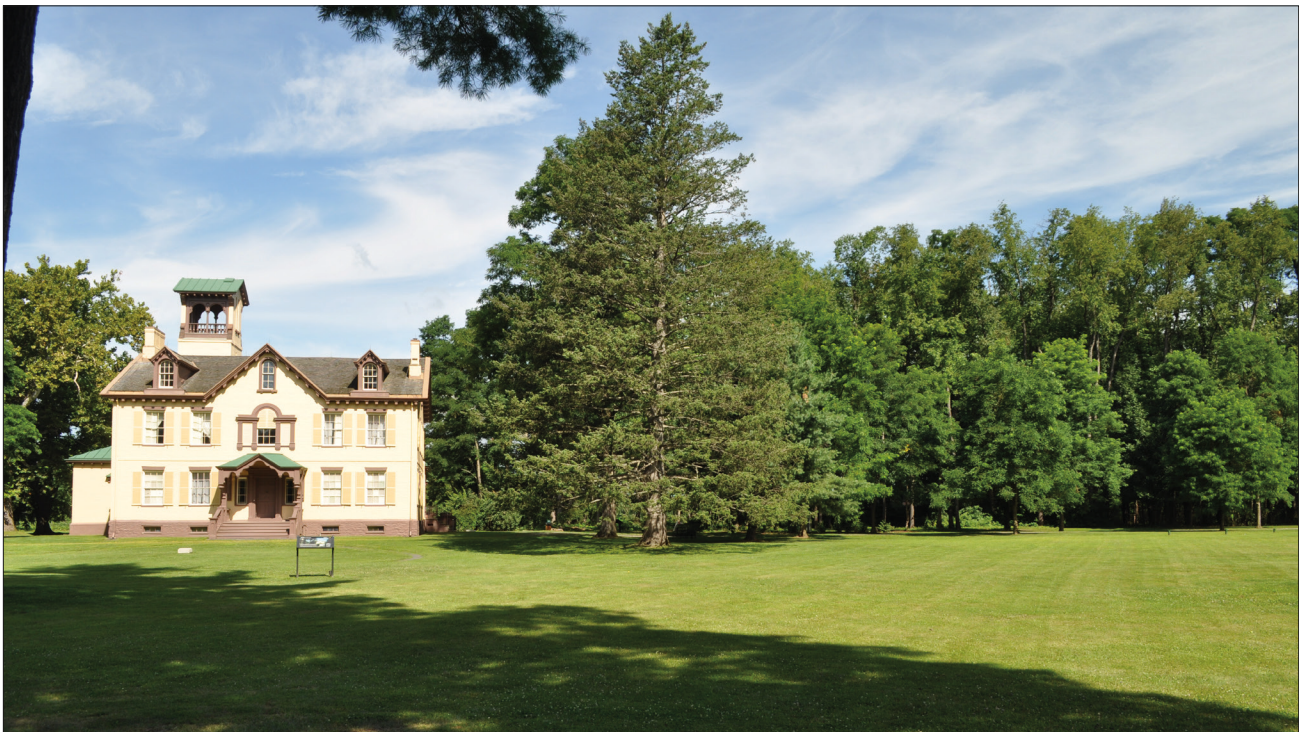
Figure 5.9. View west to Lindenwald. The replanted allée grows along the drive and is backed by the north woodlot, 2014 (OCLP).

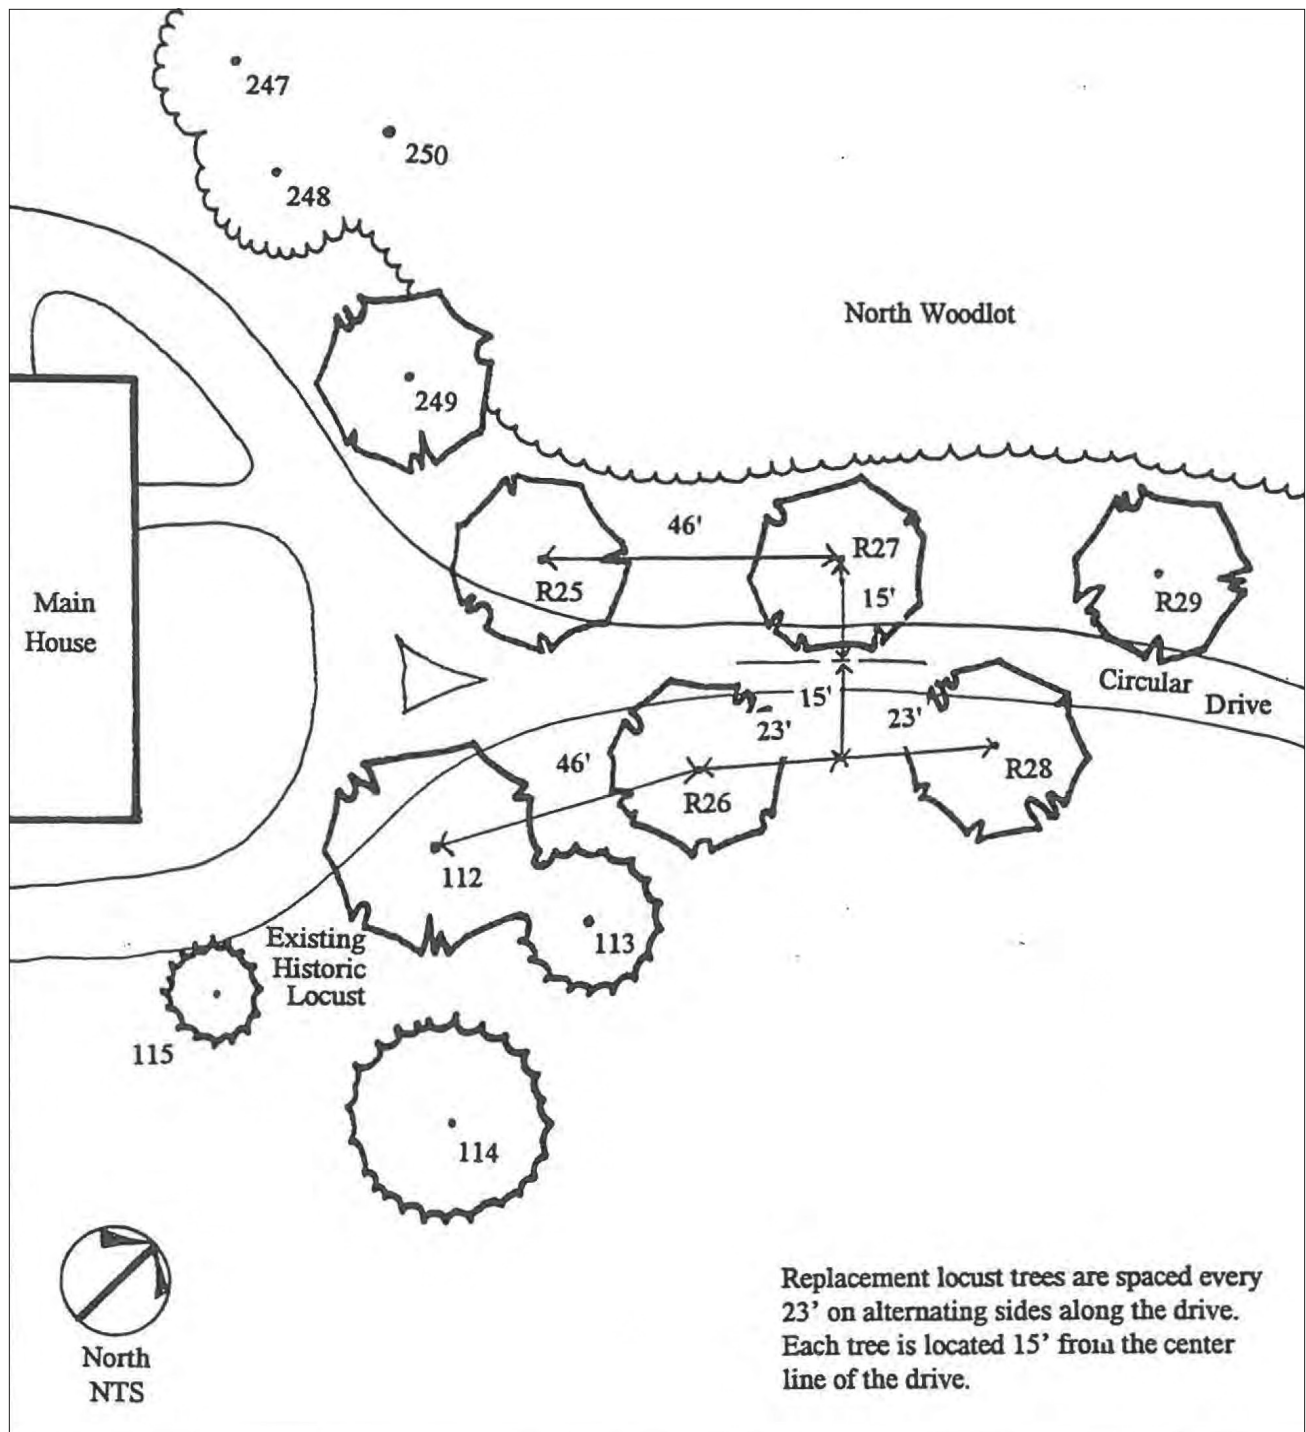
Figure 5.12. Locust allée planting plan. Note the preservation of tree #112, a portion of the original allée, which remains today, 1997 (OCLP).

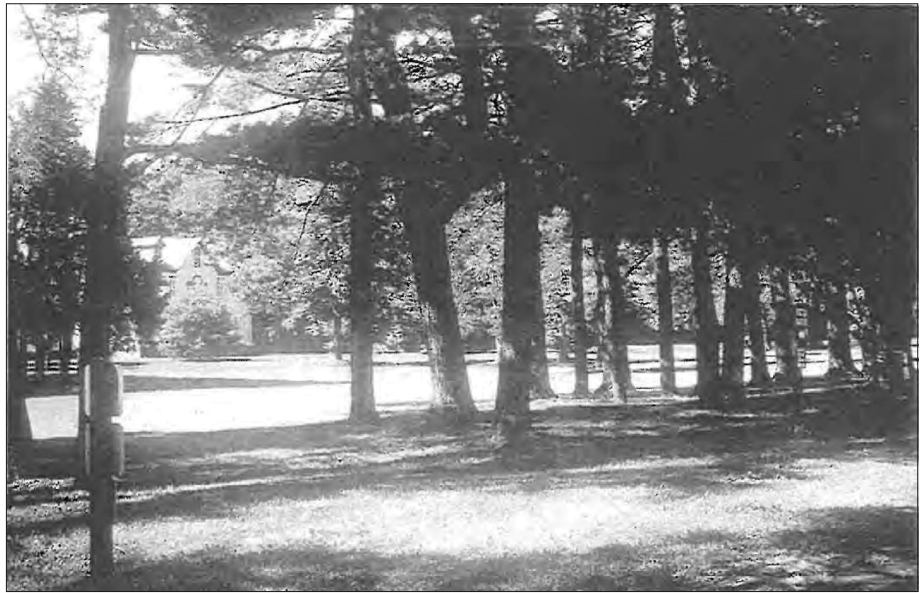
Figure 5.13. View northeast to the pine row along the Old Post Road, 1996 (OCLP).

The following species are recorded in *Volume II: Treatment Plan* in the white pine row and grove: pine, cherry, locust, linden, cedar, bitternut hickory, and maple. Figure 5.13 illustrates a portion of the hedgerow in 1996, and Figure 5.14 depicts the same portion in 2014. Note the young white pine at image right, planted in response to recommendations outlined in *Volume II: Treatment Plan*. During the process of removing non-historic trees, arborists found many of the remaining historic trees to be in decline, with large cavities, and thus classified them as hazardous trees. As a result, trees including the black locust (#18) and mazzard cherry (#19) were removed. Following selective removal of non-historic trees and hazardous historic trees, the park and tree crew replanted twenty-nine missing historic trees (Figure 5.15).

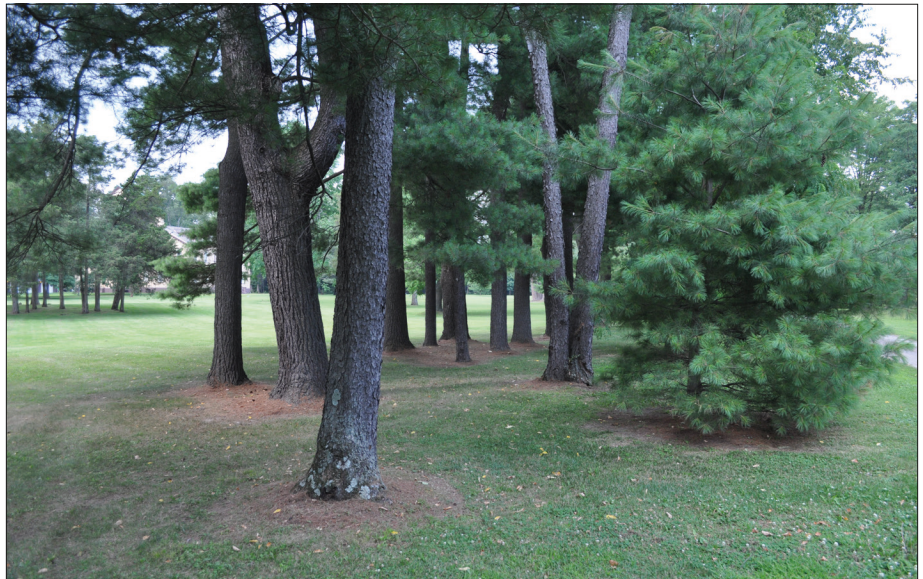
Figure 5.14. View looking northeast to the pine row along the Old Post Road. Note the replacement white pine at image right, 2014 (OCLP).

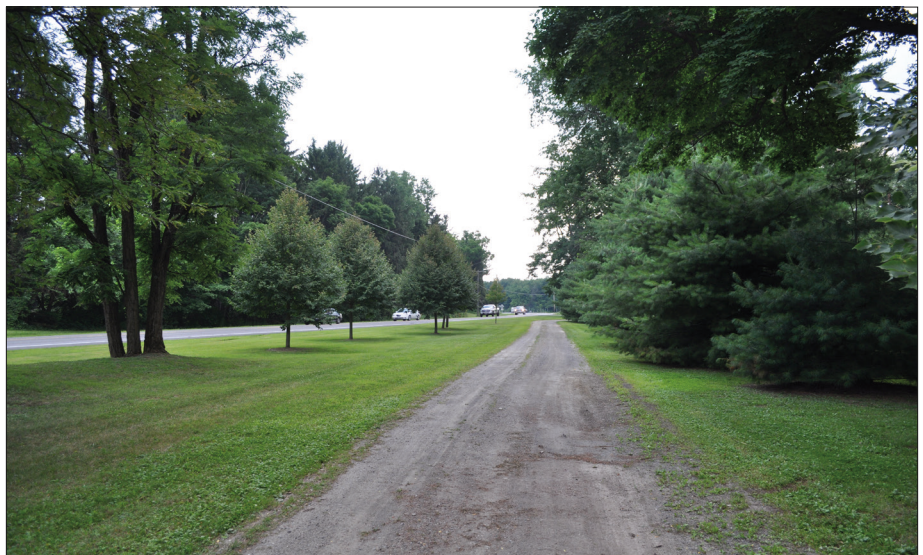
Figure 5.15. View southeast along the Old Post Road. Replanted portions of the white pine row are visible at image right. Route 9H and non-historic littleleaf linden plantings are visible at image left, 2014 (OCLP).

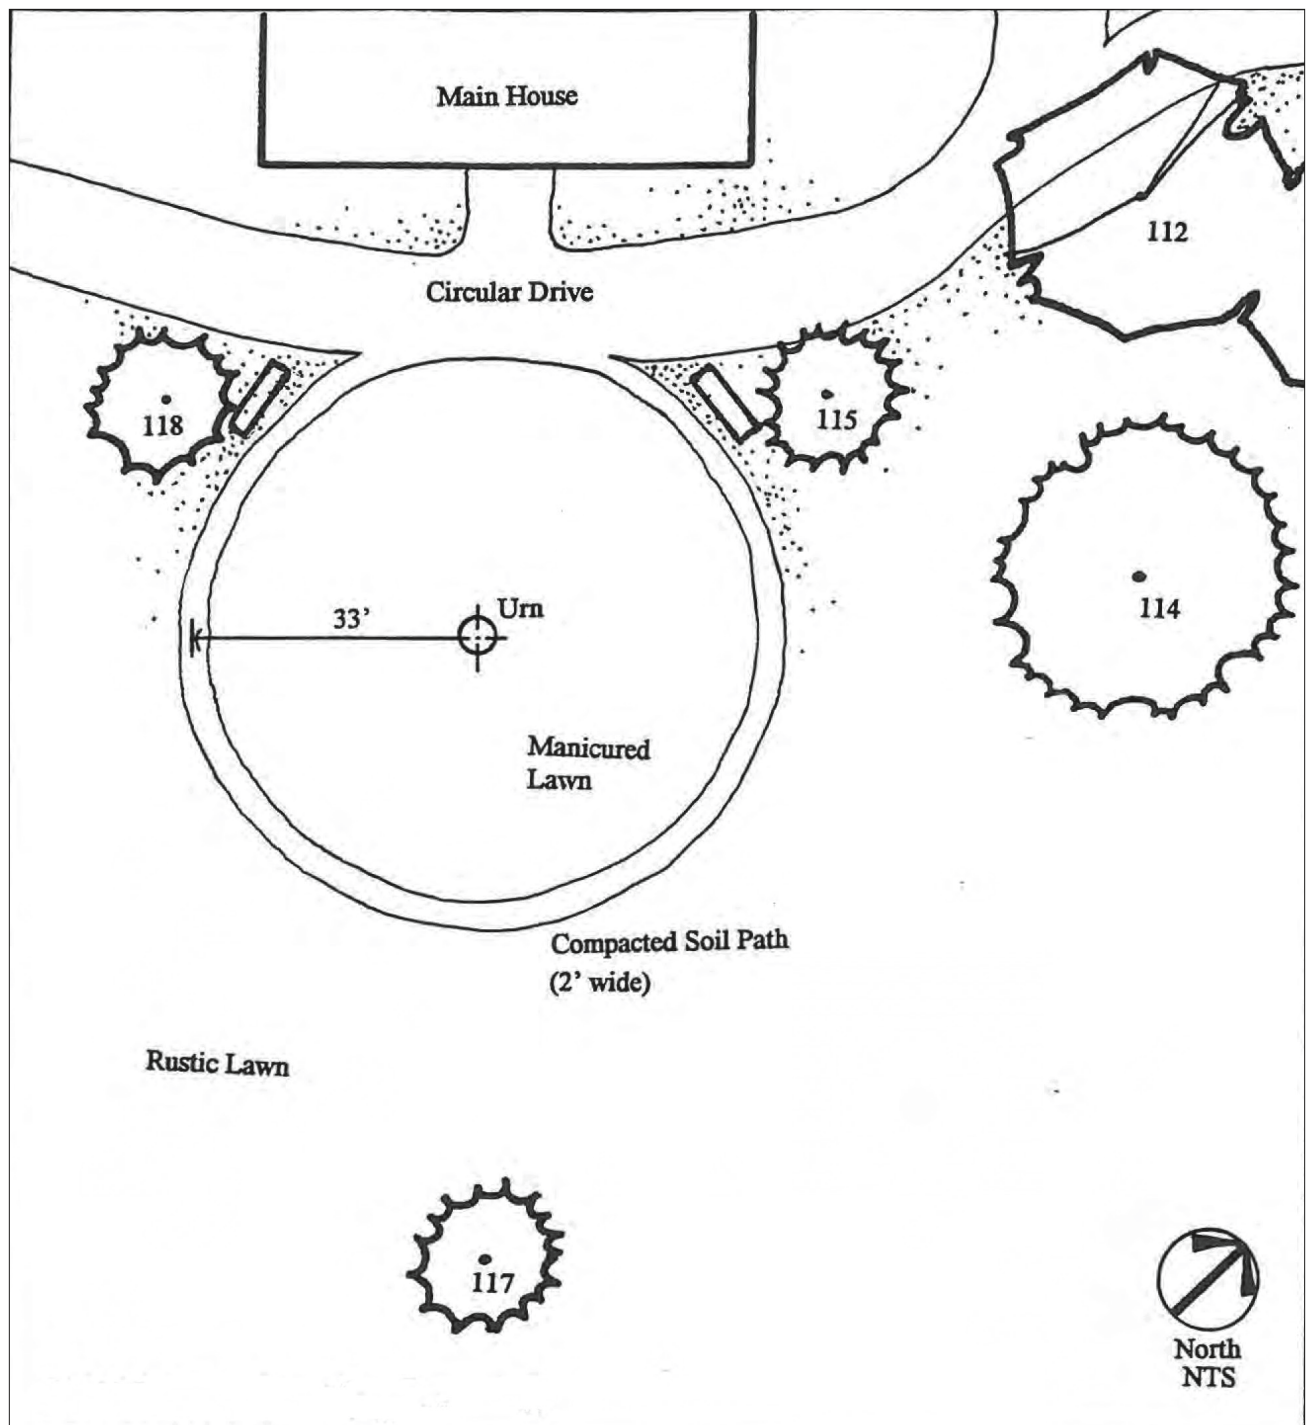
Figure 5.17. Plan for front garden restoration, 1997 (OCLP).

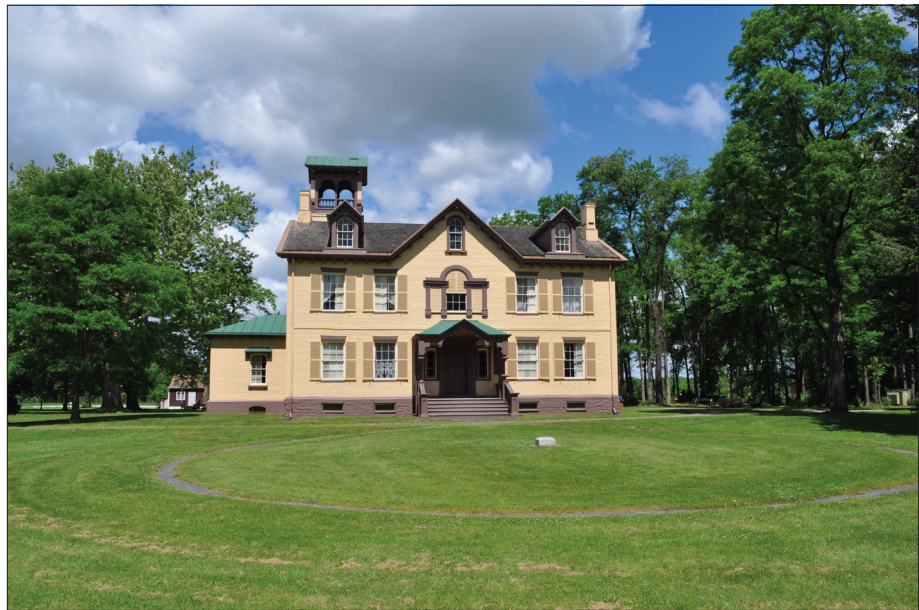
Figure 5.18. View west to the mansion. The restored circular path around the front garden is in the foreground. The reproduction urn and white pines are missing, 2014 (OCLP).

Volume II: Treatment Plan documents the removal of two of the three white pines that framed the front garden during the historic period in 1993 and the third in 1995 (Trees #115, #117, and #118). These three pines were replanted shortly after the originals were removed, however the replacement trees were damaged and misshapen. *Volume II: Treatment Plan* recommends replacement (for a second time) of tree #115 and #118 in-kind, because the leaders of each tree had broken several times and the trees had developed a globular shape. The misshapen white pines were removed c.2008 and have not yet been replaced. The Douglas fir (#114) on the north side of the garden remains, as recommended in *Volume II: Treatment Plan*. The plan recommends preservation of tree #114 until such time that it interferes with the growth of vegetation in the front garden or the locust allée (note tree #114 to the right of the Lindenwald mansion in Figure 5.18). The Douglas fir is not historically significant.

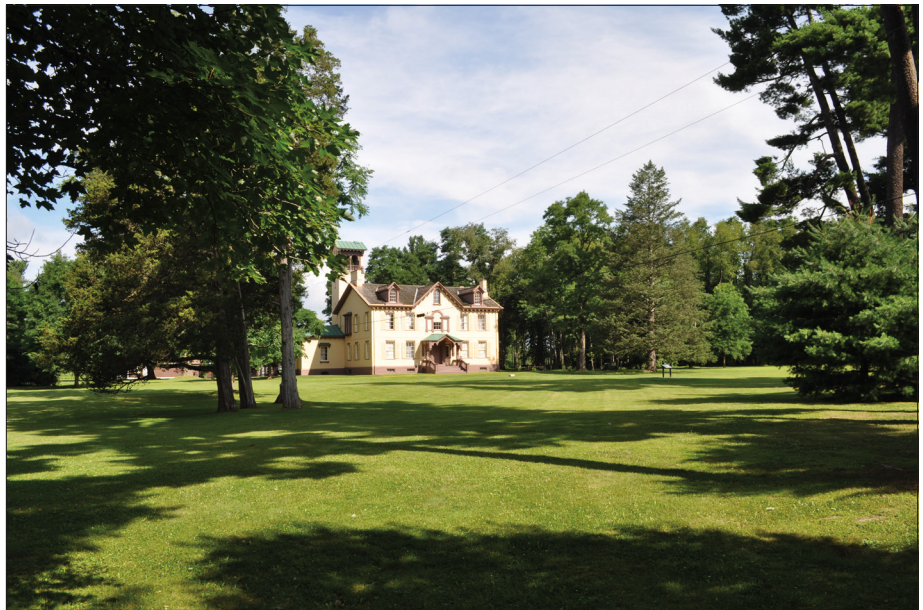
Figure 5.19. View northwest to the mansion across the front lawn dotted with specimen trees, 2014 (OCLP).

Fortunately, new knowledge presented in the *Turf Management Plan*, has restored the historically accurate manicured appearance of the front lawn (Figure 5.19). The park has heeded the guidance provided by the *Turf Management Plan* and integrated many of the suggestions into management. However, as described in Task HM-VG-1, this plan provides updated guidance of the maintenance of the formal landscape at Lindenwald. Through this plan, the turf management zones

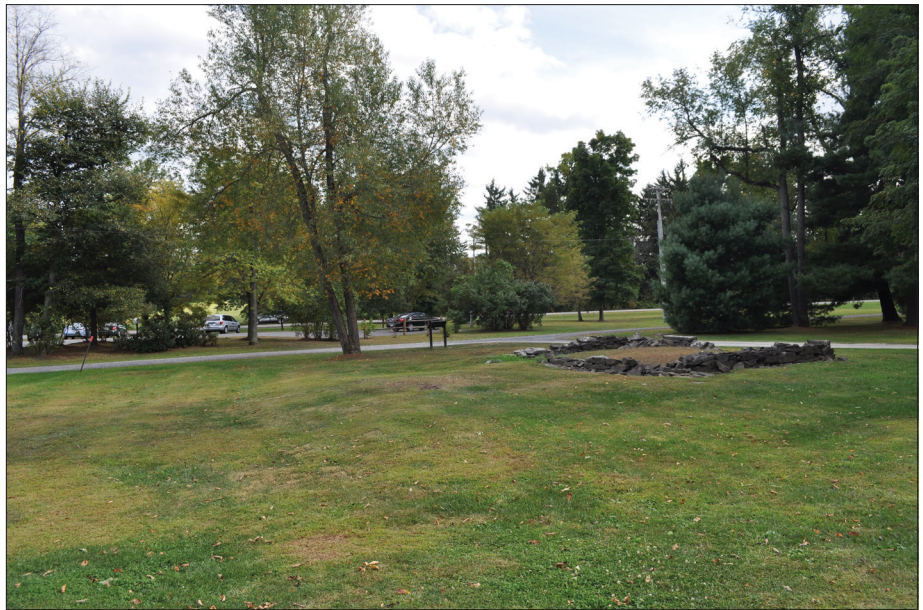
Figure 5.20. View northeast to the North Gatehouse foundation. The area was cleared of vegetation during the replanting of the allée. The parking lot is visible beyond, 2014 (OCLP).

Removal of non-historic trees surrounding the North Gatehouse was recommended in *Volume II: Treatment Plan* as part of a larger effort to reconstruct the North Gatehouse.¹¹ While efforts to reconstruct the North Gatehouse are not anticipated in the short-term, recommendations to clear non-historic vegetation were executed. Three volunteer trees, including one black locust (#100) and two cherry trees (#101-102) were removed c.2000. In addition to the recommendation for the removal of non-historic vegetation, *Volume II: Treatment Plan* recommends preservation of a lilac (#99). However, this potentially historic specimen is no longer extant. During the historic period it is likely that lilacs and five black locusts (#336-340, formerly #R86-90) grew in close proximity to the North Gatehouse. Existing conditions today are documented in Figure 5.20.

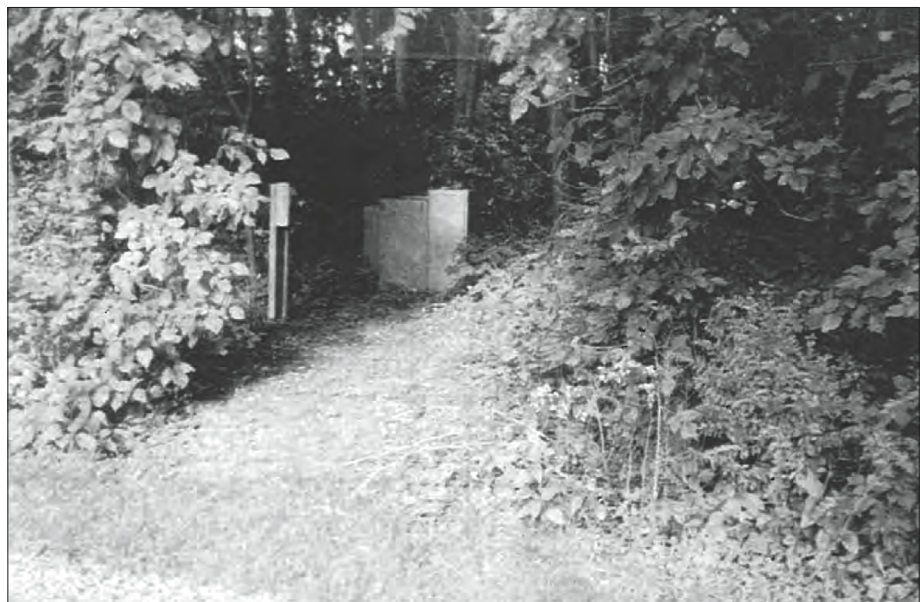
Figure 5.21. Prior to a vegetation removal project, the electric transformer was partially screened by low underbrush, 1996 (OCLP).

The provided guidance was developed to complement recommendations for clearing of a portion of the north woodlot (Figure 5.10). Figure 5.21 documents the screening provided by the woodlot in 1996, prior to a substantial clearing project. Figure 3.76 is the recommended planting plan included in *Volume II: Treatment Plan*. Existing conditions are documented in Figure 5.22, which illustrates how the current plant palette does not adequately screen the transformer. Updated guidance for appropriate methods to screen this non-historic intrusion in close proximity to the mansion is provided in Task HM-UT-2.

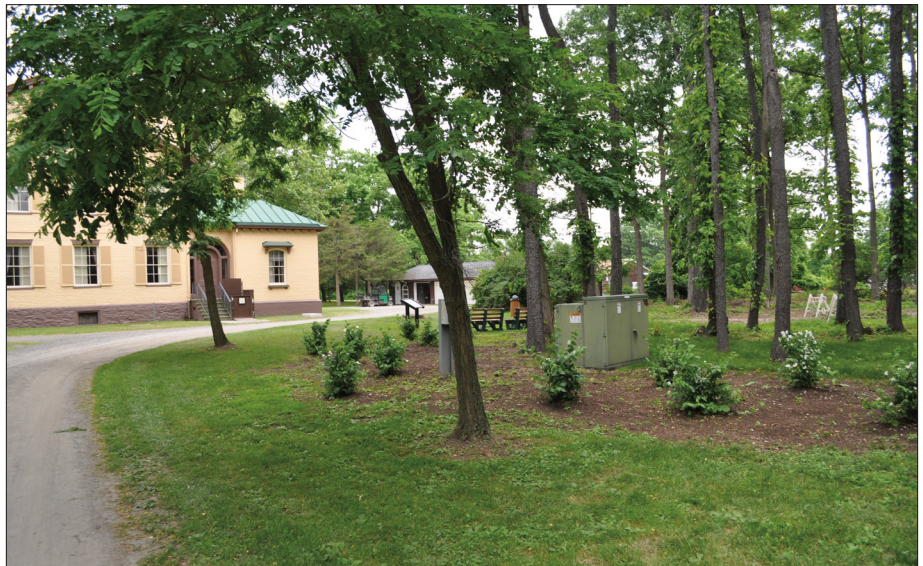
Figure 5.23. Mounting platform during the deProsse period, c. 1930 (MAVA archives).

Replacement of the missing mounting platform used by Van Buren and others was recommended in *Volume II: Treatment Plan*.¹⁴ During the historic period the stone was located at the north entry to the main house (Figure 5.23). The stone was removed in the 1960s, and today the whereabouts of the original stone is unknown. A replacement stone, funded by donations from visitors, was placed in the historic location in 2000 (Figure 5.24).
