# OHANAPECOSH CAMPGROUND MOUNT RAINIER NATIONAL PARK

Rehabilitation Proposal and Design Guidelines

MAY 2018

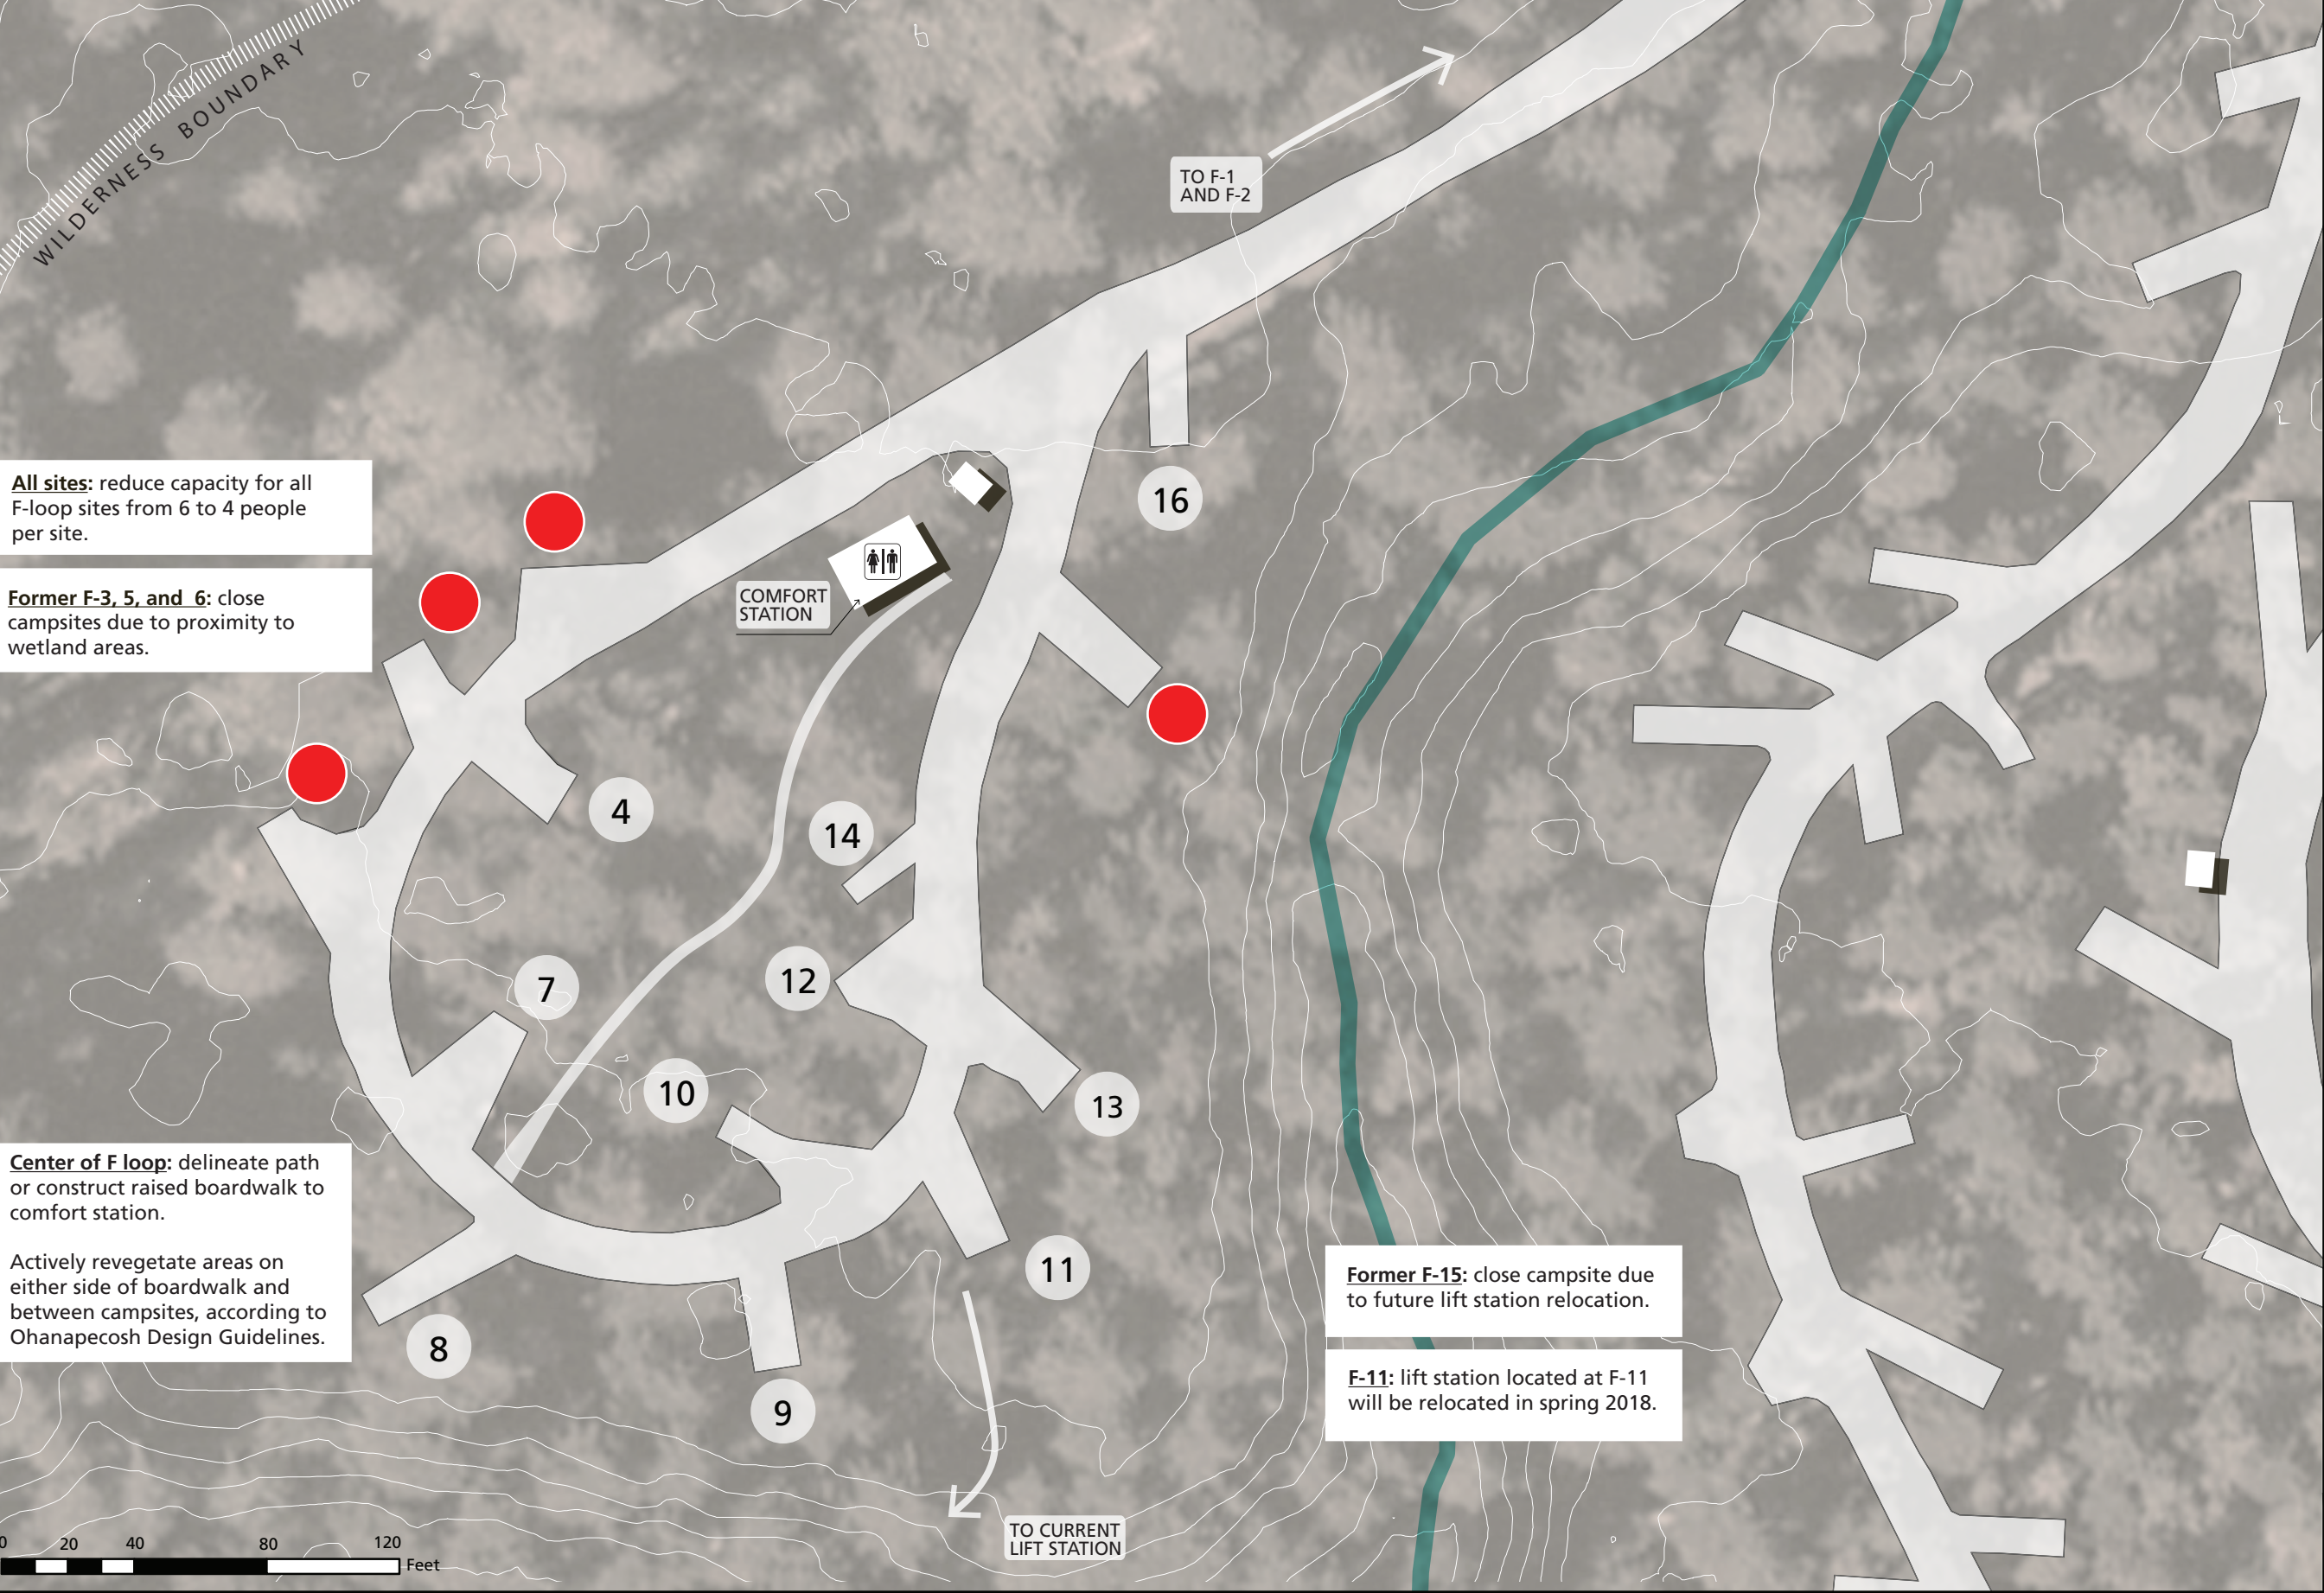
**All sites:** reduce capacity for all F-loop sites from 6 to 4 people per site.

**Former F-3, 5, and 6:** close campsites due to proximity to wetland areas.

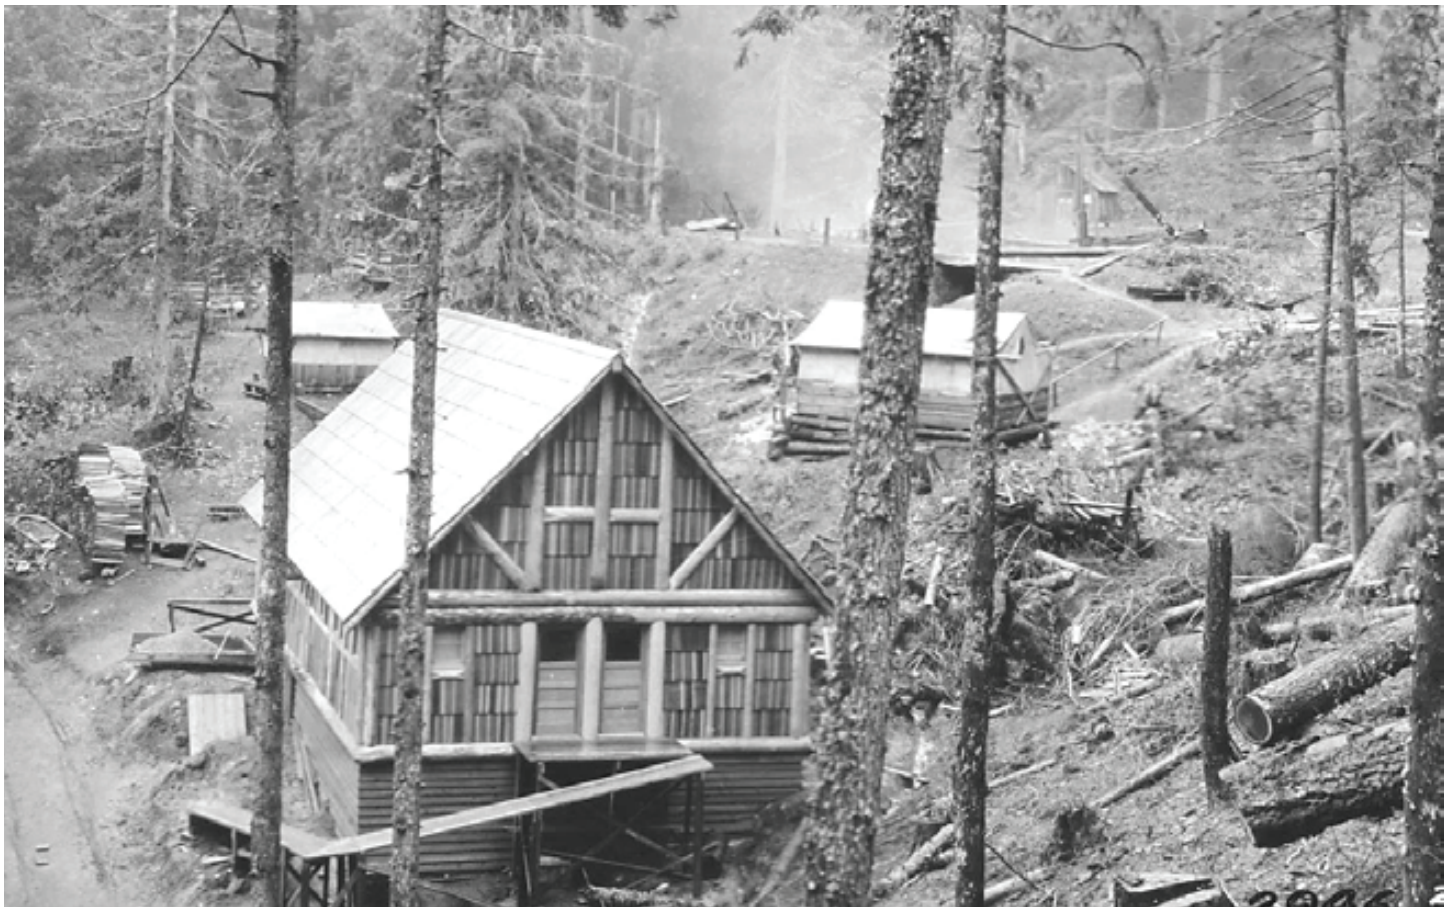
Figure 5. The Ohanapeosh Hot Springs Resort Bath House Under Construction, 1927. Source: NPS 2016.

following B loop out to the hot springs (Ben Diaz pers. comm. 2018). Dr. Bridge assumed control of the Ohanapecosh Hot Springs Company in 1925, and would continue to develop the site (figures 5–7). By 1929, the Ohanapecosh Hot Springs Resort could accommodate 4,000 visitors annually (NPS 2016, 23–26).

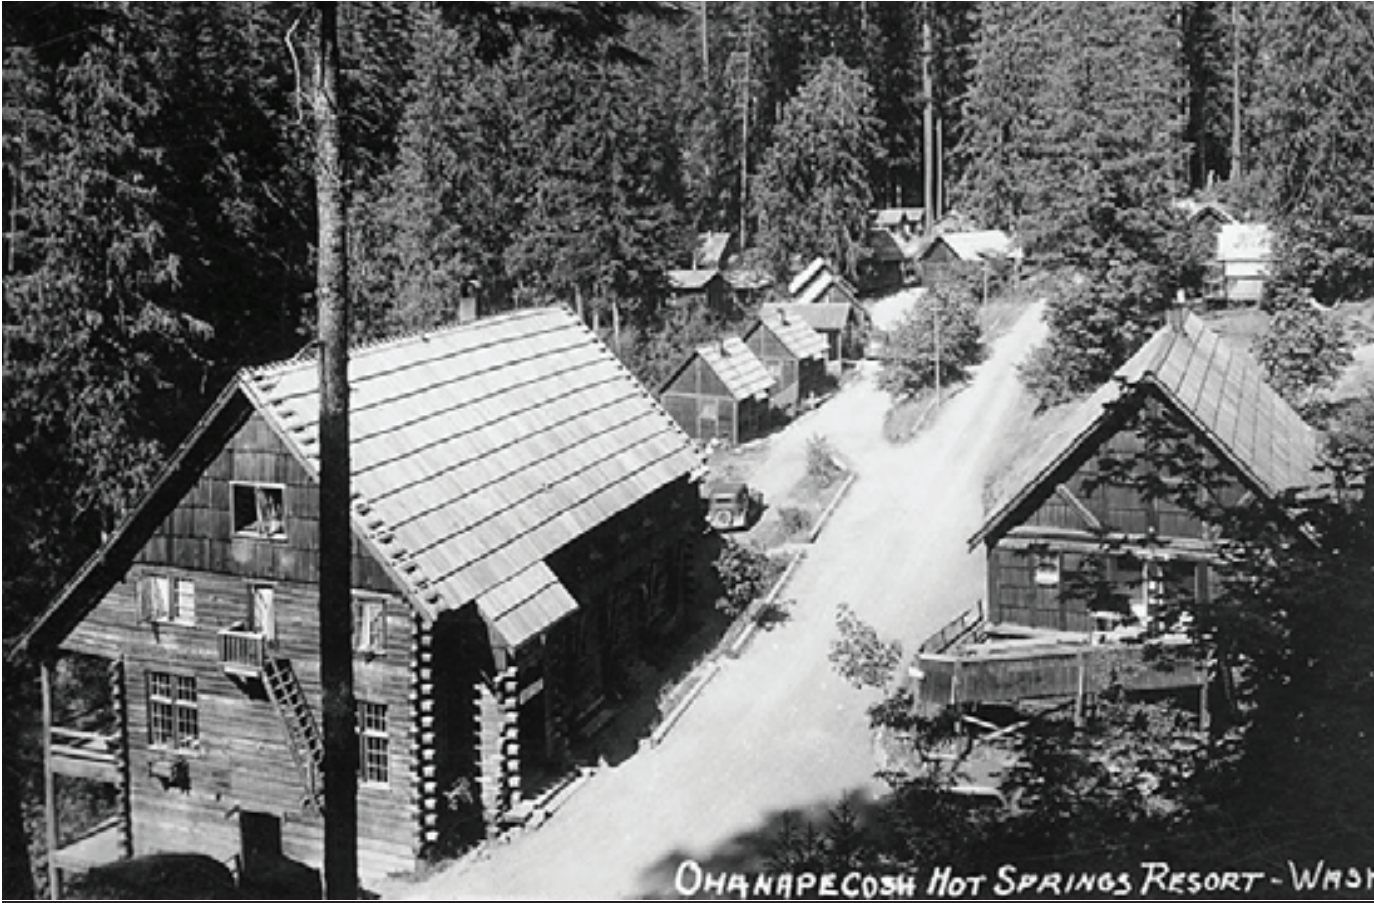
Figure 7. The Ohanapecosh Hot Springs Resort in its heyday, n.d.. Source: NPS 2016.

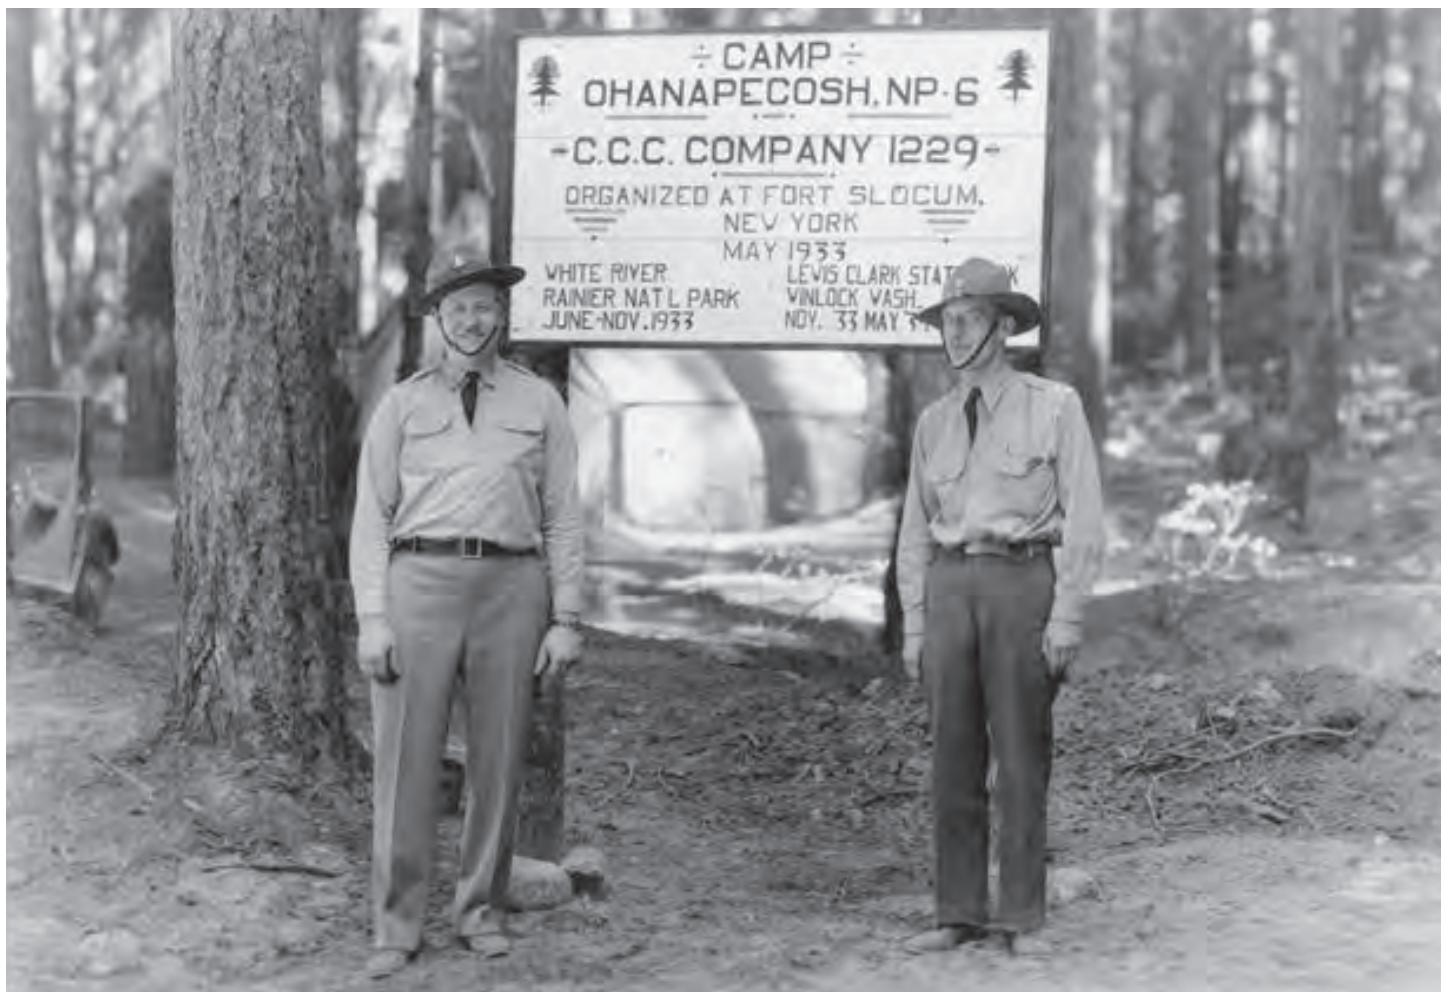
Figure 8. The Ohanapecosh CCC Camp, 1930s. Note the lack of understory vegetation. Source: NPS 2016.

Anticipating that the new road would increase visitation to the Ohanapecosh area, other Depression-era programs focused on increasing visitor facilities and infrastructure. To this end, the Civilian Conservation Corps (CCC) Camp 6 arrived at Ohanapecosh in 1934 and began to expand the campground into the relatively level landscape southeast of the river and southwest of the hot springs (figure 8). As its name

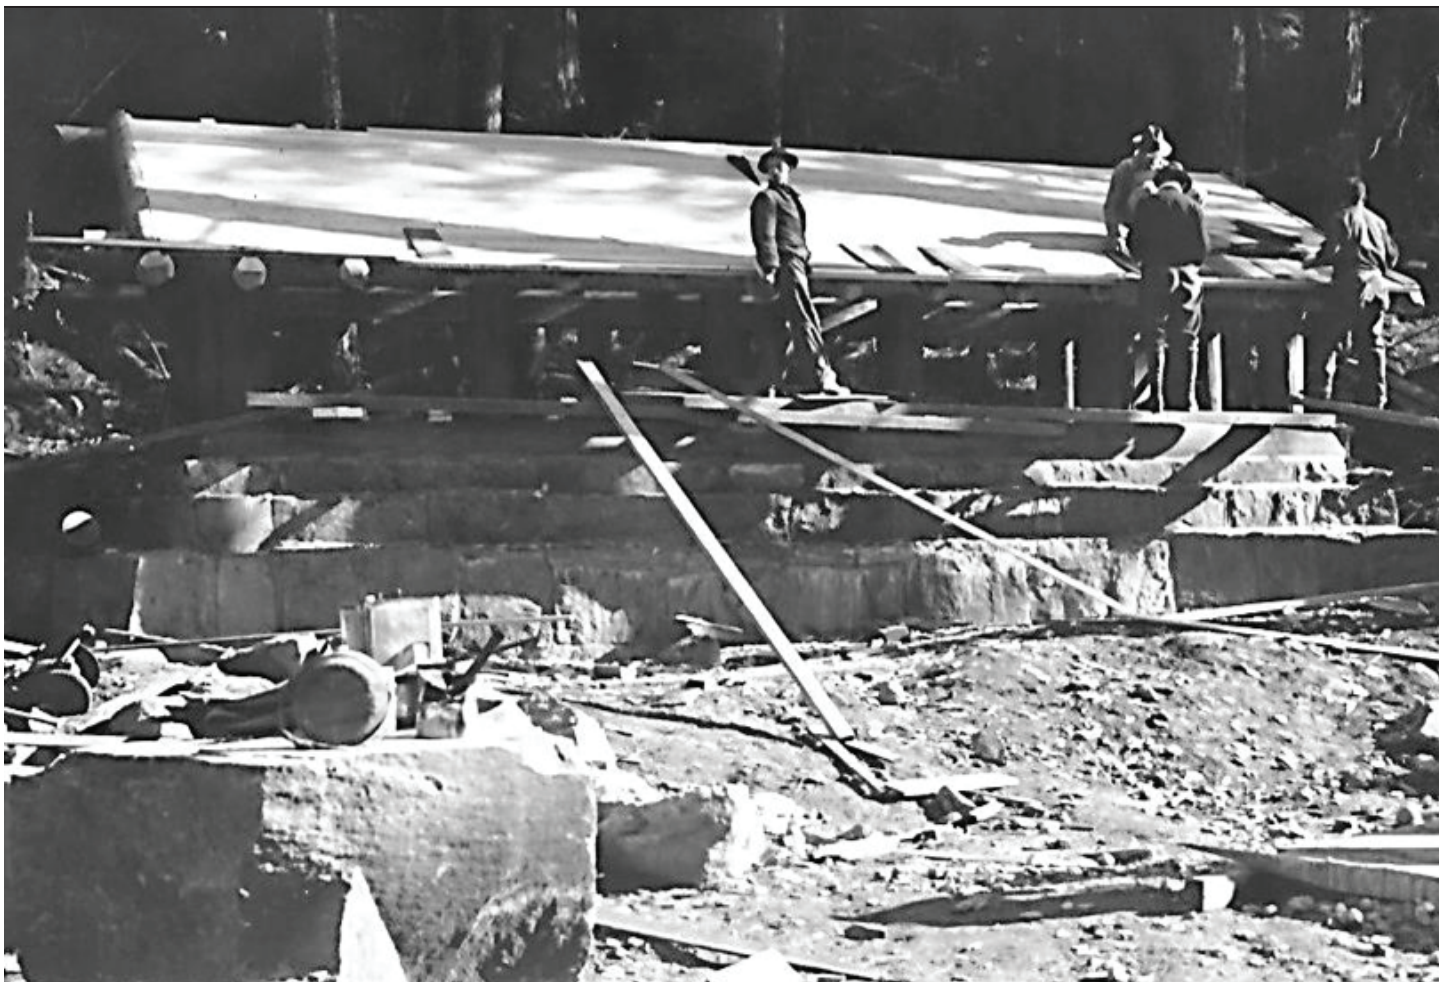
Figure 10. Construction of a comfort station at Ohanapecosh, 1934. Source: NPS 2016.

Although the entrance station and small museum were removed by the NPS in the 1960s, the four comfort stations persist in loops A, B, and C and are listed on the National Register of Historic Places as significant structures within the campground (figures 9–11). The comfort stations' characteristic rustic features can still be appreciated by visitors: these include stepped or battered rock foundations, vertical log and half-log walls, exposed log purlins, wood shingled roofs, and pivoting wood windows (Lentz 2003, 14–15).

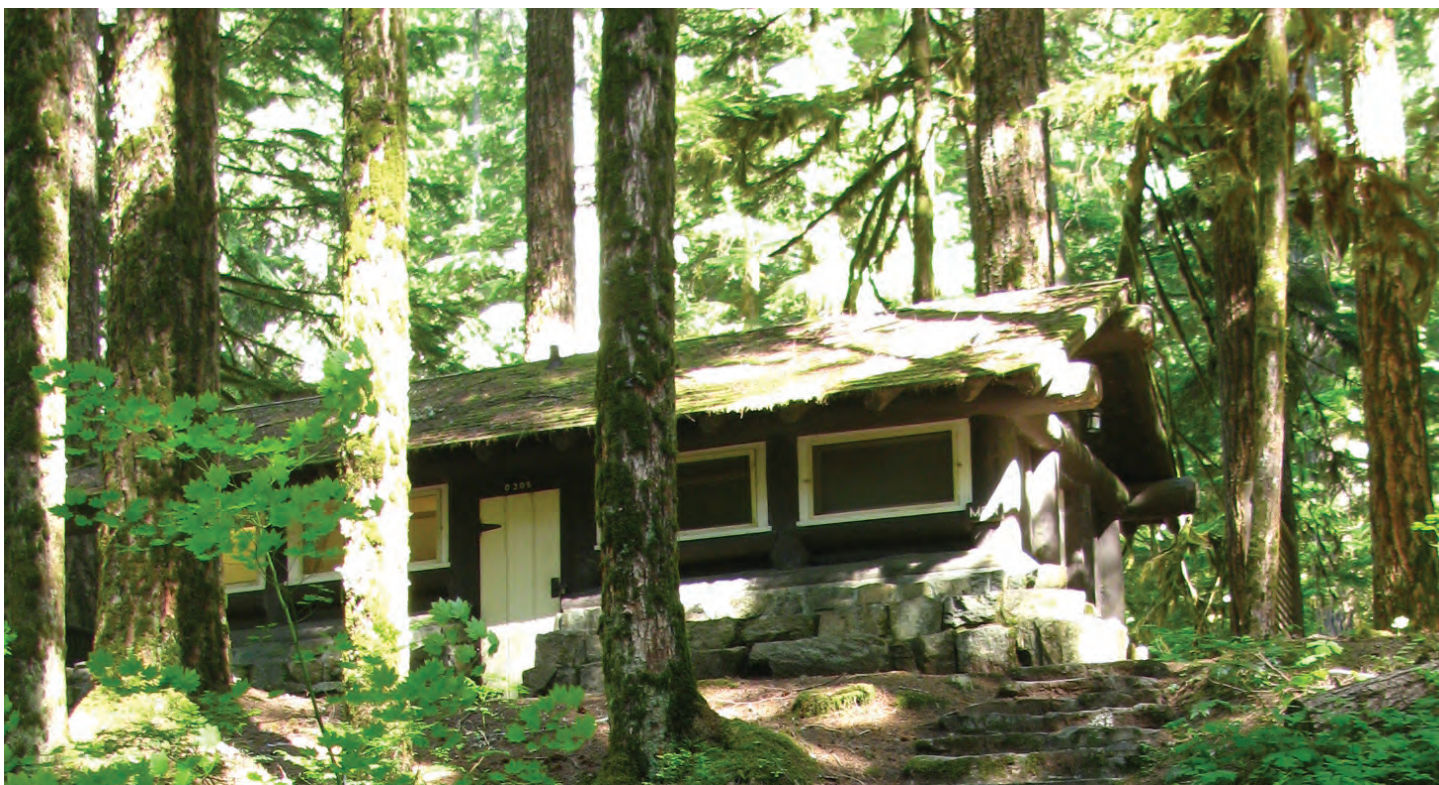
Figure 11. One of the comfort stations in A loop, 2017. Source: NPS.

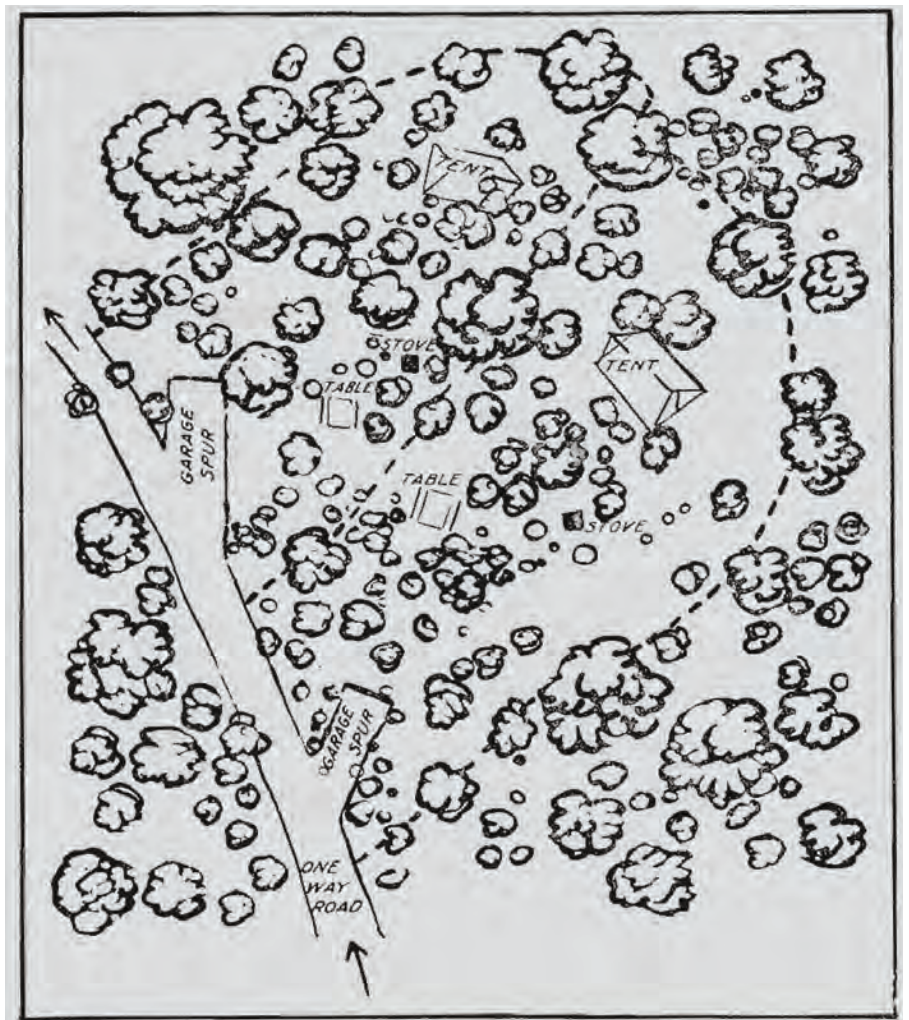
Figure 13. E. P. Meinecke proposal for individual campsites, with tents, tables, stoves, and "garage spurs" for parking. Source: *A Camp Ground Policy*, 1932.

The CCC crews followed this service-wide design guidance, inspired by the NPS rustic style of landscape architecture so prevalent at Mount Rainier and in other national parks. In the 1920s and '30s, forest pathologist E. P. Meinecke was retained by the federal government to provide campground design rehabilitation guidance for campgrounds on federal lands. Heavy and unregulated visitor use—particularly the use of automobiles—was already leading to the degradation of vegetation and other natural resources in national forest and national park campgrounds. To offset these impacts and improve visitor experience, Meinecke proposed a system of one-way loop roads with angled parking spurs (figures 12–13). To constrain visitor impacts, individual campsites and parking areas were to be clearly delineated by sturdy vegetation, rocks, boulders, or logs (Meinecke 1935, 12). Meinecke believed that thoughtful campsite design and circulation would reduce the visitor's tendency to create social trails and expand campsites and parking areas beyond intended boundaries (Meinecke 1932, 10). He also stressed that the planning and siting of campsites should take into account soil types and vegetation that would prove more durable to visitor impacts, such as compaction (Ibid., 8–9).

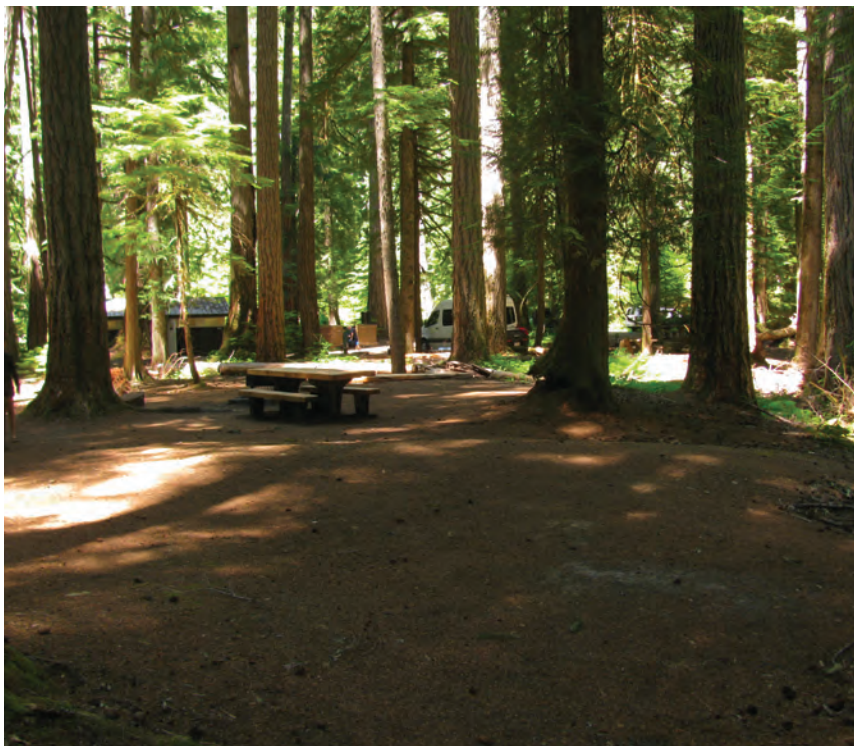
Figure 20. Current conditions: there is a significant loss of understory vegetation in many areas in the campground, including this campsite in F loop, 2017. Source: NPS.

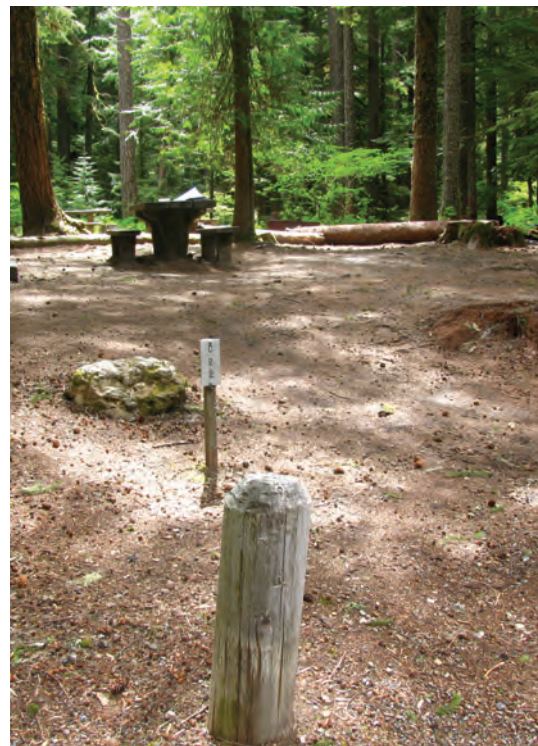
Figure 21. Parking area and campsite in E loop, 2017. Source: NPS.

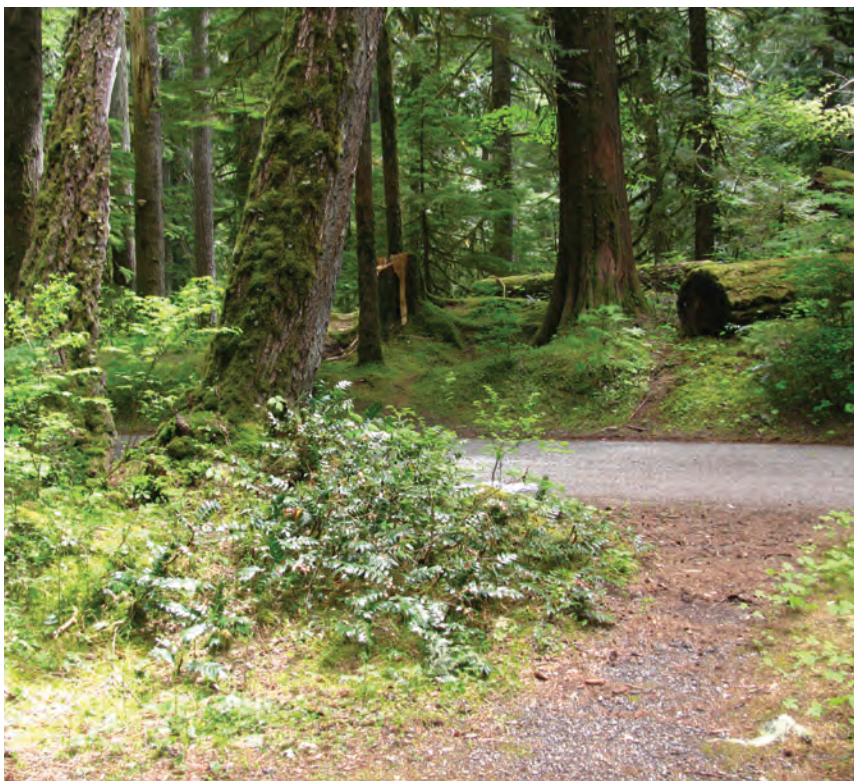
Figure 22. Conditions in G loop, where there are fewer impacts to understory vegetation, 2017. Source: NPS.

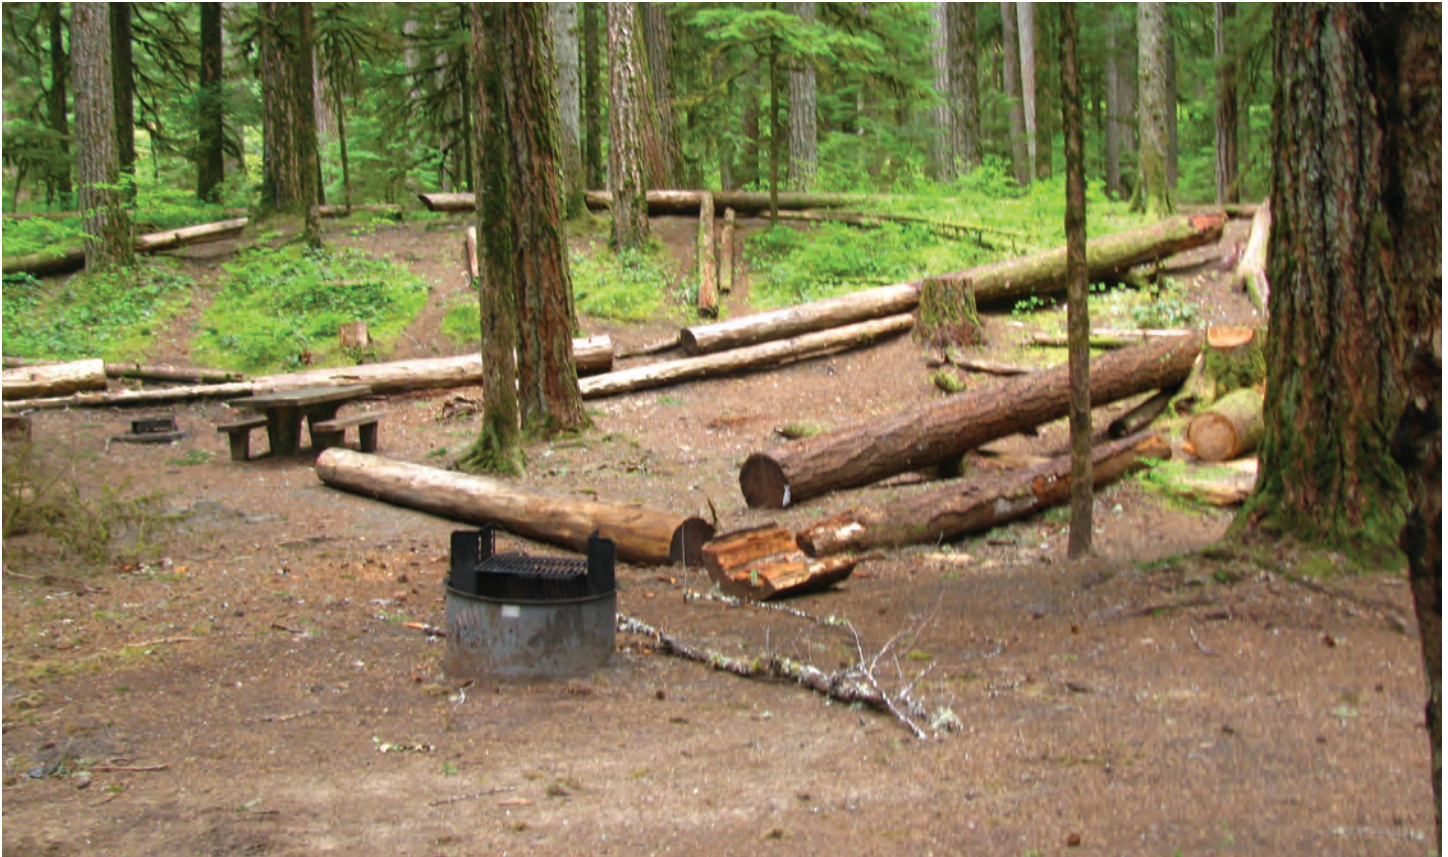
Figure 24. Loop A campsite conditions, 2017, illustrating a loss of understory and a confusing arrangement of multiple campsites. Note also the social trails leading up the hillside. Source: NPS.

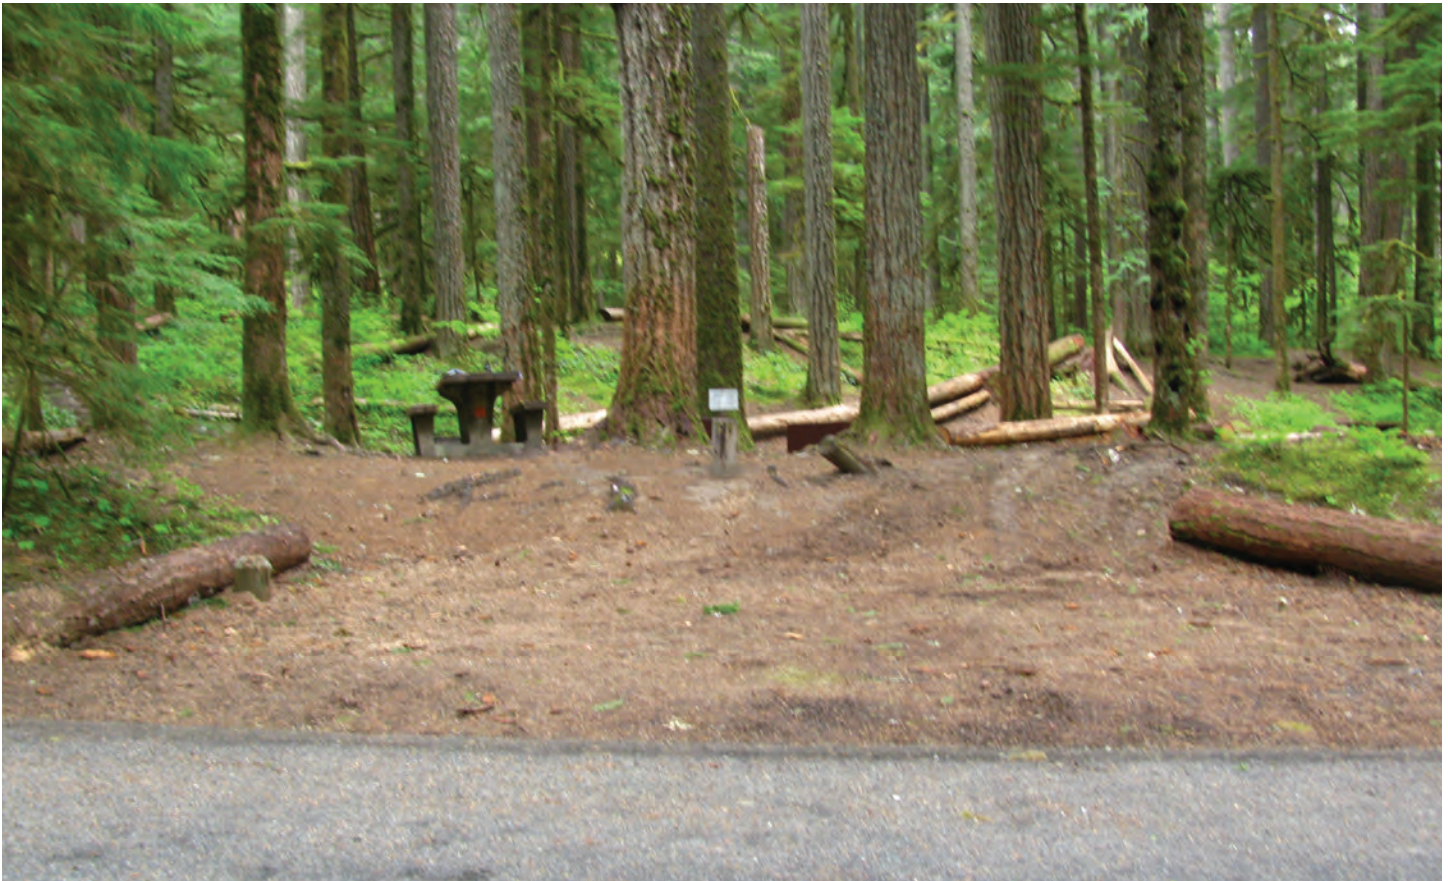
Figure 25. An ill-defined parking area in loop A, 2017. Source: NPS.

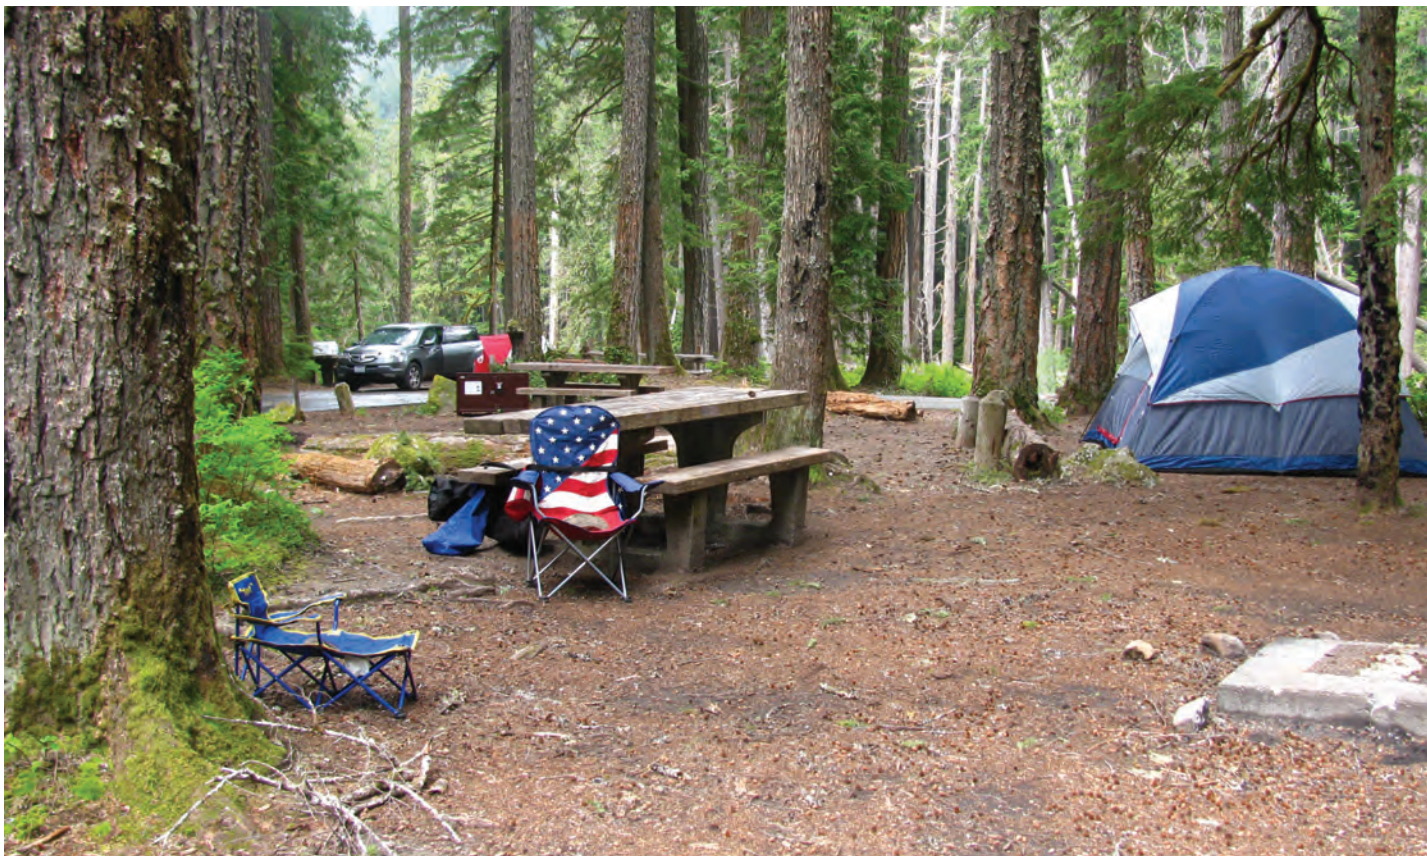
Figure 26. Confusing, crowded campsite conditions inside the center of C loop, 2017. Source: NPS.

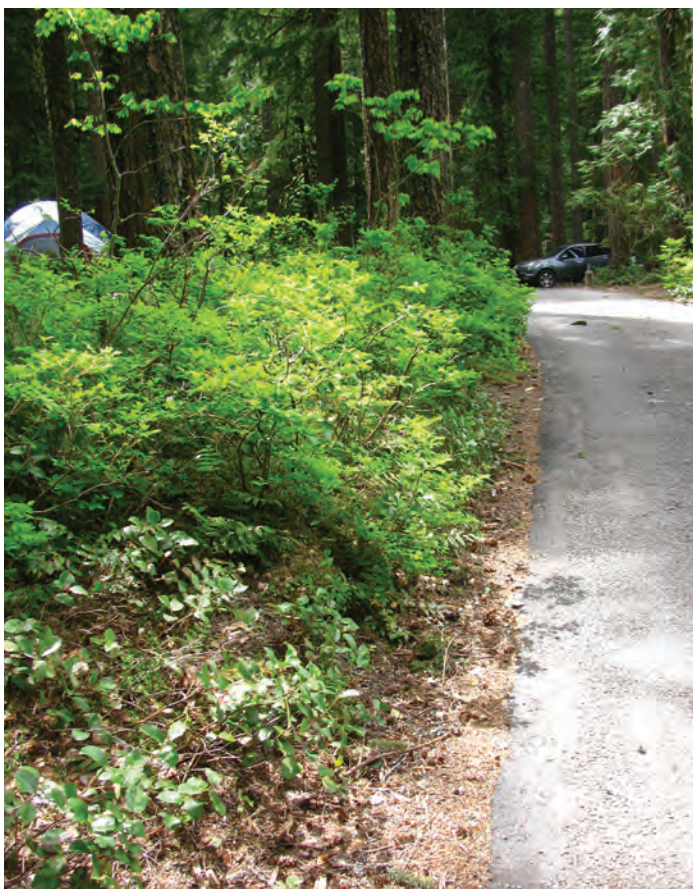
Figure 27. Desired edge conditions, C loop roadside, 2017. Source: NPS.

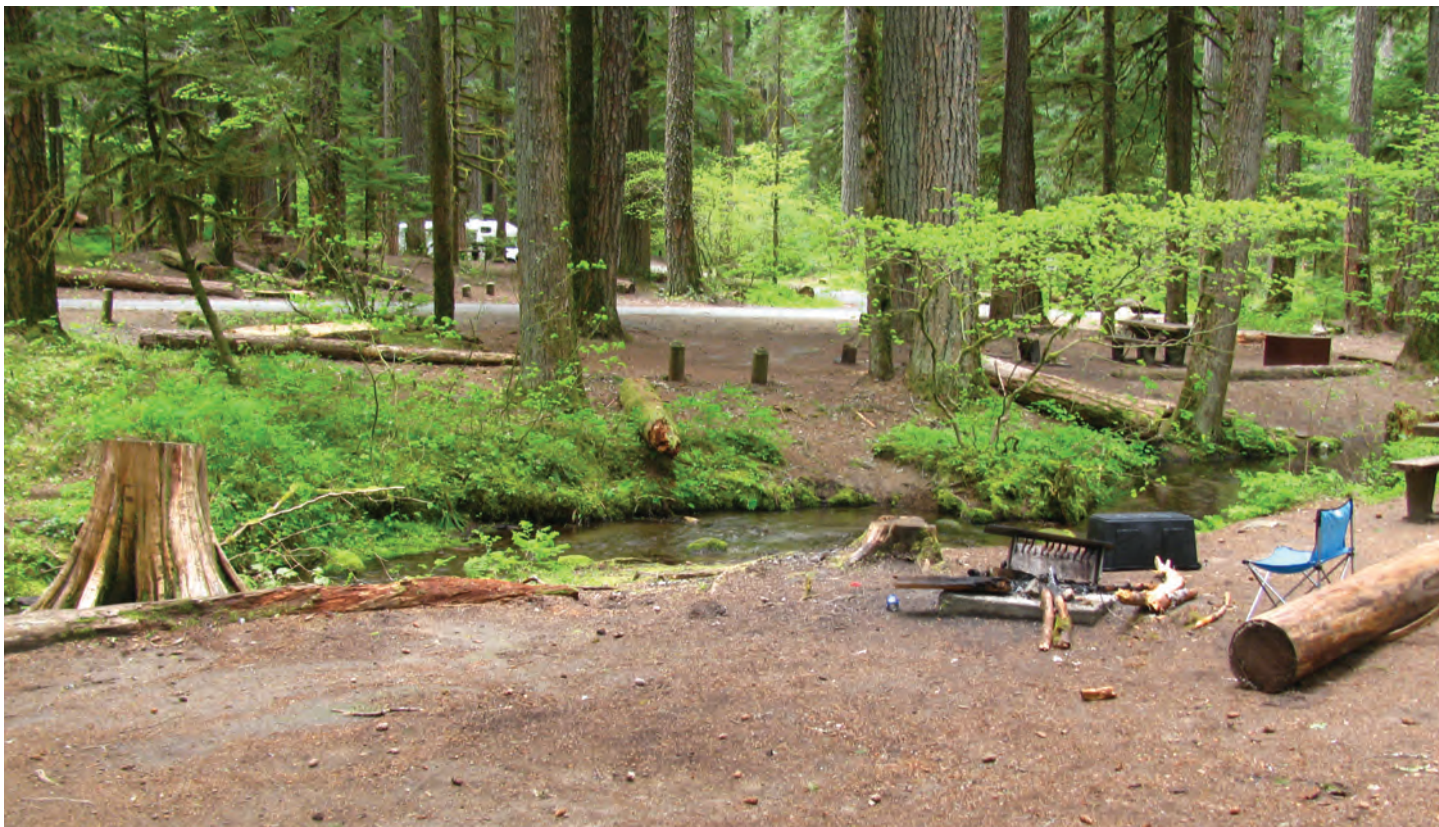
Figure 29. Campsite C-27 adjacent to stream, with significant loss of vegetation. This campsite was closed shortly after this photo was taken, in 2017. Source: NPS.

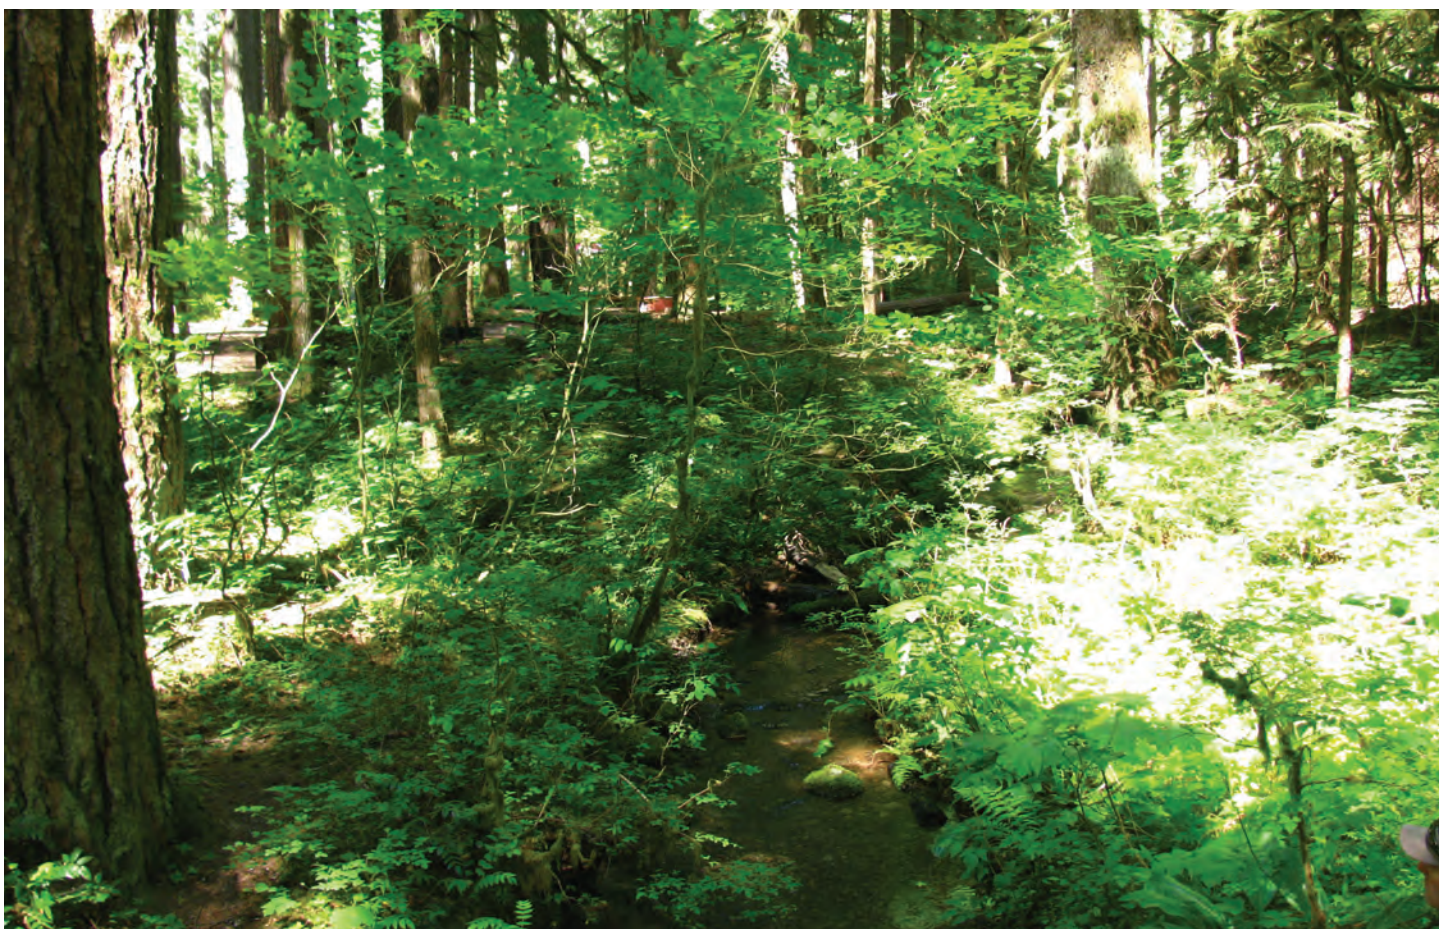
Figure 30. Improved riparian conditions upstream of campsite C-27, 2017. Source: NPS.

and vegetation type and range from 25 to 150 feet (figure 30). To determine appropriate buffer sizes, campsites should be evaluated on a case-by-case basis with the park's historical landscape architect, plant ecologist, and aquatic resources specialist.

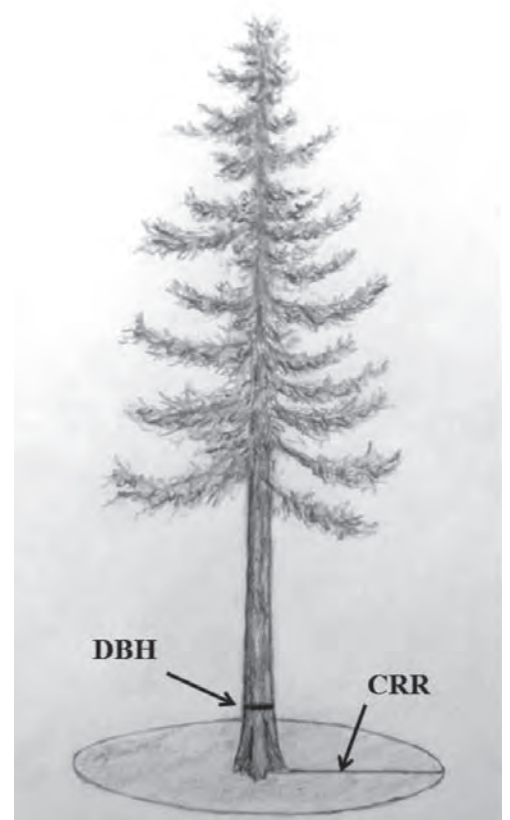
Figure 41. Critical root radius (CRR). Source: T. Degerman, NPS.

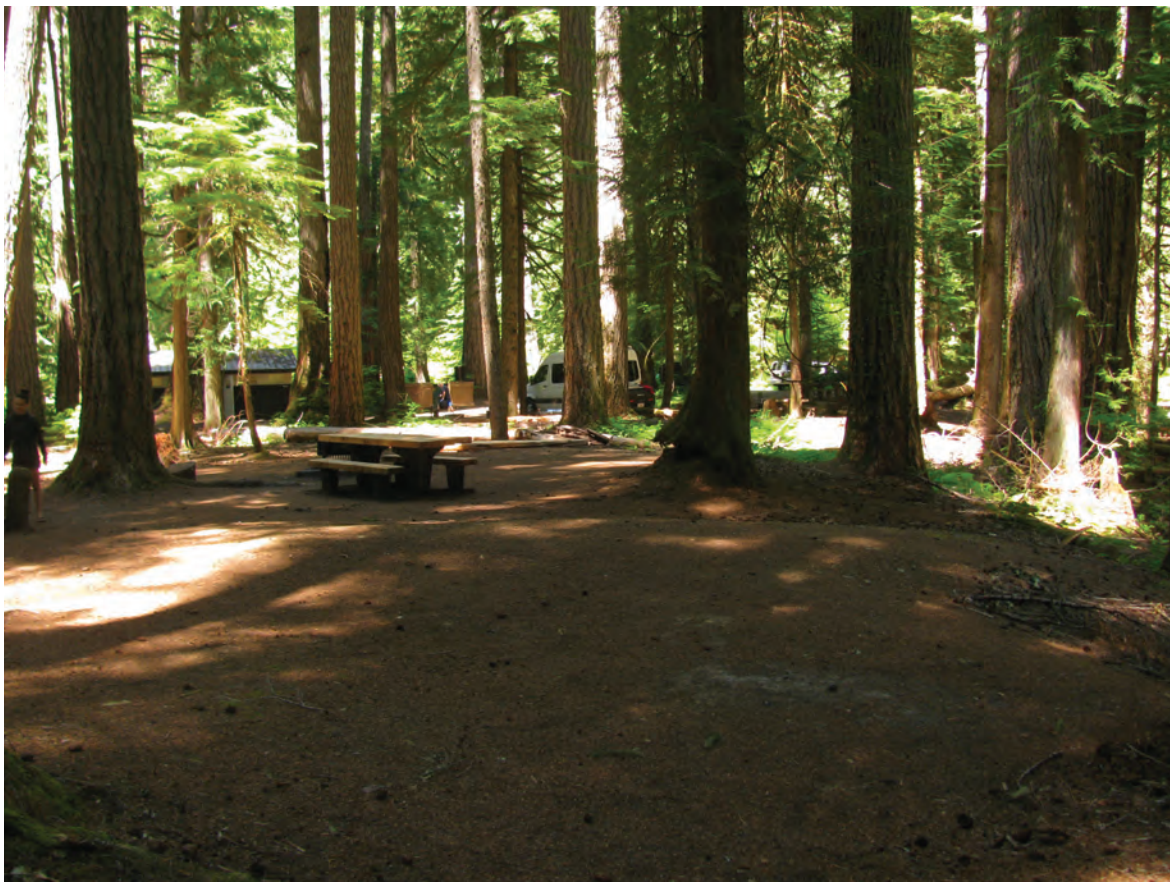
Figure 42. Existing campsite without tree root protection, 2017. Source: NPS.
