# OHANAPECOSH CAMPGROUND MOUNT RAINIER NATIONAL PARK

Rehabilitation Proposal and Design Guidelines

MAY 2018

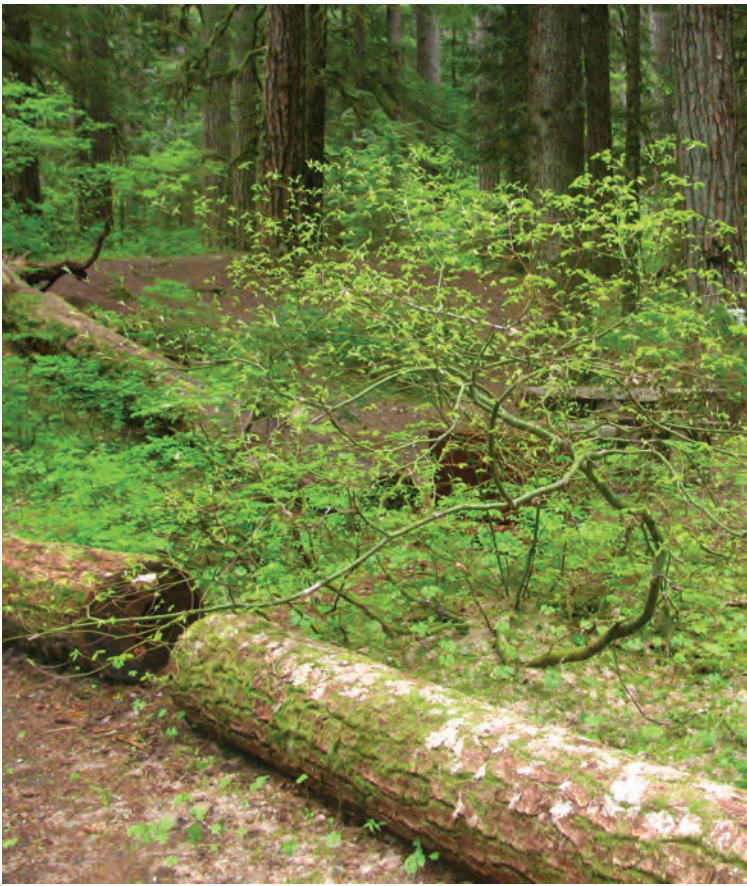
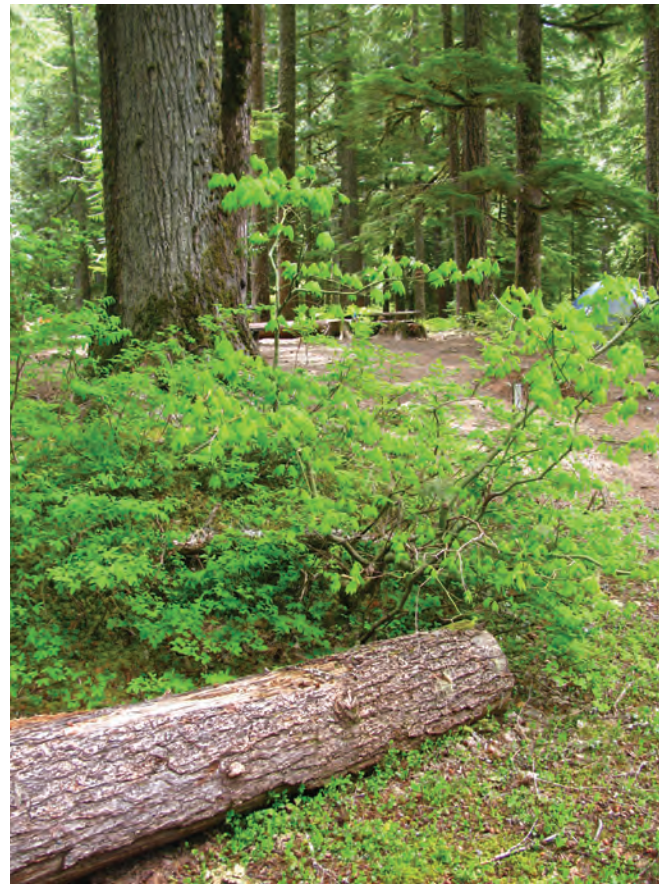
Figures 44 and 45. Vine maple paired with fallen logs provide optimal screening and definition between campsites. This exists in some areas of campground (seen here in 2017) and should be replicated elsewhere. Source: NPS.

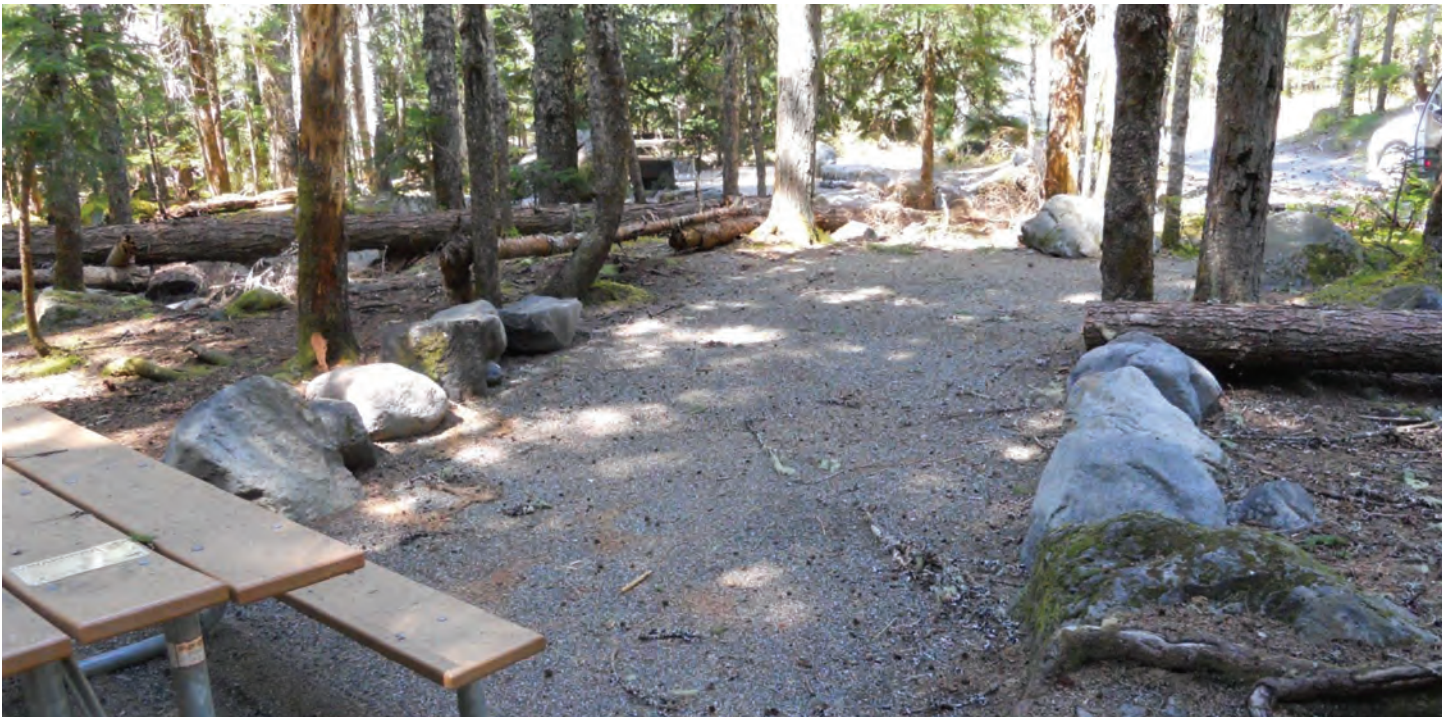
Figure 46. Boulders used to delineate use areas, Cougar Rock Campground, Mount Rainier National Park. Source: Degerman 2015.

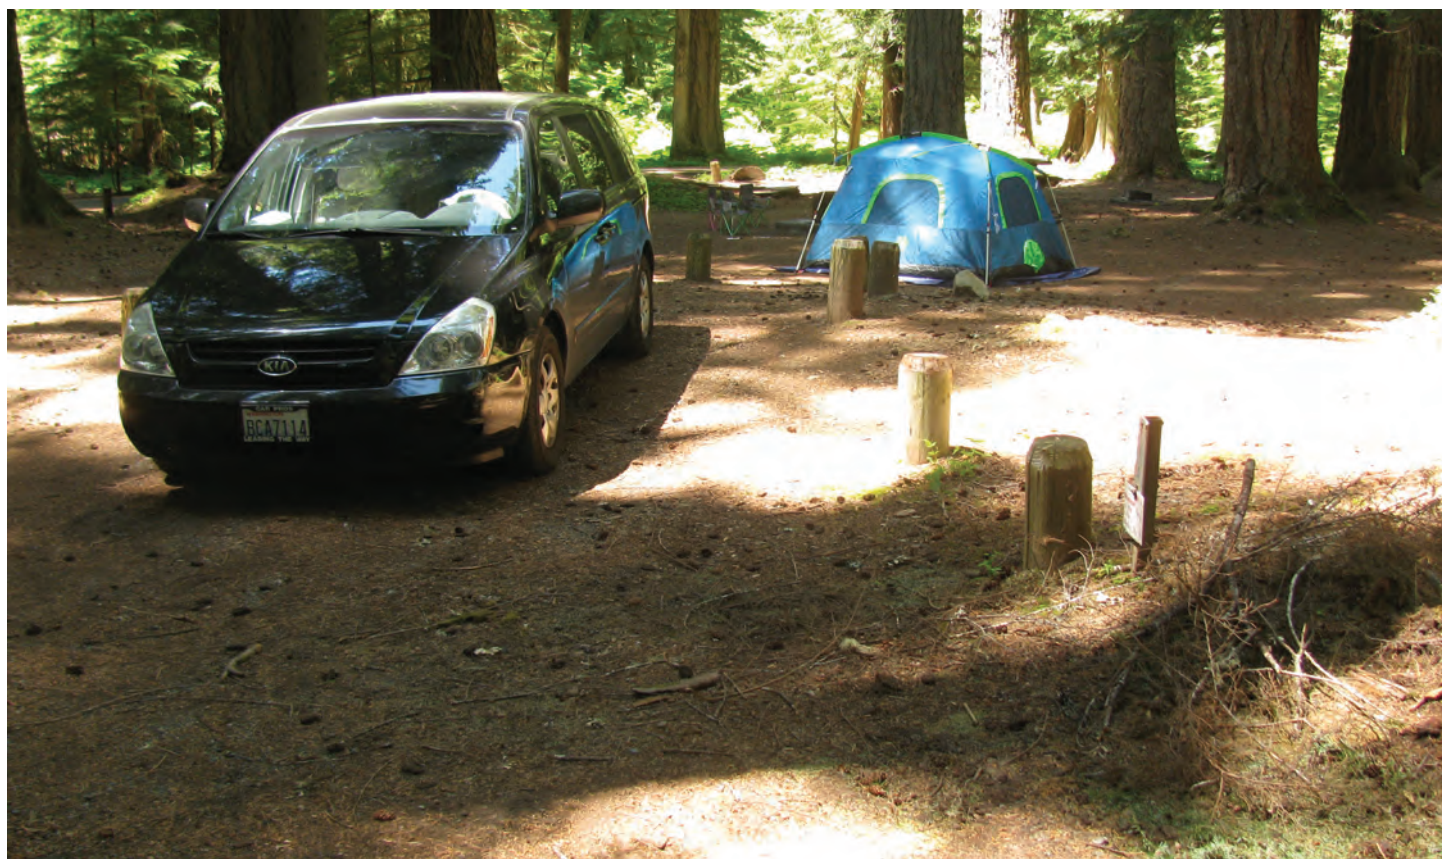
Figure 50. Existing parking area delineated by bollards, with ground surface denuded of vegetation, 2017. Source: NPS.

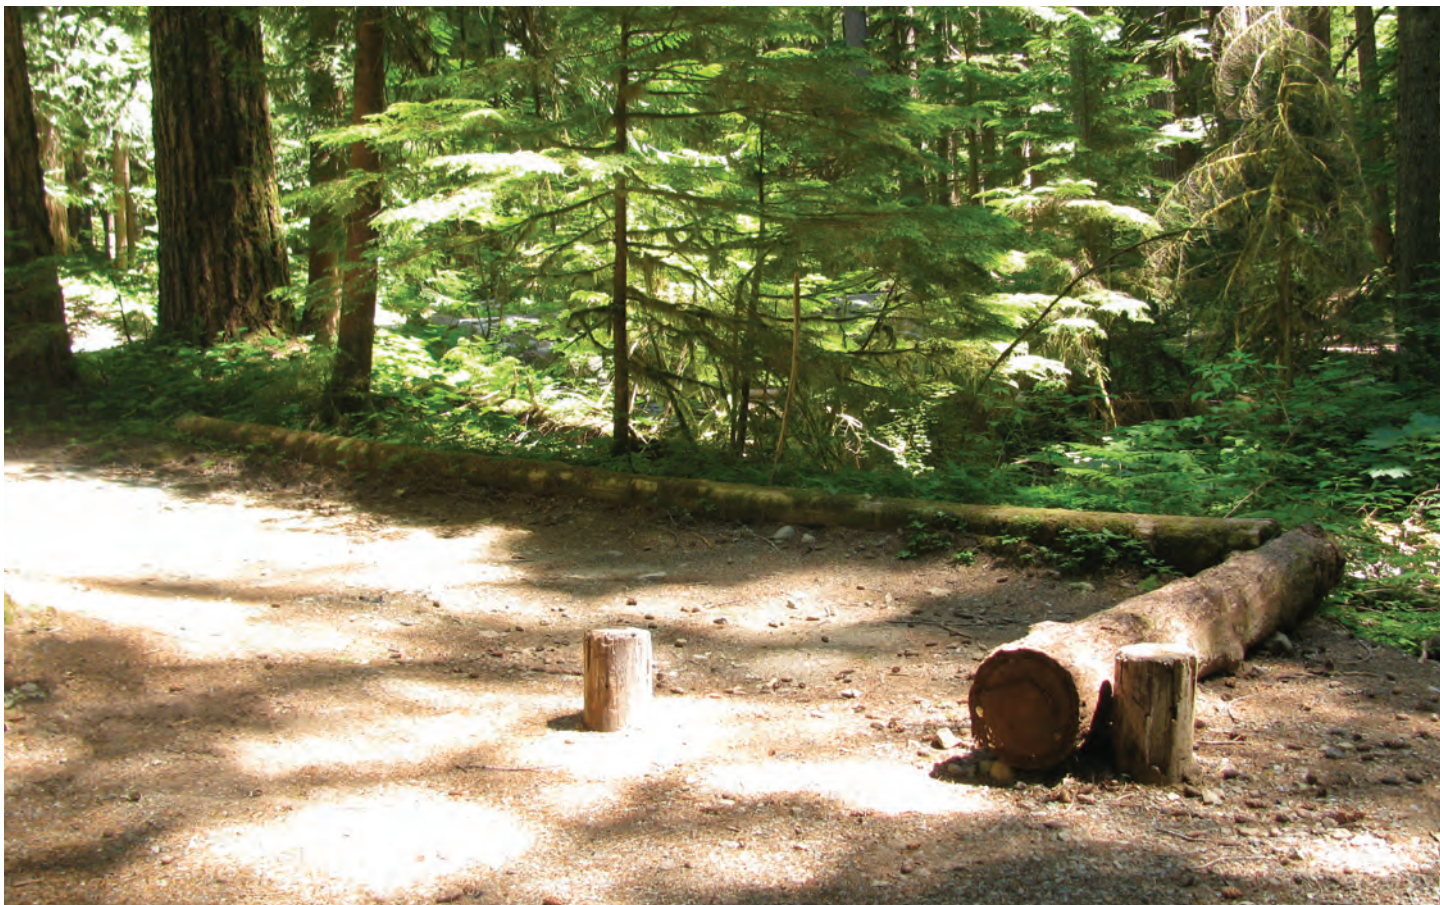
Figure 51. Existing parking area delineated by both fallen logs and bollards, E loop, 2017. Source: NPS.

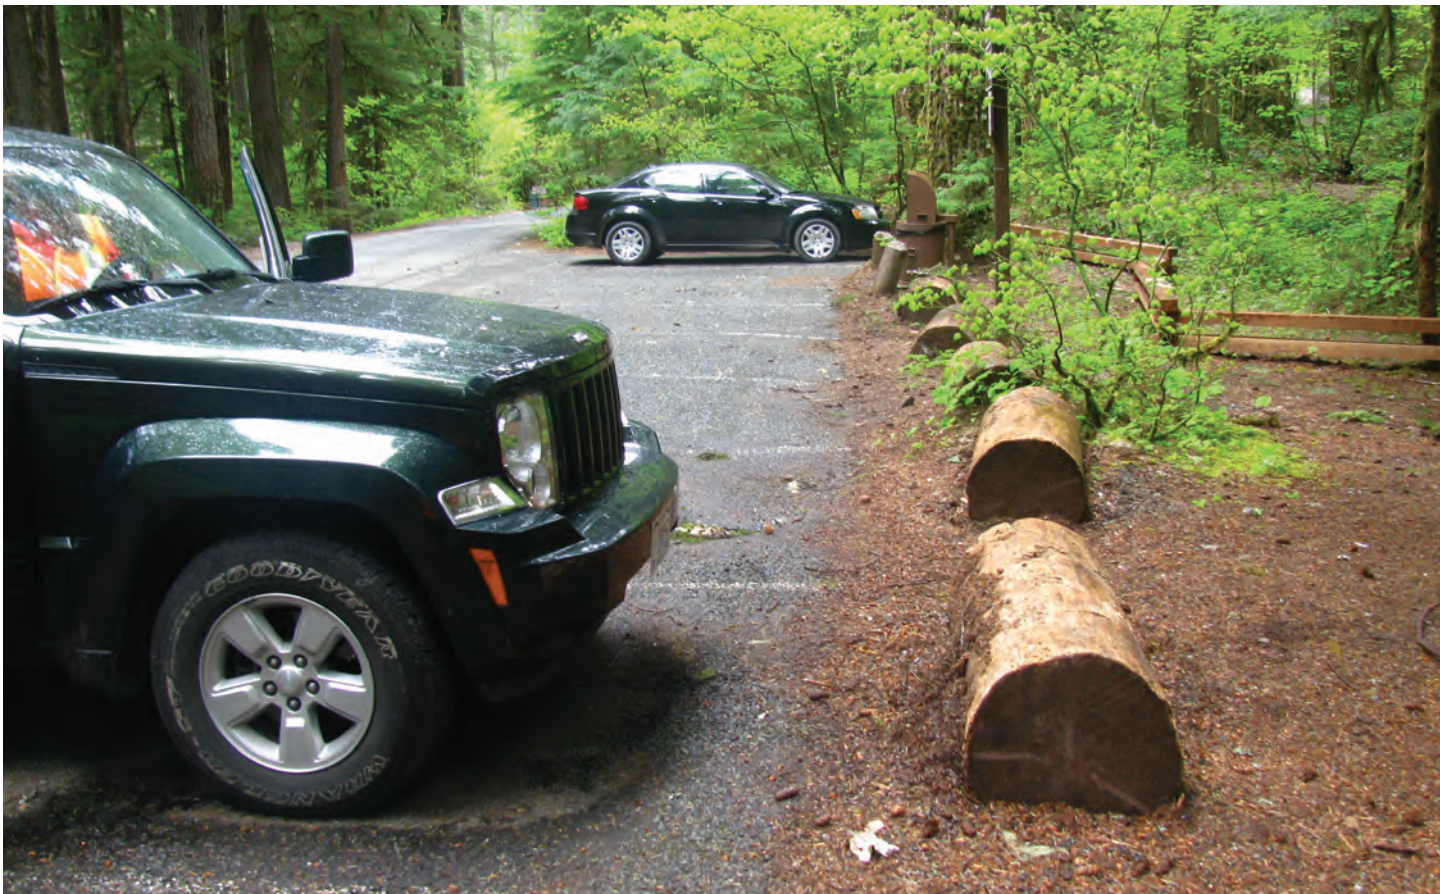
Figure 52. Day-use parking area in A loop with log barriers and split-rail fencing, 2017. Source: NPS.

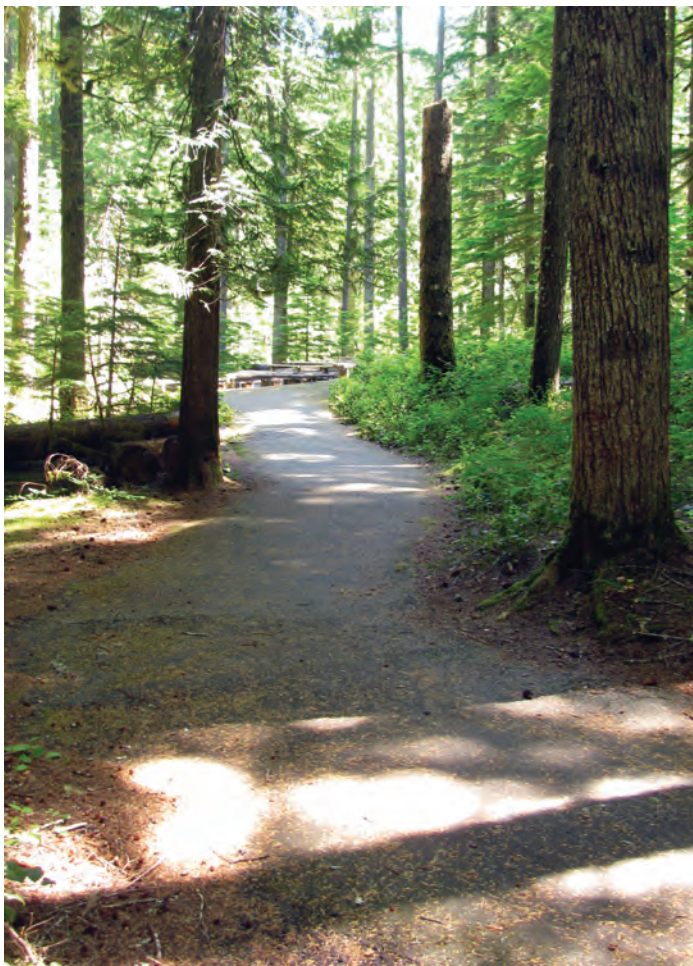
Figure 55. Asphalt path leading to amphitheater, 2017.  
Source: NPS.

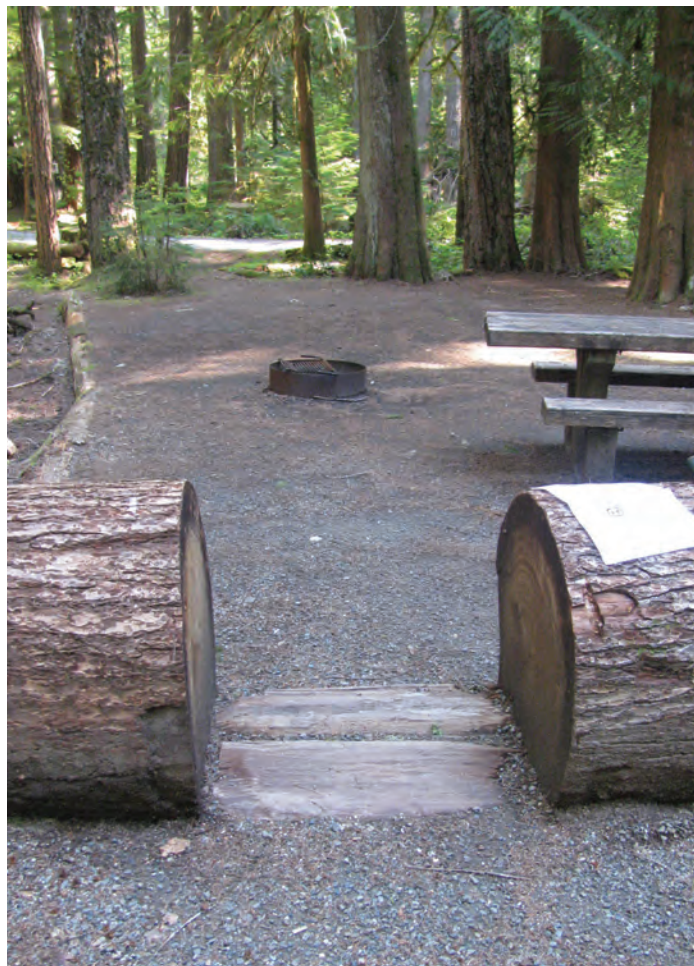
Figure 56. Newly resurfaced campsite, 2017; forest duff begins to accumulate in the compacted gravel. Source: NPS.

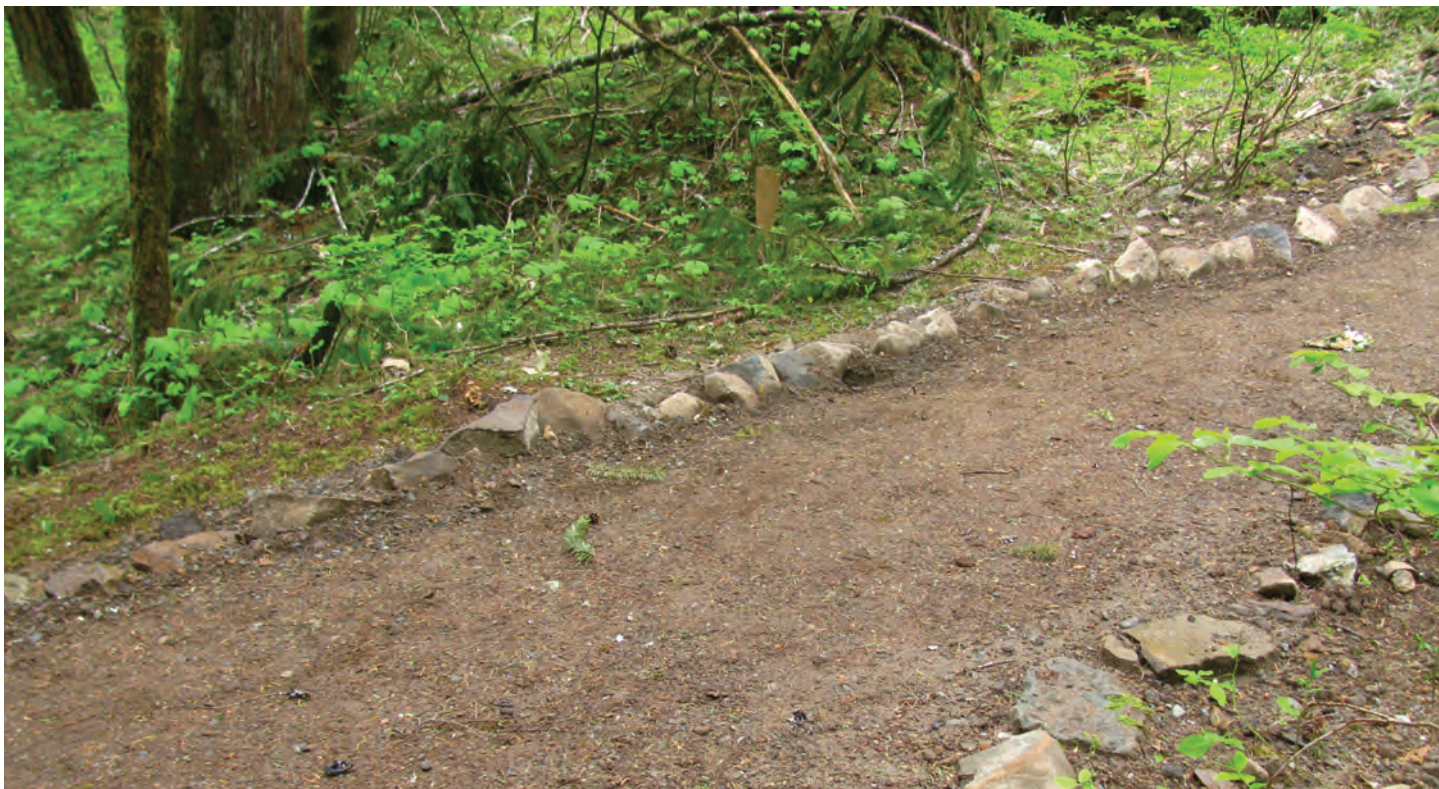
Figure 57. Stone-lined path leading to bridge between A and C loops, 2017. Note the partially buried stones. Source: NPS.

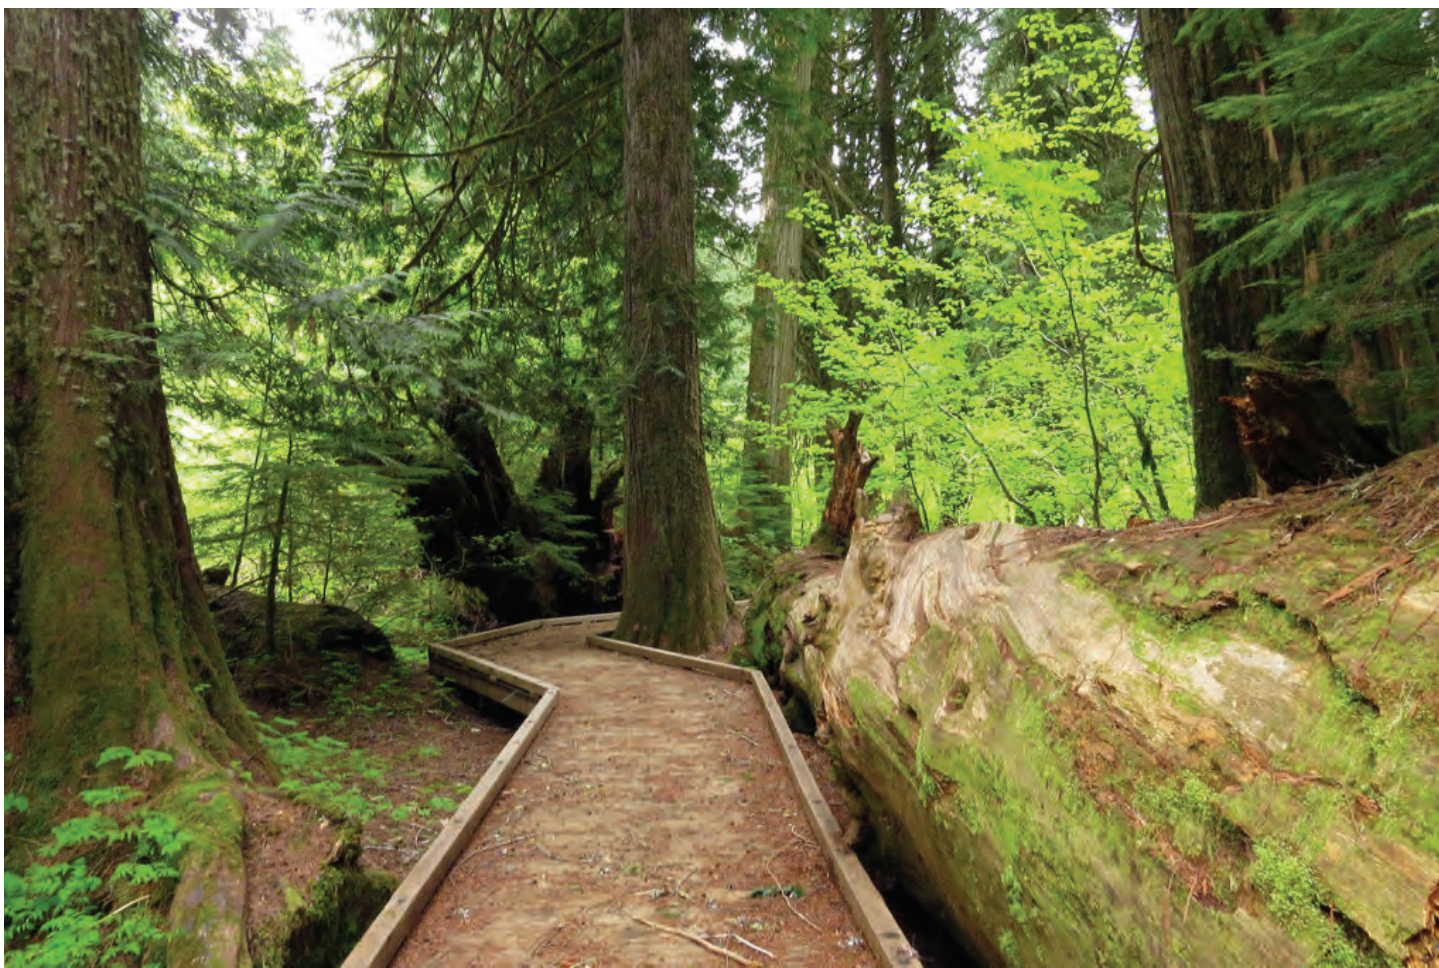
Figure 58. Boardwalk pathways such as those at the Grove of the Patriarchs (seen here) are a suitable option for areas with sensitive resources (e.g., old-growth trees and wetland/riparian areas). Source: visitrainier.com.

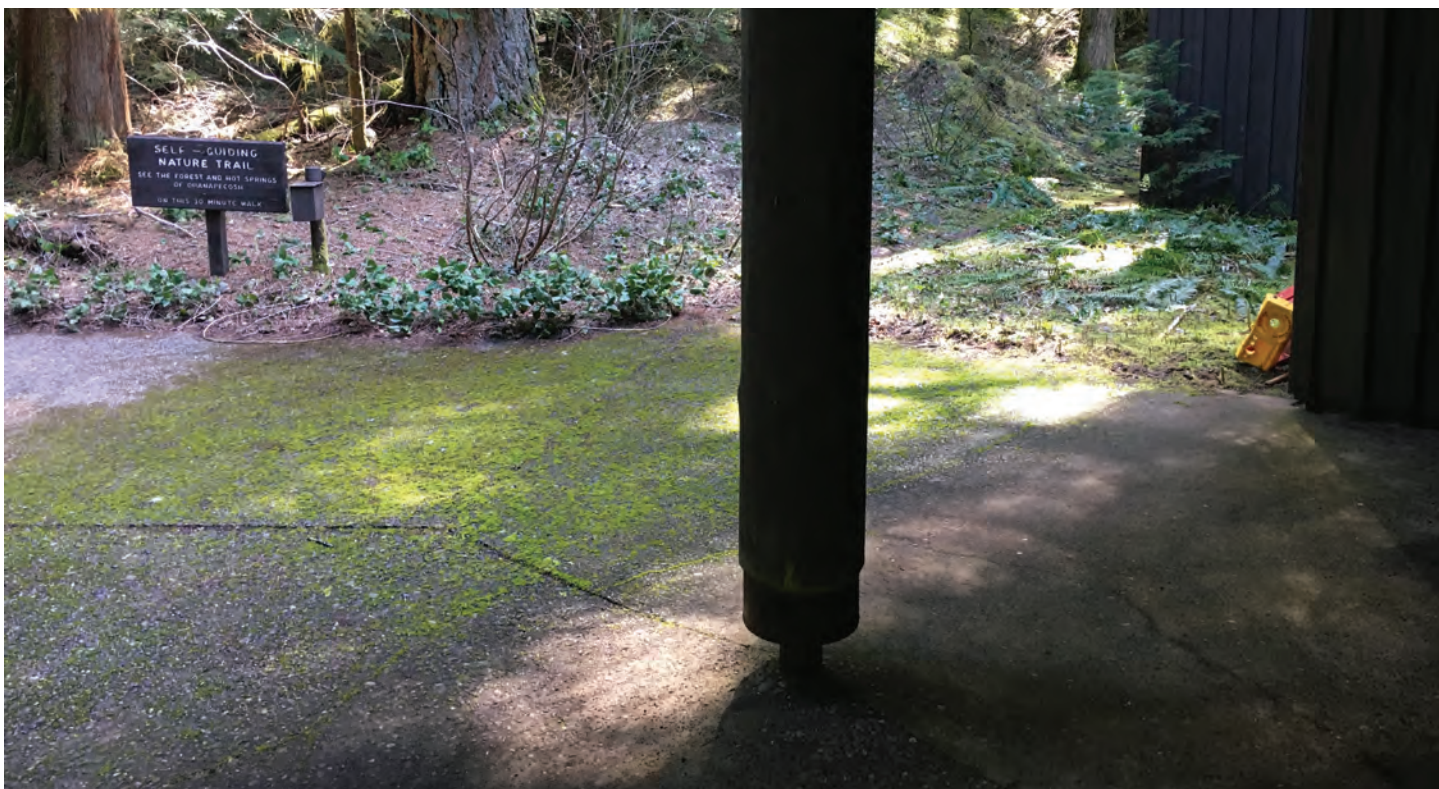
Figure 59. Care should be taken to select path and walkway surfaces that are not slippery in the campground's damp climate. The concrete aggregate around the visitor center (seen here) is very slippery. Source: NPS.

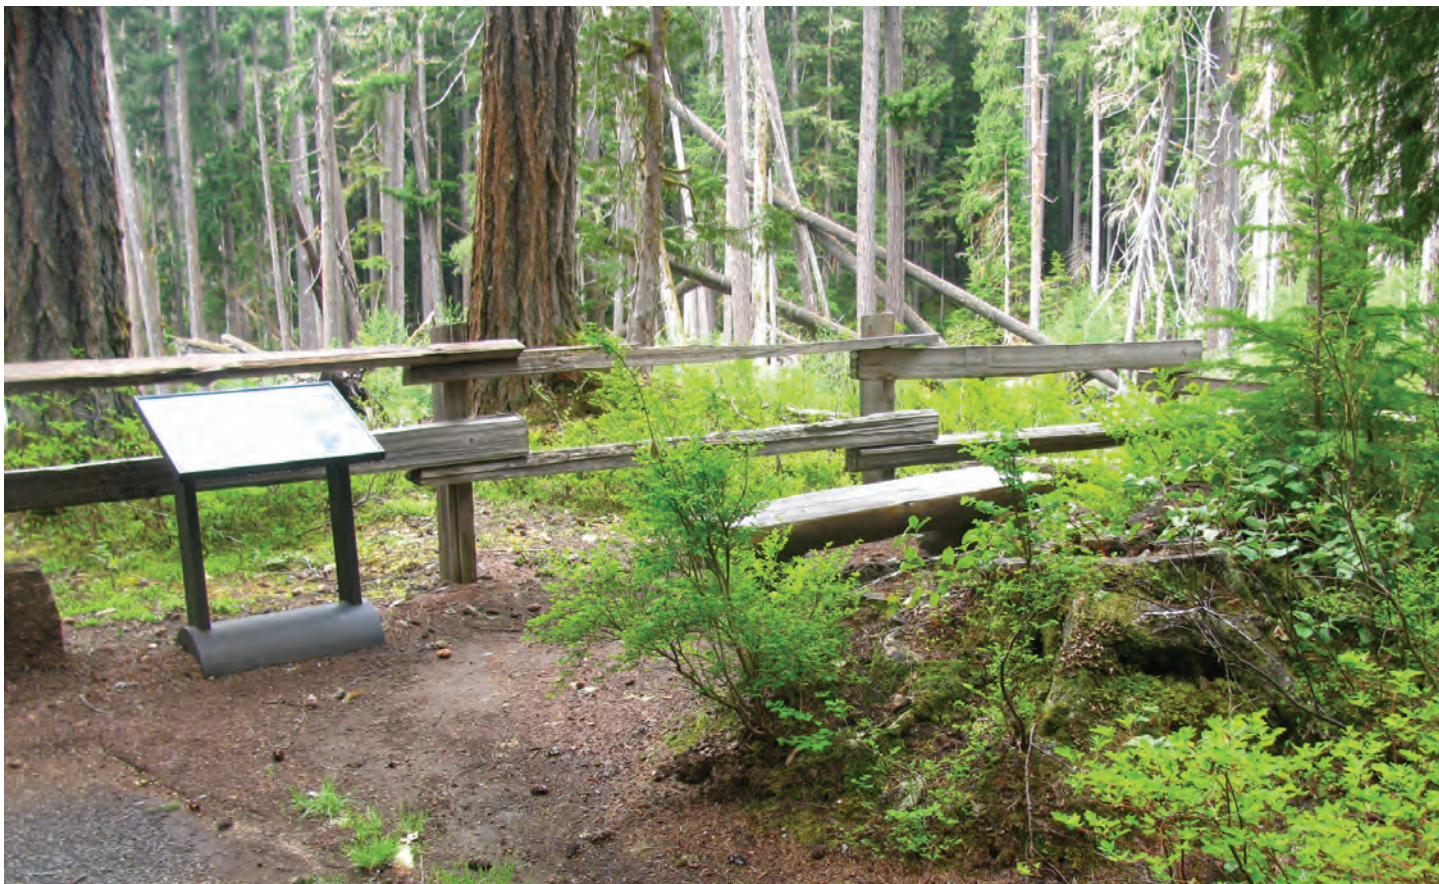
Figure 60. Split-rail fencing is an appropriate edging choice if a higher barrier is desired. Source: NPS.

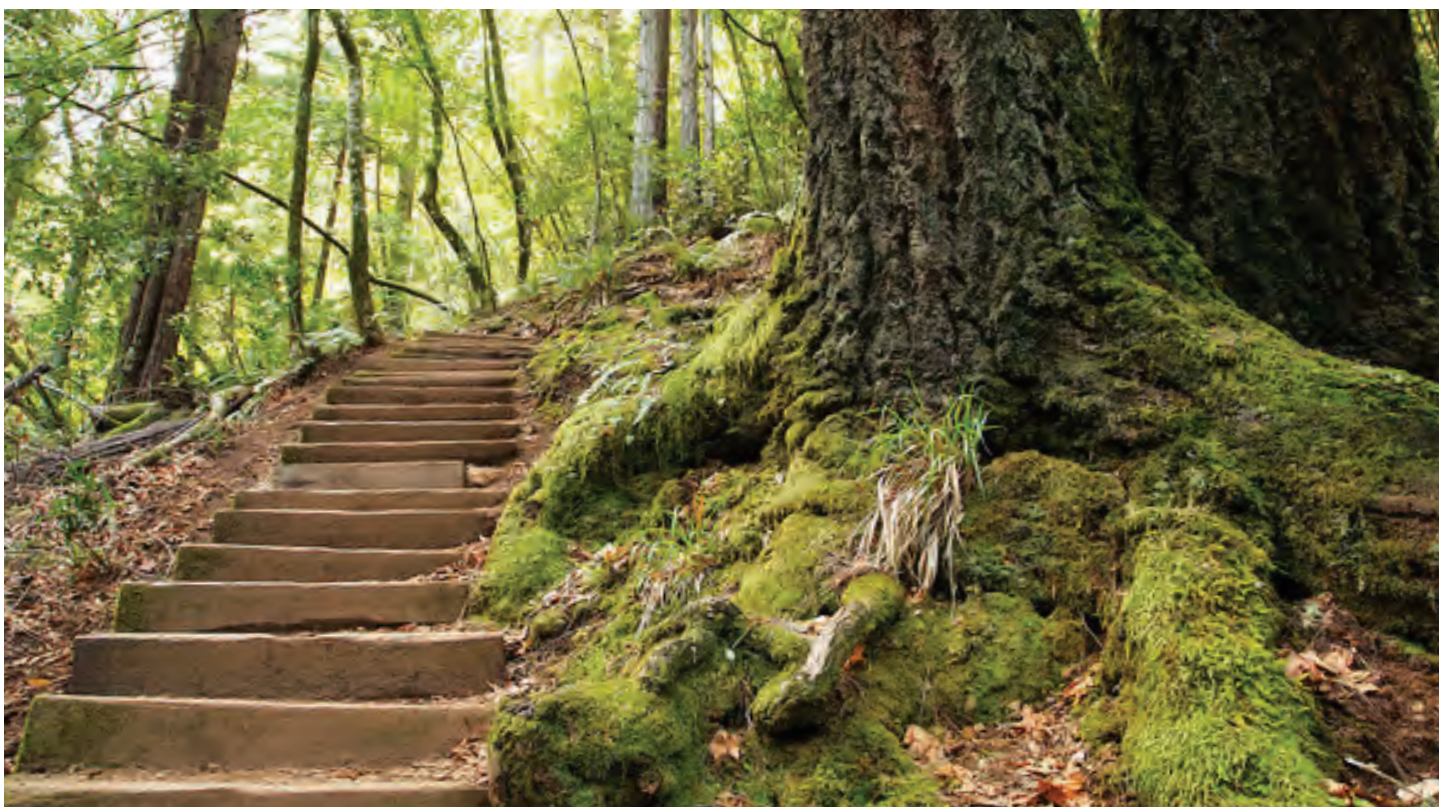
Figure 61. Example of box steps created from milled lumber, Cataract Falls Trail. Source: eastbaytrails.com.

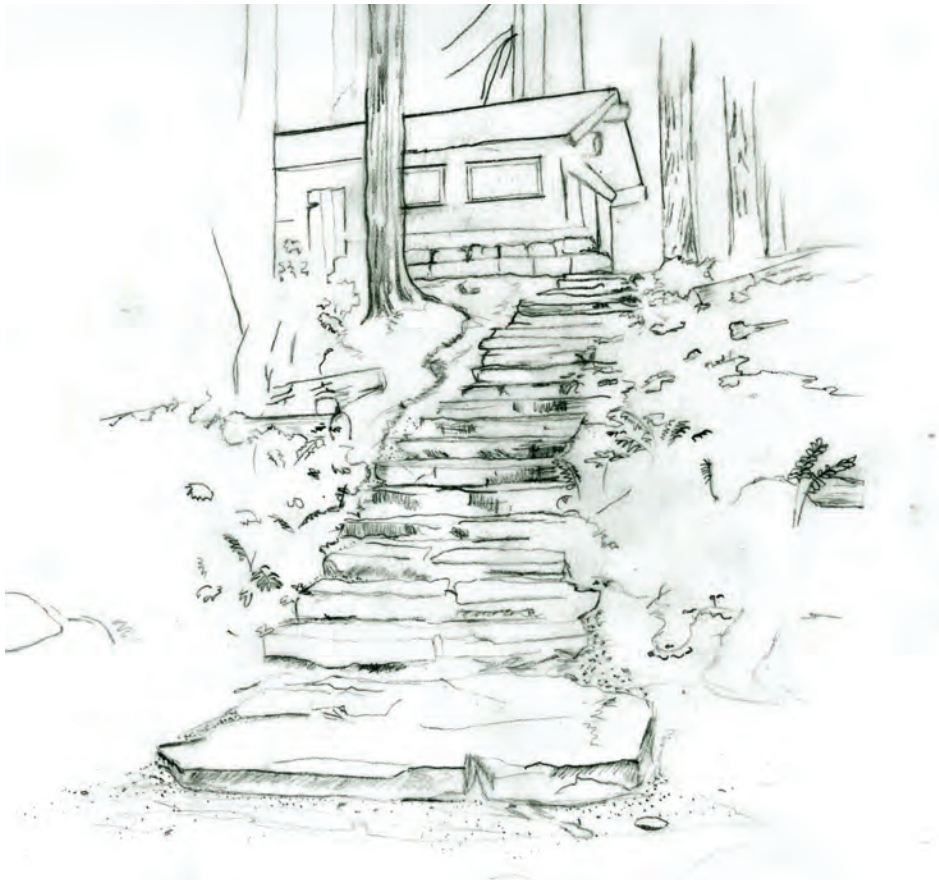
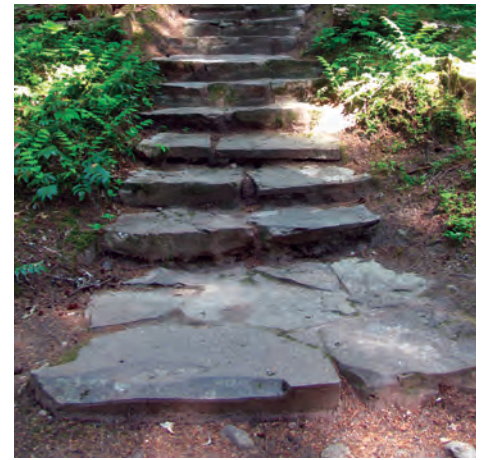
Figures 62 and 63. Existing stone steps in the Ohanapecosh Campground, loop A. Source (left): C. Moore, NPS; (right) NPS.

Few staircases exist in the campground because of the relatively level nature of the site. Those that do exist are constructed of either stone or timber. At the west end of loop A, an existing flight of stone steps leads uphill to the CCC comfort station. Constructed of native stone, these stairs are a good example of rustic CCC-era trail steps that are suitable in the campground (figures 62–63). In steep areas, rock stairs can help stabilize slopes and create a more stable and comfortable path. Other steps in the campground are built of milled or rough-hewn lumber or logs. These are generally located in more rugged and informal areas.

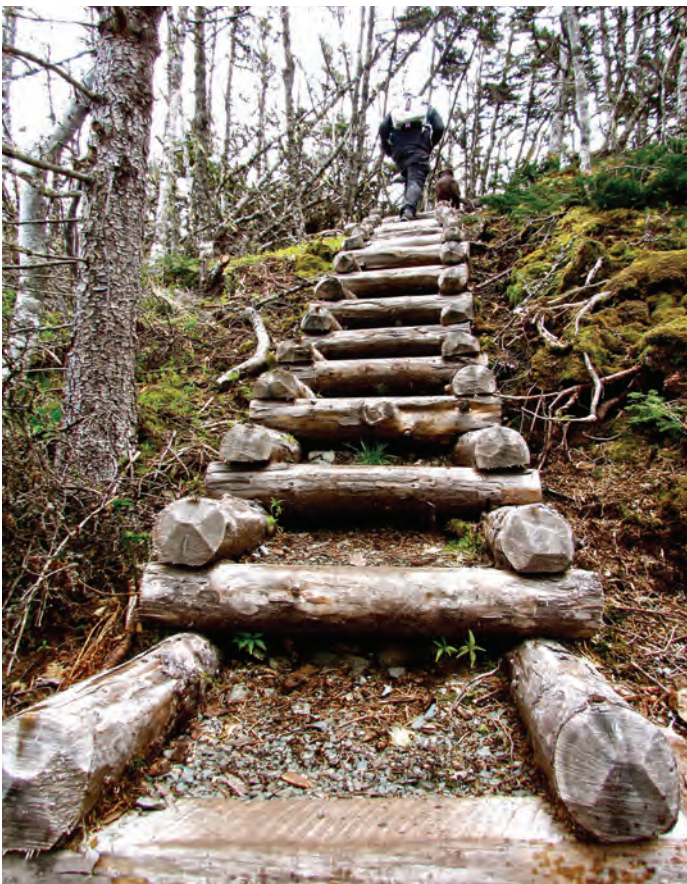
Figure 64. Example of steps built from logs, Skerwink Trail, Newfoundland. Note the scoring on the first tread to improve traction. Source: adventuresinnewfoundland.wordpress.com.

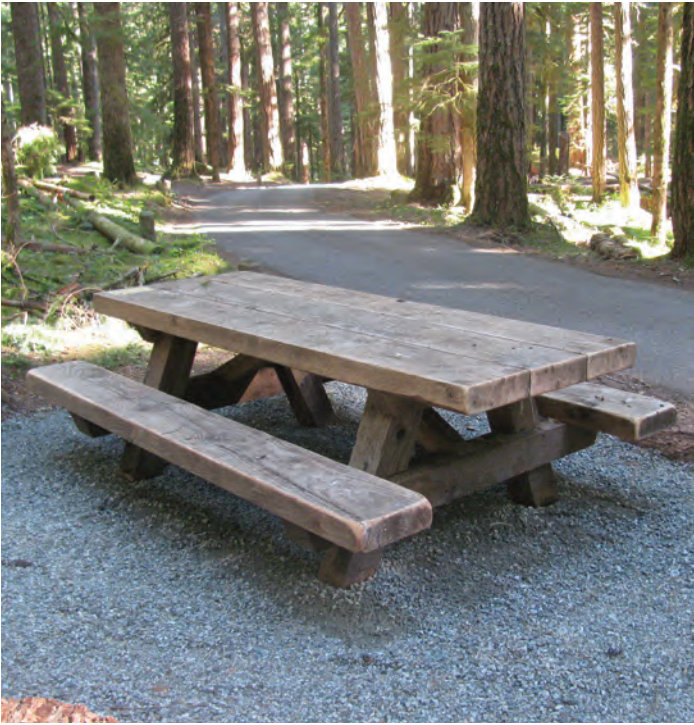
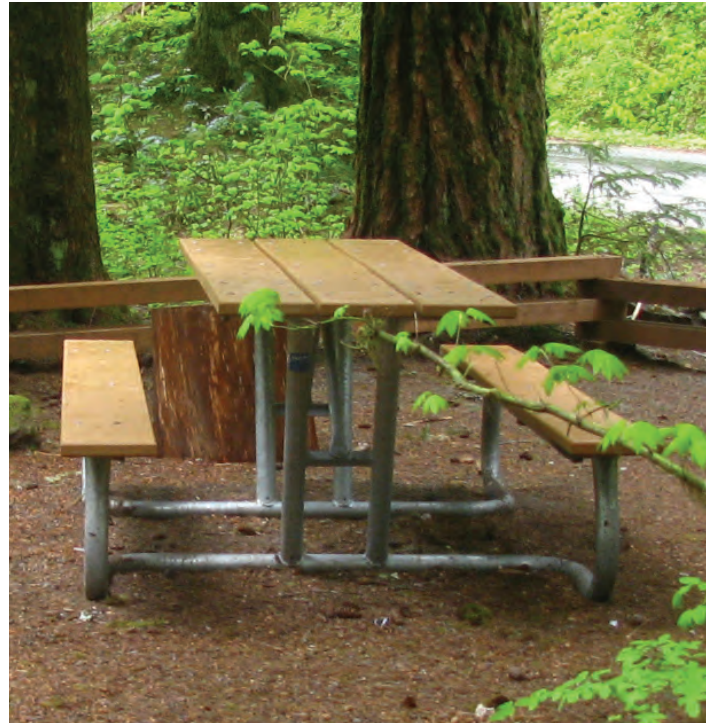
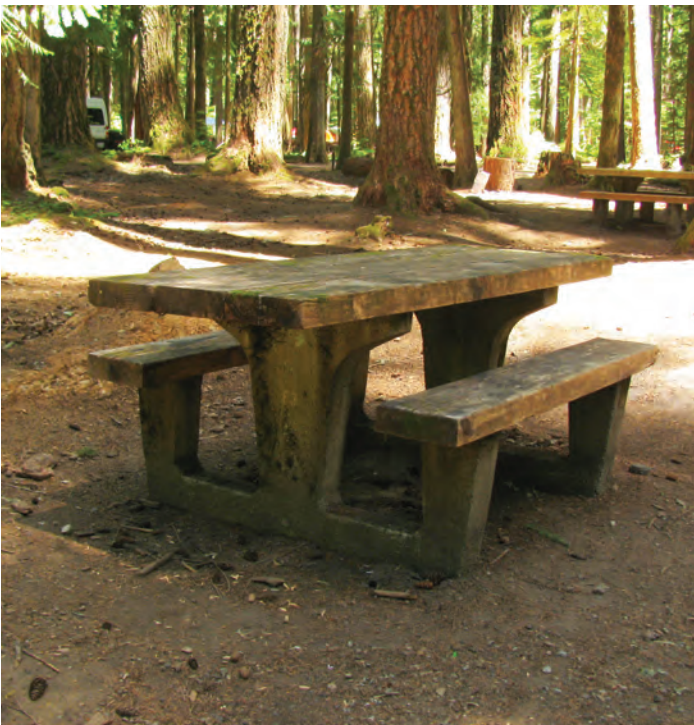
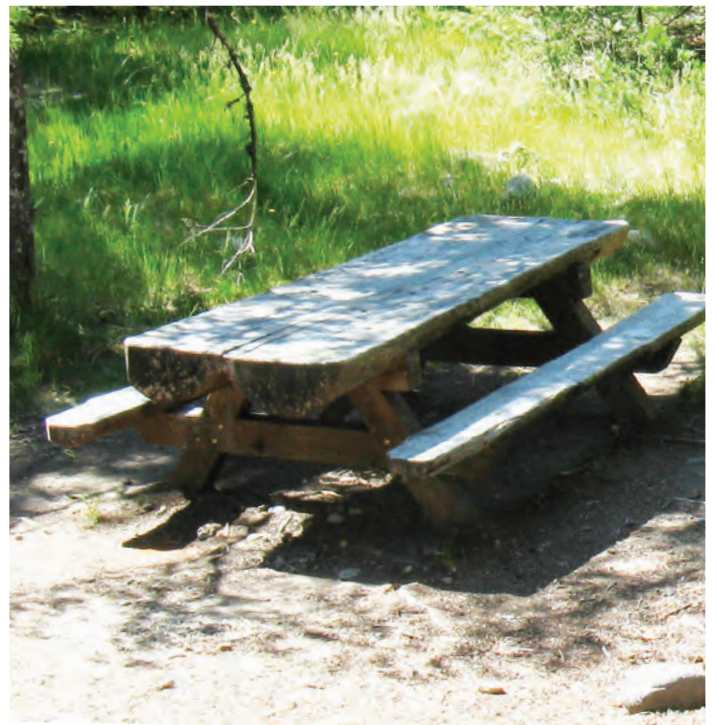
Figures 68–71. Appropriate picnic table styles for the Ohanapecosh Campground. Source: NPS.

Three styles of picnic table can be found in the campground: all-wood, concrete-and-wood, and metal-and-wood (see figures 68, 69, and 70). The majority of picnic tables in the campground date from the Mission 66 era, with wooden components that have been replaced over the years. The 1959 NPS “Campground Study” called for “camp tables [that are] standardized more than they are at present, with perhaps three designs” (NPS 1959, 3). The three designs, illustrated in figure 67, correspond to the three styles of picnic table that exist in the campground.

- Retain Mission 66 picnic tables and replace deteriorating wooden components in kind, as necessary.
- For replacement picnic tables, select from the four styles illustrated in figures 68–71. Avoid the use of synthetic materials in picnic table construction.
- For visual cohesion, locate picnic tables of the same style in the same geographic area.
- Picnic tables at accessible sites and in day-use areas should conform to the requirements in the *Architectural Barriers Act Accessibility Standards*. This includes providing wheelchair seating spaces (see figure 72) and ensuring 36–48” of clear ground around each table. Ensure that the ground space has a firm and stable surface, with a maximum cross slope of 2%.
- For all other sites, where feasible provide 36” of clear ground space around each picnic table; ensure ground space has a firm and stable surface.

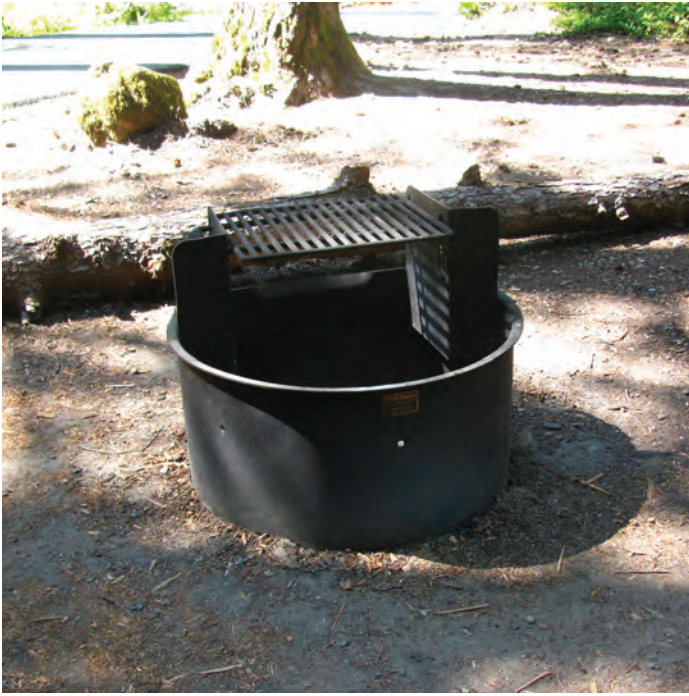
Figure 73. Round-style fire pit in the campground, 2017.  
Source: NPS.

Two styles of steel fire pit are present in the campground: a round style and a rectangular style (figures 73–74). Mission 66 campground design guidance favored these no-frills metal fireboxes, which could be produced in large quantities and ensure uniform, low-maintenance performance (figure 75). Every campsite is equipped with a fire pit, and group sites possess several. The ability to build and enjoy a campfire is considered one the most quintessential aspects of the camping experience, however excessive fire from campfire smoke sometimes creates significant air quality issues in the Ohanapecosh district in the summer. Park managers are interested in exploring fire ring options that will allow this much-loved activity to continue in the campground while reducing the air quality impacts.

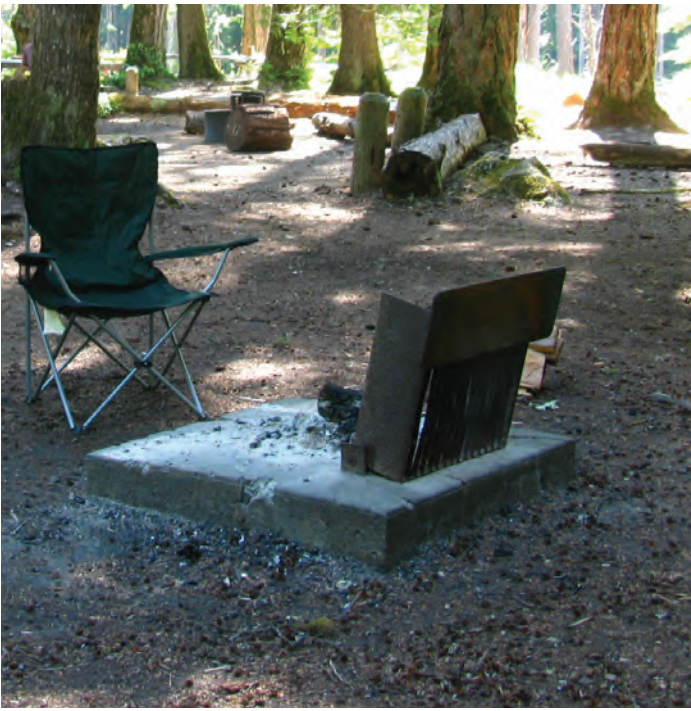
Figure 74. Rectangular-style fire pit in the campground.  
Source: NPS.

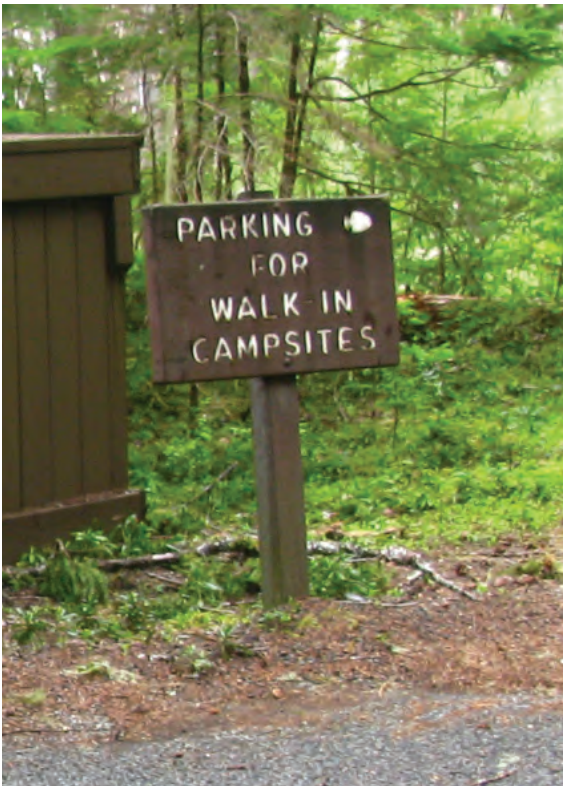
Figure 78. Dark-stained wood wayfinding sign, C loop, 2017. Source: NPS.

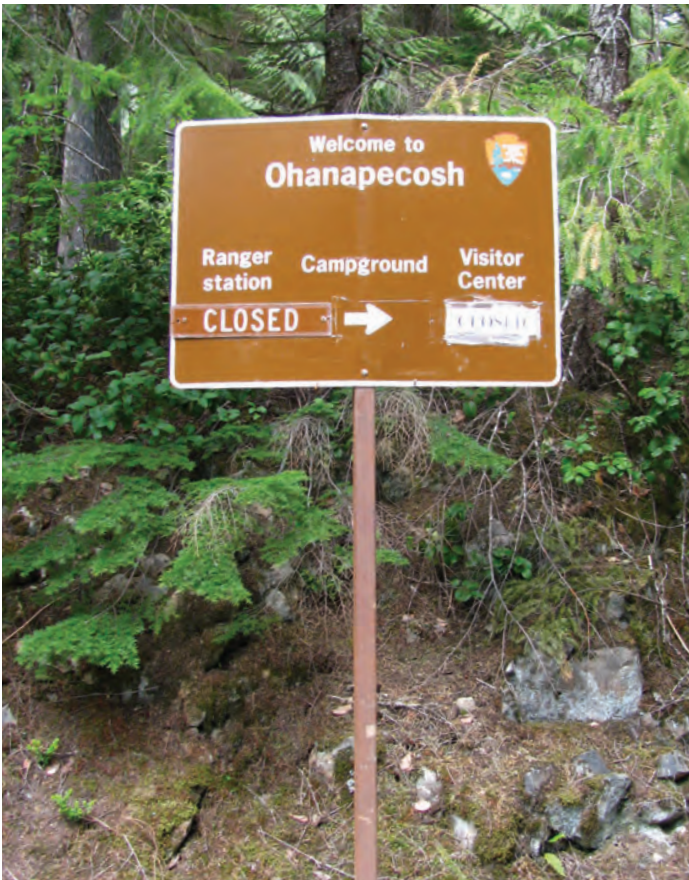
Figure 80. Aluminum informational/wayfinding sign, 2017. This sign is too small and not clearly legible for its intended purpose (to be seen by entering vehicles). Source: NPS.

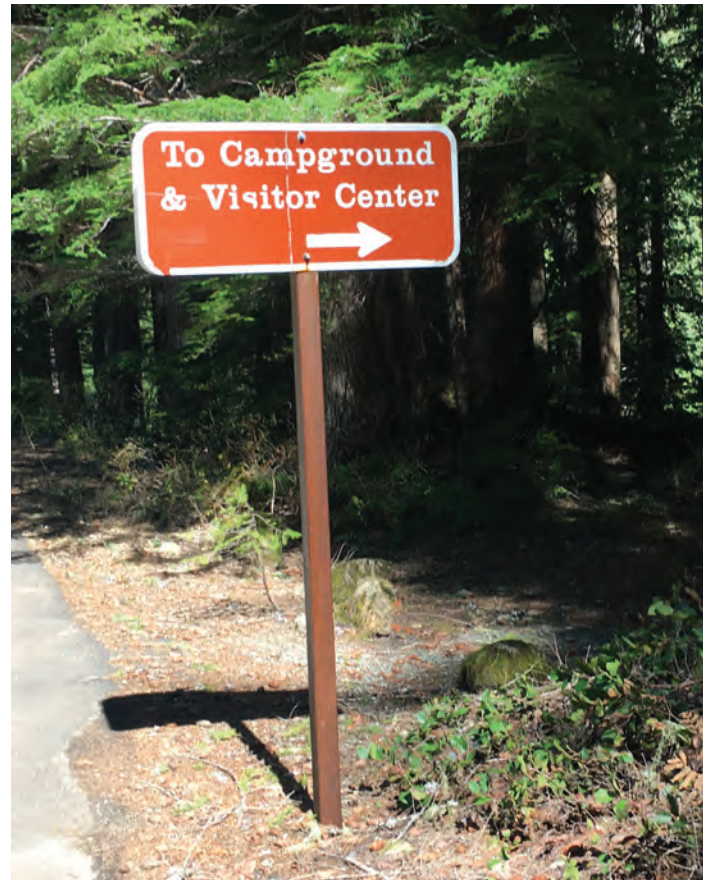
Figure 81. Aluminum wayfinding sign, 2017. This style of wayfinding sign is suitable for signs intended to be seen from moving vehicles. Source: NPS.

- 2) **Wayfinding** signs are directional, indicating the location of campground sites such as the ranger station, visitor center, amphitheater, trails, and individual loops. Some of these signs are aluminum with reflective white lettering on a brown vinyl background (figures 80–81). Others are dark brown-stained routed wood with white lettering. The hierarchy between informational and wayfinding signs is currently difficult to distinguish.

- 2) **Wayfinding** signs should be either reflective aluminum or dark brown-stained wood, depending on the location and purpose of the sign. Signs intended to be seen from moving vehicles should be made from aluminum, with a brown vinyl background and reflective white lettering that is clearly visible at night (figure 81). Signs should be mounted on a cor-ten steel post. Ensure that all aluminum signs have a brown backing to allow them to blend more seamlessly into their natural setting. Sign design for roadways should also conform to the Federal Highway Administration's *Manual on Uniform Traffic Control Devices* and the *NPS UniGuide Standards: Volume 2, Roadway Sign Design Standards* (2005).

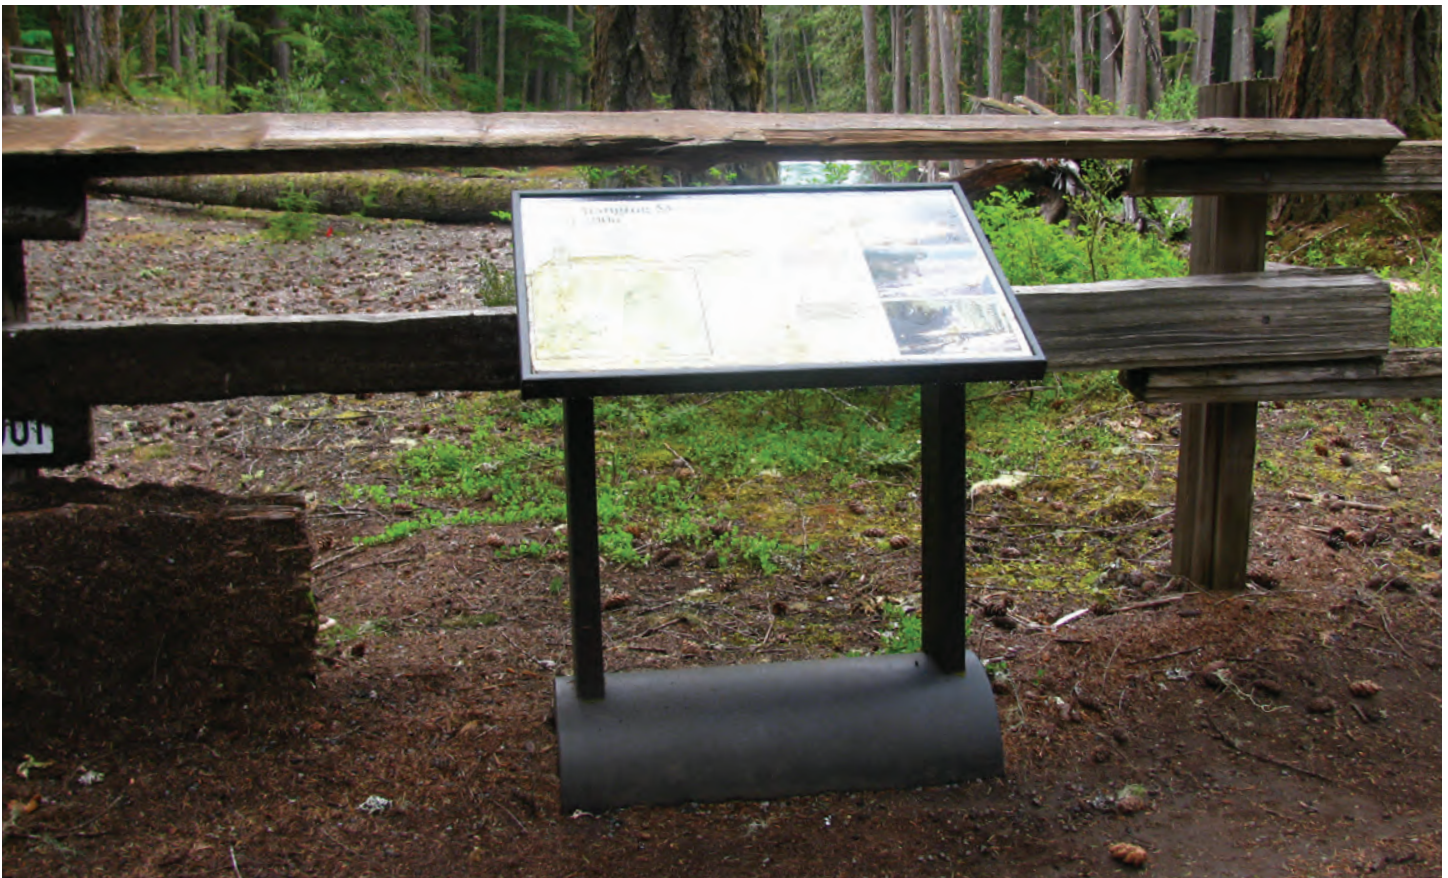
Figure 82. Interpretive wayside in C loop, 2017. Source: NPS.

- 4) **Interpretive waysides** are located in one area of the campground, near the Ohanapecosh River overlook in C loop. Waysides are constructed of weathering steel with inlaid information panels (figure 82).
