# OHANAPECOSH CAMPGROUND MOUNT RAINIER NATIONAL PARK

Rehabilitation Proposal and Design Guidelines

MAY 2018

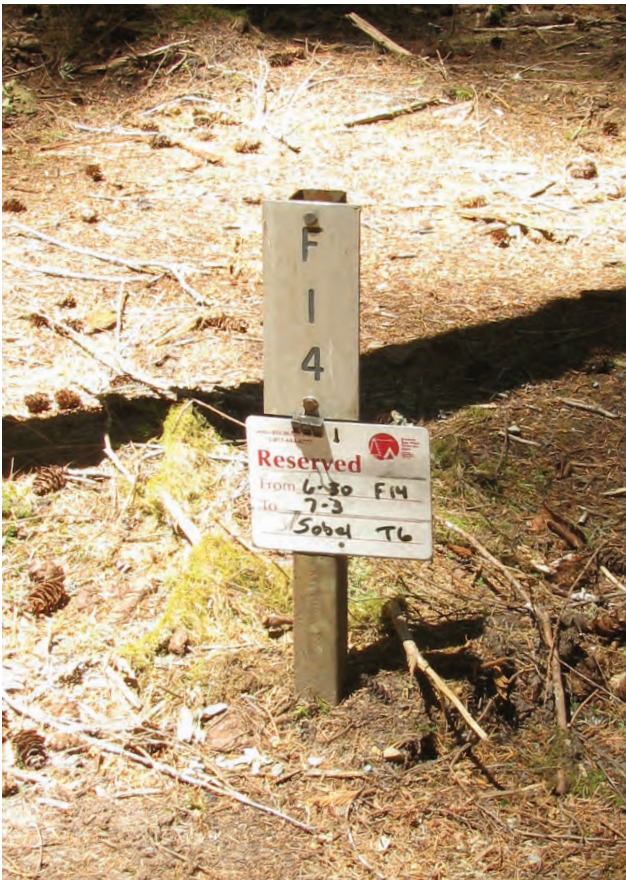
Figure 83. Existing campsite identification signs with sharp metal corners, 2017. Source: NPS.

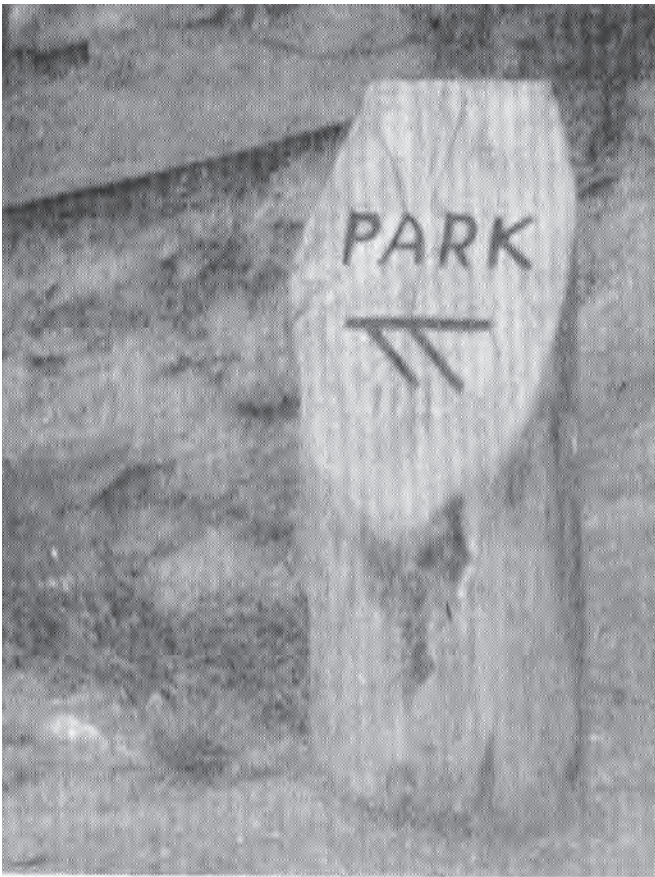
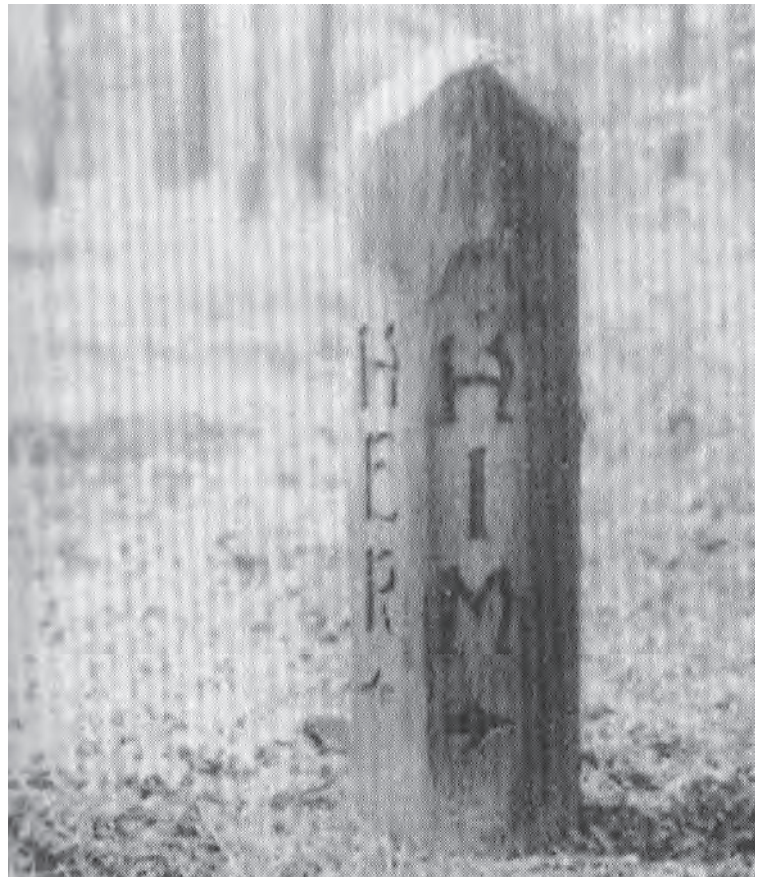
Figures 86–87. Log/bollard-style sign examples from the NPS Rustic era. Note that the design for campsite identification signs is still being developed with the park's sign shop. Source: Albert H. Good, *Park and Recreation Structures from the 1930s*.

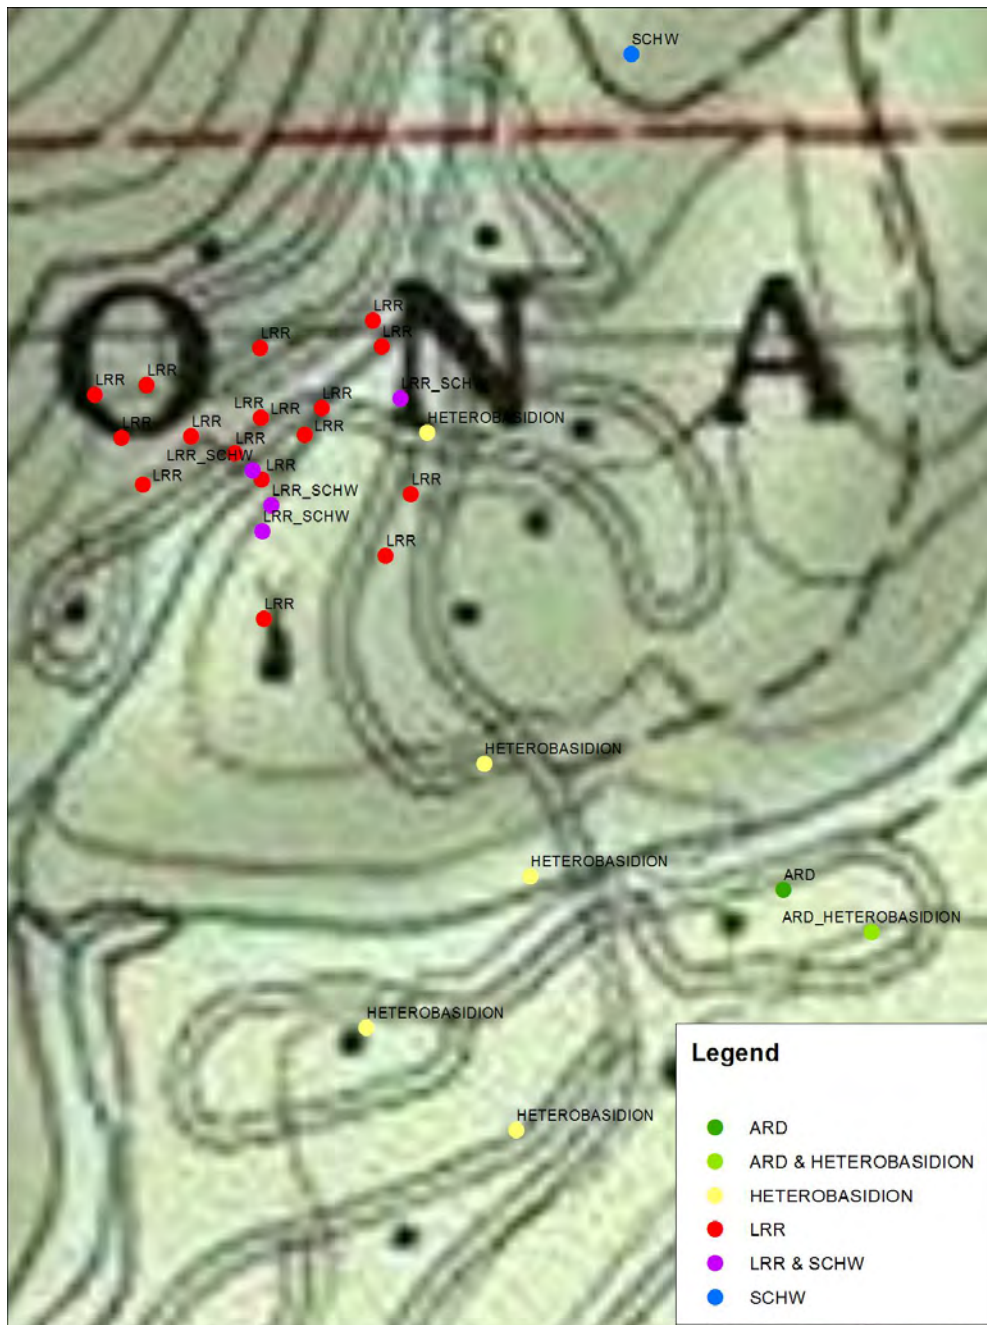
Figure 1. General location information of observed root disease and butt rot by FHP pathologists in July 2017. A list of diseases observed and their GPS coordinates, tree species susceptible to each disease and best-suited alternate tree species for each disease was sent and is on file with Arnie Peterson and Traci Degerman. The FHP site visit only determined the extent of laminated root rot and several additional locations of unknown mortality and decay, identified as Heterobasidion root disease and Armillaria root disease. Full campground hazard-tree surveys on file with park (Traci Degerman, Hazard Tree Management Coordinator). ARM = Armillaria root disease, Heterobasidion = Heterobasidion root disease, LRR = laminated root rot, SCHW = schweinitzii root and butt rot.

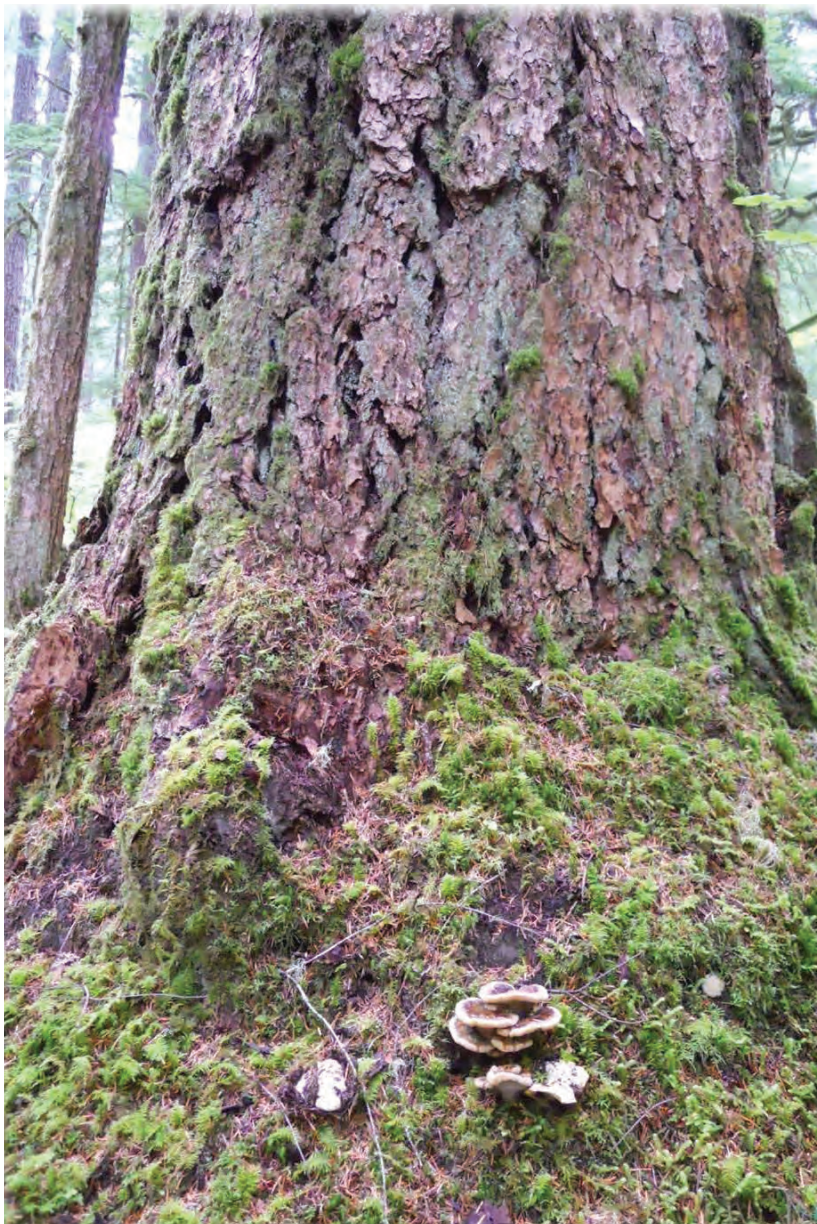
ABOVE: *Phaeolus schweinitzii* sporophore emerging from an old-growth Douglas-fir in H loop, 2014. The fungus causes Schweinitzii root and butt rot. Source: T. Degerman, NPS.

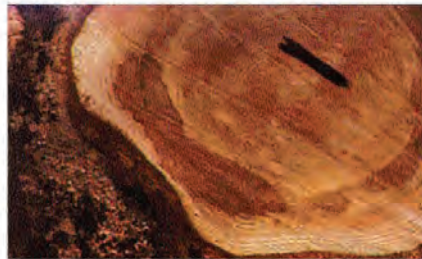
**Figure 1.** One to two inch-wide, crescent-shaped bands of stained and/or decayed wood in the inner outer heartwood.

In infected trees, stain and decay of laminated root rot usually extend upward from the roots several feet into the main bole. At the stump surface, stain usually will be seen as 1 to 2 inch wide crescent-shaped bands in the inner sapwood-outer heartwood area (Figure 1). Sometimes stain will also be found in the center of the heartwood (Figure 2). It will range in shade from a slightly darker color than the surrounding wood

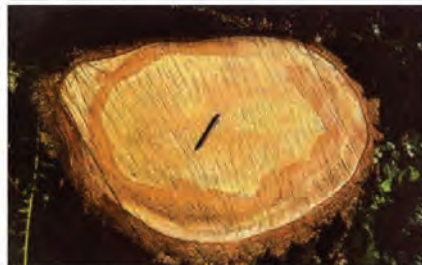
**Figure 3.** Stain appearing as a light shade of discoloration.

(Figure 3), to a dark brown, wet-appearing discoloration (Figure 4). Stumps must be marked soon after tree felling since characteristic stain fades within several days. Stain is the initial stage of wood decay. After several years stained wood will develop into advanced rot. Advanced decay will often be found in the center of stained wood (Figure 5). Advanced decay is characterized by wood separating (delaminating) at the annual growth rings. There are small pits on both sides of the sheets and red-brown fuzzy fungal growth on the surface (Figure 6). In infected older trees, hollows will often form in the butt after years of decay.

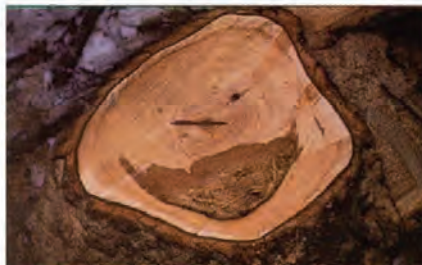
**Figure 5.** Decayed wood surrounded by stain. Decay is laminated, separating at the annual rings.

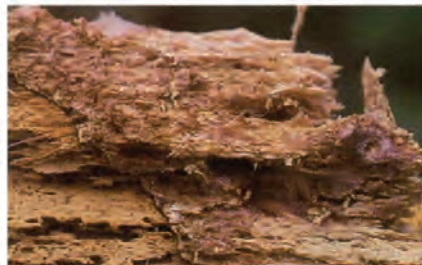
**Figure 6.** Laminated and pitted decayed wood with red-brown fuzzy fungal growth.

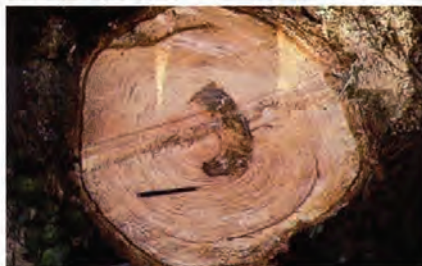
**Figure 7.** This stain and decay is the result of an old wound. It is not laminated root rot. Do not mark this stump.

Other stains or decays may be confused with laminated root rot. Old wounds that heal often leave a zone of stain or decay behind the wound face (Figure 7). Other types of root and butt decay may be confused with laminated root rot. A common example is red-brown butt rot of Douglas-fir (Figure 8). This damage is common in mature-over-mature Douglas-fir. Stumps with this dry-crumbly red-brown decay should not be marked. To best meet contract specifications, stumps with laminated root rot stain or decay at the cut surface should be marked with a saw within one hour of felling. Stumps should be marked by making two parallel grooves, 2 inches deep and 6 inches apart (Figure 9).

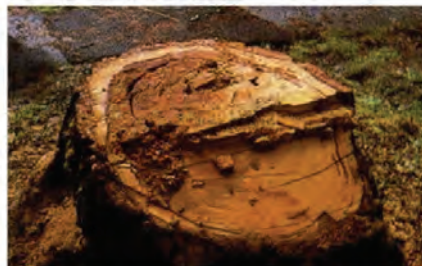
**Figure 8.** Brown cubical decay, the result of another disease. Do not mark this stump.

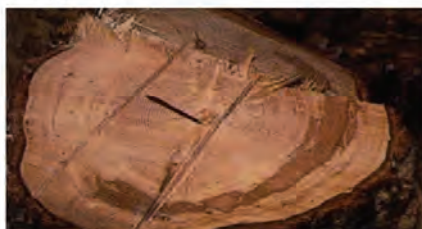
**Figure 9.** Example of marking infected stumps: two parallel grooves, 2 inches deep, and 6 inches apart.

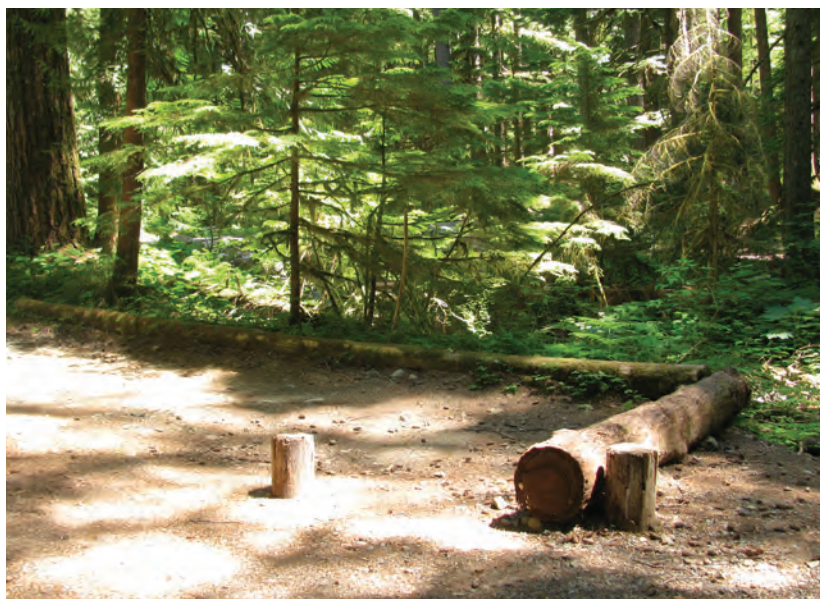
TOP: Mission 66 parking designs proposed by the National Park Service Western Regional Office. Source: *Campground Study*, 1959.

BOTTOM: Existing parking area delineated by fallen logs, E loop, 2017. Source: NPS.

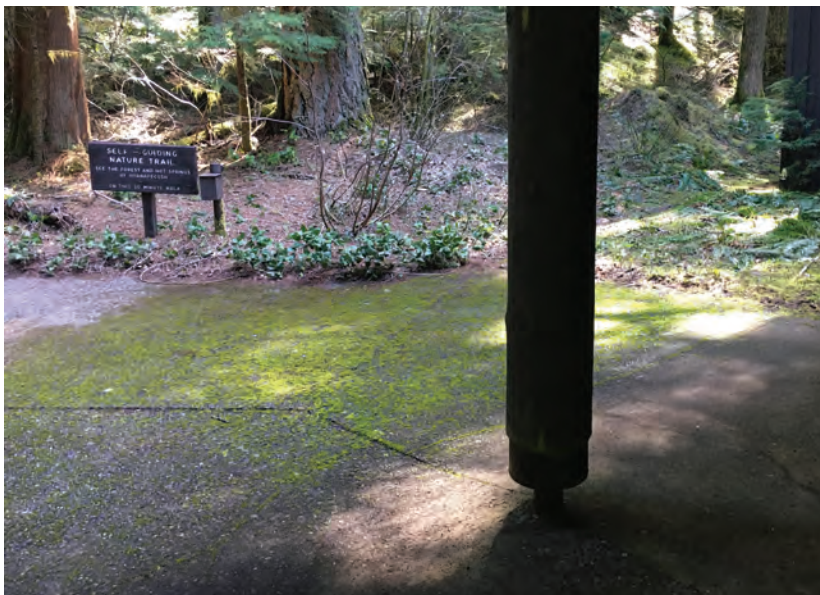
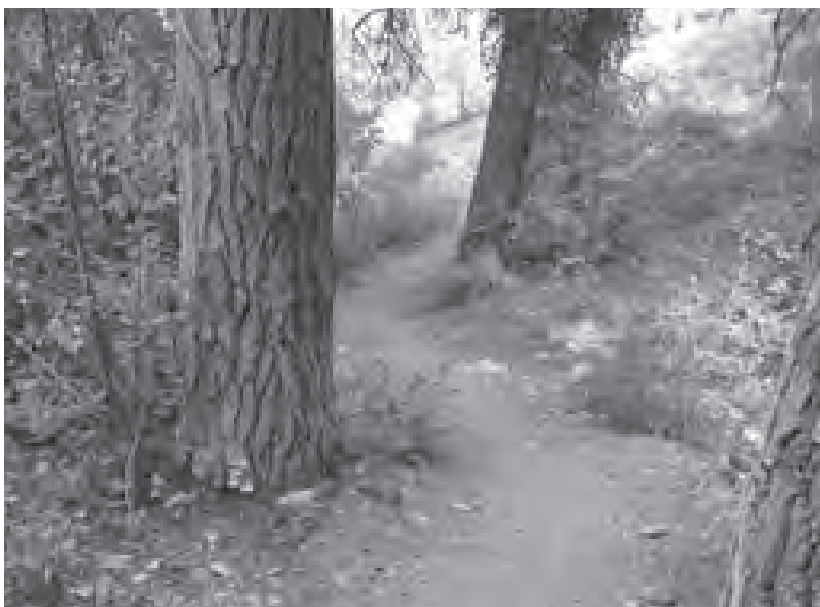
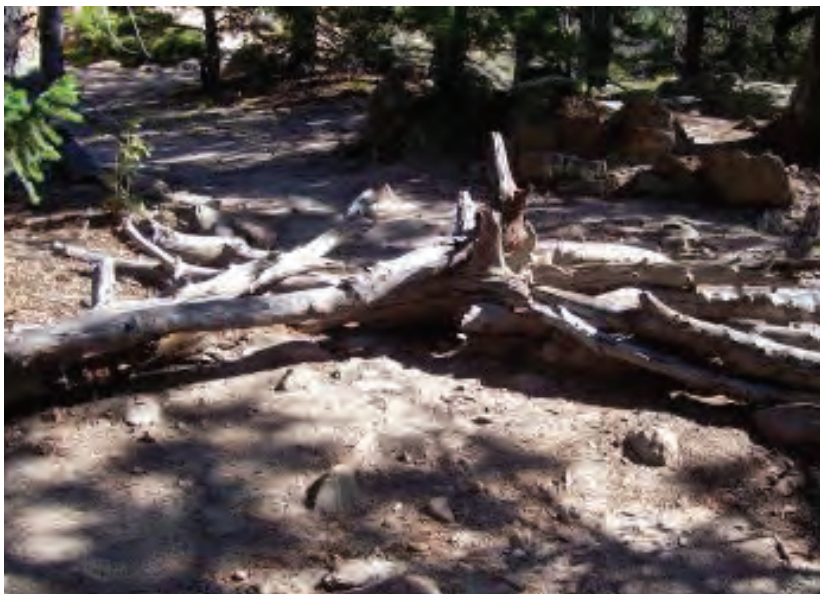
MIDDLE: A trail alignment that is responsive to natural features. Source: U.S. Forest Service *Trail Construction and Maintenance Notebook*, 2007.

BOTTOM: An example of a social trail barrier created with fallen branches. Source: [blog.twoknobbytires.com](http://blog.twoknobbytires.com).

- Wherever feasible, use pervious, compacted granular material for path surfaces, installed on a compacted subgrade to encourage stormwater infiltration. In some areas it may be appropriate to incorporate an integral stabilizer to ensure accessibility. Before initiating a new surfacing project, consider creating a test plot to test color choice and durability.

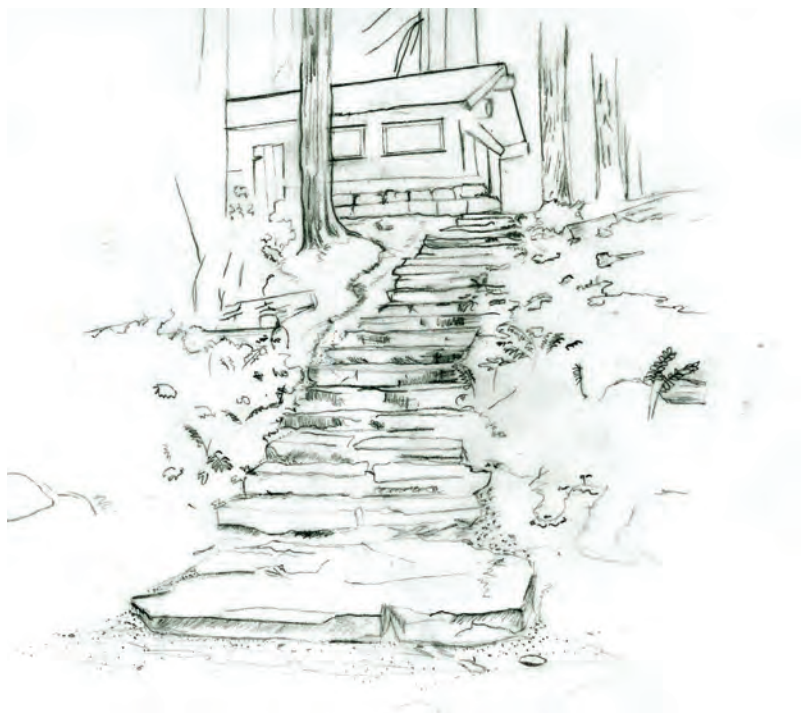
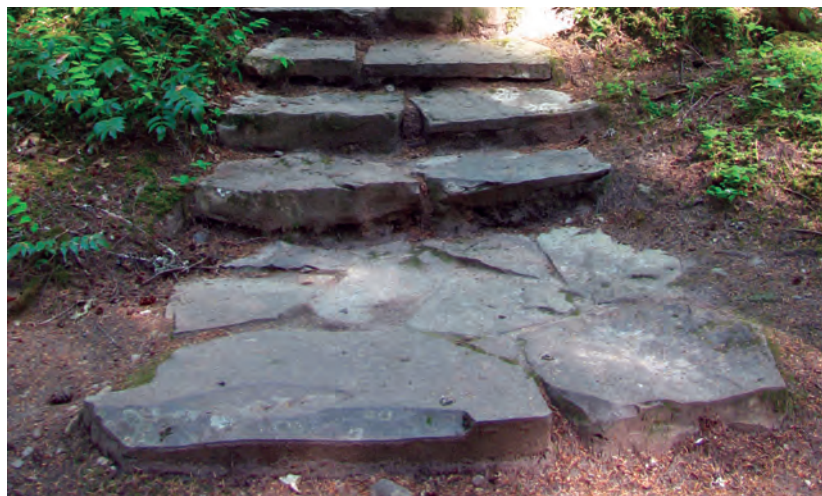
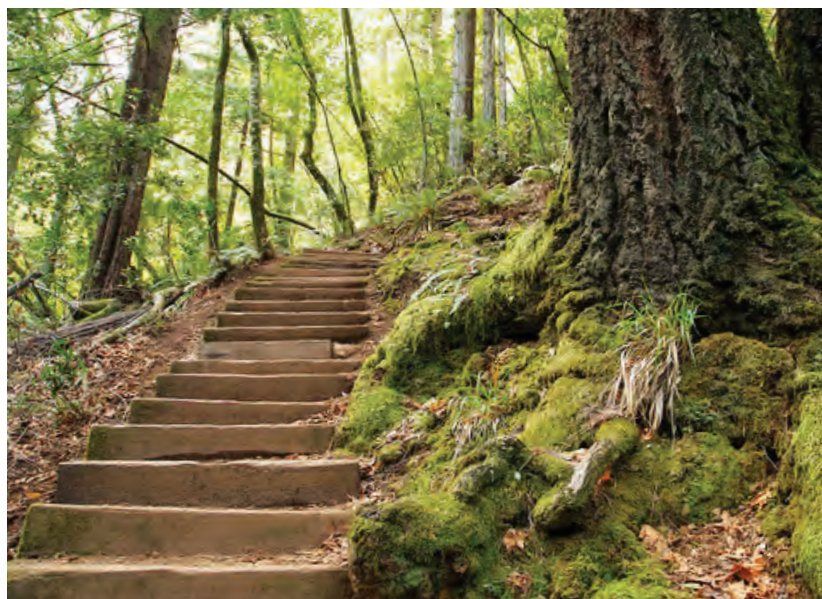
OPPOSITE, BOTTOM RIGHT: Common types of steps for trails. Source: U.S. Forest Service *Trail Construction and Maintenance Notebook*, 2007.

- For safety and erosion control, install steps where pathway grades exceed 20%.
- Consider the location and size of the pathway when choosing staircase materials. Stone steps are most appropriate for heavily used trails and staircases in more developed areas of the campground, for example near comfort stations and other facilities. Timber stairs are useful for more lightly used or remote areas of the campground.

- Stone treads should be set with flattened faces up for safety reasons. Use the largest stones possible to ensure a more rustic appearance and reduce maintenance. The color and form of the stone selected should complement the rock types in the surrounding landscape.

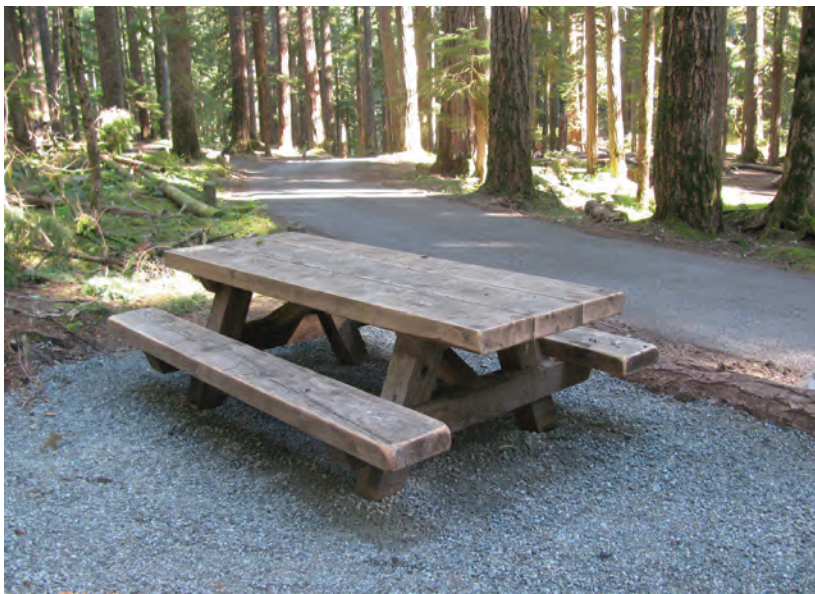
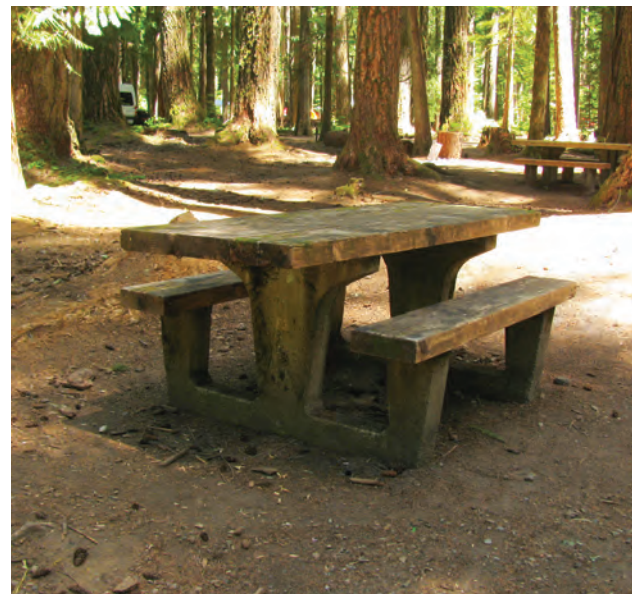
THIS PAGE, TOP: Conceptual picnic site layout illustrating suggested dimensions for accessible picnic tables. Source: Bureau of Reclamation, 2013.

THIS PAGE, BOTTOM: Appropriate picnic table styles for the Ohanapecosh Campground. Source: NPS.

- Retain Mission 66 picnic tables and replace deteriorating wooden components in kind, as necessary.
- For replacement picnic tables, select from the four styles illustrated below. Avoid the use of synthetic materials in picnic table construction.
- For visual cohesion, locate picnic tables of the same style in the same geographic area.
- Picnic tables at accessible sites and in day-use areas should conform to the requirements in the *Architectural Barriers Act Accessibility Standards*. This includes providing wheelchair seating spaces and ensuring 36–48" of clear ground around each table. Ensure that the ground space has a firm and stable surface, with a maximum cross slope of 2%.
- For all other sites, where feasible provide 36" of clear ground space around each picnic table; ensure ground space has a firm and stable surface.

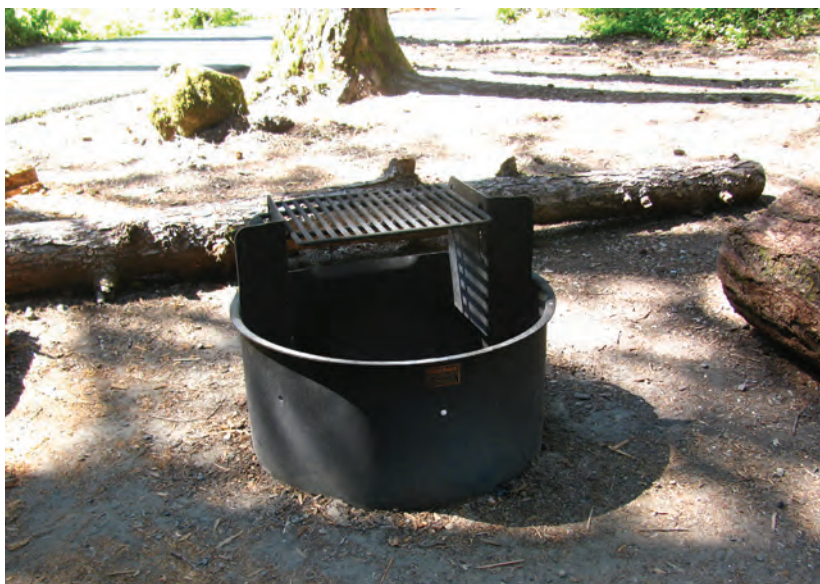
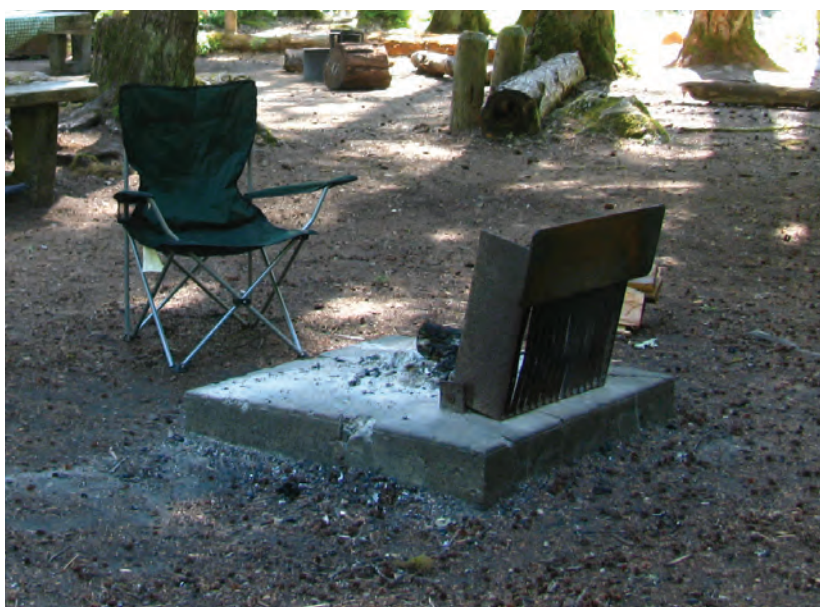
BOTTOM: Mission 66 recommendation for fire pit design, proposed by the National Park Service Western Regional Office. Source: *Campground Study*, 1959.

- Keep fire rings 10 to 20 feet away from any vegetation and a minimum of 20 feet away from tent areas to minimize the accidental spread of fire. Consider the prevailing wind direction and locate fire rings downwind of tent areas and picnic areas wherever possible.

- Ensure 48" of clear ground space around all usable sides of the fire ring, wherever possible. Consult with the park's historical landscape architect if providing such clearance requires significant ground disturbance or removal of vegetation.

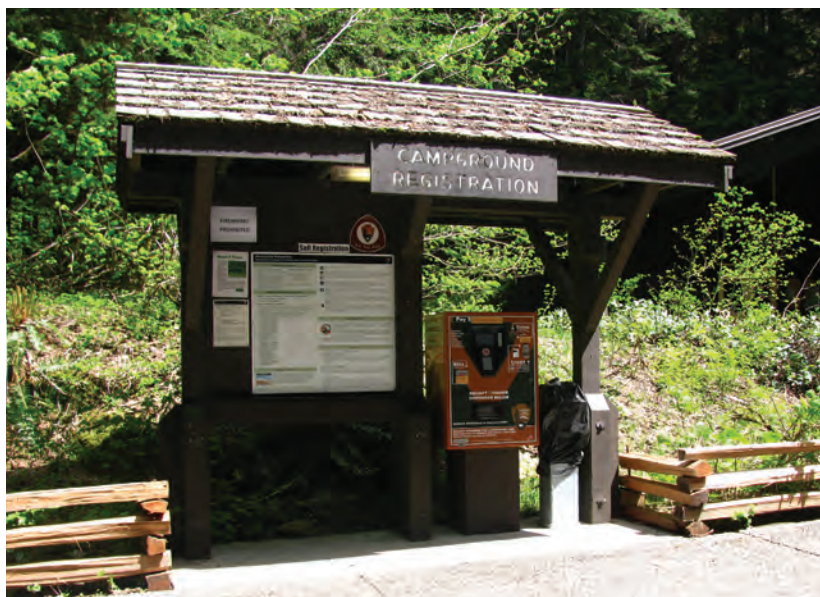
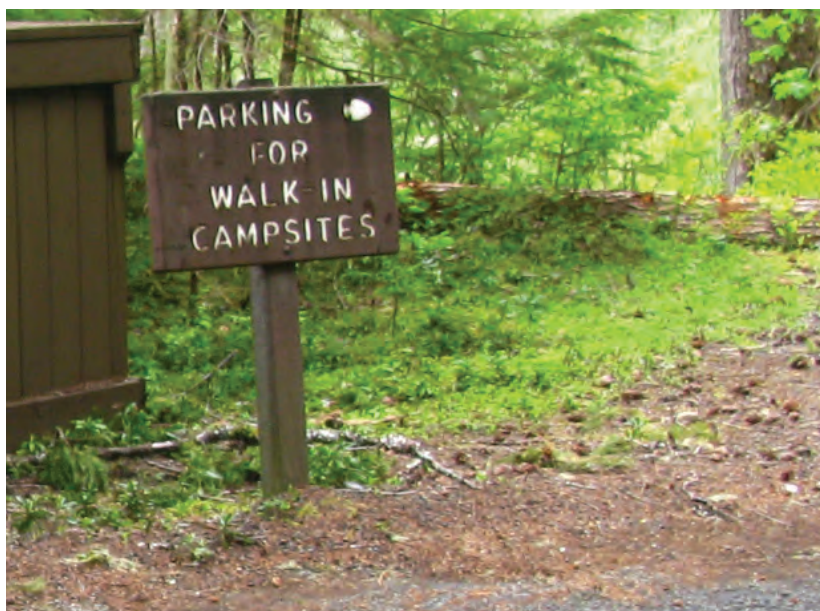
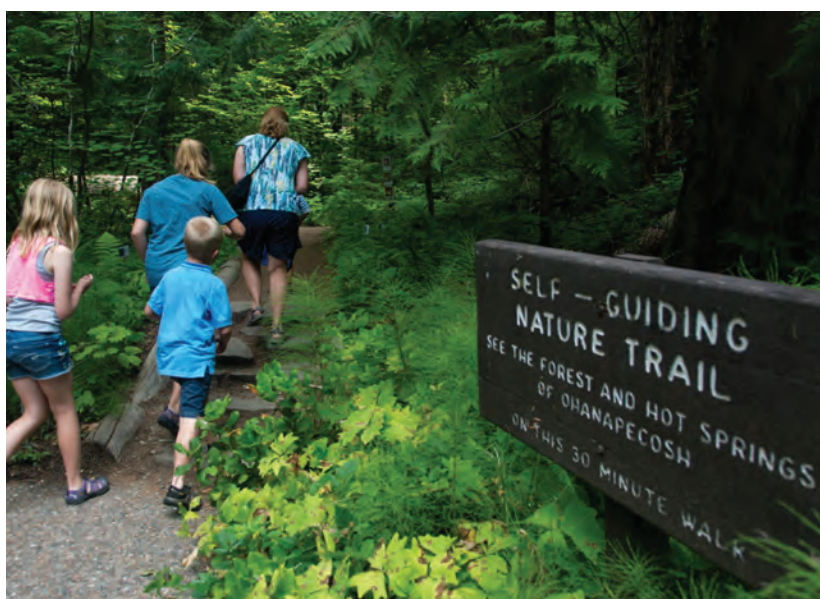
TOP: Dark-stained wood informational sign identifying the campground registration station, 2017. Source: NPS.

MIDDLE: Dark-stained wood wayfinding sign, C loop, 2017. Source: NPS.

BOTTOM: Dark-stained wood informational sign for Nature Trail outside visitor center. Source: visitrainier.com.

1. **Informational signs** should be dark brown-stained wood with white lettering. Use clear cedar whenever possible; the thickness of cedar board will depend on the overall size of the sign (consult with the park's lead sign designer to confirm thickness).

The dark brown stain used on the park's wooden signs is Sherwin Williams SW2014 Beatrix Brown™. The white used for the lettering is currently not specified. Fonts used for wooden signs at Ohanapecosh should match the modified Gothic used for the campground's existing Mission 66-era signage.

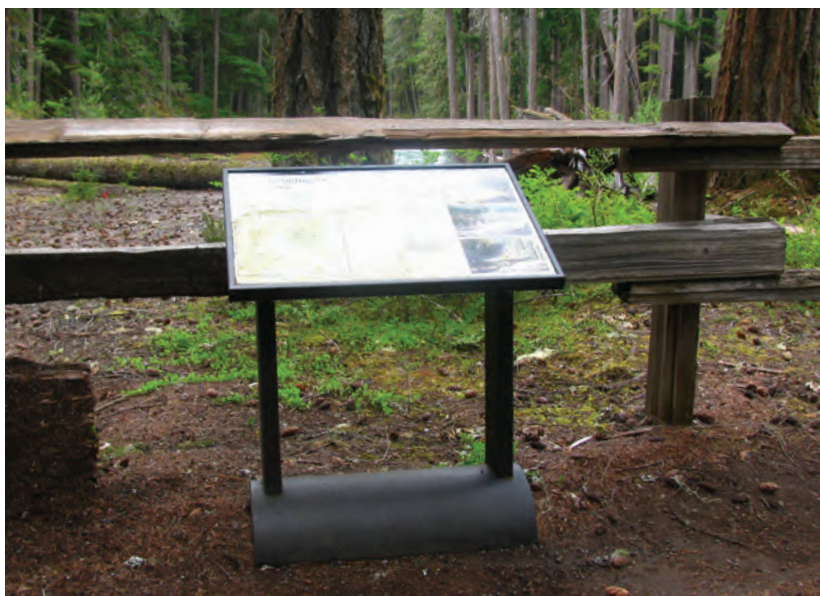
TOP: Aluminum wayfinding sign, 2017. This style of wayfinding sign is suitable for signs intended to be seen from moving vehicles. Source: NPS.

BOTTOM: Interpretive wayside in C loop, 2017. Note that this wayside style does not currently conform to guidelines in the *Visitor Information Sign System*. Source: NPS.

2. **Wayfinding signs** should be either reflective aluminum or dark brown-stained wood, depending on the location and purpose of the sign. Signs intended to be seen from moving vehicles should be made from aluminum, with a brown vinyl background and reflective white lettering that is clearly visible at night. Signs should be mounted on a cor-ten steel post. Ensure that all aluminum signs have a brown backing to allow them to blend more seamlessly into their natural setting. Sign design for roadways should also conform to the Federal Highway Administration's *Manual on Uniform Traffic Control Devices* and the *NPS UniGuide Standards: Volume 2, Roadway Sign Design Standards* (2005).

4. **Interpretive waysides.** The design of interpretive waysides will follow the guidelines articulated in the NPS *Visitor Information Sign System* and *Wayside Exhibits* guide. Low-profile, sled-based interpretive waysides are most appropriate for use within the campground. Sled-based signs are relatively portable and can be relocated to new areas to describe dynamic environmental processes impacting the campground.
5. **Campsite identification signs.** Existing signs should be replaced with a style similar to the routed wooden posts or wooden bollards illustrated. Campsite signs could also indicate campsite type by incorporating the suggested campsite identification symbols on the following pages.

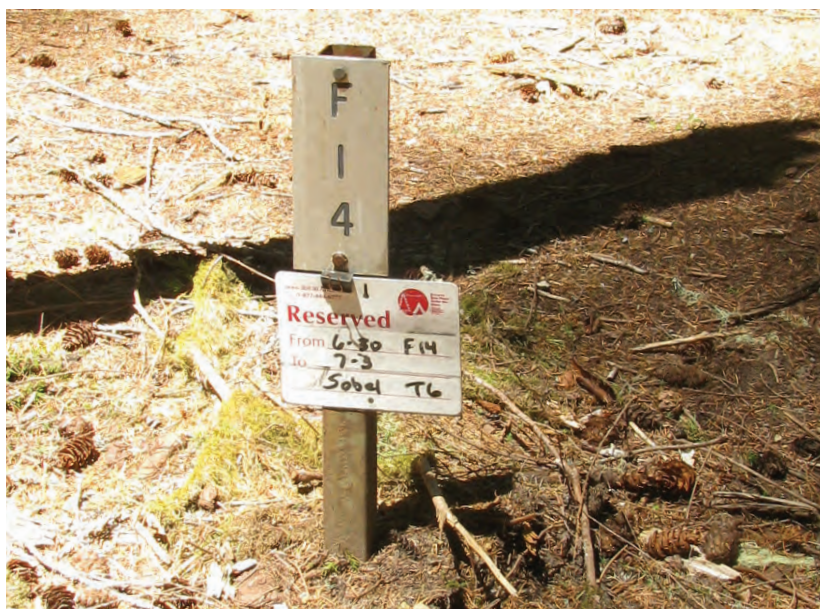
## CAMP SITE MARKERS

EACH CAMPSITE SHOULD BE NUMBERED AND INDICATED ON A MARKER. A 3"X6" RED WOOD POST IS SUGGESTED. THE 6" WIDE FACE WILL ALLOW NUMBERS TO 3 DIGITS.

BOTTOM: Mission 66 design recommendation for campsite markers. Source: *Campground Study*, 1959.

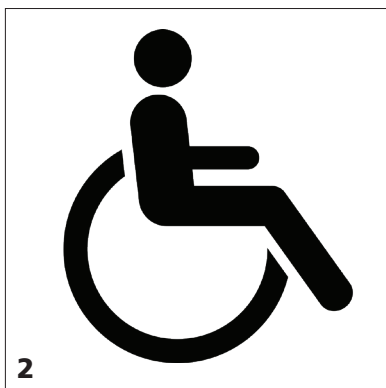
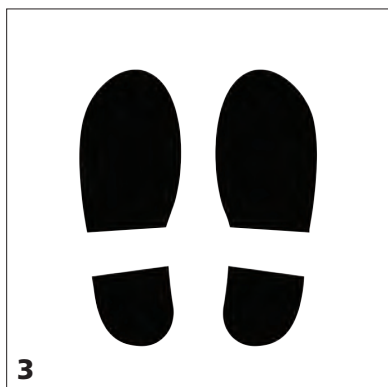
### POSSIBLE SYMBOLS FOR CAMPSITE TYPES

1. Small tent (low-density); 4-person capacity
2. Accessible
3. Standard walk-in; 6-person capacity
4. Small walk-in; 4-person capacity
5. Small group; 12-person capacity
6. Large group; 25-person capacity
