# Pictured Rocks

PIRO 93-2

## EVIDENCE OF PHYSICAL AND BIOLOGICAL CHANGE WITHIN THE BEAVER LAKE WATERSHED ATTRIBUTABLE TO A TURN-OF-THE-CENTURY LOGGING DAM

by Walter L. Loope, Research Ecologist

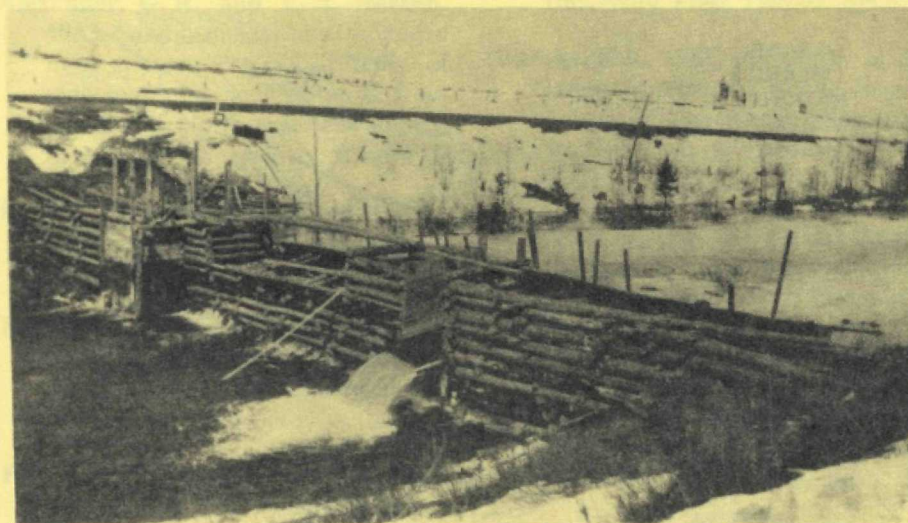
Figure 2: Logging dam typical of the type constructed at the mouth of Beaver Creek around 1905. Earthen materials may have been more important in construction of the wings of the Beaver Creek Dam.

The logging dam on Beaver Creek was primarily earthen with a central wooden sluiceway and protective pilings (Figure 2). During operation of the dam, water was backed up Beaver Creek and into Beaver and Little Beaver Lakes, affording access to the surrounding red and white pine and white cedar forests. The mouths of Little Beaver, Lowney, Bill's and Arsenault Creeks (tributaries to Beaver and Little Beaver Lakes) were annually inundated during the spring melt. Large scale logging of the area was over by 1910

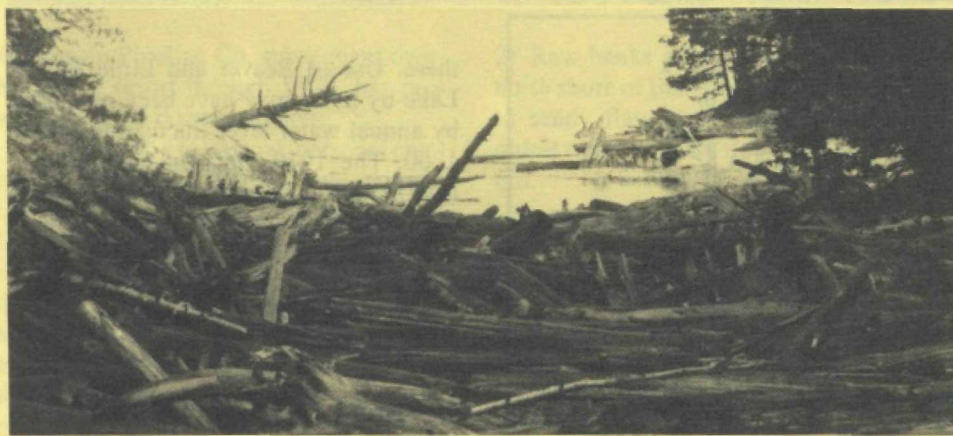
Downstream view of Beaver Creek logging dam.
