## Interpreting The Secretary of the Interior's Standards for Rehabilitation

### Subject: Industrial Bridges in Mill Complexes

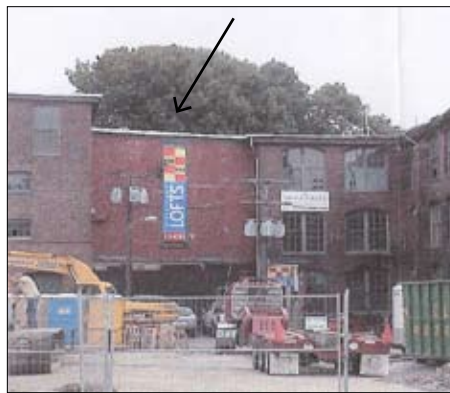
*Two-story industrial bridge before rehabilitation.*

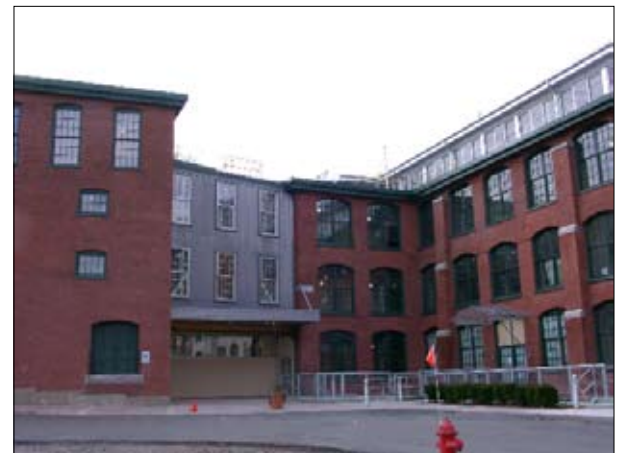
*Introducing a three-story glass wall as seen above in the drawing, would have altered the character of the bridge and did not meet the Standards. A more compatible treatment was approved where existing window openings were retained and a metal corrugated wall membrane and simple canopy were added (bottom).*

**Application 1** (**Incompatible** treatment corrected to meet the Standards): A mill complex built in 1901 and substantially expanded in 1939 was converted to residential use creating 60 live/work lofts. The complex included a two-story industrial bridge that linked the second and third floors of two of the buildings. In the initial proposal, the two-story bridge was to be stripped of its outer metal sheathing and encased in a three-story wall of glass that extended to the ground. Converting the two-story metal covered bridge into a three-story glass connector would have changed the historic industrial character of the bridge and the mill complex and, therefore, did not meet the Secretary of the Interior's Standards for Rehabilitation. The design was revised using a more industrial vocabulary of materials that included new corrugated metal resheathing of the two-story bridge

and a new metal canopy. This revised treatment, which was determined to be compatible with the historic mill complex, meets the Standards.

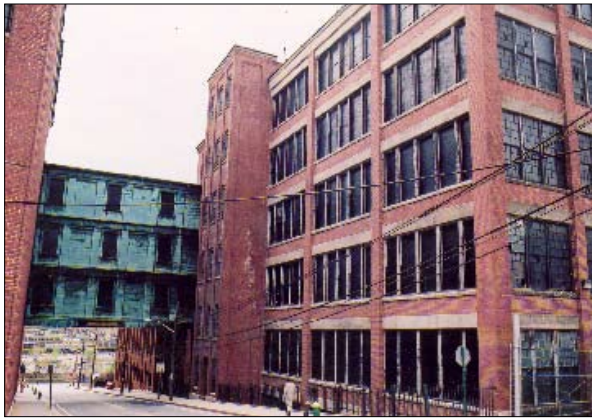
*Industrial bridge before rehabilitation.*

**Application 2** (Compatible treatment): A historic industrial bridge in this 19th century mill complex connects the second, third, and fourth floors of two adjacent buildings. Once a manufacturer of precision tools, this complex was recently converted to market-rate housing. Recognizing the importance of the bridge in his rehabilitation program, the owner repaired the existing structural members, replaced the exterior siding and roofing in kind and installed windows to match those that existed historically. This projects meets the Standards.

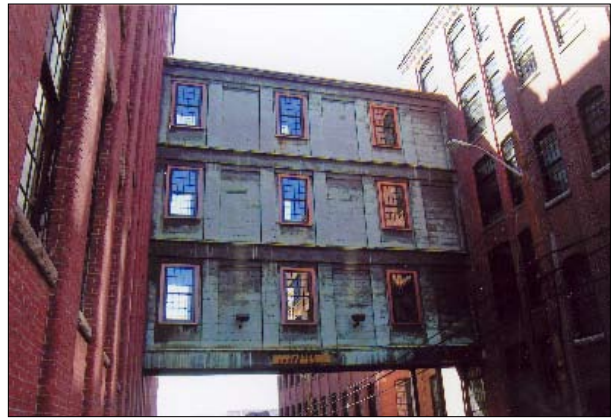
*Repair and replacement in kind allowed this industrial bridge to retain its historic appearance and to continue its service as a connector.*

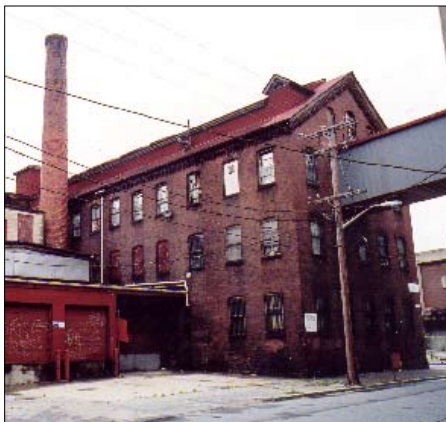
*Industrial building and bridge before rehabilitation.*

**Application 3** (Compatible treatment): This mill complex, which was constructed between 1849 and 1951, consists of six buildings. The property includes an industrial bridge that links the third floors of the two buildings. Investigation of the bridge revealed that it was an early wood-frame feature of the complex originally clapboarded, but now covered with a steel membrane. The proposal for converting the property into

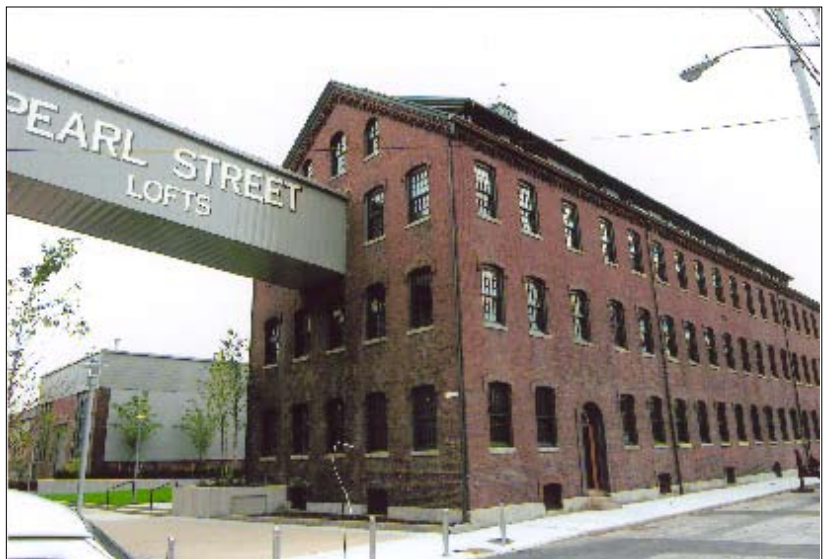
*An important historic feature such as this industrial bridge can serve a variety of useful purposes in the new use of the property. Enveloped in steel a number of years ago and found to be in good condition, the bridge became an ideal backdrop for the property's new name and a focal point of the complex.*

*Industrial building and bridge after rehabilitation.*

commercial and residential use—including 38 low-income and market rate units—called for reusing the bridge, but not as a pedestrian walkway. Instead, the bridge was chosen to serve as a signboard to showcase the new name of the complex—a practical, creative and compatible new use for this historic covered industrial bridge. This treatment meets the Standards.
