**National Park Service
Cultural Landscape Inventory
2004**

**English Camp
San Juan Island National Historical Park**

MANAGEMENT CATEGORY: **A: Must be preserved and maintained**

CONDITION ASSESSMENT: **Fair**

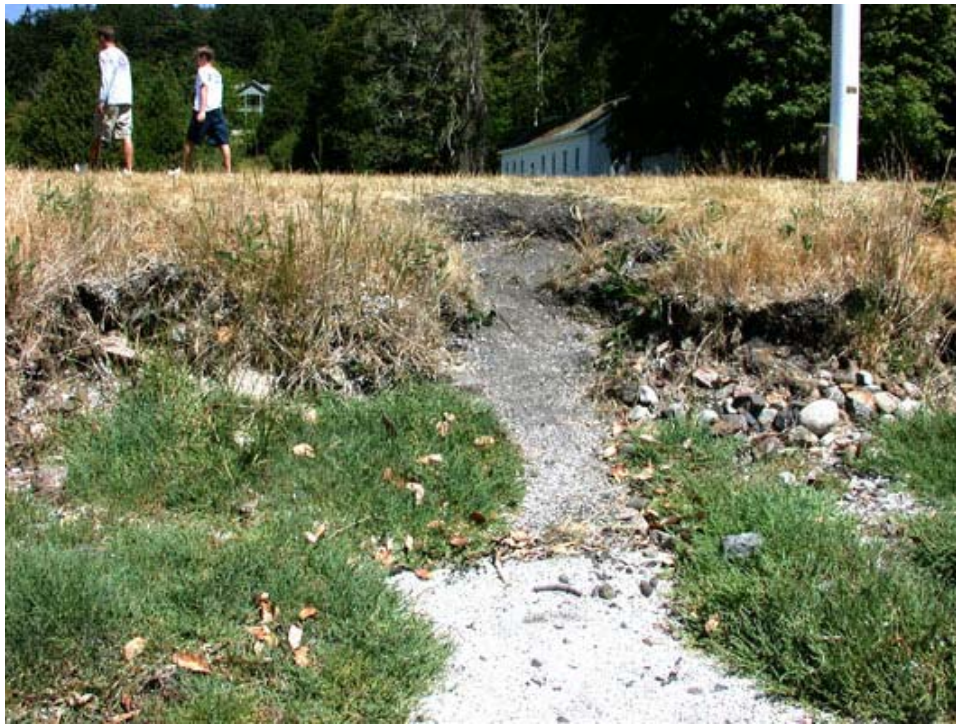
this bank and eroding into the water. Human traffic from the parade ground to the beach has accelerated this erosion, wearing ruts and trails and causing portions of the bank to collapse. Several resources at English Camp are threatened by this erosion. In addition to the attrition of the midden bank and the reduction of the parade ground, the features such as the blockhouse and the garden, both of which are very close to the edge of the bank, are in danger. Furthermore, archaeological resources in the shell midden are being lost daily. Immediate measures should be taken to stabilize the bank, prevent further erosion, and protect the resources of English Camp.

Contemporary photo showing the erosion of the shell midden bank due to human traffic and wave action. (CCSO, 2003)

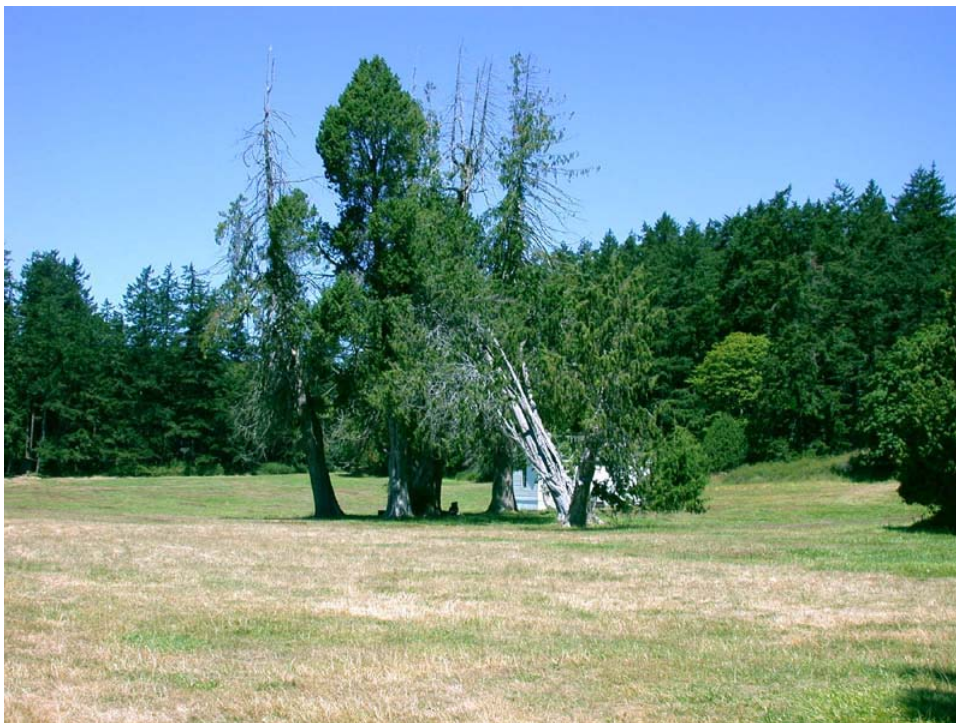
Contemporary photo of the clump of cedars and junipers on the parade ground. Several of the trees are in declining health. (CCSO, 2003)

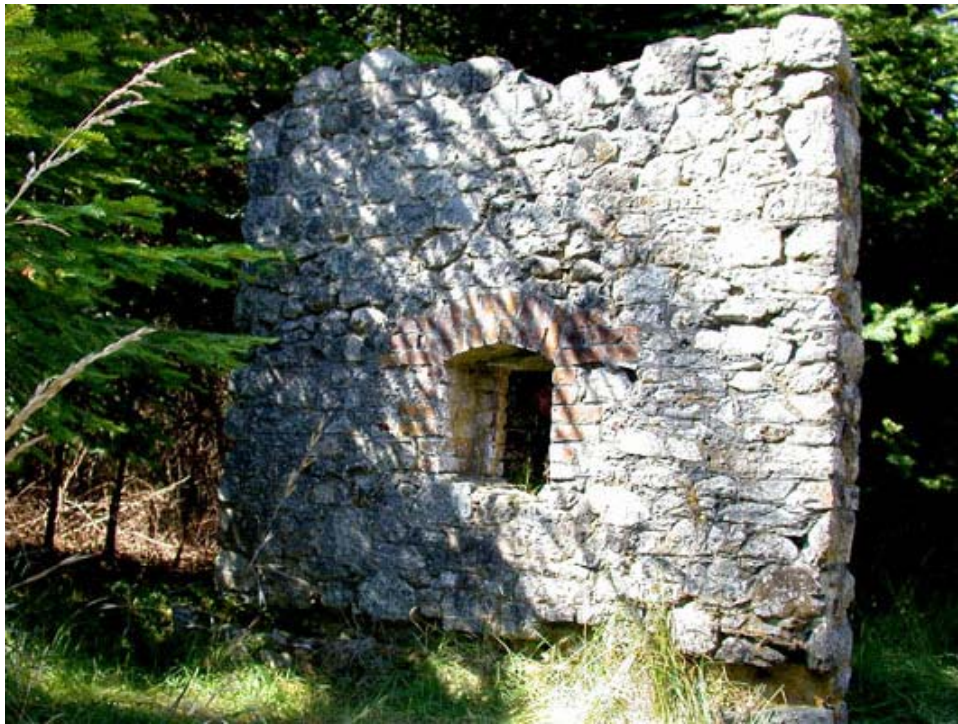
Contemporary photo of the masonry ruins at English Camp. These are thought to be the remnants of the blacksmith shop. (CCSO, 2003)

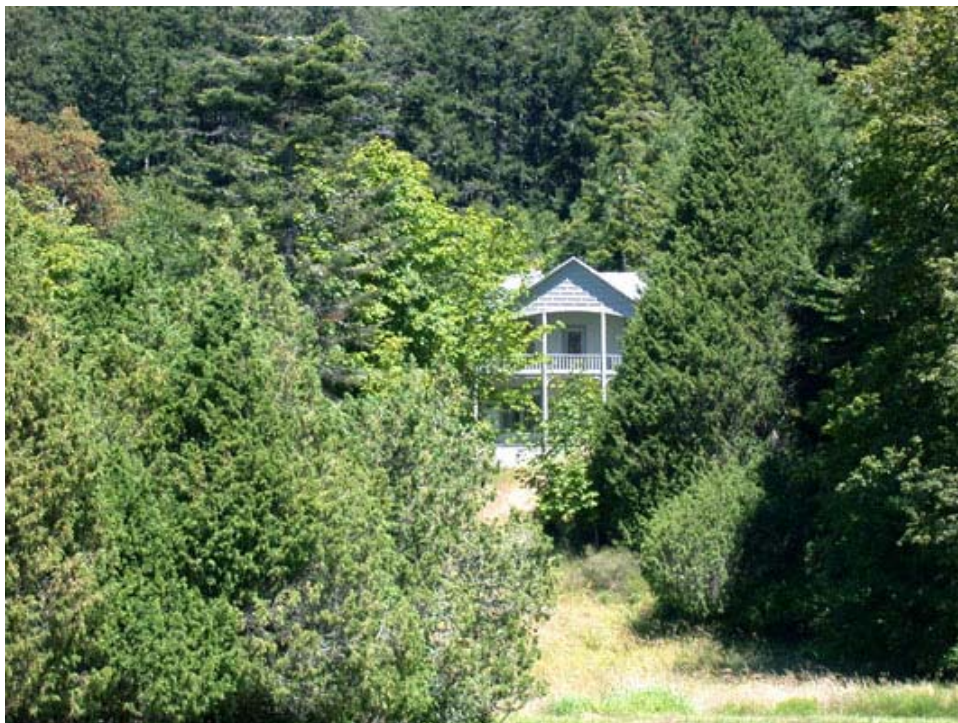
Contemporary view of the Crook house at English Camp showing vegetation that has grown up since the Crook period. (CCSO, 2003)

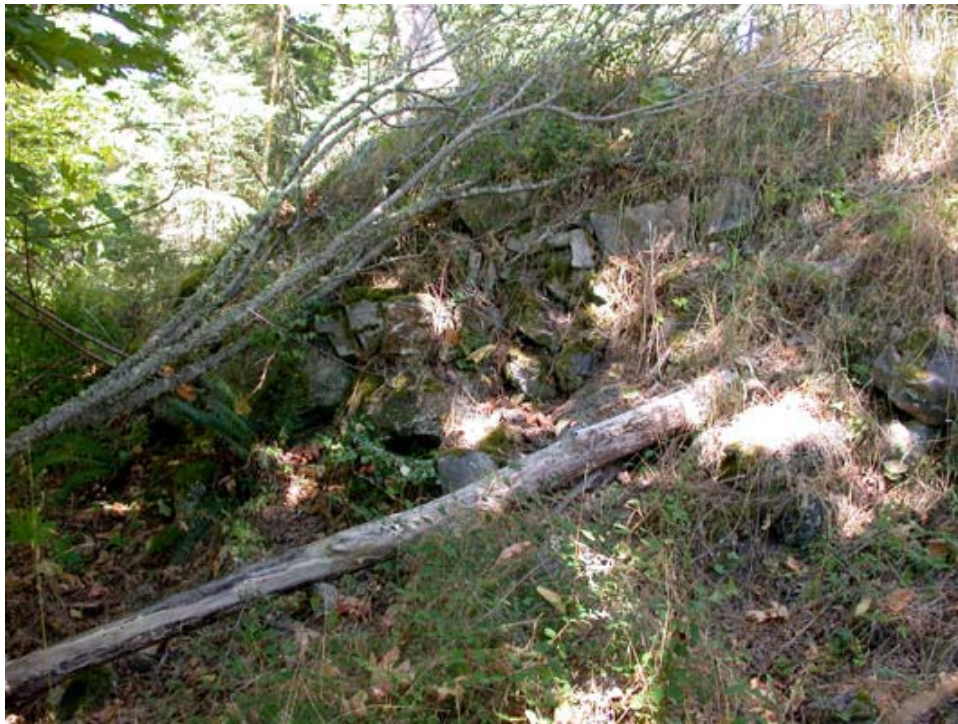
Contemporary view showing damage to a retaining wall by vegetation and erosion. (CCSO, 2003)

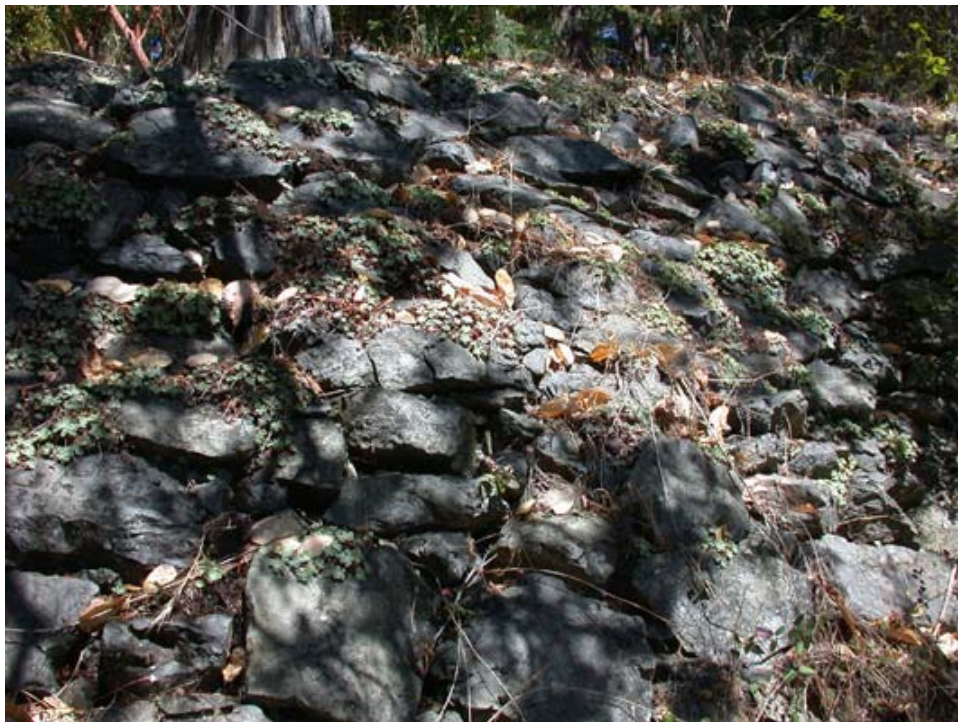
Contemporary view of a retaining wall on Officers' Hill. The lichens and herbaceous vegetation growing in the wall do not pose a significant threat to the wall's integrity. (CCSO, 2003)

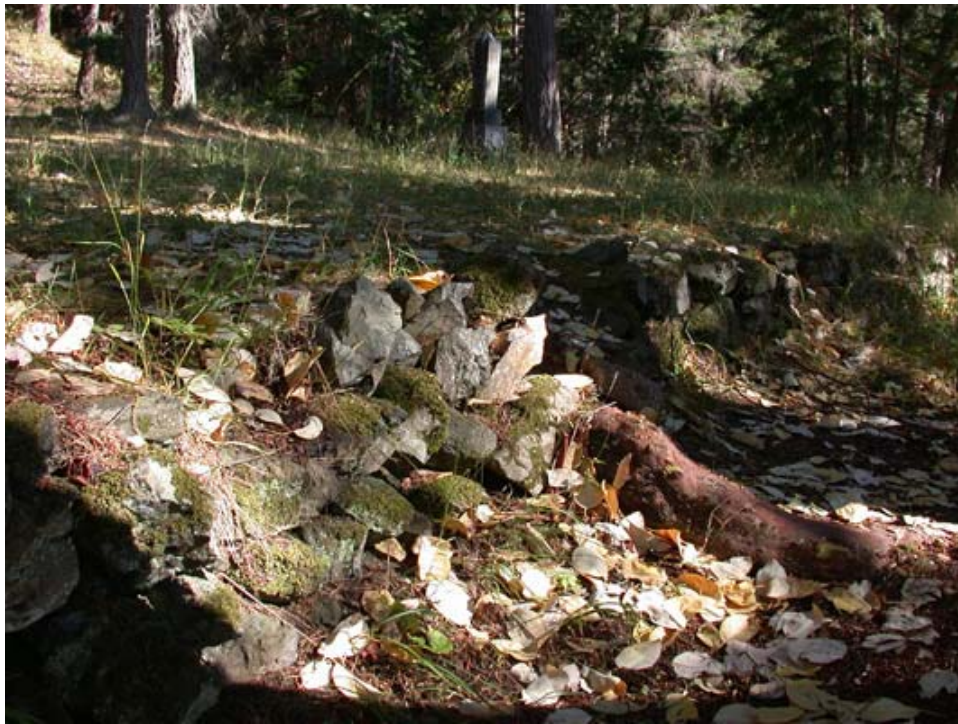
Contemporary view of a retaining wall on the top terrace of Officers' Hill. This wall has been damaged by visitor traffic over the wall. (CCSO, 2003)

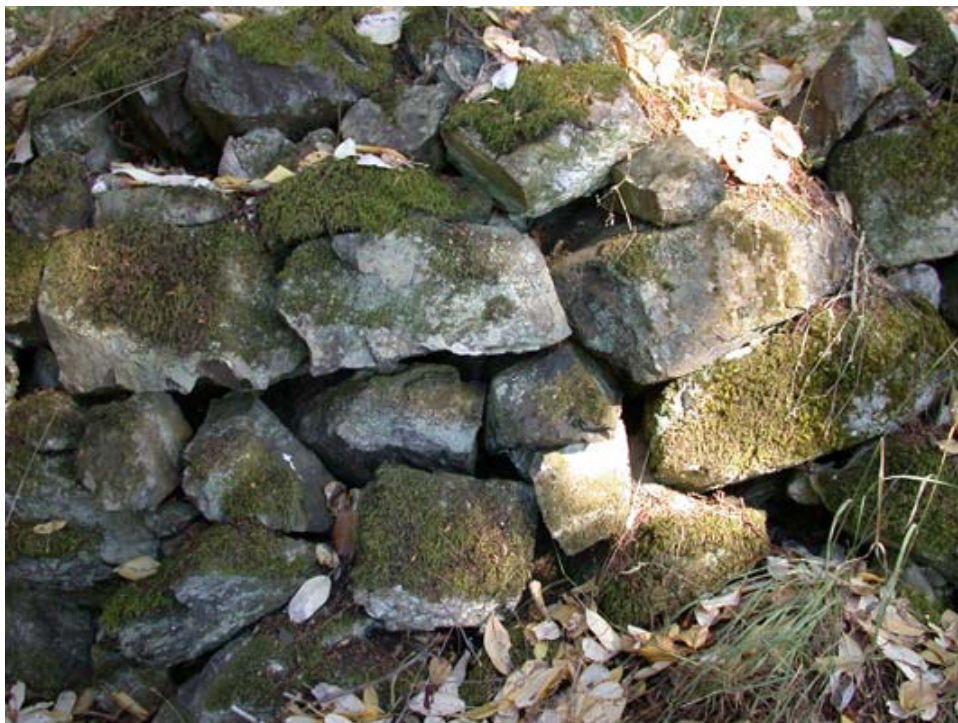
Contemporary photo showing a detail of a retaining wall. This shows a construction method of dry and mortared stone typical of the circulation and retaining walls at English Camp. (CCSO, 2003)

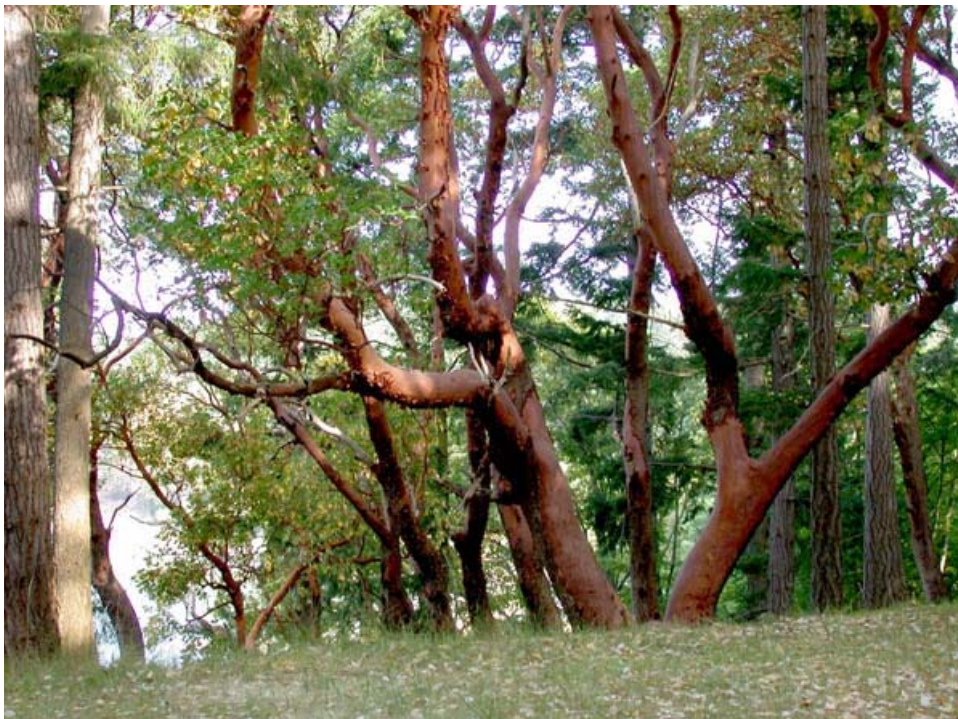
Contemporary photo illustrating a view from Officers' Hill that is being obscured by vegetation. (CCSO, 2003)
