CENTRAL RAILROAD OF NEW JERSEY  
SUBURBAN COACH No. 1157  
HISTORIC STRUCTURE REPORT

Part I

Steamtown National Historic Site

April 1993

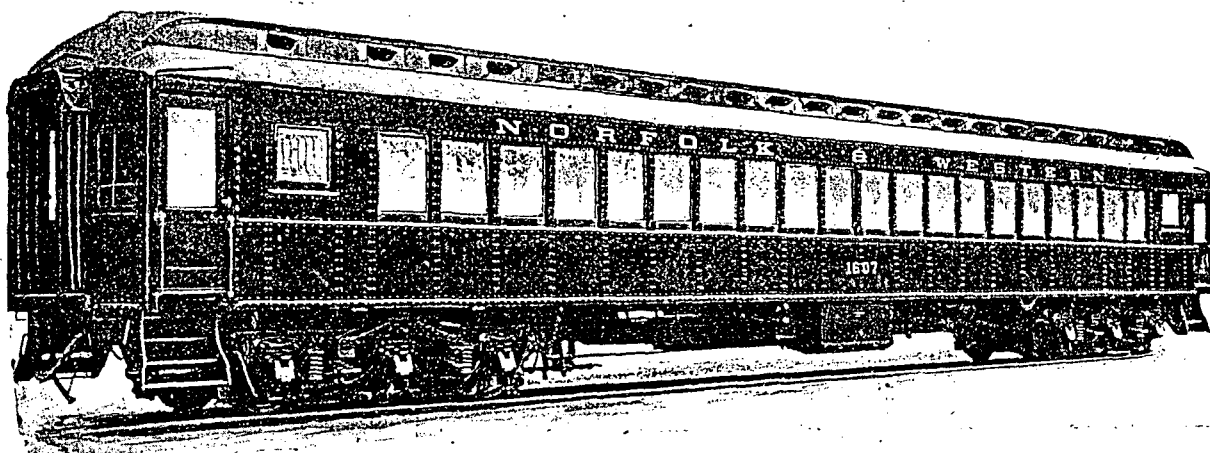
Fig. 1. Heavyweight steel passenger coach built by Bethlehem Shipbuilding Corporation's Harlan Plant for the Norfolk and Western Railroad. Roy V. Wright, ed., Car Builder's Cyclo-  
pedia of American Practice 10th ed. (New York: Simmons-  
Boardman Publishing Company, 1922), 314.

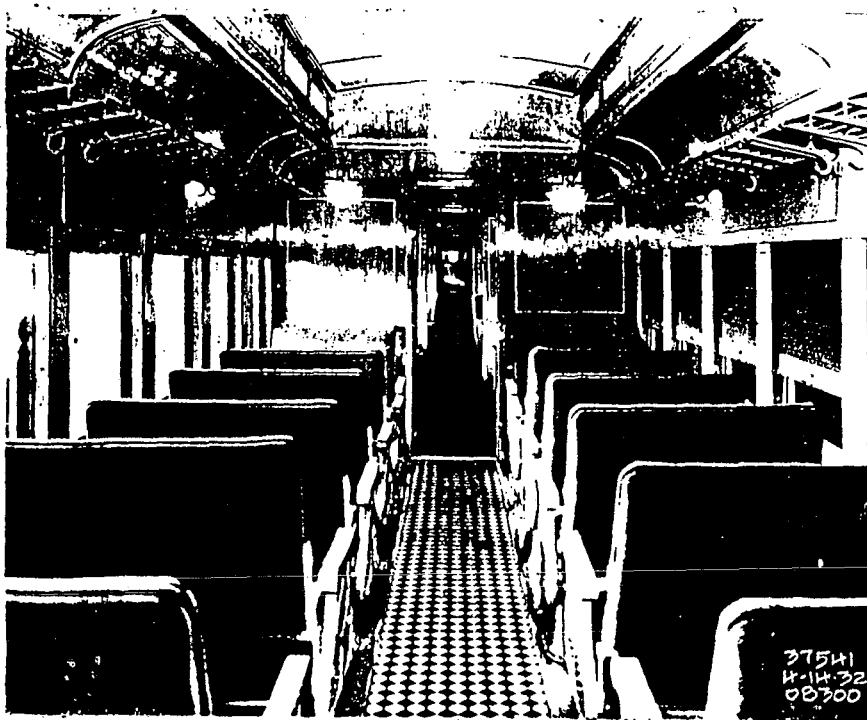
Fig. 2. Interior view of a CNJ passenger coach compartment, showing parcel racks, floor material and walkover seats, 14 April 1932. Photograph No. 30 from the Reading Company Collection, Pictorial Collections and Audiovisual Services Department, Hagley Museum and Library.

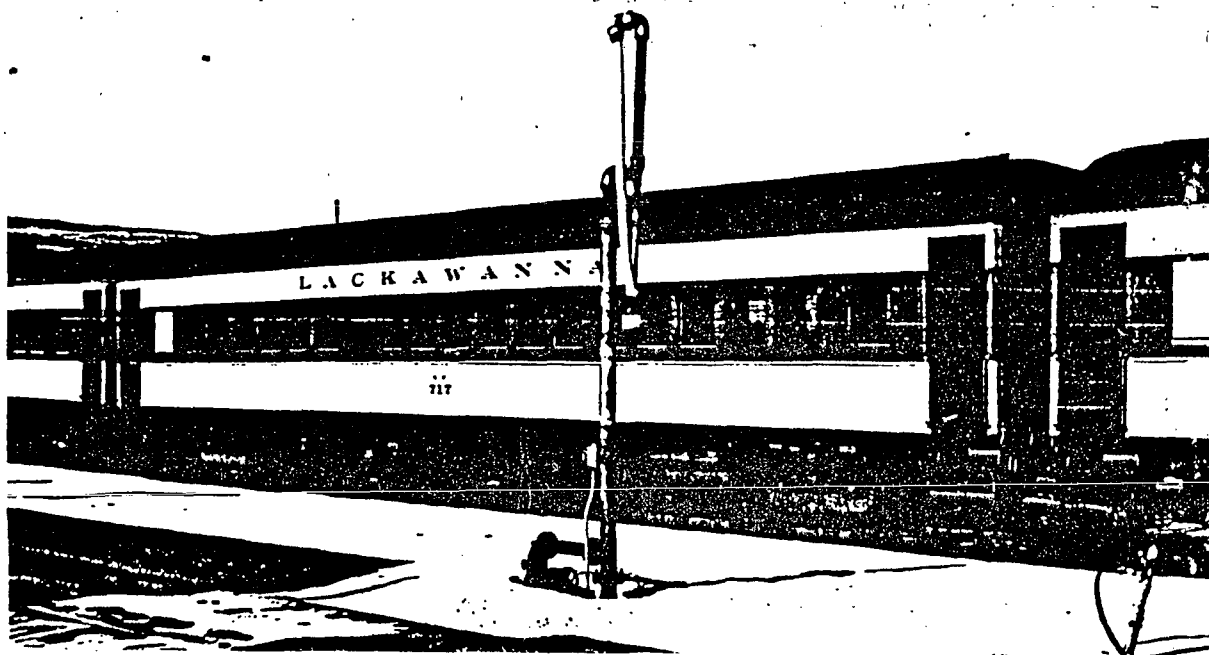
Fig. 3. CNJ coach No. 1157 prior to restoration. Gordon Chappell, Flanged Wheels on Steel Rails: The Railroad Cars of Steamtown. Draft. (Denver: National Park Service, 1991), 35.

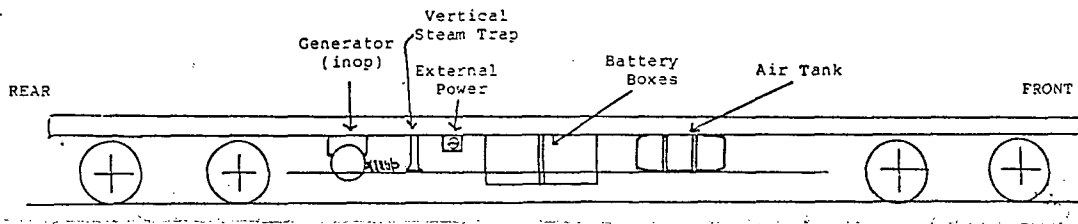
Fig. 4. Underbody equipment on coach No. 1157, right side. Illustration by author.

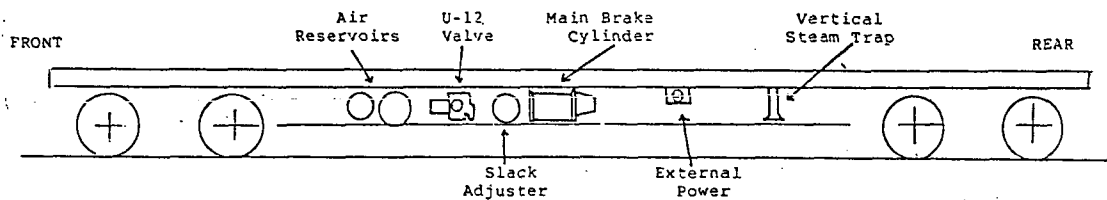
Fig. 5. Underbody equipment on coach No. 1157, left side. Illustration by author.

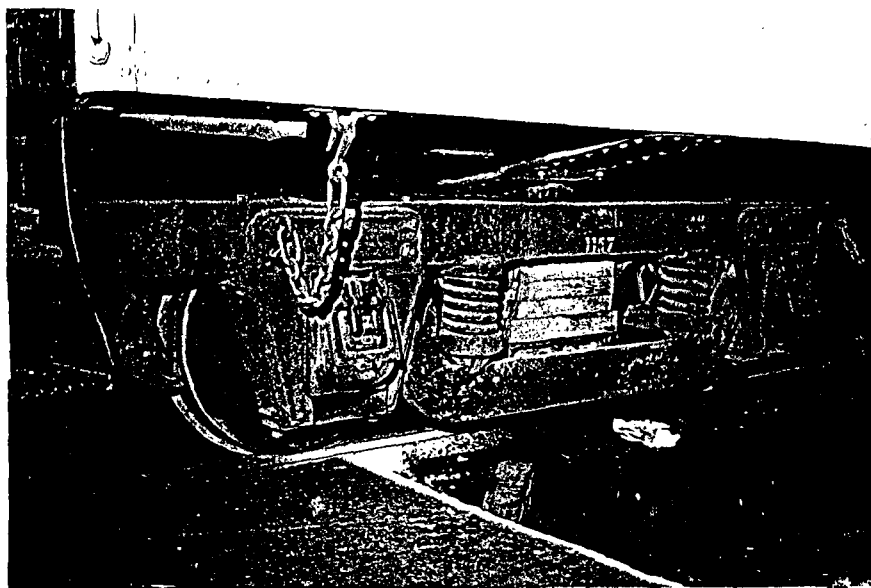
The Harlan & Hollingsworth trucks marked for coach No. 1157 are currently under CNJ suburban coach No. 1022.

Fig. 8. Correct Harlan & Hollingsworth passenger car truck for coach No. 1157, currently installed on CNJ coach No. 1022. Photograph by Kenneth Ganz.

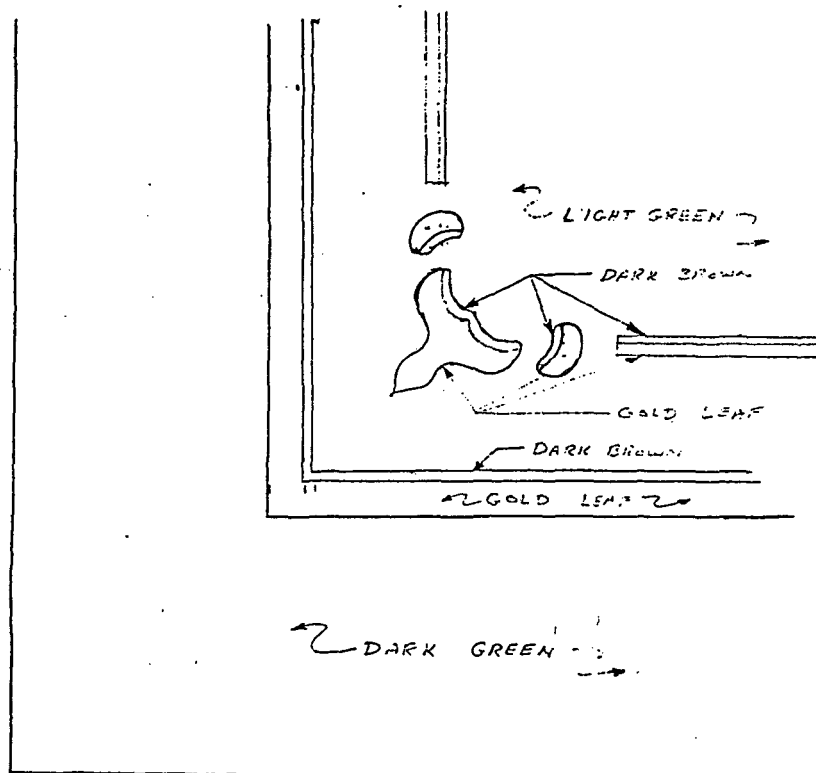
Investigation of No. 1157 and other Central of New Jersey passenger cars in the Steamtown collection has revealed the presence of detailed gold leaf scroll work, applied to a base coat of light green and Pullman green (Figure 10).

Fig. 10. Sketch of gold leaf detailing found on the interior roof panels of Central Railroad of New Jersey coaches in the Steamtown collection. Drawing by Willard Sturdevant.

This decorative detailing is underneath the Old English Ivory and other layers of paint on the ceiling panels of No. 1157. It should be restored.

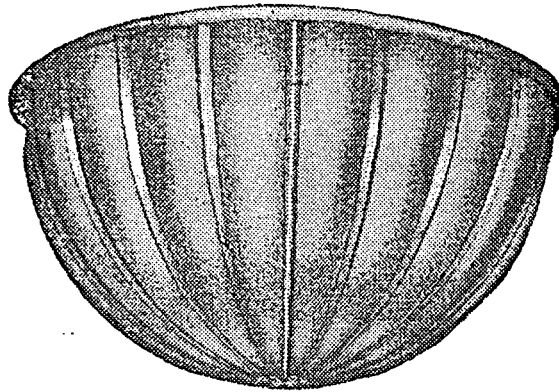
**Lighting-** The six passenger compartment lights have globes similar to Safety Car & Heating Co. model No. 51855, a twelve inch Opal Bowl.<sup>74</sup> These globes match the type globes found in other CNJ passenger cars in the Steamtown collection, and are believed to be original equipment (Figure 11).

Fig. 11. Safety Car & Heating Company model No. 51855.  
Wright, Cyclopedia, 10th ed., 937.

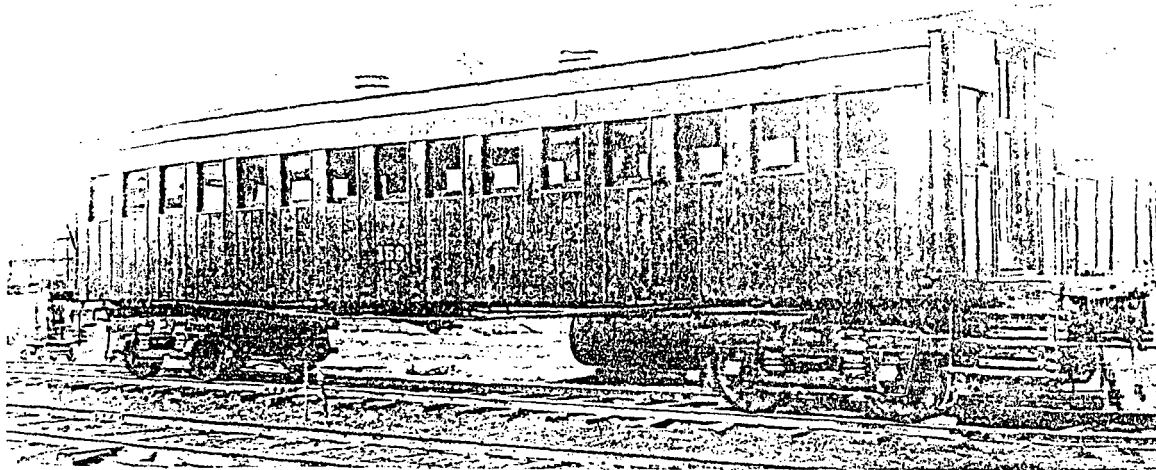
Fig. 12. Example of the first Central Railroad of New Jersey passenger car paint scheme, as depicted by coach No. 159. From John White, Jr., The American Railroad Passenger Car, pt. 1 (Baltimore: Johns Hopkins University Press, 1978), 26.

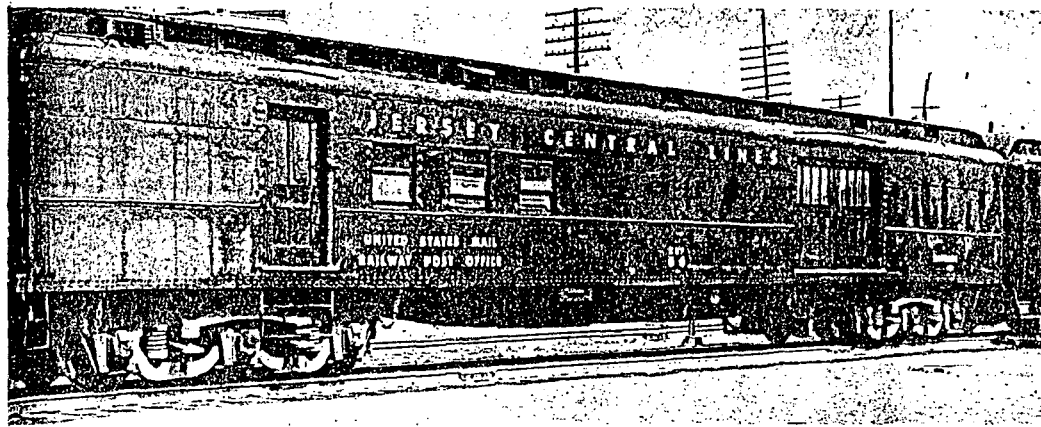
A photograph of CRP Railway Post Office No. 66 depicts a variation of the third scheme (Figure 14.) The lettering for the Jersey Central Lines remains, but the "Statue of Liberty" logo is absent. The car number is centered on the body, below the lower window line, and the CRP initials are centered above the numbers.

Fig. 14. The third Central Railroad of New Jersey paint scheme, minus the "Statue of Liberty" markings, on Central Railroad of Pennsylvania Railway Post Office car No. 66. Railroad Magazine, January 1968, 19.

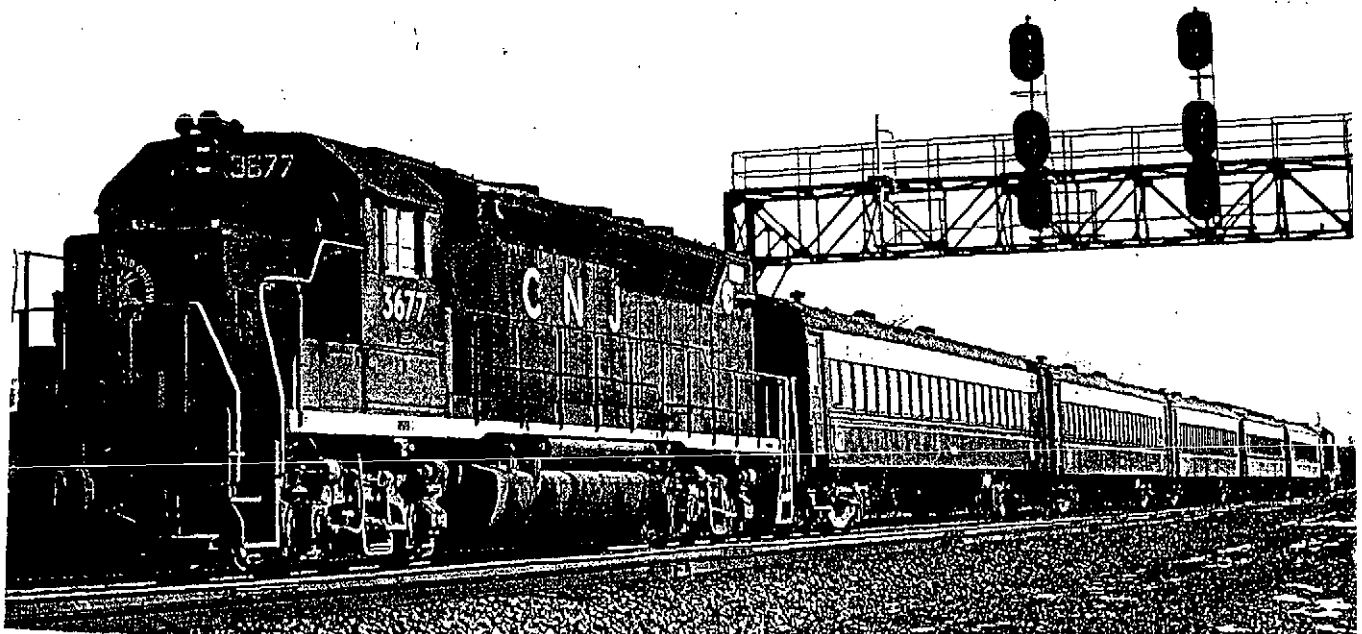
The cars were dark blue, with a broad yellow letter board. A thin yellow stripe (approximately two inches wide) was painted below the window line, encircling the body.<sup>78</sup> The car number was centered at mid-body. The CNJ liberty head emblem was applied at the left corner of the car; "Central Railroad of New Jersey" replaced "Jersey Central Lines" on the circular emblem (Figure 15).

Fig. 15. Joint-use Central of New Jersey/New Jersey Department of Transportation coaches display the fourth scheme while operating near Bound Brook, NJ. From William J. Brennan, Jersey Central Lines In Color (Edison, NJ: Morning Sun Books, 1991), 62.
