PRAIRIE NATIONAL PARK (PROPOSED):

CULTURAL RESOURCES SURVEY

Prepared by  
Ronald W. Johnson

November, 1974

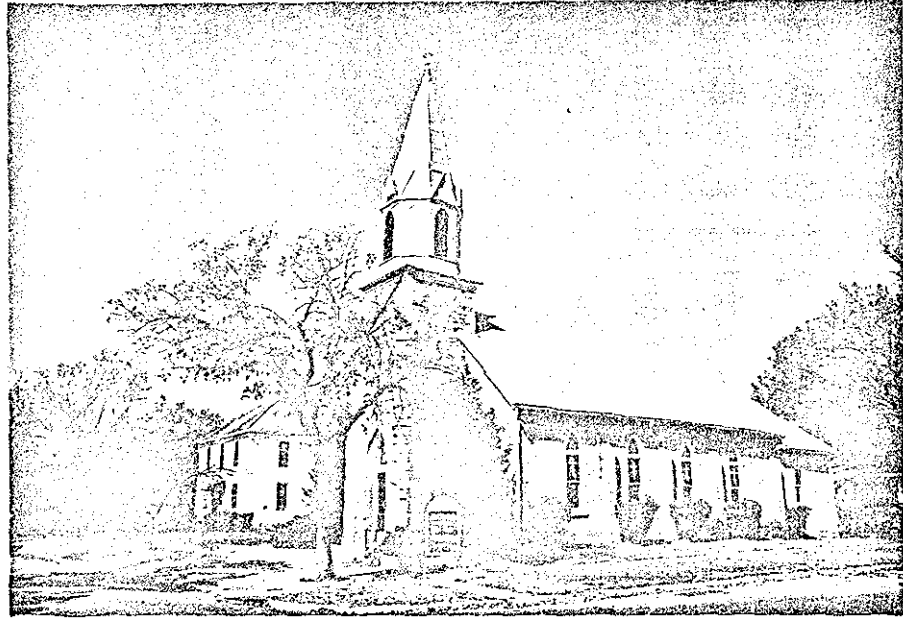
Fig. 6

Limestone. Rectangular plan with small rear addition. Church tower with louvered belfry and tower, Church first organized in 1874. Datestone (1897). Excellent condition. Northwest view.

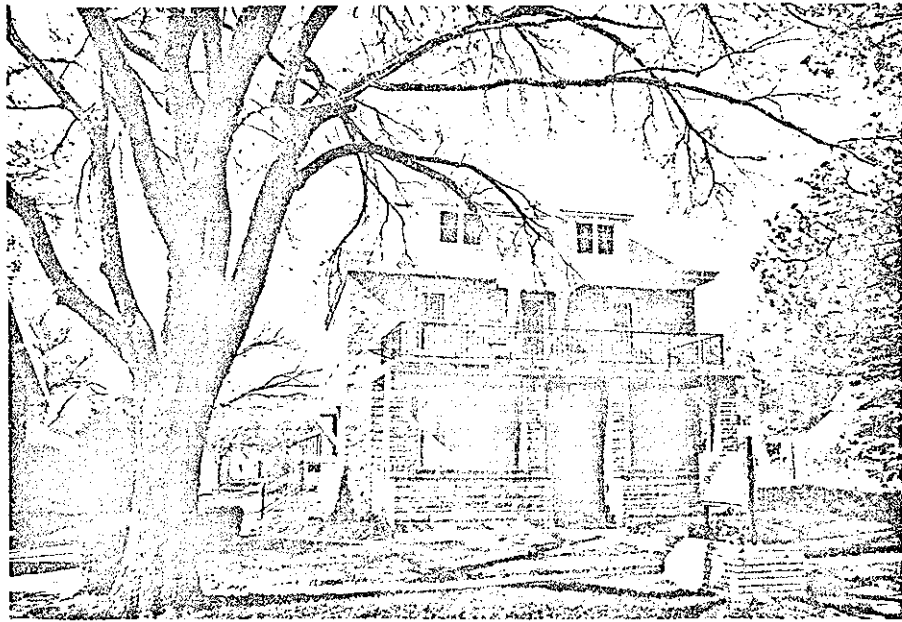
Fig. 8

Ohio & Sixth. Limestone. Square plan. Two stories plus mansard. Metal sheathed dormers. Two story porch with deck and iron railing. Excellent condition. Presently used for commercial purposes. West view, Located outside study area boundaries.

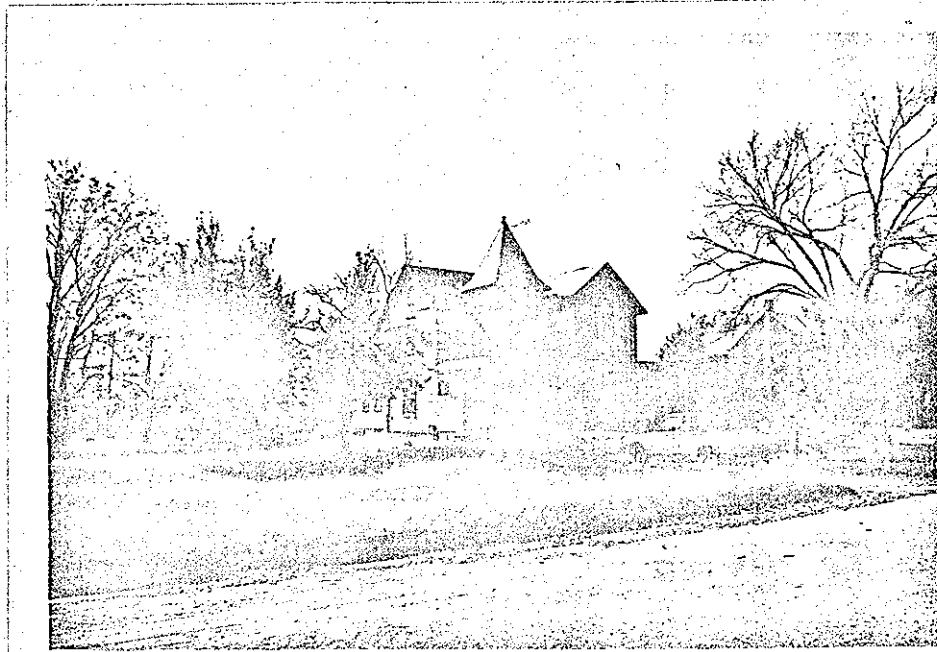
Fourth & Illinois. Frame. L plan with tower in notch of L. 2 story, porch on front & side. 2 gables. Rear addition. Good condition. Southwest view. Located outside study area boundaries.

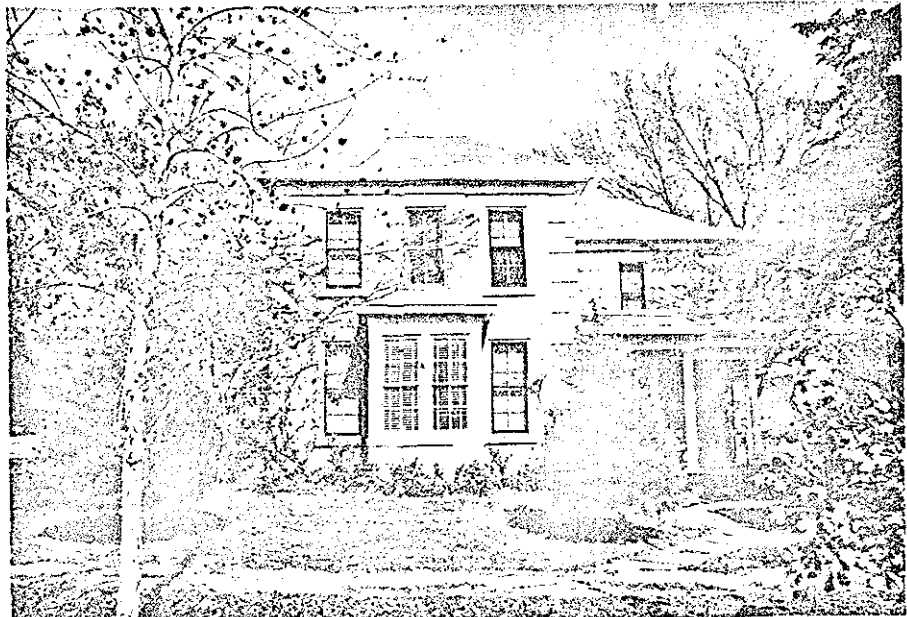
Fourth & Illinois. Limestone. L plan. 2 story with porch in notch of L. Note quoin work. Hip roof. 1 chimney. Excellent condition. North view. Both of the above are located outside of study area boundaries.

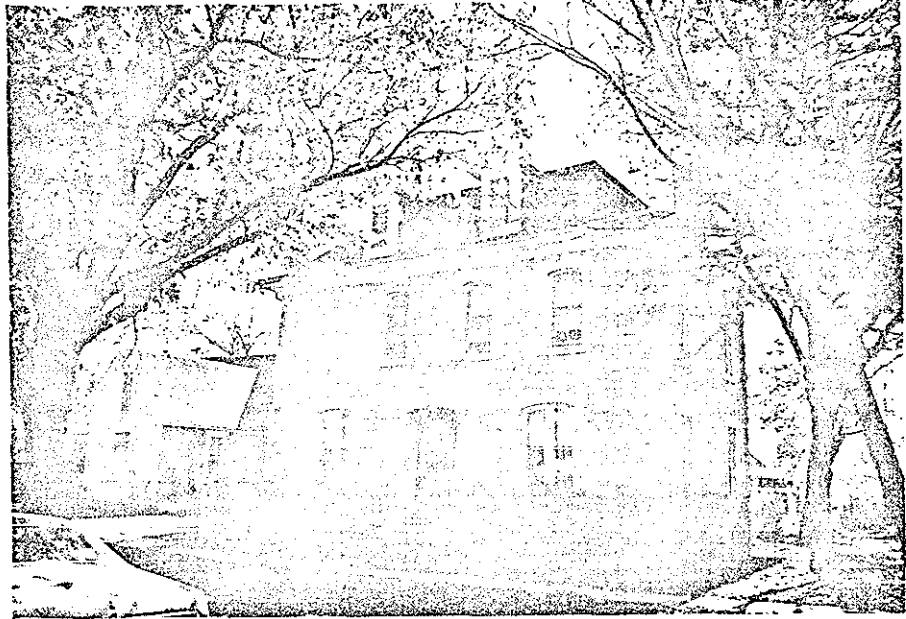
Fourth and Illinois. Limestone. Rectangular plan. 3 bay. 2 story with Mansard roof. 2 inside end chimneys. 2 gabled dormers. Date-stone (1888) Excellent condition. South view. Located outside study area.

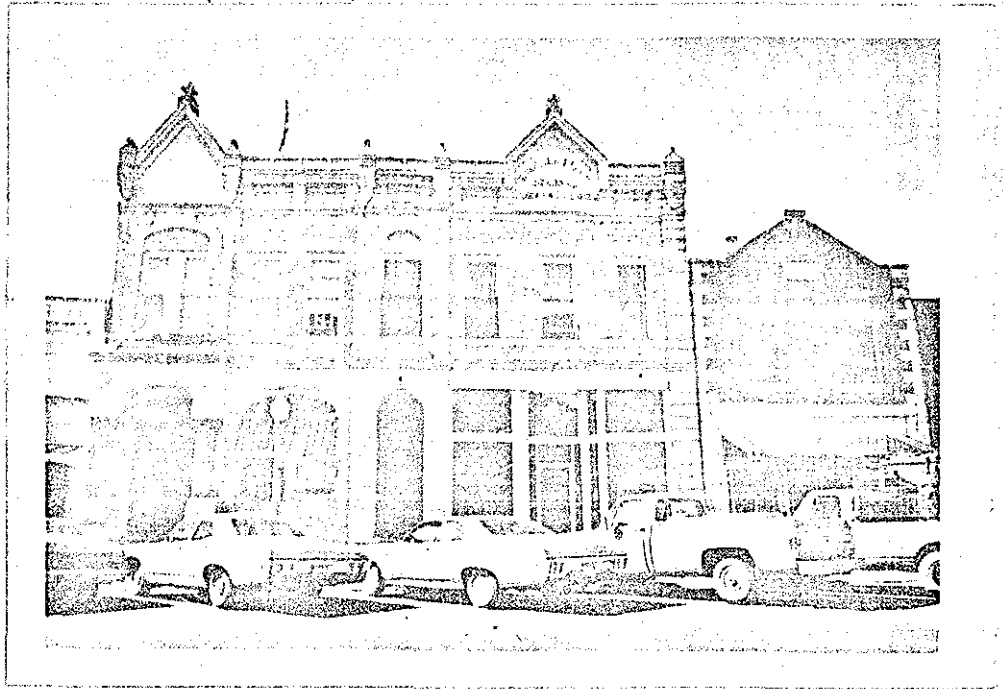
Missouri Street. Limestone & brick. Rectangular plan. Large two story (high ceilings) commercial building. Named "Kinne & Kearens General Merchandise." To its right is the Weaver Building. Datestone (1906). Note pilasters on the larger structure, quoin work on the smaller one. Facades in good condition. West view.

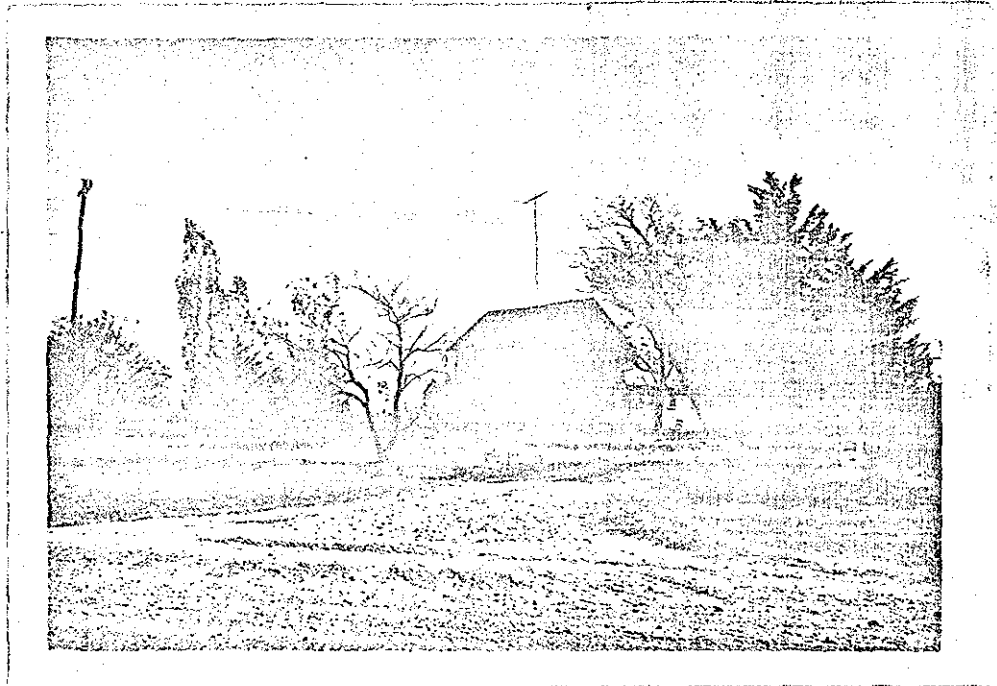
Mill Creek Road. T12S; R10E, Section 16, Wabaunsee County. Limestone and frame. Rectangular plan with rear addition. These houses date from the 1880's & 1890's. 2 story with gable roof. Good condition. Southwest view. Located outside study area boundary.

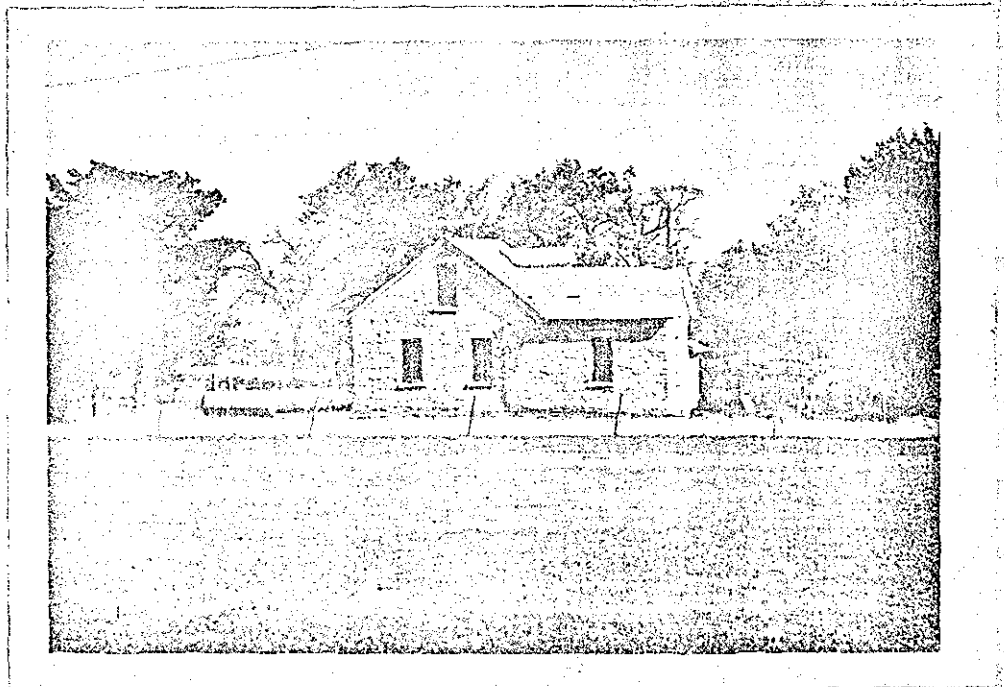
Mill Creek Road. T12S; R10E; Section 21; Wabaunsee County. Limestone. T plan. 1½ story, gable roof. 1 central chimney, 1 inside end chimney. Good condition. South view. Located outside study area boundaries.

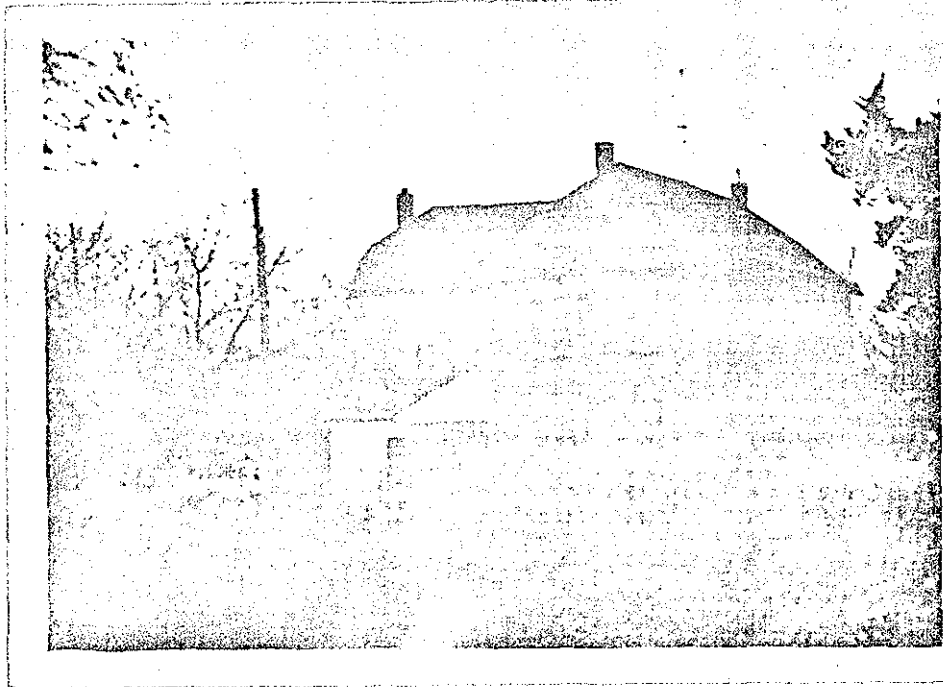
Mill Creek Road. T12S; R10E; Section 30; Wabaunsee County.  
Limestone, T Plan. Large 2 story, 5 bay. Gable roof. 3 inside  
end chimneys. Enclosed porch in notch of L. Good condition.  
At least two smaller buildings at rear. South view. Located inside  
study area boundaries.  
Farmhouse

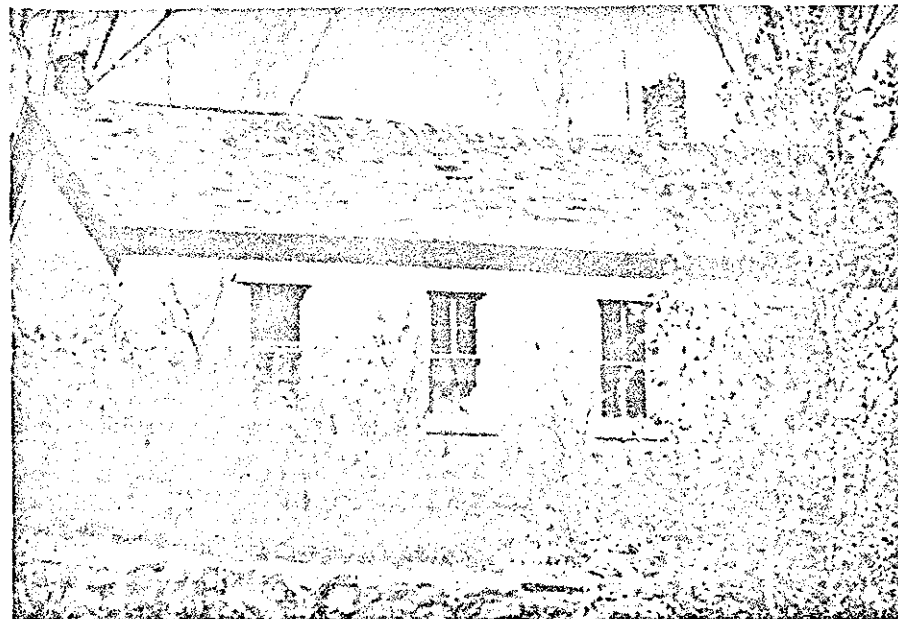
Mill Creek Road. T12S; R9E; Section 25; Wabaunsee County. Limestone. Rectangular plan. 1 story, 4 bay. 1 inside end chimney, 1 central chimney. Gable roof with shingles. Deteriorated condition. North view. Located outside study area boundaries.

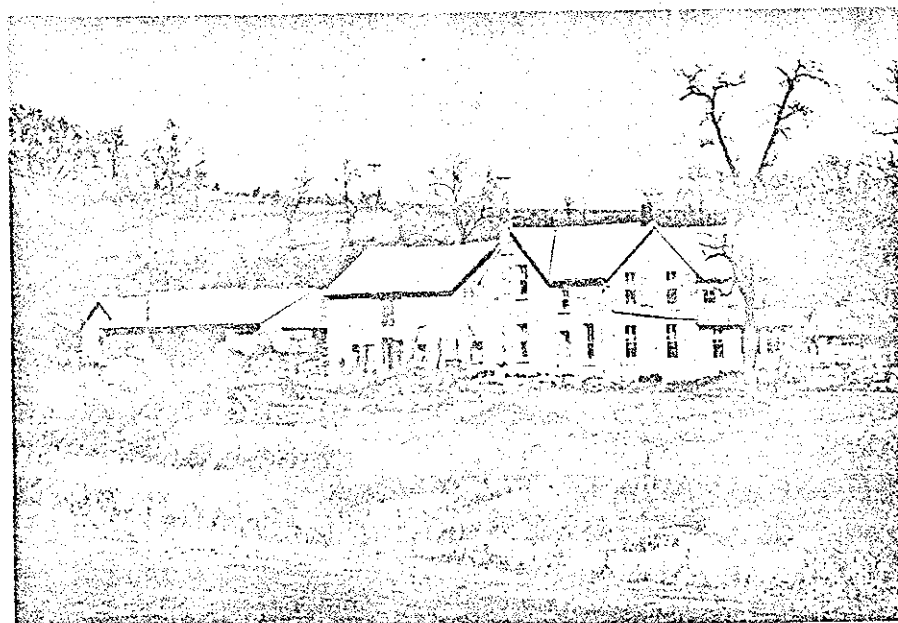
Mill Creek Road. T12S; R9E; Section 25; Wabaunsee County. Limestone L plan, 2 story, 3 bay. Porch in notch of L. Gable roof. 2 outside end chimneys, 1 inside end chimney, Large stone outbuilding at rear. Good condition. Northeast view. Located outside study area boundaries.

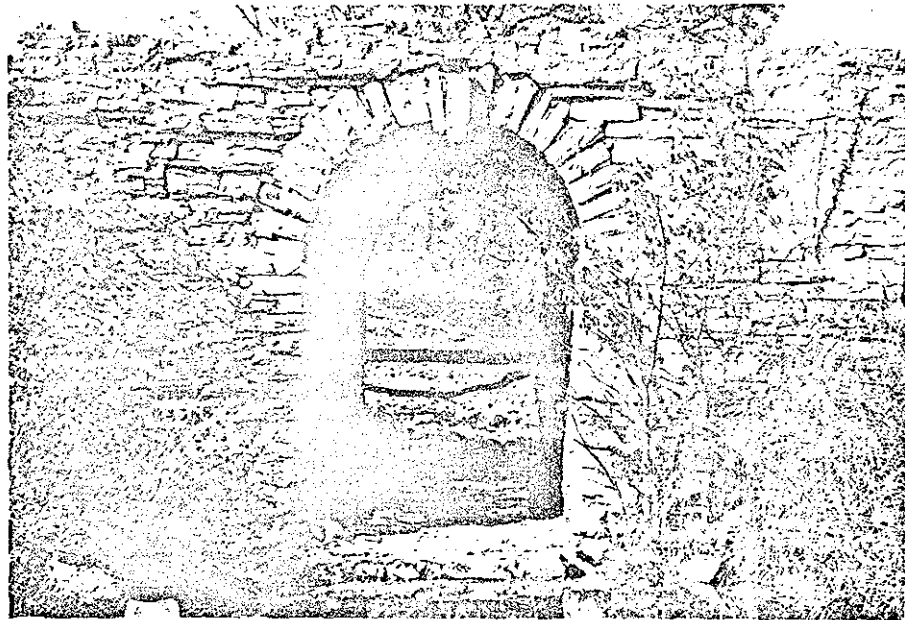
Fig. 32

T13S; R9E; Section 3; Wabaunsee County. An example of prevalent limestone bridge craftsmanship in Wabaunsee County. Note the arch & keystone that support the stone filler and roadway. North view.

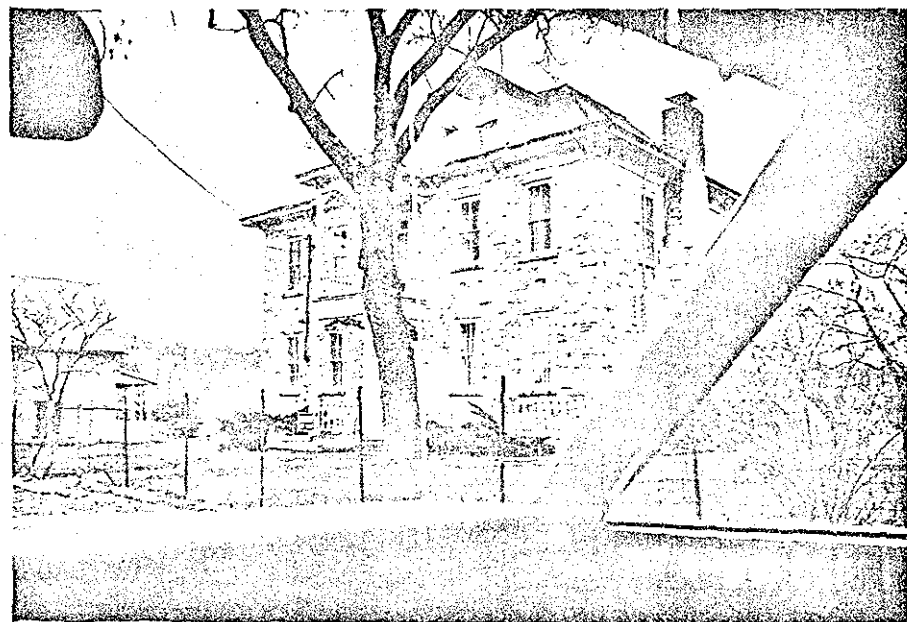
Mill Creek Road. T13S; R9E; Section 3; Wabaunsee County. Limestone. Rectangular plan. Large 2 story with modified mansard roof. 5 bay. Outside end fireplace chimney on west facade. 3 gable dormers. Stone outbuildings. Clausen owns. Good condition. Southeast view. Fig. 32 is located outside proposed park boundaries; Fig. 33 is located within study area boundaries.

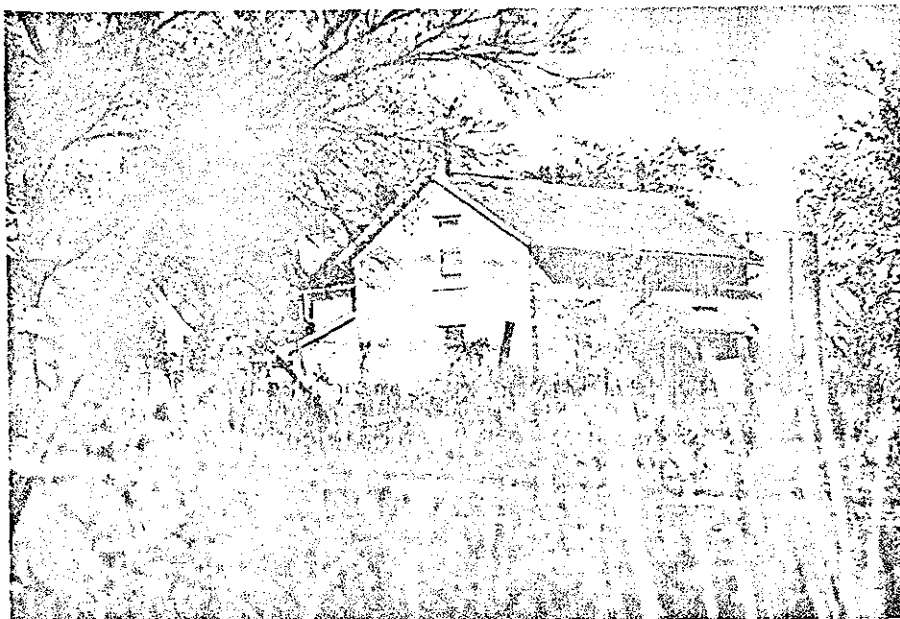
Mill Creek Road. T13S; R9E; Sec3; Wabaunsee County. Limestone and frame. T plan. 2 story, 3 bay. Porch on main facade. Gable roof with 3 inside end chimneys. Shingle roof. Fair condition. Stone outbuildings. Northeast view. Located outside of study area boundaries.

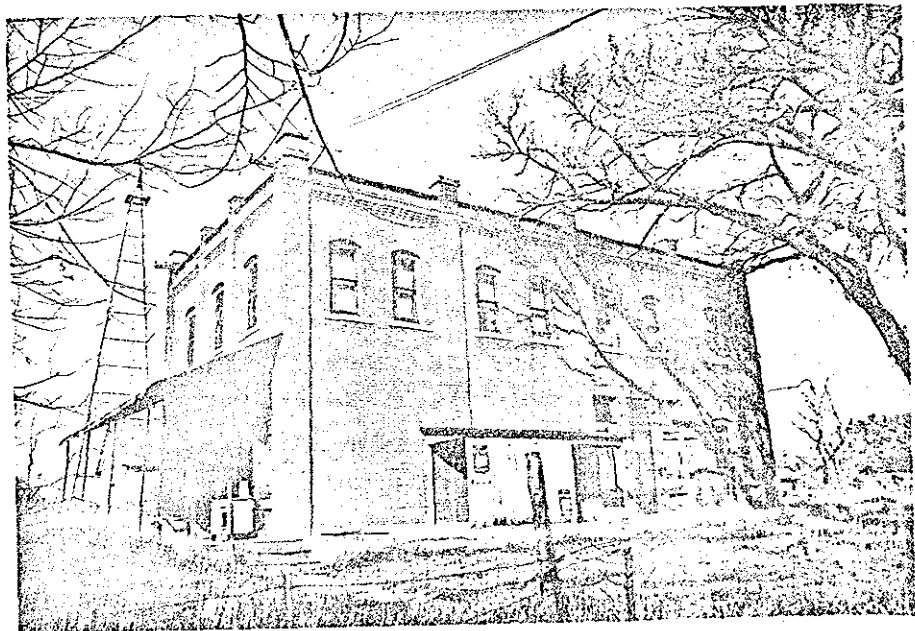
Volland, Mill Creek Road (See Fig. 36). Large early 20th Century 2 story rectangular shaped brick structure. Used as store, cafe, and apartments. Tin roof over porch. One of the few older brick structures in this rural area. Volland housed railway workers at one time, then declined after the 1920's. Fair condition. West view.

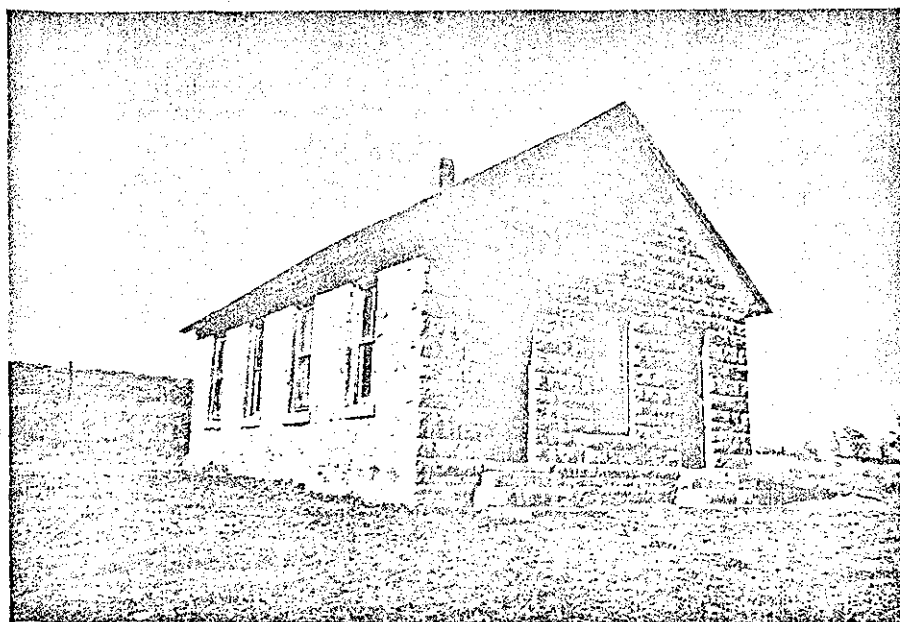
Mill Creek Road. T13S; R9E; Section 9; Wabaunsee County. Limestone. 1 story, gable roof with 1 central chimney. 3 bay. Datestone (1906). Rests in pasture. Fair condition. Northeast view. Both of the above are located outside study area boundaries.

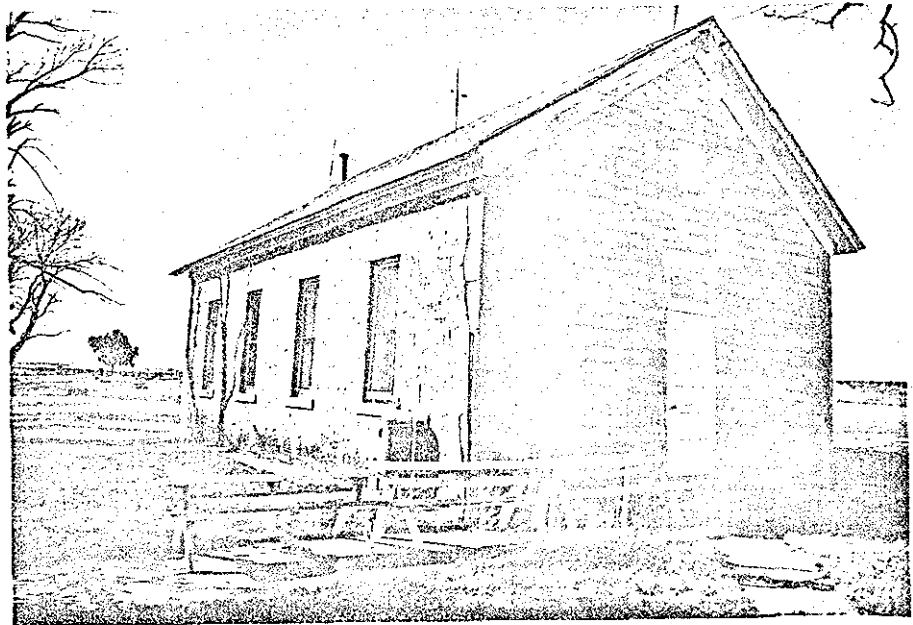
Mill Creek Road. T13S; R9E; Section 18, Wabaunsee County.  
Rectangular plan. Gable roof. Datestone (1904) May be utilized  
for meetings. Good condition. Northwest view. Both of the above  
are located outside study area boundaries.

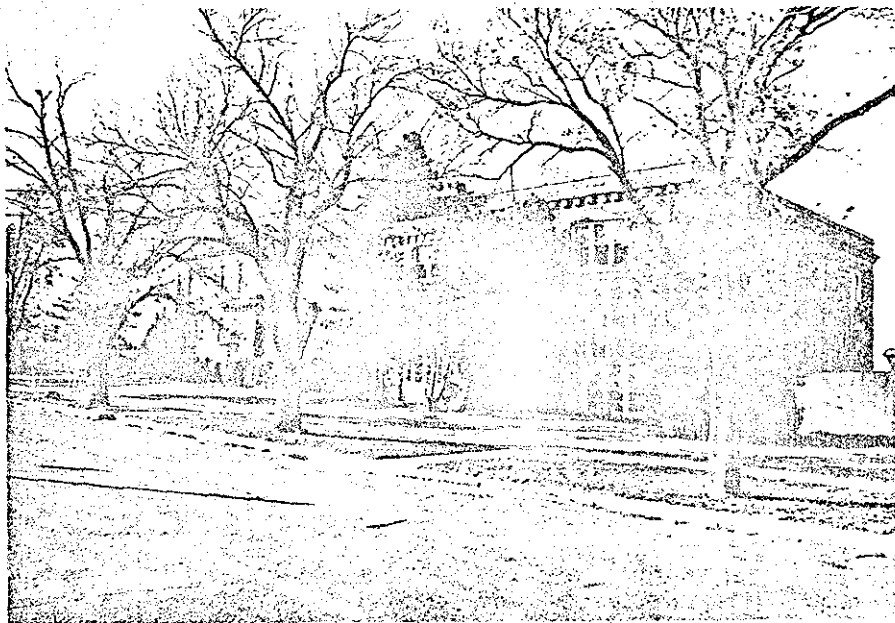
Fig. 45

Limestone. Rectangular plan. 3 story structure. Good condition. Northwest view. Located outside study area boundary.

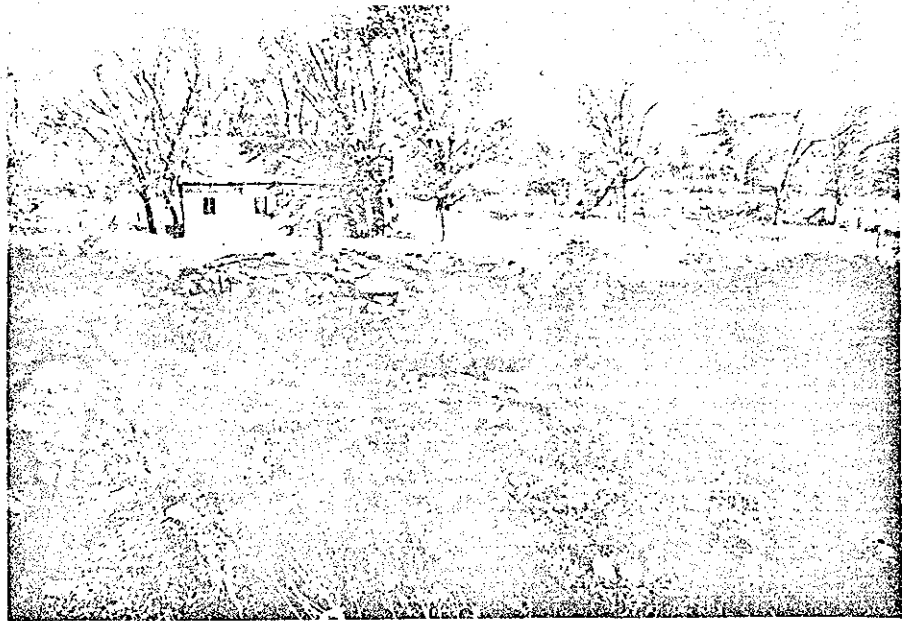
Near Illinois Creek. T13S; R9E; Section 26. Wabaunsee County. Machine shed with equipment in it. Foundation of farmhouse. An iron pump remains. Ruins. East view.

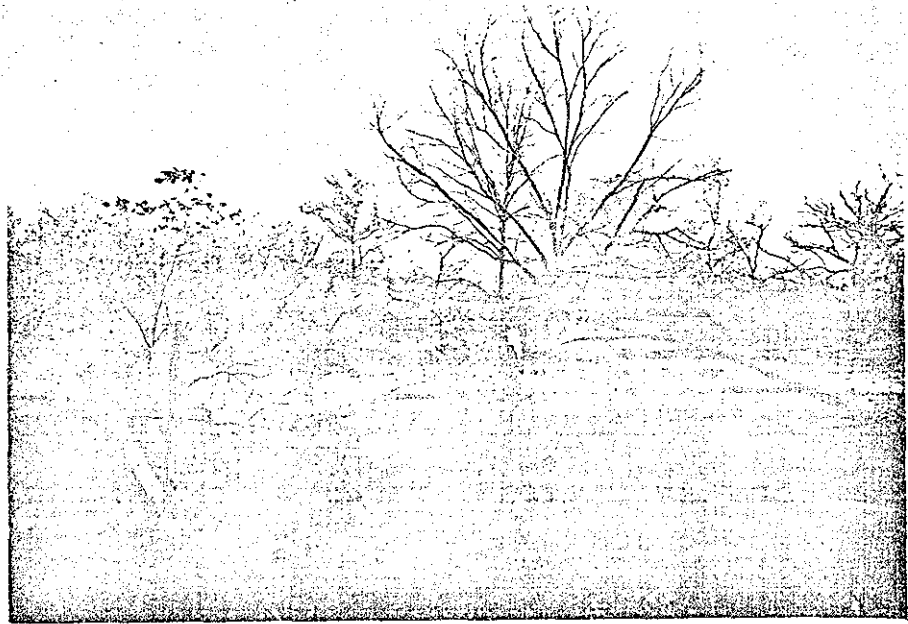
Fig. 48

T13S; R9E; Section 35; Wabaunsee County. About 200 yards west of Figure 47. Mostly ruins, frame sheds remain. South view.

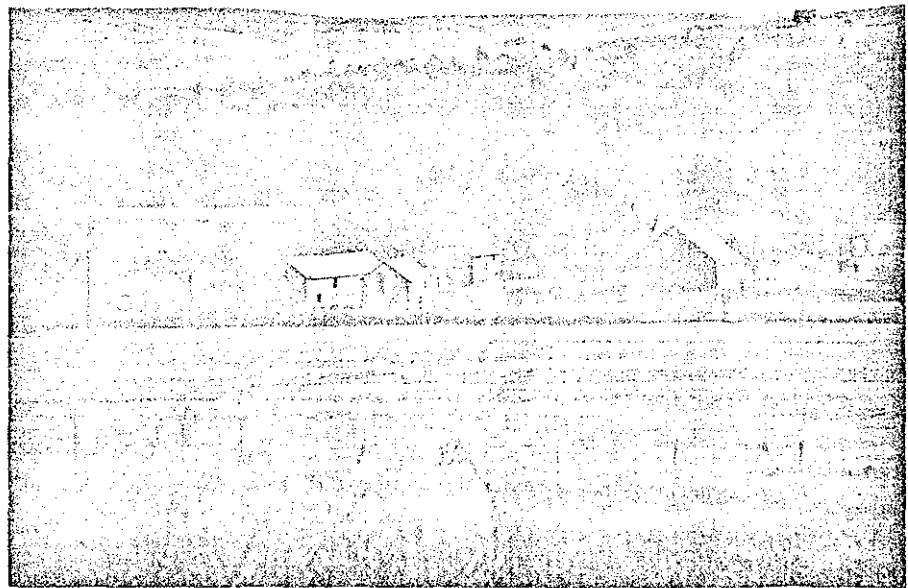
Fig. 49

Near Illinois Creek. T13S; R10E; Section 35; Wabaunsee County. Limestone. L plan. 2 story, 3 bay. Gable roof, 2 outside end chimneys. Several stone outbuildings and a log structure. Good condition. East view. Both of the above are located within the study area boundary.

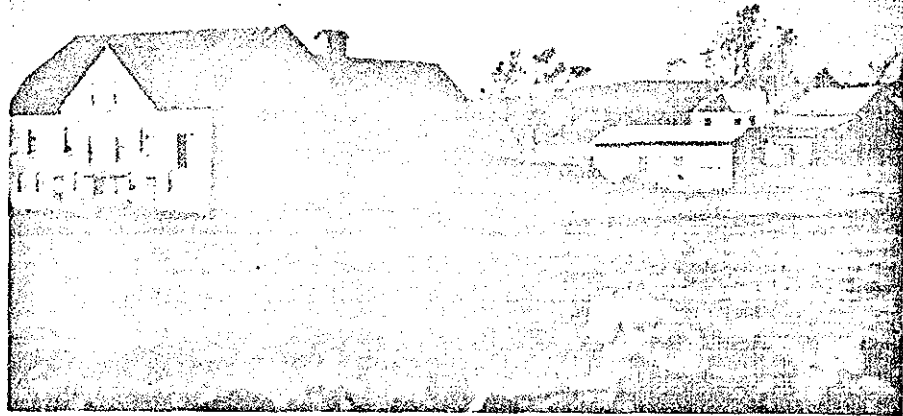
Fig. 50

T13S; R10E; Section 6; Wabaunsee County. Stone house in ruins. Large L plan dairy barn, 3 story. Stone first story, frame upper story. Fair condition. Southwest view.

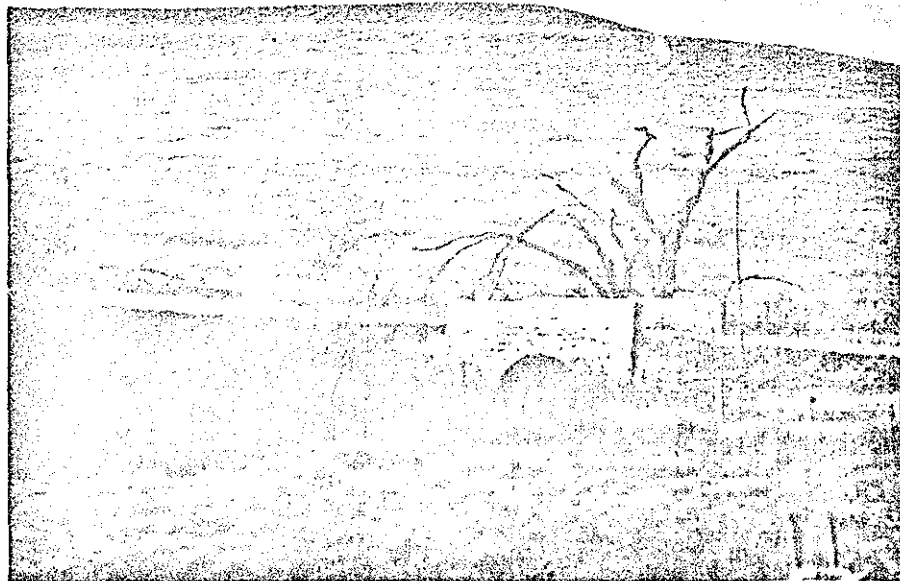
Fig. 51

Near Fig. 50. Excellent example of stone craftsmanship on a bridge. Arched with protective abutments on either side of road. Scene graphically illustrates the prairie's vastness. Numerous stone bridges are located in/near the Wabaunsee Site. West view. Both of the above are located within the study area boundary.

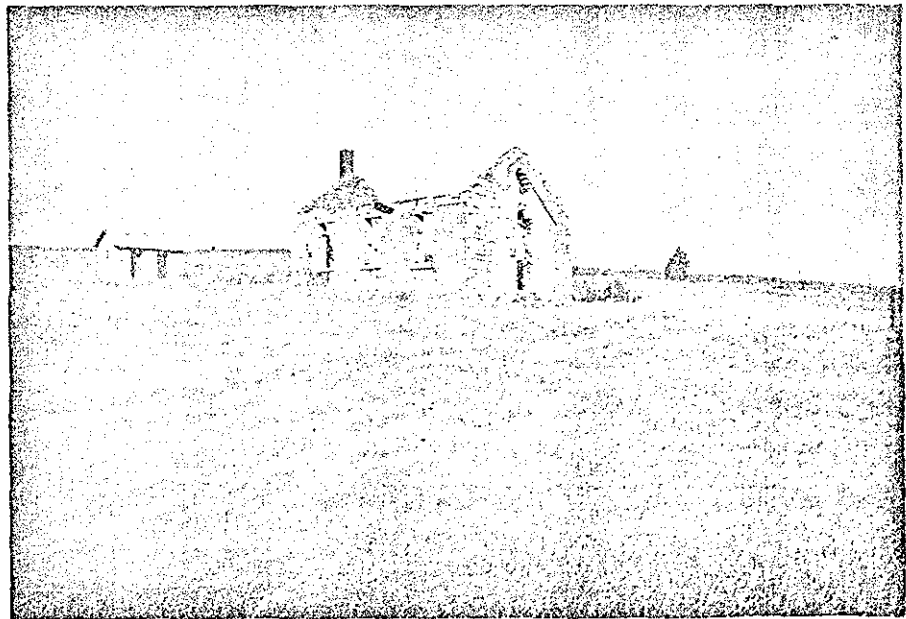
Fig. 53

T13S; R9E; S13. Wabaunsee County. Gutted limestone schoolhouse, restrooms at rear. Northwest view. Both of the above were located within the study area boundary.

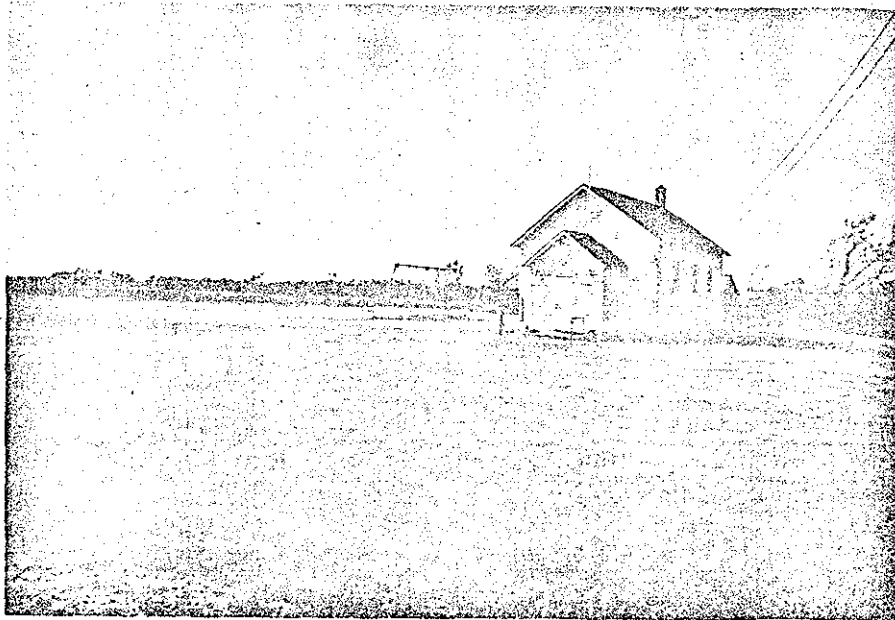
Kansas #4 east of Alta Vista. T14S; R9E; Section 8; Wabaunsee County. Frame 1 room school. Water pump, outbuildings. Presently may be used as Community Hall. Fair Condition. Southwest view. Both of the above are located within the study area boundary.

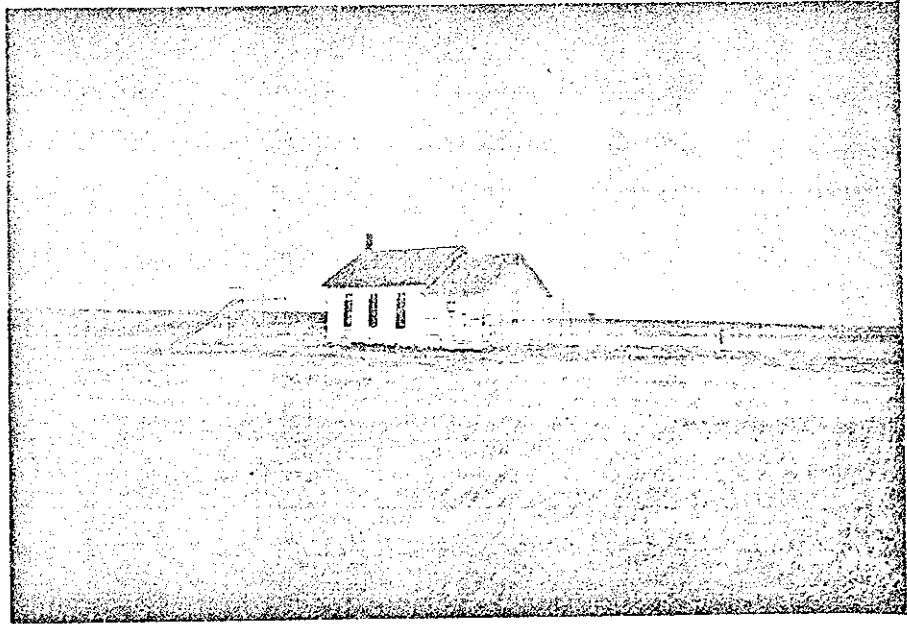
Fig. 58

One mile south of Kansas #4. T14S; R7E; Section 11; Wabaunsee County. Frame. 1 room school. Wood shingles, faded paint. Rests on open prairie. Fair condition. Northwest view.

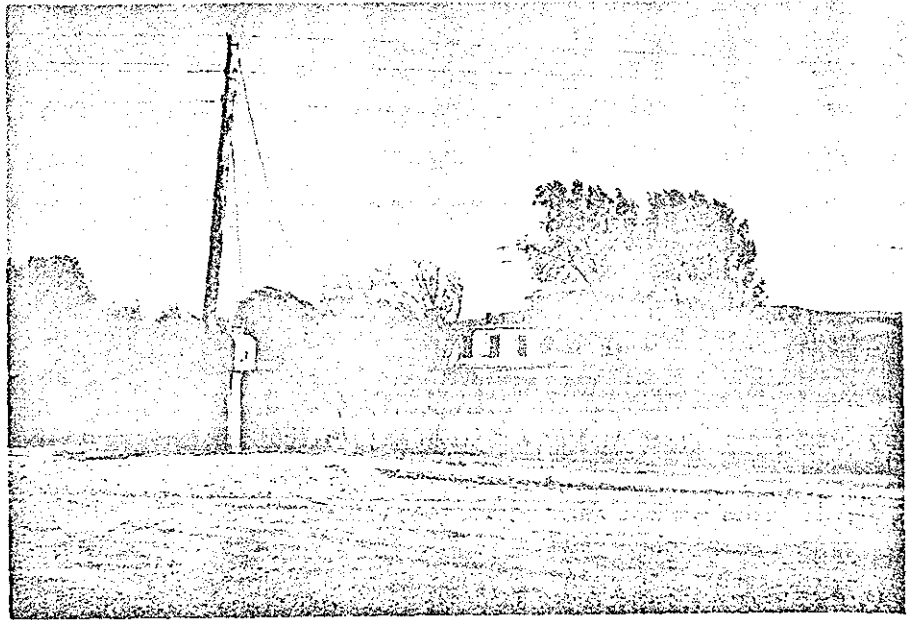
5 miles south of Alma on Kansas #99. T13S; Range 10E; Section 11; Wabaunsee County. Combination limestone & frame. Rectangular plan. 2 story mansard, 6 bay with porch in front. 2 inside end chimneys. Good condition. East view. Located within study area boundary.

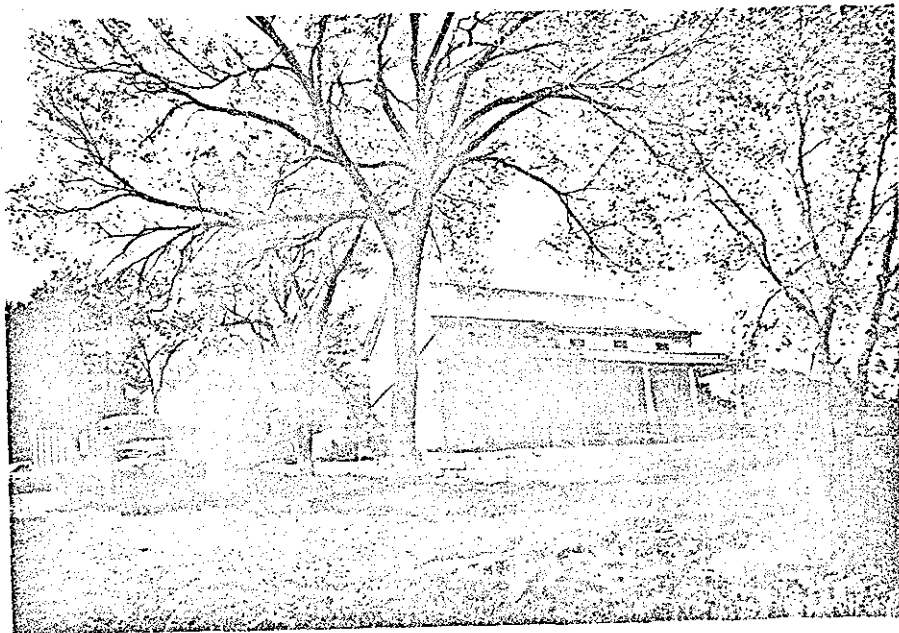
One mile south of Alma. T12S; R10E; Section 15; Wabaunsee County. Limestone. Rectangular plan. 2 story, 5 bay. Gable roof. Full length gallery porch on main facade. Good condition. Northwest view. Located outside study area boundary.

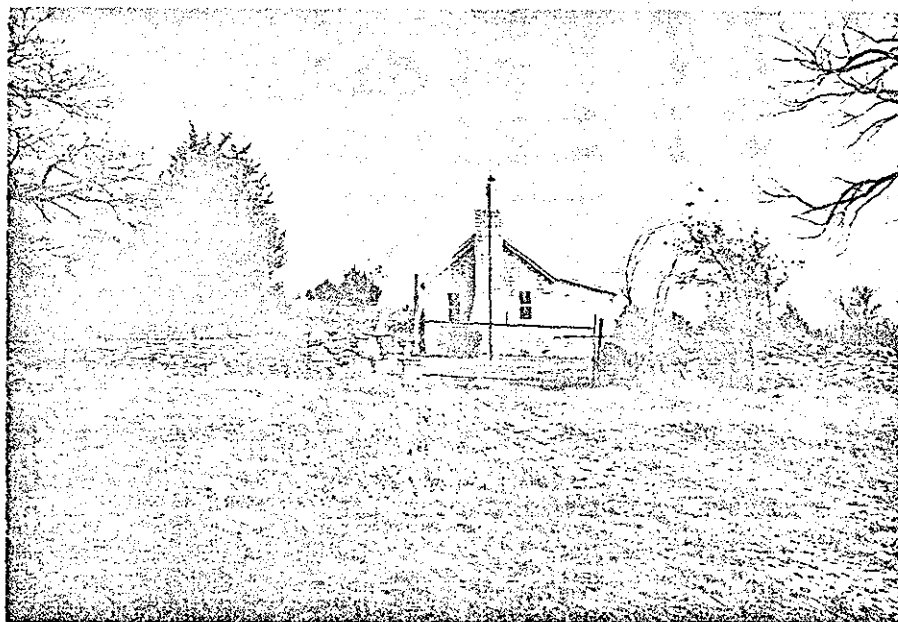
T12S; R10E; Section 36; Wabaunsee County. Limestone. May have been a school or church at one time. Frame addition. Large outside end fireplace chimney on west facade. Stone fence in foreground. Good condition. East view. Located outside study area boundary.

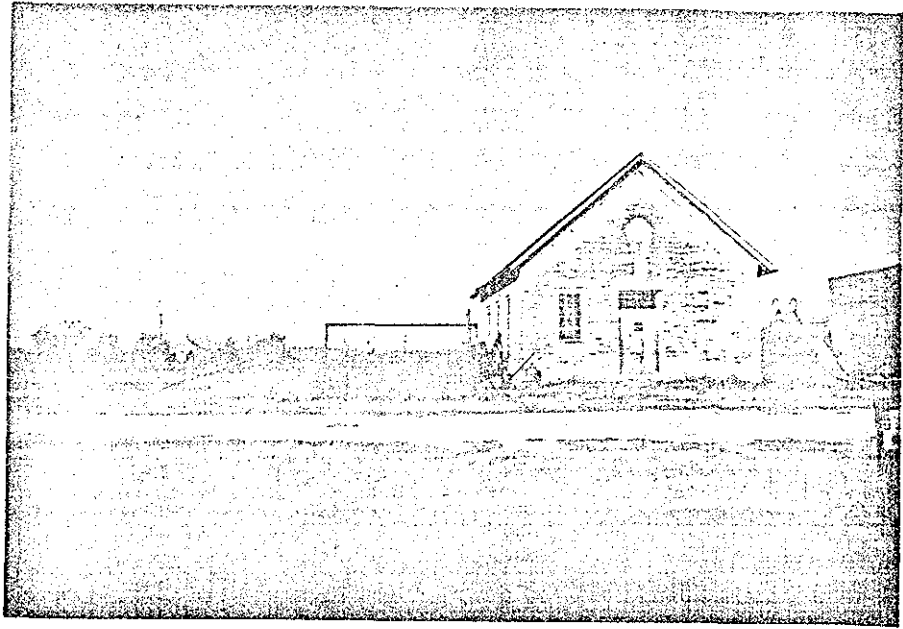
Fig. 66

Limestone. Several blocks north of Fig. 65. 3 bay, abandoned. Fair condition. West view.

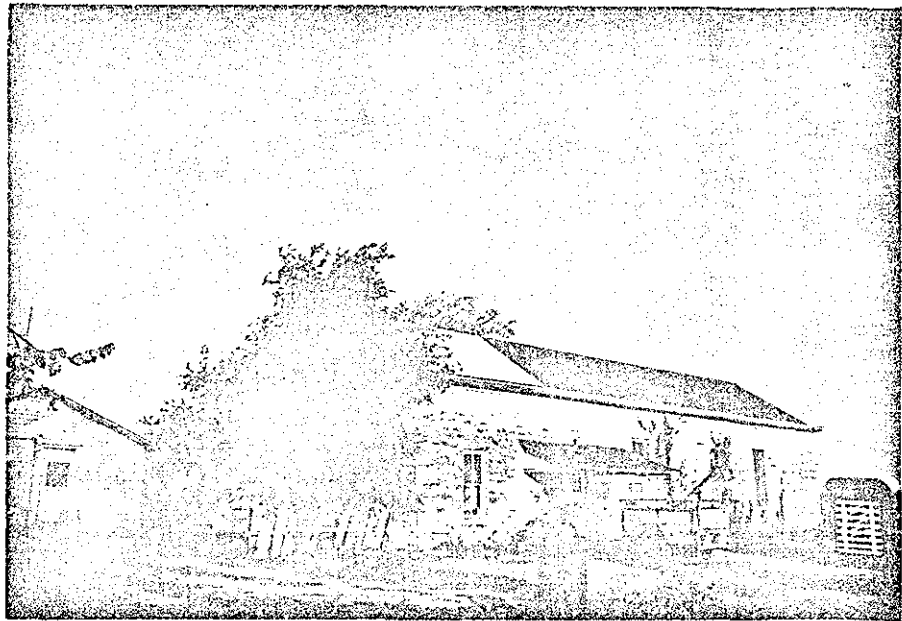
Fig. 67

Near Fig. 66. Limestone. 1 story, 5 bay, gable roof. Combination apartments and store. Fair condition. Northwest view.

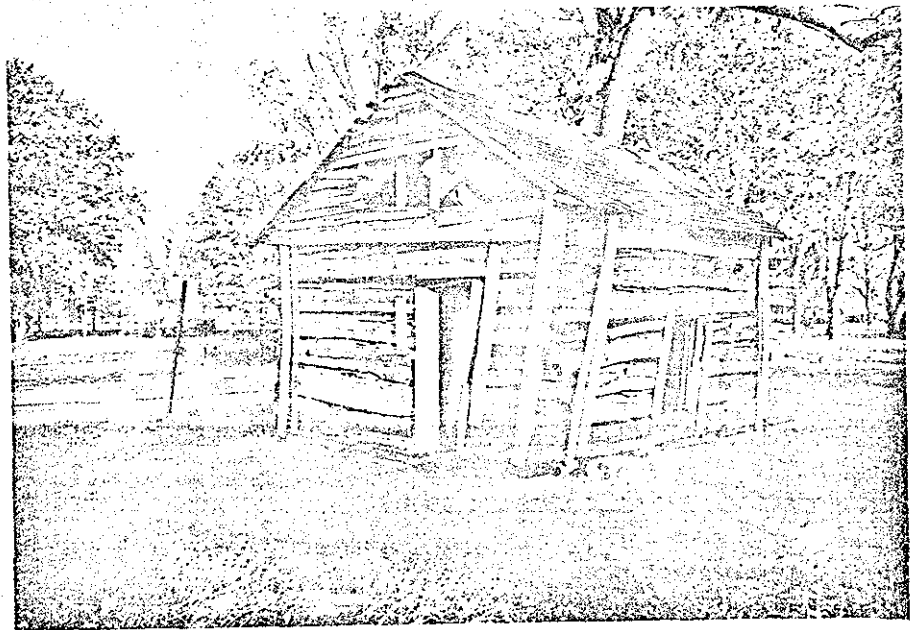
City Park, near Kansas #99, 17 miles north of Alma. 19th Century log structure moved to park. Lacks integrity. Poor condition.

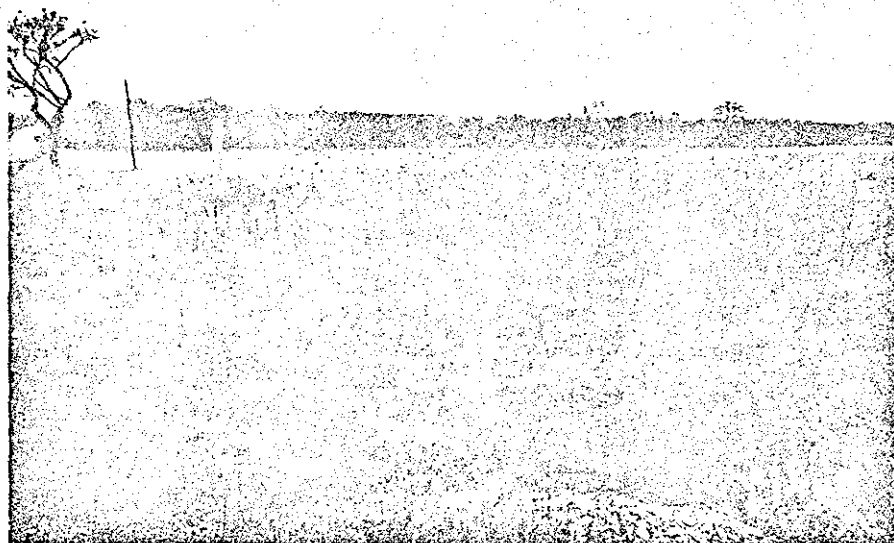
Fig. 72

T22S; R9#; Section 9; Chase County. Example of stone fence posts erected in this region. Southwest view. Located within study area boundary.

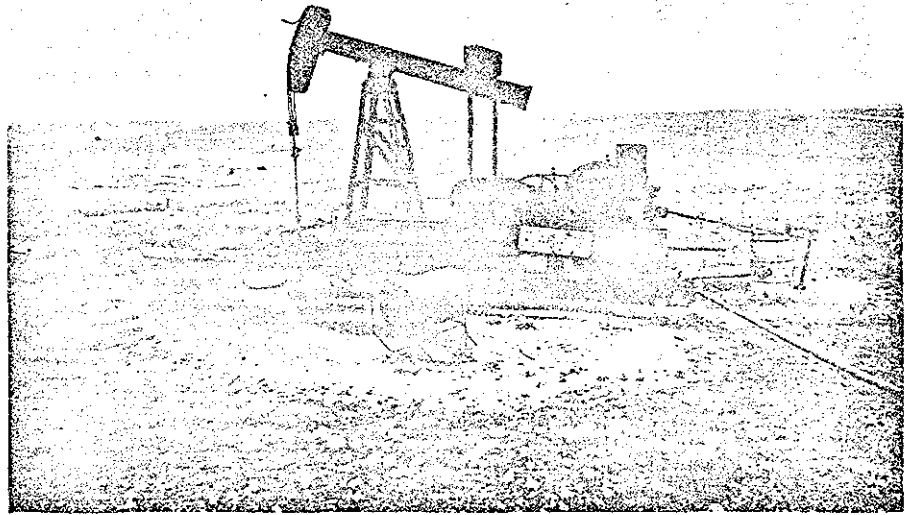
Fig. 75

T22S; R9E; Section 35; Chase County. The Texas Company, W.L. Hartley Lease, Well #4. Other pumps are much larger. Note denuded area near well and connecting pipes. Many similar pumps found on eastern escarpment of Osage Site.

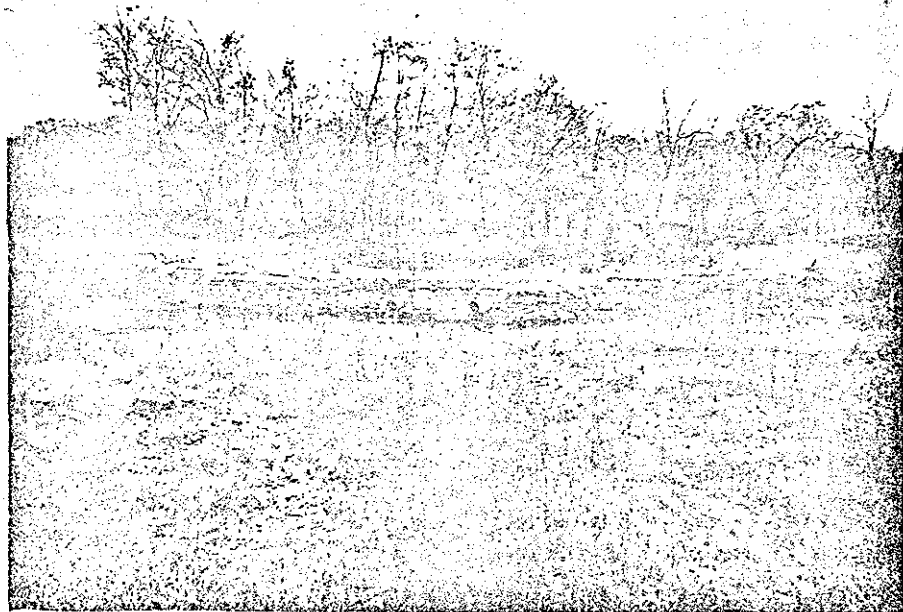
Fig. 76

T22S; R10E; Section 22; Chase County. Stone low-water bridge with cement covering. Now located in pasture, new bridge 100' north. Fair condition. South view. Located outside study area boundary.

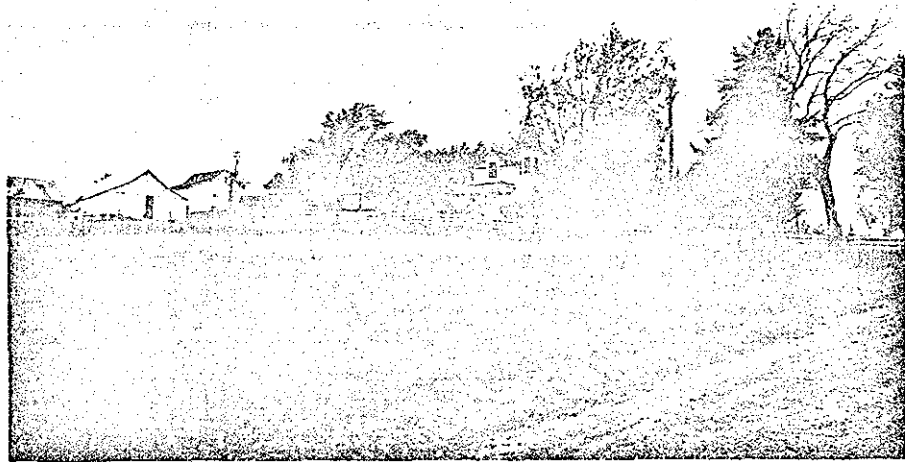
Fig. 77

T22S; R10E; Section 22; Chase County. Frame. Rectangular plan. 2 story house with corner turret. Dormers. Porch on east with bargeboard ornamentation. Good condition. Southwest view.

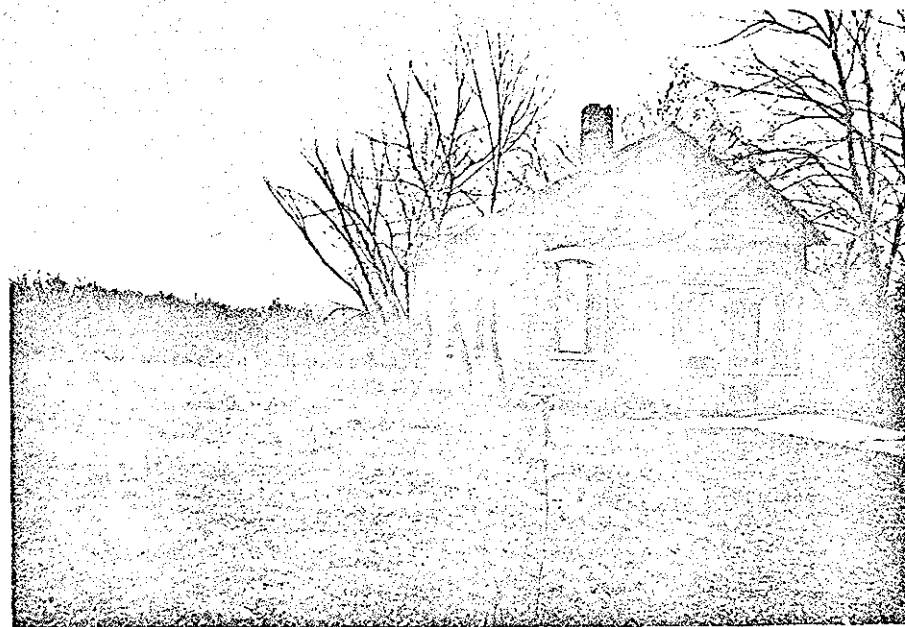
T22S; R10E; Section 14; Chase County. Limestone. Frame entrance. 1 story, gable roof, center chimney. Windows out, used for cattle feed storage. On the left, a sidewalk parallels the structure. Poor condition. East view. Both of above located outside study area boundary.
