PRAIRIE NATIONAL PARK (PROPOSED):

CULTURAL RESOURCES SURVEY

Prepared by  
Ronald W. Johnson

November, 1974

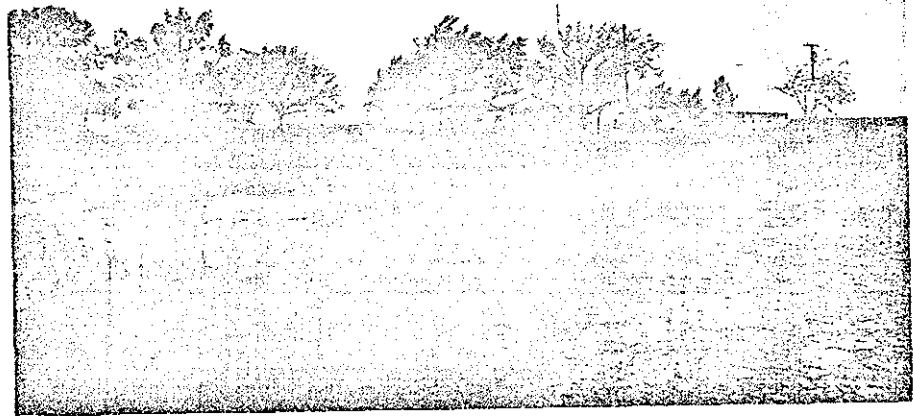
Fig. 81

T21S; R10E; Section 33; Chase County. Several small frame buildings. May have been a small trading center. Phillips Oil leases nearby. About  $\frac{1}{2}$  dozen buildings, 2 trailers. Fair condition. Northwest view. Located outside study area boundary.

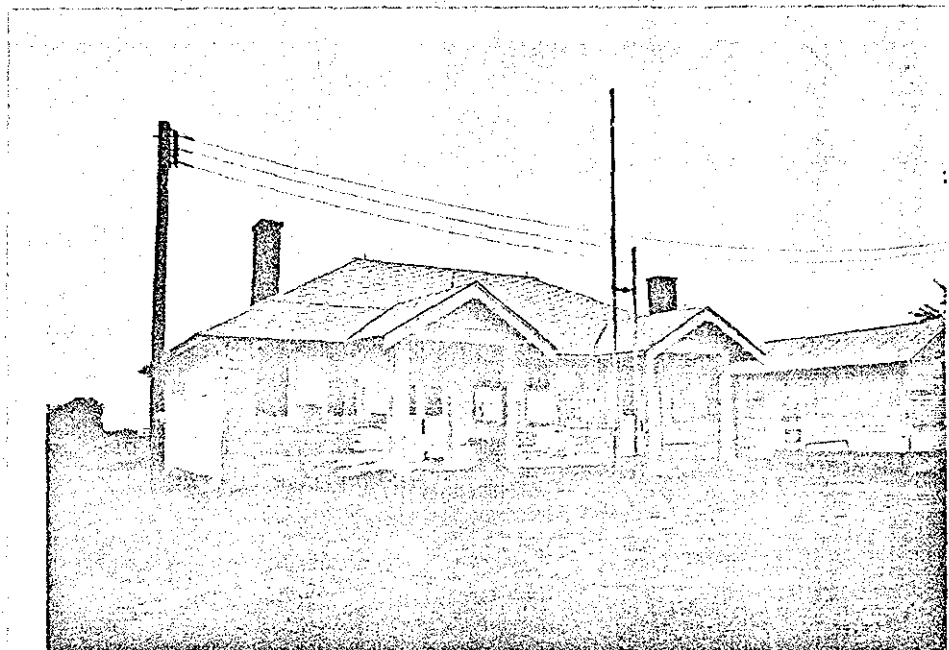
T20S; R9E; Section 27; Chase County. Abandoned frame school. Double entrance & porches. 2-4 rooms inside. Used for storage. Hip roof. 2 chimneys. Fair condition. South view. Both of above located outside study area boundary.

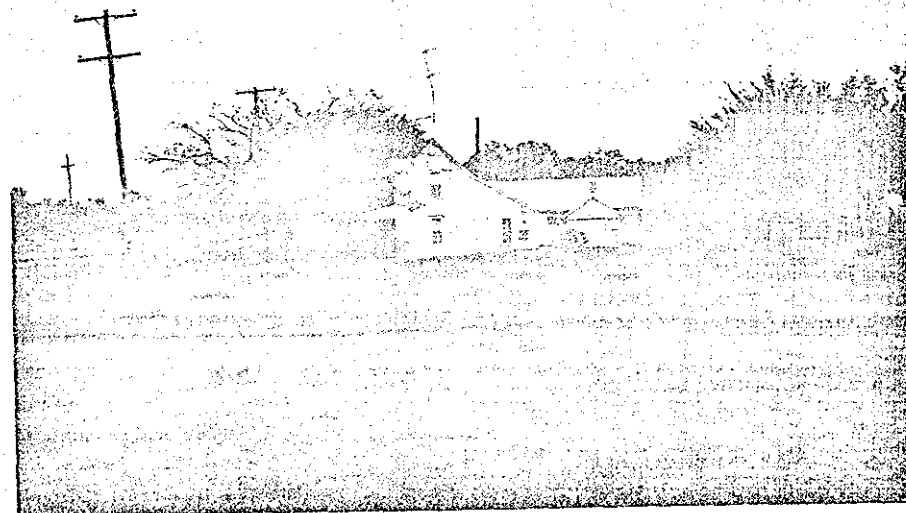
Fig. 85

T20S; R9E; Section 27; Chase County. Frame. Rectangular plan. 2 story house with rear addition. 3 bay, small porch in front. 1 dormer. Steeply pitched front roof, rear has gentle slope. Good condition. South view. Located outside study area boundary.

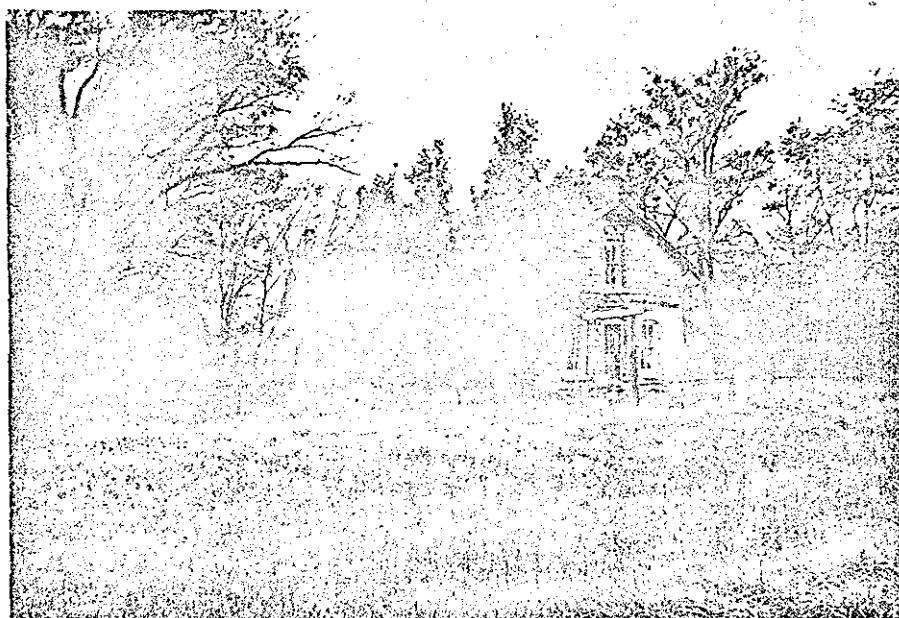
T20S; R9E; Section 27; Chase County. Stone. L plan. 1½ story, 3 bay with small porch over front door. 3 inside end chimneys. Poor condition. West view. Located outside study area boundary.

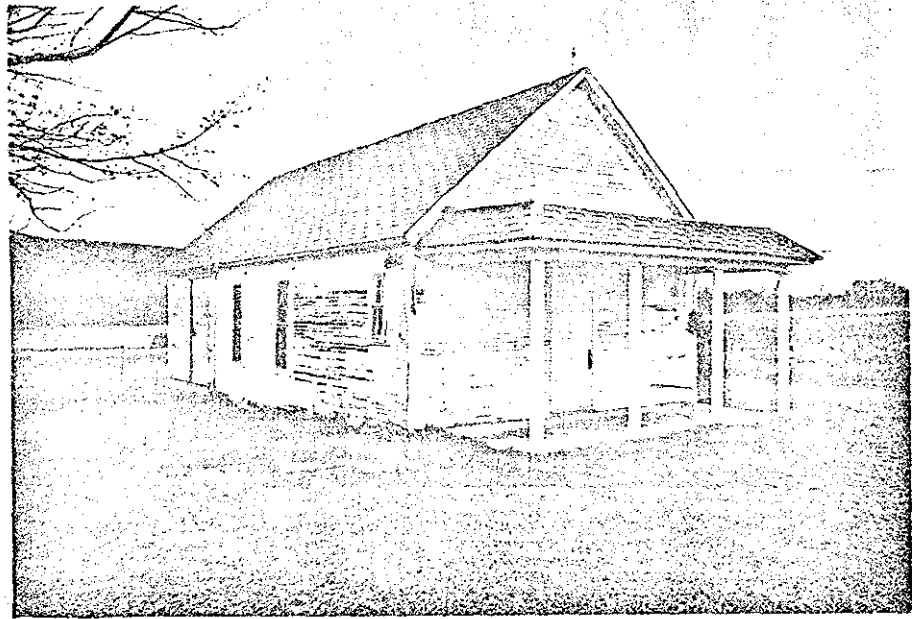
T20S; R9E; Section 14; Chase County. Frame. Rectangular plan. Re-cycled church or school. Porch on main facade. Fairly recent roof. Note double-wide door at rear left. Fair condition. Northwest view. Both structures located outside study area boundary. Going north & south along dirt road at rear of above structure, one finds a number of farm-not ranches. A few stone buildings in the vicinity.

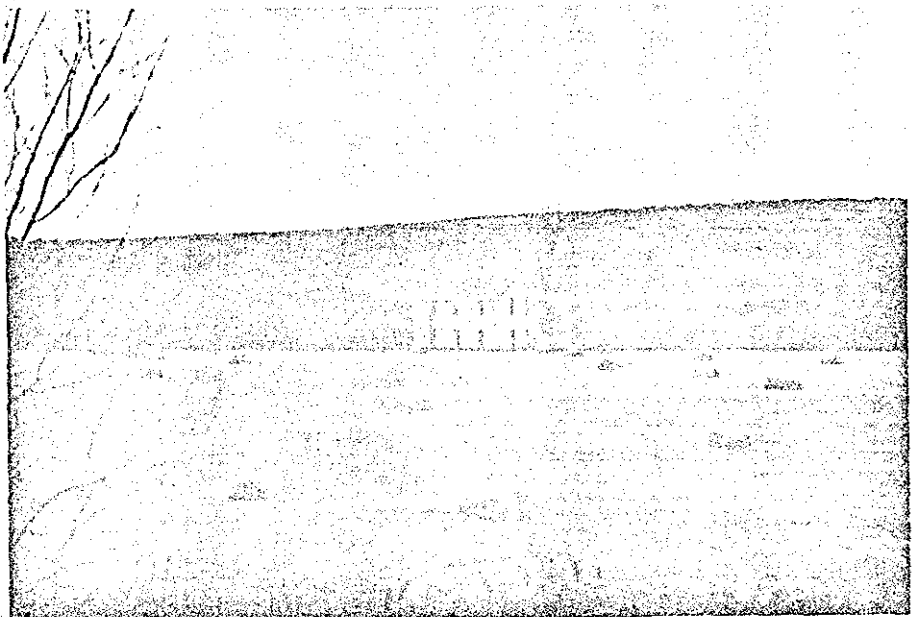
Fig. 88

T20S; R9E;  
Section 11;  
Chase County.  
Limestone. T  
plan. Large  
2 story, gable  
roof, 3 bay.  
Stone arches  
& lintels.  
Note the  
interesting  
quoin work  
and pattern

around windows. 2-3 inside end chimneys. Fair condition. East view.

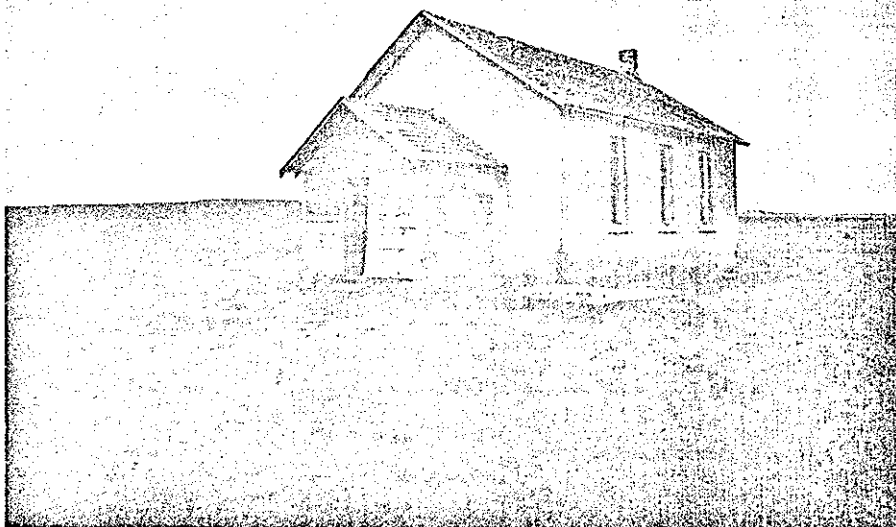
Fig. 90

T20S; R8E; Section 10; Chase County. Stucco faced 1 room school. Gable roof. Poor condition. Northwest view. Located within study area boundary.

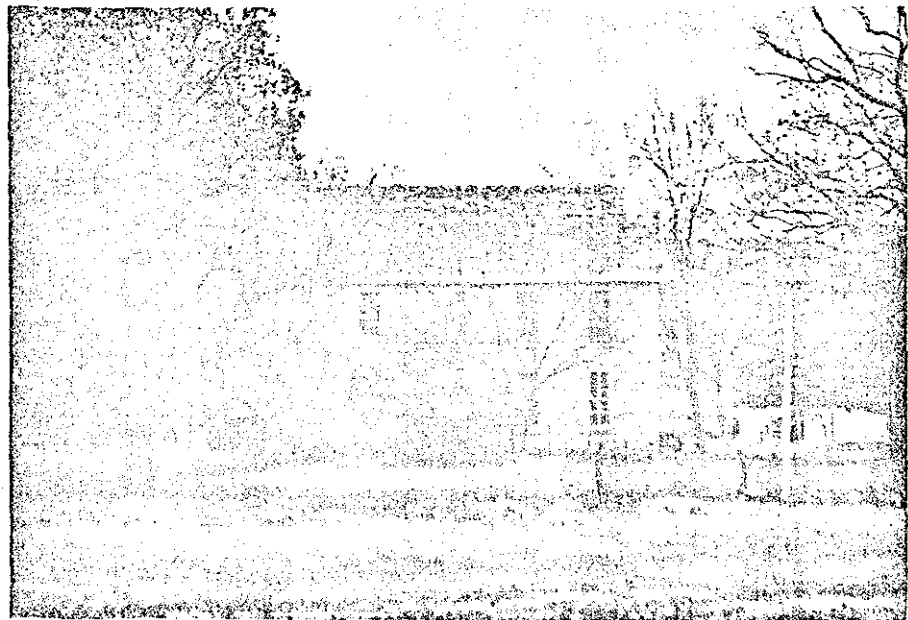
T20S; R9E; Section 2; Chase County. Limestone. Rectangular plan. 2 story, 4 bay, gable roof, shingles, 2 inside end chimneys. Fair condition. East view. Located outside study area boundary.

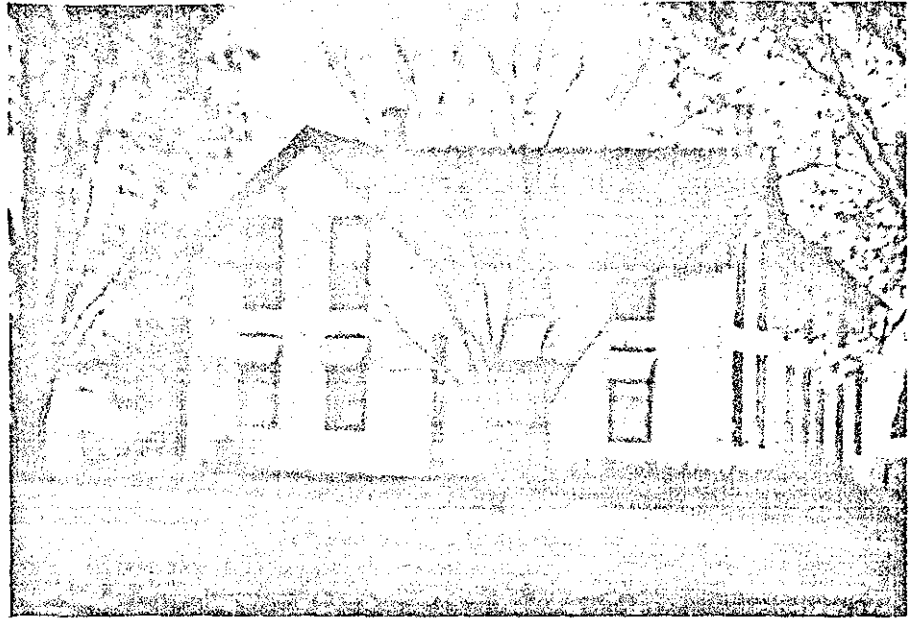
T21S; 9E; Section 32; Chase County. Frame. T plan. 2 story with 3 chimneys, rear addition. Good condition. East view.

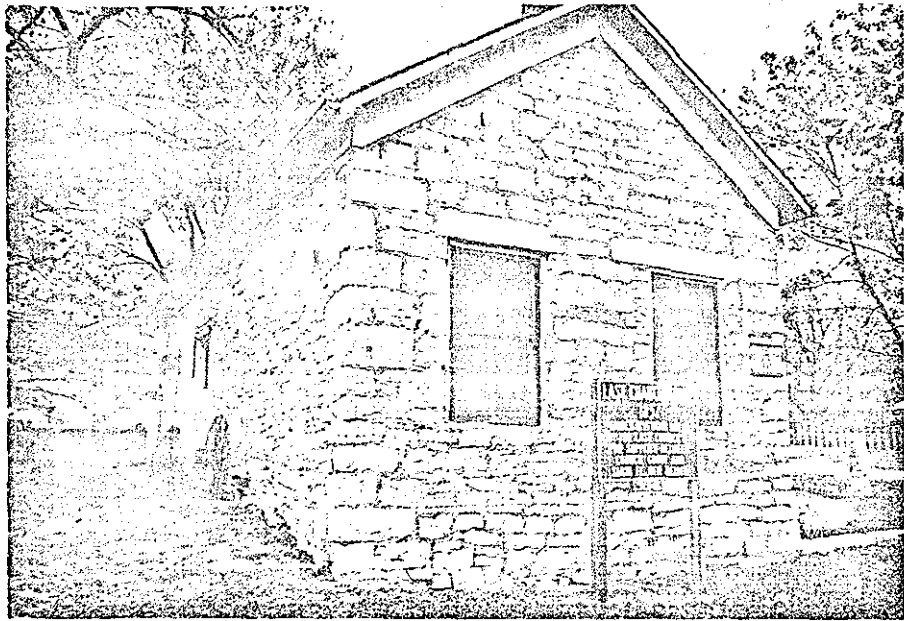
Fig. 97

Historic limestone store. Served to re-supply westward settlers; used as antique store now. Part of the Council Grove Historic District. Listed on the National Register. See appended material.

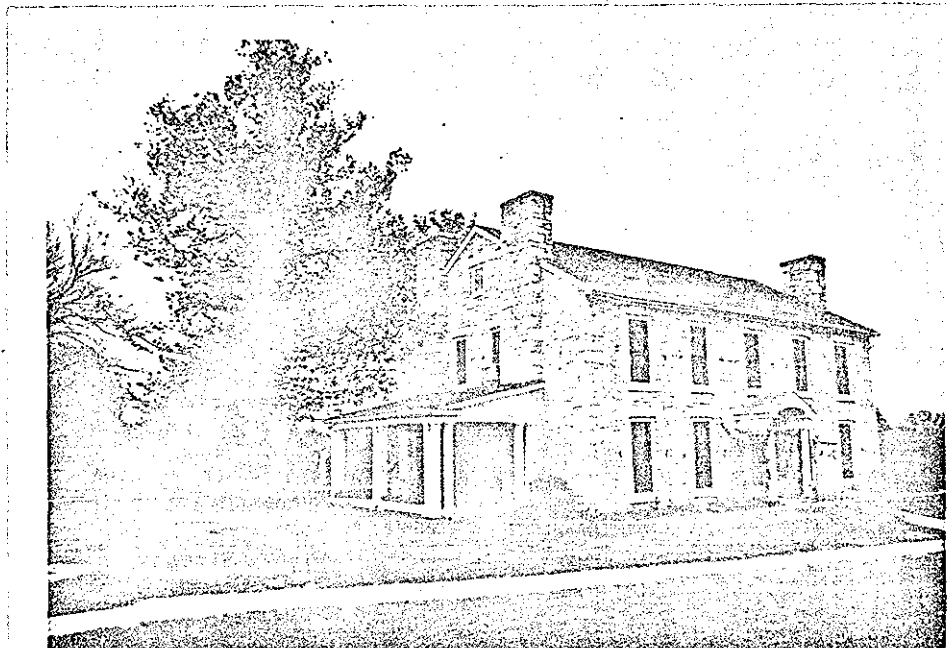
Fig. 101

Constructed 1850. Used as hotel, school, Indian agency. Now a museum. Historical District. See appended material.

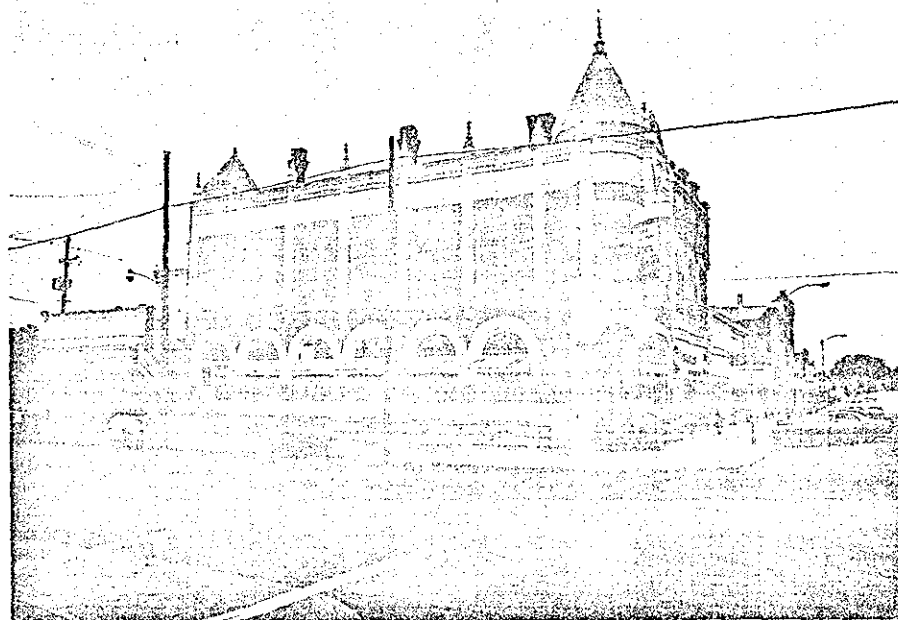
Fig. 104

Well preserved bank building. National Register listing.  
Southwest view. See appended material.

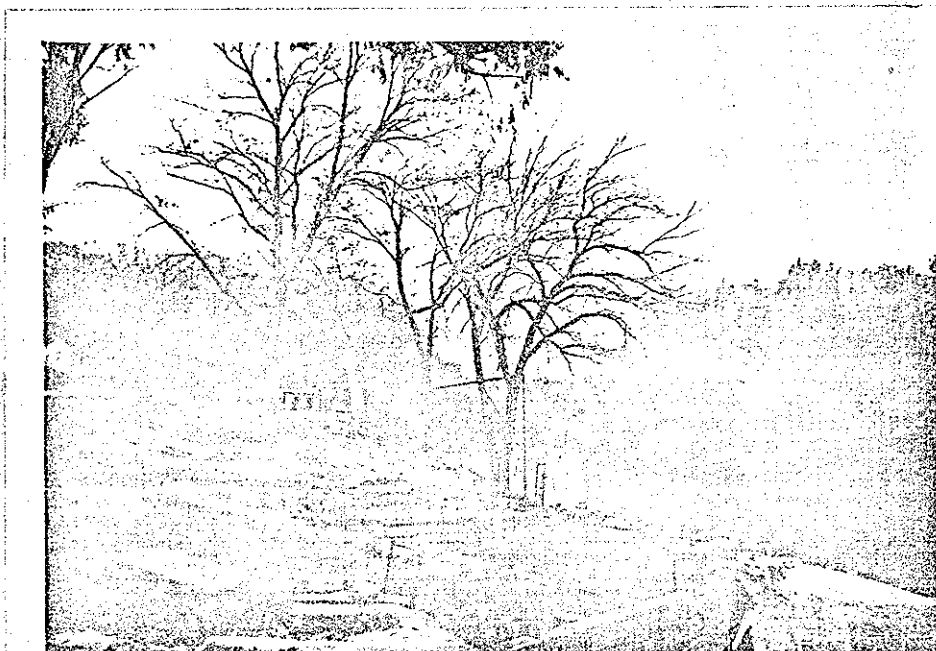
Fig. 109

Mill ruins near Kansas #177. Erected 1859, destroyed 1934.  
Only 2 mill sites in or near the 3 sites. Others certainly  
erected but little remains to mark their location.

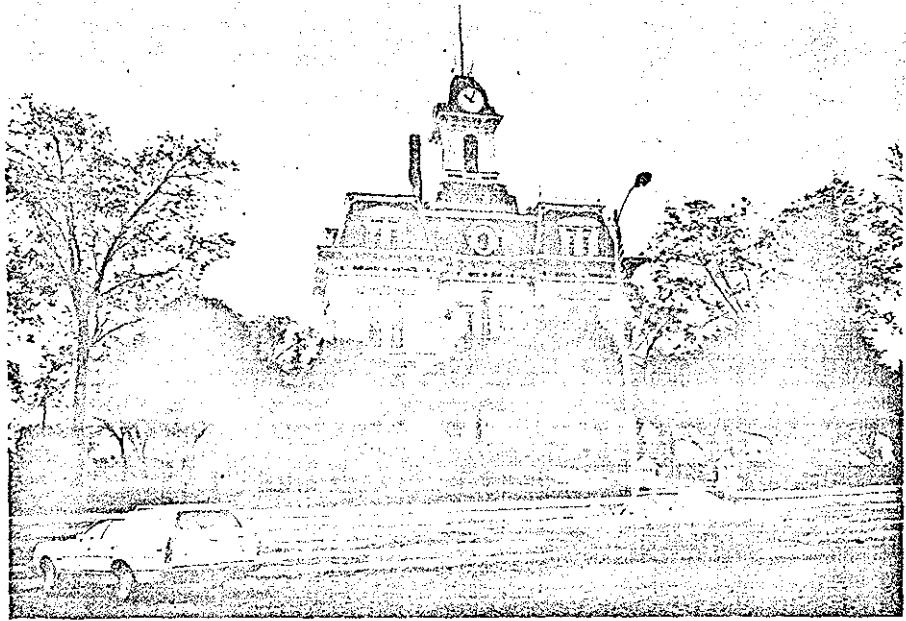
Fig. 114

A National Register landmark. The oldest operative courthouse in Kansas. South view.

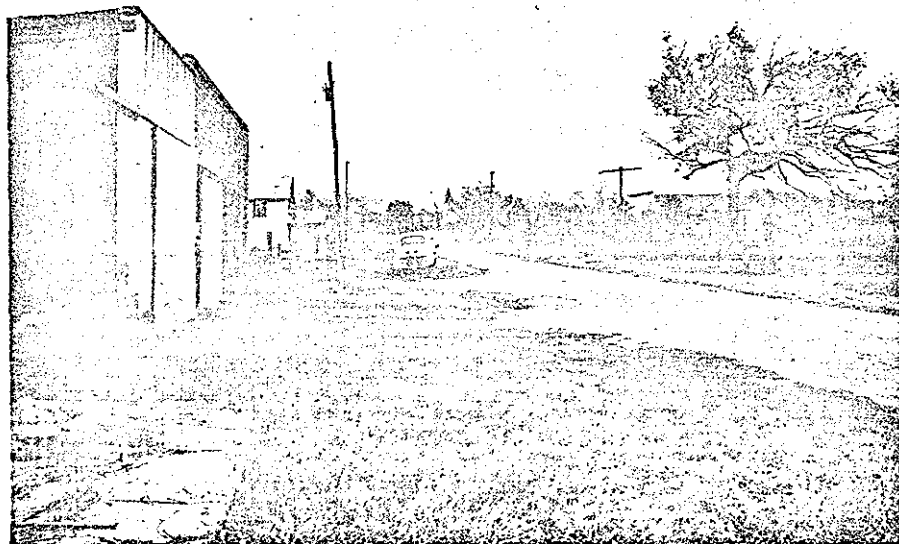
Fig. 118

Chase County. Main business area. Most commercial businesses closed and boarded. Little evidence of activity. West view.

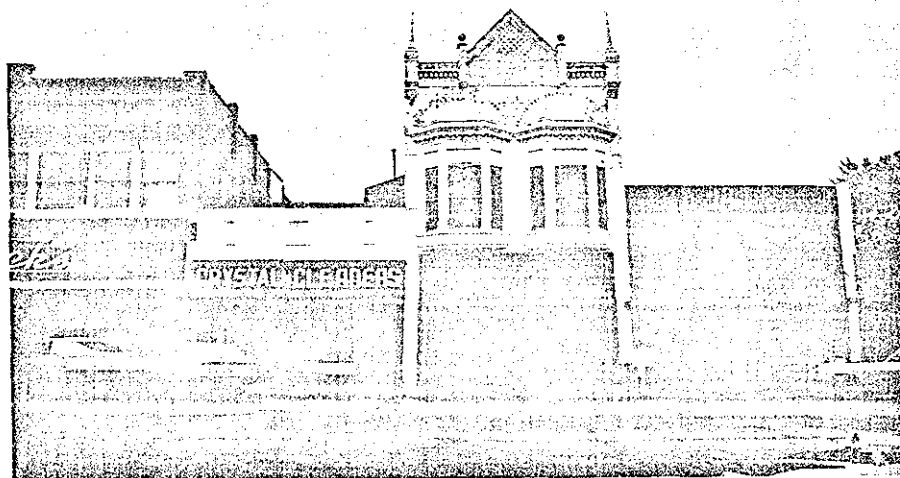
Fig. 120

Main Street - late 19th Century commercial building. Structure significance stems from intricate facade. Note the small towers and 2 protruding bays. East view.

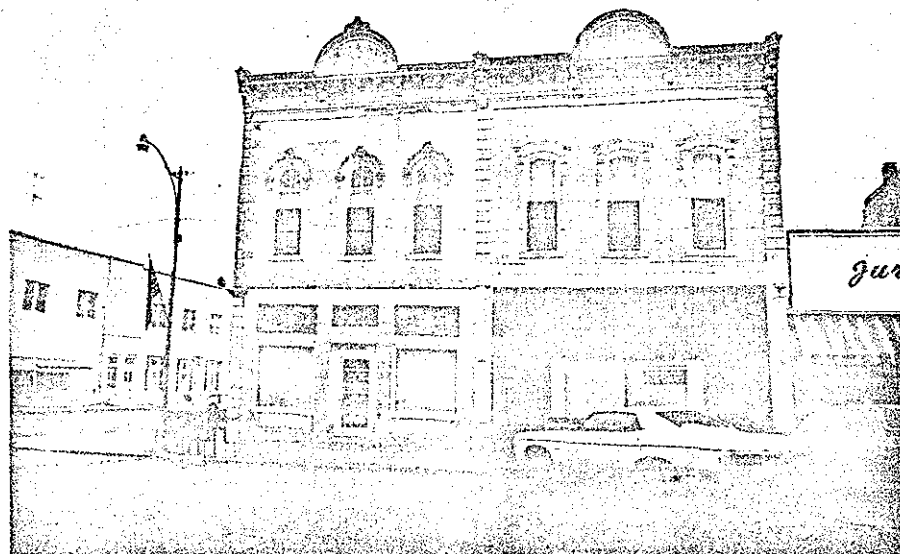
Fig. 120 A

Main Street-constructed 1879. Not quite identical designs. Different quoin work & window arches and lintels. West view.

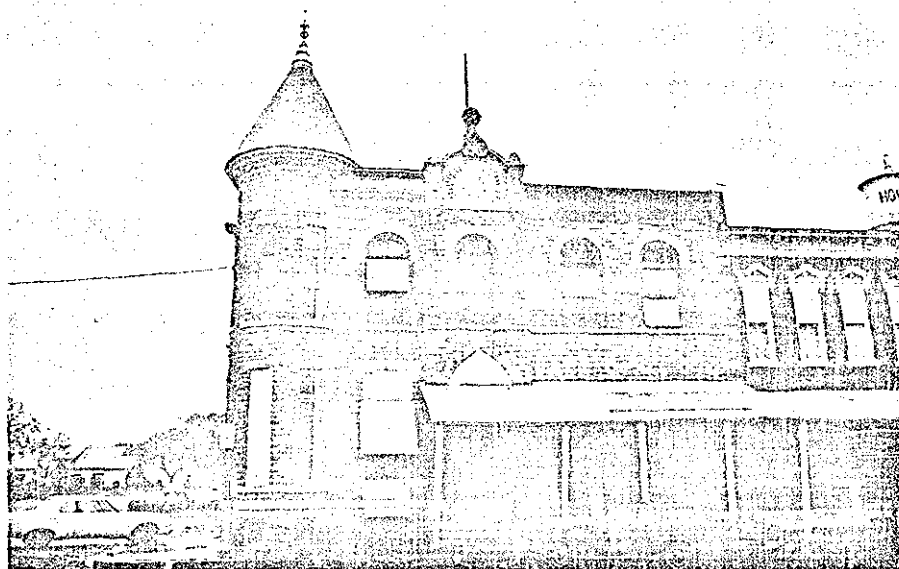
Fig. 121

Main Street - Howard, Kansas. Kansas #99. Large corner tower enhances rectangular plan building. Shaped stone. Canopy porch added later. East view. Located some distance south of the Chase site.

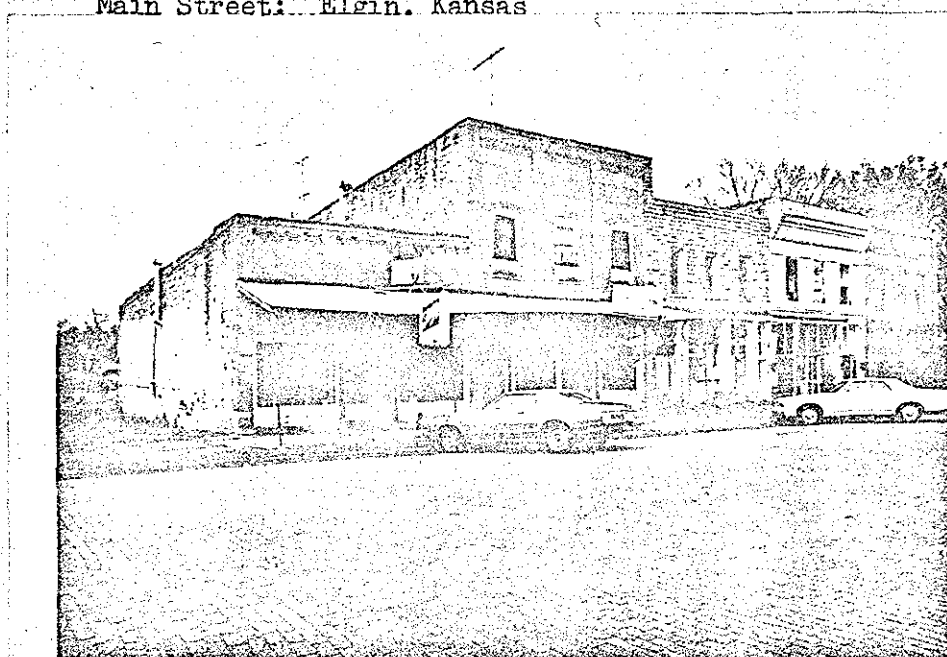
Fig. 123

Main commercial block. 3 structures at right completely gutted. Building (second from left) houses a local museum - open on Sundays. Located outside study area boundary.

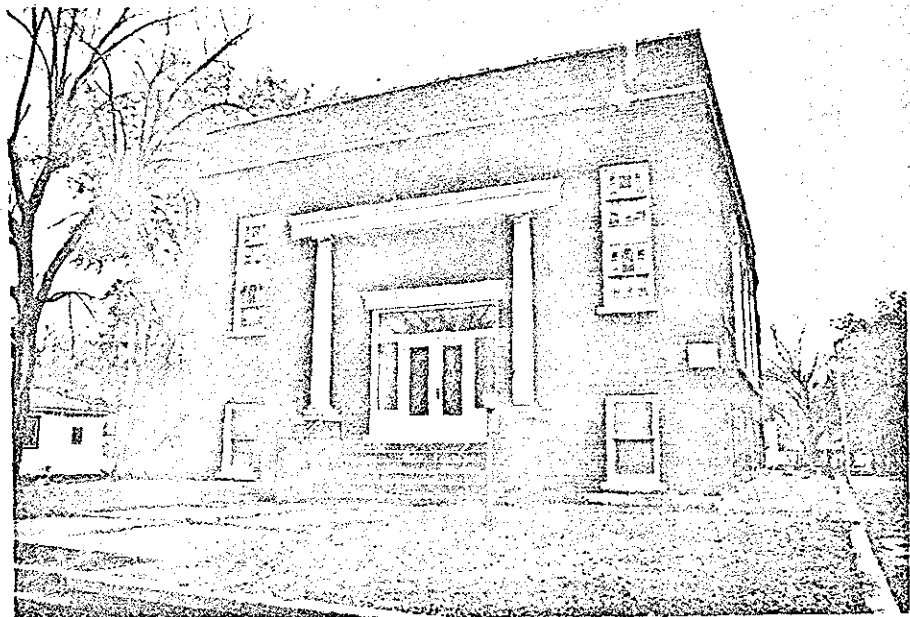
Fig. 127

Built 1892, rebuilt 1921. Brick, 2 doric columns. Leaded glass windows. Unique arch style for small town church. Located outside study area boundary.

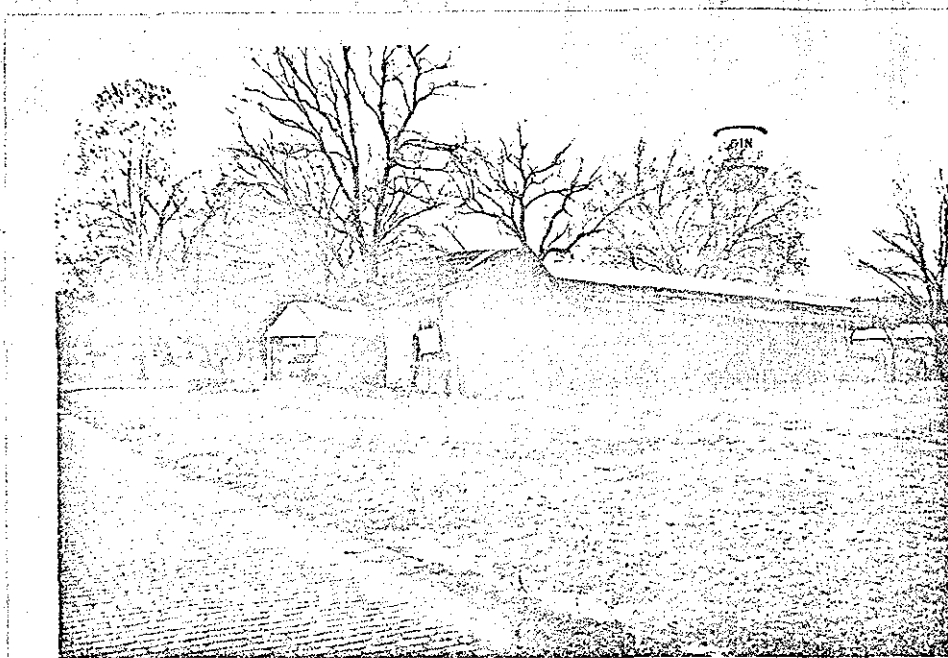
Fig. 128

Structure used as a livery stable and as a horse and mule feeding. Also employed as a sale barn. Many saddle horses were stabled here in connection with the local cattle industry. Later used for feed store, hay storage, cattle & hog feeding. An old treadmill used for pumping water, operated by a vicious stallion.

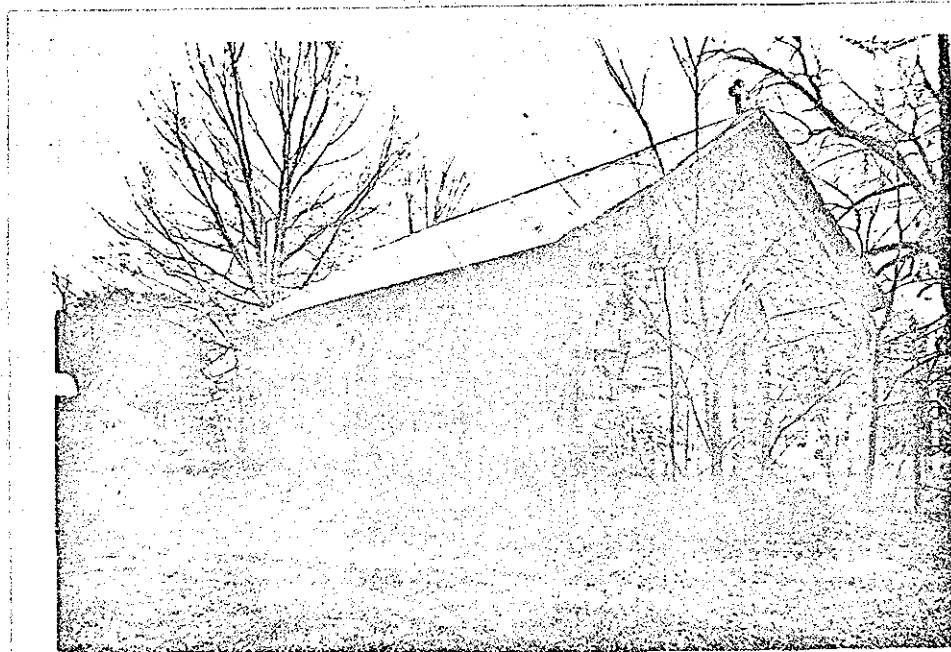
Fig. 129

Stone church, currently used for hay storage. Both of the above structures located outside study area boundary.

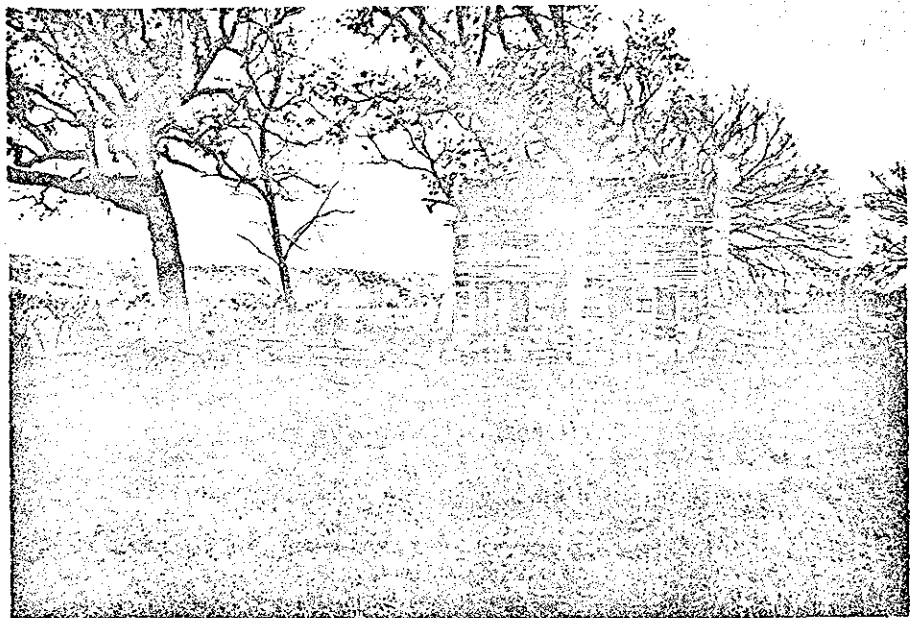
Fig. 134

T35S; R10E; Section 17; Chautauqua County. Frame.  $1\frac{1}{2}$  story.  
Rectangular plan. Gable roof. Outside end chimney almost sep-  
erated from structure. Note stone fence in foreground. Deter-  
iorated. East view. Located outside study area boundary.

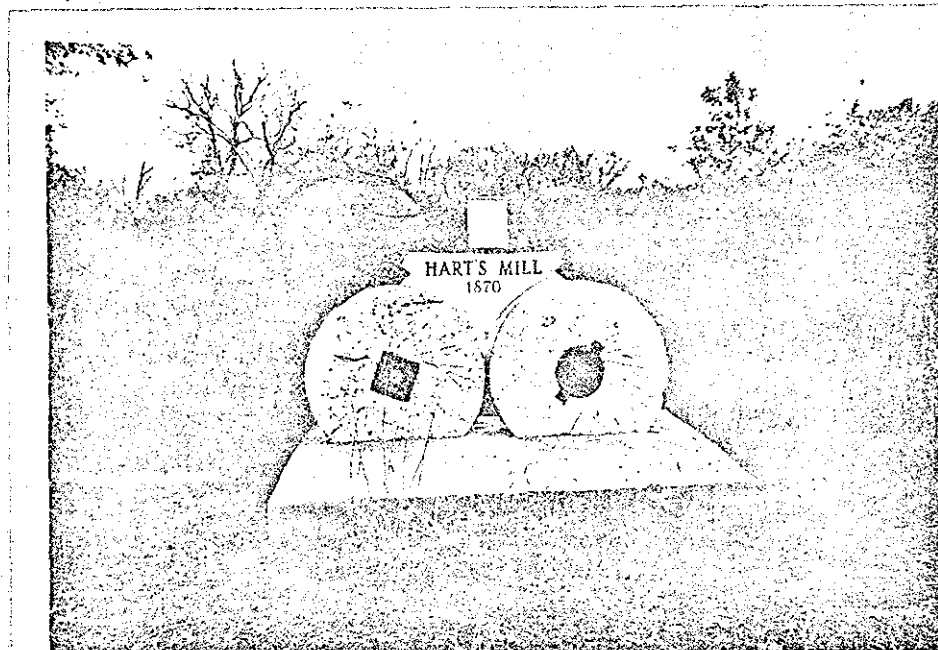
Fig. 136

T35S; R9E; Section 1; Chautauqua County. Mill site near a two span iron bridge, single lane, no plate. Sign above burr stones reads as follows: "Hart's Mill, the town of Hart's Mill originated in 1870 when James Henry Hart built the mill. James Henry (see next page)

Hart was appointed postmaster by the U.S. Government on October 11, 1872, and thus the Hart's Mill consisted of a mail stop, a grist mill, grocery store, and a growing farm community. Oldtimers can recall when horse thieves and cattle rustlers reportedly were caught, and then tried, and sentenced all within the shade of an old oak tree. When the mill was partially destroyed by a flood in May of 1885, the Post Office was later established at the new town of Hewins on April 6, 1887, and the facilities were then transferred there from the Hart's Mill. Hart's Mill was subsequently relegated to the past and its history almost forgotten.

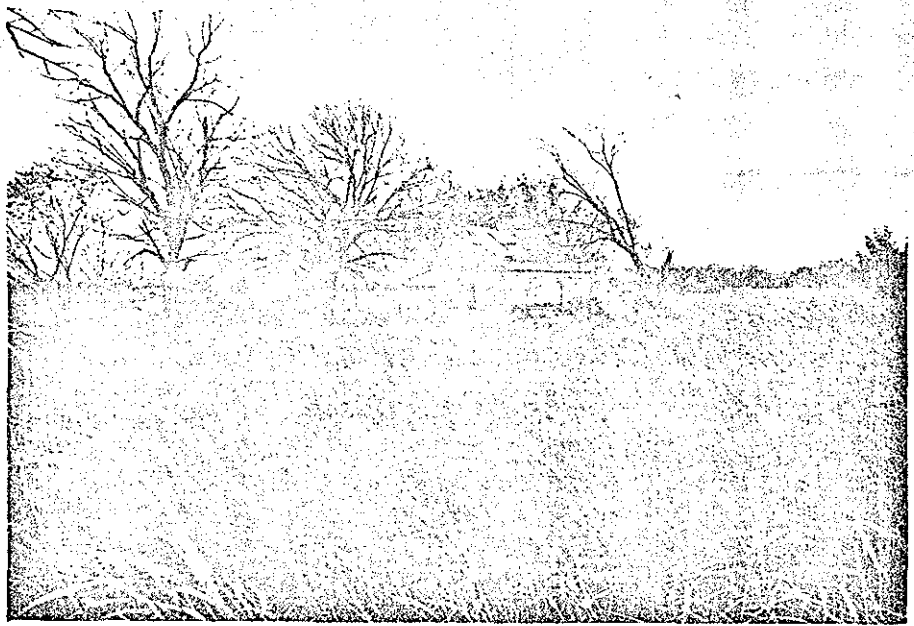
T34S; R9E; Section 35; Chautauqua County. Frame. Rectangular plan. 1-2 room cabin, 1 sotry, 3 bay, rear porch. Shingle roof. Deteriorated condition. Northeast view. Located outside study area boundary. Note tall grass in foreground.

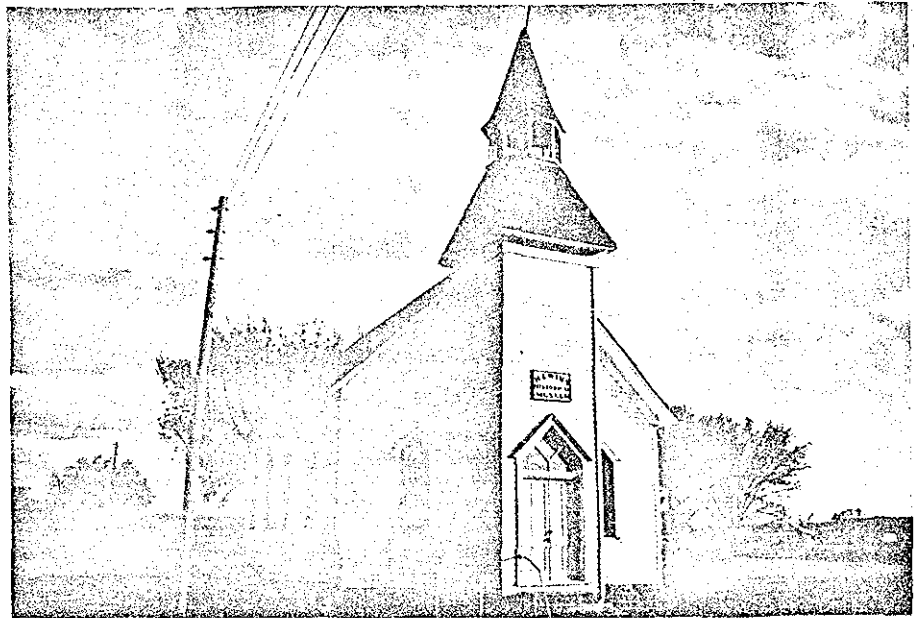
Fig. 140

Hewins, Kansas. Curator (Mrs. Leonard) lives across the street. Re-cycled frame church. Good condition. East view. Located outside study area boundary.

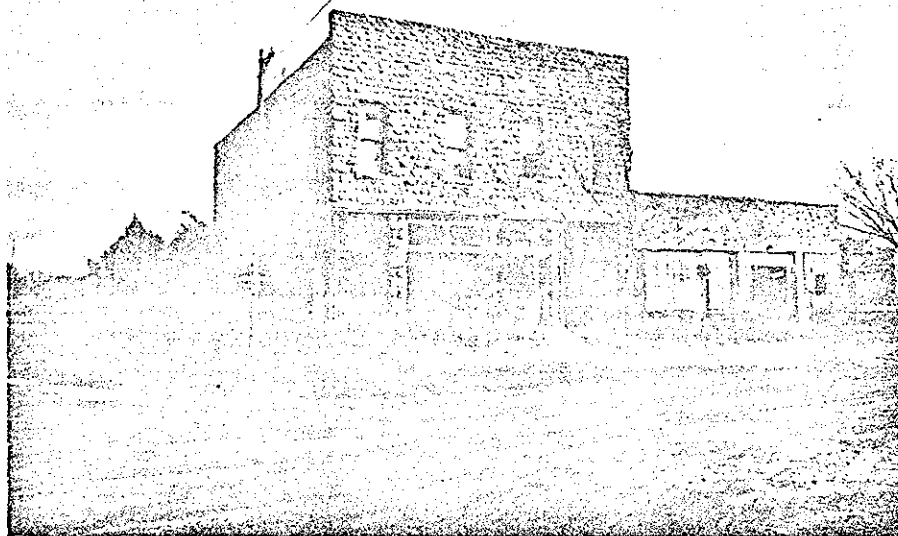
Fig. 141

Gutted commercial structure in Hewins, Chautauqua County. Largest in community. Datestone (1887). Deteriorated condition. East view. Located outside study area boundary.

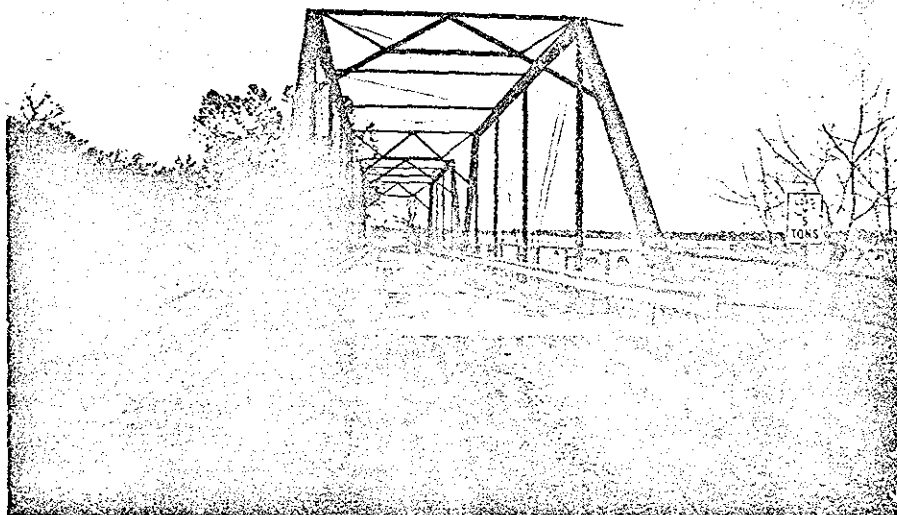
Fig. 142

T35S; R9E; Section 10; Chautauqua County. About 1 mile south of Hewins. Plate (1904) Midland Bridge Company. Kansas City, Missouri, Trocan and Freigang, Proprietors. Fair condition. North view. Located within study area boundary.

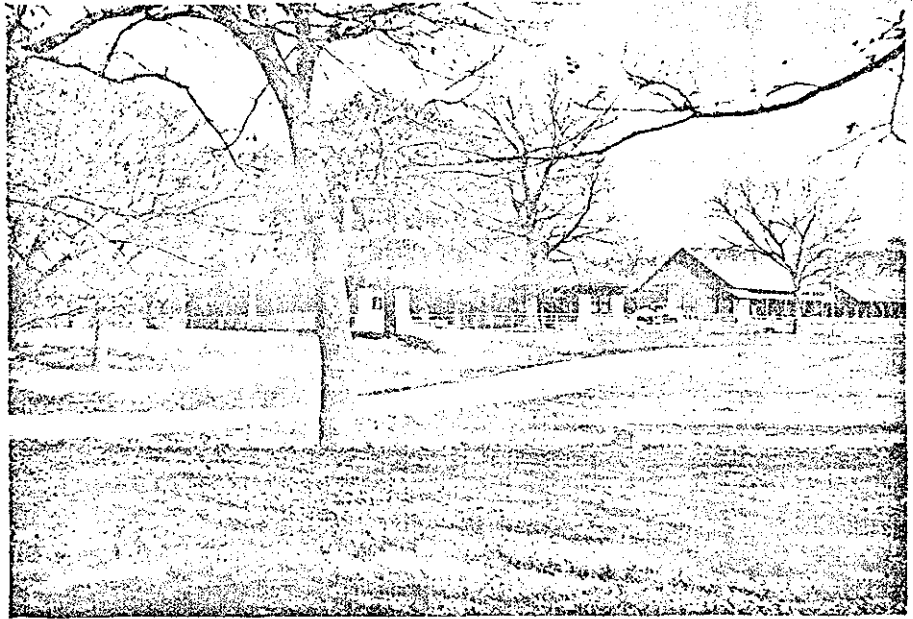
Fig. 144

T27N; R8E; Section 30; Osage County. Large, modern cattle ranch amidst the proposed park. Numerous buildings. Painted red. Northeast view. Located within study area boundary.

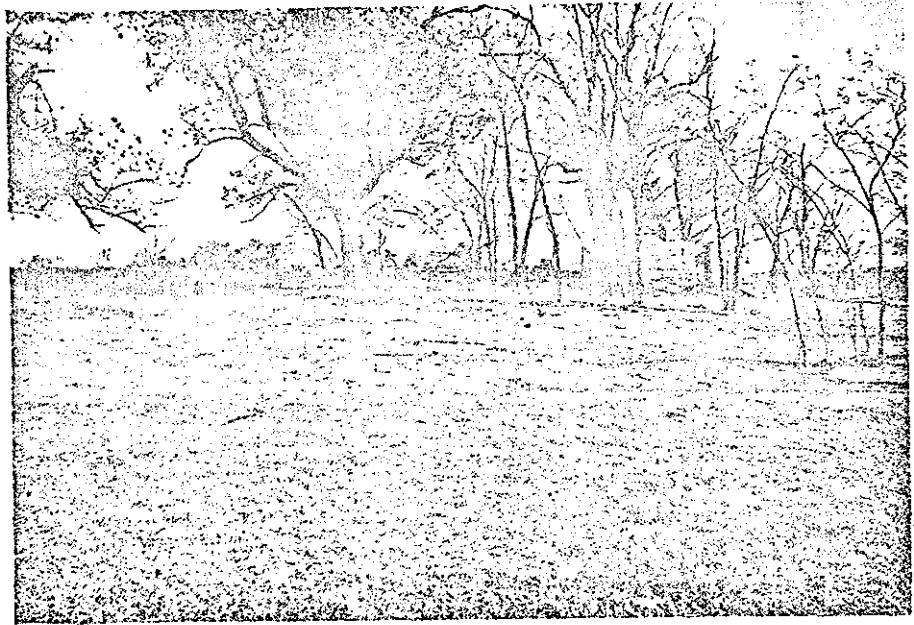
Fig. 146

T27N; R9E; Section 35. Stone ruins, L plan. East view. Osage County.  
Located outside study area boundary.

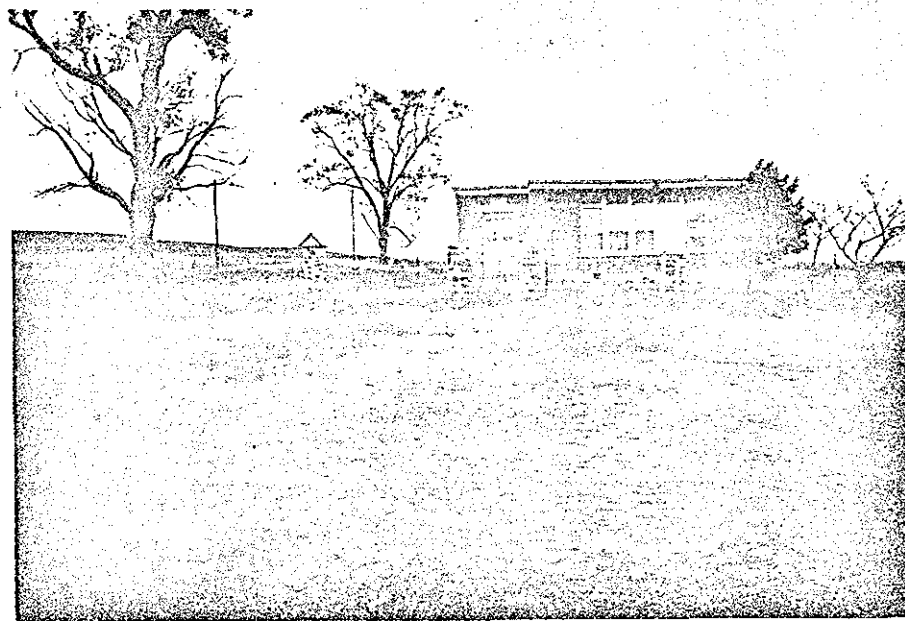
Fig. 148

Near Pearsonia. T27N; R8E; Section 21. Osage County. Brick structure. Irregular plan. Of more recent vintage. Fair condition. North view. Located outside study area boundary.

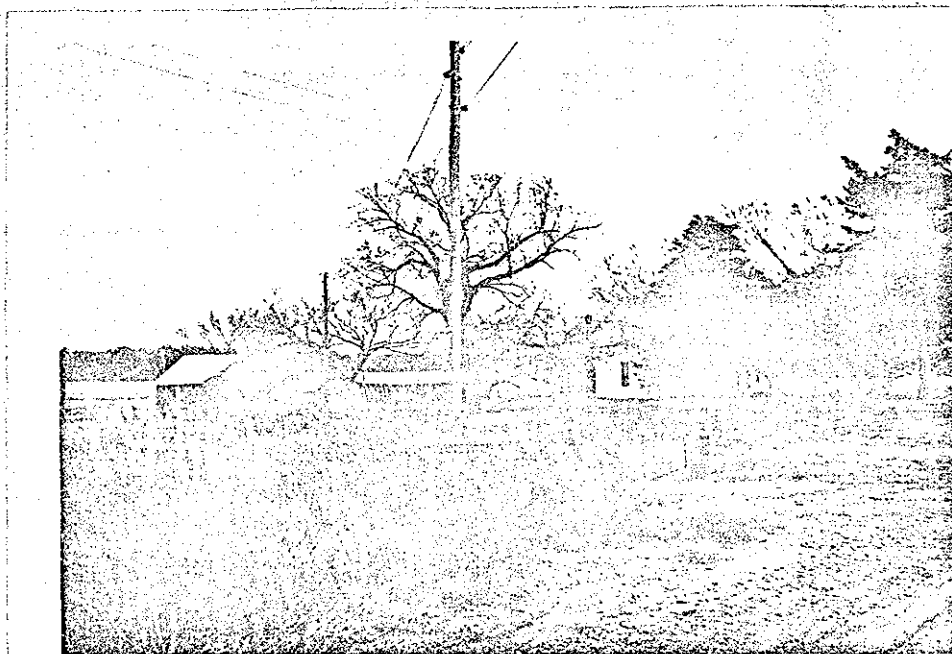
T35S; R8E; Section 36. Chautauqua County. Frame. T plan.  
2 story, porch in front. Recently vacated. Fair condition.  
Northeast view. Located within study area boundary.

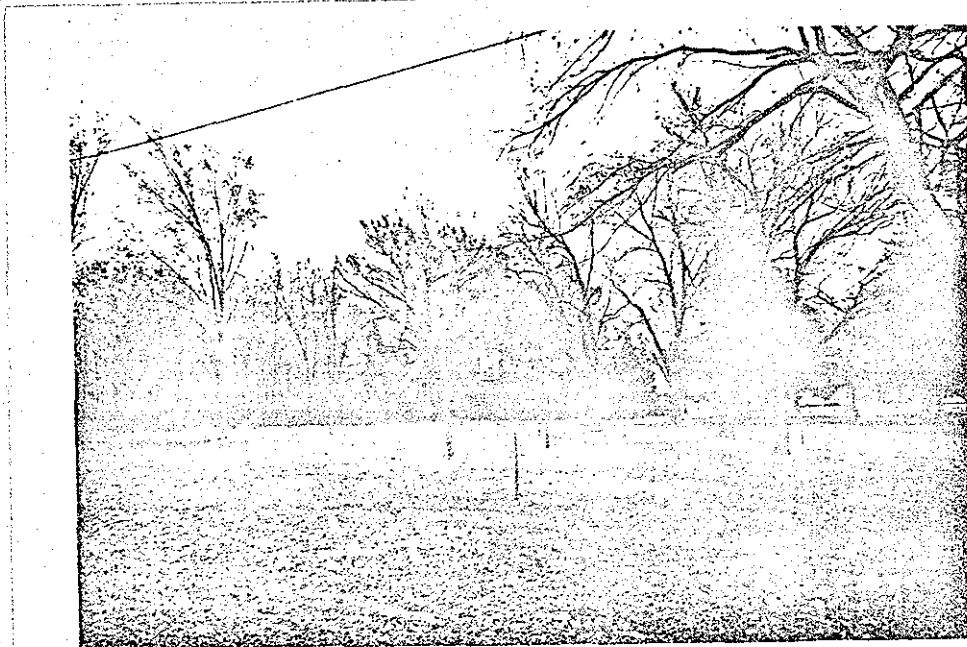
West Washington Street. Large frame structure, red with green  
roof. 3 story, towers. Rests on a single block, porch in  
front. Grove of trees. Carriage house/barn in rear. Good  
condition. Northeast view.

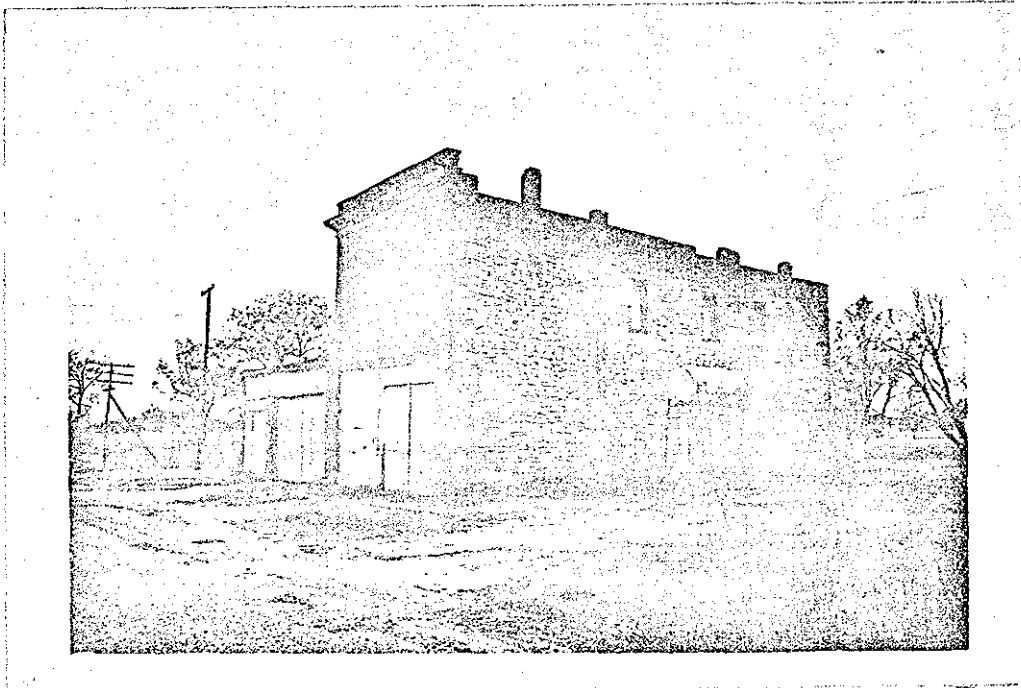
Fig. 155

Osage County. Small community just west of park. Best preserved community structure. Main building removed. Once on Midland Valley Railroad. Northwest view. Located outside study area boundary.

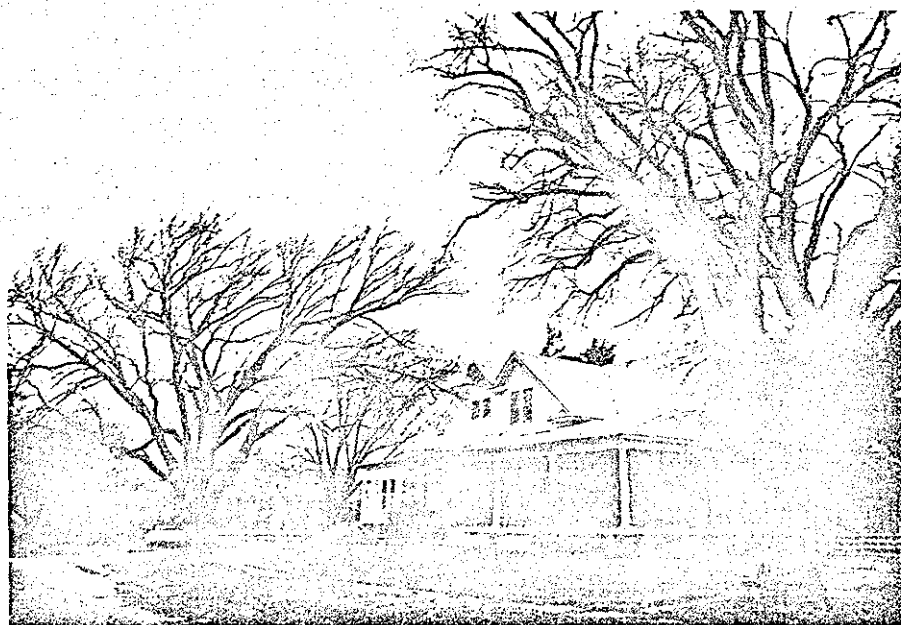
Fig. 156

Double gable house. Wide veranda. Note the carriage barn at rear. Northwest view. Located outside study area boundary.

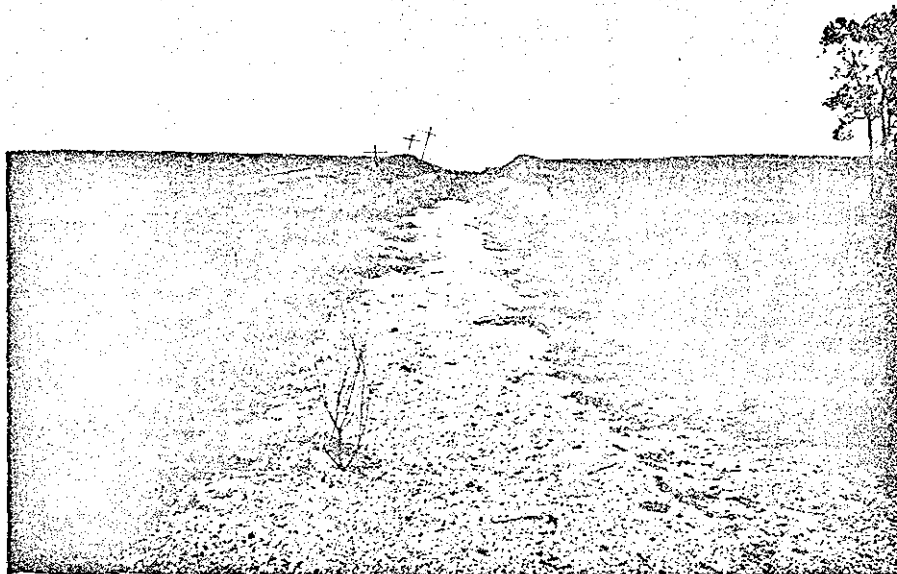
Fig. 157

T28W; R7E; Section 36; Osage County. Abandoned Midland Valley Railroad right-of-way. It skirts that western boundary of the proposed park. Southeast view. Located within study area boundary.

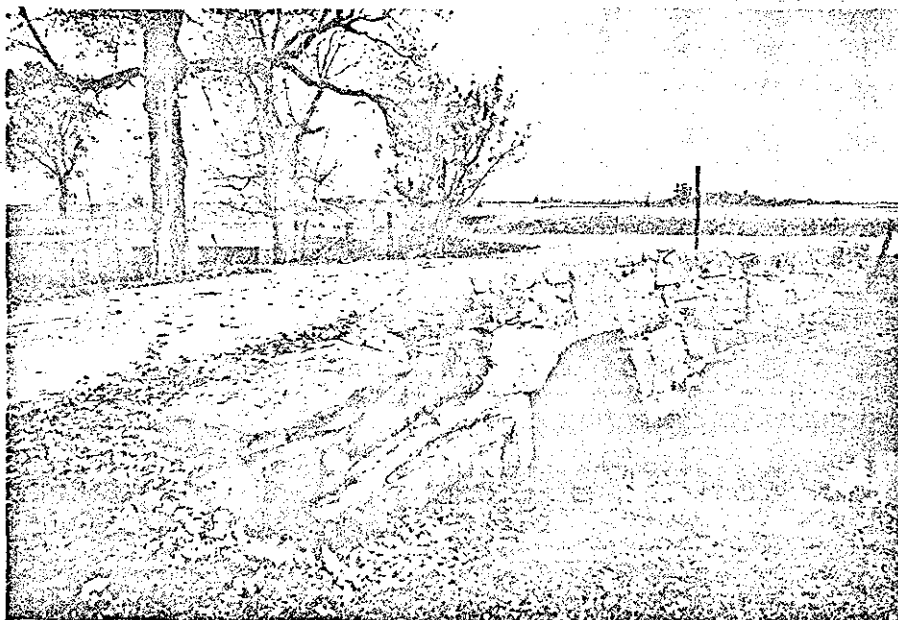
T28N; R7E; Section 25/26; Osage County. Just east of Foraker, near Foraker Cemetery. Stone arch bridge in good condition. Southeast view. Located within study area boundary.

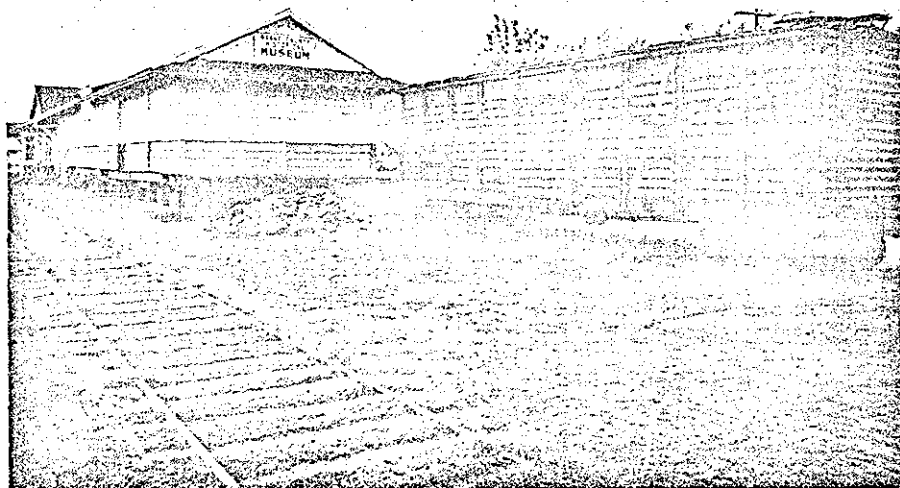
Fig. 160

Pawhuska, Oklahoma Museum housed in re-cycled ATSF depot.  
Note cattle car adjacent. South view.
