Geomorphic Adjustment of the Washita River

Washita Battlefield National Historic Site, Oklahoma

Natural Resource Technical Report NPS/NRPC/WRD/NRTR—2007/070

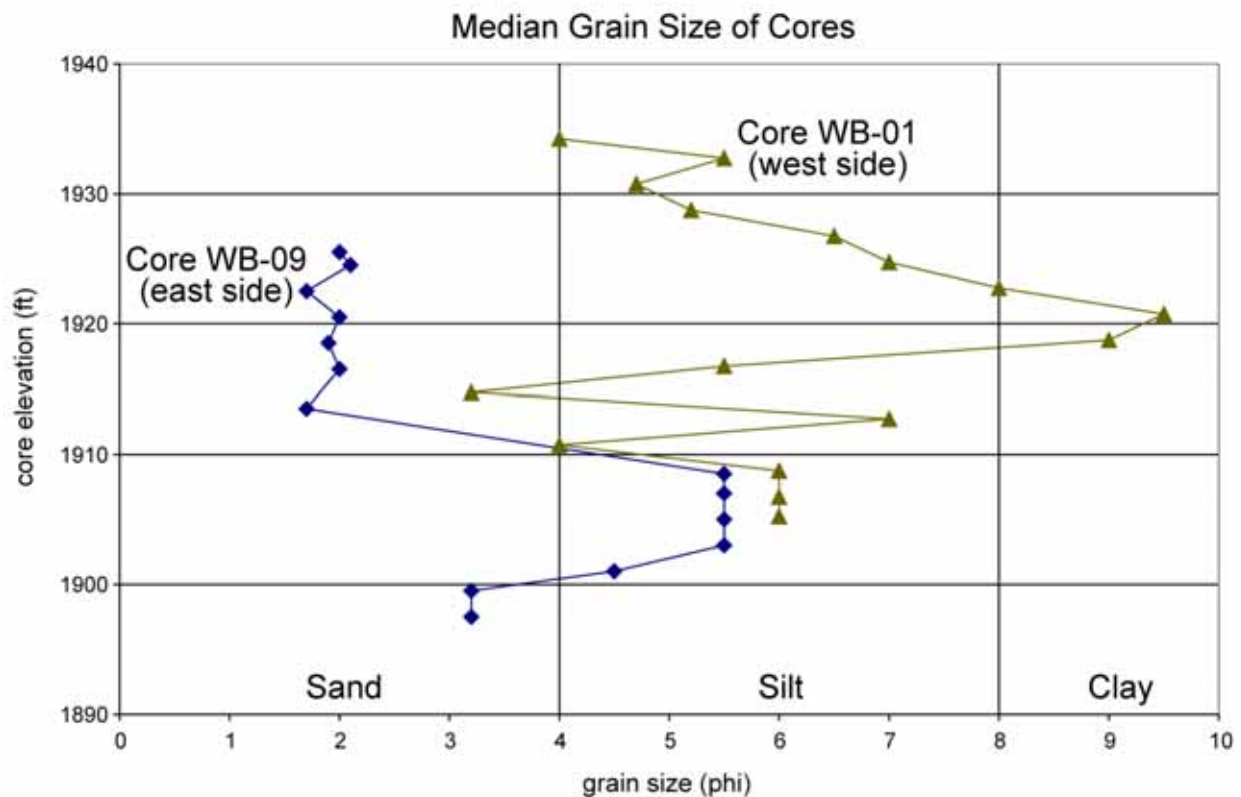
Figure 4. Median grain size for two cores collected from site. A wide range of grain sizes exist on the site, but the site is dominated by silt with sandy areas and limited clay lenses.

The particle size analyzer technique provided good repeatability for the core samples (Figure 4). The core from the west side of the site, WB-01, was predominantly silt. A small clay layer and a fine sand layer were present, but the core was dominantly medium silt. The east side of the site had obvious sand exposed at the surface. The sand extended 15 feet into the subsurface until it reached a silt layer. The core became sandier again at depth, but finer sand than at the surface.

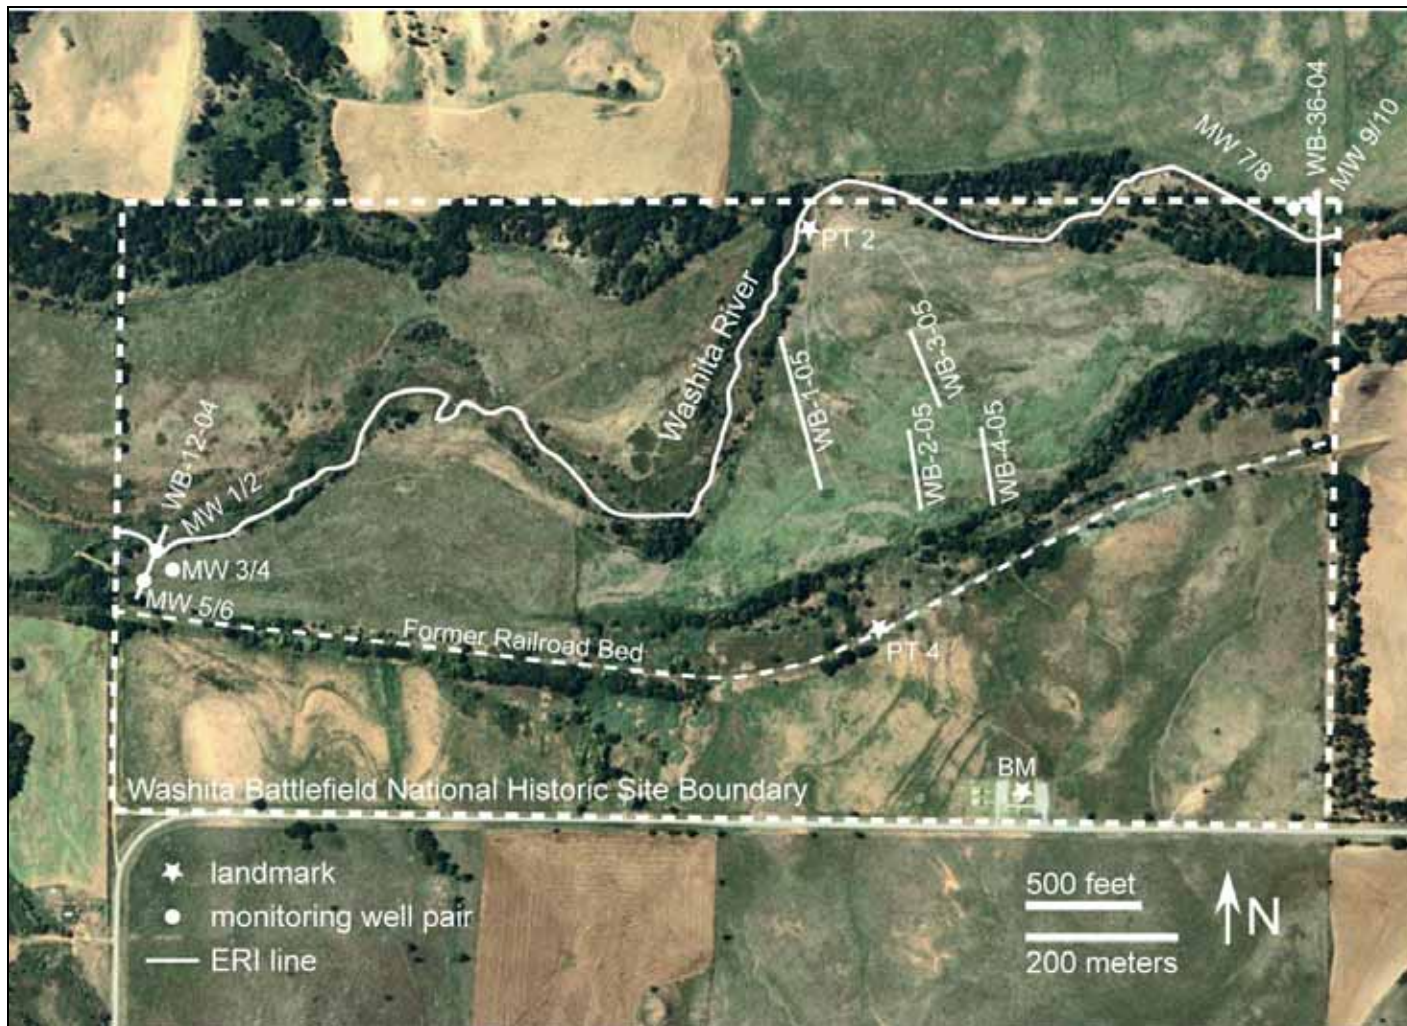
Figure 5. Map of subsurface investigations of WBNHS. Aerial photo is one meter resolution image collected on 10/1/2003 and downloaded from terraserver.com.

The first phase of ERI data collection occurred during June 2004. This data was collected to coincide with the locations of the wells and sediment coring locations (Figure 5 and Appendix C). The results were promising for providing a method to locate older channel deposits and were subsequently deployed during May 2005 to sample the area of the park where the 1868 channel was expected to exist.

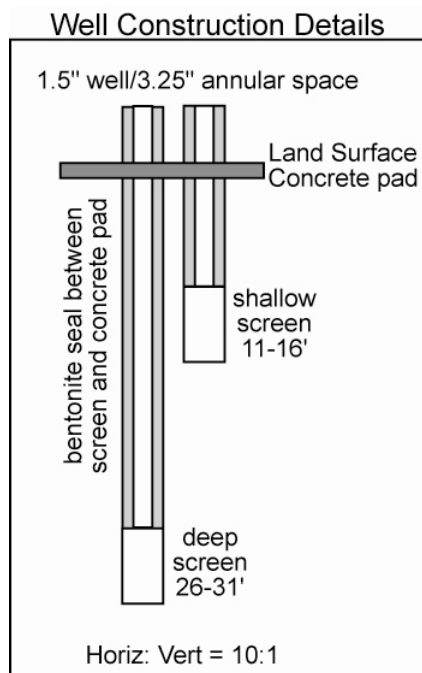
Figure 6. Well construction for monitoring wells at WBNHS. Screen depths were based on construction requirements and sufficient distance to obtain a vertical hydraulic gradient, not on knowledge of aquifer structure.

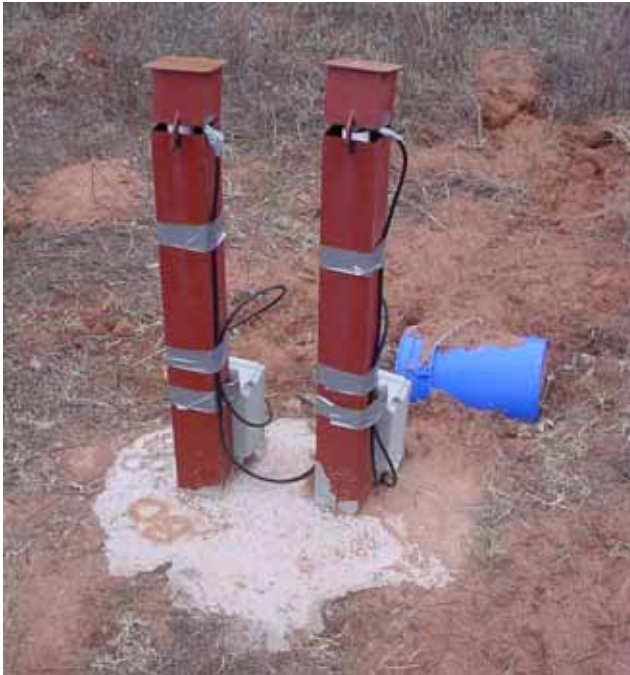
Figure 7. Photo of Wells WB-07 and WB-08, showing standpipe completion and transducer installation (2003).

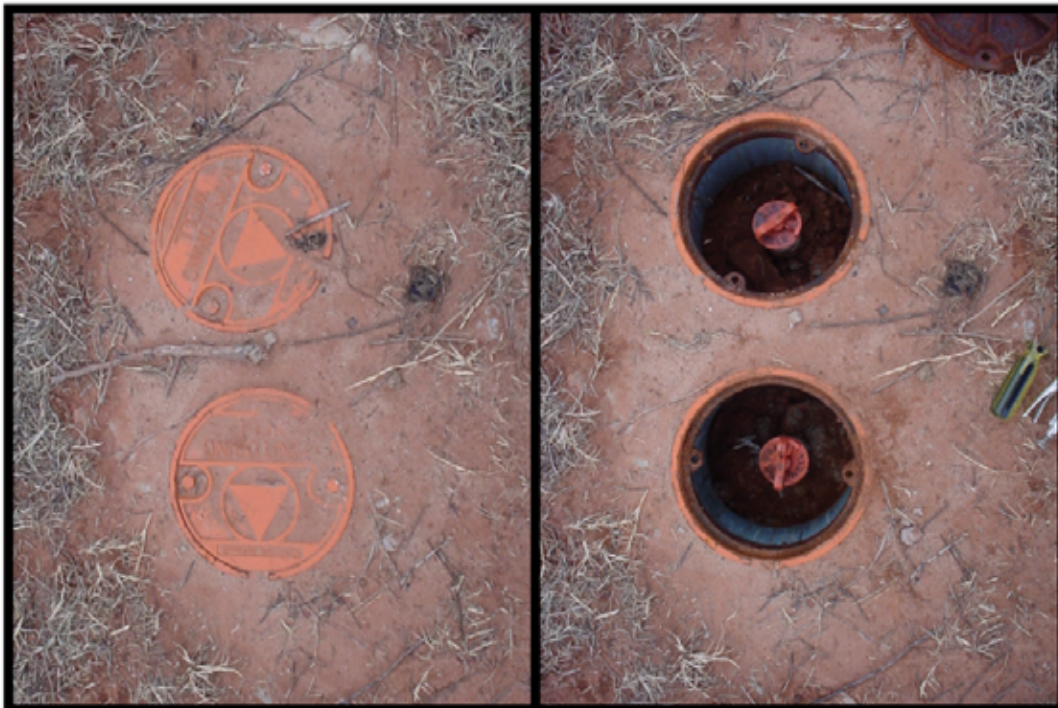
Figure 8. Photo of Wells WB-09 and WB-10 showing ground-level completion well caps used to protect PVC wells (2003).

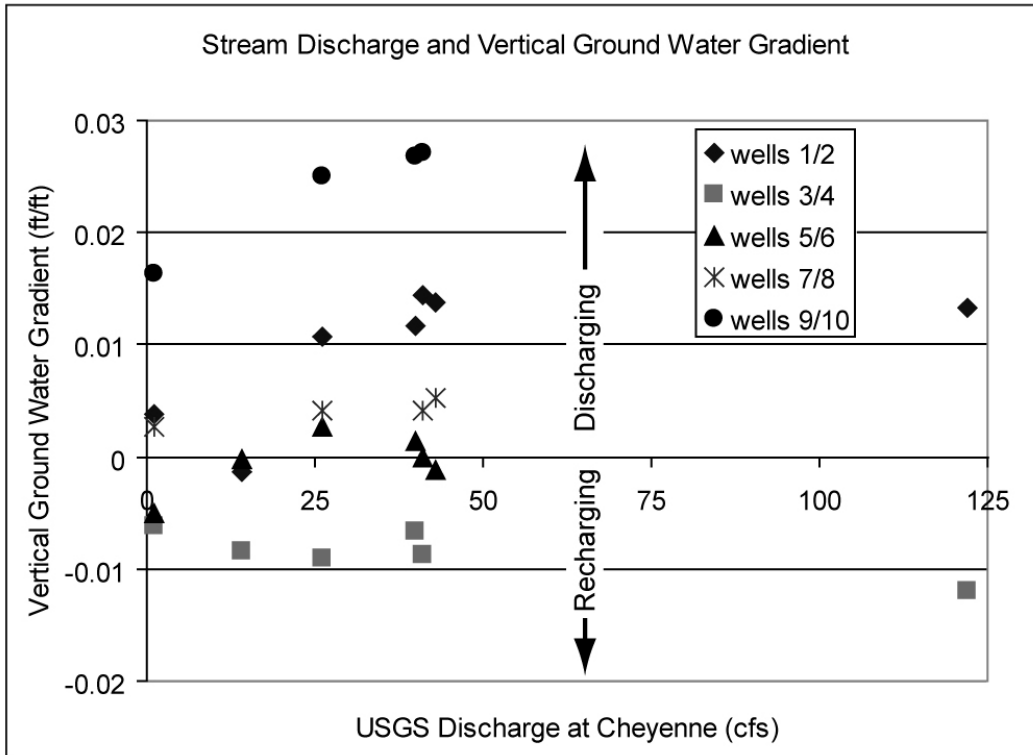
Figure 9. Vertical ground water gradient at the WBNHS compared to stream discharge.

If we examine the vertical hydraulic gradient for both sites, the dominant gradient is upward from the deeper portions of the aquifer to the shallower portions (Figure 9). The gradients range from 0 – 0.17 ft/ft downward and 0 – 0.027 ft/ft upward. Only Wells 3 and 4 demonstrated a downward gradient from the shallow to the deeper portions during the normal periods. During the high flow period monitored, Wells 5 and 6 indicated that downward flow was occurring during that time along with Wells 3 and 4 with the high downward gradient of 0.17 occurring between Wells 5 and 6. The normal downward gradient generally did not exceed 0.011 ft/ft. Even during the high flow event, Wells 1 and 2 still maintained an upward vertical gradient. In general, higher upward gradients correspond to higher discharge in the Washita River.

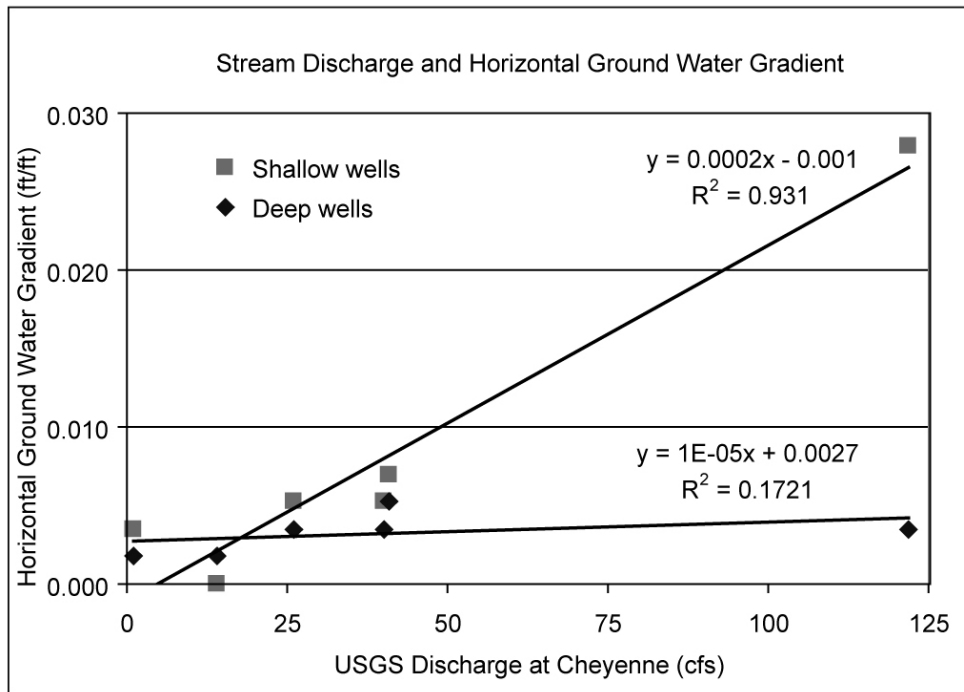
Figure 10. Horizontal ground water gradient at the WBNHS compared to stream discharge.

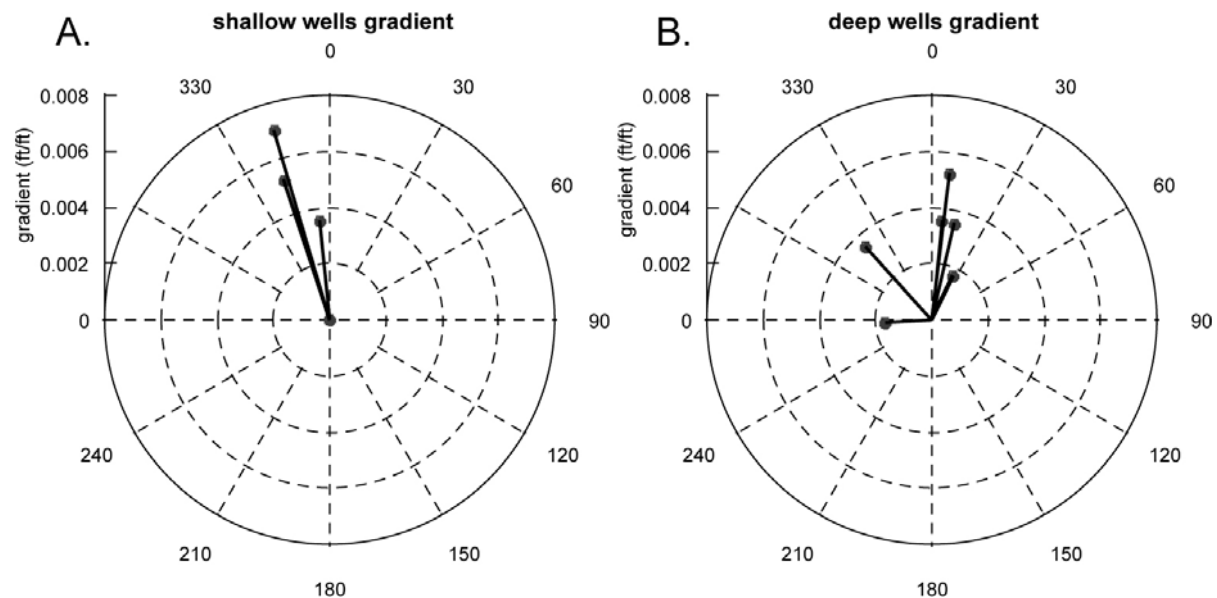
Figure 11. Direction and magnitude of the horizontal hydraulic gradient for the west well site at WBNHS. A high gradient value of 0.028 is left off of the shallow well plot for the high flow event as it is well off scale for the two plots. The dip direction for the high gradient value is 16 degrees.

The deeper wells had a similar orientation as the shallow wells, but during extreme highs and lows would tend to have a gradient towards the west to northwest. During normal periods, the gradient was from 0 – 30 degrees with a magnitude of 0.0017 – 0.0052 ft/ft.

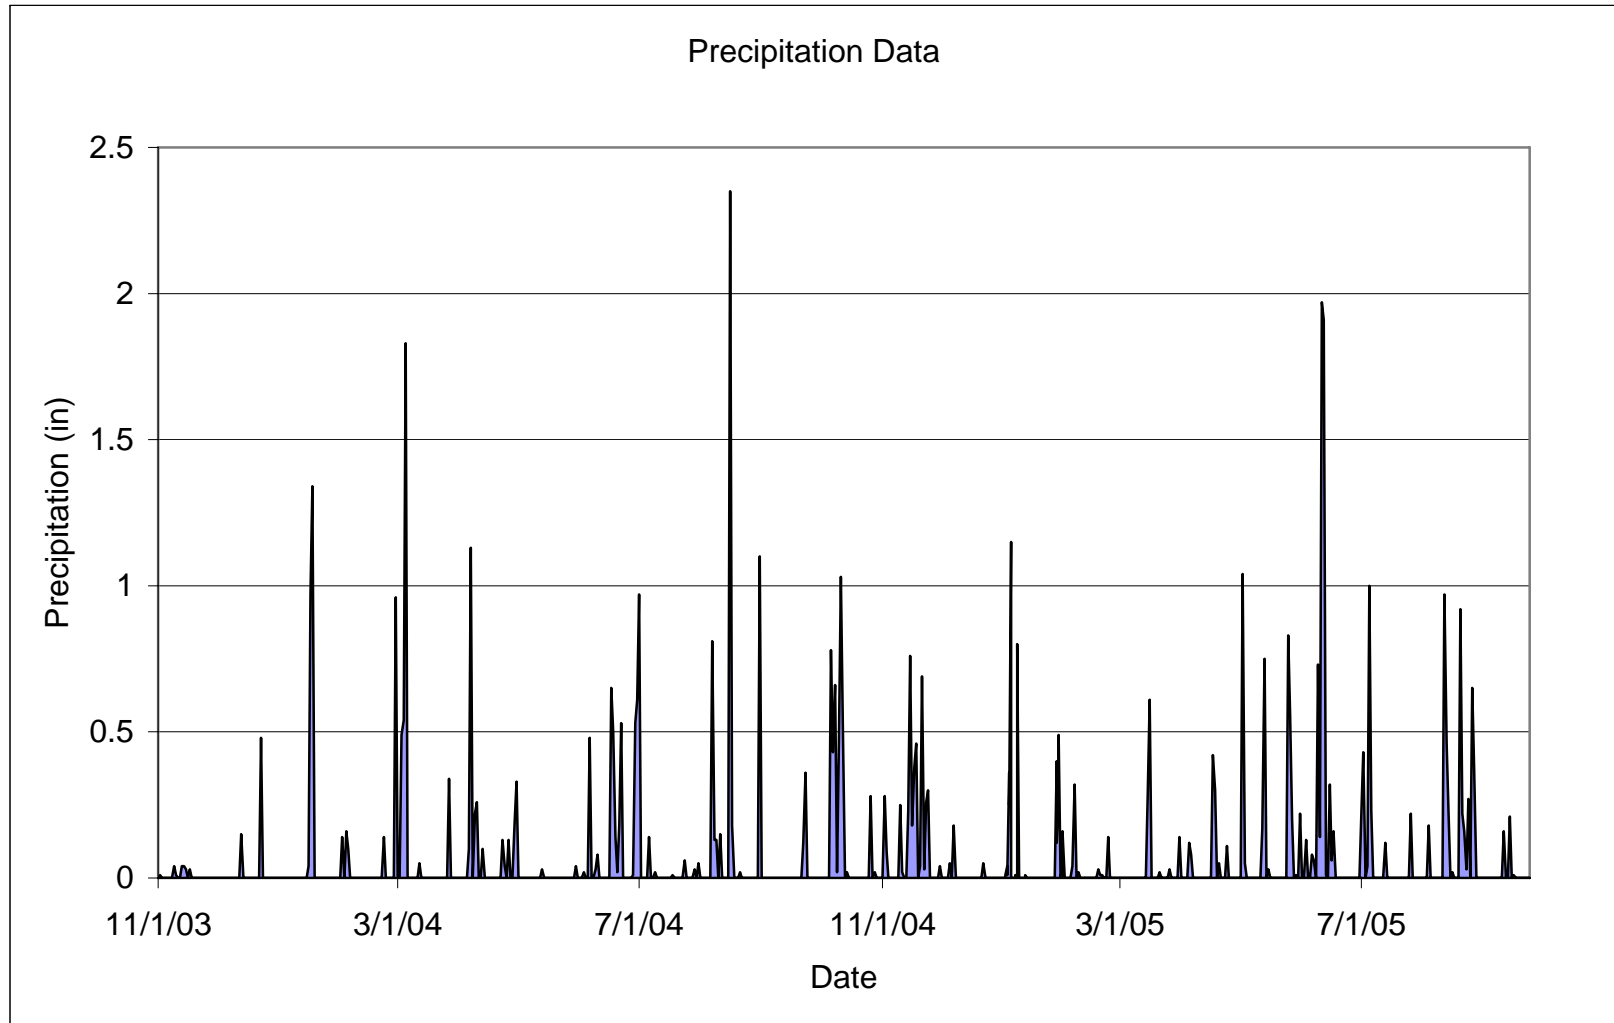
Figure 12. Precipitation record for Cheyenne, OK, during study period (Mesonet).

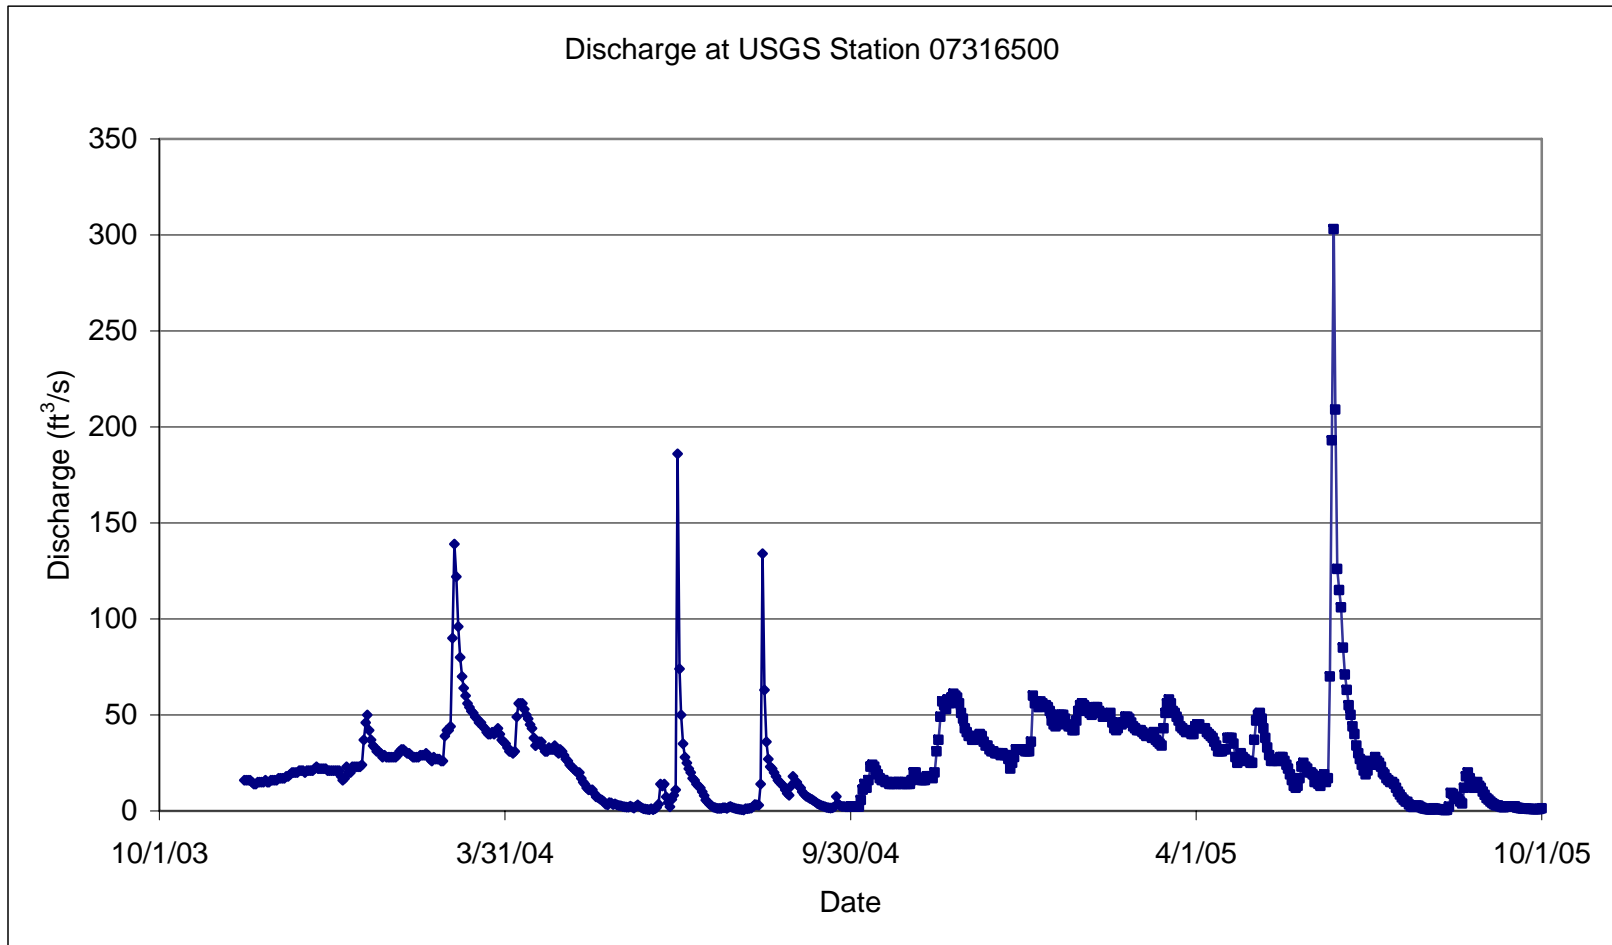
Figure 13. Stream discharge at U.S. Geological Survey gauging station at Cheyenne, OK, during study period.

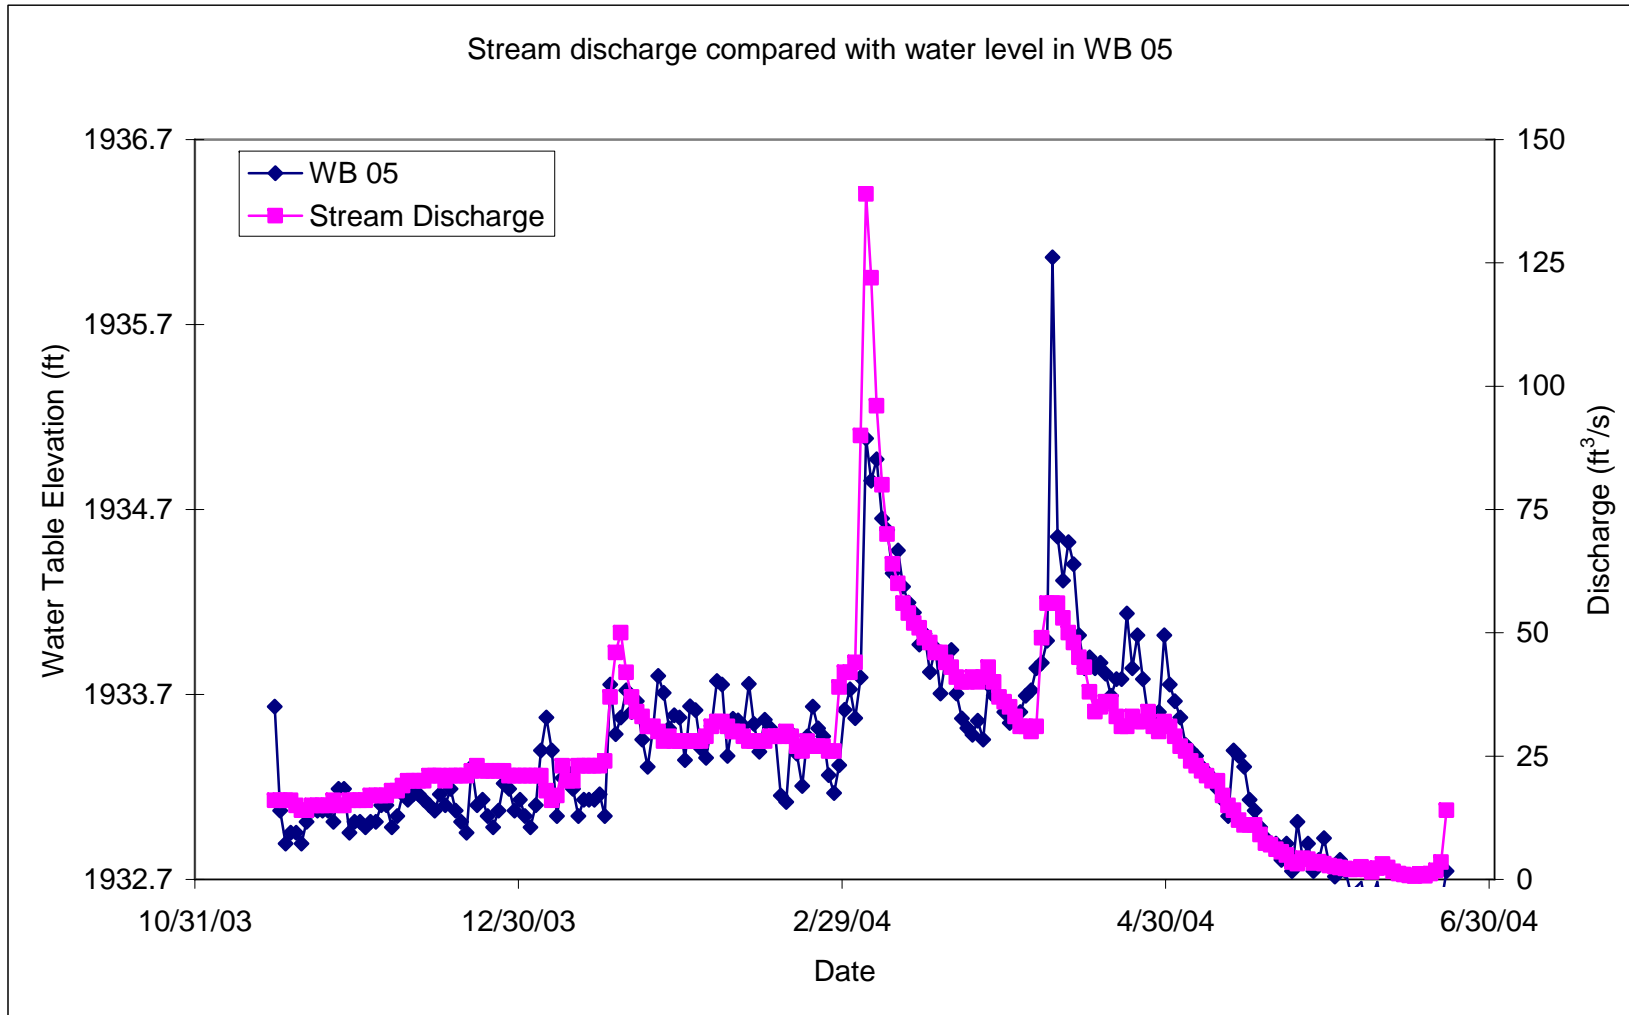
Figure 14. Comparison of Washita River stream discharge and water level in Well WB 05.

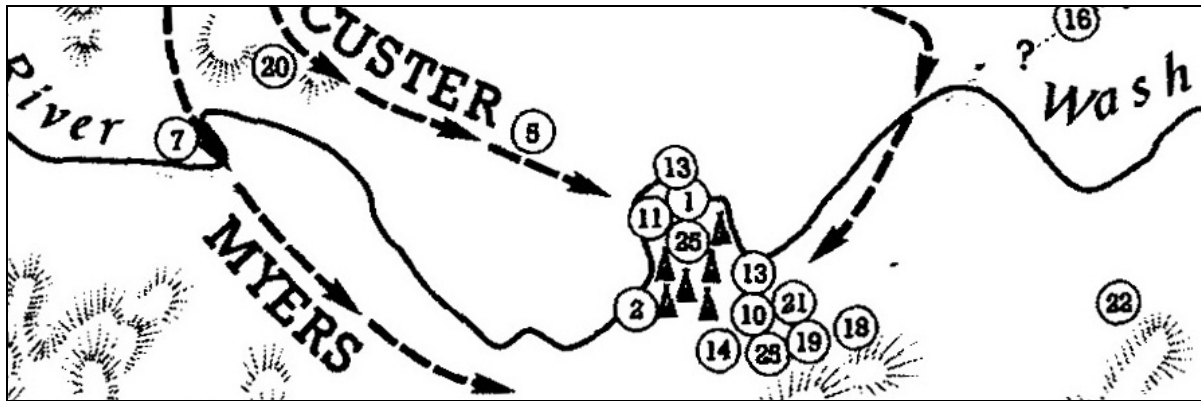
Figure 15. Sketch map of the Washita River and the 1868 battle, showing the location of Black Kettle's village (Barde, ca. 1900).

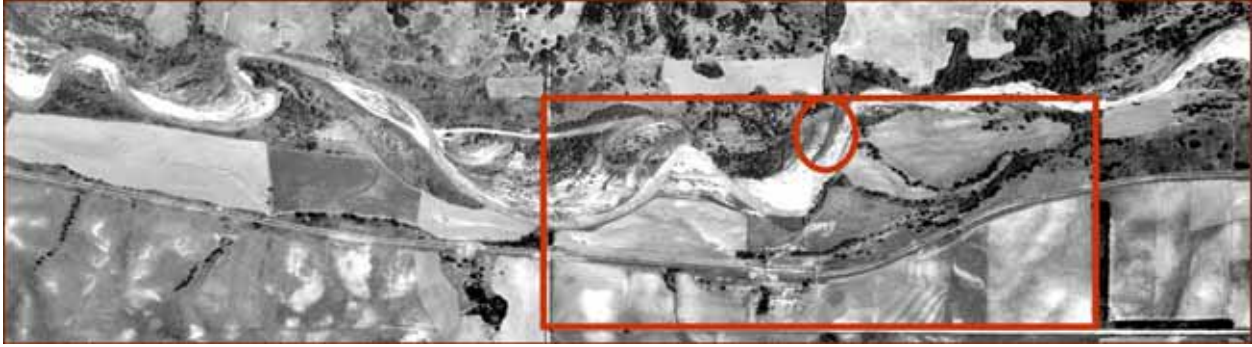
Figure 16. 1961 aerial photograph of the WBHNS acquired 30 June 1961 (streamflow = 19 cfs) (ASCS). The artificial cut-off of the gooseneck meander is in the right-most one-third of the figure. Remnants of the former meander loop are reflected in the arcuate vegetation pattern. White areas are unvegetated sand bars. The site of Black Kettle’s village is shown in the oval; by 1961, and in times since, the village site is north of the river.

By 1961 the Washita River had returned to its pre-Dust Bowl morphology as a single-thread, sinuous channel (Figure 16). Vegetation had encroached on the active channel.

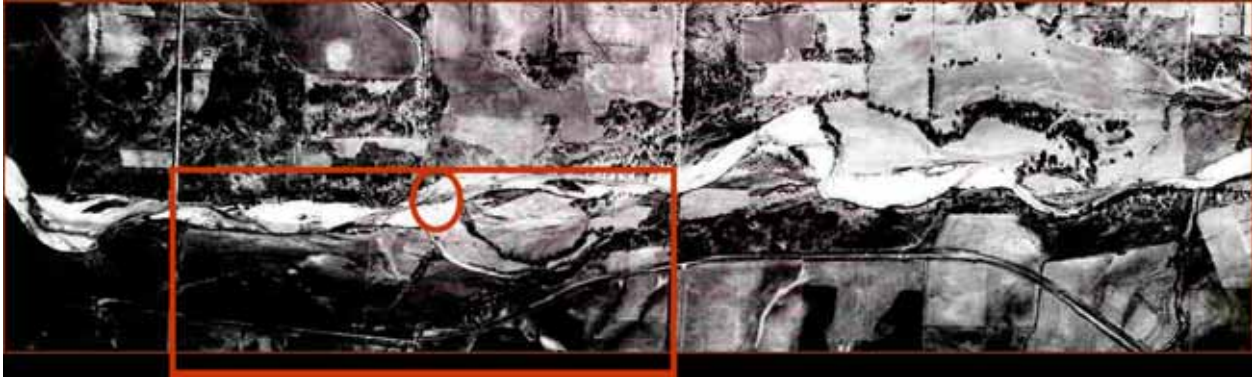
Figure 17. 1936 aerial photo acquired 31 December 1936 (National Archives). White areas are unvegetated sand bars. The site of Black Kettle’s village is shown in the oval; in 1936, this was in the active channel.

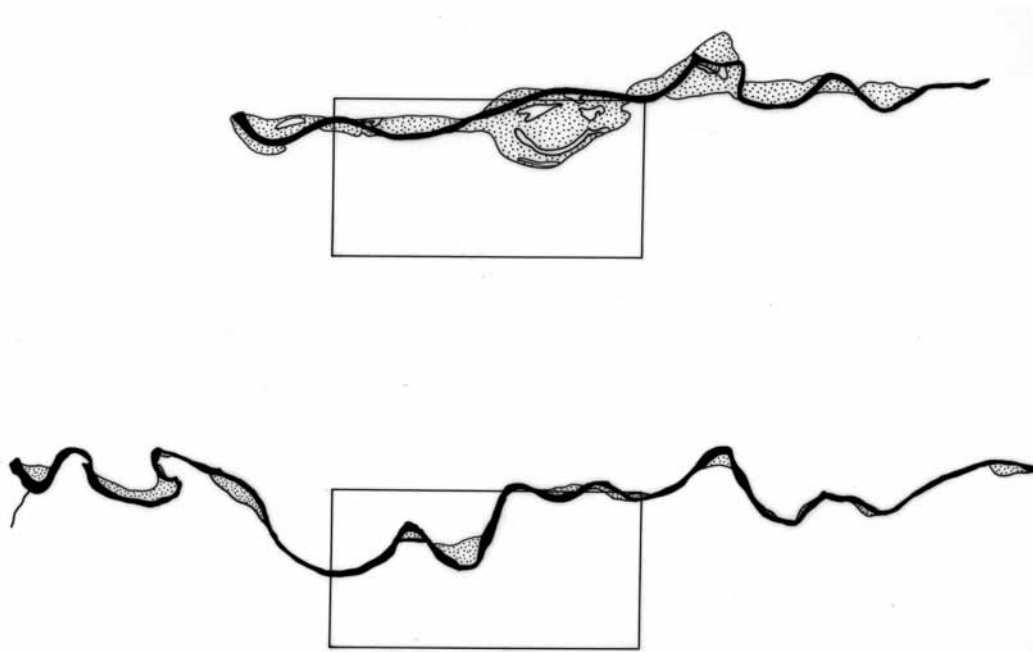
Figure 18. Comparison of the 1936 channel (above) and the 1961 channel (bottom). The boundaries of the WBNHS are shown as a box (0.5 mi. x 1 mi.) for reference. The stippled areas indicate unvegetated sand bars.

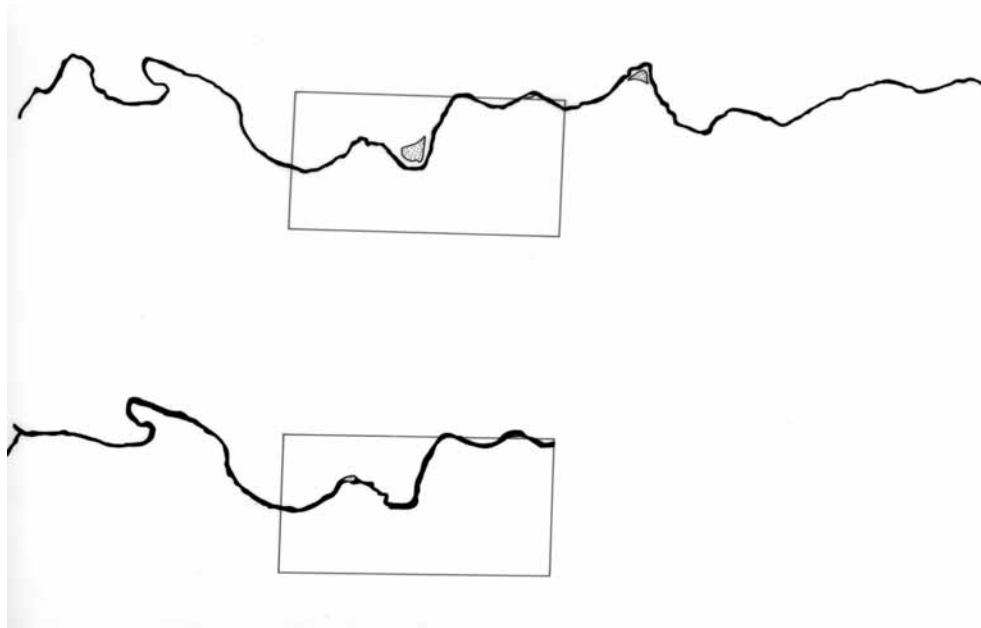
Figure 19. Comparison of the 1982 channel (above, $Q = 13$ cfs) and the 1999 channel (bottom, $Q = 47$ cfs). The boundaries of the WBNHS are shown as a box (0.5 mi. x 1 mi.) for reference.

In the period 1961-1999, only very minor changes were observed in plan view channel pattern of the Washita River. The channel continued to become more narrow as vegetation encroached on the channel in the absence of high peak flows. At the present time, the Washita River in the WBNHS is a single-thread, sand channel with moderate entrenchment, moderate width-to-depth ratio, and sinuosity characteristic of a Rosgen type B5 channel. Reach # 1 is cut in more clay-rich sediments, as reflected in the electrical resistivity data (Figure C1), and the channel banks are steeper, as one would expect. Reach # 4 is carved in more sand-rich sediments, again reflected in the electrical resistivity data (Figure C2), so the channel is wider and banks are not as steep.

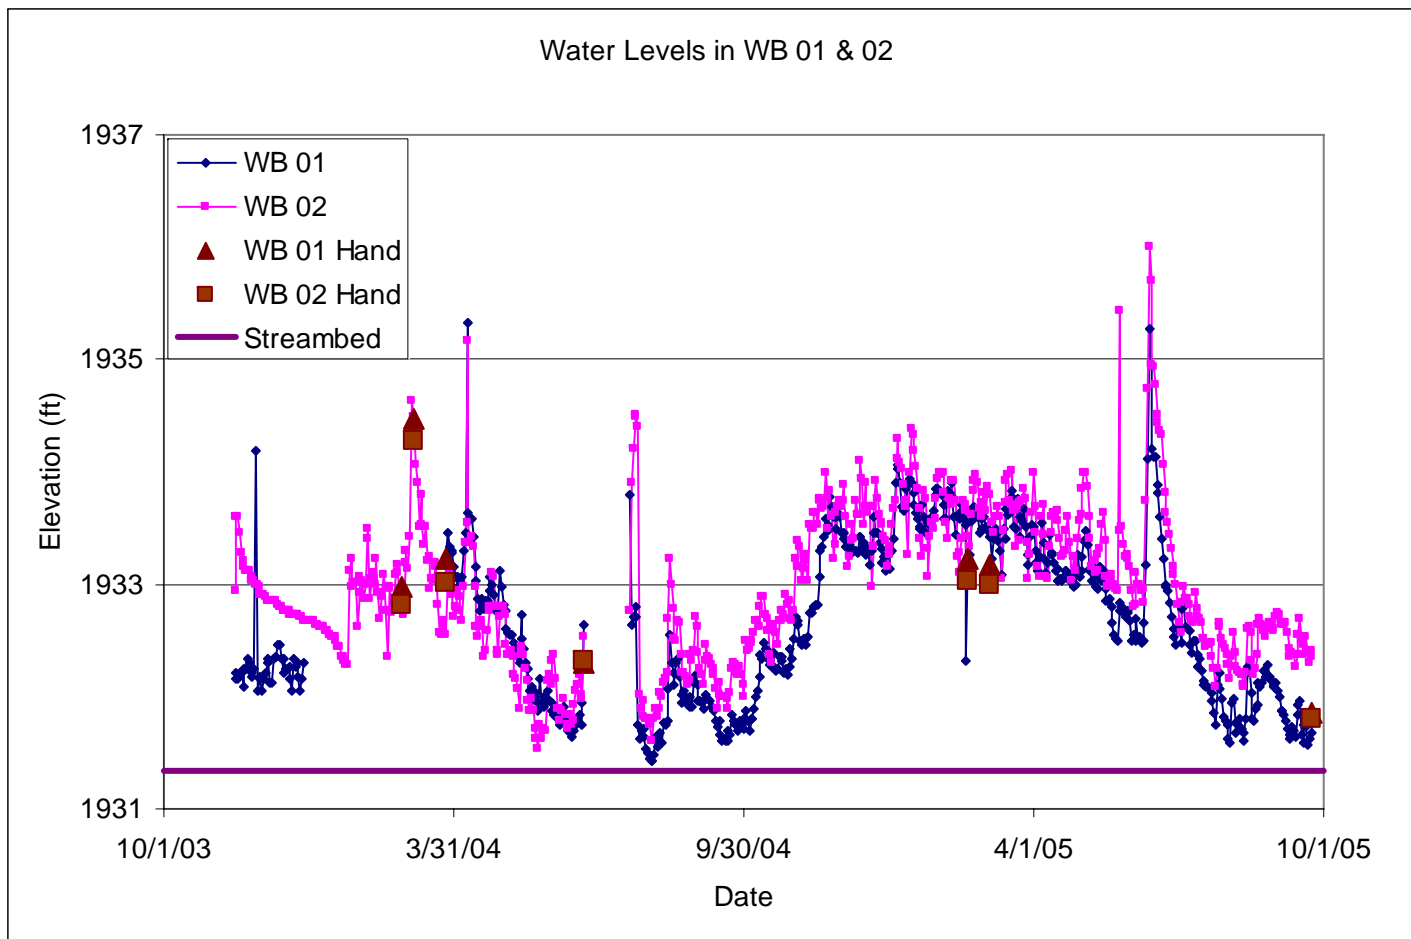
Figure B1. Water level data from monitoring Wells WB-01 and WB-02 on the western side of the WBNHS. Continuous lines represent transducer data collected continuously during the study period. Individual symbols represent hand measurements collected during sampling periods. Note that during the study period the elevation of the ground water never went below the elevation of the streambed.

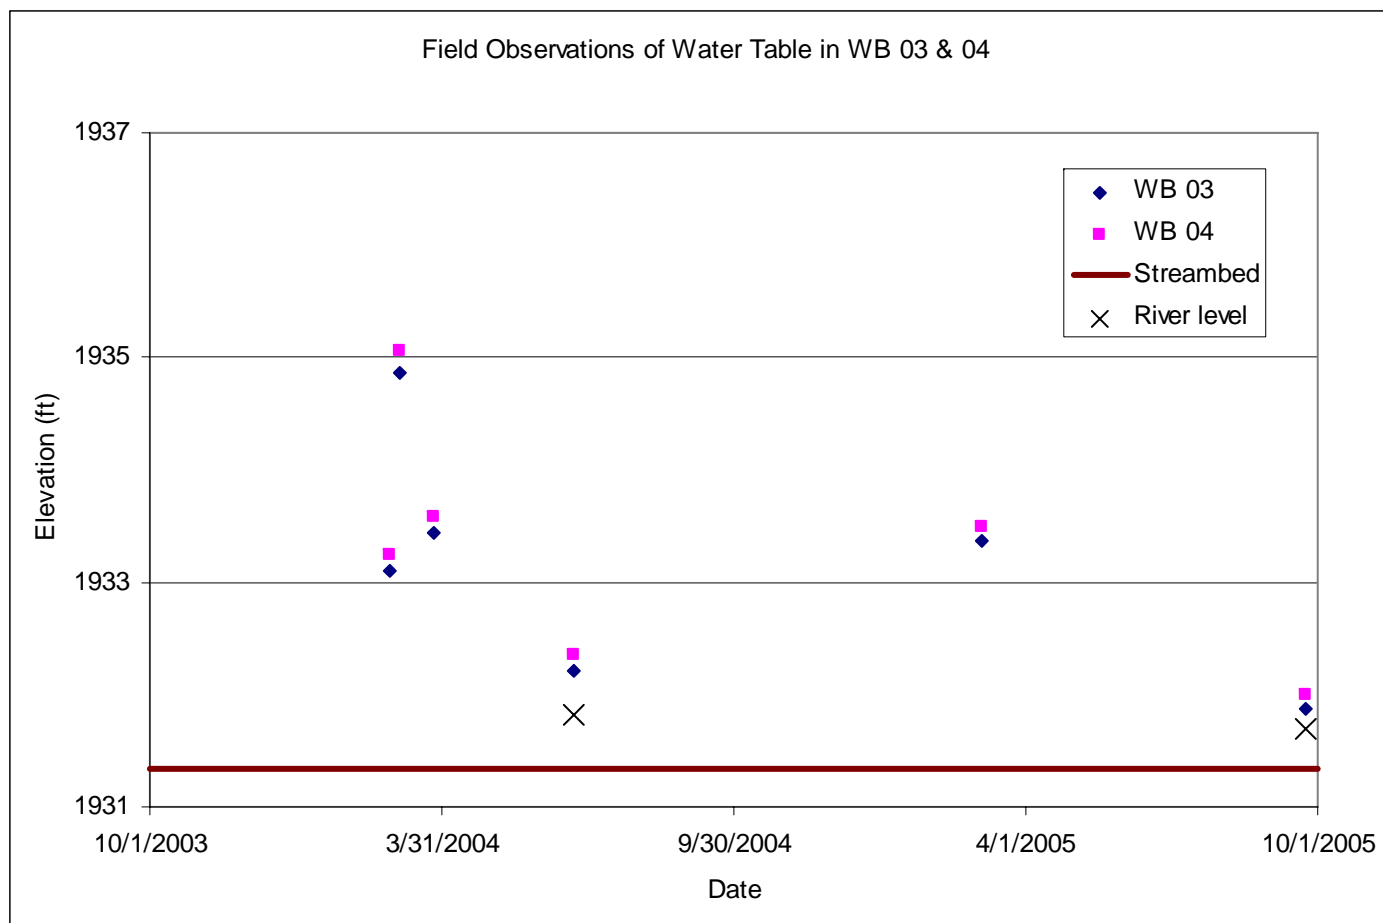
Figure B2. Water level data from monitoring Wells WB-03 and WB-04 on the western side of the WBNHS. No transducers were installed in these wells during the study period. Individual symbols represent hand measurements collected during sampling periods. Note that during the study period the elevation of the ground water never went below the elevation of the streambed or the level of the river.

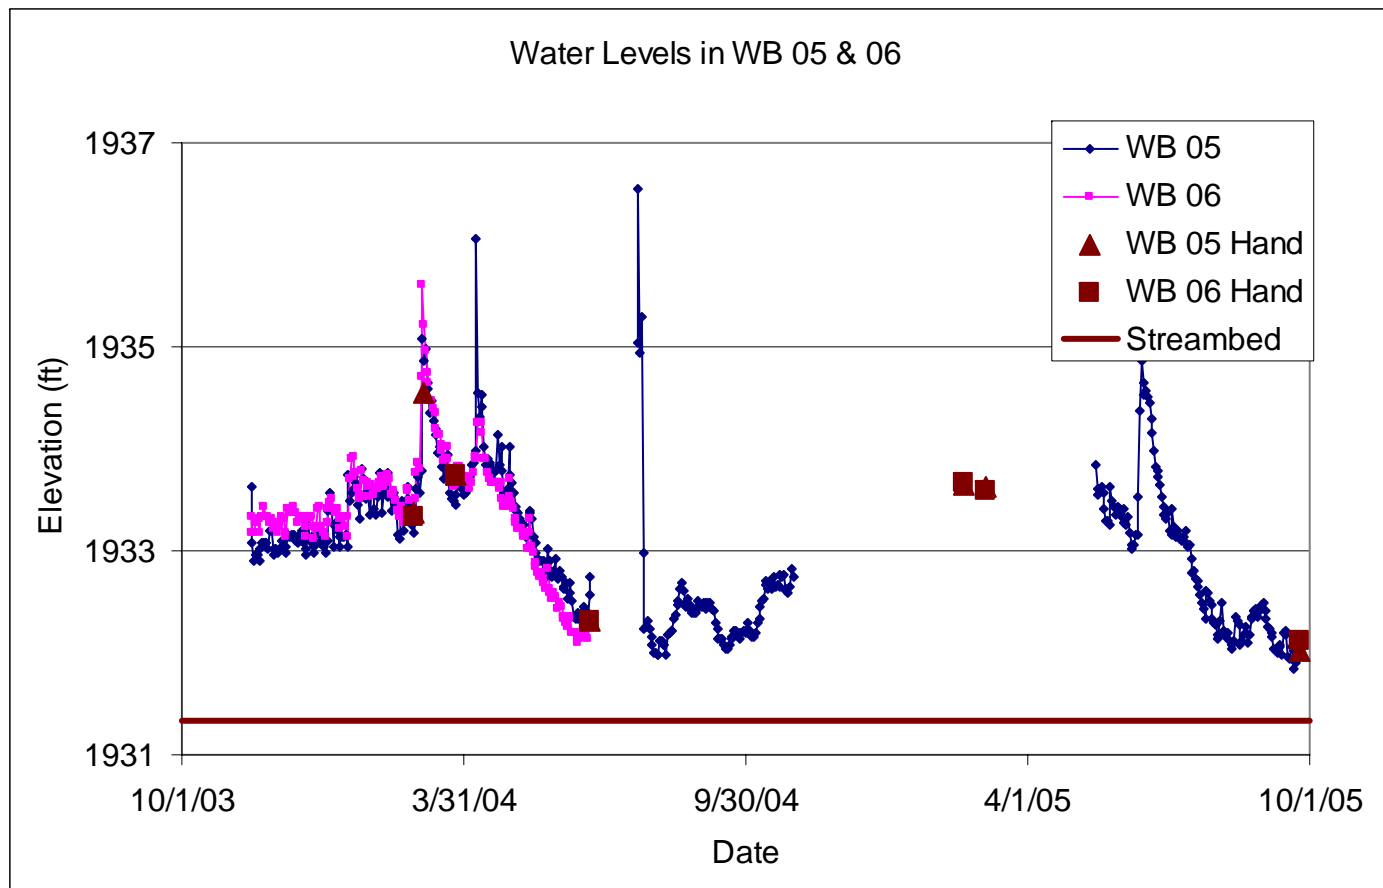
Figure B3. Water level data from monitoring Wells WB-05 and WB-06 on the western side of the WBNHS. Continuous lines represent transducer data collected continuously during the study period. Individual symbols represent hand measurements collected during sampling periods. Note that during the study period the elevation of the ground water never went below the elevation of the streambed.

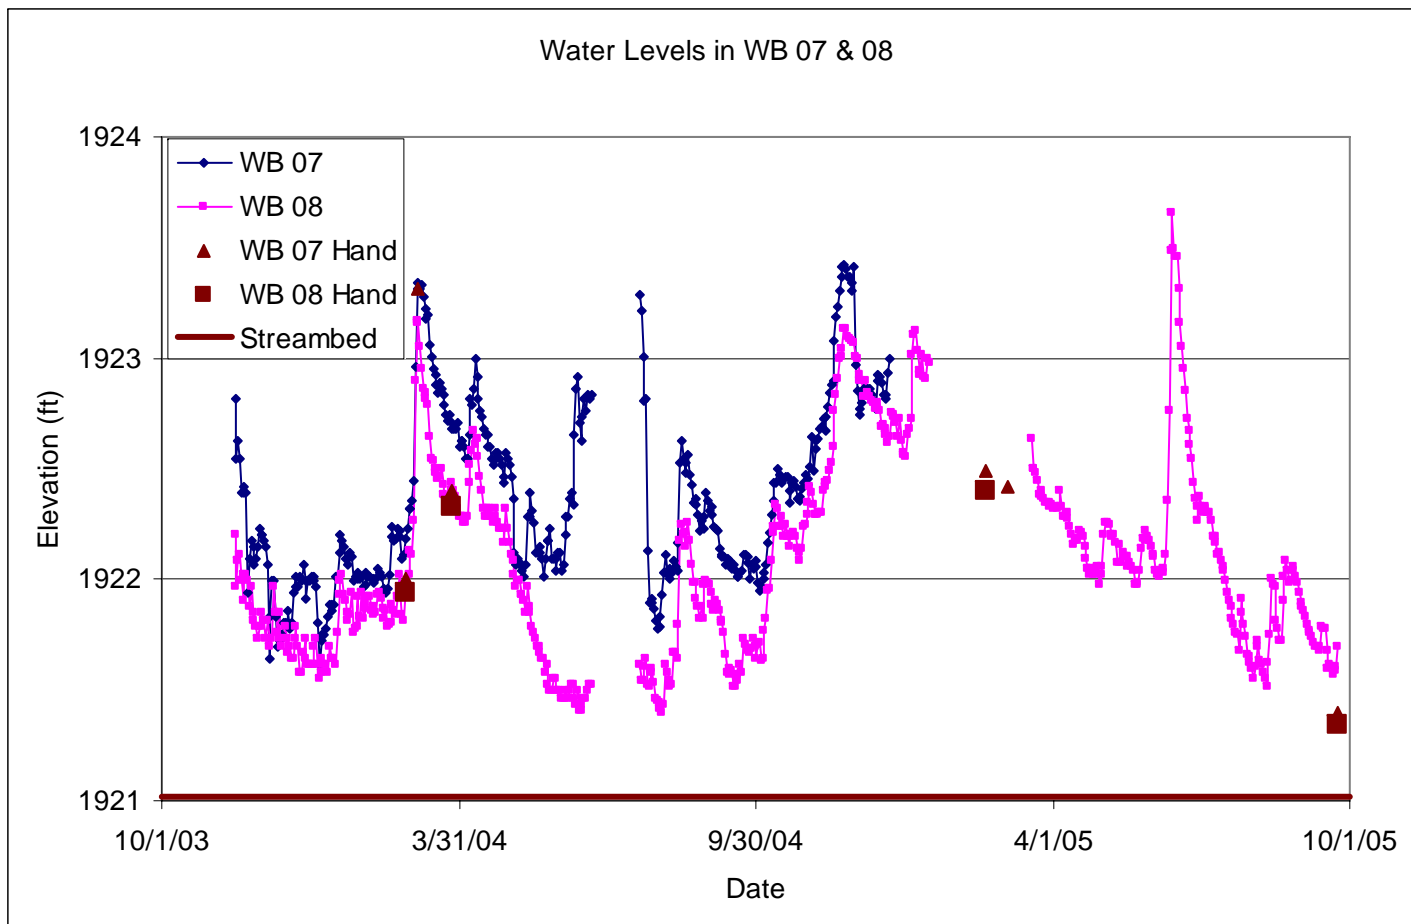
Figure B4. Water level data from monitoring Wells WB-07 and WB-08 on the eastern side of the WBNHS. Continuous lines represent transducer data collected continuously during the study period. Individual symbols represent hand measurements collected during sampling periods. Note that during the study period the elevation of the ground water never went below the elevation of the streambed.

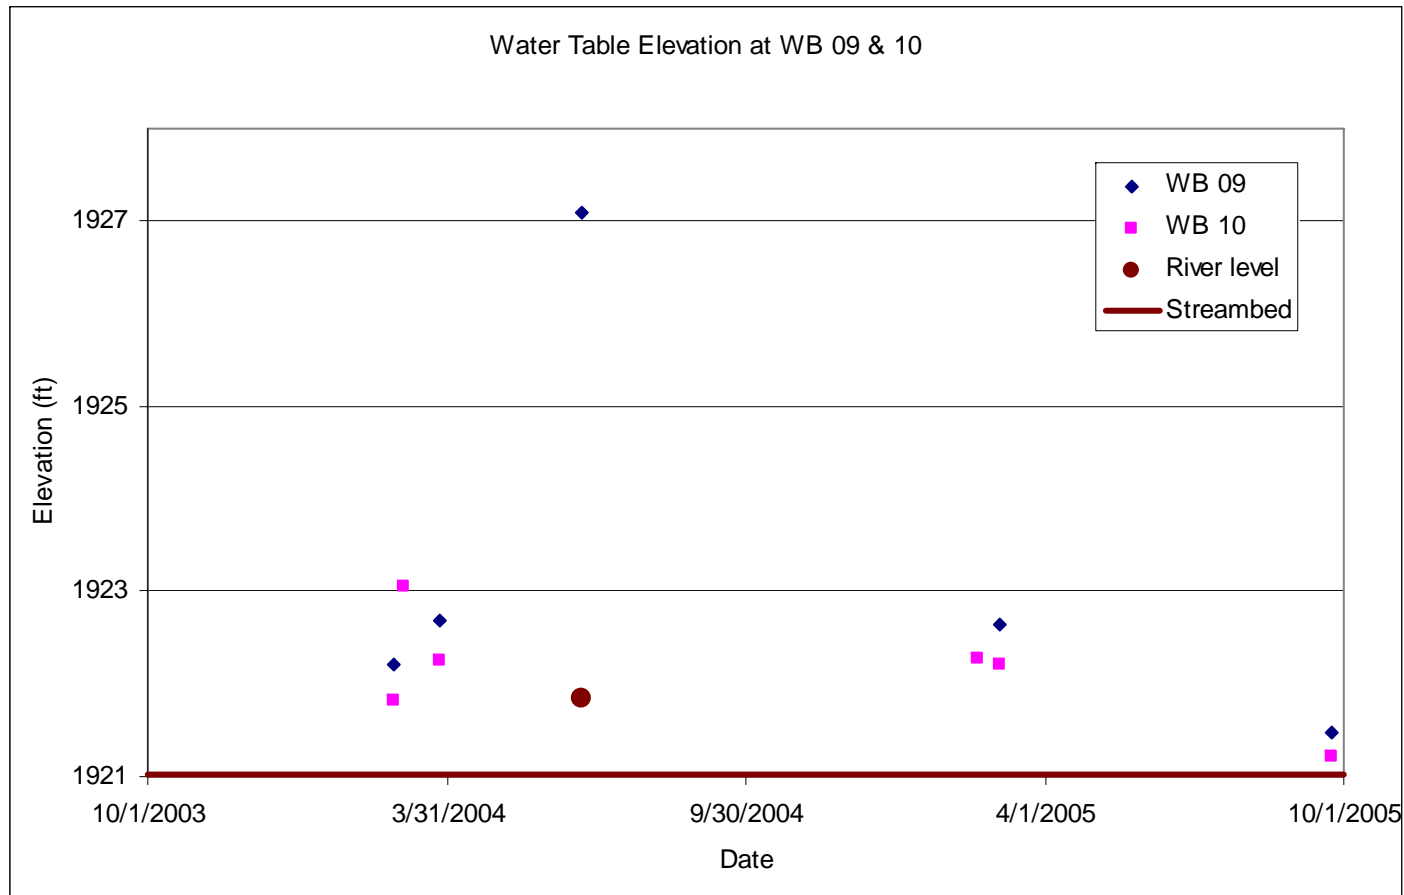
Figure B5. Water level data from monitoring Wells WB-09 and WB-10 on the western side of the WBNHS. No transducers were installed in these wells during the study period. Individual symbols represent hand measurements collected during sampling periods. Note that during the study period the elevation of the ground water never went below the elevation of the streambed or the level of the river.
