Geomorphic Adjustment of the Washita River

Washita Battlefield National Historic Site, Oklahoma

Natural Resource Technical Report NPS/NRPC/WRD/NRTR—2007/070

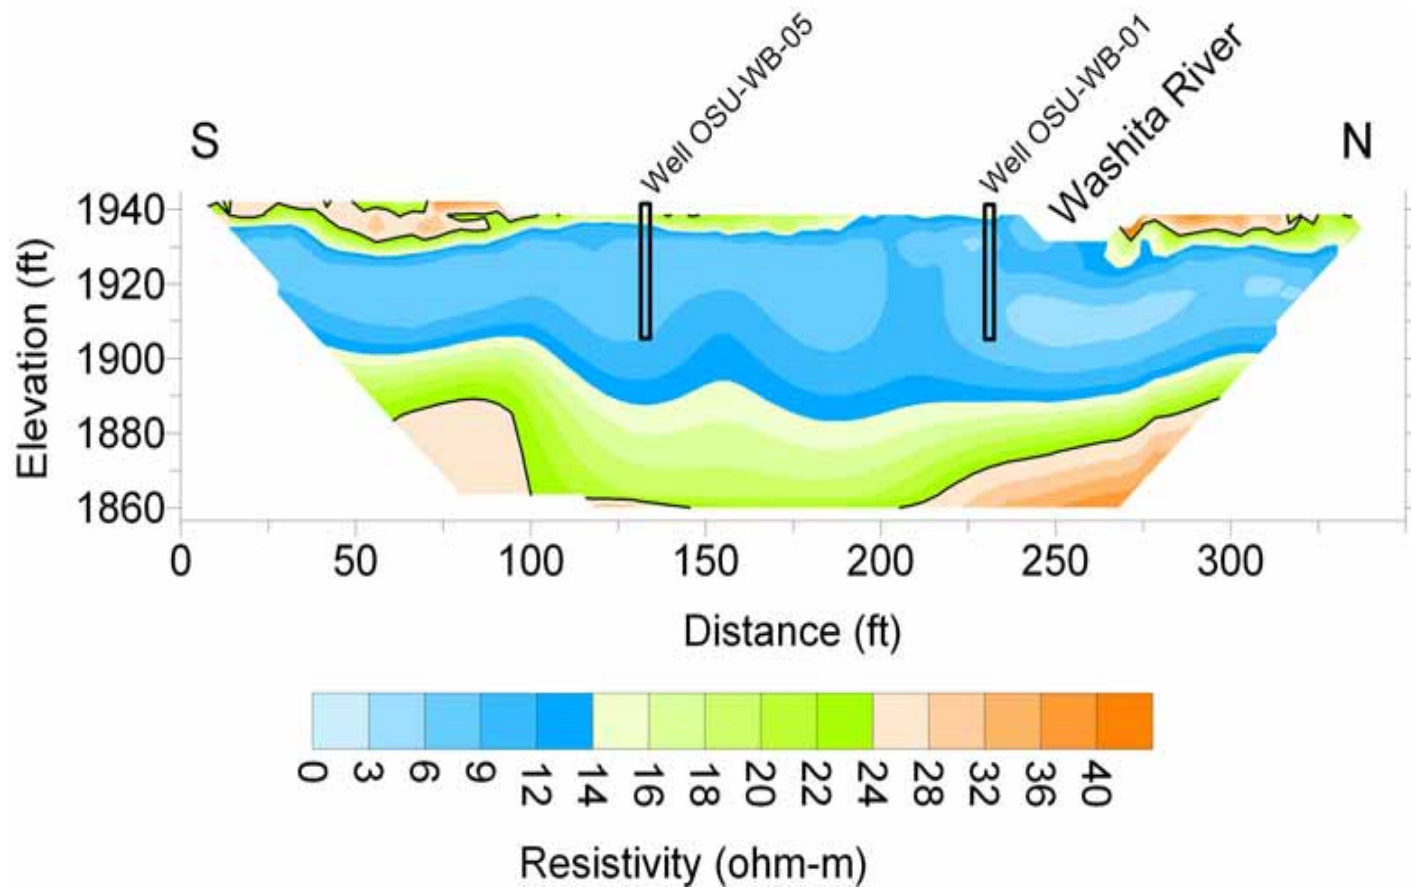
Figure C1. Electrical resistivity image (ERI) WB-12-04 collected through two well pairs on western edge of WBNHS during June 2004. The image has been calibrated with cooler colors equating to finer grain sediments. Warmer colors at the bottom of the image are likely bedrock.

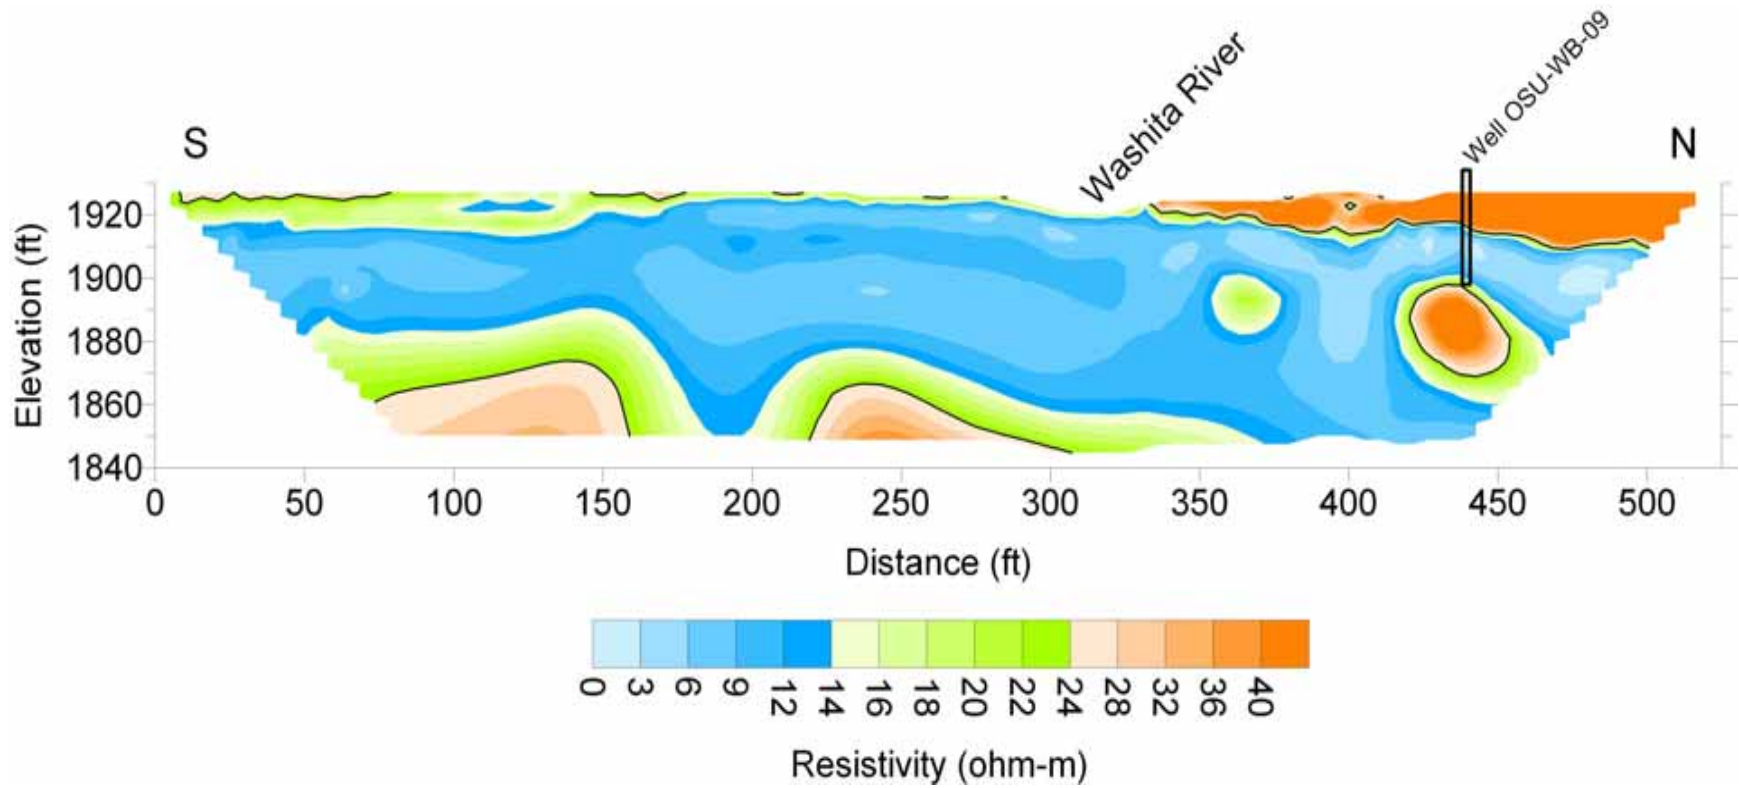
Figure C2. Electrical resistivity image (ERI) WB-36-04 collected through a well pairs on the eastern edge of WBNHS during June 2004. The image has been calibrated with cooler colors equating to finer grain sediments. Warmer colors at the bottom of the image are likely bedrock.

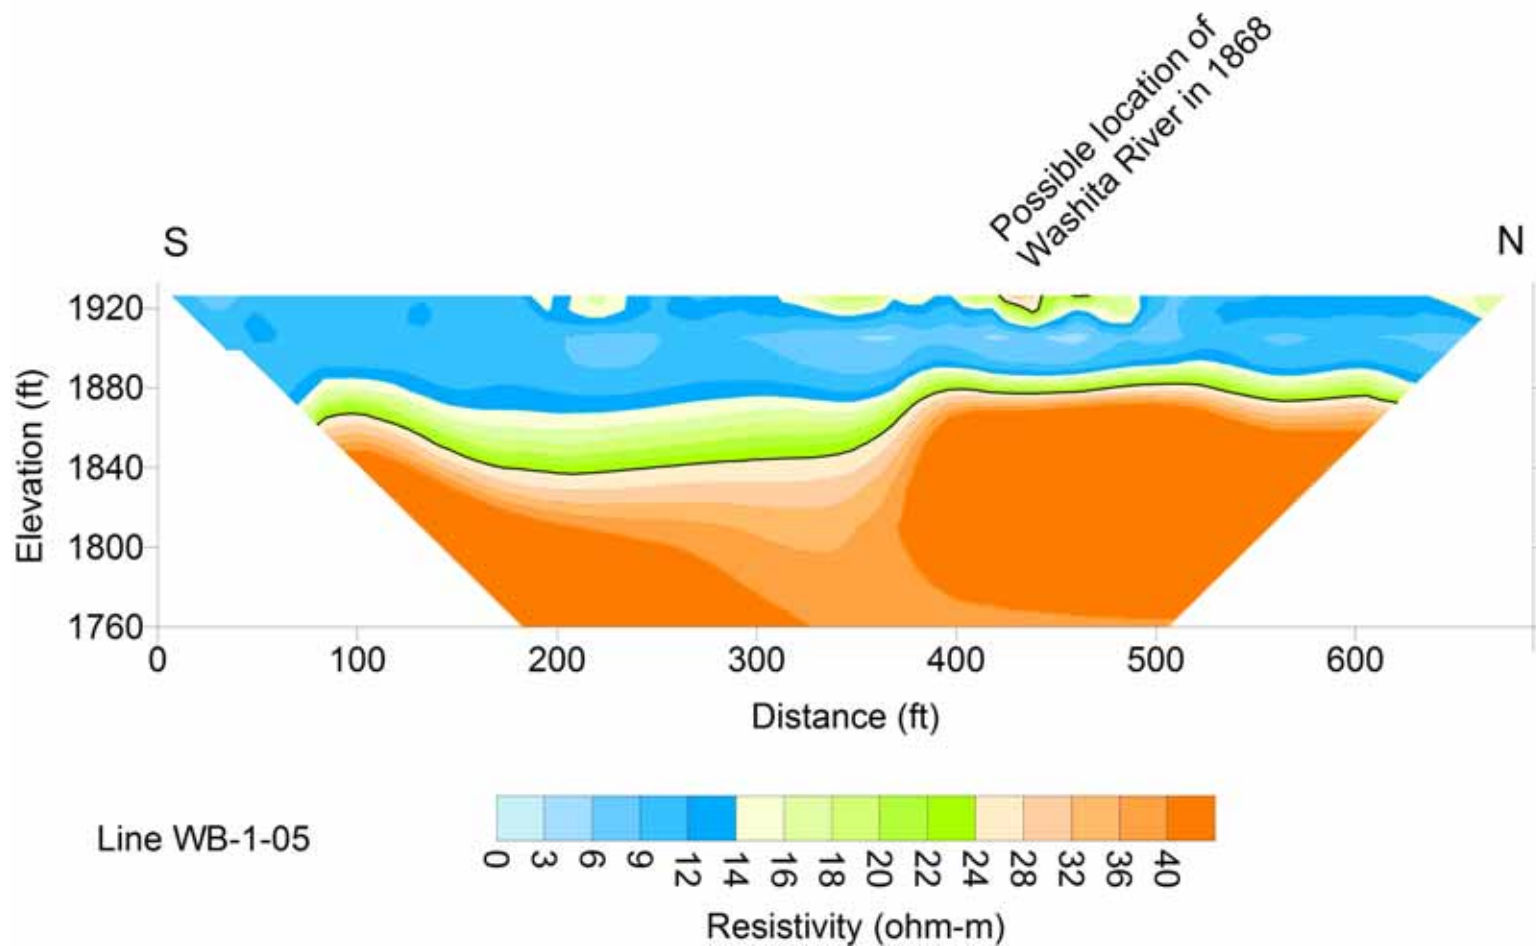
Figure C3. Electrical resistivity image (ERI) WB-1-05 collected through the potential location of the Washita River during 1868. Data were collected at WBNHS during May 2005. The image has been calibrated with cooler colors equating to finer grain sediments. Warmer colors at the bottom of the image are likely bedrock.

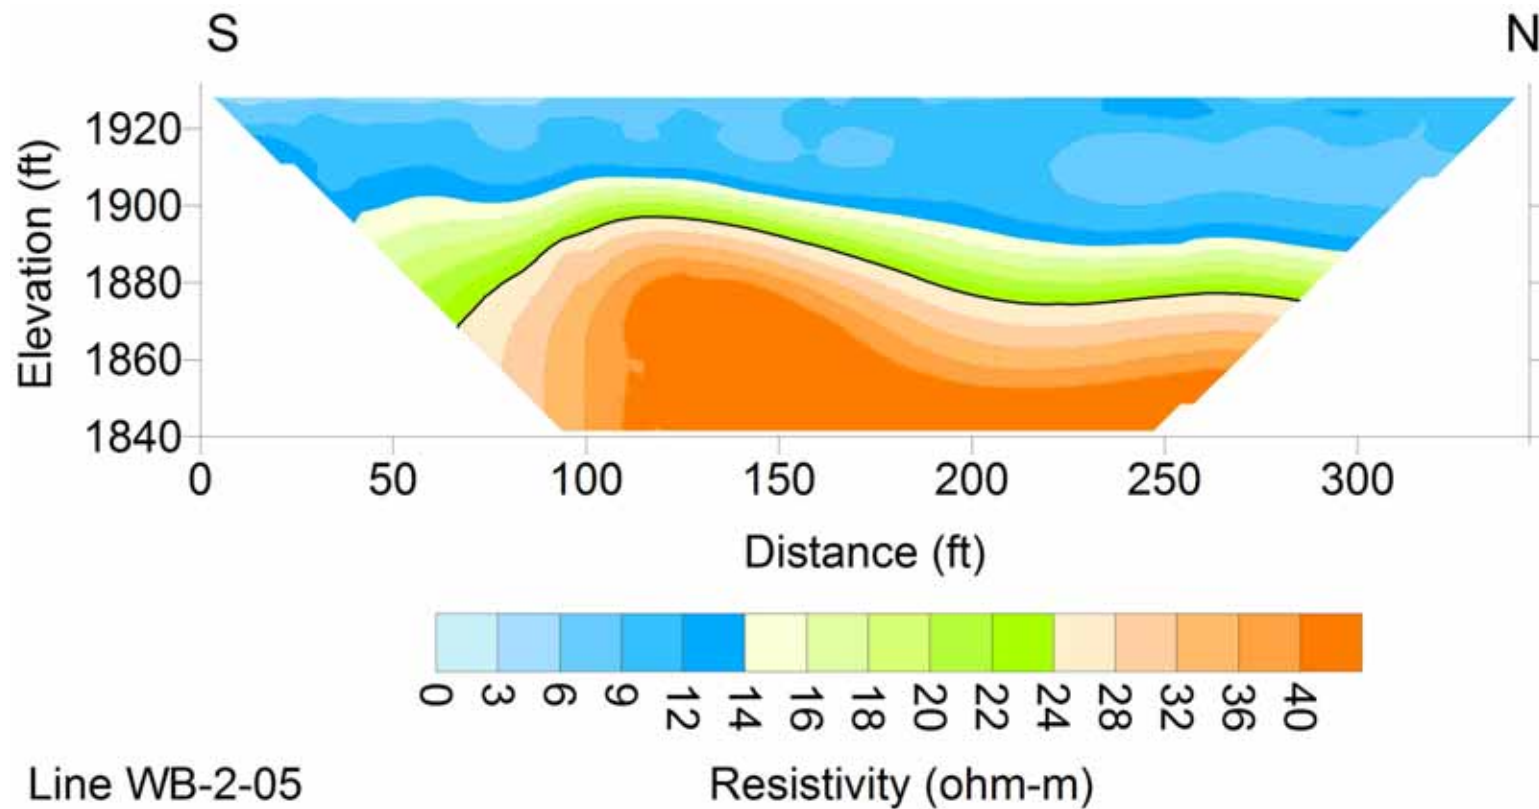
Figure C4. Electrical resistivity image (ERI) WB-2-05 collected through the potential location of the Washita River during 1868. Data were collected at WBNHS during May 2005. The image has been calibrated with cooler colors equating to finer grain sediments. Warmer colors at the bottom of the image are likely bedrock.

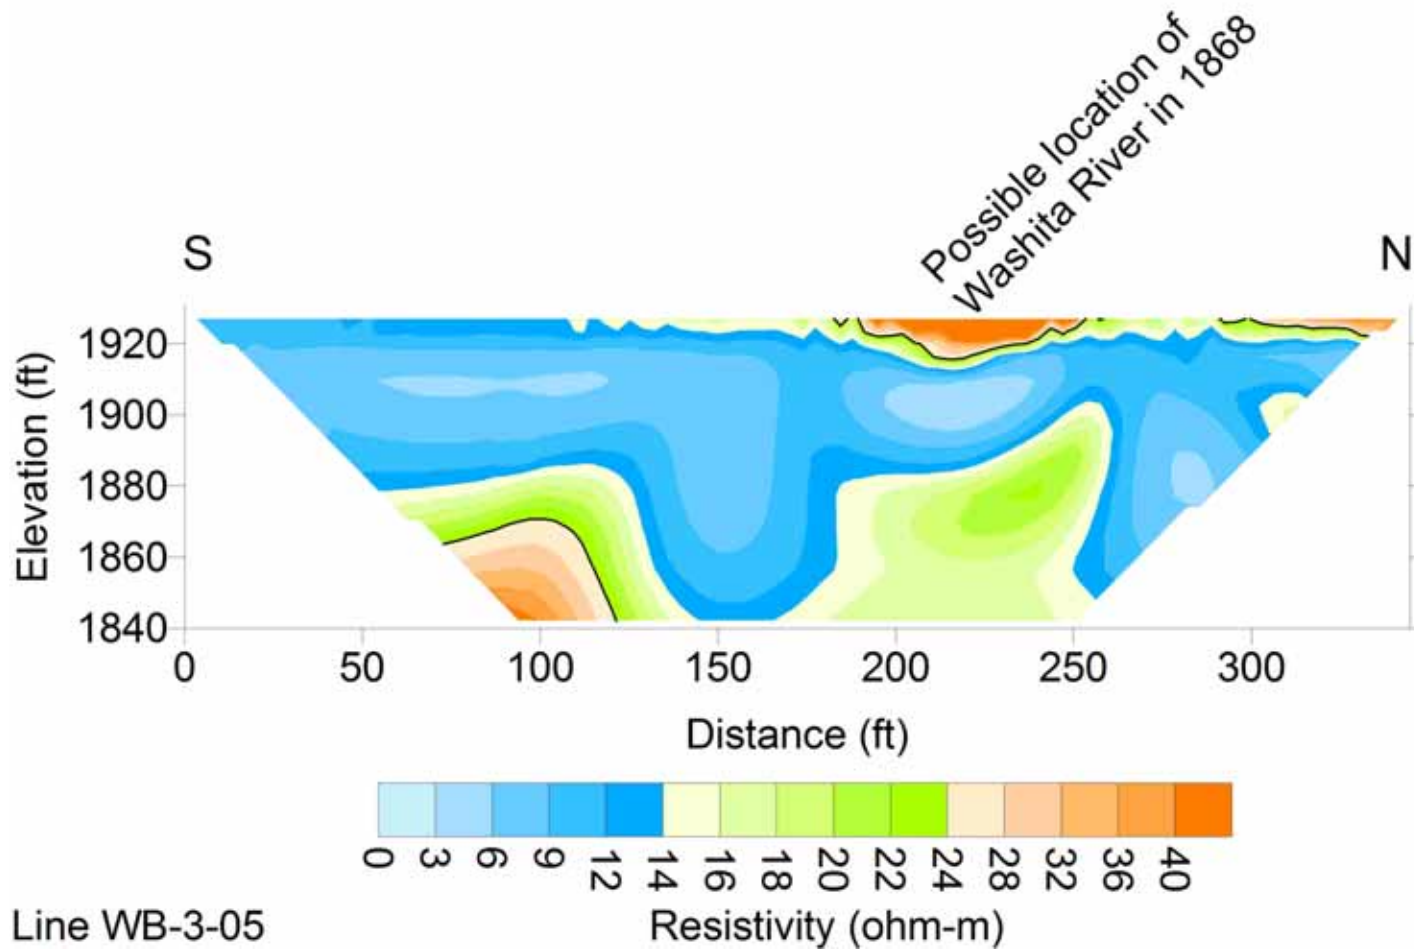
Figure C5. Electrical resistivity image (ERI) WB-3-05 collected through the potential location of the Washita River during 1868. Data were collected at WBNHS during May 2005. The image has been calibrated with cooler colors equating to finer grain sediments. Warmer colors at the bottom of the image are likely bedrock.

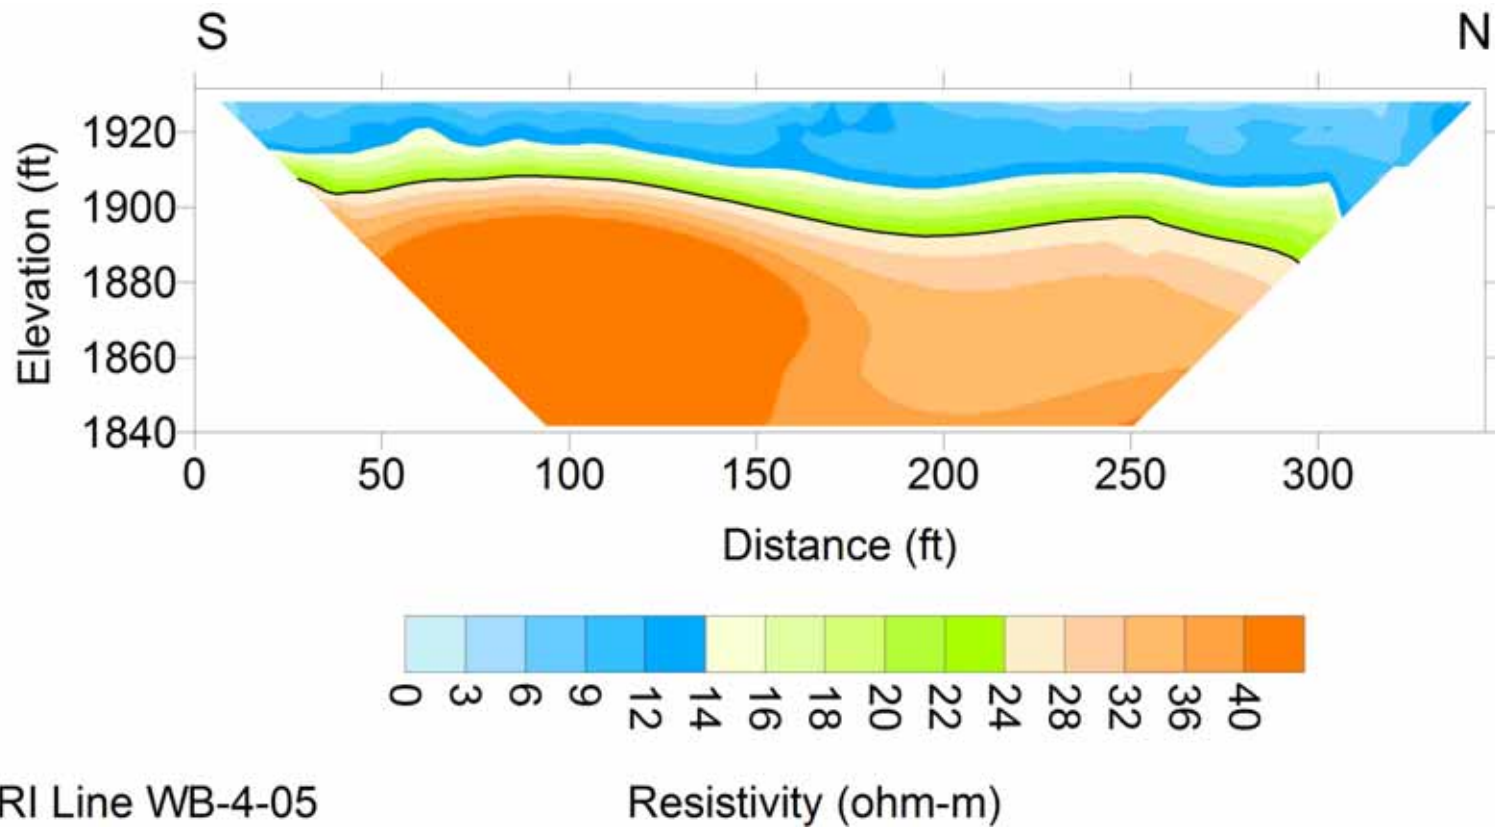
Figure C6. Electrical resistivity image (ERI) WB-4-05 collected through the potential location of the Washita River during 1868. Data were collected at WBNHS during May 2005. The image has been calibrated with cooler colors equating to finer grain sediments. Warmer colors at the bottom of the image are likely bedrock.
